FLOOD ON PEARL RIVER AT JACKSON, MISSISSIPPI IN 1961

By
James D. Shell
1964

FLOOD ON PEARL RIVER AT JACKSON, MISSISSIPPI

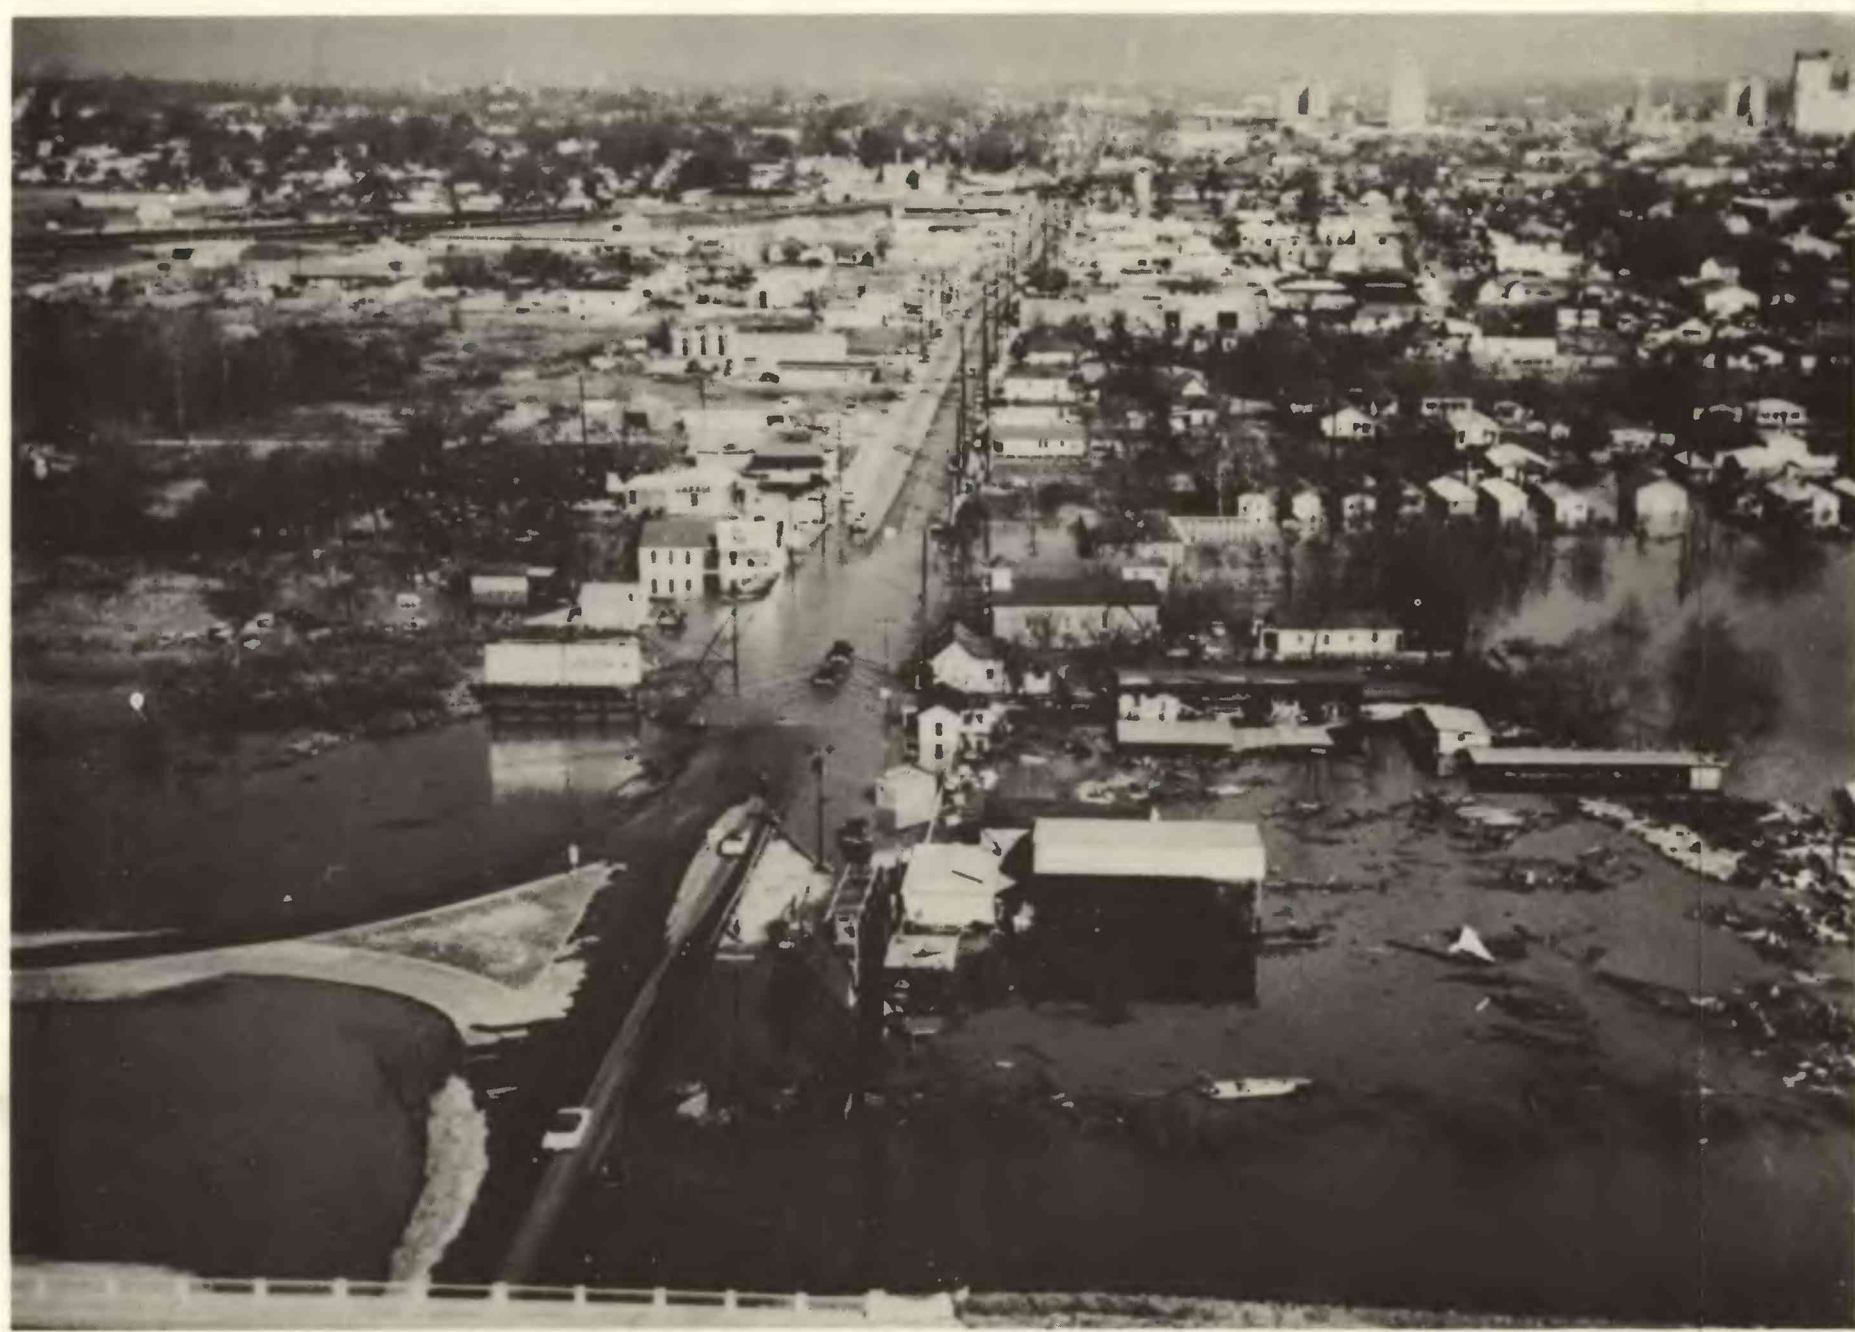
PHOTOGRAPH BY PERRY NATIONS, JACKSON CLARION LEDGER
AERIAL VIEW OF FLOODED AREA ALONG GALLATIN STREET, JACKSON, MISS., DECEMBER 21, 1961

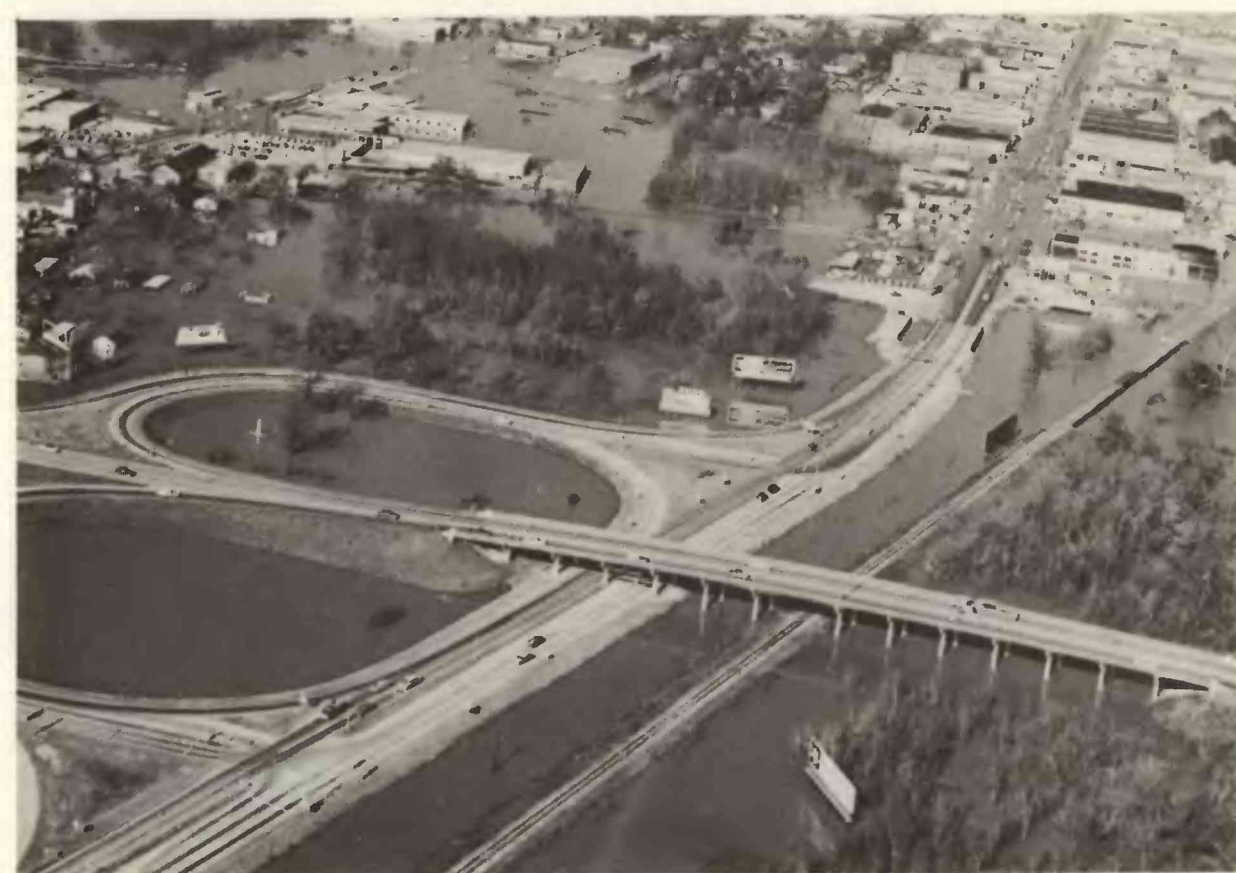
PHOTOGRAPH BY PERRY NATIONS, JACKSON CLARION LEDGER
FLOODED AREA ALONG SOUTH STATE STREET, JACKSON, MISS., DECEMBER 21, 1961
