Geological Map of the Cerro La Tuza Area

Geology mapped in 1955-57

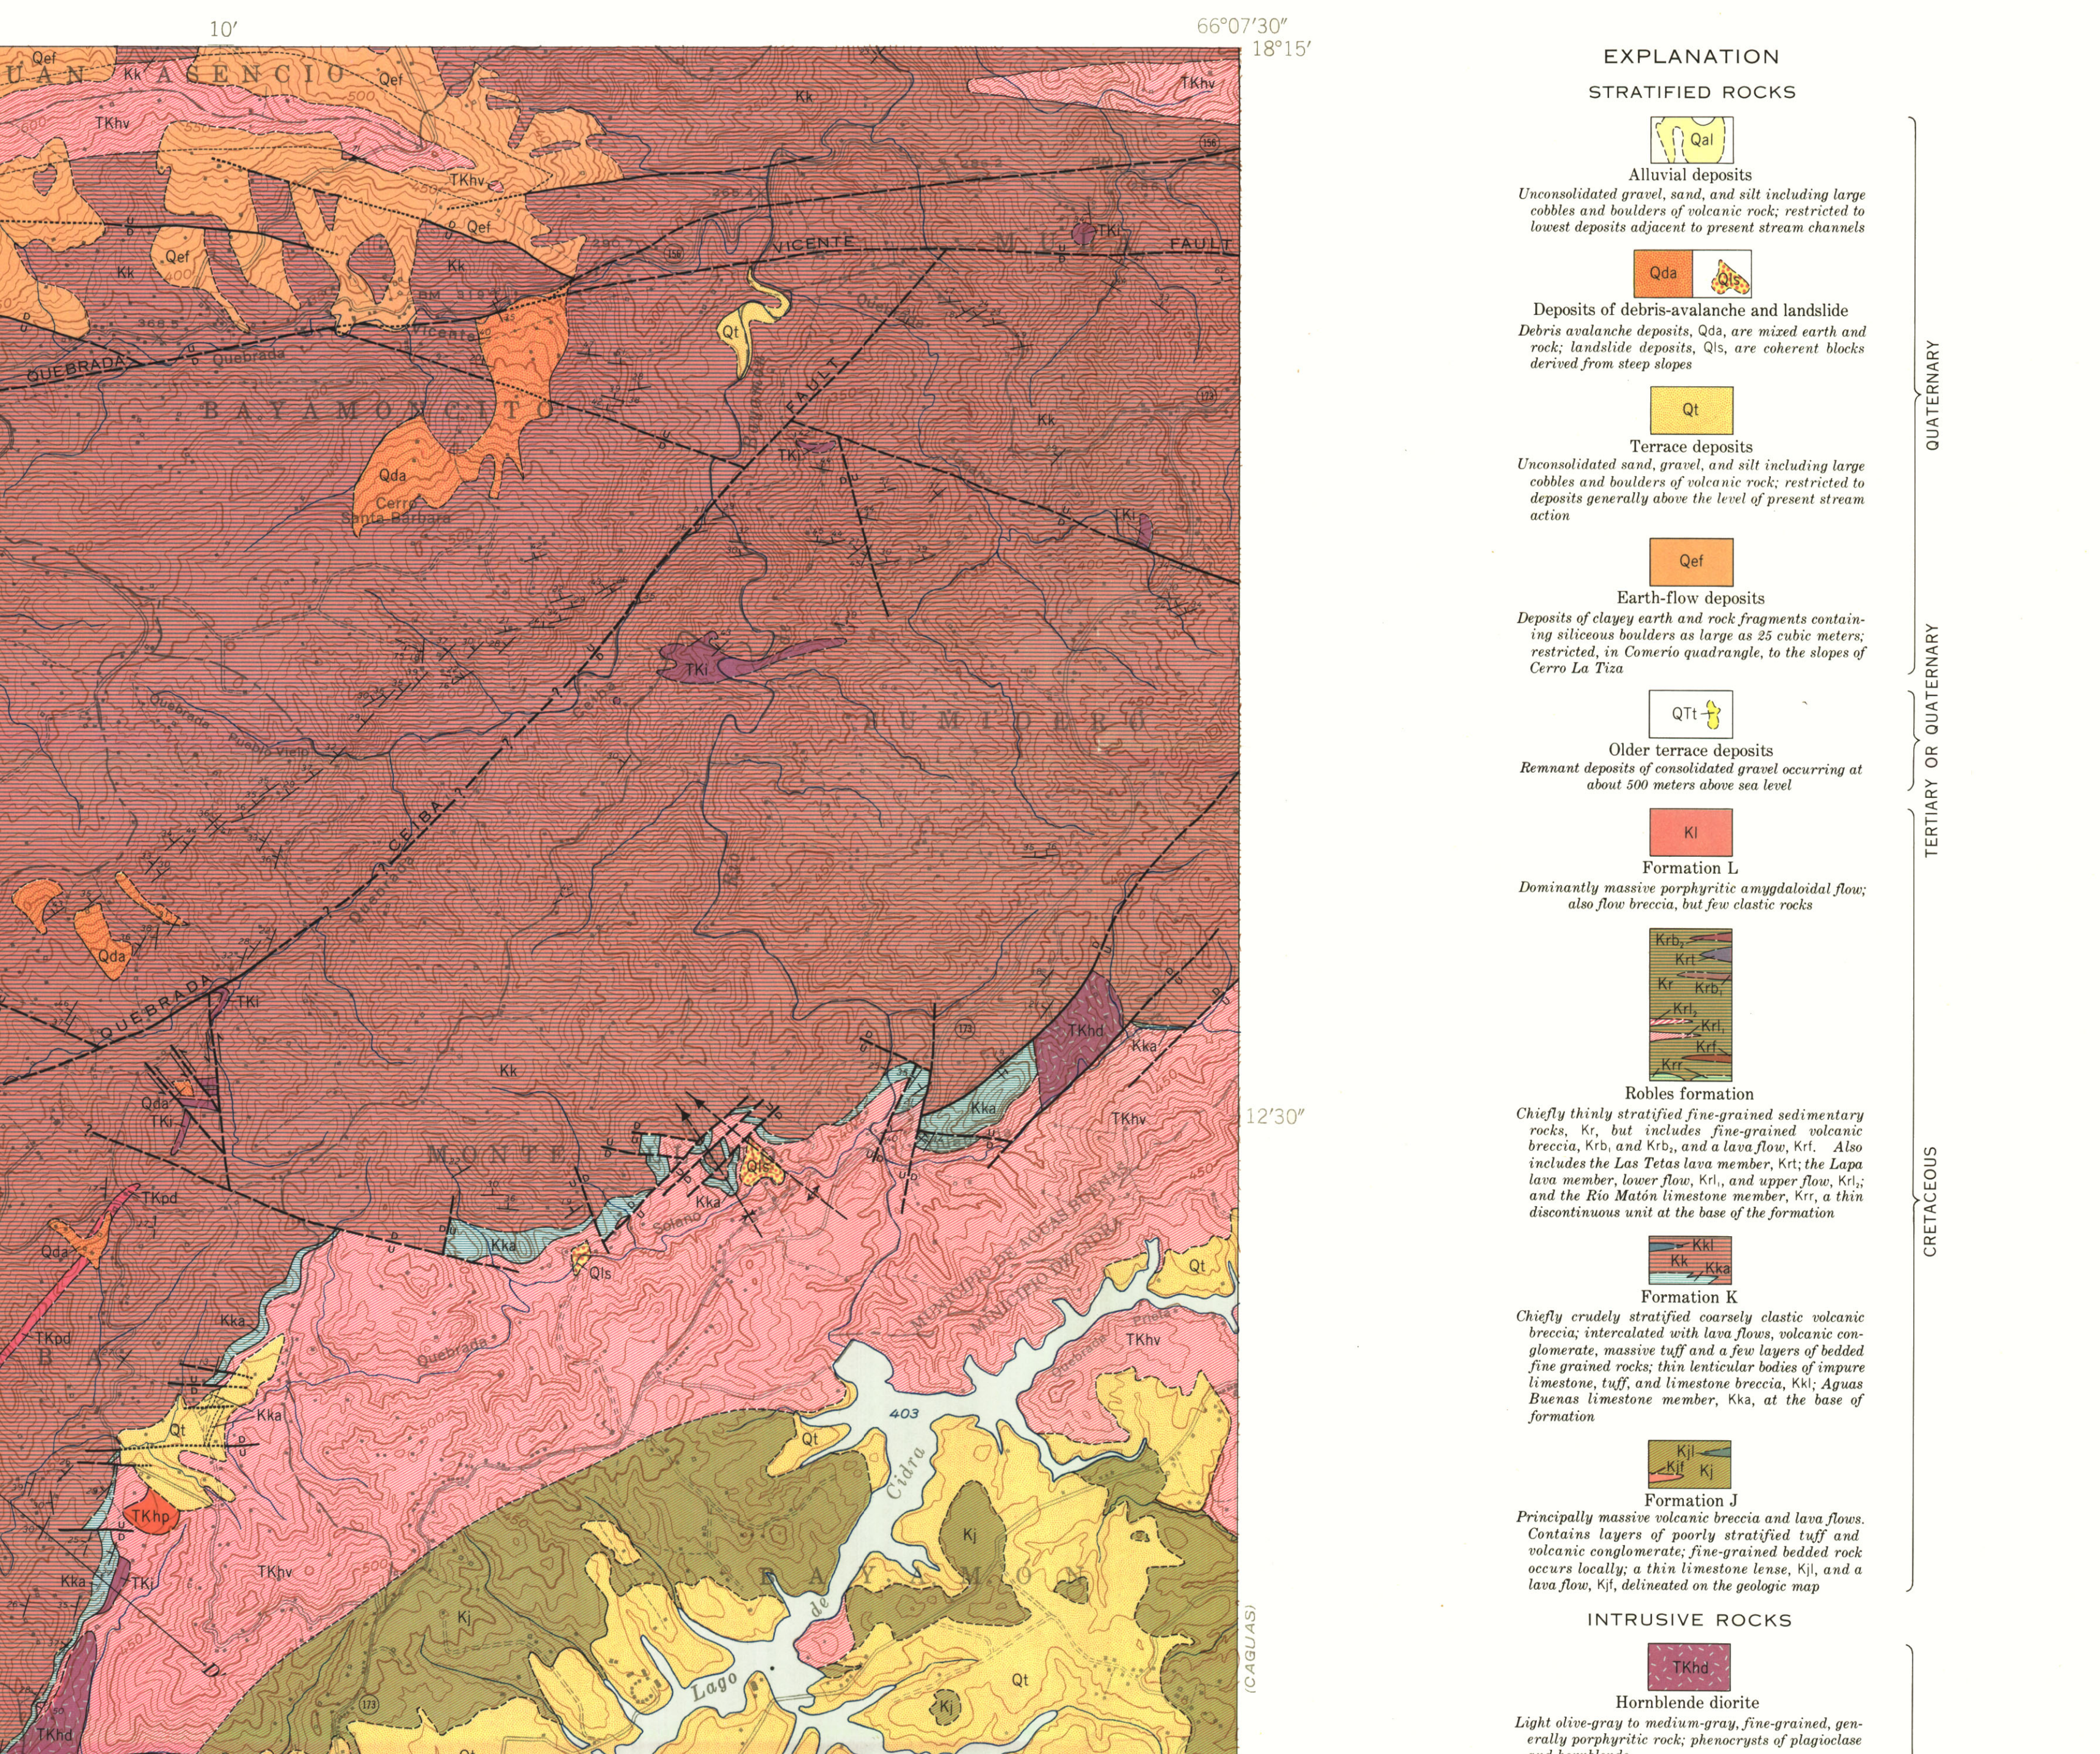
Horblende porphyry
Dark-colored rock characterized by hornblende phenocrysts as much as 25 millimeters in length

Pyroxene diorite
Melting gray to pinkish gray fine-grained intercrystalline rock composed chiefly of plagioclase and pyroxene

Geological map of the area around Monte Corno. The map shows topographic contours and various geological units labeled with letters (K, D, G, M, L, S, T, C, P, Q). Key features include the quarry (marked with a star) and the clay pit (marked with a cross). The map also shows the location of the village of Corno and the road to the quarry. A scale bar indicates distances in meters (0, 100, 200, 300, 400, 500, 600, 700, 800, 900, 1000).

LITHOLOGY TYPE		DISTRIBUTION	EXCAVATION	ENGINEERING GEOLOGY	
				STRENGTH AND STABILITY	UTILIZATION
	Massive fine	Widely distributed in formation 1 and formation K. Stone is relatively hard and brittle. Available for construction purposes through most of the quadrangle.	Requires extensive drilling and blasting, except when severely shattered.	Foundation strength is good for dams, bridges, and foundations of most structures, although where shales are approximately parallel to bedding, some shales may be weak with respect to sliding. Stone stability is good with exception as above.	Non-argillaceous fine provides good base for road and concrete foundations for roads. Good concrete aggregate. Some use for concrete. Possible rock fill for earth dams.
	Monocut and breccia.	Occurs chiefly in formation 1 and formation K. Readily available for construction purposes through most of the quadrangle.	More easily excavated than massive fine, but drilling and blasting necessary in most cases.	Foundation strength is good for heavy construction, except where shattered. Stability of steep slopes is poor as mass movement may occur thereon.	Good fill and earth dam fill material with washing.
