By
J. D. Love
1973

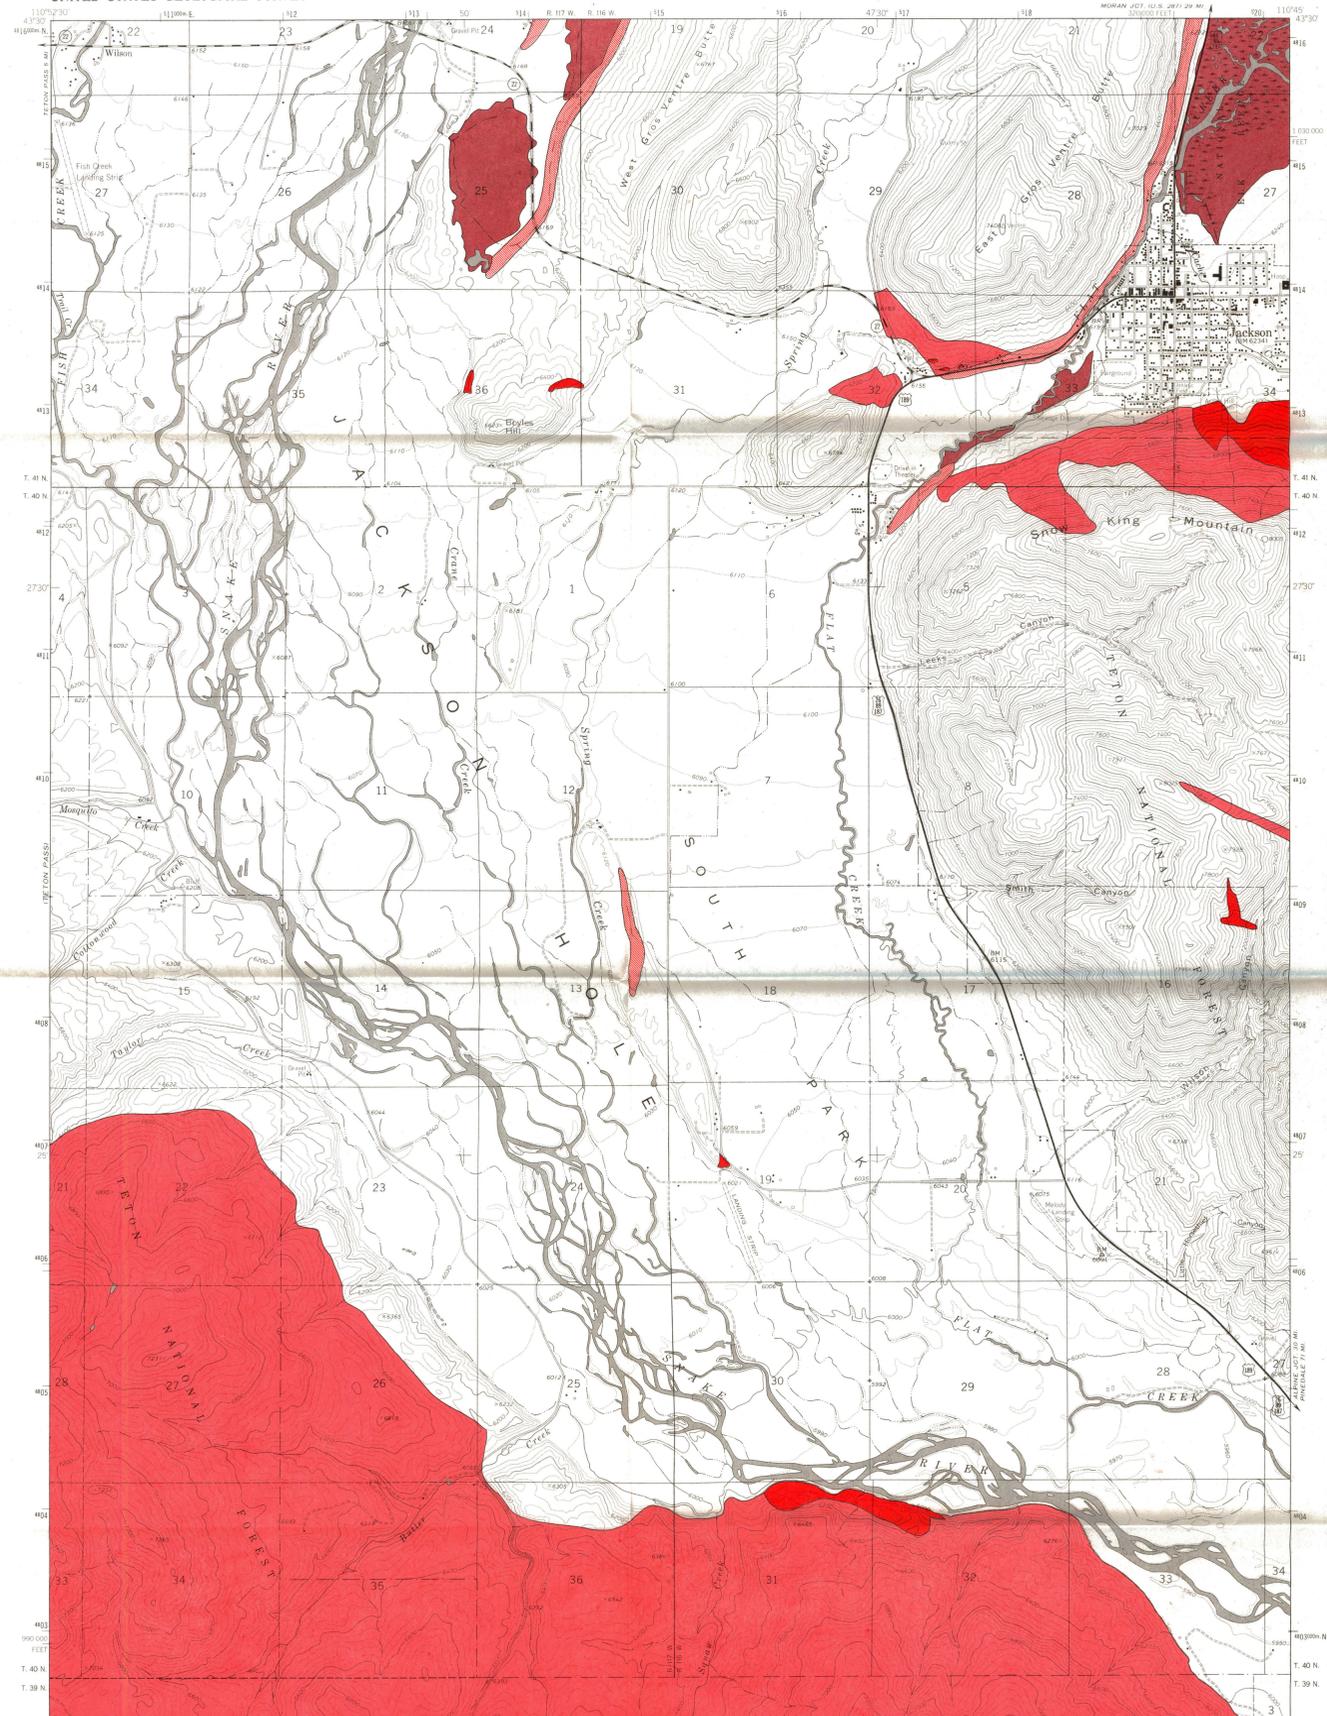
- PRESENTLY STABLE GROUND — Flat areas are underlain by unconsolidated alluvial deposits, chiefly gravel; hills consist mostly of hard bedrock that contains little clay. Few high cliffs are present and rockfalls are uncommon. There is no evidence of faulting in the last 12,000 years.

- UNSTABLE GROUND — Areas underlain by unstable deposits which show evidence of downslope movement.
- GROUND WITH VARIABLE STABILITY — Rocks and soils contain much unevenly distributed plastic clay and variable amounts of water. Degree of stability depends on local conditions.

- SWAMPS — The wet ground in and adjacent to these areas would probably shake violently during an earthquake.
- AREA ALONG RECENT AND ALMOST-RECENT FAULTS — The ground surface here has been ruptured along a fault, and this movement probably accompanied earthquakes. Most of this faulting occurred during the last 12,000 years. Repeated movement commonly occurs along lines of weakness of this type.

In many parts of the Jackson quadrangle, areas of ground that show evidence of being unstable are not likely to affect man's activities. Other unstable areas, however, present hazards that should be recognized. Buildings and roads on and directly downhill from these areas may be tilted and pulled apart; some may be destroyed by masses of rock and earth that might slide from the slope uphill. The speed by which such destruction may be accomplished would depend on whether an earthquake shock were involved and whether the ground were dry or very wet (wet ground is much less stable). If no earthquake were involved, sliding could still be caused by normal pull from the earth's gravity on water-saturated ground. One area of immediate and major environmental concern is an old and partly stabilized landslide within the south-east part of the town of Jackson (named in 1970, so is not shown in the town limits on the topographic map). It can be recognized by its lumpy bulbous surface studded with rock slabs. The slide extends across the cemetery and to the east beyond the quadrangle boundary. The surface of this landslide has an average slope of 30 percent and is flatter on the lower slopes and steeper (more than 50 percent) on the upper (see Love, 1973). Road and house excavations, and shallow wells drilled for water within and directly east of this part of the quadrangle, show that the slide debris consists of soft plastic clay interspersed with broken masses of sandstone and some large limestone slabs that have skidded down from high up on the steep slopes to the south. In parts of the slide area, the lower 10 feet of old living trees curve uphill into the slope, indicating that as the ground moved the trees were tilted and, as they grew, had to bend upward in order to return to a vertical position. Tilted trees are common in areas of slow earth movements. The unstable debris poses a construction problem that, over a period of years, may become very expensive in terms of repairing or replacing roads and buildings. (See discussion accompanying Love, 1973).

Areas shown as "Ground with variable stability" are those in which rocks and soils contain a considerable amount of unevenly distributed plastic clay that slides easily, where slopes range from steep to moderate, and where the water content ranges from high to low as a result of differential porosity, permeability, and location of thick and thin snowpacks. Most of the slopes face north, and the snowpack tends to be thick but irregular. Layers of bedrock may be unstable where their bedding planes, on which sliding occurs most easily, dip nearly parallel to the ground slope. The same rock units may be stable, however, where the beds dip into the hill and breakage would have to occur across rather than along the layers.

Northeast of the junction of State Highway 22 and U.S. Highway 189, on the steep south face of East Gros Ventre Butte, homesites cut into the slopes expose a considerable thickness of soft plastic clay. This clay, now that it has been exposed, disturbed, and this more easily susceptible to water saturation, may cause some future stability problems, partly because of its plastic nature and exposure on the steep slope, and partly because of its nearness to a large fault at the base of the butte. If the ground here were wet and buildings heavy, an earthquake might cause a significant amount of sliding.

Several large and small swampy areas are shown in the northern part of the quadrangle. An earthquake of even moderate intensity anywhere in the region probably would cause these local areas, which are saturated with water, to shake like jelly, and this would cause considerable damage to buildings and roads. Parts of the swampy areas north and west of Jackson presently are being filled with broken rock, and buildings are planned or are being constructed on these fills. In places where the swamp deposits are not entirely removed down to a solid gravel base and replaced by broken rock, or where pilings are not sunk to a stable layer below the swamp debris, buildings might be vulnerable to considerable earthquake damage unless they are constructed to earthquake-resistant specifications. Swampy areas also pose problems of differential settling beneath heavy buildings.

The swampy area along Flat Creek, near the west margin of the town of Jackson, is caused in part by drainage of water from the downstream margin of the Cache Creek fan deposits (Love, 1973). The northern part of this swamp has been filled in with crushed rock to create building sites. If differential settling of buildings in this area is to be avoided, foundations need to be adequately supported. In addition, buildings here and in adjacent localities should be designed to withstand earthquakes, not only because of the effects of shocks transmitted through (and perhaps intensified by) the swamp, but also because the area is directly adjacent to several faults that have been active in the last 12,000 years (see purple areas on map). Movement along these faults (in places 10 to 50 feet or more) must have been accompanied by major earthquakes. In comparison, faults that moved during the earthquake of 1959 near West Yellowstone, Montana, 90 miles north of Jackson, had 20 feet maximum displacement. That earthquake, which was distinctly felt in the Jackson area, took 28 lives, caused major landslides (one of which dammed a large river), and destroyed many roads and much property. Evidence for the age of faulting and amount of movement in and north of the Jackson quadrangle has been described by Love and Taylor (1962).
