MAP SHOWING WATERCOURSES AND AREAS INUNDATED BY HISTORIC FLOODS
IN THE MORRISON QUADRANGLE, JEFFERSON COUNTY, COLORADO

By
Glenn R. Scott
1972

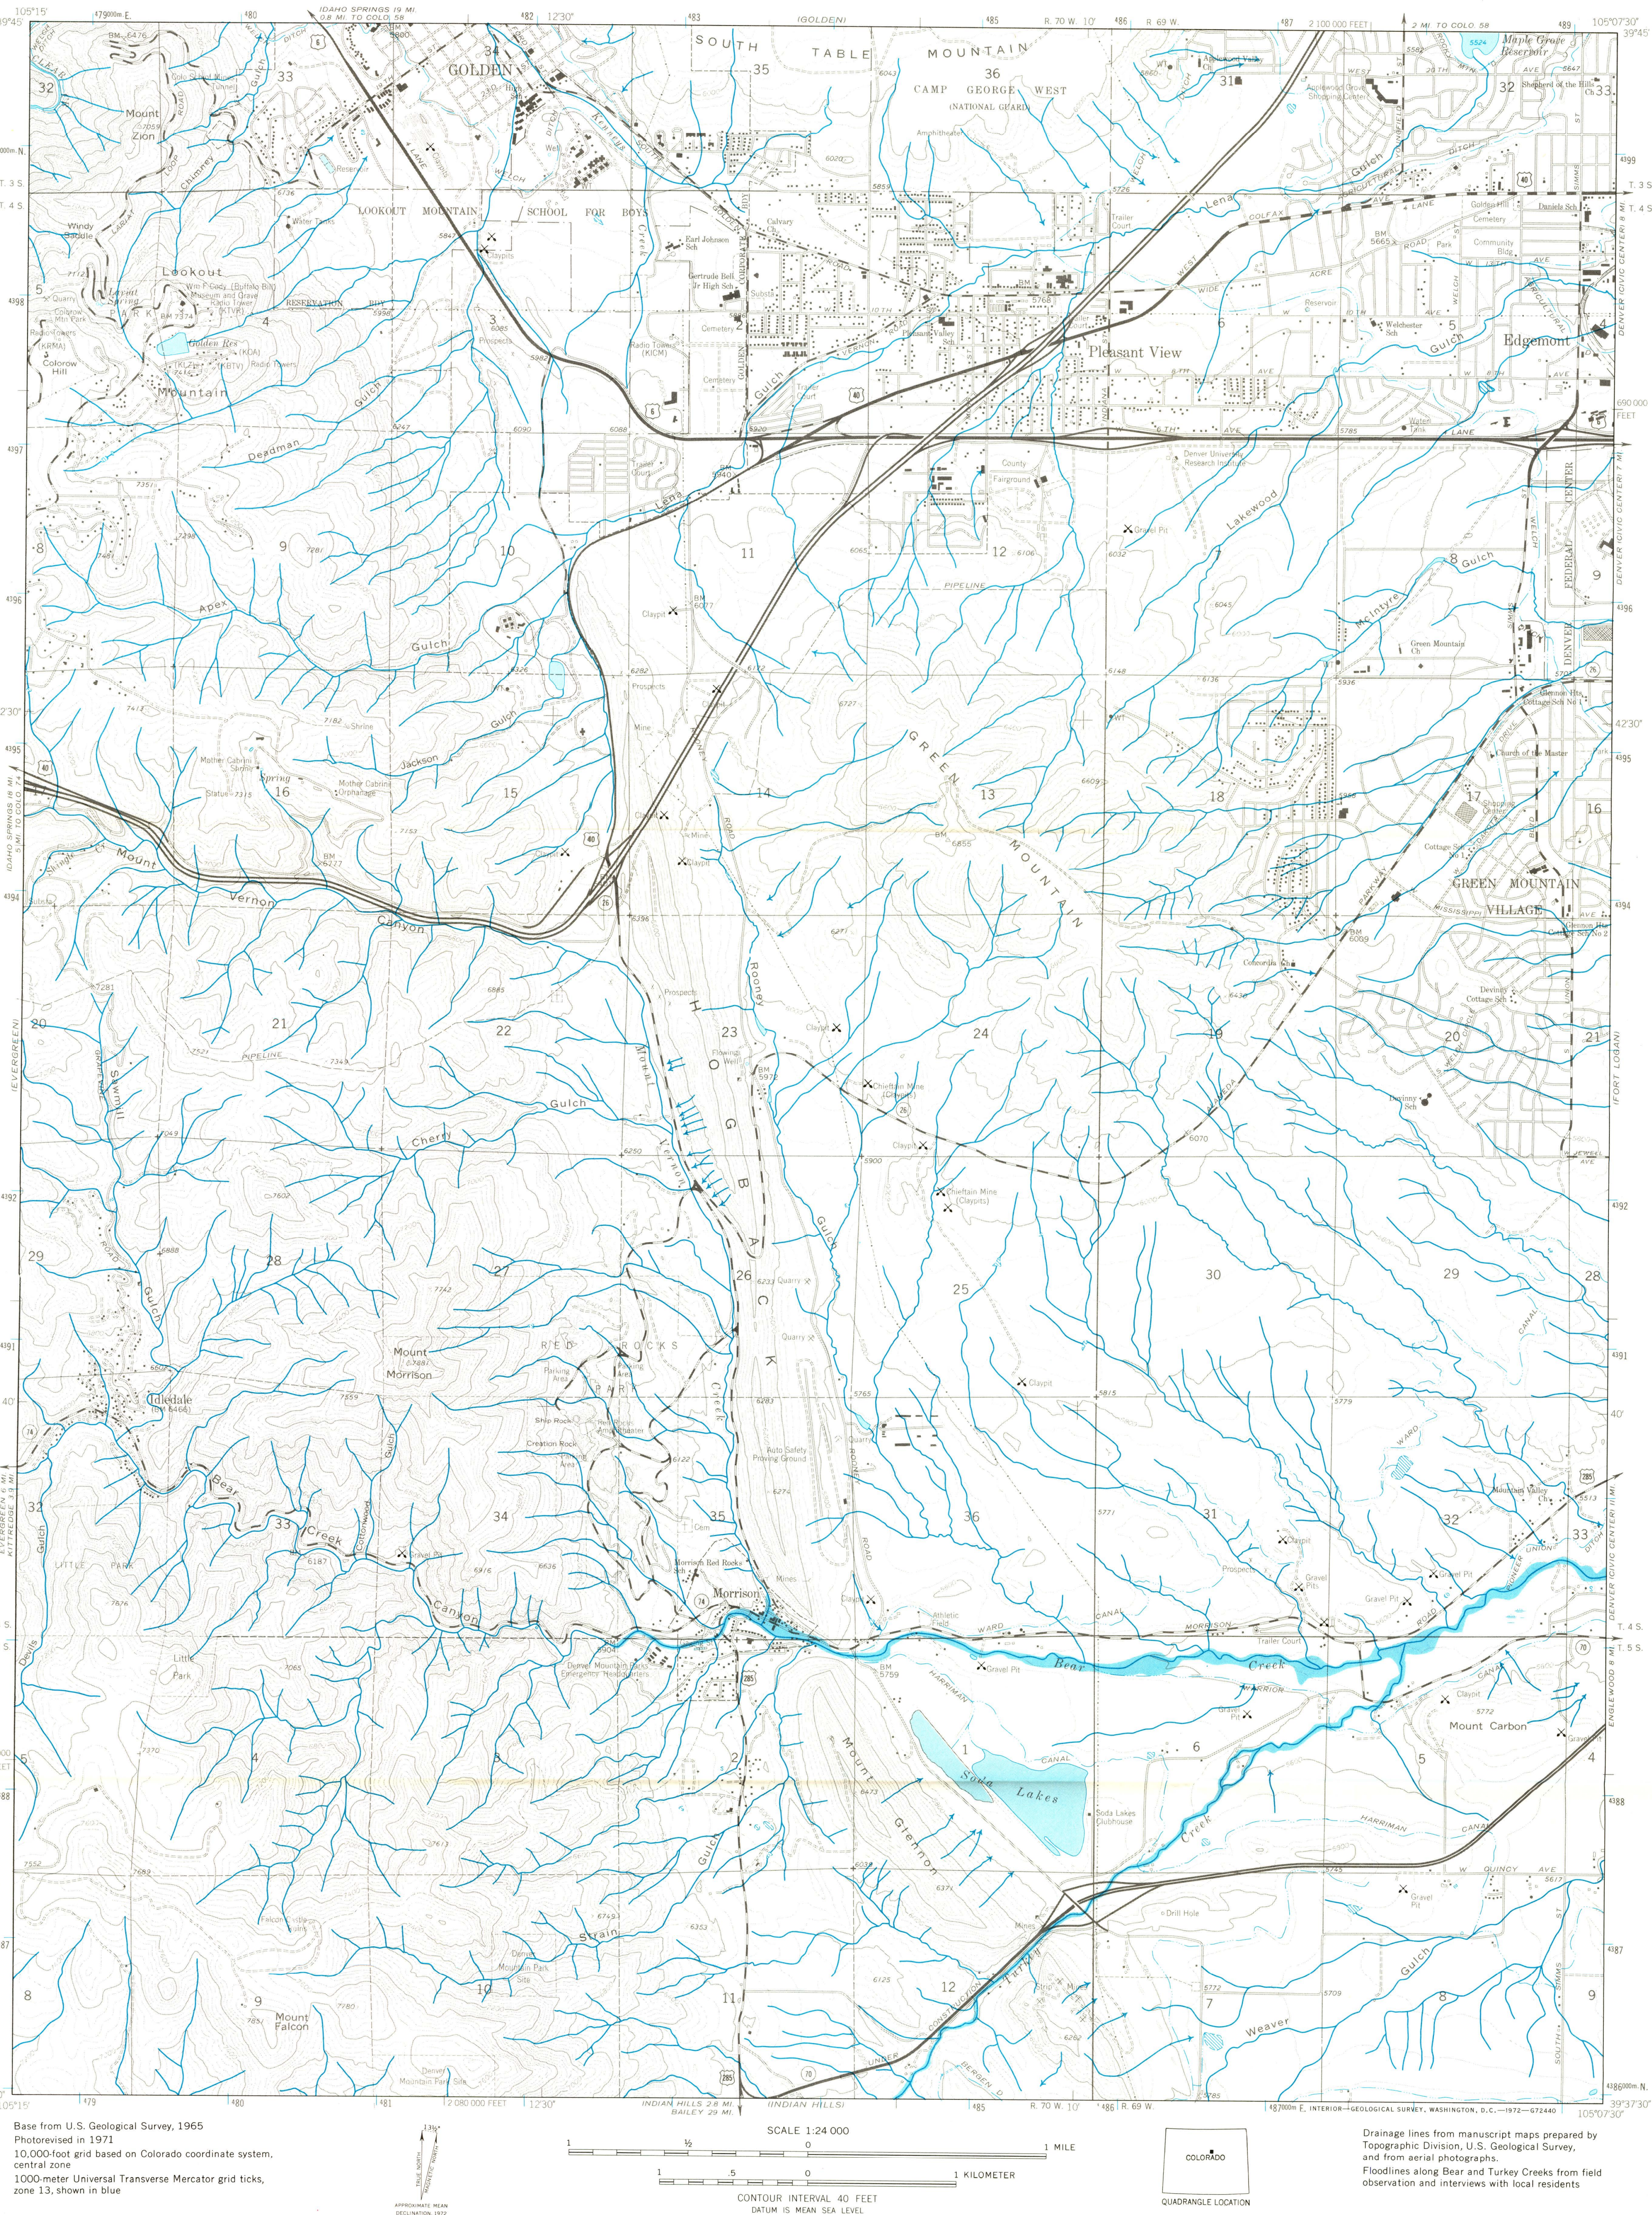
WATERCOURSES SUBJECT TO FLASH FLOODS -
In this area, intense summer rainstorms cause flash
floods of variable magnitudes. Temporary inunda-
tion of land in and adjacent to watercourses during
such floods is a natural process. Consequently if
buildings, bridges, or roads are placed in water-
courses, they are subject to the hazards of flooding.
Furthermore, if these structures reduce the area
through which water must flow, the degree of the
hazard is increased. The degree of hazard is de-
pendent on the intensity, duration, and areal dis-
tribution of rainfall and on physical characteristics
of the drainage basin, such as permeability of sur-
face material, slope, antecedent conditions, and
other variable factors. All watercourses shown on
the map, plus unmapped smaller watercourses, are
probably subject to flash flooding during high-
intensity rainfall. Rainfalls of 8 inches in less than
24 hours have been reported in this area by the U.S.

Army Corps of Engineers (1971, p. 11) and by
Follansbee and Sawyer (1948, p. 33). Assessment
of the potential effects of high-intensity rainfall
and resultant flooding should be made before struc-
tures are built. Arroyos and swales that are com-
pletely filled during grading operations at a building
site will generally still carry seepage water beneath
the fill. To provide for such subsurface drainage,
tiles are commonly installed along the original
watercourses. Along larger arroyos where drainage
structures are placed, adequate cross-sectional area
is needed for conveyance of both water and float-
ing debris. Individual lot sites astride watercourses
should be investigated for hazardous conditions.
Most flood damage along the smaller watercourses
in the quadrangle has occurred where manmade
structures constrict the course through which the
water must flow.

FLOOD AREAS ALONG BEAR AND TURKEY
CREEKS - Areas of known maximum flooding
determined from interviews with local residents
and from observed field evidence of level of max-
imum flooding, such as trash and weeds against trees
and fenceposts, and height of scoured banks. Bear
and Turkey Creeks, for which flood areas are shown,
are the only large permanent streams crossing the
Great Plains part of the quadrangle. Flood areas
shown there probably are not everywhere as large
as the area of the maximum historical flood. Bound-
aries of "intermediate regional flood" and "standard
project flood" mapped by U.S. Army Corps of En-
gineers (1971) are much higher than the maximum
elevation shown here, indicating that the theoretical
maxima are higher than the observed maximum for
the period of record. Lena Gulch, Lakewood Gulch,
and McIntyre Gulch, in addition to Bear and Turkey
Creeks, are subject to flooding, according to the

city of Lakewood (Denver Post article, March 8,
1972).
