This map shows the trace of the main surface rupture in the San Andreas fault zone formed during the earthquake of April 18, 1906, as reconstructed from published and unpublished descriptions of earthquake-related damage, airphoto interpretations, and recent field investigations. Publications by Schussler (1906), Lawson and others (1908), Reid (1910), and Louderback (1937) are the principal sources of published "eyewitness" data. Historical photographs, maps, and information about the San Francisco Water Department (SFWD) and its predecessor in this area, the Spring Valley Water Company (SVWCo), were provided by E. L. Fonseca of the Peninsula Division, SFWD, and the archives of the San Francisco Public Utilities Commission (SFPUC). Additional information on the fault trace comes from geologic studies in the area by Bonilla and others (1978) and Pampeyan (1975: 1981a: 1981b) and from Gary Halkens, of the San Francisco Utilities Engineering Bureau, who generously undertook to locate and mark the position of specific submerged structures in Lower Crystal Springs Reservoir by scuba diving. Other faultrelated studies in this area have been done by Wahler and Associates (1977), Earth Sci

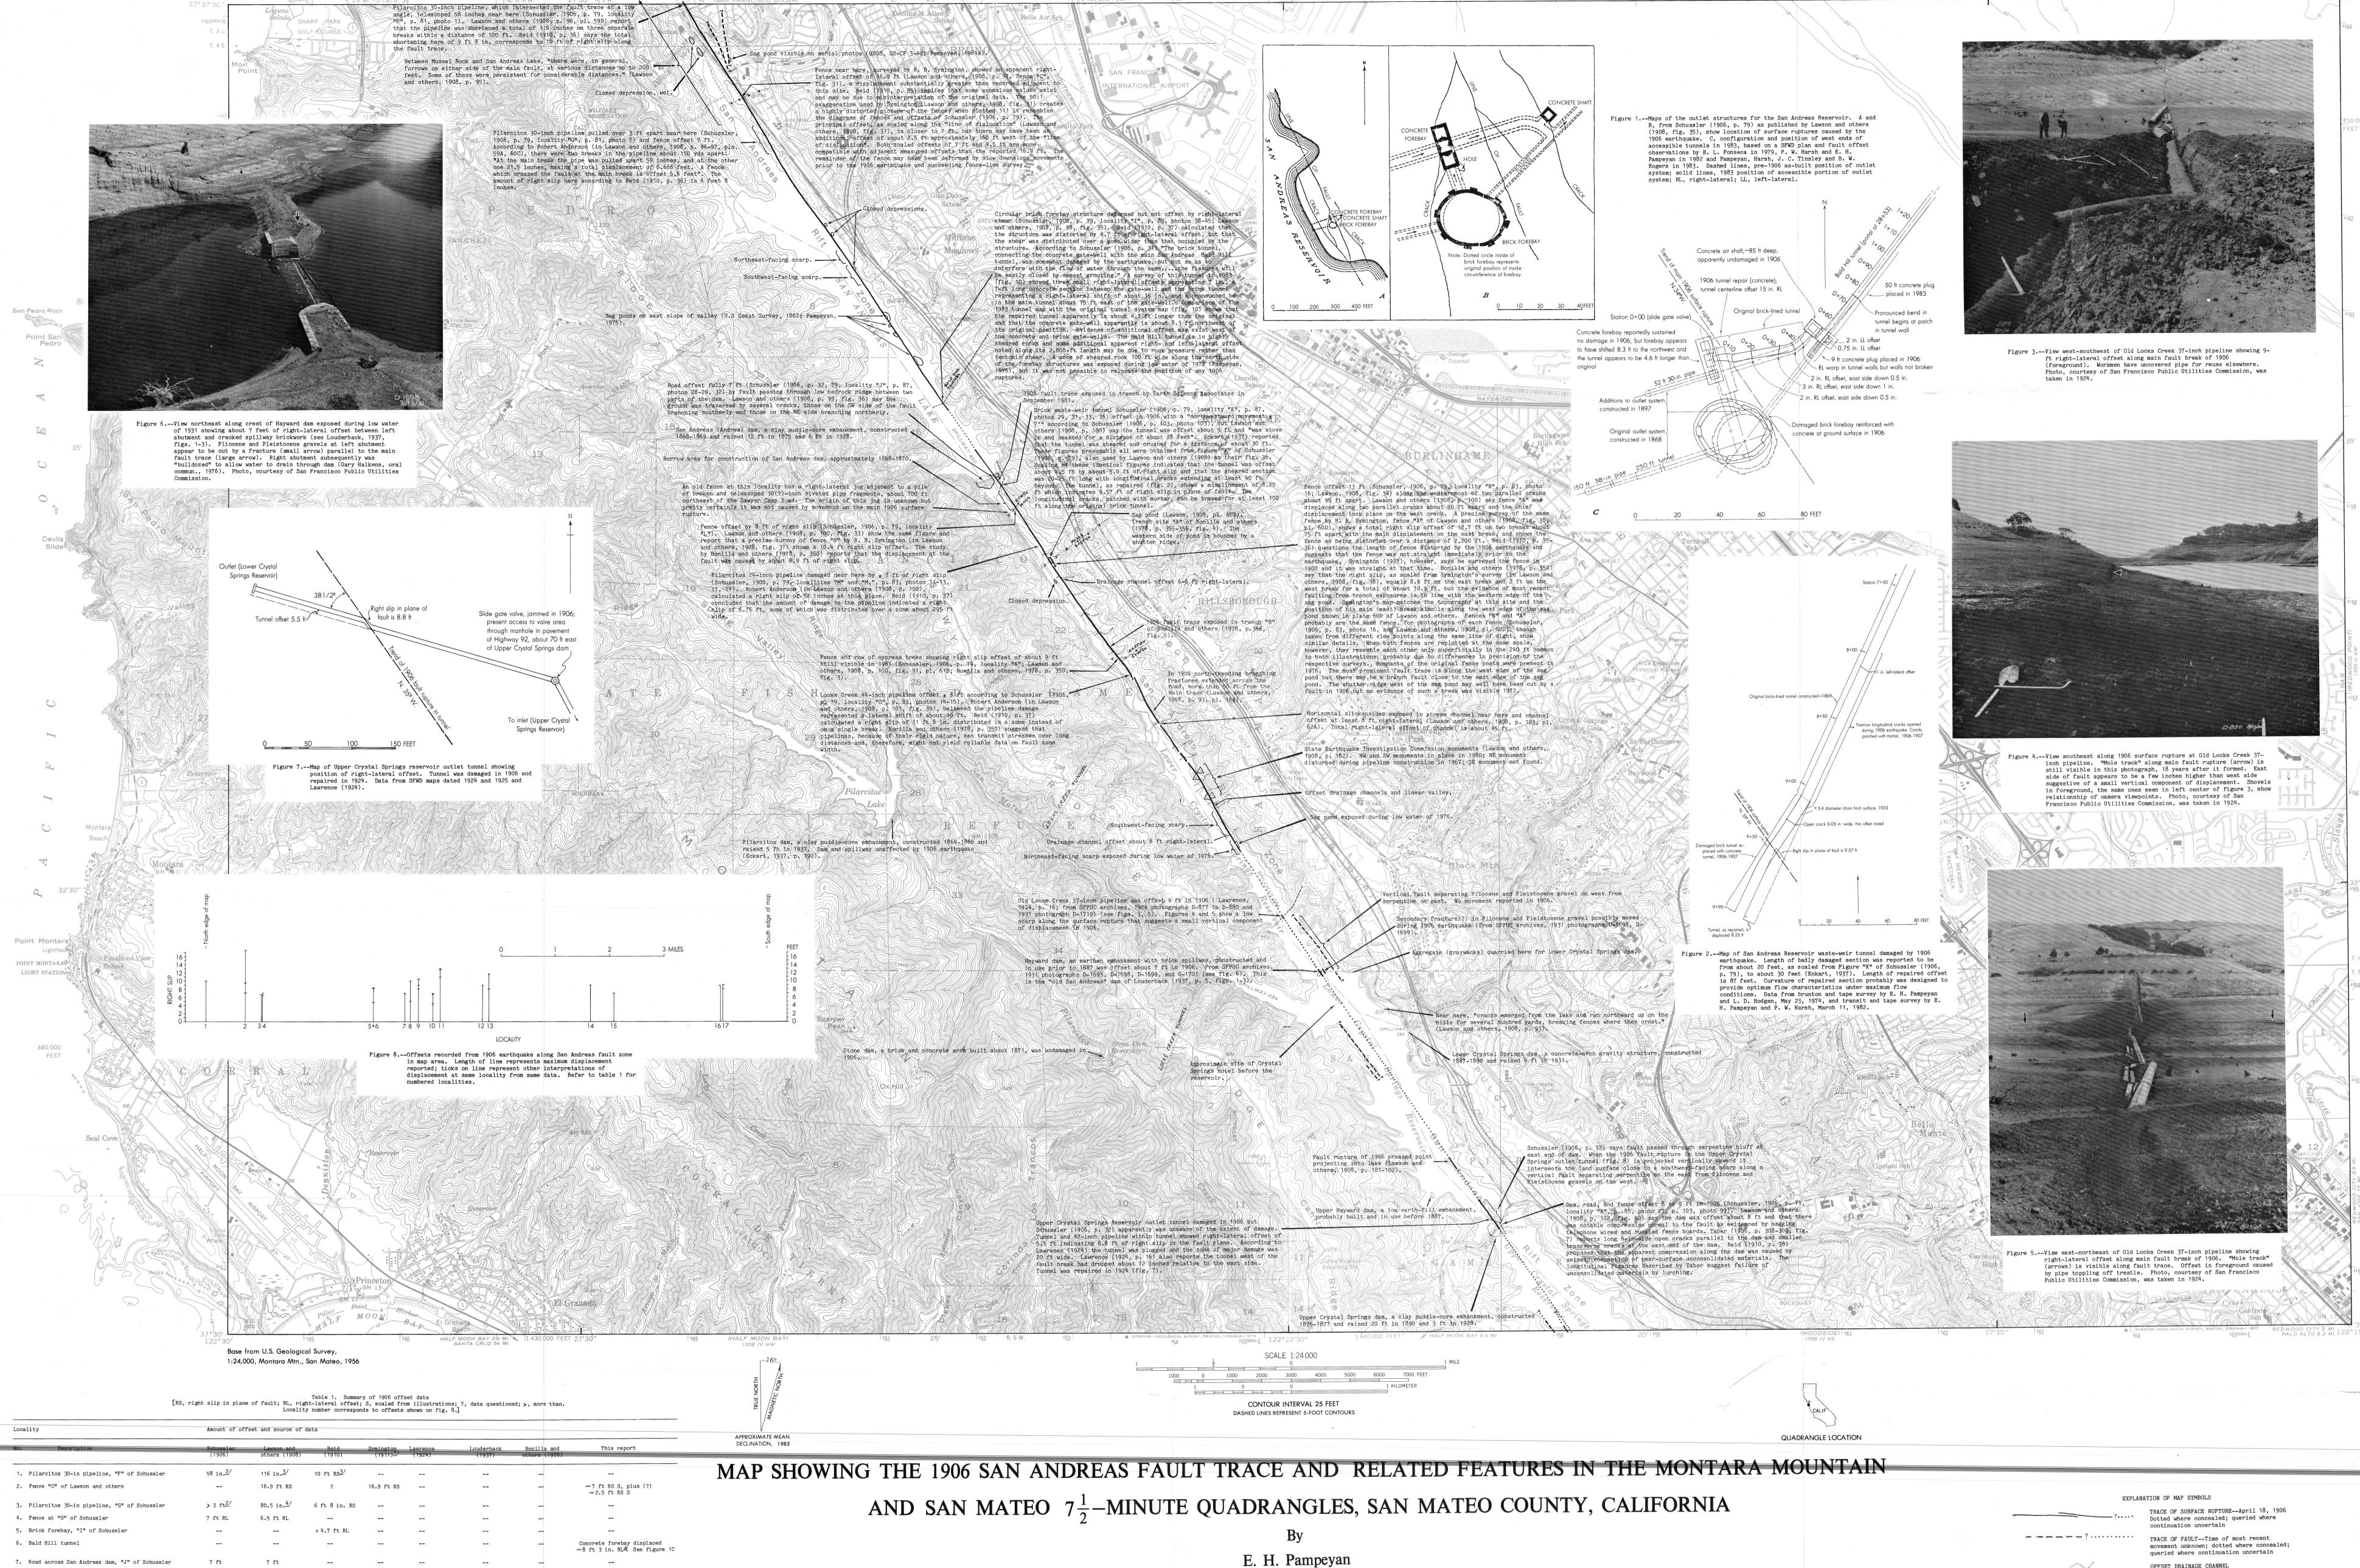
This map, as well as the original maps by Schussler (1906, p. 79) and Lawson and others (1908), shows the main fault trace as a single line, because the original observers focused their attention upon the surface rupture along which the major offsets were noted. There are, however, references in print to branching, secondary, and sets of en echelon fractures, but only a few of such features were adequately described or shown on maps or in photographs. In addition, there were problems associated with relocating significant fault features, for some of the published location descriptions are ambiguous and

occurred here in 1906. The branching and secondary fractures, some of which originally may have resulted from nontectonic processes triggered by earthquakes, are less persistent and, therefore, virtually impossible to Notations on the accompanying map indicate the sites of published descriptions of fault damage ascribed to the earthquake of April 18, 1906 and to other sites where surface rupture most likely did or, in some cases, did not occur in 1906. In addition, a few notations supply historical data of interest and value to this study. Geologic relations along the fault are complex and poorly exposed, hence rock outcrops are not commonly diagnostic in pinpointing the site of 1906 surface rupture without the aid of some offset cultural feature for a nearby reference point. The data on fault offsets that occurred on April 18, 1906, are summarized
