INTERIOR—GEOLOGICAL SURVEY, RESTON, VIRGINIA—UNPUBLISHED 1990

TYPES OF DAMAGE THAT COULD RESULT FROM A GREAT EARTHQUAKE IN THE NEW MADRID, MISSOURI, SEISMIC ZONE

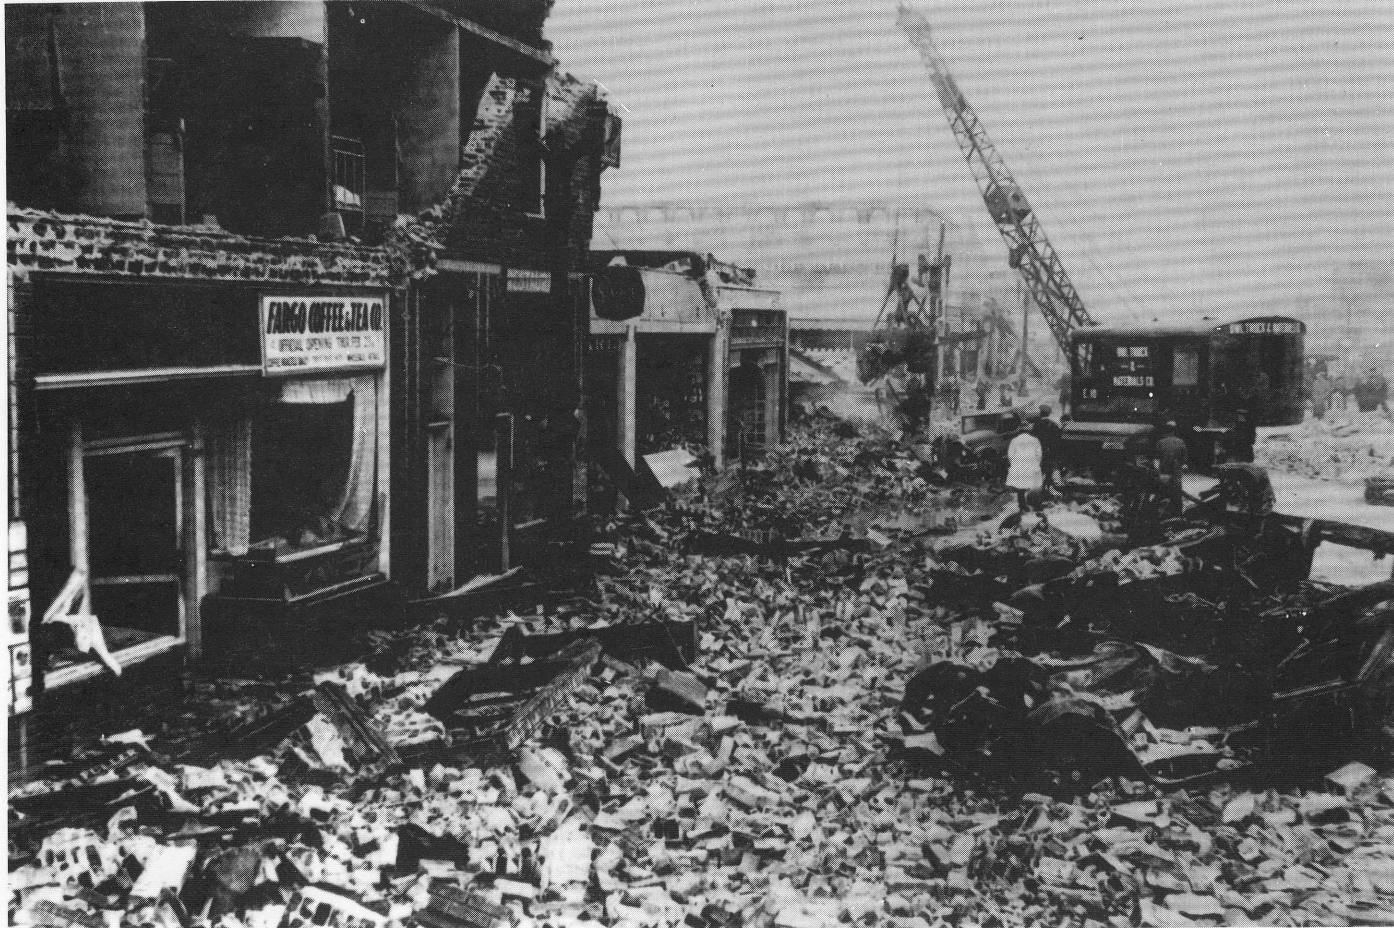
Photograph from the Wilfred N. Ball Collection. Copy courtesy of Karl V. Steinbrugge.
FIGURE 1.—Damage to downtown Compton, Calif., 40 km (25 mi) from the epicenter of the 1933 Long Beach earthquake. This damage is typical of the effects of a moderate to large (magnitude 6-8) earthquake on old, unreinforced brick masonry. Note that the second story wall has collapsed and the roof is supported only by the interior partition (nonbearing) walls.

Photographs 1-10 show typical damage to structures that occurred during various earthquakes in the United States. Structural damage to buildings in the Modified Mercalli intensity scale as scale used for assigning numbers to earthquake effects, begins at intensity VIII. Minor or architectural damage (cracked plaster, windows, and chimneys) occurs at intensities VI and VII, and effects on people and small objects predominate at intensities below VI (earthquake felt, direction and duration noted, dishes broken). Photographs 1-10 illustrate damage caused by intensities VIII and above. None of the damage shown in these photographs occurred in earthquakes larger than the 1811-1812 New Madrid shocks, and most of the examples are from considerably smaller shocks. Photographs 1-4 and 7 show damage to masonry buildings, mostly old and unreinforced, none designed to be earthquake resistant. How many such buildings are in use in your community? Photographs 5 and 6 show damage to modern structures close to the epicenter of a magnitude 6.5 earthquake, a small shock compared to the magnitudes (8.4-8.7) of the New Madrid earthquakes. Photographs 8-10 are typical of damage that can occur at large distances from great earthquakes. Tall buildings are particularly susceptible to ground motions with relatively long periods (greater than 1 second), while short, rigid buildings are generally more likely to be damaged by ground motions with periods of less than 1 second. The period ground motions attenuate more rapidly with distance from the epicenter than do the longer period motions.

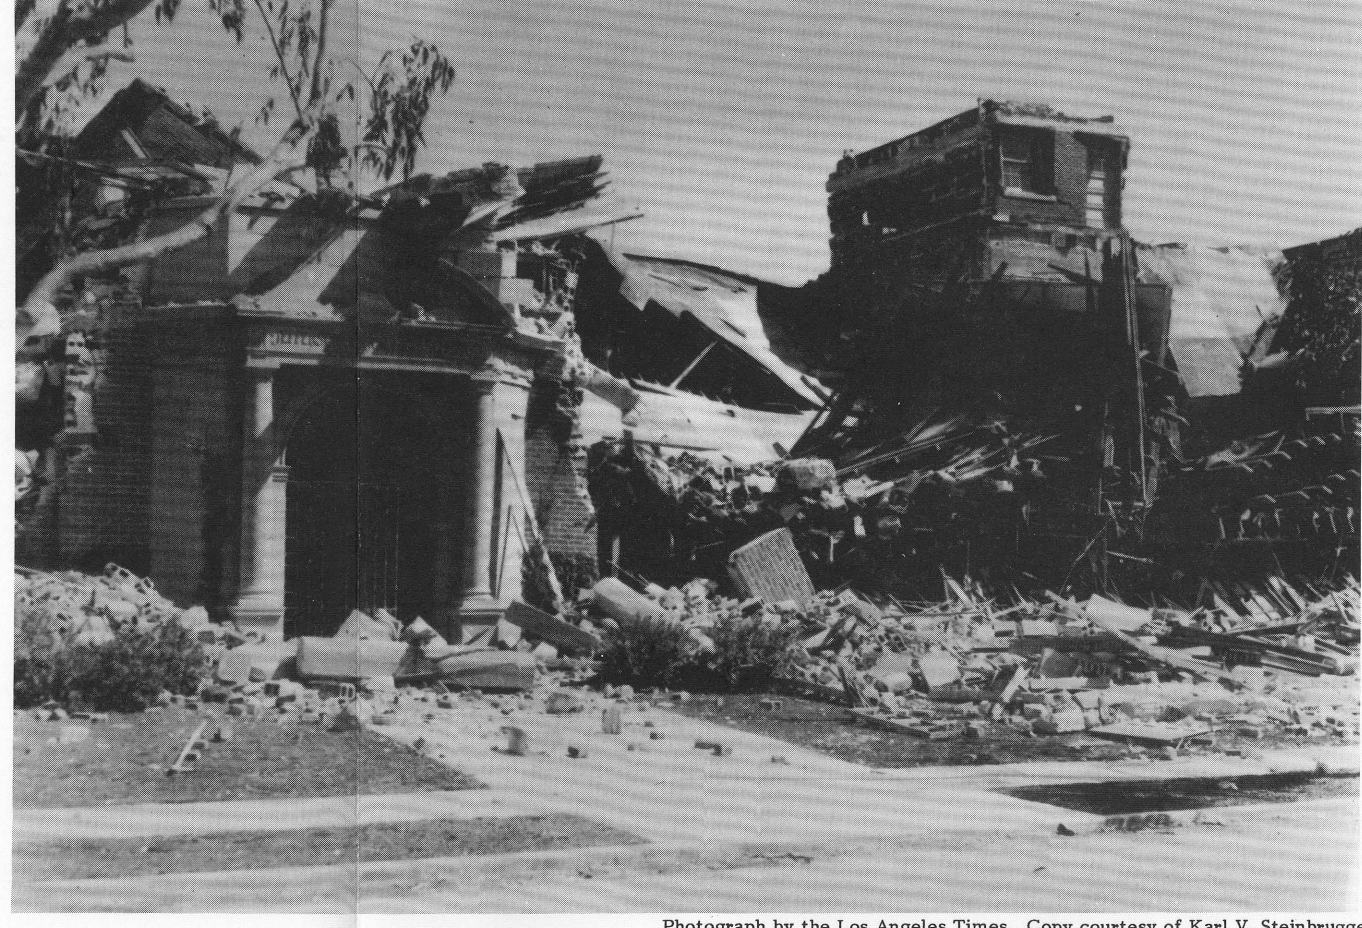
Photograph by the Los Angeles Times. Copy courtesy of Karl V. Steinbrugge.
FIGURE 2.—Damage to Jefferson Junior High School from the 1933 Long Beach earthquake. This earthquake caused the destruction of many public schools and caused the California legislature to pass the Field Act, mandating that all new public schools in the state be built to resist earthquake vibrations. The effectiveness of this legislation has been demonstrated by the superior performance of post-1933 schools in California earthquakes (Richter, 1958).

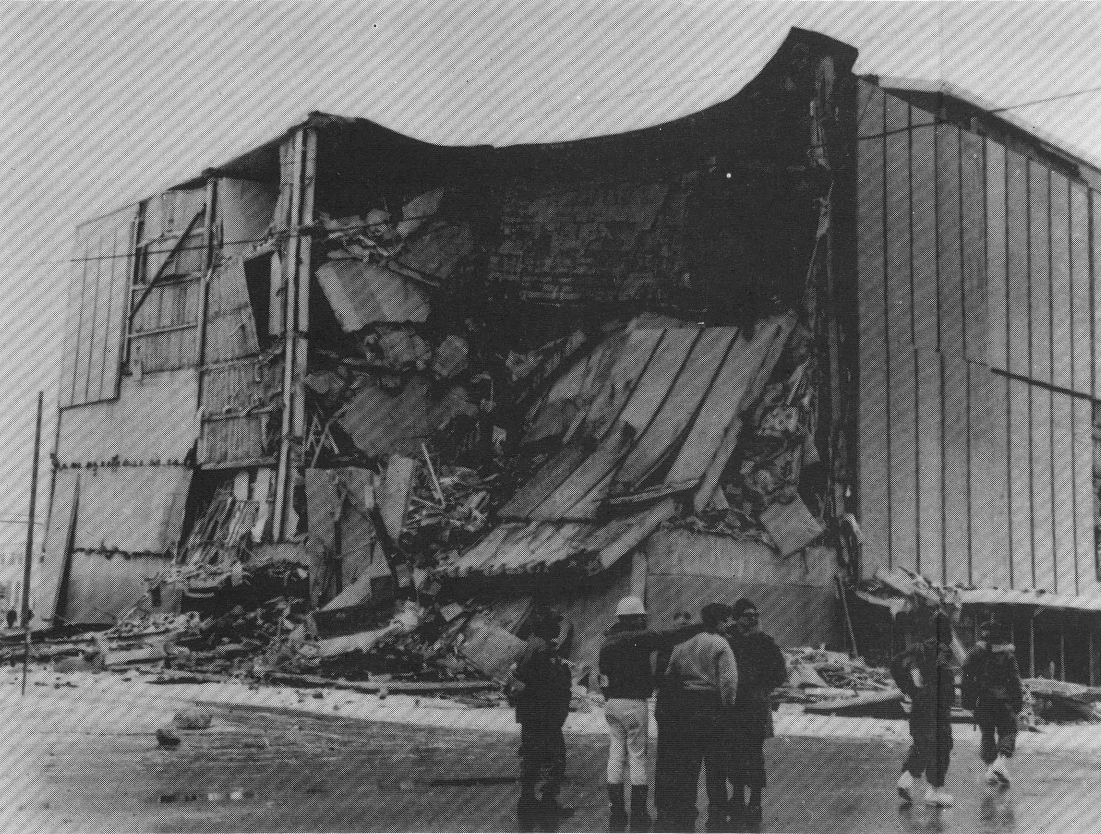
Photograph by Bureau of Land Management. Copy courtesy of Karl V. Steinbrugge.
FIGURE 10.—Damage to the Penny Building in Anchorage during the 1964 Alaska earthquake. This building, constructed in 1962, was supported by bearing walls on all (or parts of all) sides except the north; this photograph shows the northeast corner. Lack of shear walls above the first story along the north side gave the building a U-shaped shear-wall bracing system, which is especially susceptible to torsional (twisting or rotational) forces. An eyewitness described the Penny Building as twisting, with movement along the second floor construction joints (Steinbrugge, Manning, and Degenskolb, 1967).

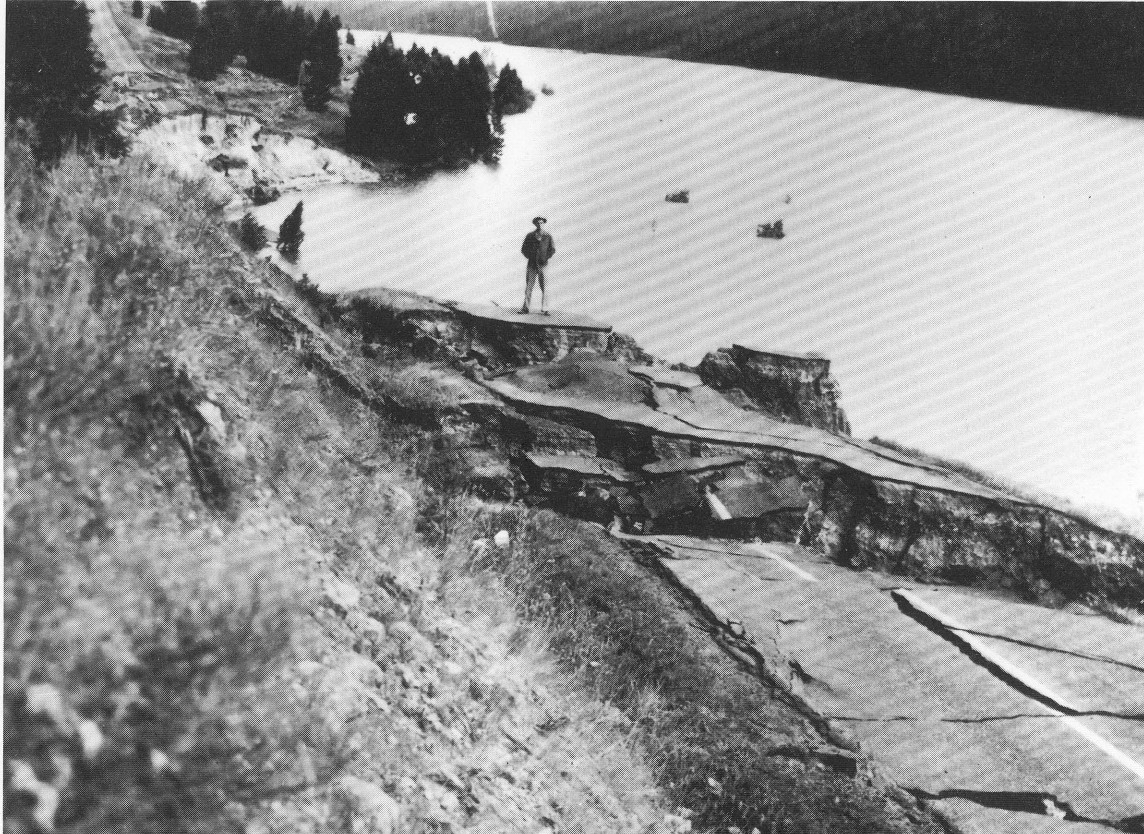
Photograph from the NOAA National Geophysical Data Center.
FIGURE 11.—Slump that destroyed a section of road during the Hebgen Lake, Mont., earthquake of 1959 (magnitude 7.1).

The 1811-1812 earthquakes produced extensive ground effects. Earthquakes can cause many different kinds of ground effects, ranging from minor fissures, slumps, and rockslides to major landslides and disturbances of the ground surface. Photographs 11-17 show typical earthquake ground effects and the kinds of damage they can cause to manmade structures.

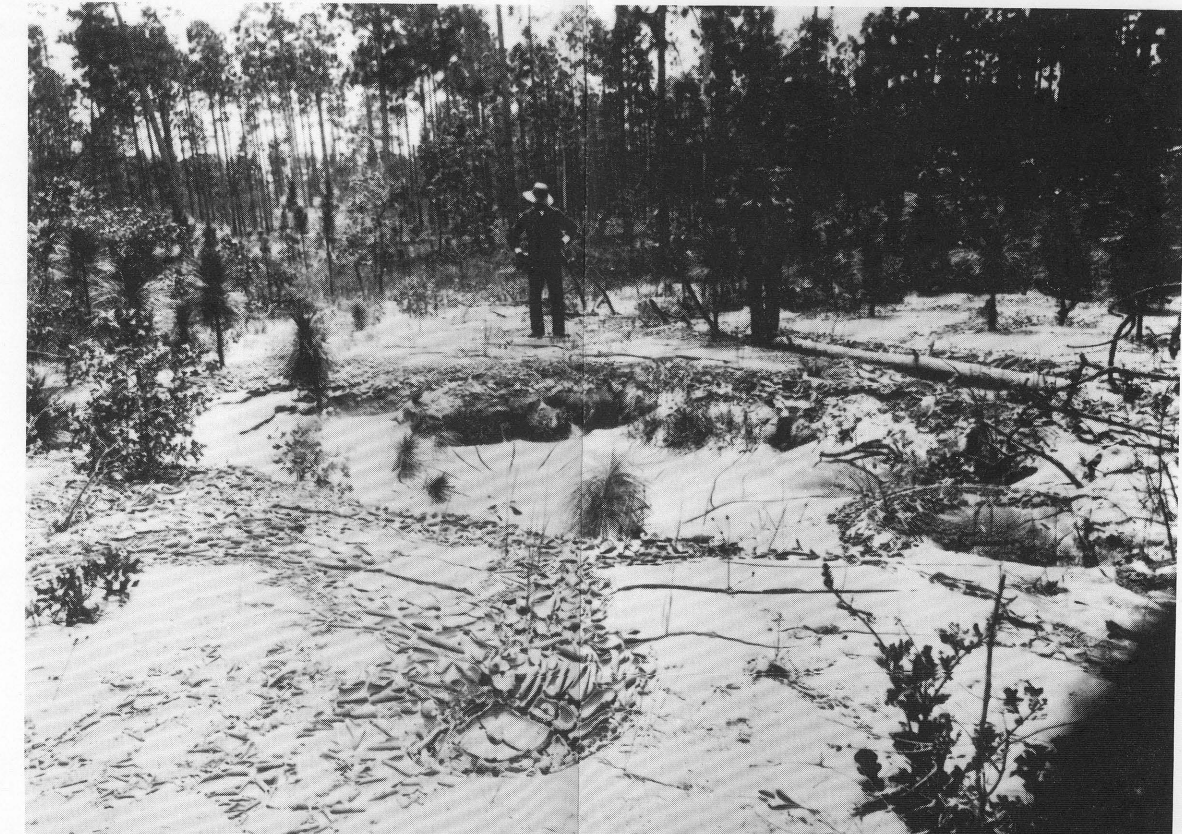
Photograph by J. K. Killers. Copy from the NOAA National Geophysical Data Center.
FIGURE 12.—Sand blow created during the 1886 Charleston, S.C., earthquake. Sand blows are a result of liquefaction, a phenomenon that occurred over a wide area during the 1811-1812 New Madrid earthquakes. Liquefaction is the sudden transformation of a loose, silty soil into a fluid, as a result of repeated vibrations such as those produced by a large earthquake. Earthquake shaking can pump or squeeze the fluid from a liquefied layer up through cracks in the overlying material, producing sand blows.

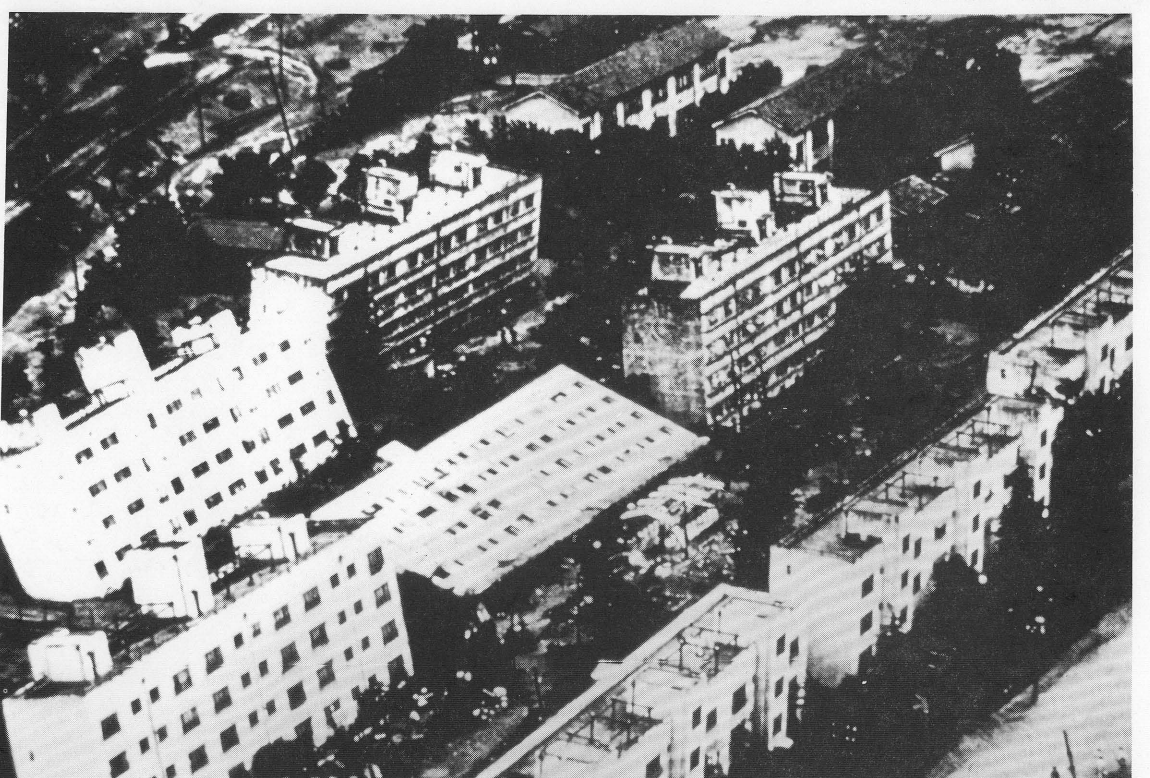
Photograph from NOAA National Geophysical Data Center.
FIGURE 13.—Apartment buildings that tilted due to liquefaction at the base of the buildings during the 1964 earthquake in Niigata, Japan (magnitude 7.5). The buildings remained intact and the people inside escaped unharmd (Kawasumi, 1968).

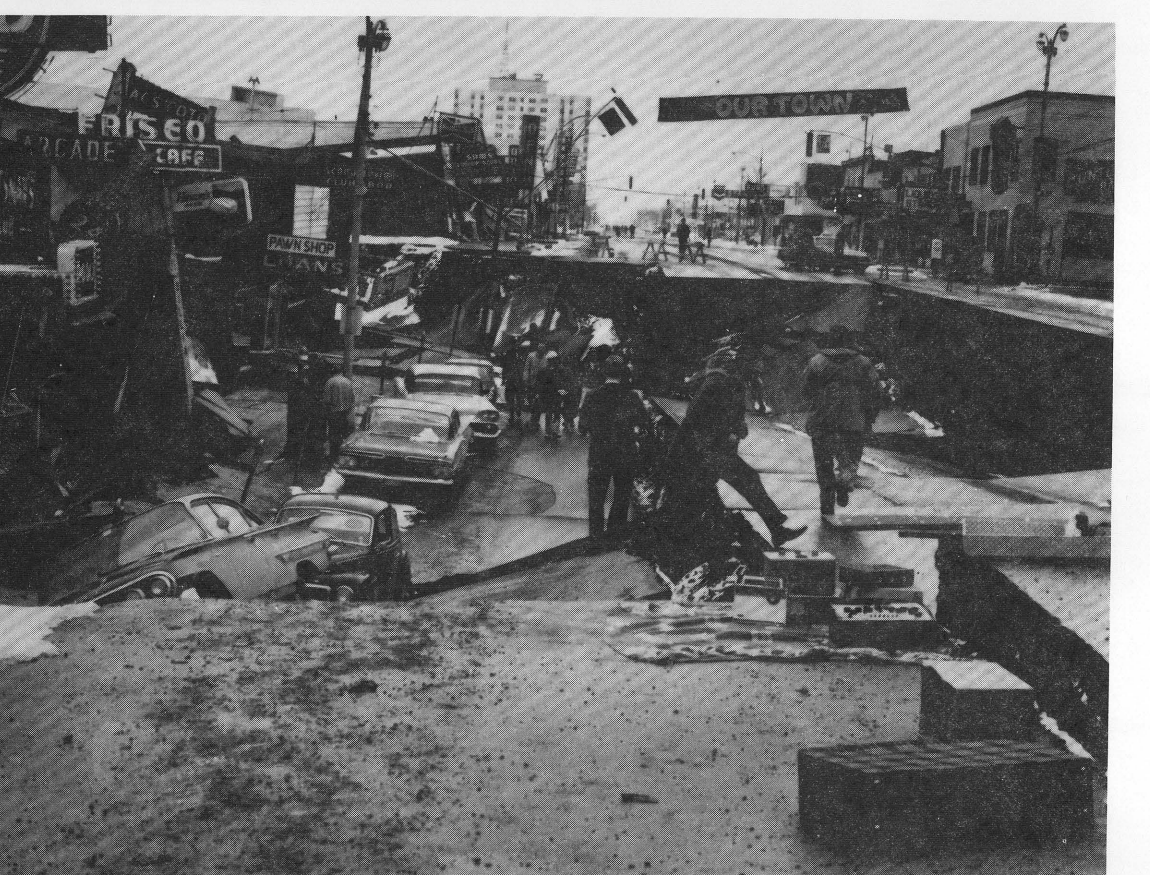
Photograph by the U.S. Army. Copy from the U.S. Geological Survey Photographic Library.
FIGURE 16.—Streets that collapsed in downtown Anchorage along the Fourth Avenue slide during the 1964 Alaska earthquake.

Photograph from the U.S. Geological Survey Photographic Library.
FIGURE 14.—Turnagain Heights slide after the 1964 Alaska earthquake. In this case, and in figures 15 and 16, upper strata in a liquefied lower layer known as the Bootlegger Cove Clay. If you look at this picture carefully you can see the houses on the blocks of earth that dropped.

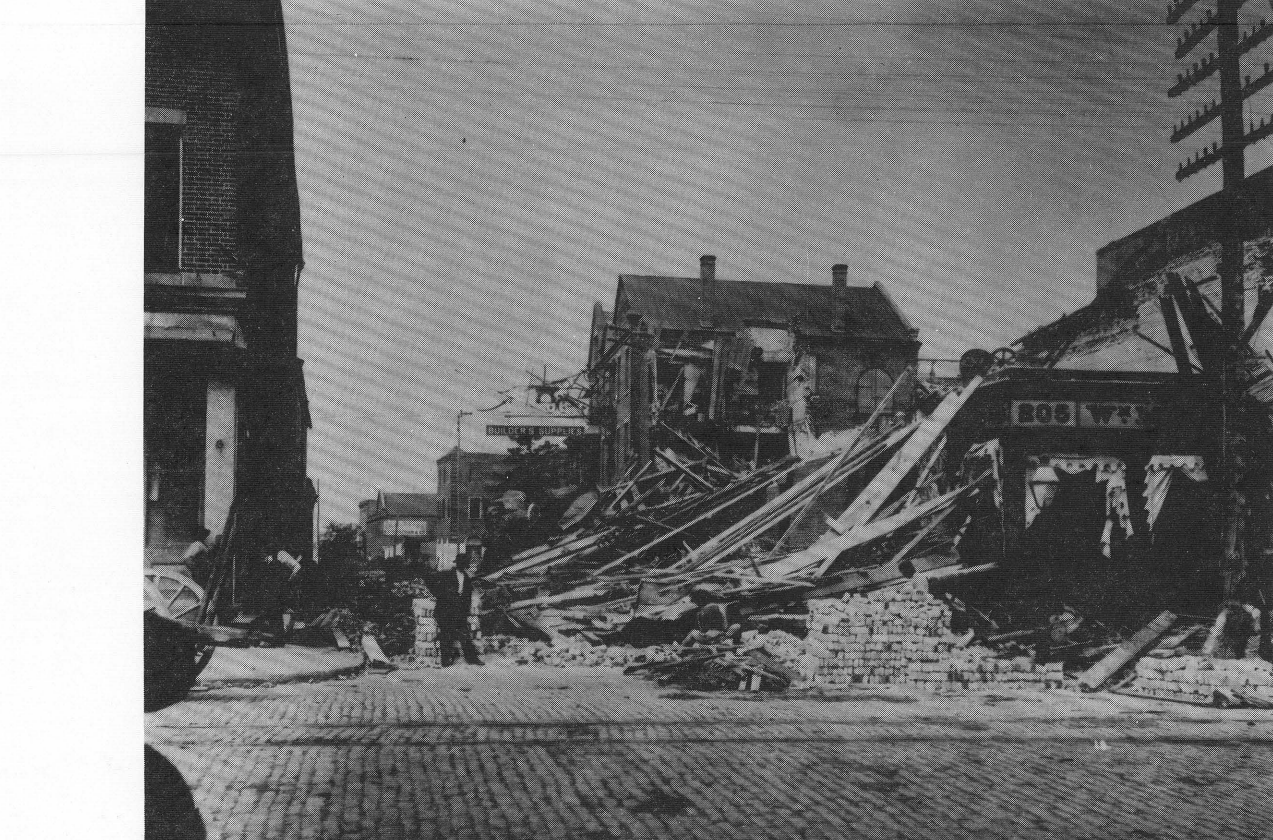
Photograph by J. K. Killers. Copy from the U.S. Geological Survey Photographic Library.
FIGURE 3.—Street in Charleston, S.C., after the 1886 earthquake (estimated magnitude $m_b=6.8-7.1$; Bollinger, 1977). Note that although some of the buildings have collapsed, others are relatively undamaged. There are even two tall chimneys still standing on the right.

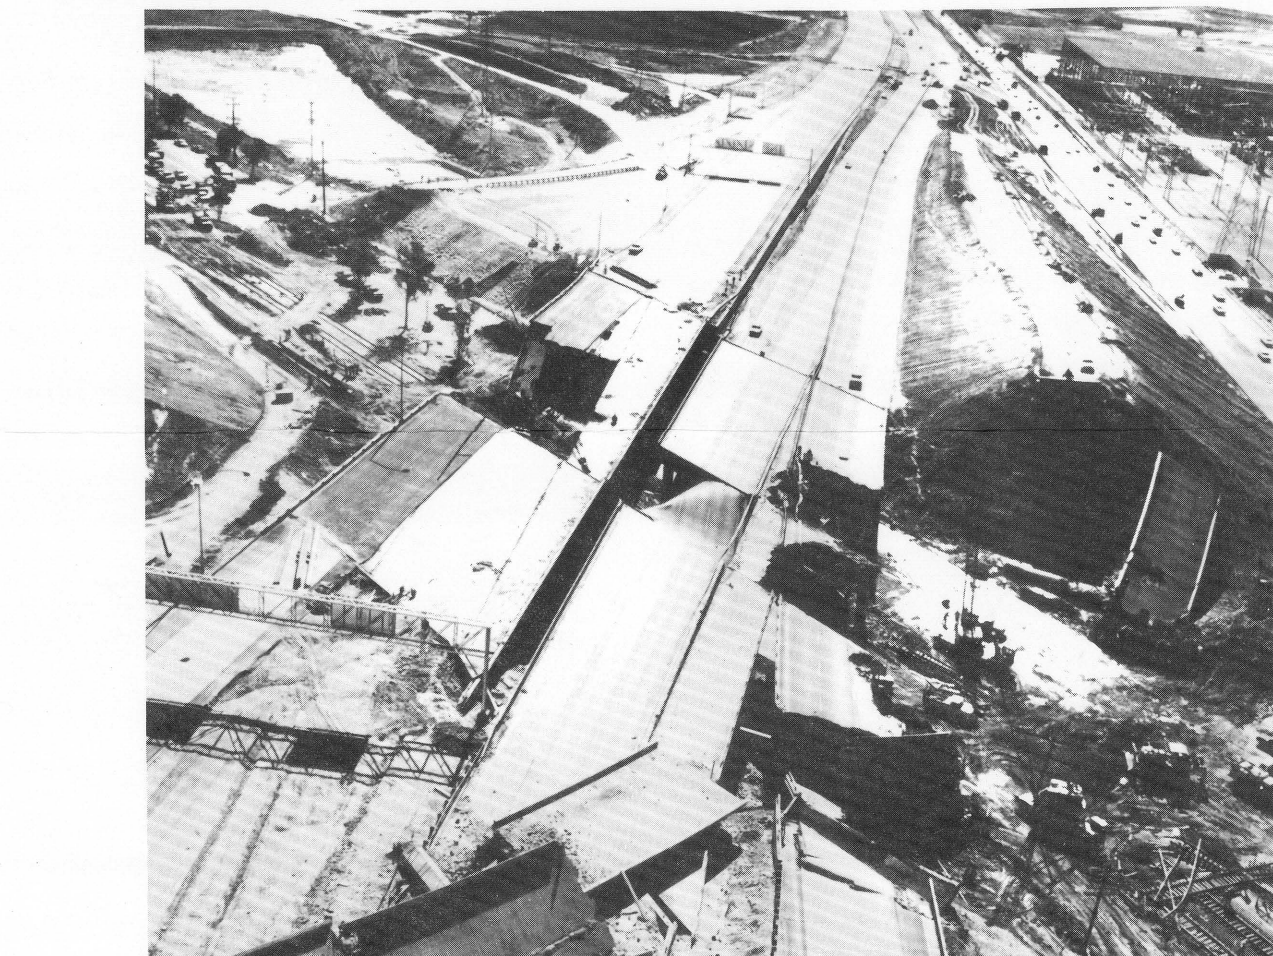
Photograph from the U.S. Geological Survey Photographic Library.
FIGURE 5.—Highway overpass that collapsed during the 1971 San Fernando, Calif., earthquake (magnitude $M_w=6.5$), and blocked an interstate highway, several other roads, and the main lines of the Southern Pacific Railroad (Youd and Olsen, 1971).

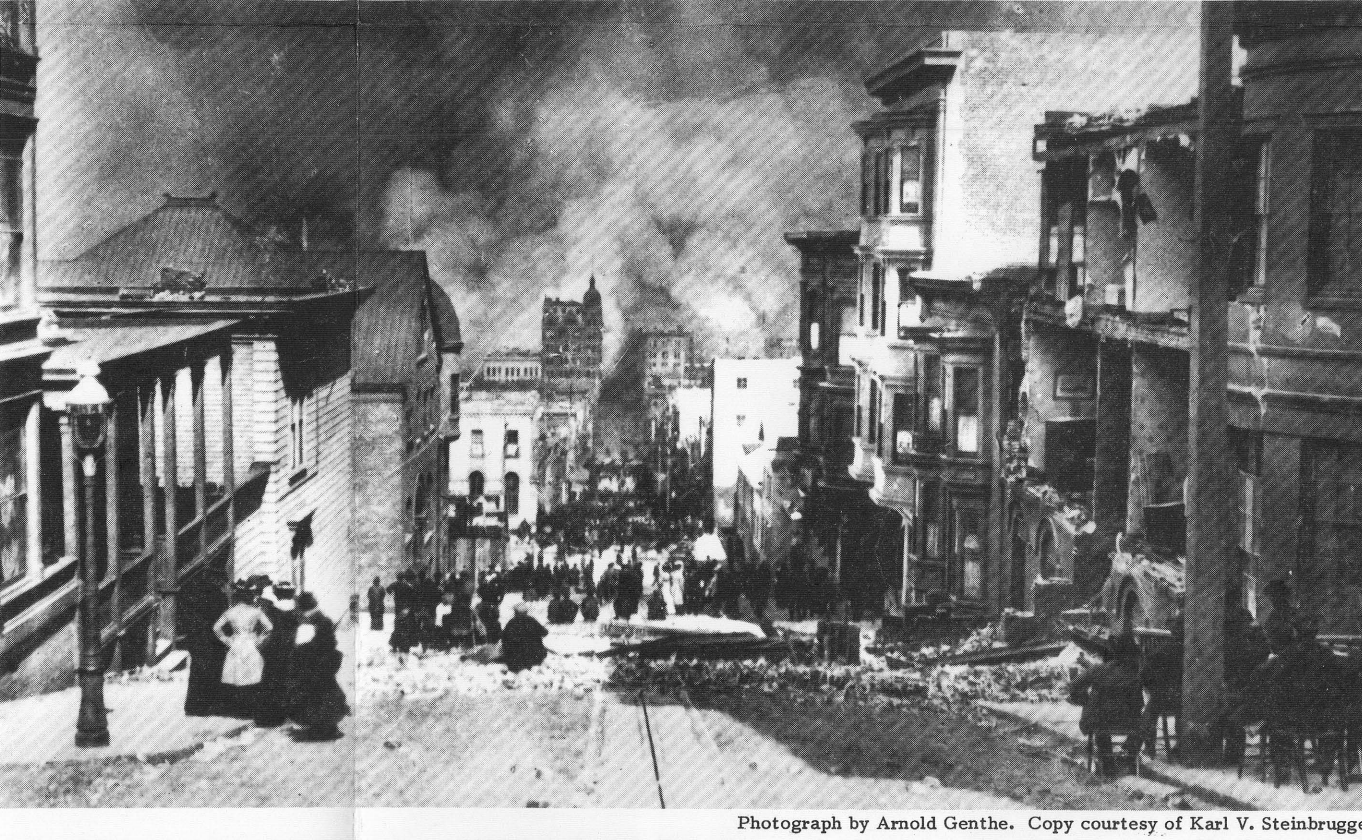
Photograph by Arnold Genthe. Copy courtesy of Karl V. Steinbrugge.
FIGURE 4.—San Francisco after the earthquake of 1906 (magnitude 8.3). Note that many of the visible buildings are not seriously damaged. Much of the damage in 1906 was caused by the fire rather than the ground shaking (although the lack of water with which to fight the fire resulted from the mains broken by the shaking). In the photograph, note from the left, an intact wood-frame building, two masonry buildings (the first has two collapsed chimneys), more buildings standing in the distance, and the fire several blocks away. From the right, notice cracks below the second story window of the first building, the unreinforced brick front of the second building collapsed above the first floor level and its debris scattered across the sidewalk and street, other buildings on the right that seem relatively intact.

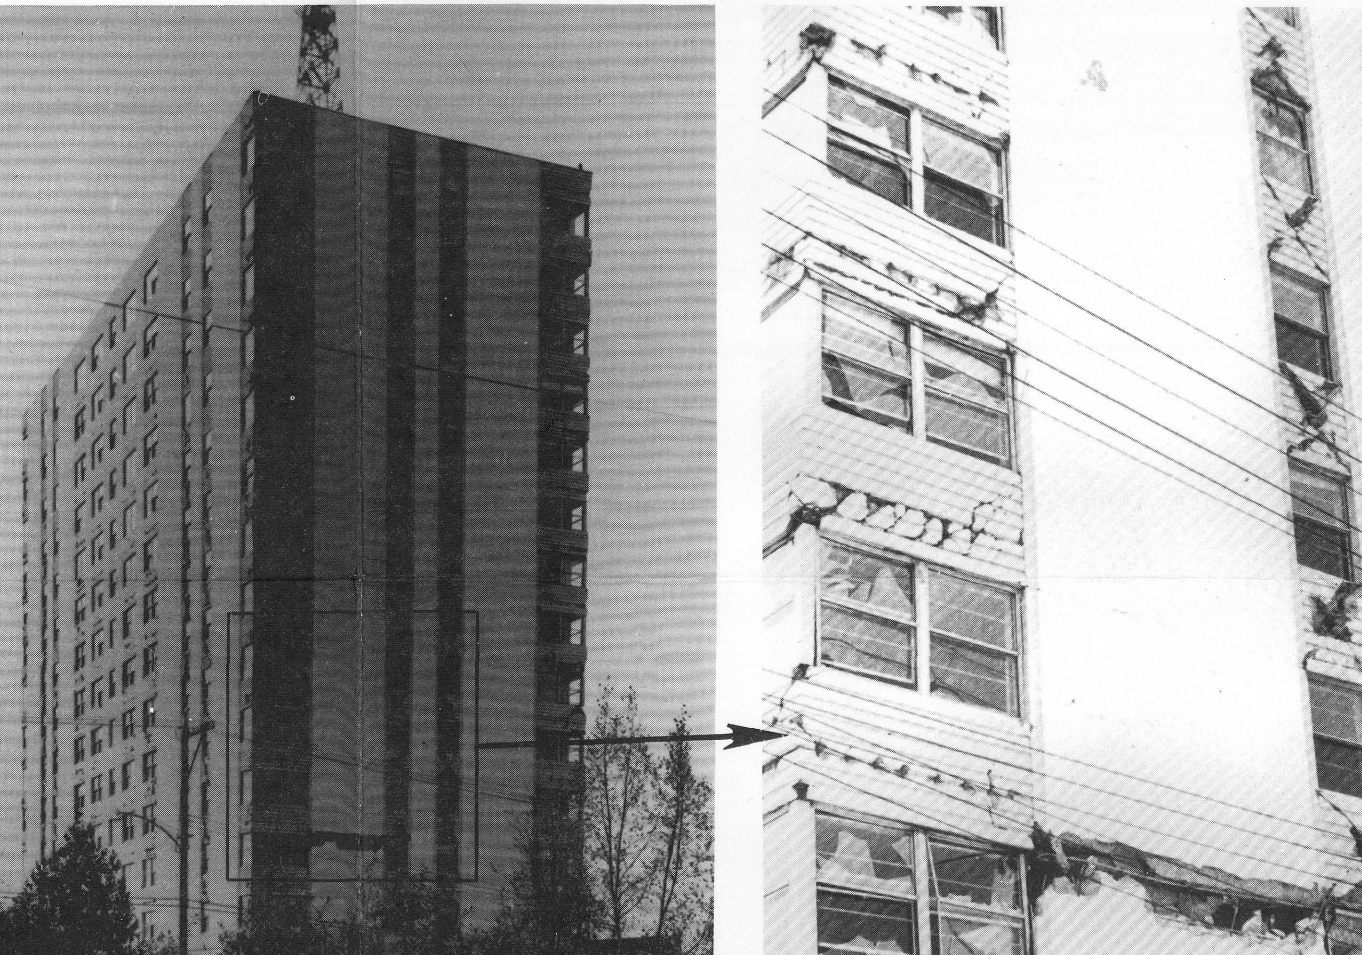
Photograph courtesy of Karl V. Steinbrugge.
FIGURE 9.—Close-up view of the part of figure 8 indicated by the rectangle, showing the failure of the pier at the third floor level, cracking at each floor level at the corners of the building, and X-cracking.

FIGURE 9.—Close-up view of the part of figure 8 indicated by the rectangle, showing the failure of the pier at the third floor level, cracking at each floor level at the corners of the building, and X-cracking.
