MAP SHOWING STRUCTURAL CONTOURS ON BEDROCK
 IN THE MILL CREEK AREA, CALIFORNIA

Geology and hydrology by
 L. C. Dutcher and W. L. Burnham, 1953 - 55

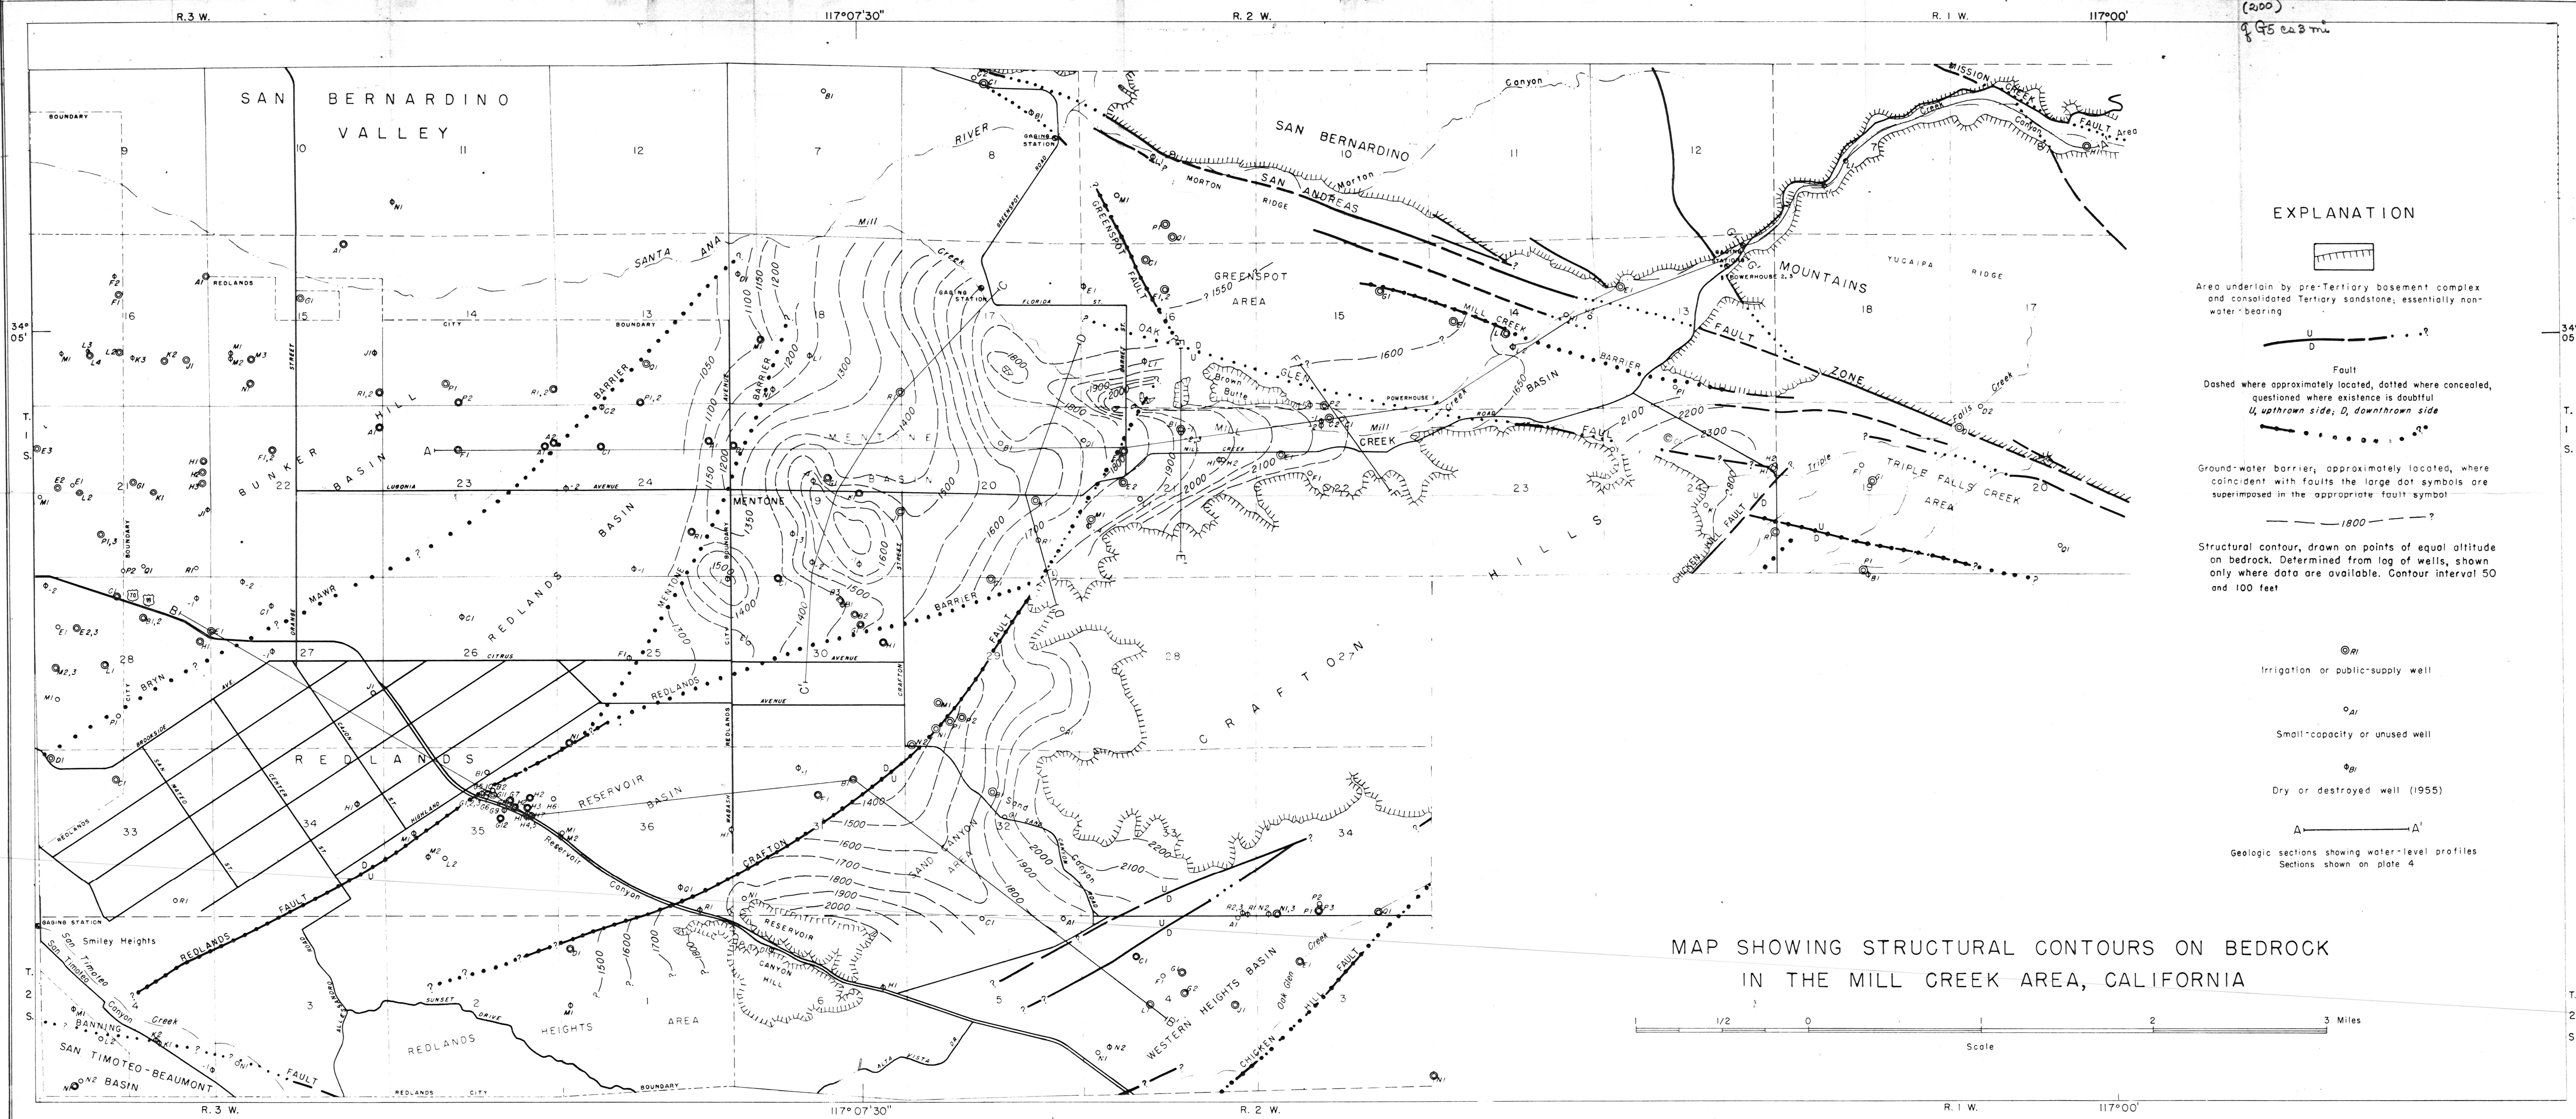
- Area underlain by pre-Tertiary basement complex and consolidated Tertiary sandstone, essentially non-water-bearing
- Fault
 Dashed where approximately located, dotted where concealed, questioned where existence is doubtful
 U, upthrown side; D, downthrown side
- Ground-water barrier, approximately located, where coincident with faults the large dot symbols are superimposed in the appropriate fault symbol
- Structural contour, drawn on points of equal altitude on bedrock. Determined from log of wells, shown only where data are available. Contour interval 50 and 100 feet
- Irrigation or public-supply well
- Small-capacity or unused well
- Dry or destroyed well (1955)
- Geologic sections showing water-level profiles
 Sections shown on plate 4
