UNITED STATES
DEPARTMENT OF THE INTERIOR
GEOLOGICAL SURVEY
Water Resources Division

THE GEOHYDROLOGY OF
PINNACLES NATIONAL MONUMENT
CALIFORNIA

J. P. Akers

67-2
OPEN-FILE REPORT

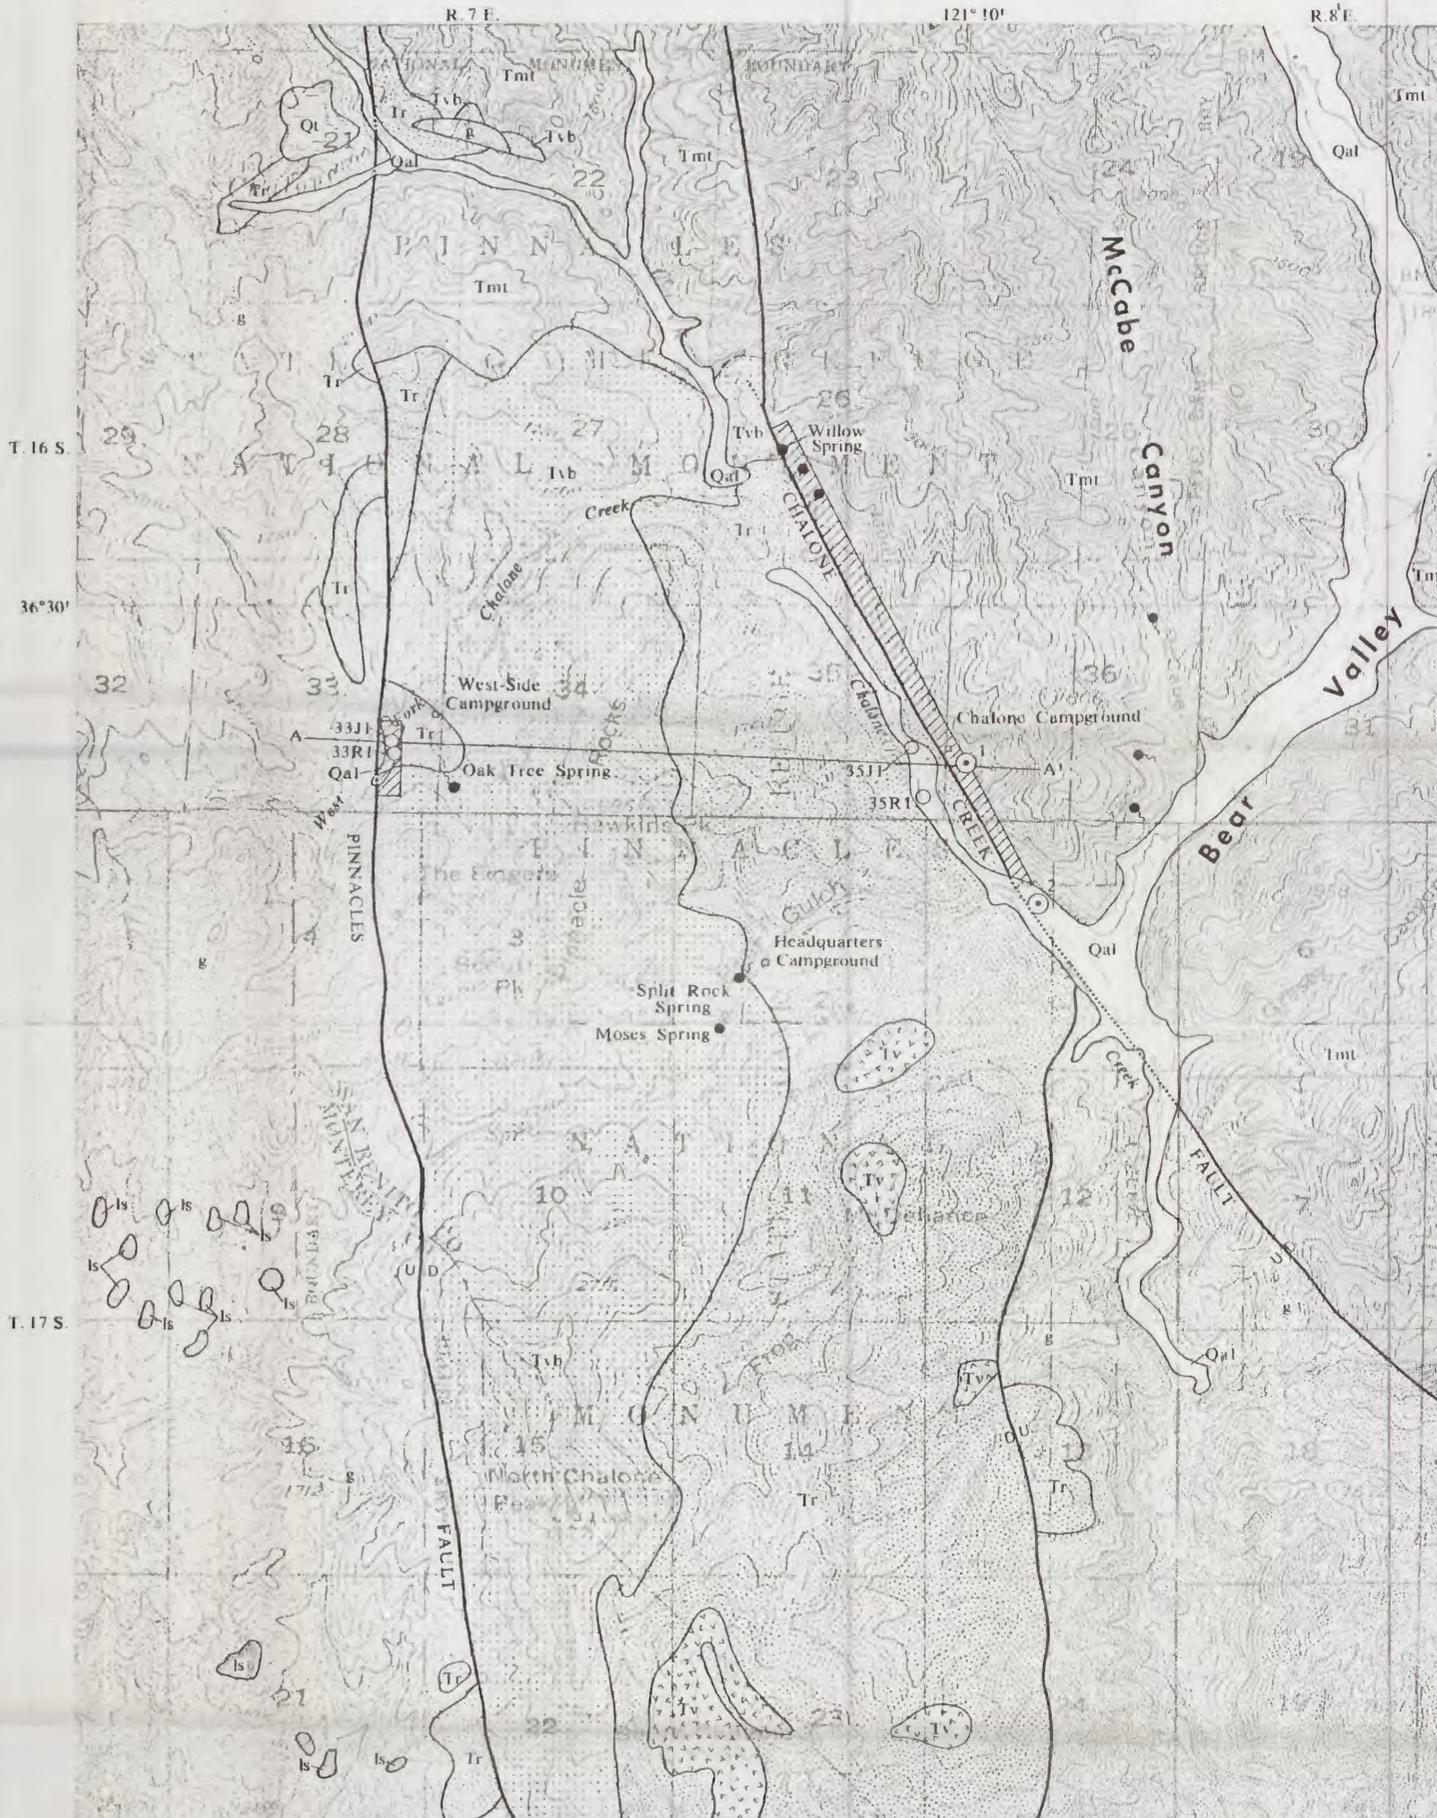
Base from Greenfield and San Benito topographic quadrangles, scale 1:62 500

Geology modified by R.E. Evenson, 1959, after Philip Andrews, 1936, and Ivan Wilson, 1943

The fact that the wells flow under considerable pressure indicates that the recharge area to the fractures is higher than the well sites. As indicated in figure 2, the recharge area is in the surrounding hills and could be in the fault zone itself or in fractures in the breccias to the east. Perhaps, some water moves westward down dip through the permissive bedding planes in the breccias.

Prior to the construction of wells in the alluvium along Chalone Creek, water for use at Pinnacles National Monument was obtained from Split Rock Spring (fig. 2) just upstream from a picnic ground near the park headquarters. This spring emanates from fractures in volcanic breccias and tuffs. The yield is reported to be less than 2 gpm.

The long-term yield of this well is conjectural. The water comes from a fracture system of unknown size in volcanic breccias and tuff. Probably, the fracture system is extensive and occupies a fairly broad zone along the Pinnacles fault (fig. 2).

The most favorable area for development of ground water on the west side of the monument is along the east side of the Pinnacles fault. Most of the area, indicated on figure 2, is easily accessible to a drilling rig and wells drilled within the area should encounter conditions similar to those in the existing wells.
