WATER AND COPPER-MINE TAILINGS
IN KARST TERRANE OF RIO TANAMA BASIN,
PUERTO RICO

WATER AND COPPER-MINE TAILINGS IN KARST TERRANE
OF RIO TANAMA BASIN, PUERTO RICO

by *George*
Donald G. Jordan, 1926-
U.S. Geological Survey

October 1970

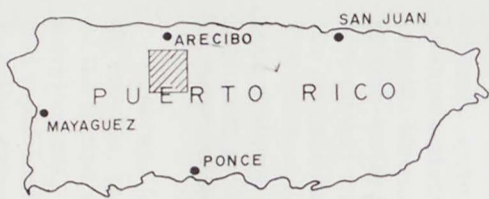
Figure 1.--Tailings disposal area, dye-injection points, and sampling station in lower Río Tanamá and Río Grande de Arecibo basins.

In the first two injection phases, observation sites were monitored only on Rfo Tanamá. In the third phase, all the observation sites shown in figure 1 in the Rfo Tanamá and Rfo Grande de Arecibo basins were monitored.

Traces of dye were observed in San Pedro Spring (fig. 1) during Phase III, indicating subsurface movement of water from Río Tanamá. The dye first was detected at 1215 November 13, but the edge of the dye cloud is estimated to have reached the spring from 12 to 18 hours earlier. No traces of dye were observed in Quebrada Jobos during Phase III, nor would it be expected because Quebrada Jobos lies beyond a ground-water divide.

The water loss from Río Tanamá probably occurred somewhere between Site C and Charco Hondo (fig. 1). One possible area is about 0.8 mile downstream of Site C, and a second is about 0.2 mile upstream of the old hydroelectric plant at Charco Hondo. A subsurface velocity of about 6 feet per minute from the first site and about 3 feet per minute from the second would be required for dyed water to move from river to spring.

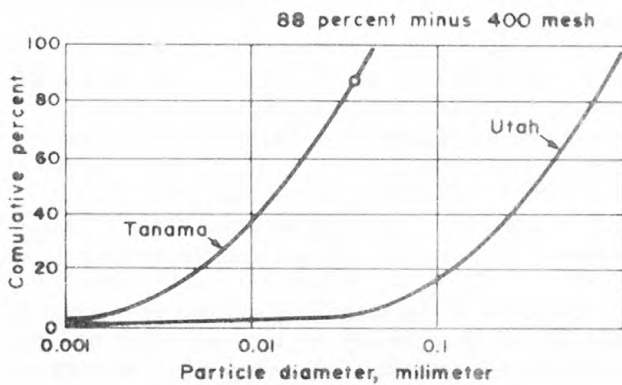
Figure 10.--Cumulative curve of particle size of tailings, Tanamá ore body and Utah mine.

The size of the tailings particles is critical to the degree of transport the tailings might undergo once deposited in the tailings ponds. Hjulstrom (Krumbein and Sloss, 1951) formalized the hydrodynamic relations of particle movement in running water, demonstrating that at certain critical velocities particles will be eroded, transported, or deposited. A comparison of particle size of the Utah tailings and the theoretical particle size of the Tanamá tailings is shown in figure 10.
