ARTIFICIAL RECHARGE

YUCAIPA, CALIFORNIA

U.S. DEPARTMENT OF THE INTERIOR
GEOLOGICAL SURVEY

PREPARED IN COOPERATION WITH THE
SAN BERNARDINO VALLEY MUNICIPAL
WATER DISTRICT

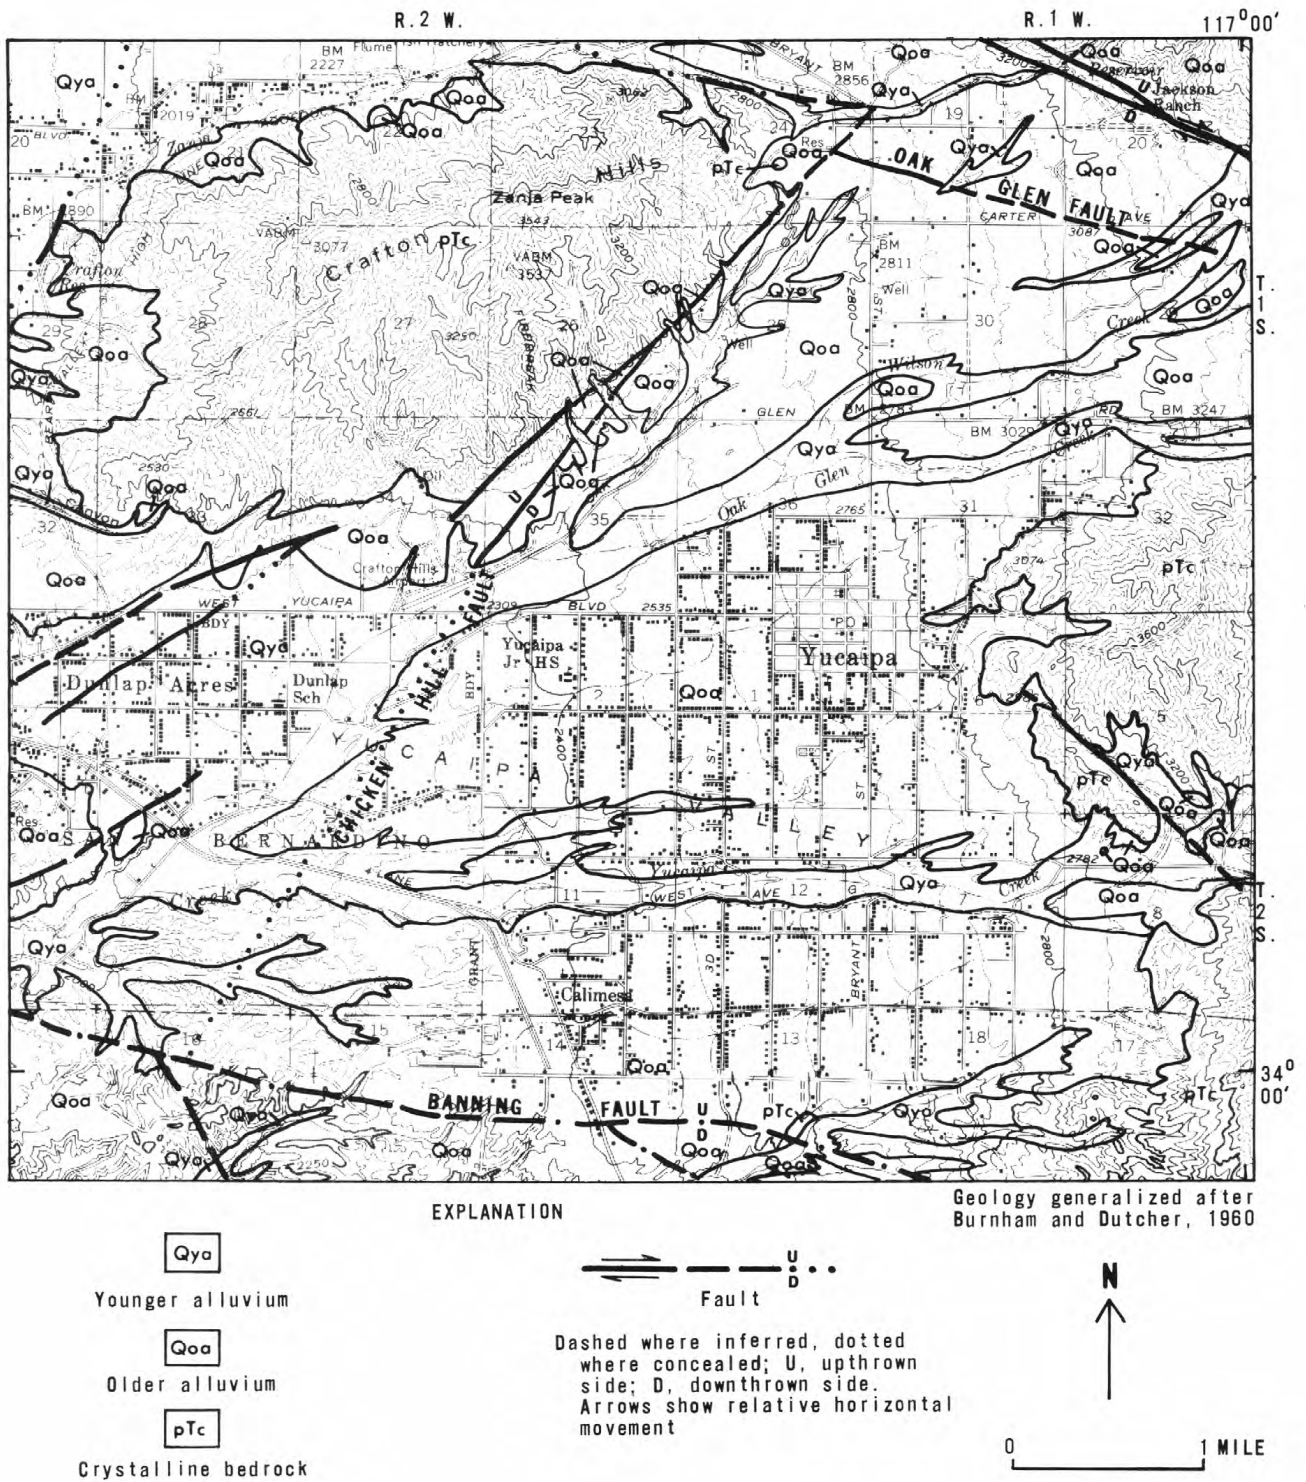
FIGURE 3.--Geology of study area.

Figure 3 shows the generally surficial geology of the Yucaipa area and the faults that restrict ground-water movement. In this study three geologic units have been identified--crystalline bedrock, older alluvium, and younger alluvium.

Crystalline bedrock composes the basement complex underlying the Yucaipa plain and forms the bordering hills. These igneous and metamorphic rocks are of pre-Tertiary age and consist of granite, quartz monzonite, dioritic gneiss, and mica schist. The unit is considered to be non-water-bearing and is impermeable except where fractured or weathered.

Older alluvium unconformably overlies most of the basement complex. These deposits are of middle to late Pleistocene age and consist of boulders, gravel, sand, silt, and clay. The permeability of these unconsolidated deposits, which constitute the main ground-water aquifer, ranges from 50 to 300 gallons per day per square foot (Burnham and Dutcher, 1960, p. 80). Most of the ground water pumped by wells is from this unit.

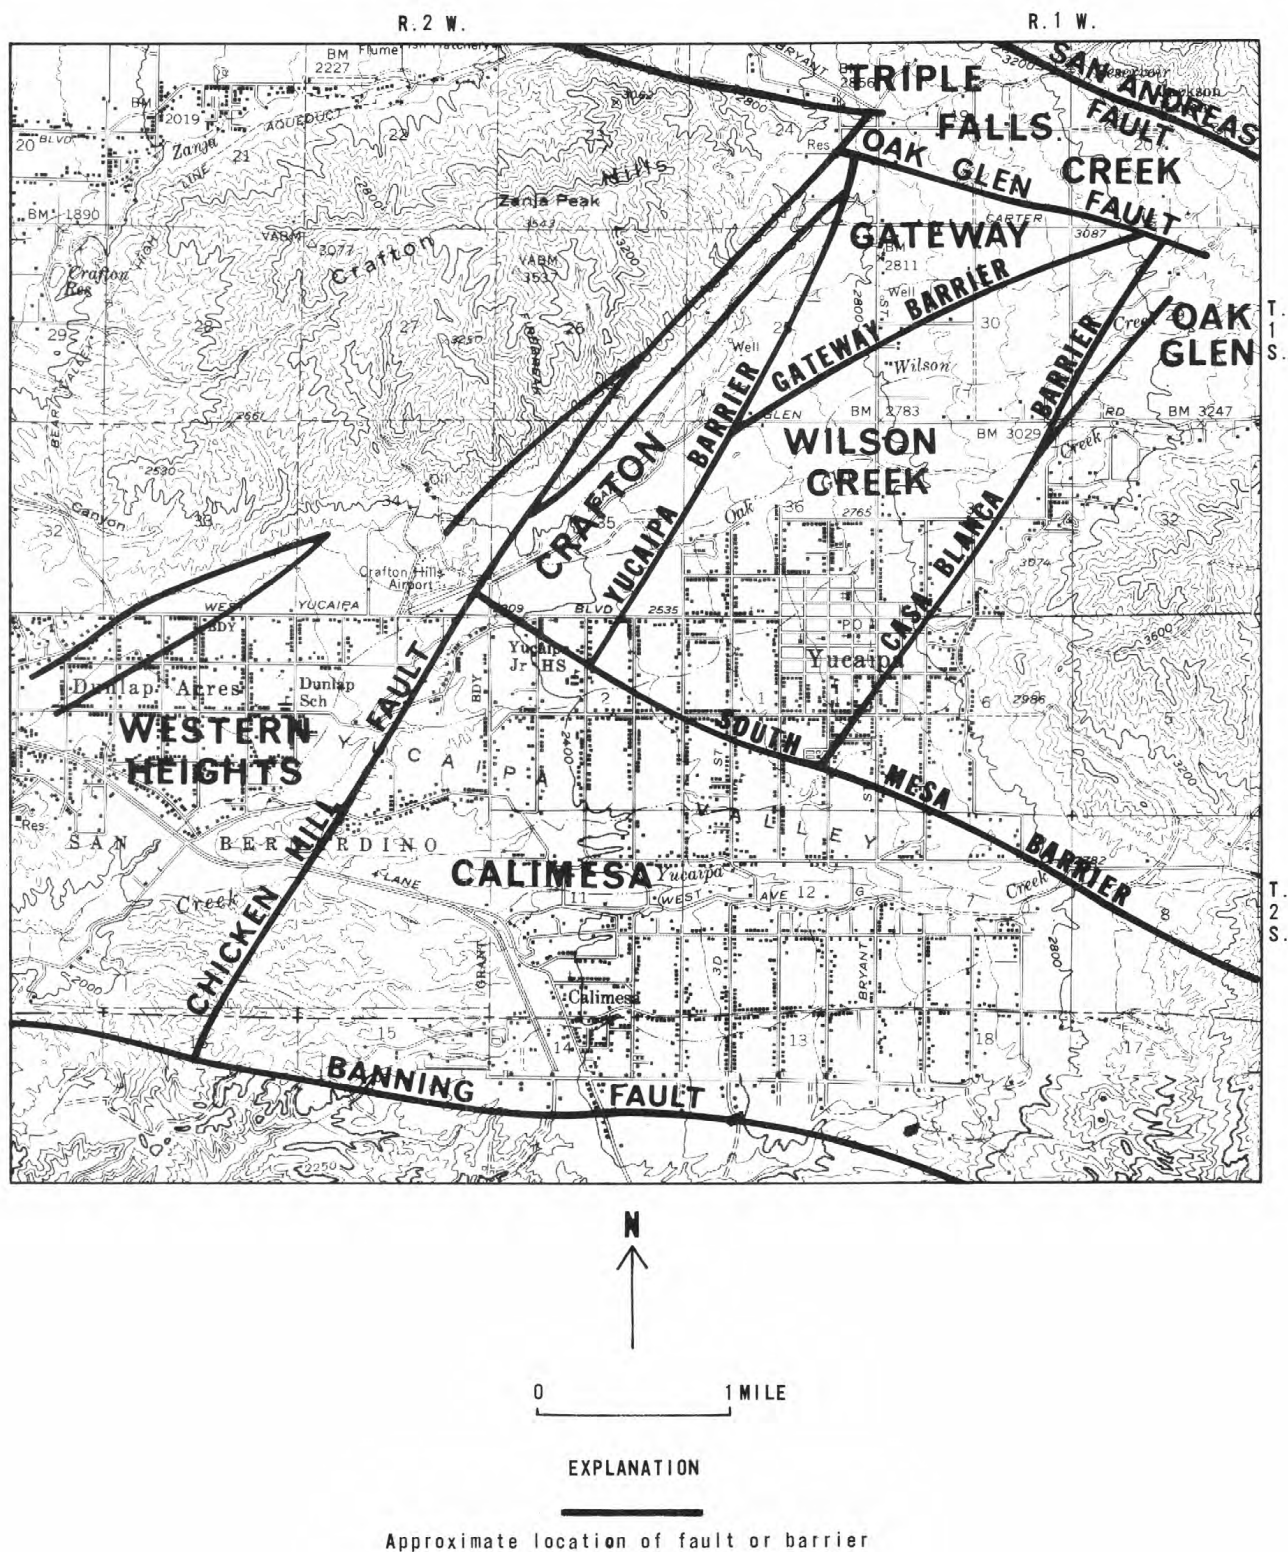
FIGURE 4.--Location of ground-water subbasins, faults, and barriers to ground-water flow.

Faults are important in a hydrologic study not only because of their influence on the general topography but also because of their influence on the flow of ground water. Fault zones in consolidated rocks often consist of cracks and fissures which serve as conduits for ground-water flow. Conversely, faults that transect permeable unconsolidated materials may produce barriers to ground-water flow. Although the barrier effects displayed by faults are not completely understood, offset beds, gouge material, sharp folds, and chemical cementation are suspected to contribute to reduced permeability. In the Yucaipa area faults have divided the ground-water basin into several nearly isolated subbasins (fig. 4).

Two groups of faults are present in the Yucaipa area. One group, which includes the Banning and Oak Glen faults, is nearly parallel to the northwest-trending San Andreas and San Jacinto fault systems. The other group, which includes the Chicken Hill fault, trends northeast between the Banning and San Andreas faults. The existence of other faults is postulated from geophysical and water-level data. These unnamed faults are referred to as barriers to ground-water flow in figure 4.

Evidence for the Gateway barrier is based on hydrologic data. The barrier effectively retards the flow of ground water, as shown in figures 6, 7, and 8. Projected water-level contours indicate a water-level drop of at least 160 feet across the barrier. Because there are few wells in the area of the suspected barrier, the location of the fault is not well defined. The fault is known to exist north of wells 1S/2W-36C1 and 1S/2W-25R1 and south of wells 1S/2W-25K1 and 1S/1W-30G1, and is shown in figure 4 in approximately the same location as described by Burnham and Dutcher (1960).

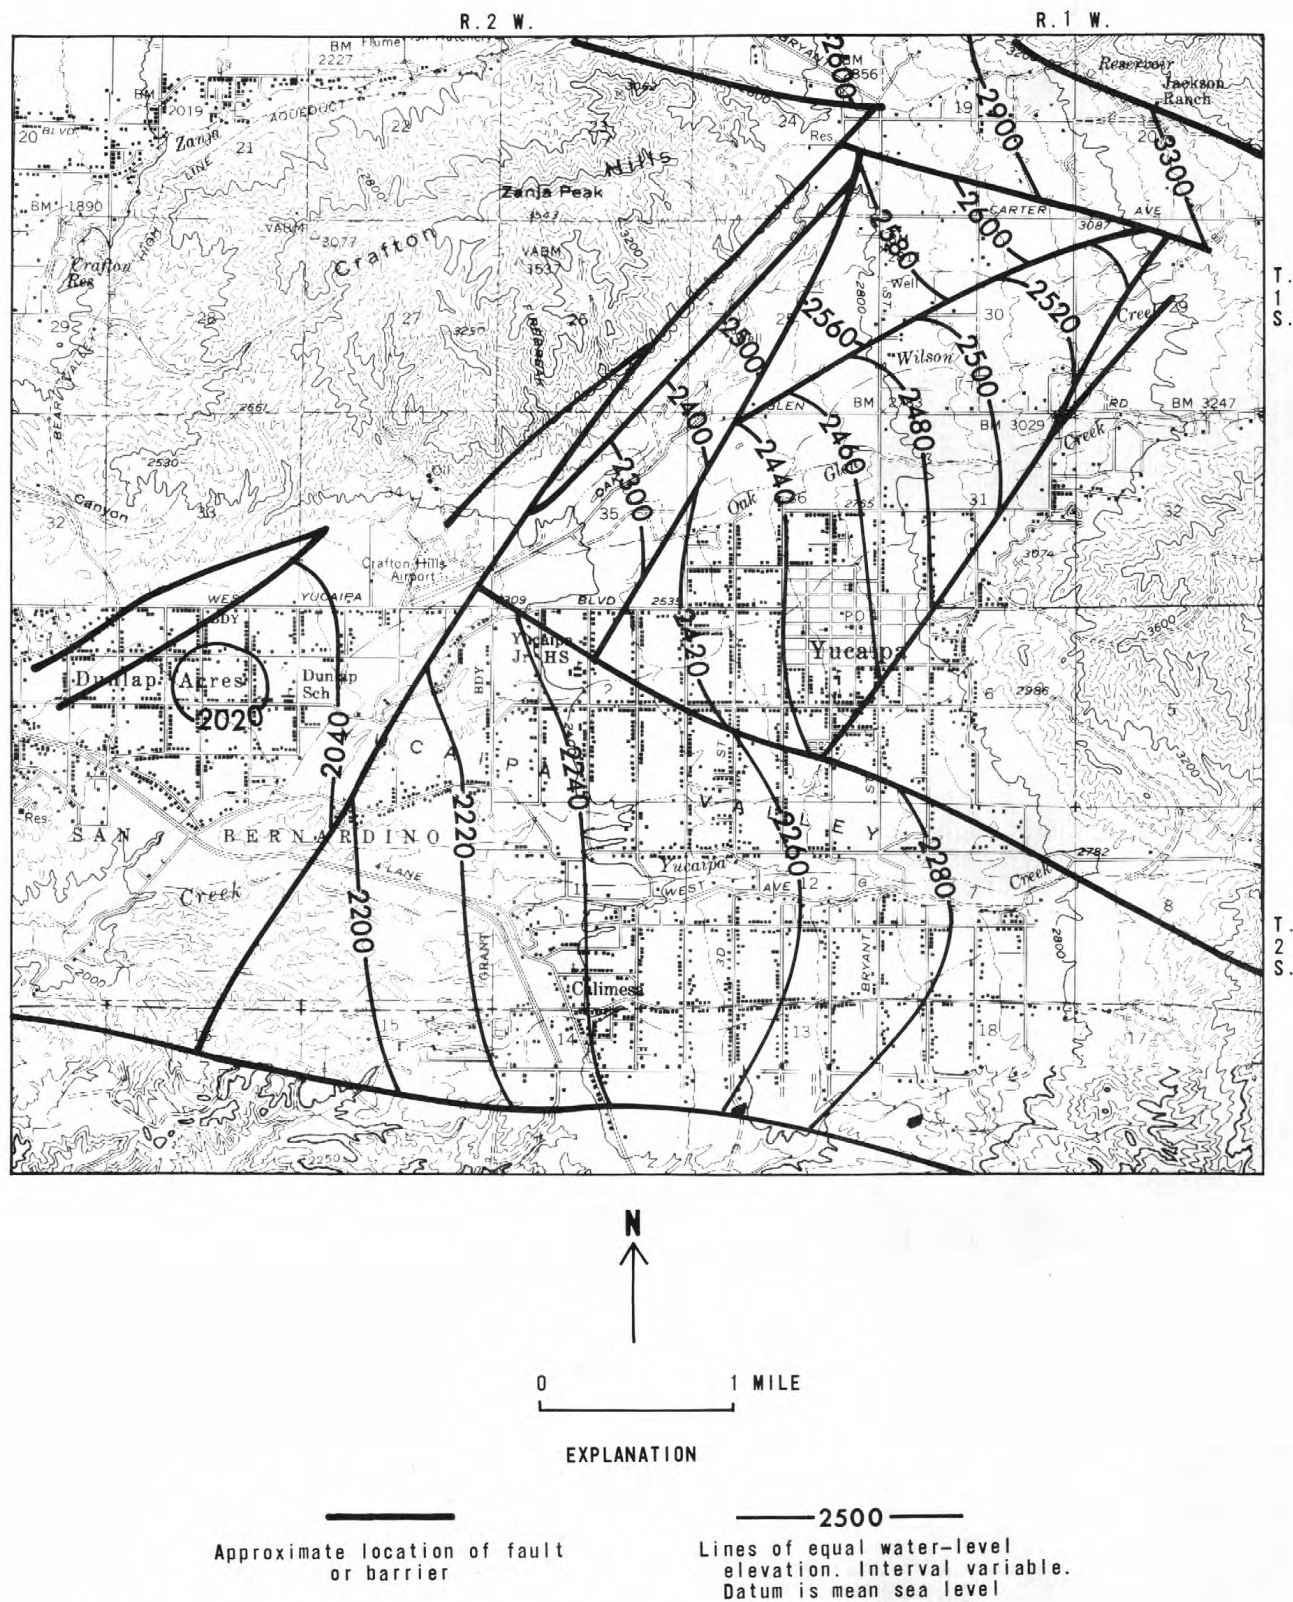
FIGURE 6.--Water-level elevations, 1930.

The effectiveness of this fault as a barrier to ground-water flow is shown by water-level contours (figs. 6-8). Most of the ground water north of the fault flows to the west into the Mill Creek area while the remainder leaks across the barrier into the Gateway subbasin. Water-level differences of as much as 400 feet exist across part of the fault.

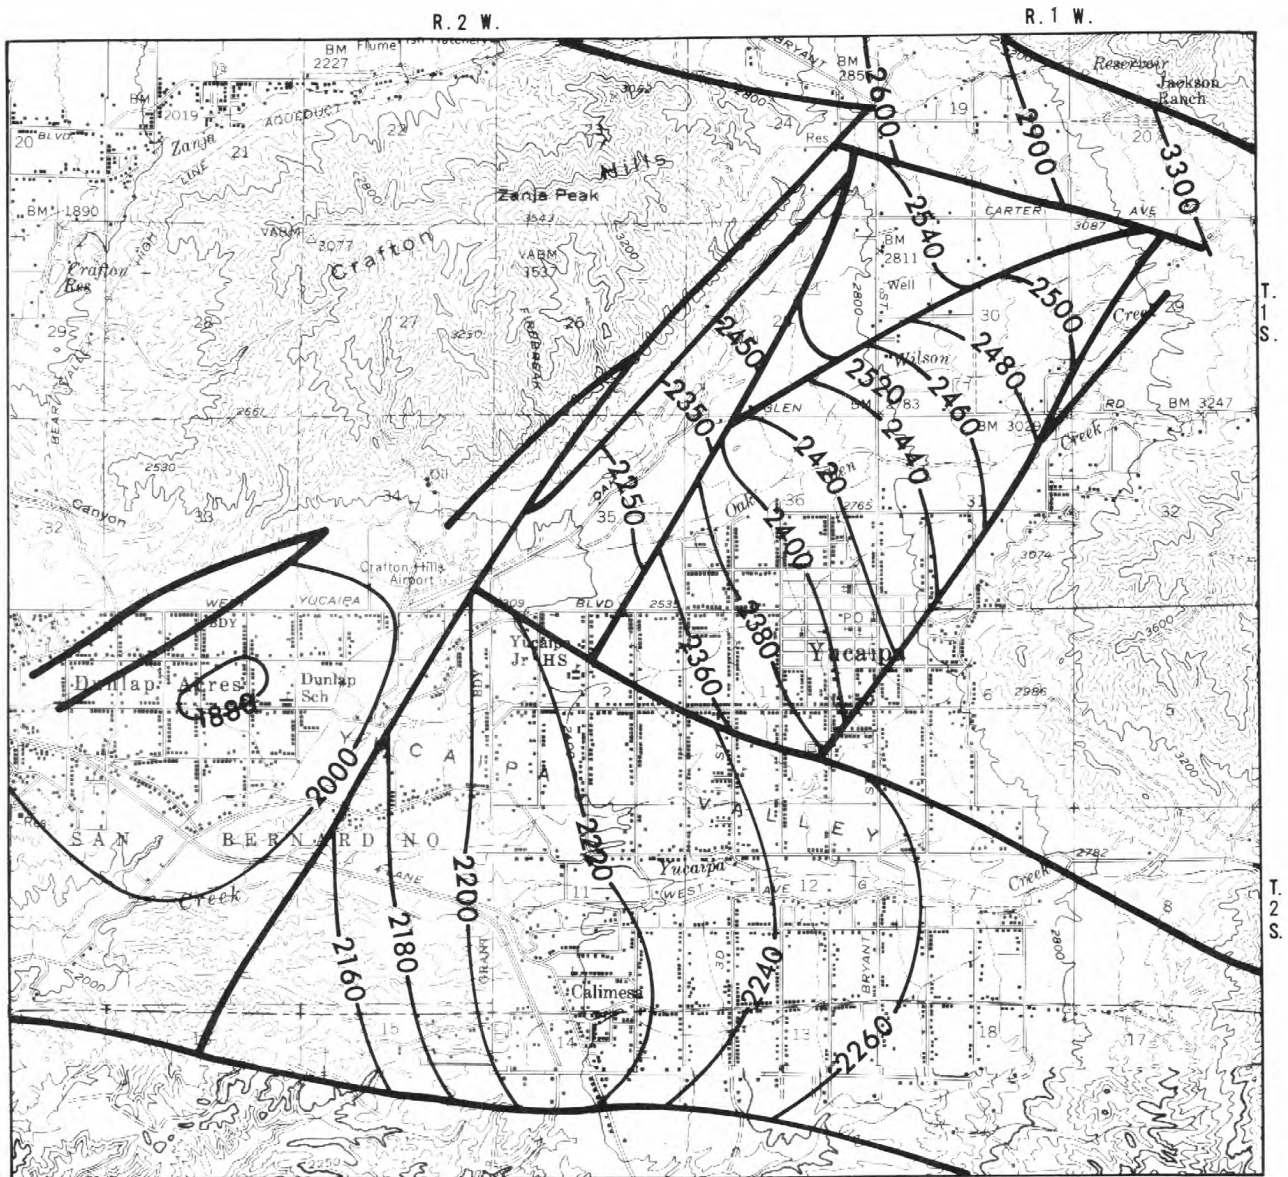
FIGURE 7.--Water-level elevations, 1945.

—
Approximate location of fault
or barrier

— 2500 —
Lines of equal water-level
elevation. Interval variable.
Datum is mean sea level

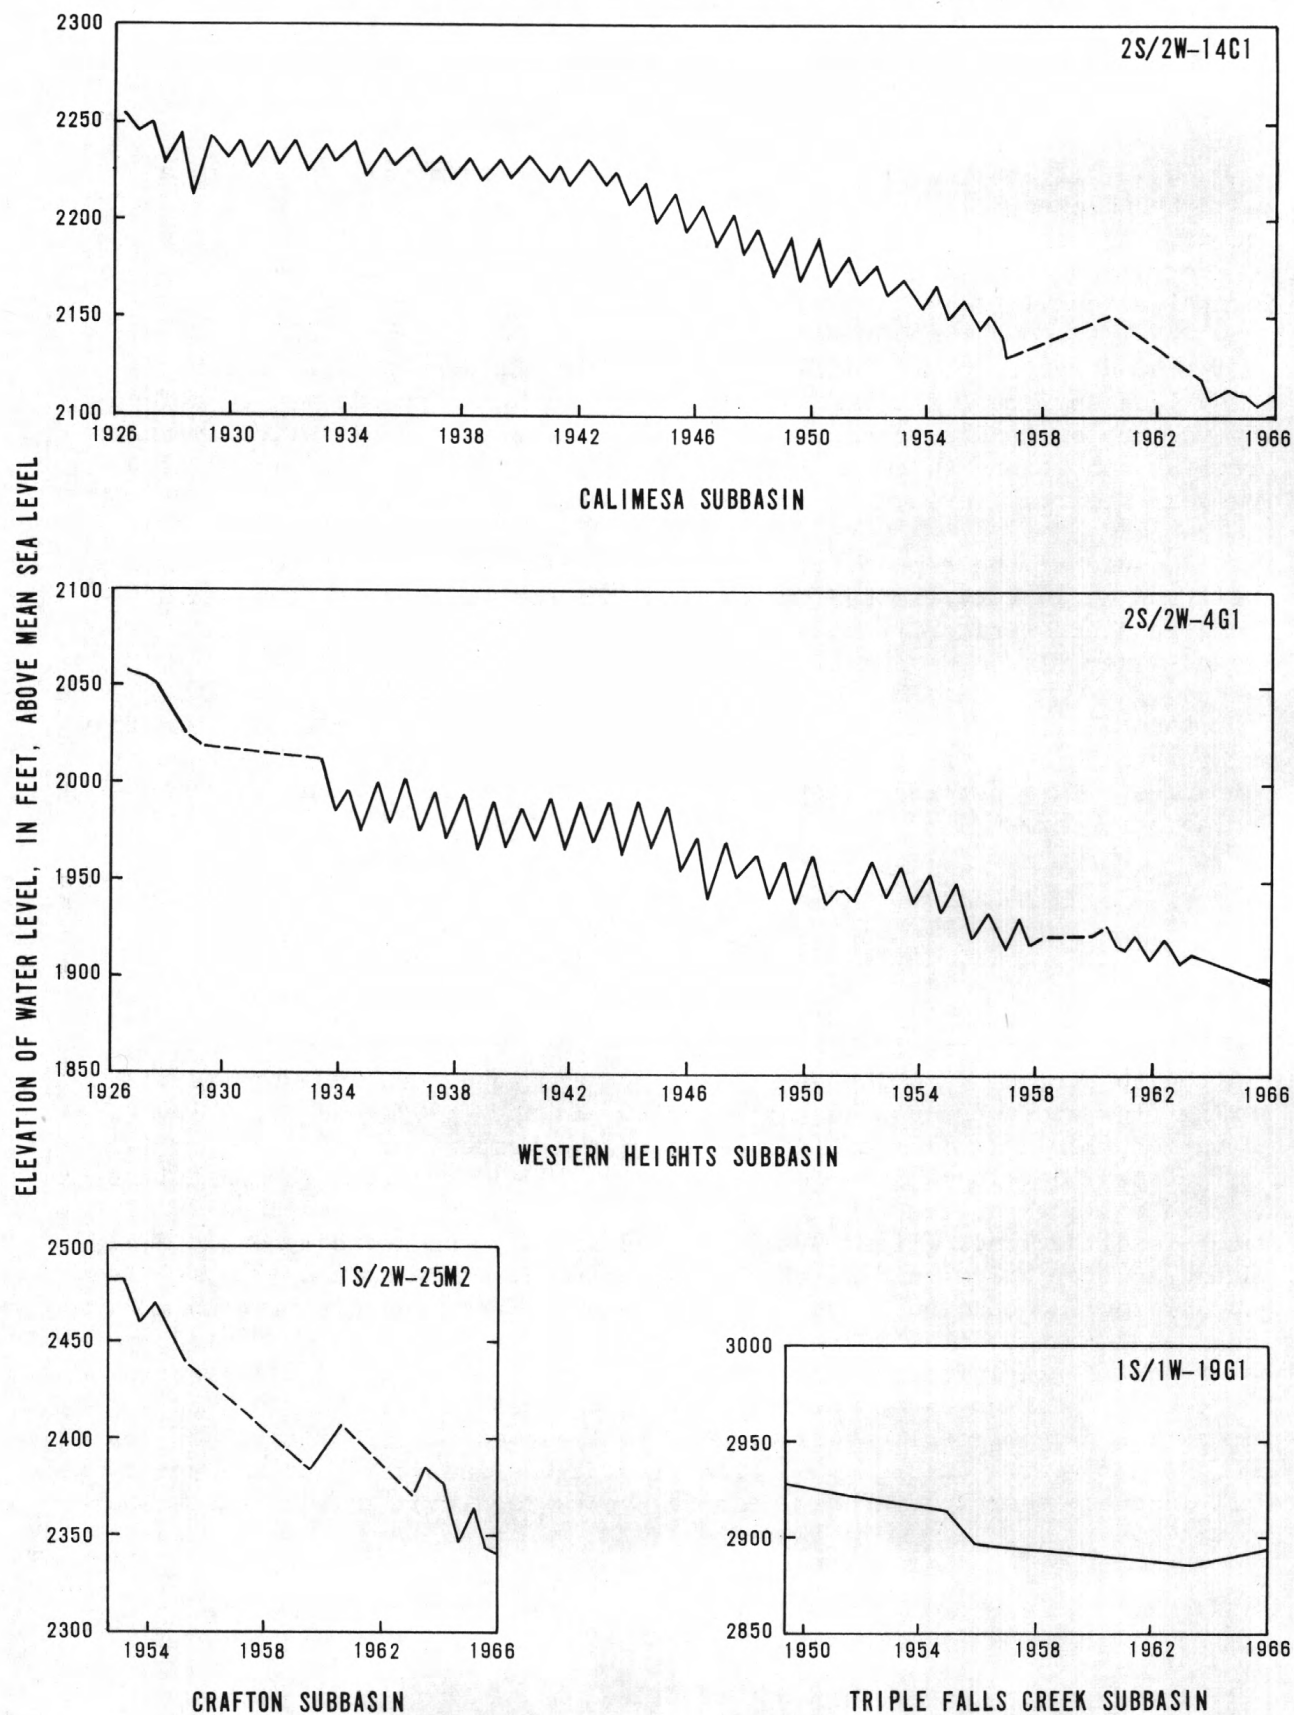
FIGURE 9.--Hydrographs of selected wells.

The annual pumpage from 1960 through 1965 from the Yucaipa basin as shown in table 1 was about 12,000 acre-feet. This value exceeds the average available water supply of 7,000 acre-feet per year, as computed in table 2 from the method outlined by Crippen (1965). The imbalance of discharge in excess of recharge is illustrated in the declining water levels.

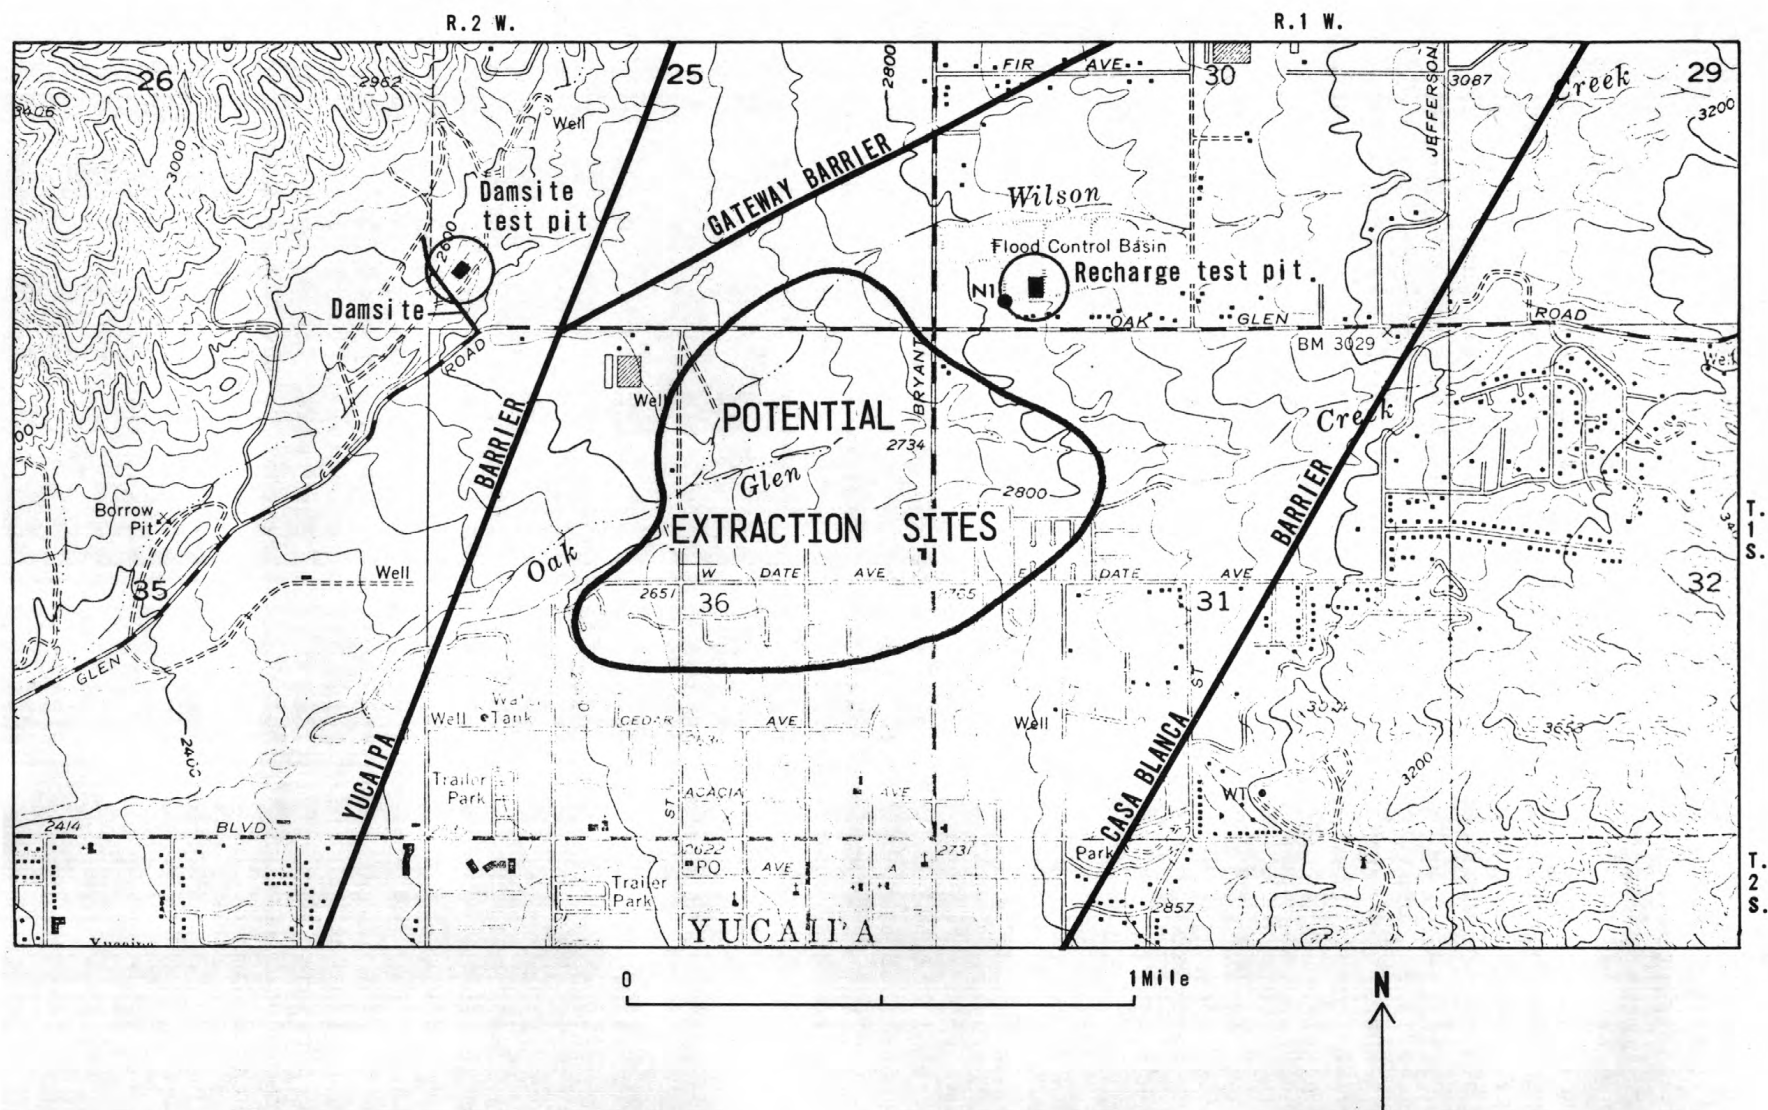
FIGURE 11.--Location of test pits, damsite, and potential extraction sites.

Use of the Wilson Creek subbasin as a storage and distribution system is dependent on its ability to accept recharge. The prime recharge site is the Wilson Creek retaining basins in sec. 30, T. 1 S., R. 1 W. (fig. 11). The retaining basins are owned and operated by the San Bernardino Flood Control District and are used only during floodflow. Total surface area is about 34 acres ranging in elevation from 2,850 to 2,950 feet. The location, surface elevation, and long periods of disuse, plus the fact that retaining walls already exist, make this ideal as a recharge site.

Figure 11 delineates the areas which would be most favorable as extraction sites based on the above factors.

The dam and reservoir site (fig. 11) is in an unnamed stream channel deeply entrenched in the older alluvium of the Yucaipa plain. The floor of the stream channel is underlain with 10 to 30 feet of younger alluvium, mainly poorly sorted and unconsolidated channel deposits, consisting of boulders, gravel, sand, and small quantities of silt and clay. The older alluvium that underlies the channel deposits and is exposed in the steep banks of the channel consists of moderately sorted, slightly weathered and compacted boulders, gravel, sand, silt, and clay.

The site for the infiltration pit (fig. 11) was selected near the location of the proposed dam where the highest head conditions will exist when the reservoir is filled to capacity. A test pit was constructed by excavating an area of 80 feet by 90 feet to a depth of about 1 foot and placing the excavated material around the perimeter. Water for the test was made available by installing a metered connection to the pipeline from Improvement District A well No. 9 (1S/2W-25M2).

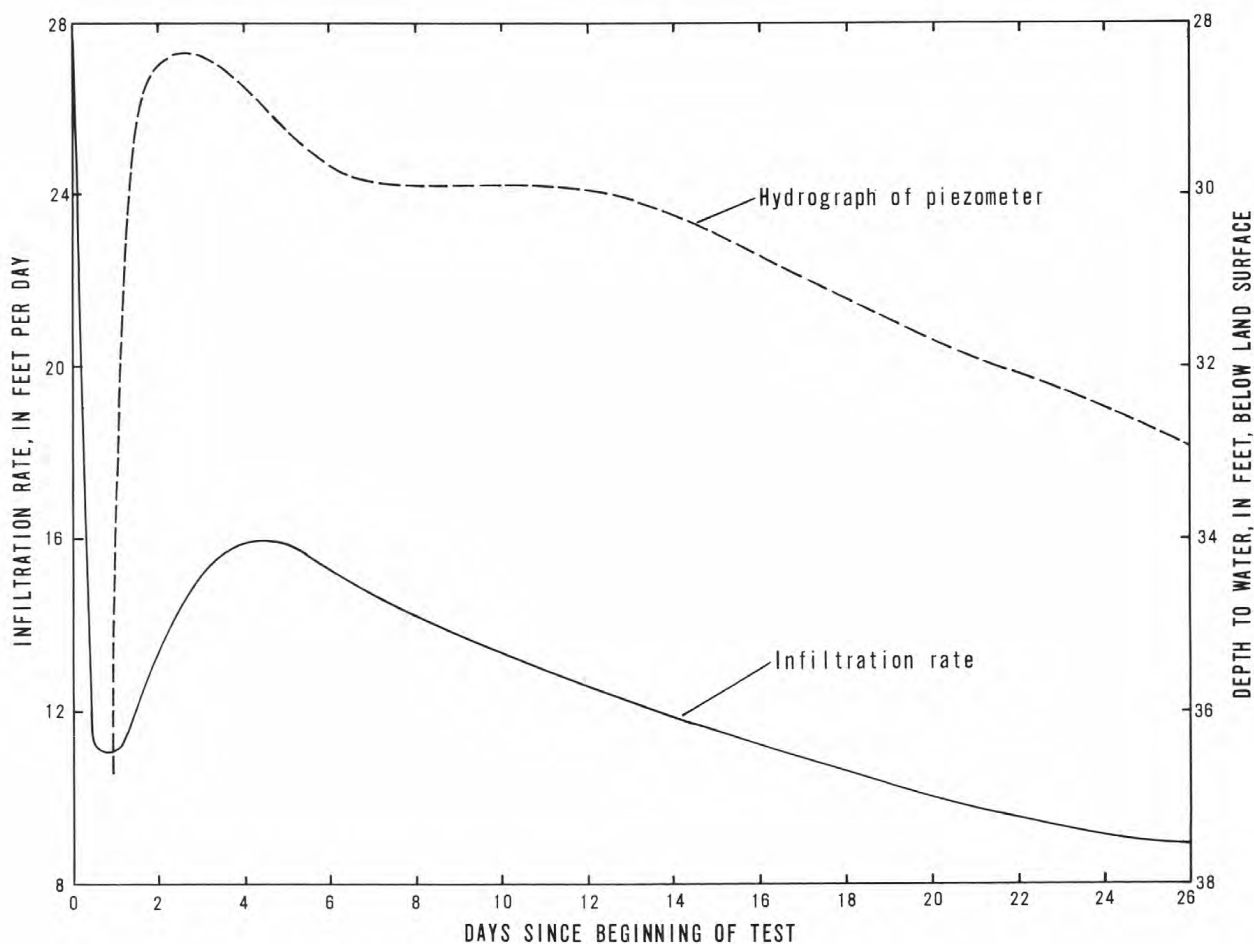
FIGURE 12.--Infiltration rate and depth to perched water body, Wilson Creek recharge site.

The infiltration rate (fig. 12) at the beginning of the test was nearly 26 feet per day as the water was drawn into the soil by absorption forces that exceed the usual gravity forces. As the moisture deficiency of the soil was made up, infiltration rapidly decreased until a rate of 11 feet per day was reached after about 24 hours. This lower rate was caused by air trapped in the downward moving water. As the air escaped, infiltration rate increased. The increase continued through the 5th day when the rate reached 17 feet per day. During the remaining 3 weeks of testing, saturation and clogging resulted in a gradual decrease in the infiltration rate to a minimum of 9 feet per day. The rate would apparently have continued to decline although at a progressively smaller rate.

Water-level measurements from the piezometer (fig. 12) that survived the floods show formation of a perched water body beneath the test pit. Water was detected in the piezometer 12 hours after the test began and rose to a height of 28 feet below land surface in less than 2 days. A 2-foot decline during the next 4 days was followed by a gradual decline of 3 feet during the remaining 3 weeks of the test. The piezometer was dry 18 hours after water delivery to the test pit was stopped. The regional water table in the test pit area was about 470 feet below land surface during the test.

The test was begun March 13, 1969, and continued through April 7, 1969, during which time a total of 27 acre-feet of water was spread over a wetted area which ranged from 3,000 to 5,125 square feet. Depth of water in the pit ranged up to a maximum of 3 feet but averaged less than 1 foot.

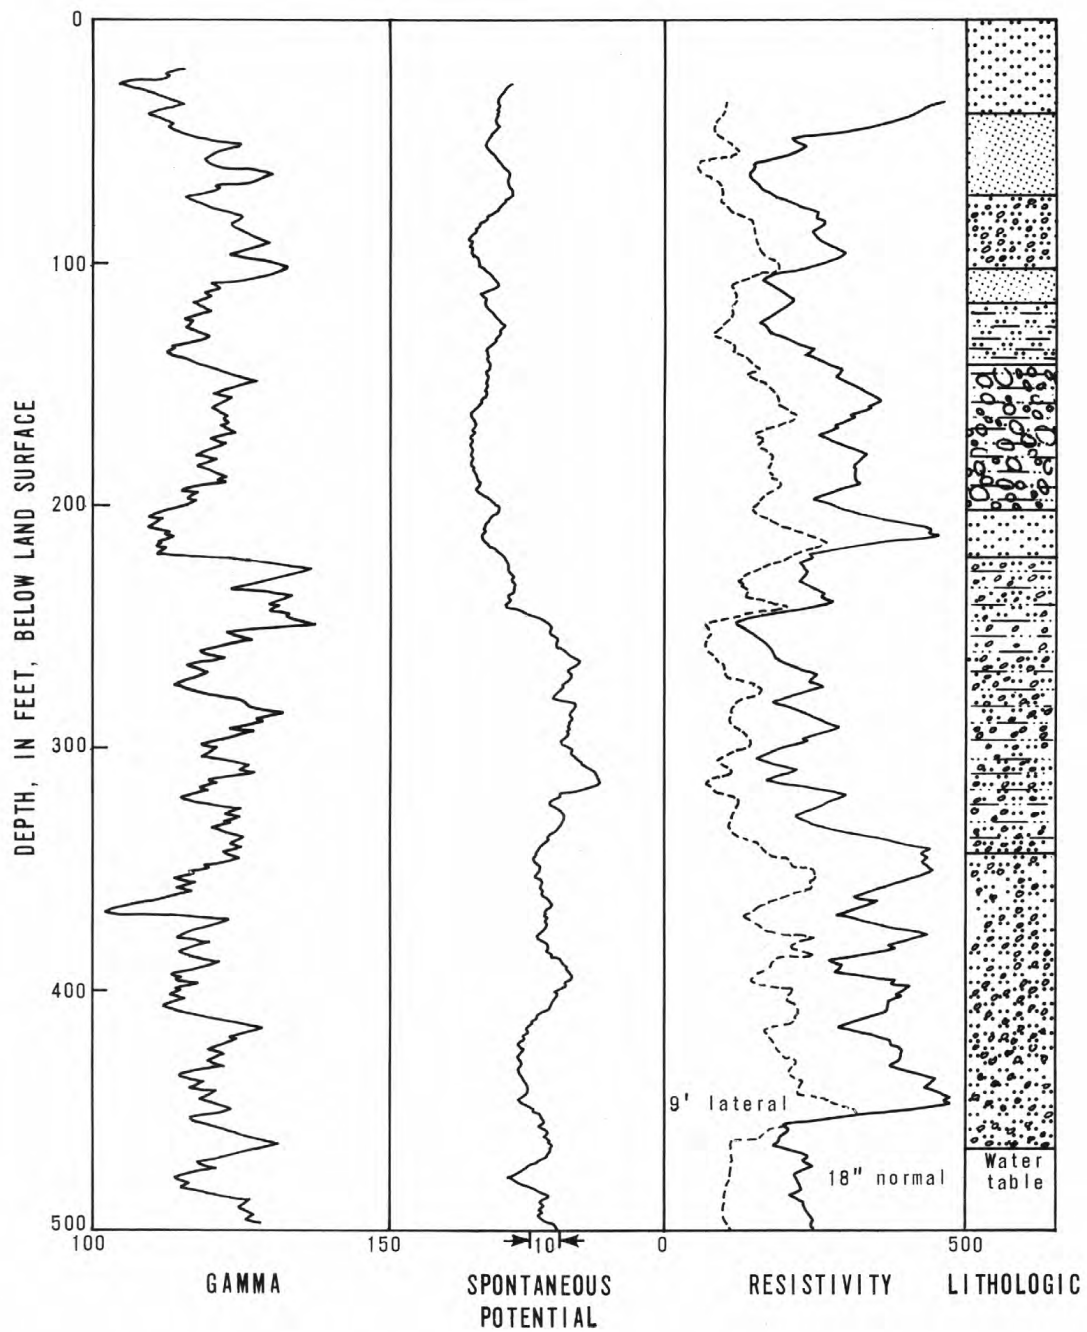
FIGURE 13.--Geophysical and lithologic logs of test well, 1S/1W-30N1.

The test hole, 1S/1W-30N1, was drilled by conventional rotary method to a depth of 500 feet. Geophysical logs were made to determine the location and thickness of any impermeable horizons. A composite log (fig. 13), constructed from the driller's log and interpretations of the electric and gamma logs, indicates that no clay deposits exist above the water table. Although the material encountered is not highly permeable, primarily because of poor sorting and weathering, it appears to be permeable enough to allow recharged water to percolate to the water table.

A 2-inch observation well was installed to monitor the effects of recharge in the water table in the event that Wilson Creek retaining basins are used as recharge pits.

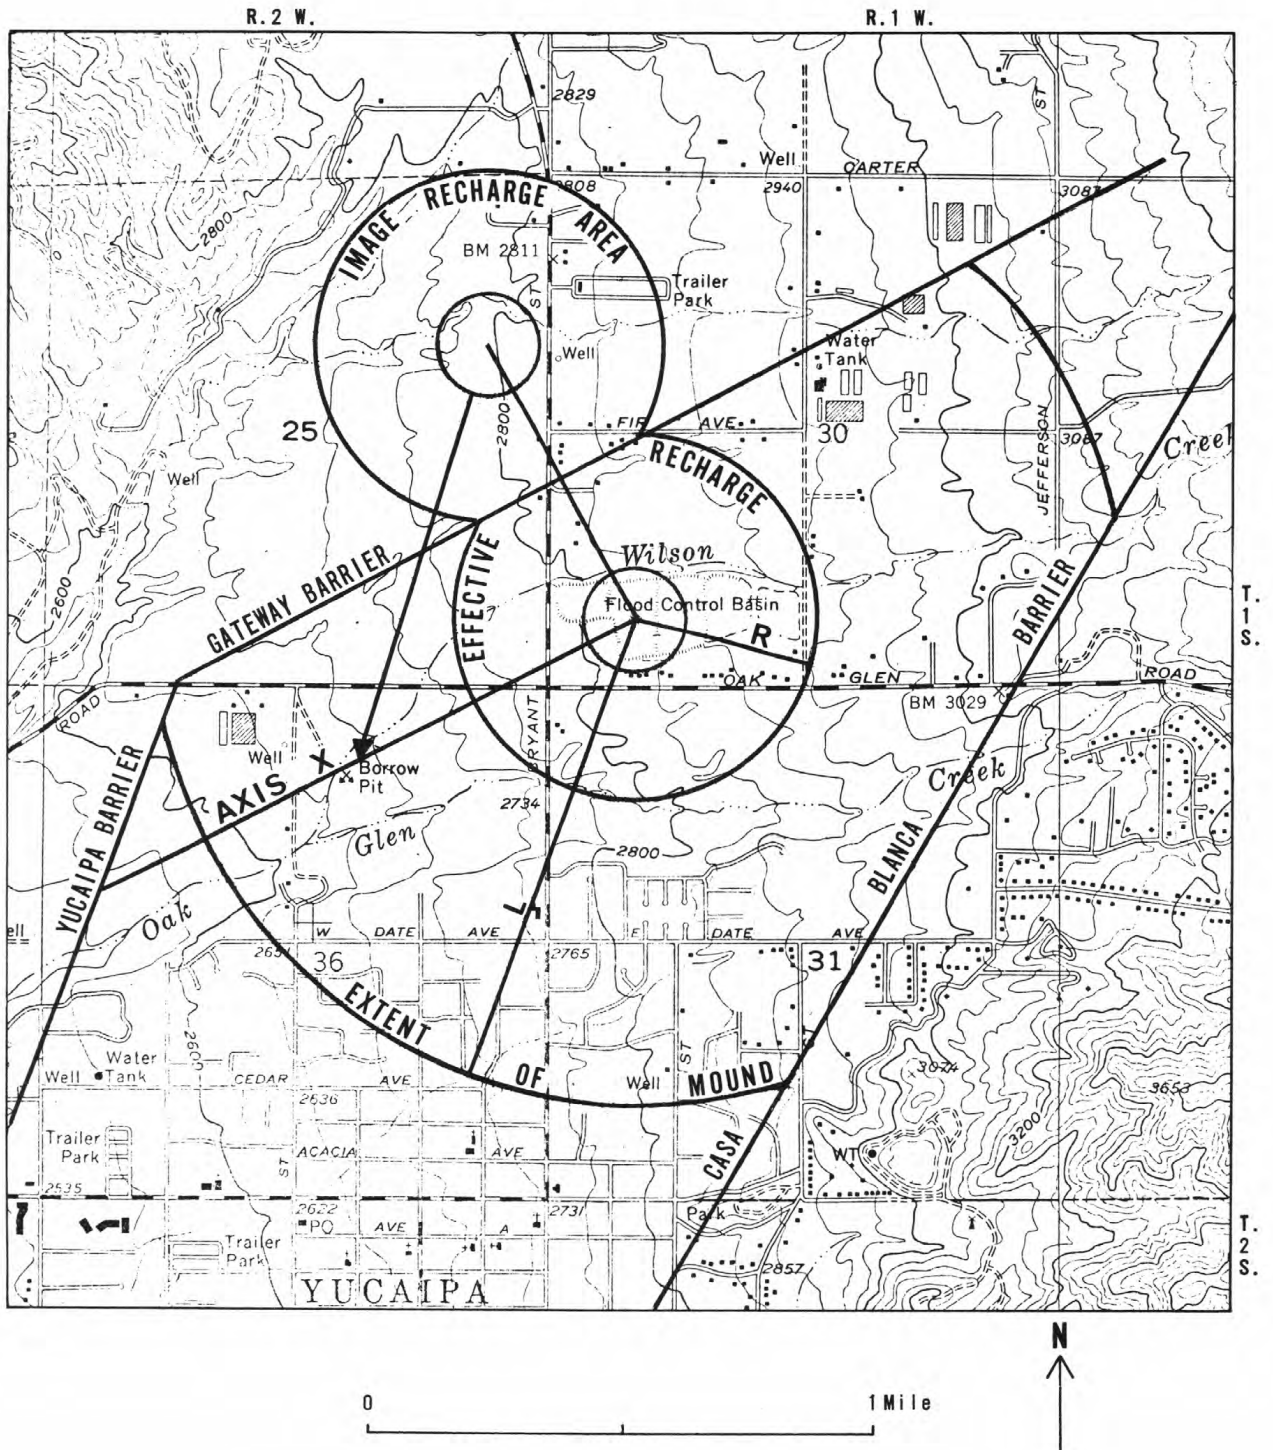
FIGURE 14.--Hypothetical recharge area mound.

Baumann's theory assumed no boundaries within the influence of the recharge mound. Obviously, this is invalid in the Wilson Creek subbasin because of the proximity of the fault barriers, particularly the Gateway barrier, only 1,500 feet northwest of the recharge site. To handle this problem, the method of image theory (Ferris and others, 1962) was used. The barrier is replaced with an image recharge area located equidistant from the barrier on the opposite side (fig. 14). The resultant mound is then the sum of effects of the real and imaginary recharge areas. This obtains:

$$= \sqrt{X^2 + 3,000^2} \quad (\text{fig. 14}).$$

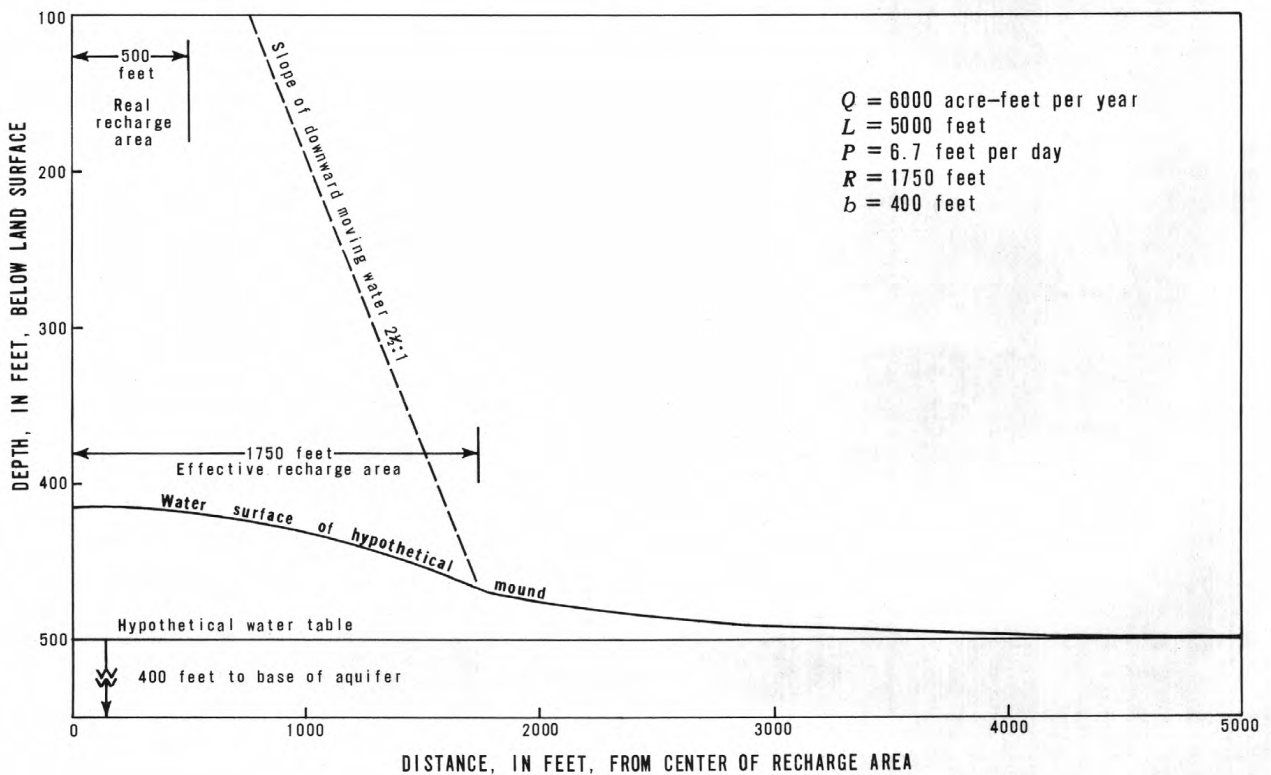
FIGURE 15.--Hypothetical recharge mound.

For calculation of the mound shown in figure 15, the following assumptions were made:

$Q = 6,000$ acre-feet per year = 715,000 cubic feet per day
 $L = 5,000$ feet
 $P = 50$ gallons per day per square foot = 6.7 feet per day
 $R = 1,750$ feet
 $b = 400$ feet.

The mound as calculated above is very idealized. The assumptions that the aquifer is homogeneous and isotropic, that recharged water will be evenly distributed over an area with a radius of 1,750 feet, and that the water table is horizontal are invalid. However, the calculations give some indication of the magnitude of water-level changes that will result from injecting water into the Wilson Creek subbasin.

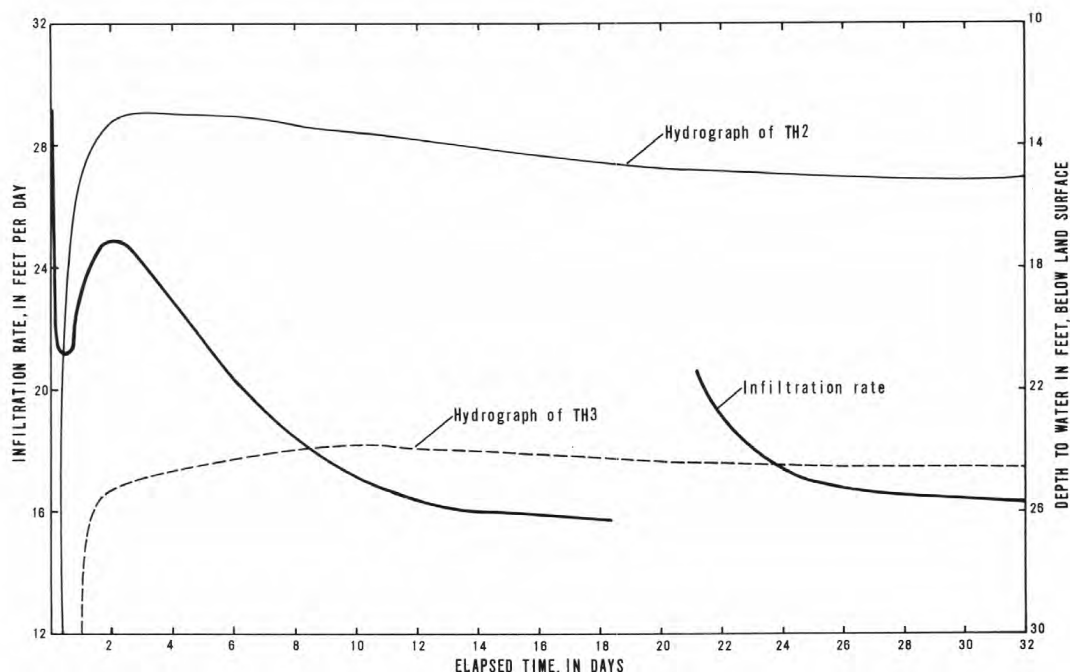
FIGURE 16.--Infiltration rate and depths to perched water body, Yucaipa dam test site.

The infiltration test was begun January 6, 1969, and continued to January 25, 1969, when a severe storm halted operations. The test was resumed January 28 and was terminated February 16 by a power failure resulting from a second storm. During the test, 56.4 acre-feet of water were spread over an average wetted area of 4,000 square feet in a period of about 6 weeks. The computed infiltration rate during the first 5 days of the test rose from 21 feet per day to 25 feet per day. The rate gradually decreased during the rest of the test to a minimum of 15 feet per day after 6 weeks of testing and would apparently have continued to decline (fig. 16).

A perched water body was detected on the second day of the test in test hole 2 located 20 feet south of the pit. Water rose in the observation well until it reached a maximum of 12 feet below land surface on the fourth day after the test began. The water level then stabilized for two days and receded slightly through the rest of the test. Test hole 3, 100 feet south of the pit, began filling with water on the third day of the test. The water level rose slowly to a maximum of 23 feet below land surface on the 10th day, after the test started and then began to recede. Test hole 4, 200 feet south of the pit, remained dry throughout the test. All test wells were dry within 2 days after the test was terminated. This indicated that the older alluvium retarded downward percolation but did not halt it.
