SOME ASPECTS OF REMOTE SENSING FOR  
CONSIDERATION IN PLANNING FOR ENVIRONMENTAL  
MONITORING OF THE ALYESKA PIPELINE, ALASKA

By Herbert E. Skibitzke <sup>1974</sup>

Open-File Report 77-643

ABSTRACT

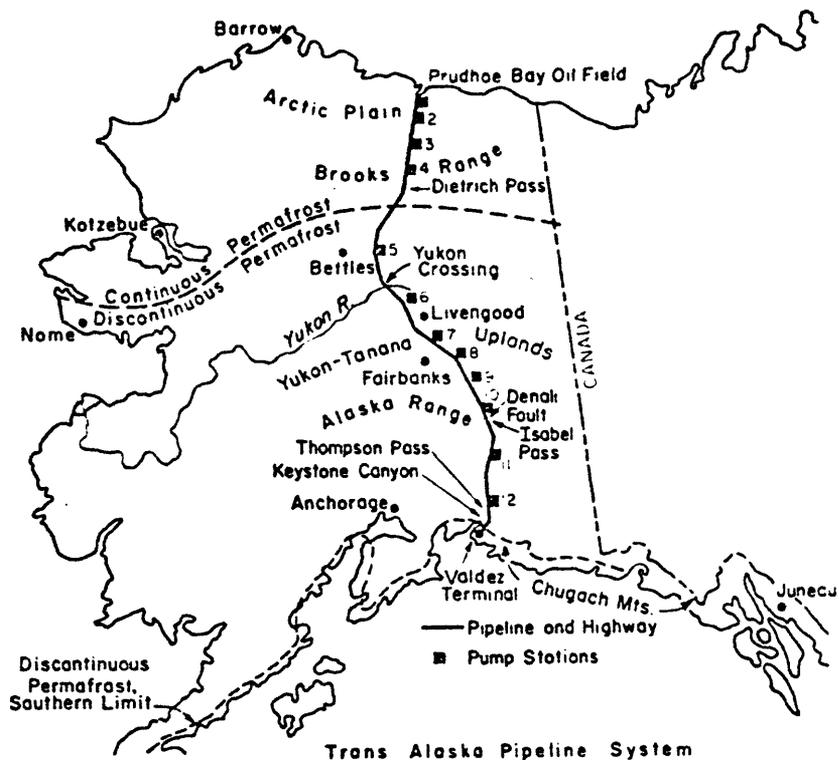
Illustration 1 -Map of Alaska indicating route of trans-Alaska pipeline system, including pump stations, major and specific physiographic and geomorphic features along the route, and the boundary between the continuous and discontinuous permafrost zones.

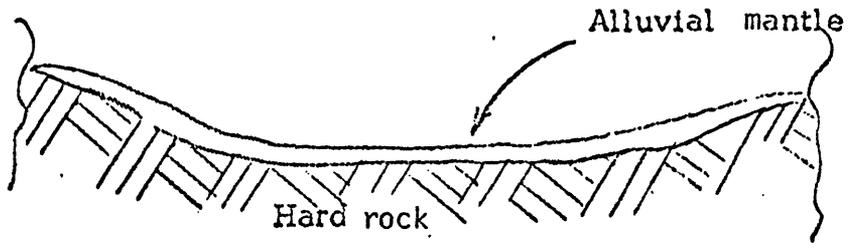
True Vertical Scale  
Scale 1:63,360

Illustration(2a)- Cross section through typical valley, drawn to true scale.

Simplifying the more complex geomorphic and geologic considerations, the valleys generally appear as shown at true vertical scale in illustration 2a. Sedimentary or metamorphic rocks (hard rock) form the lower part of the diagram and overlying these rocks is alluvium. The thickness of the alluvium varies but averages about 200-feet, with rapid thinning at the hilltops.

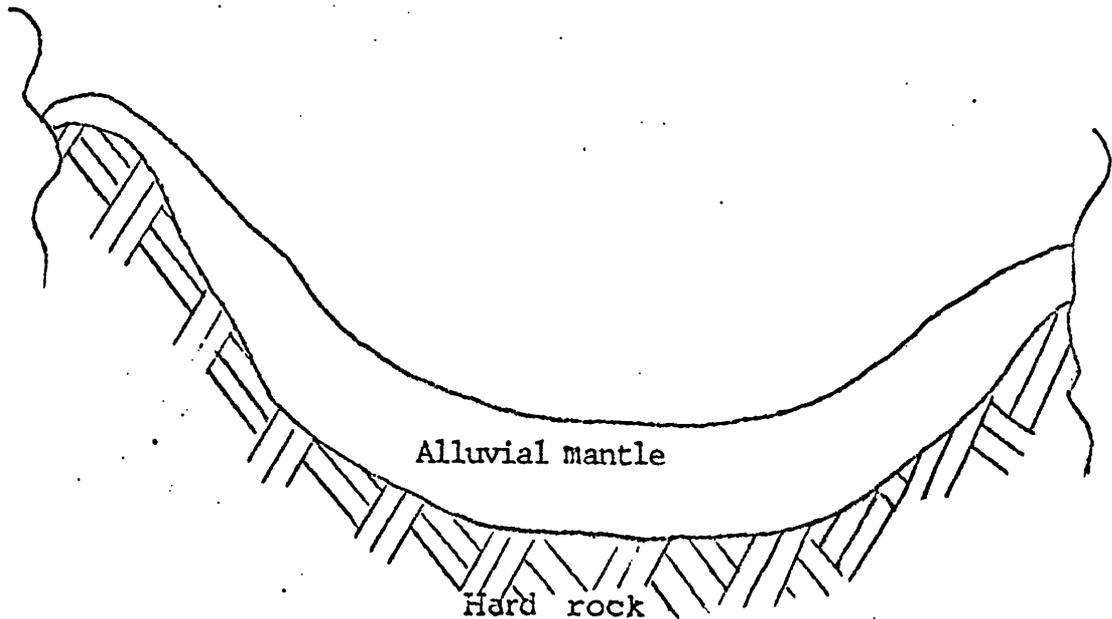
Vertical Scale Enlarged 5 Times

Illustration(2b)- Cross section of Illustration(2a) with vertical scale enlarged five times.

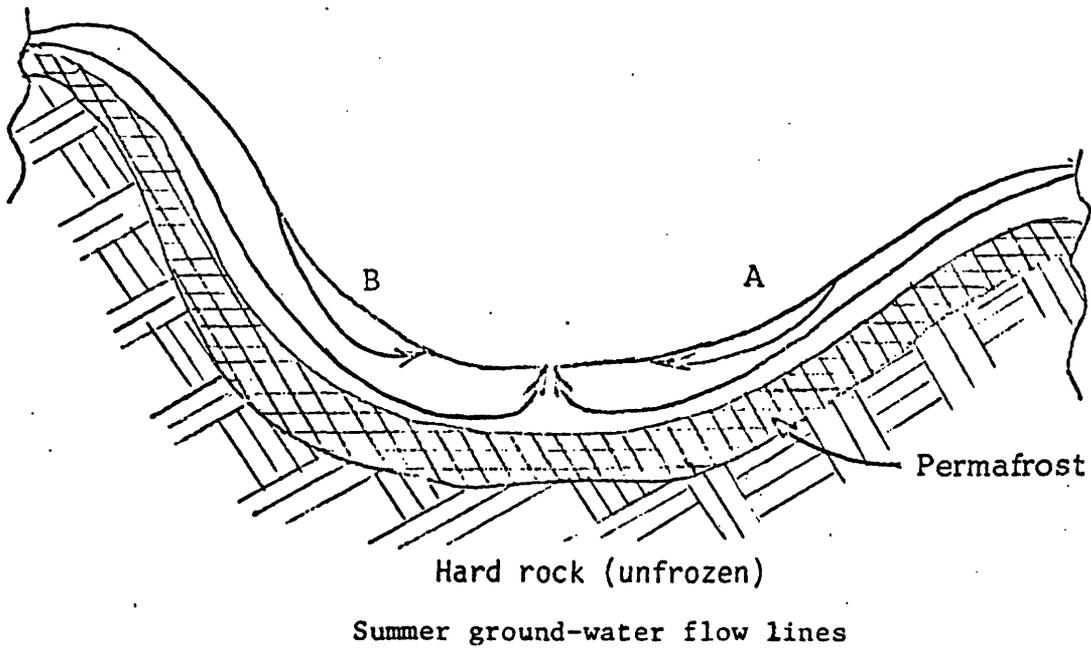
Illustration (3) - Diagram of idealized summer ground-water flow lines (vertical scale exaggerated).

During the summer, the flow below points A and B (illustration 3) is from seeps, which ranges from just enough moisture to keep the surface wet to small springs. Deep surface indentations produce more discharge at gully heads than at nearby shallow headcuts.

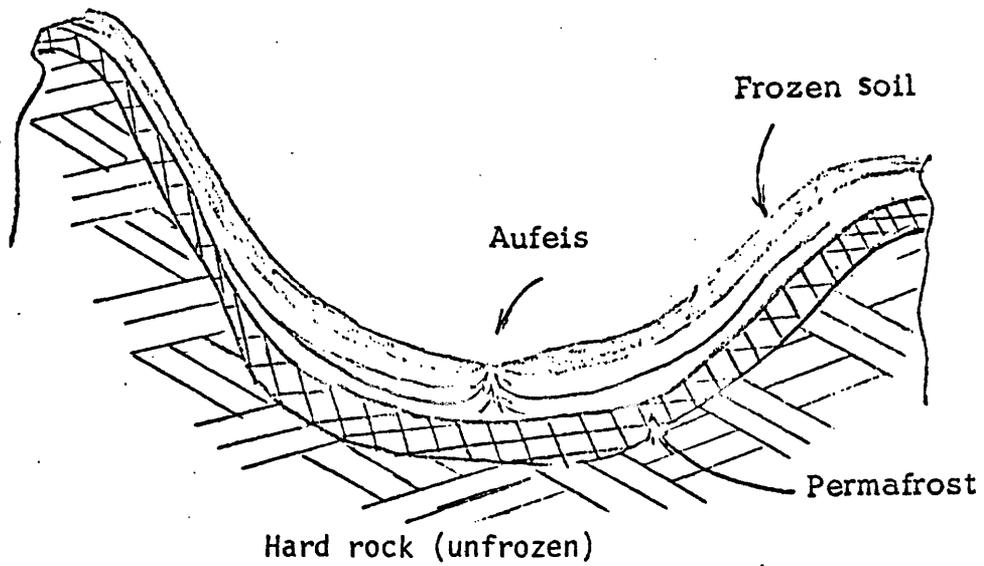
Early winter ground-water flow lines

Illustration (4) - Diagram of idealized early winter ground-water flow lines.

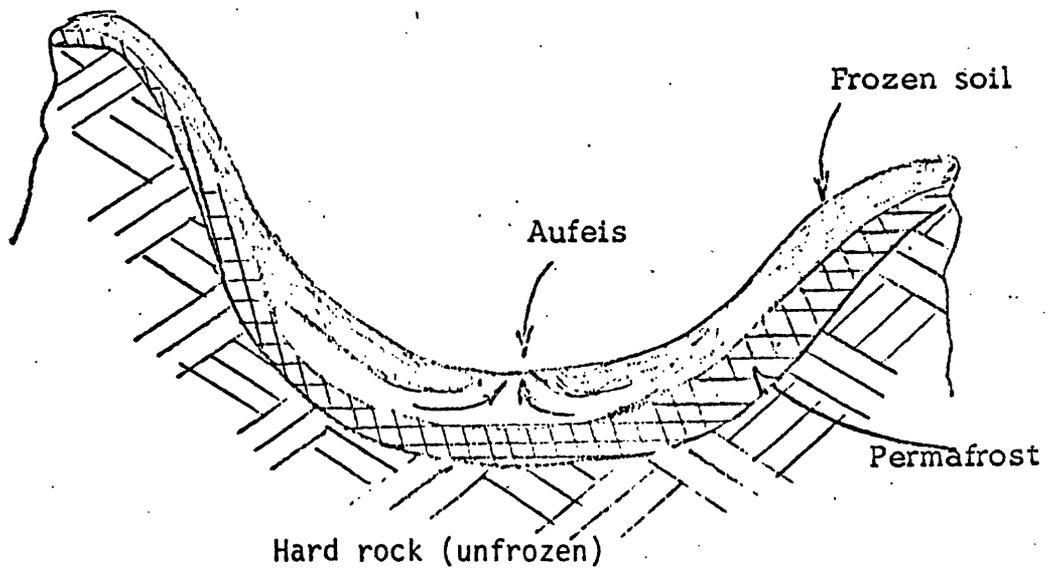
Late Winter Ground-Water Flow Lines

Illustration (5) - Diagram of idealized late winter ground-water flow lines.

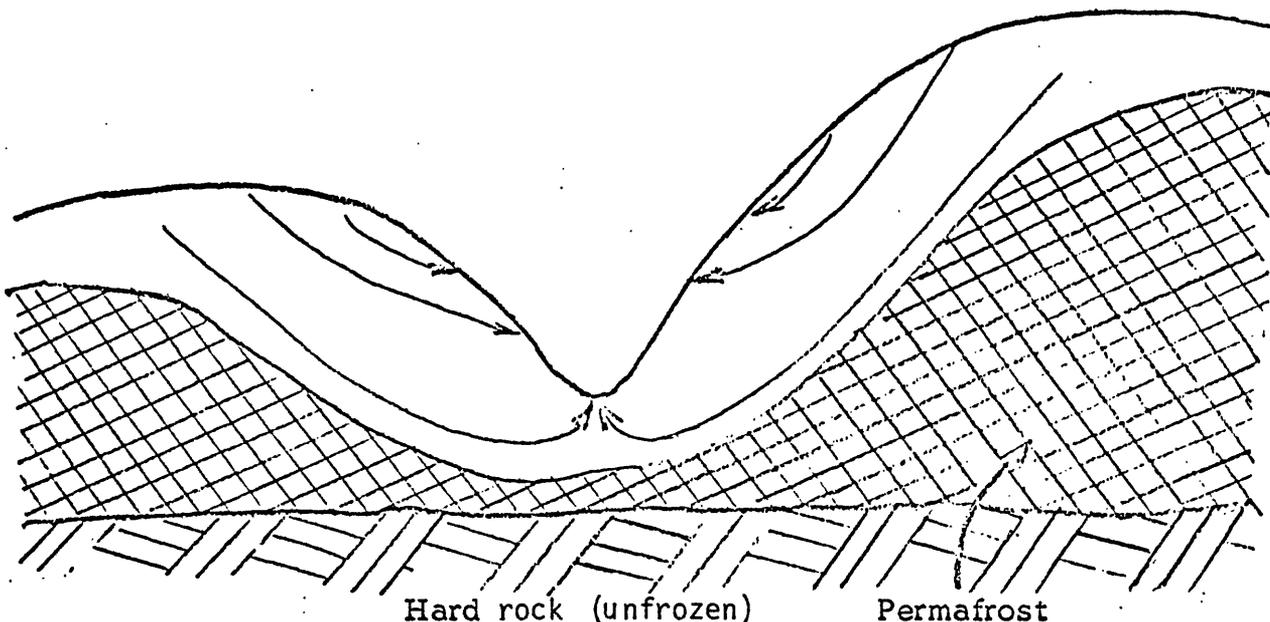
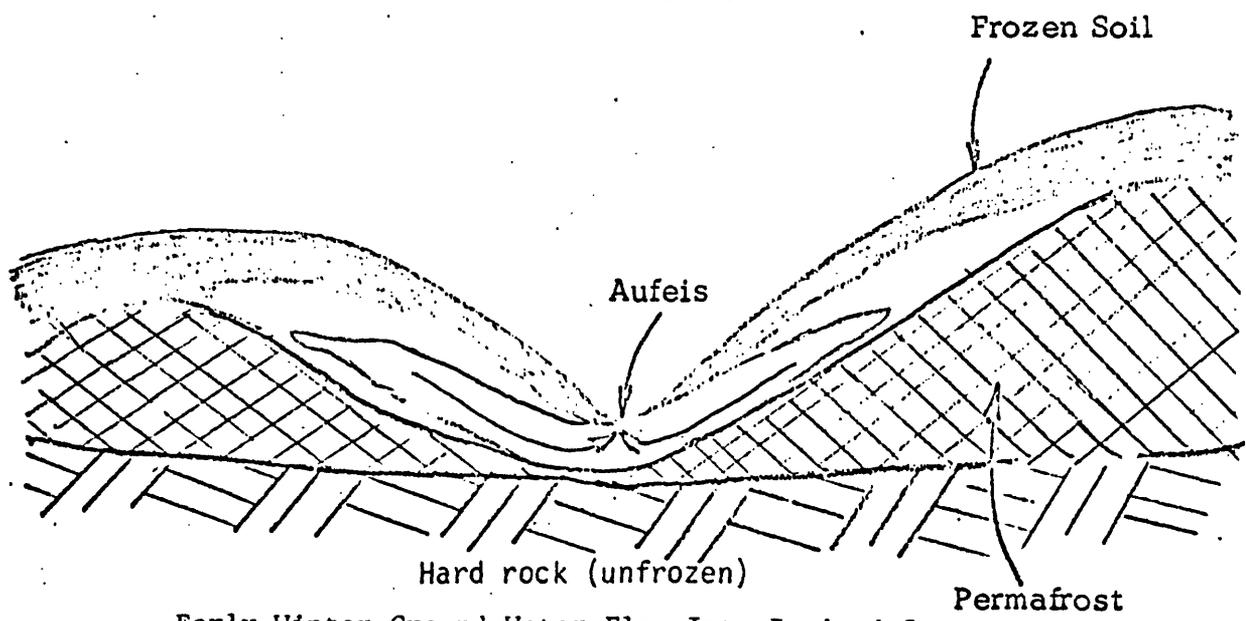
Illustration (6) - Diagram of idealized summer and early winter ground-water flow into incised streams.

Summer Ground-Water Flow Into Incised Streams

Early Winter Ground-Water Flow Into Incised Streams

The locations of four icing sites are shown on the frame photographs of figure 10B and the topographic map (Livengood B-3) of figure 10C. This is an area where additional investigation would be of interest because in June 1974, extensive icings were forming where creeks flowed toward the south and southwest. The sites in this imagery are examples of situations of the type shown in illustration 6.

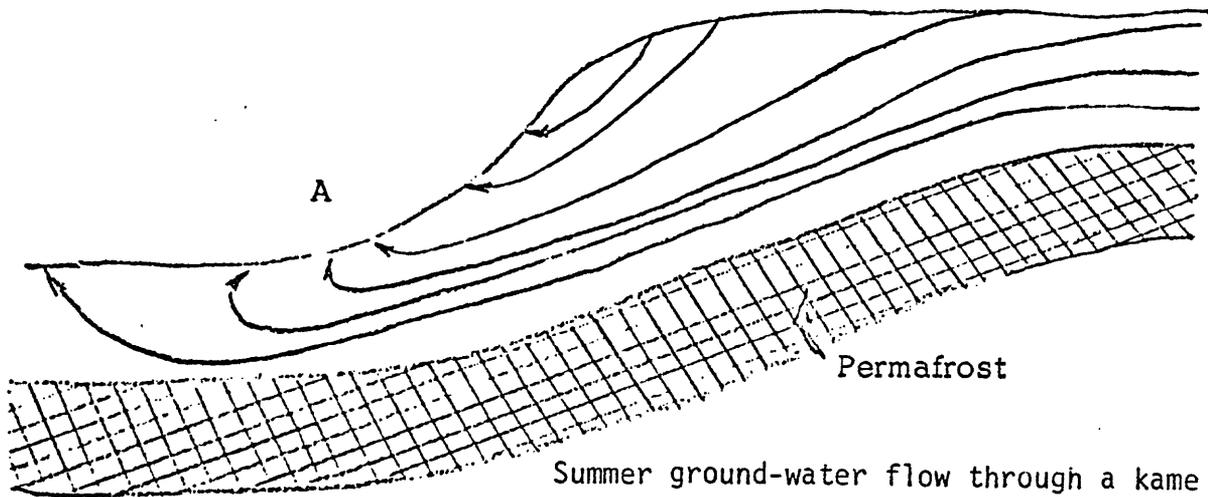
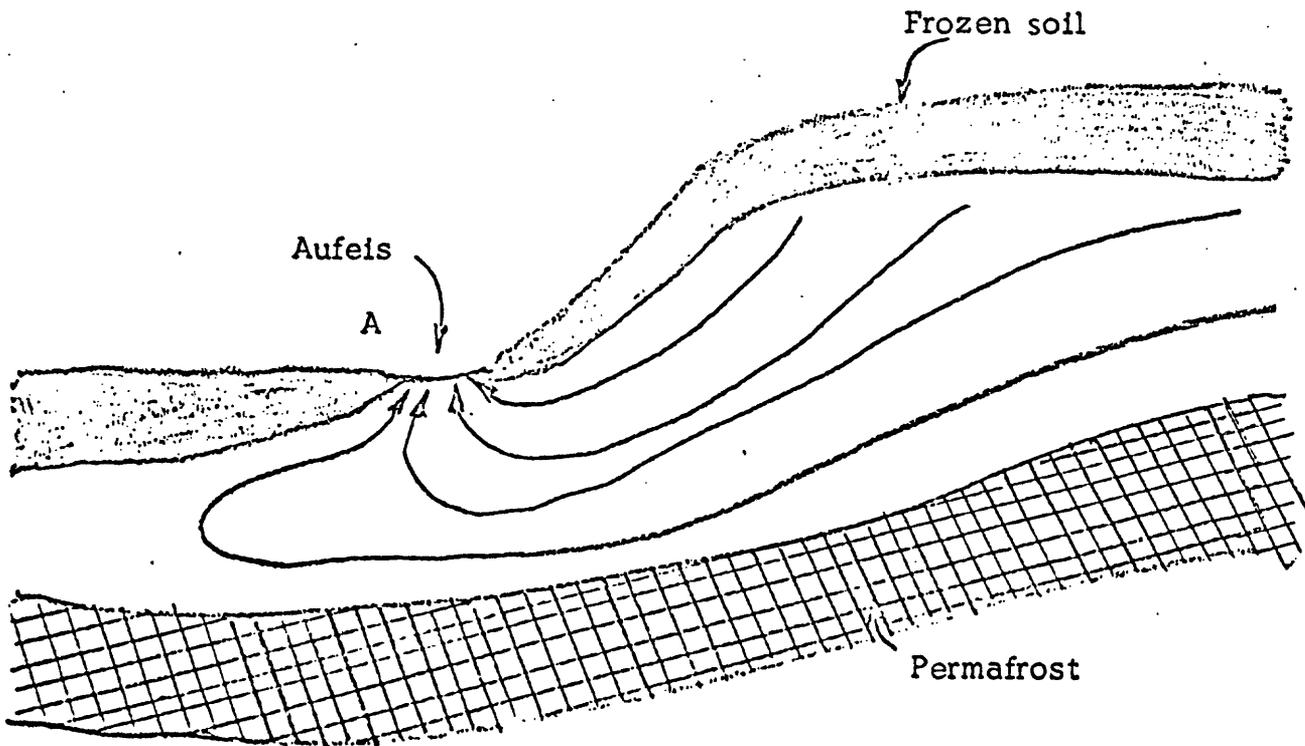
Illustration (7) - Diagram of idealized summer and early winter ground-water flow through a kame terrace.

Summer ground-water flow through a kame terrace.

Early winter ground-water flow through a kame terrace.

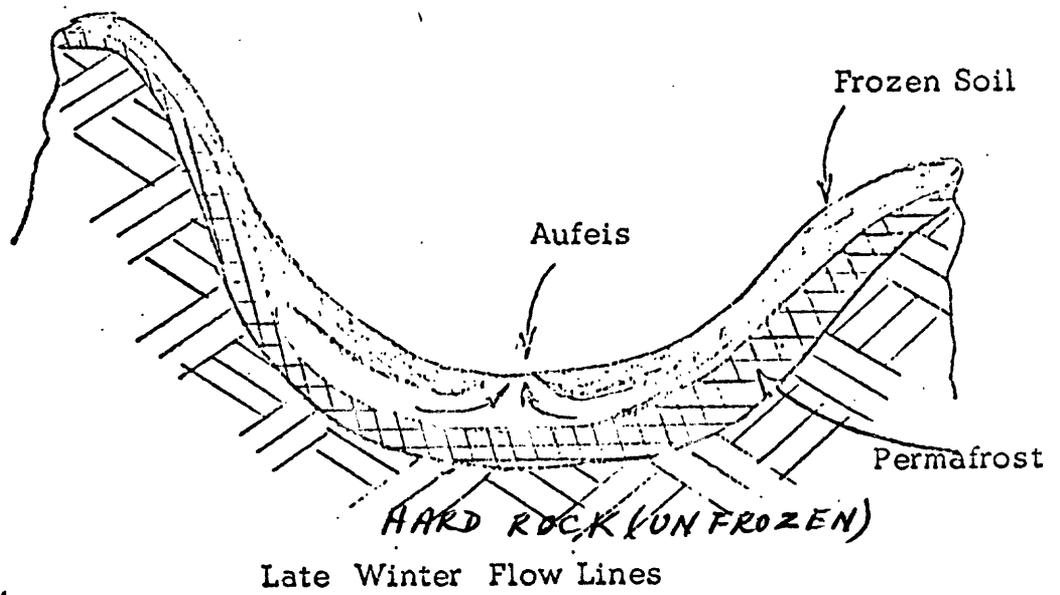
Figure 4 -- Cross section illustrating source of icing.

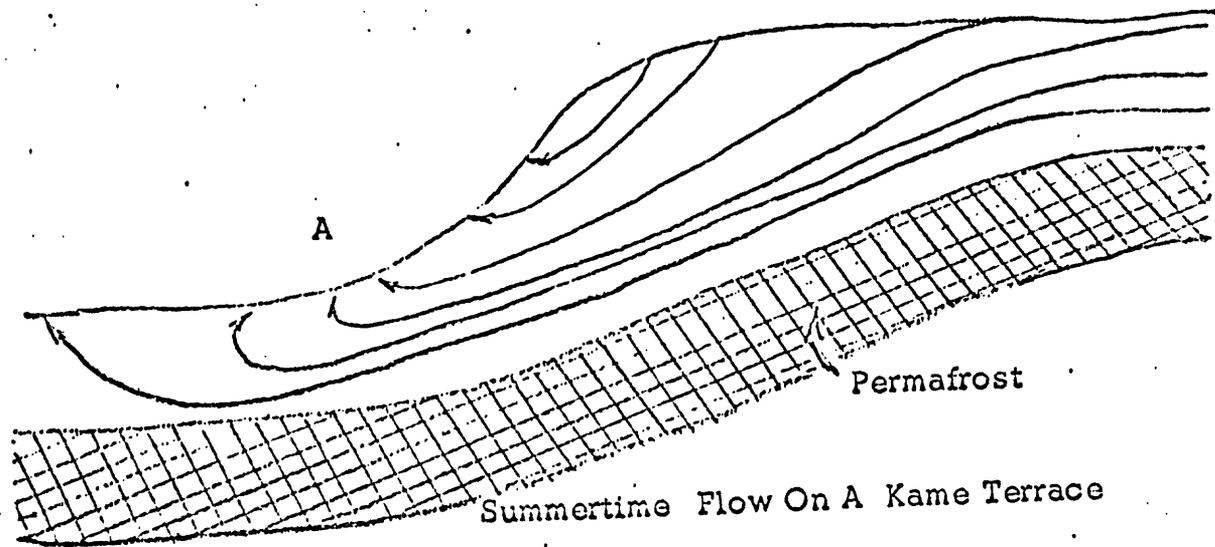
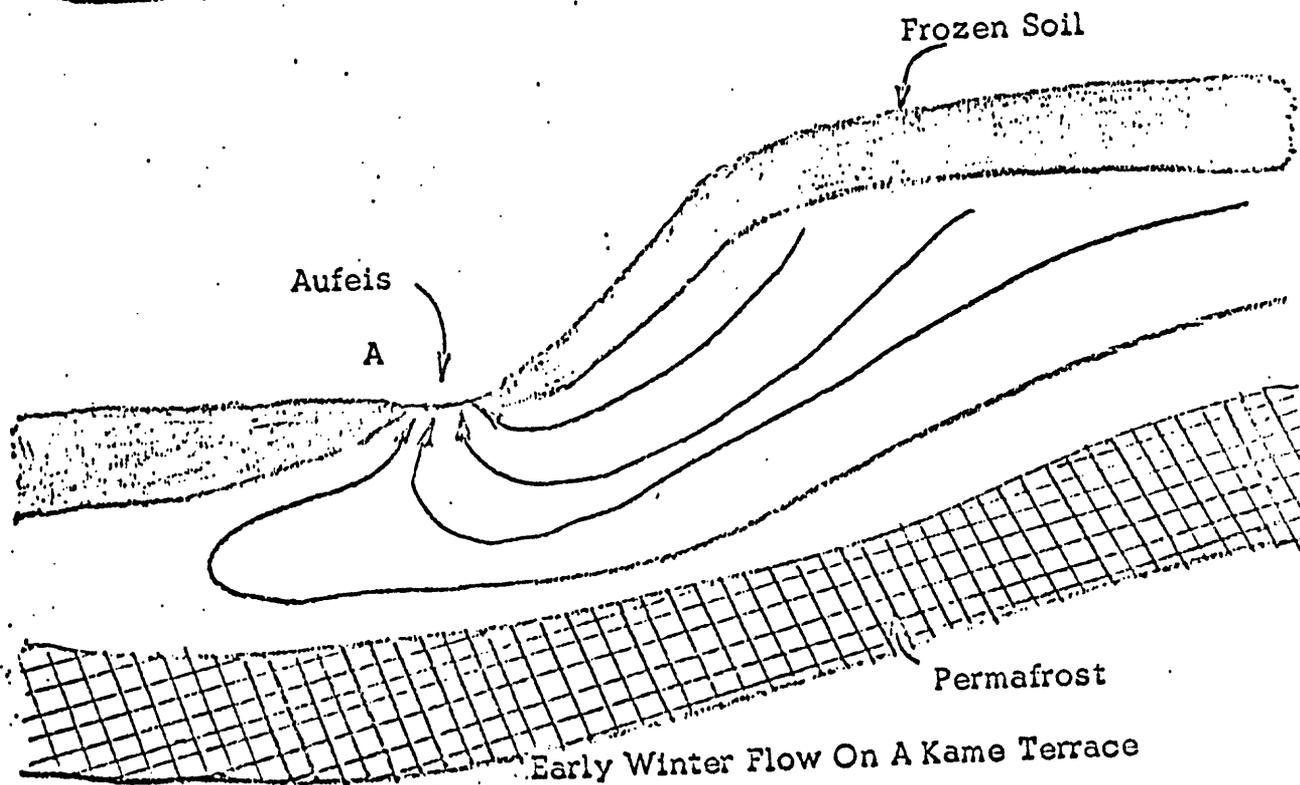
*idealized*  
 Figure 7 -- Diagram showing physical occurrence of icing.

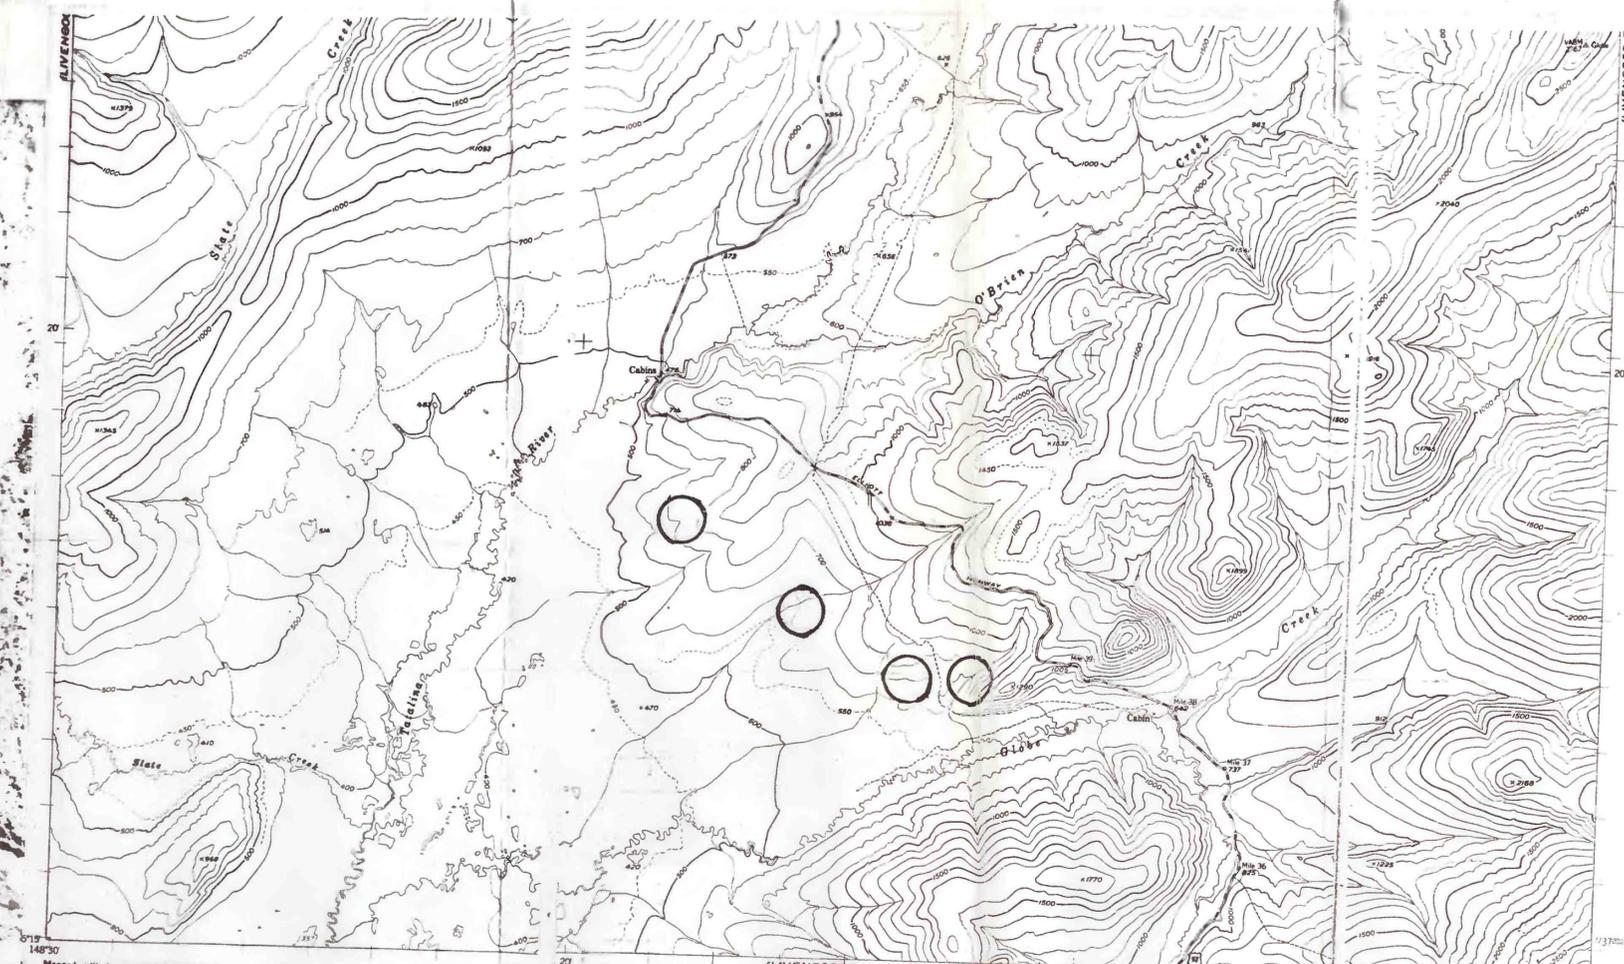
Figure 10C Livengood B-3 topographic  
 map showing location of  
 icings

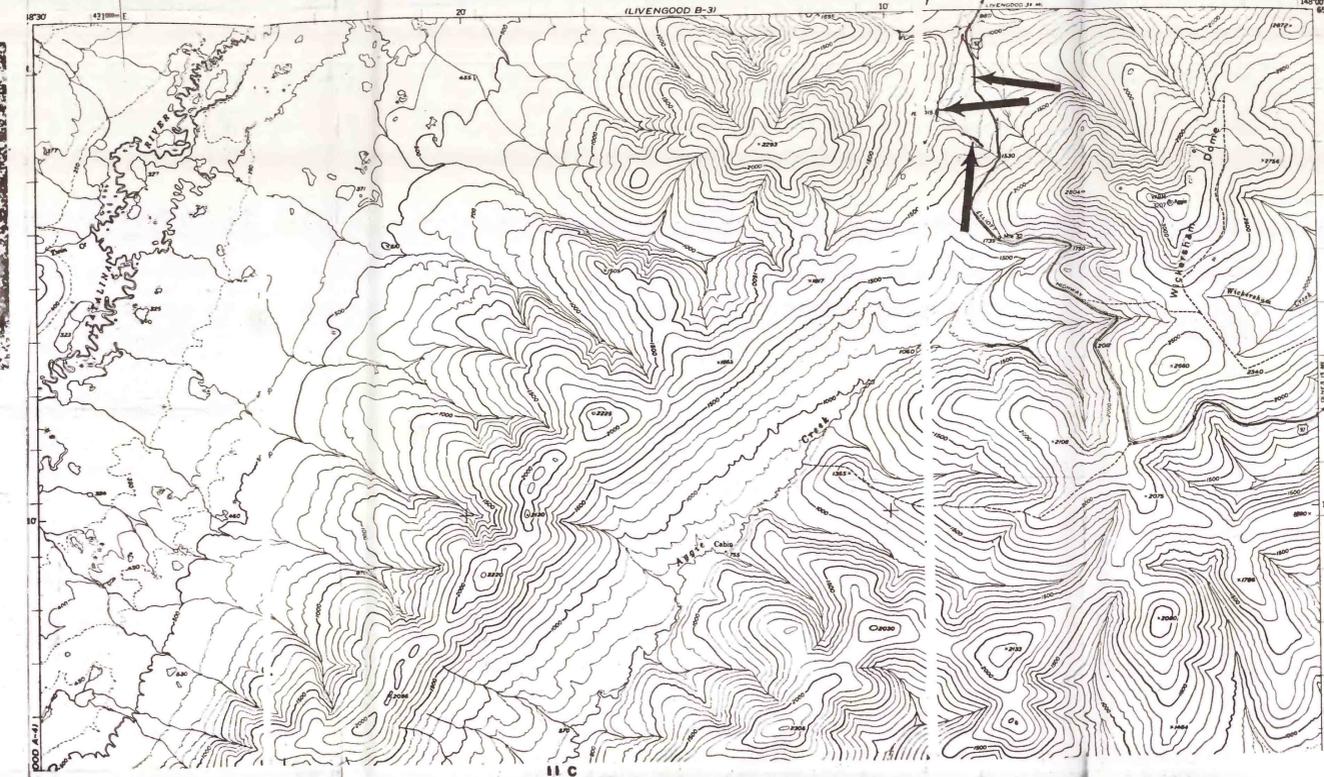
11C

Figure 11C. Livengood A-3 topographic map showing area of icing.

The regional topography is shown in the map of figure 11C, and the details of the area can be seen in the frame photograph (figure 11D). It would be of interest to survey the areas to the northeast and to the southwest by thermal imagery in the coldest part of the year. This might reveal considerably more about the hydrology of the ground-water system and of the controls on aufeis formation.

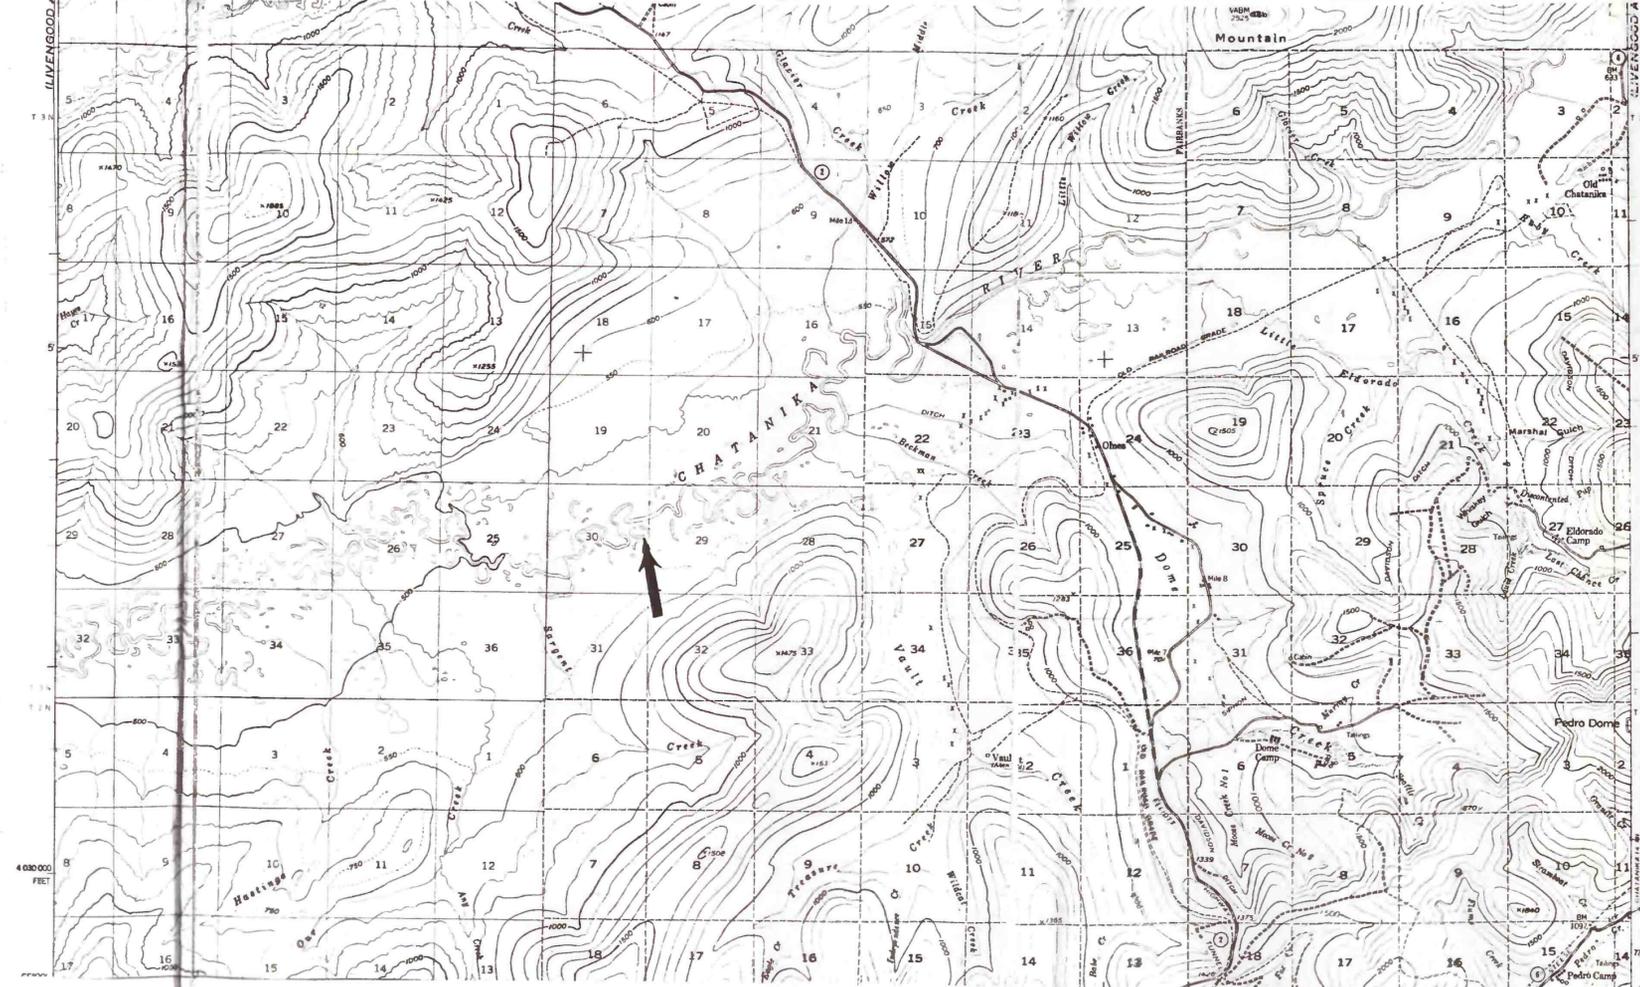
3C

- Figure 3A. Thermal image showing icing in cut-off meander of Chatanika River.
- Figure 3B. Oblique photo taken from low altitude showing cut-off meander of Figure 3A. Orange color of water is caused by iron content of groundwater.
- Figure 3C. Livengood (A-2) quadrangle sheet. Arrow points to icing site.
- Figure 3D. Continuous strip photograph made in April 1974 shows area after thawing.
- Figure 3E. 9 by 9 inch frame photograph made January 17, 1974. Icing appears as dark line, representing water flowing over the ice.
