no.78-1057

Adamsville, OH

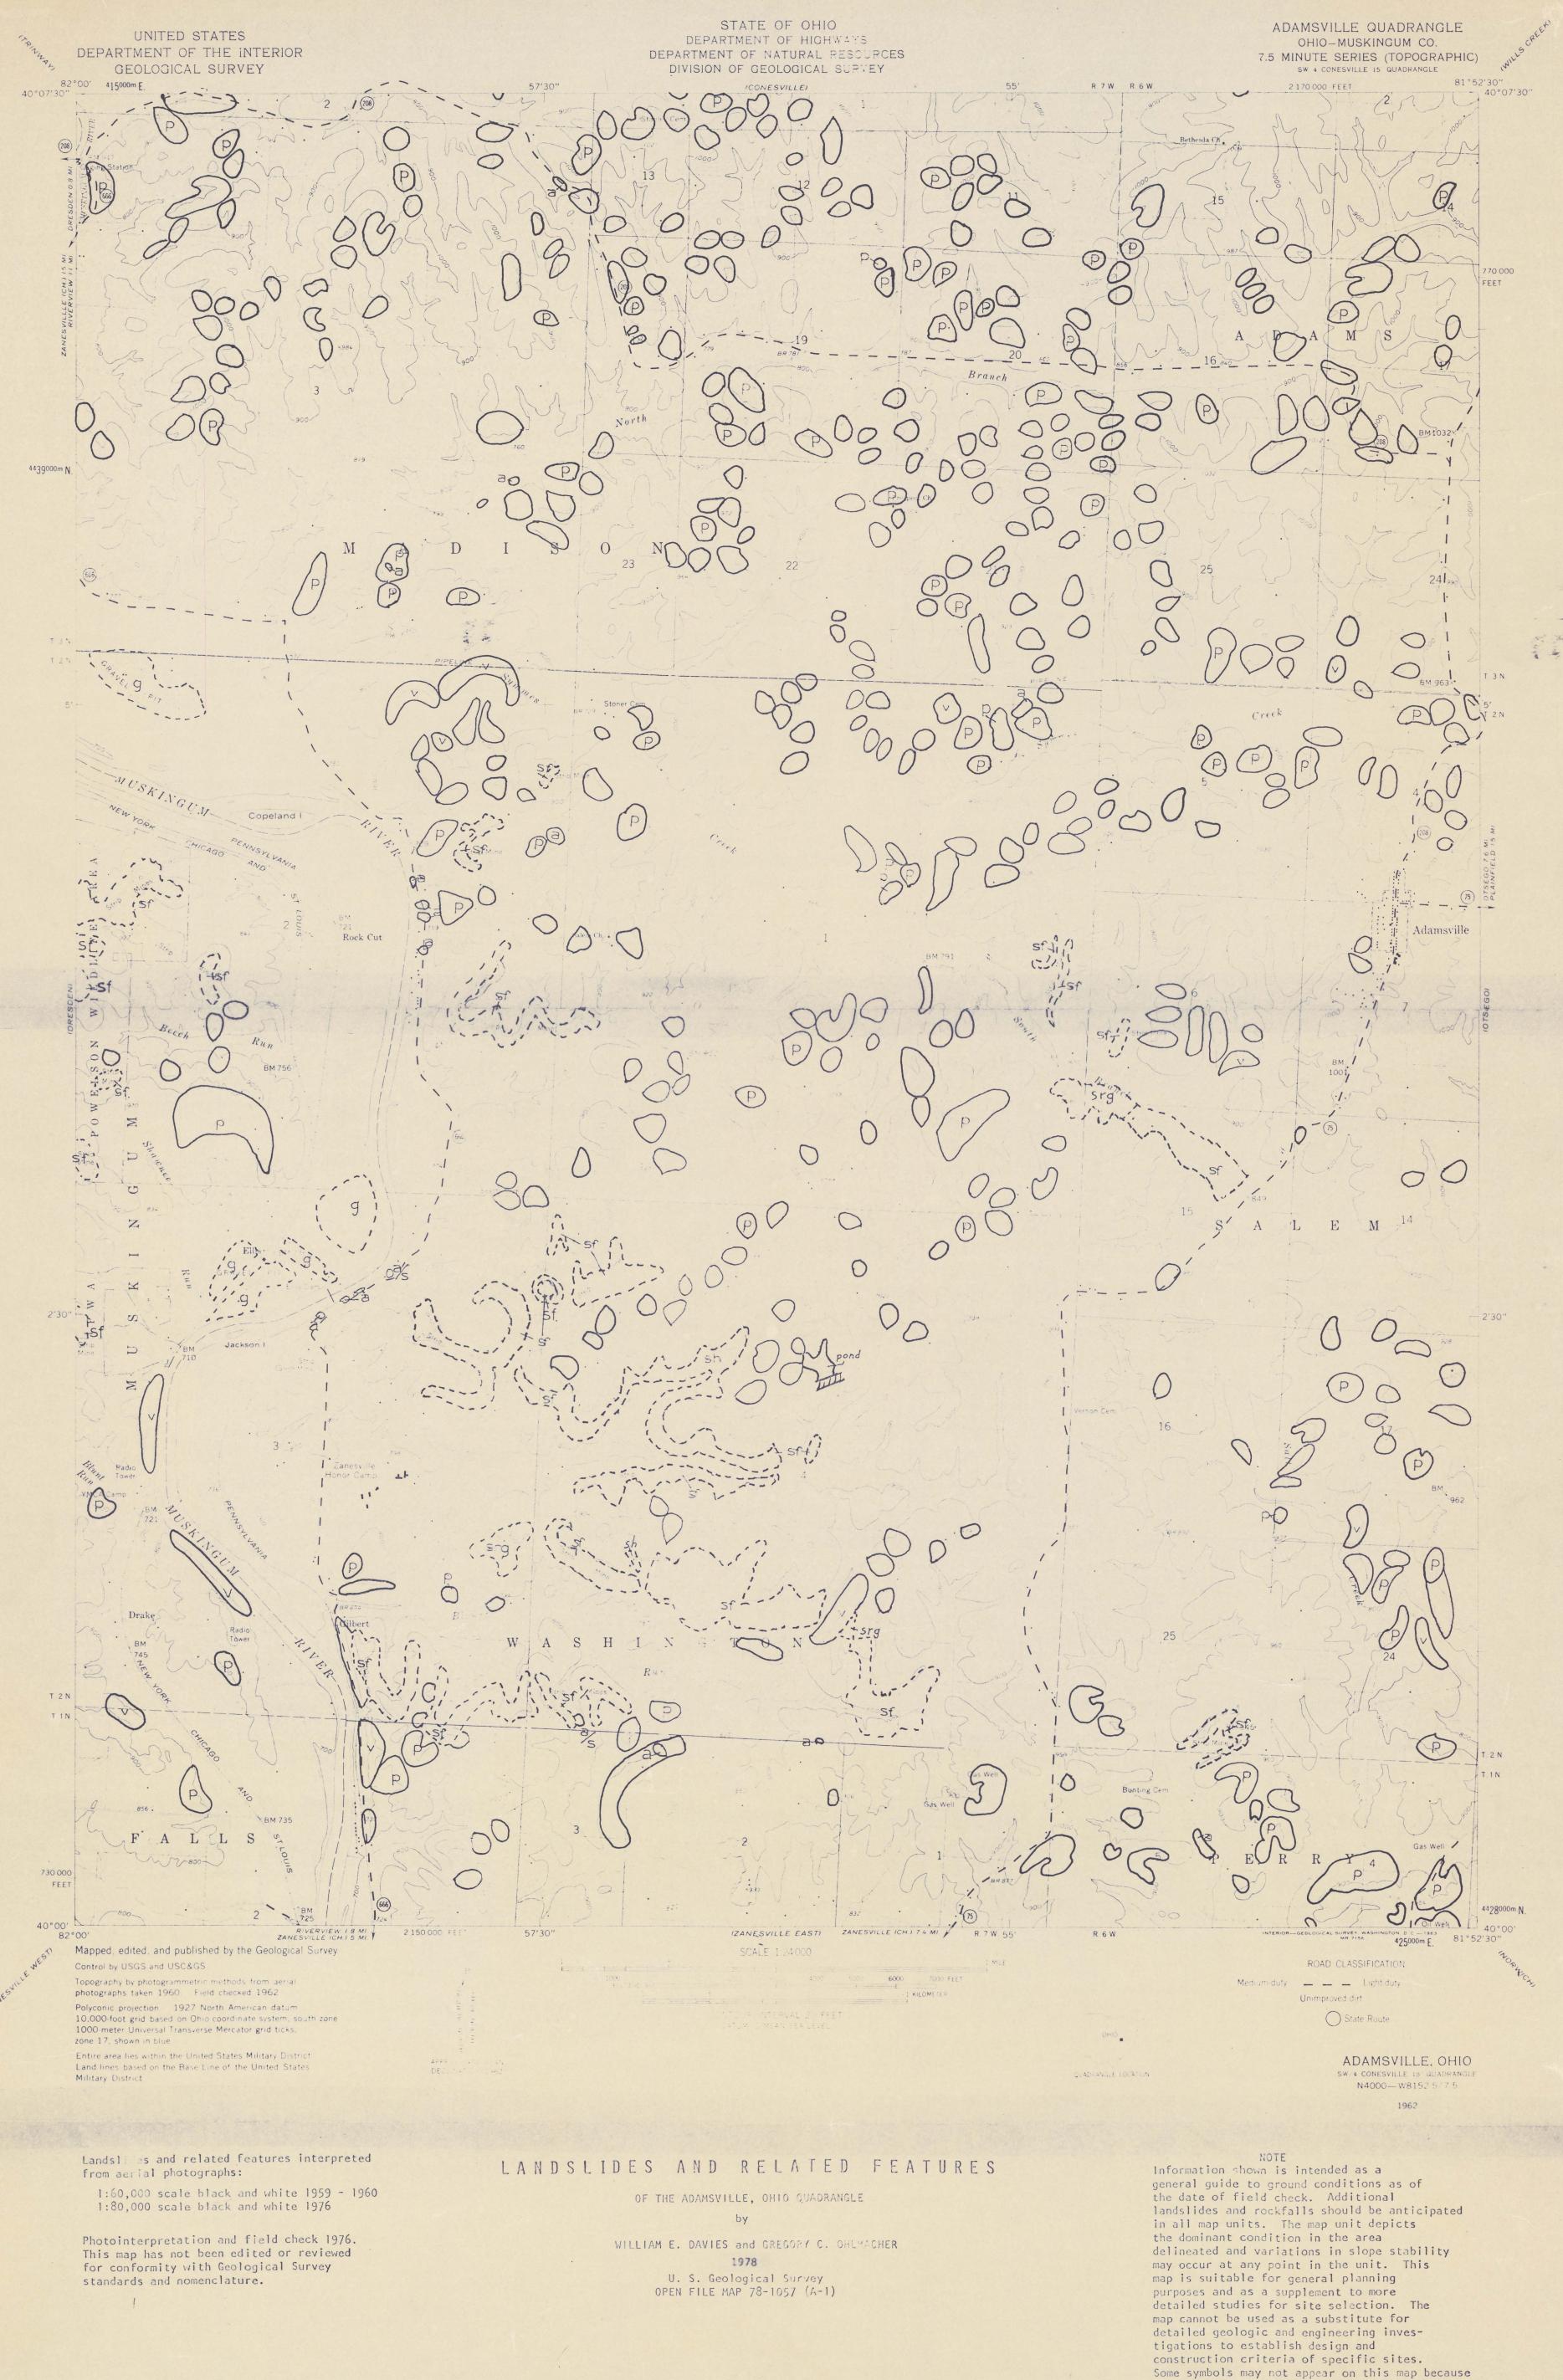
ACTIVE OR RECENTLY ACTIVE LANDSLIDE Complex landslide composed of earthflow, debris slide, earth and rock slump. Identified from historical records, and from scars, debris and other field evidence. Ground extremely unstable; sliding accelerated by excavation, loading and changes in drainage conditions. May include areas with several active slides too small to be shown separately. Questioned where doubtful.

LANDSLIDE Area of extensive hummocky ground caused by earthflow and earth and rock slump. Lacks clear evidence of active sliding. Relatively stable in natural, undisturbed state, generally not affected by small structures properly sited in areas away from the edge of the toe; can be reactivated by extensive, rapid excavation, loading, and changes in ground water and surface water conditions. Area of old landslide probably includes recent ches not identified from field evidence or otherwide documented. Upslope boundary of landslide generally defined by modified scarp, but downslope (toe) may be gradational and not well defined. Questioned where doubtful.

COLLUVIAL SLOPE Valley wall along major streams with slope as steep as 40° (85%); stony, clayey silt soil up to 50 ft. (15 m) thick; commonly buttressed by a terrace or bench at the toe of the slope; very susceptible to sliding by cutting of toe area, removal of terrace or bench, and overloading; landslide commonly activated without apparent cause.

AREAS SUSCEPTIBLE TO DEBRIS FLOWS AND DEBRIS AVALANCHES Primarily shallow, narrow ravines and chutes with accumulation of stony colluvium generally 10 ft. (3 m) or less in thickness; susceptible to rapid movement during intense rainfall. Most ravines designated show evidence of former debris flows and avalanches. Symbol - designates historical debris flow or

AREAS SUSCEPTIBLE TO ROCKFALL Steep, locally vertical, natural and man-made slopes and cliffs, 15 ft. (4.5 m) or higher. formed dominantly of sandstone, limestone, sandy shale, mudstone and claystone. Interbedded mudstone, claystone and shale weather rapidly leaving sandstone and limestone rock faces unsupported.

AREAS LEAST PRONE TO LANDSLIDES Map areas in which no patterns or symbols are shown; primarily valley floors, ridge tops and broad benches; modification by excavation and fill may lead to local landslides.
