HYDROGEOLOGY OF THE SELDOVIA AREA, ALASKA

By Gordon L. Nelson and Wesley R. Danskin

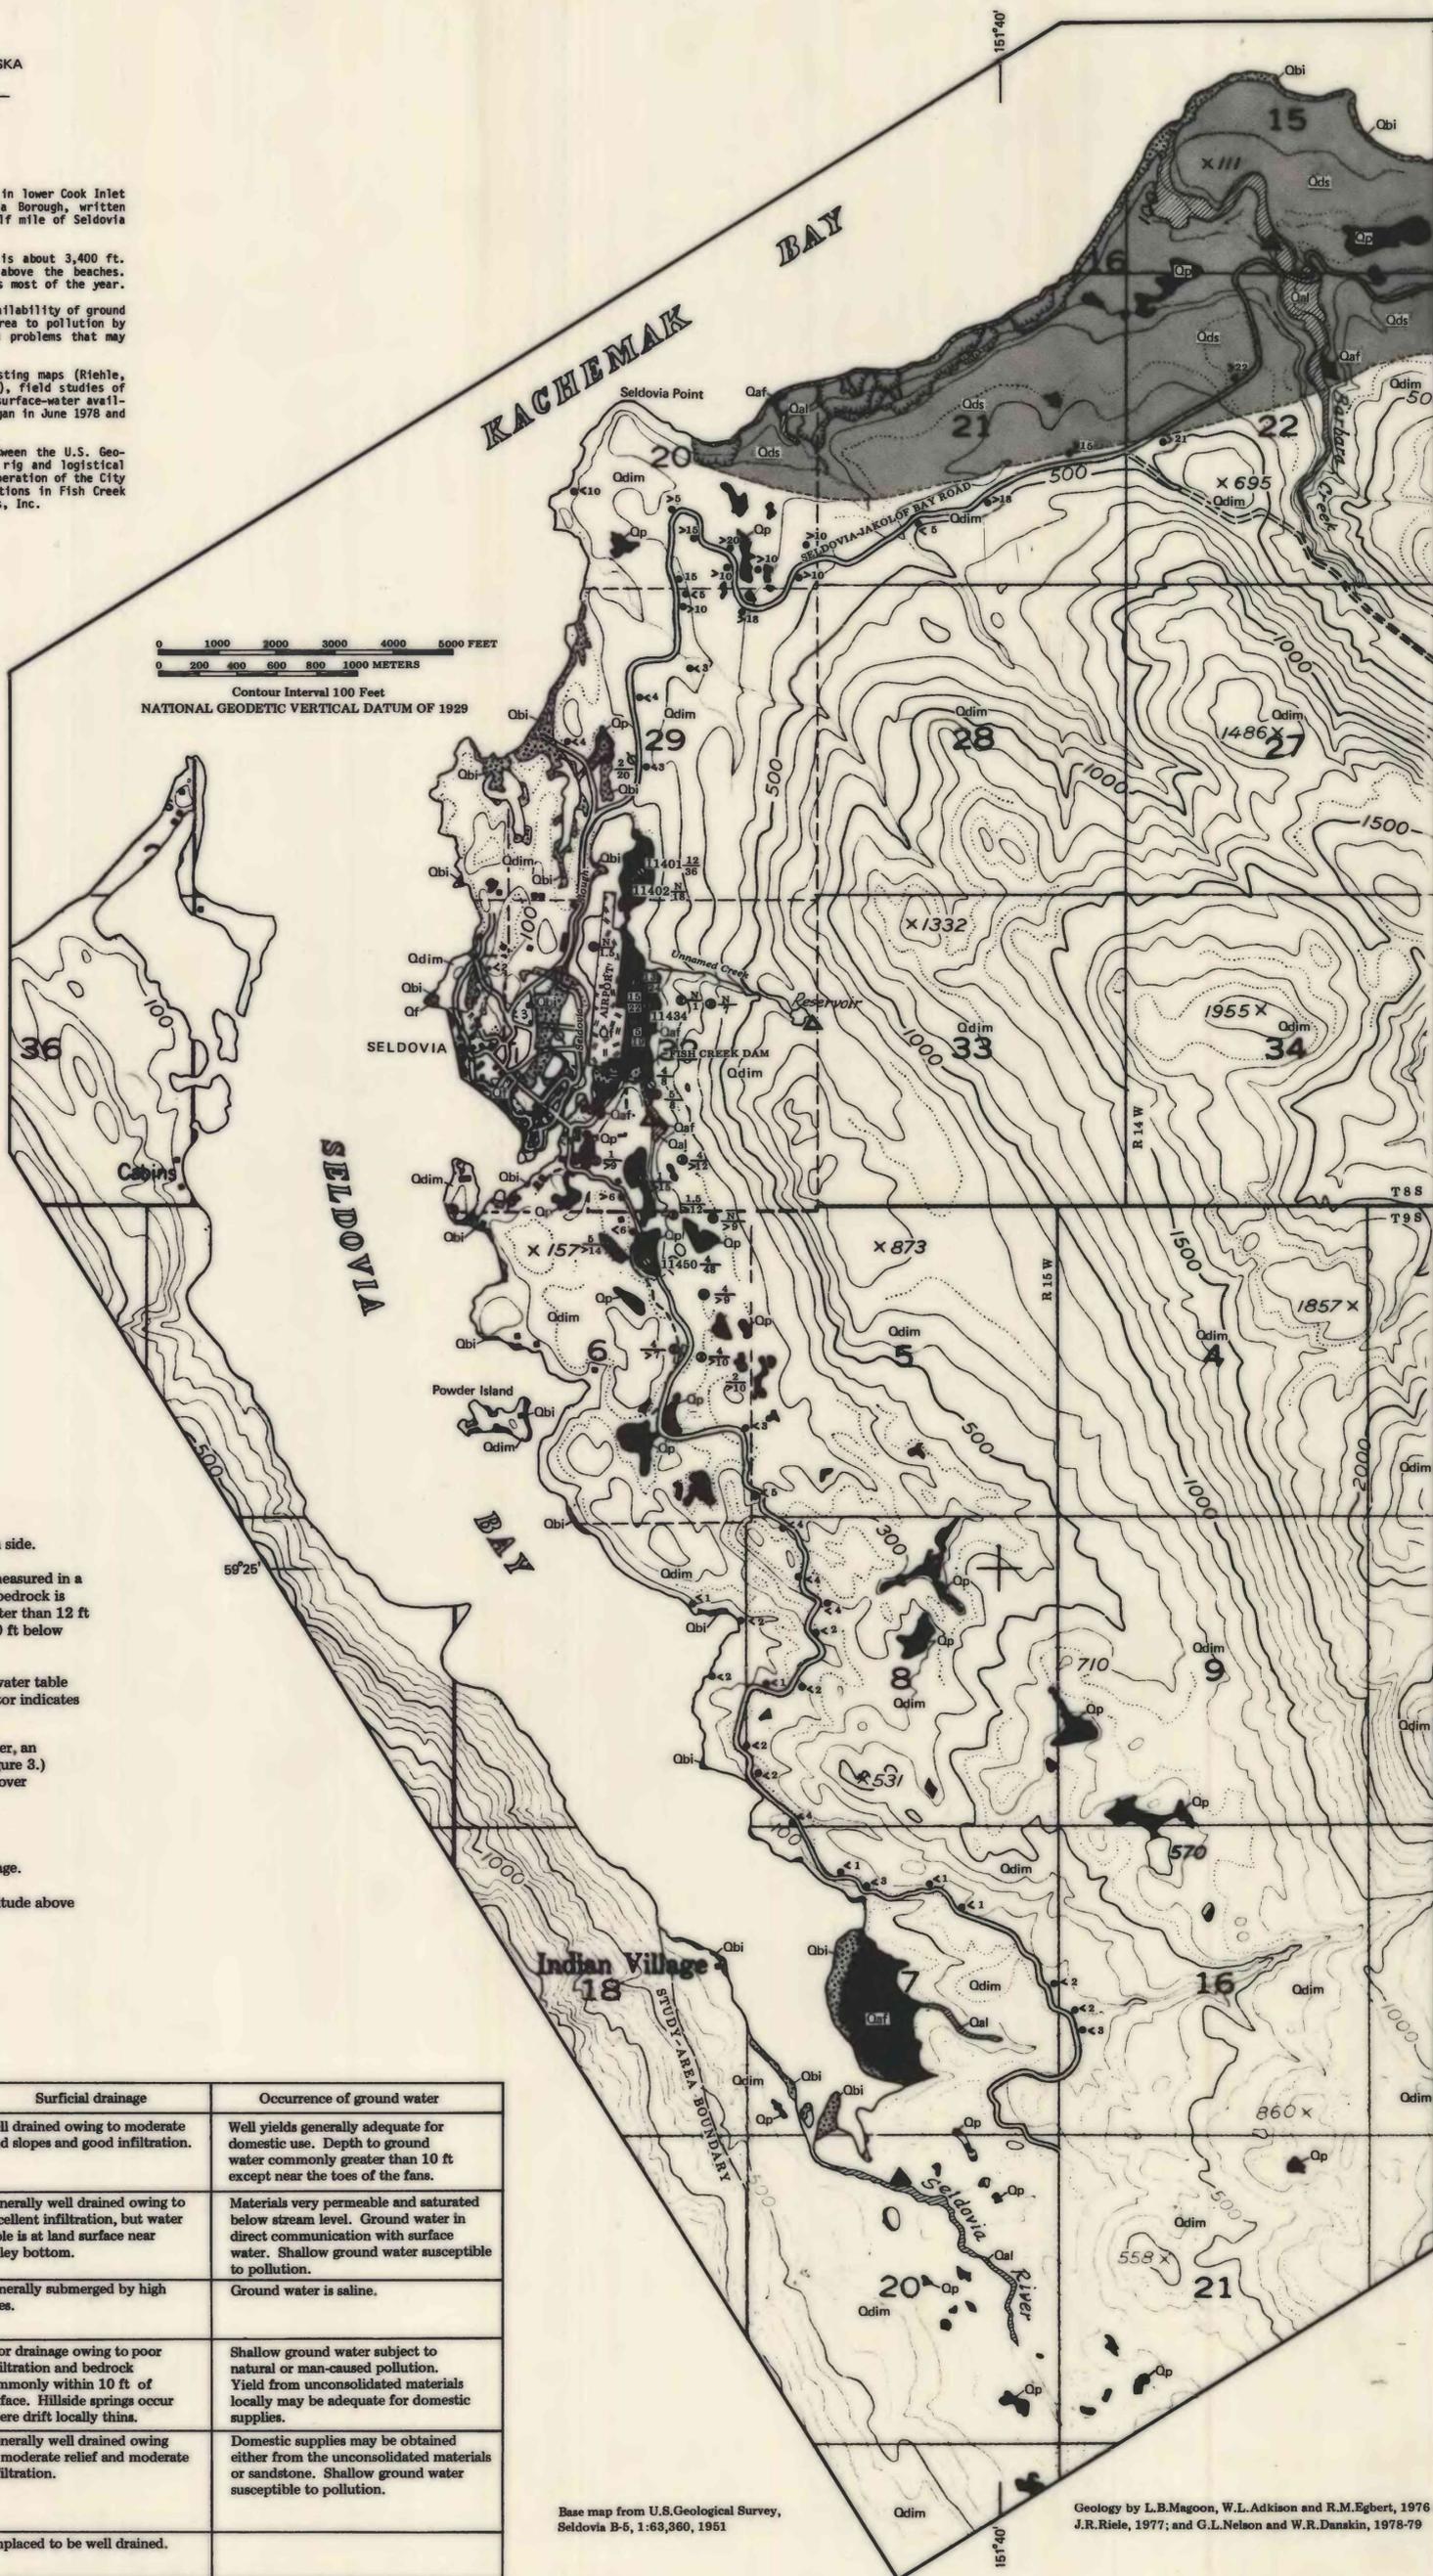
Figure 2.--Hydrogeologic map of the Seldovia area.

- Geologic contact. Dashed where inferred.
- ⌒ Slump block. Hachures are on down-throw side.
- 15 Data point where depth to bedrock can be measured in a road cut or streambank. In this example, bedrock is 15 ft below land surface. (>12 means greater than 12 ft below land surface; <10 means less than 10 ft below land surface.)

- ⊕ 2/10 Test boring. Numerator indicates depth to water table (N means no water in hole) and denominator indicates depth to bedrock.
- ⊕ 11450 4/48 Observation well with Alaska Register number, an arbitrary index number. (See well logs, figure 3.) Fraction 4/48 indicates depth to water table over depth to bedrock.

- ▲ Continuous-record stream-gaging station
- △ Partial-record stream-gaging site without a gage.
- 500— Topographic contour. Number indicates altitude above National Geodetic Vertical Datum.

Map unit	Materials and occurrence	Surficial drainage	Occurrence of ground water
Qaf	Poorly sorted silt, sand, and gravel deposited at the mouths of steep tributaries. May be several tens of feet thick.	Well drained owing to moderate land slopes and good infiltration.	Well yields generally adequate for domestic use. Depth to ground water commonly greater than 10 ft except near the toes of the fans.
Qal	Well-sorted sand and gravel deposited by major streams. Deposits generally thin and underlain by bedrock.	Generally well drained owing to excellent infiltration, but water table is at land surface near valley bottom.	Materials very permeable and saturated below stream level. Ground water in direct communication with surface water. Shallow ground water susceptible to pollution.
Qbi	Materials vary from mud to boulder gravel, depending on wave action. Deposited below high tides.	Generally submerged by high tides.	Ground water is saline.

Qdim	Undifferentiated glacial drift overlying relatively impermeable crystalline bedrock. Locally redeposited by fluvial or colluvial processes.	Poor drainage owing to poor infiltration and bedrock commonly within 10 ft of surface. Hillside springs occur where drift locally thins.	Shallow ground water subject to natural or man-caused pollution. Yield from unconsolidated materials locally may be adequate for domestic supplies.
Qds	Undifferentiated glacial drift overlying poorly indurated sandstone and siltstone. Drift locally redeposited by fluvial and colluvial processes. Top of bedrock commonly more than 10 ft below land surface.	Generally well drained owing to moderate relief and moderate infiltration.	Domestic supplies may be obtained either from the unconsolidated materials or sandstone. Shallow ground water susceptible to pollution.
Fill	Artificial fill material (usually rock) at airport and along waterfront.	Emplaced to be well drained.

Seldovia is a fishing community situated on Seldovia Bay in lower Cook Inlet (fig. 1). The population in 1978 was 582 (Kenai Peninsula Borough, written commun., 1978). Principal development is within about one-half mile of Seldovia Slough and along the Seldovia-Jakolof Bay Road (fig. 2).
