DAMAGE IN SANTA CLARA AND SANTA CRUZ COUNTIES, CALIFORNIA
CAUSED BY THE EARTHQUAKE OF 18 APRIL 1906

Robert Nason
U.S. Geological Survey
Menlo Park, California

U.S. Geological Survey
OPEN-FILE REPORT 80- 1076
This report is preliminary and has not
been edited or reviewed for conformity
with Geological Survey editorial standards

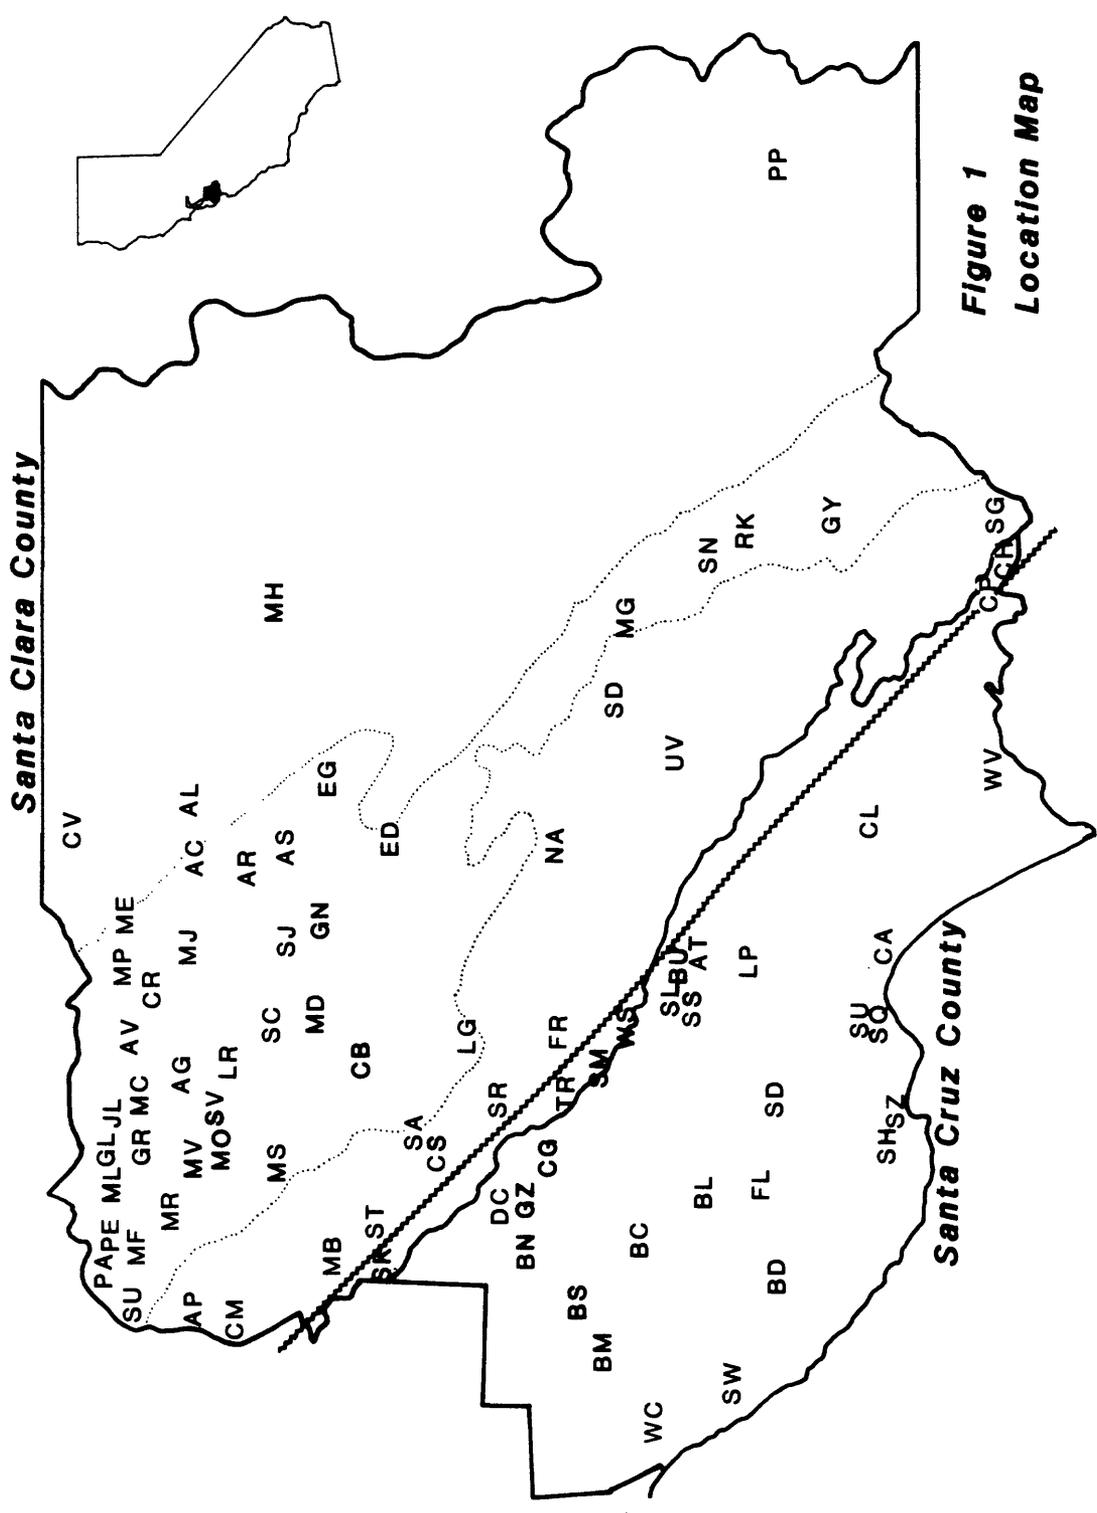
Figure 1
Location Map

Figure 1. Locations of damage and ground failure observations in Santa Clara and Santa Cruz Counties in the 18 April 1906 earthquake, as listed in Tables 3, 4, 5 and 6. The two-letter code corresponds to the locality names, with the first letter of the code being the same as the first letter of the place name. The wavy line is the position of the San Andreas fault. The dotted line is the approximate boundary between the hills and the alluvial area of the Santa Clara Valley.

The location of Santa Clara and Santa Cruz Counties in California is shown on the inset map of Figure 1. Santa Clara County is at the south end of San Francisco bay, and Santa Cruz County is south and west of Santa Clara County.

The eastern and western parts of Santa Clara County are mostly mountainous. The mountains consist of sedimentary rocks of Mesozoic and Tertiary ages. The central part of the county, which has most of the population, is an alluvial valley alongside and south of San Francisco Bay. The alluvium is several hundred feet thick in many places near the bay (Goldman, 1969), but decreases to zero thickness at the edge of the hills. The boundary between the hills and the central alluvial valley is shown by a dotted line in figure 1.

The damage is compiled by locality and listed alphabetically by locality in Tables 3, 4, 5, 6 and 7. For convenience, a two-letter code has been assigned to each locality for use on the reference map (figure 1). The first letter of the code is the first letter of the locality name.

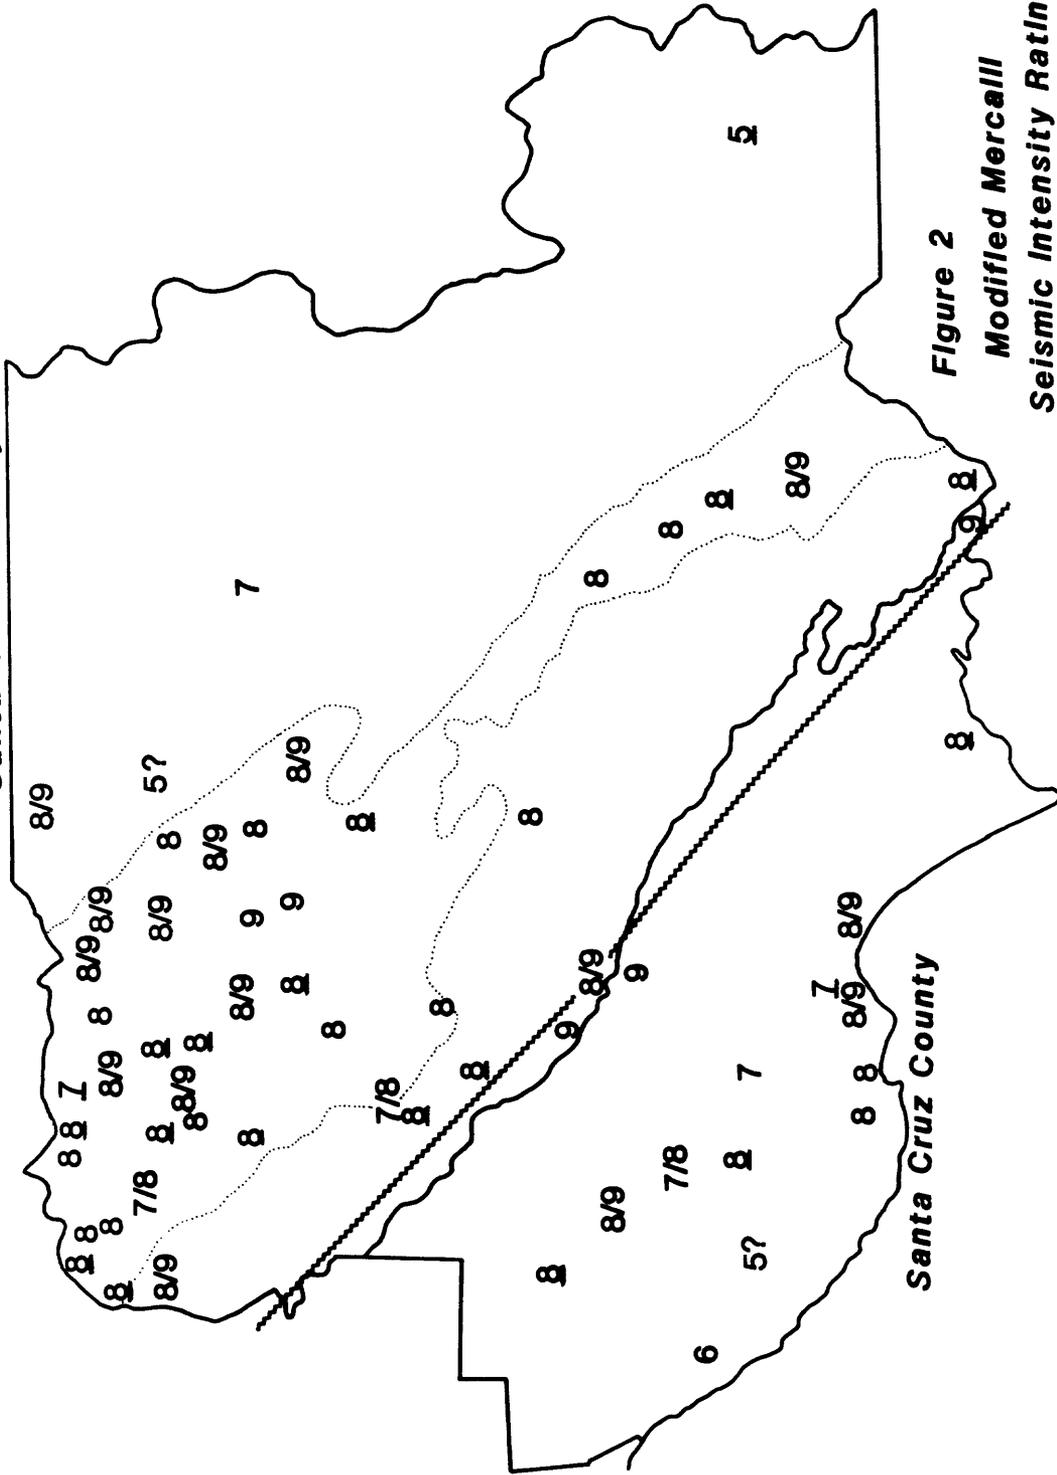
Figure 2
Modified Mercalli
Seismic Intensity Rating

Figure 2. Seismic intensity ratings at localities of building damage in Santa Clara and Santa Cruz Counties in the 18 April 1906 earthquake, as listed in Tables 3 and 4, using the Modified Mercalli scale of seismic intensity (Table 1) with the following notation to indicate the accuracy. At localities where the intensity rating is only a minimum value, the rating is underlined to indicate that the actual intensity might be higher. Where the description indicates either intensity VII or VIII, but not greater, the rating is given as VII/VIII. A rating of VIII/IX is used at localities where all or nearly all of the chimneys fell.

The seismic intensity ratings shown on the map (Figure 2) are compiled directly from the listings of Tables 3 and 4. It is noteworthy that the resulting map (Figure 2) is different in many important ways from the map shown by Lawson and others (1908), particularly in the hill regions. The Lawson report does not indicate what the map rating at any one site was based on, so it is not possible to directly evaluate the difference between the maps. But it is clear that the listed earthquake damage is significantly greater at many places in the hills than is indicated on the Lawson maps. Similarly, many places in the Santa Clara valley had a lower seismic intensity than is indicated on the Lawson maps.
