FLOODS OF SEPTEMBER 16, 1975 IN THE TALLABOA VALLEY, PUERTO RICO

by
Karl G. Johnson
1981

80-1283

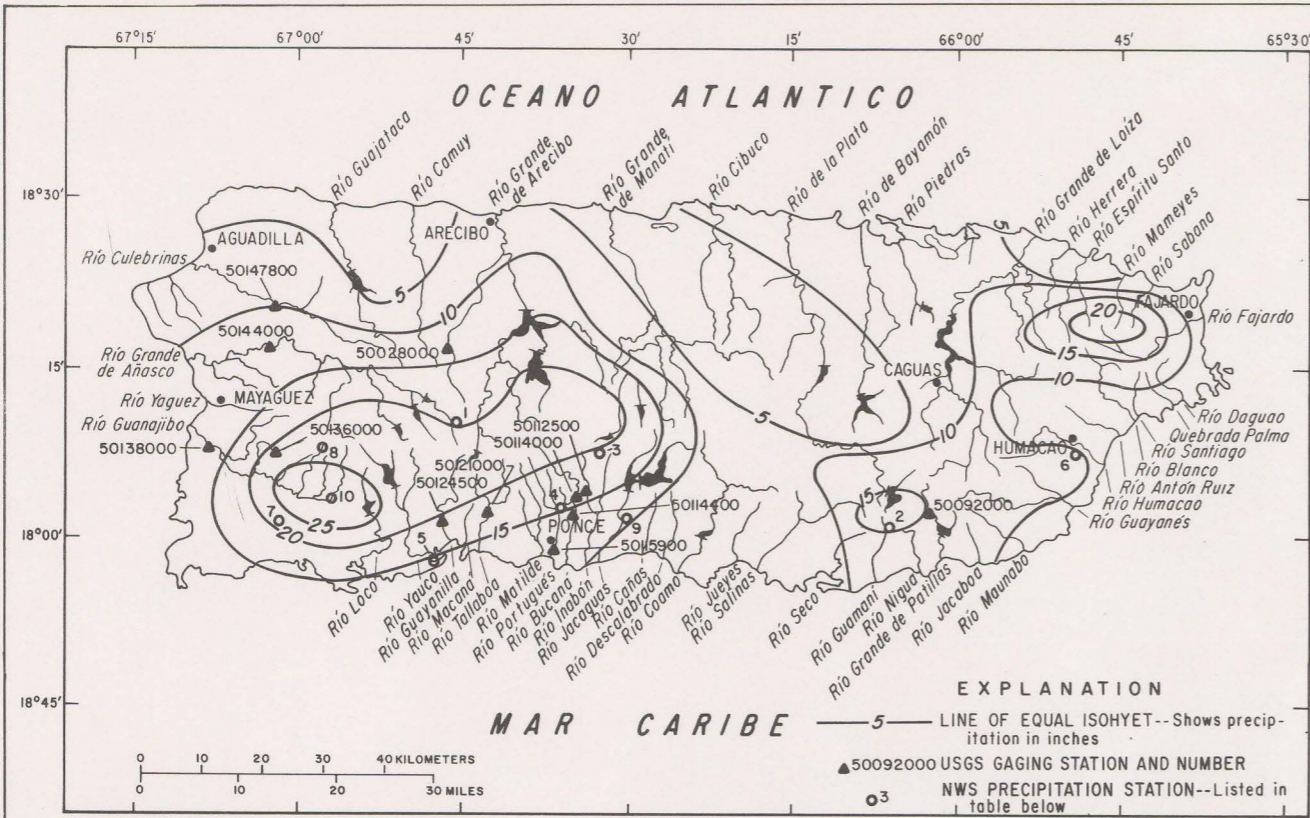
NUMBER ON MAP	LOCATION	PRECIPITATION, OF SEPTEMBER 15-17, 1975 IN INCHES			
		SEPTEMBER 15	SEPTEMBER 16	SEPTEMBER 17	TOTAL
1	ADJUNTAS SUBSTATION	0.15	11.99	4.87	17.01
2	CARITE PLANT NO. 1	.05	10.05	6.85	16.95
3	CERRO MARAVILLA	.46	16.00	2.37	18.83
4	CORRAL VIEJO	.10	7.58	8.26	15.94
5	ENSENADA	.05	5.41	10.30	15.76
6	HUMACAO	.40	8.02	5.22	13.64
7	LAJAS SUBSTATION	.29	3.10	12.26	15.65
8	MARICAO 2 SSW	2.32	6.05	14.10	22.47
9	PONCE 4 E	0	2.90	7.78	10.68
10	SABANA GRANDE 2 ENE	1.20	14.00	11.50	26.70

FIGURE 2.--Map of Puerto Rico showing isohyets for storm of September 15-17, 1975, locations of selected precipitation and stream-gaging stations, and table showing the precipitation for the selected stations.

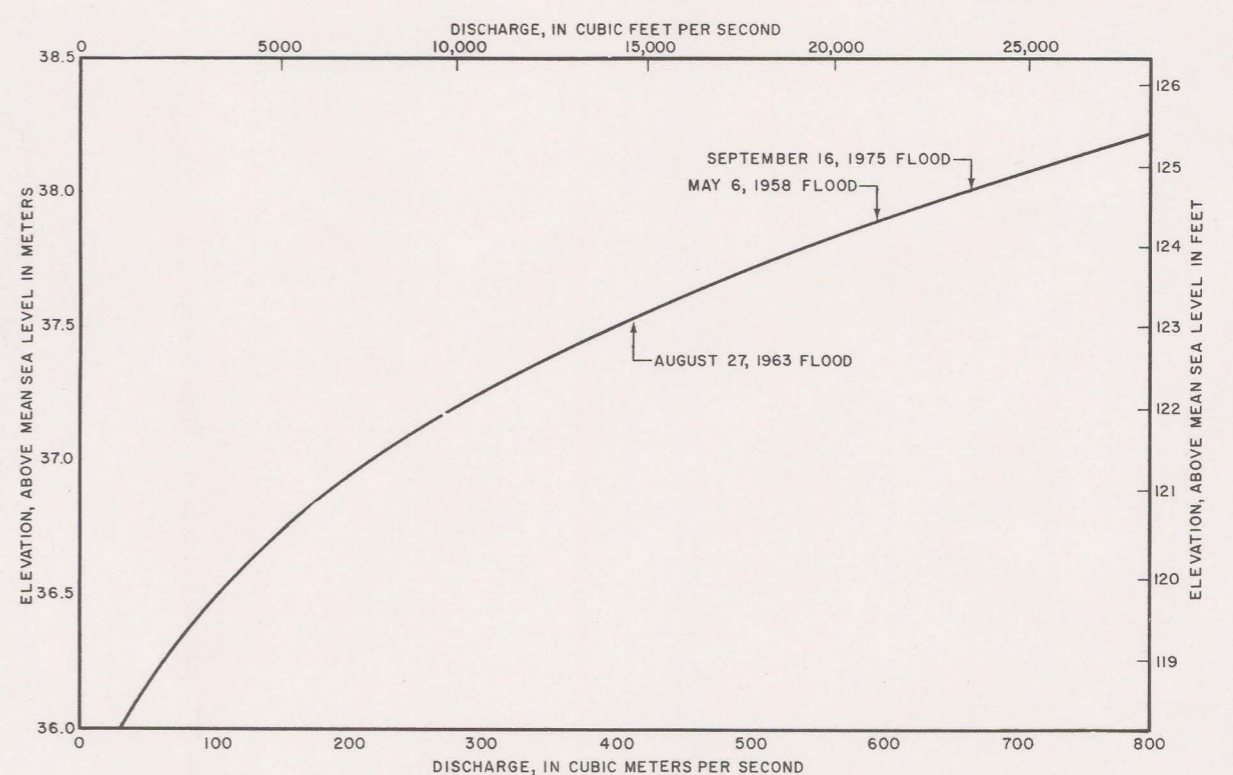
FIGURE 3.--Stage-discharge relation of gaging station 50121000, Río Tallaboa at Peñuelas.
