# SEISMIC DAMAGE ASSESSMENT FOR HIGH-RISE BUILDINGS

## ANNUAL TECHNICAL REPORT

August 1980

prepared by  
URS/John A. Blume & Associates, Engineers  
130 Jessie Street (at New Montgomery)  
San Francisco, California 94105

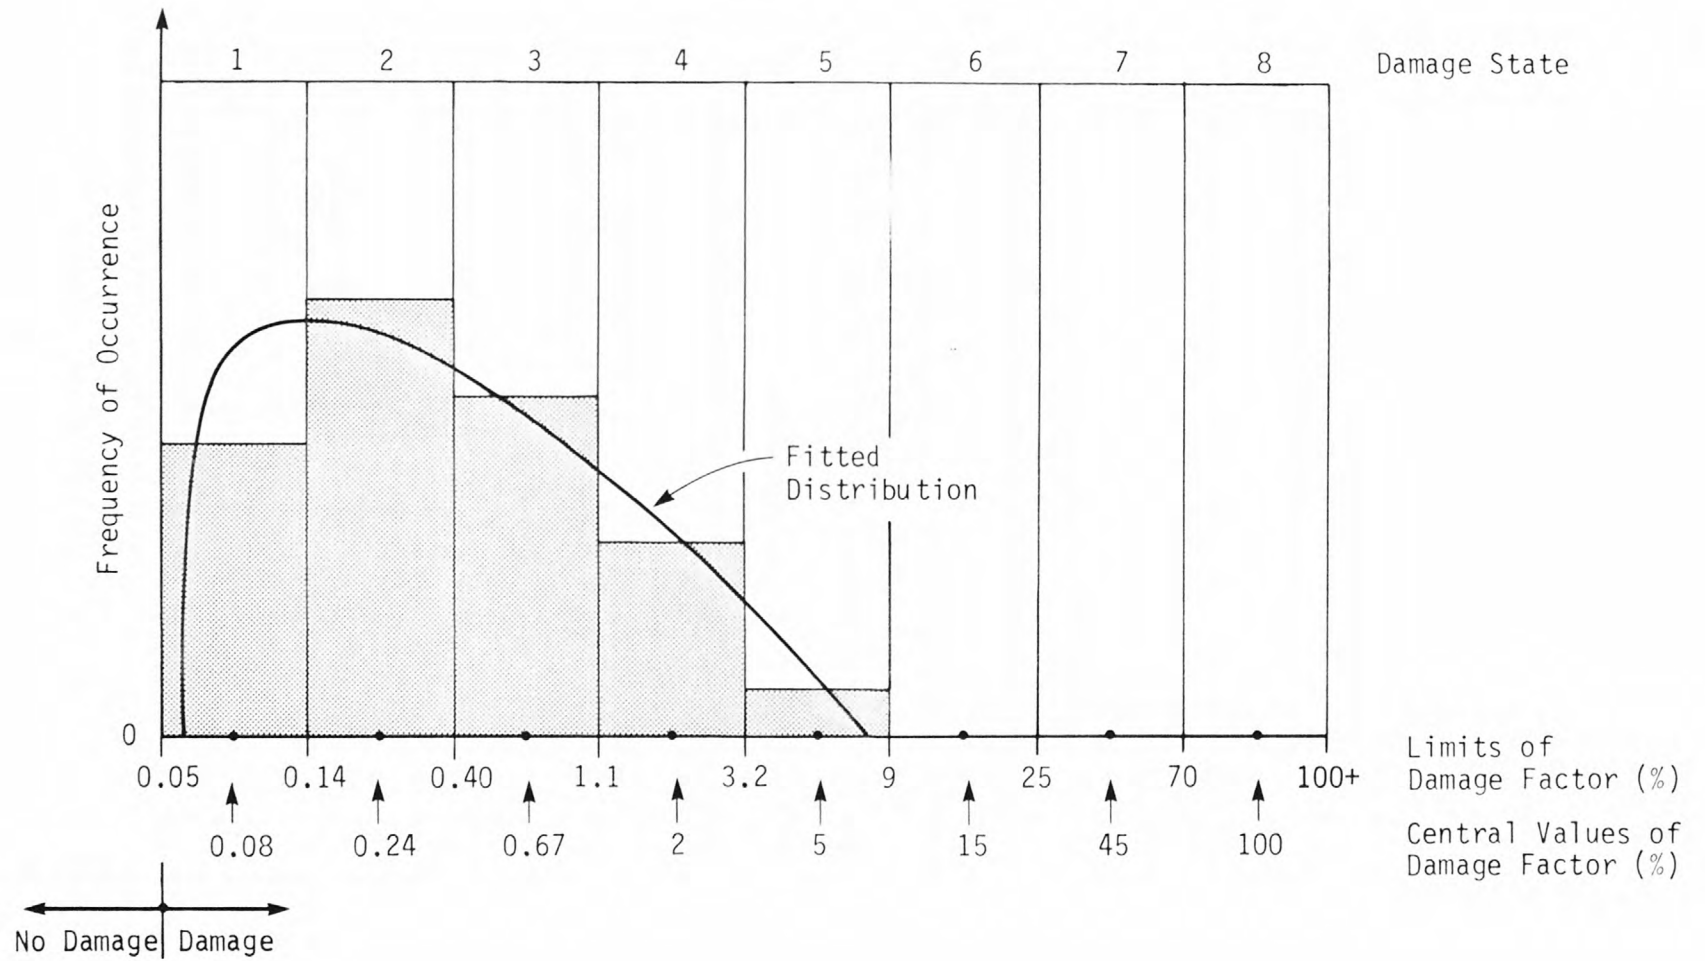
FIGURE 3.9 SAMPLE DAMAGE-STATE HISTOGRAM

A nonlinear scale based on previous experience was employed (Whitman, 1973). Table 3.2 shows the state, the description of damage, the central value, and the intervals covered. A graphic representation of this scale is shown in Figure 3.9.

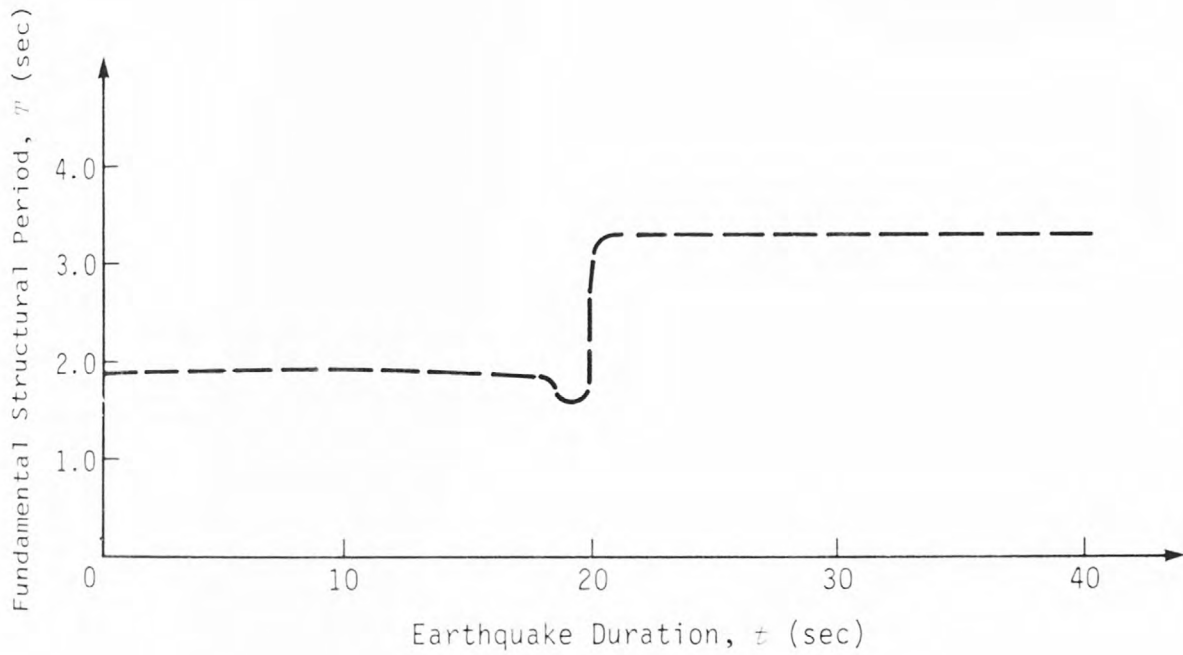
7th Floor, Transverse Direction

FIGURE 5.11 BANK OF CALIFORNIA BUILDING: CHANGE OF FUNDAMENTAL PERIODS DURING EARTHQUAKE EXCITATION

Two different approaches were used for the calculation of transfer functions. In the first approach, 10-sec segments of the time histories were used to generate the transfer function. If the structure stays within the elastic range, the dominant structural frequencies should be steady for all segments. To eliminate the instability in numerical analysis, time-history segments were overlapped. The plots of the variation of fundamental period shown in Figures 5.10 (cases 1 through 7) and 5.11 show that the structural fundamental period was approximately 1.8 sec and shifted to around 3.5 sec at about 22 sec. This indicates that the structural members were damaged at about this time.

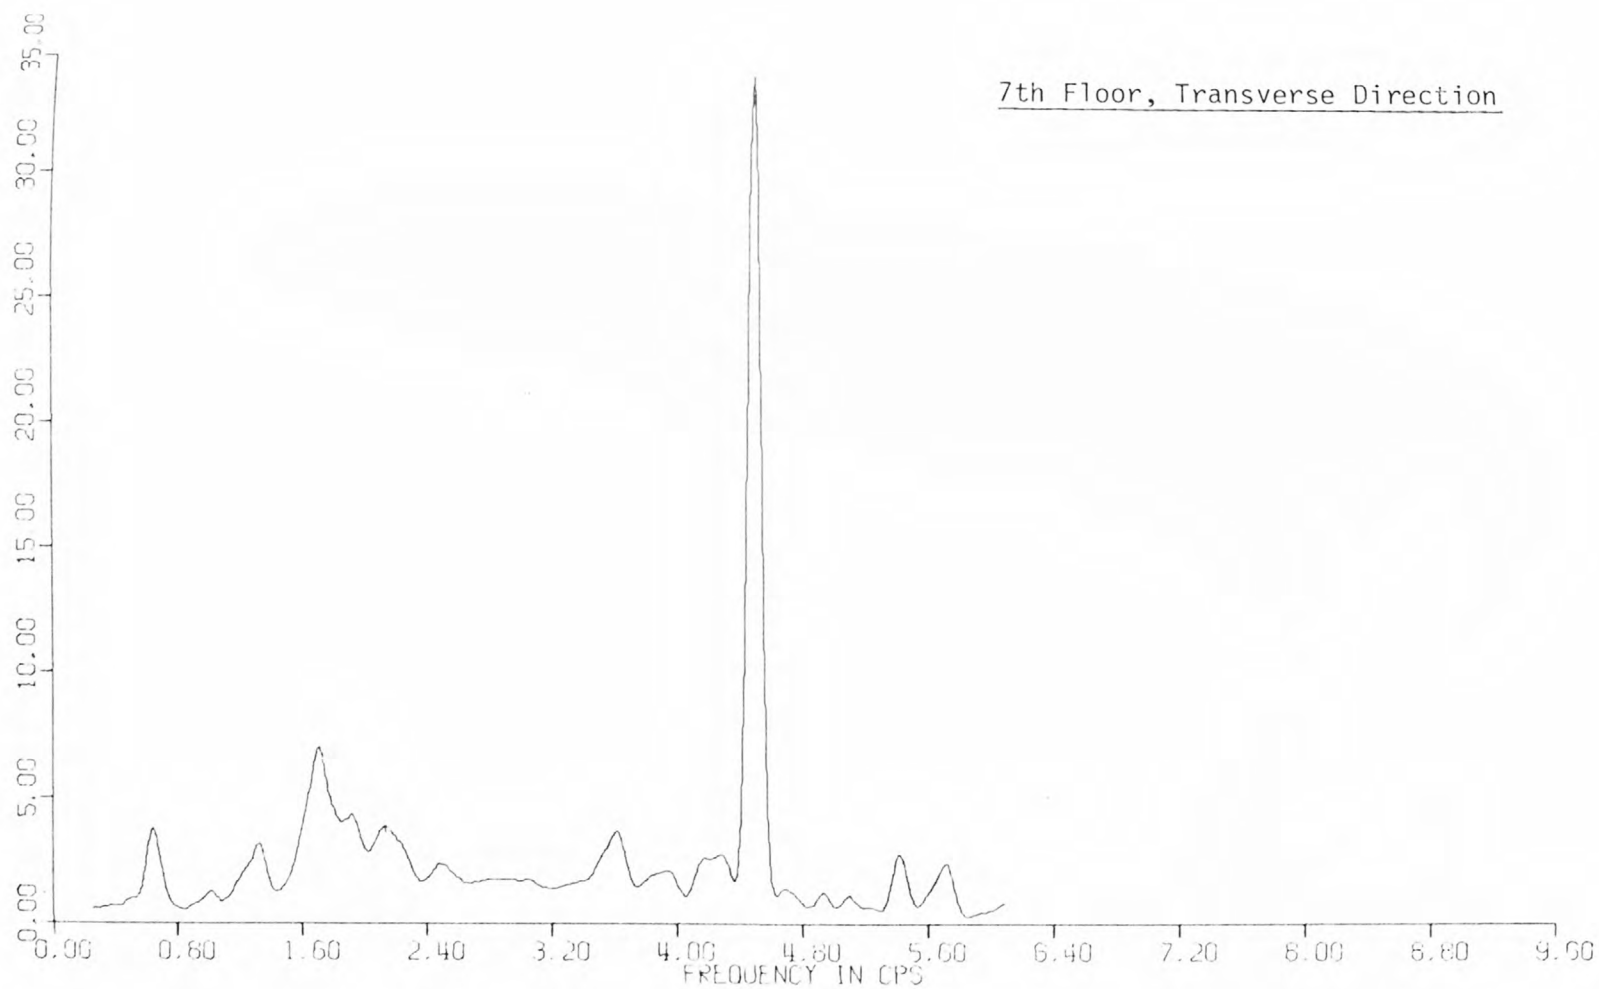
FIGURE 5.12c BANK OF CALIFORNIA BUILDING: INSTANTANEOUS TRANSFER FUNCTION: CASE 3

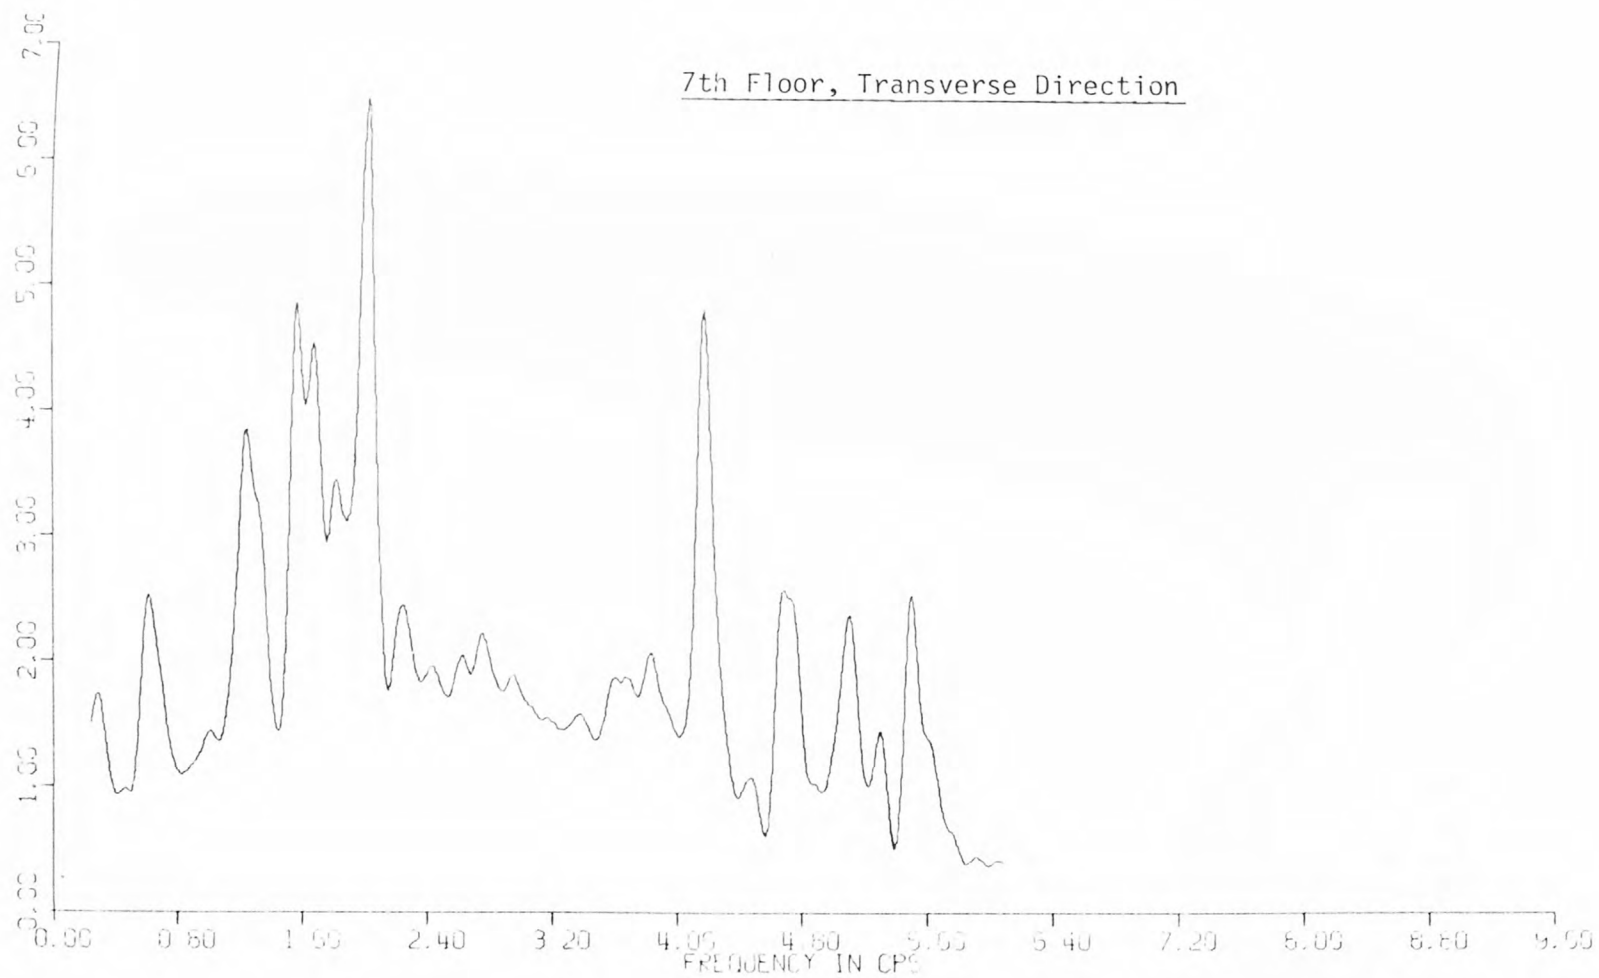
FIGURE 5.12d BANK OF CALIFORNIA BUILDING: INSTANTANEOUS TRANSFER FUNCTION: CASE 4

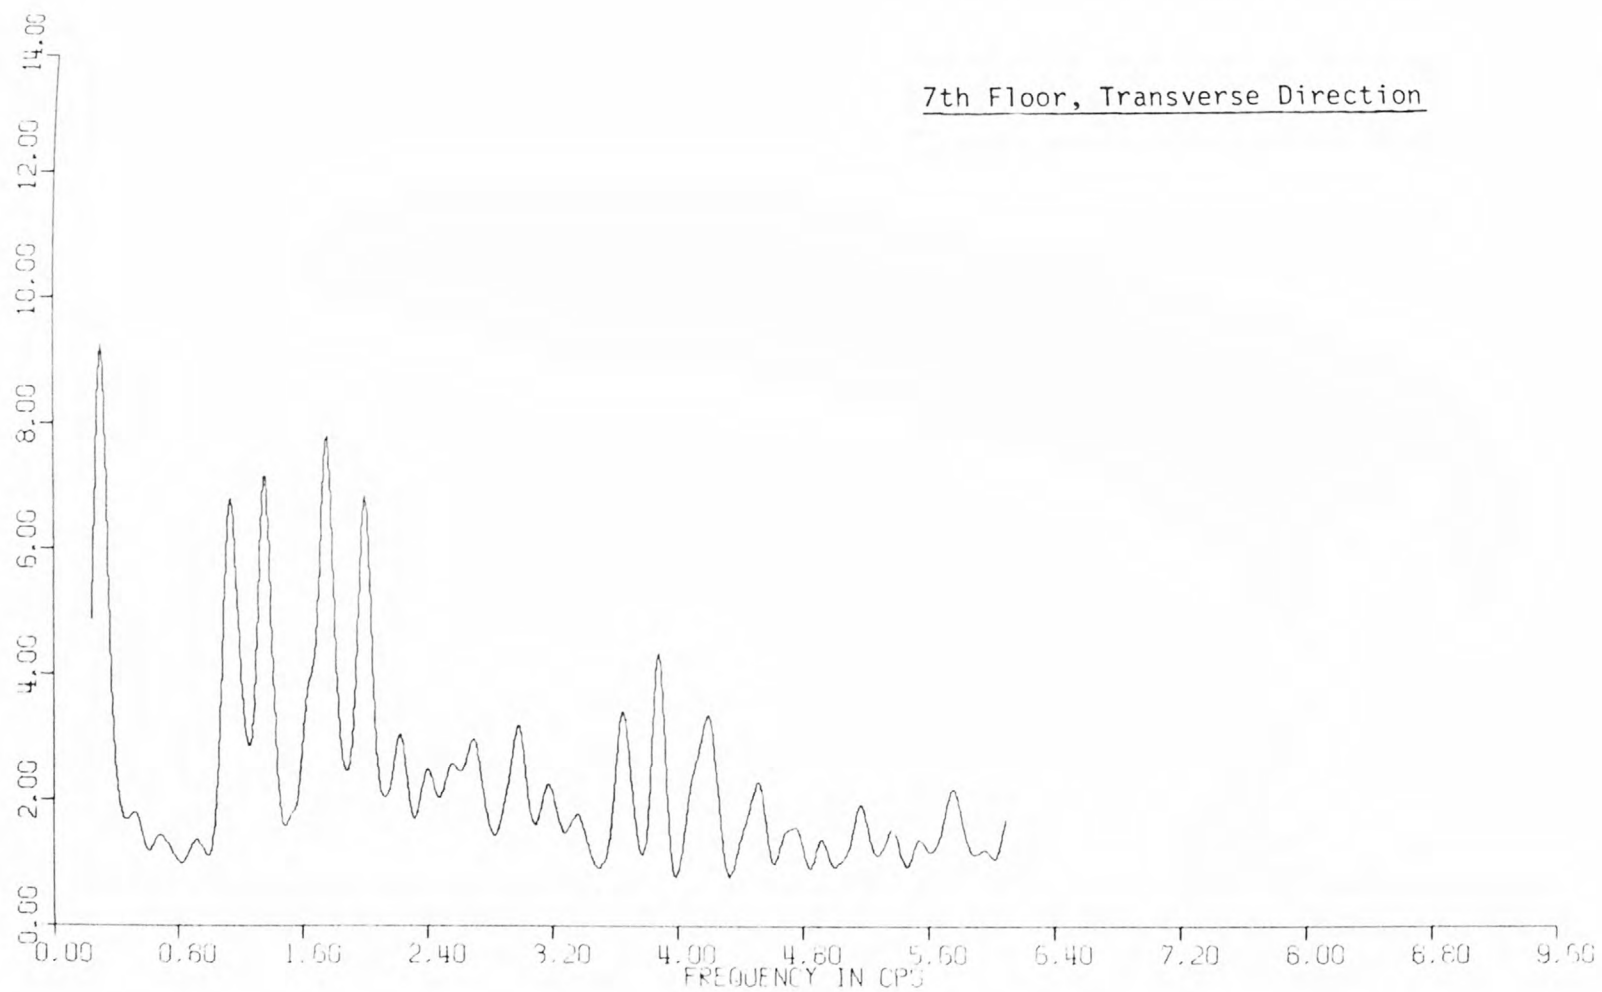
FIGURE 5.12e BANK OF CALIFORNIA BUILDING: INSTANTANEOUS TRANSFER FUNCTION: CASE 5

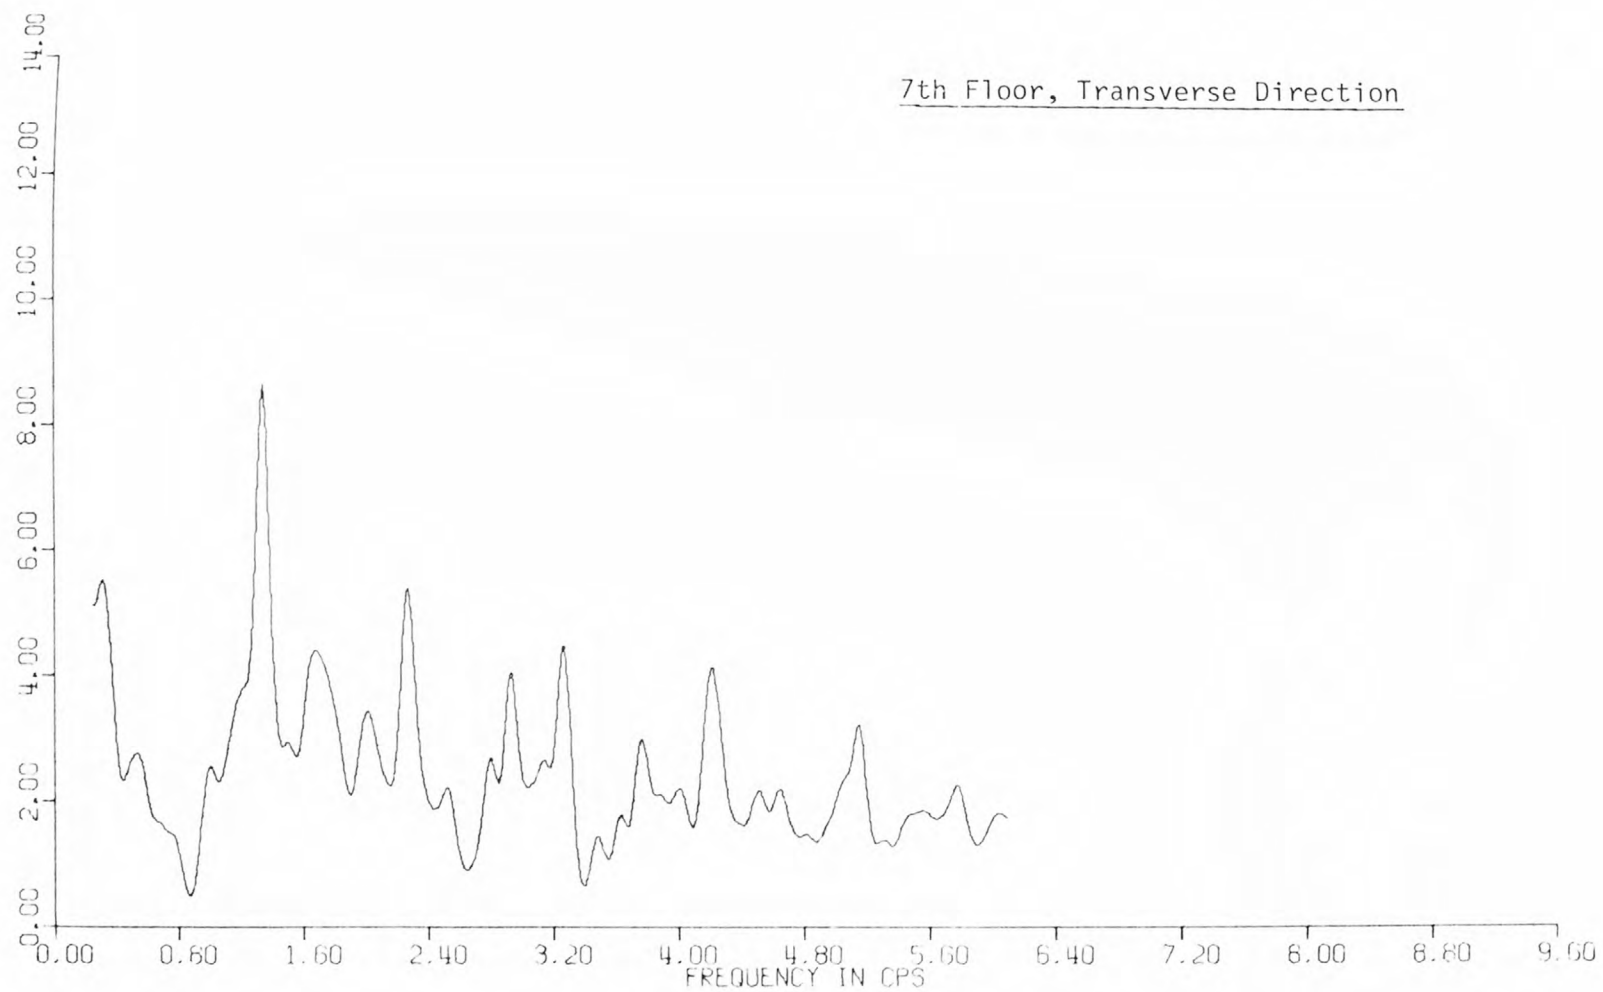
FIGURE 5.12f BANK OF CALIFORNIA BUILDING: INSTANTANEOUS TRANSFER FUNCTION: CASE 6

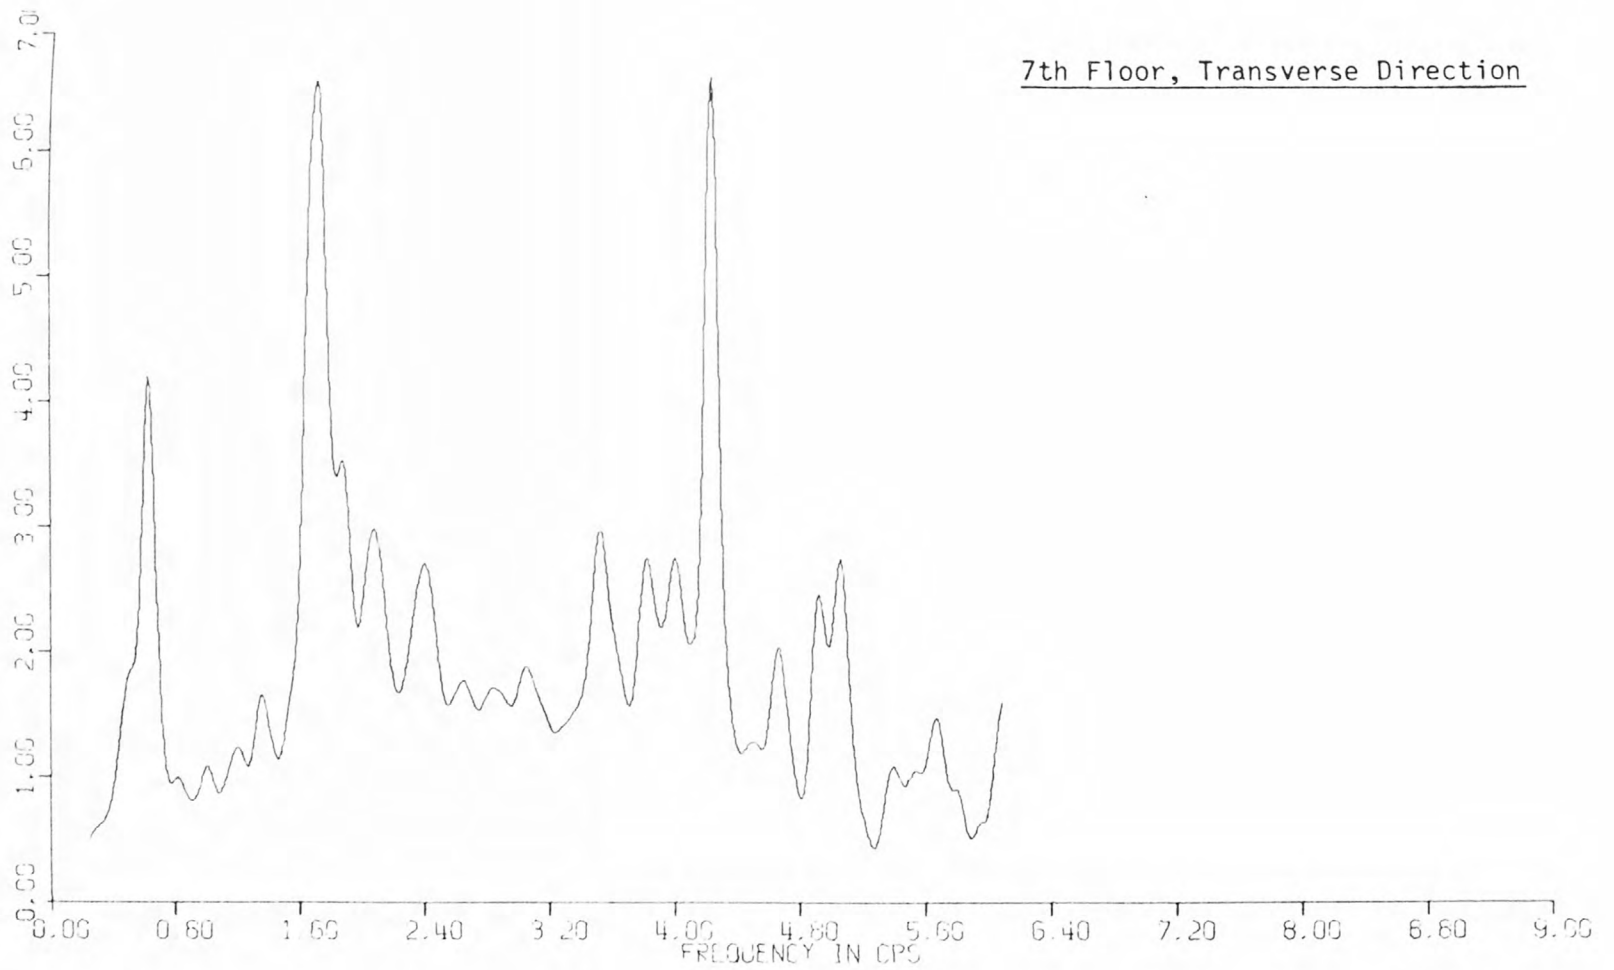
FIGURE 5.12i BANK OF CALIFORNIA BUILDING: INSTANTANEOUS TRANSFER FUNCTION: CASE C
