INTRODUCTION

FLOOD OF SEPTEMBER 16, 1975 IN THE GUANAJIBO VALLEY, PUERTO RICO

By
Karl G. Johnson

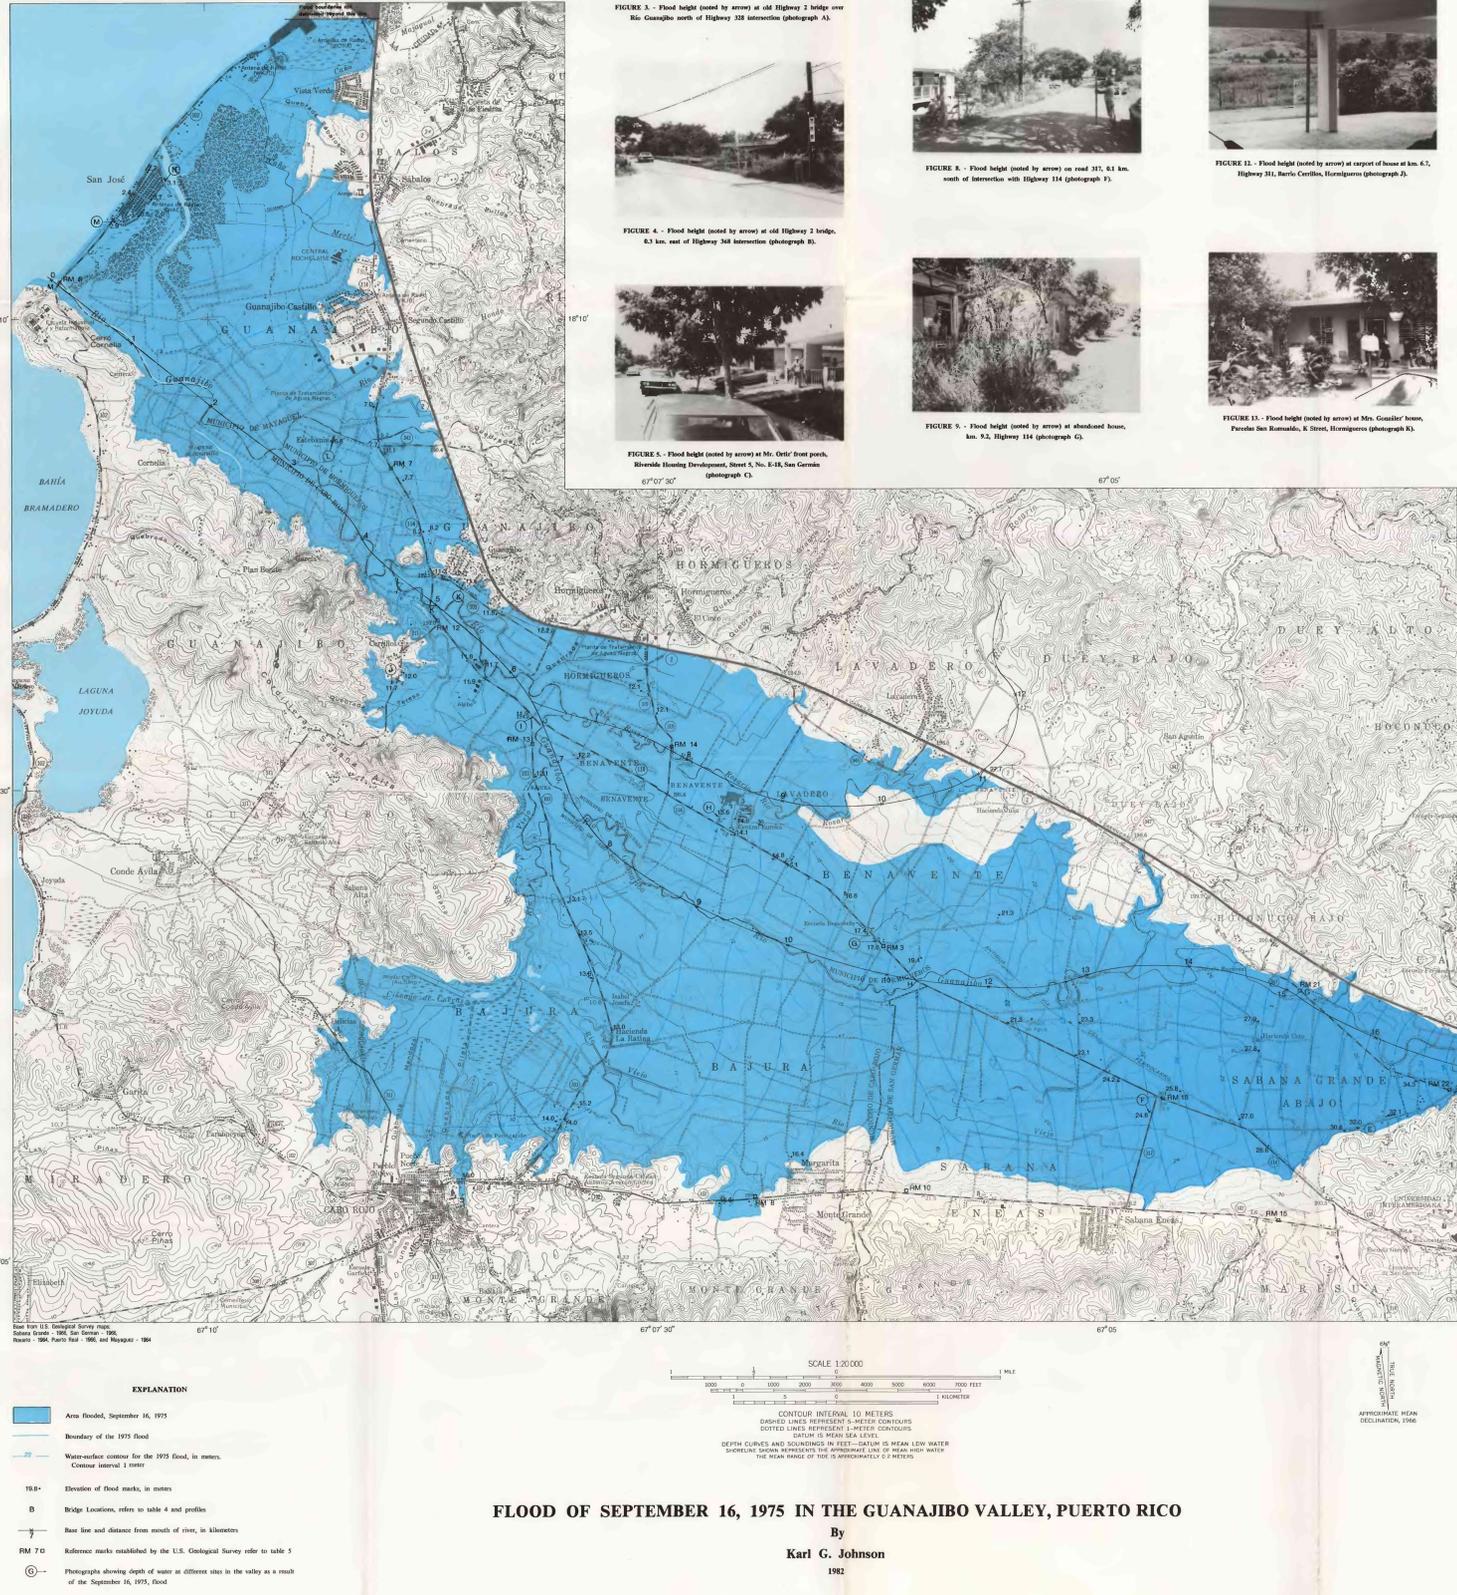
FIGURE 17. Flood height (noted by arrow) at abandoned house, San 5-2, Highway 114 (photograph O).

FIGURE 17. Flood height (noted by arrow) at abandoned house, San 5-2, Highway 114 (photograph O).
