**STORM-TIDE ELEVATIONS CAUSED
BY HURRICANE HUGO ON THE
U.S. VIRGIN ISLANDS AND
PUERTO RICO, SEPTEMBER 18, 1989**

Open-File Report 92-87

By Heriberto Torres-Sierra

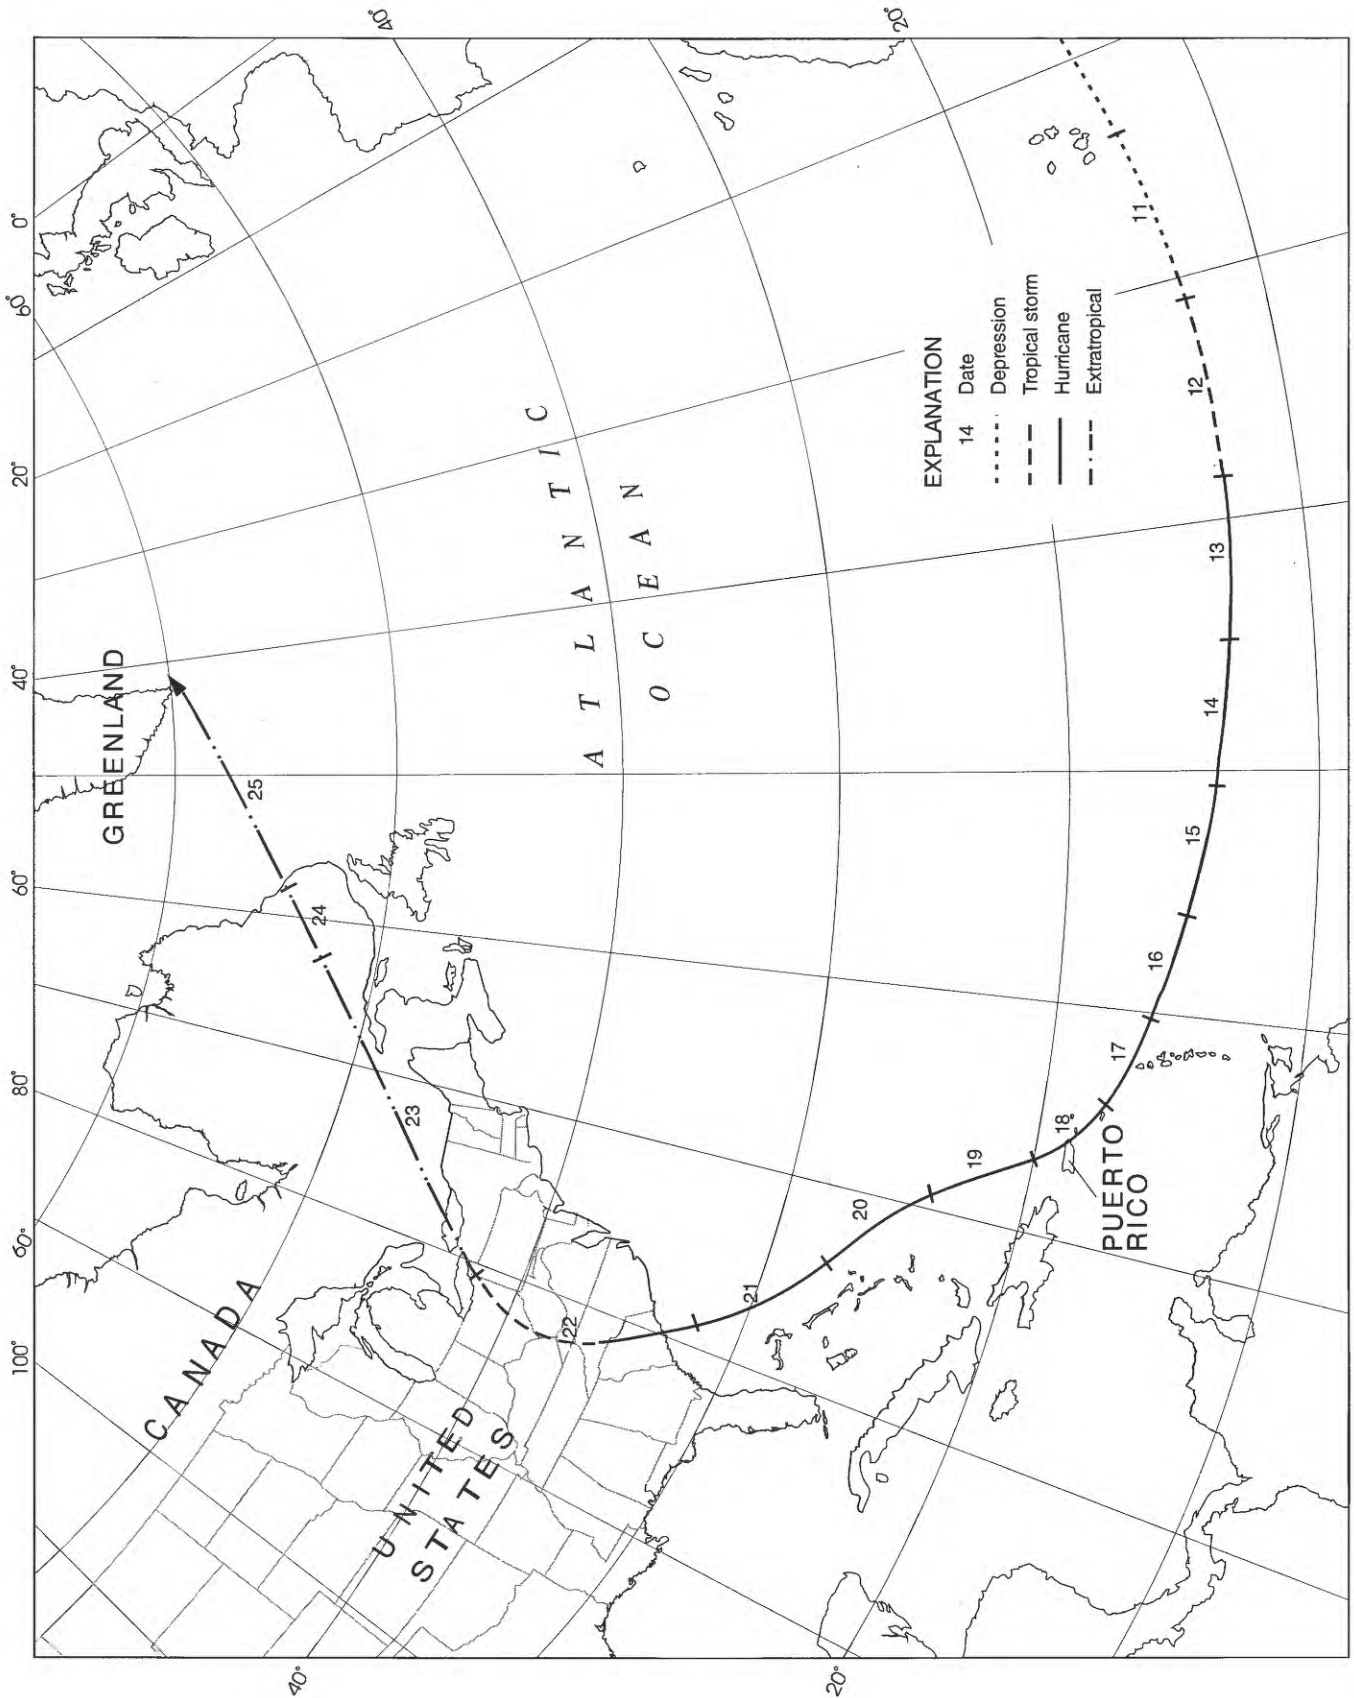
Figure 1. Track of Hurricane Hugo across the Atlantic Ocean and North America, September 1989. (Source: Modified from National Oceanic and Atmospheric Administration, 1989.)

On September 13, tropical storm Hugo, located in the middle of the Atlantic Ocean at about 13°N. latitude and 38°W. longitude (fig. 1), was upgraded to hurricane status having wind speed of 75 miles per hour (mi/hr). Over the next 4 days, the hurricane continued its westward movement and gained strength over the open water of the Atlantic Ocean. Hurricane Hugo, now a powerful category 4 hurricane (wind speeds 131–155 mi/hr), continued along a 750-mile stretch of the Lesser Antilles on Sunday, September 17, and passed over St. Croix between 4 a.m. and 5 a.m., Atlantic standard time, on Monday, September 18 (fig. 2). Traveling in a west-northwest direction and passing over the island of Vieques, Hurricane Hugo brushed the eastern coast of Puerto Rico at 8 a.m., Atlantic standard time, and had maximum sustained winds of 104 mi/hr, gusts of

Hurricane Hugo passed through South Carolina and into North Carolina, where it was downgraded to a tropical storm. The storm then moved through the eastern United States, where it was reclassified as an extratropical storm. It then passed through Canada and moved back over the North Atlantic Ocean and finally dissipated near Greenland on September 26 (fig. 1).
