# **Environmental Overview and Hydrogeologic Conditions At Federal Aviation Administration Facilities Near Fairbanks, Alaska**

Open-File Report 95-172

Prepared in cooperation with the  
FEDERAL AVIATION ADMINISTRATION

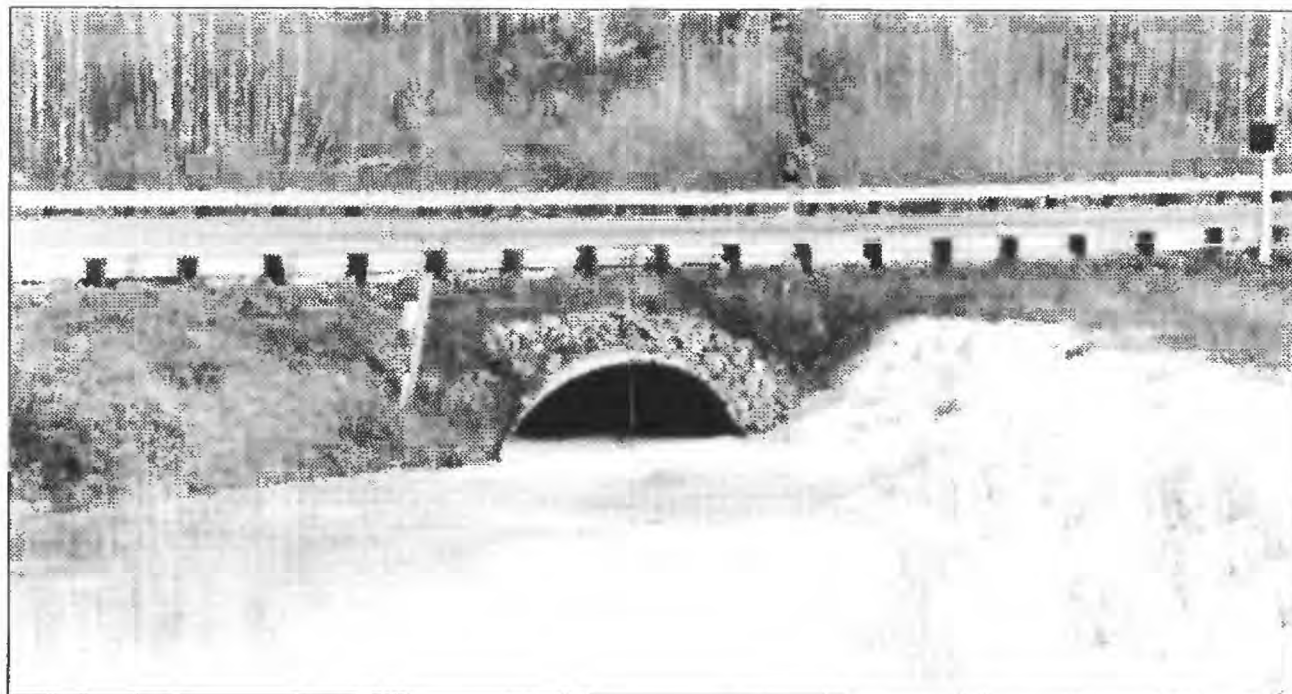
**Figure 3.** Icing on Goldstream Creek near Fox.

During winter, icings occur along the stream. When the stream freezes to the bottom, the channel is unable to convey the remaining flow. The streamflow then breaks out to the surface, forming an overflow. Overflows occur repeatedly to form a massive icing. Conditions during the winter of 1993-94 resulted in the formation of several large icings on Goldstream Creek upstream from Goldstream Road near Fox (fig. 3).
