Storm-Tide Elevations Caused by Hurricane Marilyn on the U.S. Virgin Islands, September 15-16, 1995

U.S. GEOLOGICAL SURVEY

Open-File Report 96-440

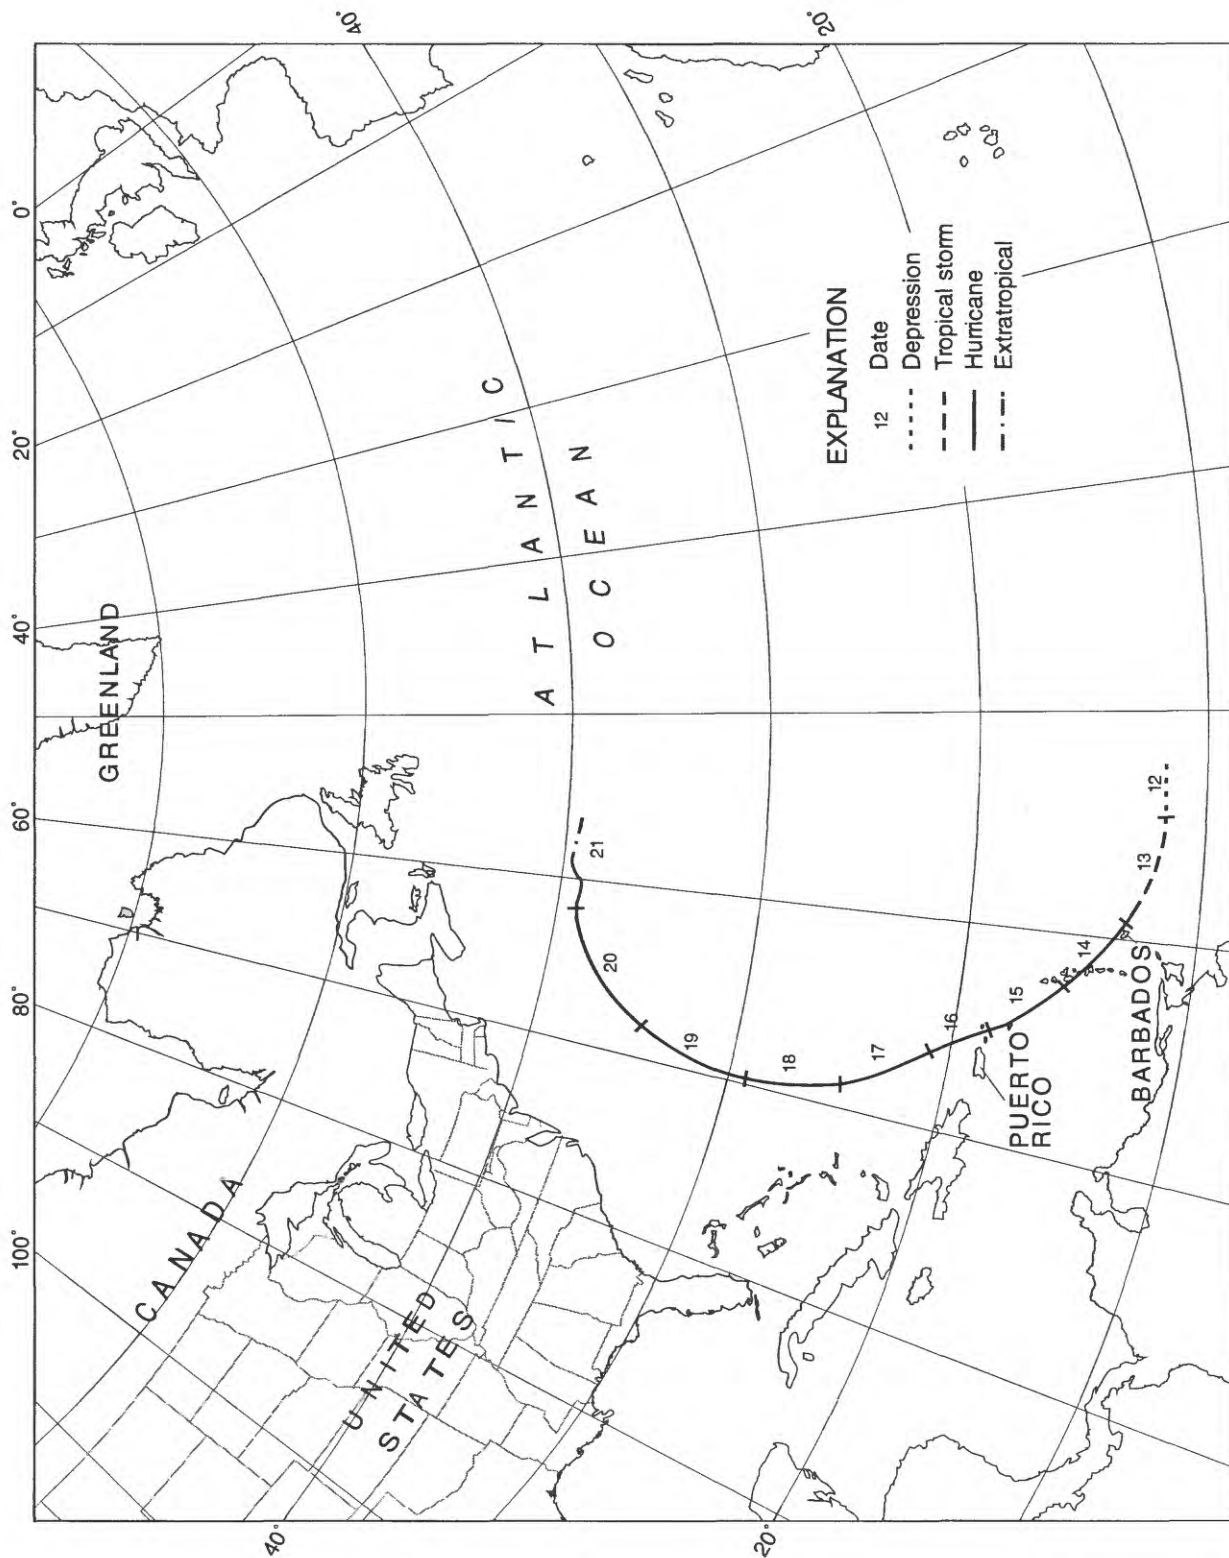
Figure 1. Track of Hurricane Marilyn across the Atlantic Ocean, September 1995 (modified from the National Oceanic and Atmospheric Administration, 1995).

Hurricane Marilyn developed from Tropical Depression 15 that originated over the west-central Atlantic Ocean on September 12 at 6 p.m., Atlantic standard time, about 470 miles east of Barbados (11.9 degrees N. latitude and 52.6 degrees W. longitude; fig. 1). The depression traveled west at about 25 miles per hour (mi/hr) and became Tropical Storm Marilyn on September 13. On September 14 at 2 a.m., Tropical Storm Marilyn, located at about 40 miles east of

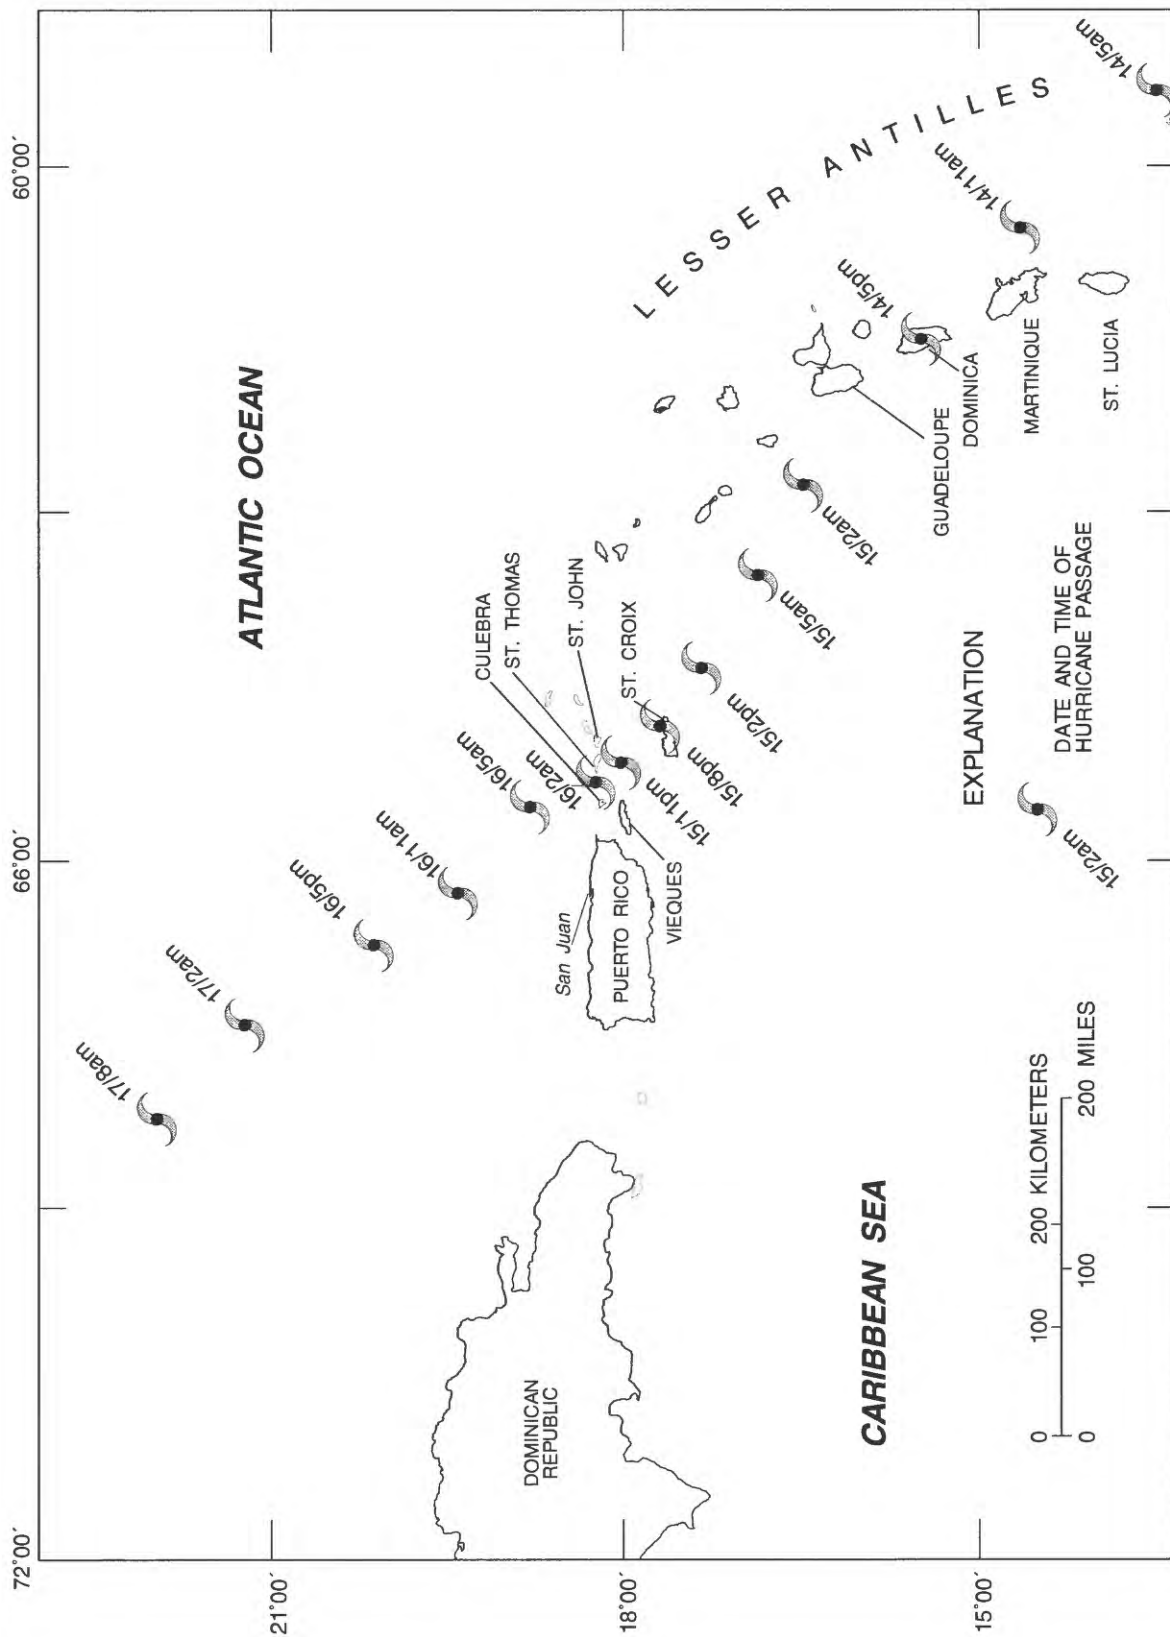
Figure 2. Track of Hurricane Marilyn across the islands of the Caribbean Sea, September 1995.

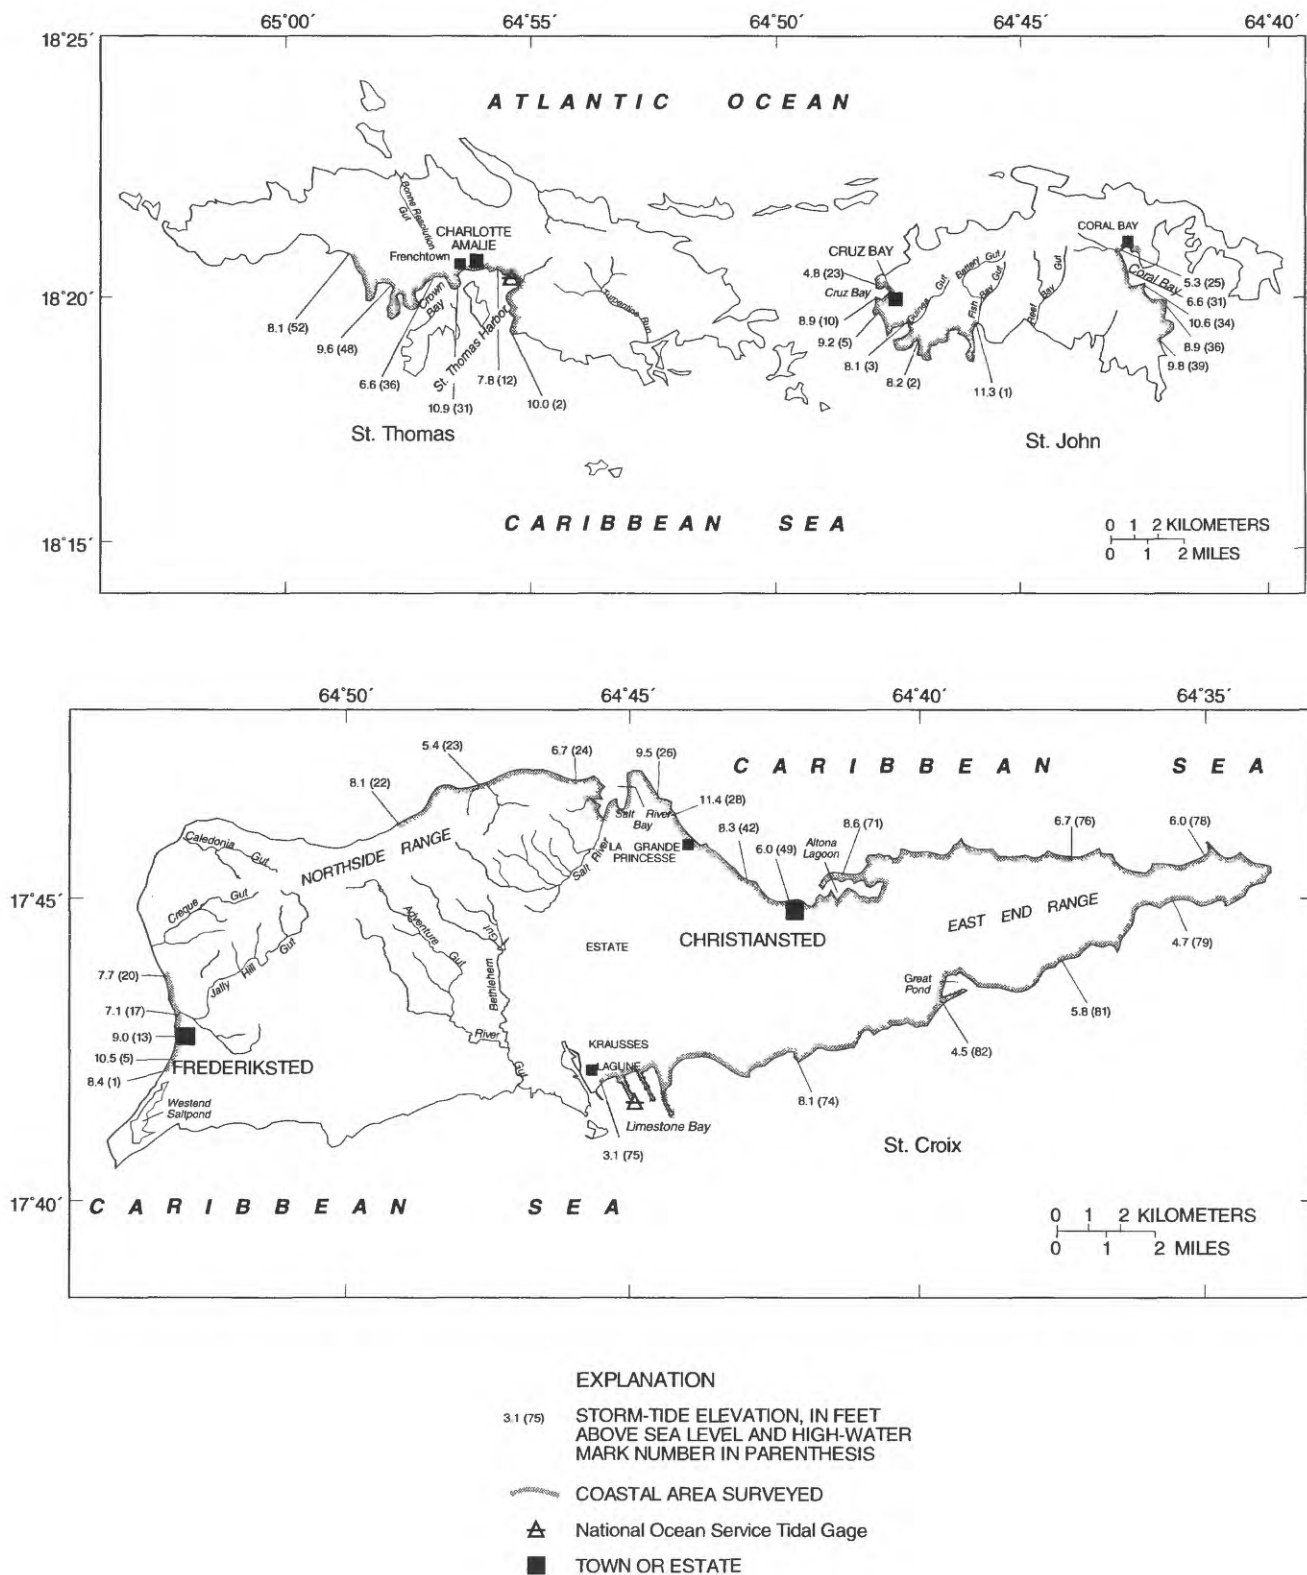
Figure 3. Study area and storm-tide elevations resulting from the passage of Hurricane Marilyn at selected locations in the U.S. Virgin Islands.

feet above mean sea level at Limestone Bay, Estate Krausses Lagune, St. Croix (fig. 3). The elevation of the storm tide at Limestone Bay, St. Croix and at St. Thomas Harbor was also recorded by the National Ocean Service (NOS) tidal gage stations in the USVI (figs. 3 and 4). As shown in figure 4, the high water elevation at the St. Croix tidal gage peaked shortly after midnight and the high water elevation at the St. Thomas gage peaked near 4:00 a.m., Atlantic standard time.

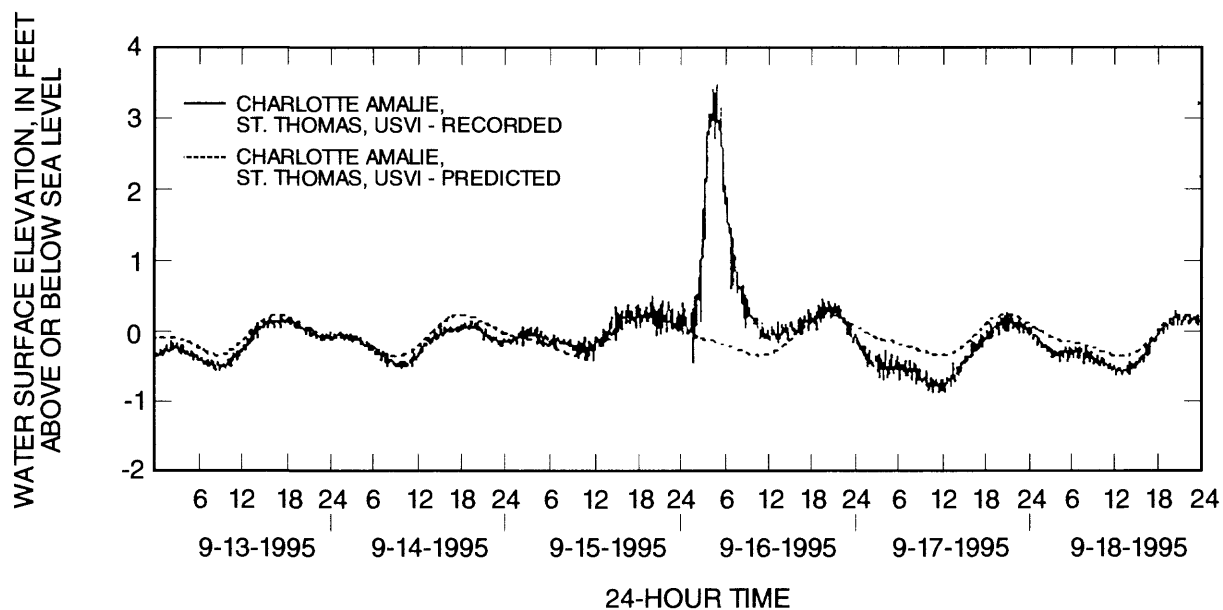
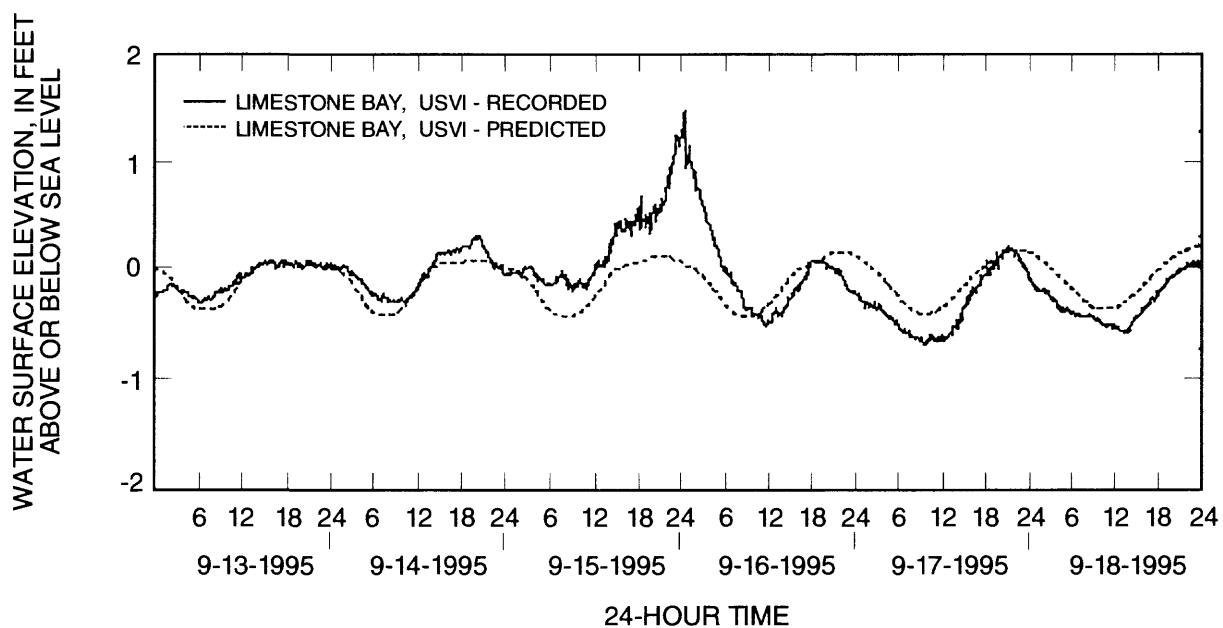
Figure 4. Recorded storm-tide elevations resulting from the passage of Hurricane Marilyn at the NOS tidal gage stations in the U.S. Virgin Islands (modified from National Oceanic and Atmospheric Administrations, 1996).

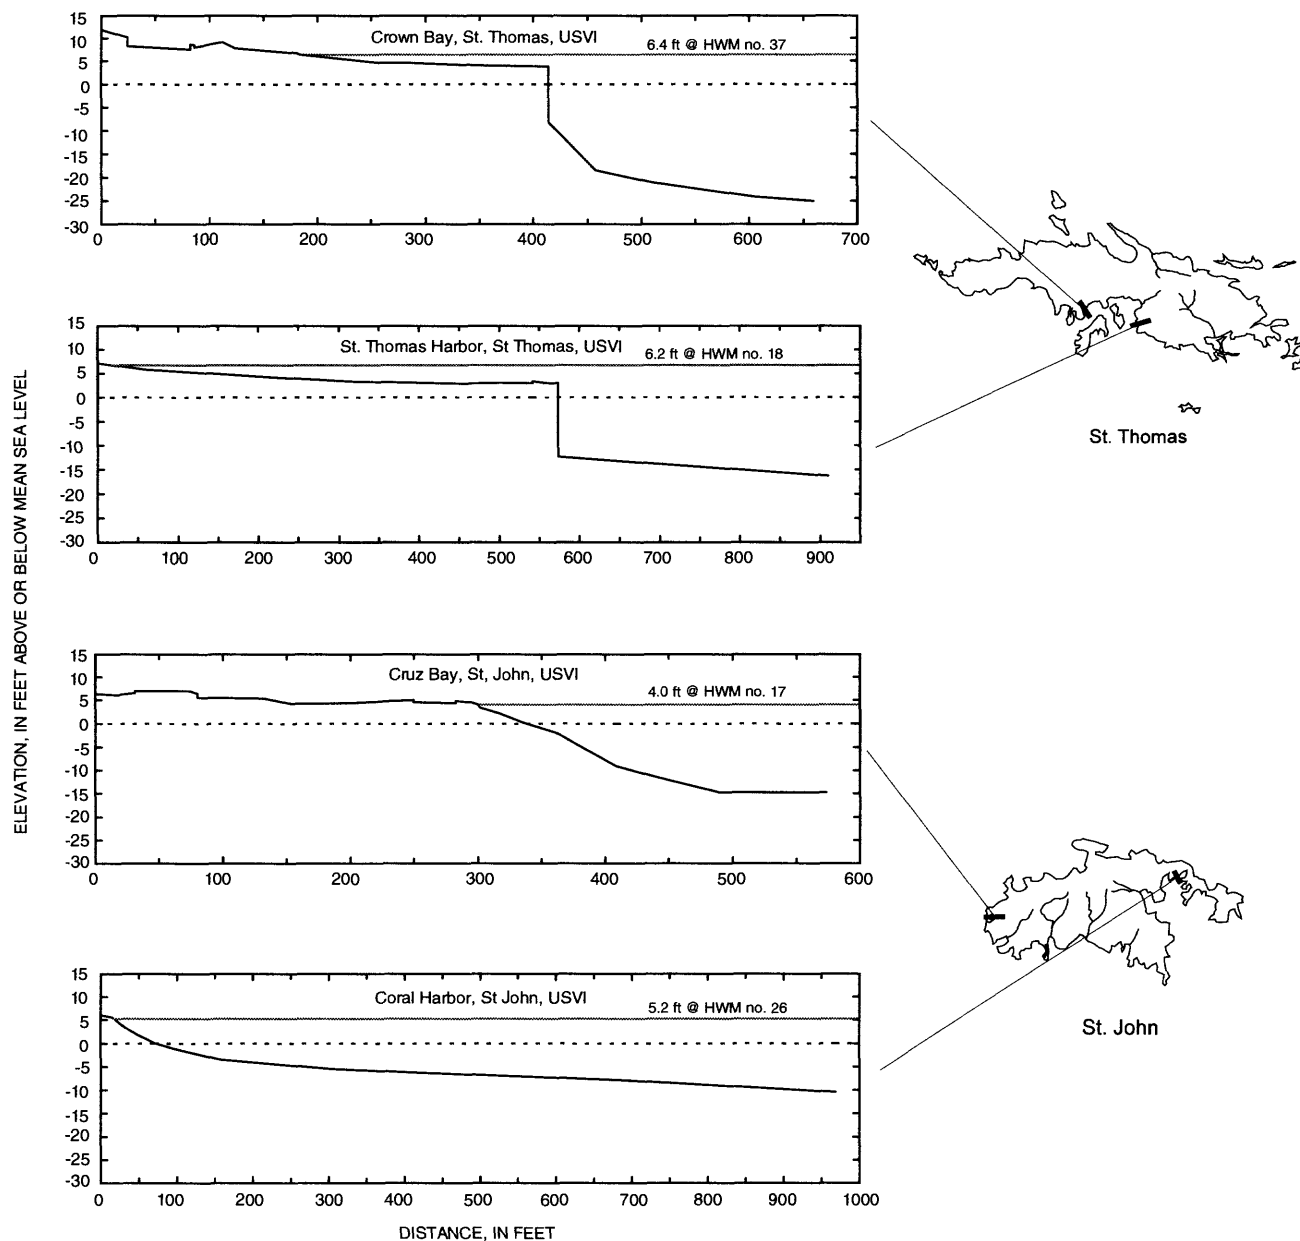
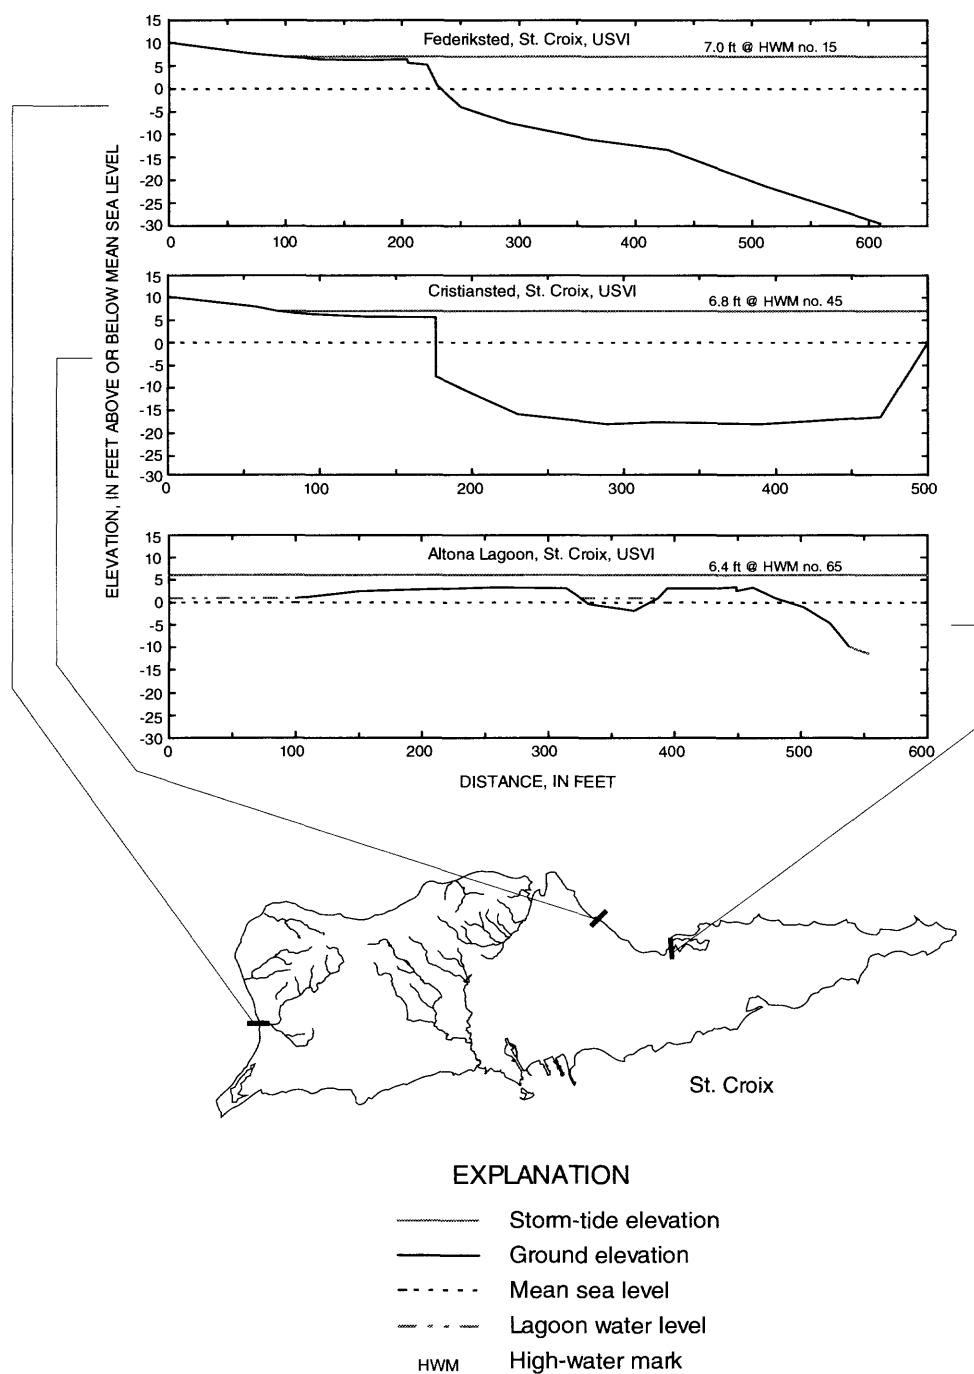
Figure 5. Measured profiles defining the storm-tide elevations resulting from the passage of Hurricane Marilyn at selected locations in the U.S. Virgin Islands.

Figure 5. Measured profiles defining the storm-tide elevations resulting from the passage of Hurricane Marilyn at selected locations in the U.S. Virgin Islands—Continued.

Profiles defining the storm-tide elevation, the inland extent of coastal flooding, and the ground elevation were surveyed at selected coastal areas on each island (fig. 5). In St. Thomas, a profile was

measured in the St. Thomas Harbor area at Charlotte Amalie and in the Crown Bay area. Two profiles were measured in St. John: one in the Cruz Bay area and another in the Coral Bay area. Three profiles were measured in St. Croix: one profile was measured in Frederiksted, one in Christiansted, and one in the Altona Lagoon Beach area. These profiles were surveyed normal to the coastline. The approximate depth of flooding at any point along the inundated area can be estimated by subtracting the ground elevation from the storm-tide elevation. The location of these selected profiles are presented on figure 5.

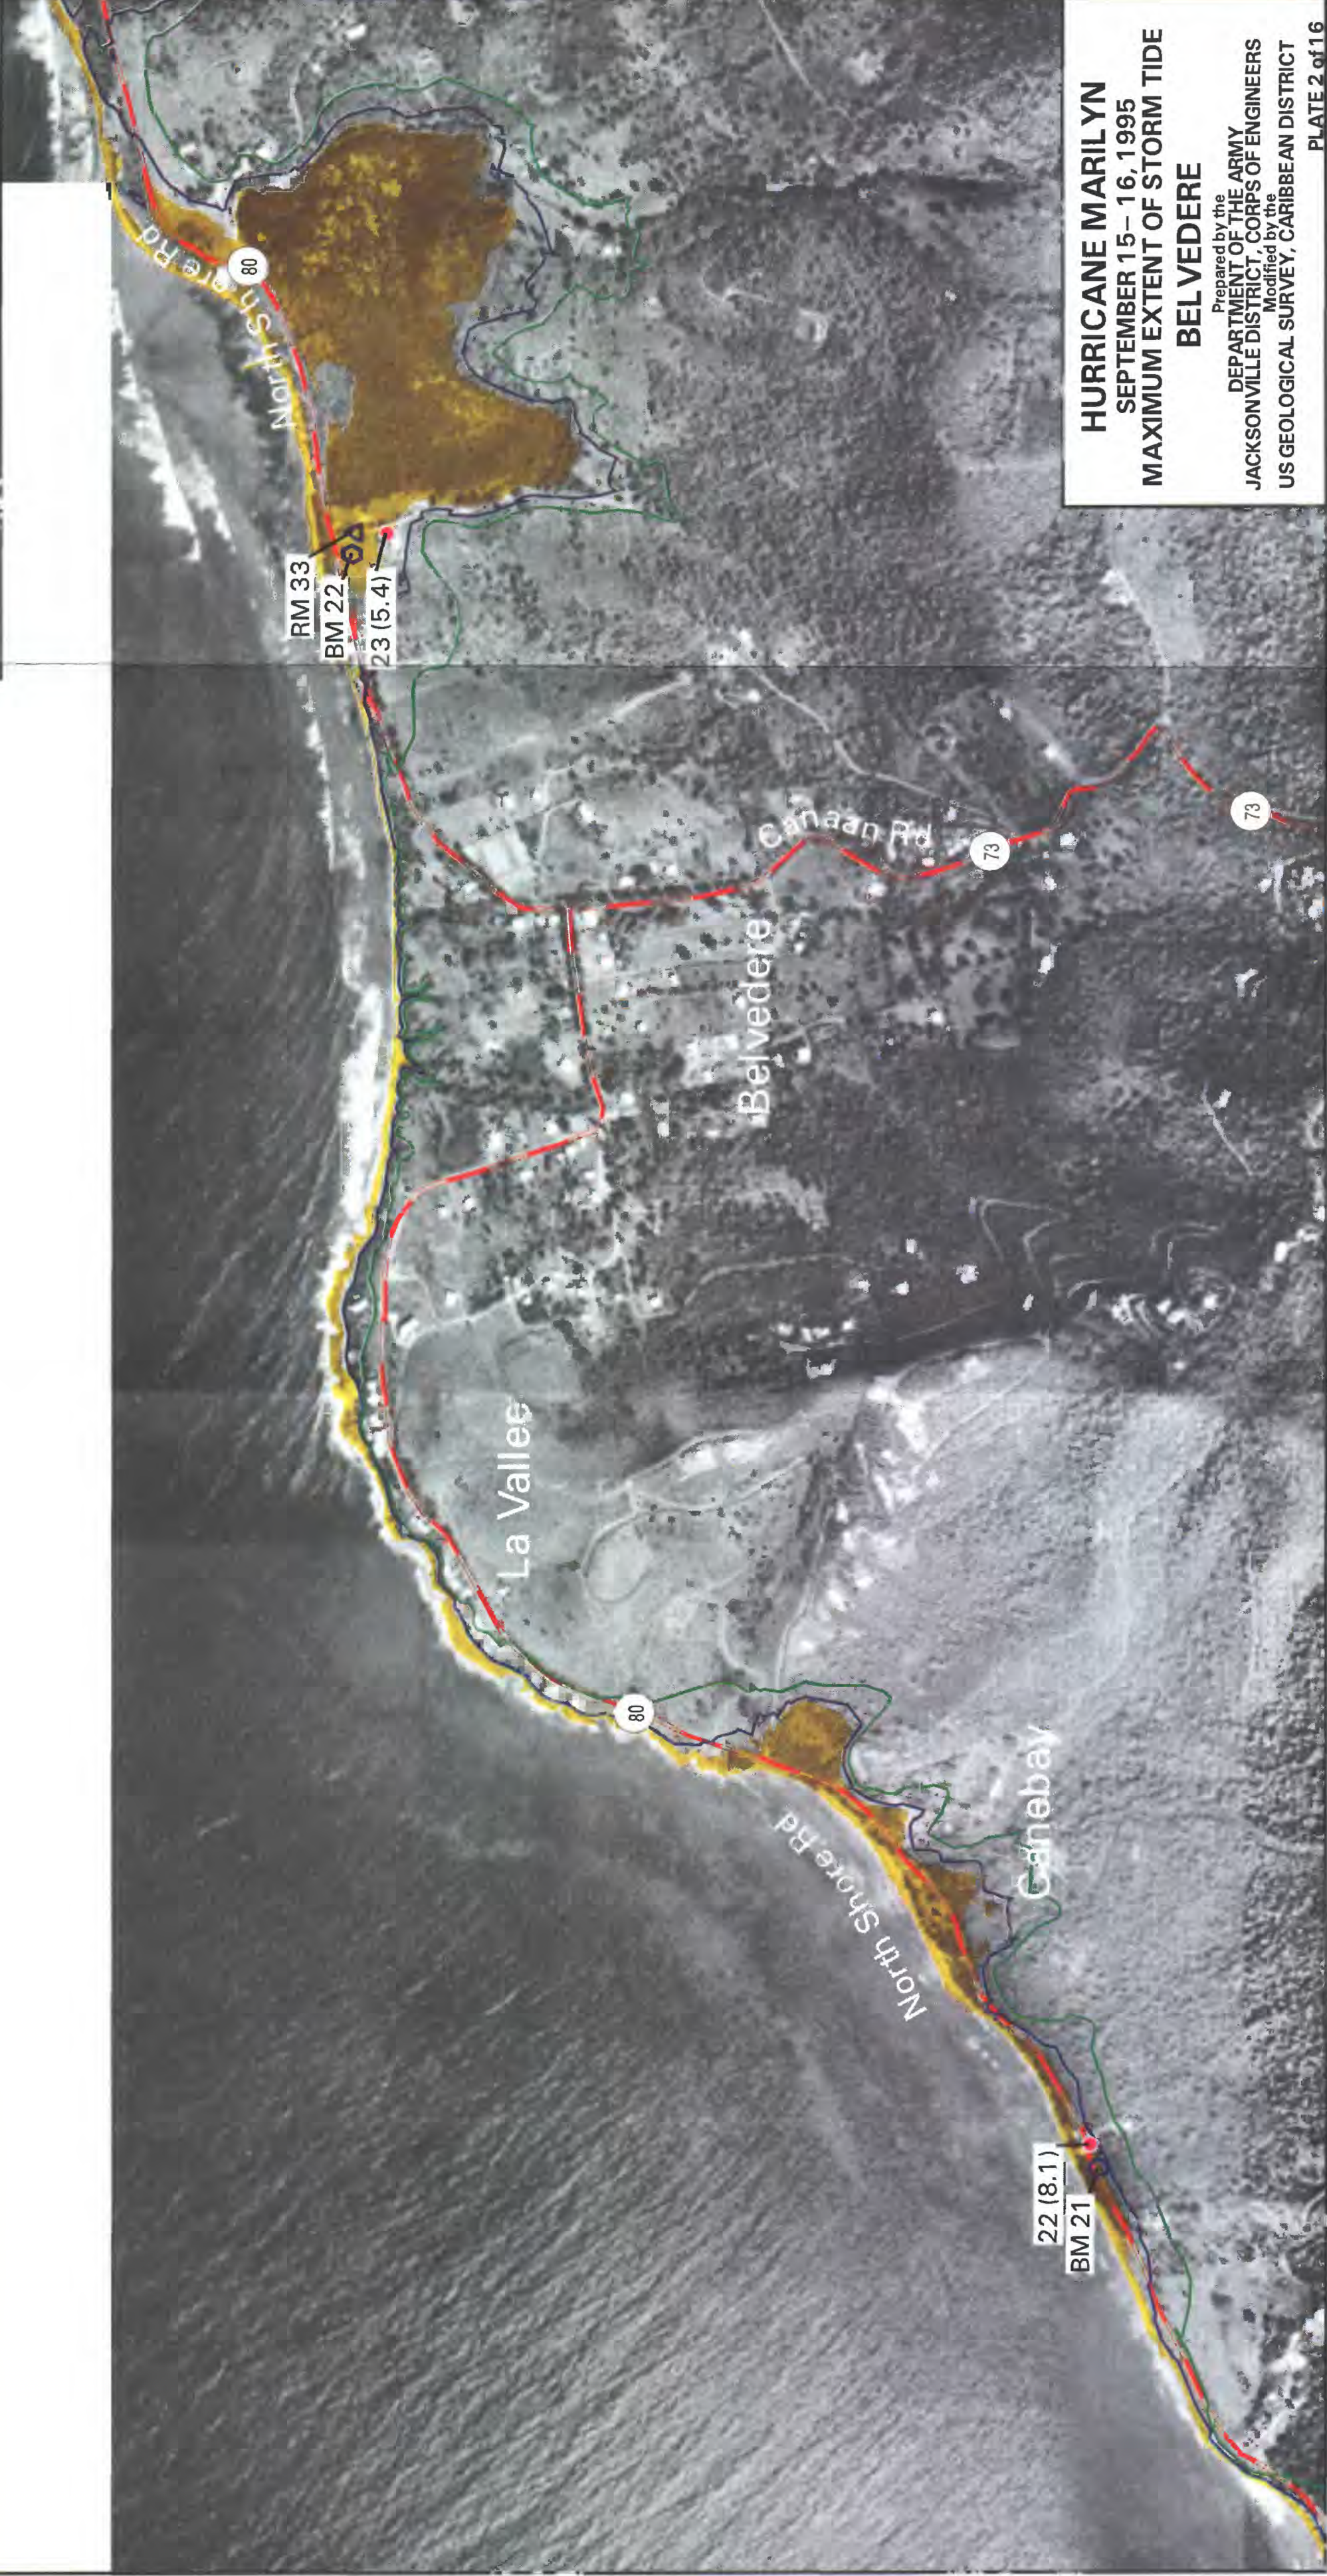
Prepared by the
DEPARTMENT OF THE ARMY
JACKSONVILLE DISTRICT, CORPS OF ENGINEERS
Modified by the
US GEOLOGICAL SURVEY, CARIBBEAN DISTRICT
PLATE 2 of 16

HURRICANE MARILYN
SEPTEMBER 15- 16, 1995
MAXIMUM EXTENT OF STORM TIDE
BELVEDERE

Plate number	Plate name	Reference mark or bench mark number	Elevation (feet above mean sea level)	Latitude	Longitude	Location and description
St. Croix, U.S. Virgin Islands						
2	Belvedere	BM 22	6.06	17°46'51"	64°47'41"	Standard U.S. Geological Survey disk stamped <i>Flood Mark</i> , set flush in right upstream side of culvert headwall on Road 80, 20 feet west of entrance to Mrs. April Williams property at Rust Up Twist Estate.
2	Belvedere	RM 33	5.75	17°46'51"	64°47'40"	Chiseled square, painted orange, set on right upstream side of culvert headwall on Road 80 near entrance to Mrs. April Williams property at Rust Up Twist Estate.
3	Salt River Bay	RM 34	8.40	17°46'56"	64°45'54"	Chiseled square, painted orange, set on corner of concrete slab, about 40 feet west of swimming pool of Gentle Winds Apartments, 0.3 mile northwest of Greig Hill at Salt River Estate.
3	Salt River Bay	BM 23	2.84	17°46'38"	64°45'45"	Standard U.S. Geological Survey disk stamped <i>Flood Mark</i> , set flush in south side of Salt River Marina boat ramp at Salt River Estate.

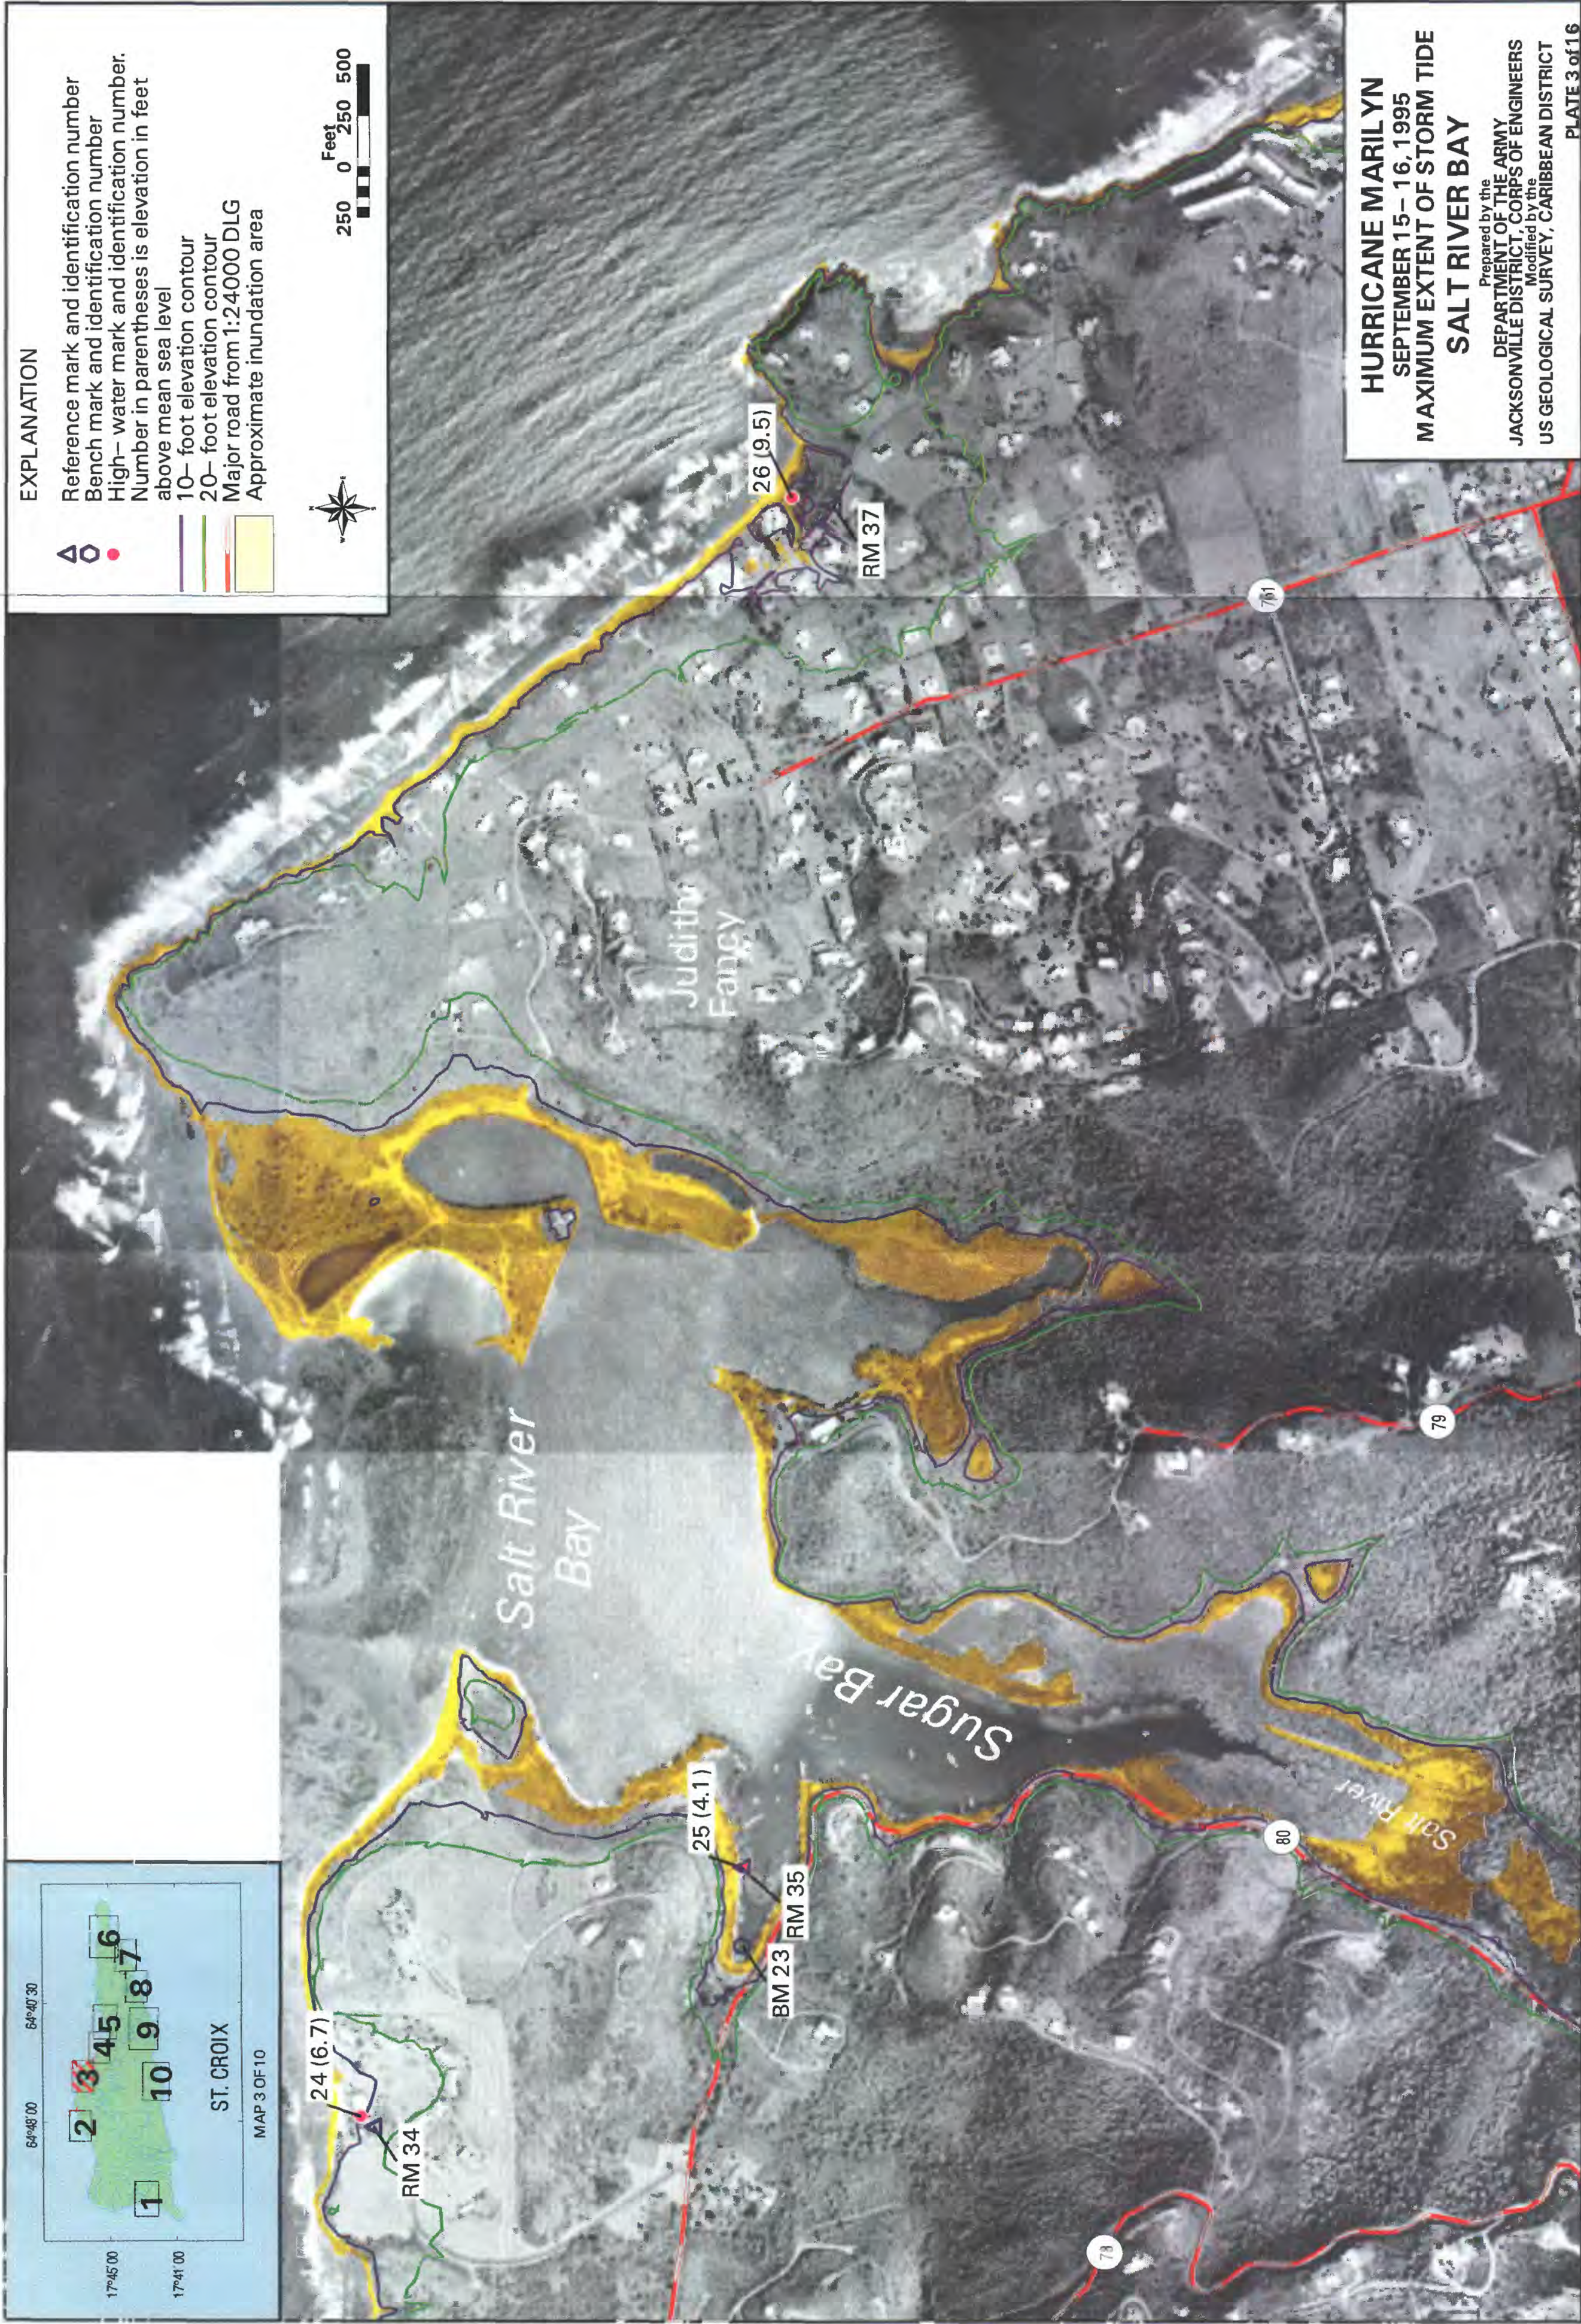
PLATE 3 of 16

HURRICANE MARILYN
SEPTEMBER 15 - 16, 1995
MAXIMUM EXTENT OF STORM TIDE
SALT RIVER BAY

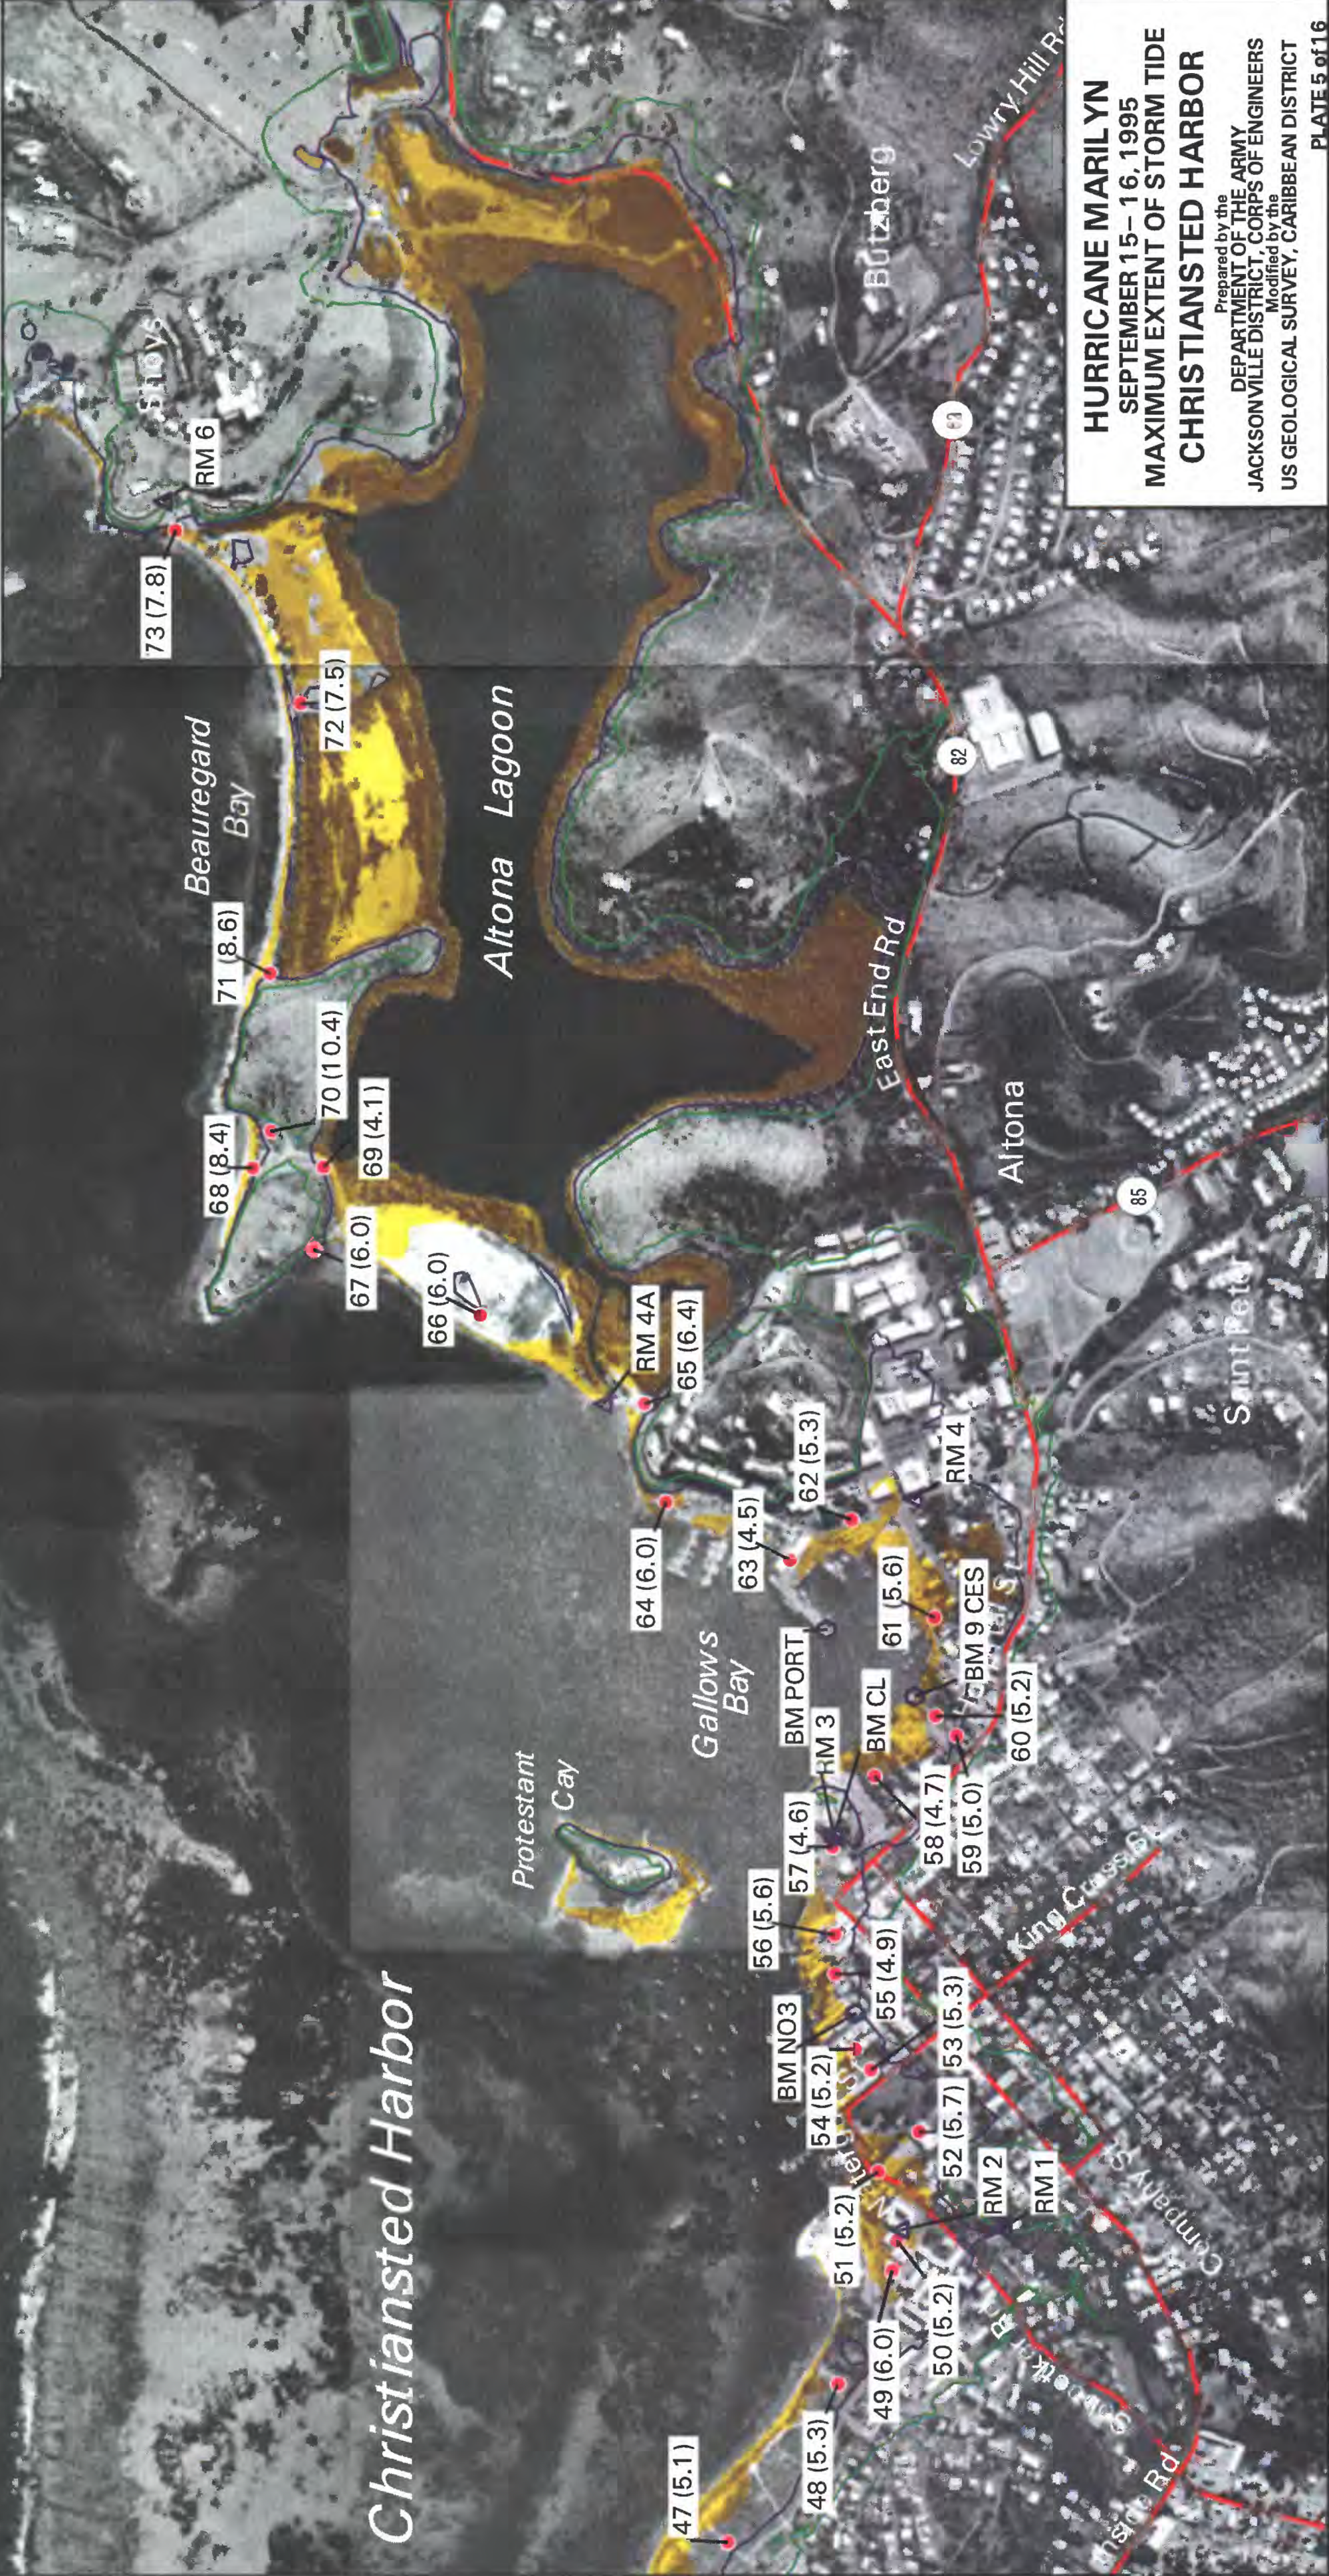
HURRICANE MARILYN
SEPTEMBER 15- 16, 1995
MAXIMUM EXTENT OF STORM TIDE
CHRISTIANSTED HARBOR
Prepared by the
DEPARTMENT OF THE ARMY
JACKSONVILLE DISTRICT, CORPS OF ENGINEERS
Modified by the
US GEOLOGICAL SURVEY, CARIBBEAN DISTRICT
PLATE 5 of 16

5	Christiansted Harbor	48	Richmont	17°44'56"	64°42'39"	Driftline/fair	1	5.3
5	Christiansted Harbor	49	Christiansted	17°44'54"	64°42'31"	Seedline/fair	1	6.0
5	Christiansted Harbor	50	Christiansted	17°44'54"	64°42'29"	Stainline ¹ /excellent	1	5.2
5	Christiansted Harbor	51	Christiansted	17°44'54"	64°42'26"	Driftline/good	1	5.2
5	Christiansted Harbor	52	Christiansted	17°44'52"	64°42'24"	Seedline ¹ /excellent	1	5.7
5	Christiansted Harbor	53	Christiansted	17°44'55"	64°42'20"	Driftline/poor	1	5.3
5	Christiansted Harbor	54	Christiansted	17°44'56"	64°42'19"	Seedline ¹ /excellent	1	5.2
5	Christiansted Harbor	55	Christiansted	17°44'56"	64°42'16"	Seedline ¹ /poor	1	4.9
