Storm-Tide Elevations Caused by Hurricane Marilyn on the U.S. Virgin Islands, September 15-16, 1995

U.S. GEOLOGICAL SURVEY

Open-File Report 96-440

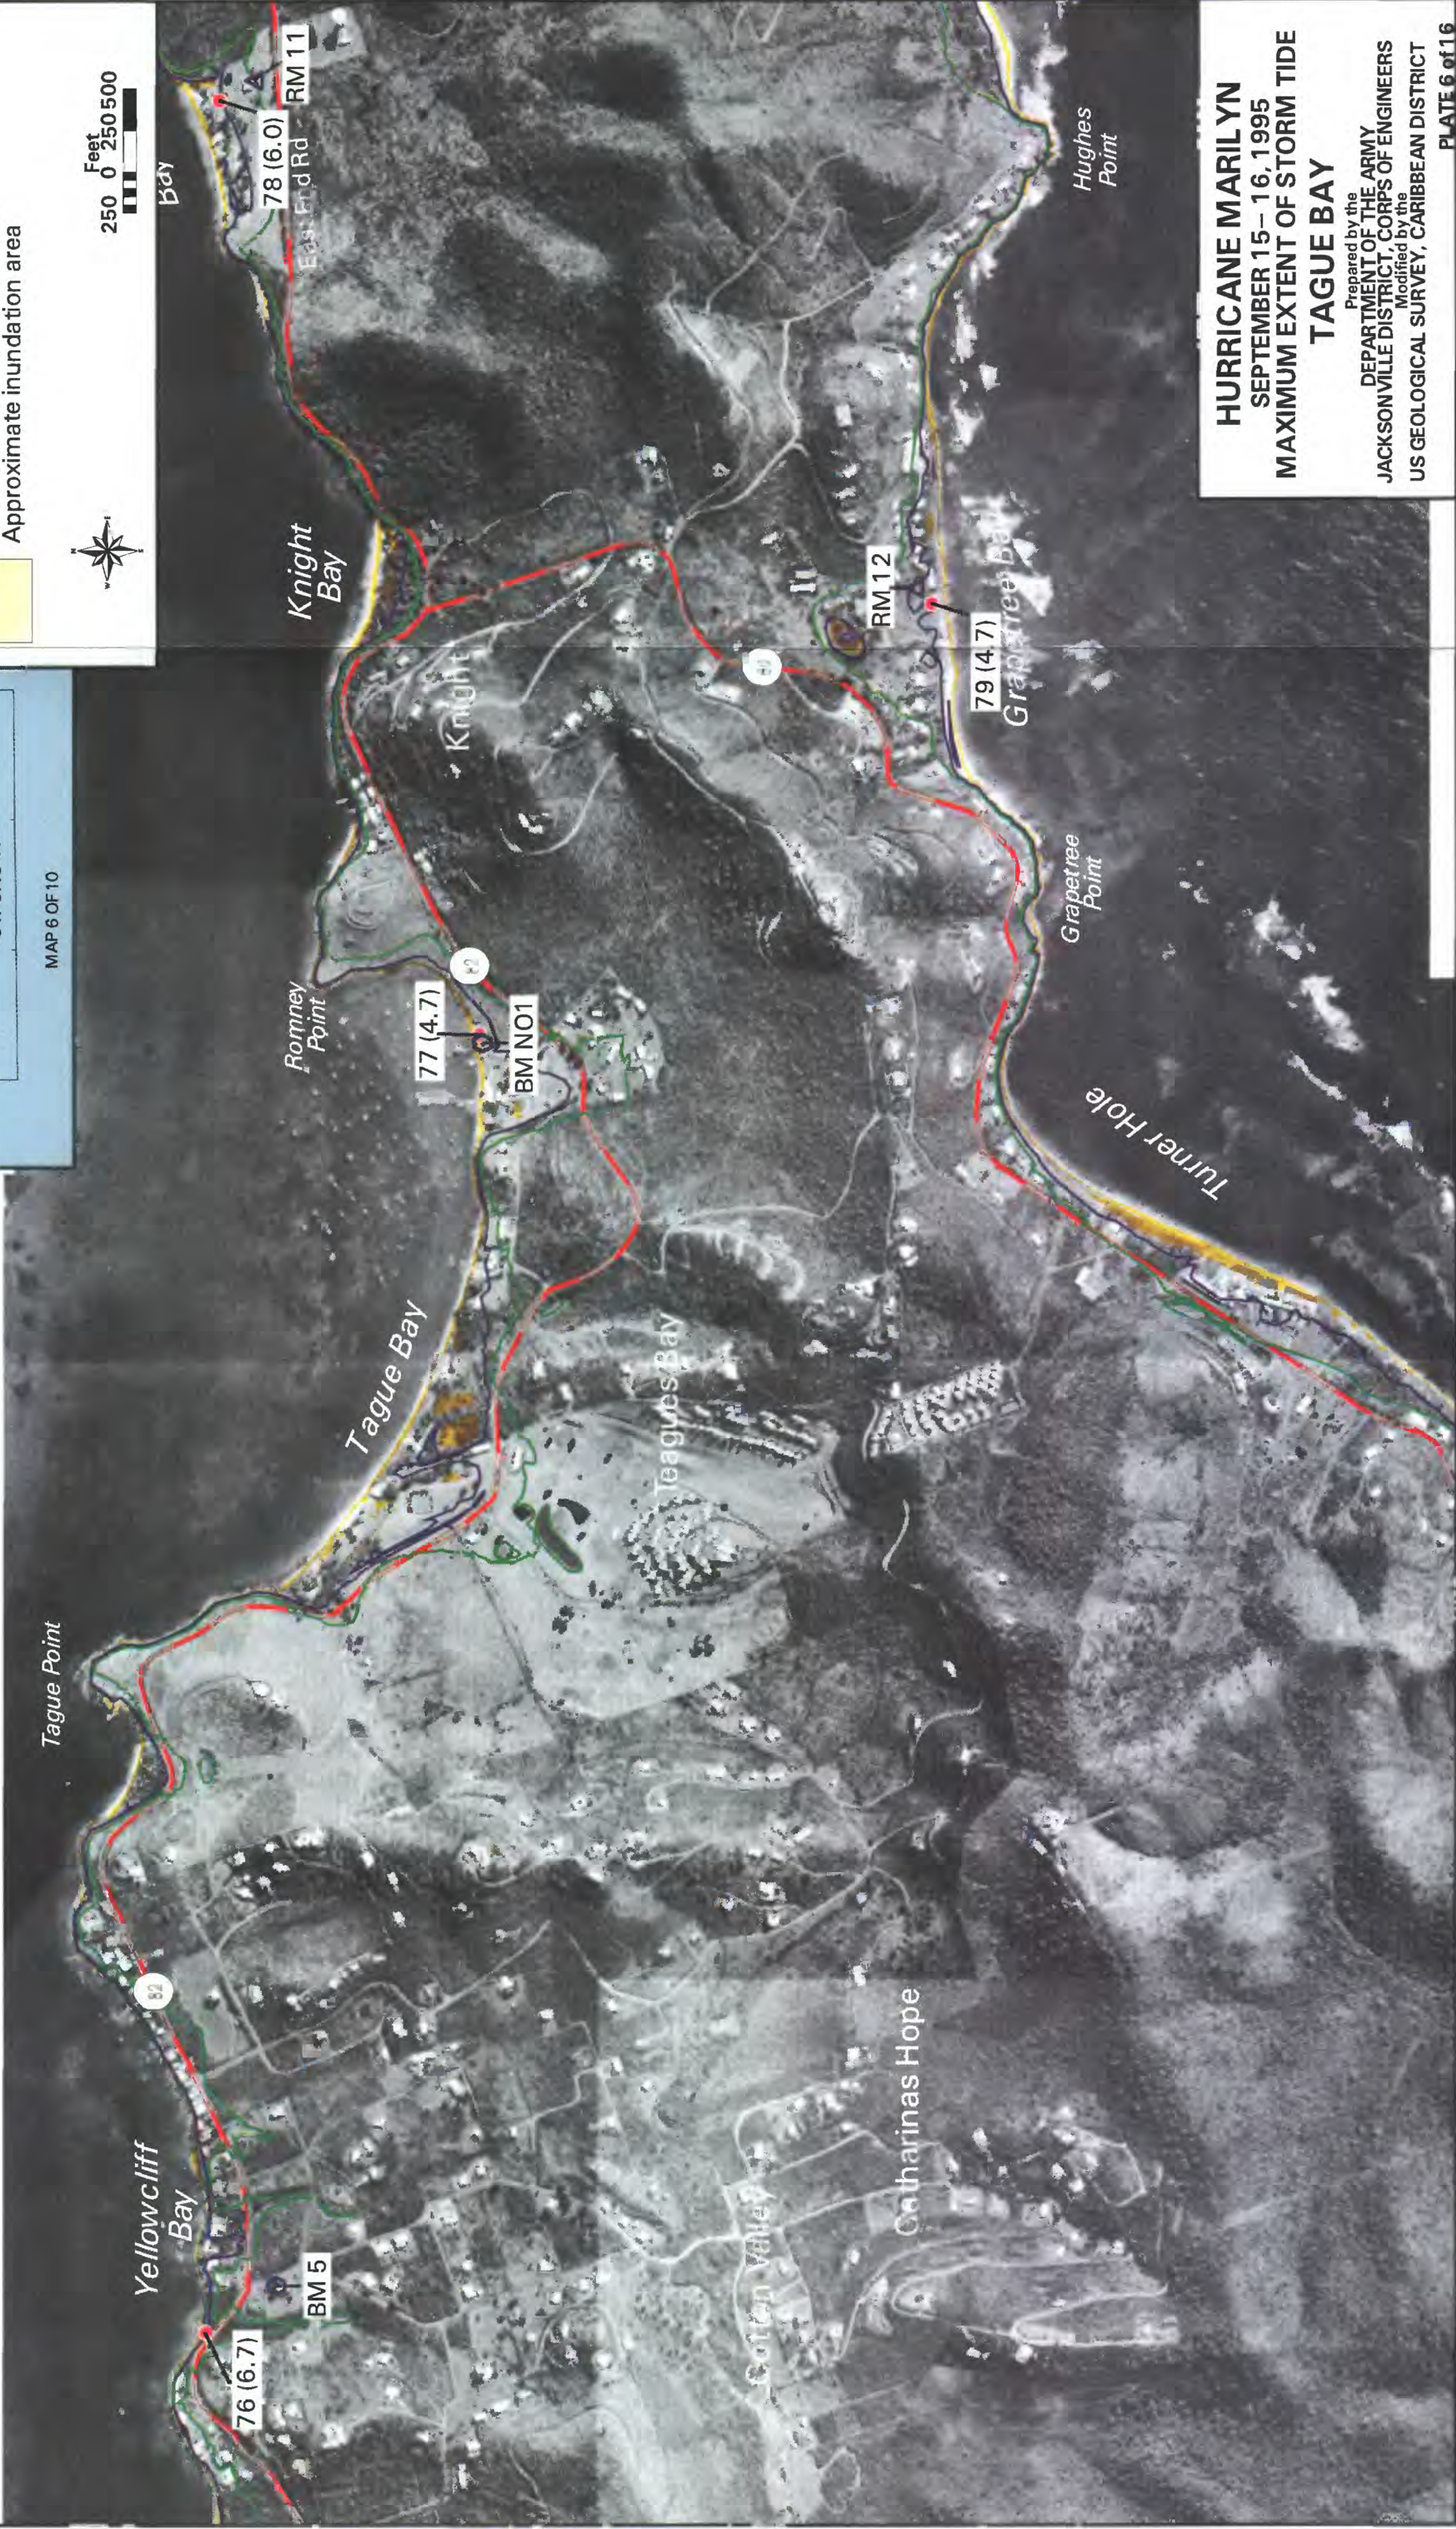
HURRICANE MARILYN
SEPTEMBER 15— 16, 1995
MAXIMUM EXTENT OF STORM TIDE
TAGUE BAY
Prepared by the
DEPARTMENT OF THE ARMY
JACKSONVILLE DISTRICT, CORPS OF ENGINEERS
Modified by the
US GEOLOGICAL SURVEY, CARIBBEAN DISTRICT
PLATE 6 of 16

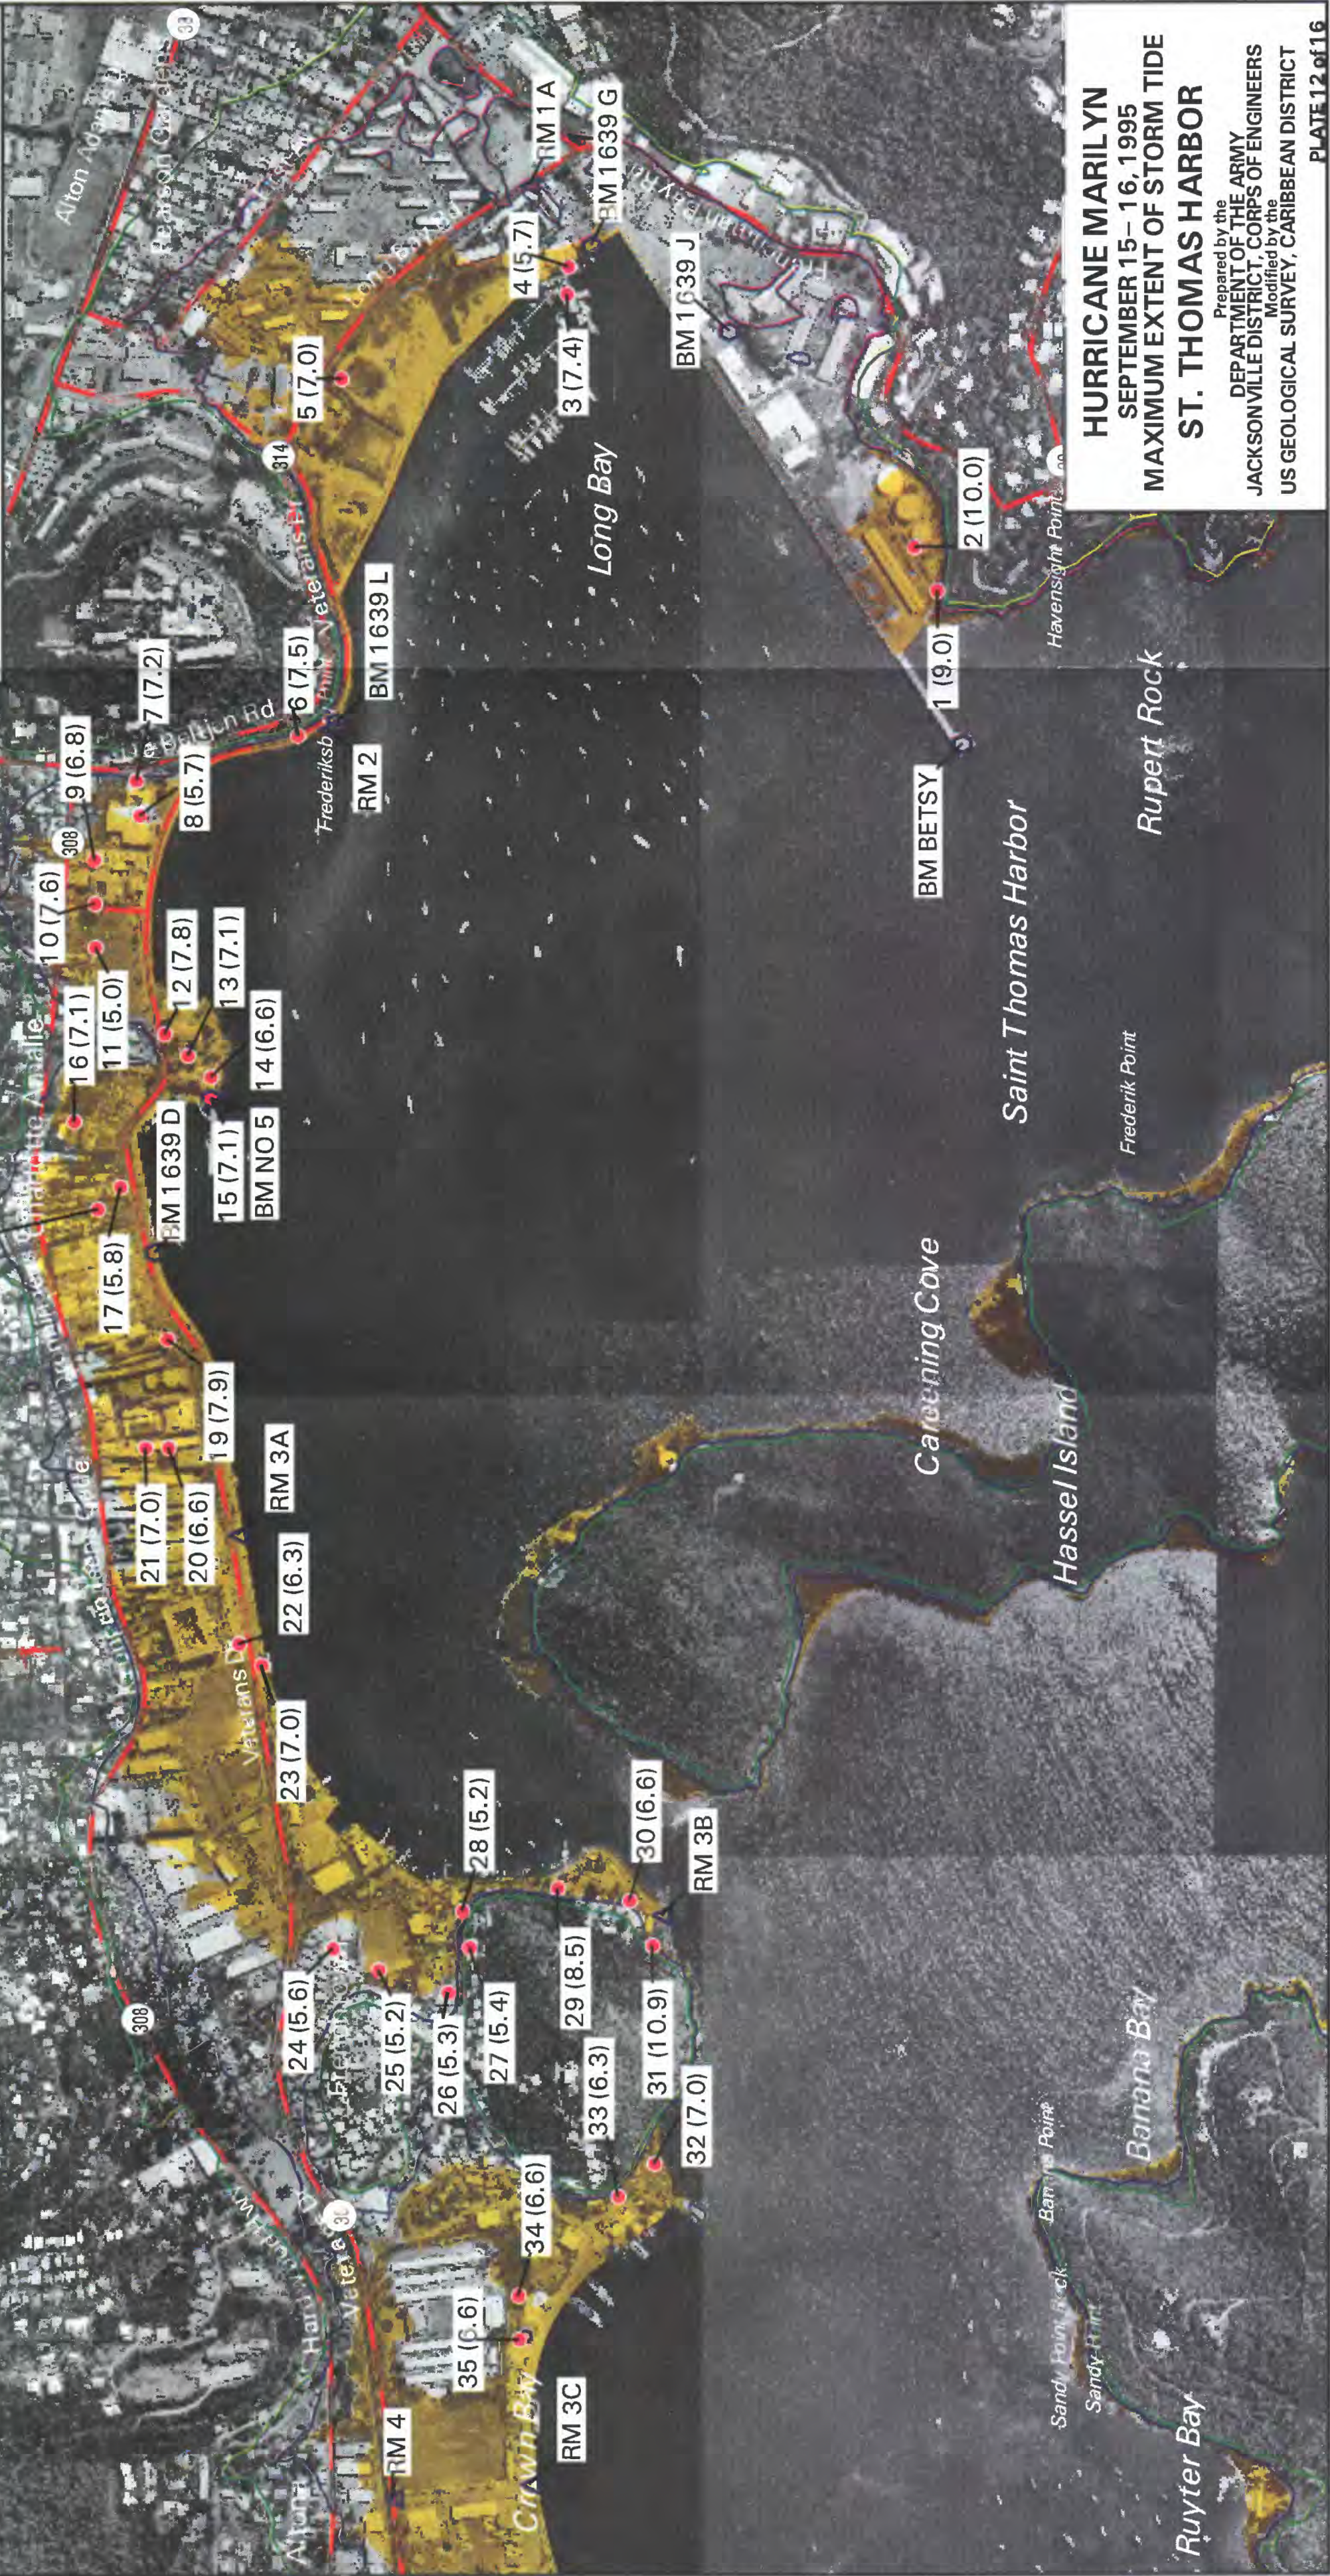
HURRICANE MARILYN
SEPTEMBER 15– 16, 1995
MAXIMUM EXTENT OF STORM TIDE
ST. THOMAS HARBOR

Plate number	Plate name	High-water mark number	Location (Estate)	Latitude	Longitude	Type/quality of mark	Number of high-water marks	Elevation (feet above mean sea level)
St. Thomas, U.S. Virgin Islands								
12	St. Thomas Harbor	11	King Quarter	18°20'35"	64°54'44"	Stainline ¹ /poor	1	5.0
12	St. Thomas Harbor	12	King Quarter	18°20'32"	64°55'48"	Washline/poor	1	7.8
12	St. Thomas Harbor	13	King Quarter	18°20'31"	64°55'49"	Driftline/fair	1	7.1
12	St. Thomas Harbor	14	King Quarter	18°20'30"	64°55'50"	Stainline ¹ /good	1	6.6
12	St. Thomas Harbor	15	King Quarter	18°20'30"	64°55'51"	Driftline/fair	1	7.1
12	St. Thomas Harbor	16	King Quarter	18°20'36"	64°55'52"	Seedline/poor	1	7.1
12	St. Thomas Harbor	17	Queen Quarter	18°20'34"	64°55'55"	Seedline ¹ /good	1	5.8
12	St. Thomas Harbor	18	Queen Quarter	18°20'35"	64°55'56"	Stainline ¹ /good	1	6.2
12	St. Thomas Harbor	19	Queen Quarter	18°20'32"	64°56'02"	Seedline/excellent	1	7.9

12	St. Thomas Harbor	BM NO 5	5.03	18°20'30"	64°55'51"	Standard National Ocean Service disk stamped <i>NO 5 1975</i> , set flush in the southwest corner of a concrete step at the entrance to the administration building, U.S. Coast Guard Station, 27.3 feet east of the east curb of the road leading to the station, and 3.5 feet west of the foundation at Kings Wharf, King Quarter Estate.

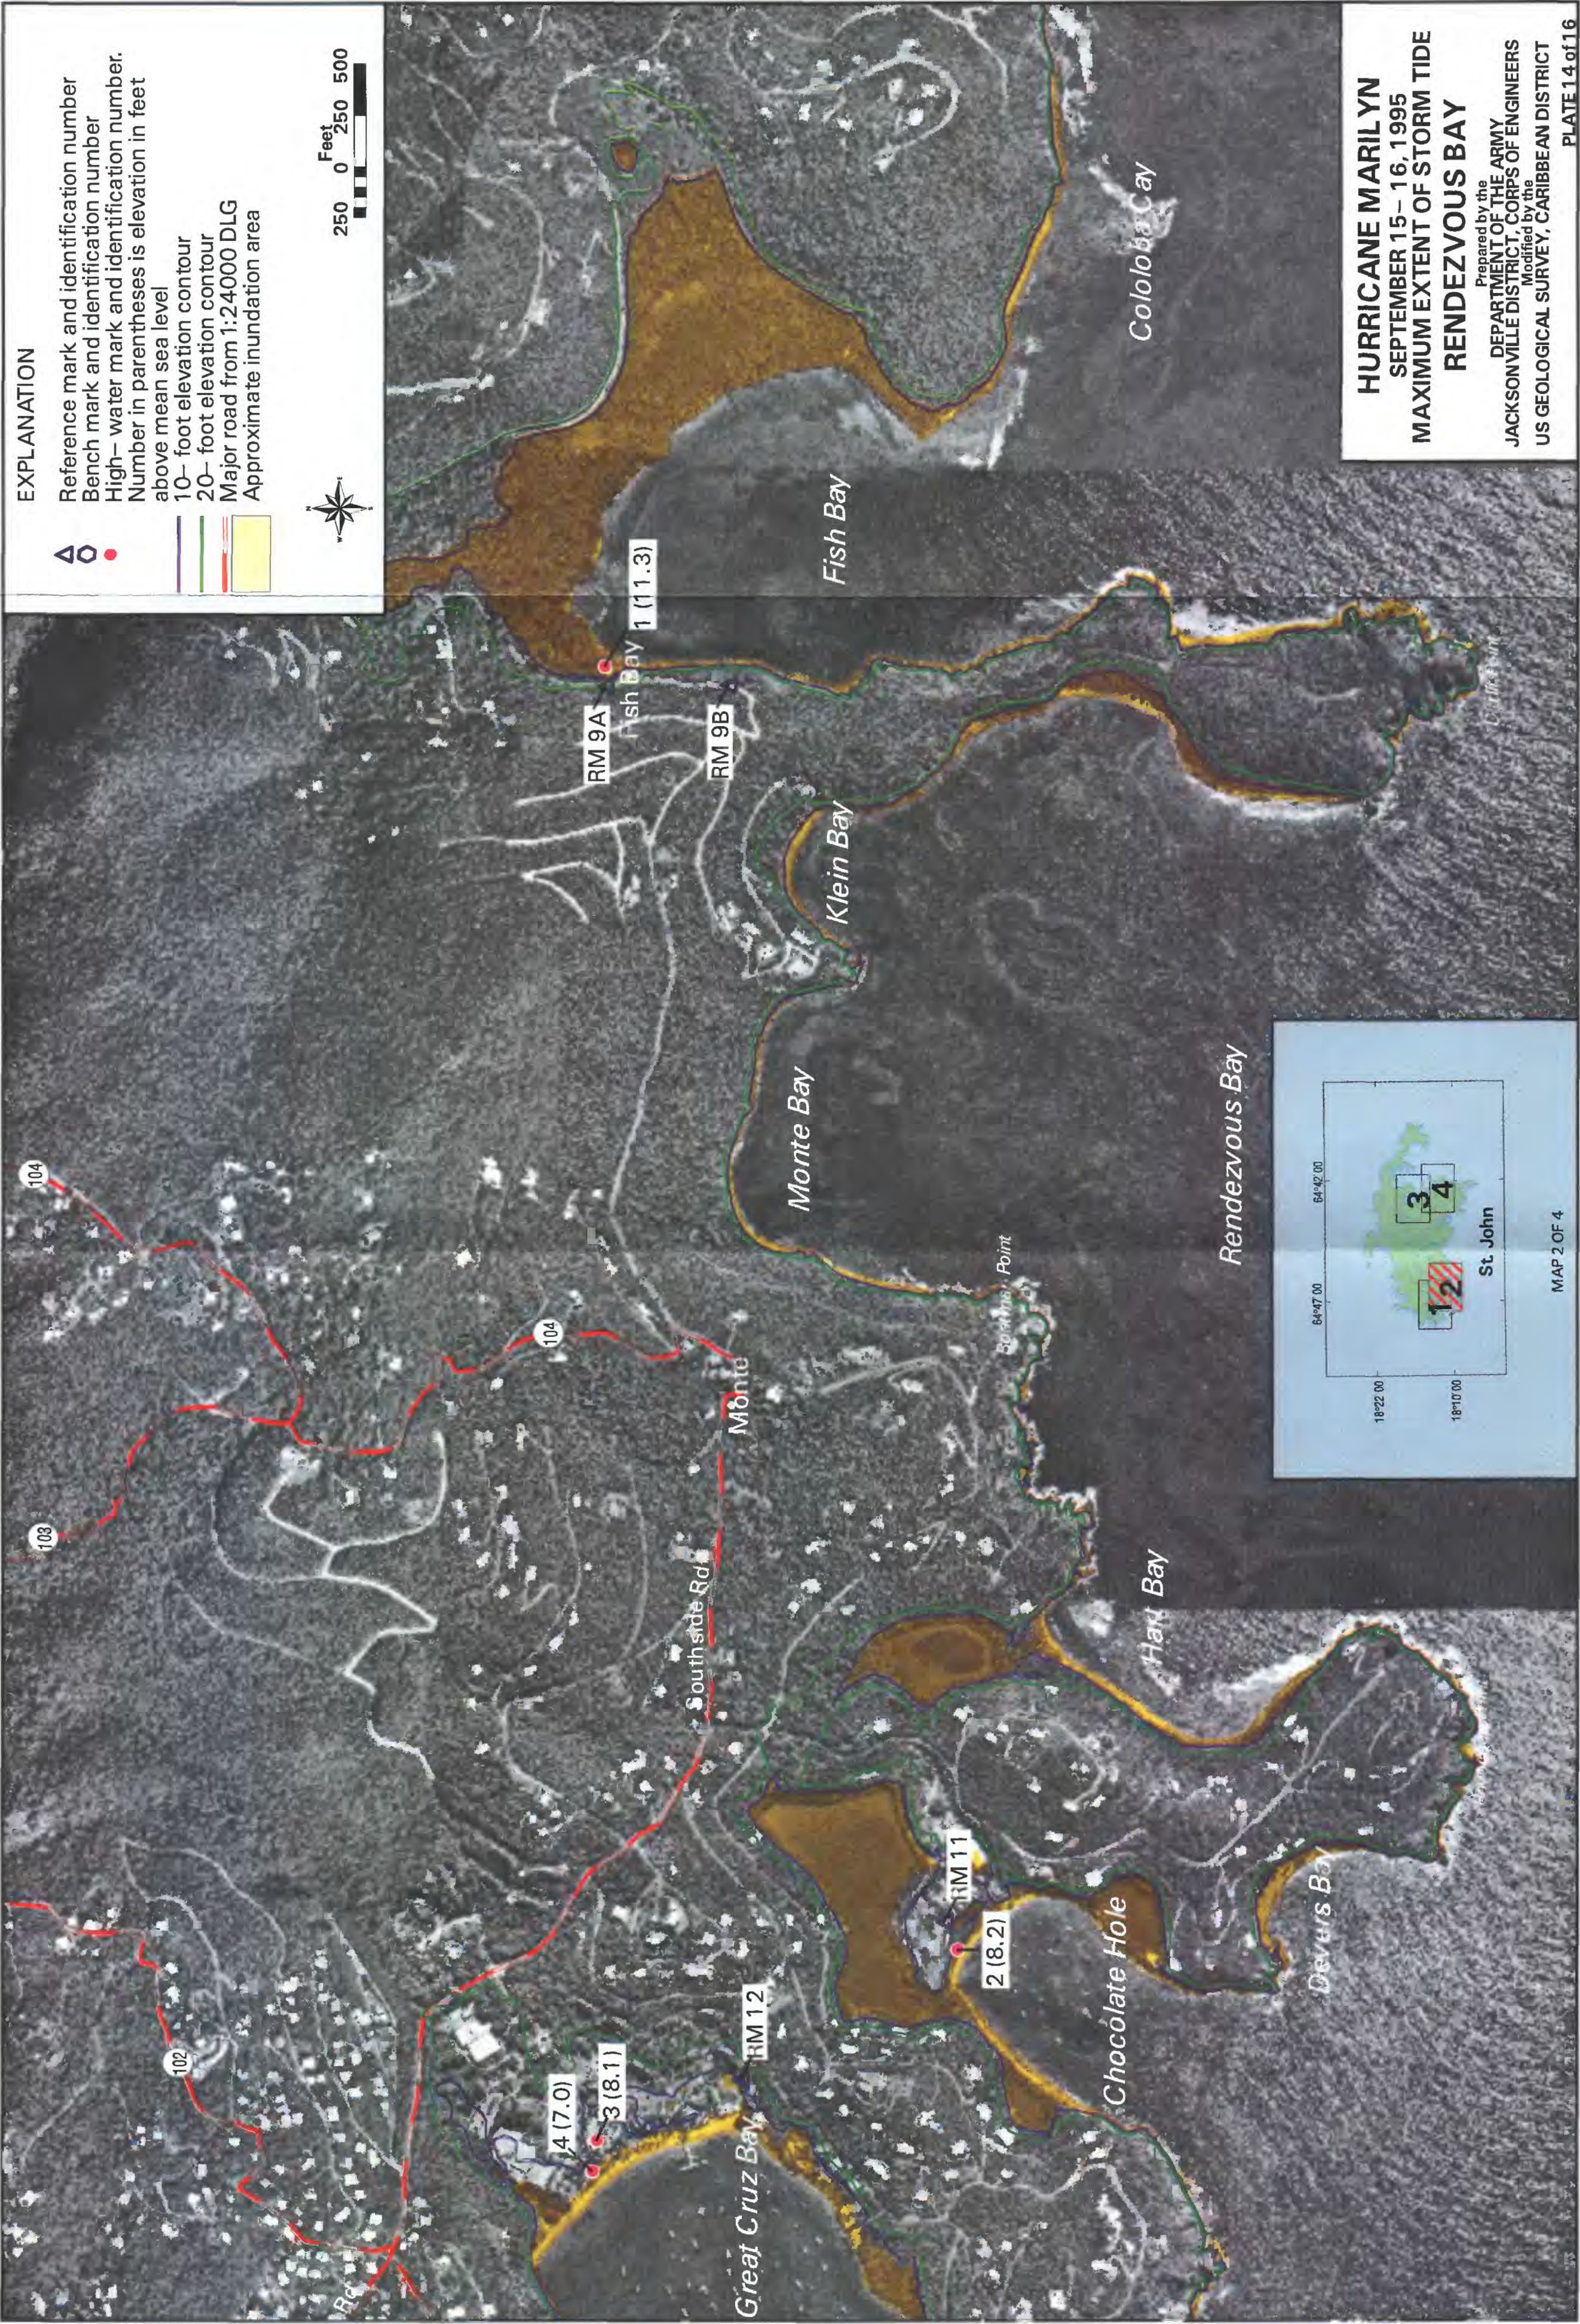
**HURRICANE MARILYN
SEPTEMBER 15-16, 1995
MAXIMUM EXTENT OF STORM TIDE
CRUZ BAY**

Plate number	Plate name	High-water mark number	Location (Estate)	Latitude	Longitude	Type/quality of mark	Number of high-water marks	Elevation (feet above mean sea level)
St. John, U.S. Virgin Islands								
13	Cruz Bay	2	Chocolate Hole and Great Cruz Bay	18°19'12"	64°47'03"	Driftlines/fair	2	8.2
13	Cruz Bay	3	Chocolate Hole and Great Cruz Bay	18°19'29"	64°47'14"	Sandline/poor	1	8.1
13	Cruz Bay	4	Chocolate Hole and Great Cruz Bay	18°19'30"	64°47'15"	Stainlines ¹ /fair	2	7.0
13	Cruz Bay	5	Enighed	18°19'45"	64°47'49"	Driftline/fair	1	9.2
13	Cruz Bay	6	Enighed	18°19'47"	64°47'51"	Seedline ¹ /excellent	1	5.2
13	Cruz Bay	7	Enighed	18°19'46"	64°47'56"	Driftline/poor	1	7.1
13	Cruz Bay	8	Enighed	18°19'48"	64°47'55"	Seedline ¹ /excellent	1	5.1
13	Cruz Bay	9	Enighed	18°19'48"	64°47'55"	Stainline/poor	1	7.7
13	Cruz Bay	10	Cruz Bay	18°19'55"	64°47'57"	Washline/poor	1	8.9
13	Cruz Bay	11	Cruz Bay	18°19'58"	64°47'57"	Sandline/poor	1	5.6
