# CHANGES IN RIPARIAN VEGETATION IN THE SOUTHWESTERN UNITED STATES: Repeat Photography at Streamflow Gaging Stations

USGS GROUND WATER RESOURCES PROGRAM

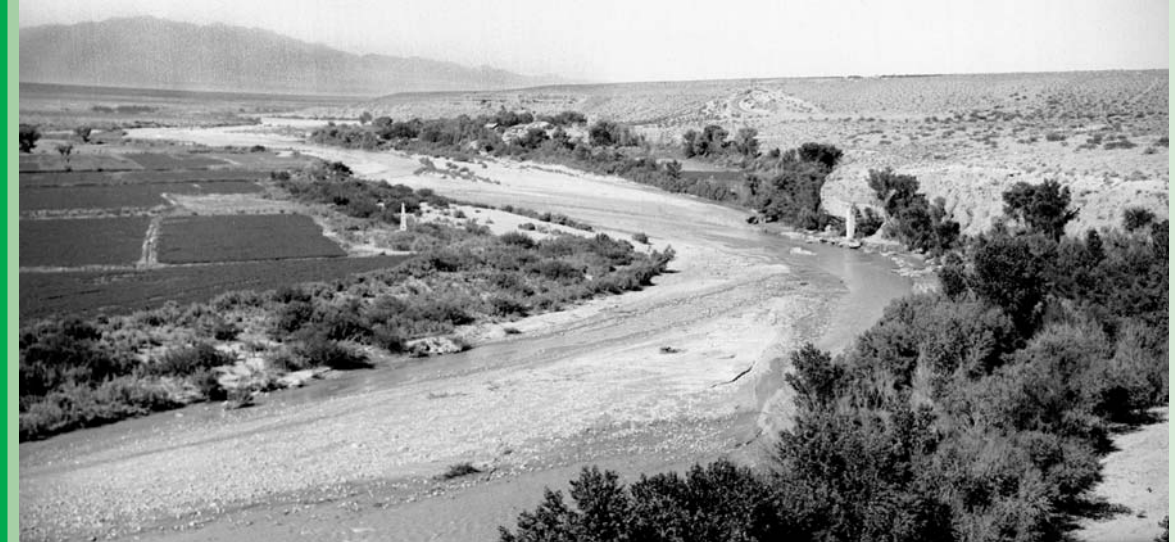
(June 4, 1942). This downstream view from a bluff above the Virgin River shows the gaging station at Littlefield, Arizona, in the extreme northwestern part of Arizona. The channel was relatively wide and free of vegetation, with cottonwoods along river right (right side of the photo) and mesquites and tamarisks along river left. Although the river is used extensively for irrigation and domestic water supply, no dams have been built across the main channels (James Baumgartner, #3601).

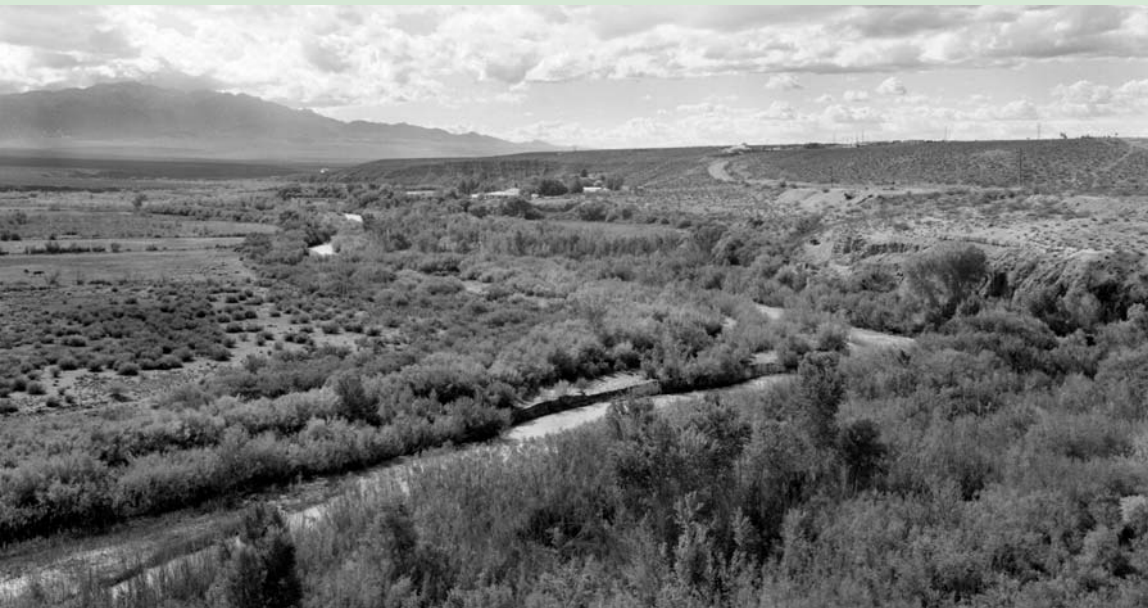
(October 30, 2000). Despite several large floods in the intervening 58 years, including a January 1, 1989, flood caused by the breaching of an off-channel dam upstream, riparian vegetation has increased in this reach. Most of the foreground vegetation is native, including cottonwood trees, arrowweed, mesquite, and catclaw. At lower right, a marsh containing reeds, cattails, and phragmites has developed. On river left, native coyote willow lines the bank, and a prominent zone of tamarisks with occasional cottonwood appears behind. The vertical bank at center is in a small floodplain terrace that developed after 1942 (Dominic Oldershaw, Stake 1727).

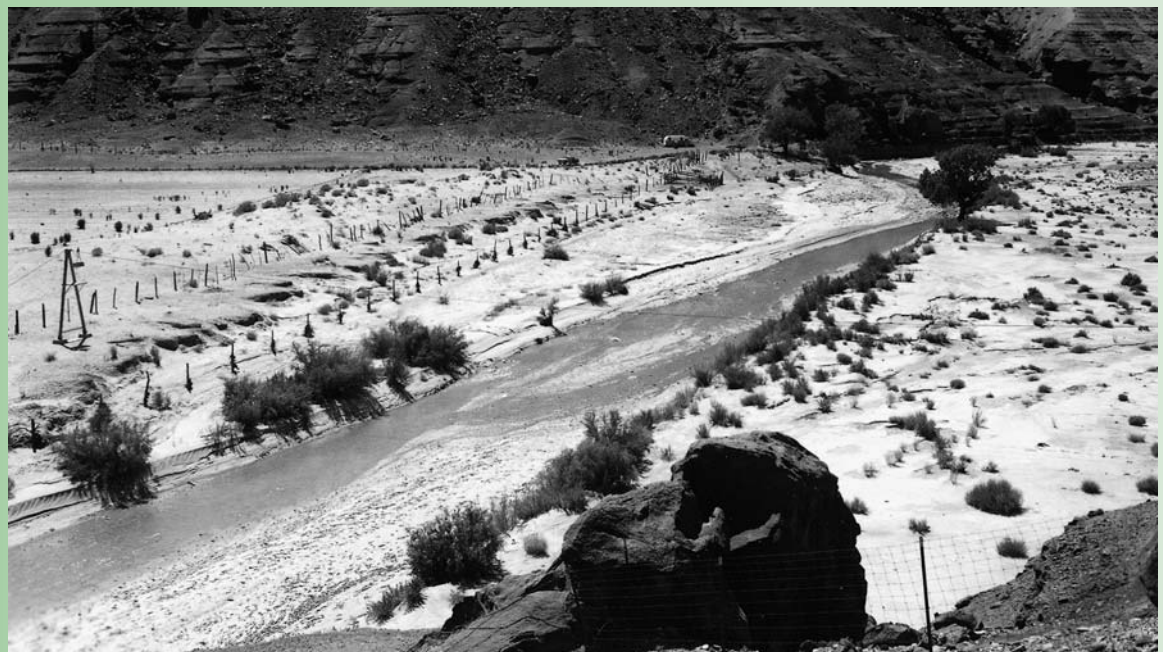
(ca. 1964-1968). In this upstream view, the photographer documented channel conditions in the reach just upstream from the gaging station. A small cottonwood tree appears at right center, just right of a relatively straight channel reach that undoubtedly was used for indirect-discharge estimates. The shrubs on both sides of the river are probably tamarisk, with other perennial shrubs on the broad floodplain at right (photographer unknown).

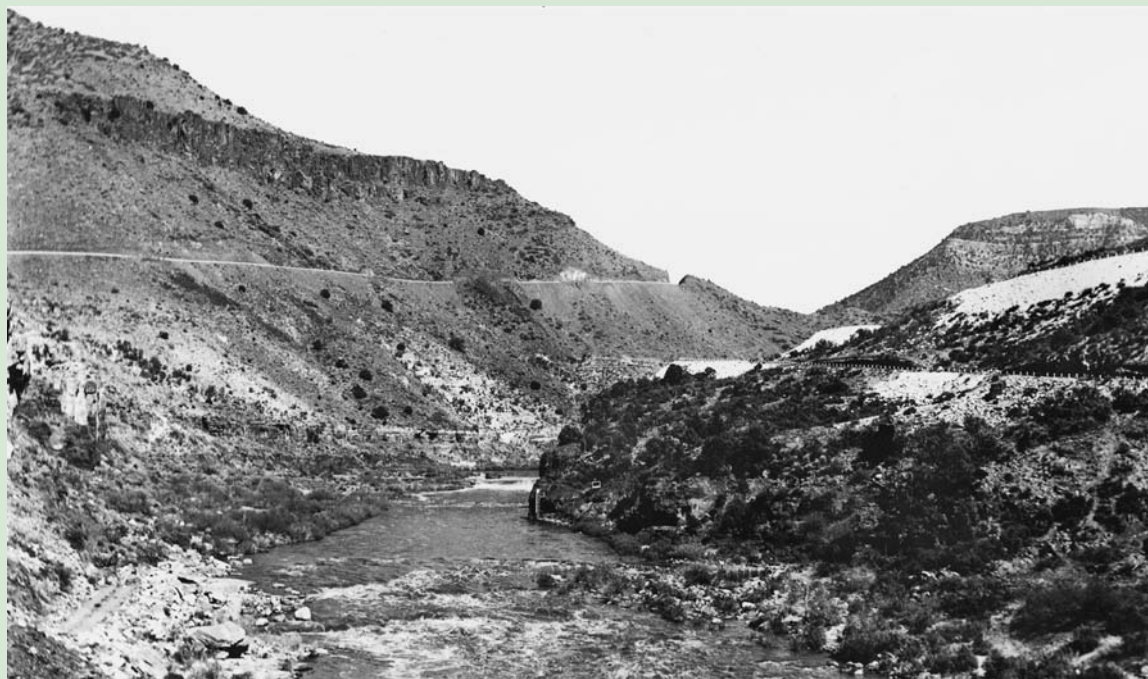
(November 26, 1935). This upstream view from the old, two-lane bridge that crosses the Salt River in Salt River Canyon shows a relatively small discharge of 277 ft<sup>3</sup>/s. Scattered native shrubs, including willows and brickellbush, appear to occupy the floodplain at right center. The road leading to Show Low, Arizona, appears as a one-lane cut through the hillslope at center (R.E. Cook, #2280).

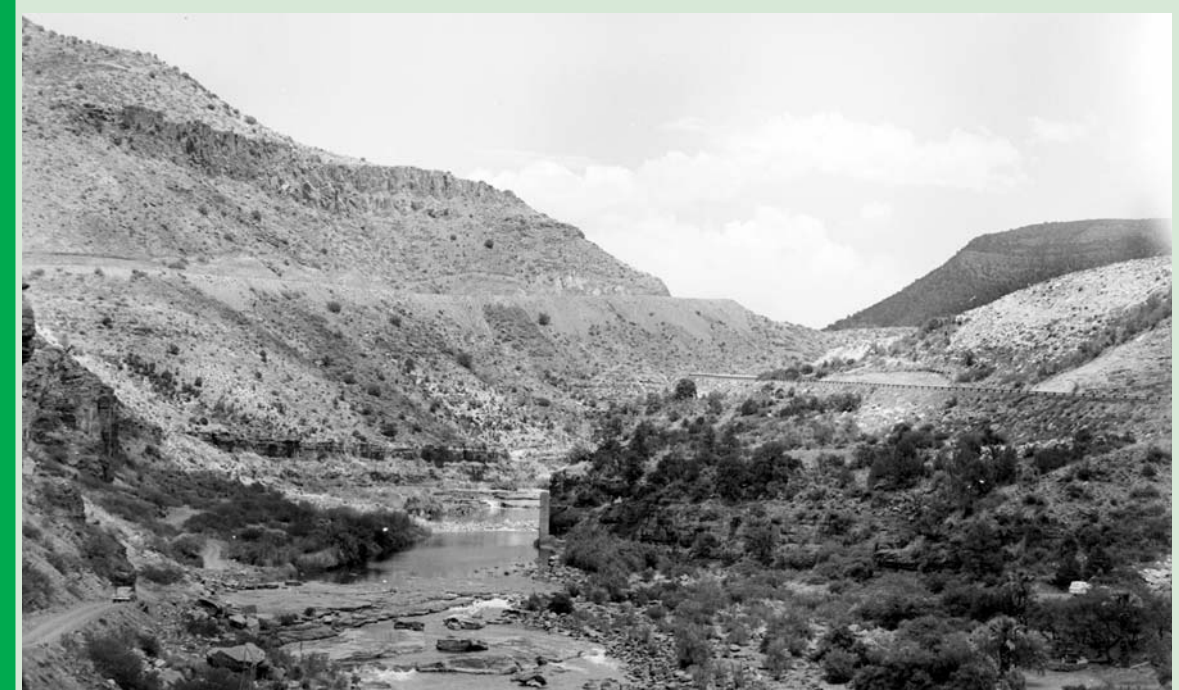
(June 25, 1964). The water is low (about 97 ft<sup>3</sup>/s), exposing the bedrock that forms the channel bed and the low-water control downstream from the gaging station. In the intervening 29 years, three floods with peaks of greater than 50,000 ft<sup>3</sup>/s passed through this reach. Tamarisk is interspersed with the native shrubs on the floodplain, and tamarisk lines river left, which was mostly devoid of woody vegetation in 1935. Palm trees (lower right), which are not native to this area, were planted as part of a roadside park well before this photograph was taken. The roadcut on the skyline has been widened (Raymond M. Turner).

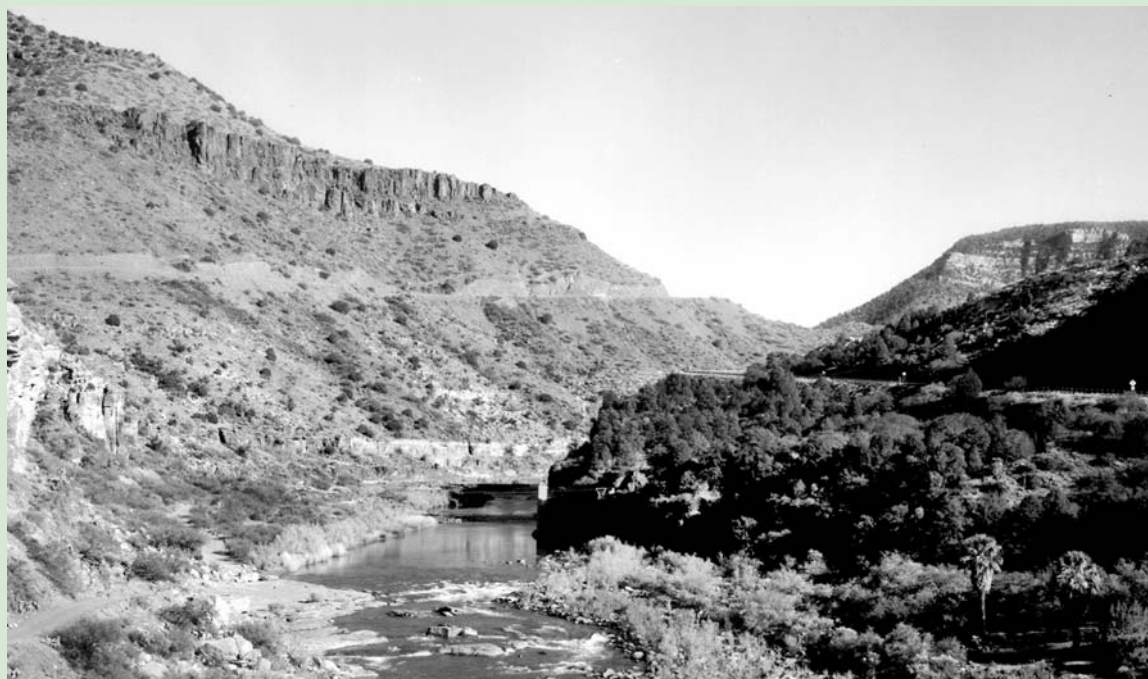
(October 25, 2000). The water level is only slightly higher than in 1964. In the intervening 36 years, two floods exceeded 70,000 ft<sup>3</sup>/s and four have exceeded 50,000 ft<sup>3</sup>/s. Despite these floods, riparian vegetation along the banks has increased, particularly non-native tamarisk. The palm trees have grown considerably (Dominic Oldershaw, Stake 363).

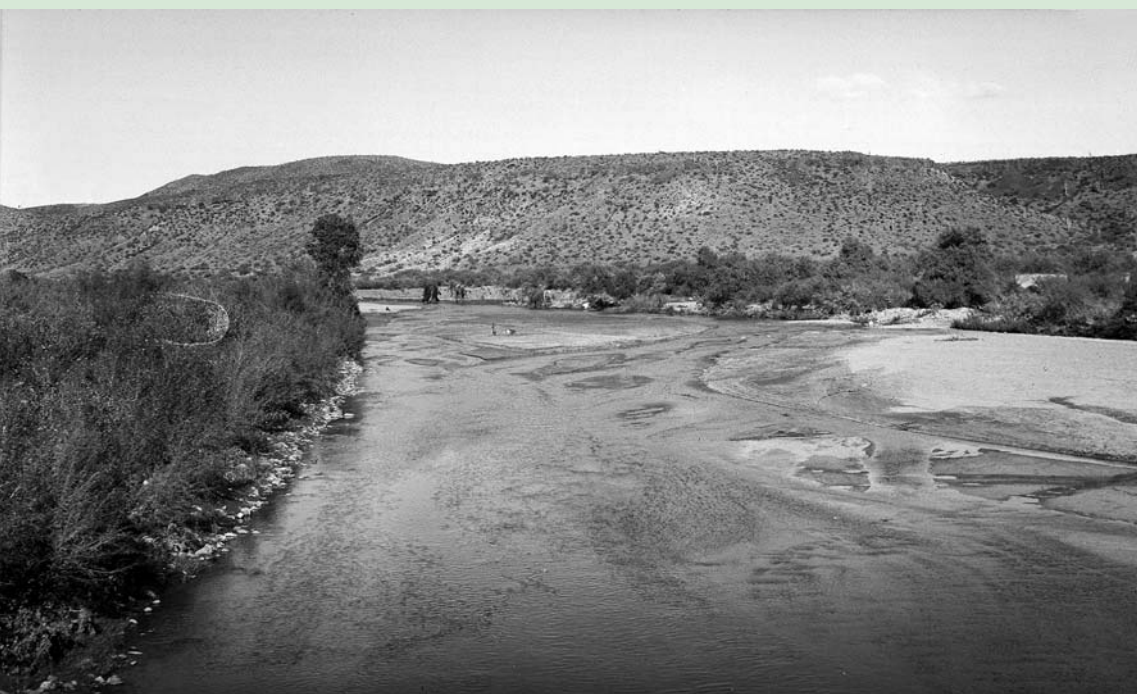
(October 21, 1941). In this upstream view from the old bridge just south of San Carlos, Arizona, native shrubs and scattered cottonwoods line the wide channel. The San Carlos River near Peridot is a very difficult river to gage accurately because of a high sediment load and shifting channel. A flood of 40,600 ft<sup>3</sup>/s passed through this reach only 7 months before this photograph was taken, contributing to the scoured appearance of the channel (A.J.H., #3550).

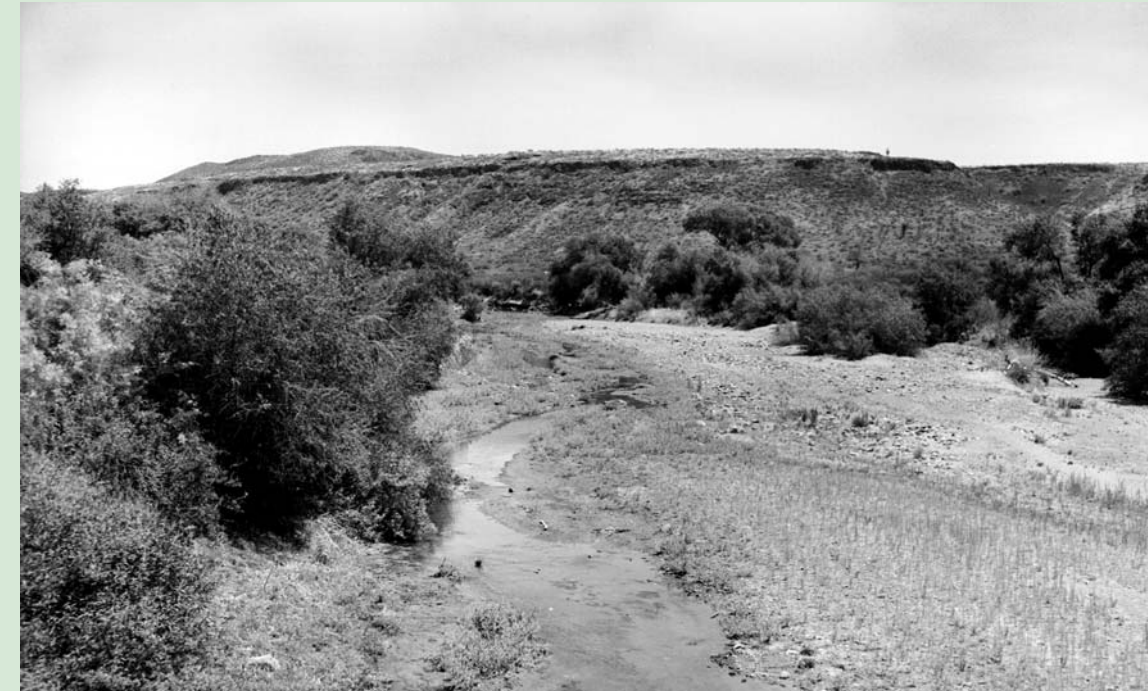
(June 4, 1964). The channel narrowed appreciably in the intervening 23 years, despite two floods exceeding 23,000 ft<sup>3</sup>/s. Part of the reason may be the increase in non-native tamarisk trees, which appear along river left (right center). Native plants have also increased, including the willows at left. The San Carlos River was unregulated at this time except for diversions for irrigation (Raymond M. Turner).

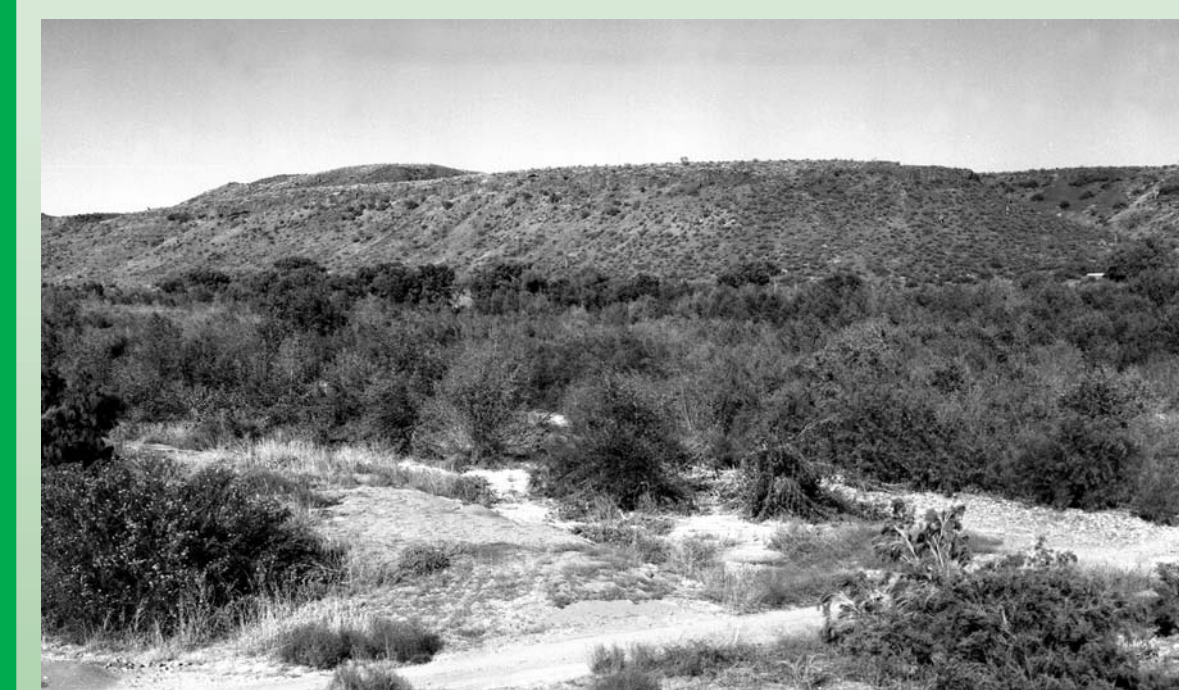
(October 6, 2000). The San Carlos River became partially regulated by Talkkai Reservoir in 1979. The channel has shifted out of the view to the right and is narrower than it was in 1964. Most of the plants in the foreground, which is now a stable floodplain, are natives, including two species of willows, two species of brickellbush, and scattered mesquite and catclaw. Riparian vegetation has increased and the channel remains narrow despite a flood of 54,800 ft<sup>3</sup>/s in 1993, which is the flood of record for this gaging station (Dominic Oldershaw, Stake 333c).

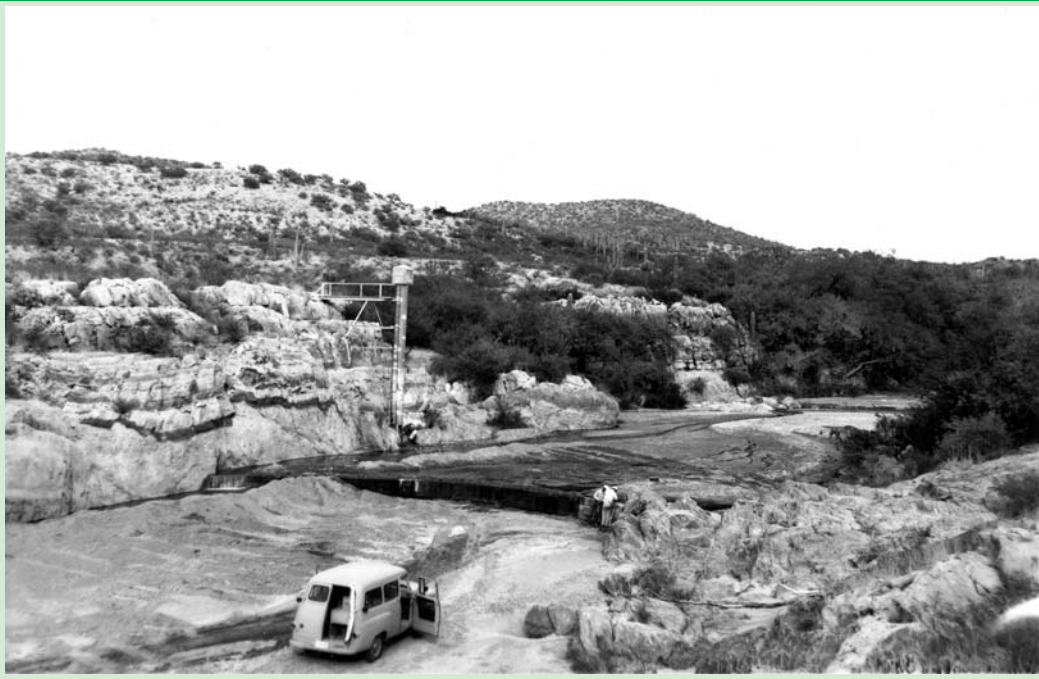
(October 30, 1961). Pantano Wash, a tributary of Rillito Creek southeast of Tucson, is perennial in this reach owing to a bedrock constriction with a concrete dam built within it. The stream is unregulated upstream from the gaging station; the concrete sill forms a weir that provides a low-water control for the gaging station. The flood of record, estimated to be 38,000 ft<sup>3</sup>/s, occurred in 1958. The channel margins support mesquite (Garrett Anderson, #4658).

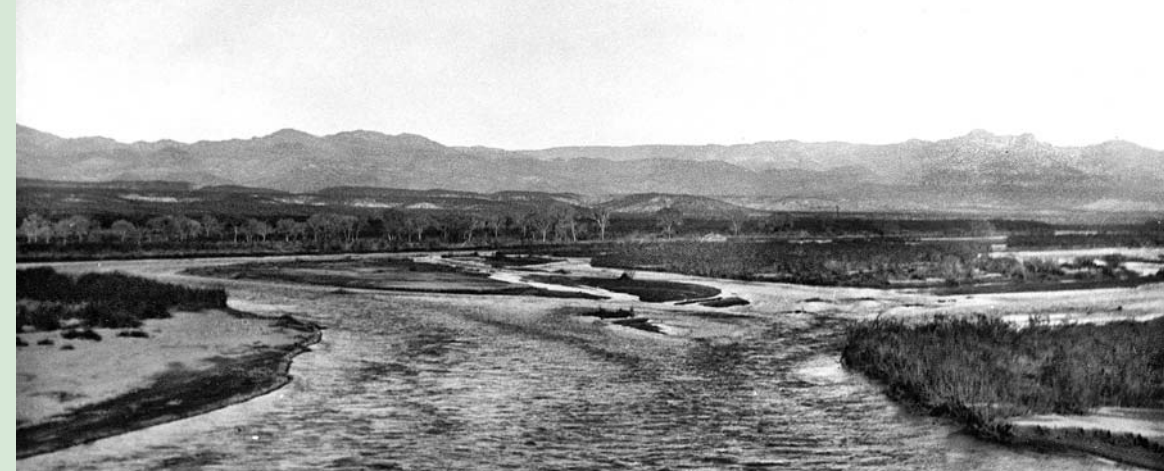
(March 6, 1932). The Gila River was ravaged by floods in the 1910s and 1920s, including one flood estimated at 100,000 ft<sup>3</sup>/s in 1916. This upstream view from the railroad bridge at Calva shows a wide, braided channel. An open cottonwood gallery forest appears in the midground at left (channel right), and the low shrubs at right appear to be native willows (W.E. Dickinson, #1053).

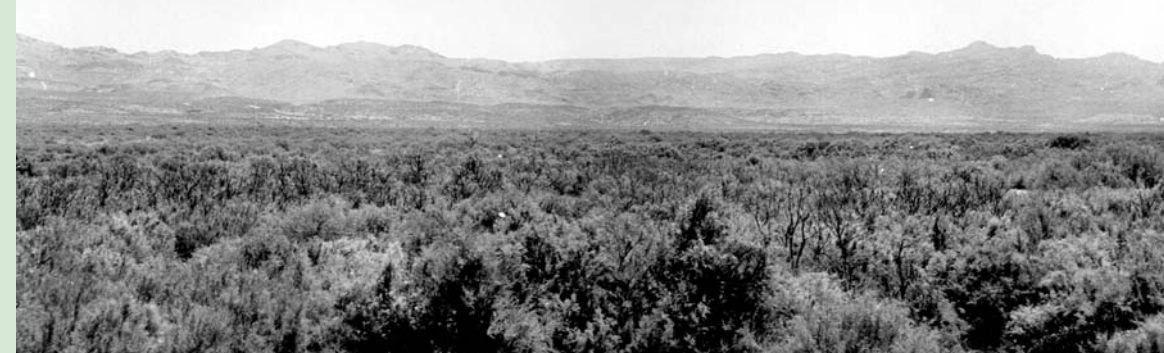
(June 18, 1964). In the intervening 32 years, the highest discharge through this reach was 27,900 ft<sup>3</sup>/s on October 1, 1941. Dense tamarisk has become established, creating a floodplain where the main channel once was. The channel has shifted to the right and is much smaller than it was in 1932 (Raymond M. Turner).

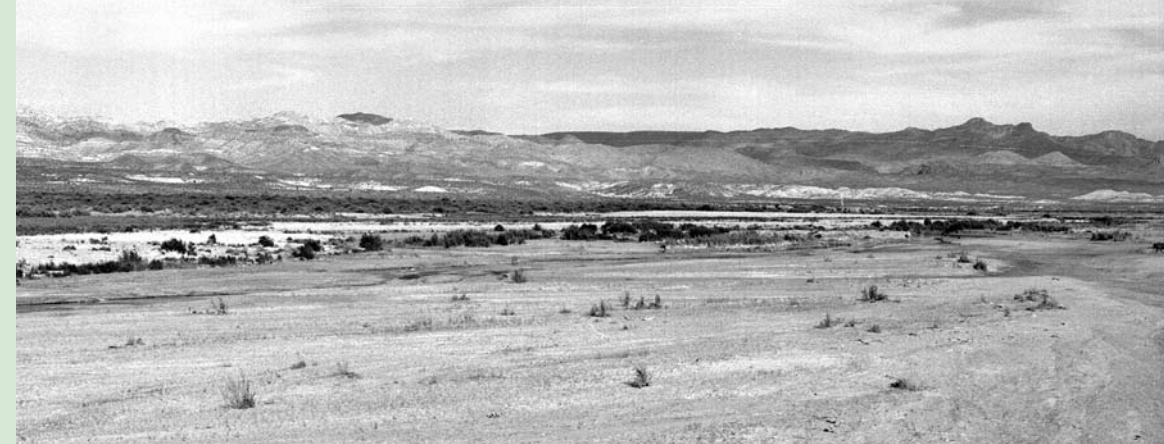
(October 17, 1973). To reduce evapotranspiration, phreatophytes (mostly tamarisk) were removed from this reach in 1970, and the floodplain was reseeded to native grasses. Those grasses are mostly gone at the time of this photograph, one year after a flood of 80,000 ft<sup>3</sup>/s passed through this reach. The small shrubs throughout the view are mostly tamarisks that are re-establishing in the reach (Raymond M. Turner).

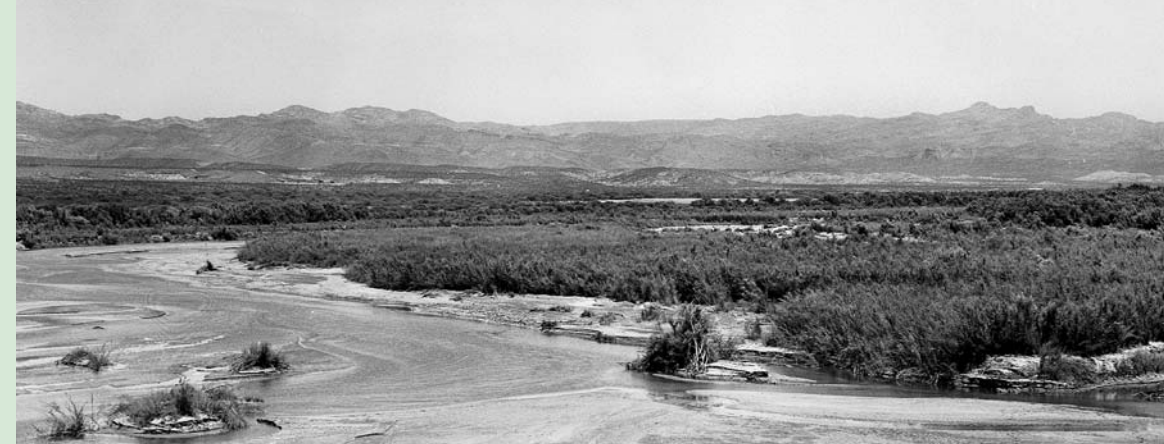
(May 21, 1984). In October 1983, a flood of 150,000 ft<sup>3</sup>/s passed through this reach in the wake of Tropical Storm Octave. This flood followed one that peaked at 100,000 ft<sup>3</sup>/s in 1978. These floods shifted the channel back into the view, and driftwood racks appear throughout the foreground. Despite this flood, dense tamarisk appears on both floodplains (Raymond M. Turner).

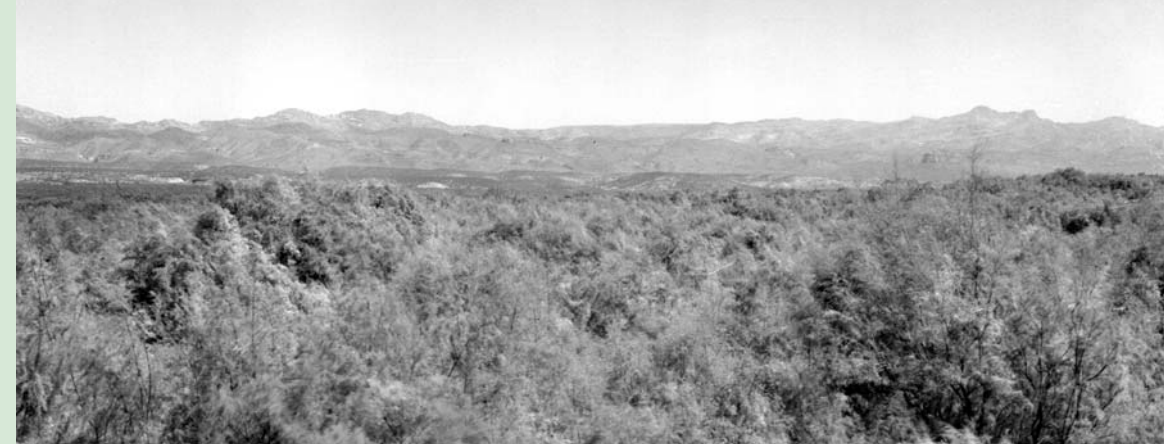
(October 6, 2000). Except for withdrawals of domestic and irrigation water at low-head diversion dams, the Gila River is unregulated upstream from Calva. In January and February, 1993, three floods passed through this reach that exceeded 100,000 ft<sup>3</sup>/s. Despite these floods, tamarisk has grown considerably, blocking the view of the river channel from this camera station. Despite the enormous effort at tamarisk removal and river restoration, the tamarisk has attained a higher biomass than it had in 1964. The channel has shifted from the right side to the left side of this view (Dominic Oldershaw, Stake 331a).

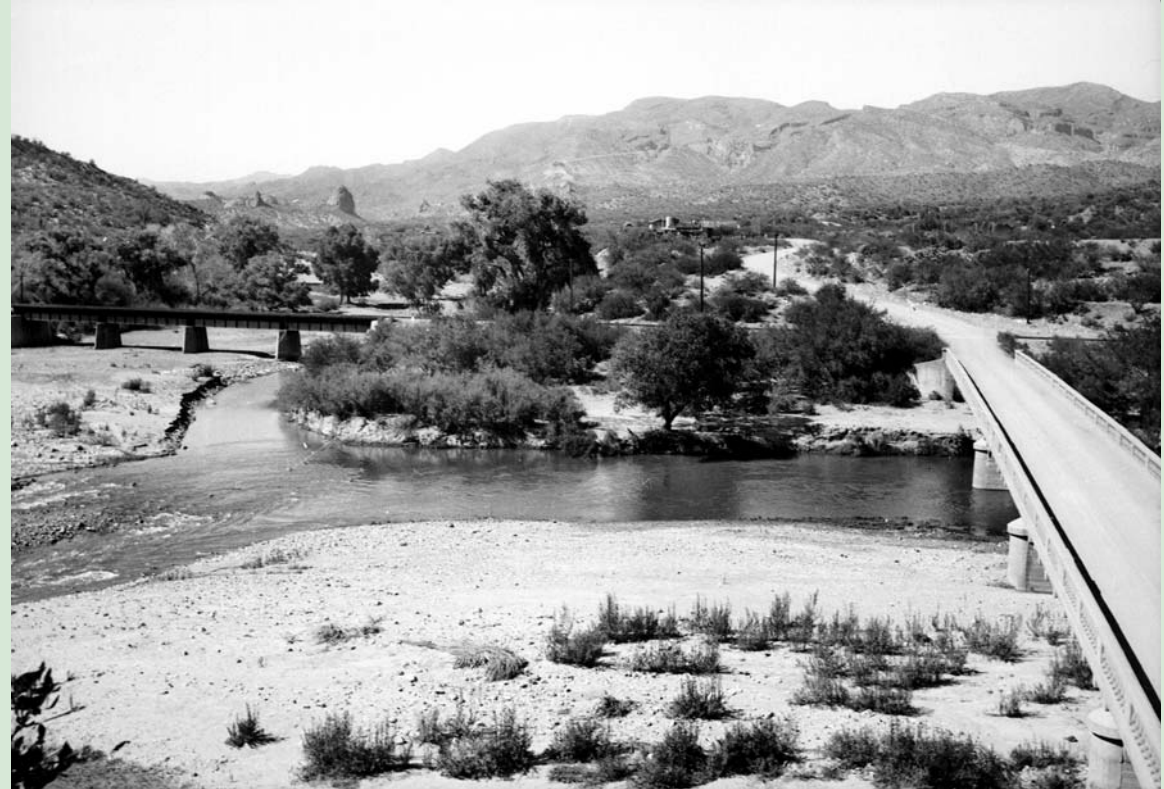
(May 21, 1945). This view, from a hill on the south side of the Gila River, shows the bridge at Kelvin from which discharge measurements are made at high flows. The river flows from right to left in this view and is regulated by Coolidge Dam, completed in 1928. The largest historic flood at this station is 132,000 ft<sup>3</sup>/s in 1916, and three other annual flood peaks exceeded 40,000 ft<sup>3</sup>/s before 1945. Floods were less than 40,000 ft<sup>3</sup>/s for 15 years prior to this photograph. Tamarisk is becoming established in the foreground, and mesquite and cottonwood trees appear on the far bank. Mineral Creek, spanned by a railroad bridge, enters the Gila River at left (W.L. Heckler, #3709).

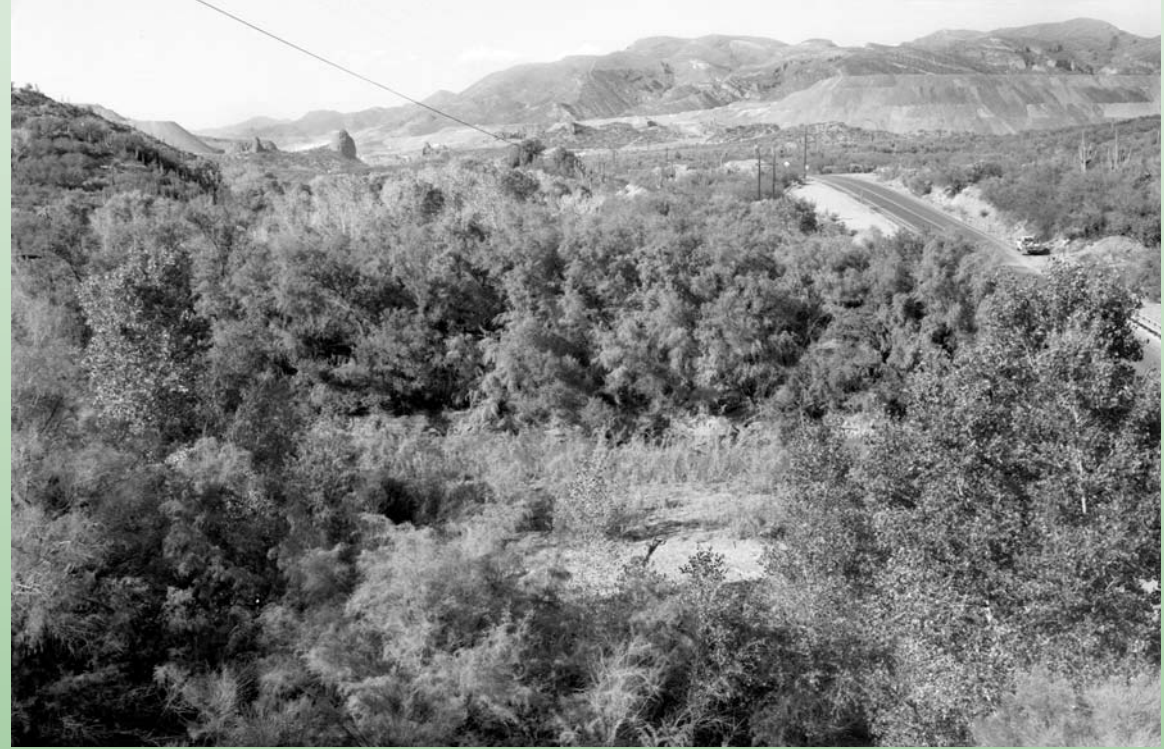
(October 2, 2000). The view is blocked by cottonwood trees, particularly at left and right with small trees in the foreground, and large tamarisk trees. This increase in riparian vegetation has occurred despite the fact that floods of 100,000 and 74,900 ft<sup>3</sup>/s in 1983 and 1993 respectively, passed through this reach (Dominic Oldershaw, Stake 430).

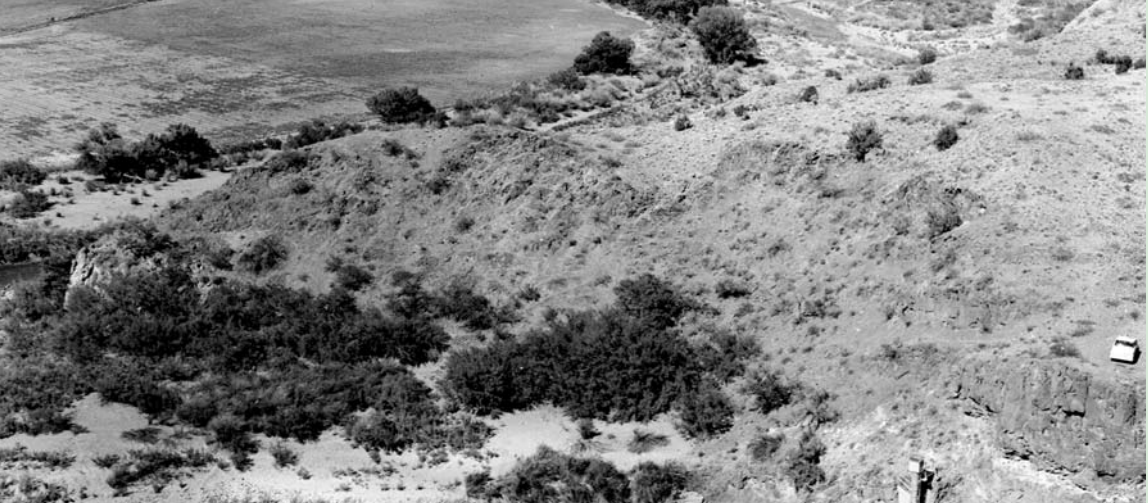
(July 23, 1931). The Gila River upstream from its juncture with Blue Creek near the Arizona-New Mexico border drains 3,203 mi<sup>2</sup> of rangeland and the Gila Wilderness. Just downstream from Blue Creek, the channel is somewhat confined within a bedrock canyon, but just upstream, as this view shows, the valley is relatively wide (James Baumgartner, #1501).

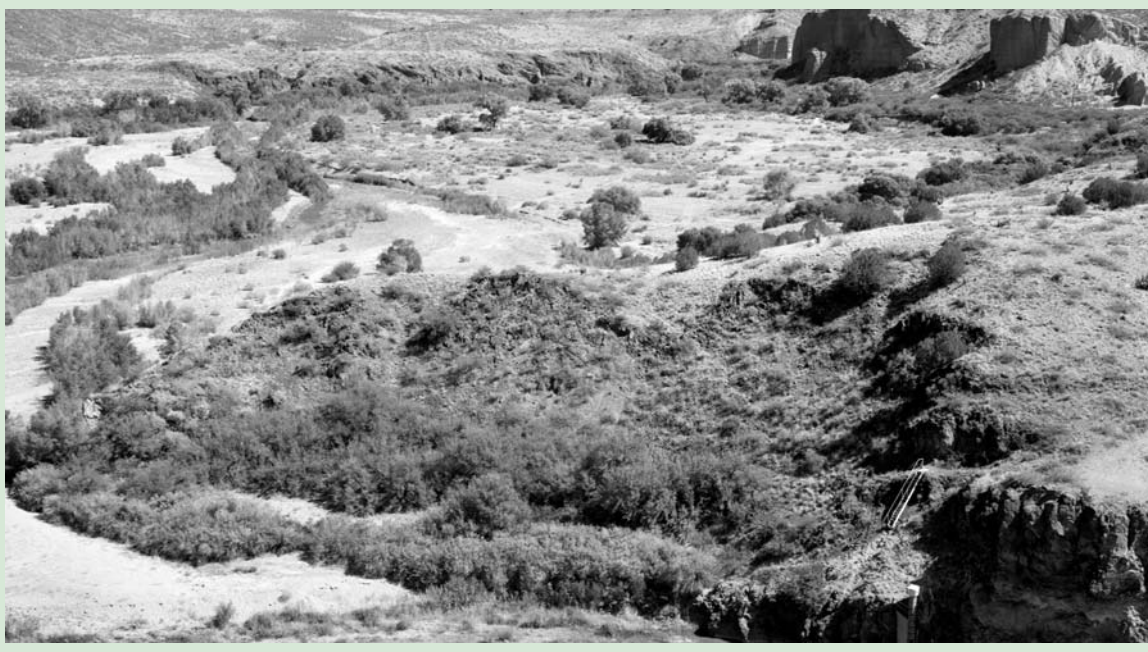
(June 11, 1964). By 1964, cottonwood trees had grown up along the banks of the river behind a lower ribbon of tamarisk trees. The channel position is the same despite a flood of 41,700 ft<sup>3</sup>/s in 1941 (Raymond M. Turner).

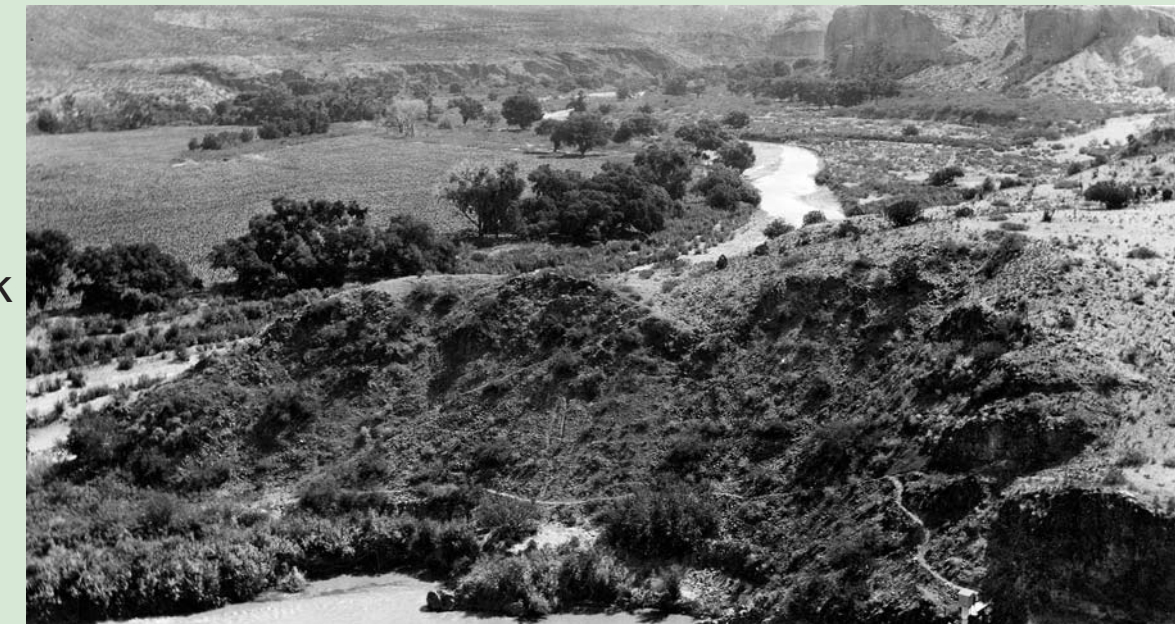
(October 5, 2000). The channel has shifted to the left, possibly during one of the four floods that exceeded 27,000 ft<sup>3</sup>/s between 1964 and 2000. The cottonwood gallery has been destroyed, and the channel is lined with tamarisk and coyote willows with scattered brickellbush (Dominic Oldershaw, Stake 346a).

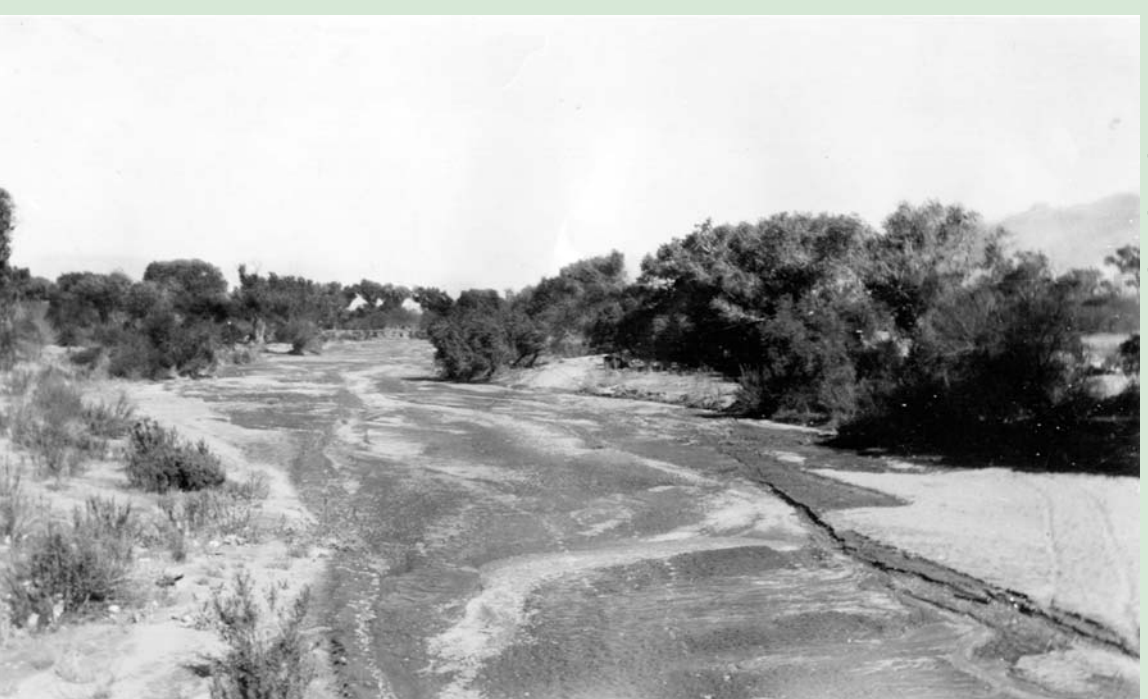
(November 22, 1930). This downstream view, taken from near the west abutment of the old Congress Street Bridge, shows the wide alluvial channel of the Santa Cruz River. At this time, the river flowed through a rural area, and cottonwood trees lined its banks. The relatively shallow arroyo began downcutting in 1878, and the 1914 flood of 15,000 ft<sup>3</sup>/s and 1917 flood of 7,500 ft<sup>3</sup>/s caused the most recent channel change before 1930 (photographer and number unknown).

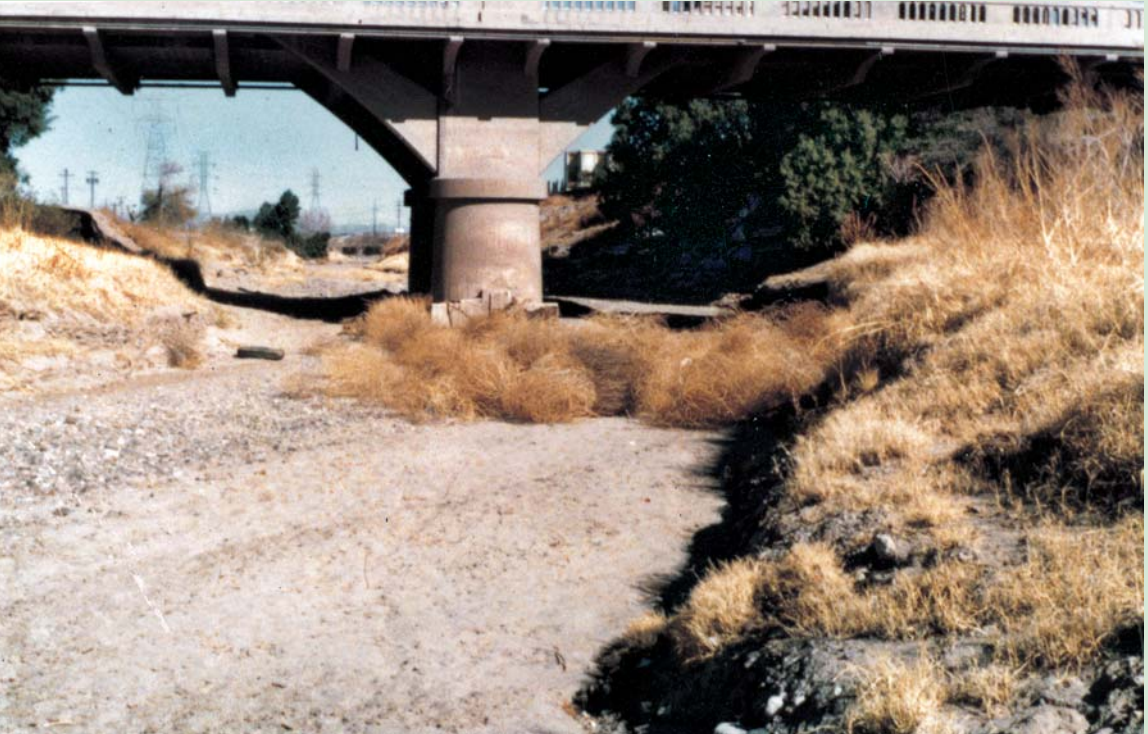
(December 17, 1994). The channel of the Santa Cruz River is now confined by soil-cemented banks. The open gallery forest of cottonwood trees was destroyed by ground-water pumpage and development, and the channel reached its present depth between 1977 and 1983 (Dominic Oldershaw, Stake 3300).

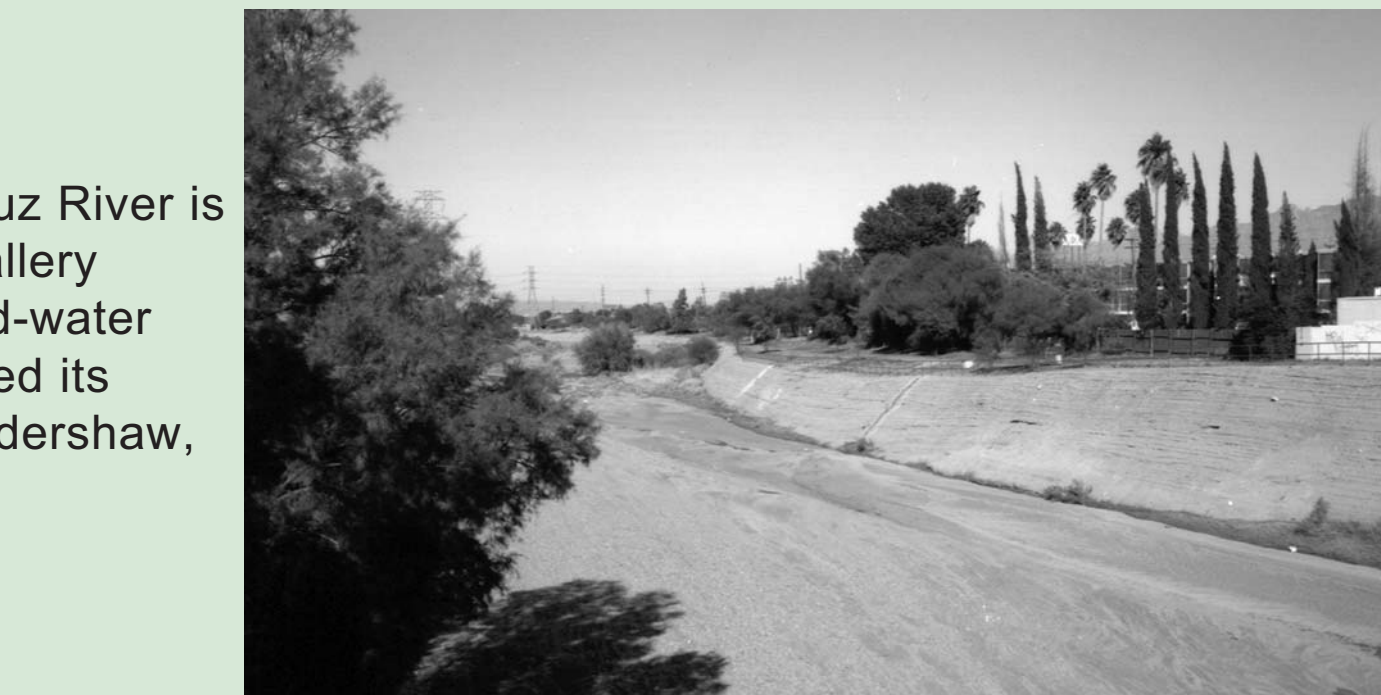
(February 3, 1964). This downstream view shows the approach to the gaging station at the Congress Street Bridge in Tucson. A relatively small channel became established within the arroyo walls in the middle part of the 20th century, when few significant floods occurred. Non-native athel tamarisk, a non-invasive species in Tucson, appears downstream from the bridge on channel right (photographer and number unknown).

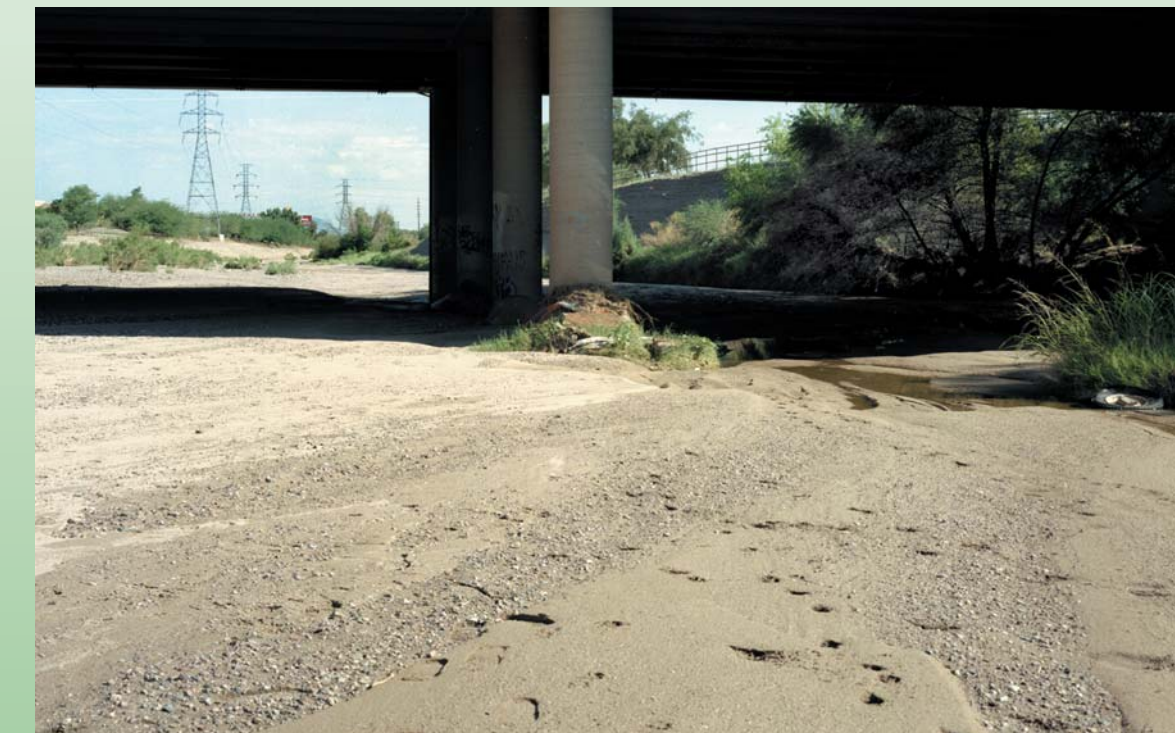
(August 22, 2000). The bridge was replaced, but its roadway surface was at about the same elevation as the old one. Channel downcutting, which primarily occurred during the 1977 and 1983 floods (the latter had a peak discharge of 52,700 ft<sup>3</sup>/s), has lowered the bed by up to 9 feet. Because of persistent problems with lateral channel change, soil cement now stabilizes the channel banks (Dominic Oldershaw, Stake 298).

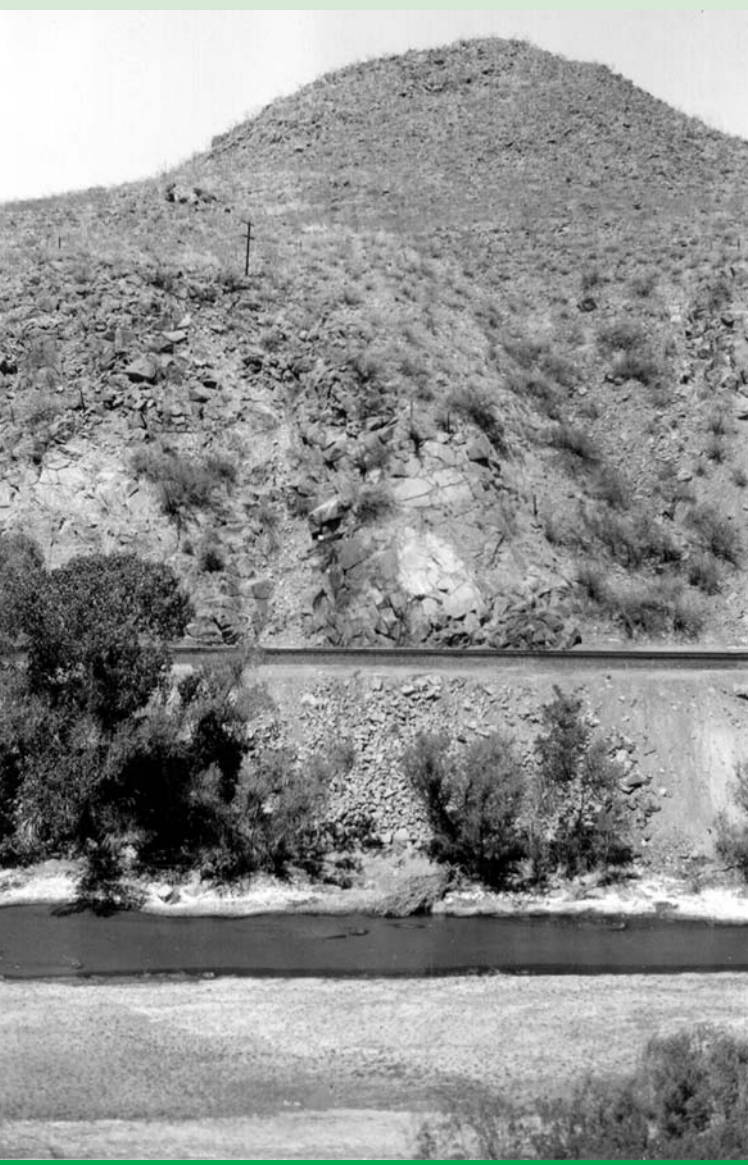
(May 4, 1954). The gaging station for the San Pedro River at Charleston has one of the longest records in Arizona. In 1954, the gaging station was at this site, about a quarter mile downstream from the current station on the highway bridge. This view shows the cableway cross section used for discharge measurements. The view is to the east, and the river flows from right to left. The trees along the far bank are cottonwoods (C.A.B., #4251).

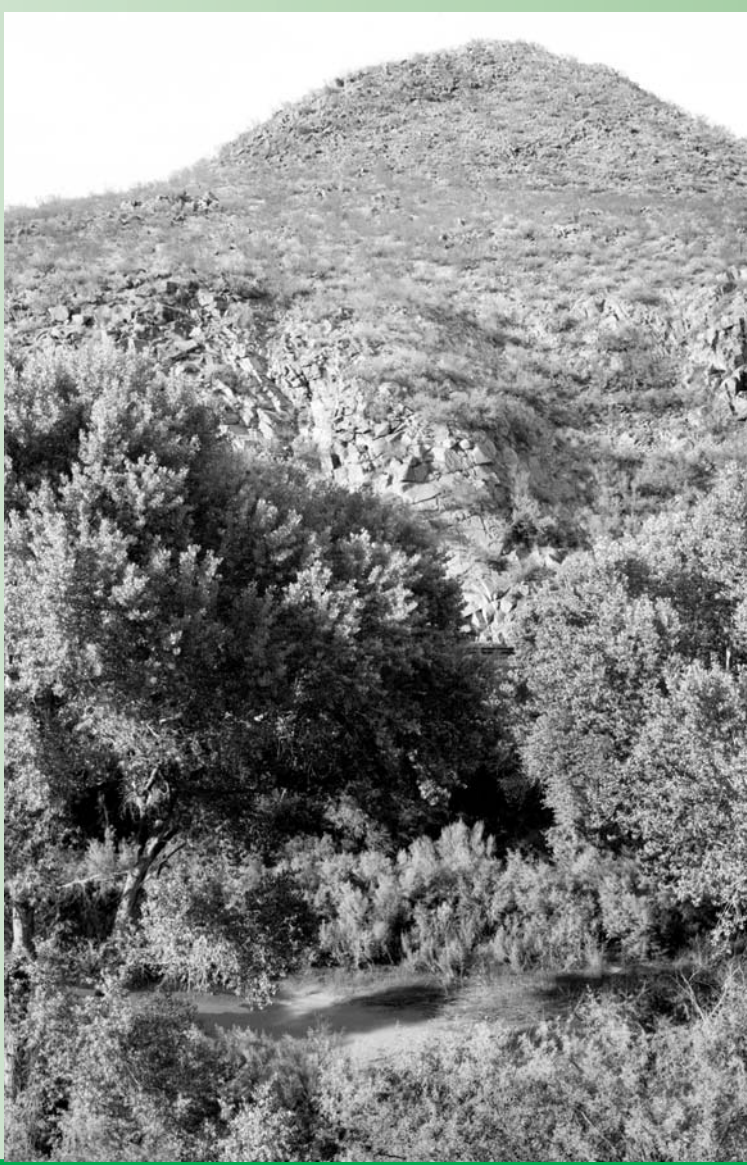
(July 29, 2000). Cottonwoods and willows, with scattered tamarisk, now block most of the view. The railroad on the opposite bank is still in operation (Dominic Oldershaw, Stake 298).
