# CHANGES IN RIPARIAN VEGETATION IN THE SOUTHWESTERN UNITED STATES: Repeat Photography at Streamflow Gaging Stations

USGS GROUND WATER RESOURCES PROGRAM

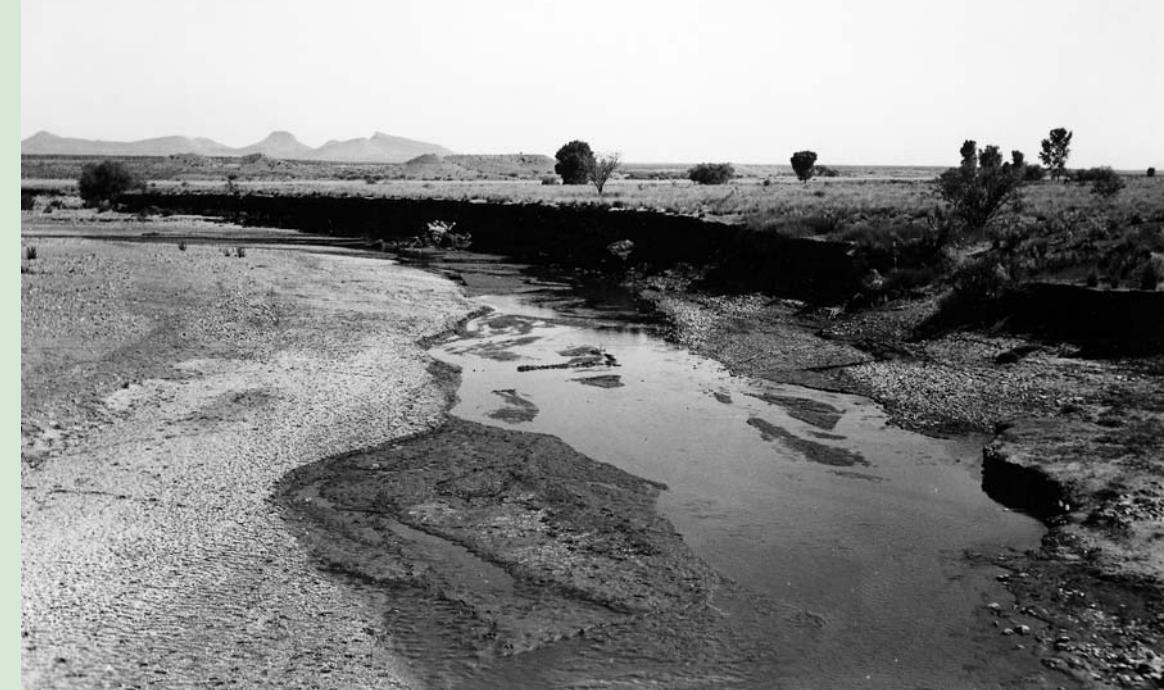
(May 24, 1939). This upstream view of the San Pedro River, from the bridge east of Palominas, looks over an open grassland towards mountains across the border in Mexico. Scattered cottonwood trees line the shallowly incised channel; vertical banks about 3 feet high appear in the midground at left. The 1926 flood was not measured at this site but had a discharge of 98,000 ft<sup>3</sup>/s downstream at Charleston (R.H. Monroe, #2503).

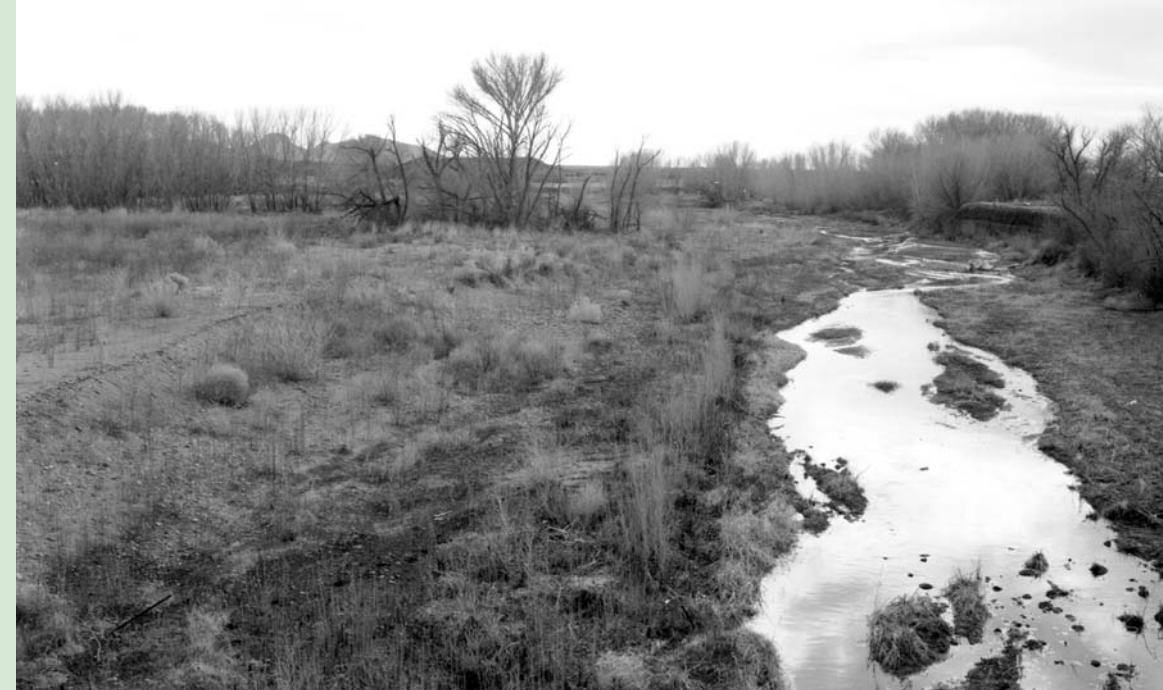
(January 23, 1981). This winter view shows small, defoliated cottonwoods and willows that block out most of the background. The channel is deeper, but the floodplain remains relatively free of woody plants. A flood of 22,000 ft<sup>3</sup>/s occurred in 1940, a flood of 16,500 ft<sup>3</sup>/s occurred in 1958, and another flood of 14,500 ft<sup>3</sup>/s occurred on October 9, 1977. Despite these floods, riparian vegetation has increased since 1939 (Raymond M. Turner).

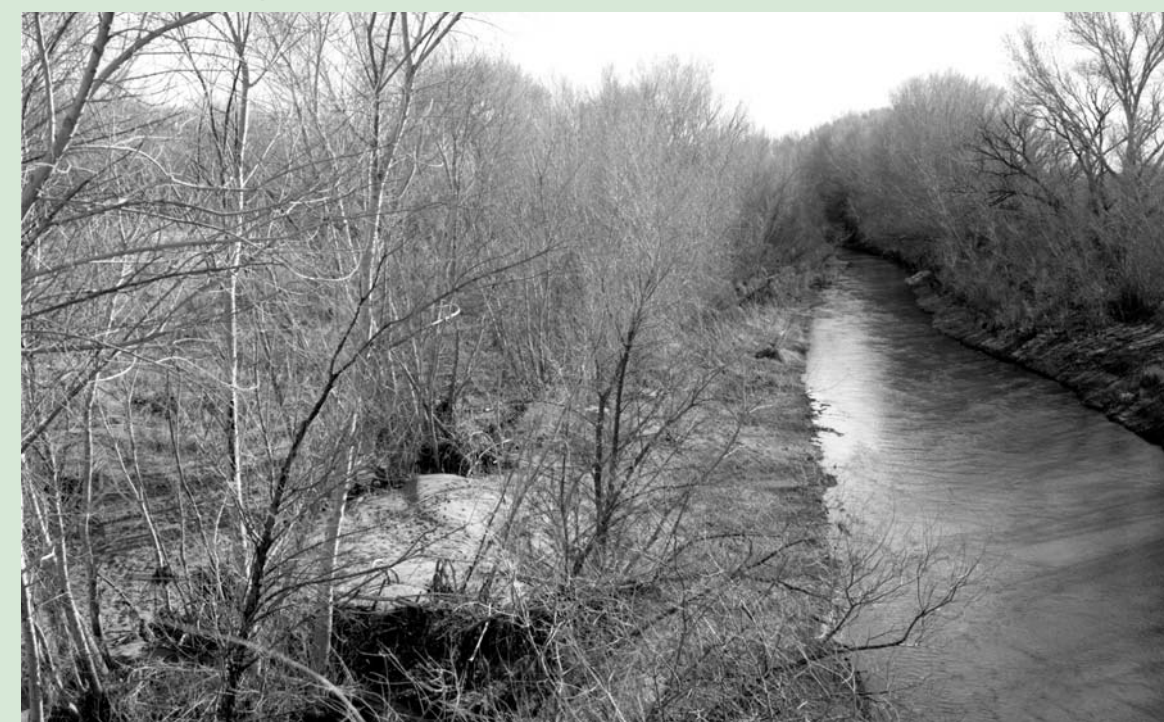
(February 7, 1995). The main channel of the San Pedro River has narrowed, possibly in response to riparian vegetation and/or earthwork. A dense thicket of trees—mostly cottonwood—line its banks, and older trees have grown up to the right. The plants are leafless in this photo (Dominic Oldershaw).

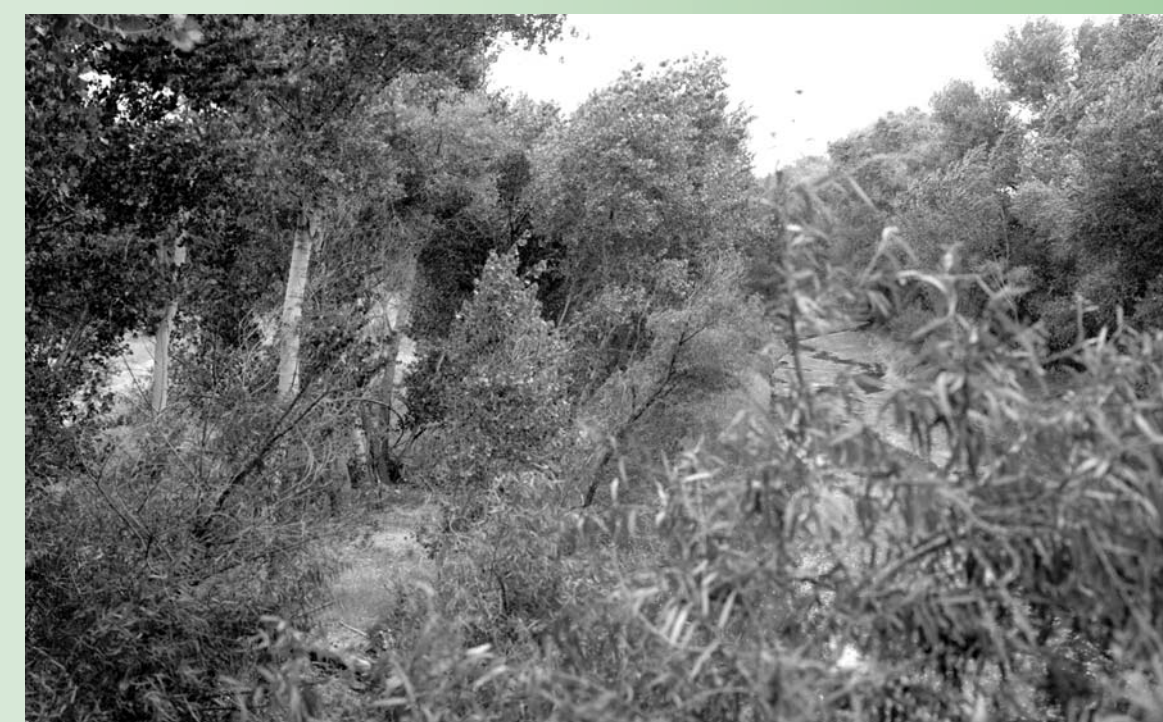
(October 8, 2000). The cottonwoods and willows completely block the view. Despite a flood of 14,800 ft<sup>3</sup>/s in late October 2000, no changes occurred in the channel or riparian community. No woody non-native species at present in this reach (Dominic Oldershaw, Stake 1009).

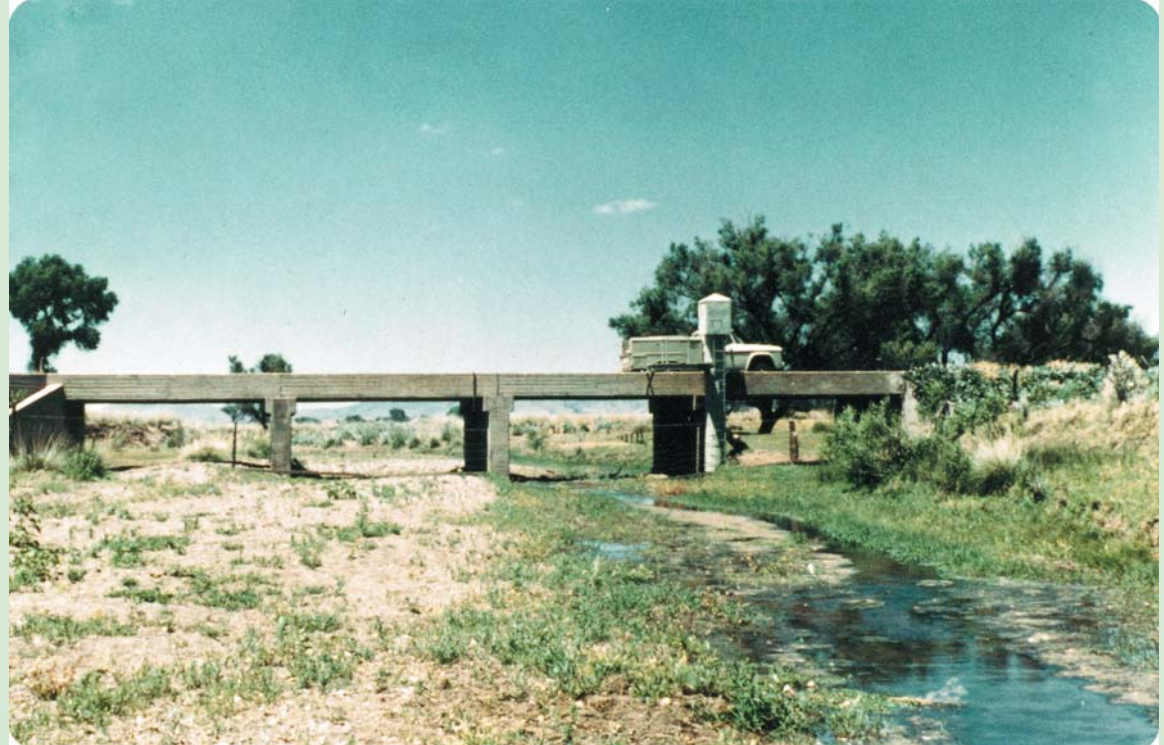
(October 8, 2000). The channel has meandered to the left despite a grade-control structure just downstream from the bridge. Cottonwoods have grown up throughout the view, and no woody non-native riparian species are present. The bed sediment in the reach has coarsened, increasing channel roughness (Dominic Oldershaw, Stake 1953).

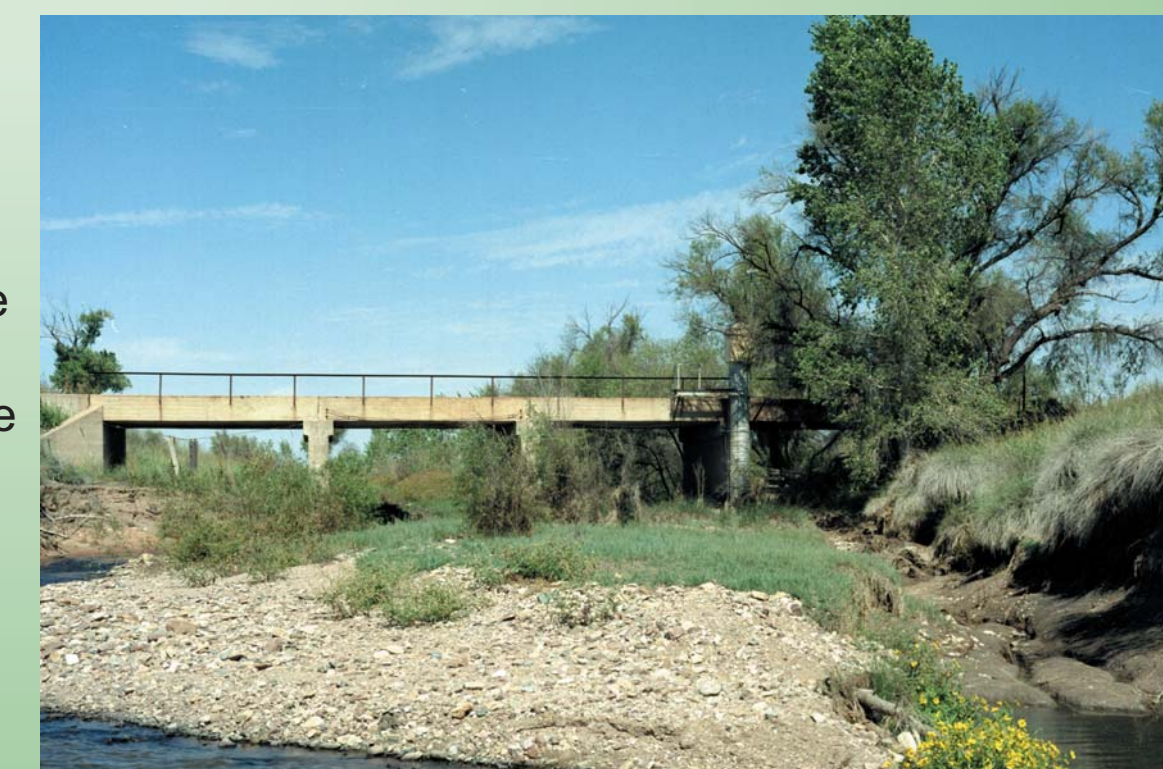
(June 1968). The gaging station at Lochiel measures flow in the Santa Cruz River before it enters Mexico. The river winds through the broad San Rafael Valley, a grassland, and the shallow channel had scattered cottonwood trees along it in 1968. This upstream view shows the gaging station and the low-water control (R.L.T., no number).
