## EFA Testing of Sample3 (pushed)

Side Wall of Scour Hole

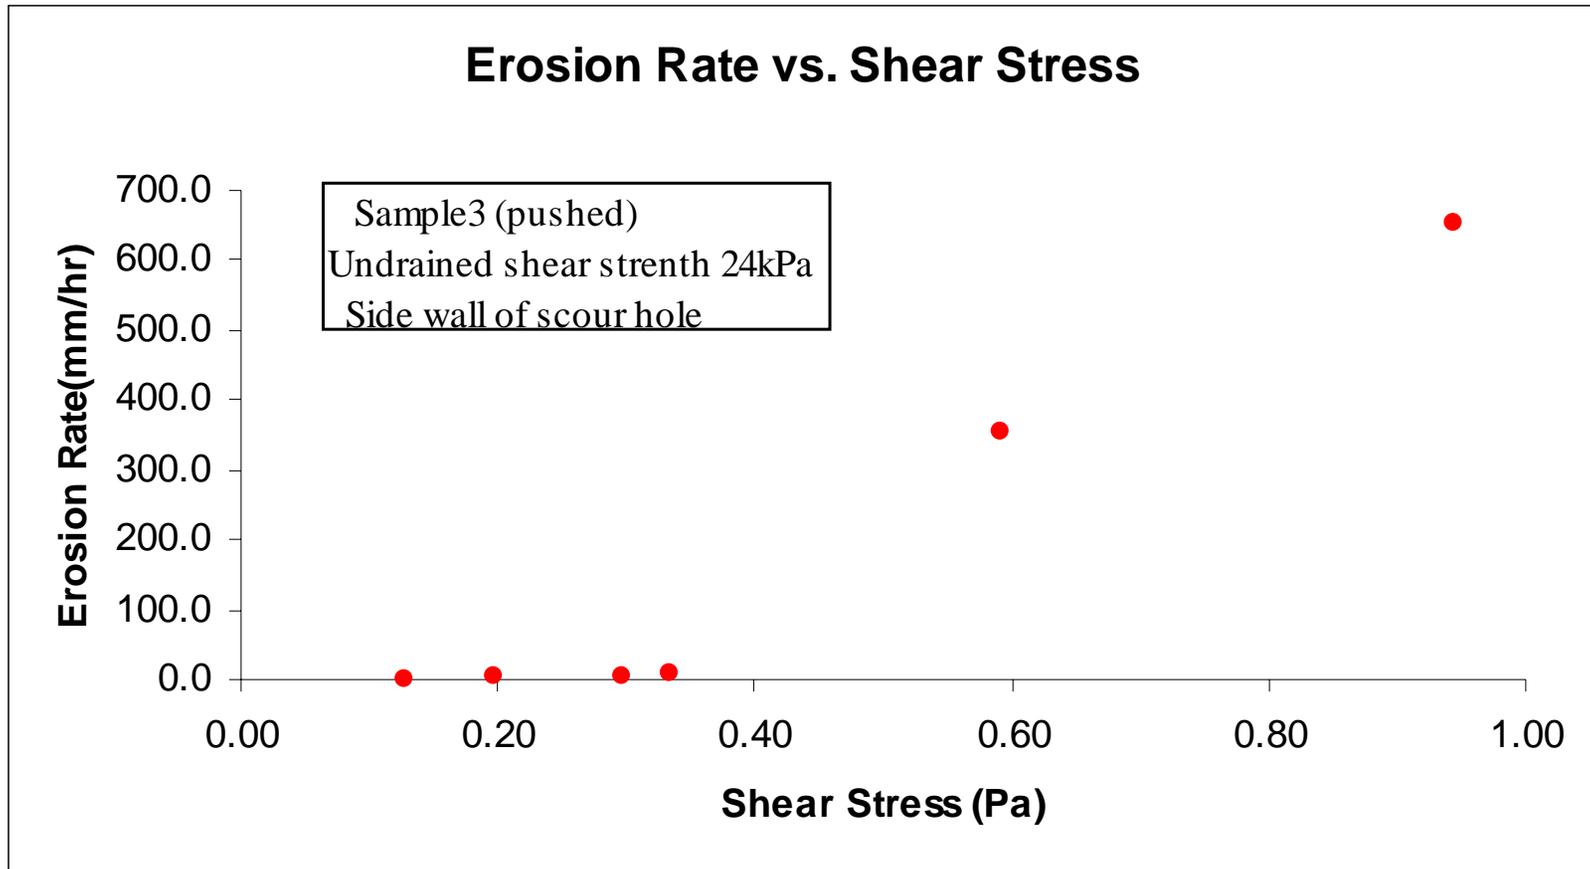
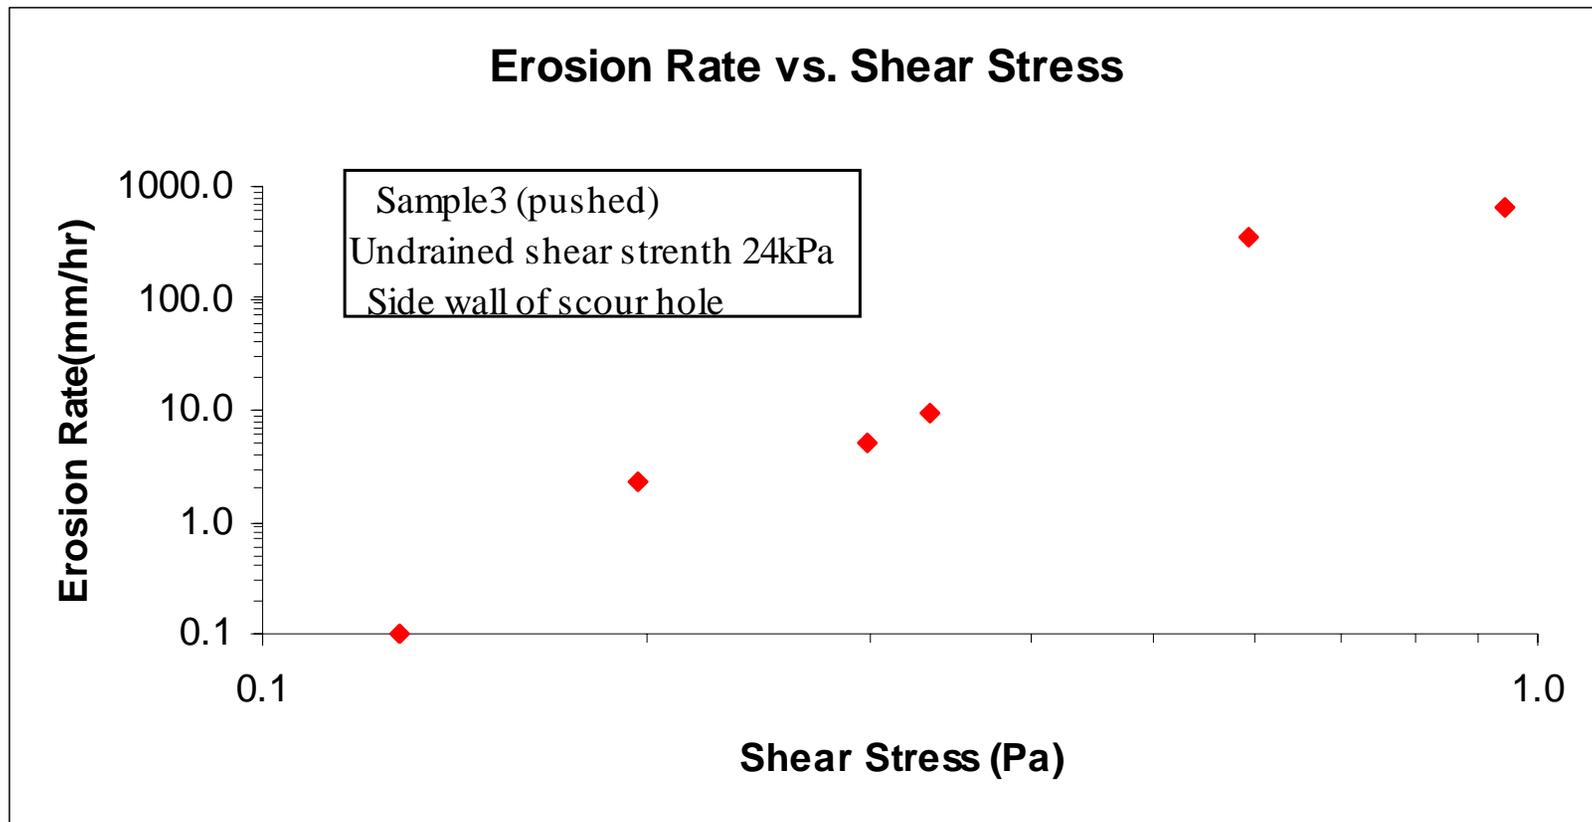
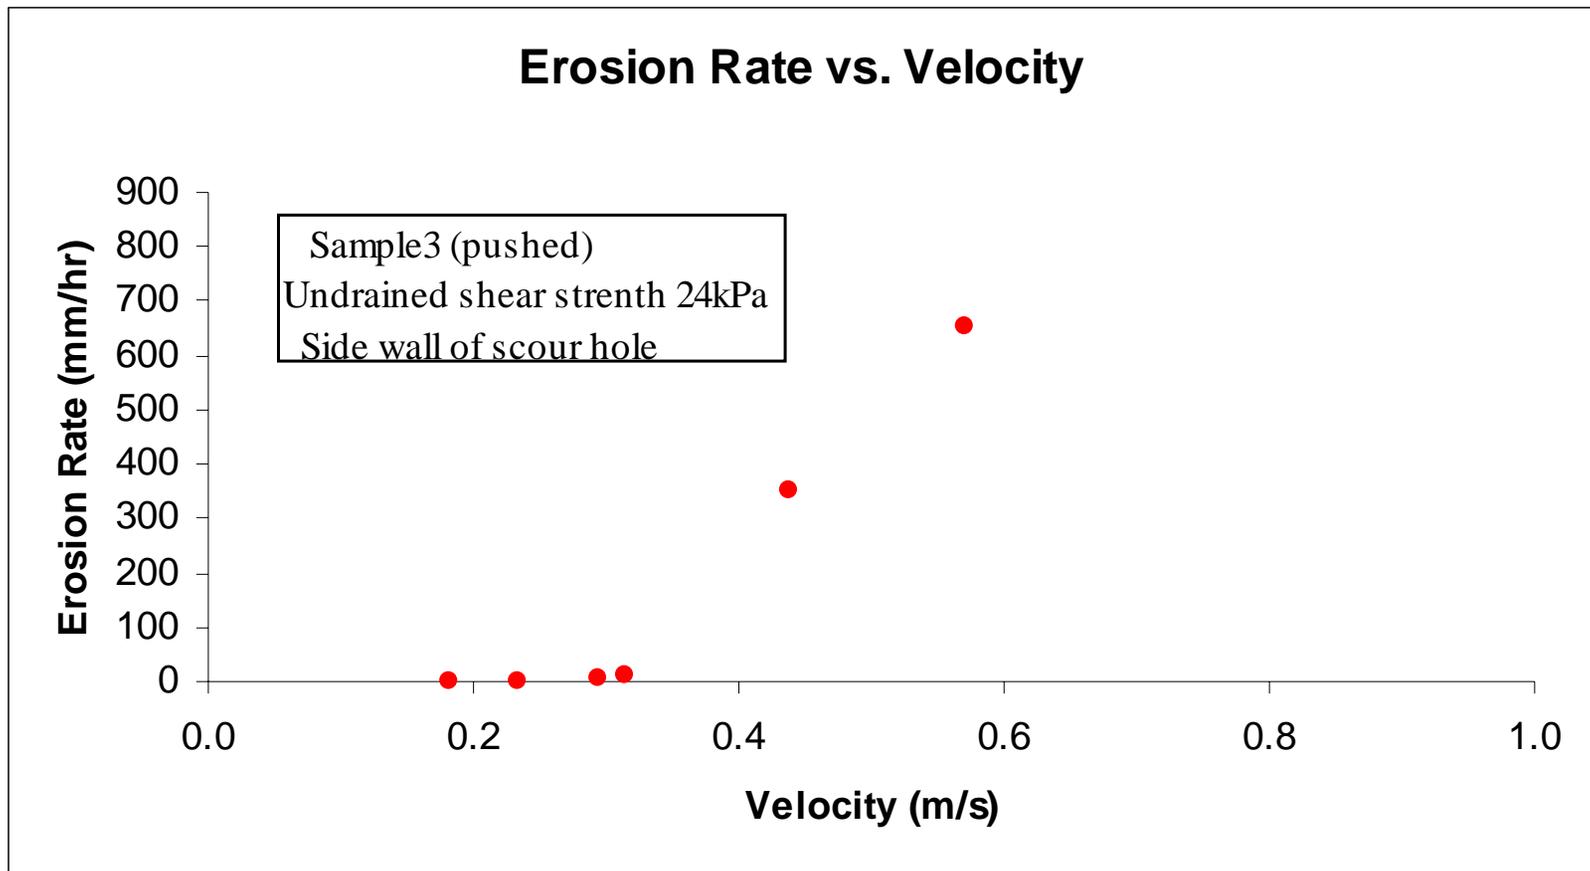
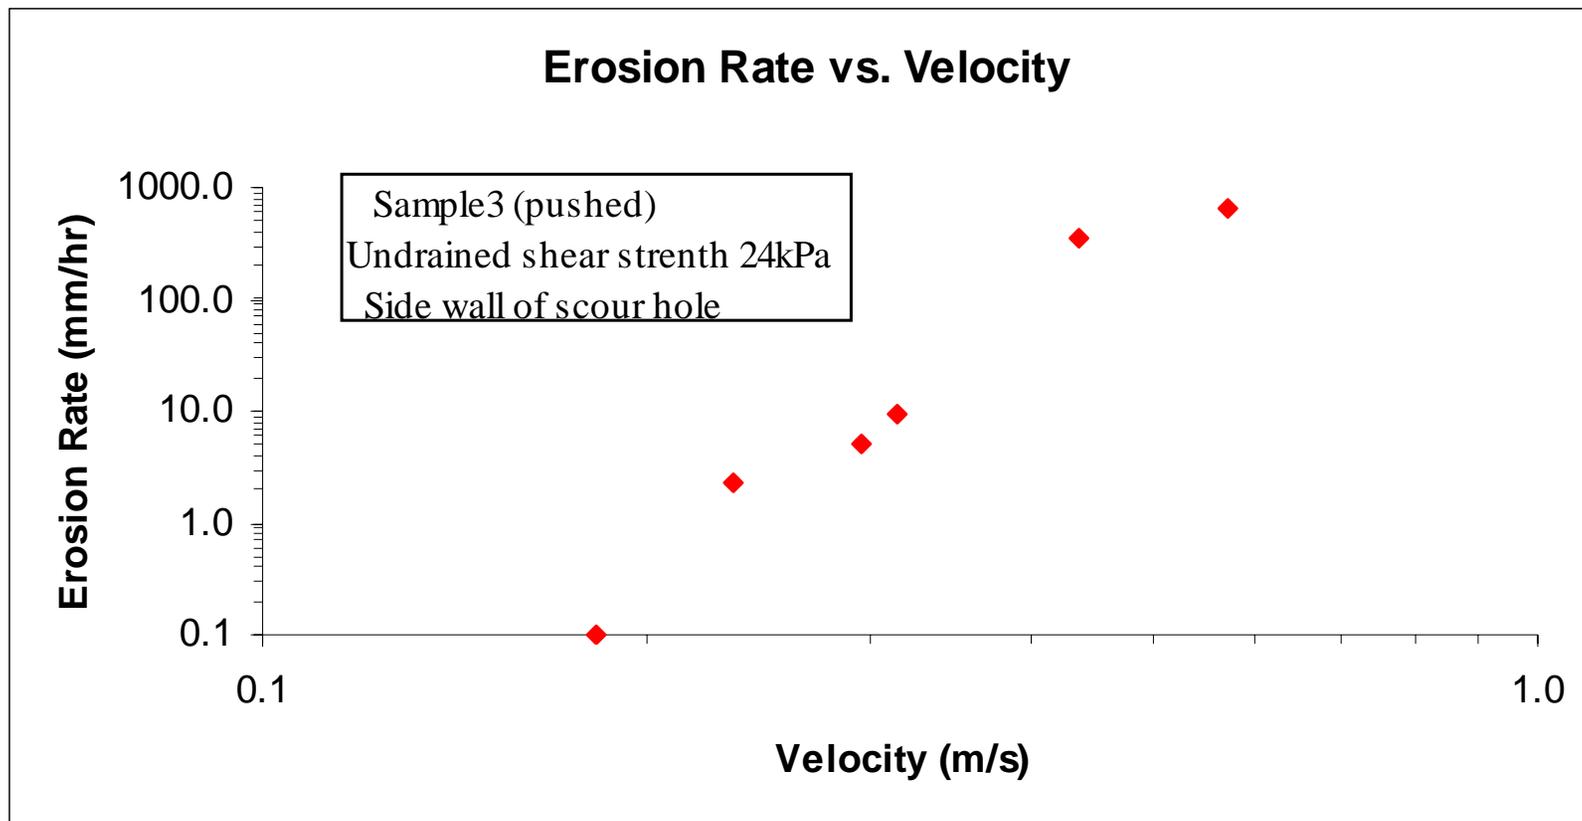
Table 1 Shear Stress, Velocity, and Erosion Rate in EFA testing of Sample3 (pushed)

Velocity (m/sec)	0.183	0.234	0.295	0.315	0.438	0.57
Shear Stress (Pa)	0.128	0.197	0.297	0.334	0.592	0.944
Erosion Rate (mm/hr)	0.0	2.348	4.986	9.574	352.941	654.545

1. In first step, velocity of testing was 0.18m/s. No scour was found after about 2 minutes.
2. Then velocity was increased to 0.23m/s. Erosion rate was very low.
3. When the velocity was increased to about 0.3m/s, erosion rate increased obviously. Fine particles were removed by the flow gradually.
4. With 0.4m/s velocity, erosion rate was very high. The sample was uniform.
5. When the velocity was increased to 0.57 m/s, the main button must be pushed continuously.
