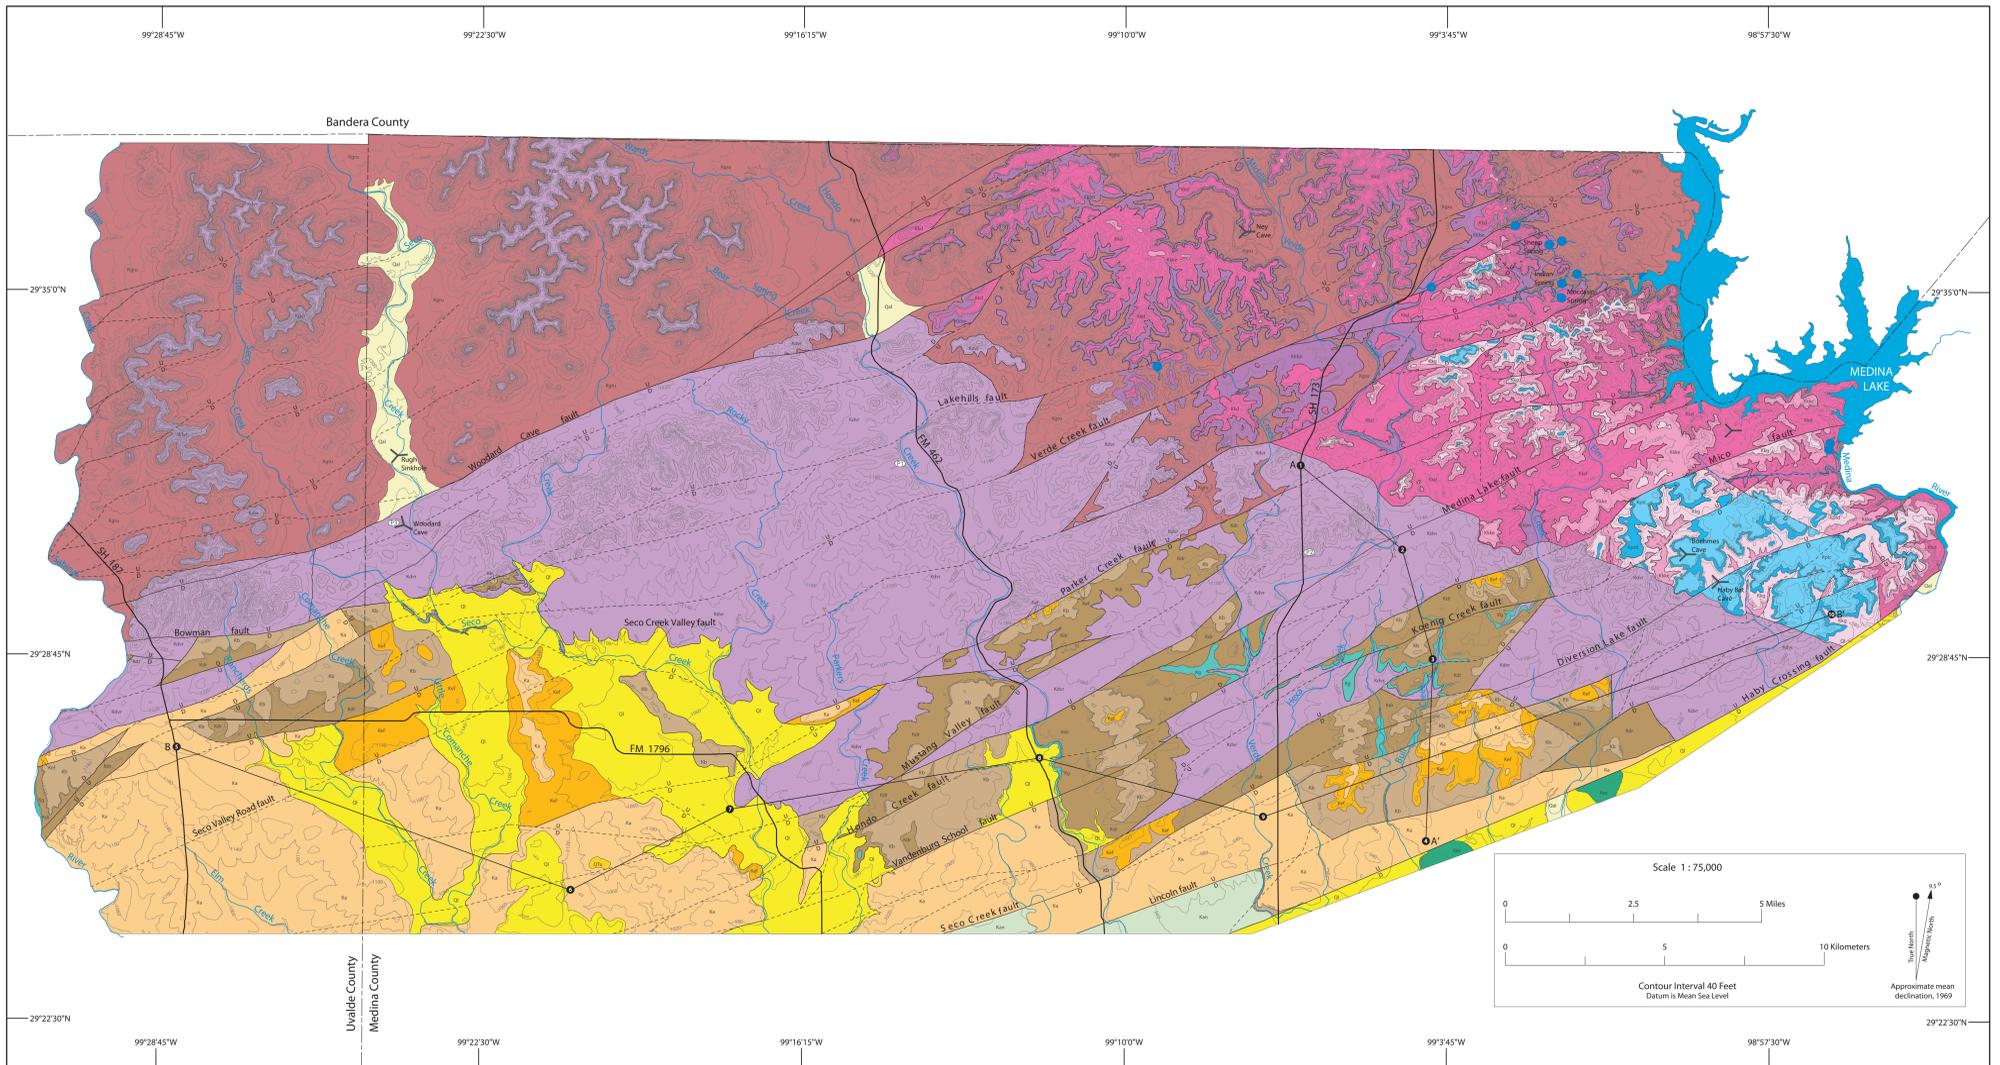
Photograph 1 (P1, looking north) shows intense fracturing of the Devils River Formation (Kdvr) in a tributary of Hondo Creek. As in most areas of the Balcones fault zone, a bimodal orientation of extensional fractures represents the resulting strain from gulfward thinning and fault block deformation of the Edwards aquifer strata. The complex network of an echelon faults and subsequent fracture patterns provide well-connected secondary porosity that enhances surface-water infiltration (aquifer recharge) and ground-water flow pathway development.
