Where's the Hayward Fault? A Green Guide to the Fault

Open-File Report 2008-1135

U.S. Department of the Interior
U.S. Geological Survey

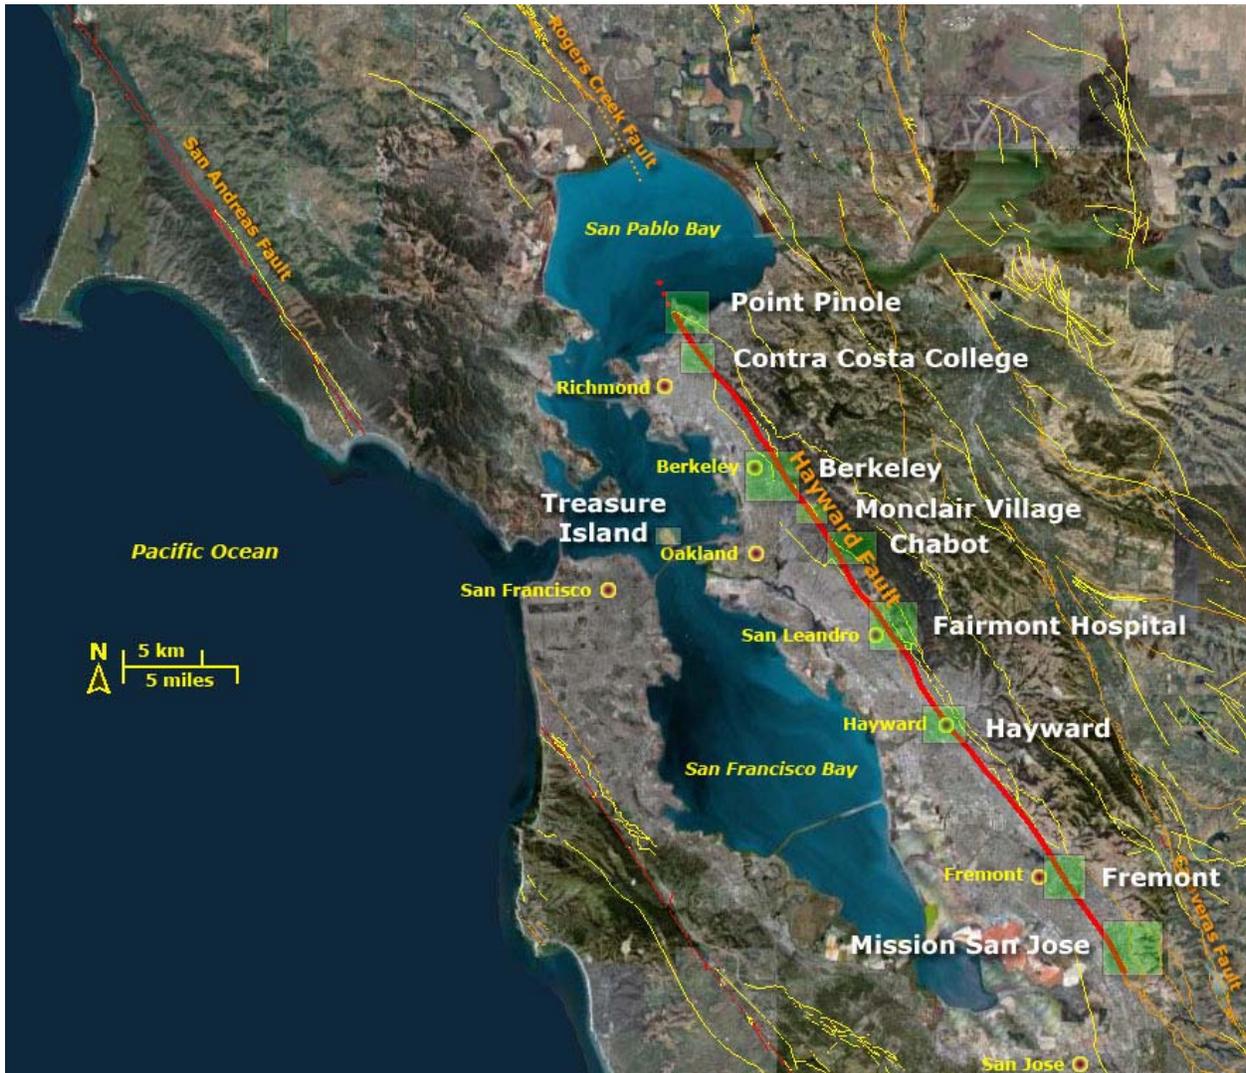
Figure 1. Locations of selected field trip destinations to observe features associated with the Hayward Fault. Locations were chosen based on public access, and some locations discussed highlight regional geologic features, historic buildings, or infrastructure. General locations of field trip destinations, shown as green boxes, are projected on a satellite image (modified from USGS Quaternary earthquake fault data and imagery retrieved from Google Earth).

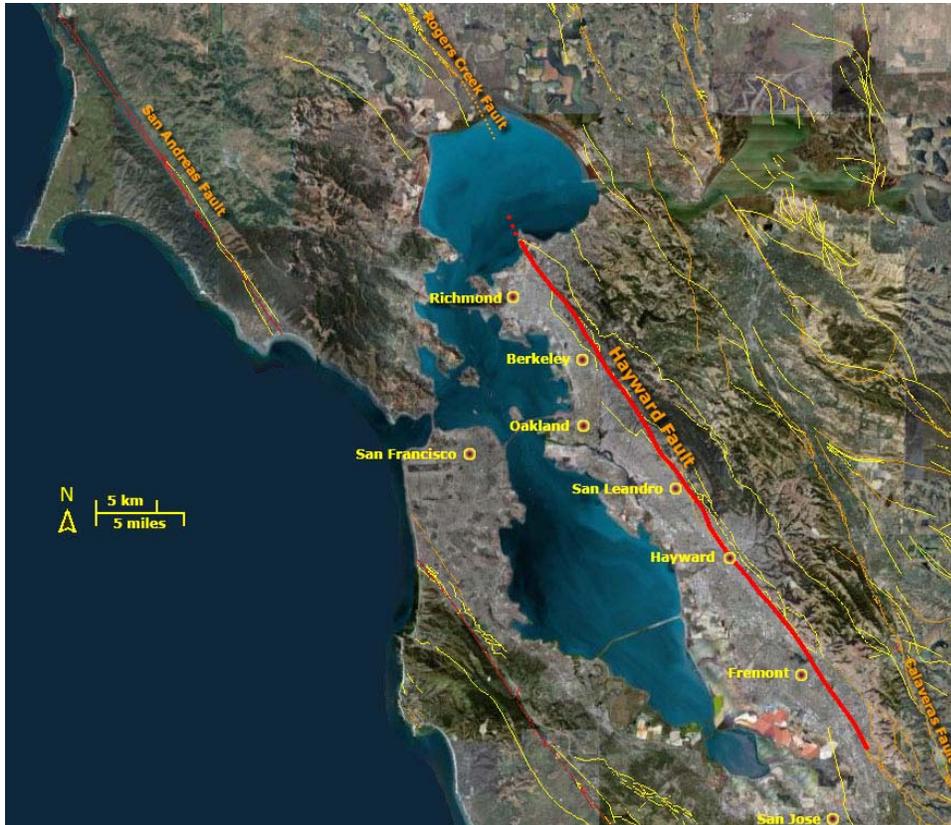
Figure 2. Location of the Hayward Fault. Fault systems in the San Francisco Bay region are shown on a satellite composite image modified from Google Earth. Faults that have had major earthquakes in historic times (since 1776) are shown in red. Faults that display movement or earthquake history in roughly the last 10,000 years (Holocene Epoch) are shown in orange. Older faults that display evidence of having activity in the last 2 million years (Quaternary Period) are shown in yellow. Fault data from Graymer and others (2006).

The Hayward Fault is a major earthquake fault that runs for nearly 50 miles (70 km) through the East Bay of the San Francisco Bay region (fig. 2). The fault and the associated greater system of Bay Area faults, have been known to generate great earthquakes in the past and will continue doing so in the future. For its length, the Hayward Fault has probably been studied more than any fault in the world. And for good reason—the Hayward Fault is a known killer. The fault runs through, or near to, some of the most densely urbanized areas in North America. These areas also support a large portion of California's economy—the region encompassing the fault is host to a maze of transportation, energy, water, telecommunications, waste disposal, and emergency infrastructure that supports millions of people (figs. 3 and 4).

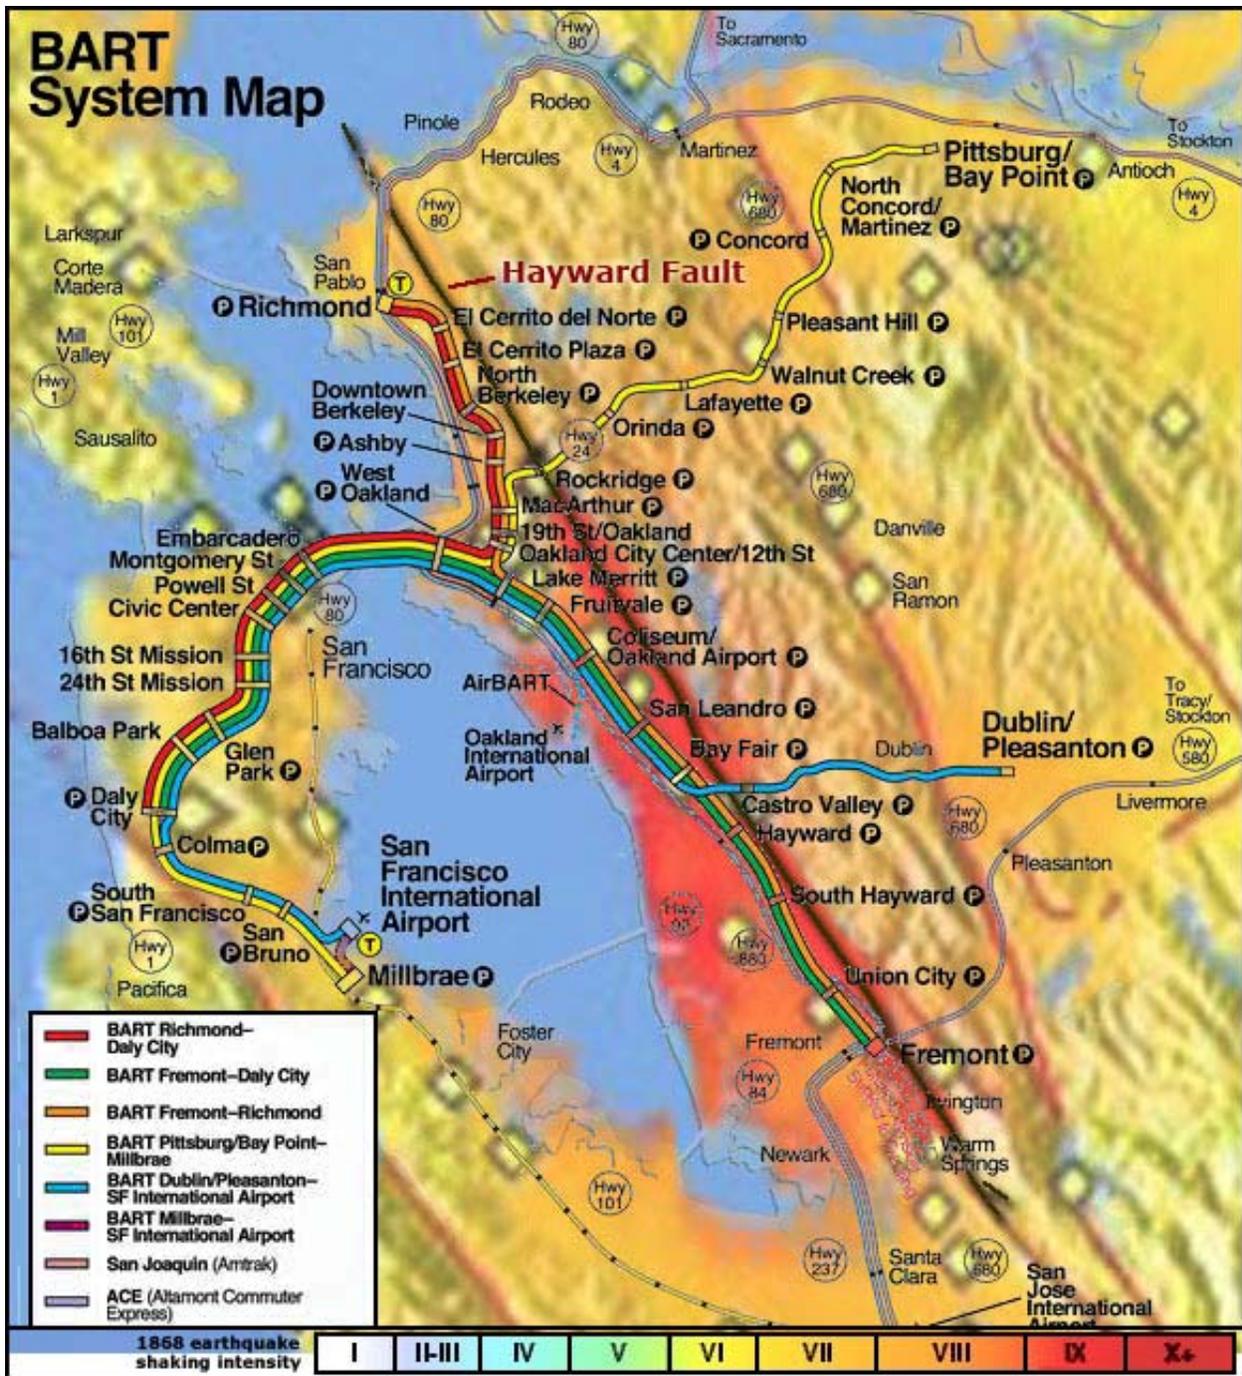
Figure 4. 1868 Hayward Earthquake Shaking Intensity Map with the BART System. The map of the San Francisco Bay Region shows the location of the BART rail system, the location of the Hayward Fault, and the earthquake shaking intensity from the USGS 1868 Hayward earthquake shakemap. The BART system is a useful indicator of the intensely urbanized corridor of the East Bay region relative to the location of the fault. For more information about the 1868 Hayward earthquake and its shakemap, see USGS Earthquake Hazards Program, 2007.

BART provides rail access to San Francisco and throughout the East Bay region, with links to other metropolitan air, rail, and bus services. Most field trip locations described in this guide are easily accessible by BART, or a combination of BART and an AC Transit metro bus. Figure 4 shows the proximity of the Hayward Fault to the Bart rail system to field trip sites. Visit www.bart.gov for more information about BART stations, schedules, and fares. With station stops fairly evenly distributed throughout the East Bay's piedmont urban corridor, BART

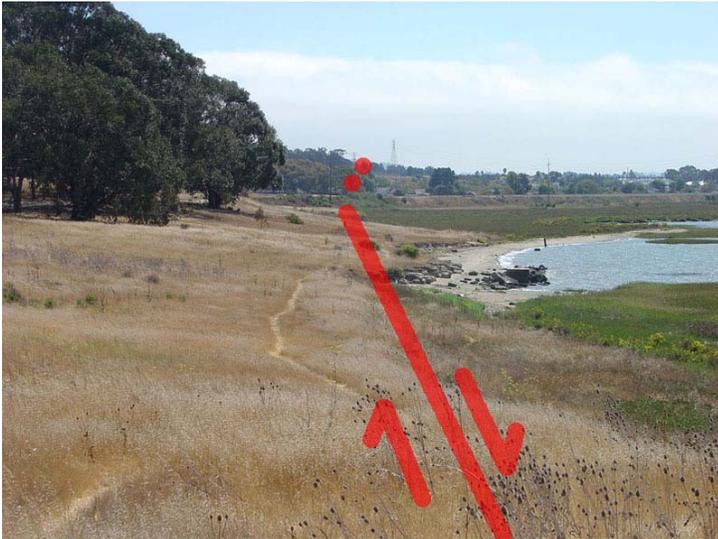
Figure 9. View south from the Pinole Point Trail toward the hillslope escarpment (left) of the Hayward Fault. The fault runs across the break in slope where it meets Parchester Marsh (on the right).

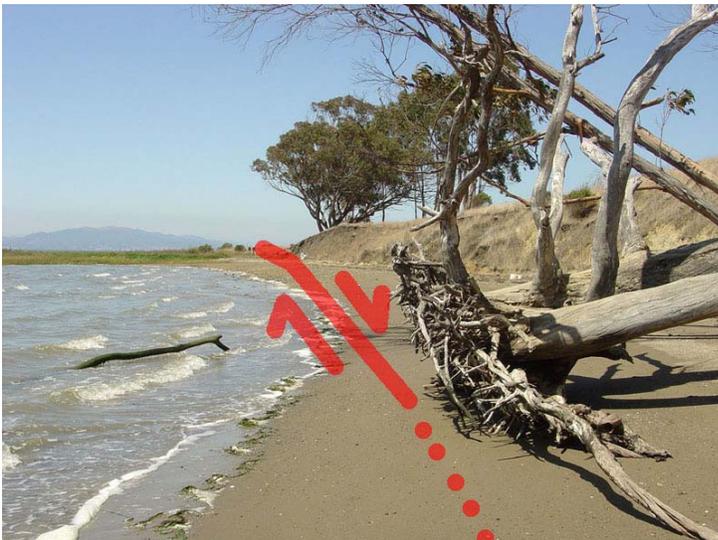
Figure 10. View looking north along the shoreline near where the Hayward Fault trace vanishes beneath the waters of San Pablo Bay. Complex small-scale fold- and fault-related structures can be observed in the bedrock between gravel and sand deposits. Wave erosion along the shoreline undercuts the hillslope, causing landsliding along the scarp of the Hayward Fault.

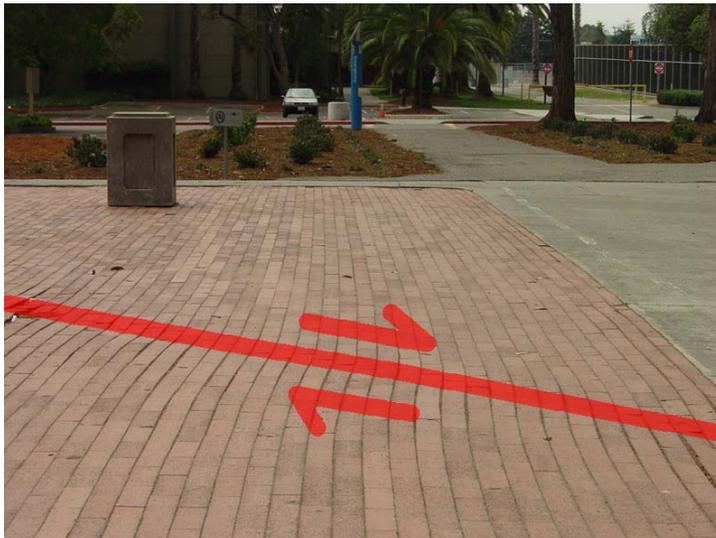
Figure 13. Rows of bricks offset by fault creep on a patio area next to the Campus Circle on the north side of the campus of Contra Costa College.

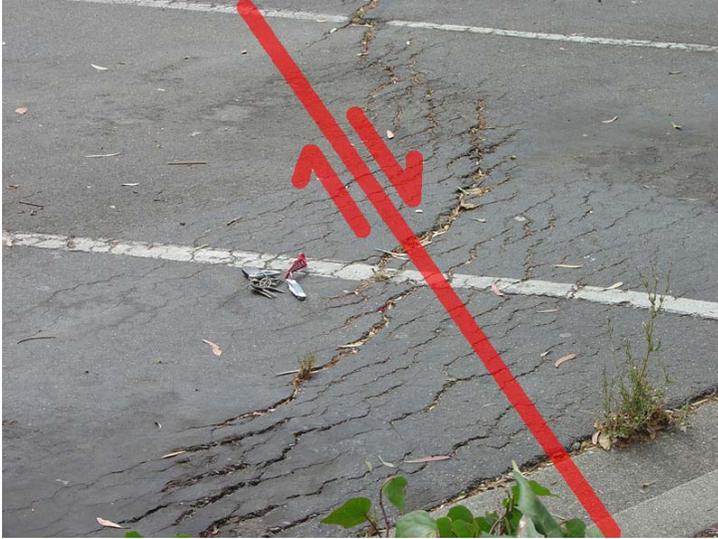
Figure 14. Strain and shear from creep on the Hayward Fault result in fractures in the asphalt of Parking Lot 10 on the campus of Contra Costa College. Car keys and a standard four- inch wide parking stripe are scale.

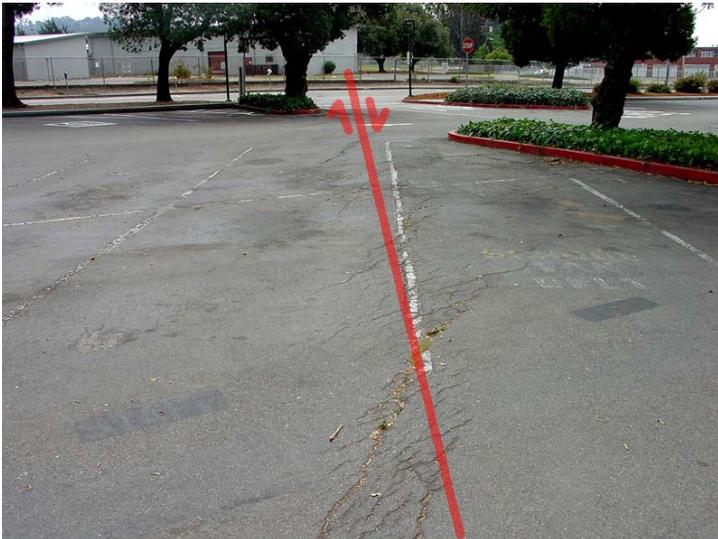
Figure 15. Strain and shear from creep on the Hayward Fault result in fractures in the asphalt of Parking Lot 10 on the campus of Contra Costa College. This shows how creep produced a series of right-stepping en-echelon fractures. This view looks south toward the abandoned El Portal School. This parking area is usually full when classes are in session.

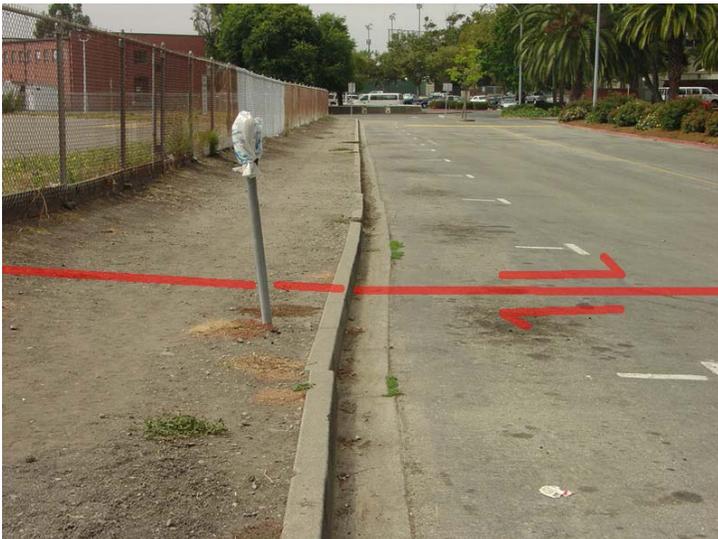
Figure 16. Free parking is available on the Contra Costa College campus in the vicinity where the Hayward Fault offsets a curb on Castro Street next to the abandoned El Portal School.

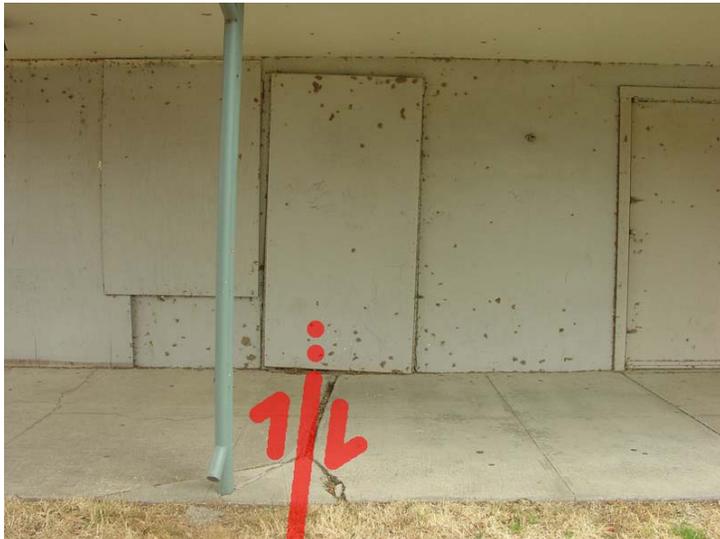
Figure 18. Creep along the Hayward Fault has caused structural damage to the now-abandoned El Portal School located next to the Contra Costa College campus. This view is perpendicular, facing north, compared to the view in Fig. 17.

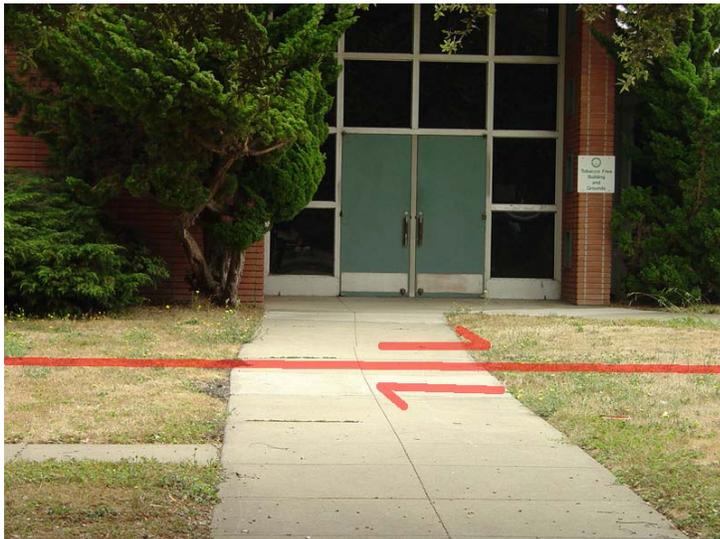
Figure 19. Creep along the Hayward Fault has offset sidewalks near the entrance to the now-abandoned El Portal School located next to the Contra Costa College Campus.

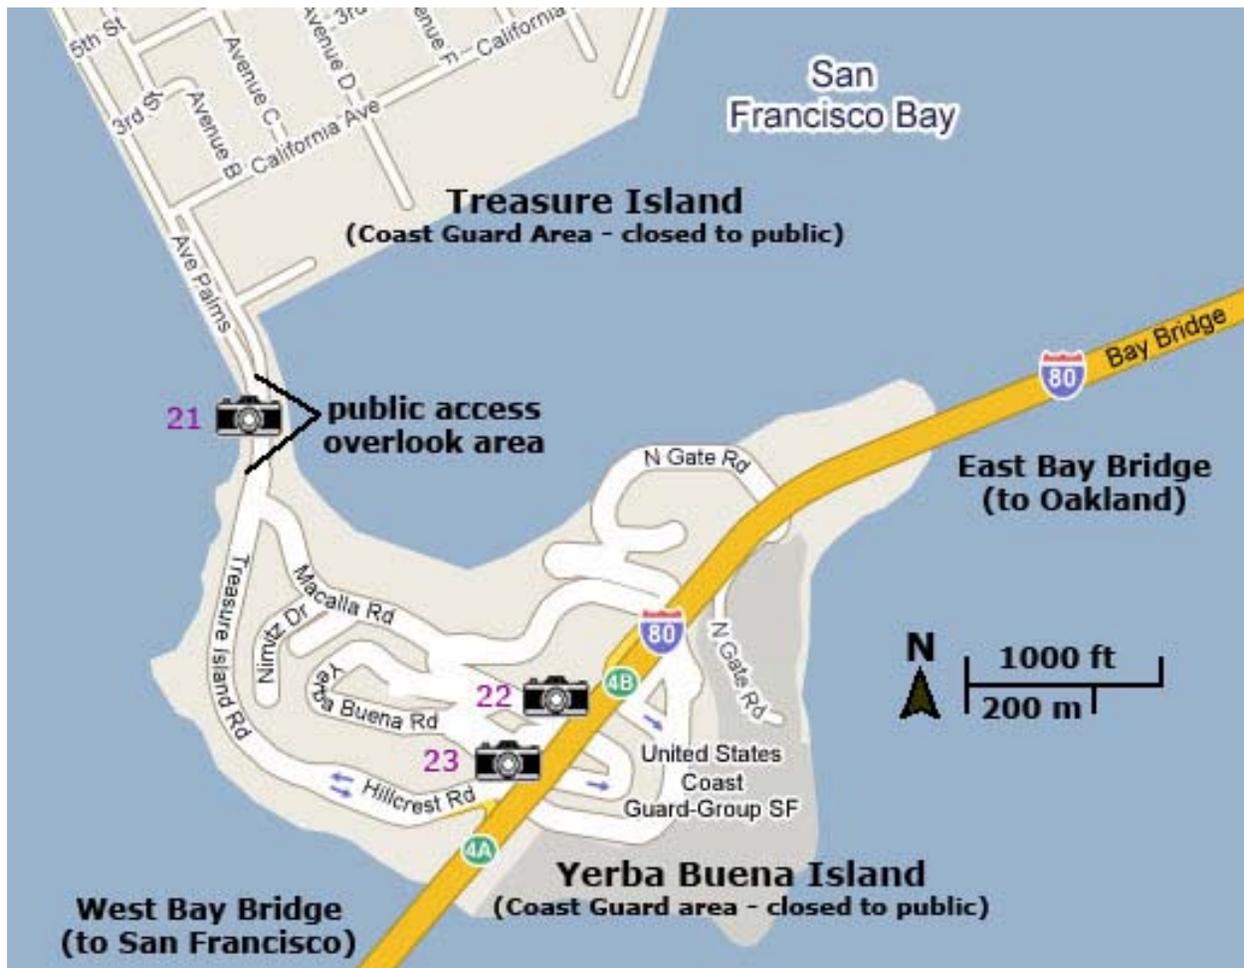
Figure 20. Map of the Yerba Buena and Treasure Island area mid span on the Bay Bridge between San Francisco and Oakland, California. Purple numbers designate photograph locations.

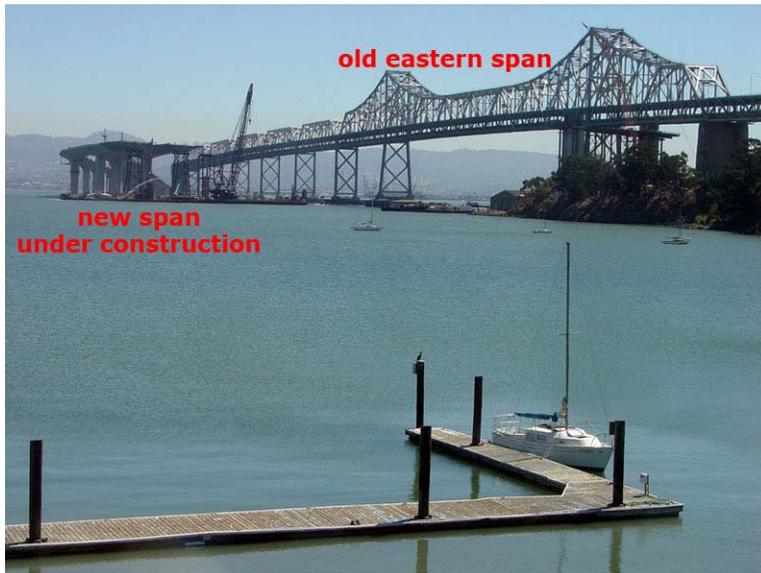
Figure 21. View east toward the eastern section of the Bay Bridge from Treasure Island. This photo taken in late summer of 2007 shows the construction of the more earthquake resistant design for the new section of the bridge.

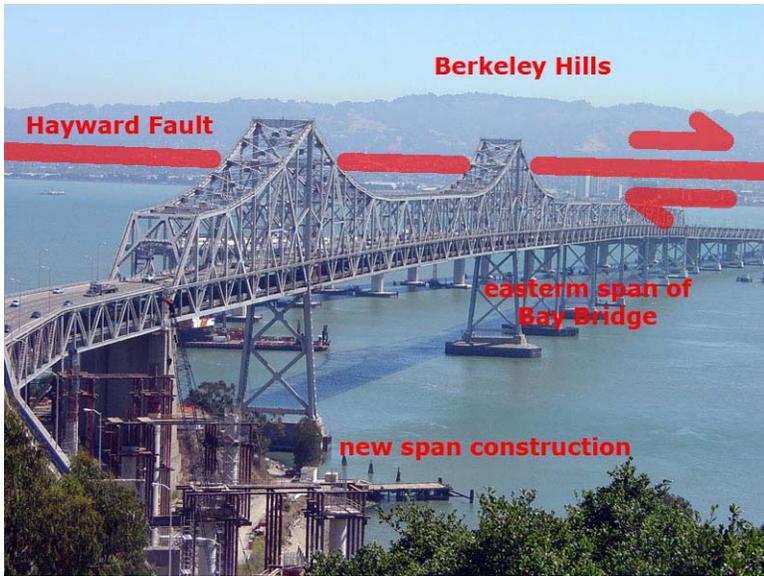
Figure 22. View east toward the eastern section of the Bay Bridge from Treasure Island. This photo taken in late summer of 2007 shows the construction of the more earthquake resistant design for the new section of the bridge. The Hayward Fault runs along the western flank of the Berkeley (East Bay) Hills near Berkeley and Oakland in the distance.

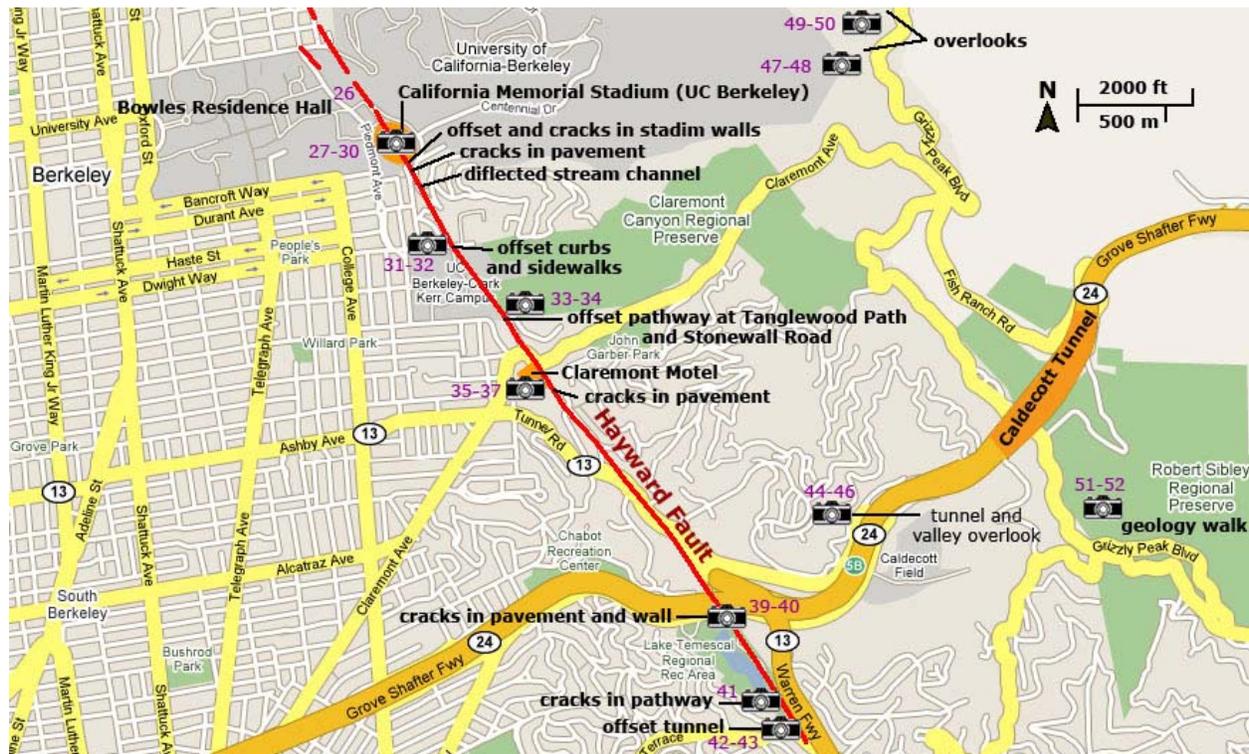
Figure 24. Location of the Hayward Fault in the Berkeley area, California. Purple numbers designate photograph locations.

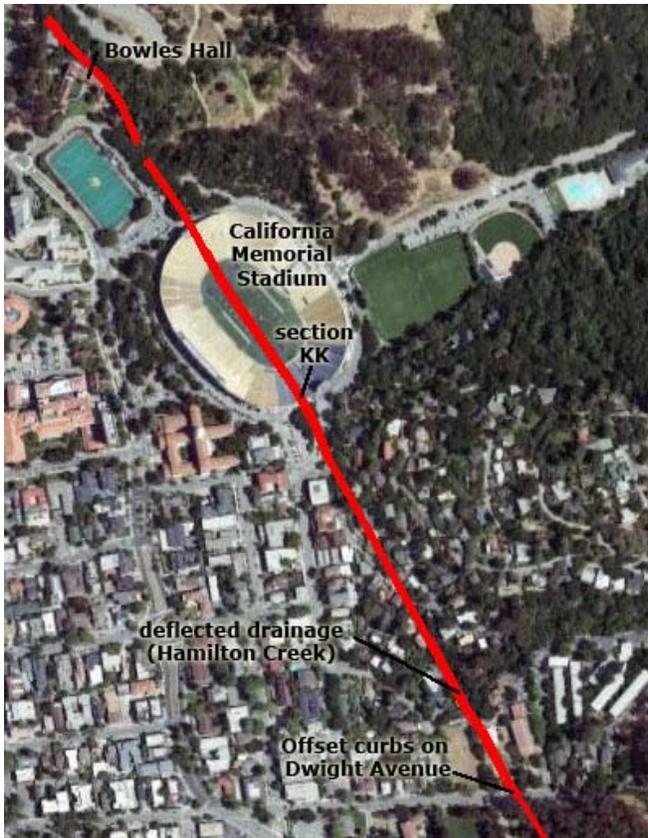
Figure 25. A Google satellite image showing the location of the Hayward Fault relative to Bowles Hall, California Memorial Stadium, a deflected stream (Hamilton Creek) and offset curbs on Dwight Avenue. California Memorial Stadium was built over another deflected stream (Strawberry Creek draining from Strawberry Canyon—to the right [east] of the stadium).

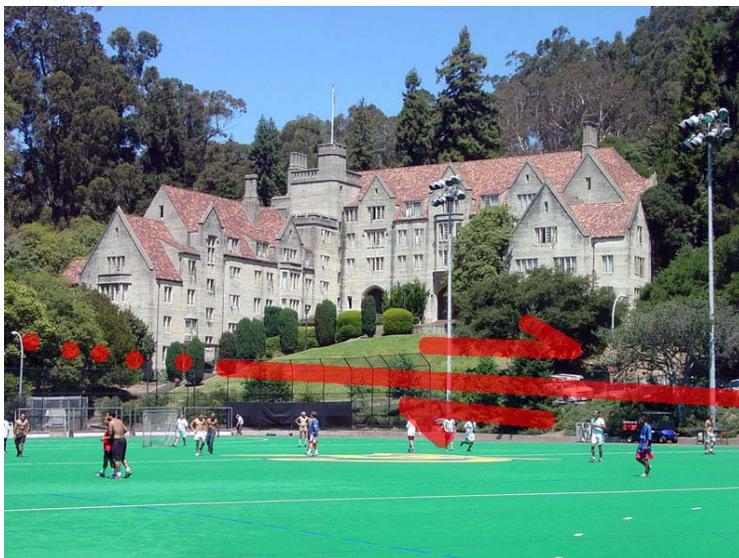
Figure 26. The Hayward Fault crosses the University of California, Berkeley campus. However, with so much construction history there is little visible evidence on the campus itself. In this view, the Hayward Fault is thought to run along the slope just behind Bowles Residence Hall on the southeast side of campus. It grazes the back corner of the building (the library), The California Memorial Stadium is out of view just to the right (south) of this playing field.

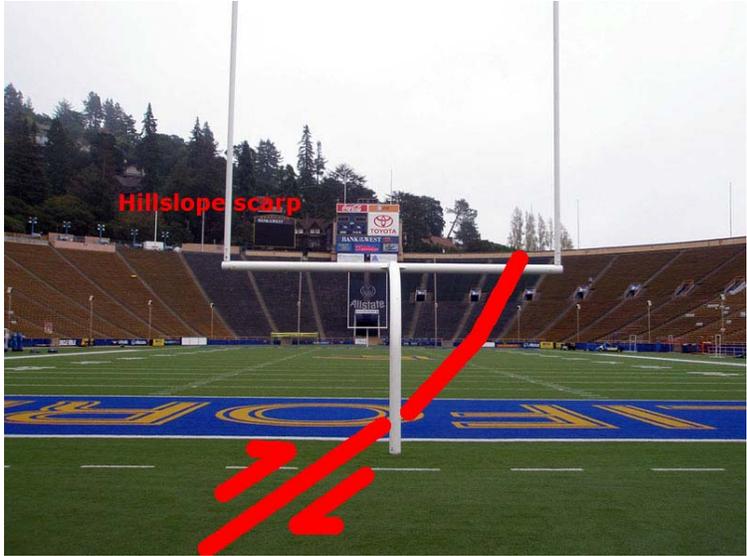
Figure 27. View looking south past the goal post near the north end of California Memorial Stadium. Beyond the stadium, the Hayward Fault continues south along the base of a slope into residential neighborhoods of Berkeley. In the stadium, the fault runs through the playing field and through the section of seats (section KK) in the distance to the right of the goal post.

- Figure 27. View looking south past the goal post near the north end of California Memorial Stadium [in the vicinity of the Hayward Fault].
- Figure 28. California Memorial Stadium straddles the Hayward Fault and its walls display visible structural damage as a result of slow creep along the fault trace.

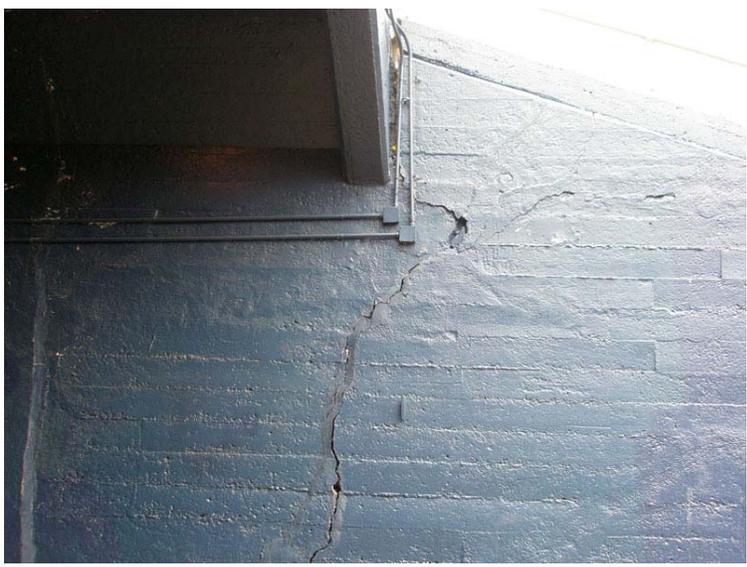
Figure 28. California Memorial Stadium straddles the Hayward Fault and its walls display visible structural damage as a result of slow creep along the fault trace. This crack in the wall is near the north entrance to the stadium, close to the photograph of the goal post shown in the previous image. Similar cracks in walls can be seen in many locations within the stadium.

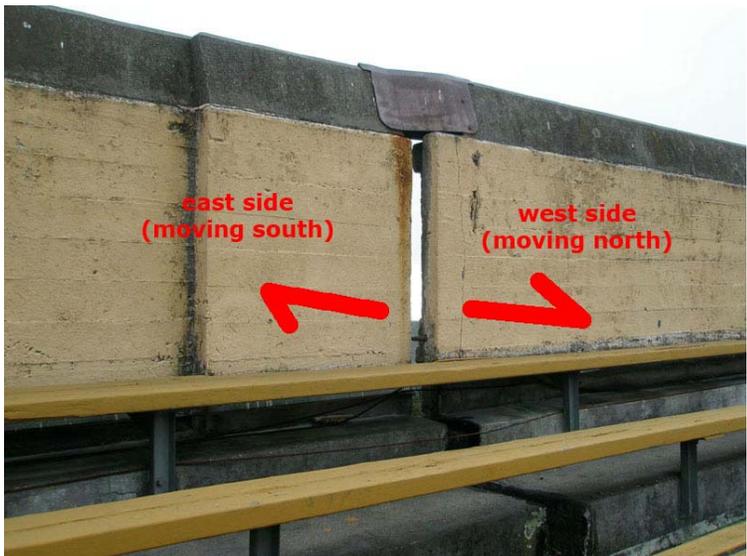
Figure 29. Offset of the rim wall of California Memorial Stadium produced by creep along the Hayward Fault. This photo is of an offset cement wall in section KK, row 64; the offset of about 7 inches (18 cm) is between seats 22 and 23.

- Figure 29. Offset of the rim wall of California Memorial Stadium produced by creep along the Hayward Fault.
- Figure 30. View looking north from the offset seating in section KK where damage to the stadium by the creeping Hayward Fault is most obvious.

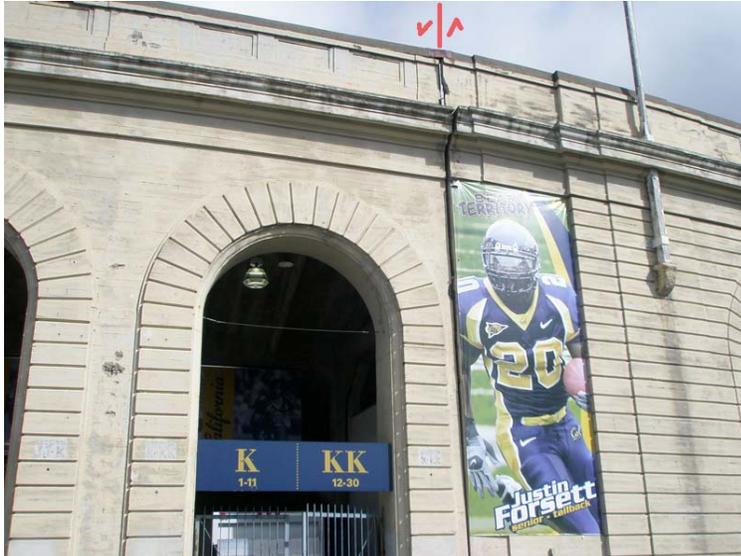
Figure 30. View of the offset outer wall on the south side of Berkeley Memorial Stadium in section KK where damage to the stadium by the creeping Hayward Fault is most obvious.

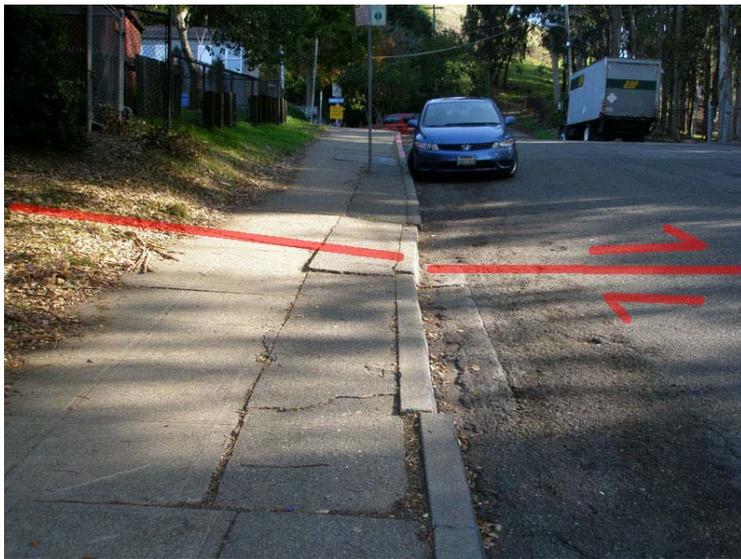
Figure 31. View looking west along a broken-up sidewalk on Dwight Way near Hillside Avenue in Berkeley. The surface trace of the Hayward Fault is complex at this location.

- Figure 31. View looking west along a broken-up sidewalk on Dwight Way near Hillside Avenue in Berkeley.
- Figure 32. One of the offset curbs where Dwight Way in Berkeley crosses the Hayward Fault.

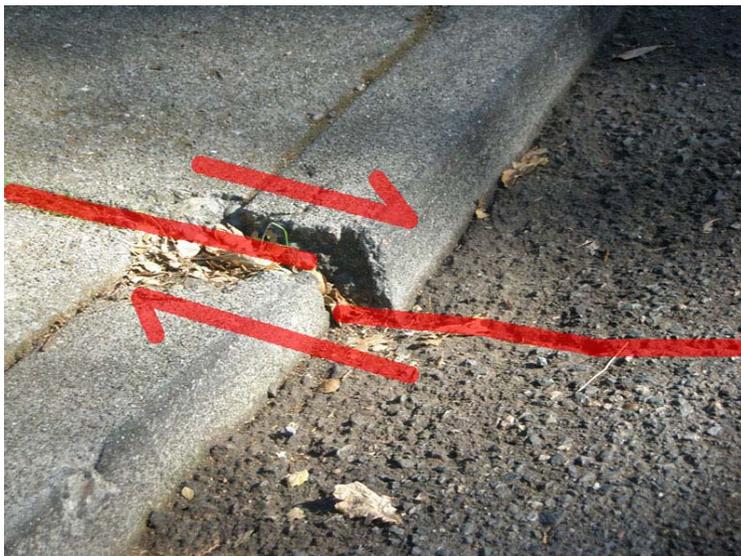
Figure 32. One of the offset curbs where Dwight Way in Berkeley crosses the Hayward Fault.

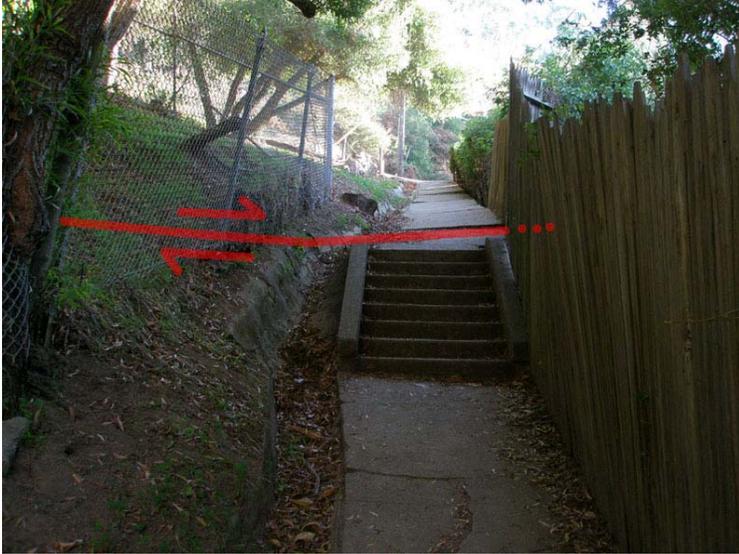
Figure 33. View looking east up Tanglewood Path just downhill of the intersection of Stonewall Road (near the Claremont Hotel in Berkeley). The pathway has been heavily damaged by both mass wasting on the hillslope and by creep along the Hayward Fault.

- Figure 33. View looking east up Tanglewood Path just downhill of the intersection of Stonewall Road (near the Claremont Hotel in Berkeley).
- Figure 34. Trailhead to Claremont Canyon Regional Preserve near the intersection of Tanglewood Path

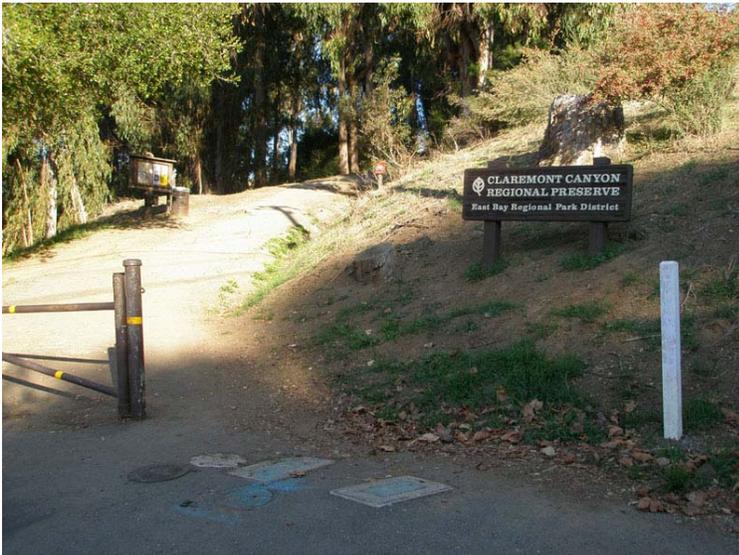
Figure 34. Trailhead to Claremont Canyon Regional Preserve near the intersection of Tanglewood Path and Stonewall Road (near the Claremont Hotel in Berkeley). The trace of the Hayward Fault is just downslope of the trailhead. The steep slope is part of the scarp of the Hayward Fault.

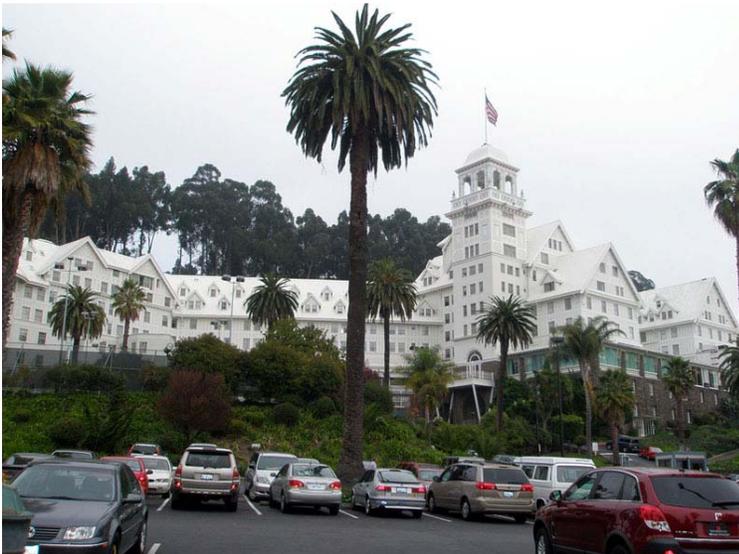
Figure 35. The Claremont Hotel. The Hayward Fault passes near the southeast corner of the building and runs along the base of the slope near the tall eucalyptus trees on the far side of the building in this view.

Figure 35. The Claremont Hotel. The Hayward Fault passes near the southeast corner of the building.

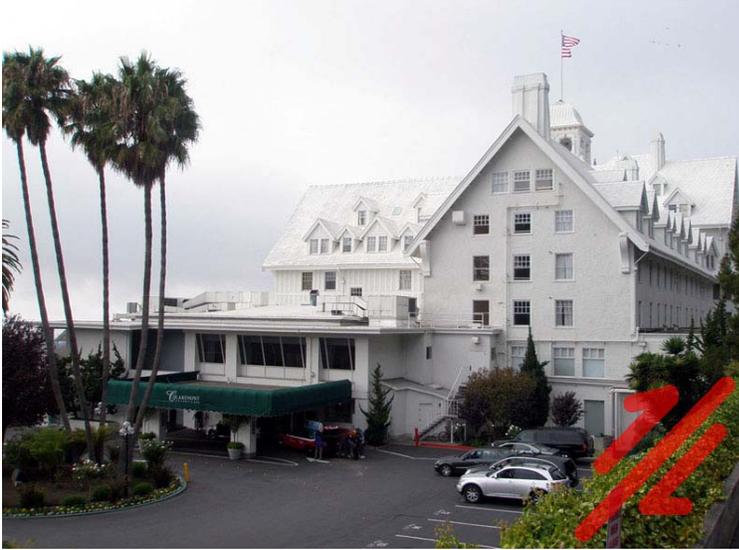
Figure 36. The Hayward Fault runs through the parking lot and beneath the corner of the building (on the right side of the photograph) near the south entrance to the Claremont Hotel.

Figure 36. The Hayward Fault runs through the parking lot and beneath the corner of the building near the south entrance to the Claremont Hotel.

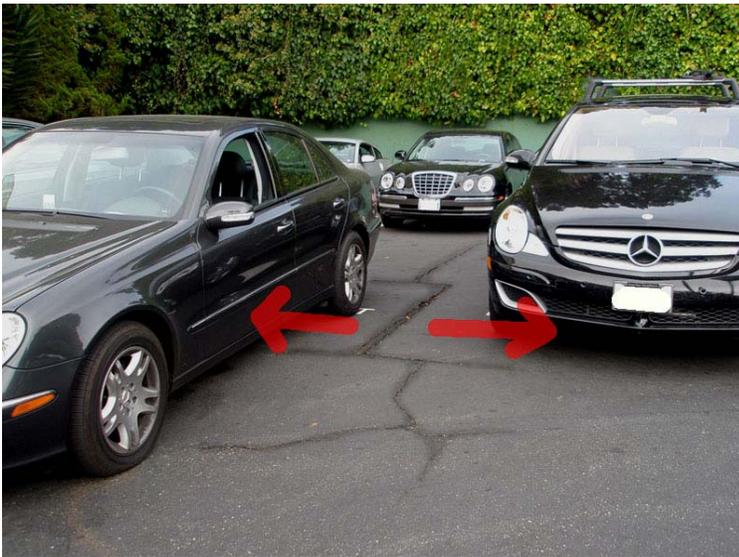
Figure 37. Fractures in the asphalt of the Claremont Hotel parking lot are probable evidence of surface movement associated with the Hayward fault. This fracture between cars in valet parking displays evidence of pull-apart (tension) offset. The mapped trace of the fault is in the parking lot behind and above these cars (also visible to the right in fig. 36).

Figure 37. Fractures in the asphalt of the Claremont Hotel parking lot are probable evidence of surface movement associated with the Hayward fault.

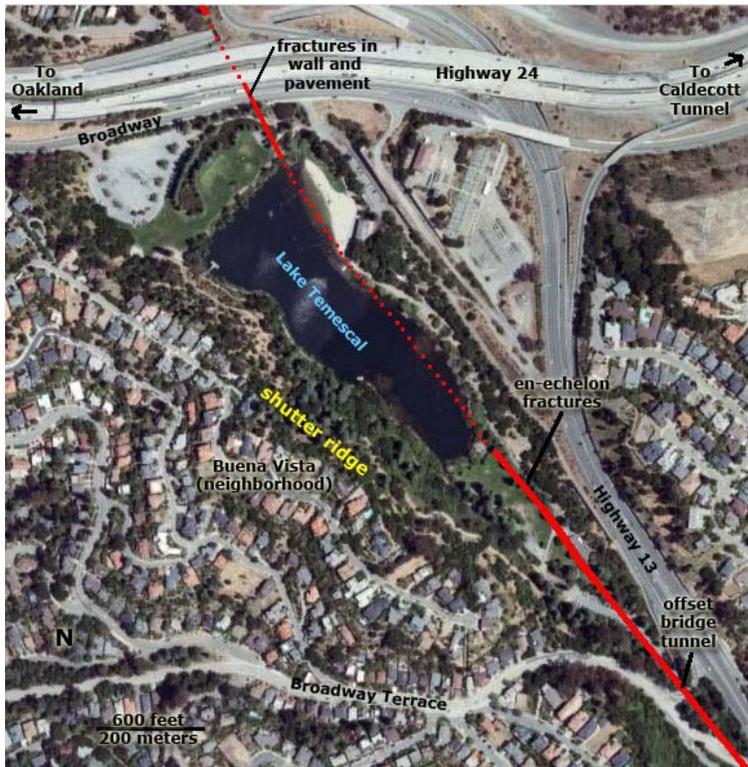
Figure 38. A *Google Earth* image map showing the location of the Hayward Fault and associated features in the Lake Temescal area. The Buena Vista neighborhood is on the shutteridge on the west side of the fault at Lake Tamescal. Highway 13 runs south from the intersection of Highway 24 down the rift valley of the Hayward Fault for much of its route. Temescal Lake was built during 1866 and 1869 by damming Temescal Creek, which happens to be offset more than 1.5 miles (2 km) right-laterally by the fault. The ridge to the west blocks the outflow of the creek, but the blockage is caused by the large displacement and the slowing of the stream by the reduced gradient along the fault, and probably not by "sagging".

Figure 38. A Google Earth image map showing the location of the Hayward Fault and associated features in the Lake Temescal area.

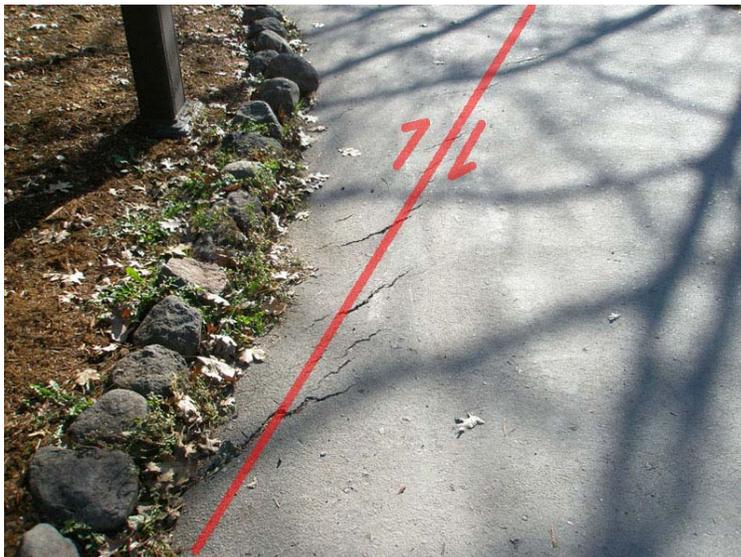
Figure 41. En echelon fractures from creep along the Hayward Fault in the pavement in front of the Park Office in Lake Temescal Regional Recreation Area. The Park Office is located near the south end of the lake.

Figure 41. En echelon fractures from creep along the Hayward Fault in the pavement in front of the Park Office in Lake Temescal Regional Recreation Area.

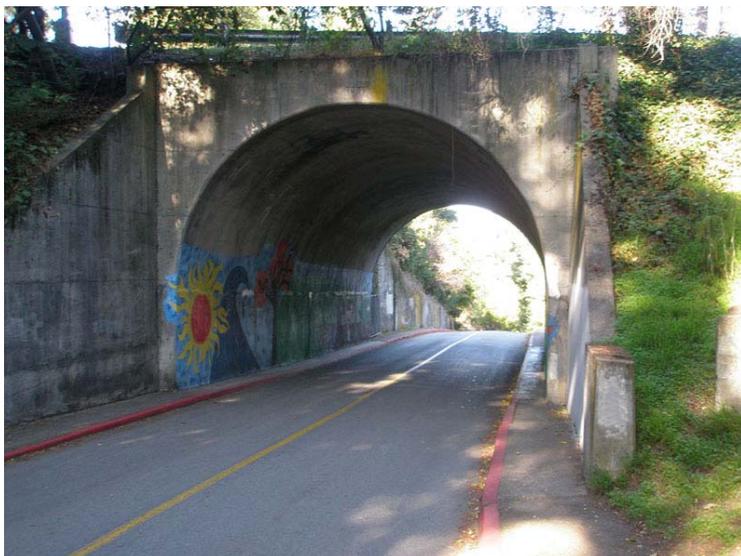
Figure 42. View looking north at the entrance to an old railroad bridge tunnel in Temescal Regional Recreation Area. The tunnel displays evidence of creep from movement along the Hayward Fault. The tunnel is at the south entrance to the park on Broadway Terrace near the intersection with Highway 13. The tunnel was probably constructed around 1918 for the Sacramento Northern Railway, a subsidiary of the Western Pacific Railroad, and was an electric train system that linked the state capitol in Sacramento with Oakland until train service ceased in 1983.

Figure 42. View looking north at the entrance to an old railroad bridge tunnel in Temescal Regional Recreation Area.

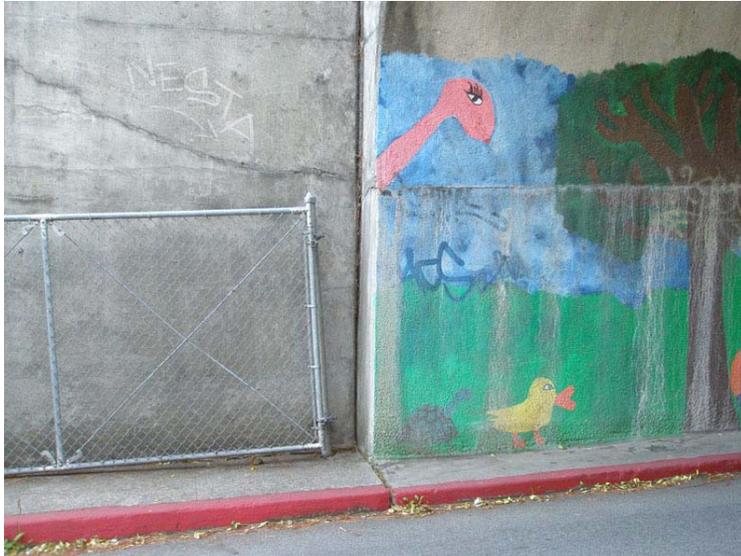
Figure 43. View of an offset curb and crack in the side of the old railroad bridge tunnel near the south end of Lake Temescal Regional Recreation Area (the tunnel is also shown in fig 42).

Figure 43. View of an offset curb and crack in the side of the old railroad bridge tunnel near the south end of Lake Temescal Regional Recreation Area.

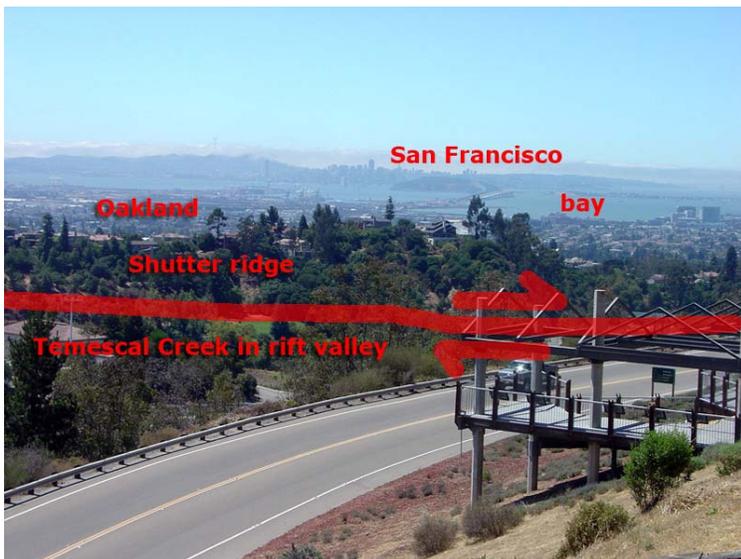
Figure 44. View southwest from an overlook on Tunnel Road near Highway 24 near where it crosses the Hayward Fault. Homes occupy the top of the forested shutteridge on the west side of the Hayward Fault rift valley. The Bay Bridge and San Francisco are visible in the distance. The overlook has exhibits commemorating the Oakland Hills Firestorm of 1991. The fire killed 25 people and injured 150 others. The fire consumed or damaged 2,843 single-family dwellings and 437 apartment and condominium units and burned an estimated 1,520 acres (6.2 km²).

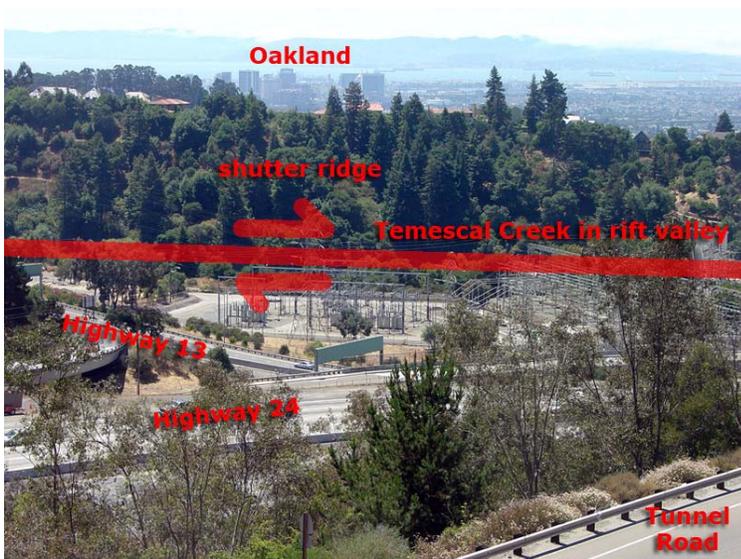
Figure 45. View southwest across Highway 24 toward the PG&E Claremont Substation near Lake Temescal. The tree-covered slope beyond the electrical power station is on the west side of the Hayward Fault rift valley incised by Temescal Creek. Downtown Oakland is in the distance. The tree-covered ridge is a shutteridge ("shutting in" and diverting Temescal Creek). Lake Temescal is to the right of this view taken from Tunnel Road, north of Highway 24. The neighborhood of Buena Vista is built on the shutteridge west of the Hayward Fault rift valley.

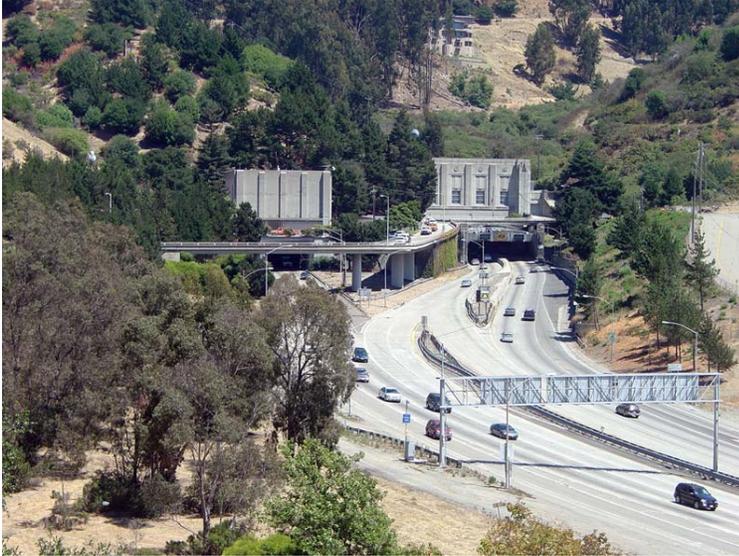
Figure 46. View of the western portal of the Caldecott Tunnel on Highway 24. The Caldecott Tunnel cuts through the Berkeley Hills. Construction of the tunnel began in 1929, and the first two tunnel bores were completed in 1937; a third bore was completed in 1964. An additional bore has been approved for construction. The western portal of the Caldecott Tunnel is located in Claremont Canyon, about one mile upstream from Lake Temescal. The forested ridge above the tunnel is mostly within the Robert Sibley Regional Preserve.
