Where's the Hayward Fault? A Green Guide to the Fault

Open-File Report 2008-1135

U.S. Department of the Interior
U.S. Geological Survey

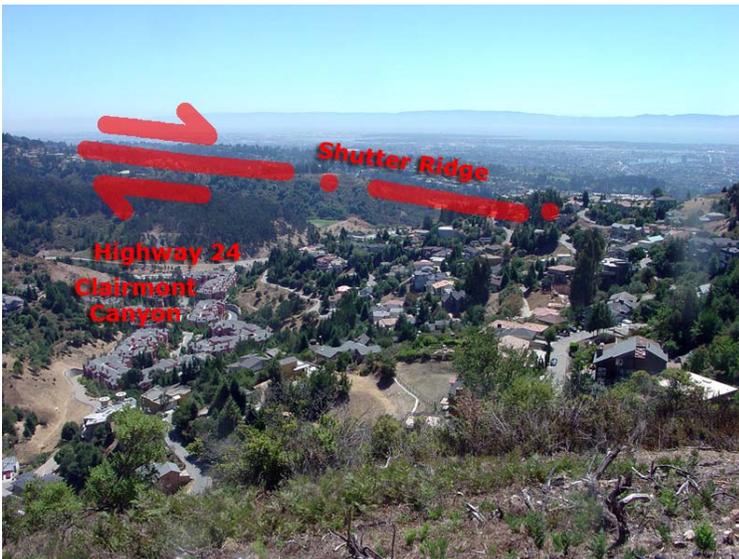
Figure 47. View looking down (southwest) into Claremont Canyon from near a water storage tank in the Berkeley Hills (near the intersection of Grizzly Peak Boulevard and Marlborough Terrace—the water tank is just to the right of this photo). The rift valley of the Hayward Fault and the shutteridge near Lake Temescal run diagonally through the upper part of the image. This area was burned during the Oakland Hills Firestorm of 1991. The western portal of the Caldecott Tunnel on Highway 24 is just to the left of this view.

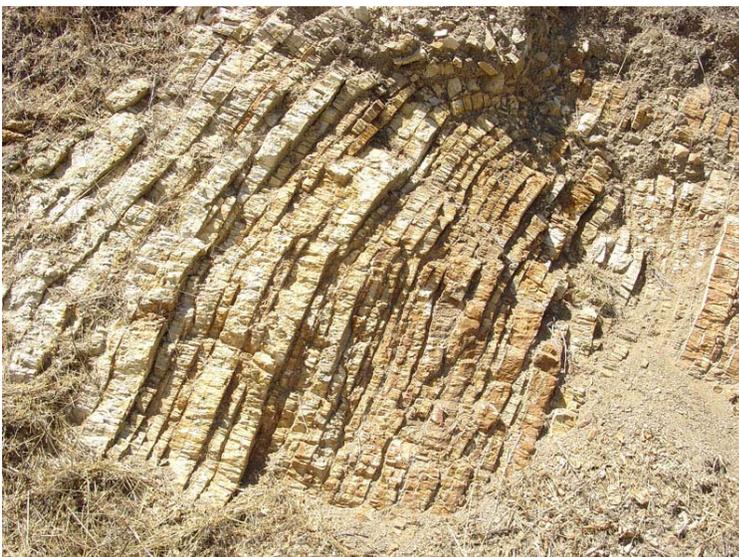
Figure 48. Folded sedimentary rocks (ribbon chert of Franciscan Formation of Jurassic age) located near the water tank and the view in fig. 47. The chert is exposed in a cut in the Berkeley Hills (near the intersection of Grizzly Peak Boulevard and Marlborough Terrace). The chert formed from radiolarian ooze originally deposited in a deep, marine setting far from any source of continental sediments. Today these rocks help form the ridgeline of Grizzly Peak—reflecting the long, complex geologic evolution of the San Francisco Bay Area landscape.

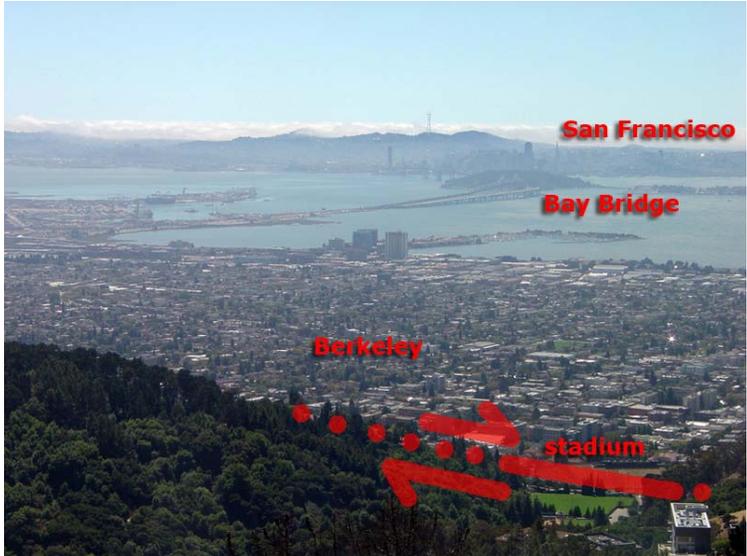
Figure 49. View looking southwest from an overlook area on Grizzley Peak in the Berkeley Hills in Charles Lee Tilden Regional Park. The view looks down the valley of Strawberry Creek (Strawberry Canyon). California Memorial Stadium is in the lower right. The densely urbanized alluvial plain of Berkeley and northern Oakland, and the Bay Bridge and hills of San Francisco are in the distance. The Hayward Fault cuts through the stadium and runs along the base of the forested hillside on the left. Strawberry Creek also has a right-lateral offset caused by displacement of the stream channel along the Hayward Fault.

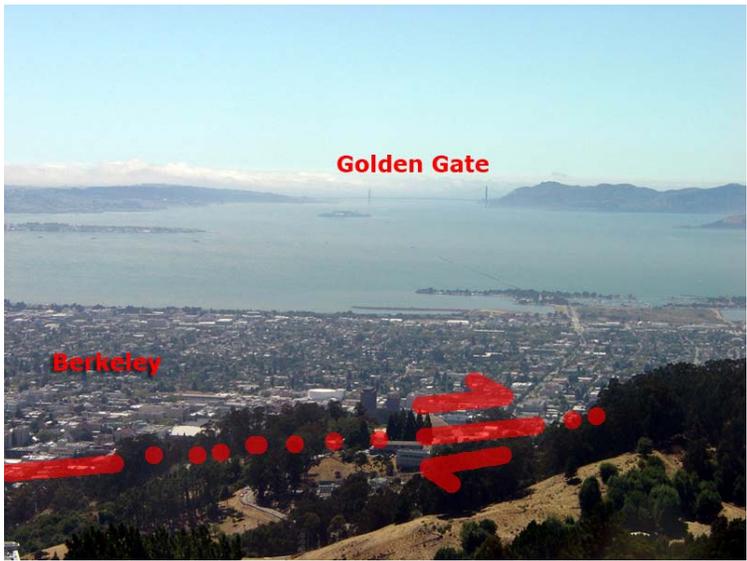
Figure 50. View looking west toward the Golden Gate from an overlook on Grizzley Peak in the Charles Lee Tilden Regional Preserve. The City of Berkeley is on the alluvial plain at the western base of the Berkeley Hills. Alcatraz, the Golden Gate Bridge, and the highlands of southern Marin County are in the distance. The Hayward Fault runs along the base of the forested slope in the foreground.

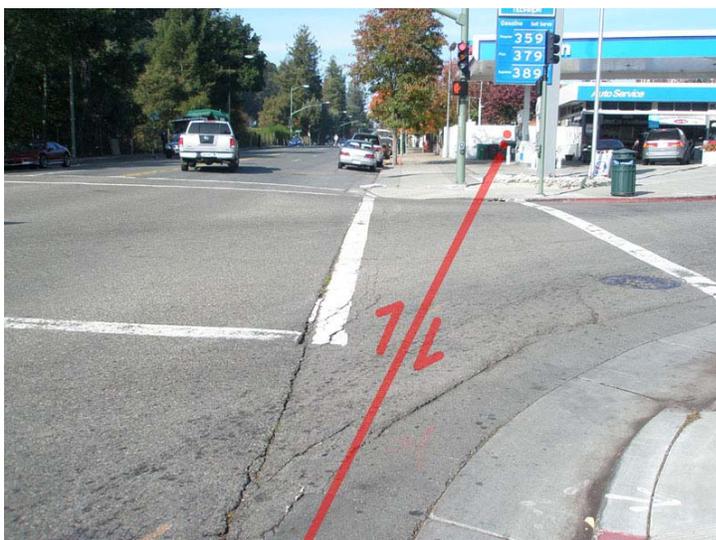
Figure 54. This view looks north along Moraga Avenue at the intersection with Mountain Boulevard in Monclair Village, where the Hayward Fault crosses the intersection. The fault passes beneath the gas station sign and just to the left of the gas station building. North of the gas station the fault crosses through several walls, streets, and buildings in the downtown area.

Figure 54. This view looks north along Moraga Avenue at the intersection with Mountain Boulevard in Monclair Village, where the Hayward Fault crosses the intersection.

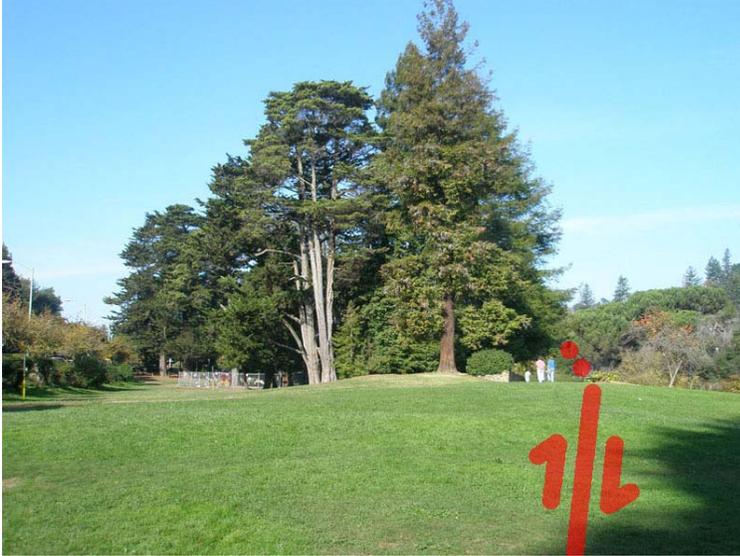
Figure 55. This view looks north along the trace of the Hayward Fault where it crosses through Monclair Recreation Center, a small park just north of Monclair Village. The trees are on a low shutteridge on the left (west) side of the fault (located about where the people are standing).

Figure 55. This view looks north along the trace of the Hayward Fault where it crosses through Monclair Recreation Center, a small park just north of Monclair Village.

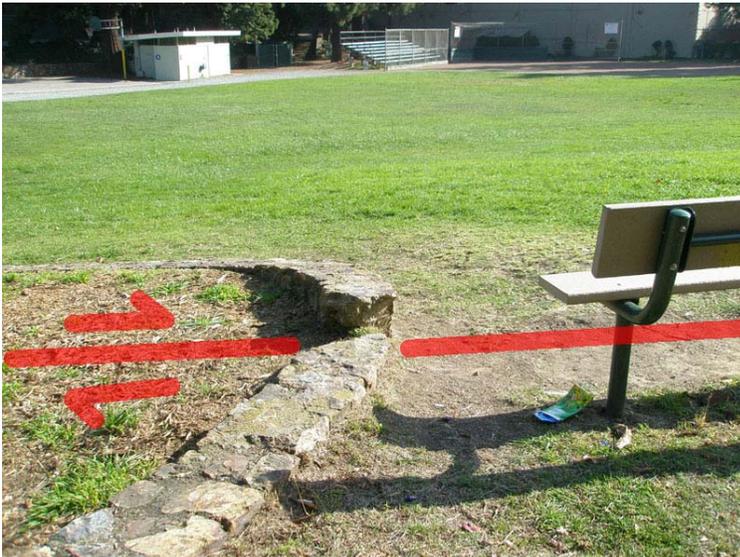
Figure 56. This broken stonewall is along the trace of the Hayward Fault in Monclair Recreation Center. The park is located just north of downtown Monclair Village.

Figure 56. This broken stonewall is along the trace of the Hayward Fault in Monclair Recreation Center.

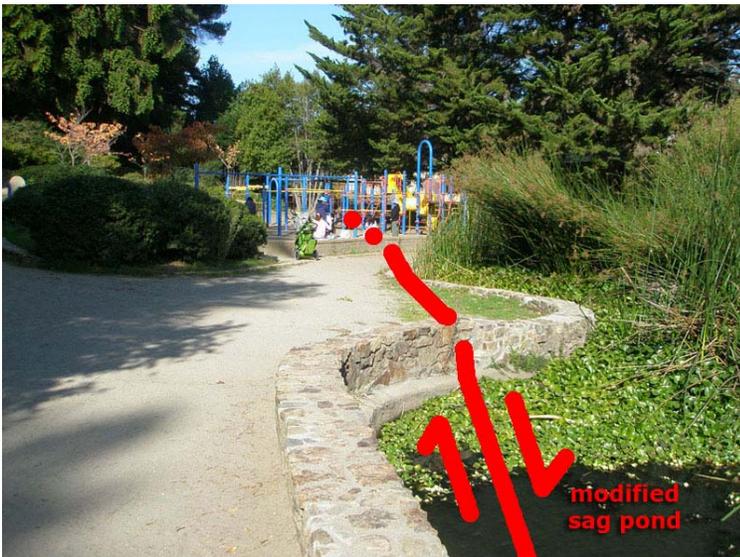
Figure 57. View along an old damaged and repaired wall in the Hayward Fault zone in Monclair Recreation Center (park). Montclair Park's pond is not a sag pond. It was formed artificially around 1910 by the construction of a railroad fill of the Oakland-Antioch line. Passenger service on the rail ended in 1941, and freight service ceased in 1957.

Figure 57. View along an old damaged and repaired wall in the Hayward Fault zone in Monclair Recreation Center (park), along the sag pond formed by the fault.

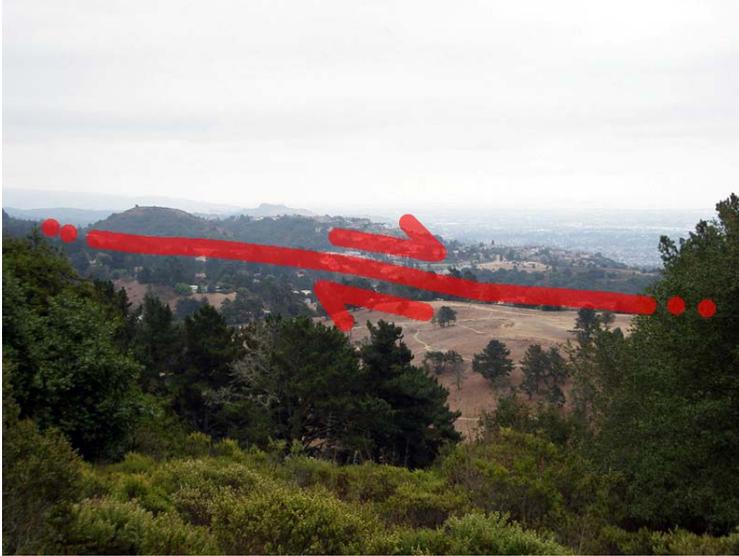
Figure 60. South-facing view from an overlook along Skyline Boulevard located about 1 mile south of the Chabot Space & Science Center in Joaquin Miller Park. The view shows the rolling upland of the East Bay Hills east of Oakland near Merritt College. The Hayward Fault crosses the western flank of the East Bay Hills in the valley beyond the grass-covered hill. The highly urbanized alluvial plain of the East Bay is in the upper right.

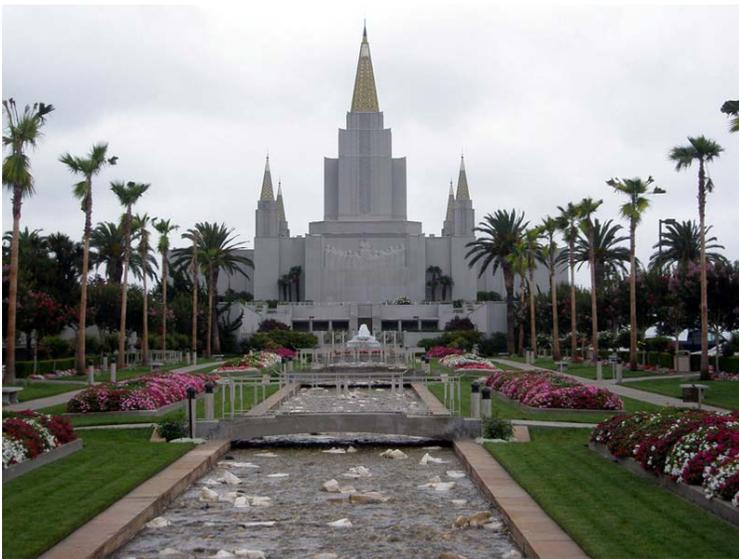
Figure 61. The Oakland Mormon Temple (Church of Jesus Christ of Latter-day Saints) is located near the intersection of Lincoln Avenue and Highway 13. The pinnacle-like towers and massive white granite facade of the temple and associated buildings are perhaps the most visible landmark on the Hayward Fault in the East Bay region. The hilltop location of the temple provides fantastic views of the San Francisco Bay region, as well as the rift zone and shutteridges formed by the Hayward Fault on which the temple buildings and ground were constructed.

The Oakland Mormon Temple (Church of Jesus Christ of Later-day Saints) is located on Lincoln Avenue near the intersection with Highway 13 (Warren Freeway). The temple is perhaps the most visible manmade feature along the Hayward Fault. Its location perched on a hilltop (shutteridge) along the fault makes it visible from practically anywhere in the San Francisco Bay Area on a clear day. Fractures along the fault can be traced on nearby streets and on the temple grounds, and the fault crosses through the Interstakes Building next to the main temple. This area was unsettled at the time of the 1868 earthquake.

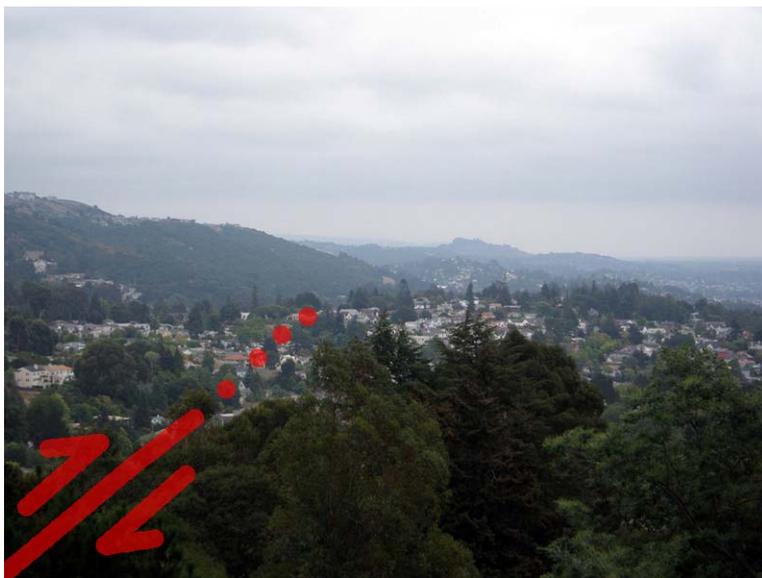
Figure 64. View is looking south from the grounds of the Oakland Mormon Temple. The Hayward Fault extends south across this rolling upland region east of downtown Oakland, crossing through older established neighborhoods before extending through the sedimentary cover of the alluvial plain west of the East Bay Hills in the vicinity of the towns of Hayward and Fremont (far in the distant right side of this image).

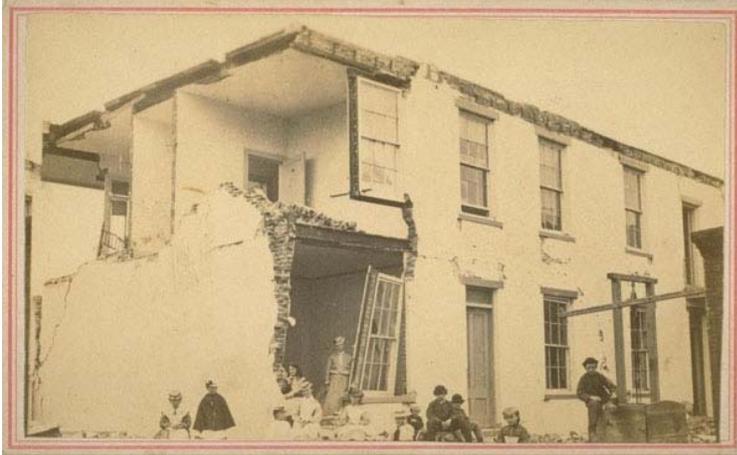
Figure 70. Historic photograph by Carleton Watkins showing the condition of the Alameda County Courthouse after the 1868 Hayward earthquake. One person was killed when the courthouse collapsed. Note that the building on the far left appeared to escape damage and still had its chimney. The old courthouse was located at the intersection of Davis and Clarke Streets.

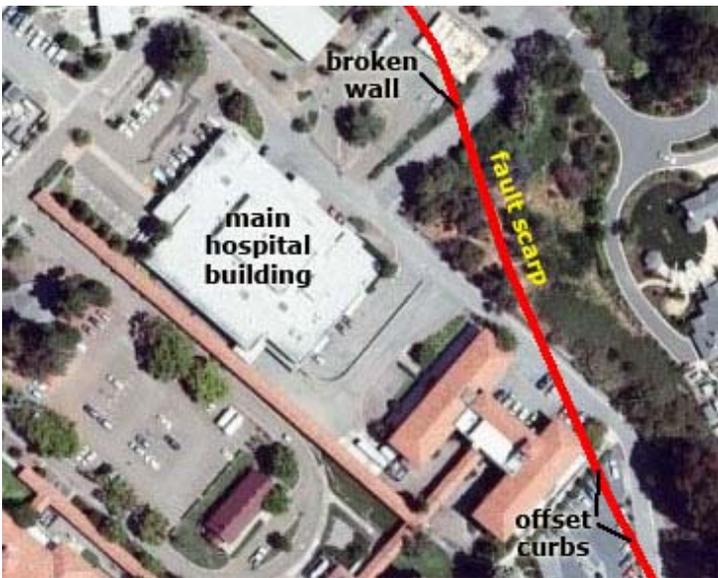
Figure 74. Fairmont Hospital is an Alameda County facility in San Leandro. Some of the original hospital buildings were constructed on the Hayward Fault but were later abandoned or modified. Evidence of the active creep of the fault can be seen on the hospital grounds in the form of cracks in the pavement and older walls and offset curbs, particularly on the east and south sides of the main hospital building.

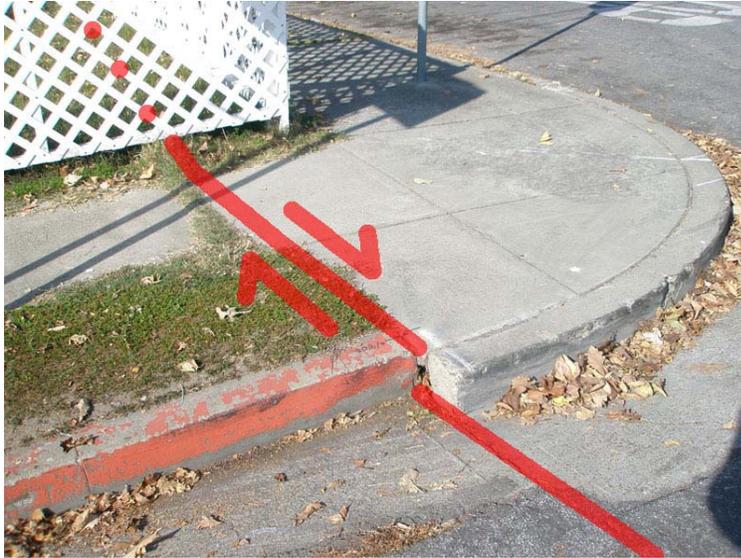
Figure 78. View of an offset curb at the southwest corner of Prospect Street and Rose Street north of downtown Hayward. The displacement of the curb is consistent with the relative right-lateral displacement of the Hayward Fault. A right-lateral displacement refers to the relative motion of the two sides of a *strike-slip fault*. Offset features along the Hayward Fault show that the west side is moving northward relative to the east side of the fault.

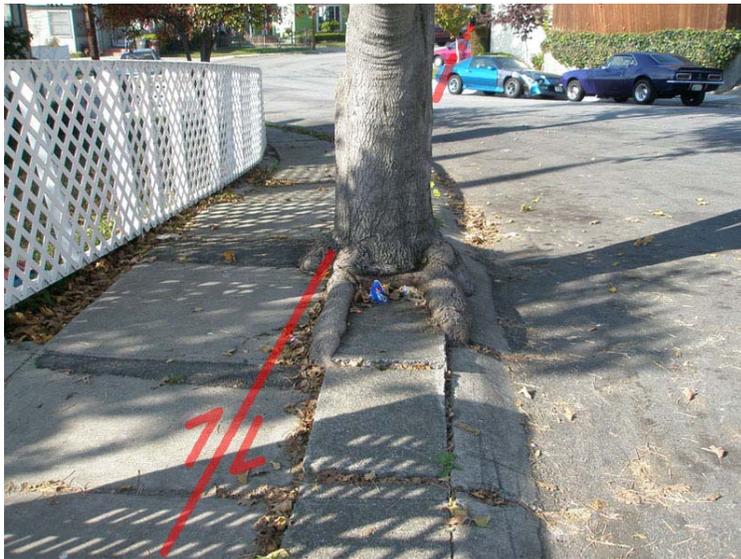
Figure 79. The roots of this old tree have split the curb and sidewalk on Prospect Street just north of the intersection with Rose Street. The tree is growing in the active trace of the Hayward Fault, which closely follows Prospect Street in this area.

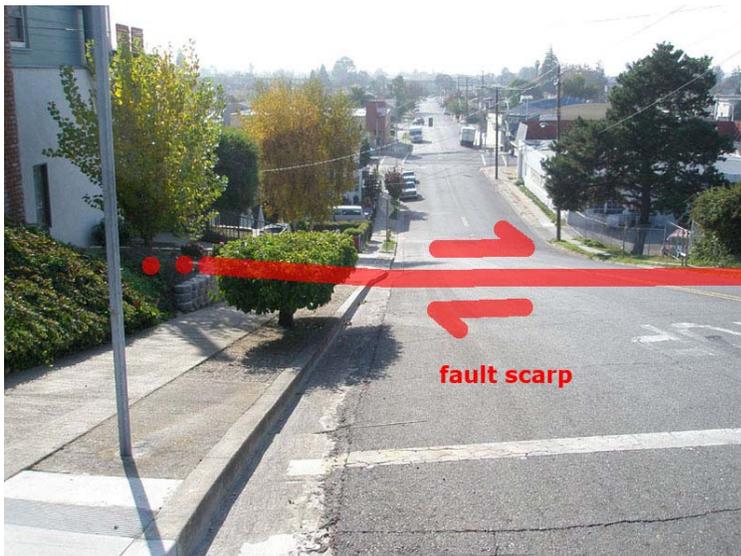
Figure 80. View west along Simon Street from the intersection of Prospect Street in Hayward (Mission Boulevard is in the distance). The slope in the foreground is a scarp of the Hayward Fault. The active trace of the fault crosses the street where the street curb (on the left side of the street) shows displacement from creep.

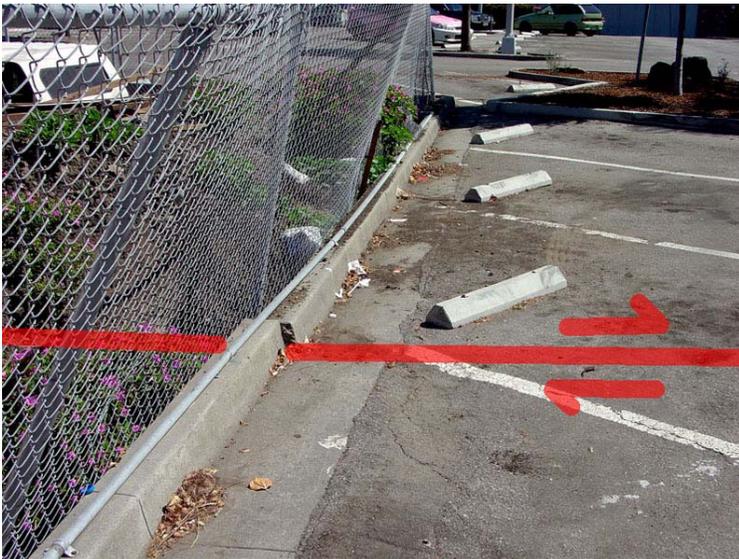
Figure 82. Offset curbs and fractures in the pavement are visible along the creeping trace of the Hayward Fault in the municipal parking area between Avenue A and Hotel Avenue on the east side of Mission Boulevard. Many of the buildings in the area show various stages of retrofit and structural repairs, but the slow fault creep never ceases.

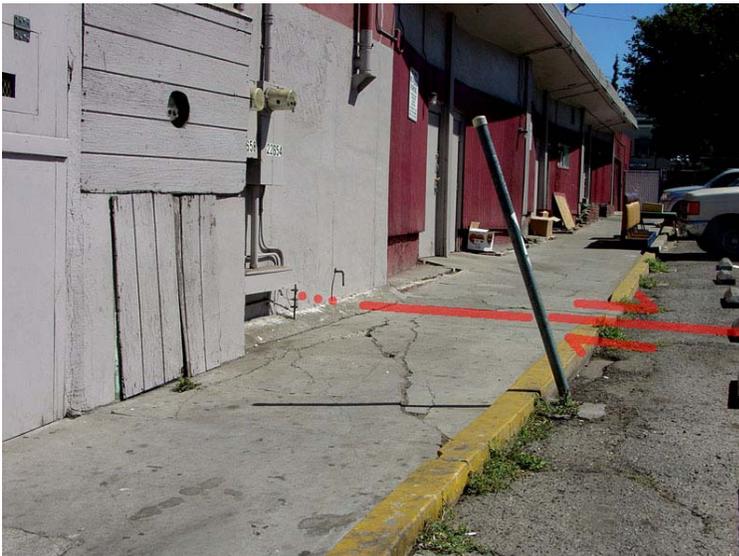
Figure 83. This view looks east along an alley between Avenues B and C in downtown Hayward where the creeping Hayward Fault has offset sidewalks, buildings, and just about everything along its trace.

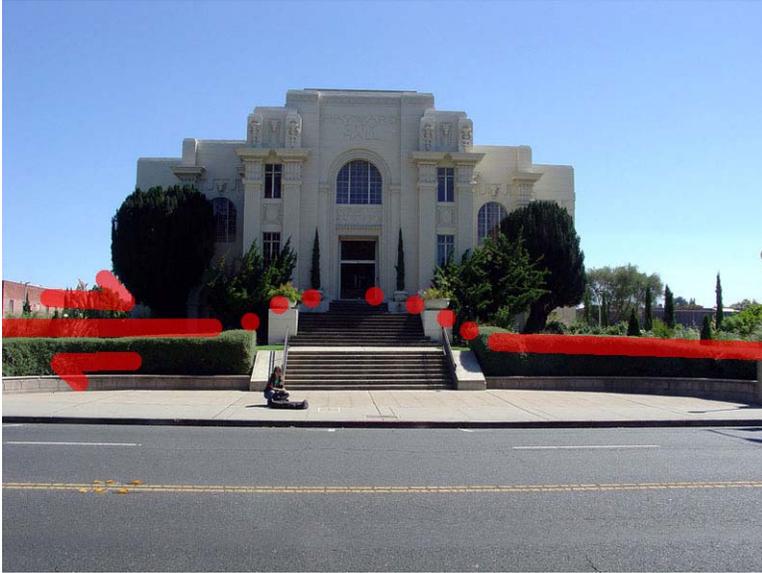
Figure 84. Hayward's old City Hall was built in 1930 directly on the Hayward Fault. This view is looking northeast across Mission Boulevard. Over the years, fault creep has severely damaged the building. Two strands of the fault occur here—one passes beneath the front of the building (shown here) and the other crosses behind the building. Damage to the building can be viewed by looking through the front side windows, and offset and cracks can be seen in the sidewalks around the building. Downtown residents are used to seeing frequent fault tours where it is easy to trace the fault where it crosses streets and alleys, and cuts through buildings, for three blocks between old City Hall northward to Hotel Avenue.

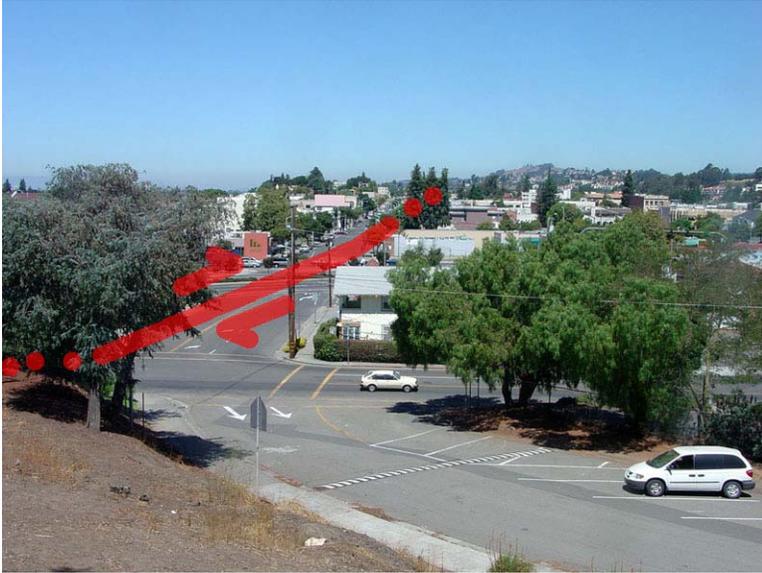
Figure 86. View from the side of a small hill east of the intersection of Jackson Street and Mission Boulevard. The view is looking northwest along Mission Boulevard and the downtown area in the vicinity of old City Hall. Ongoing road maintenance has mostly masked the creeping trace (or traces) of the Hayward Fault here, but the hill represents an eroded scarp along the trace of the Hayward Fault. Gravel in the soil on the slope reveals that the bedrock in the Hayward area consists of relatively poorly consolidated alluvial fan (see glossary) and stream channel deposits. These kinds of deposits underlie the urbanized alluvial plain between San Francisco Bay and the East Bay Hills. However, the sediments closer to the bay become mud, and many areas in the urbanized region around the bay have been filled in over the years.

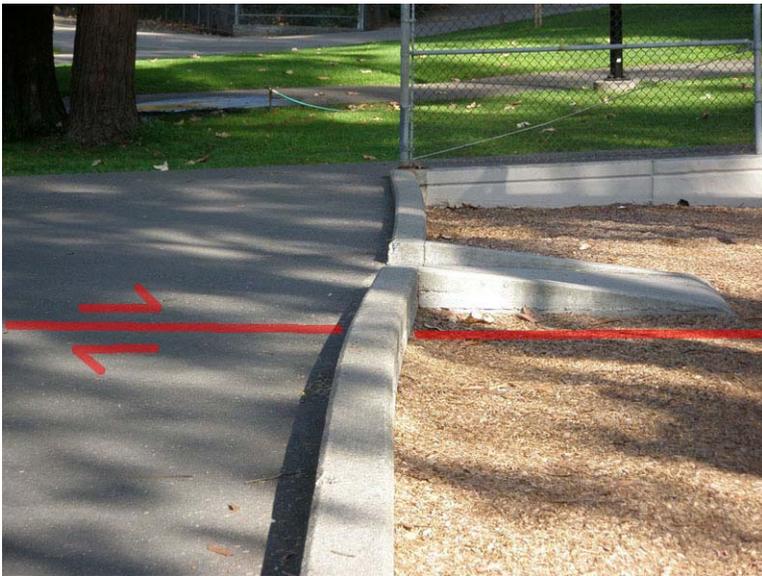
Figure 87. A twisted (displaced) cement wall of an old sandbox play area in Memorial Park near downtown Hayward. The slow creep of the Hayward Fault caused the warping of the cement. This cement wall is about 30 feet south of an old stonewall that also shows right-lateral displacement along the trace of the Hayward Fault.

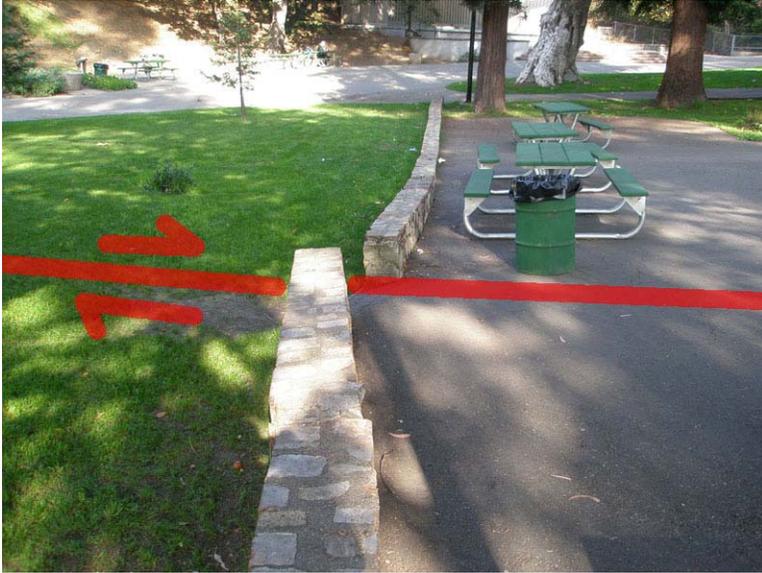
Figure 88. This old, low stonewall in Memorial Park near downtown Hayward has been displaced by creep along the Hayward Fault. This view is looking east.

Figure 89. View north past a low stonewall that has been offset by creep along the Hayward Fault (shown in fig. 88). The fault trace is in the path area between the two segments of the wall and continues toward the base of the stairs. The steep slope in the distance beyond the stairway is a fault scarp.

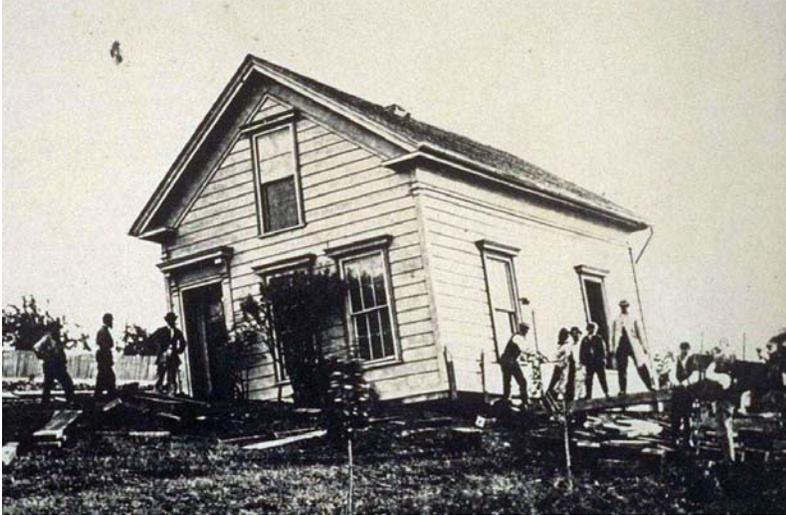
Figure 90. The Pierce's house in Hayward—knocked off its foundation by the 1868 earthquake. Image courtesy of the Bancroft Library, University of California, Berkeley.

Not many photographs or accounts survive from the 1868 Hayward earthquake, partly because the East Bay region was sparsely populated at the time. Below are three famous photographs taken after the earthquake that illustrates the kind of damage caused by the earthquake.

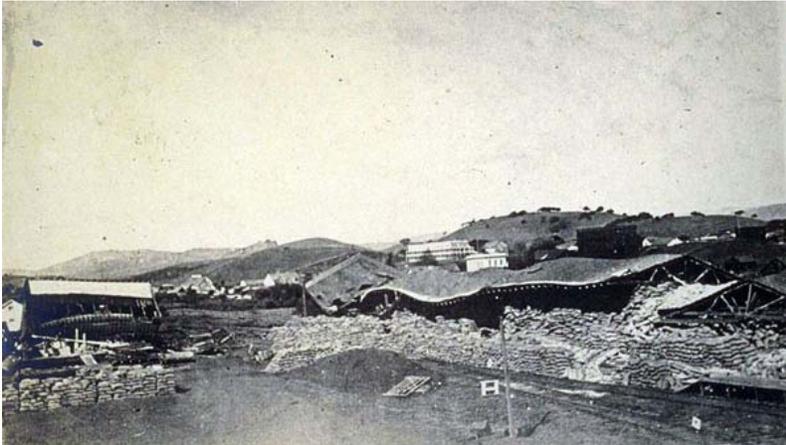
Figure 91. Edminton Grain Warehouse and flour mill—collapsed during the 1868 earthquake. The hills in the distance are the fault scarp/shutterraidge of the Hayward Fault along Prospect Street between Hotel Avenue and Rose Street on the south side of downtown Hayward. Image courtesy of the Bancroft Library, University of California, Berkeley.

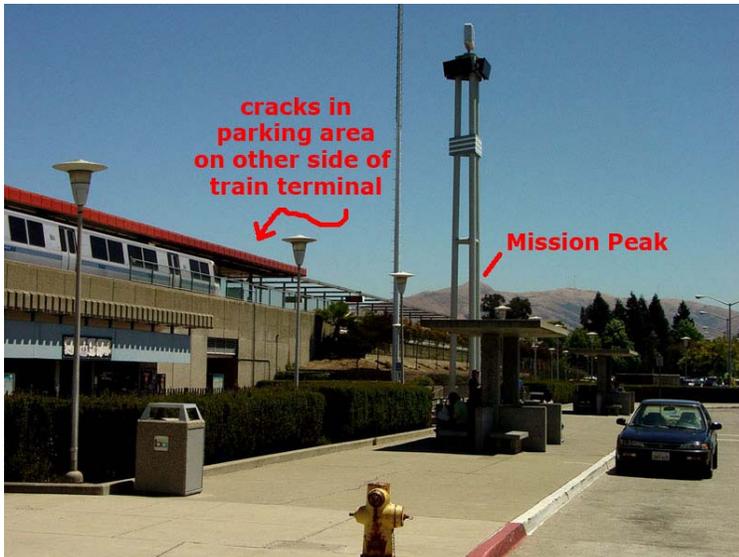
Figure 94. The Fremont BART station is the current terminus of the rail line. The track ends a very short distance from the Hayward Fault. Cracks in the pavement caused by slow creep of the fault can be seen in the train parking area on the southeast side of the train station. This view is looking southeast at the BART station with Mission Peak in the distance.

BART: Cracks in the pavement of the parking area at the Fremont BART station are a result of creep along the Hayward Fault. All locations along this route are within walking distance from the Bart Station.

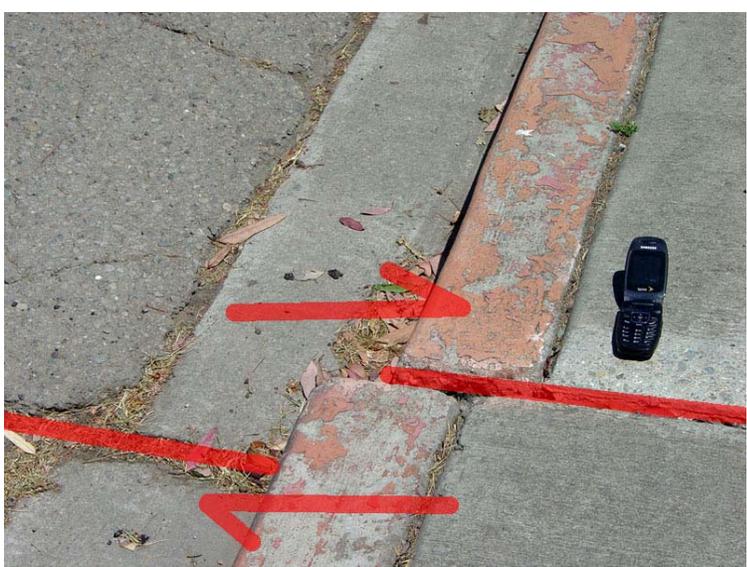
Figure 97. Close-up view of an offset curb on Sailway Drive in Fremont Central Park (in the same location as fig. 98).

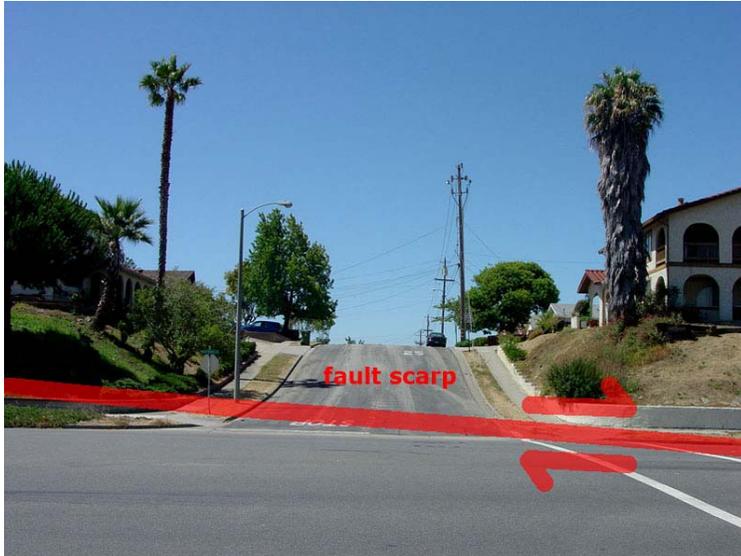
Figure 98. View looking southwest across Paseo Padre Parkway toward a low hill on Baylis Street. The hill is an escarpment along the Hayward Fault. Fractures in the pavement and offset curbs near the intersection reveal evidence of creep on the fault.

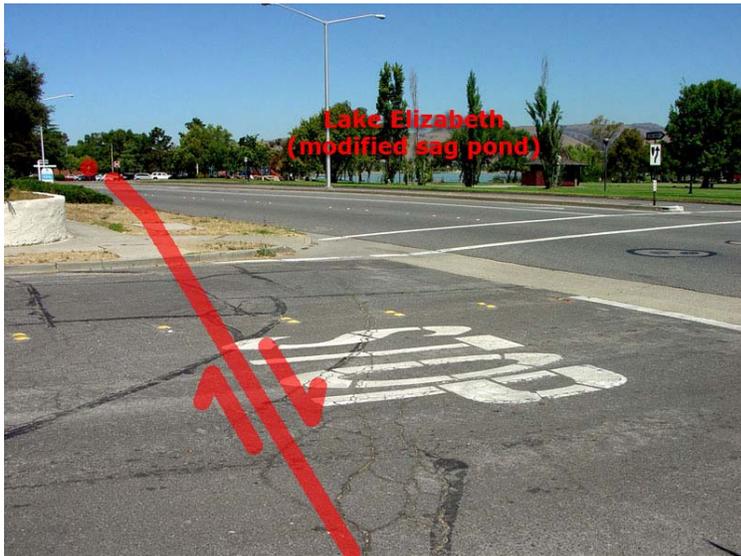
Figure 99. View north across Paseo Padre Parkway toward Lake Elisabeth from the corner of Baylis Street. Fractures in the pavement are from creep along the Hayward Fault. The 1906 Niles 15 minute quadrangle topographic map shows that what is now Lake Elisabeth was called *The Lagoon* and was a natural lake (a large sag pond) on the relatively undeveloped alluvial plain that is now Fremont.

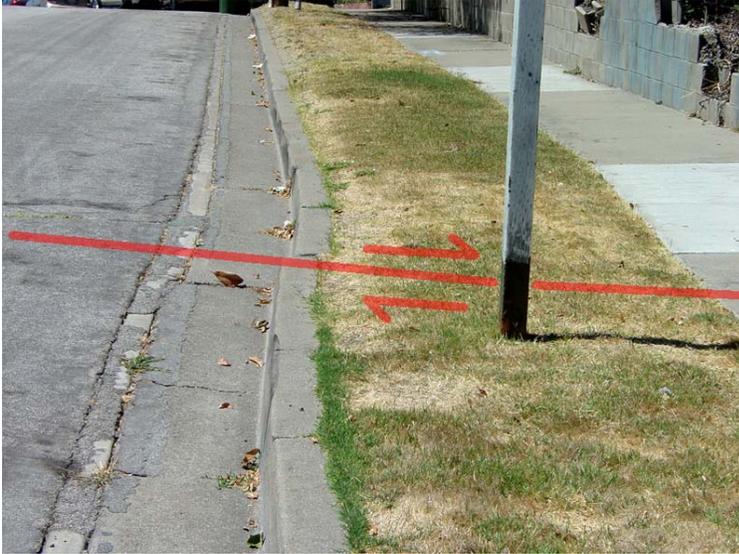
Figure 100. View of an offset curb on the north side of Rockett Drive near the intersection of Paseo Padre Parkway near Fremont Central Park.

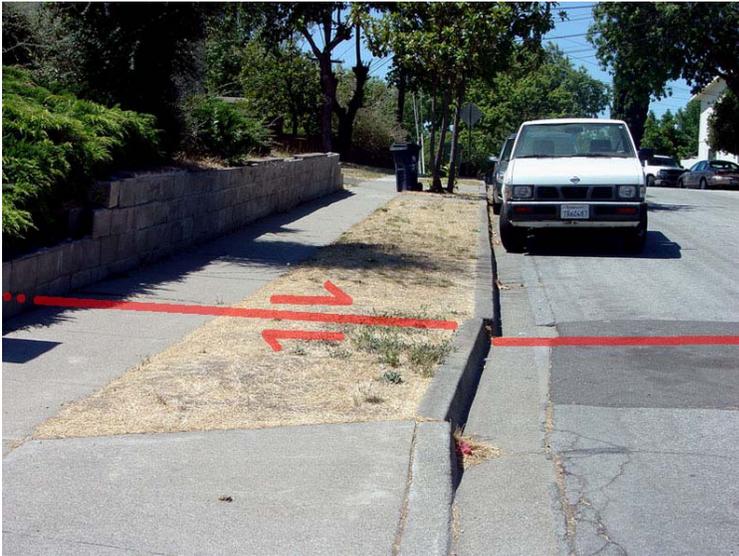
Figure 101. View of an offset curb and an attempt to repair fractures in the pavement on the south side of Rockett Drive near the intersection of Paseo Padre Parkway near Fremont Central Park. This photo is on the opposite side of the street from fig. 102.

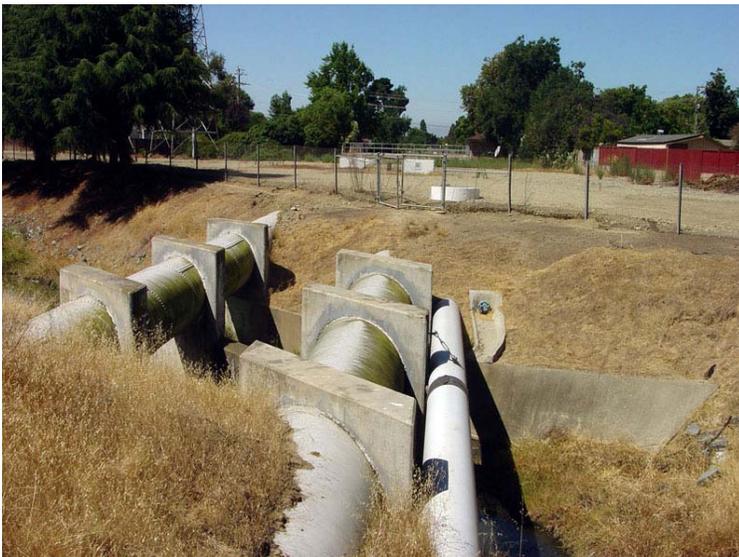
Figure 102. This view shows water mains of the Hetch Hetchy water system (water mains #1 and #2) exposed in the vicinity where they cross the Hayward Fault along Grimmer Boulevard near the intersection of Paseo Padre Parkway (near Fremont Central Park). The water mains have been retrofitted and buried in the vicinity of the Hayward Fault nearby. Two other more recently constructed water mains associated with the Hetch Hetchy system cross the Hayward Fault in south Fremont.

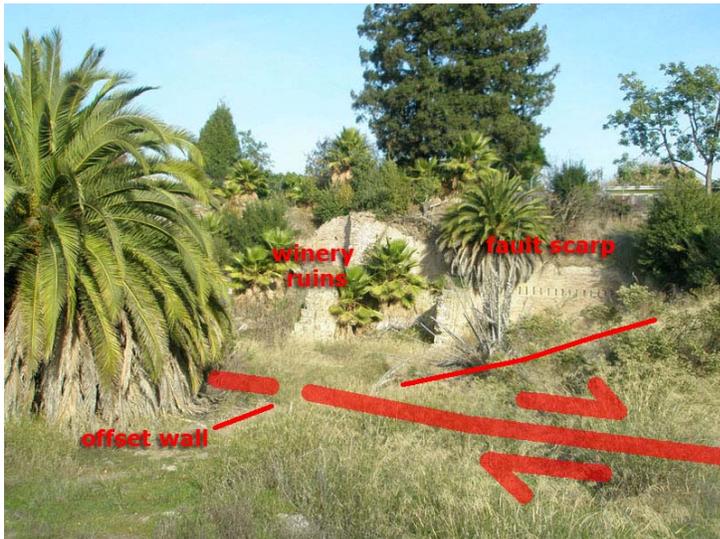
Figure 108. This view is looking east at the property owned by BART near Osgood and Washington in Fremont. The photo shows the ruins of the Gallegos (Palmdale) Winery, which was built into a hillside that is a fault scarp of the Hayward Fault. In the brush-covered field is a stone perimeter wall built in 1884. By 1985, this stone wall had been offset by 2.5 feet of accumulated right-lateral creep on the main trace of the Hayward Fault (Lienkaemper, 2006).

Figure 108. This view is looking east at the property owned by BART near Osgood and Washington in Fremont. The photo shows the ruins of the Gallegos (Palmdale) Winery, which was built into a hillside that is a fault scarp of the Hayward Fault.

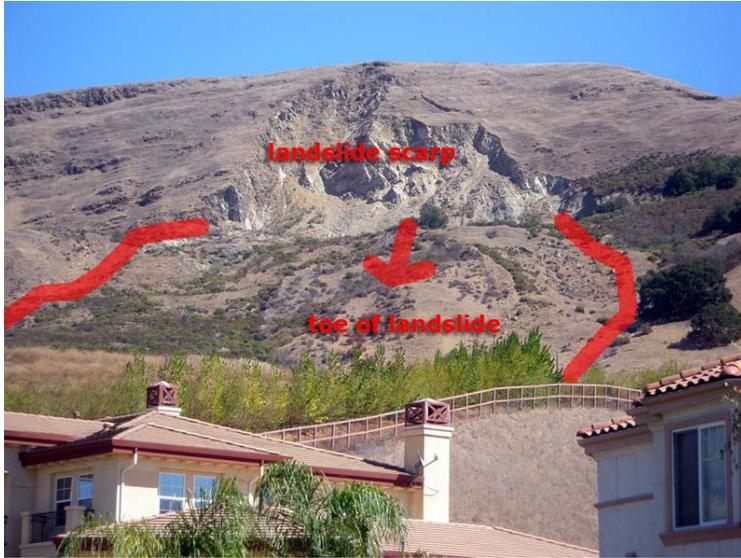
Figure 109. The Mission Peak landslide occurred on March 22, 1998 and was a partial reactivation of a large bedrock landslide complex that has developed over many thousands of years on the western face of Mission Ridge. Although the landslide displaced a great volume of rock and debris, fortunately no structures were damaged in the neighborhoods at the base of the slope.

Figure 109. The Mission Peak landslide occurred on March 22, 1998 and was a partial reactivation of a large bedrock landslide complex that has developed over many thousands of years on the western face of Mission Ridge

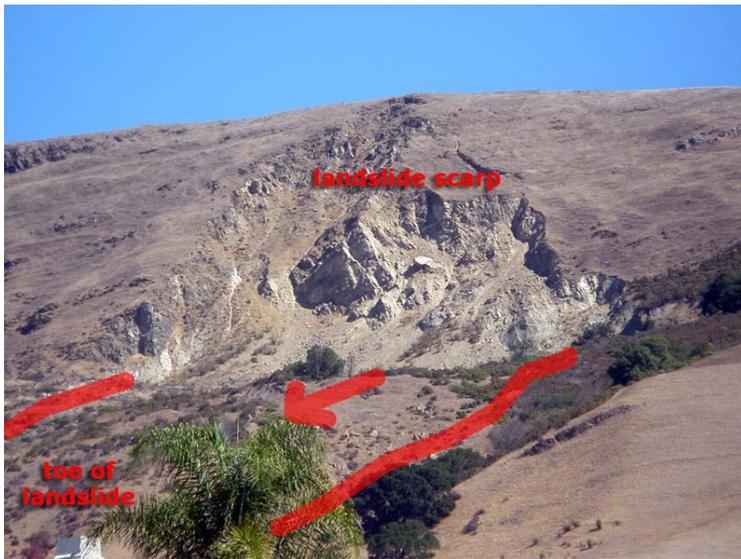
Figure 110. Detail of the headwall escarpment area of the Mission Peak landslide. See landslide features described in the Glossary.

Figure 110. Detail of the headwall escarpment area of the Mission Peak landslide.

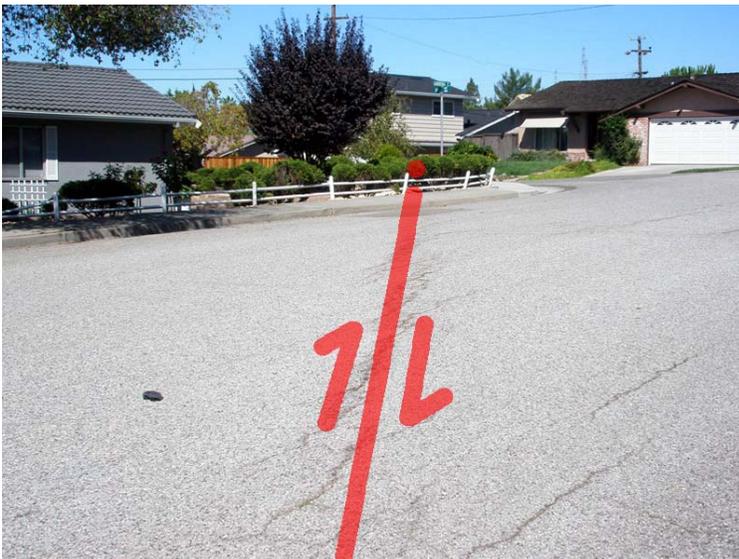
Figure 113. En echelon fractures in the pavement near the intersection of Gardenia Way and Ivy Way on the southwest side of Arroyo Agua Caliente Park in Fremont. The creeping section of the Hayward Fault continues for a couple of miles south of the park but is not accessible to the public. South of this area, the fault splays into strands that cross into the foothills of the Diablo Range east of San Jose. It is in the southern extension, south of Mission Boulevard, where the Hayward Fault is now thought to converge with the Central Calaveras Fault.

Figure 113. En echelon fractures in the pavement near the intersection of Gardenia Way and Ivy Way on the southwest side of Arroyo Agua Caliente Park in Fremont.

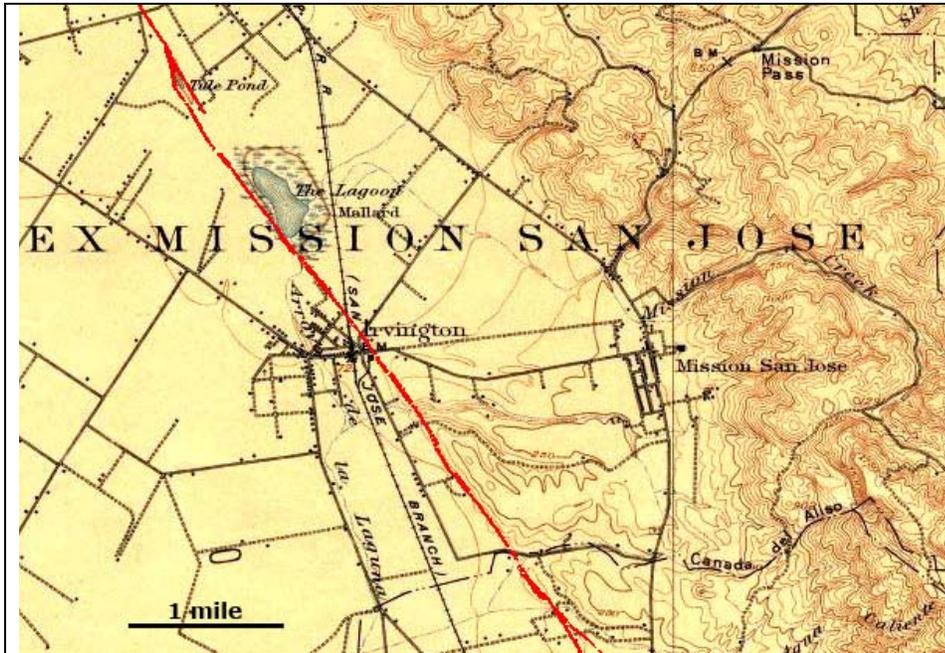
Figure 128. The villages of Irvington and Mission San Jose are the only significant settlements visible on this portion of the 1906 Livermore 15' quadrangle. "The Lagoon" and "Tule Pond" were natural sag ponds and wetlands formed by movement on the Hayward Fault.

Figure 128. The villages of Irvington and Mission San Jose are the only significant settlements visible on this portion of the 1906 Livermore 15' quadrangle.
