ShakeOut Scenario Appendix F: Seismically Induced Landslide Hazard Analysis and Deformation at Lifeline Crossings

By Rick I. Wilson¹, Timothy P. McCrink¹, Jerome A. Treiman¹, and Michael A. Silva¹

USGS Open File Report 2008-1150, Appendix F
CGS Preliminary Report 25F

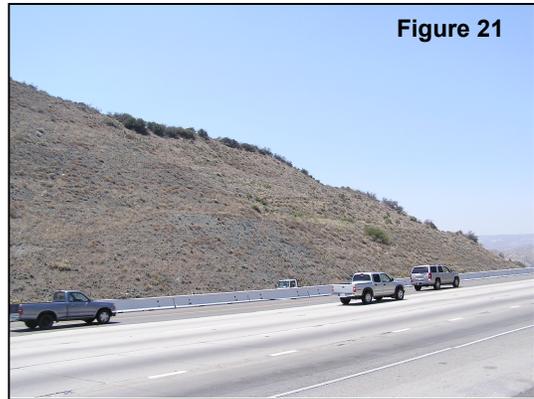
Figure 21

Road-cut RC-1 (Area E): This east-facing road cut (Figure 21 right) is approximately 65-meters tall and located in northern part of Area E. This road cut was given a “high” hazard potential rating because: 1) foliation planes within the Pelona Schist dip out of slope, creating “adverse” conditions for sliding, and 2) because it is located directly adjacent to the San Andreas fault, the cut slope material is more heavily fractured than other road cuts in the area.

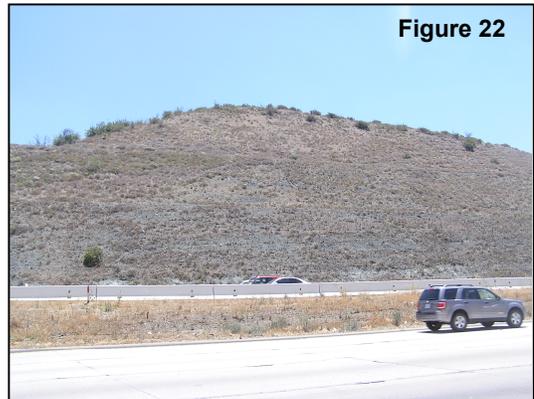
Figure 22

Road-cut RC-2 (Area E): Across from and facing RC-1, the west-facing RC-2 (Figure 22) is also 65-meters tall but was given a “moderate” hazard potential rating because, per area, the flat-lying benches make up a significant portion of the cut slope in plane-view. These “low” hazard bench areas offset the “high” hazard potential of the slopes, making the average hazard potential “moderate.”

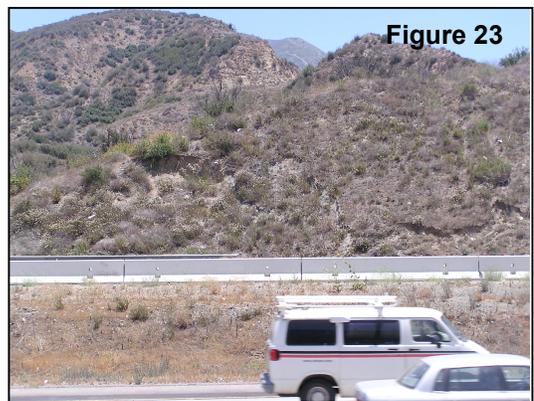
Figure 23

Road-cut RC-3A (Area E): This portion of road-cut RC-3 is approximately 60-meters tall and forms the northern end of this large road-cut. RC-3A was given a “high” hazard potential rating because sections of this slope contain small landslides (Figure 23). The geologic material that makes up this section appears to be weaker than the surrounding material.

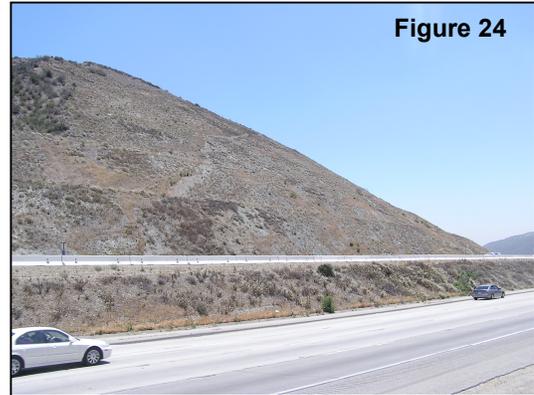
Road-cut RC-3B (Area E): This central section of the RC-3 is the tallest (>100 meters) slope of any road-cut in the Cajon Canyon area (Figure 24). Due to the great height of this slope, and fewer debris catchment benches (two) proportional to that slope, this slope was given a “high” hazard potential rating overall.

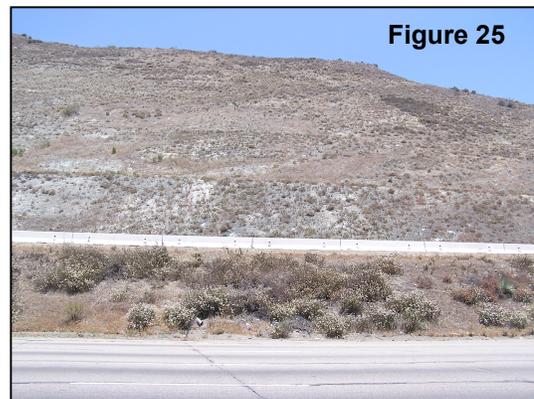
Road-cut RC-3C (Area E): This portion of road-cut RC-3 is approximately 60-meter tall and forms the southern part of that road-cut (Figure 25). This slope area was given a “moderate” hazard potential rating because, per area, the flat-lying benches make up a significant portion of the cut slope in plane-view. These “low” hazard bench areas offset the “high” hazard potential of the slopes, making the average hazard potential “moderate.”

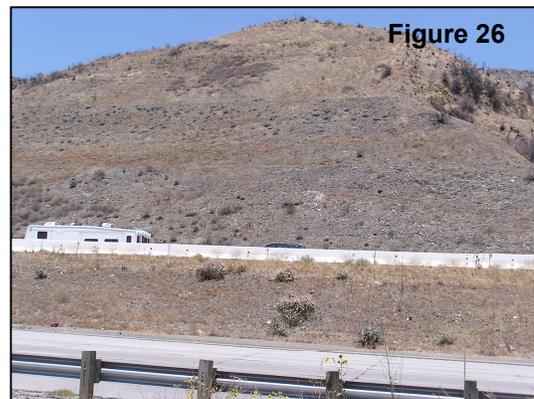
Road-cut RC-4 (Area E): This west-facing road-cut (Figure 26) is approximately 60-meters tall. RC-4 was given a “moderate” hazard potential rating because, per area, the flat-lying benches make up a significant portion of the cut slope in plane-view. These “low” hazard bench areas offset the “high” hazard potential of the slopes, making the average hazard potential “moderate.”

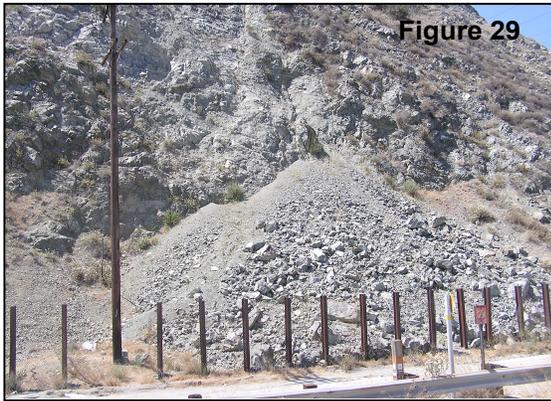
All three slopes are prone to slope failures and are already a source of damage to the road. The hazard is so severe that rockfall fences (Figure 29) and concrete barriers (Figure 30) currently protect the Old Highway. In the event of a large earthquake on the San Andreas Fault, these slopes could be susceptible to significant failure, causing considerable damage to the Old Highway. This damage might not only limit access to that road but also to other lifelines throughout the Cajon Pass corridor.

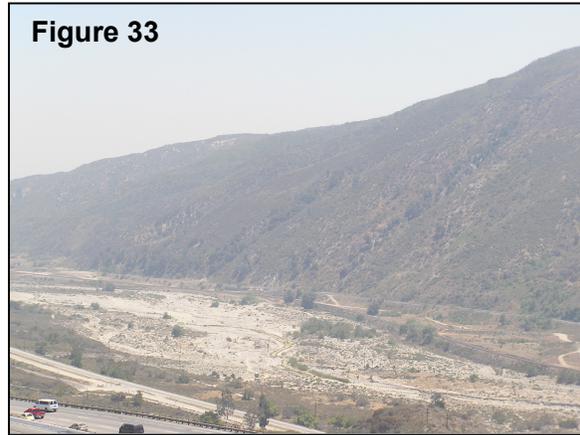
Area D: The steep, east-facing bedrock slopes along Cajon Canyon contain many landslides and weakened, east-dipping bedrock (Figure 33); a detailed analysis of landslide LS-1 in the central part of this slope was analyzed previously. If slopes in Area D fail, they could impact the railways, overhead transmission lines, and other buried utilities on or below the slopes. As shown in Figure 34, most of the east-dipping slope is identified as having a high landslide hazard potential. The specific lifelines that could be damaged by landslides include extensive portions of two railways.

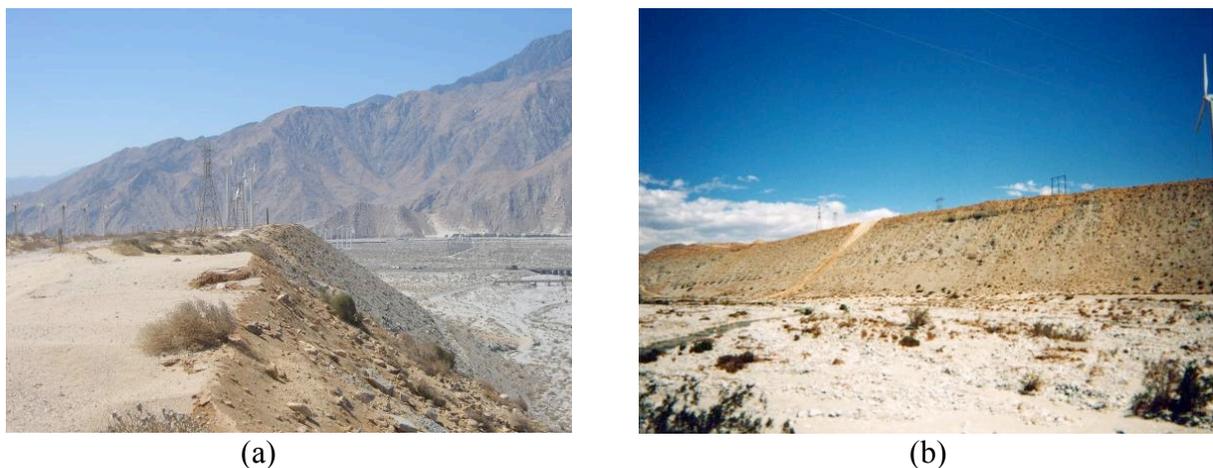
This slope stability analysis was performed to evaluate the stability of a steep, +60-meter-tall slope that has in close proximity (~30 meters) several overhead power-line towers. This slope has been down-cut by the Whitewater River over time. These towers and the slope are shown in the photos below (Figure 38).

Figure 38. The 60-meter-high bluff showing (a) the close proximity of the overhead power-line towers to the edge of steep bluff slope, and (b) the steepness of the bluff slope. The material making up this slope is the late Pleistocene age Cabezon Fanglomerate.

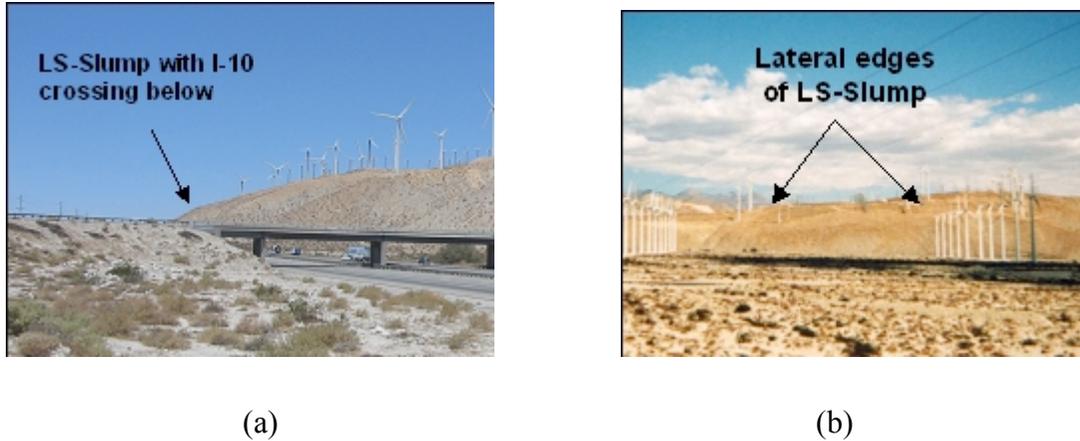
This slope stability analysis was performed to evaluate the stability of a south-facing “landslump”, known as LS-Slump in this analysis, formed in Cabazon Fonglomerate as mapped by Proctor (1968). Interstate 10 crosses directly below the base of LS-Slump and might be impacted by failure of this slope (Figure 39 and 40). Other utility lifelines that follow the I-10 corridor, two SCE utility lines and two Sprint fiber-optic lines, could also be impacted (Figure 40).

Figure 39. Photos of LS-Slump showing (a) a partial profile of the landslide with I-10 in the foreground, and (b) the lateral extent of LS-Slump.

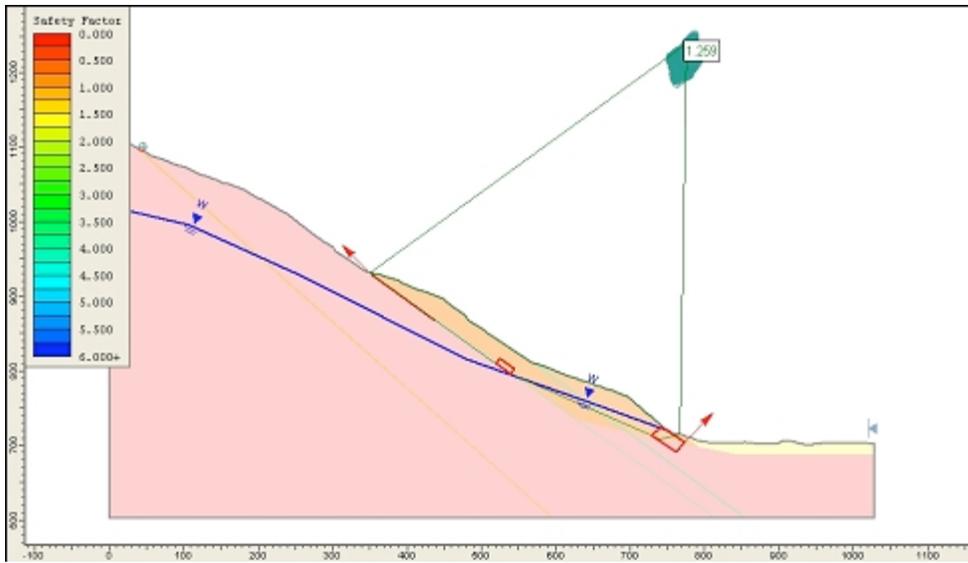
Figure A3. Static slope stability analysis result for Landslide LS-1B.
