Advanced Earthquake Monitoring System for U.S. Department of Veterans Affairs Medical Buildings—Instrumentation

Open-File Report 2012–1241

U.S. Department of the Interior
U.S. Geological Survey

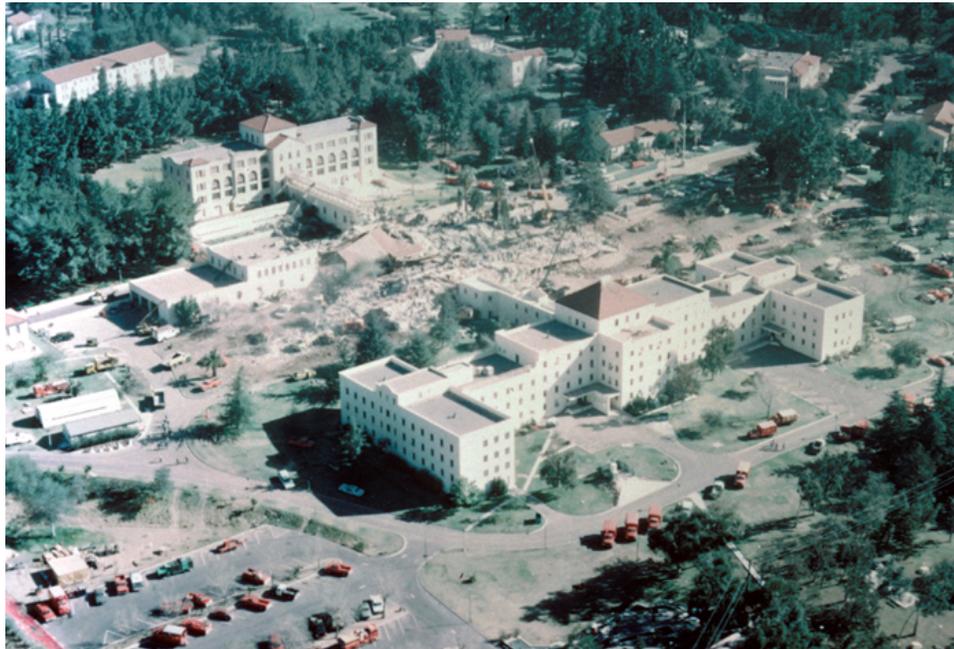
Figure 1. During the San Fernando, California, earthquake in February 1971, buildings 1 and 2 (older unreinforced masonry structures) of the Veterans Hospital collapsed and killed 49 people (U.S. Geological Survey Photographic Library: ID. Kachadoorian, R. 57ct).

The 1971 magnitude 6.6 San Fernando Earthquake in Southern California resulted in collapse of several hospital buildings, including the older unreinforced masonry buildings at the San Fernando VA medical center ([fig. 1](#)). Following this earthquake, the VA established its Seismic Vulnerability Assessment Program to identify and strengthen VA medical facilities that needed to be brought up to acceptable seismic safety standards. An important component of this program is monitoring earthquake shaking in hospital buildings. Shortly after the 1971 earthquake, the U.S. Geological Survey (USGS) collaborated with the VA on installing analog accelerographs in 60 VA hospital buildings across the country. These accelerographs were mostly placed on the base level of the buildings to record input ground motion to the building. Because these instruments recorded data on photographic film, it often took many days or even weeks after an earthquake to process and analyze the records. Later, in 2003, 45 of these seismic

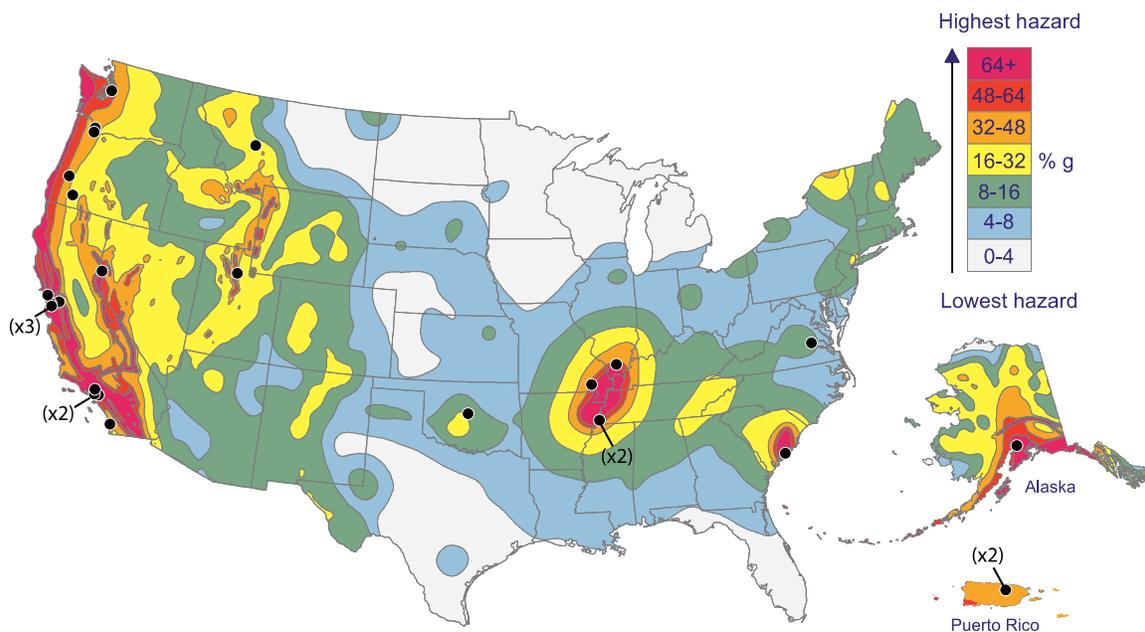
Figure 2. Seismic hazard map of the conterminous United States, Alaska, and Puerto Rico, showing the locations of 28 Veterans Affairs medical centers (black dots); “x” sign indicates multiple hospital buildings on campus for instrumentation; the seismic hazard map can be found at <http://pubs.usgs.gov/fs/2008/3018/>. Colors on this map show the levels of horizontal ground shaking that have a 2-in-100 chance of being exceeded in a 50-year period. Shaking is expressed as a percentage of g (g is the acceleration of a falling object due to gravity).

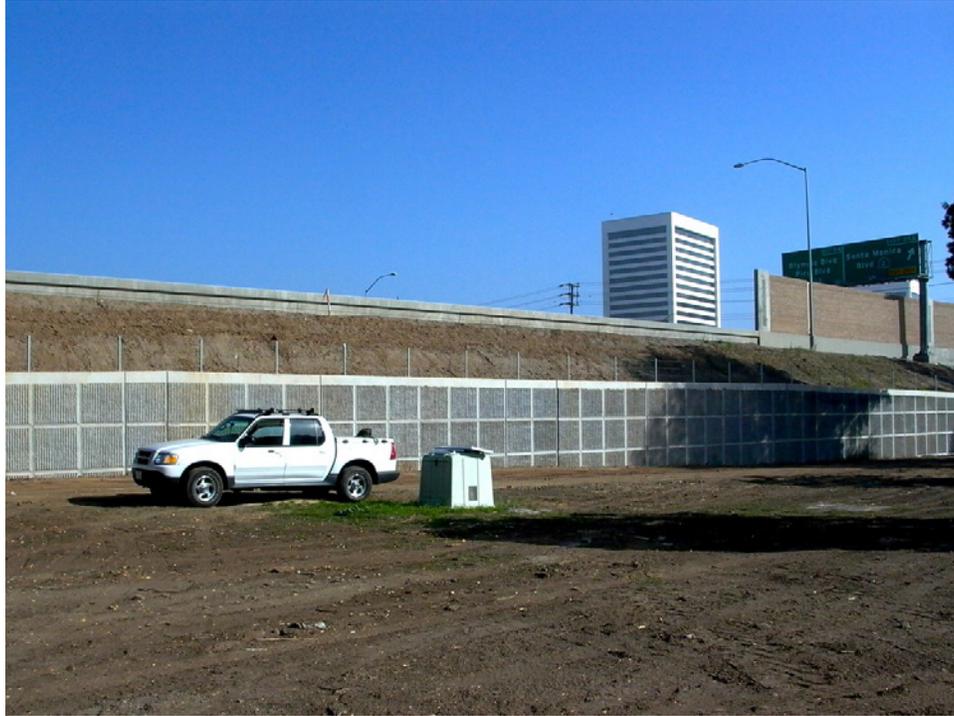
Figure 3. Photograph of a typical free-field station in West Los Angeles Veterans Affairs Medical Center, California (U.S. Geological Survey photograph).

Other seismic motion sensors located away from the building record free-field ground shaking. These free-field or reference stations are generally located at twice the height of the nearest structure to eliminate structural interference to recorded data. A typical free-field station is shown in [figure 3](#) for the West Los Angeles VA medical center, located roughly 660 feet (ft) away from the main hospital building. Motions recorded at the free-field site and at ground level of the instrumented building help to quantify the wave-propagation and soil-structure interaction. Such free-field data is also useful for development of ground-motion prediction equations (for example, Boore and others, 1997) and quantification of site transfer functions. Free-field motion also provides input for USGS ShakeMaps, maps that depict ground motion and shaking intensity after significant earthquakes, and USGS ShakeCast, an application for automating ShakeMap delivery to the VA for facilitating notification of shaking levels at VA facilities. Data from the free-field station may also be used for earthquake early warning systems, which are currently under development. Details of free-field and reference stations are given in appendix B.

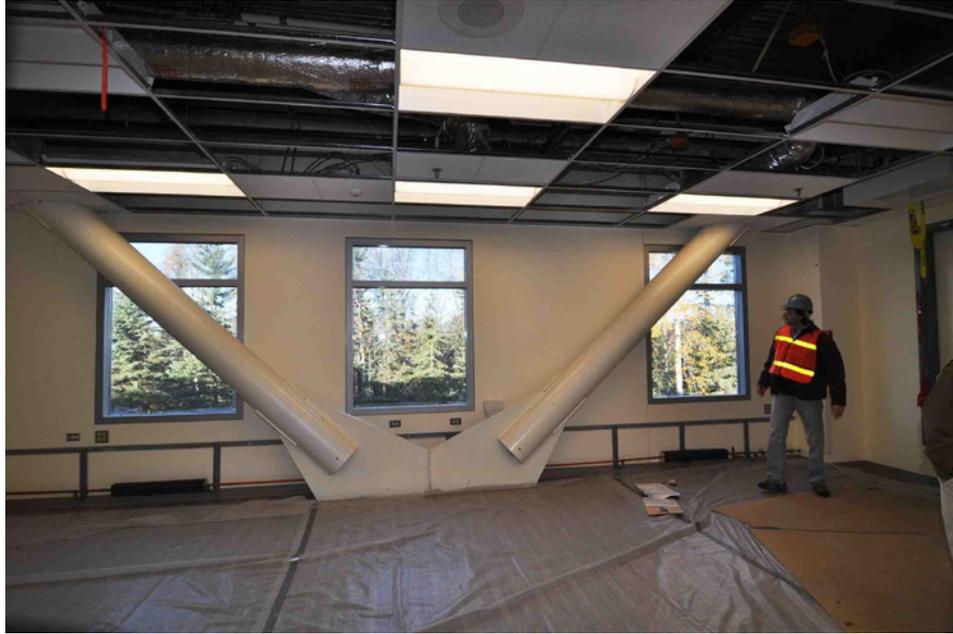
Figure 7. Photograph of steel braces providing additional lateral stiffness in Building B100, Anchorage Veterans Affairs Medical Center, Alaska (U.S. Geological Survey photograph).

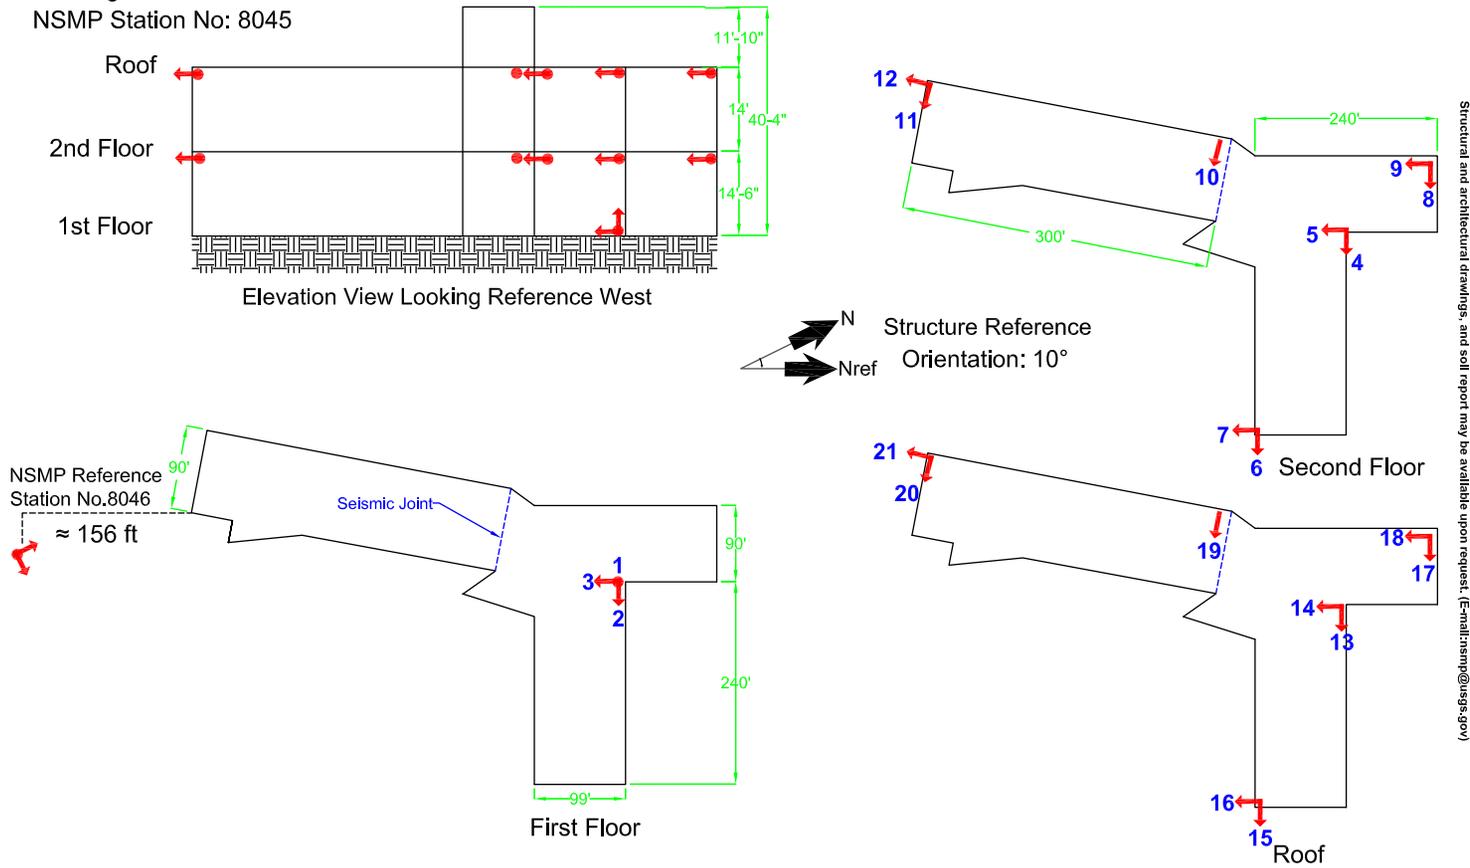
U.S. Department of Veterans Affairs
 Anchorage, AK - Steel Moment Frame, Two-Story Hospital Building
 Building No: B100
 NSMP Station No: 8045

Figure 8. Diagram of sensor layout showing 21 sensors in Building B100 of the Anchorage Veterans Affairs Medical Center, Alaska (circle denotes a sensor oriented outward; for example sensor 1 in first floor plan is oriented in vertical direction).

A total of 21 accelerometers are deployed in the building to obtain its lateral and torsional motion as well as inter-story drifts (fig. 8) during an earthquake. A triaxial accelerometer (channels 1 through 3) is placed on first floor ground level to measure the three components of input ground motion. Nine accelerometers oriented parallel to the building sides (channels 4 through 12) are placed on the first-floor ceiling to measure the lateral motion of each wing. Another nine accelerometers (channels 13 through 21) are placed on the second-floor ceiling to monitor the roof diaphragm's lateral motion. The floor relative displacements can be computed from accelerometers located at the same corner of the building on the same vertical axis. Also, the relative motions of the wings can be computed using sensors on the same floor pointing the same direction (for example, channels 14 and 15; 19 and 20). The building's accelerometers are complemented by a three-component seismic accelerometer located at a free-field site (NSMP Station No. 8046), approximately 156 ft away from the building, to monitor ground shaking without interference from the building's earthquake response.

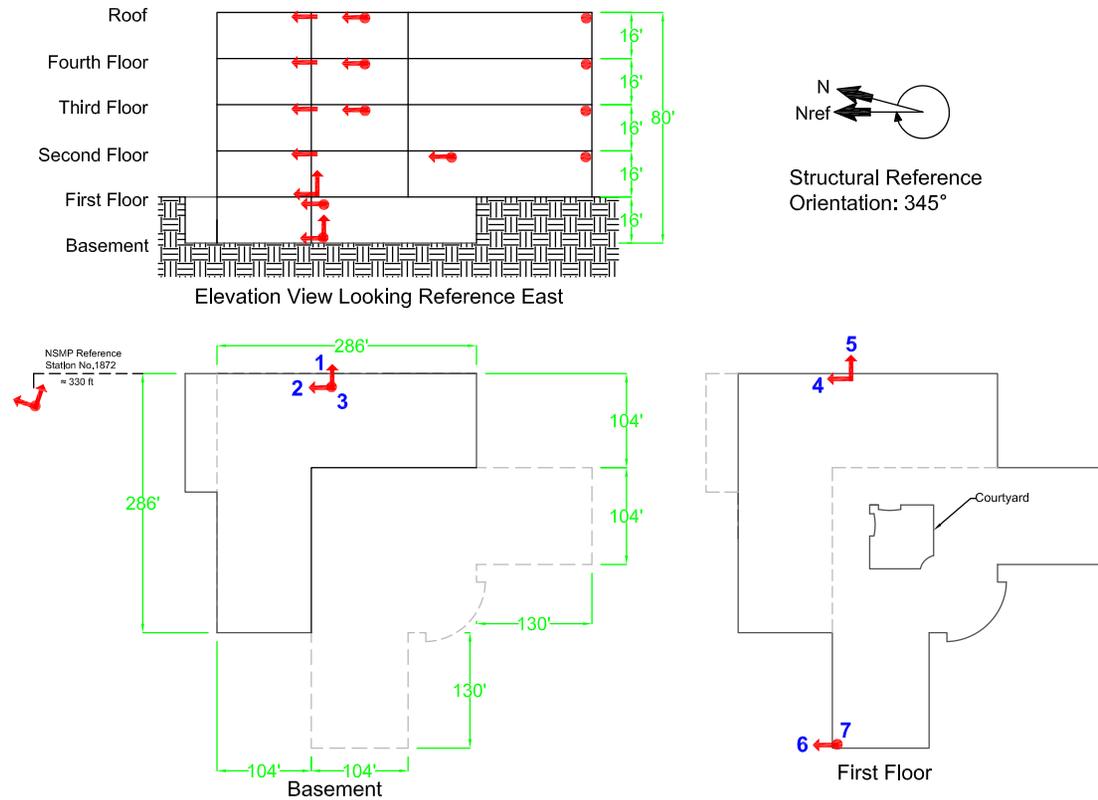
Figure 13. Diagram of sensor layout showing a total of 24 sensors in Building 100 of the Palo Alto Veterans Affairs Medical Center, California (page 1 of 2; see also fig. 14).

A total of 24 accelerometers are deployed in the building to measure its earthquake response (fig. 13 and fig. 14). Every floor is instrumented by at least four accelerometers. A triaxial accelerometer (channels 1 through 3) is placed on the basement. Because the basement is partial and does not cover the building's entire footprint, two additional accelerometers (channels 6 and 7) are also located on the part of the first-floor slab sitting on the ground to measure the horizontal and vertical input motions at this level. These sensors together with the triaxial sensors at the basement will measure the input ground motion to the building. Two accelerometers (channels 4 and 5) are mounted on the basement ceiling to measure the first-floor slab lateral movement. To measure the second-floor lateral motion in reference east-west and north-south directions, four accelerometers (channels 8 through 11) are placed on the first-floor ceiling. The floor torsional motions and diaphragm rigidity can be computed using accelerometers pointing the same direction on the same level (for example channels 8 and 11 or channels 9 and 10). Four accelerometers (channels 12 through 15) are placed on the second-floor ceiling, and four accelerometers (channels 16 through 19) are mounted on the third-floor ceiling to obtain the third and fourth floor's lateral and torsional motions, respectively. Another five accelerometers (channels 20 through 24) are placed on the fourth-floor ceiling to measure the lateral motion of the roof diaphragm. Relative motion of the west wing as compared to the main building can be obtained by differentiating data from channels 22 and 23 at the roof level (fig. 13 and fig. 14). The inter-story drift can also be computed from likewise oriented accelerometers on the same vertical axes (for example, channels 1, 5, 9, 13, 17, and 21 for the east-west direction and channels 6, 11, 14, 18, and 22 for the north-south direction).

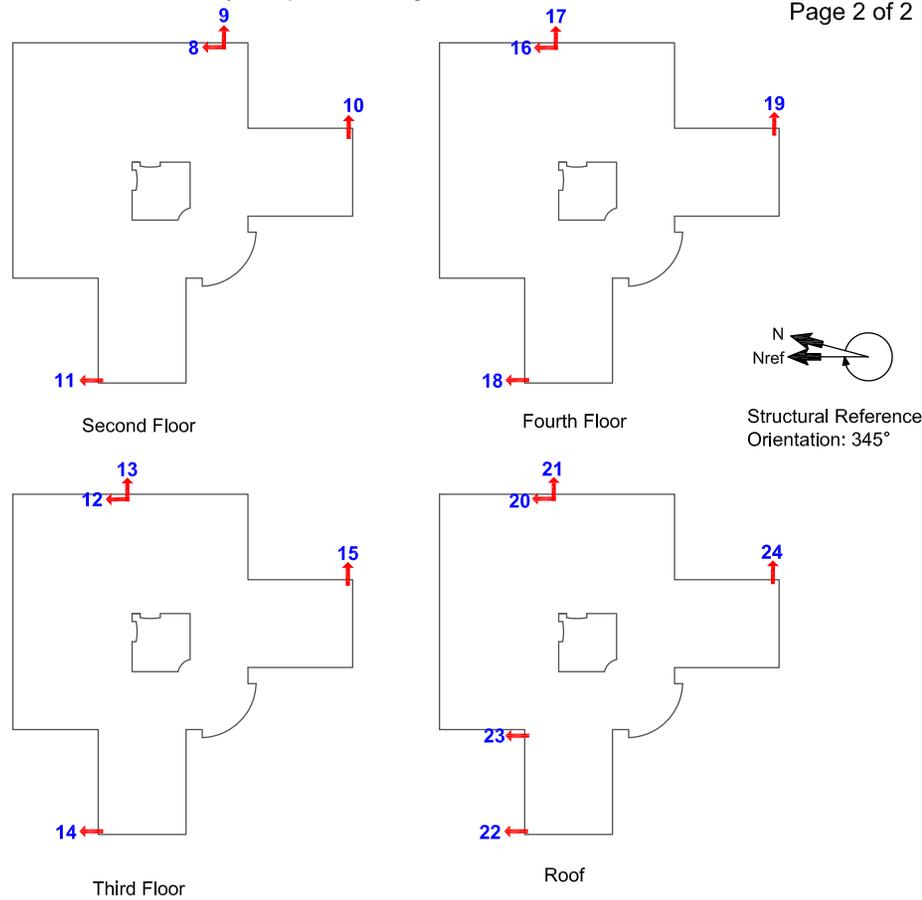
U.S. Department of Veterans Affairs
 Palo Alto, CA - Steel Moment Frame, Four-Story Hospital Building
 Building No: 100
 NSMP Station No: 1868

Figure 14. Sensor layout showing a total of 24 sensors in Building 100 of the Palo Alto Veterans Affairs Medical Center, California (page 2 of 2; see also fig. 13).

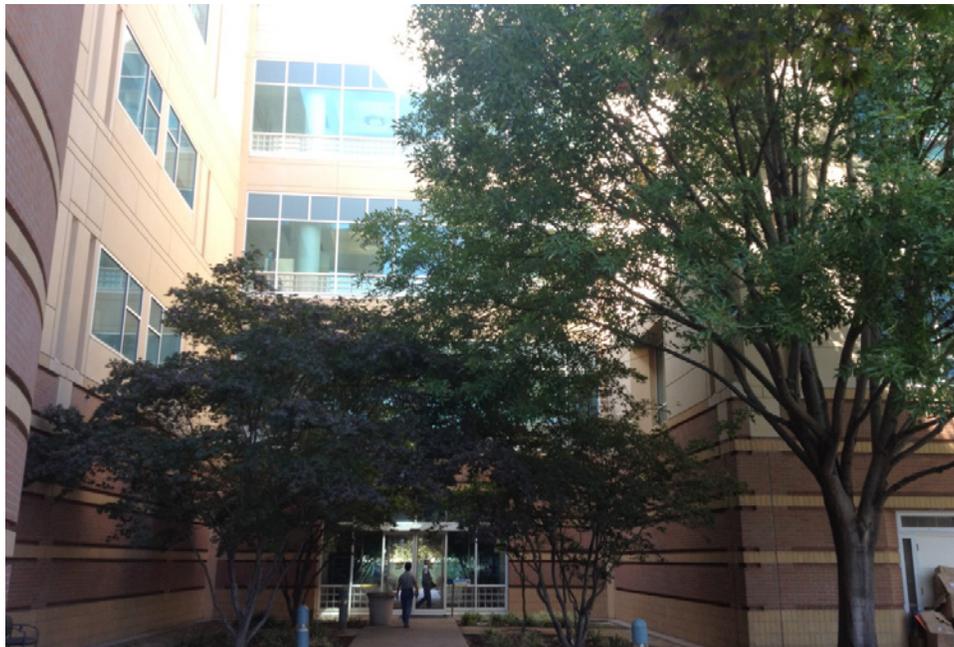
Figure 19. Photograph showing 4-story high connecting structure between Building 100 and Building 101 Palo Alto Veterans Affairs Medical Center, California (U.S. Geological Survey photograph).

Building 101, located in Palo Alto, California, is part of the VA Palo Alto Health Care System (<http://www.paloalto.va.gov>). This 4-story structure is approximately 110,700 ft² (fig. 15 through fig. 18). The building has not been heavily renovated since its initial design in 1994. The structural system of the building is composed of steel moment-resisting frames and concrete slabs. The building's base shape at ground level is a square with the southwest quarter removed, and an extended, circular protrusion at the northeast and southwest directions. The stories above the first floor are similar except without the circular protrusion continuing to the roof of the structure. Story heights are typically 16 ft, with a total height of 80 ft above the ground. The building has a concrete mat foundation. Building 101 is connected to Building 100 at all floor levels, separated by seismic joints (fig. 19).

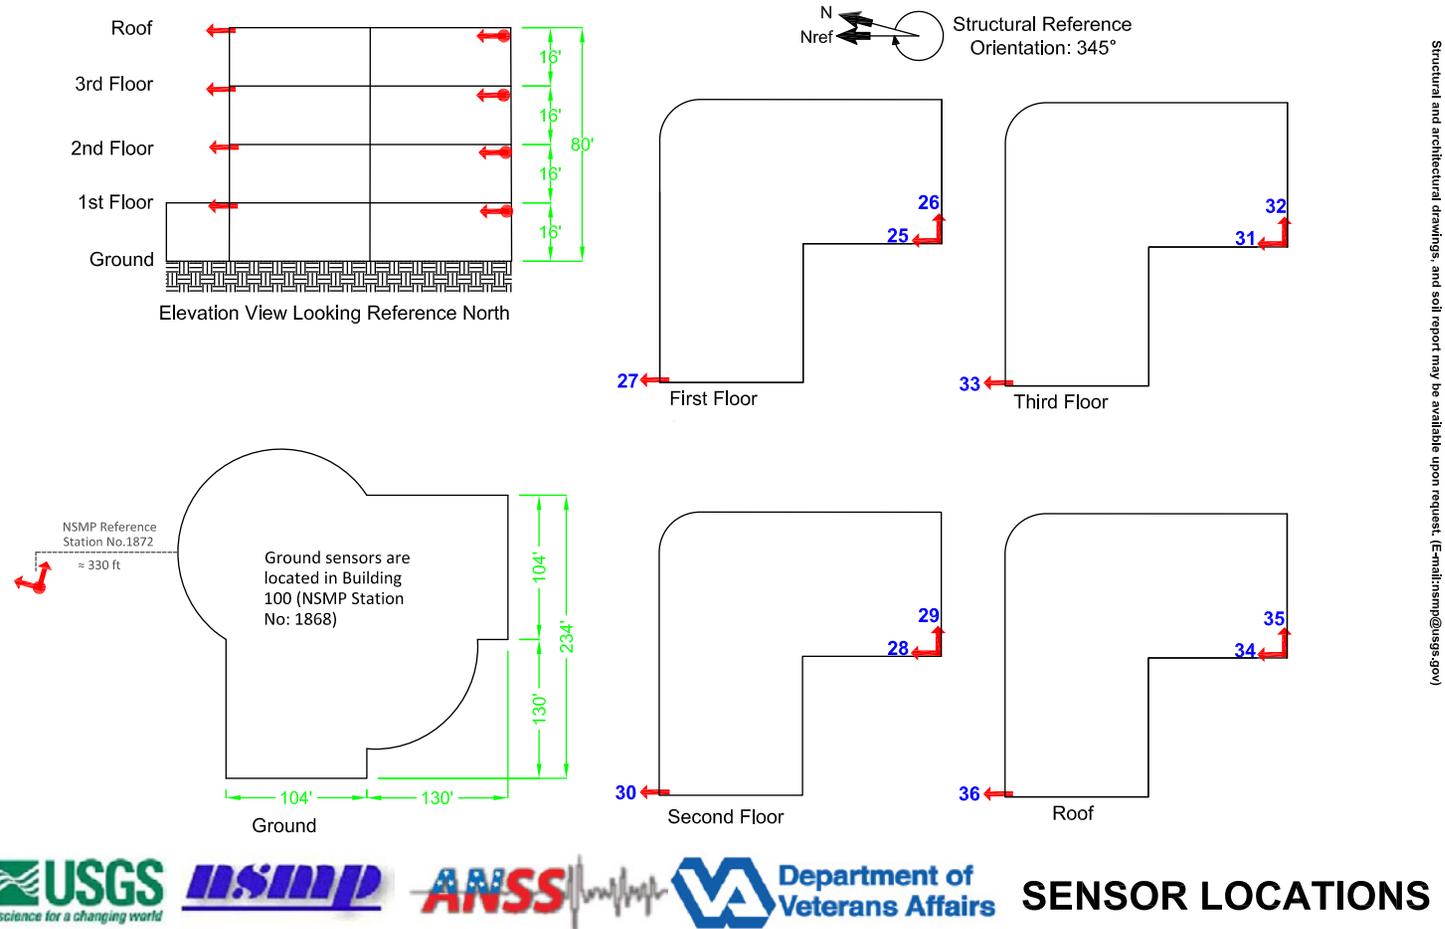
U.S. Department of Veterans Affairs
 Palo Alto, CA- Steel Moment Frame, Four Story Hospital Building
 Building No: 101
 NSMP Station No: 1869

Figure 20. Diagram of sensor layout showing a total of 12 sensors in Building 101, Palo Alto Veterans Affairs Medical Center, California.

A total of 12 accelerometers are deployed in the building at four levels to measure its lateral motion in the reference east-west and north-south directions (fig. 20). Three accelerometers (channels 25 through 27) are placed on the ground-floor ceiling to monitor the first-floor lateral motions. Nine accelerometers (channels 28 through 36) are distributed on the ceilings of the first, second, and third floors to measure floor lateral motions and compute floor torsional motions. The accelerometers are placed at the same corner of the building so that the inter-story drift computations in reference east-west and north-south direction can be performed along the same vertical axis (for example, channels 27, 30, 33, and 36 for the north-south direction drifts). Because the recorder for sensors deployed in Building 101 is located in Building 100, the sensor numbers start from 25. The first 24 channels of the recorder are dedicated to motion sensors in Building 100. The building's channels will be presented separately during the post-processing of recorded data.

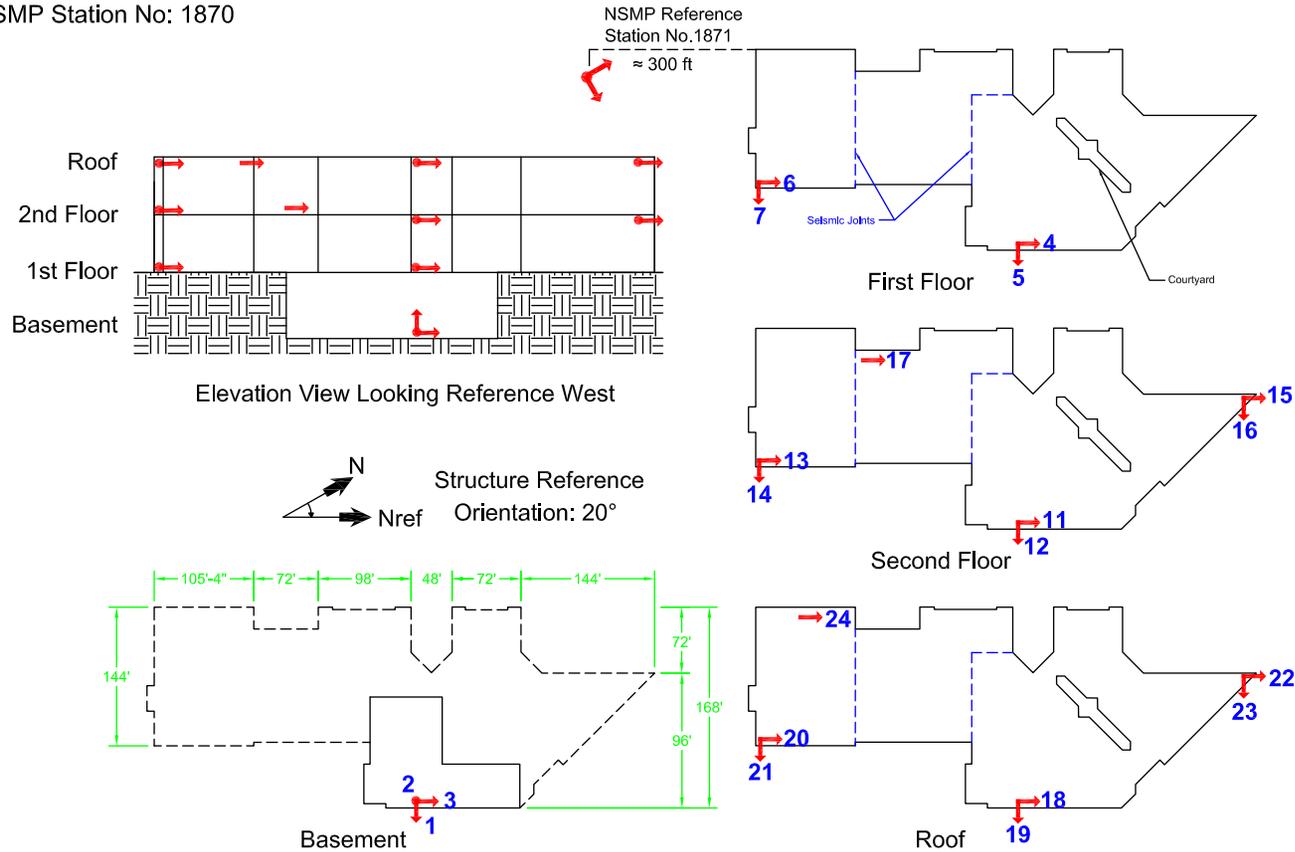
U.S. Department of Veterans Affairs
 Menlo Park, CA - Steel Moment Frame, Two-Story Hospital Building
 Building No: 334
 NSMP Station No: 1870

Figure 24. Diagram of sensor layout showing a total of 24 sensors in Building 334, Menlo Park Veterans Affairs Medical Center, California.

The building is split into three blocks by two seismic joints. A total of 21 accelerometers are deployed in the building at critical locations to capture translational and torsional motions of each block at each floor level (fig. 24). A triaxial accelerometer (channels 1 through 3) is placed on the basement level to measure the three components of input ground motion. Four accelerometers (channels 4 through 7) are placed on the first floor to measure the lateral floor motions of the side blocks in the reference east-west and north-south directions. Likewise, four accelerometers (channels 8 through 13) are placed on the first-floor ceiling level to monitor the second-floor lateral motion and compute floor torsional motion. Another seven accelerometers (channels 15 through 21) are placed on the second-floor ceiling level to measure the roof lateral motion along the reference directions, and to compute diaphragm torsional response.

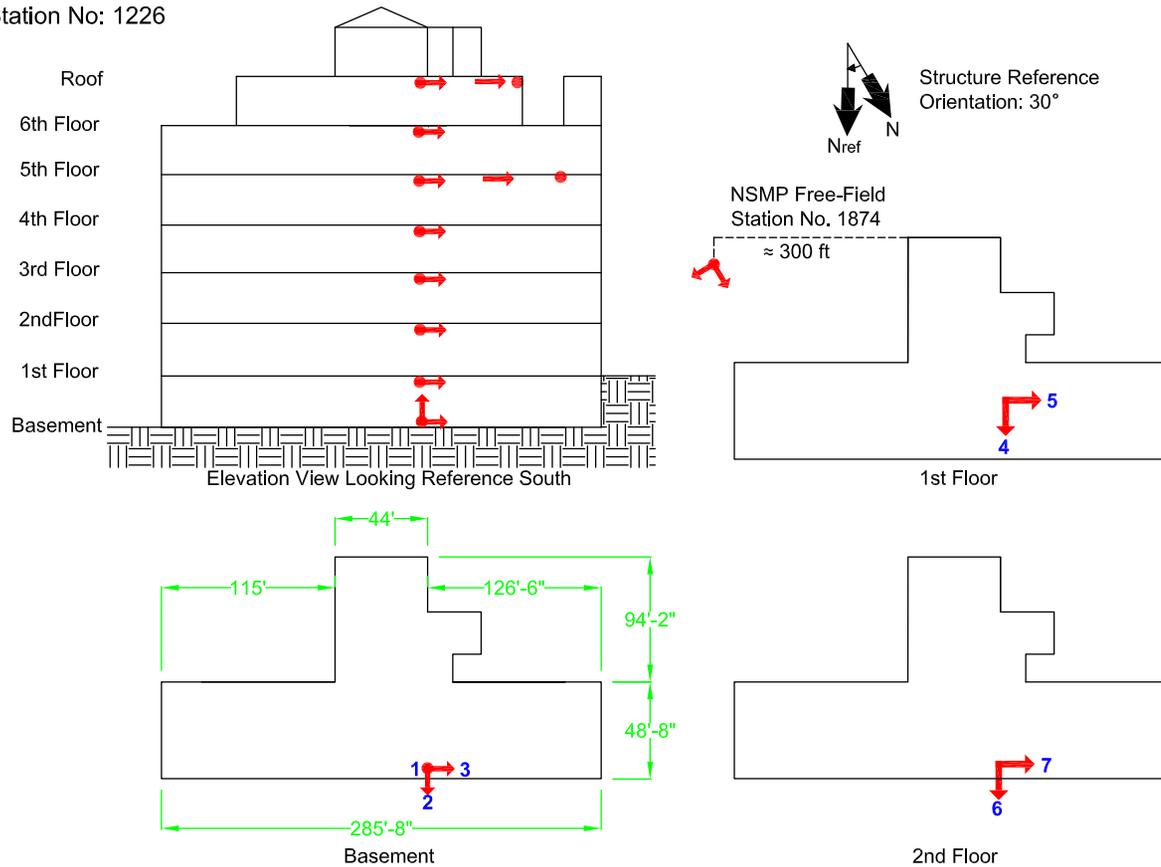
U.S. Department of Veterans Affairs
 Livermore, CA - Reinforced Concrete, Six-Story Hospital Building
 Building No: 62
 NSMP Station No: 1226

Figure 27. Diagrams of sensor layout showing 24 sensors in of Building 62, Livermore Veterans Affairs Medical Center, California (page 1 of 2; see also fig. 28).

A total of 21 accelerometers are deployed in Building 62 to measure its lateral response at each floor level (fig. 27 and fig. 28). A triaxial accelerometer (channels 1 through 3) is placed in the basement to measure ground shaking in three orthogonal directions as input motion to the building. Two accelerometers (channels 4 and 5) are placed on the ceiling of the basement floor to measure the lateral motion of the first floor in the reference east-west and north-south direction. Similarly, two accelerometers (channels 6 and 7) are placed on the first-floor ceiling to measure second-floor lateral motion. The second-floor and the third-floor ceilings are similarly instrumented with three accelerometers each (channels 8 through 13). Four accelerometers (channels 14 through 17) are placed on the fourth-floor ceiling level. The fifth-floor ceiling is monitored by three accelerometers (channels 18 through 20). Another four accelerometers (channels 21 through 24) are placed on the sixth-floor ceiling to measure the lateral floor motion of the roof in two orthogonal directions. For example for the fifth floor, the floor torsional motion can be computed using data either from channel 14 and 15 or from channel 16 and 17. Throughout the building, a rigid diaphragm behavior is expected to occur due to a thick concrete slab.

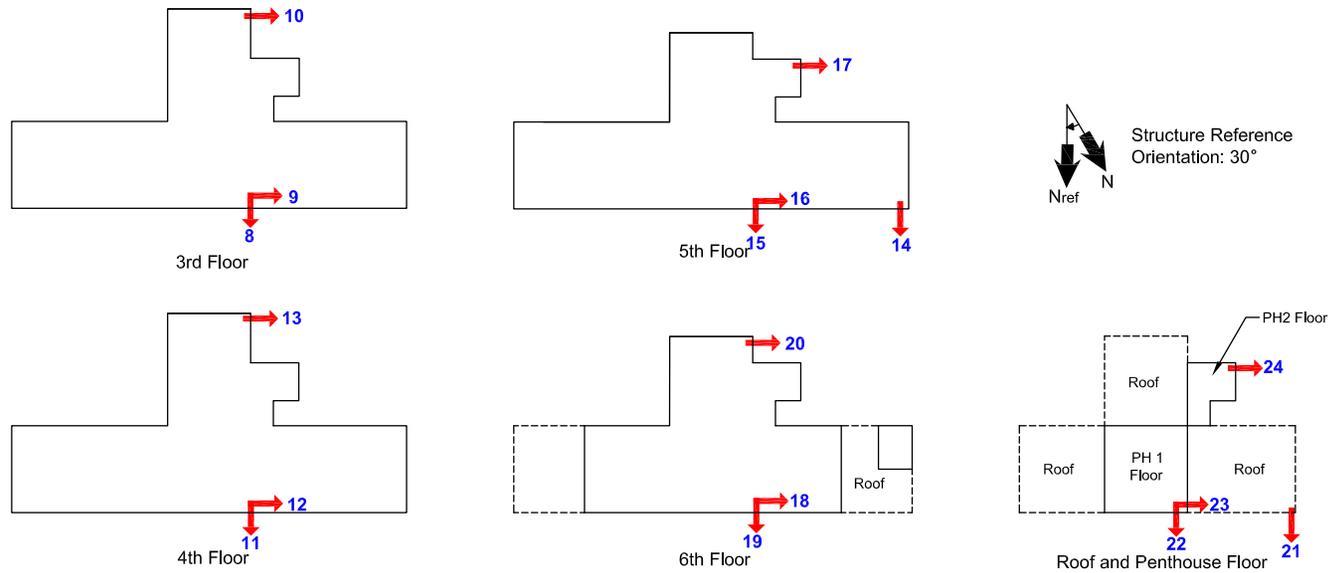
Figure 28. Diagrams of sensor layout showing 24 sensors in of Building 62, Livermore Veterans Affairs Medical Center, California (page 2 of 2; see also fig. 27).

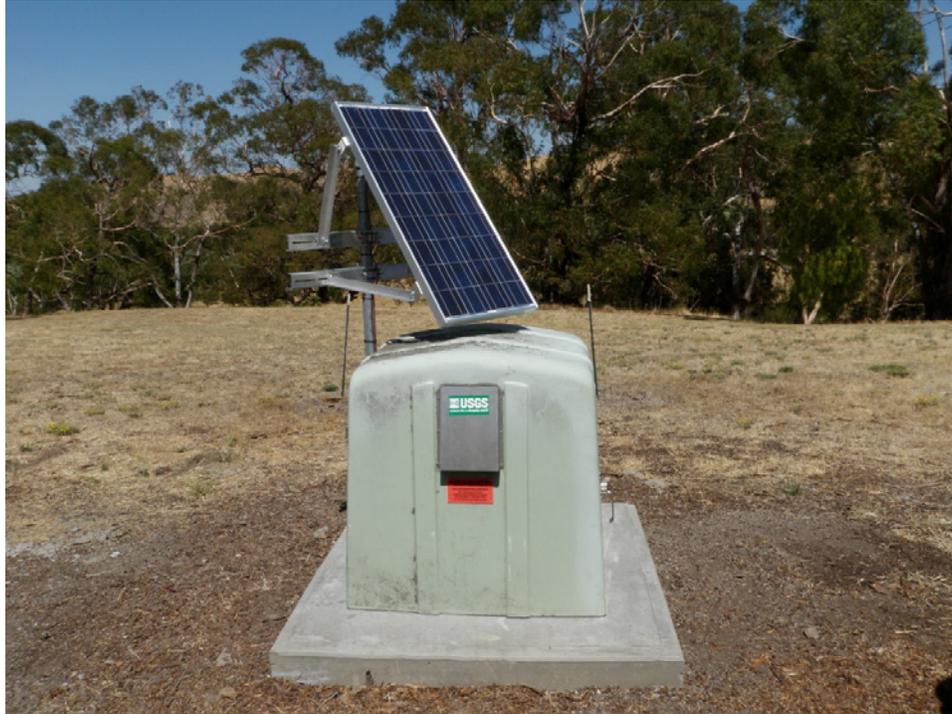
Figure 29. Photograph of free-field station (NSMP Station No. 1874) at Livermore Veterans Affairs Medical Center, California (U.S. Geological Survey photograph).

As shown in figure 29, the building accelerometers are complemented by a three-component seismic accelerometer located at a free-field site (NSMP Station No. 1874), approximately 300 ft away from the building to monitor ground shaking without interference from the building's earthquake response.

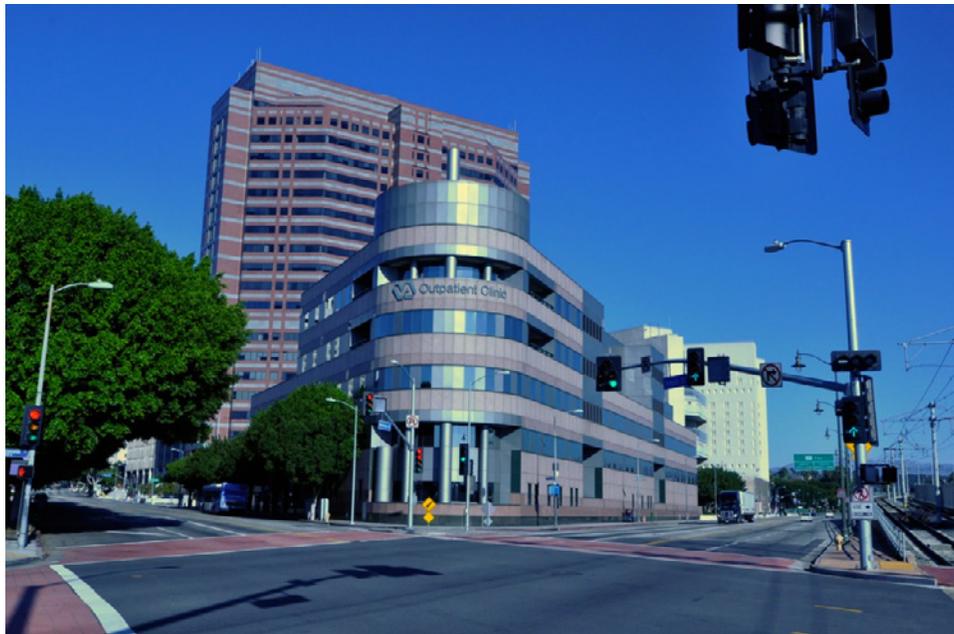
Figure 32. Photograph of Building 1, Los Angeles Veterans Affairs Medical Center, California (side view) (U.S. Geological Survey photograph).

Building 1, located in Los Angeles, California, is part of the VA Greater Los Angeles Healthcare System (<http://www.losangeles.va.gov>). This five-story structure with two underground parking levels has approximately 201,395 ft² (fig. 32 and fig. 33). It has an irregular plan shape and several offsets in vertical directions. The typical story height is 15 ft, although the underground parking levels have heights from higher than 13.5 ft to lower than 10.5 ft. The structure's foundation is composed mainly of spread footings to support both exterior and interior columns. Some of the spread footings are isolated, whereas others are combined. The vertical load carrying system and lateral-force resisting systems both consist of reinforced concrete walls and steel frames.

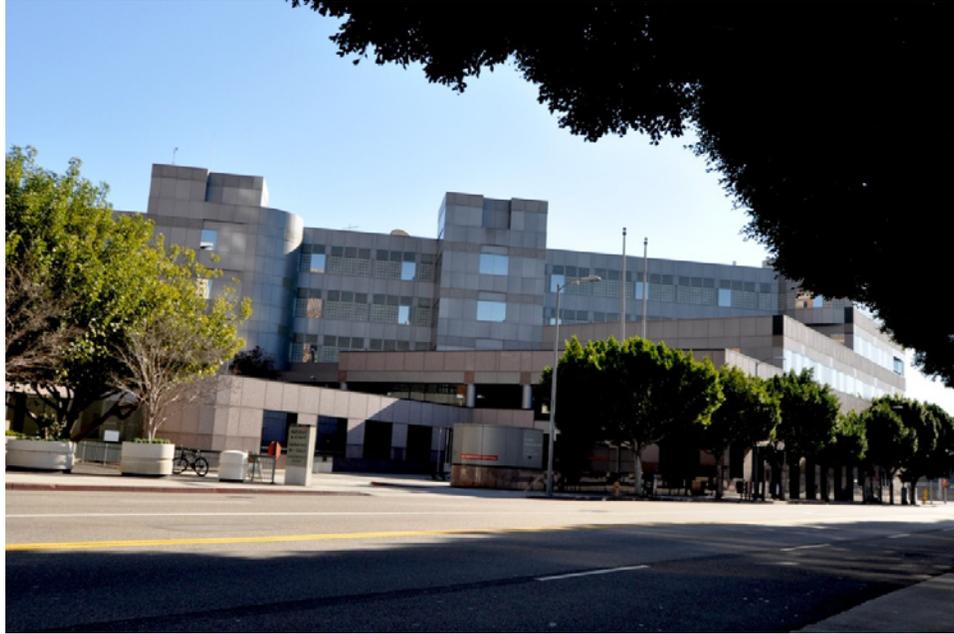
Figure 33. Photograph of Building 1, Los Angeles Veterans Affairs Medical Center, California (looking east; back side view) (U.S. Geological Survey photograph).

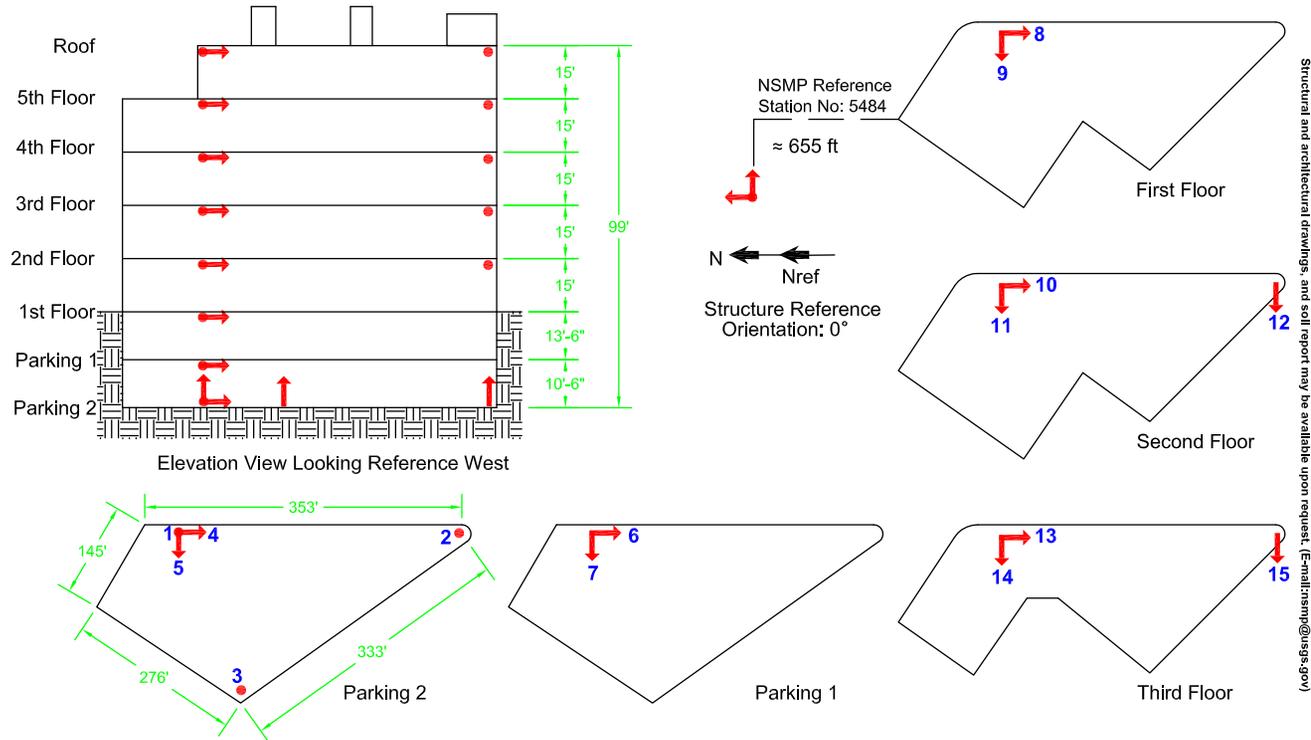
Figure 34. Diagrams of sensor layout showing 24 sensors in Building 1, Los Angeles Veterans Affairs Medical Center, California (page 1 of 2; see also fig. 35).

A total of 24 accelerometers are deployed in the building to measure its lateral response in the reference east-west and north-south directions (fig. 34 and fig. 35). A triaxial accelerometer (channels 1, 4, and 5) is placed on the ground of the parking level 2 to measure the three components input to ground motion. Another two accelerometers oriented vertically (channels 2 and 3) are also placed on the parking level 2. The rocking motion of the building can be computed from channels 1, 2, and 3. Two accelerometers (channels 6 and 7) are placed on the ceiling of parking level 2. Another two accelerometers (channels 8 and 9) are placed on the ceiling of parking level 1 to measure slab lateral motions in two orthogonal directions. Fifteen accelerometers (channels 10 through 24) are evenly distributed on the ceilings of the first, second, third, fourth, and fifth floors to monitor their motion in two horizontal directions. The accelerometers are located at the same corners of the building so that inter-story drifts can be computed from likewise oriented accelerometers along the same vertical axes. Because the building has an irregular plan, same direction oriented sensors at each floor level will help to compute torsional motion of each floor.

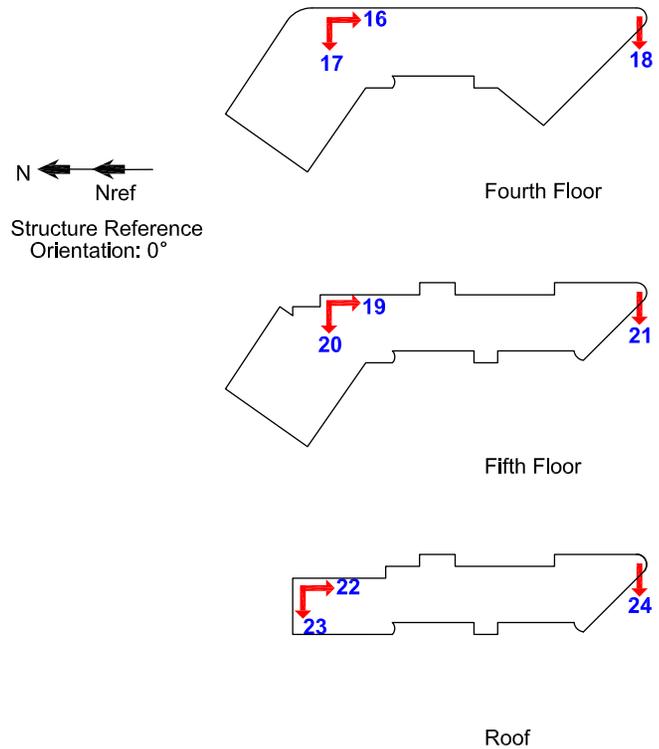
Figure 35. Diagrams of sensor layout showing 24 sensors in Building 1, Los Angeles Veterans Affairs Medical Center, California (page 2 of 2; see also fig. 34).

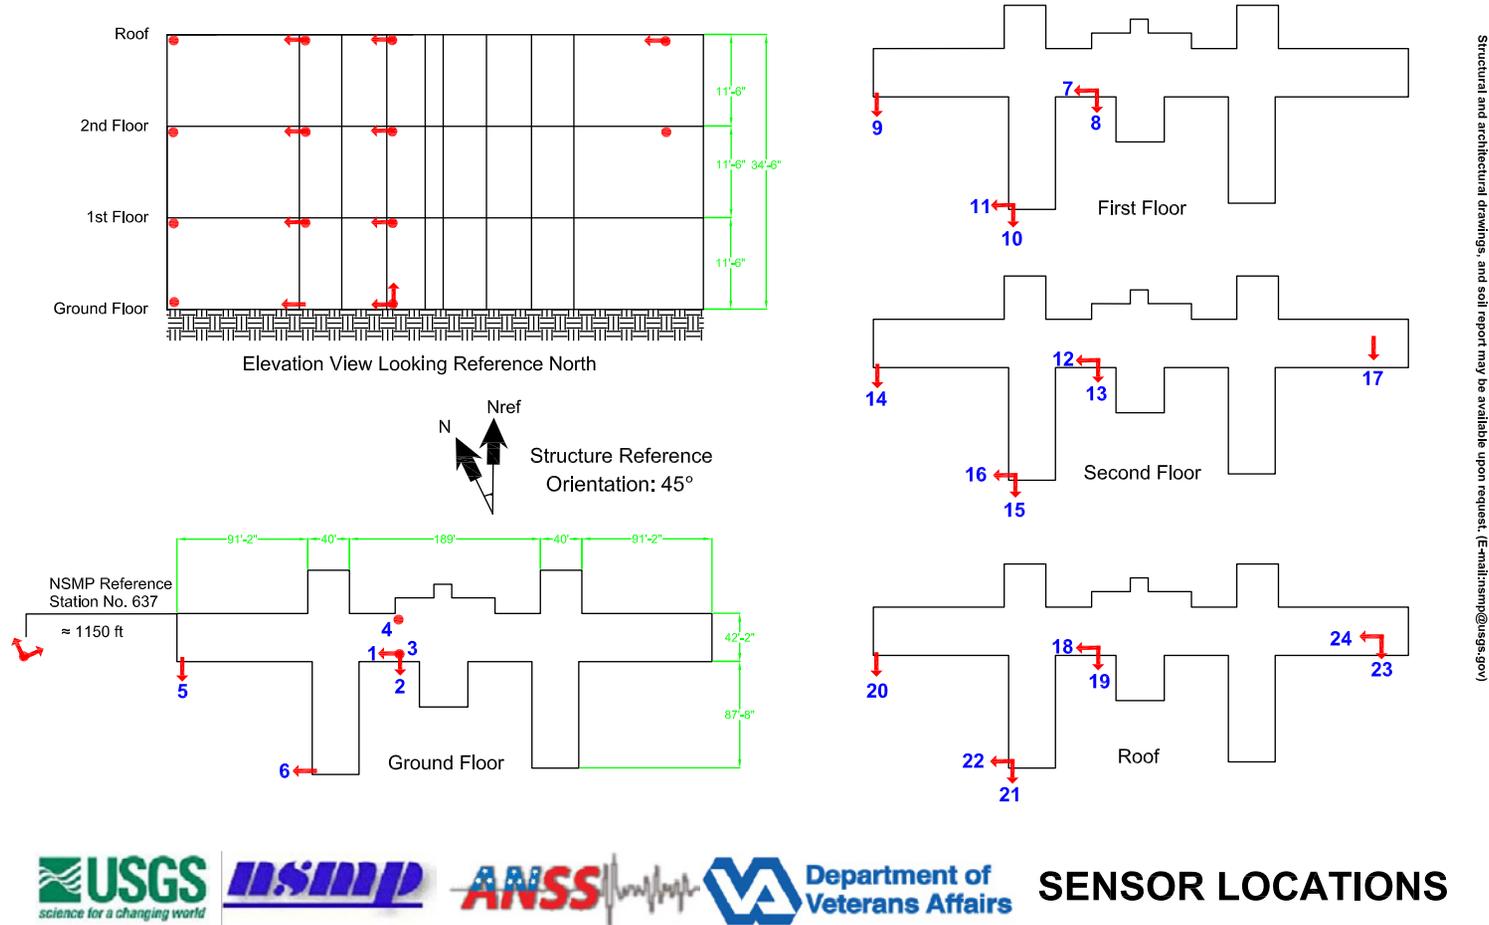
U.S. Department of Veterans Affairs
 Sepulveda, CA - Steel Moment Frame, Three-Story Hospital Building
 Building No: 10
 NSMP Station No: 5478

Figure 40. Diagram of sensor layout showing 24 sensors in Building 10 of the Sepulveda Veterans Affairs Medical Center, California.

A total of 24 accelerometers are deployed in the building at four different levels (fig. 40). A triaxial accelerometer (channels 1 through 3) is placed on the ground floor to measure the input ground motion. A vertically oriented accelerometer (channel 4) is also placed on the ground floor so that the rocking motion of the building around the reference east-west axis can be obtained. Two accelerometers (channels 5 and 6) are placed on the ground floor to measure the spatial variation of input ground motion due to the lengthy wings of the structure. Eighteen accelerometers (channels 7 through 24) are distributed on ceilings of the ground, first, and second floors to measure lateral floor motion along the reference east-west and north-south directions, and compute torsional response of each floor. Channels 18 and 24 are oriented in the same direction to compute floor diaphragm flexibility. The response of the wings as opposed to the response of the main structure will be computed by comparing channels 7 and 8 with channels 10 and 11 for the first floor and for other floors by using the corresponding channels on similar vertical axes.

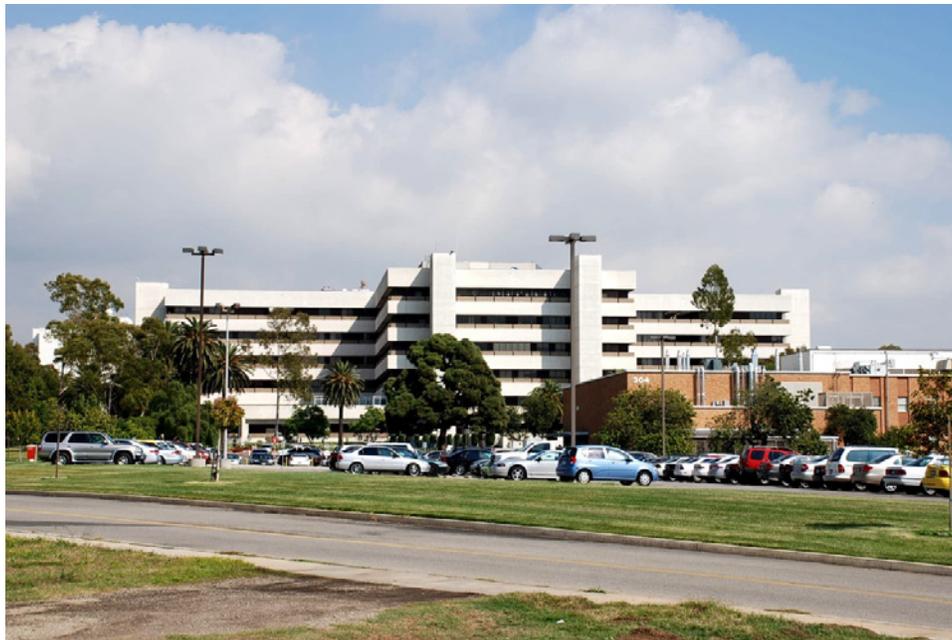
Figure 41. Photograph of Building 500, West Los Angeles Veterans Affairs Medical Center, California (side view) (U.S. Geological Survey photograph).

Building 500 located in West Los Angeles, California, is part of the VA Greater Los Angeles Healthcare System (<http://www.losangeles.va.gov>). The building, built in 1976, is a six-story structure of approximately 937,000 ft² (fig. 41 and fig. 42). It serves as the main hospital on the VA medical campus. This steel-frame building has a square plan on the lowest two stories and a cruciform plan above the second floor, with an overall width of 457 ft in each direction. It has an isolated central core above the second floor, connected by enclosed bridges to the main sections of the building. Story heights are typically 17 ft 3 inches with an unfinished basement approximately 10 ft below the ground floor. There is a partial full-height basement under the center of the building and a centrally located mechanical penthouse above the core at the roof. Typical floor and roof construction consists of composite slabs supported by steel trusses and steel columns. The bottom chords of the trusses form an interstitial space with steel catwalks installed to provide access to the numerous mechanical systems located above the ceiling of each floor. The basement floor is a concrete slab on grade, and the foundations are concrete pile caps with drilled concrete piers. The perimeter walls below the first floor are reinforced concrete.

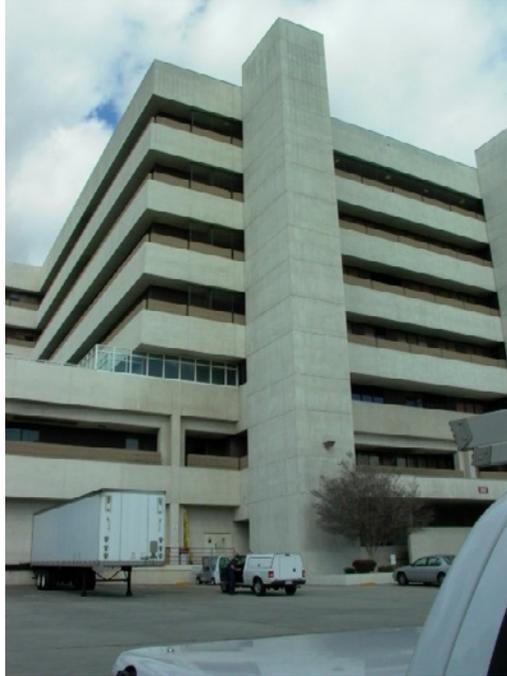
Figure 42. Photograph of Building 500, West Los Angeles Veterans Affairs Medical Center, California (looking northwest) (U.S. Geological Survey photograph).
