Advanced Earthquake Monitoring System for U.S. Department of Veterans Affairs Medical Buildings—Instrumentation

Open-File Report 2012–1241

U.S. Department of the Interior
U.S. Geological Survey

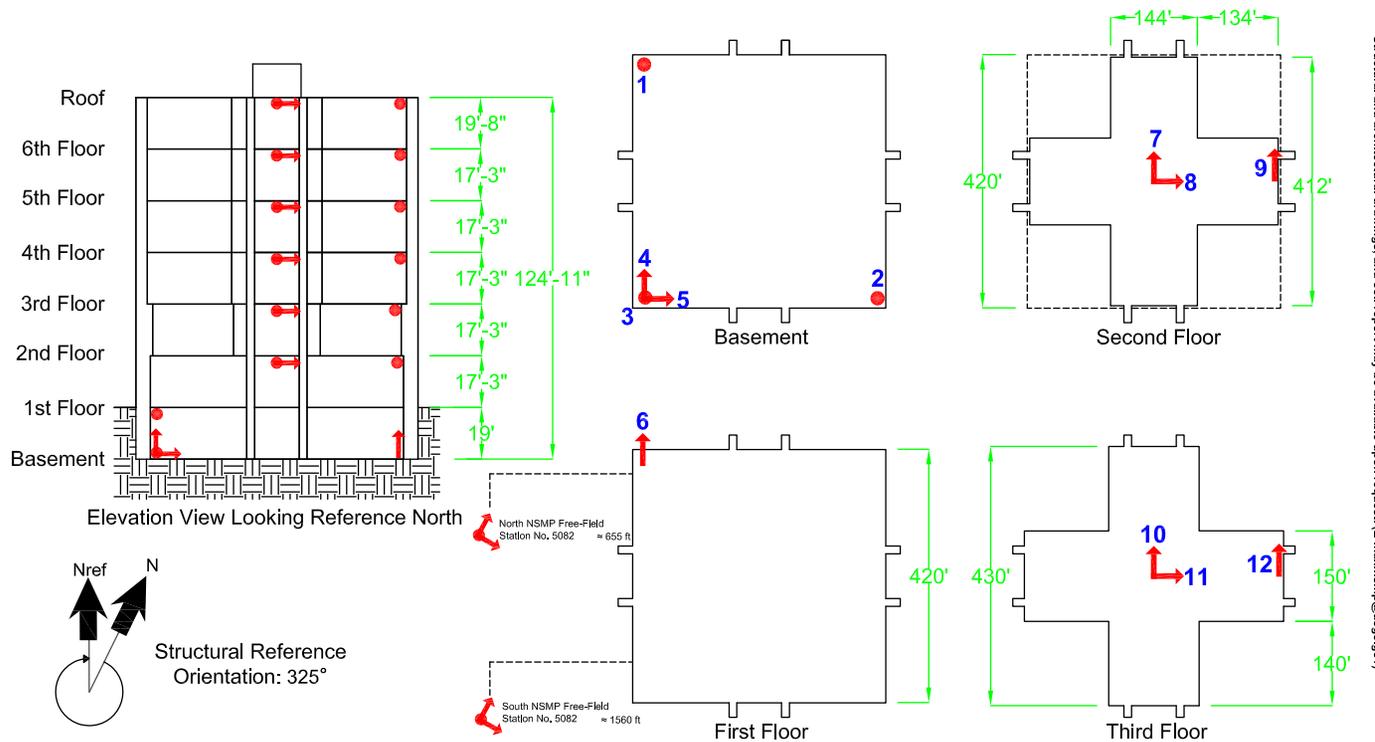
Figure 43. Diagrams of sensor layout showing 24 sensors in Building 500 of the West Los Angeles Veterans Affairs Medical Center, California (page 1 of 2; see also fig. 44).

A total of 24 accelerometers are deployed in the building at different floor levels to measure floor lateral motions in two orthogonal directions (fig. 43 and fig. 44). A triaxial accelerometer (channels 3 through 5), together with vertically oriented accelerometers (channels 1 and 2), is placed on the basement to measure ground motion input to the building. The recordings of the three vertically oriented accelerometers also provide the rocking motions of the building around the reference east-west and north-south axes. Another accelerometer (channel 6) is placed on the basement-floor ceiling level to monitor first-floor slab motion. Eighteen

accelerometers (channels 7 through 24) are evenly distributed on the ceiling of the upper floors to measure floor lateral motion. The floor torsional motion can be computed from likewise oriented accelerometers on the same floor (for example, channels 22 and 24 will be used to compute roof torsional motion)

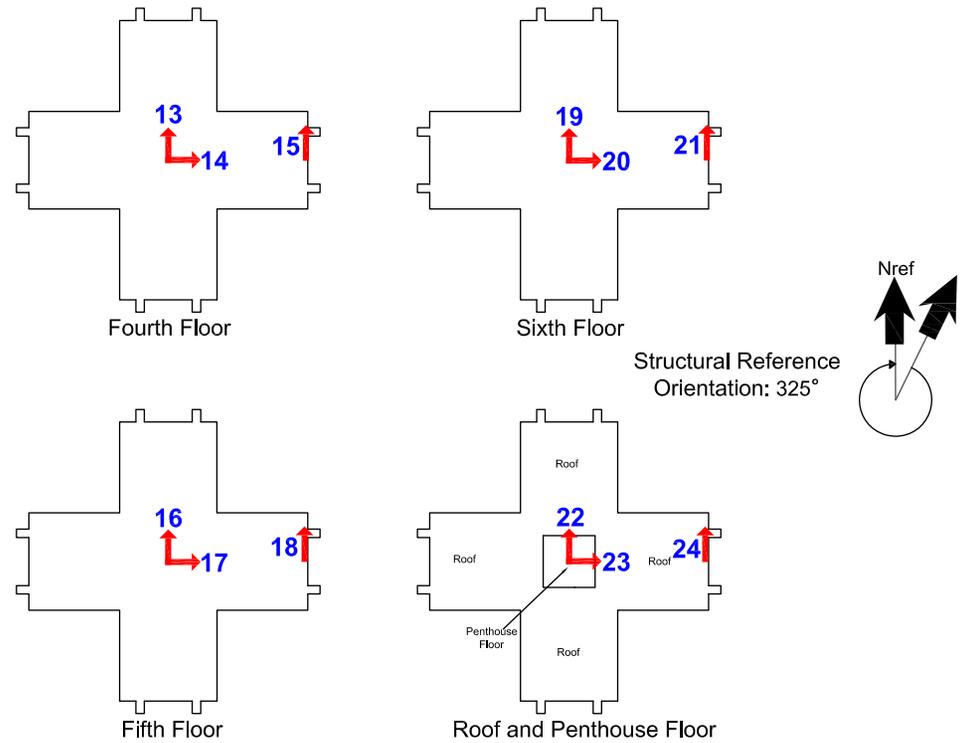
Figure 44. Diagrams of sensor layout showing 24 sensors in Building 500 of the West Los Angeles Veterans Affairs Medical Center, California (page 2 of 2; see also fig. 43).

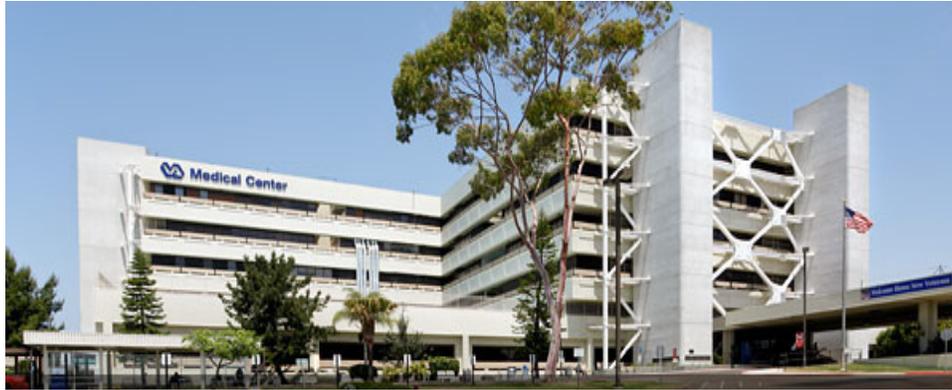
Figure 48. Photograph of Building 1, San Diego Veterans Affairs Medical Center, California (front view) (U.S. Department of Veterans Affairs photograph).

Building 1, located in San Diego, California, is the main hospital building in VA San Diego Healthcare System (<http://www.sandiego.va.gov>). This 125-foot tall, steel-braced frame building was constructed in 1972 and has six-stories with a basement. Its total area is approximately 854,900 ft², with a typical floor area of approximately 106,000 ft² (fig. 48).

The building plan comprises four wings and a central core. Each wing is 158 ft wide and 149 ft long projecting from the central core as shown in figure 48. The floor height of the interstitial floors is approximately 17 ft. The first story is 450 ft square in plan extending entirely to the ends of the wings, which results in a vertical irregularity due to the large increase of floor area relative to the levels above. The sloping site results in a partial basement level below the northern three wings, which is approximately 19 ft in height.

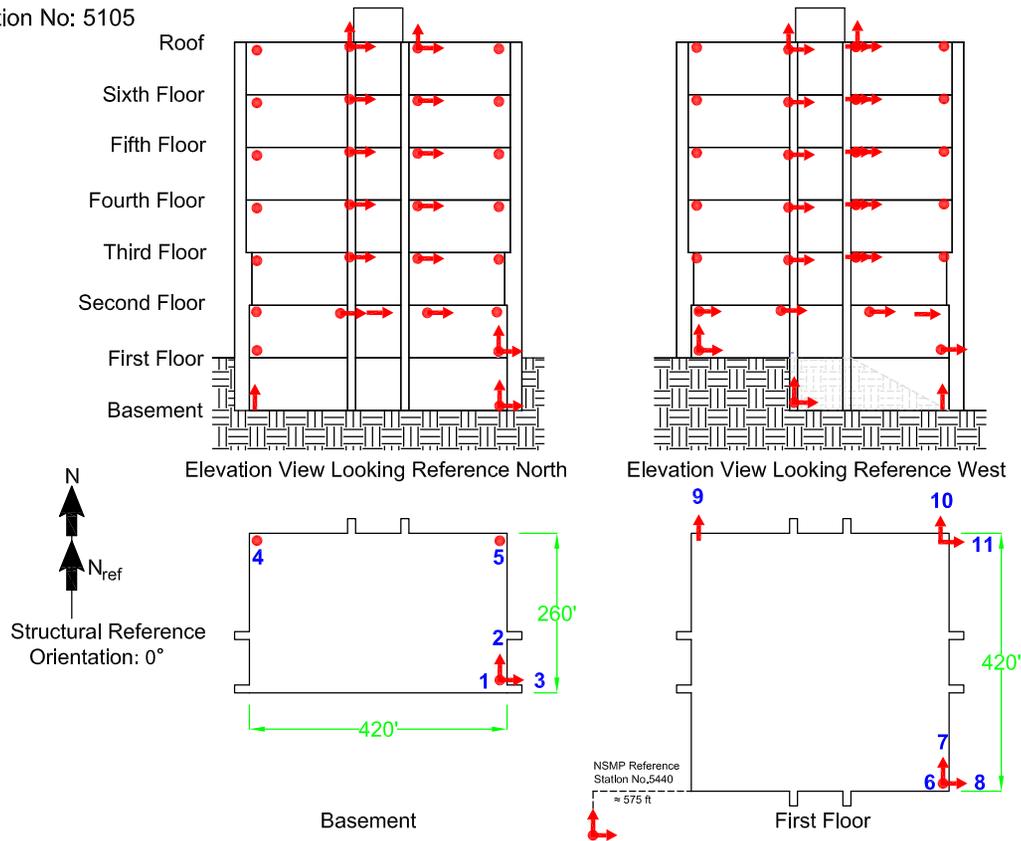
Figure 49. Diagrams of sensor layout showing 60 sensors in Building 1 of the San Diego Veterans Affairs Medical Center, California (page 1 of 3; see also figs. 50 and 51).

A total of 60 accelerometers are placed at eight levels in the building to measure its response to ground motion (fig. 49 through fig. 51). A triaxial accelerometer (channels 1 through 3) and two vertically oriented accelerometers (channels 4 and 5) are placed at the corner of the basement to measure input ground motion. The rocking motions of the building can be obtained from vertically oriented accelerometers (channels 1, 4, and 5). A triaxial accelerometer (channels 6 to 8) and three accelerometers (channels 9 through 11) are placed on the first-floor ground level. Accelerometers are placed on the upper floor edges and centers to measure the response of the wings and core of the building. Two triaxial accelerometers (channels 52 through 53 and channels 56 through 58) are also mounted on the core at the sixth-floor ceiling level; the vertically oriented sensors here will provide measurements of the rocking motion of the superstructure, as well as of the flexural response of the core.

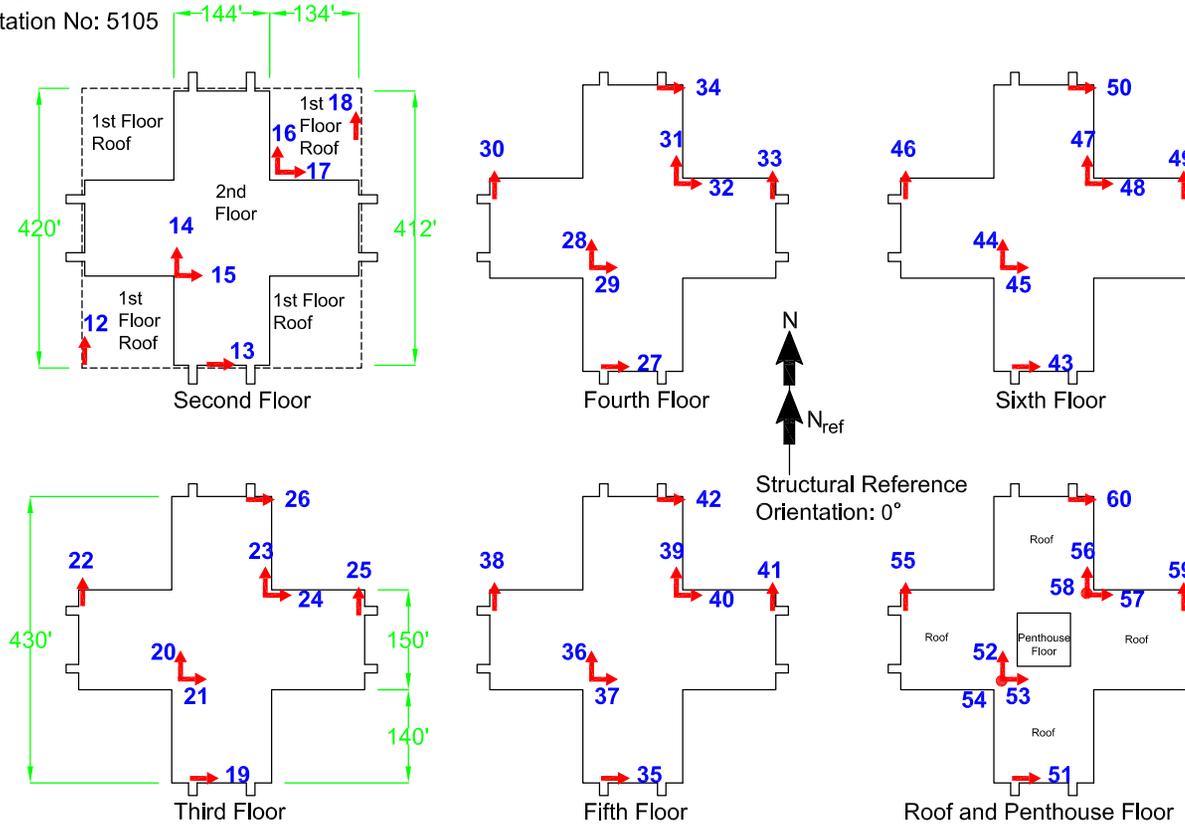
Figure 50. Diagrams of sensor layout showing 60 sensors in Building 1 of the San Diego Veterans Affairs Medical Center, California (page 2 of 3; see also figs. 49 and 51).

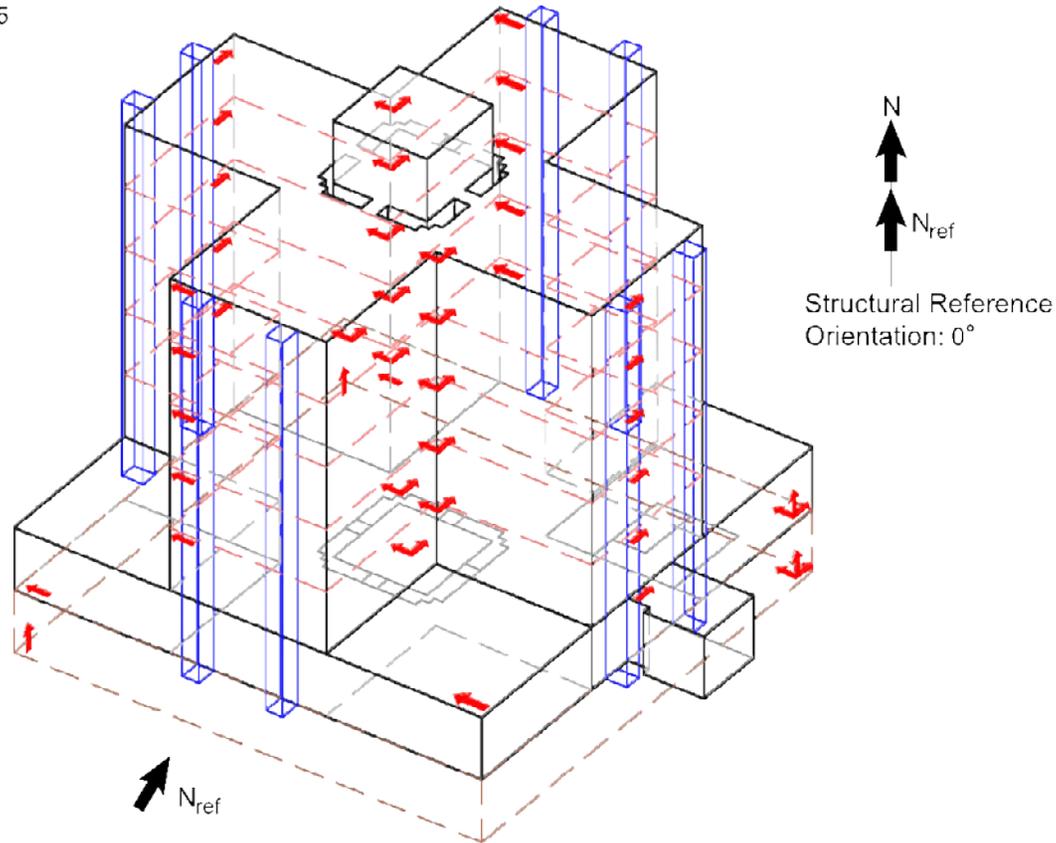
Figure 51. Diagrams of sensor layout showing 60 sensors in Building 1 of the San Diego Veterans Affairs Medical Center, California (page 3 of 3; see also figs. 49 and 50).

The number of sensors deployed in each medical building varies, depending on the floor area, the number of stories, and the number of blocks (or wings). For instance, the instrumentation design for the main hospital building at the VA medical center in San Diego, California, has 60 sensors ([fig. 51](#)). Locations for these sensors are strategically selected to be

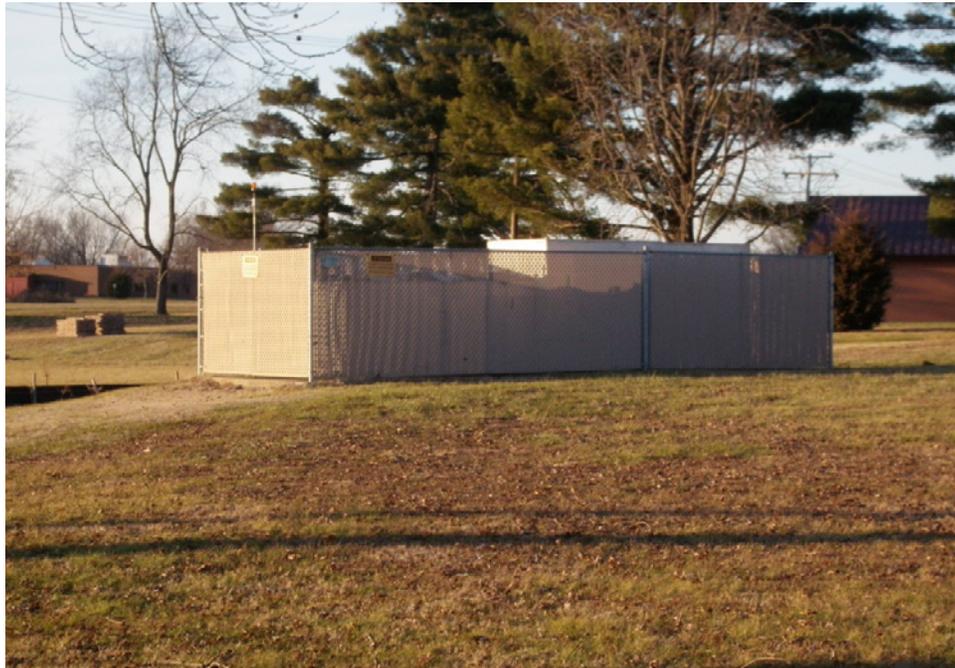
Figure 54. Photograph of free-field site at the Marion Veterans Affairs Medical Center, Illinois (U.S. Geological Survey photograph).

As shown in figure 54, the building's accelerometers are complemented by a three-component seismic accelerometer located at a free-field site (NSMP Station No. 7415), approximately 2,625 ft away from the building, to monitor ground shaking without interference from the earthquake response of the building.

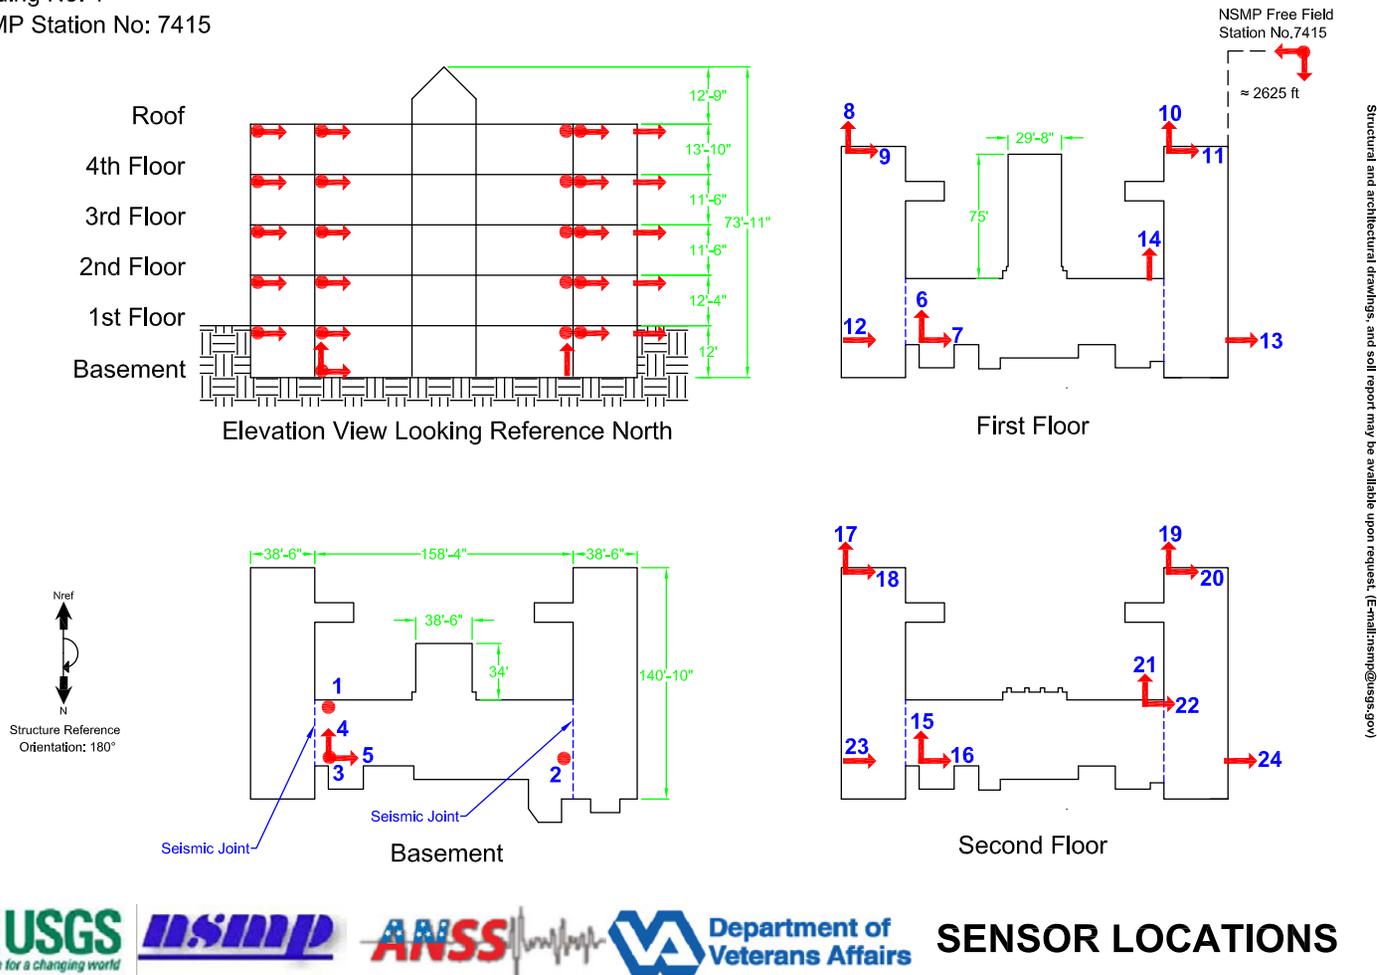
Figure 55. Diagrams of sensor layout showing 48 sensors in Building 1 of the Marion Veterans Affairs Medical Center, Illinois (page 1 of 2; see also fig. 56).

A total of 48 accelerometers are deployed in the building to measure its lateral motion along the reference east-west and north-south directions (fig. 55 and fig. 56). A triaxial accelerometer (channels 3 through 5) is placed on the basement to measure the three components of input ground motion. Two vertically oriented accelerometers (channels 1 and 2) are also placed on the basement. The rocking motion of the building can be obtained from the vertically oriented accelerometers. Nineteen accelerometers are placed at different floor levels in the middle block to measure its lateral motions and compute its torsional motions. The side blocks are instrumented likewise; each has twelve accelerometers to measure lateral and torsional response. The relative floor displacement for each block can also be computed from the accelerometer located at the same corner of the building along the same vertical axis.

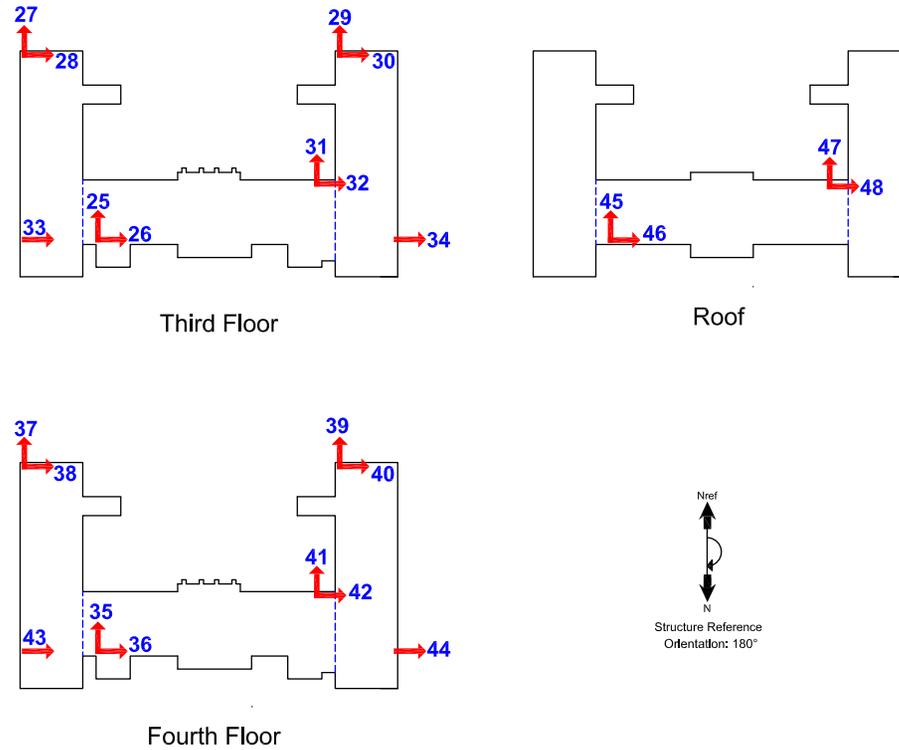
Figure 56. Diagrams of sensor layout showing 48 sensors in Building 1 of the Marion Veterans Affairs Medical Center, Illinois (page 2 of 2; see also fig. 55).

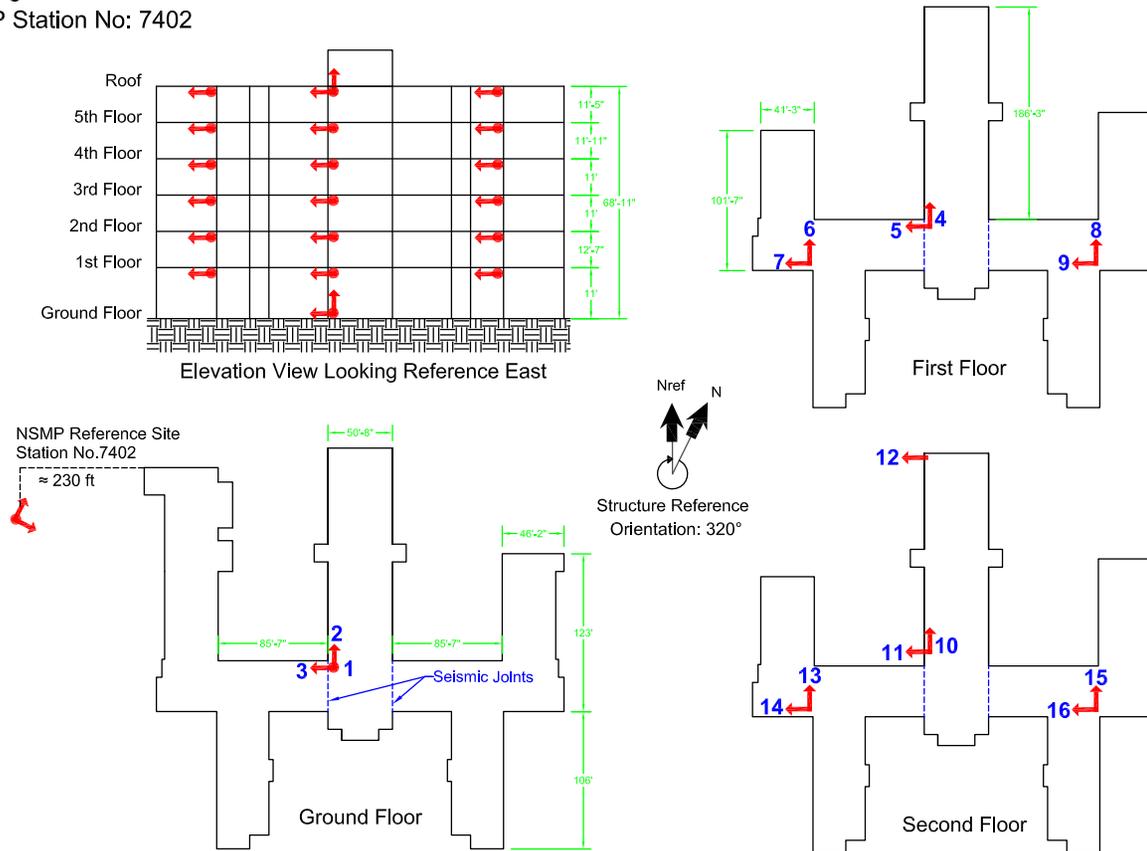
U.S. Department of Veterans Affairs
 Poplar Bluff, MO - Reinforced Concrete, Six-Story Hospital Building
 Building No: 1
 NSMP Station No: 7402

Figure 58. Diagrams of sensor layout showing 48 sensors in Building 1 of the Poplar Bluff Veterans Affairs Medical Center, Missouri (page 1 of 2; see also fig. 59).

A total of 48 accelerometers are placed in the building at different levels and locations to measure the significant response of the building during an earthquake (fig. 58 and fig. 59). The accelerometers are placed in the critical corners of the building so that both the lateral and torsional responses can be measured and computed. A triaxial accelerometer (channels 1 through

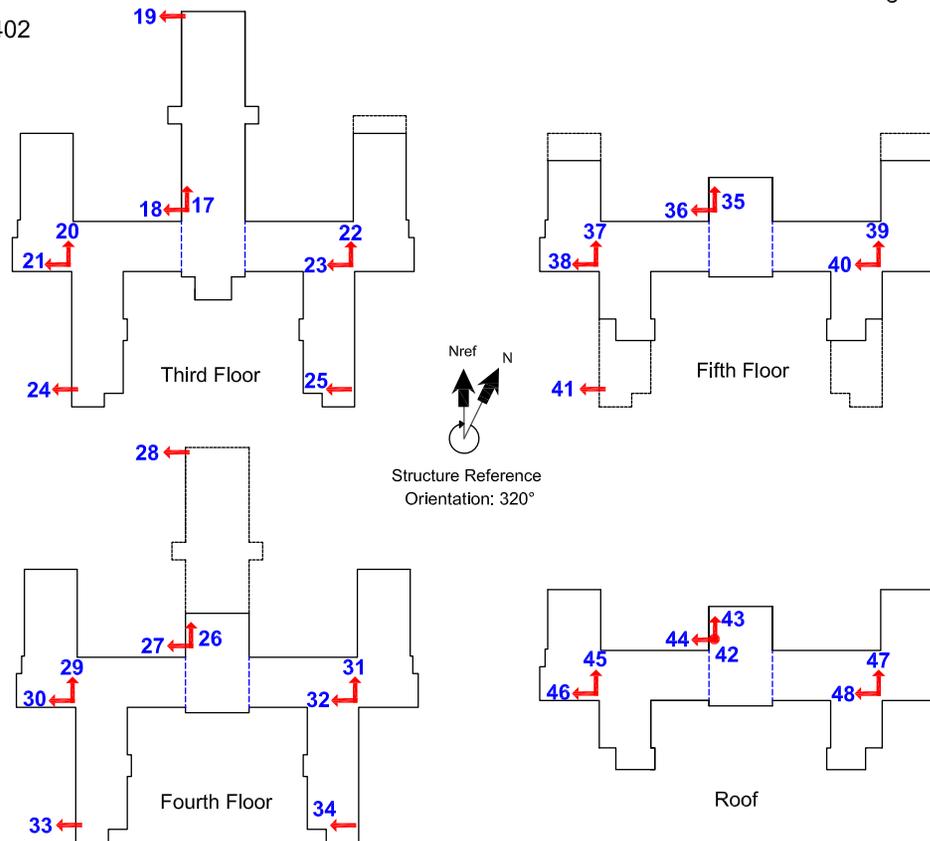
Figure 59. Diagrams of sensor layout showing 48 sensors in Building 1 of the Poplar Bluff Veterans Affairs Medical Center, Missouri (page 2 of 2; see also fig. 58).

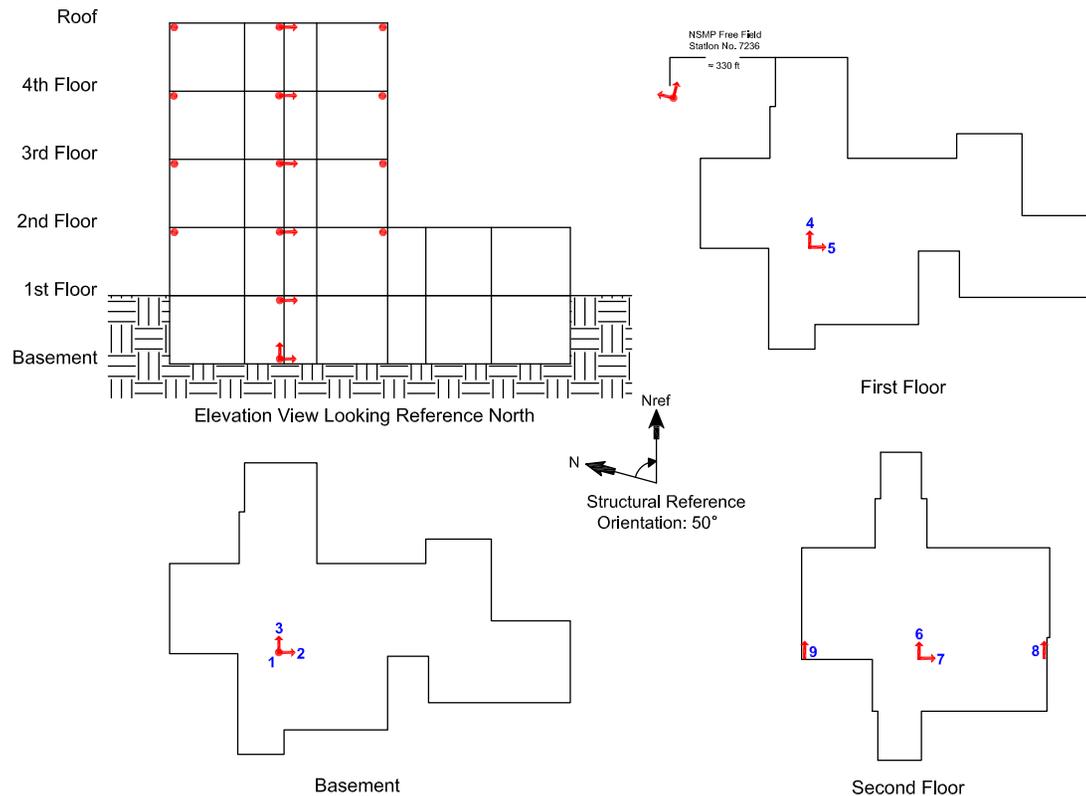
Figure 66. Diagrams of sensor layout showing 24 sensors in Building 154 of the Fort Harrison Veterans Affairs Medical Center, Montana (page 1 of 2; see also fig. 67).

A total of 24 accelerometers are deployed in the building to measure its response to ground motion (fig. 66 and fig. 67). A triaxial accelerometer (channels 1 through 3) is placed on the basement to measure the input ground motion. Two accelerometers (channels 4 and 5) are placed on the ceiling of the basement to monitor first-floor diaphragm motion in two orthogonal directions. Four accelerometers (channels 6 through 9) are placed on the ceiling of the first floor to measure floor lateral motion of the second floor. Another 15 accelerometers (channels 10 through 23) are distributed on the ceiling of the second, third, and fourth floors. The accelerometers are placed at the same corner of the building at each level so that the relative floor displacements, and thus inter-story drifts, can be obtained. Floor torsional motion can be obtained from any pair of two likewise oriented accelerometers located on the same floor. Channels 13, 18, and 23 together with channels 10, 15, and 20 will be used to compute the relative motion of the west wing with respect to the main structure.

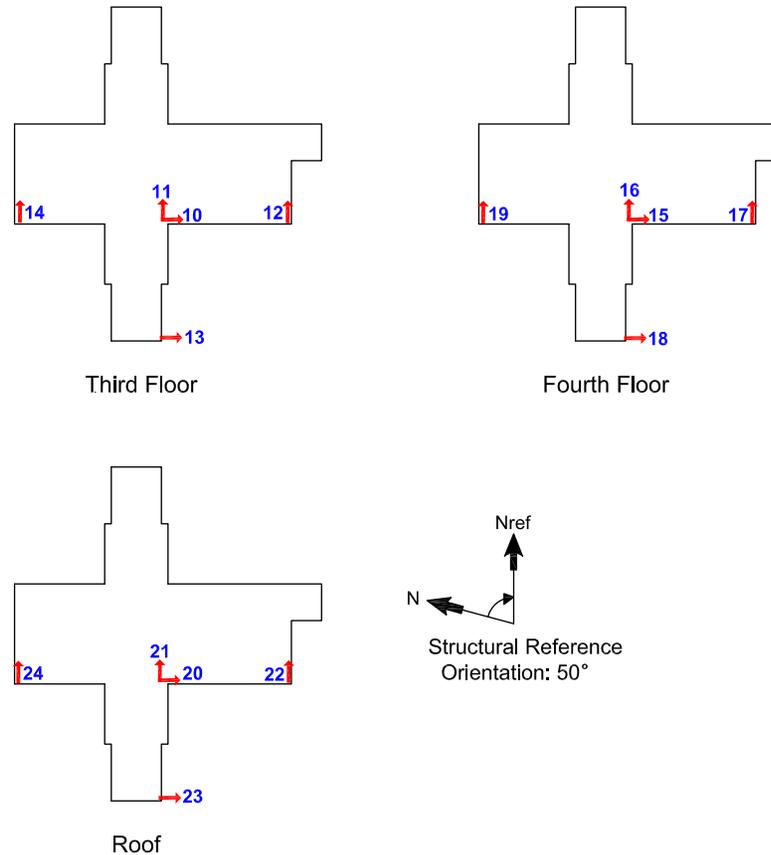
Figure 67. Diagrams of sensor layout showing 24 sensors in Building 154 of the Fort Harrison Veterans Affairs Medical Center, Montana (page 2 of 2; see also fig. 66).

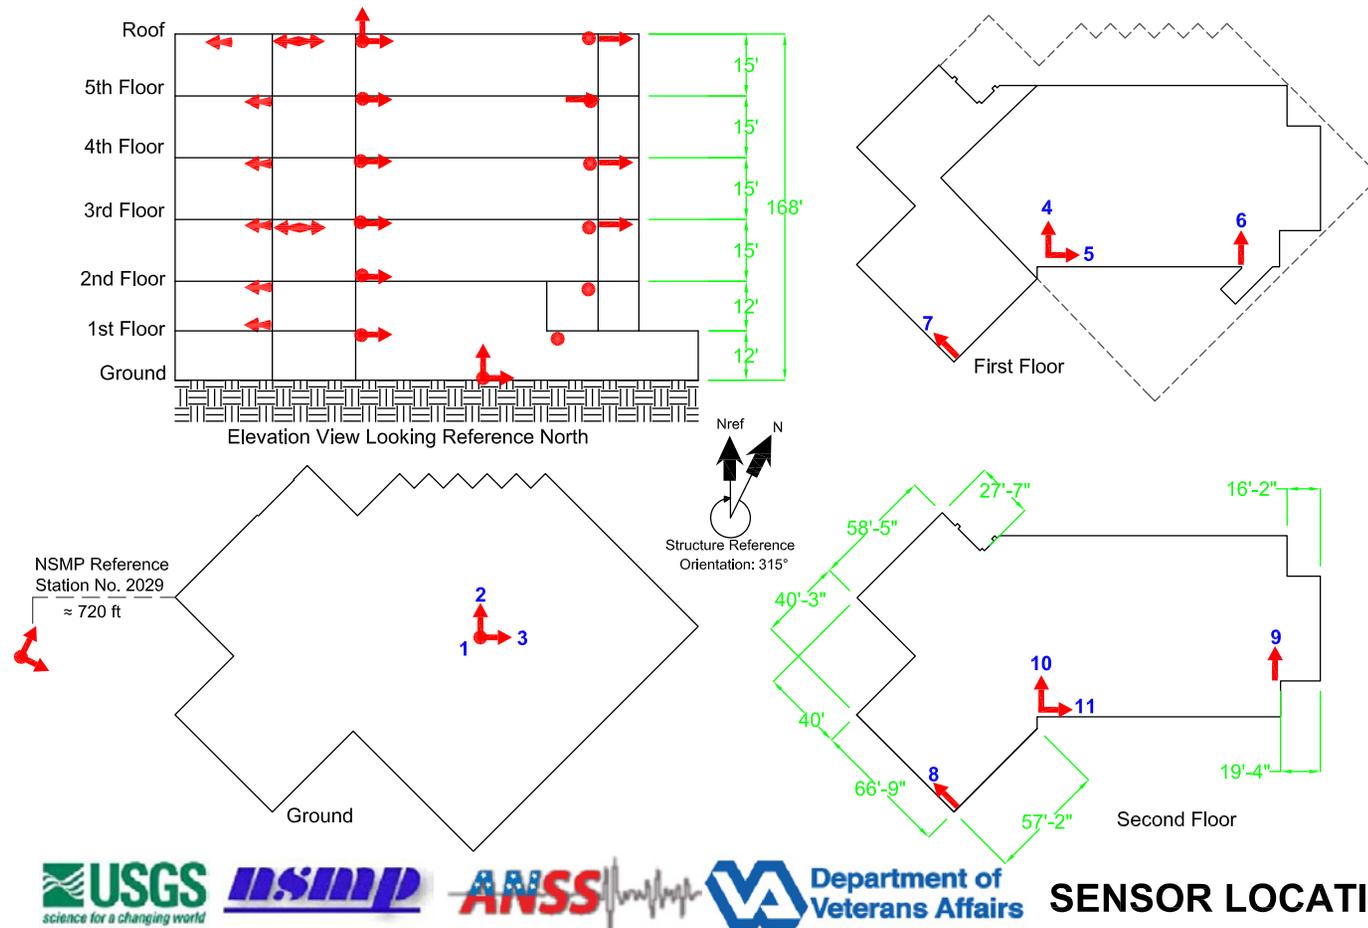
Figure 71. Diagrams of sensor layout showing 36 sensors in Building 12 of the Reno Veterans Affairs Medical Center, Nevada (page 1 of 2; see also fig. 72).

This steel building has an unsymmetrical plan; therefore, significant torsion is expected to occur under strong ground shaking. To capture the building's lateral, vertical and torsional response, 36 accelerometers are distributed strategically in the building (fig. 71 and fig. 72). At the ground level, a triaxial accelerometer (channels 1 through 3) is used to record base-level ground shaking in two horizontal and a vertical direction. Four accelerometers (channels 4 through 7) are located at the first-floor level to measure the building's response in two horizontal directions and compute floor torsional motion. The higher floors are instrumented likewise. The floor relative displacements can be computed from the recordings of the accelerometers located at the same corner of the building at different levels.

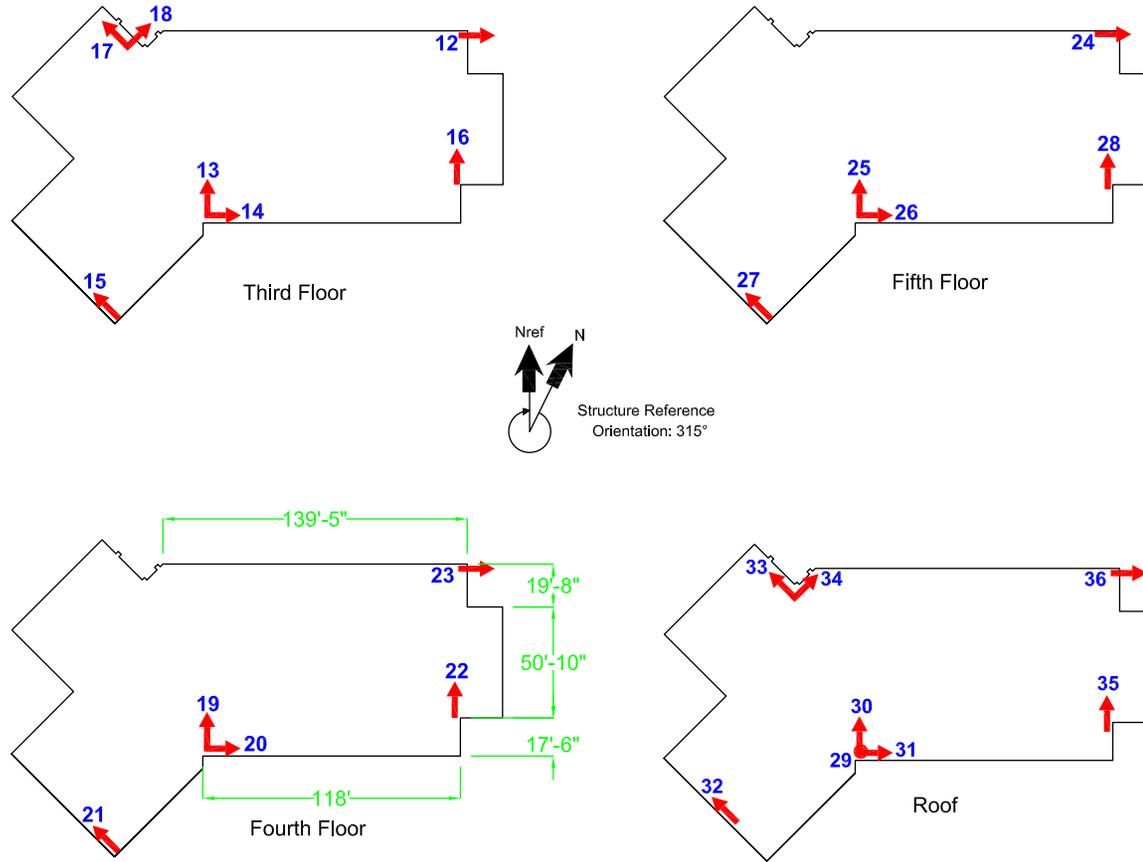
Figure 72. Diagrams of sensor layout showing 36 sensors in Building 12 of the Reno Veterans Affairs Medical Center, Nevada (page 2 of 2; see also fig. 71).

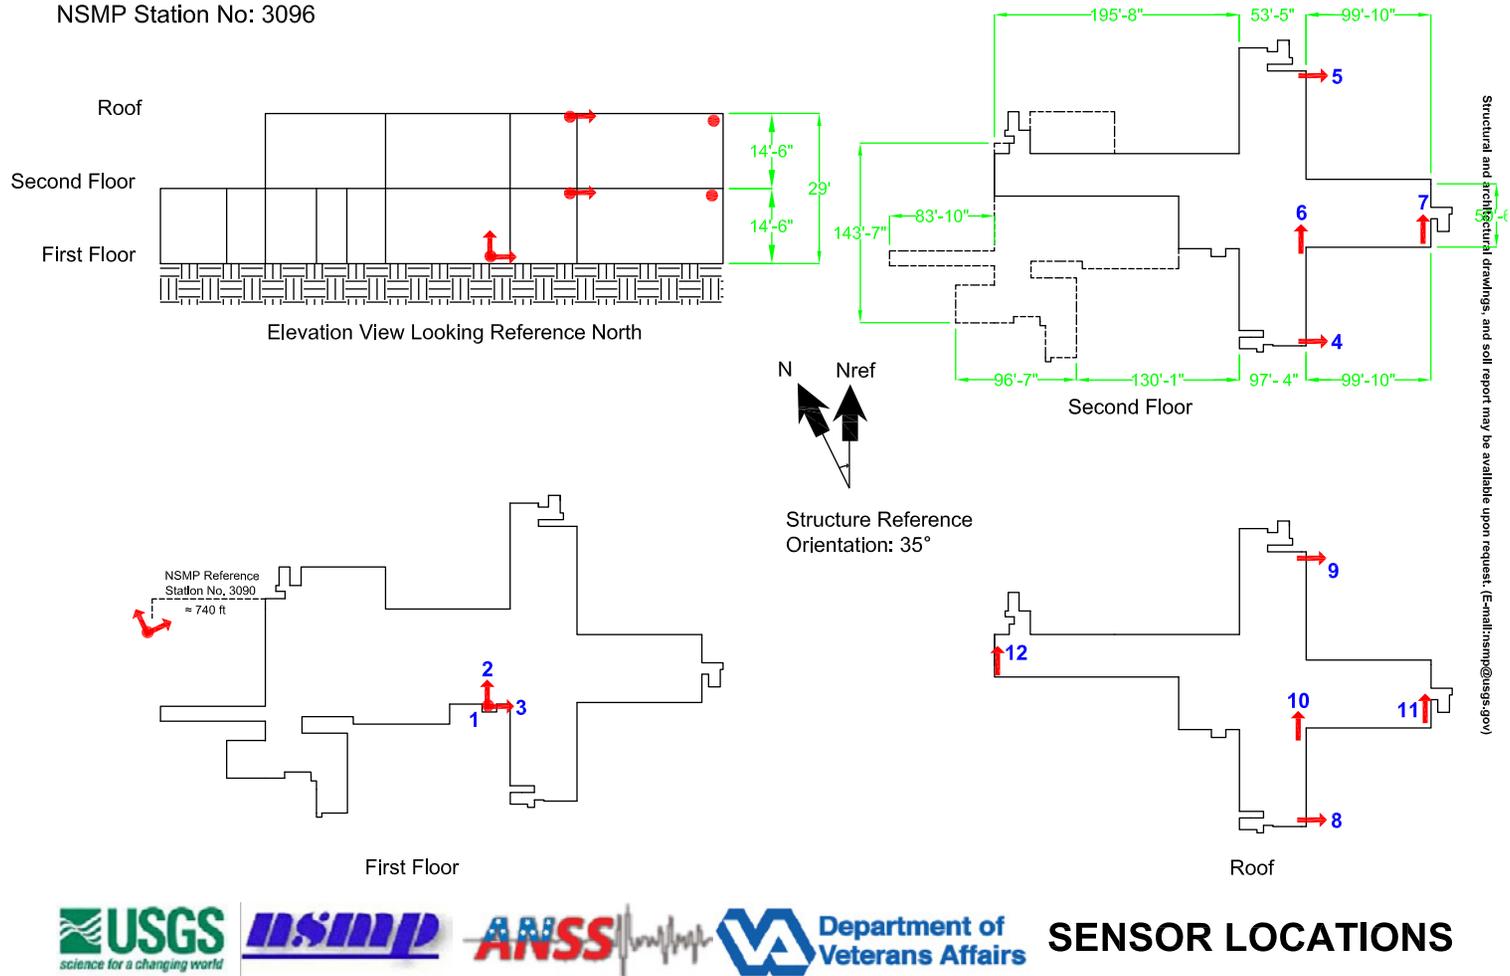
U.S. Department of Veterans Affairs
 San Juan, Puerto Rico - Reinforced Concrete, Two-Story Hospital Building
 Building No: 10
 NSMP Station No: 3096

Figure 76. Diagram of sensor layout showing 12 sensors in Building 10 of the Photograph of Building 10, San Juan Caribbean Veterans Affairs Medical Center, Puerto Rico.

The building has two stories and a T-shape plan with three wings. To monitor translational and torsional responses of all three wings during a strong shaking, 12 accelerometers are located strategically throughout the building (fig. 76). A triaxial accelerometer (channels 1 through 3) is placed on the first-floor ground level. Four accelerometers (channels 4 through 7) are placed on the first-floor ceiling level to monitor second-floor diaphragm motion. Another five accelerometers (channels 8 through 12) are placed on the second-floor ceiling level to measure floor lateral and torsional motions of the roof.

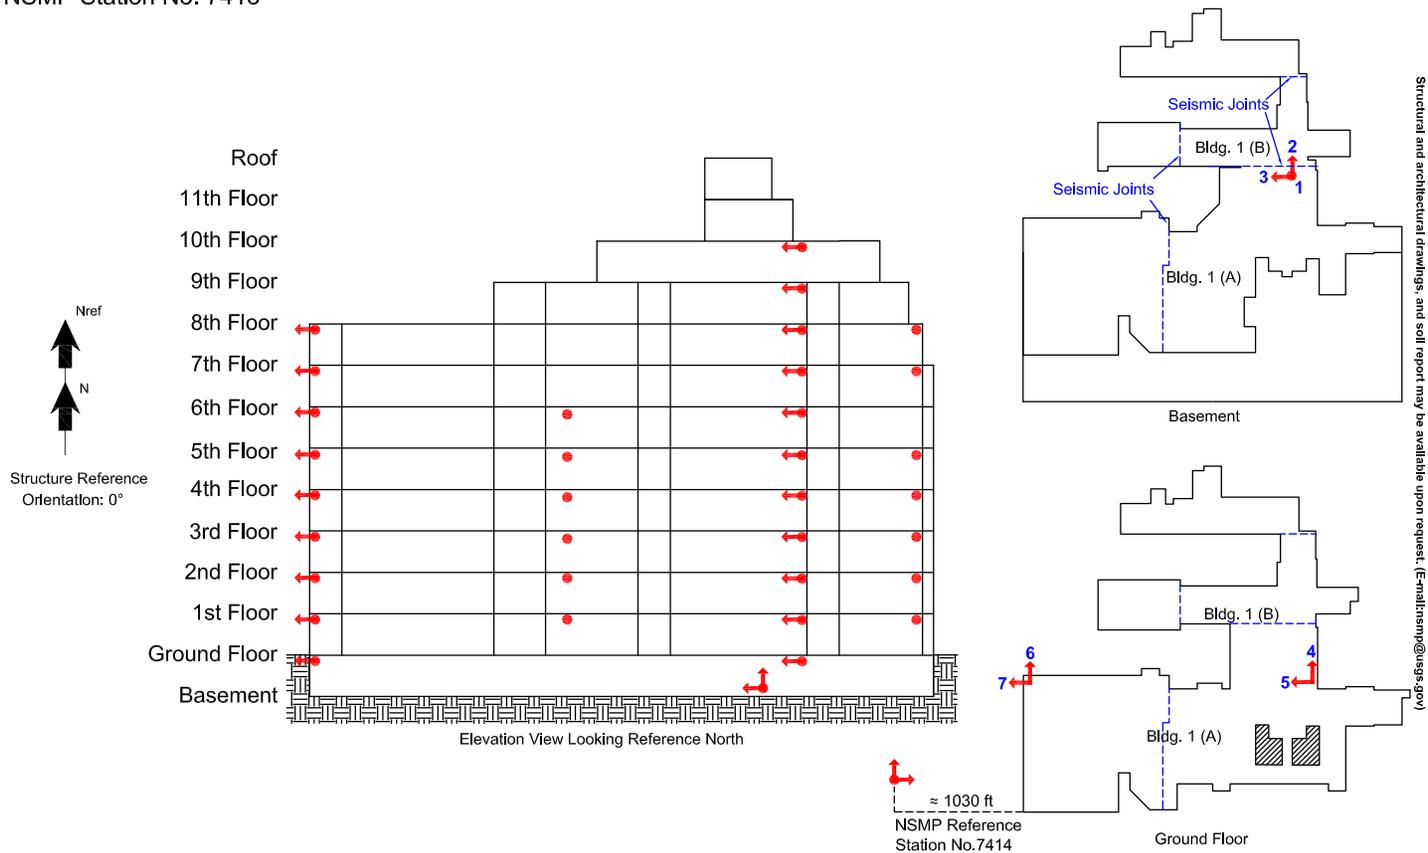
U.S. Department of Veterans Affairs
 Oklahoma City, OK - Steel Moment Frame, Twelve-Story Hospital Building
 Building No: 1
 NSMP Station No: 7413

Figure 85. Diagrams of sensor layout showing 96 sensors in Building 1 of the Oklahoma City Veterans Affairs Medical Center, Oklahoma (page 1 of 3; see also figs. 86 and 87).

Building 1 consists of several major blocks separated by four major seismic joints. A total of 60 accelerometers are deployed in the building at each floor level to measure the significant response of the building during strong shaking (fig. 85 through fig. 87). The accelerometers are placed in the critical corners of each block so that both the lateral and torsional responses can be measured and computed. A triaxial accelerometer (channels 1 through 3) is placed on the basement slab to measure the three components of input ground motion. Every floor of each major block is instrumented by at least three accelerometers to monitor lateral movement of each major block.

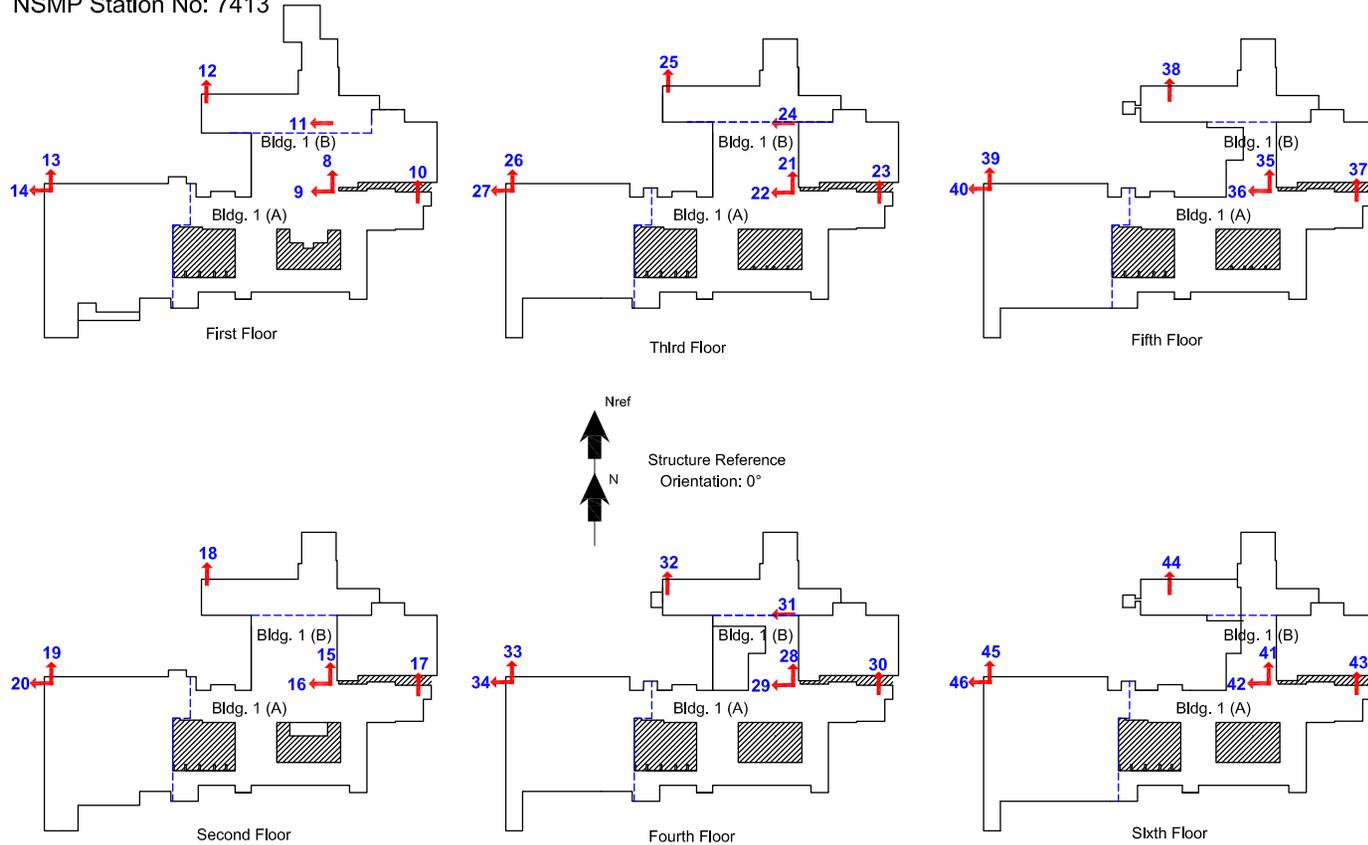
Figure 86. Diagrams of sensor layout showing 96 sensors in Building 1 of the Oklahoma City Veterans Affairs Medical Center, Oklahoma (page 2 of 3; see also figs. 86 and 87).

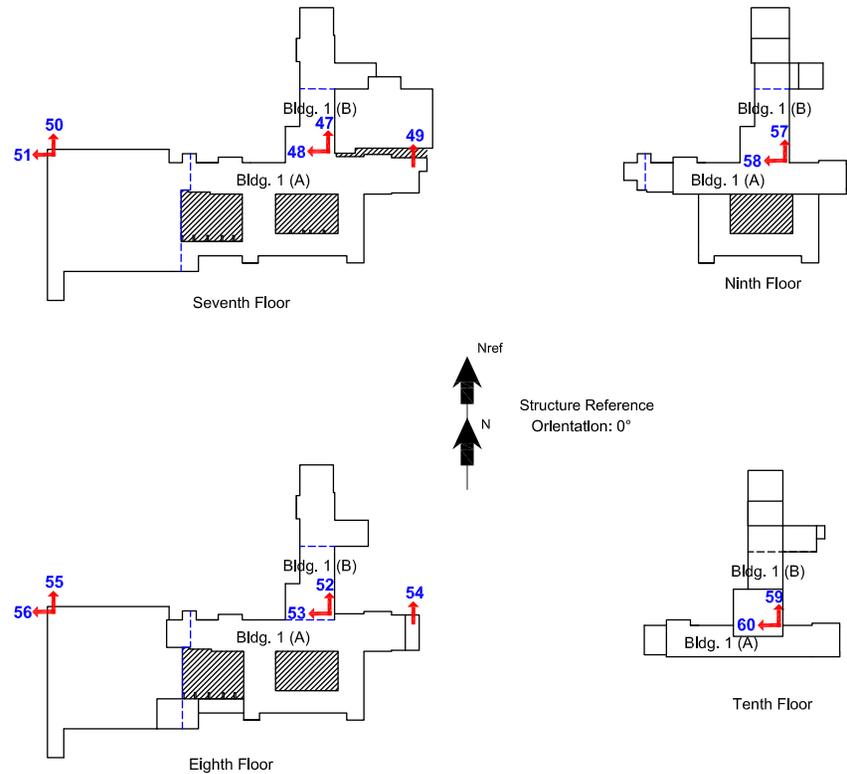
Figure 87. Diagrams of sensor layout showing 96 sensors in Building 1 of the Oklahoma City Veterans Affairs Medical Center, Oklahoma (page 3 of 3; see also figs. 85 and 86).

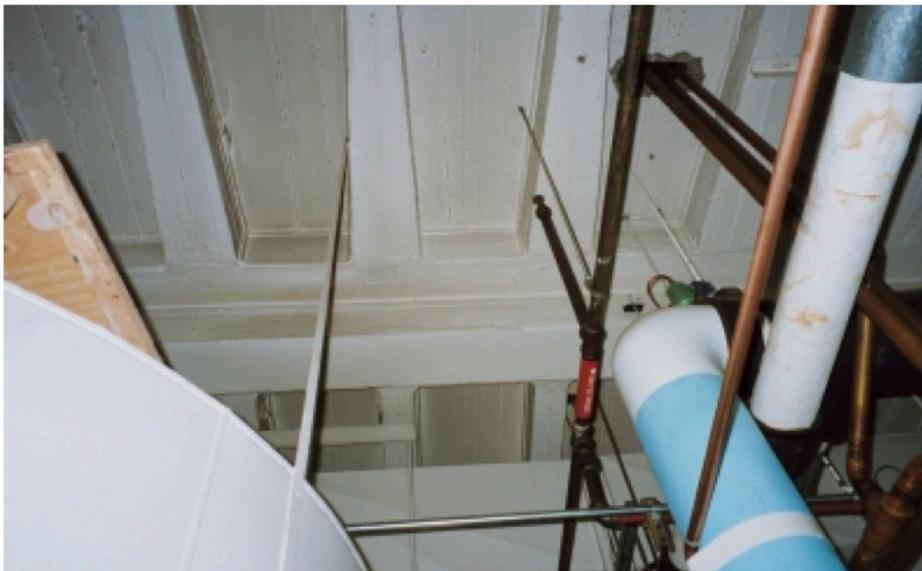
Figure 90. Photograph of typical floor slab, viewed from below, in Building 1, Roseburg Veterans Affairs Medical Center, Oregon (U.S. Department of Veterans Affairs photograph).

The floors consist of concrete pan joist slabs (fig. 90) that are supported by reinforced-concrete beams and columns. The main roof and penthouse roof are wood framed (fig. 91), supported at the perimeter by concrete beams, and supported on the interior with structural steel beams and posts. The interior and exterior columns are founded on individual spread footings, and the masonry walls are founded on concrete strip footings. The ground floor consists of the unfinished basement.

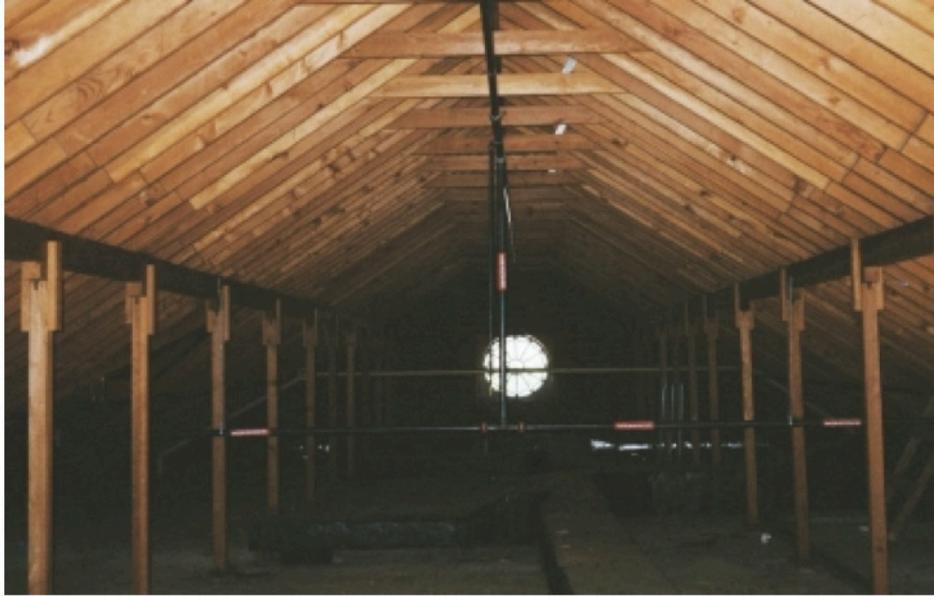
Figure 91. Photograph of roof framing in Building 1, Roseburg Veterans Affairs Medical Center, Oregon (U.S. Department of Veterans Affairs photograph).

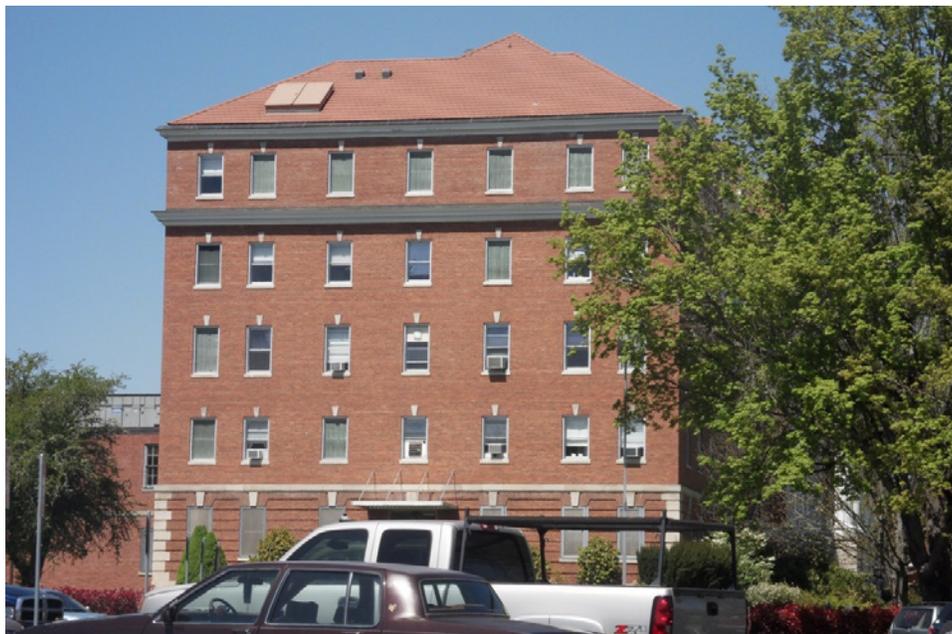
Figure 92. Photograph of Building 1, Roseburg Veterans Affairs Medical Center, Oregon (looking north) (U.S. Geological Survey photograph).

The building's lateral-force resisting system consists of a nonductile reinforced concrete frame with 8-inch thick perimeter infill walls of unreinforced brick masonry (fig. 92). The perimeter masonry infill walls have many openings. The concrete walls below the ground floor around the perimeter transfer lateral loads to the foundation. The floor diaphragms are reinforced concrete slabs that typically span between the interior columns and exterior masonry walls. The roof diaphragm consists of one layer of straight sheathing and spans between the perimeter walls and interior lines of wood framing that are braced with wood posts.
