Advanced Earthquake Monitoring System for U.S. Department of Veterans Affairs Medical Buildings—Instrumentation

Open-File Report 2012–1241

U.S. Department of the Interior
U.S. Geological Survey

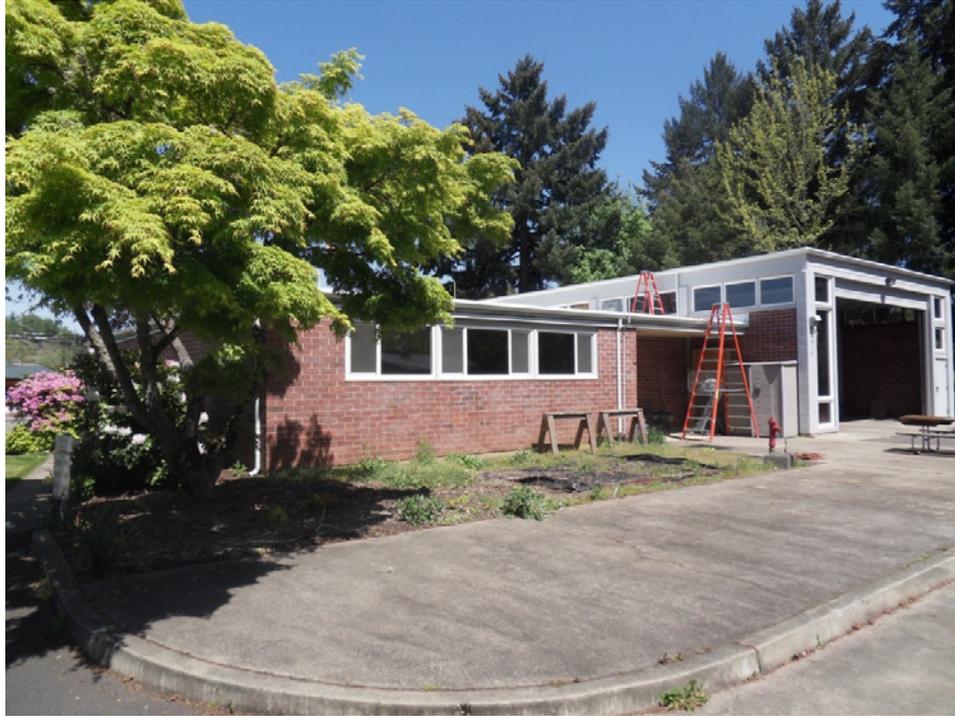
Figure 93. Photograph of reference station to measure ground shaking on Roseburg Veterans Affairs Medical Center, Oregon, away from Building 1 (U.S. Geological Survey photograph).

The building accelerometers are complemented by a three-component seismic accelerometer located at a reference site (NSMP Station No. 7058), approximately 1,410 ft away from the building, to monitor ground shaking without interference from the earthquake response of the building (fig. 93).

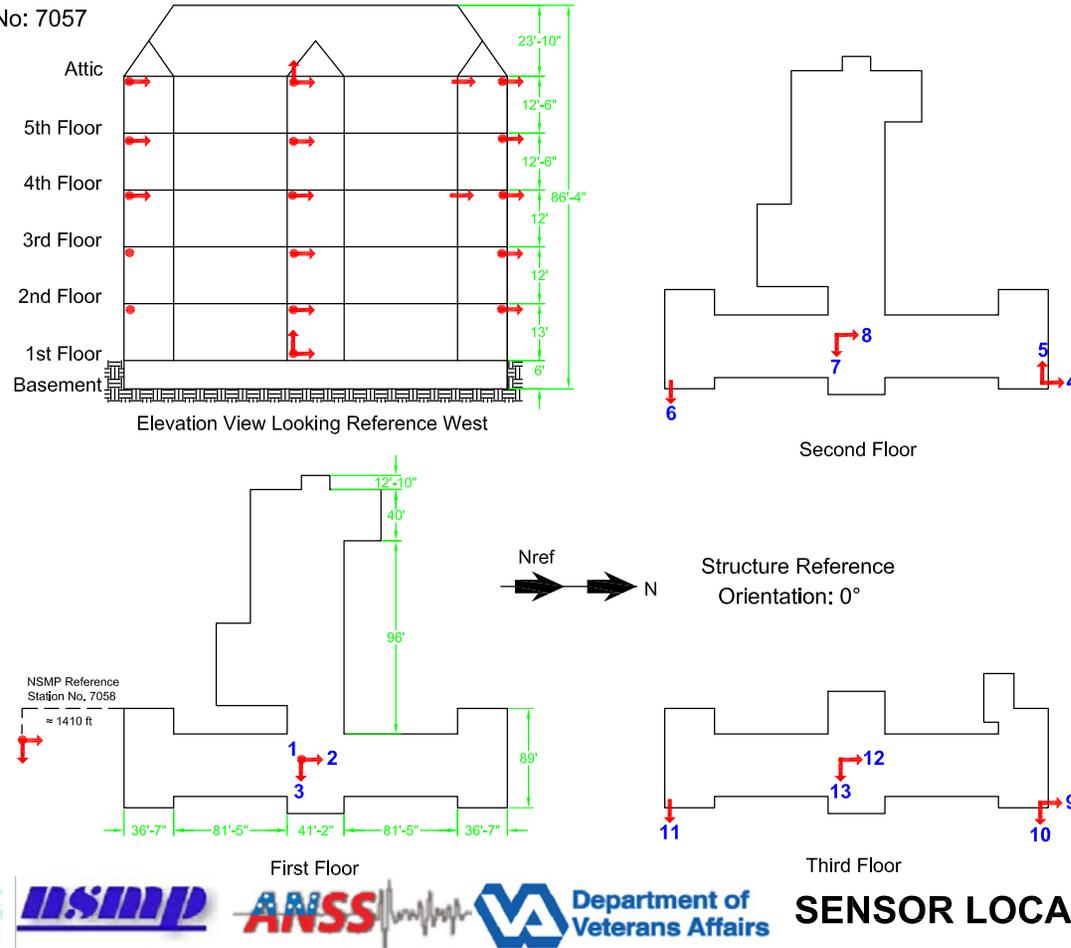
U.S. Department of Veterans Affairs
 Roseburg, OR - Reinforced Concrete/Masonry, Five-Story Hospital Building
 Building No:1
 NSMP Station No: 7057

Figure 94. Diagrams of sensor layout showing 36 sensors in Building 1 of the Roseburg Veterans Affairs Medical Center, Oregon, (page 1 of 2; see also fig. 95).

A total of 36 accelerometers are deployed in the building (fig. 94 and fig. 95). A triaxial accelerometer (channels 1 through 3) is placed on the first-floor ground level to measure the three components of input ground motion. The first- and second-floor ceilings are instrumented with five accelerometers each (channels 4 through 13) to measure floor lateral motion and

compute floor and torsional motion. Eight accelerometers (channels 14 through 21) are placed on the third-floor ceiling to monitor forth floor diaphragm motion. The fifth floor ceiling is monitored by six accelerometers—three are oriented in the reference east-west direction and three sensors are oriented in the reference north-south direction. A triaxial accelerometer (channels 28 through 30) together with six other accelerometers (channels 31 through 36) is placed on the fourth-floor ceiling level to measure floor lateral and vertical motion at the roof level. This added vertical sensor will allow for studying vertical wave propagation in the building.

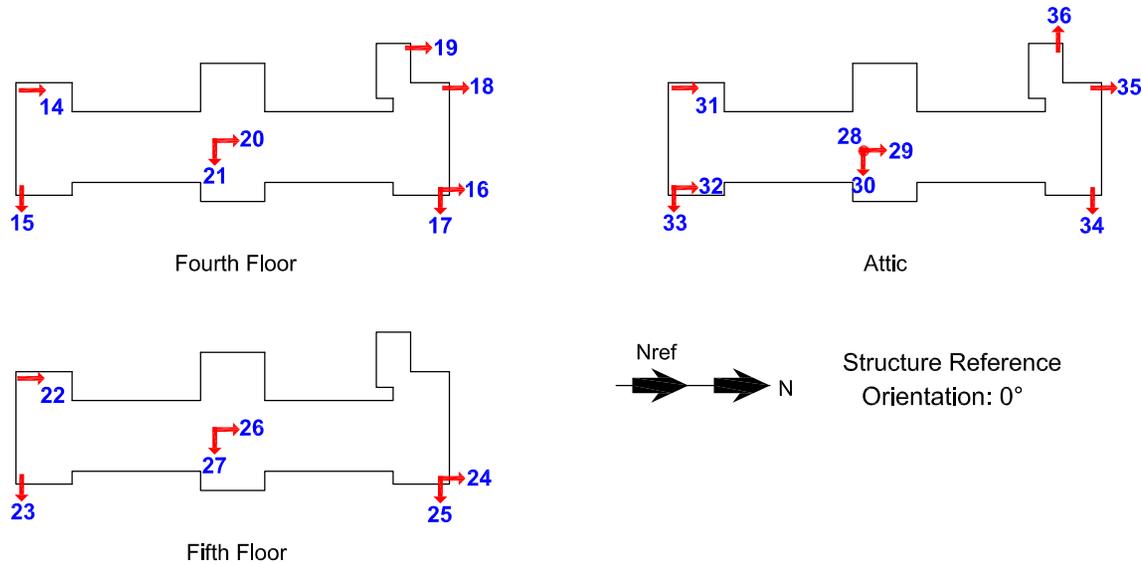
Figure 95. Diagrams of sensor layout showing 36 sensors in Building 1 of the Roseburg Veterans Affairs Medical Center, Oregon, (page 2 of 2; see also fig. 94).

95. Diagrams of sensor layout showing 36 sensors in Building 1 of the Roseburg Veterans Affairs Medical Center, Oregon, (page 2 of 2; see also fig. 94).....	96

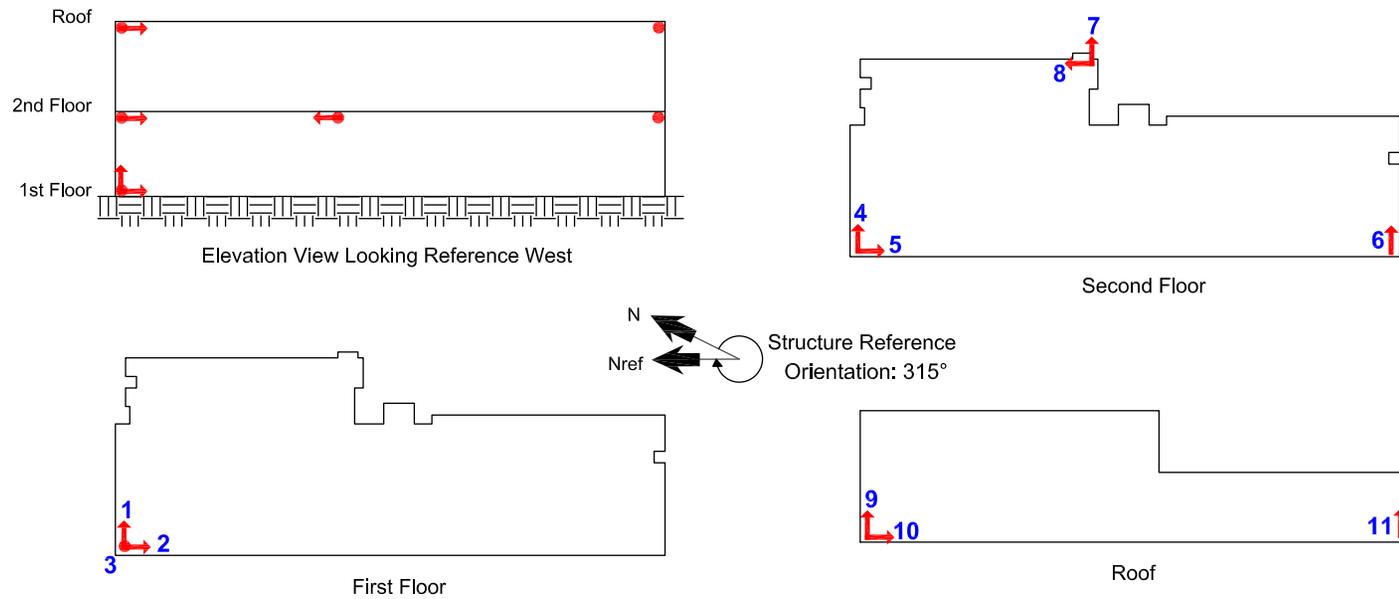
Figure 99. Diagram of sensor layout showing 11 sensors in Building 201 of the White City Veterans Affairs Medical Center, Oregon.

A total of 11 accelerometers are deployed in the building to measure its lateral motion (fig. 99). A triaxial accelerometer is placed on the first-floor ground level to measure the three components of input ground motion. Eight accelerometers are distributed at the corners of the building to measure floor translational motion and compute floor torsional response to input ground shaking. Five accelerometers (channels 4 through 8) are placed on the first-floor ceiling level to monitor the second floor. The second-floor ceiling is equipped with three accelerometers (channels 9 through 11) to measure roof-diaphragm motions. The floor relative displacement can be computed from the accelerometers located at the same corners of the building. Floor torsional motion can also be obtained from two likewise oriented accelerometers at the same level.

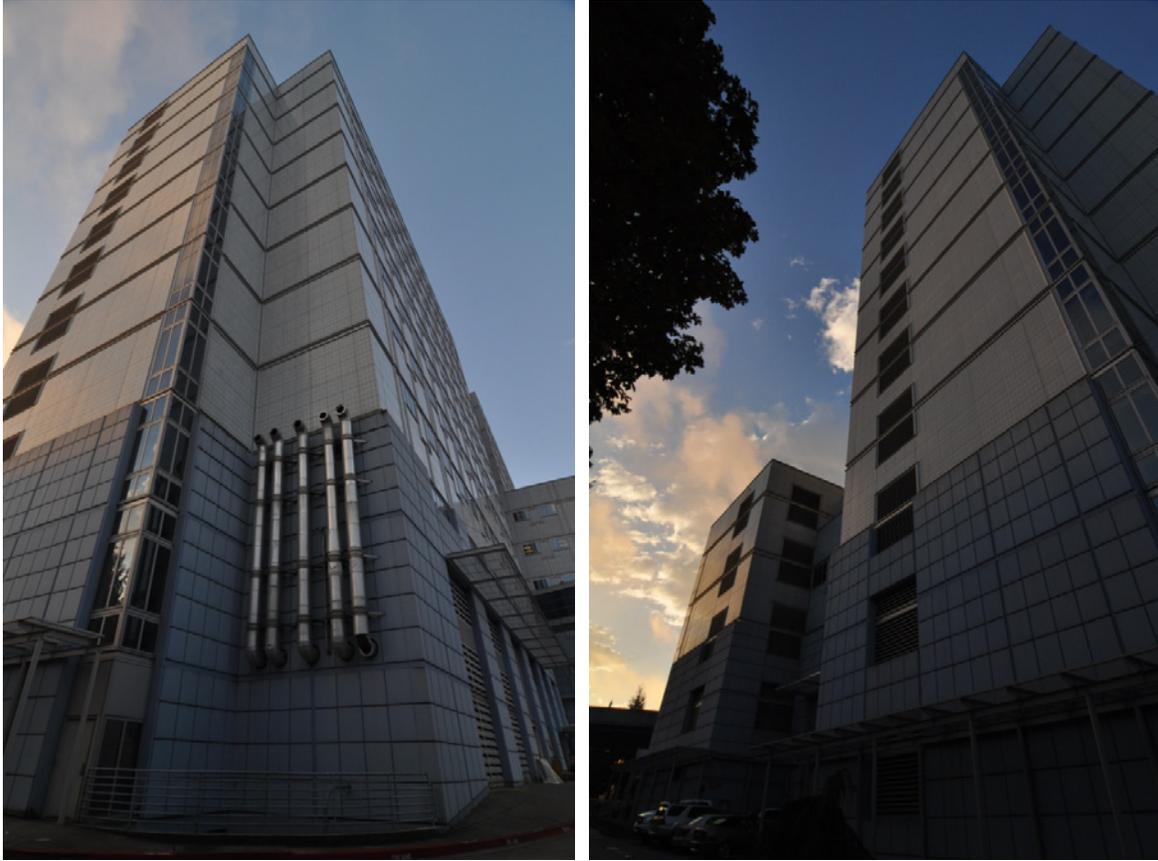
Figure 101. Photographs of Building 100, Portland Veterans Affairs Medical Center, Oregon (side views) (U.S. Geological Survey photograph).

The gravity system consists of main floors and roof composed of concrete on metal decking supported by steel beams and columns. The interstitial floors are lightweight vermiculite concrete suspended from the main floors above and (or) connected to the columns at the interstitial level. In addition, the floors are connected to the braces themselves where braced frames pierce the interstitial floors. The foundation system is steel-pipe piles with reinforced concrete pile caps connected by reinforced concrete grade beams.

The building's lateral-force resisting system consists of steel-braced frames that transfer lateral loads to the pile foundations. The main floor and roof diaphragms are reinforced concrete on metal decking with 3/4-inch-diameter stud connections. The exterior face of the building consists of ceramic veneer wall panels and glass.

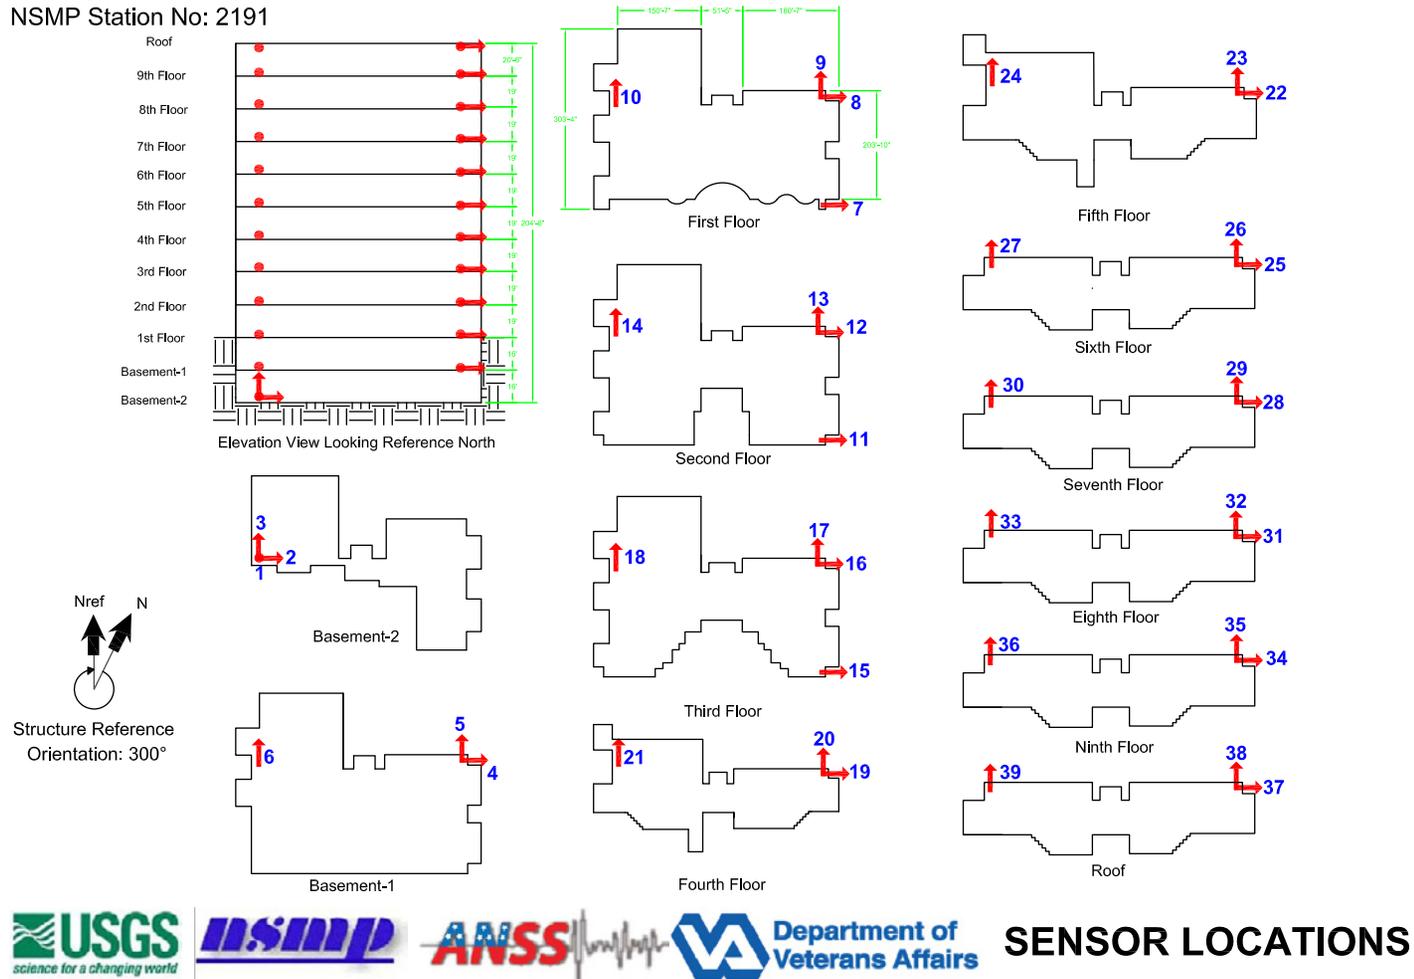
U.S. Department of Veterans Affairs
 Portland, OR - Steel Moment Frame, Nine-Story Hospital Building
 Building No: 100
 NSMP Station No: 2191

Figure 102. Diagram of sensor layout showing 39 sensors in Building 100 of the Portland Veterans Affairs Medical Center, Oregon.

A total of 39 accelerometers are deployed at 12 levels in the building (fig. 102). A triaxial accelerometer (channels 1 through 3) is placed on the basement level 2 to measure the input ground motion. Three accelerometers (channels 4 through 6) are placed on the ceiling of the basement level 2. Twelve accelerometers (channels 7 through 18) are similarly distributed on the ceilings of basement level 1 and the first and second floors to monitor slab motions. The accelerometers are located near the floor edges and oriented parallel to the building sides. The total area of the upper floors is smaller than the lower levels; therefore, upper floors are

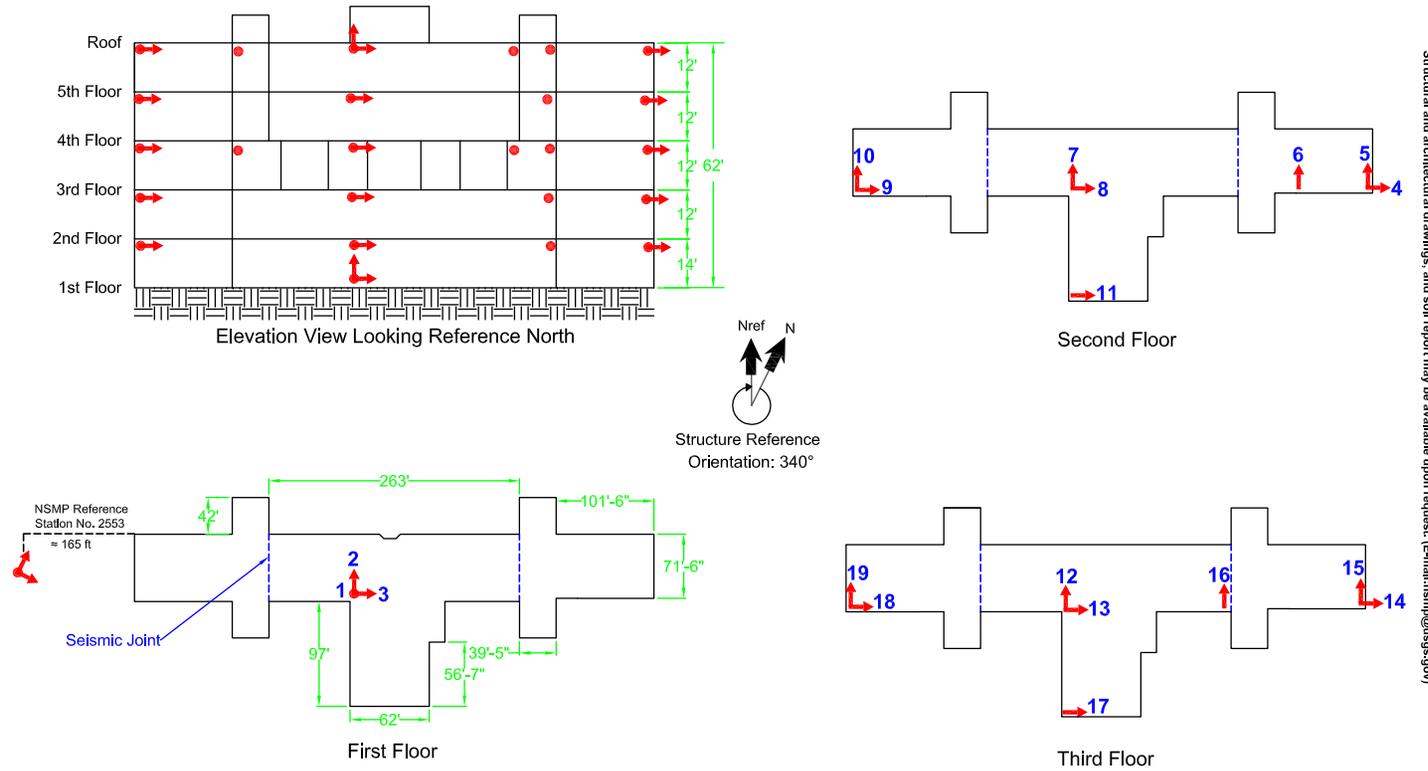
U.S. Department of Veterans Affairs
 Charleston, SC - Reinforced Concrete, Five-Story Hospital Building
 Building No: 1
 NSMP Station No: 2561

Figure 106. Diagrams of sensor layout showing 48 sensors in Building 1 of the Charleston Veterans Affairs Medical Center, South Carolina (page 1 of 2; see also fig. 107).

measure its response to ground shaking (fig. 106 and fig. 107). The accelerometers are strategically located at the corners of the building at each floor level to measure translational motion and compute torsional responses of each block and wing. A triaxial accelerometer (channels 1 through 3) is placed on the ground-floor level to measure the three components of input ground motion. Eight accelerometers (channels 4 through 11) are placed on the ground-floor ceiling level to monitor the first-floor slab. Thirty-seven accelerometers are similarly distributed on the ceilings of the first through the fifth floors to measure the translational motions of the slabs. At least three accelerometers are placed on the each floor so that floor torsional motion can be computed. For each block, the floor relative displacements, thus inter-story drifts, can be obtained at two different points along the same vertical axis.

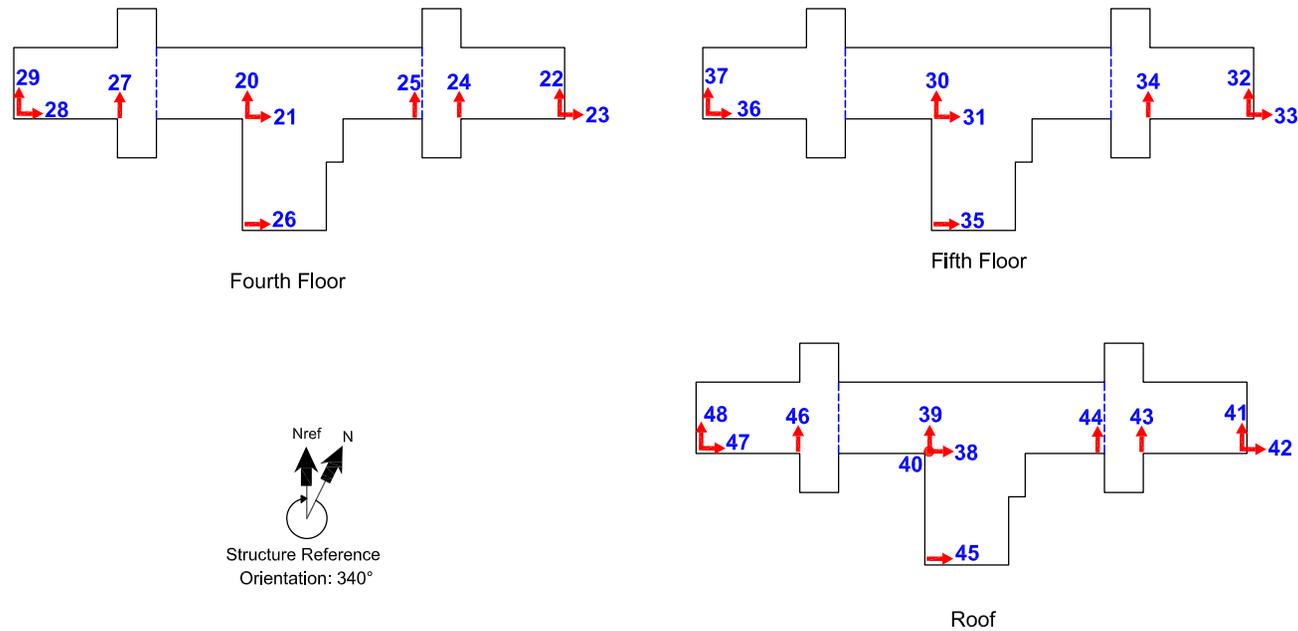
Figure 107. Diagrams of sensor layout showing 48 sensors in Building 1 of the Charleston Veterans Affairs Medical Center, South Carolina (page 2 of 2; see also fig. 106).

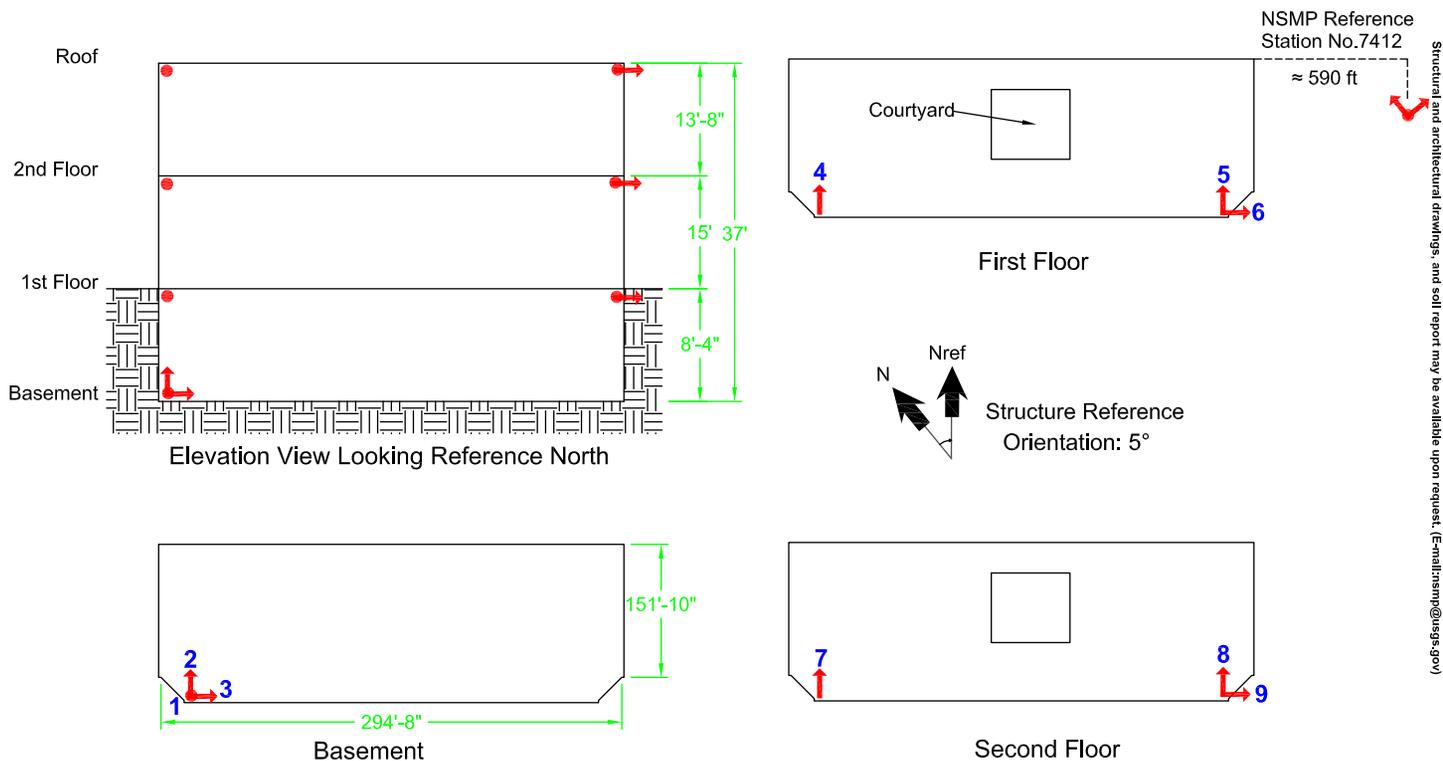
Figure 111. Diagrams of sensor layout showing 12 sensors in Building 7 of the Memphis Veterans Affairs Medical Center, Tennessee (page 1 of 2; see also fig. 112).

A total of 12 accelerometers are deployed in the building to measure its lateral motion in reference east-west and north-south directions (fig. 111 and fig. 112). A triaxial accelerometer (channels 1 through 3) is placed on the basement slab to measure the three components of input ground motion. Nine accelerometers (channels 4 through 12) are placed on the ceilings of the basement, first, and second floors to measure slab lateral motions. The reference southwest corner of the building has an accelerometer (channels 4, 7, and 10) oriented in the weak direction at each floor level. The relative floor displacement, thus inter-story drifts, at this corner can be computed from these accelerometers. Similarly, the reference southeast corner of the building has two accelerometers (channels 5, 6, 8, 9, 11, and 12) at each floor so that the floor relative displacement at this corner can be computed. The floor torsion can be obtained from two likewise oriented accelerometers on the same floor.

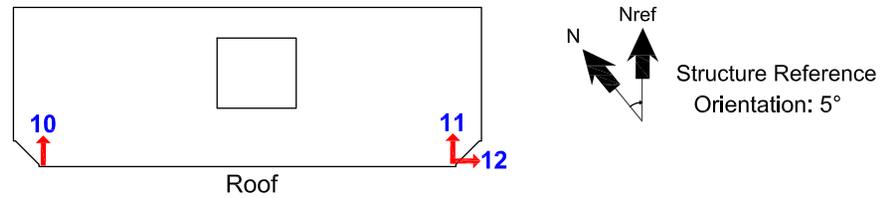
Figure 112. Diagrams of sensor layout showing 12 sensors in Building 7 of the Memphis Veterans Affairs Medical Center, Tennessee (page 2 of 2; see also fig. 111).

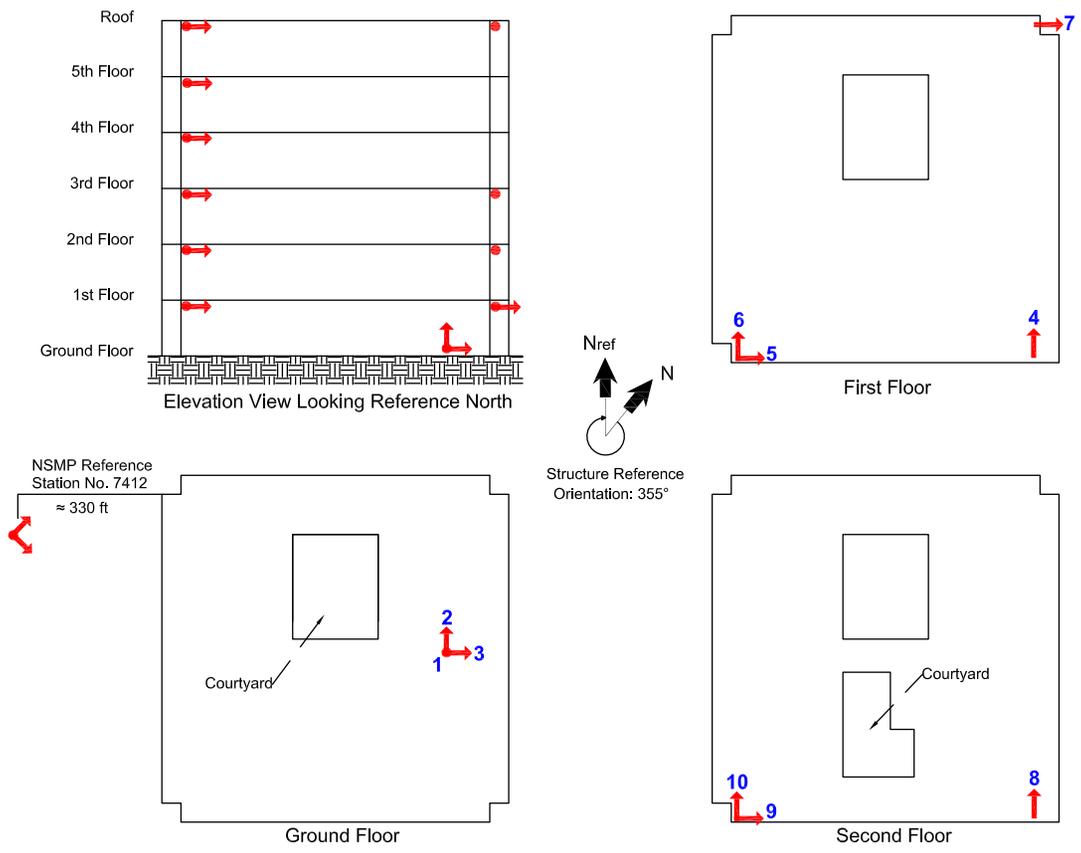
Figure 116. Diagrams of sensor layout showing 24 sensors in Building 1A of the Memphis Veterans Affairs Medical Center, Tennessee (page 1 of 3; see also figs. 117 and 118).

A total of 24 accelerometers are deployed at seven levels in the building (fig. 116 through fig. 118). A triaxial accelerometer (channels 1 through 3) is placed on the ground floor to measure the three components of input ground motion. The accelerometers are placed at the corners of the building oriented parallel the building's sides. Four accelerometers (channels 4 through 7) are placed on the ceiling of the basement to measure the building response at three corners. The first-floor ceiling is instrumented with three accelerometers (channels 8 through 10). Four accelerometers (channels 11 through 14) are placed on the ceiling of the second floor at three corners to measure floor lateral response in the reference east-west and north-south directions. The ceilings of the third and fourth floor are similarly instrumented with three accelerometers each to monitor slab movement. Four accelerometers are placed on the fifth-floor ceiling level to measure roof lateral motion. The floor torsional motion can be obtained from two likewise oriented accelerometers on the same floor. The floor relative displacements and inter-story drifts can be computed from the accelerometers located at the same corner of the building along the same vertical axis.

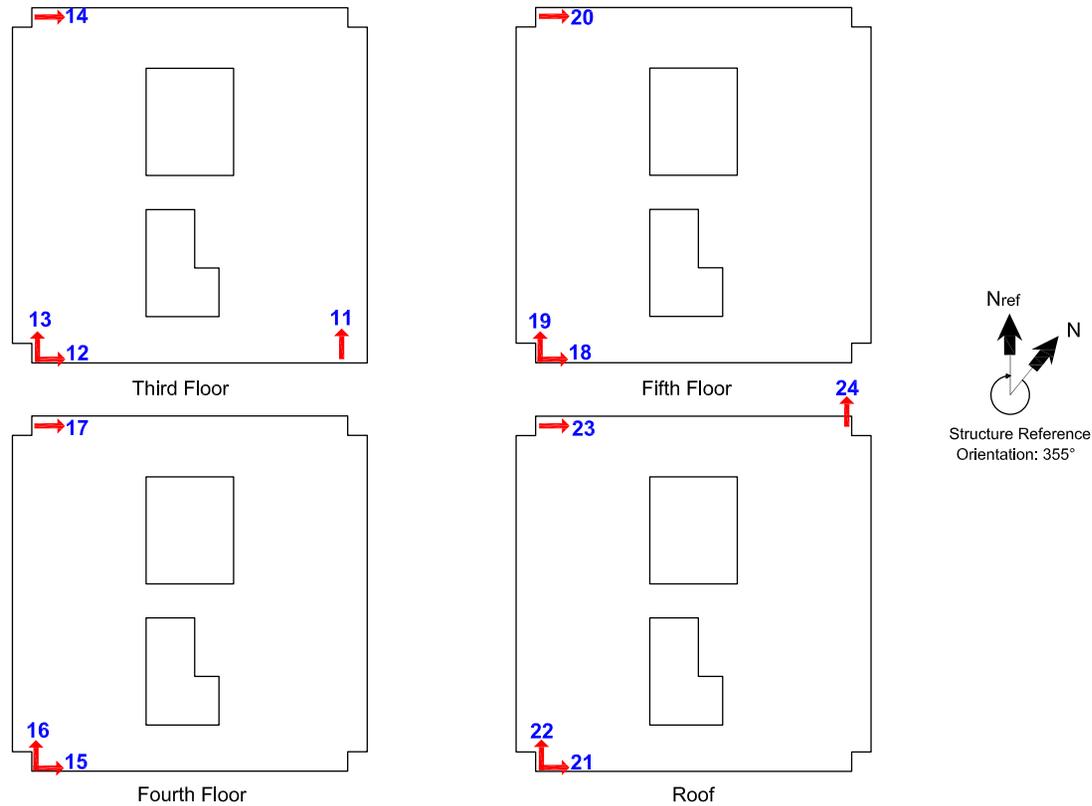
Figure 117. Diagrams of sensor layout showing 24 sensors in Building 1A of the Memphis Veterans Affairs Medical Center, Tennessee (page 2 of 3; see also figs. 116 and 118).

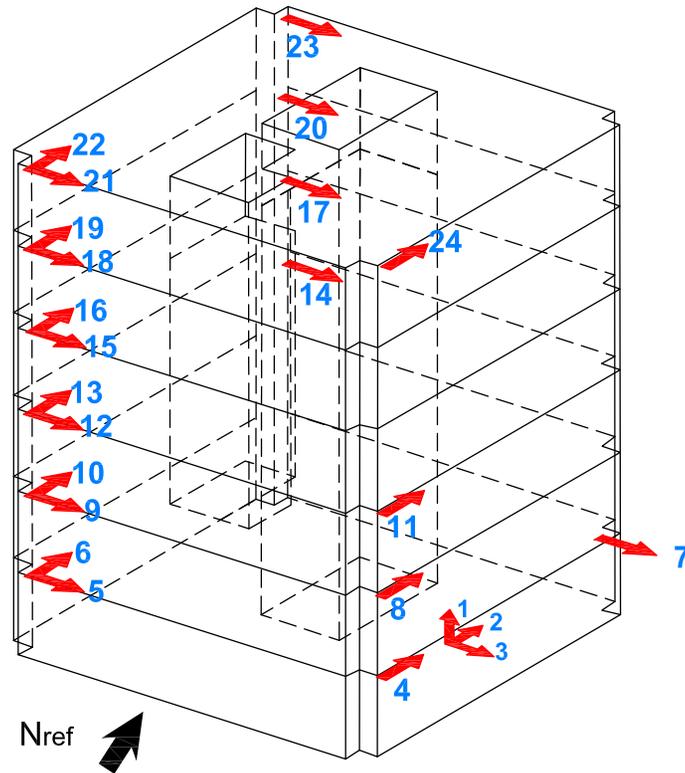
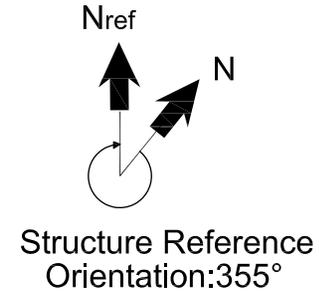
3-D Elevation View

Figure 118. Diagrams of sensor layout showing 24 sensors in Building 1A of the Memphis Veterans Affairs Medical Center, Tennessee (page 3 of 3; see also figs. 116 and 117).

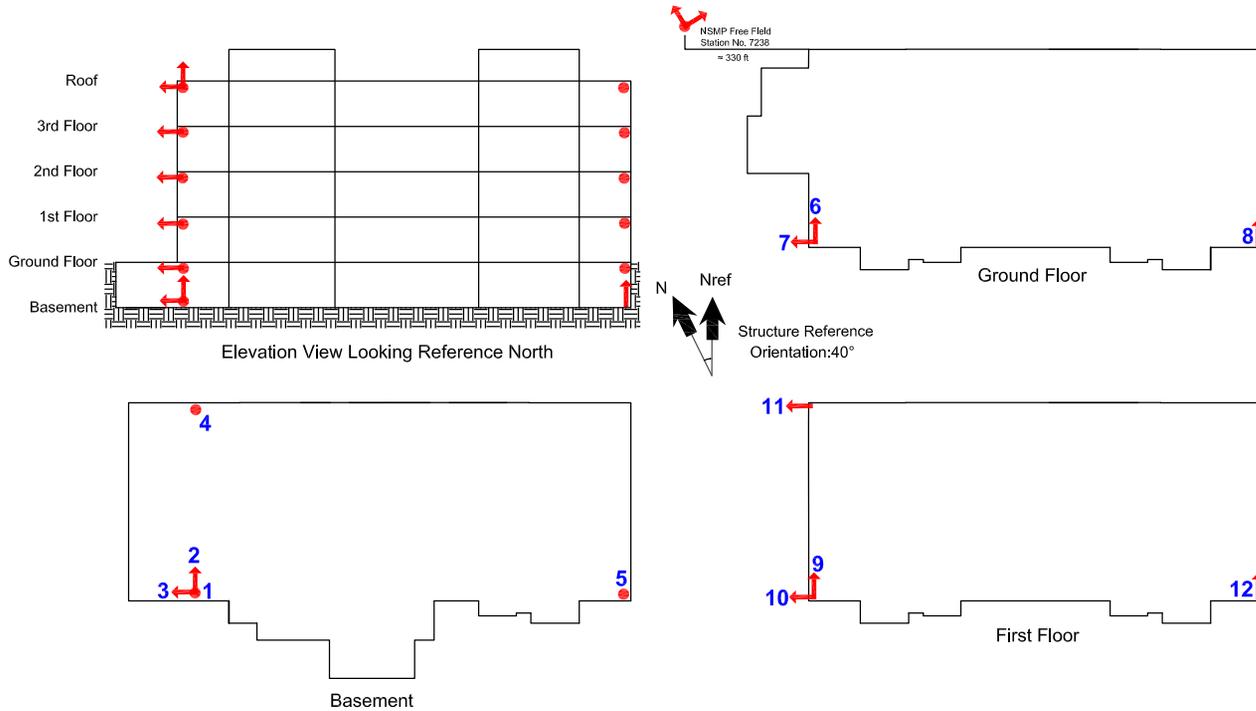
Figure 120. Diagrams of sensor layout showing 24 sensors in Building 14 of the Salt Lake City Veterans Affairs Medical Center, Utah (page 1 of 2; see also fig. 121).

A total of 24 accelerometers are deployed in the building to measure and compute its lateral and torsional motion (fig. 120 and fig. 121). A triaxial accelerometer (channels 1 through 3) is placed on the basement slab to measure the three components of input ground motion. Another two accelerometers oriented vertically (channels 4 and 5) are also placed on the basement slab near two corners of the building. The rocking motion of the building about the reference east-west and north-south directions can be obtained from vertically oriented accelerometers in the basement. The basement ceiling is instrumented with three accelerometers (channels 6 through 8) to monitor first-floor motions. Similarly, four accelerometers (channels 9 through 12) are placed on the first-floor ceiling level to measure lateral motions of the second floor. The floor lateral motions in reference east-west and north-south directions can be captured by a pair of accelerometers: Channels 10 and 11 will define the reference north-south lateral

motion, and channels 9 and 12 will define the reference east-west lateral motion. The torsional motion of the floor can be obtained from either channels 10 and 11 or channels 9 and 12. Twelve accelerometers are placed on the ceilings of the second floor through the fourth floor in a similar manner to measure floor lateral and compute torsional motions. The floor relative displacements and inter-story drifts can also be computed from accelerometers located at same corner of the building at different elevations.

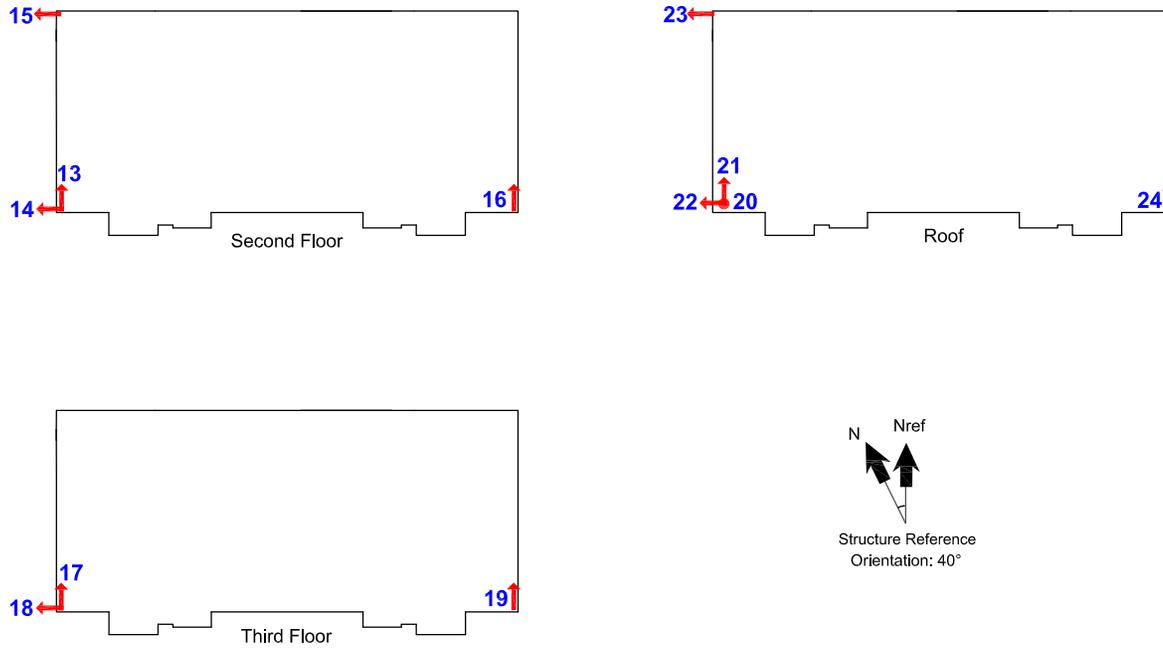
Figure 121. Diagrams of sensor layout showing 24 sensors in Building 14 of the Salt Lake City Veterans Affairs Medical Center, Utah (page 2 of 2; see also fig. 120).

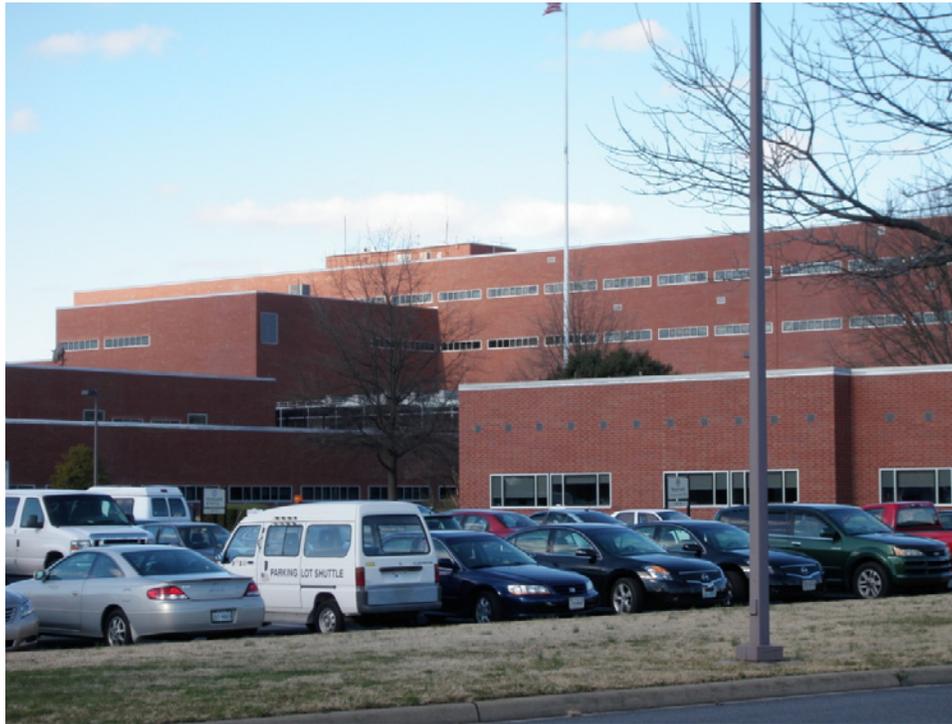
Figure 122. Photograph of Building 1, Richmond Veterans Affairs Medical Center, Virginia (U.S. Geological Survey photograph).

Building 500, located in Richmond, Virginia, is part of the Hunter Holmes McGuire VA Medical Center (<http://www.richmond.va.gov/>). This 260,000-ft² building is a five-story steel structure (fig. 122). The original structure was designed in 1978 and has not been modified heavily since. The structure has an irregular plan shape with several vertical offsets. A system of three seismic joints is used in strategic parts of the building to isolate different sections. The plan for each level is different as the building narrows down near the roof. The typical story height is 18 ft. The vertical- and lateral-load resisting system is composed of steel frames. The foundation of the structure consists of isolated square footings.

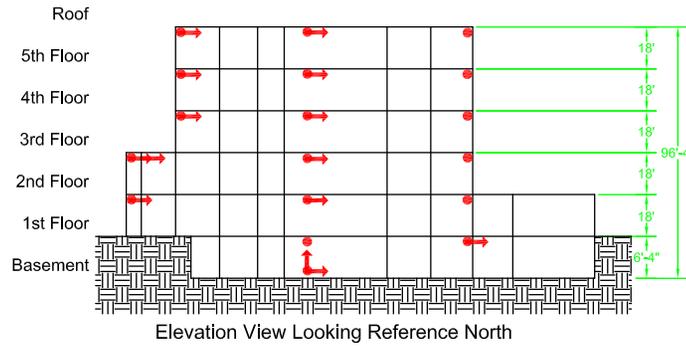
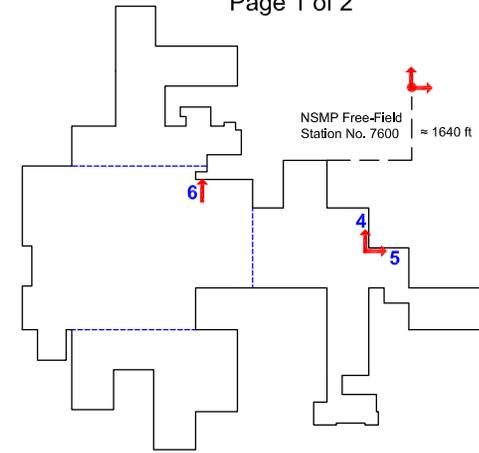
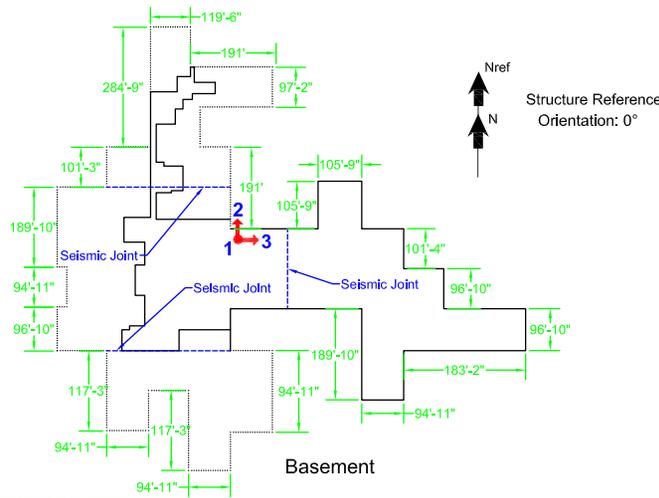
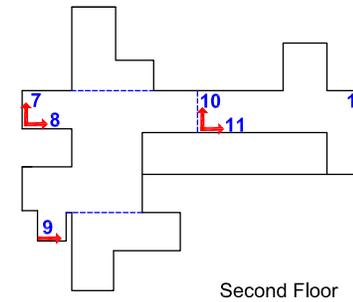
U.S. Department of Veterans Affairs
 Richmond, VA - Steel Moment Frame, Five-Story Hospital Building
 Building No: 500
 NSMP Station No: 7600

Figure 123. Diagram of the sensor layout showing 36 sensors in Building 500 of the Richmond Veterans Affairs Medical Center, Virginia (page 1 of 2; see also fig. 124).

The building consists of several blocks separated by seismic joints. The two blocks in the middle have five stories, and other blocks rise up to the second-floor level. Therefore, a considerable number of accelerometers are deployed in the two middle blocks to capture overall response of the building during a possible earthquake. A total of 36 accelerometers (fig. 123 and fig. 124) are placed in the building. A triaxial accelerometer (channels 1 through 3) is placed on the basement slab level to measure the three components of the input ground motion. Three accelerometers (channels 4 through 6) are placed on basement-floor ceiling level to monitor first-floor slab movement. Thirty accelerometers (channels 7 through 36) are evenly distributed on the ceilings of the first through the fifth floors to measure floor lateral motions and compute floor torsional motions. The floor relative displacements and inter-story drifts can be computed from accelerometers located at the same corner of the building along the same vertical axis.

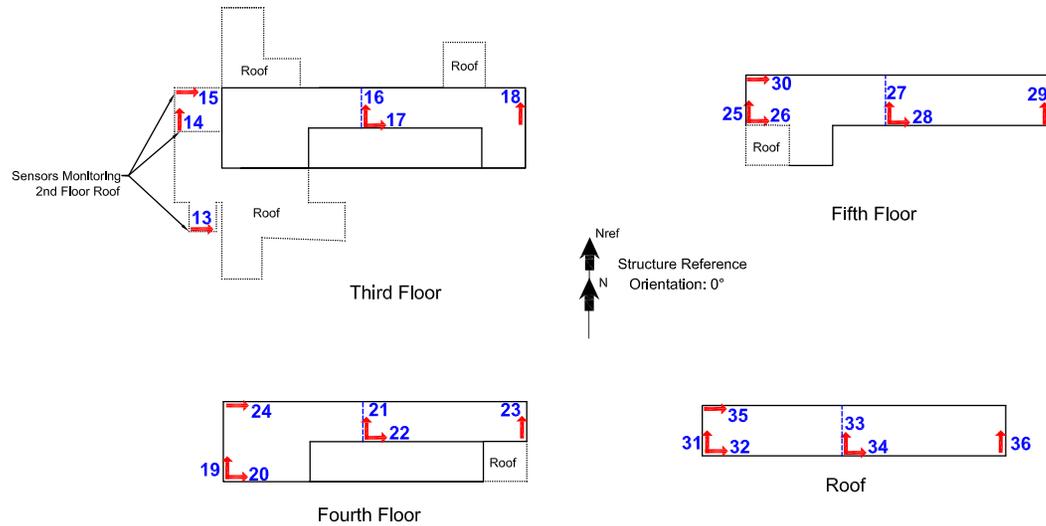
Figure 124. Diagram of the sensor layout showing 36 sensors in Building 500 of the Richmond Veterans Affairs Medical Center, Virginia (page 2 of 2; see also fig. 123).

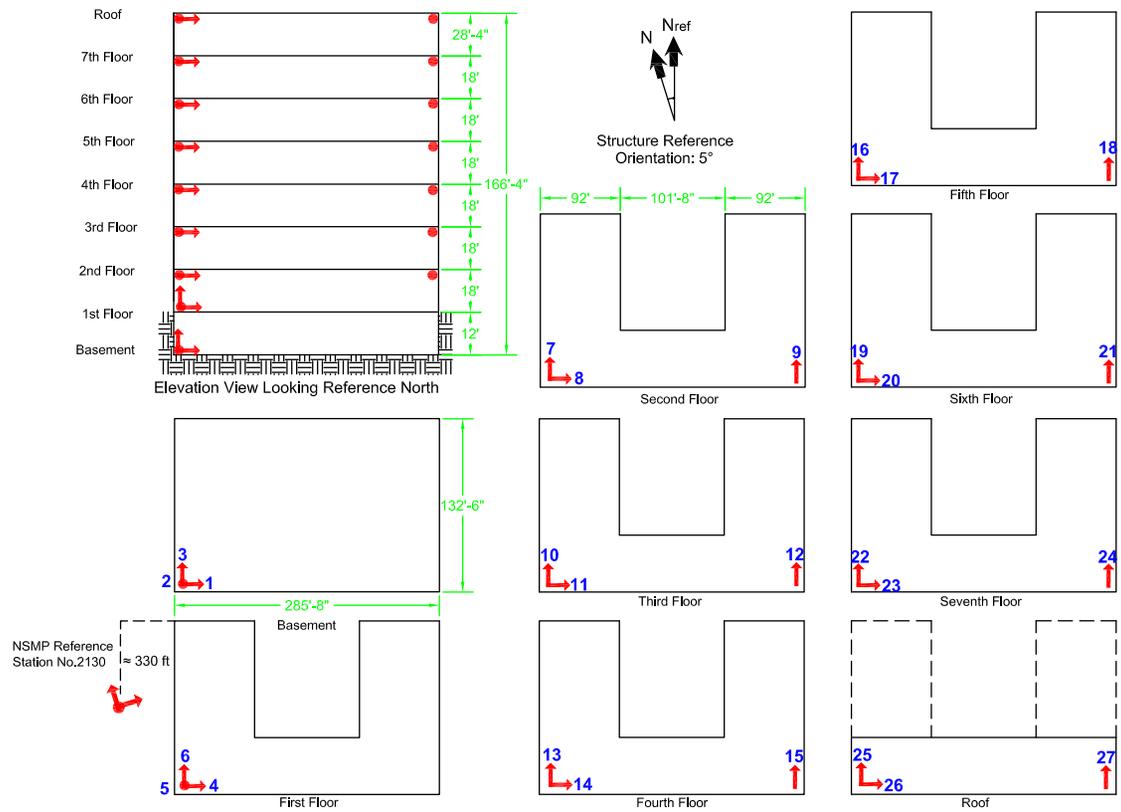
Figure 127. Diagram of sensor layout showing 27 sensors in Building 100 of the Seattle Veterans Affairs Medical Center, Washington.

A total of 27 accelerometers are deployed at eight levels in the building (fig. 127). A triaxial accelerometer (channels 1 through 3) is placed on the basement to measure the three components of input ground motion. Twenty-one accelerometers (channels 7 through 27) are evenly distributed on the ceilings of the first through seventh floors to measure floor lateral motion in the reference east-west and north-south directions. Floor torsional motion can be obtained from likewise oriented accelerometers located on the same floor. The reference southwest corner of the building has two accelerometers oriented parallel to the building sides at each floor level. The relative floor displacements, thus inter-story drift, can be computed from the recordings of these accelerometers. The reference southeast corner of the building also has an accelerometer at each floor level. The relative floor displacements can be similarly computed at this corner of the building.

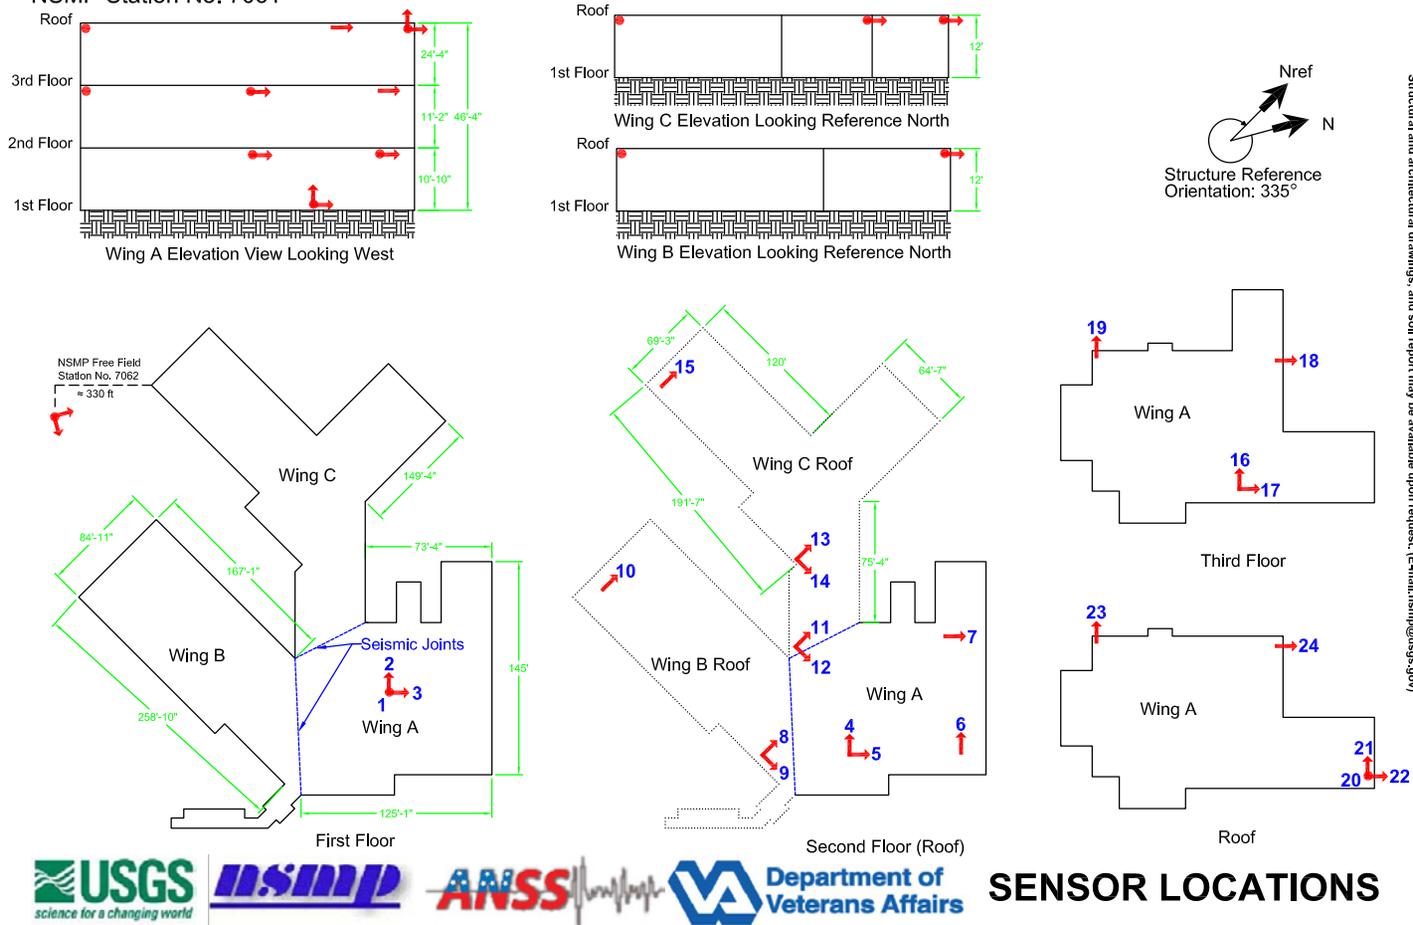
U.S. Department of Veterans Affairs
 Vancouver, WA - Steel Moment Frame, Three-Story Hospital Building
 Building No: 11
 NSMP Station No: 7061

Figure 131. Diagram of sensor layout showing 24 sensors in Building 11 of the Vancouver Veterans Affairs Medical Center, Washington.

Building 11 has an asymmetrical floor plan; therefore, some level of torsional response is expected to occur under strong ground shaking. To capture the building's earthquake response, and possible pounding during an earthquake by adjacent wings, which are separated by seismic joints, 24 accelerometers are distributed strategically between the three-story main building and two adjacent single-story wood-frame wings (fig. 131). At the first-floor level of the main building, a triaxial accelerometer (channels 1 through 3) is to record base-level input ground shaking in two horizontal and one vertical direction. Each floor of Wing A, B, and C has at least three accelerometers; therefore, the floor lateral and torsional motion can be obtained.

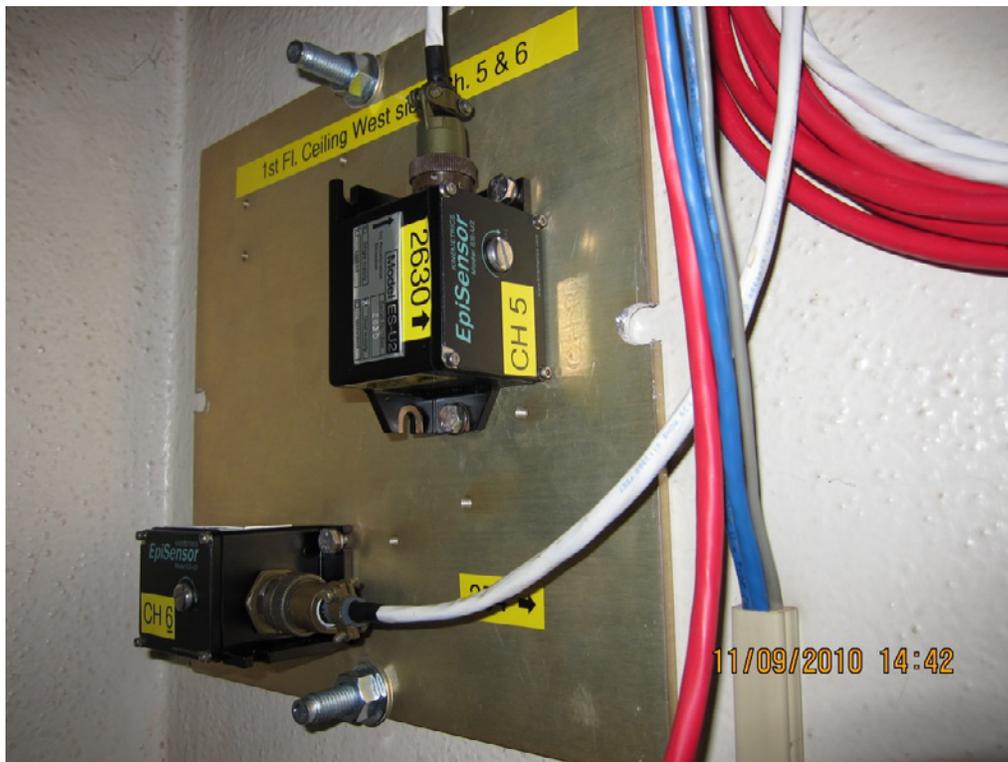
Figure 132. Photograph of uniaxial force-balance accelerometers installed on a mounting plate (U.S. Geological Survey photograph).

The typical motion sensor used in free-field stations is a triaxial force-balance accelerometer (FBA); the same sensor is also used in medical buildings together with its uniaxial version (fig. 132). FBAs used are designed for measuring accelerations as large as $\pm 4 g$ and as low as the ambient noise level from 1 Hz to 200 Hz. No micro-electro-mechanical-systems (MEMS)-based sensors were used because their noise level is currently too high for structural-health monitoring applications in hospitals.
