Advanced Earthquake Monitoring System for U.S. Department of Veterans Affairs Medical Buildings—Instrumentation

Open-File Report 2012–1241

U.S. Department of the Interior
U.S. Geological Survey

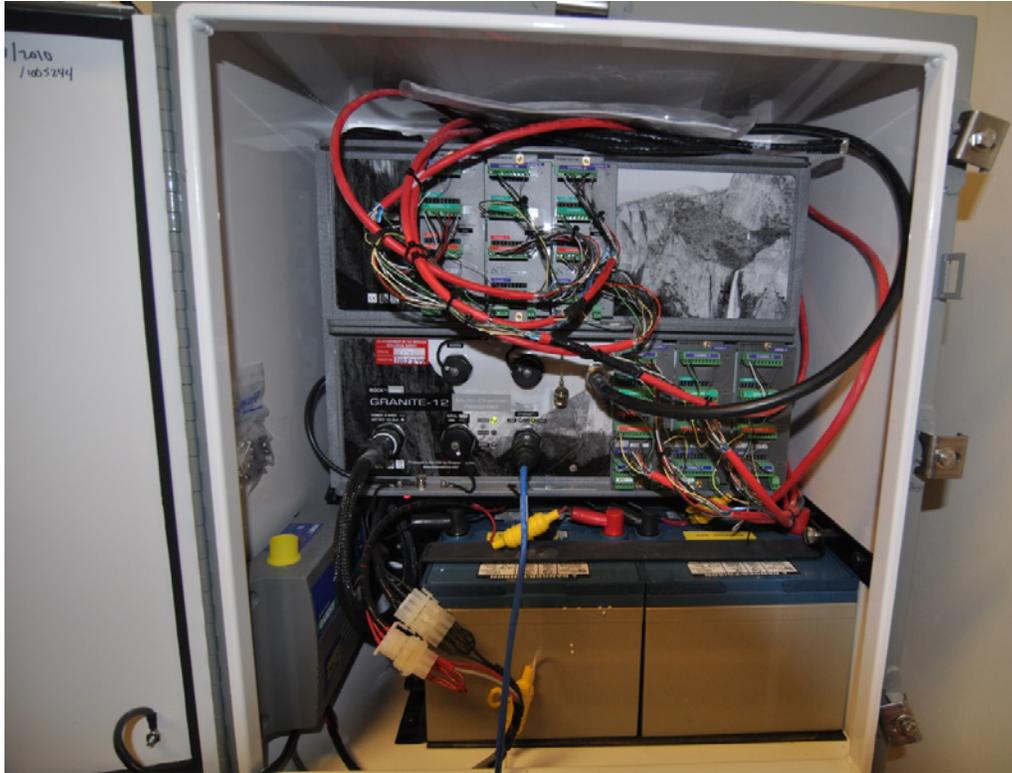
Figure 133. Photograph of 24-bit digital Internet Protocol (IP)-based recorder with batteries and charger installed within a National Electrical Manufacturers Association (NEMA) cabinet (U.S. Geological Survey photograph).

To record accelerations measured by sensors, Internet Protocol (IP)-based 24-bit multichannel digital recorders (digitizers) are used (fig. 133). These recorders have high dynamic range on as many as 36 channels offering multiple real-time data streams. They also allow for

remote access through a Web browser to change operational parameters, change recording and telemetry modes and formats, and to view or retrieve recorded files. Sampling rate in all recorders is set to 200 samples per second (sps). Recorders have internal batteries for back up power and use the Internet for telemetry.

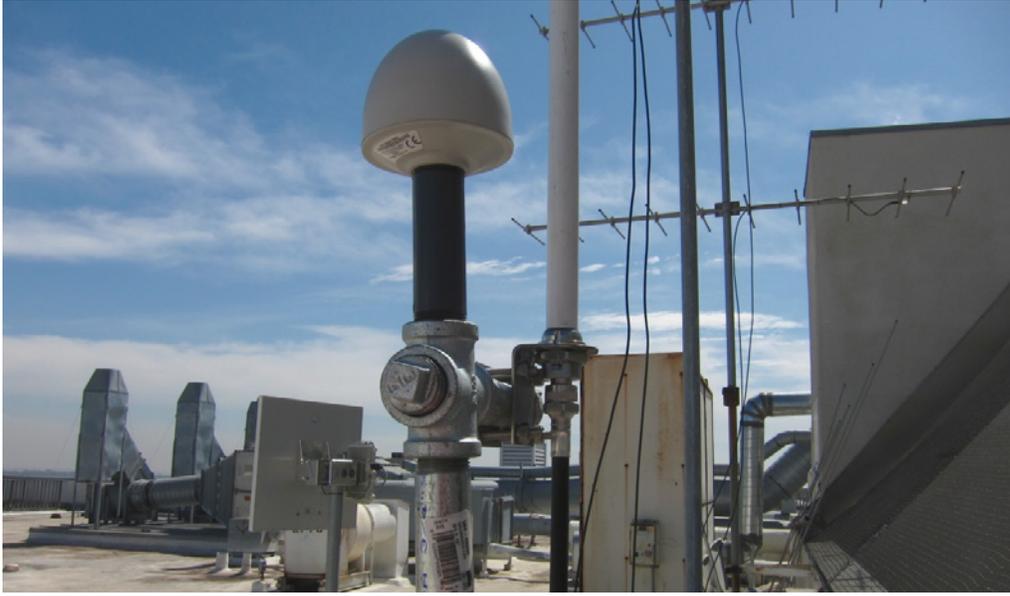
Figure 134. Photograph of Global Positioning System (GPS) antenna installed at the roof level of a medical building for absolute timing (U.S. Geological Survey photograph).

Within medical buildings, recorders are generally located at a level close to the roof or a outside wall for the shortest possible run to facilitate the installation of the GPS antenna for absolute timing for records (fig. 134).

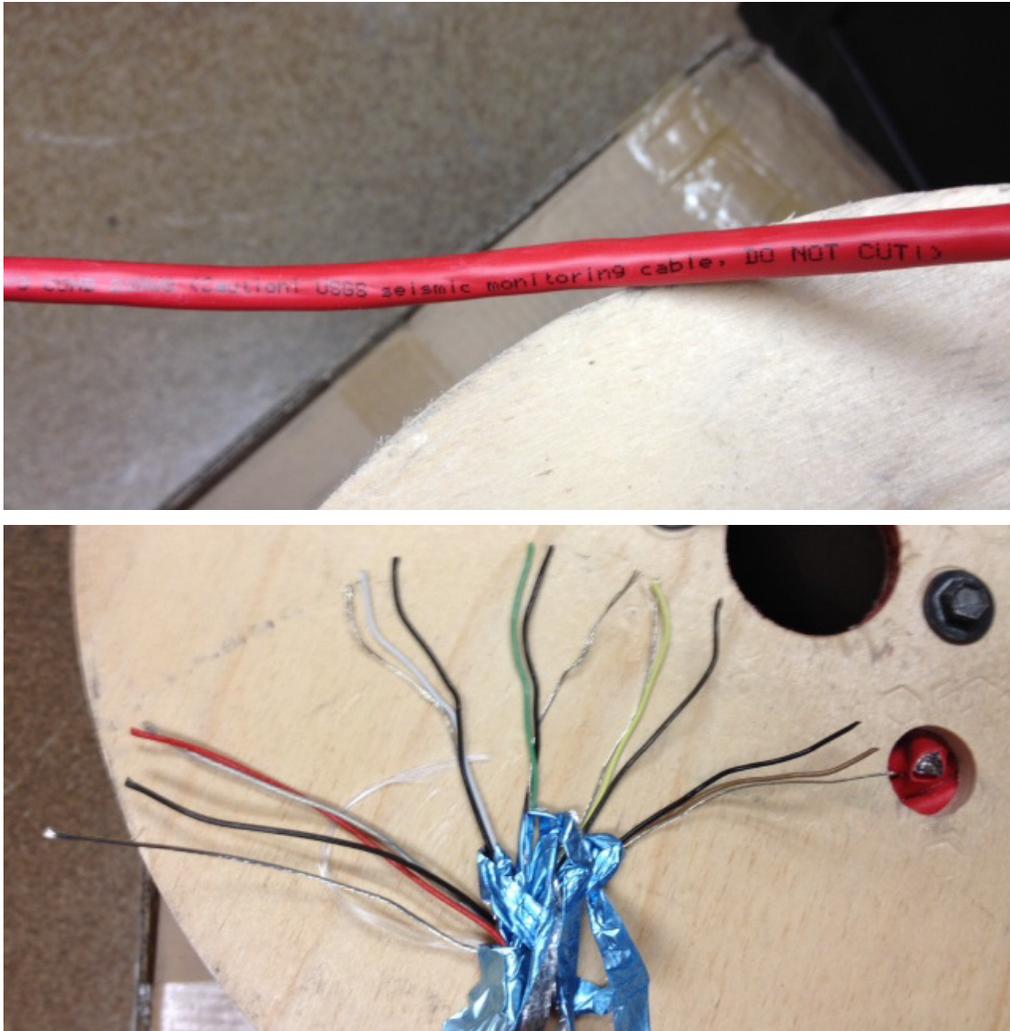
Figure 135. Photographs of custom-made U.S. Geological Survey (USGS) cable used for connecting accelerometers to recorders. Top, red-jacketed cable printed with the words “(CAUTION! USGS Seismic monitoring cable, DO NOT CUT!).” Bottom, cable with jacket removed showing four pairs of individually shielded 22 AWG (American wire gauge) stranded (7×30) and tinned copper wires, as well as three individual 20 AWG stranded conductors (7×28) that are non-shielded tinned copper (U.S. Geological Survey photograph).

Custom made USGS cable is used to connect sensors to central recorders. This cable has four pairs of 22 AWG (American wire gauge) stranded (7×30) and tinned copper wires. Each pair of wires is individually shielded (fig. 135). In addition to the four pairs, there are three individual 20 AWG stranded conductors (7×28), which are non-shielded tinned copper. The outer cable jacket is plenum rated and has an overall foil shield with a 20 AWG stranded drain wire. The outside jacket of the cable is red in color and has the following printed in addition to the standard National Electrical Code (NEC) plenum cable nomenclature, “(CAUTION! USGS Seismic monitoring cable, DO NOT CUT!).” Cable is manufactured as a spool of 1,000 ft, which is enough to connect a single sensor without splicing. No cable splicing is used in installations. Also for GPS antennas, low-loss coaxial communications cable (LMR 400) is used.

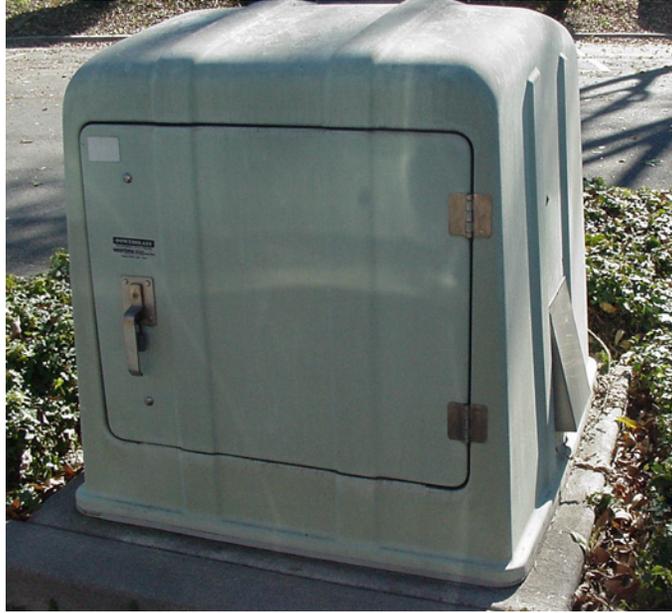
Figure 136. Photograph of a typical free-field station where a triaxial accelerometer and a recorder are installed to measure ground motion at Veterans Affairs medical centers away from structures that are being seismically monitored (U.S. Geological Survey photograph).

VA medical buildings have a dedicated free-field station ([fig. 136](#)) or a reference station, where a triaxial accelerometer and a recorder are installed to measure ground motion away from the structures. The reference station is a single story light-weight structure as shown in [figure 137](#). Free-field stations use a “T-hut” mounted on a concrete foundation, details of which are shown in [figure 138](#).

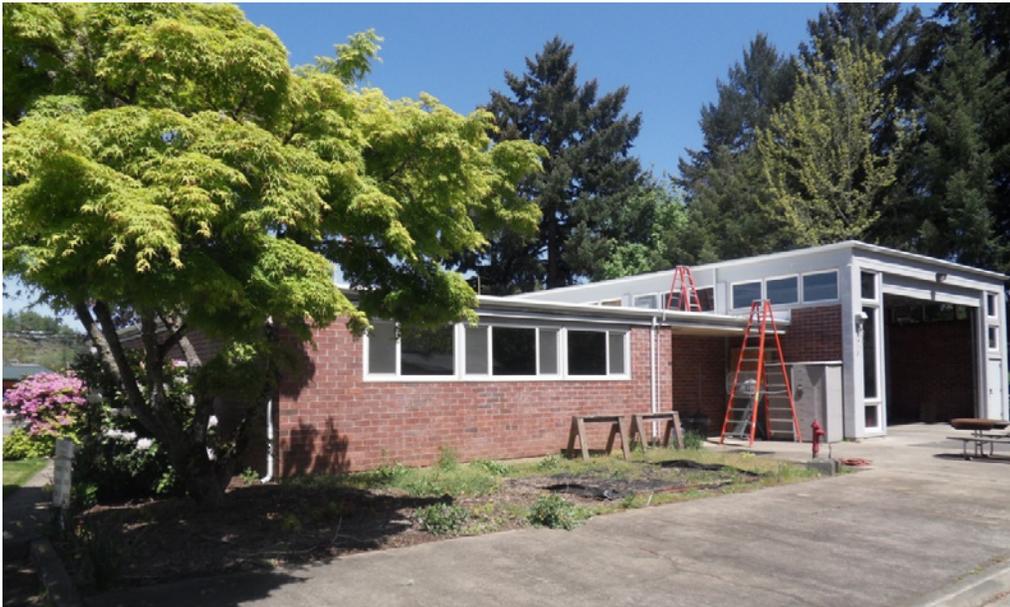
Figure 137. Photograph of a typical reference station where a triaxial accelerometer and a recorder are installed to measure ground motion at Veterans Affairs medical centers away from structures that are being seismically monitored (U.S. Geological Survey photograph).

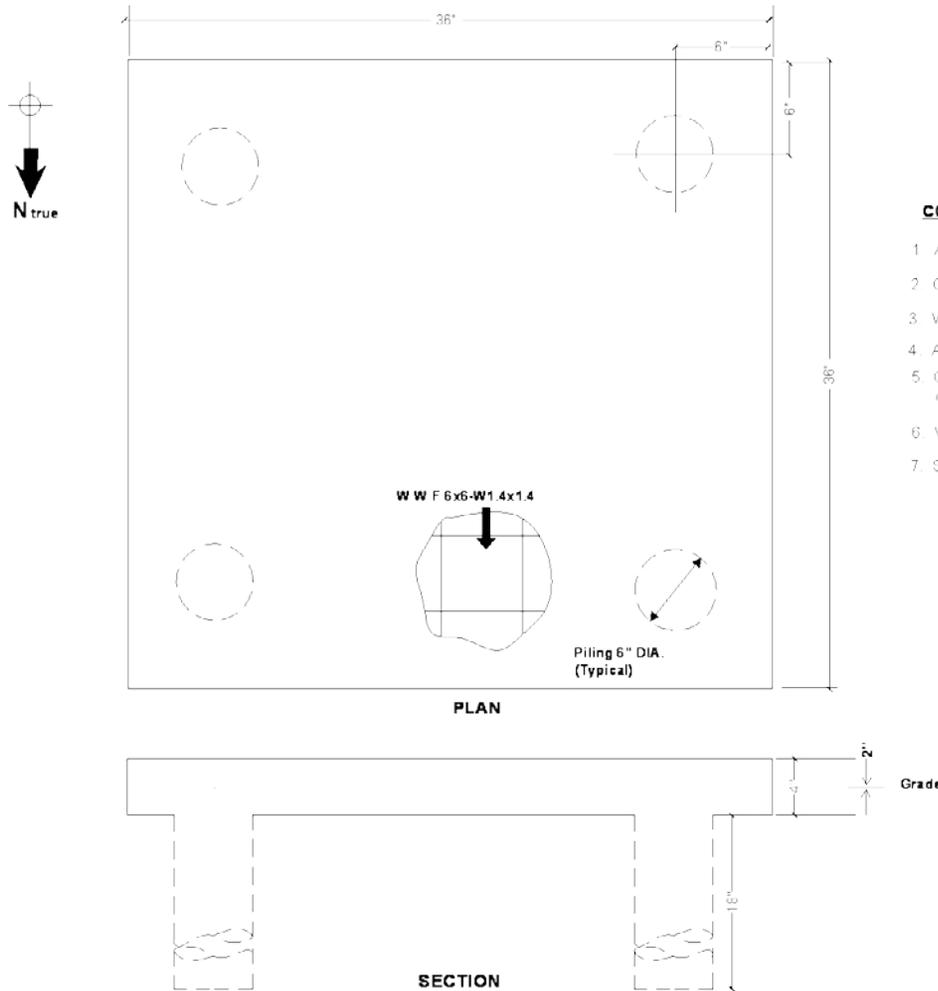
Foundation Design for Strong Motion Free-Field Station

1. Approximately 1/2 cubic yard of concrete is required for the slab
2. Concrete is six (6) sack mix, 3/4 inch maximum aggregate
3. Wire mesh is 6"x6" W 1 4xW1 4 (10 gauge wire)
4. All rebar is half (1/2) inch (number 4)
5. Corner pilings extend approximately below the slab and are 6 inches in diameter (these are typically made with a post hole digger).
6. Wire mesh and rebar are secured with wire ties.
7. Slab to be level and concrete should be troweled to a smooth finish.

Figure 138. Foundation details for free-field ground-motion recording stations.
