Resurvey of Cross Sections on the Yampa and Little Snake Rivers in Lily and Deerlodge Parks, Colorado

Open-File Report 2023–1070

U.S. Department of the Interior
U.S. Geological Survey

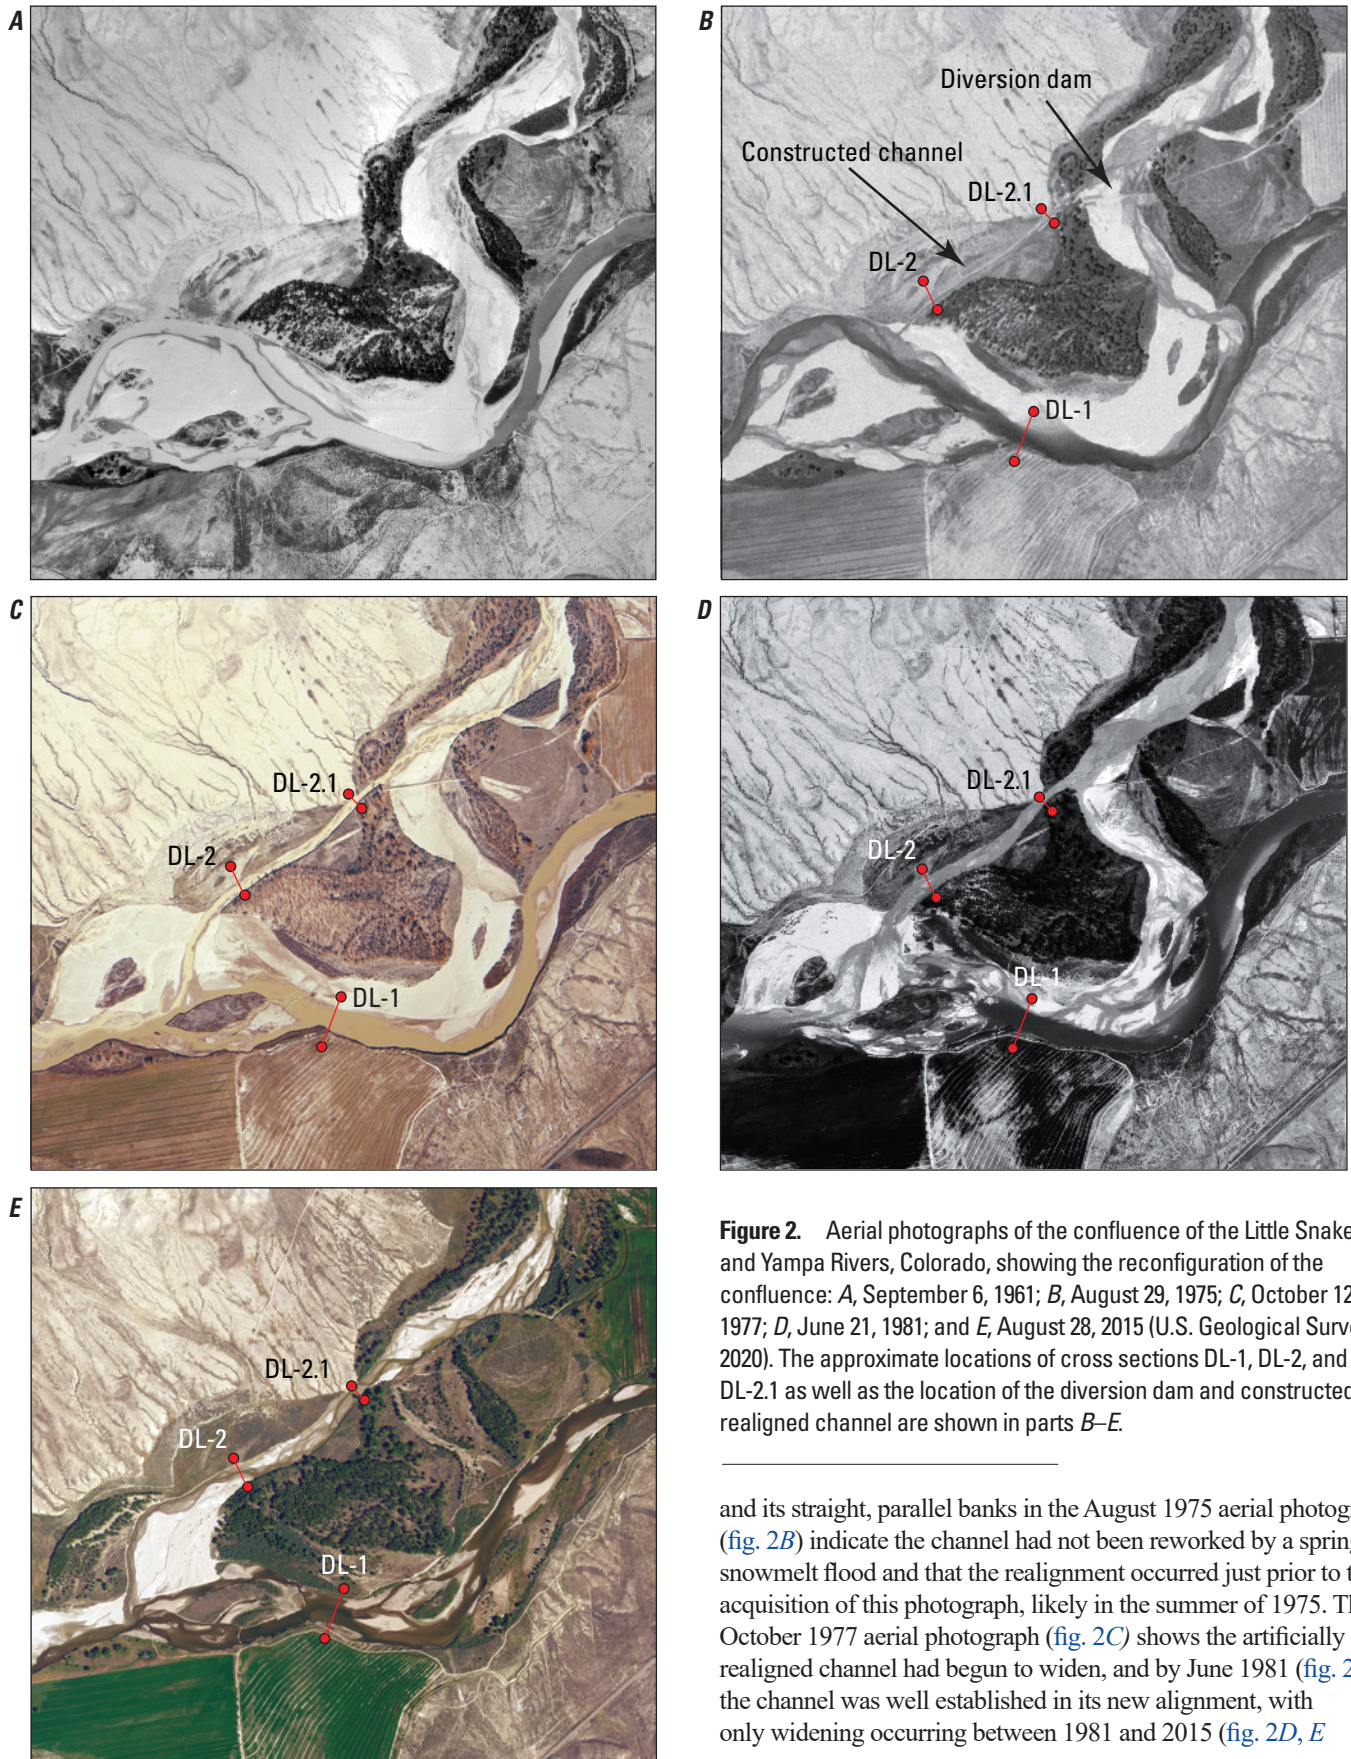
Figure 2. Aerial photographs of the confluence of the Little Snake and Yampa Rivers, Colorado, showing the reconfiguration of the confluence: *A*, September 6, 1961; *B*, August 29, 1975; *C*, October 12, 1977; *D*, June 21, 1981; and *E*, August 28, 2015 (U.S. Geological Survey, 2020). The approximate locations of cross sections DL-1, DL-2, and DL-2.1 as well as the location of the diversion dam and constructed realigned channel are shown in parts *B–E*.

Historical aerial photographs (U.S. Geological Survey, 2020) were analyzed to contextualize measured changes at cross sections, confirm the longitudinal positions of the cross sections along the rivers, and verify the timing of artificial relocation and straightening of the Little Snake River. This analysis indicates that FLO Engineering, Inc. (1998) was inexact in their assessment that the artificial relocation and straightening of the confluence of the Little Snake and Yampa rivers occurred between 1980 and 1982. Our analysis indicates that the relocation and straightening occurred earlier between September 1961 and August 1975 (fig. 2A, B, respectively). The diversion dam and artificially constructed channel were present in the August 1975 aerial photograph (fig. 2B) but not in the September 1961 aerial photograph (fig. 2A). The narrow width of the artificial channel

and its straight, parallel banks in the August 1975 aerial photograph (fig. 2*B*) indicate the channel had not been reworked by a spring snowmelt flood and that the realignment occurred just prior to the acquisition of this photograph, likely in the summer of 1975. The October 1977 aerial photograph (fig. 2*C*) shows the artificially realigned channel had begun to widen, and by June 1981 (fig. 2*D*) the channel was well established in its new alignment, with only widening occurring between 1981 and 2015 (fig. 2*D*, *E*

Consequently, substantial widening and deepening has occurred at cross section DL-1 since it was first surveyed in 1983 ([fig. 5](#), [table 2](#)). The reduction in the sand supply to cross section DL-1 caused by the confluence reconfiguration is evident in [figure 2A and E](#). The composition of the Yampa River bed at cross section DL-1 is now much more like the Yampa River bed upstream of the former confluence, dominantly gravel with only patches of sand, and completely unlike the almost fully sand-bedded Yampa River downstream from the current confluence. The documented artificial reduction in the sand supply to this cross section indicates substantial widening and mean bed scour can be expected at other cross sections in response to a major reduction in sand load.

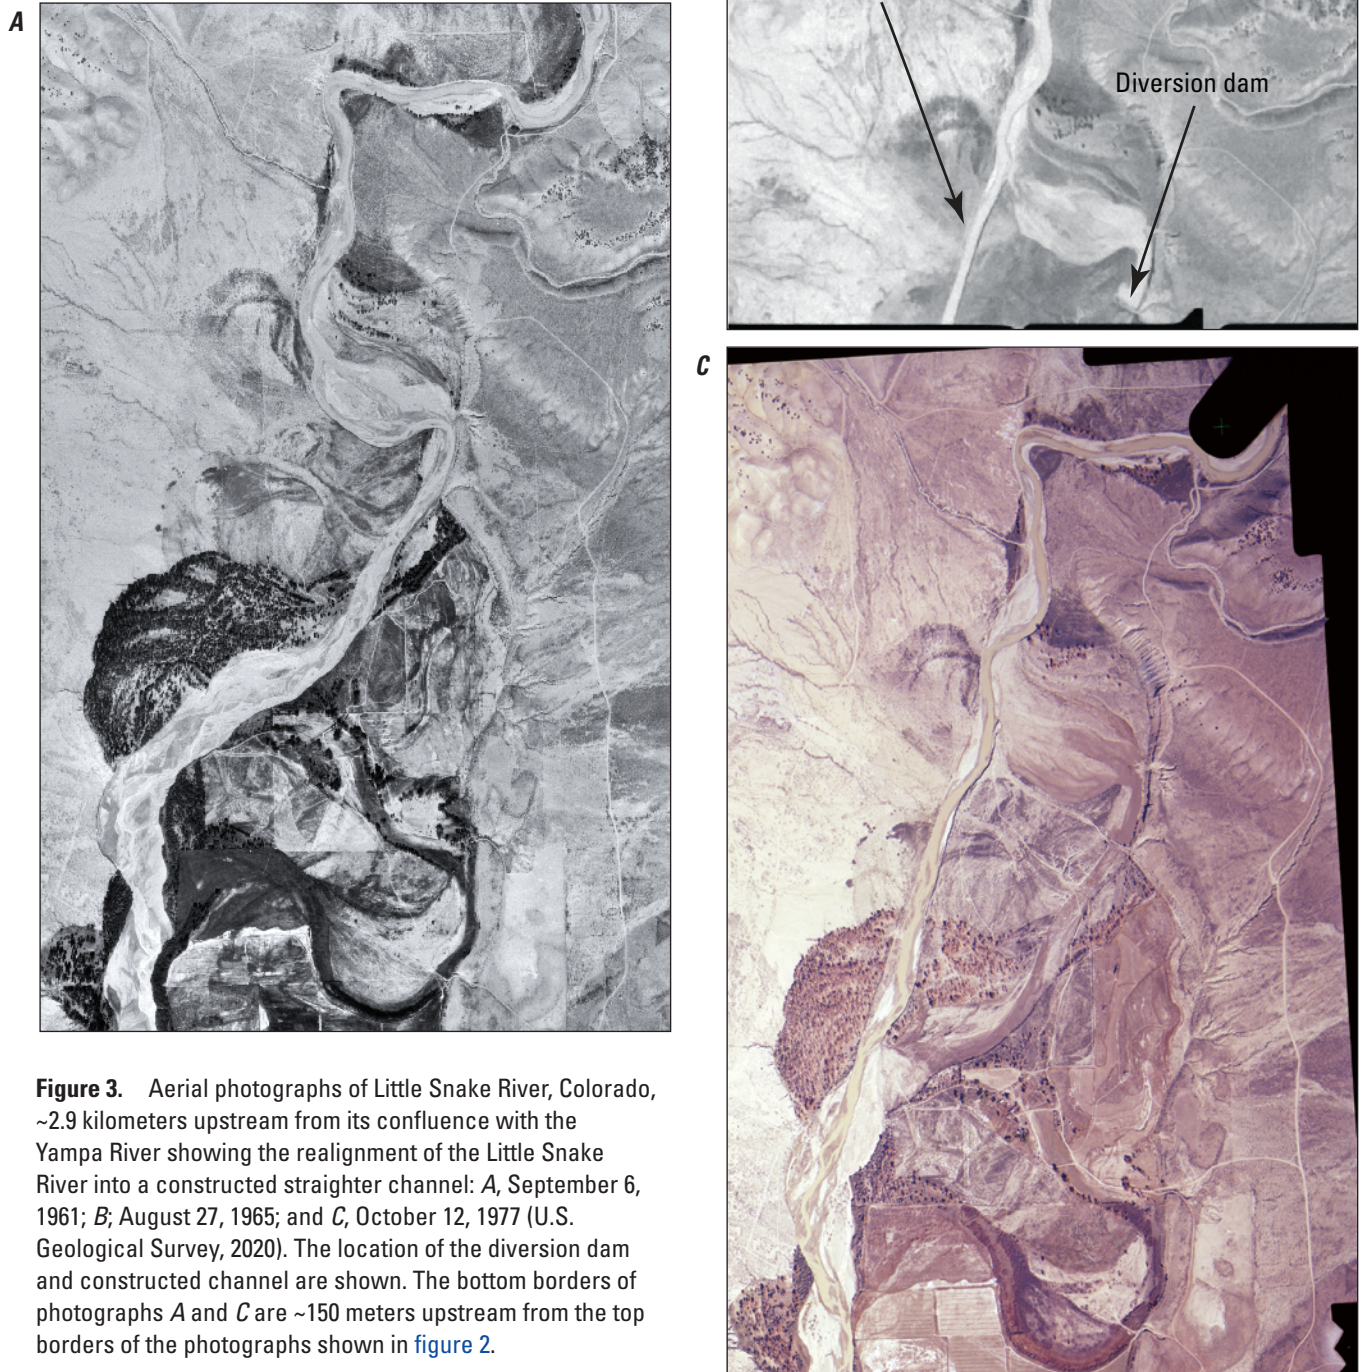
Figure 3. Aerial photographs of Little Snake River, Colorado, ~2.9 kilometers upstream from its confluence with the Yampa River showing the realignment of the Little Snake River into a constructed straighter channel: A, September 6, 1961; B, August 27, 1965; and C, October 12, 1977 (U.S. Geological Survey, 2020). The location of the diversion dam and constructed channel are shown. The bottom borders of photographs A and C are ~150 meters upstream from the top borders of the photographs shown in figure 2.

cross section DL-2.1, was also artificially realigned into a straighter channel (figs. 3A, B). The Little Snake River was well established in the artificially realigned channel by October 1977 (fig. 3C). This channel reconfiguration reduced the length of the Little Snake River by ~0.6 km. This reduction in channel length, in addition to the 1-km channel-length

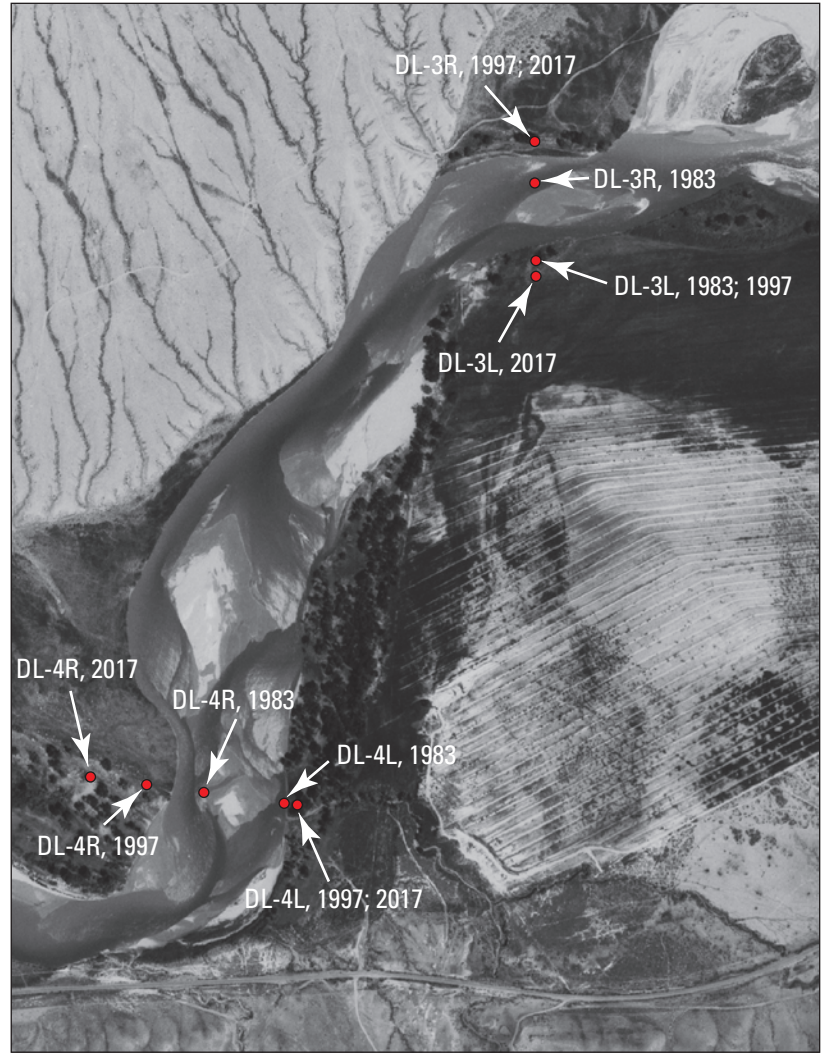
Figure 4. Aerial photograph, taken June 21, 1981, showing the supposed locations of the DL-3 and DL-4 left-bank (L) and right-bank (R) cross-section endpoints in the 1983 survey and the known locations of these endpoints in the 1997 and 2017 surveys (U.S. Geological Survey, 2020).

Historical aerial photographs taken June 1981 show that the 1997 relocation of the 1983 cross-section endpoints were consistent with the likely positions of the 1983 riverbanks, except in cross sections DL-3 and DL-4. The 1983 right-bank endpoints of these cross sections determined during the 1997 resurvey are impossibly located mid-channel in the June 1981 aerial photograph (fig.4). The likely 1997 mis-relocation of cross sections DL-3 and DL-4 would require 80 and 60 m of lateral sediment deposition, respectively, on the right bank between June of 1981 and the fall of 1983, up to the elevation of the modern bank top. There is no evidence in 1975, 1982, 1984, or 1988 aerial photographs to indicate deposition of that magnitude occurring at the 1997 locations of cross sections DL-3 and DL-4. The locations of these cross sections were likely mis-identified from the 1983 field notes during the 1997 resurvey. Because the 1997 relocation of the original 1983 cross sections DL-3 and DL-4 do not correspond to available imagery, we excluded the 1983 data at these cross sections from our analysis of cross-sectional change and treated cross sections DL-3 and DL-4 as “new” 1997 cross sections.
