Prehistoric Near-Surface Subsidence Cracks in Western Fresno County, California

GEOLOGICAL SURVEY PROFESSIONAL PAPER 437-C

By WILLIAM B. BULL

*A study of filled tension cracks
in alluvial-fan deposits*

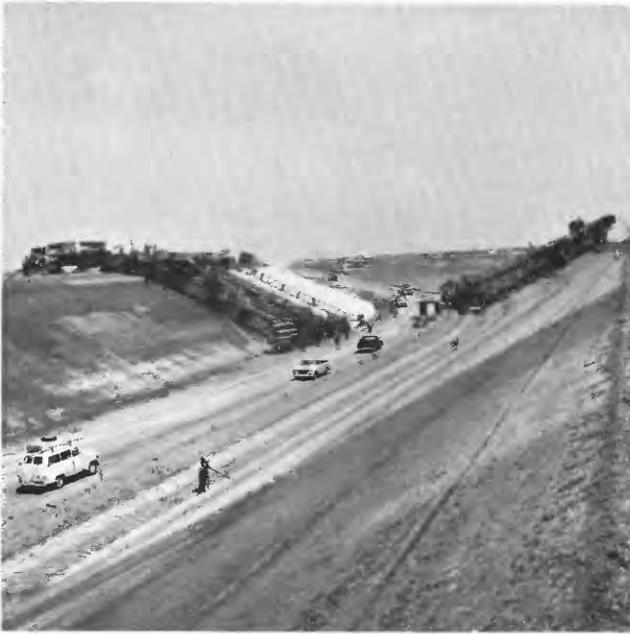
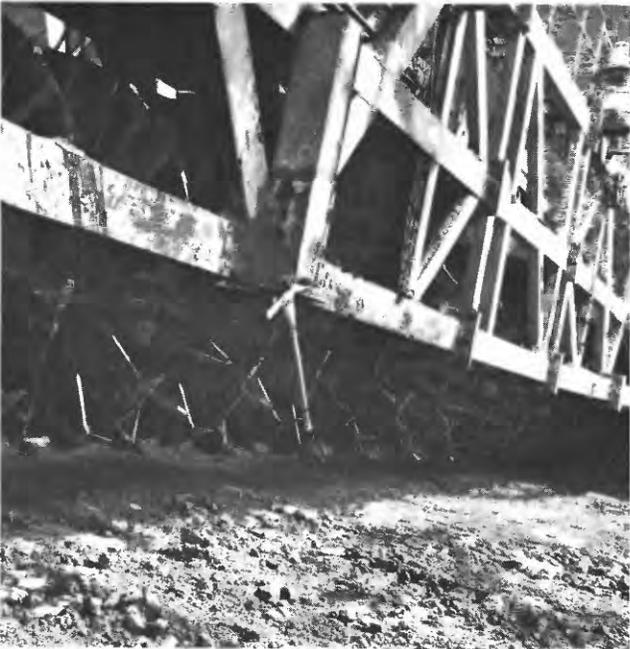
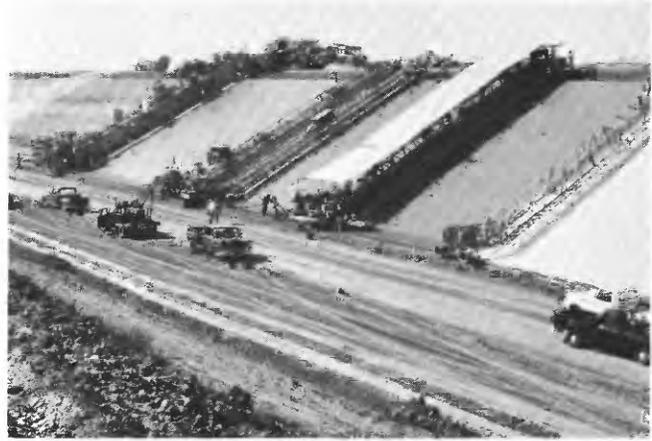
Trimming and paving of the San Luis Canal are shown in figure 5. The general shape of the canal prism

was excavated in advance of the trimming and paving operations. The trimmer, shown on the right side of figure 5A, removed the final 1½ feet of material from the canal prism and dumped it on the top of the canal bank. The teeth of the trimmer are shown in figure 5B. The result is a cleanly trimmed slope that has 1 foot of vertical distance for every 2 feet of horizontal distance. The slope generally provides excellent exposures of the alluvial-fan deposits and the compacted fill overlying the original land surface. Most of the horizontal marks shown in the photographs of the canal banks are not bedding features, but are trim marks left by the scraping blade of the trimmer, or scrape marks caused by damaged trimmer teeth. Between the time the slope was trimmed and paved, water trucks kept the slope wet (fig. 5C), and after repeated soakings, the fan deposits and the cracks were barely discernible. The area in the right foreground of figure 5A has been wetted about 1 hour after trimming.

The paving operation consists of four independent units that provide a continuous pour of concrete, insert plastic strips along expansion joints, smooth surficial blemishes, and spray the concrete with white plastic for proper curing (fig. 5C). As shown in figures 5A and 5C, the truck and trailer units drive onto the paver, and discharge their loads of concrete as they are carried along by the paver. The result is a continuous pour of unreinforced concrete that is 4 inches thick. These huge machines are capable of trimming and paving about two-thirds of a mile of canal bank each day.

FIGURE 5.—Trimming and paving the San Luis Canal. A, Trimmer and paver on the Arroyo Ciervo fan, station 2800. B, The teeth of the trimming machine. Three-foot mattock handle for scale. C, The paving equipment.

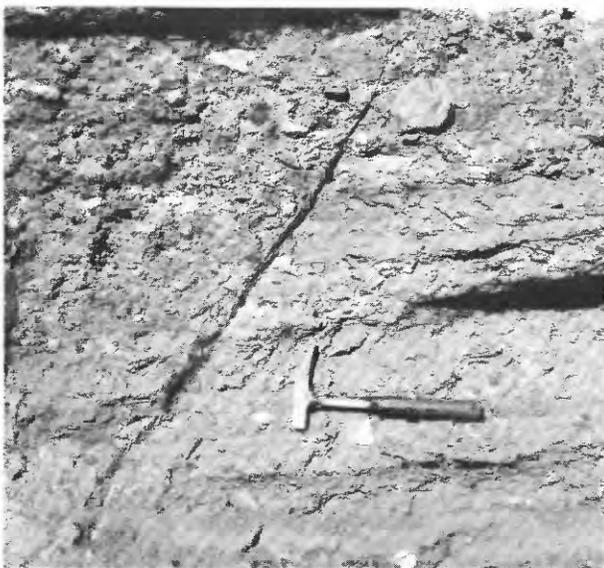
The blocks of alluvial-fan deposits within the northeast- and northwest-trending faults are broken by numerous minor normal faults with displacements that range from a few inches to a few feet. The cracks are narrow and contain calcareous material. A normal fault in alluvial-fan deposits with a displacement of several feet is shown in figure 6.

FIGURE 6.—Normal fault in alluvial-fan deposits adjacent to the south side of the Catalina Mountains, Ariz.

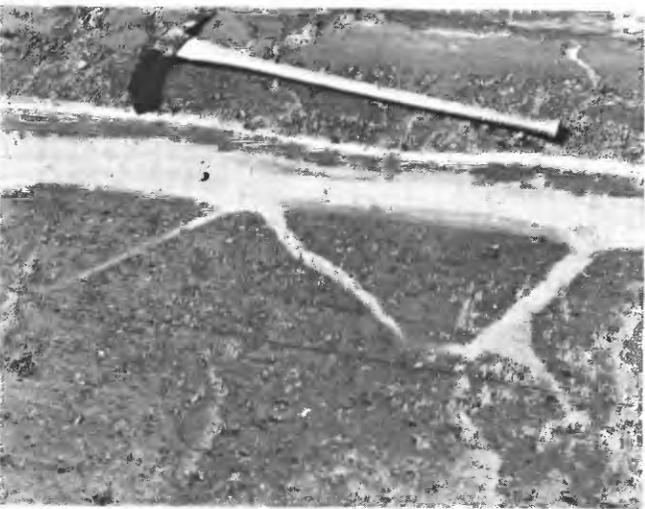
Water-laid material that is deposited after desiccation cracks form, fills the cracks with sediment. The polygonal cracks in the mudflow deposit shown in figure 7B are filled with water-laid sand from the overlying bed.

FIGURE 7.—Desiccation cracks in mudflow deposits. *A*, Mudflow deposit on the Arroyo Hondo fan; the polygonally cracked mudflow in the foreground is overlain by water-laid sands in the background. *B*, Sand-filled polygonal cracks in a mudflow in the Tumey Gulch fan. Looking up the trimmed slope of the San Luis Canal at station 2576 + 96R. Three-foot mattock handle for scale.

The alluvial-fan deposits consist of mudflow deposits and water-laid sediments. The modern deposits are described in detail by Bull (1964a). Mudflow and water-laid deposits are shown in figures 7 and 26.

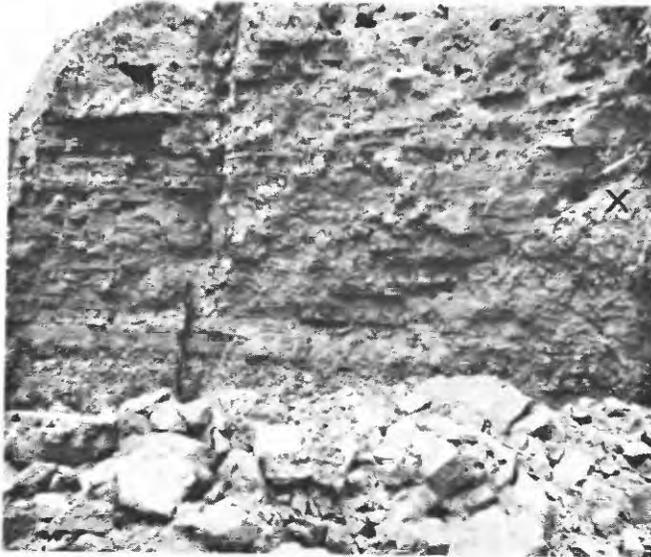
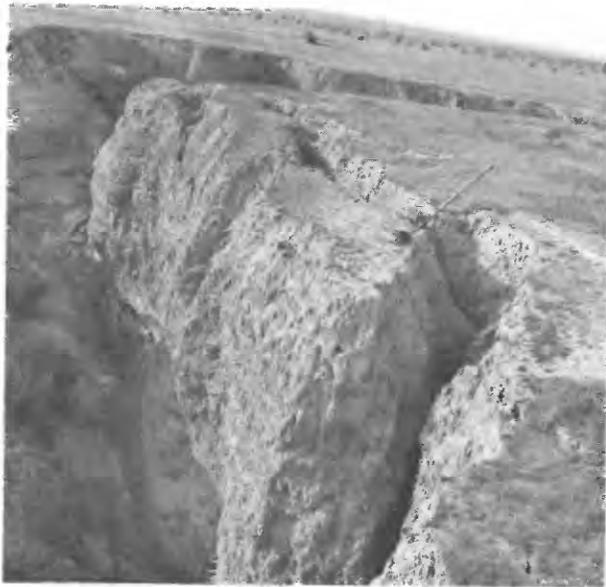
A slump and slump crack in the stream channel of Arroyo Hondo are shown in figure 8*A*. This crack formed shortly after undercutting by the stream during an unusually wet winter, and part of the slump rotation block had collapsed into the stream channel within 4 months after the crack first opened. The remaining part of the slump rotation block, the crack, and fresh exposures of thin-bedded water-laid sediments of the fan are shown in the photograph.

FIGURE 8.—Slump cracks adjacent to stream channels incised in alluvial-fan deposits, western Fresno County, Calif. A, Arroyo Hondo; shovel for scale above X. B, Tamey Gulch; shovel for scale.

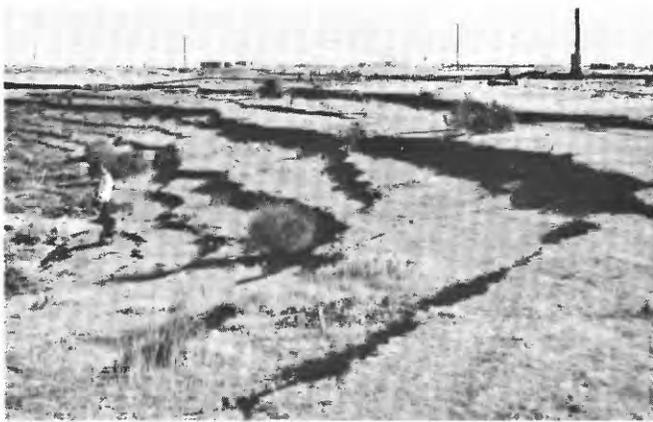
FIGURE 11.—Concentric near-surface subsidence cracks along one side of a test plot on the Arroyo Ciervo fan, Mendota test site of the California Department of Water Resources.

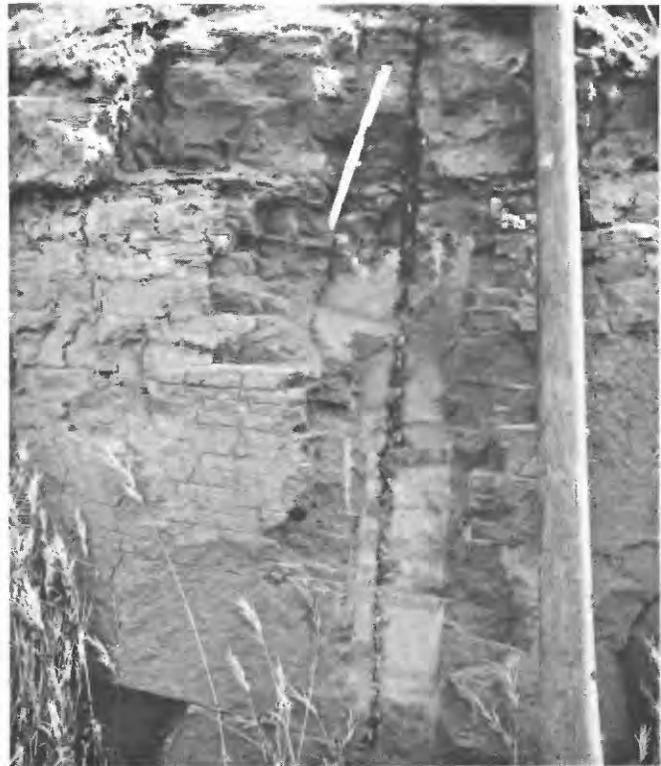
FIGURE 16.—Clay-filled crack that narrows downward in the bank of Panoche Creek. Location is about 7,000 feet southwest of San Luis Canal station 2060.

A clay-filled crack that narrows downward from one-fourth to one-eighth of an inch in $2\frac{1}{2}$ feet is shown in figure 16. The top of the crack is truncated about 4-5 feet below the surface of the Panoche Creek fan.

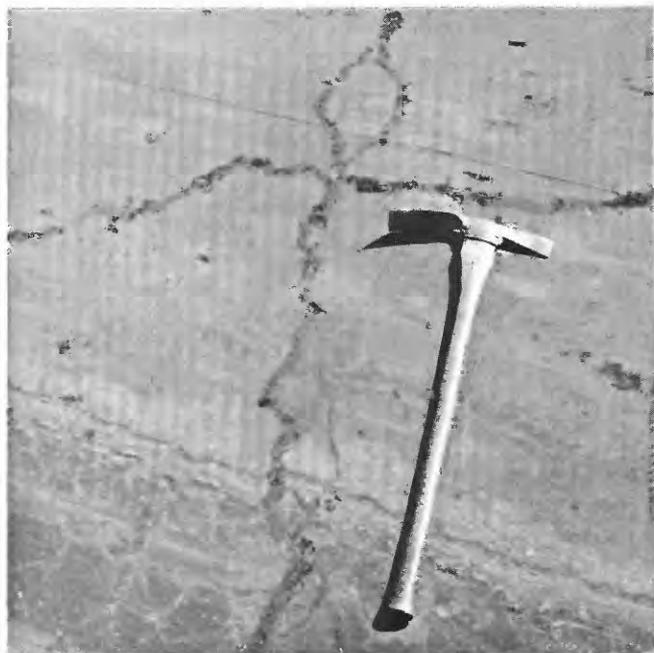
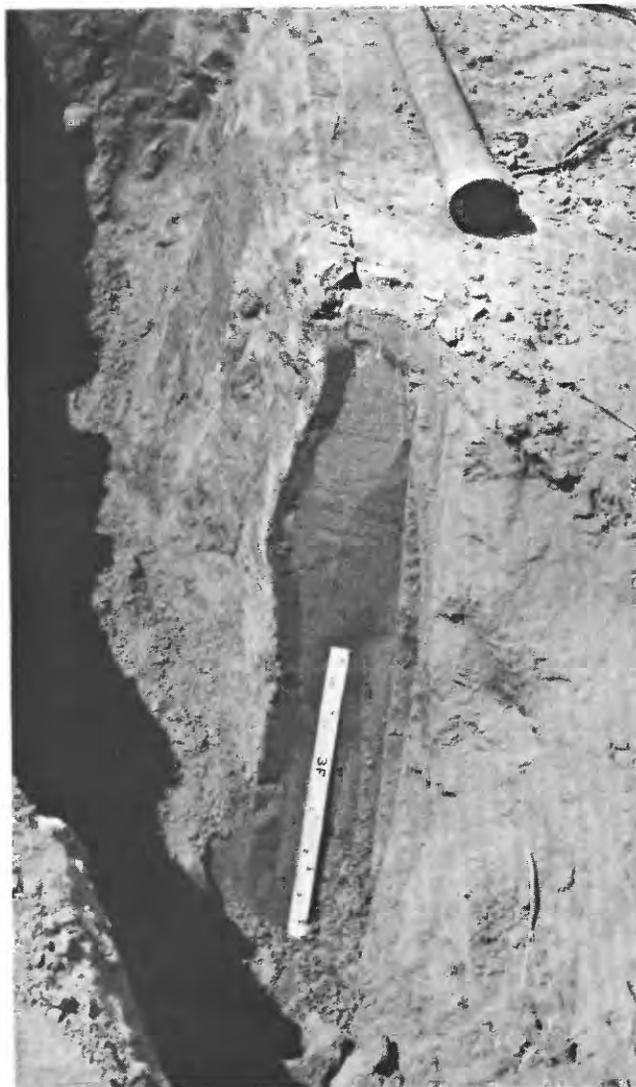
FIGURE 17.—Trimmed sections showing irregular sides of clay-filled cracks in the Los Gatos Creek fan. *A*, San Luis Canal station 4783L. Minor offset bedding at bottom of photograph. *B*, San Luis Canal station 4811 + 68B. Piece of measuring tape is 7 inches long.

The contacts between the crack fillings and the adjacent sediments suggest that the sides of the cracks had a rough hackly fracture before they were filled. This can be seen readily in excavated pits and by the sharp angles and changes in direction of the crack filling exposed in the trimmed banks. Figure 17A shows typical clay-filled cracks with angular margins that indicate a hackly fracture before filling. Figure 17B shows the undulating nature of the sides of a crack exposed in a pit in the canal bottom. The particle-size distribution of a sample from the crack filling is shown in table 3 and figure 34 (sample 19). Evidence of shearing along the sides of the crack fillings or in the adjacent fan deposits was not observed.

78°. Changes in overall dip with depth were not apparent. Vertical crack fillings are shown in figure 18. Desiccation cracks in the crack fillings form only after exposure to air, and are not found in fresh excavations (figs. 17*B*, 32*A*). In figure 18*A*, desiccation cracks do not occur at distances of more than 1½ feet in from the edge of the untrimmed canal bank. The particle-size distribution of a sample from the crack filling is shown in table 3 and figure 34 (sample 18). The armored mud balls occur in the clean water-laid sand, and one of the mud balls is cut in half by the clay-filled crack. Part of a 12-foot exposure of vertical crack filling is shown in figure 18*B*. The crack filling is almost parallel to the streambank, and continues into the bank to the left of the mattock.

Bedding on the opposite sides of the cracks does not show any signs of bending or deflection along the crack, and offset, which is not common, rarely exceeds a few inches as exposed on the 2-to-1 slopes. Lack of offset bedding is shown in figure 26. Minor offset bedding may be present at the bottom of the photograph in figure 17*A*.

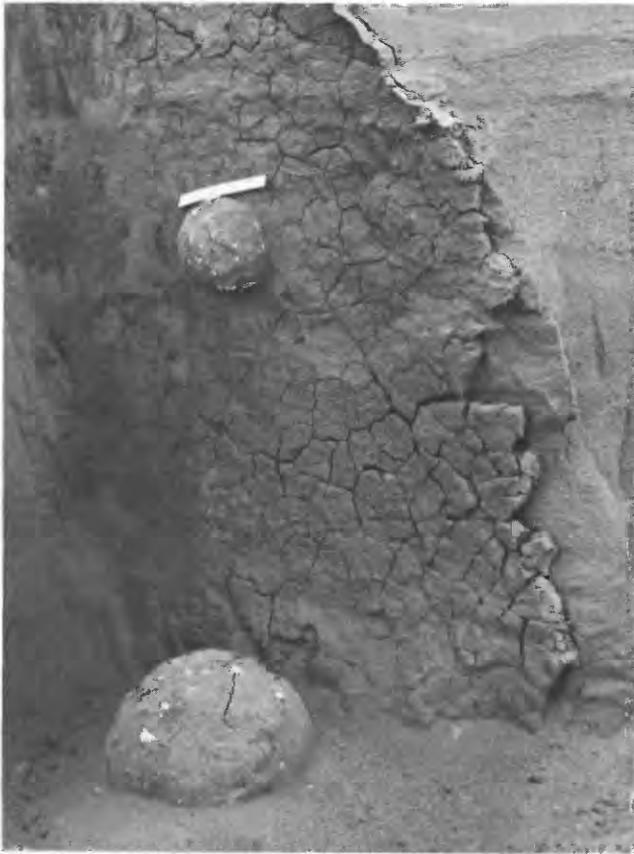
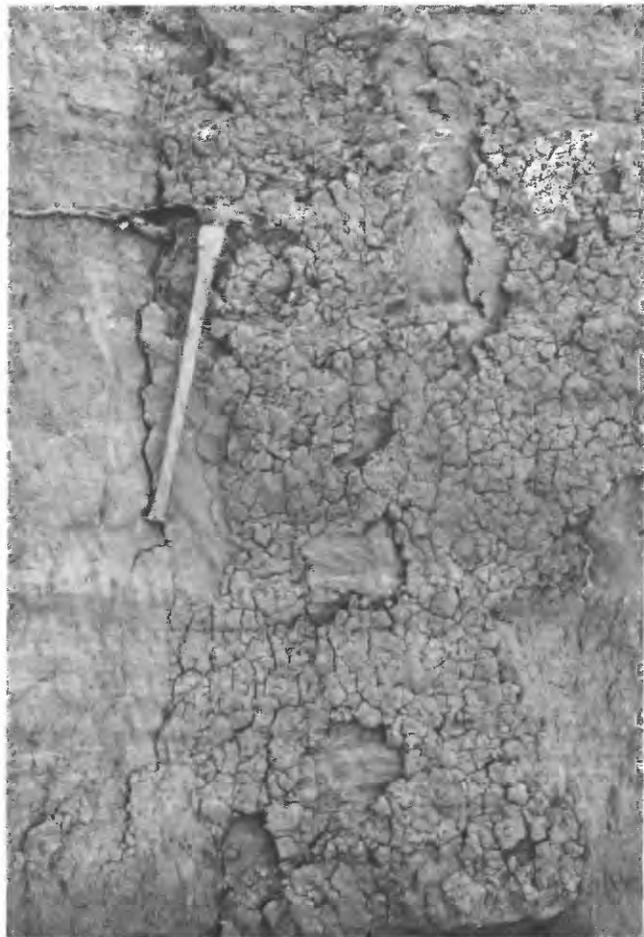
FIGURE 18.—Sides of vertical clay-filled cracks, Los Gatos Creek fan. *A*, San Luis Canal station 4712 + 21R. Scale is 4 inches long. *B*, Bank of Los Gatos Creek. Mattock handle is 3 feet long. Location of crack is shown by the letter *H* in figure 52.

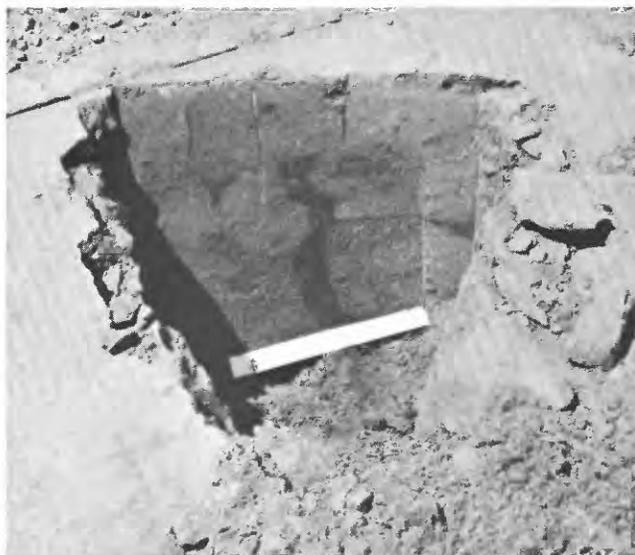
FIGURE 20.—Truncated tops of clay-filled cracks. A, Crack in trench on Panoche Creek fan about 1,000 feet southwest of canal station 2060. Mattock handle is 3 feet long. B, Crack in the Los Gatos Creek fan at canal station 4796 + 33R. White scale is 4 inches long.

Most of the upper parts of the cracks end within the bedded fan deposits and appear to have been cleanly truncated during the process of erosion, transportation, and deposition of the water-laid sediments. Truncated clay-filled cracks are shown in figure 20. In figure 20*A*, the truncation is 9 feet below the fan surface, and in figure 20*B*, the truncation is 1-2 feet below the top of the bedded fan deposits. Some cracks disappear at the base of the tilled zone, about 2 feet below the fan surface, and it is not possible to determine the nature of the original tops of these cracks.

A photograph of the easternmost crack filling on the north side of the trench (fig. 25) is shown in figure 26. The truncated top and lack of offset bedding of the bedded fan deposits on opposite sides of the crack are typical of the cracks studied in the trench. A more complete view of this crack is shown in figure 20A.

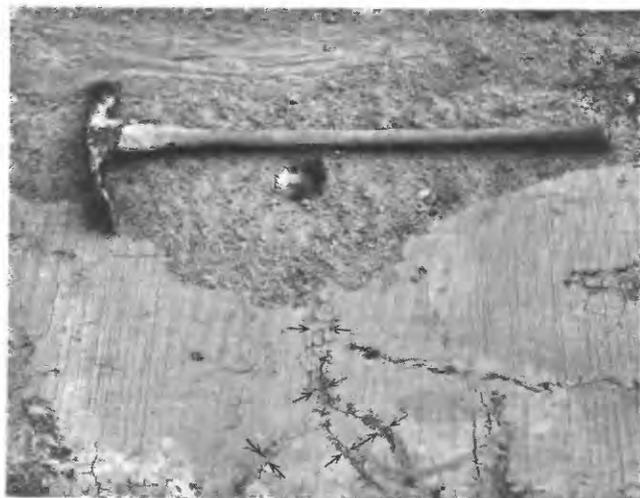
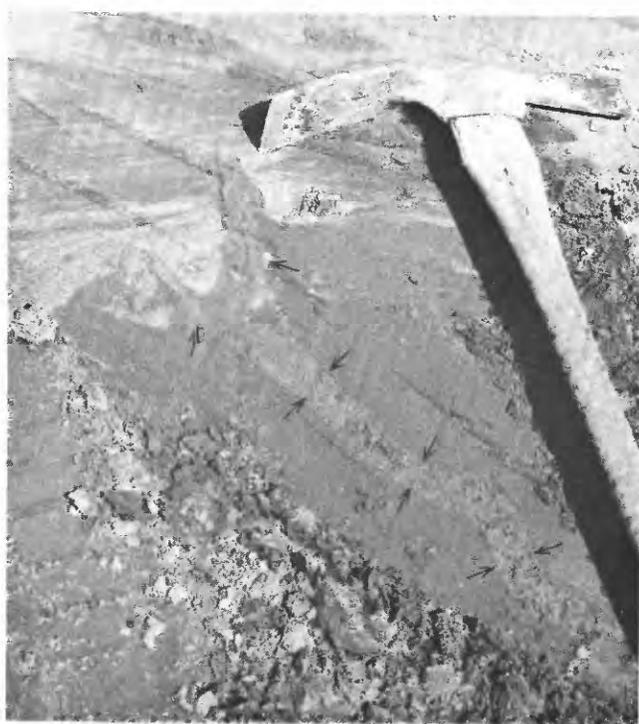
FIGURE 24.—Clay-filled cracks truncated by cut-and-fill structures. A, Panoche Creek fan, San Luis Canal station 2138 + 10R. The paired arrows end at sides of cracks. B, Los Gatos Creek fan, San Luis Canal station 4805 + 00L. The paired arrows end at sides of crack and funnel top.

Existing cracks were truncated during the course of channel entrenchment. Crack fillings that are truncated by cut-and-fill structures are shown in figure 24. In figure 24A, a 1-inch clay-filled crack in massive clayey sand is truncated by a buried stream channel 25 feet below the present land surface. Gravelly sand in the bottom of the channel is overlain by crossbedded sand. This channel was 490 feet wide as exposed in the canal bank. In figure 24B, a 1½-inch crack filling consisting of clay with some sand in the middle of the filling, protrudes as a truncated stub 4–5 inches into the bottom of a former stream channel about 18 feet below the present land surface. Massive clayey sand underlies the channel, which is filled with clean crossbedded

sands containing less than 5 percent clay. The widening of the crack filling near the base of the channel suggests that this part of the crack may be part of a funnel top that has been largely removed by erosion.

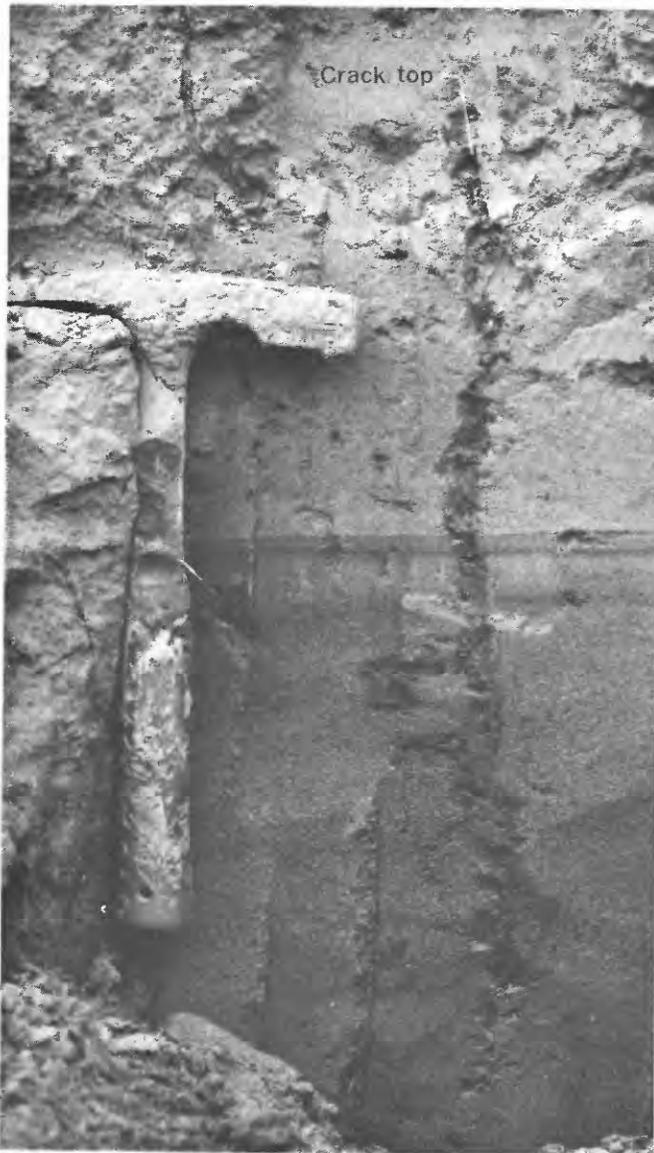
FIGURE 26.—Clay-filled crack in thin-bedded fan deposits exposed in trench about 1,000 feet southwest of San Luis Canal station 2060. Rock hammer for scale.

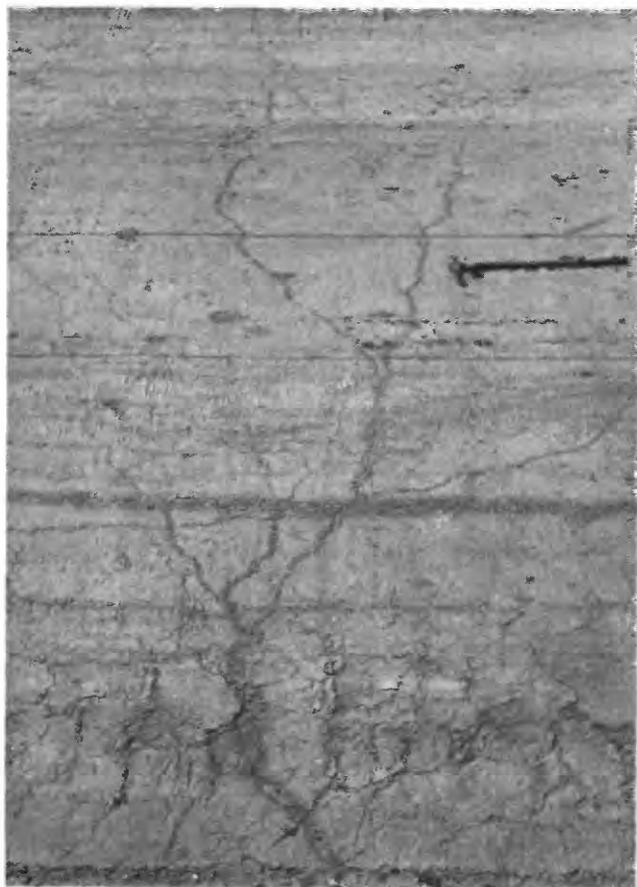
FIGURE 31.—Network of clay- and sand-filled cracks that split into many small cracks that die out within a short distance. Cantua Creek fan, San Luis Canal station 3192L.

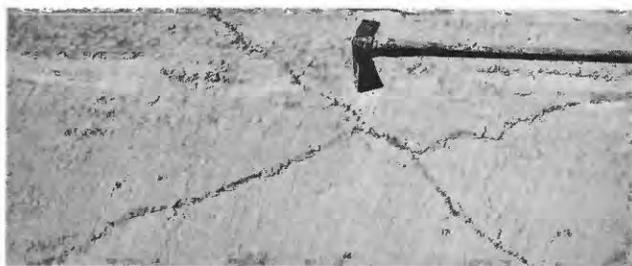
FIGURE 32.—Intersecting and intercepting clay-filled cracks. A, Intercepting and intersecting cracks in the Los Gatos Creek fan, San Luis Canal station 4785 + 21B. B, Offset of intersecting cracks in the Panoche Creek fan, San Luis Canal station 1974 + 65L.

6 inches is shown in figure 32B. Apparent offsets that were examined generally were less than 3 inches on the trimmed slopes, but displacements of 6, 12, and 21 inches were noted.

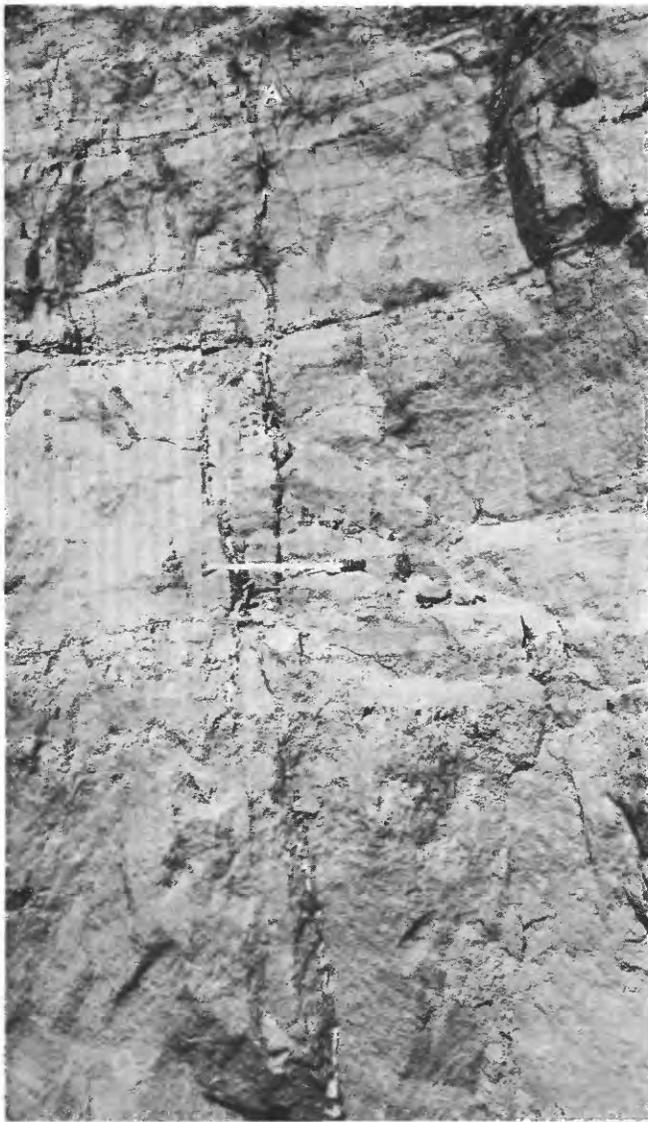
FIGURE 33.—Vertical en echelon clay-filled cracks that end in a funnel top (A) 3-4 feet below land surface. Right bank of Los Gatos Creek, location shown by letter G in figure 52. Tape is extended 1 foot.

Vertical en echelon cracks in the bank of Los Gatos Creek are shown in figure 33.

The samples tested from the Los Gatos Creek crack (fig. 33) were not homogeneous, particularly those from the upper 6 feet. The type of material in the sample from a depth of 4.0–5.0 feet below the top is shown in figure 40. The material near the sides of the crack consists of clay with minor amounts of silt, but the medial part of the crack contains sand and silt, and has a lithology that ranges from silty clay to clayey sand. Pieces of the crack filling have been stacked to show the variations in thickness and lithology of the medial part. The sand on the sides of the crack filling is from the adjacent beds of crossbedded water-laid sand that enclose most of the crack. The particle-size distribution of a thick adjacent sand bed is shown in table 3 (sample 9).

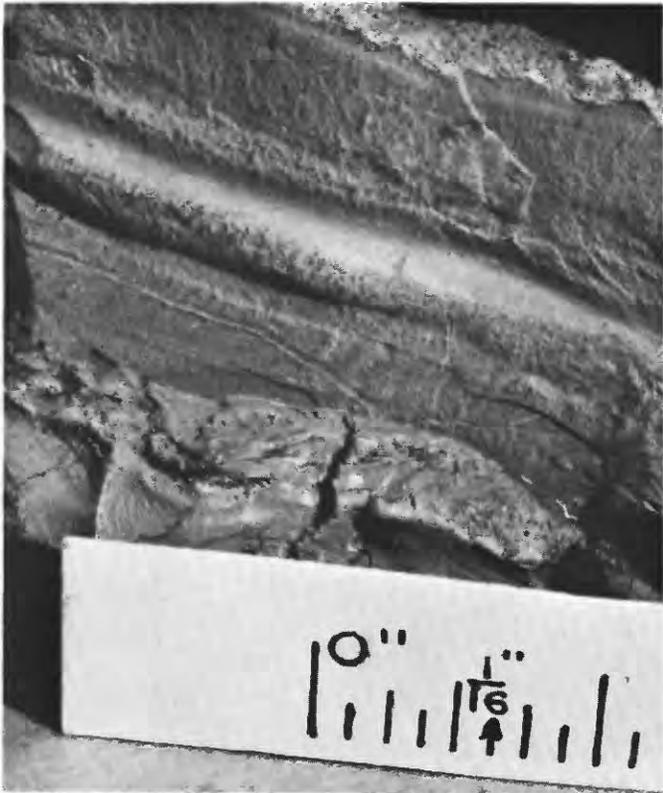
FIGURE 35.—Folds in a clay-filled crack that are parallel to the crack sides. Sample from left bank of Los Gatos Creek; location shown by the letter *H* in figure 52.

by folding which is seen best in the shrinkage cracks that form after the filling has dried. Compression folds in the center of a faintly laminated crack filling are shown in figure 35. In many crack fillings, only the central part of the crack is folded. In others, the folds occupy almost the entire width of the crack (Bradley and Bateman, 1966, pl. 6, fig. 2). The axes of the folds are parallel to the crack, and thus are oriented vertically in the fans. When a broken surface normal to a fold axis is examined, small arcuate desiccation cracks may be seen. The folds, as seen in figure 35, are the surfaces of discontinuous arcuate cracks extending vertically along the cracks. The particle-size distribution of a sample from the folded crack filling is shown in table 3 (sample 5).

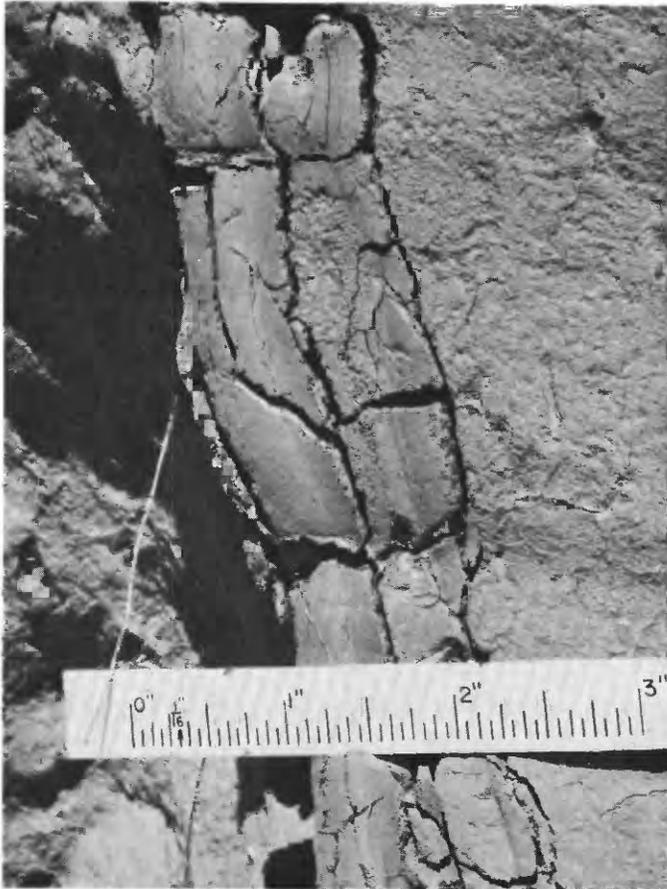
FIGURE 36.—Medial partings and lithologies in clay-filled cracks in the banks of Los Gatos Creek. Location shown by the letter *H* in figure 52. *A*, Medial parting in 1-inch laminated clay-filled crack. *B*, Sand in medial part of a $\frac{1}{2}$ -inch clay-filled crack.

Laminations are common and characteristically occur as matching pairs on both sides of the crack. The number of laminae range from two to as many as eight in the wider cracks. A laminated crack filling is shown in figure 36A.

Medial partings, or stringers of sand or silt, are common in the clay-filled cracks, and are seen best in the dry crack fillings exposed in the banks of the stream channels. In figure 36A, a conspicuous medial parting has opened as the result of desiccation of a 1-inch crack filled with laminated clay. The smooth surface of the truncated crack is the result of erosion by the previous winter's streamflow along Los Gatos Creek. The cracks that are roughly normal to the medial crack are part of the overall pattern of poly-

A medial stringer of sand in a massive clay-filled crack is shown in figure 36B. The sand was similar to the sand enclosing the $\frac{1}{2}$ -inch crack filling. The sand stringer is sufficiently thin and discontinuous that the bond between the clay in both sides of the crack was not broken, and a medial parting was not visible. Sand stringers in the medial parts of clay-filled cracks commonly can be traced for more than 10 feet both vertically and horizontally.

Open, or partly filled, cracks are rare. All the cracks studied in the canal banks were closed completely, and most of the openings in the cracks exposed in the stream-channel banks appeared to be medial partings that can be attributed to desiccation, such as the one shown in figure 36A. A crack that is only partly filled is shown in figure 37. The sides of the crack are coated with two matching laminae of clay. The crack width ranges from one-eighth to one-half of an inch, and the opening between the clay coating the sides of the crack is as much as one-third of an inch. At a few points, the crack was completely closed with clay. The

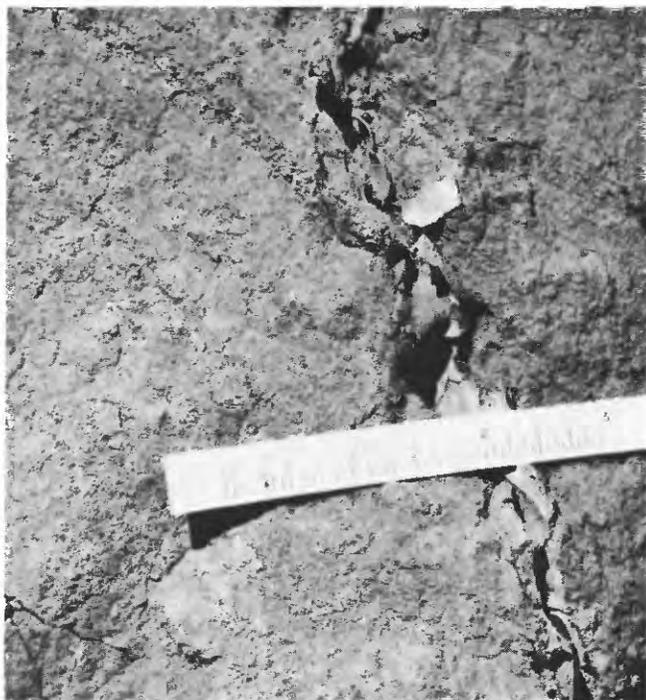
FIGURE 37.—Partly filled crack in the right bank of Los Gatos Creek. Location is shown by the letter *G* in figure 52.

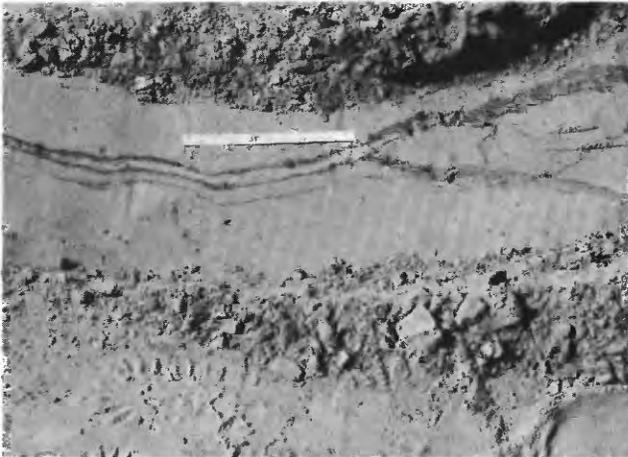
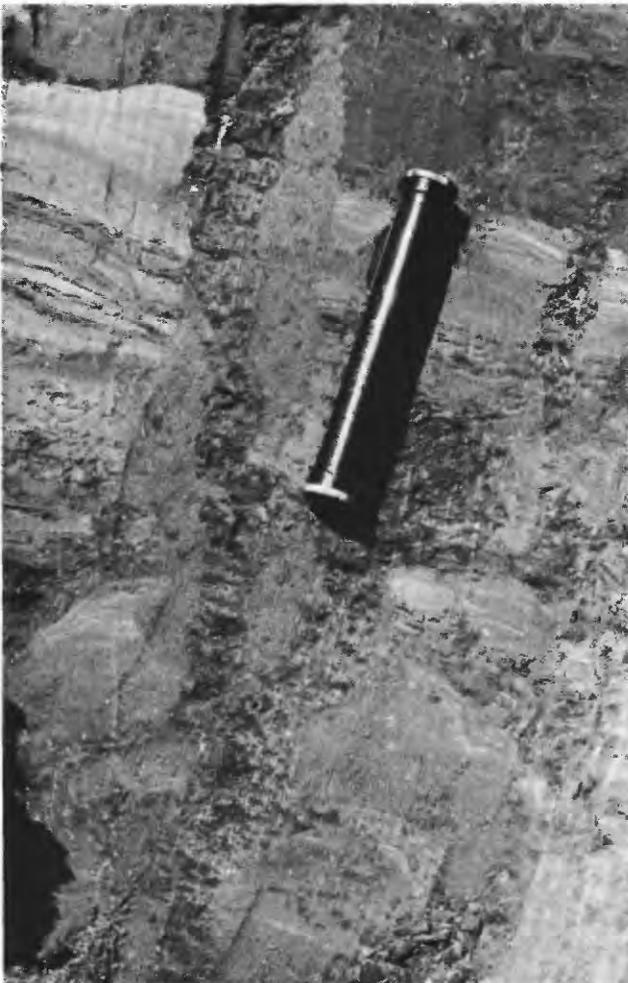
FIGURE 44.—Multilithologic crack fillings. *A*, Los Gatos Creek fan, San Luis Canal station 4810 + 23B. Piece of measuring tape is 7 inches long. *B*, Cantua Creek fan, San Luis Canal station 3192L. Hand level for scale.

Some of the cracks that are not filled with clay have thin films of clay lining their sides (fig. 44A.) The clay in the thin coating may be derived from the adjacent beds of clayey sand, or may be brought into the crack by water percolating through the sand adjacent to

The multilithologic crack in the Cantua Creek fan (fig. 44B) is a different type than that shown in figure 44A. Two clay-filled cracks intercept below the hand level in the cut made in the canal bank. Clayey sand containing organic particles was deposited adja-

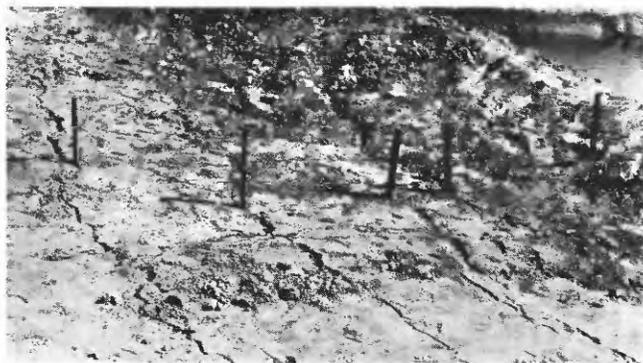
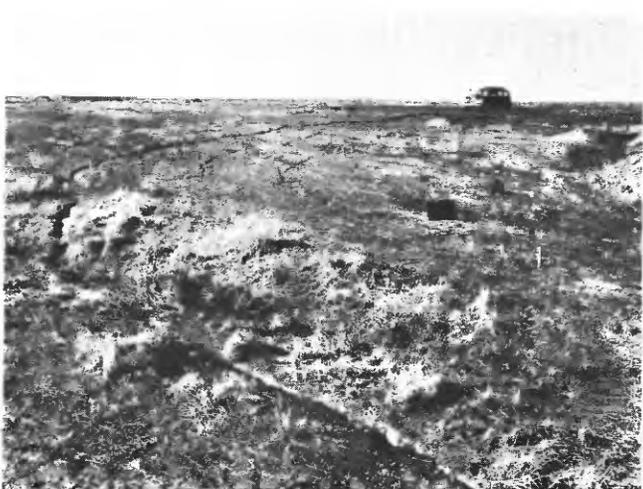
FIGURE 46.—Near-surface subsidence cracks around Inter-Agency Committee test plot D. *A*, Five days after flooding of the plot began. Photograph by Wallace Fuqua of the California Department of Water Resources. *B*, Six months after flooding of the plot began. Photograph by B. D. Glaha of the U.S. Bureau of Reclamation.

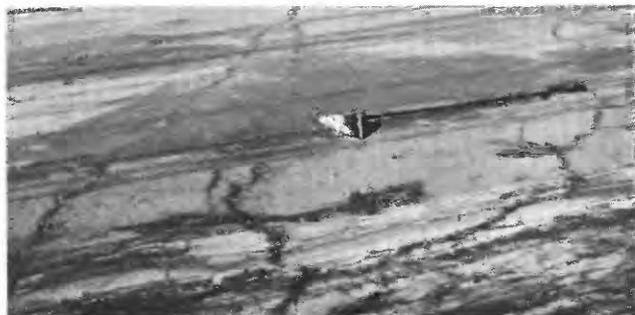
C, Anastomosing cracks, Panoche Creek fan, San Luis Canal station 1923 + 40L. View looking down the trimmed slope.

The anastomosing cracks in figure 47A resulted from the partial disintegration of a block of fan deposits between two primary cracks. The clay-filled cracks in figure 47B have a similar anastomosing appearance. In figure 47C, crack width is a function of both variation in the amount of separation in a primary crack and secondary slumpage in the throat of a crack bifurcation. Figure 47D shows a crack in the Panoche Creek fan that is almost identical to the one in the Arroyo Ciervo fan in figure 47C, even to the bifurcation of the primary crack that occurs at one end of the secondary slump. The en echelon cracks at the Mendota test site shown in figure 47E cause the fracture zone to be offset about 3 feet in 10 along the strike of the cracks. The en echelon clay-filled cracks in the Los Gatos Creek fan shown in figure 47F cause an offset of the fracture zone of about 1 foot in 6. Cracks that inter-

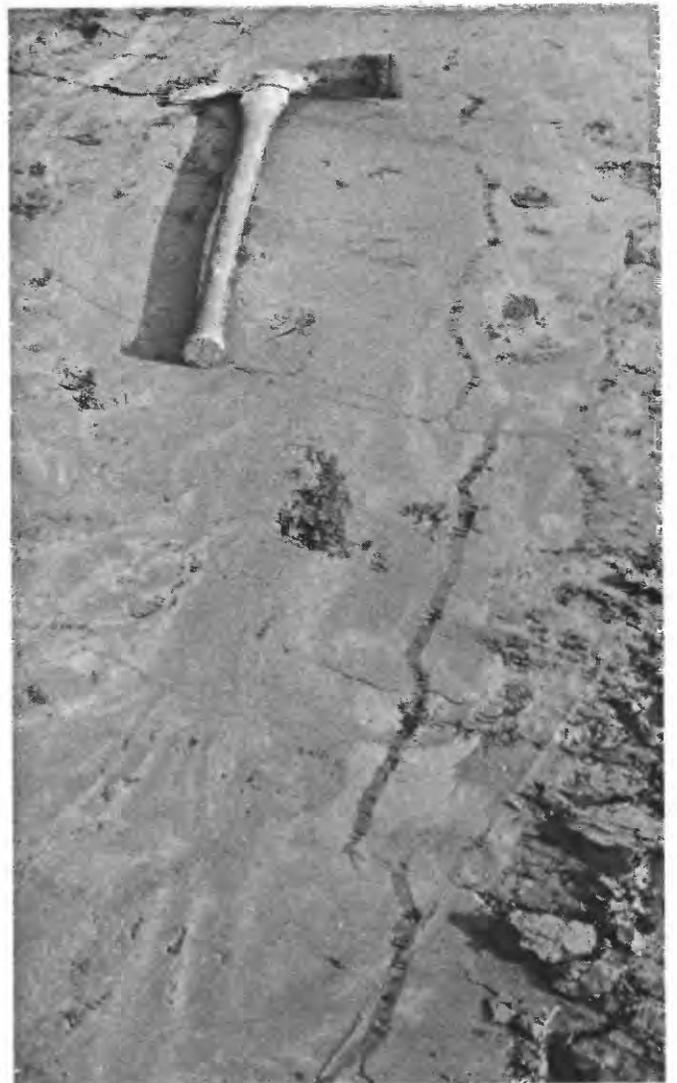
D, En echelon cracks in the Los Gatos Creek fan, San Luis Canal station 4791 + 25B.

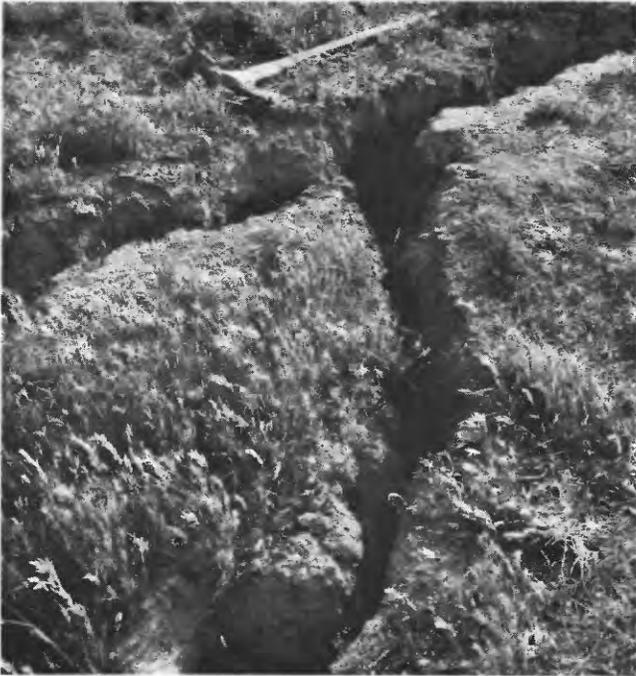
E, Intersecting crack at the Mendota test site.

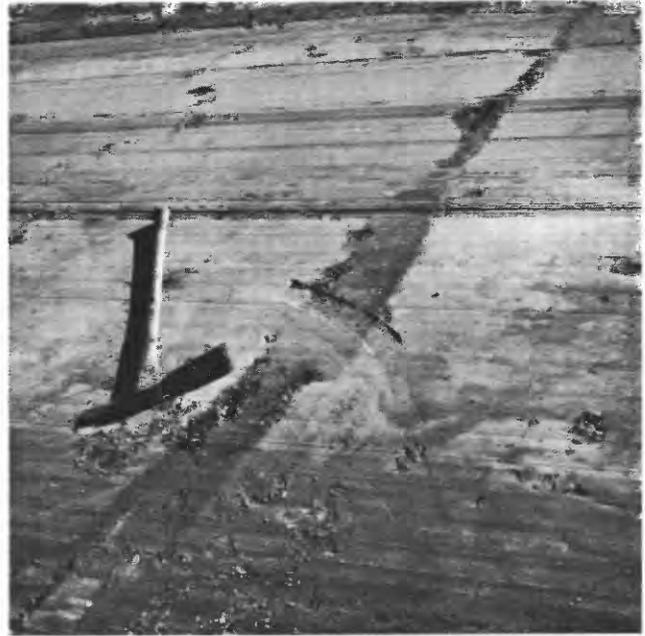
G, Abrupt widening of crack, note bifurcation of crack at bottom of photograph; Panoche Creek fan, San Luis Canal station 1921L.

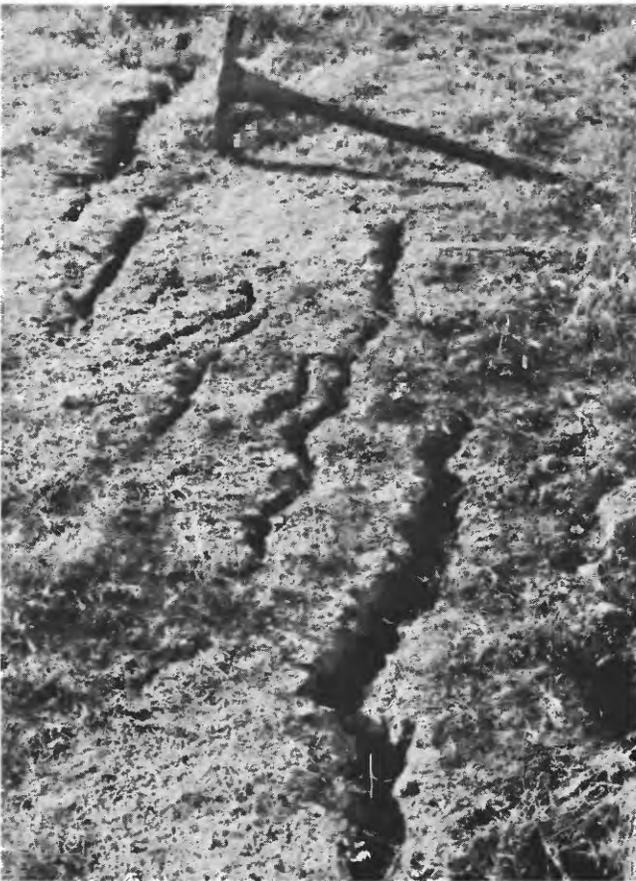
F, En echelon cracks at the Mendota test site.

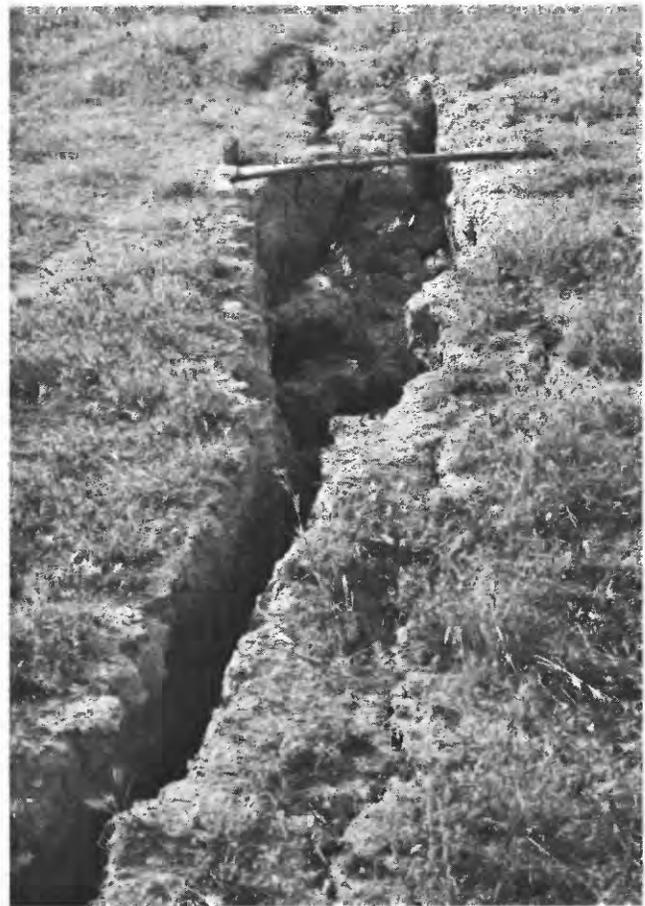
H, Widening of crack due to secondary slumpage; bifurcation of crack at top of photograph; Mendota test site.

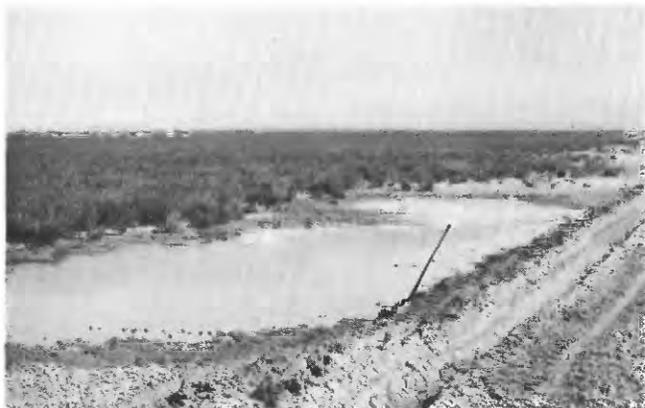
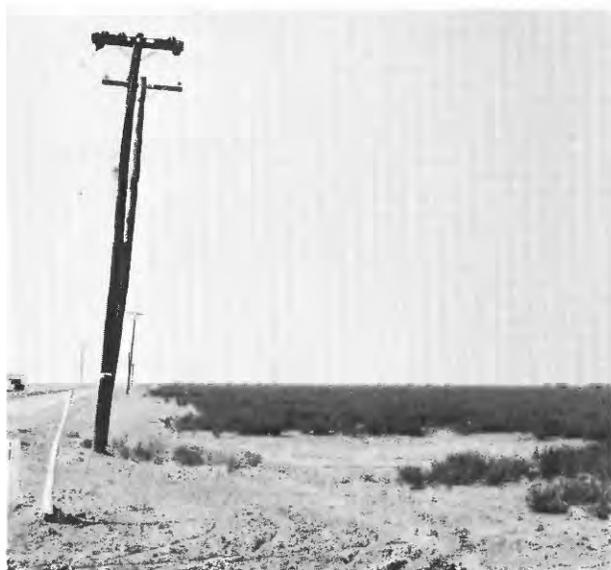
FIGURE 48.—Historic near-surface subsidence hollows on the Panoche and Los Gatos Creek fans. *A*, Water in subsidence hollow along old ditch alignment; Panoche Creek fan slope is toward the left. *B*, Powerline poles tilt toward subsidence hollows near old well site. Panoche Creek fan slope is toward the right. Location of hollows in figures 48A and 48B is about $4\frac{1}{2}$ miles southwest of San Luis Canal station 2060. *C*, Water in subsidence hollow adjacent to sprinkler pipeline on the Los Gatos Creek fan. Location is about 3 miles southwest of San Luis Canal station 4250. Photograph taken by the Topographic Division of the U.S. Geological Survey, June 1955.

A small area of moderate near-surface subsidence is present south of Panoche Creek, about $4\frac{1}{2}$ miles southwest of San Luis Canal station 2060 (Richard Bateman, oral commun., June 1966). Photographs of shallow subsidence hollows in this small near-surface subsidence area are shown in figures 48A and 48B. Most of the visible settlement is along the alinement of one or two former ditches. Undulating topography occurs in the nearby fields, but some of the breaks in slope visible in the fields are remnants of low terraces of Panoche Creek.

Although the subsidence hollows have been largely filled by agricultural operations, water still floods these low areas when crops are irrigated (fig. 48A). In figure 48B, the powerline poles in the foreground as well as most of those in the background lean toward the former ditch alinement. It is estimated that as much as 4–5 feet of near-surface subsidence may have occurred locally within this area.

of one of the 1955 hollows is shown in figure 48C. None of the 1955 subsidence hollows were present in 1967.

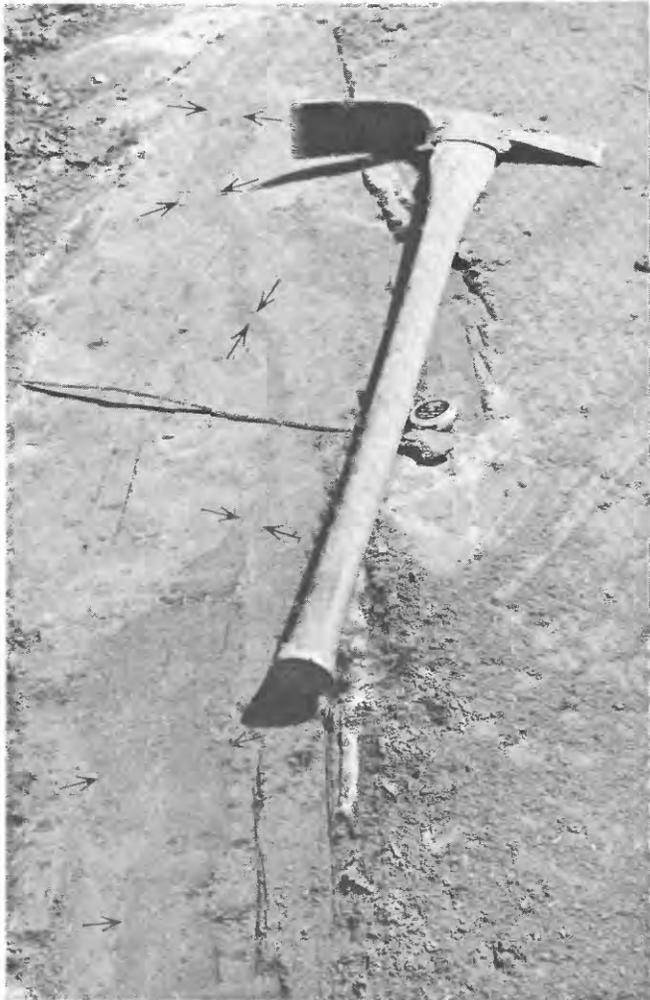
FIGURE 54.—Variation in width of crack filled with clayey sand in the Moreno Gulch fan. San Luis Canal station 1702 + 60L. Paired arrows end at sides of crack.

Some cracks have irregular widths such as the one in the Moreno Gulch fan shown in figure 54. A rough hackly break of the deposits adjacent to the crack is apparent where the tape crosses the crack filling. Abrupt widening of a crack such as in the foreground of figure 54, commonly is the result of secondary

slumpage into primary cracks. Clay lines the edges of the crack, but the bulk of the crack filling consists of clayey sand.

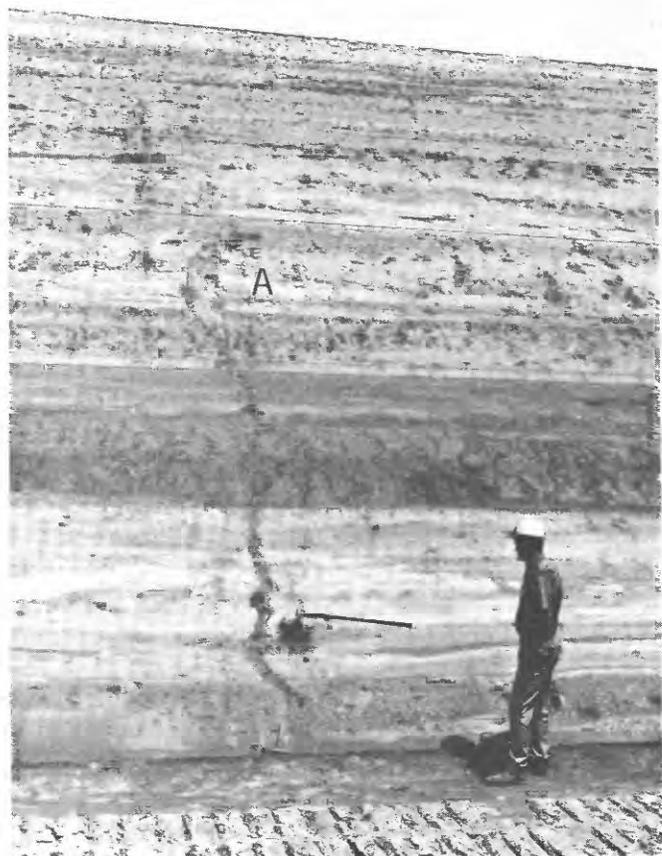
FIGURE 55.—Five-inch wide clay-filled crack with no primary offset bedding. Secondary cracking at A is shown in figure 56B. Arroyo Hondo fan, San Luis Canal station 2992.

Most of the cracks do not have offset bedding on opposite sides of the crack (figs. 55, 58, and 61). Figure 55 is a typical crack in the Arroyo Hondo fan. Most of the cracks in this fan occur as sets or single cracks that commonly are spaced more than 1,000 feet apart. The primary crack shown in figure 55 is 5 inches wide and is filled with silty clay that has 15 percent sand. (See sample 28 in fig. 63 and table 3.) The crack filling contains fragments of reeds and other organic matter. A closer view of area A is shown in figure 56B.

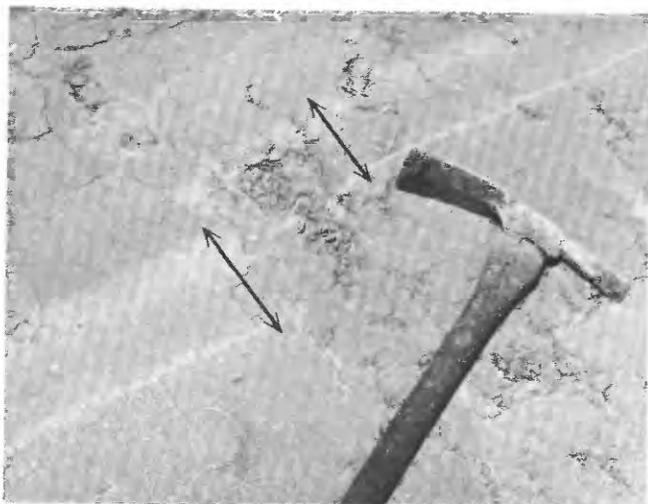
FIGURE 56.—Offset bedding adjacent to cracks. *A*, Offset bedding on opposite sides of a primary crack in the Arroyo Ciervo fan, San Luis Canal station 2820 + 20L. Lengths of double arrows indicate differences in apparent thickness on opposite sides of the crack. *B*, Offset bedding associated with a secondary slump in a primary crack in the Arroyo Hondo fan, San Luis Canal station 2992L.

The few cracks that had offset bedding rarely had more than a few inches of offset bedding as exposed on the 2-to-1 slopes. Offset bedding in the Arroyo Ciervo and Arroyo Hondo fans is shown in figure 56. Offset
