Prehistoric Near-Surface Subsidence Cracks in Western Fresno County, California

GEOLOGICAL SURVEY PROFESSIONAL PAPER 437-C

By WILLIAM B. BULL

*A study of filled tension cracks
in alluvial-fan deposits*

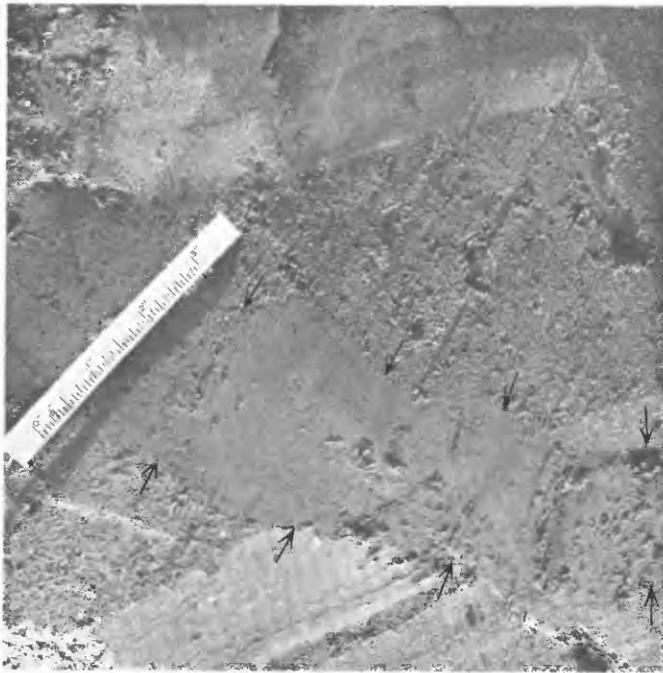
FIGURE 58.—Crack filled with massive sandy clay, Tumey Gulch fan. San Luis Canal station 2530 + 70R. Paired arrows end at sides of crack.

The crack fillings may be massive, laminated, contain medial partings or lithologies and show internal folding. Some cracks are filled with bedded sand or gravel. Most of the crack fillings are massive. A massive crack filling consisting of sandy clay is shown in figure 58. The particle-size distribution of a sample from the crack filling is shown in table 3 and figure 63 (sample 26). The crack width changes abruptly along the strike and ranges from 1 to more than 3 inches wide. The bedding on opposite sides of the crack is not offset.

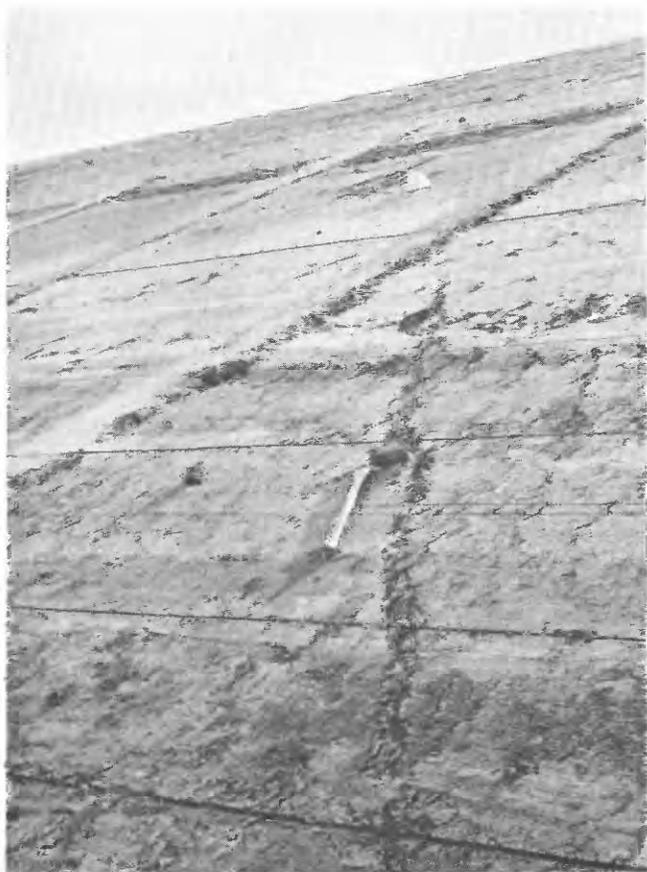
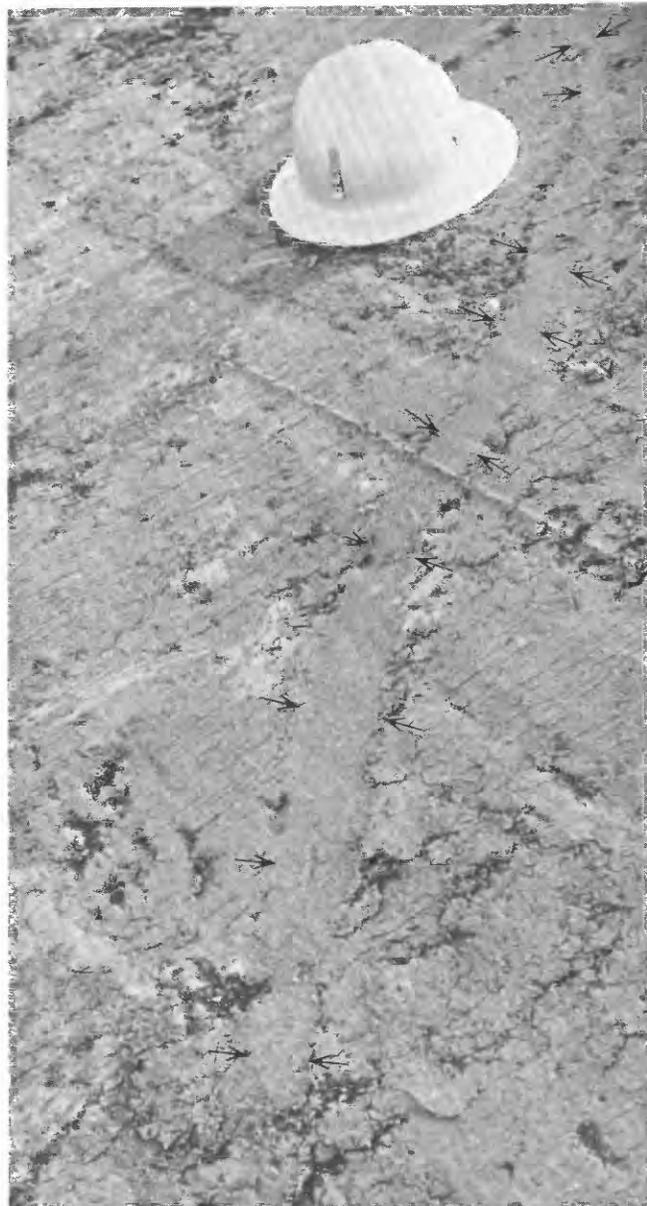
(linear feature normal to the trimmer marks), the crack is filled with clayey sand and sand. The hard hat in figure 59A is near the upper end of the crack. A view of the sand-filled part of the crack in the vicinity of the hard hat is shown in figure 59B. The crack width is about 2 inches in the foreground, but the crack pinches out rapidly upslope from the hard hat.

FIGURE 59.—Crack filling in the Tumey Gulch fan that changes from sand-silt-clay where exposed on the lower part of the slope to sand on the upper part of the slope. *A*, Crack filled with sand-silt-clay at station 2529 + 66R. *B*, Crack filled with clayey sand at station 2529 + 85R.

The particle-size distribution of samples collected from two parts of the crack shown in figure 59 are shown in figure 60 and table 3. The lower part of the crack consists of a poorly sorted mixture of sand, silt, and clay (sample 24). The upper part of the crack consists mainly of fairly well sorted sand, but about one-fourth of the sample from the crack filling consisted of poorly sorted silt and clay (sample 25). The massive nature of both the sand-silt-clay and the clayey sand suggests that the crack was filled rapidly after it opened.

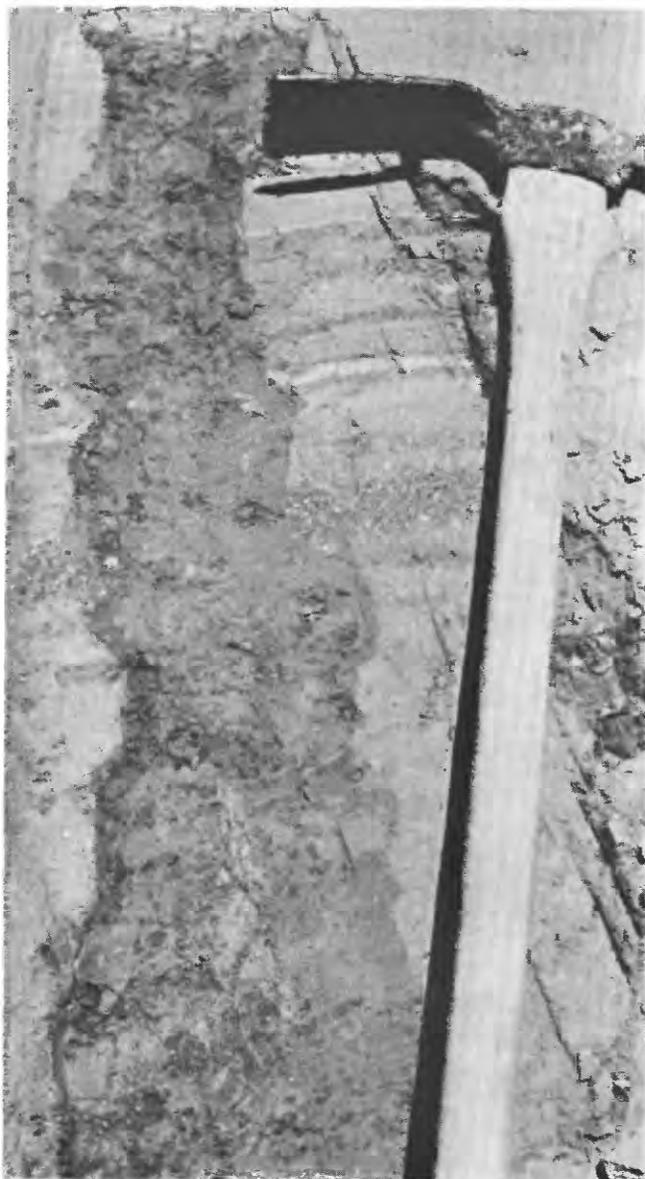
FIGURE 61.—Wide crack filled with silty clay. Tumey Gulch fan, San Luis Canal station 2311 + 26L.

Some of the crack fillings consist of extremely poorly sorted material, such as samples 22 and 28 in table 3 and figure 63. The crack filling from which sample 22 was obtained is shown in figure 61. This crack is as much as 6 inches wide, and the sides of the crack are lined with clay that is darker than the silty clay that fills the center of the crack. Although the crack cuts beds containing coarse grained sand and gravel, the crack filling does not contain particles larger than 0.5 mm (millimeter).

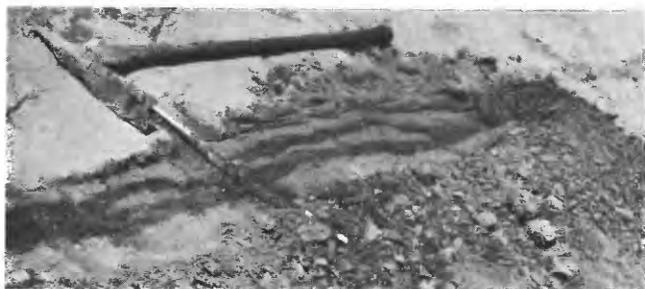
FIGURE 62.—Discontinuous sand filling in the center of a clay-filled crack. Arroyo Ciervo fan, San Luis Canal station 2820 + 80L.

Medial partings, or stringers of sand or pebbly sand, are common in the clay-filled cracks of the small fans. An intermittent sand filling as much as 1½-inches wide in the center of a clay-filled crack is shown in figure 62. Parts of the clay seams on either side of the sand-filled center have medial parts of clayey sand. The clay contains mica that is oriented parallel to the crack sides.

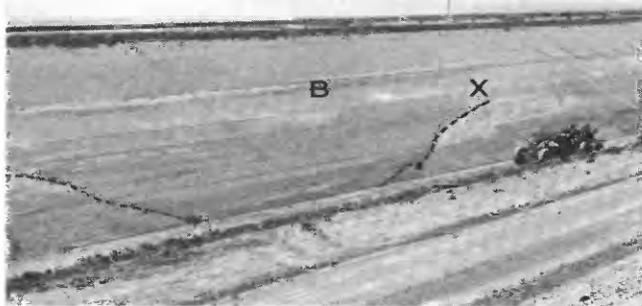
FIGURE 64.—Prehistoric buried stream channels and near-surface subsidence cracks at the Arroyo Hondo-Cantua Creek fan boundary. Boundaries of buried channels are dotted. The point X is common to all four photographs. A, Buried channels cut by Cantua Creek. B, Channel cut by Cantua Creek and backfilled by flows from Arroyo Hondo. C, Multiple cut-and-fill structures made by Cantua Creek and Arroyo Hondo. D, Clay-filled cracks extending through multiple cut-and-fill structures.

The abundance of cracks in the Arroyo Hondo fan adjacent to the Cantua Creek fan is the result of a complex history of channel cutting and filling and of intertonguing deposition by the streams of both fans. The series of photographs in figure 64 shows the general relations at the fan boundary, the details of some of the channel cutting and filling, and clay-filled cracks. Two large buried channels are shown in figure 64A. Both channels are of a size typical of the buried channels observed in the Cantua Creek fan at this distance from the mountain front, and both are much larger than the channels of Arroyo Hondo found in the trimmed canal banks. Channel A was cut by Cantua Creek and was backfilled with sand and gravel containing serpentine fragments typical of 12 percent of the Cantua Creek source area. The top of the bedded fan deposits is approximately at the top of the finger drains. Location X is the same on all four photographs in figure 64.

Channel B in figures 64A and 64B also was cut by Cantua Creek, as is indicated by its size and shape. The channel has been backfilled with material that is distinctly different than the material that fills channel A in figure 64A. Instead of water-laid sands and gravels, channel B is filled with clayey deposits, many

Details of the channel and the cracks near location X in figure 64B are shown in figures 64C and 64D (the shovel shows the scale). A smaller cut-and-fill structure that has a size typical of the channels of Arroyo Hondo along the canal alignment occurs beneath the side of the larger channel cut by Cantua Creek. Both fine-grained channel fills are cut by many clay-filled cracks, as is the coarse-grained fill of channel A (fig. 64A):

The following history is postulated for this part of the Arroyo Hondo fan. Deposition by Arroyo Hondo of water-laid sediments, and deposits intermediate between water-laid sediments and mudflows, was interrupted occasionally by channel entrenchment (foreground of fig. 64D). Deposition by Arroyo Hondo was followed by encroachment of Cantua Creek. A period of channel cutting and filling by Cantua Creek made the cut-and-fill structure (fig. 64A, channel A). A second period of channel cutting by Cantua Creek made the channel shown in figure 64B; however, the channel was backfilled principally by Arroyo Hondo. The presence of clay-filled cracks in all the buried channel fills shown in figure 64 indicates that compaction due to wetting did not occur as a result of streamflow during the channel cutting and backfilling. The stream channels probably were cut by flashy flows of short duration that did not percolate down to moisture-deficient deposits.

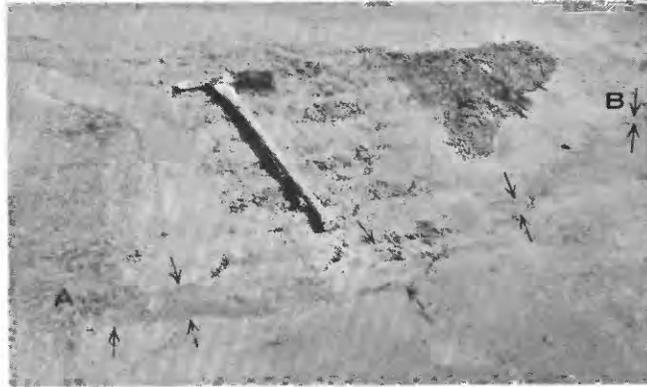
FIGURE 65.—Crack filling extending down from the side of buried stream channel in the Tumey Gulch fan, San Luis Canal station 2548 + 75. A, View looking diagonally down the trimmed canal bank. Three-foot mattock handle is parallel to overall fan bedding. Arrows end at sides of crack and funnel top. B, Isometric diagram of channel and crack filling; heavy lines are parallel to canal centerline. Drawn by M. E. Royce from photographs.

A crack filling that extends down from the side of a buried channel at station 2548 +75 is shown in figure 65 and plate 2C. The channel is narrow near its deepest part, but widens near its top and extends to the top of the bedded fan deposits. The bottom of the channel is filled with lag gravel, and clayey bedded deposits fill the rest of the channel. Upslope from the mattock (to the left), a bed of clayey sand in the channel is exposed in arcuate fashion on the trimmed slope, and is overlain by bedded clayey gravel. In the foreground, to the right of location A, the arcuate bed of clayey sand is breached and a crack filling extends down the canal slope past the bottom of the buried channel. The top of the crack is filled with clayey gravel that is similar to that in the channel immediately above the crack top. The crack filling under the clayey gravel consists of sandy clay, and the crack filling at the base of the canal bank consists of sand-silt-clay. A sample of sand-silt-clay with 22 percent sand was collected from the crack filling at location B (fig. 65). The particle-size distribution of the sample is shown in table 3 (sample 27).

The following sequence of events is postulated for the near-surface subsidence crack shown in figure 65. The channel was entrenched and backfilled to the top of the arcuate clayey sand bed above the mattock. Compaction associated with infiltration that occurred during the trenching and partial backfilling caused a crack several inches wide to open and rupture the arcuate clayey sand bed. Subsequent flows in the channel allowed bedded sediments to be deposited in the crack. Movement of water-transported material down the crack rounded the lip of the arcuate sand bed adjacent to the crack. Clayey gravel was deposited in the stream channel and the top of the crack, and backfilling continued to the fan surface.
