# Icings along the Trans-Alaska Pipeline Route

GEOLOGICAL SURVEY PROFESSIONAL PAPER 979

By CHARLES E. SLOAN, CHESTER ZENONE, *and* LAWRENCE R. MAYO

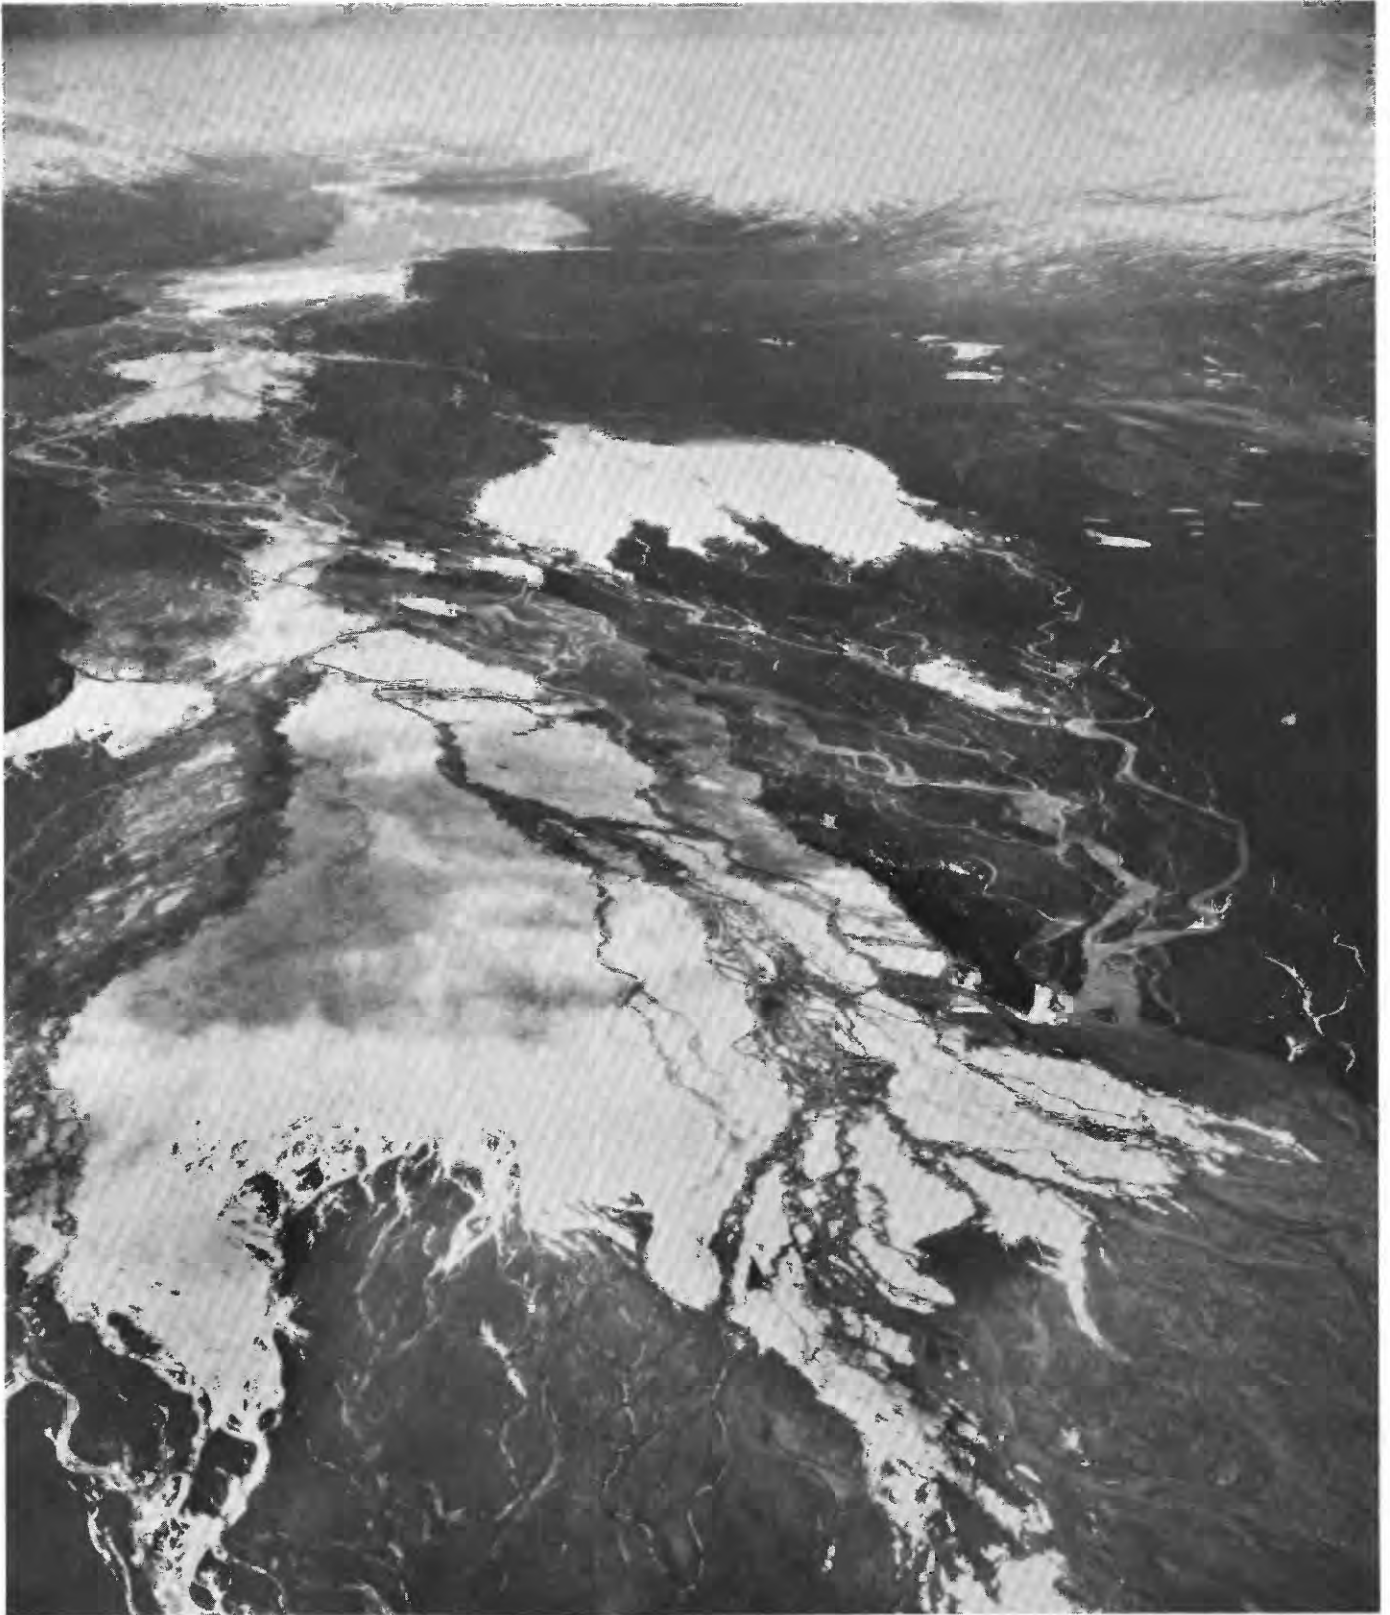
South of Black Rapids the pipeline crosses the active flood plain of the Delta River where extensive icings form annually.

**FRONTISPIECE.** Photograph showing the pipeline crossing the active flood plain of the Delta River where extensive icings form annually.

Small hillside and channel icings occur along the pipeline route between Donnelly Dome and Black Rapids (fig. 24). South of Black Rapids the pipeline route is in the active flood plain of the Delta River where extensive icings form annually (frontispiece; figs. 2, 25, and 26). Large icings form each winter at

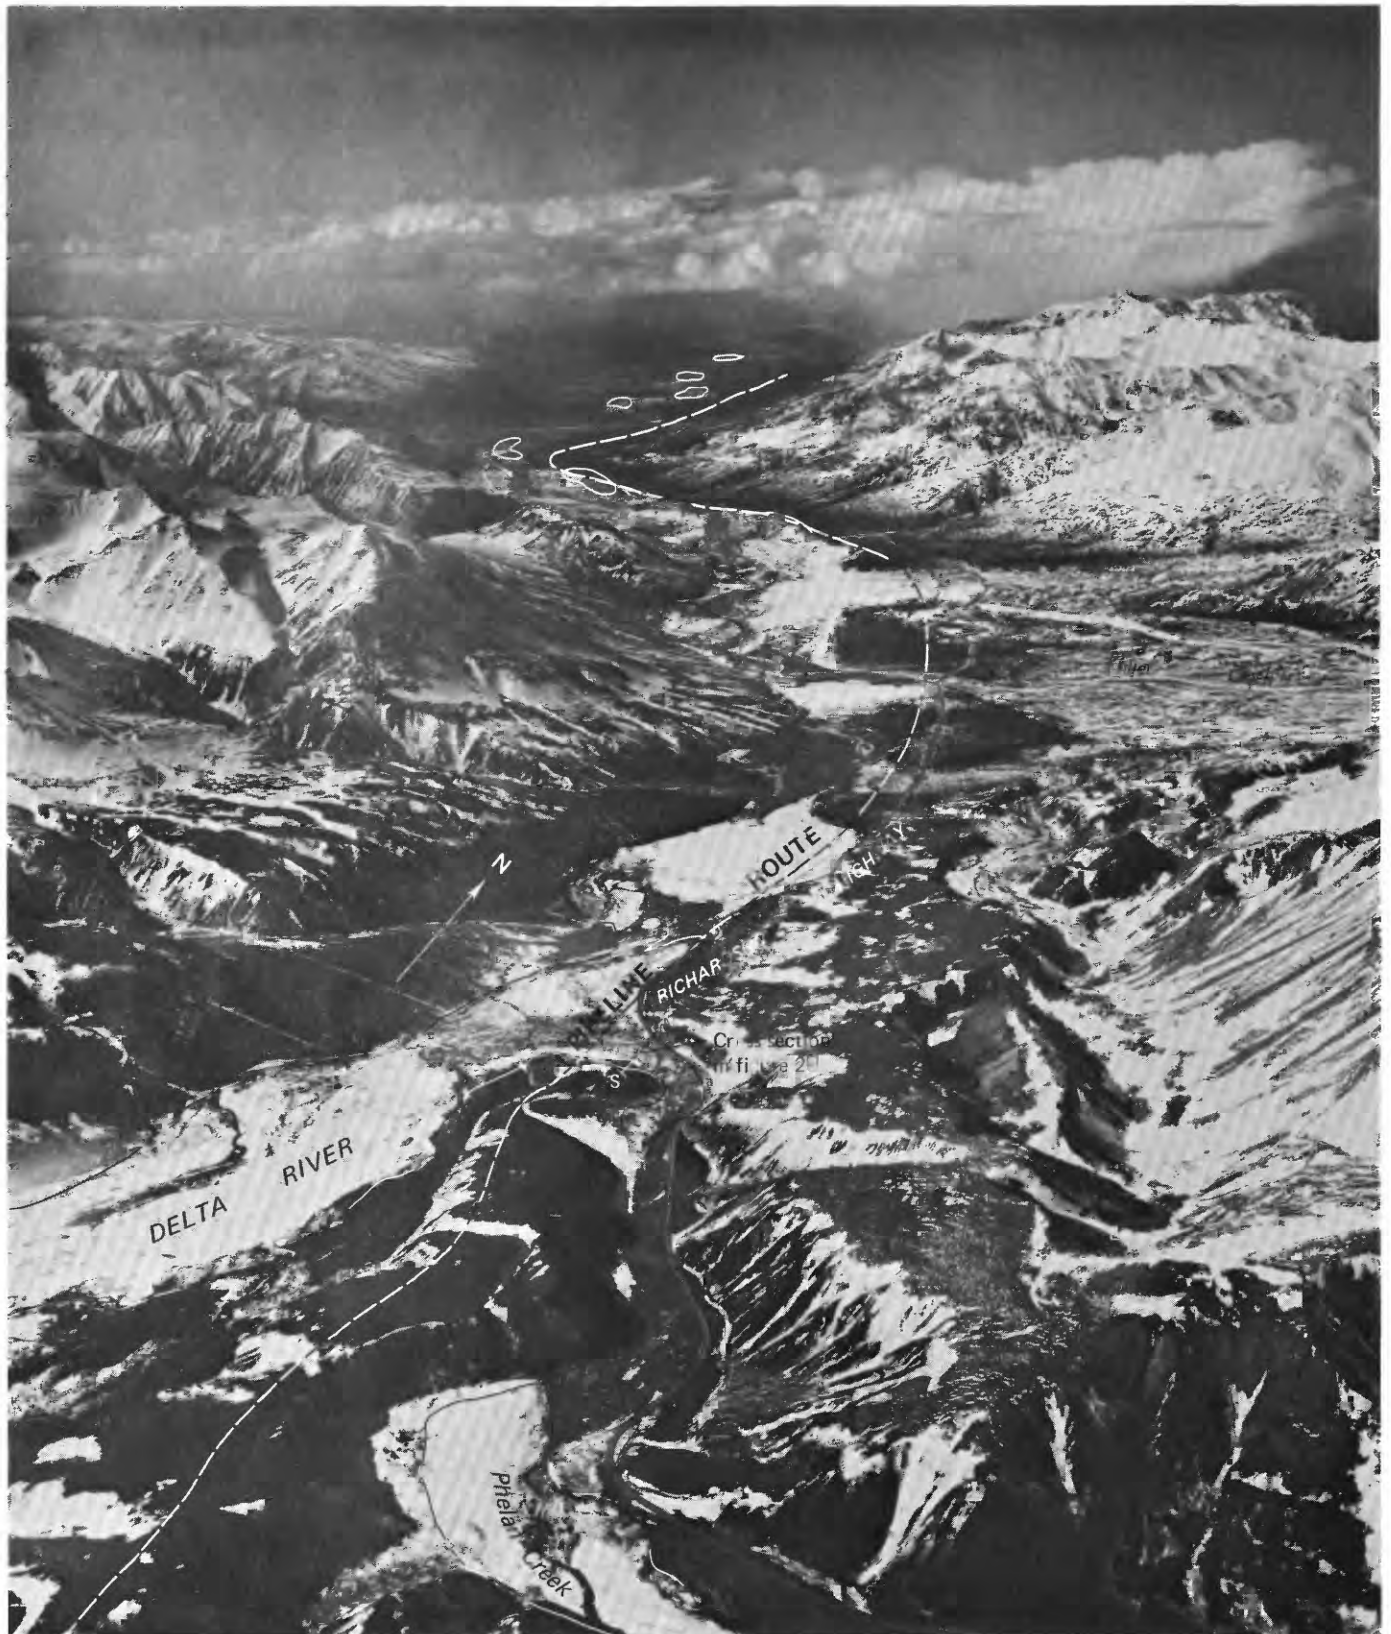
FIGURE 2.—Flood-plain icings on the Delta River and tributaries. View north along the pipeline route, May 22, 1972.

Thick flood-plain icings commonly form on braided rivers (fig. 2) because the channels are shallow and readily frozen. On the other hand, icings can be the cause of braided channels by diverting flow during spring breakup and also by inhibiting plant growth on the flood plain. Icings are not common on large rivers where the flow is confined to a narrow or single channel because of the greater channel depth. Icings form readily along small, single, shallow channels in those areas where winter streamflow is sustained by ground water. Large springs are the source of major icings in some river valleys. Small springs and seeps of ground water form small upland or hillside icings.

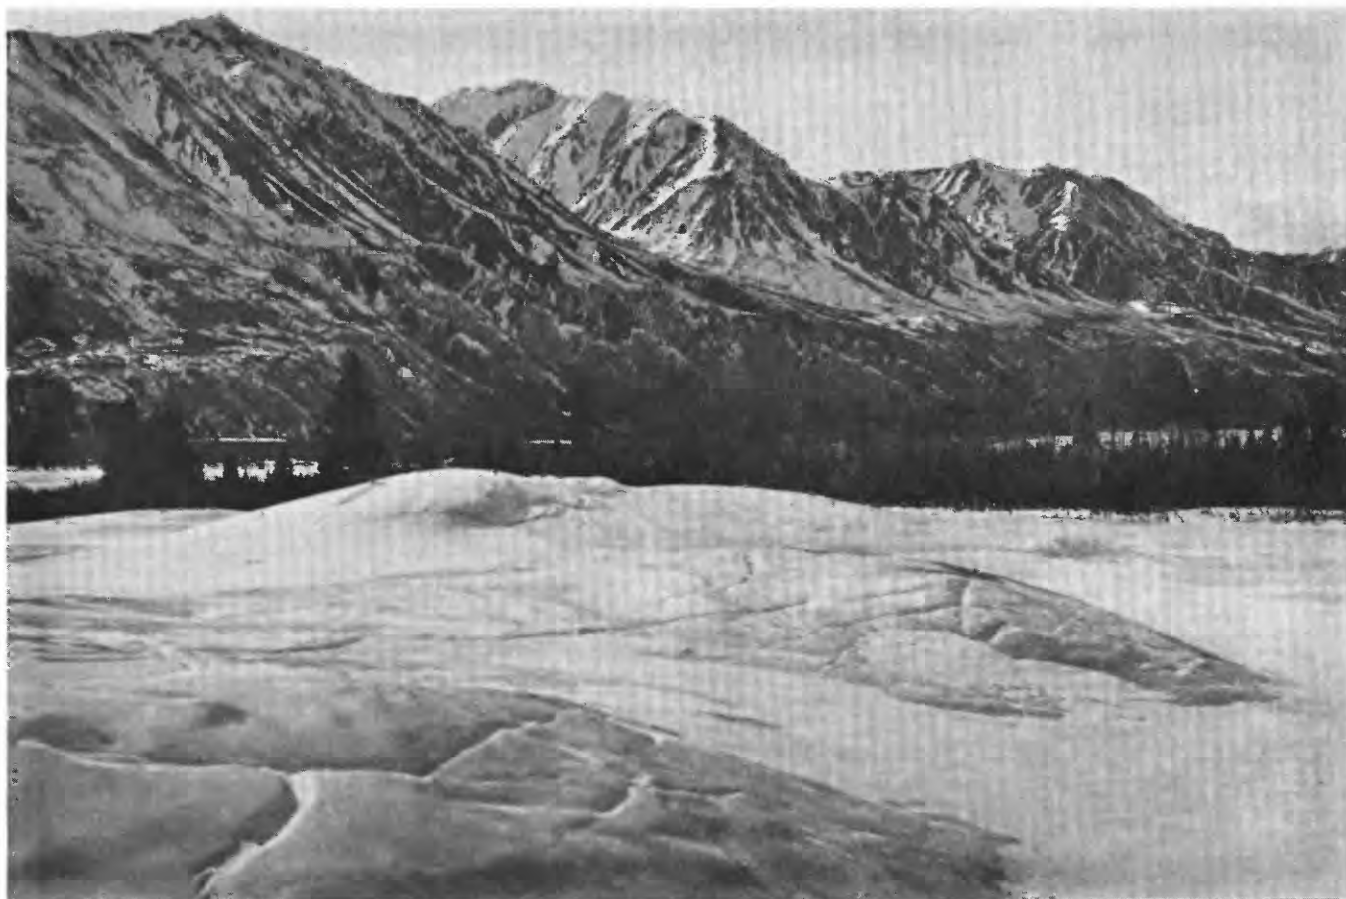
FIGURE 3.—Icing mounds on Trims Creek near pipeline crossing, Delta River valley, April 18, 1974.

Icing mounds or hummocks are uplifted ice ridges, broad humps, or smaller conical domes (fig. 3) that are common features on large icings. As ice freezes downward, pockets of water may become isolated. The volume expansion that results from the freezing process in these pockets sharply increases the hydrostatic pressure. Doming may also occur when the hydrostatic pressure due to an increase in discharge or decrease in channel size is sufficient to deform the ice sheet upward at weak places. The pressure is relieved as water bleeds out through radial or circular cracks.

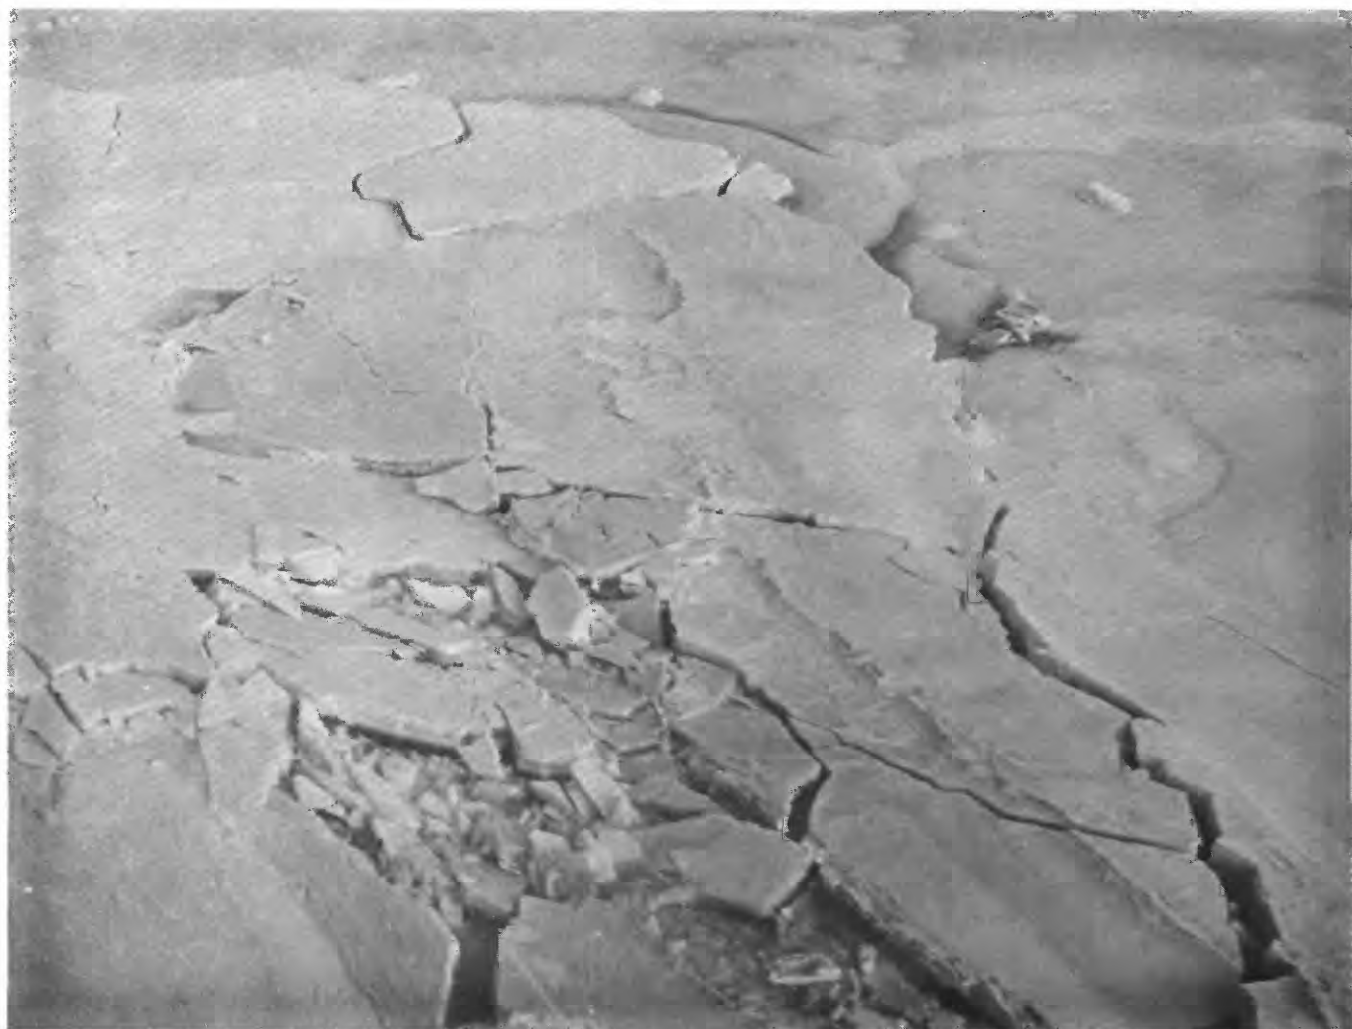
FIGURE 4.—Fractured icing mound on Dietrich River approximately 2 miles (3.2 km) downstream from confluence with Big Jim River, March 15, 1972. Explosive force scattered ice blocks for tens of feet.

Pressure in icings can result from accumulations of entrapped gas, such as air or methane. Pockets of gas under pressure have been discovered by drilling into domes that show no evidence of overflowing water. Occasionally, relief of gas pressure can occur suddenly and explosively, resulting in displaced and shattered blocks of ice (fig. 4 and 5).

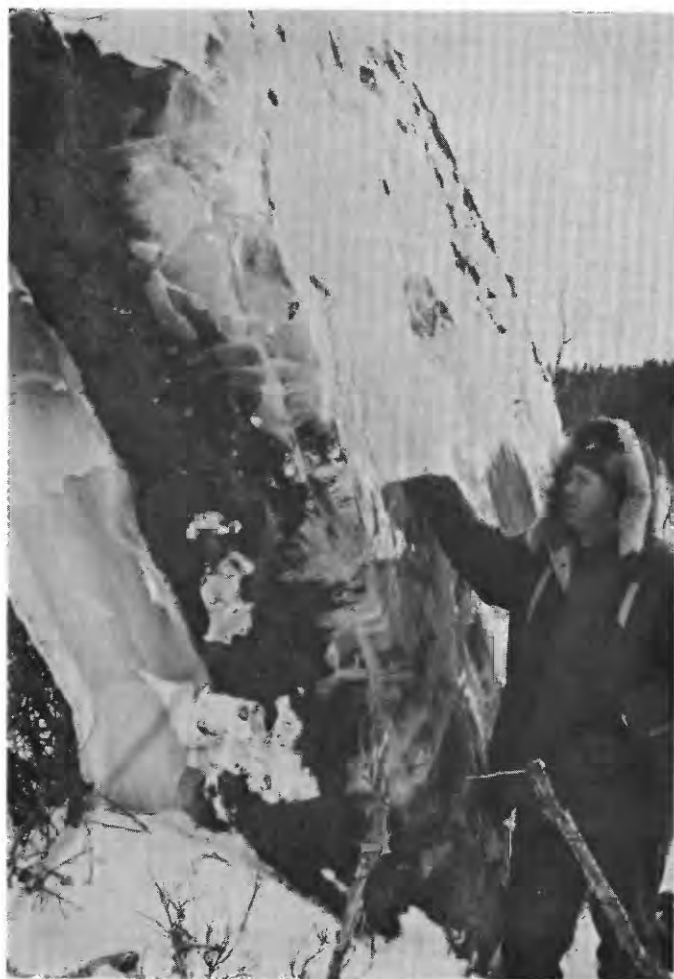
FIGURE 5.—Upheaved ice and soil block from exploded hillside icing mound north of Old Man camp in Fish Creek valley, March 21, 1974.

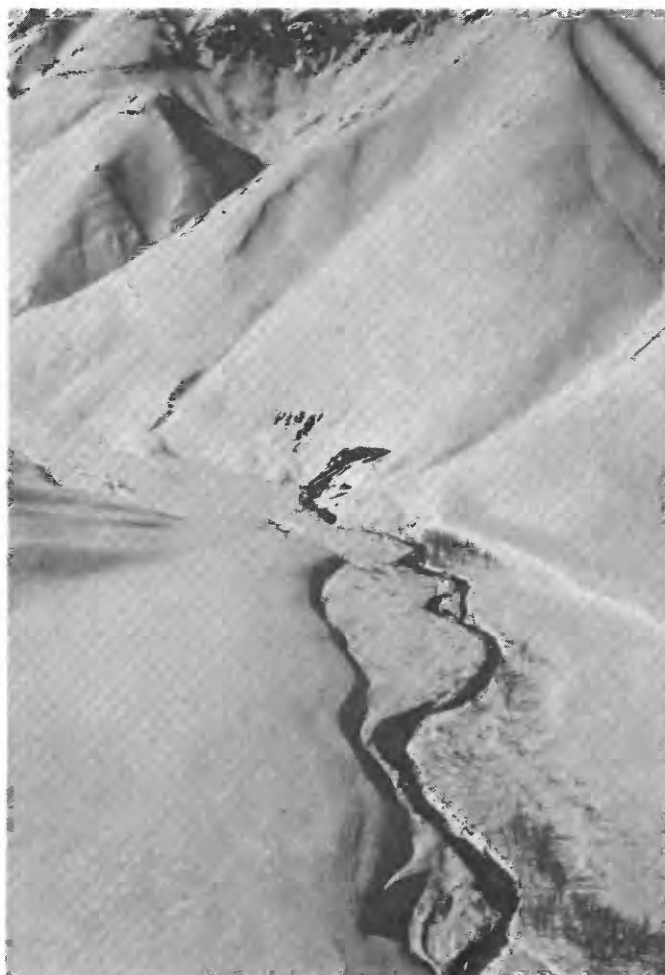
FIGURE 6.—Hillside spring in Brooks Range near Ivishak River, May 11, 1973. Balsam poplar are 30–40 feet (10–12 m) tall.

Large icings near the front of the Brooks Range are fed by springs discharging from carbonate bedrock directly to the river or alluvium in the river bed (fig. 6).

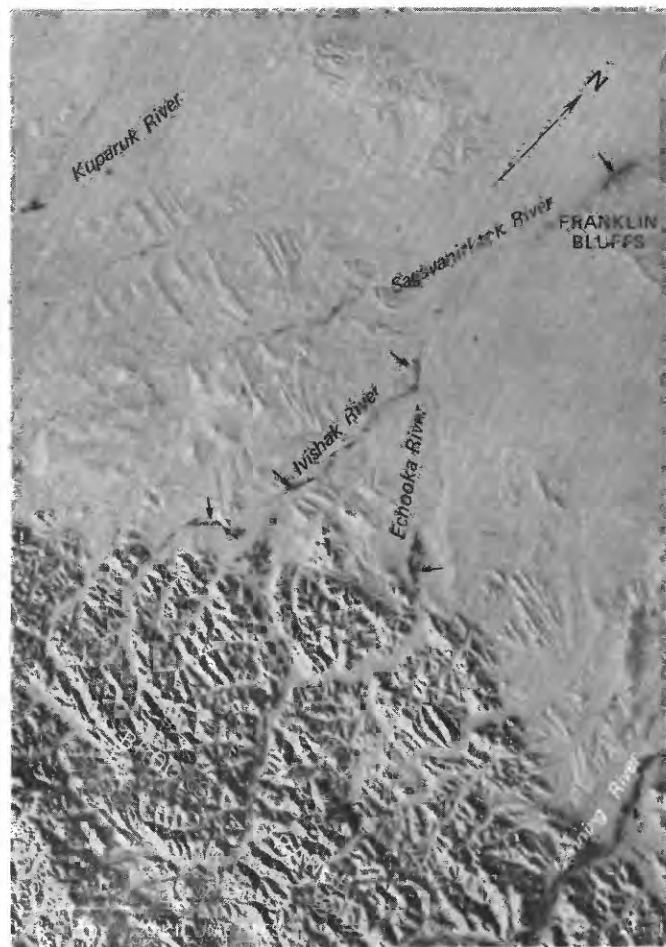
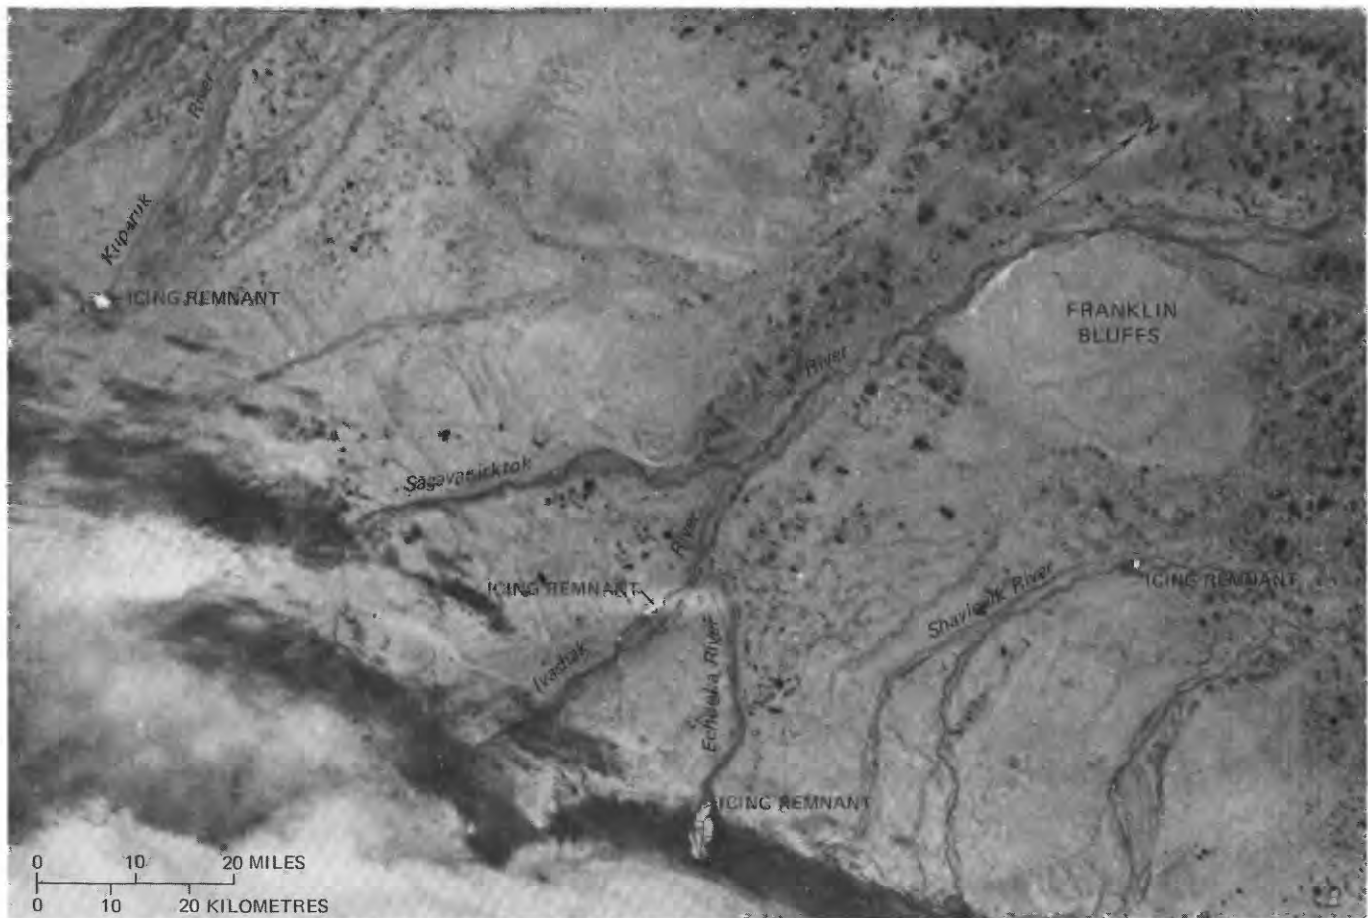
FIGURE 9.—ERTS-1 images of the Sagavanirktok River basin. A, ERTS-1 image taken on March 31, 1973 showing water surfaces (arrows) in icing areas (scene No. 12511-21123, band 7).

*B*, ERTS-1 image of the same area in *A*, taken on August 4, 1973, showing icing remnants on Echooka, Ivishak, and Shaviovik Rivers (scene No. 1377-21112, band 6).

Broad flood-plain icings form on many of the braided reaches of the Sagavanirktok and Ivishak Rivers (figs. 7 and 8). An ERTS-1 (Earth Resources Technological Satellite) near-infrared image taken on March 31, 1973, shows the icing overflow activity in the Sagavanirktok River basin. Water absorbs infrared radiation and is shown as black on the image (fig. 9a) in contrast to the white snow and ice. Broad overflow can be seen (fig. 9a) on the icings of the Echooka and Ivishak Rivers near the front of the Brooks Range and extending some distance downstream. An ERTS-1 scene of the same area on August 4, 1973, shows remnants of ice on the Echooka, Shaviovik, and Ivishak Rivers (fig. 9b). The large icing on the Echooka River may not melt entirely from year to year (fig. 10). These icings are continuous for many miles, except along the lower reaches of the Sagavanirktok River. The amount of winter streamflow decreases downstream because water is stored in the icings. Except for unfrozen sand and gravel adjacent to the main channels of these rivers, most of the alluvial materials within the river systems are frozen. Thus, little or no ground-water discharge is available to maintain streamflow during the winter.

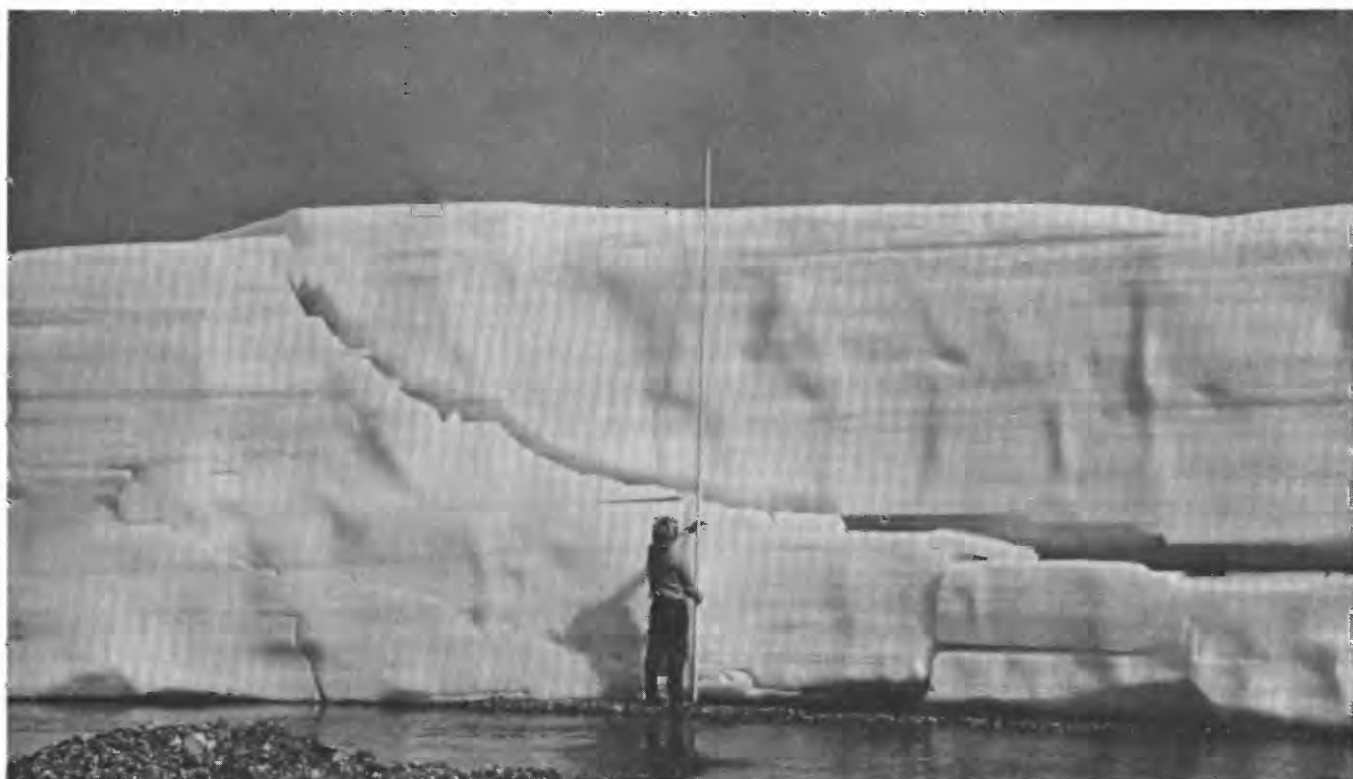
FIGURE 10.—Echooka River icing about 16 feet (5 m) thick, July 11, 1972. Layering in ice shows that numerous overflows make up the icing.

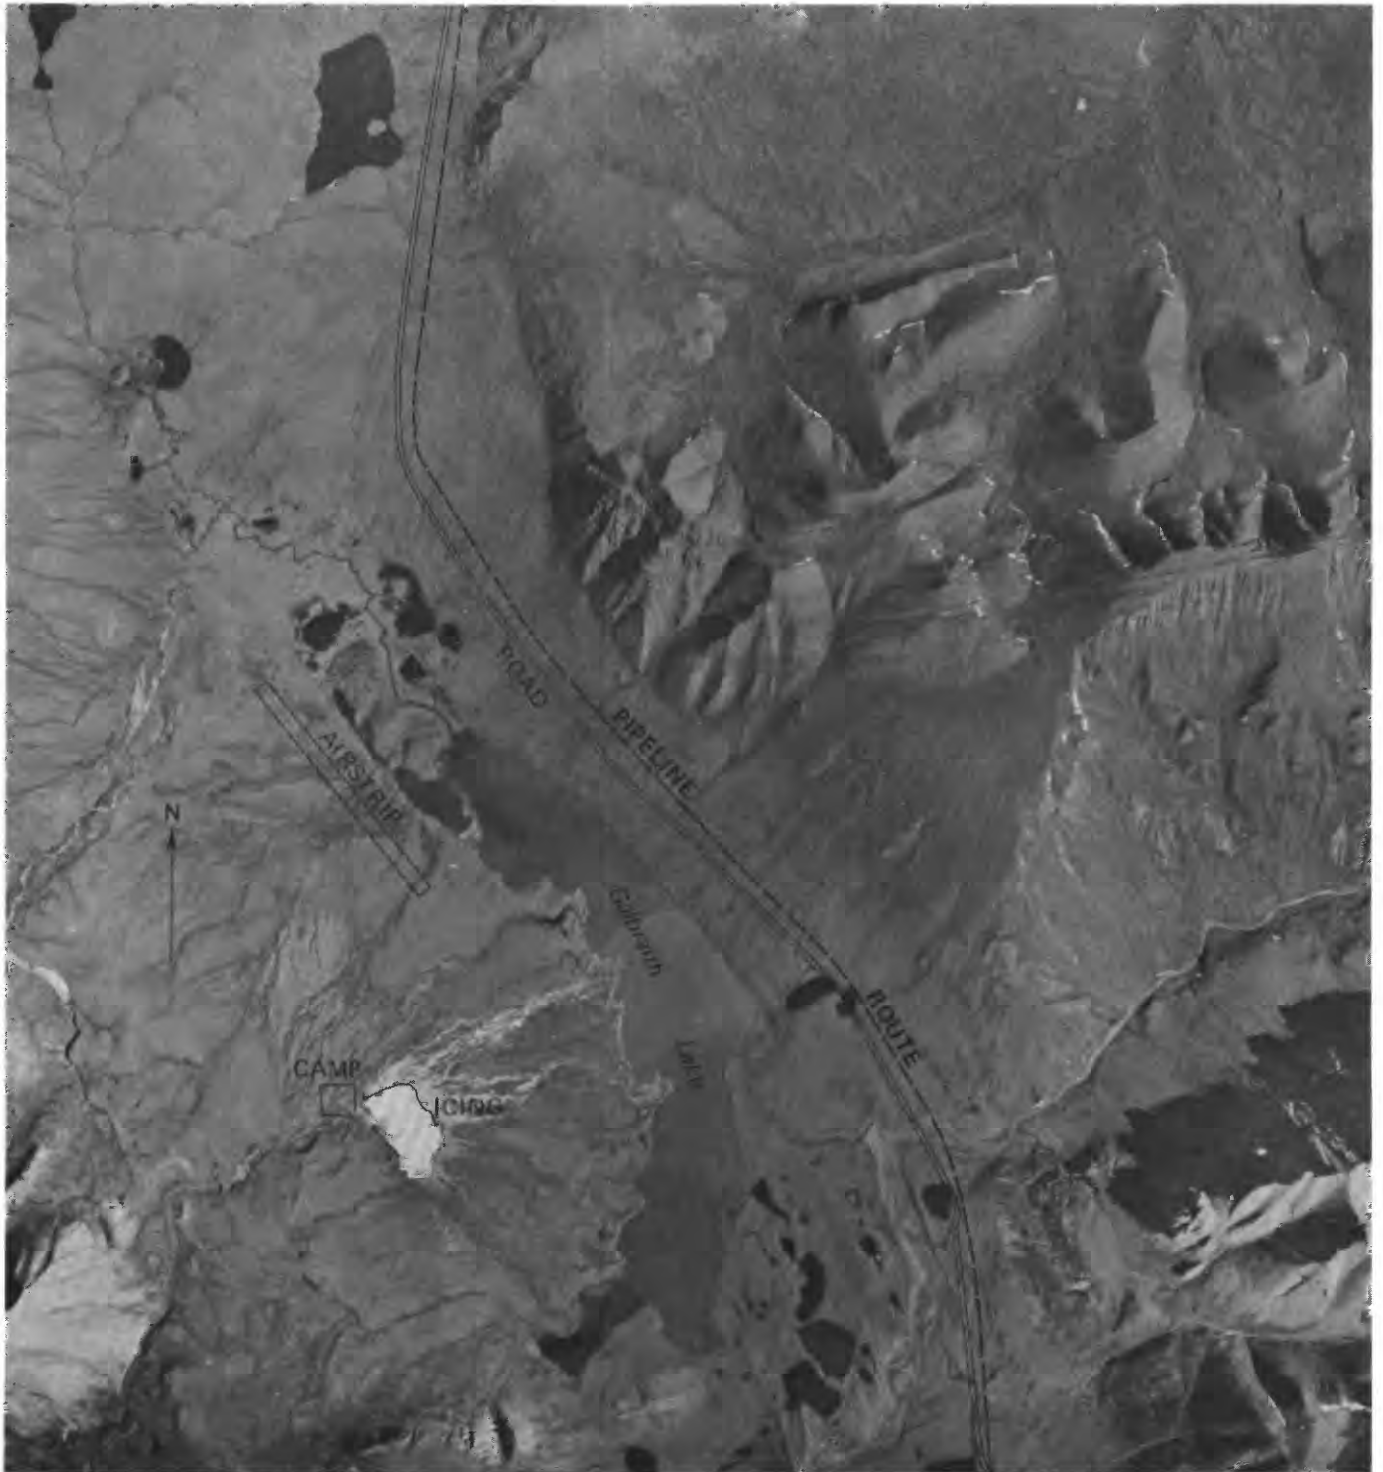
FIGURE 12.—Icing on alluvial fan at Galbraith Lake, July 21, 1956. (Approximate scale: 1 in.=4,000 ft or 1 cm=480 m.)

A large icing forms annually on the alluvial fan west of Galbraith Lake (figs. 11 and 12). Large icings also occur at wide, braided channel reaches of the upper Atigun River valley (figs. 11 and 13).

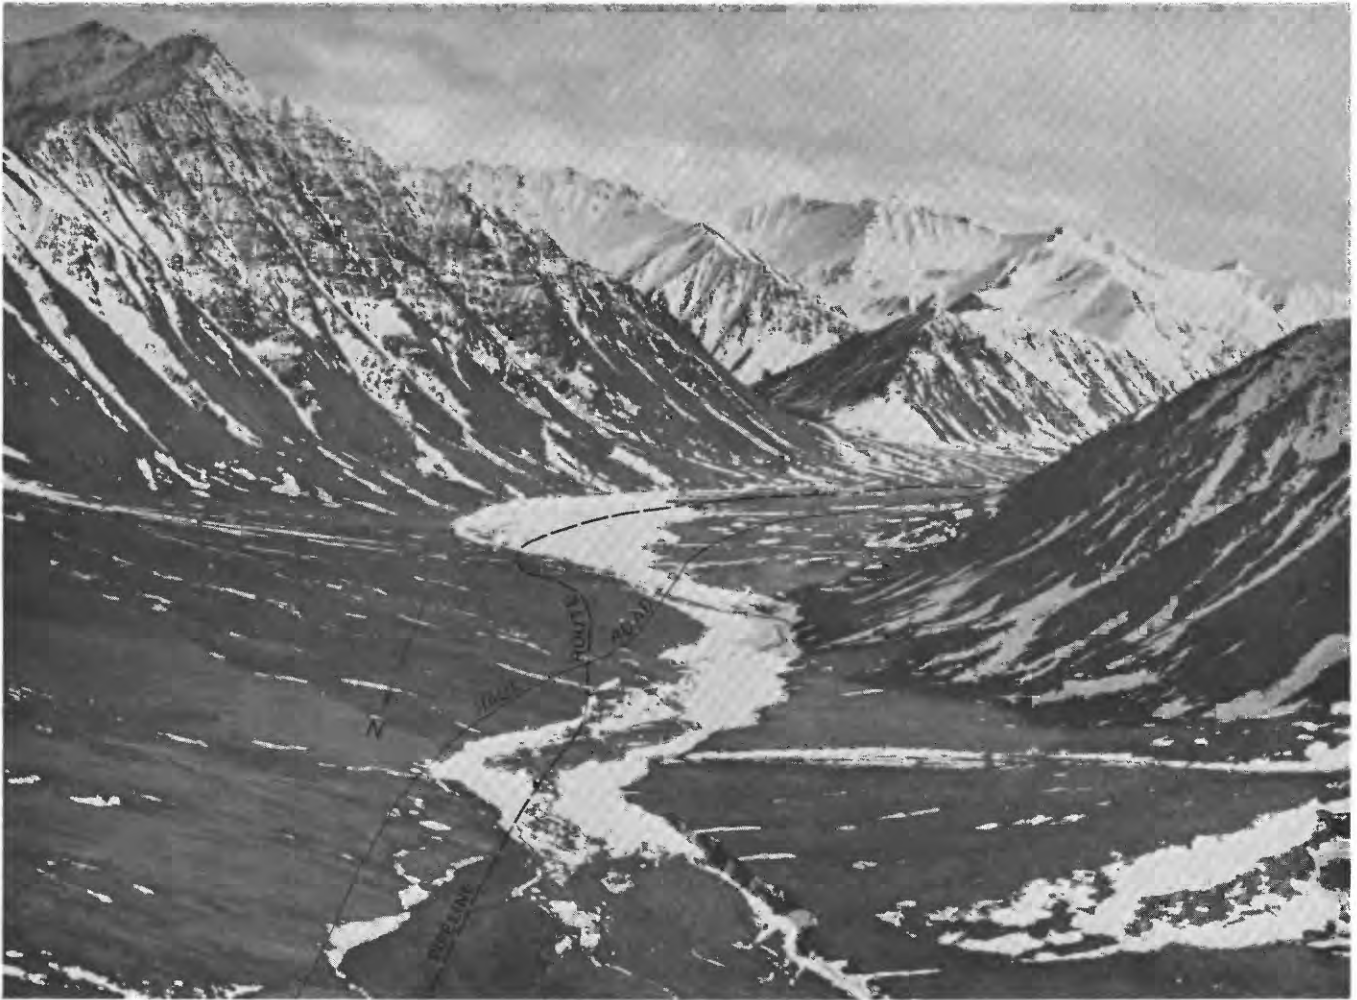
FIGURE 13.—Icings in braided reaches of Atigun River, May 29, 1973.

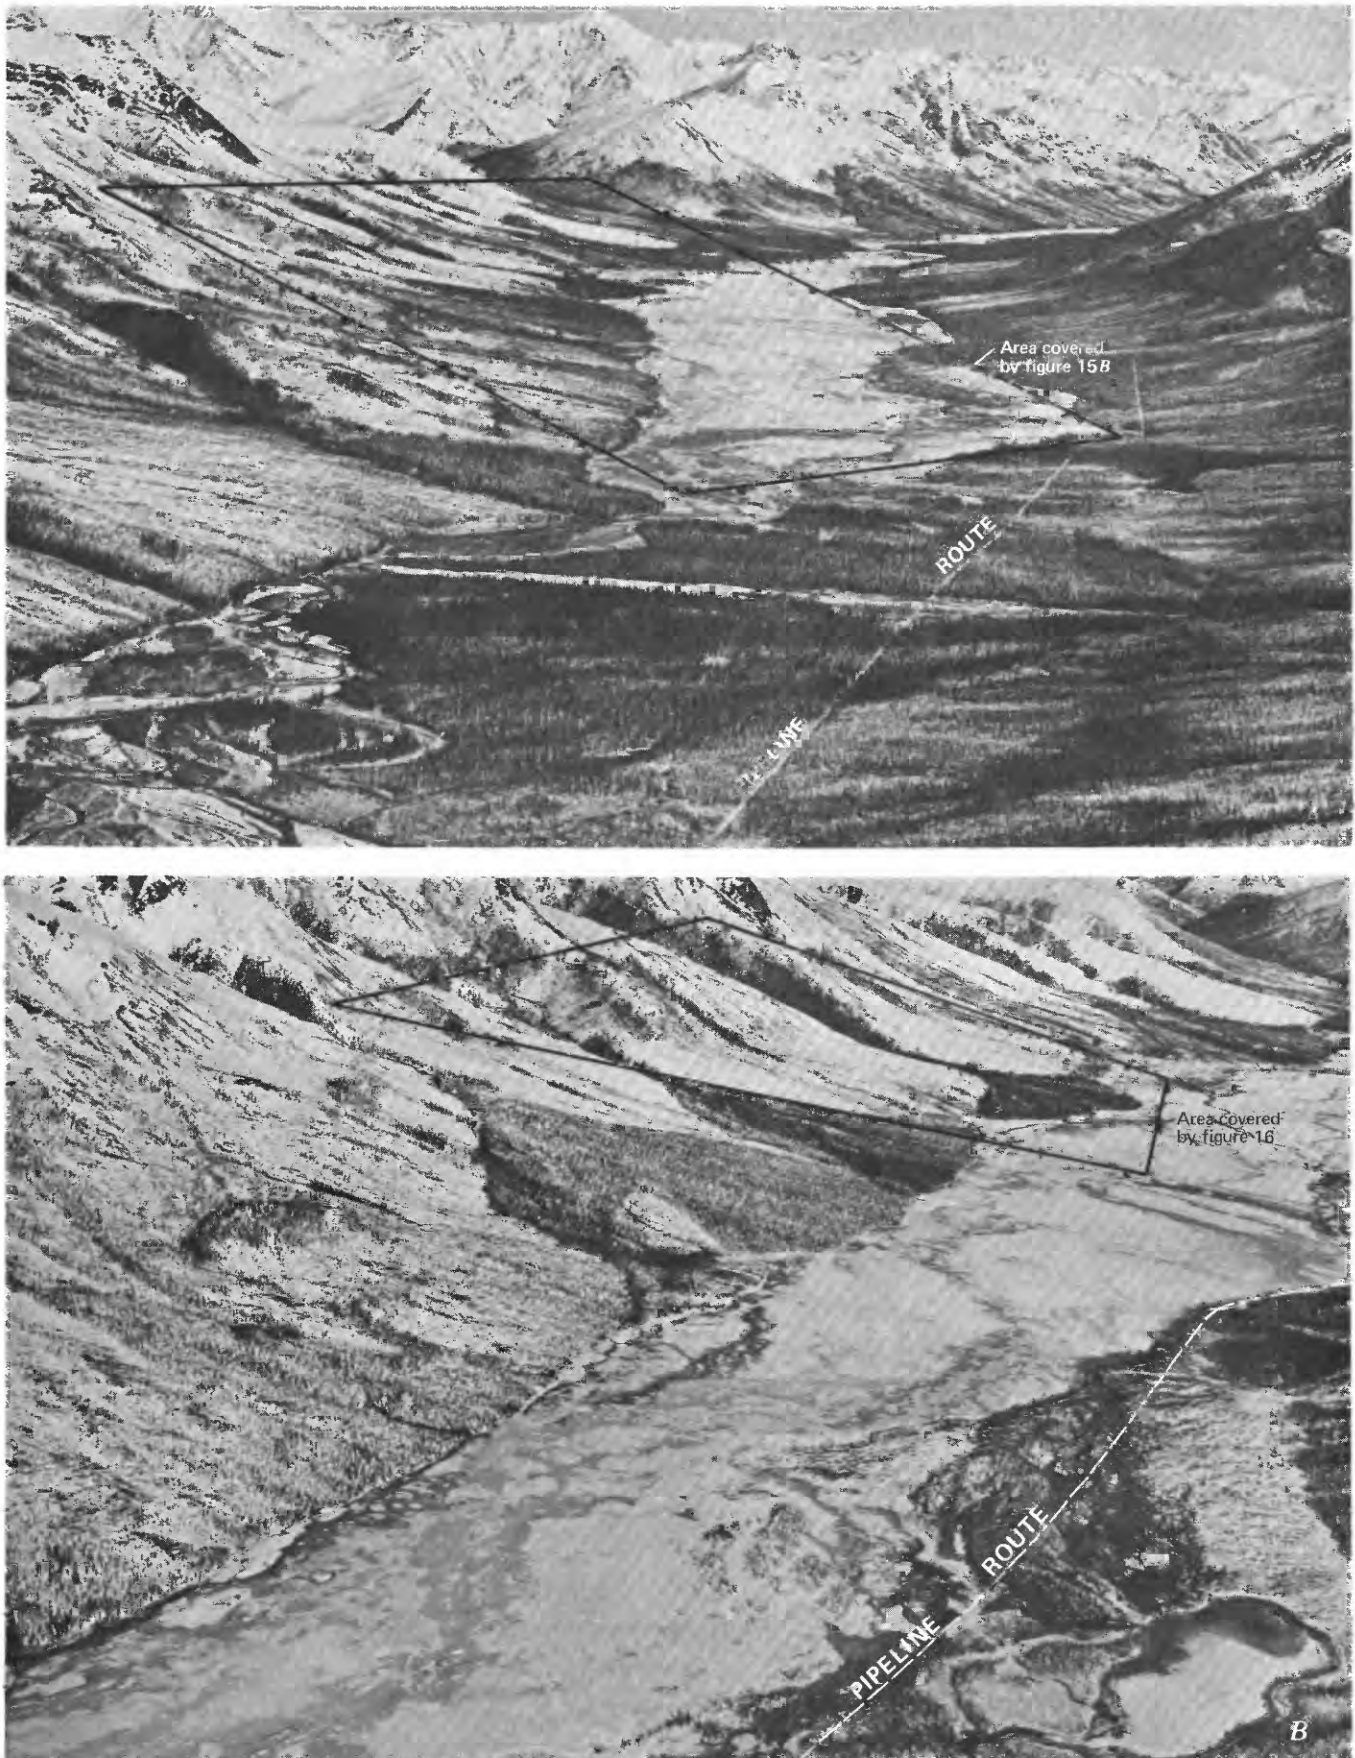
FIGURE 15.—Icings on the Dietrich River flood plain. A, Icing in Dietrich River valley upstream from Snowden Creek, May 1, 1974. B, Closeup view of part of icing shown in A.

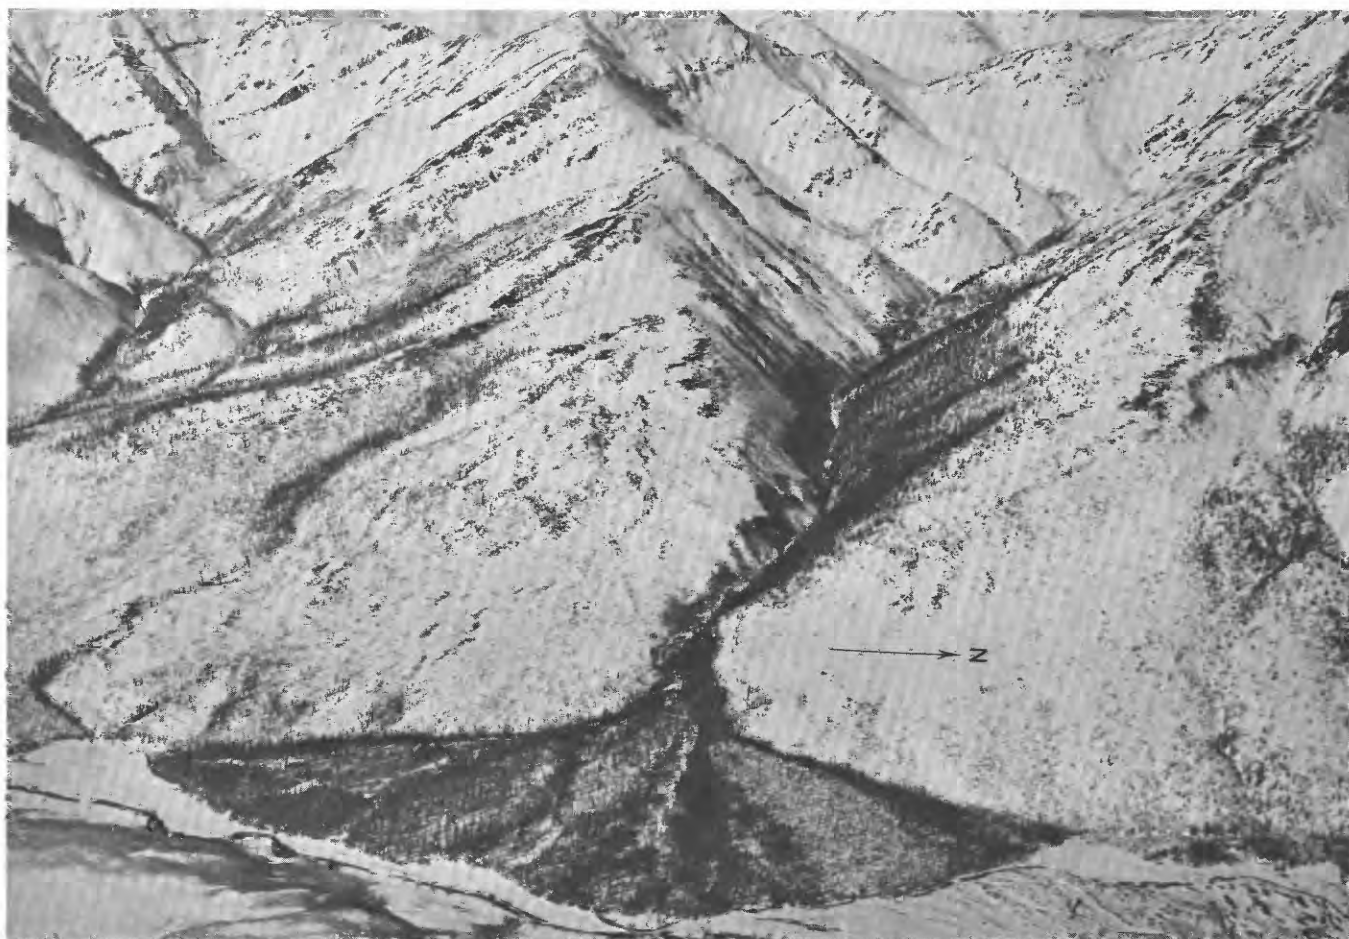
4 FIGURE 16.—Alluvial fan in Dietrich River valley upstream from Snowden Creek, May 1, 1974. Open leads at toe of fan are source of water for downstream icings.

Icings inundate almost the entire active flood plain along braided channel reaches of the Dietrich River (fig. 14). Where the river channel is incised and the reach not braided, channel ice or only minor overflow icing occurs. The large icings on the Dietrich River seem to have their water source from the steep alluvial fans which have built out onto Dietrich River flood plain (figs. 15a and 15b). Open leads in the Dietrich River icings can be seen at the base of the alluvial fans where ground water is emerging (fig. 16).

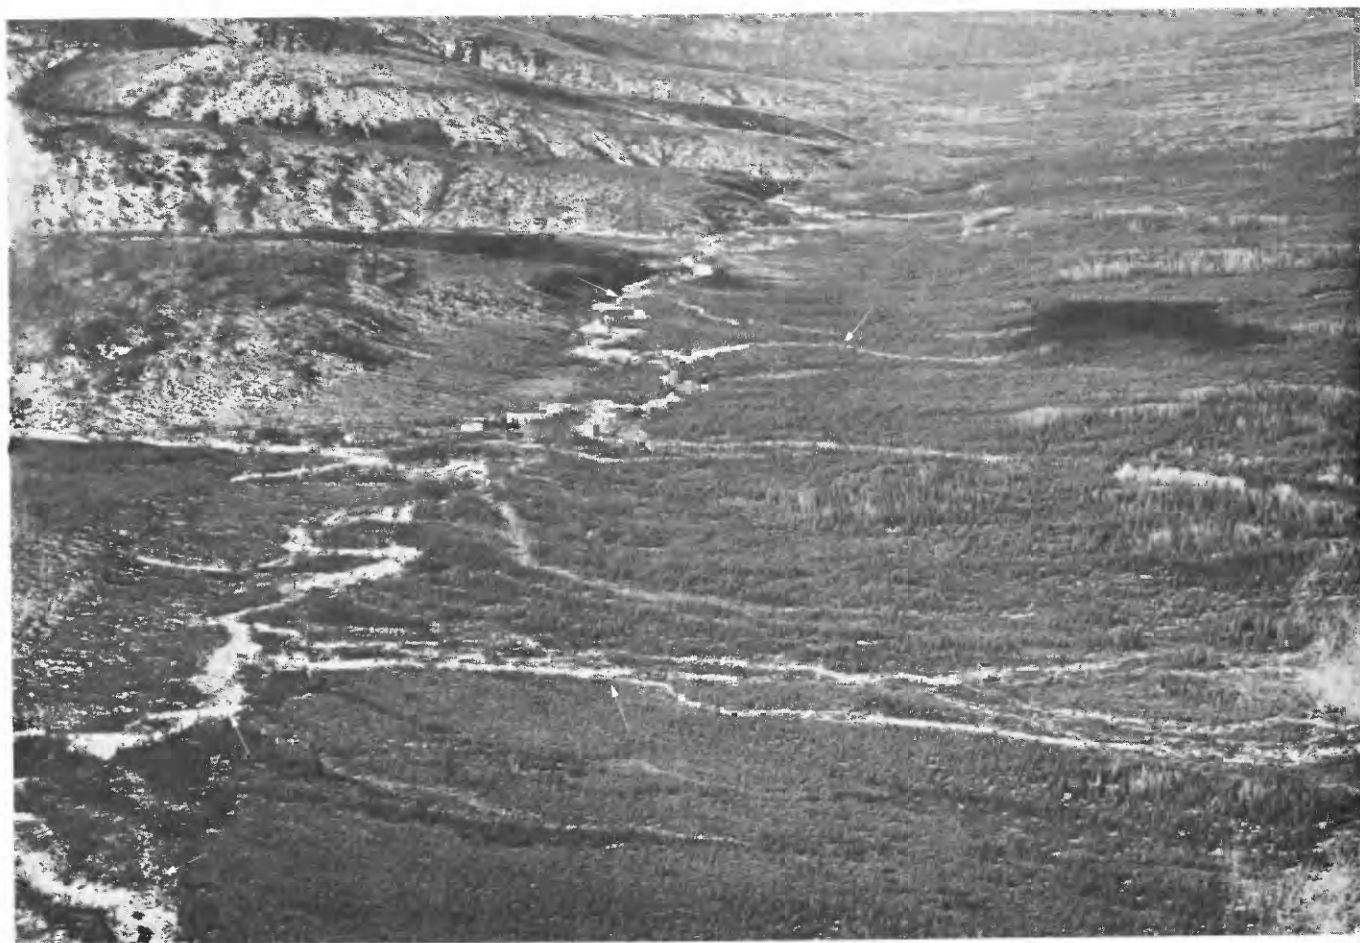
FIGURE 19.—Channel and hillside icings along Aggie Creek in Yukon-Tanana Uplands north of Fairbanks, May 23, 1973.

South of the Yukon River, narrow channel icings form on the small streams in the uplands (figs. 18 and 19). The source for these icings may be artesian water from bedrock drainage or from unfrozen ground above permafrost. The water emerges in small depressions or gullies that drain to the larger stream valleys.

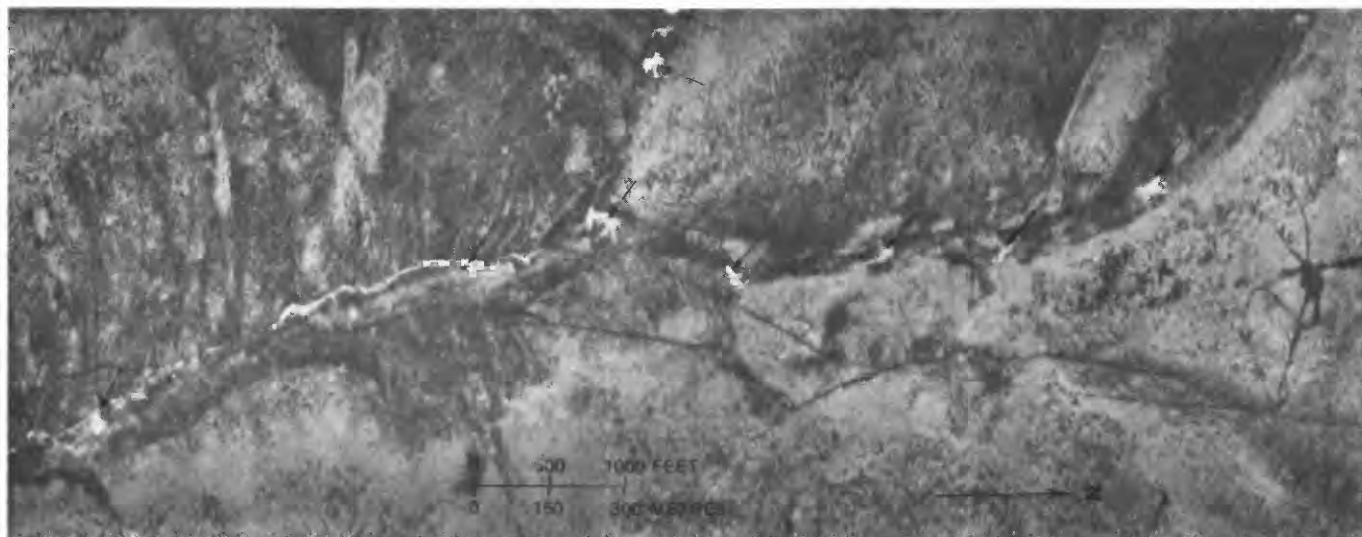
FIGURE 22.—Thermal infrared image of icings along Minton Creek, February 4, 1974. Water surfaces (arrows) contrast with snow and vegetation background.

Channel ice and minor overflow icing occurs on the major streams crossed by the pipeline between Fairbanks (fig. 20) and Big Delta (fig. 21). Icings form on many smaller streams draining the Yukon-Tanana Uplands. Thermal infrared imagery obtained in February 1974 shows water overflowing the icings in the Minton Creek area (fig. 22). In this imagery, the presence of water is indicated by the white areas that signify relatively higher temperatures. A large icing occurs along the pipeline route in the flats north of Shaw Creek (fig. 23). An open channel is usually maintained along the Tanana River at the planned pipeline crossing because relatively warm ground water is discharged along the south bank.
