# Icings along the Trans-Alaska Pipeline Route

GEOLOGICAL SURVEY PROFESSIONAL PAPER 979

By CHARLES E. SLOAN, CHESTER ZENONE, *and* LAWRENCE R. MAYO

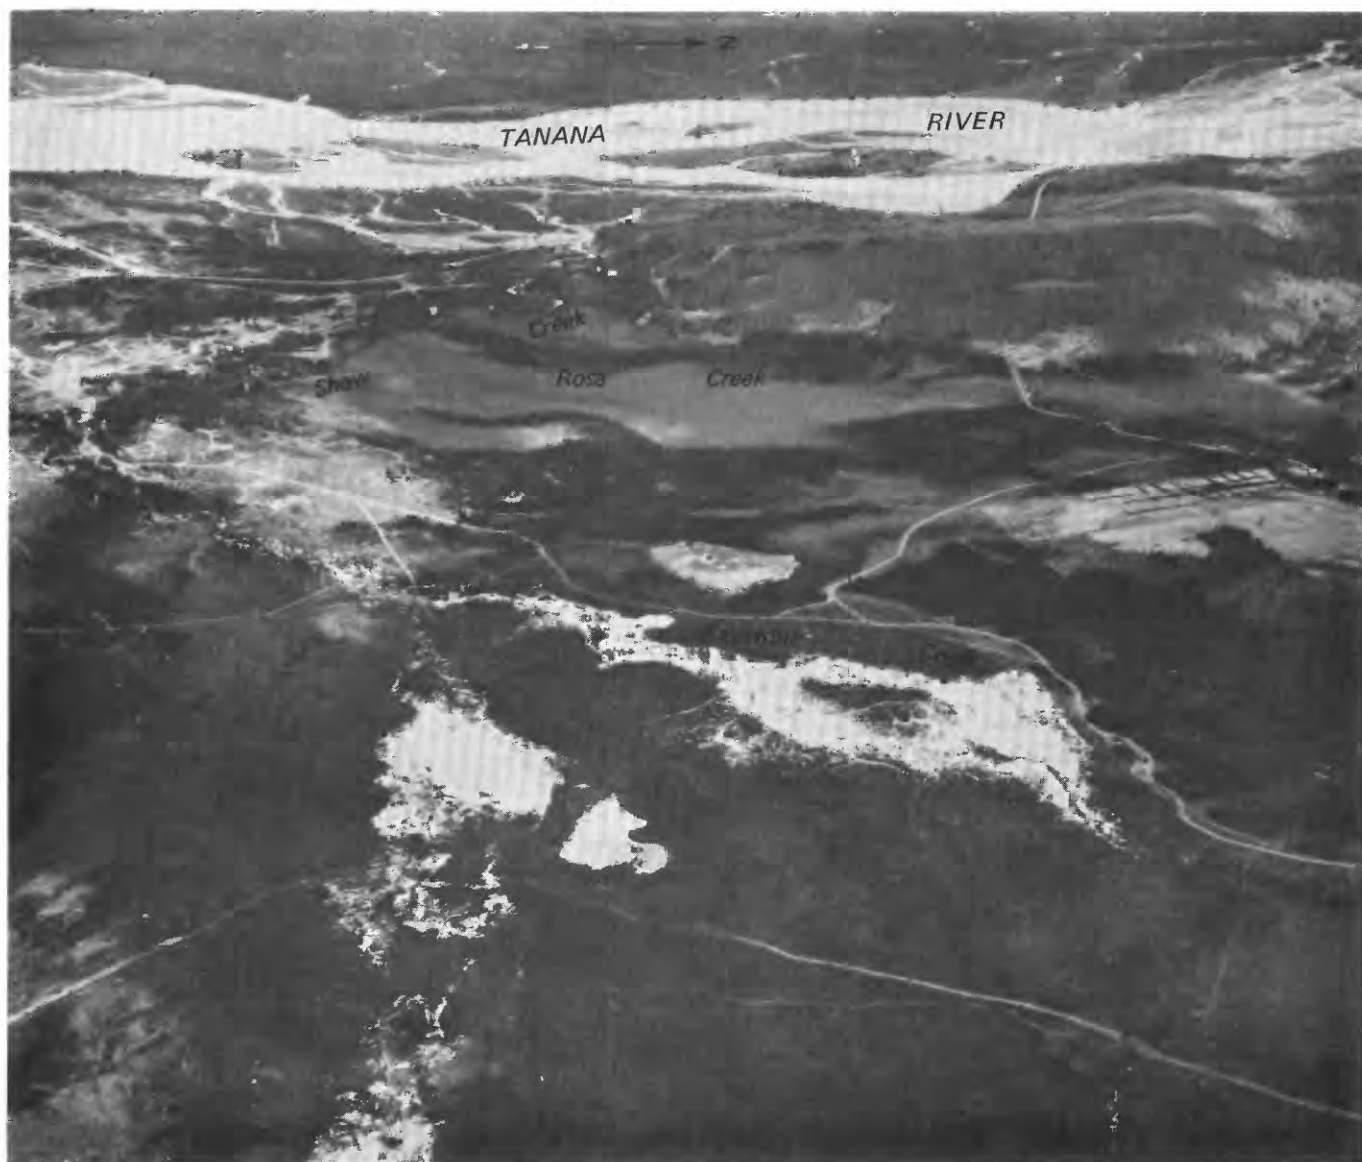
FIGURE 23.—Icings in flats north of Shaw Creek, May 22, 1972.

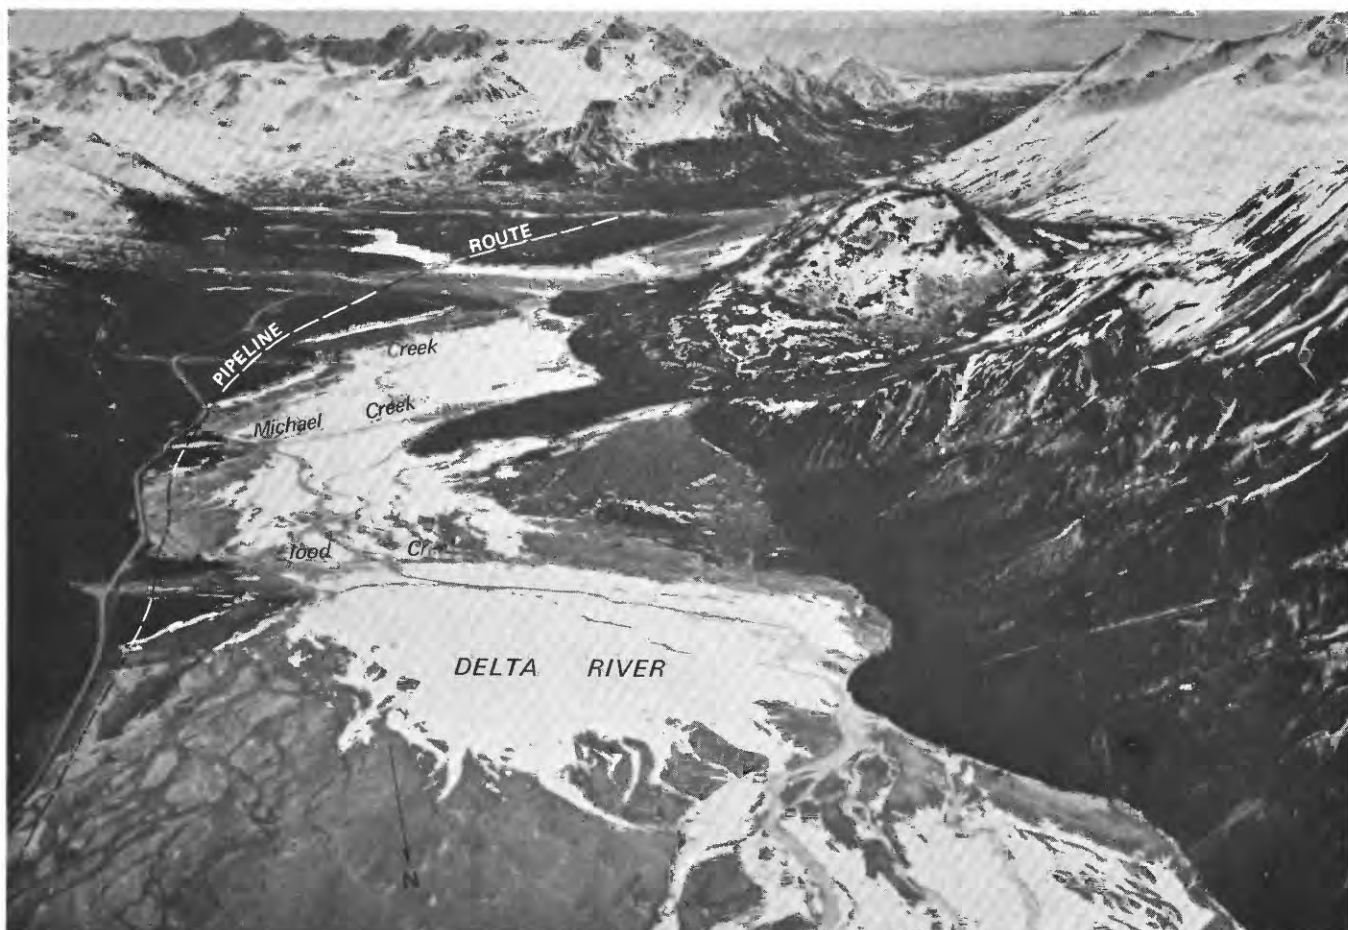
FIGURE 25.—Flood-plain icings along Delta River. Alluvial fans of Flood, Michael, and Trims Creeks in left foreground. View south (upstream) on May 29, 1973.

Small hillside and channel icings occur along the pipeline route between Donnelly Dome and Black Rapids (fig. 24). South of Black Rapids the pipeline route is in the active flood plain of the Delta River where extensive icings form annually (frontispiece; figs. 2, 25, and 26). Large icings form each winter at

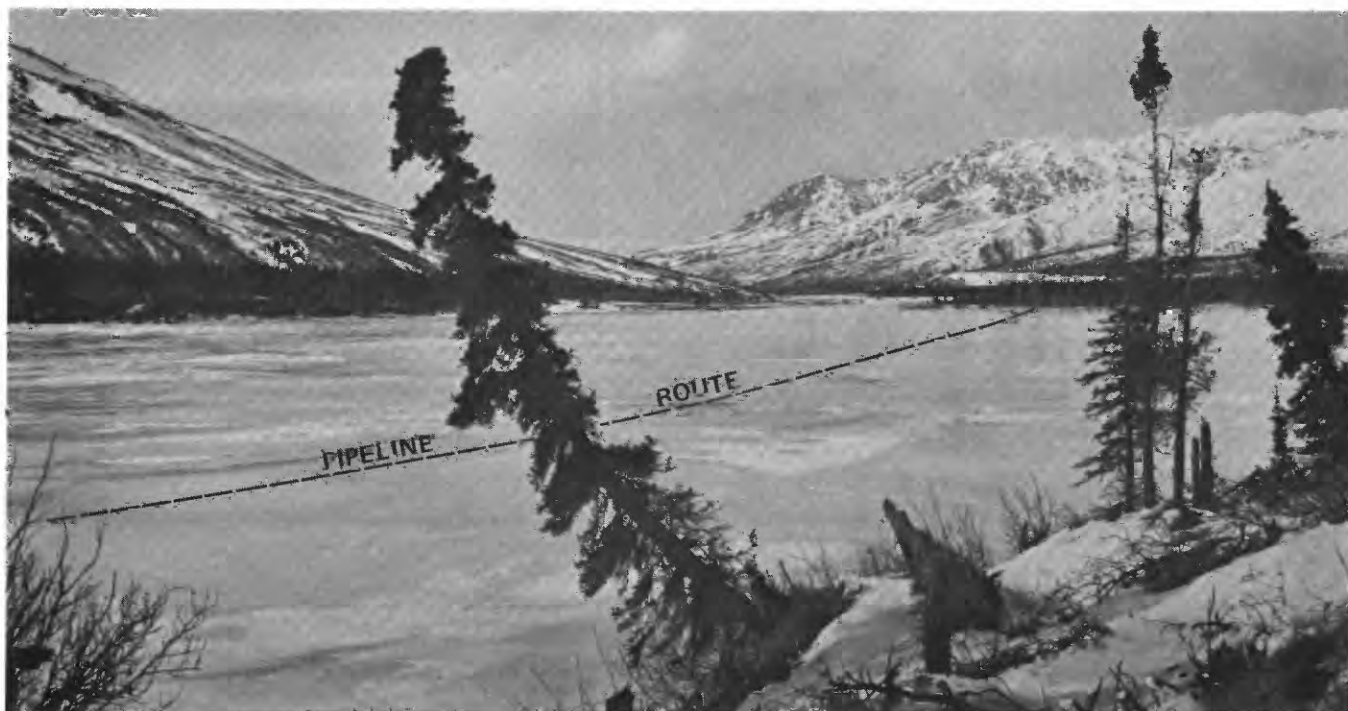
FIGURE 26.—Flood-plain icing in Delta River valley upstream from Miller Creek, April 18, 1974.

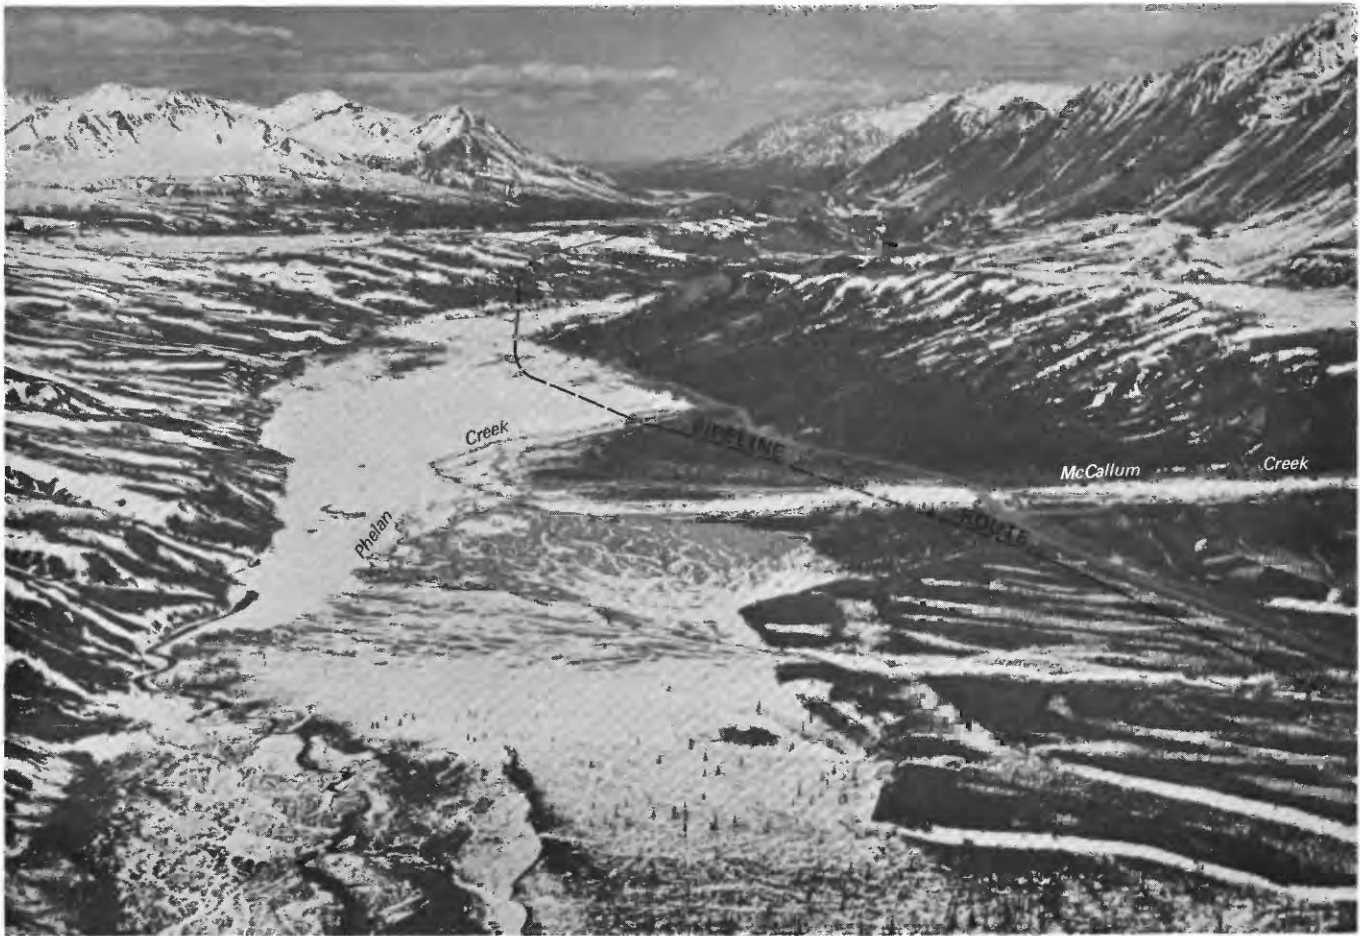
FIGURE 27.—Icing in Phelan and McCallum Creeks, May 29, 1973.

Castner Creek, lower Miller Creek, Miller Creek, Phelan Creek, and McCallum Creek (fig. 27), streams crossed by the pipeline.

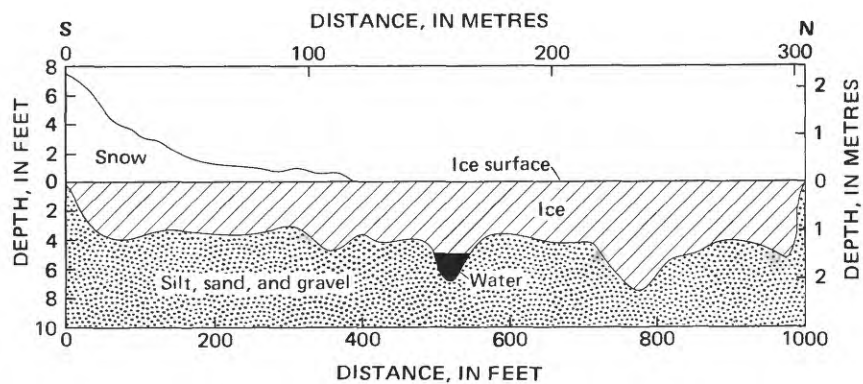
FIGURE 28.—Cross section through icing at mouth of Phelan Creek, April 27, 1972. (See location of section in fig. 2.)

Borings were made through the Phelan Creek icing at the confluence of the Delta River and Phelan Creek on April 27, 1972 (fig. 28). The ice averaged about 5 feet (1.5 m) thick, and of 31 holes drilled along a 1,000-foot (305-m) section, only 1 reached water in a channel under the ice. In the remainder of the holes, ice was resting directly on sand and gravel channel deposits.

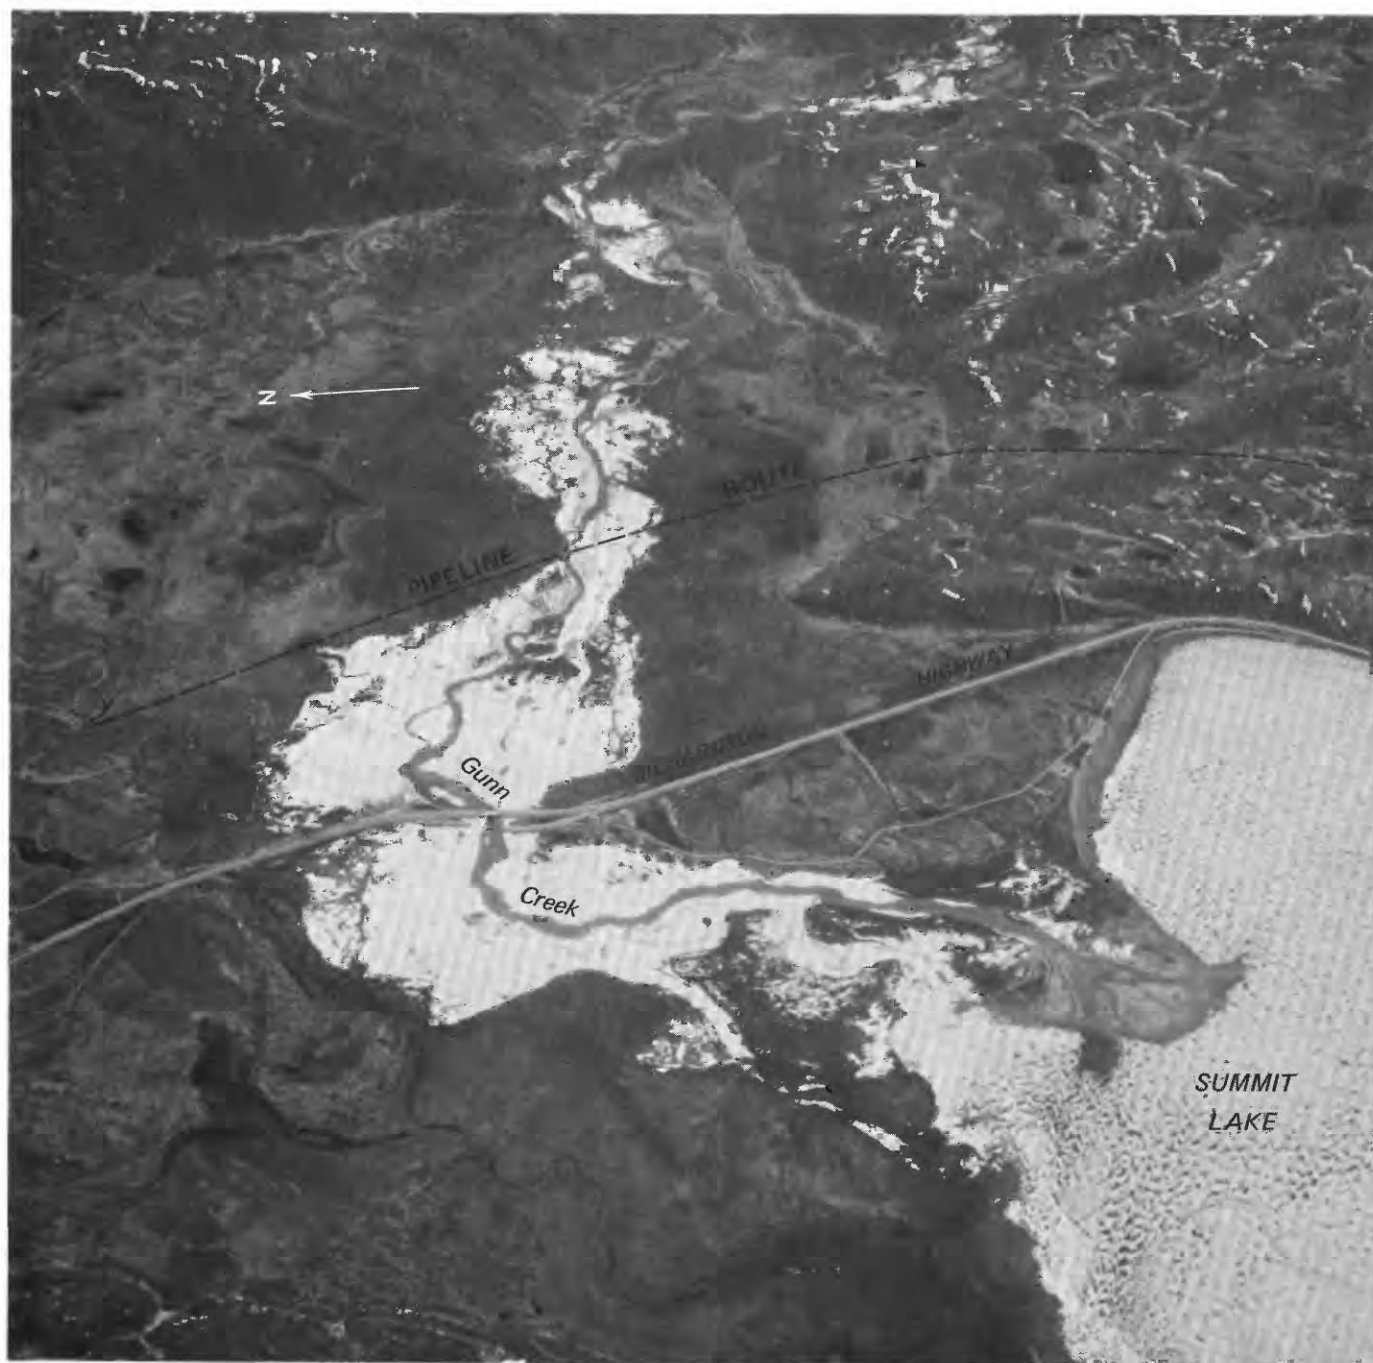
FIGURE 29.—Icing on Gunn Creek at Richardson Highway and pipeline crossing, June 6, 1970.

Near Isabel Pass a large icing forms annually on Gunn Creek at the Richardson Highway bridge (fig. 29).

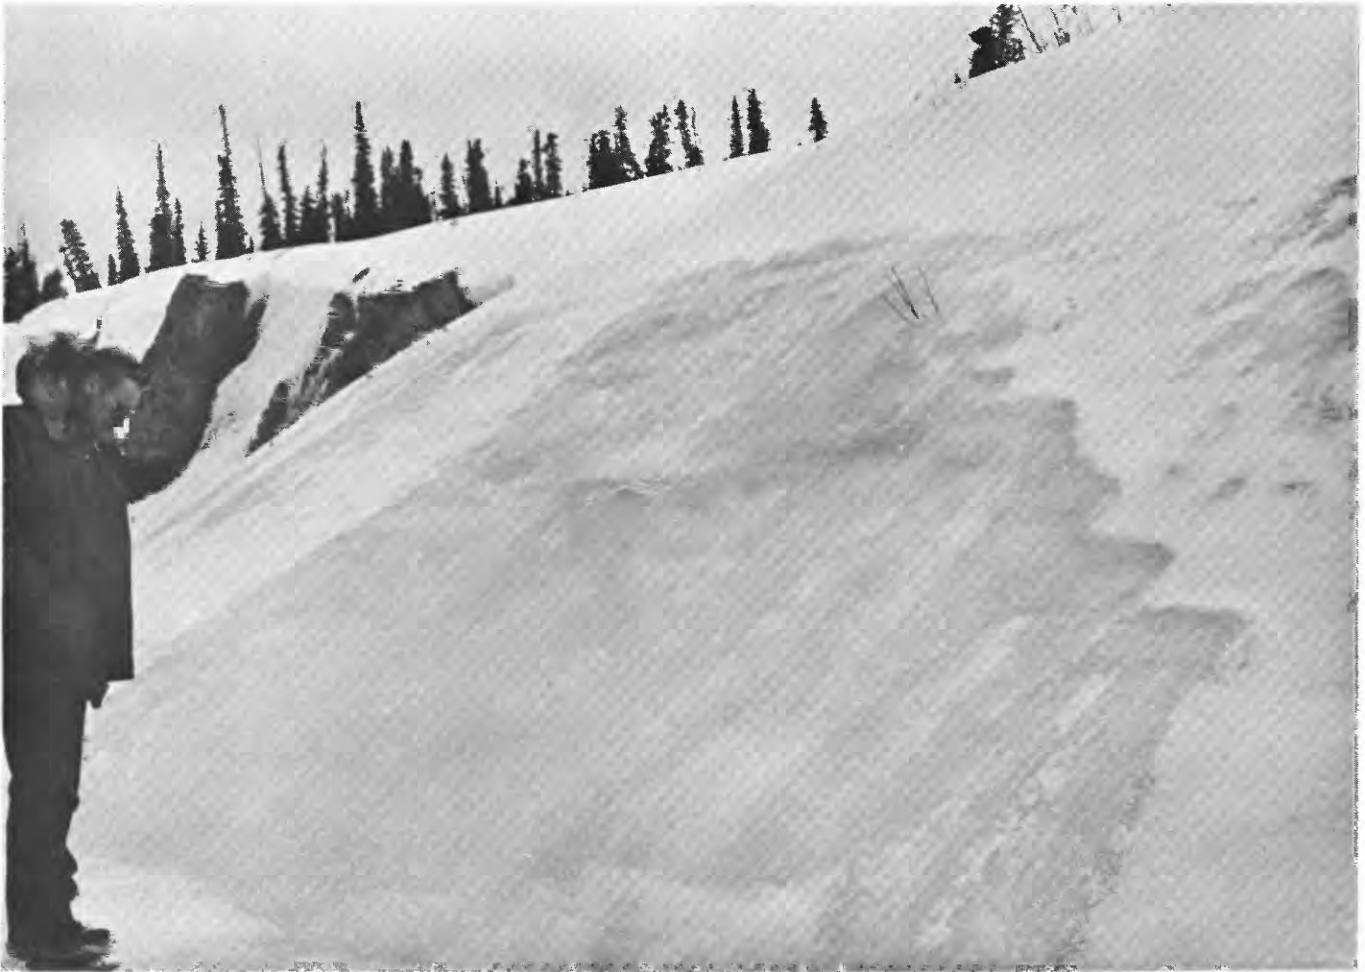
FIGURE 32.—Icing formed from ground-water seepage at face of gravel pit near Little Tonsina River, April 1, 1971.

Hillside icings formed by seeps and springs in the Little Tonsina valley (fig. 32) have been particularly bothersome requiring repeated culvert maintenance by the Alaska Department of Highways. The occurrence of icings in the Chugach Mountains indicates that icings are not unique to the northern parts of Alaska. They are scattered along the entire length of the trans-Alaska pipeline route.

the albedo and snow cover, thereby affecting the thermal regime. In addition, a very thick fill might act as an insulator, causing aggradation of permafrost into the fill embankment (Ferrians and others, 1969). This permafrost dam constitutes a barrier to ground-water movement. Road and borrow-pit cuts (fig. 32) and trenches for the pipeline could intercept shallow ground water. In permafrost areas, a common result of deeper winter freezing, greater summer thawing, growth of frost dams on hillsides, and exposure of ground-water flow zones is a greater than normal flow of ground water to the surface (Eager and Pryor, 1945) with consequent growth of icings.
