Borehole Geophysical Investigation of a Formerly Used Defense Site, Machiasport, Maine, 2003–2006

By Carole D. Johnson, Remo A. Mondazzi, and Peter K. Joesten

Scientific Investigations Report 2009–5120

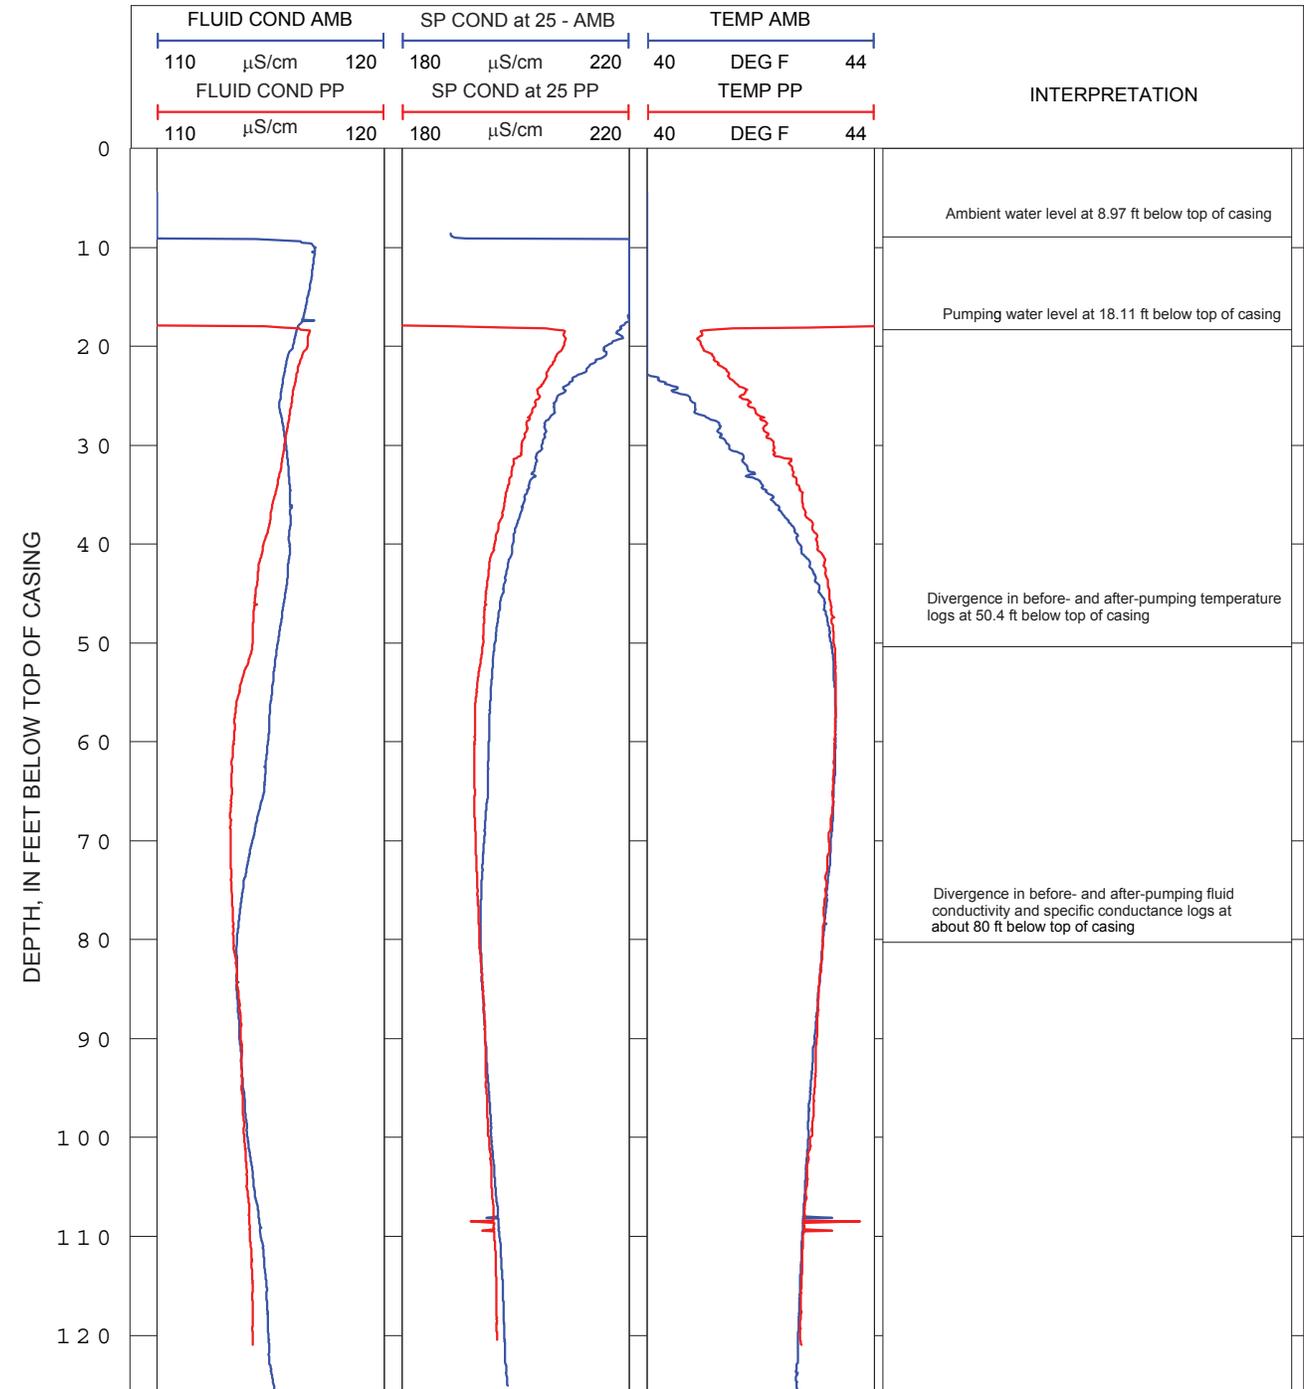
Figure 2. Example showing differences in fluid logs before and after imposing a hydraulic stress. (COND, conductivity; AMB, ambient; SP Cond at 25, specific conductance at 25 degrees Celsius; TEMP, temperature; PP, post pumping; Deg F, degrees Fahrenheit; $\mu\text{S/cm}$, microsiemens per centimeter)

Similar to fluid logging, water-quality data can be collected under ambient and pumped conditions, and the differences can help identify hydraulically active zones in the borehole. For this investigation, the water-quality parameter tool was used in the ambient water column, unless otherwise noted. The water-quality parameter tool was checked with pH standards (4, 7, and 10) and conductivity standards (usually 98, 494, and 1,000 $\mu\text{S}/\text{cm}$) prior to measurements.

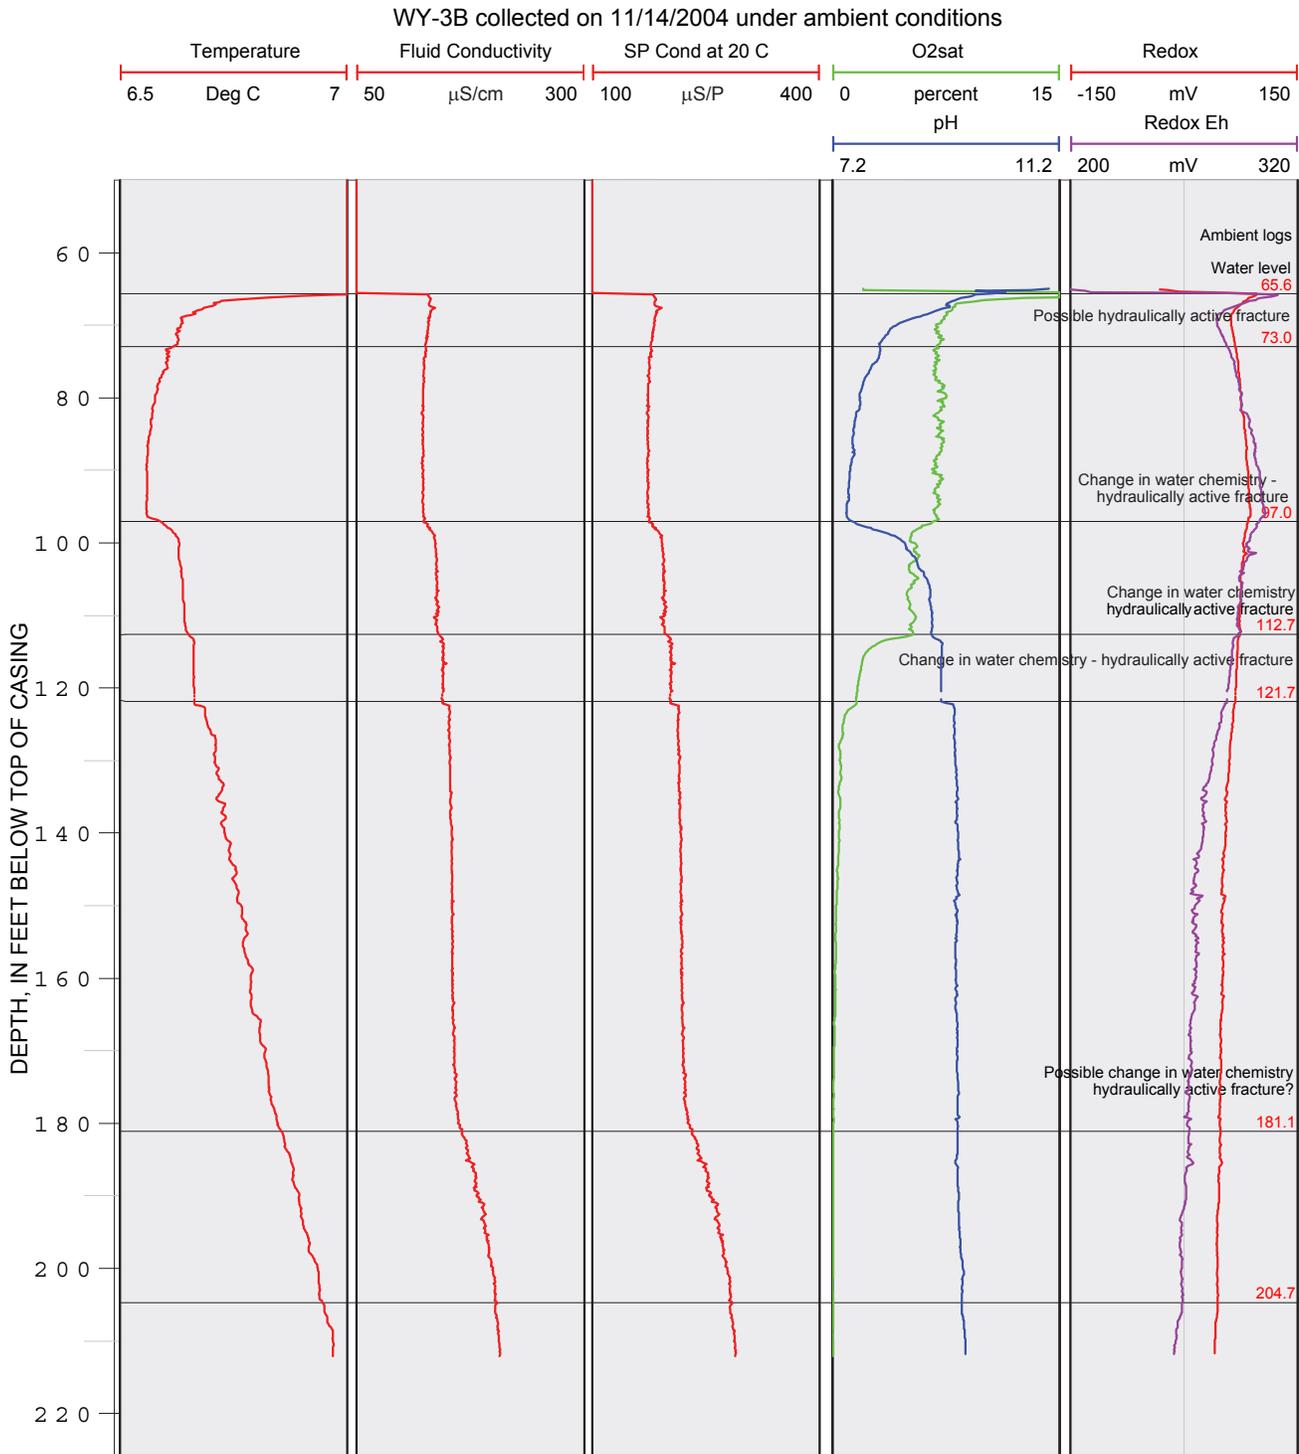
Figure 3. Example of interpretation of water-quality data to identify hydraulically active fractures. (Deg C, temperature in degrees Celsius; µS/cm, microsiemens per centimeter; SP Cond at 20C, specific conductance at 20 degrees Celsius; O2sat, dissolved oxygen in percent; Redox, oxidation-reduction potential, uncorrected; Redox Eh, redox oxidation-reduction potential relative to the potential of hydrogen, Eh; mV, millivolt)

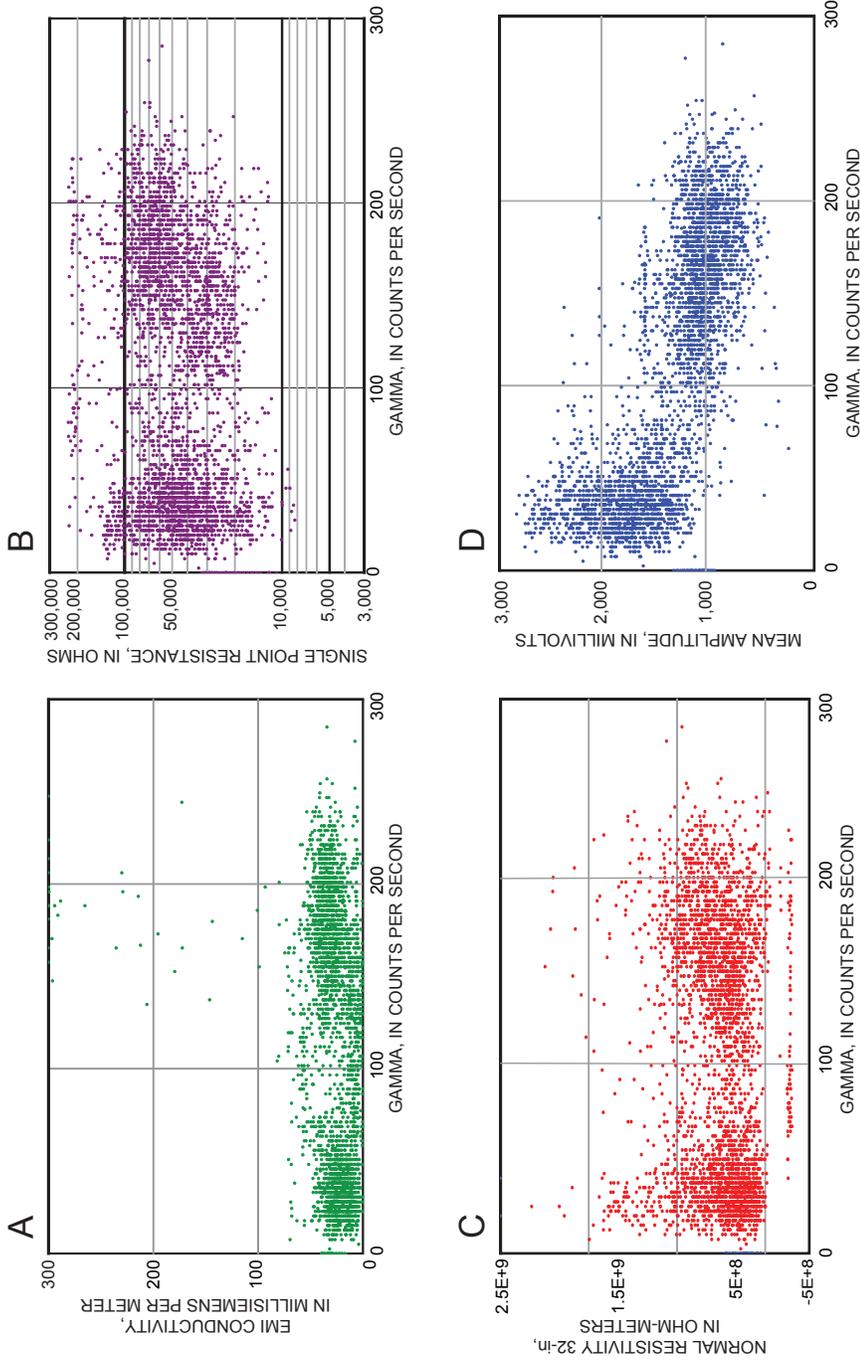
Figure 4. Cross-plots of selected borehole geophysical logs from borehole DW-10, near Machiasport, Maine. (EMI, electromagnetic induction)

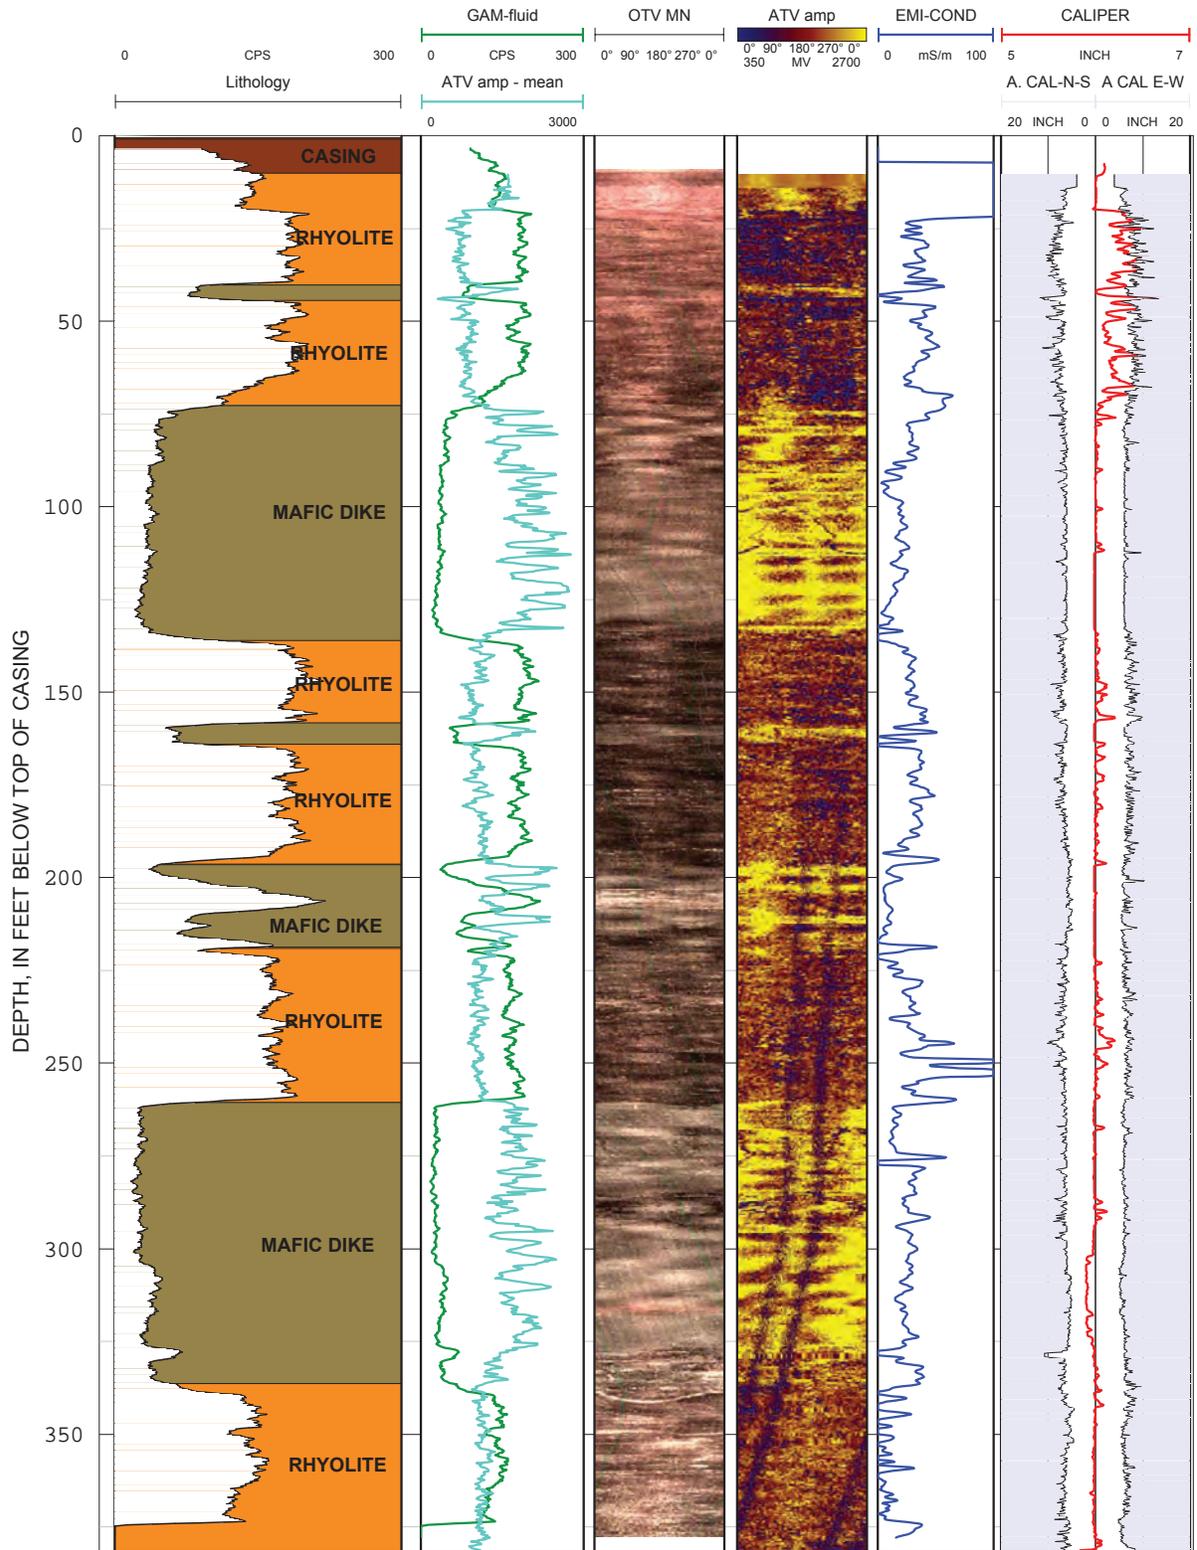
Figure 5. Selected borehole geophysical logs and lithology in borehole DW-10, near Machiasport, Maine, showing correlation of logs to the lithology. (cps, counts per second; GAM, gamma log; ATV, acoustic televiwer; OTV, optical televiwer; MN, magnetic north; amp, amplitude; mV, millivolts; EMI-COND, electromagnetic conductivity; μ S/m, microsiemens per meter; CALIPER, mechanical caliper; CAL-N-S, north-south measurement (shown in reverse); CAL E-W, east-west measurement)

These logs describe two of the rock units in the study area, and hence borehole DW-10 was used as a borehole geophysical “type locality” for responses of the gamma and acoustic reflectivity tools to mafic dikes and rhyolite.

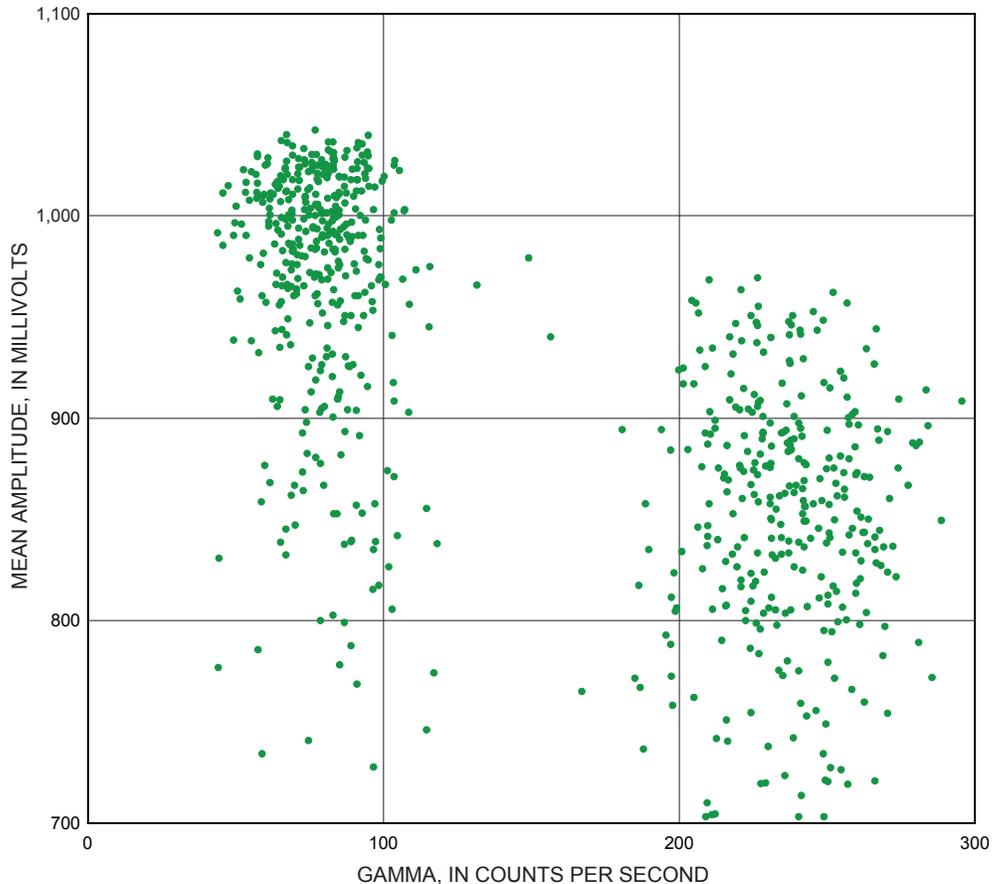
Figure 6. Cross-plot of data from gamma and acoustic televiewer reflectivity logs from borehole MW-14, near Machiasport, Maine.

For borehole MW-14, the gamma and reflectivity logs were helpful in delineating major changes in the rock units. Geophysical logs collected in borehole MW-14 in June 2003 were plotted and compared to descriptions of the lithologic core (Weston Solutions, 2005) and to geologic maps (Gates and Moench, 1981). The core obtained from this borehole was described for texture, color, and mineralogy and is interpreted as quartz monzonite in the upper part of the borehole and diabase or gabbro in the lower part of the borehole. Relatively high gamma activity and low acoustic reflectivity amplitudes characterize the upper unit from the bottom of casing to about halfway down the borehole. The rock in the bottom half of the borehole is characterized by low gamma activity and high reflectivity. The cross-plot for gamma and acoustic reflectivity in borehole MW-14 shows a bimodal population in the gamma counts with one mode clustering just below 100 cps and the other clustering over 200 cps (fig. 6). For the acoustic reflectivity, there is a large range of values, but the reflectivity values associated with low gamma values are higher than the reflectivity values associated with the higher gamma emissions. These logs are shown in further detail in the description of borehole MW-14. Because of the unique response of the gamma and reflectivity logs to the rock types in borehole MW-14, this borehole was used as another “type locality” for the gamma and acoustic reflectivity tools for two additional rock types in the study area—quartz-monzonite and diabase and (or) gabbro.

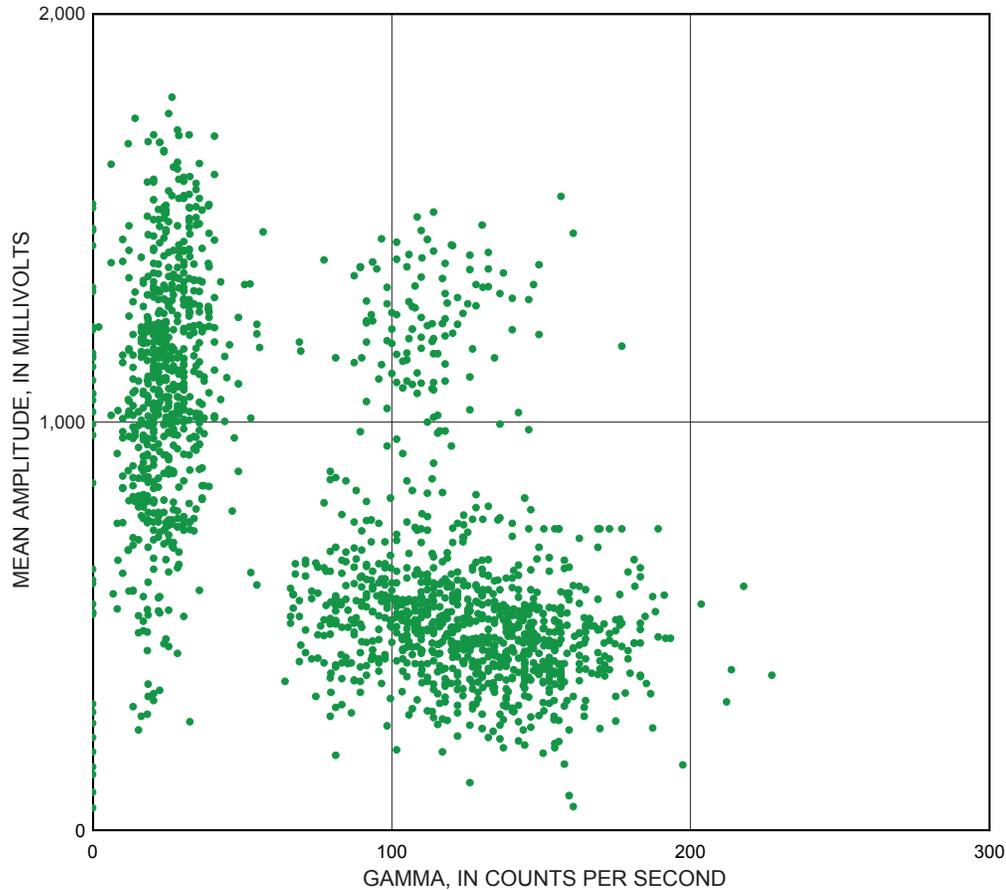
Figure 7. Cross-plot of data from gamma and acoustic televiewer reflectivity logs from borehole DW-23, near Machiasport, Maine.

The other major rock unit in the study area is the sedimentary sequence of the Eastport Formation (Gates and Moench, 1981). Borehole DW-23 was used as the “type locality” for the metasedimentary unit. Gamma counts in the metasedimentary unit are higher than in the quartz monzonite, gabbro/diabase, and mafic dikes. In borehole DW-23, the acoustic reflectivity and hardness of the metasedimentary units are generally lower and softer than the reflectivity and hardness of the gabbro/diabase (fig. 7). The more reflective, low-gamma-count unit that is represented on the left side of figure 7 was observed in the bottom half of borehole DW-23 and was interpreted as gabbro or diabase. The rocks in the upper part of borehole DW-23, interpreted to be metasedimentary units of the Eastport Formation, are represented on the right side of figure 7, with the higher gamma counts. The

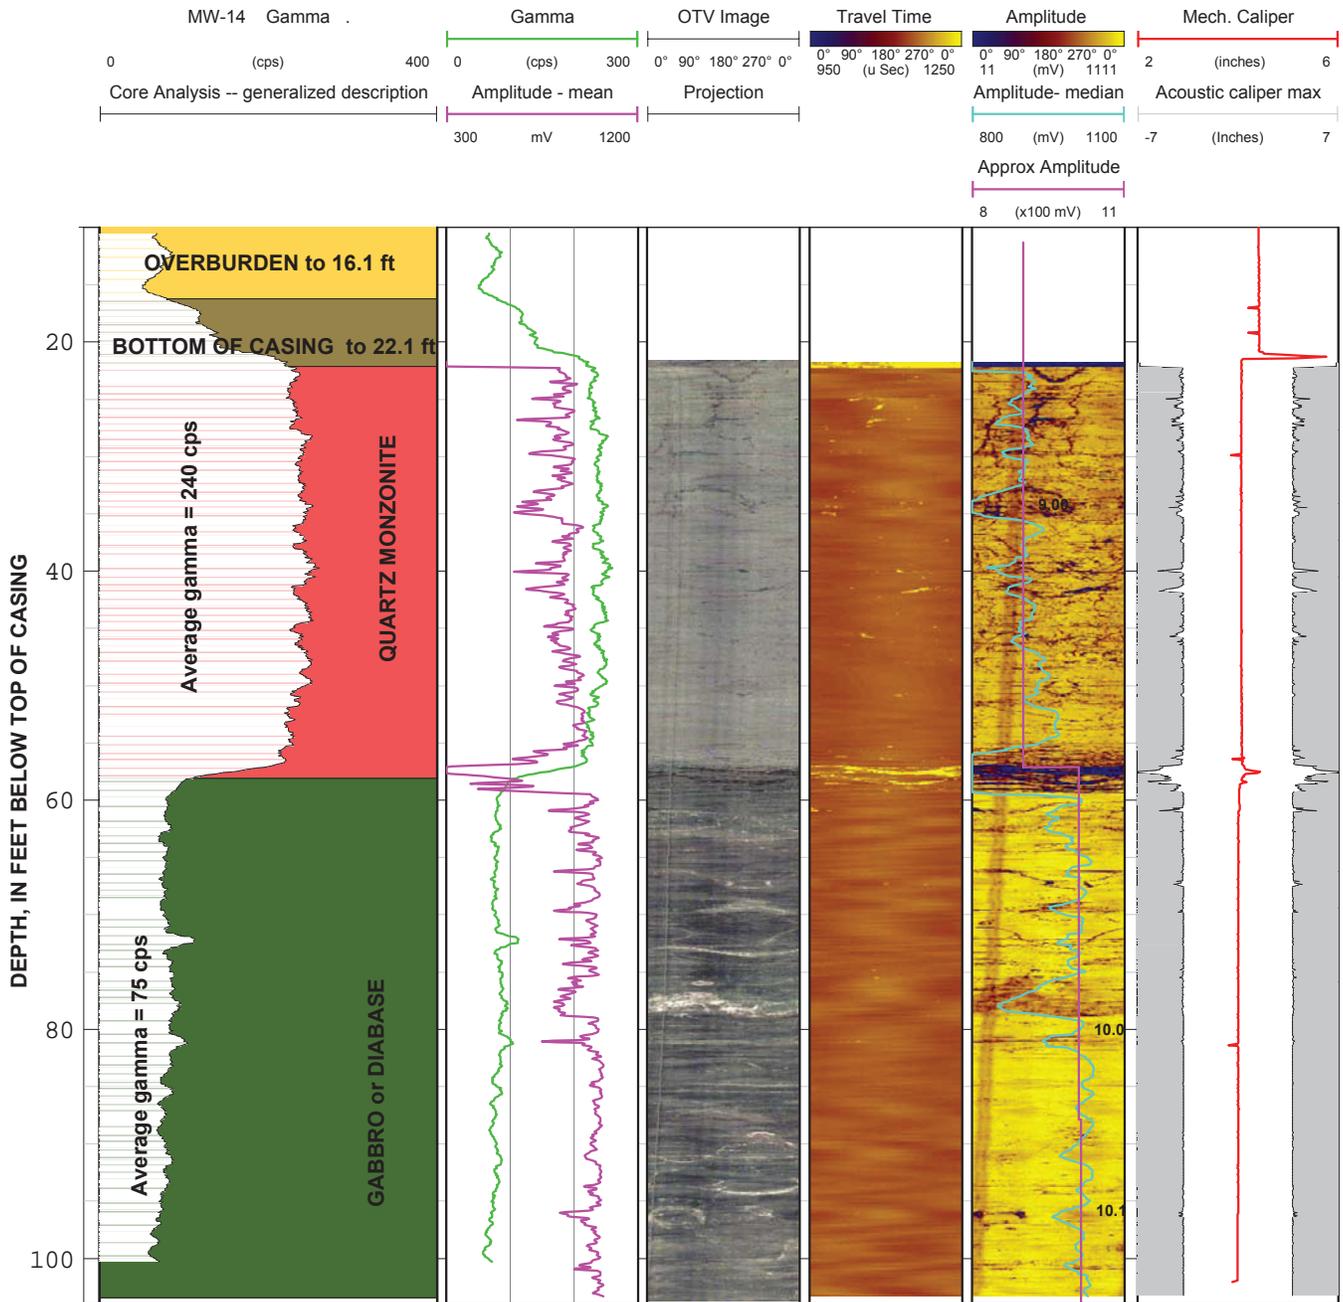
Figure 8. Selected borehole geophysical logs and rock types in borehole MW-14, near Machiasport, Maine. (cps, counts per second; mV, millivolts; OTV, optical televiewer; μ Sec, microseconds; Mech., mechanical; max, maximum; ft, feet)

Lithology. The ATV, OTV, gamma, and selected logs were plotted along with lithologic descriptions of core obtained from the borehole (fig. 8). The OTV log indicates the bedrock from the bottom of casing to a depth of about 57 ft below the top of casing is gray with some reddish and pink color. The rock unit appears to be massive, uniform, and fine grained, which is consistent with the quartz monzonite observed in core samples and the maps of Gates and Moench (1981). The contact at a depth of 57.8 ft, which is coincident with several fractures, is clearly evident in the OTV log. Above the contact, the fractures appear to be open and have no felsic infilling. Below the contact, the fractures appear to have felsic infilling. The generalized description of the drilling log is on the left, and the rock types are color-coded. The upper zone has been interpreted as quartz monzonite (Weston Solutions, 2005), and the lower unit, color-coded in green, has been interpreted as gabbro or diabase. The gamma log, shown in the shaded stratigraphic plot and in the standard line plot, shows a strong correlation to the rock types; the more mafic

gabbro/diabase unit has low gamma emissions. The adjacent ATV logs show a slight variation in acoustic reflectivity above and below the contact at a depth of 57.8 ft. By converting the acoustic reflectivity image data to an average or median value for each depth increment, the results can be compared to the gamma log in a cross-plot (fig. 6). These plots indicate the uppermost zone, which has an average gamma of 240 cps and a median reflectivity of 900 mV, is associated with the more felsic quartz monzonite. The unit below the contact at a depth of 57.8 ft below the top of casing, which has an average gamma count of 75 cps and a median reflectivity of 1,010 mV, is associated with the more mafic and very hard, reflective gabbroic or diabase unit.

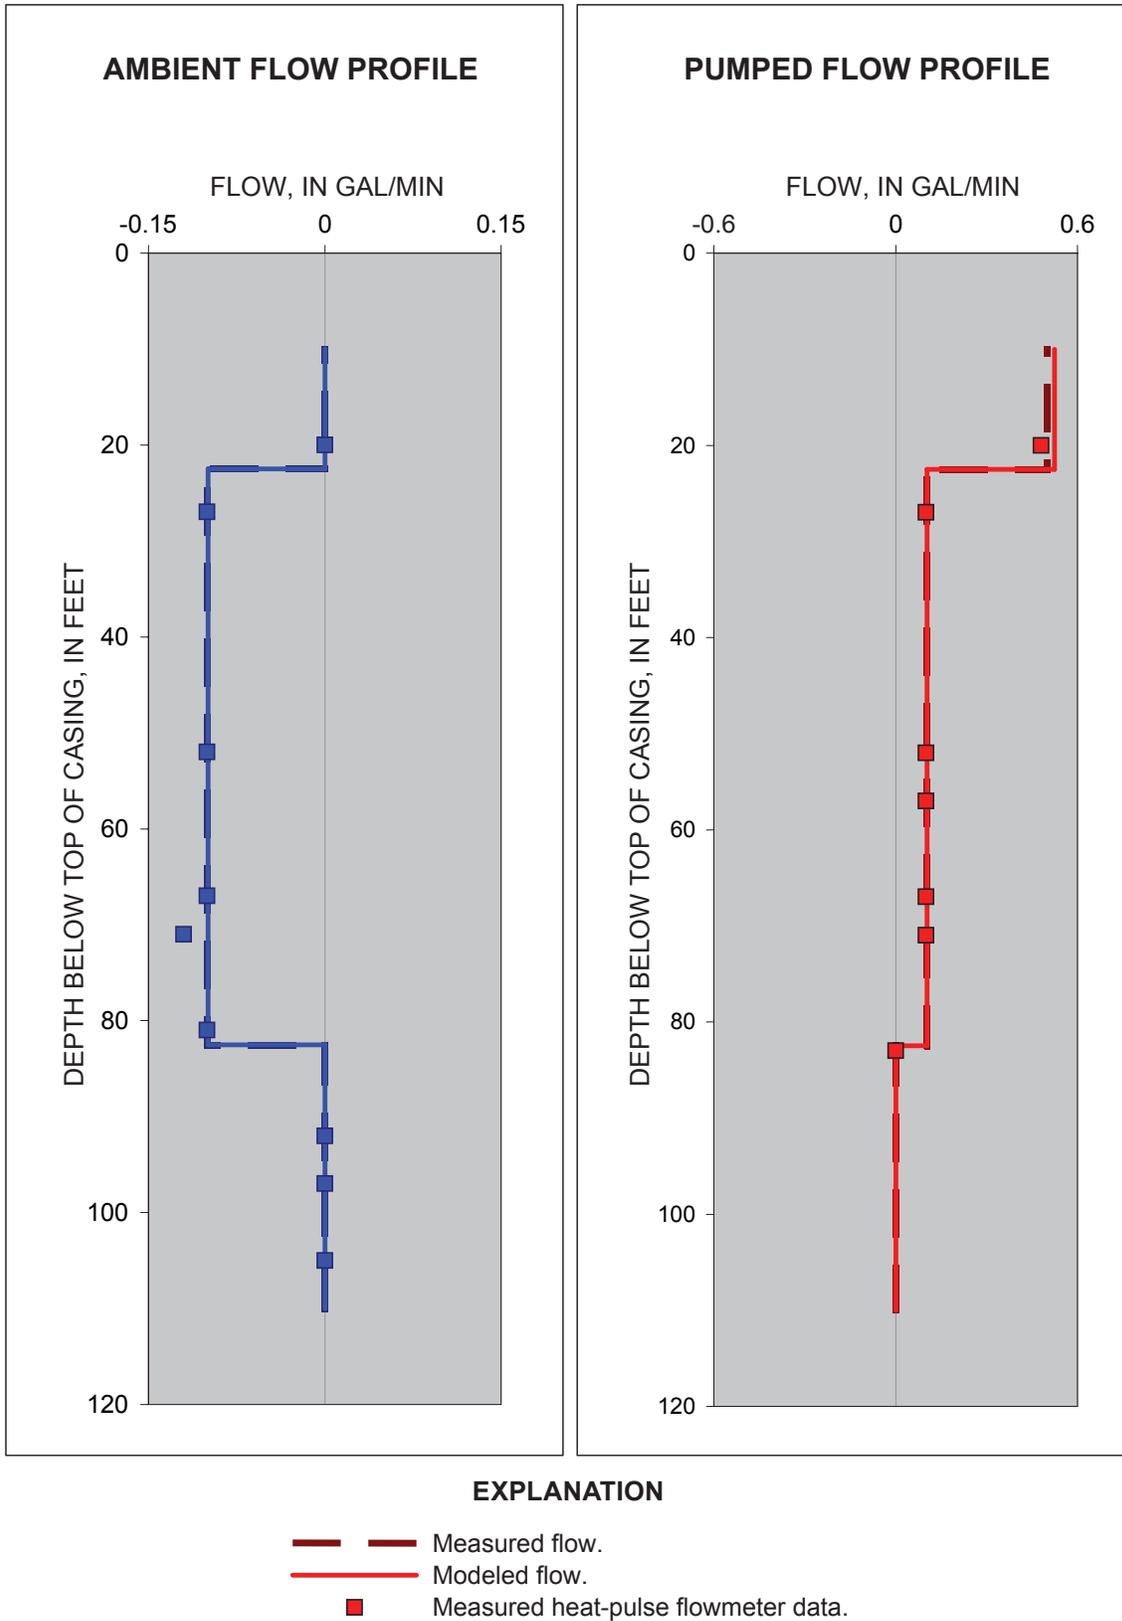
Figure 9. Flowmeter model for borehole DW-22, near Machiasport, Maine, showing solid model lines overlying interpretation of measured flow (dashed lines). (gal/min, gallon per minute; positive values of flow are upward flow, negative values of flow are downward flow)

The HPFM data were modeled using FWRAP to determine the transmissivity and head for the two transmissive zones in the borehole (fig. 9). Similar figures were constructed for the final model results for each borehole and are shown in the appendixes. Figure 9 is used to describe this presentation of HPFM data and the modeling results. In this figure, the points indicate HPFM measurements along the borehole. Dashed lines show the interpreted flow regime in the borehole, with downflow from a depth of about 25 to 82 ft below the top of casing. After interpretation of the image and fluid logs, the inflow and outflow were attributed to specific fractures. By adjusting the transmissivity and initial heads in FWRAP, the model generates ambient and pumped profiles (shown with solid lines) that are compared to the interpreted profiles. The transmissivity and head parameters were adjusted as needed to generate a good match between the observed and modeled profiles. In borehole DW-22, the modeled profile directly overlays the observed profiles over most of the borehole. The

upper fracture or feature at the base of casing, at a depth of about 22.5 ft below the top of casing, was modeled to have a transmissivity of 11.7 ft²/d and the deeper zone, 82.5 ft below the top of casing, a transmissivity of 6.8 ft²/d. The head of the upper fracture was 4.4 ft more than the head in the lower zone, consistent with the ambient downflow in the borehole. Under pumped conditions, the ambient outflow through the fracture at a depth of 82.5 ft was reversed, and additional water entered the borehole at the base of casing. These results are summarized in table 5, figure 9, and appendix 1, figure 1B–4. The SSE was 0.0006 (gal/min)² or a RMS error of 0.017 gal/min. By this method, the open-hole transmissivity is 18.5 ft²/d.

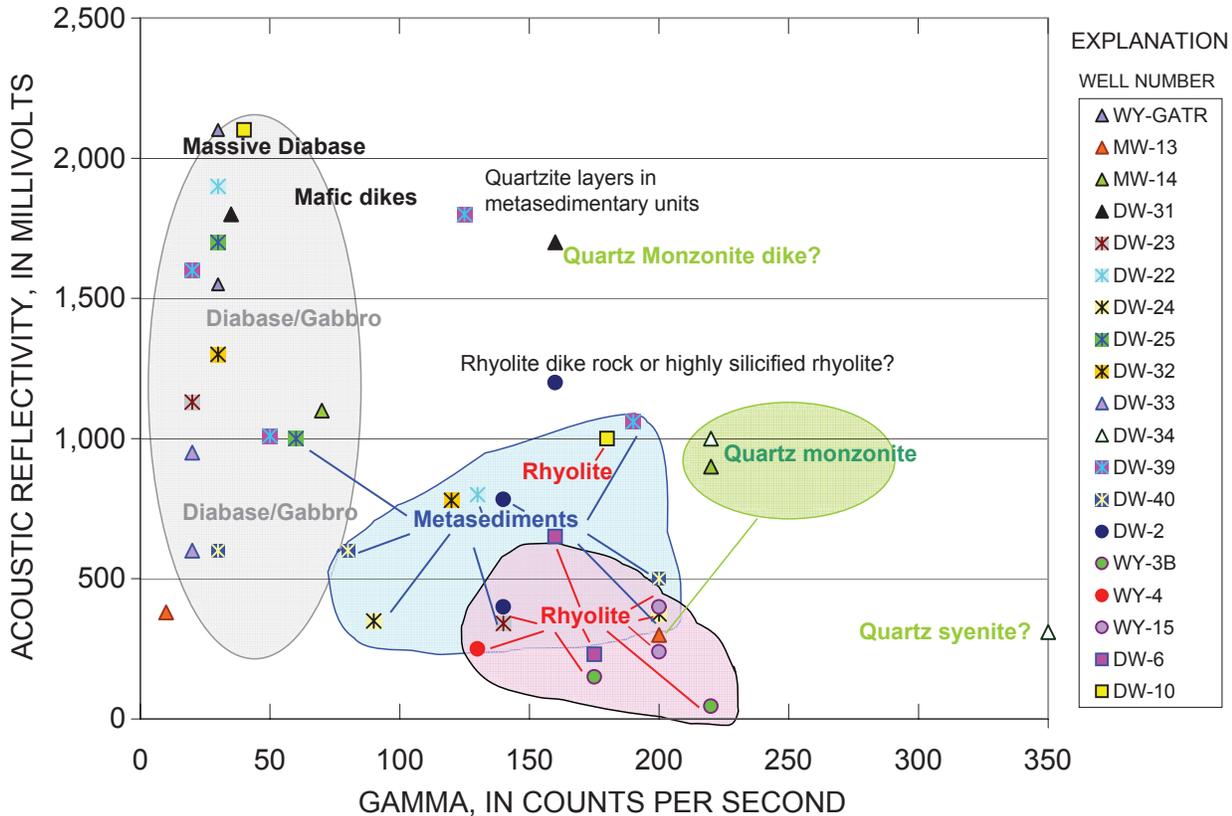
Figure 10. Cross-plot of gamma emissions and acoustic reflectivity for selected segments of boreholes near Machiasport, Maine.

Cross-plots were constructed using borehole logs from the boreholes in the study area (fig. 10). Average gamma and reflectivity values are shown for selected segments of the boreholes that appear to represent the major rock type in each borehole. Care was taken to avoid sections that were heavily fractured or enlarged and would give lower gamma and reflectivity values. Most of the boreholes had more than one value per well. The resultant plot was used to help identify similar rock units and determine gamma and reflectivity signatures that could be used to identify the rock types in other boreholes in the study area. Through this analysis, one of the rock types, that had previously not been “mapped” in the boreholes was identified in some of the boreholes. The interpretation of metasedimentary rocks of the Eastport Formation was corroborated by other geophysical logs and field mapping and is consistent with published geologic maps.

In this study area, the majority of the gamma emissions are thought to come from potassium. Because igneous rocks have varying amounts of potassium, the gamma tool can be effective in identifying changes in the rock related to compositionally different magmas or melts. In addition, the metasedimentary units have varying amounts of gamma emissions that are related because of clay content and emissions from other natural sources. The reflectivity of the rocks is related to the hardness (density and velocity), which is a function of the rock type (including mineralogy, texture, grain size, and the rugosity of the borehole wall). By combining the tool responses for natural-gamma emissions and acoustic reflectivity, signatures were determined for the major rock types in the study area. The signatures observed in figure 10 are described for each of the major rock types in the study area.

- The mafic dikes (example borehole DW-10) exhibit a very low gamma signature and high reflectivity.
- The gabbro/diabase units (example boreholes WY-GATR and MW-14) exhibit very low gamma emissions and variable but generally high reflectivity.

- The metasedimentary units show the most variation in signature but tend to have moderate gamma and reflectivity counts. Some short-depth intervals of the boreholes (such as in borehole DW-40) have very high gamma counts and may be an original depositional layer that was rich in clay and fine sediments. Other short-depth increments show very high reflectivity relative to the rocks above and below them without a change in gamma. These zones may be the metasedimentary layers of quartzite, such as the very high reflectivity unit in the metasedimentary rocks in borehole DW-39. Because of the variation in the original depositional sediments, the reflectivity and gamma logs for the metasedimentary layers tend to be highly variable.

- Quartz monzonite (example borehole MW-14) has high gamma counts and moderate reflectivity. The gamma and reflectivity signatures of quartz monzonite were similar to those of the metasedimentary units. But where OTV logs were available, the massive quartz monzonite could be distinguished from the laminated to banded metasedimentary units. In addition, the reflectivity logs in the metasedimentary units appear to be more variable over short distances than the more uniform and massive quartz monzonite.

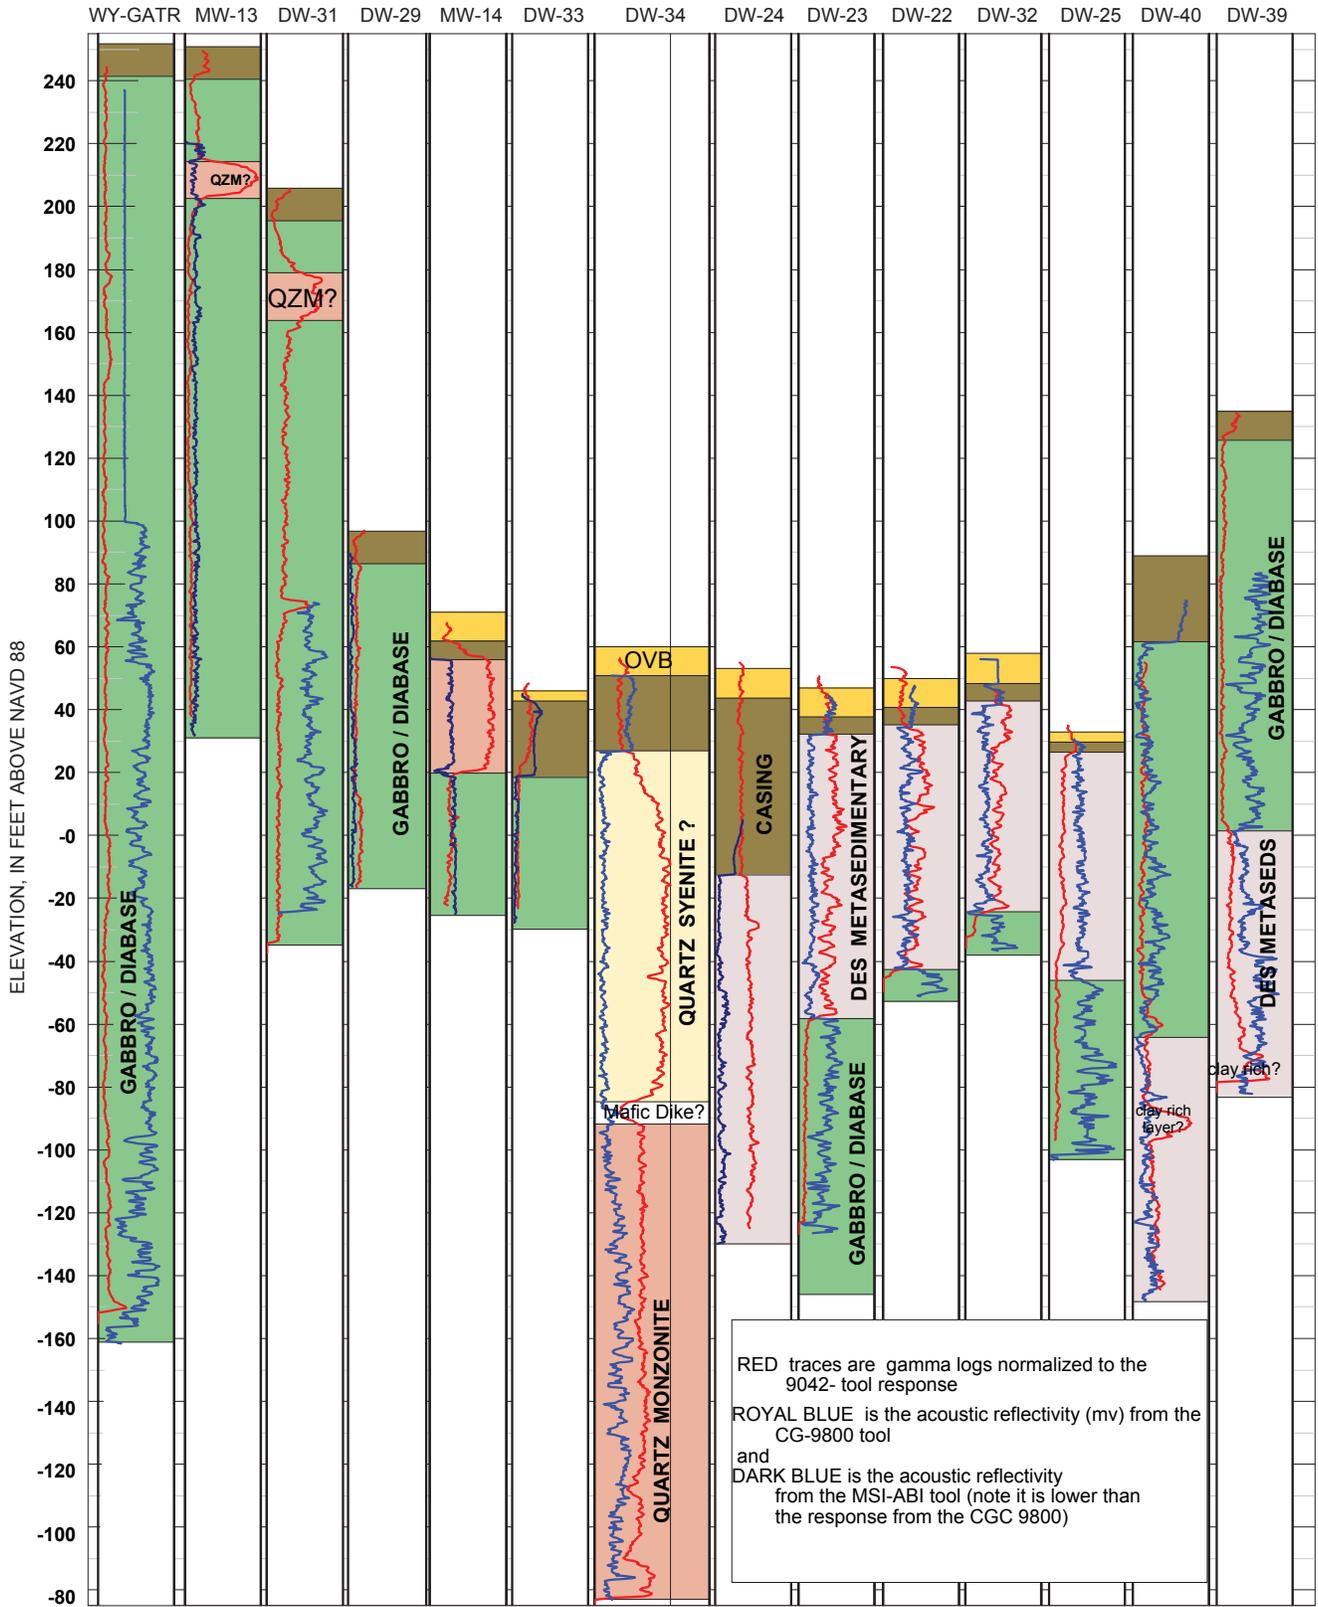
Figure 11. Gamma and reflectivity logs and interpretations for boreholes in the Miller Mountain site, near Machiasport, Maine. All gamma logs are shown from 0–300 cps, except for DW-34, which is 0–600 cps. Reflectivity is shown from 0–3,000 millivolts. (cps, counts per second; mV, millivolts; QZM, quartz monzonite; DES Metaseds, Devonian-Silurian metamorphosed sedimentary unit; OVB, overburden)

Collectively, these signatures were used to characterize the rock types in the boreholes. The borehole logs for the Miller Mountain site are shown in figure 11. The reflectivity and the gamma logs are superimposed on the general interpretation of the rock types. The logs have been plotted to a common elevation datum in feet above NAVD 88.

The borehole logs indicate the rock types at the summit of Miller Mountain are mainly mafic gabbro or diabase (boreholes WY-GATR, MW-13, DW-31, and MW-29). Along the southeast flank of Miller Mountain, the rock types are quartz monzonite and possibly quartz syenite, an igneous rock that has more potassium feldspar than the quartz monzonite and could account for the increase in gamma emissions relative to those of the quartz monzonite (borehole DW-34). Further east of the Miller Mountain summit, there is at least a 60-ft-thick zone of metasedimentary rock overlying the gabbro and diabase (boreholes DW-22, DW-23, DW-32, and DW-25). In borehole DW-24, only metasedimentary units were identified. North and east of the summit of Miller Mountain, gabbro and (or) diabase overlays the metasedimentary units (boreholes DW-40 and DW-39).

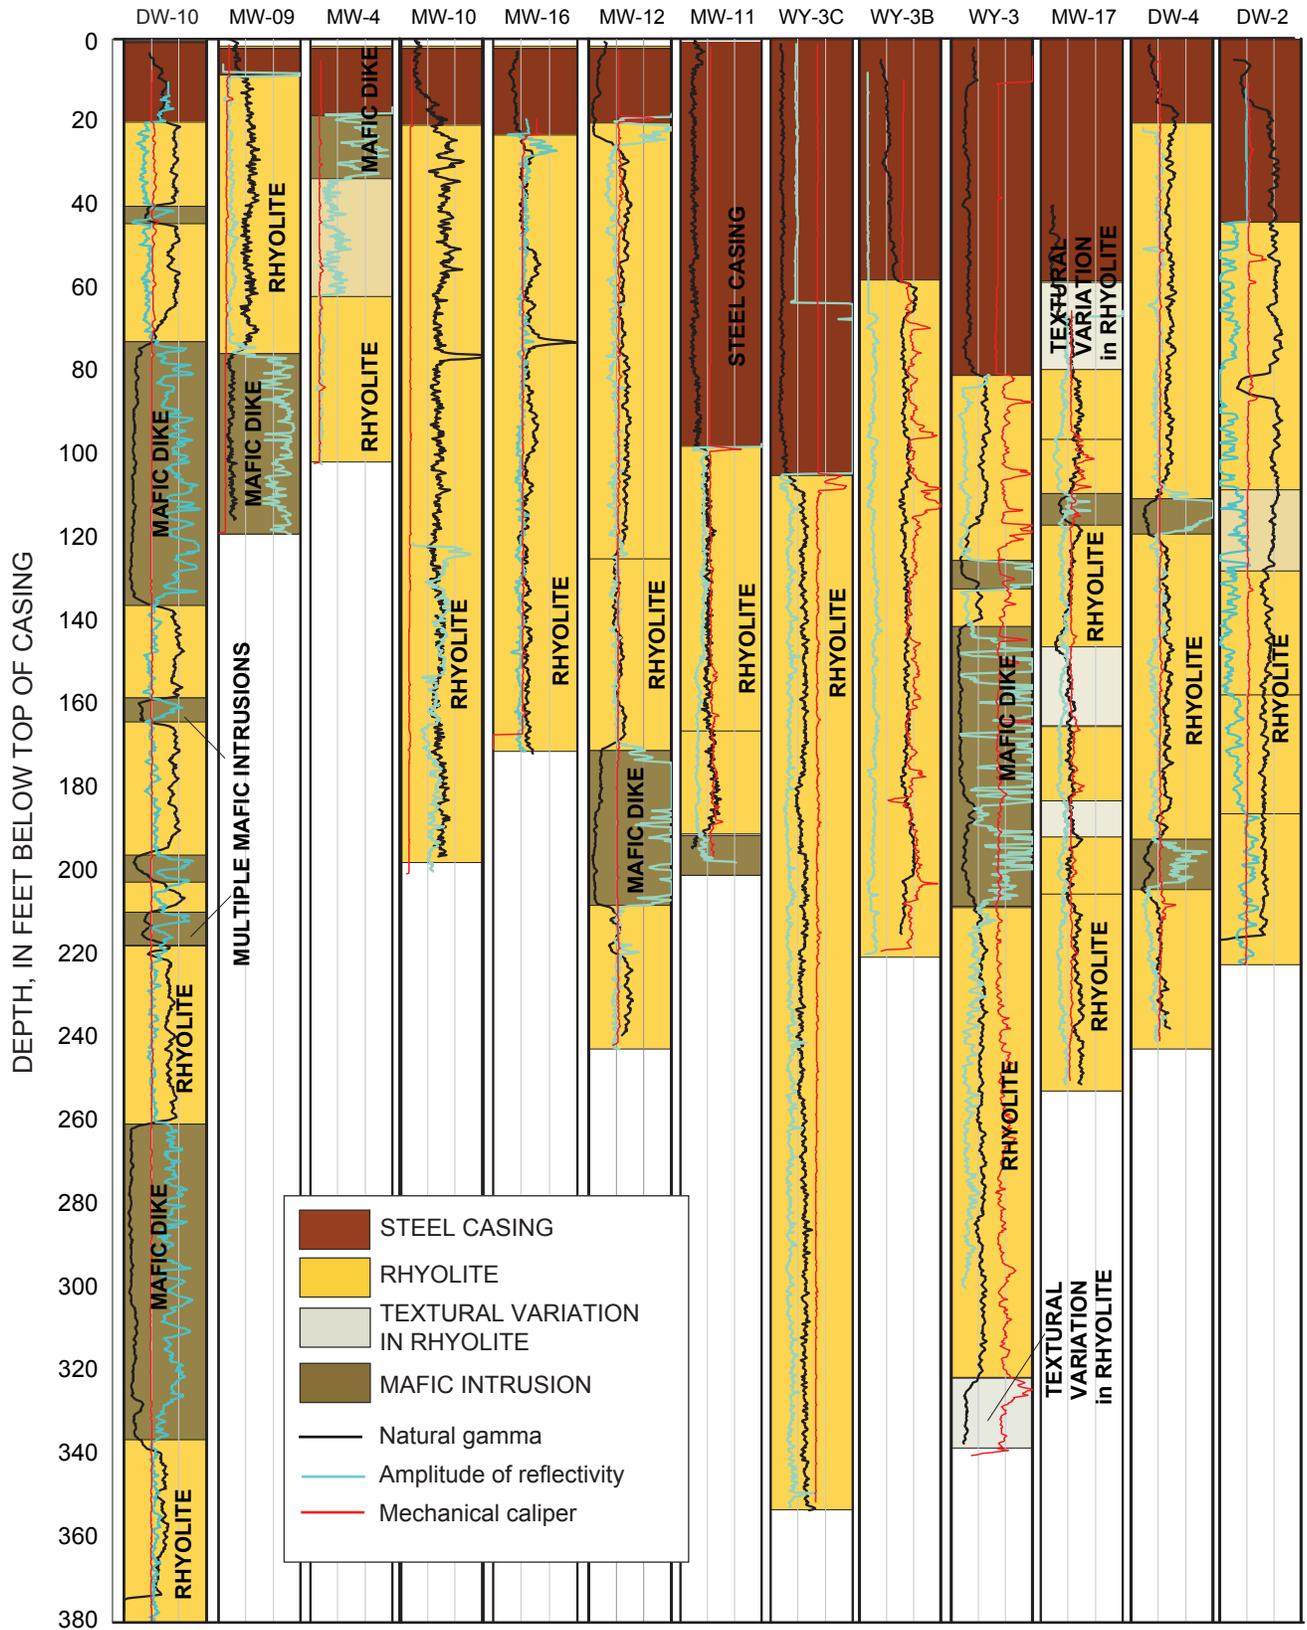
Figure 12. Gamma and reflectivity logs and interpretations for boreholes in the Howard Mountain area, near Machiasport, Maine. Shading indicates lithology.

The rock types on Howard Mountain are predominantly rhyolite with some mafic-dike intrusions (fig. 12). The rhyolitic rock units show some variation in texture and hardness, possibly depending on whether they are rhyolite country rock or rhyolite dikes; the rhyolite dikes have a higher reflectivity. The rock types at the Transmitter Site, southwest of the summit of Howard Mountain, also are rhyolite intruded with mafic dikes that dip steeply toward the west, which is consistent with the geologic maps (Gates, 1981). Most of the boreholes at the Howard Mountain and Transmitter Sites (boreholes DW-10 and MW-4) were logged with MSI tools; hence, the overall magnitude of the reflectivity is lower than the reflectivity obtained with the CGC tool. A cross-plot of gamma emissions and acoustic reflectivity for selected segments of the boreholes on or near Howard Mountain is shown in figure 13.
