Borehole Geophysical Investigation of a Formerly Used Defense Site, Machiasport, Maine, 2003–2006

By Carole D. Johnson, Remo A. Mondazzi, and Peter K. Joesten

Scientific Investigations Report 2009–5120

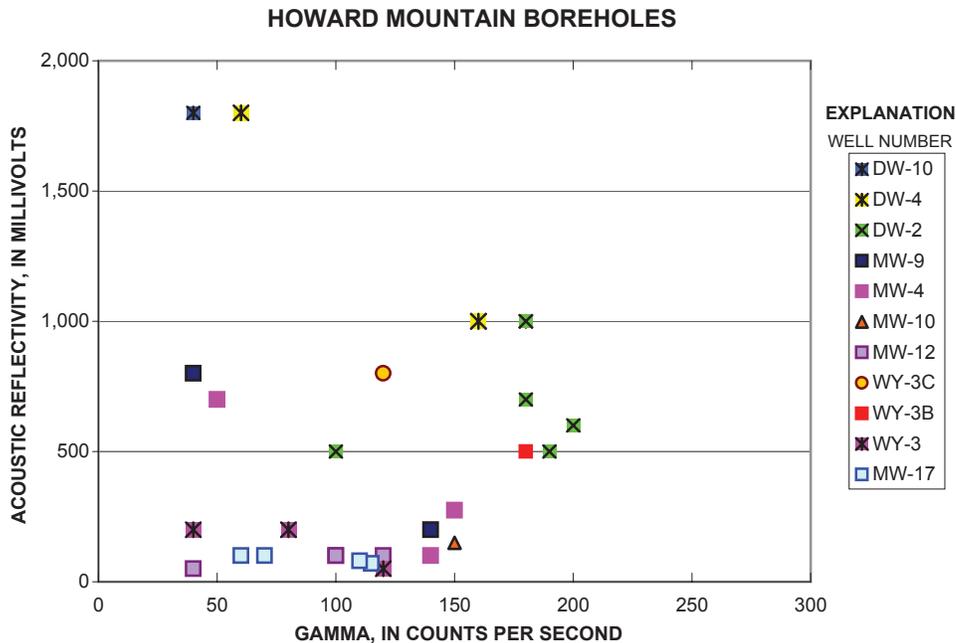
Figure 13. Cross-plot of gamma emissions and acoustic reflectivity for selected segments of the boreholes in the Howard Mountain area, near Machiasport, Maine. Boreholes MW-9 and MW-4 were interpreted in core samples. Boreholes DW-10, DW-4, and DW-2 were logged with a Century Geophysics acoustic televiwer; all other boreholes were logged with the Mount Sopris Instruments televiwer.

The rock types on Howard Mountain are predominantly rhyolite with some mafic-dike intrusions (fig. 12). The rhyolitic rock units show some variation in texture and hardness, possibly depending on whether they are rhyolite country rock or rhyolite dikes; the rhyolite dikes have a higher reflectivity. The rock types at the Transmitter Site, southwest of the summit of Howard Mountain, also are rhyolite intruded with mafic dikes that dip steeply toward the west, which is consistent with the geologic maps (Gates, 1981). Most of the boreholes at the Howard Mountain and Transmitter Sites (boreholes DW-10 and MW-4) were logged with MSI tools; hence, the overall magnitude of the reflectivity is lower than the reflectivity obtained with the CGC tool. A cross-plot of gamma emissions and acoustic reflectivity for selected segments of the boreholes on or near Howard Mountain is shown in figure 13.

Core samples collected from boreholes MW-9 and MW-4 provided hand samples for description of mineralogy and texture and determination of the rock type. The borehole logs were compared to these interpretations. Borehole MW-9, which has rhyolite at the top of the borehole down to a depth of about 75 ft below the top of casing, was characterized by moderate and variable gamma counts and low reflectivity. The mafic or gabbro dike below a depth of 75 ft in borehole MW-9 is characterized by high gamma emissions and higher reflectivity than the rhyolite (fig. 12). The core in borehole MW-4 is interpreted as a mafic dike overlying a rhyolite with the contact at a depth of about 34 ft below the top of casing. The entire core sample from borehole MW-4, from a depth of about 34 ft to the bottom of the borehole, is interpreted as rhyolite. However, the acoustic reflectivity (and to a lesser extent the gamma log) shows variation from a depth of about 34 to 62 ft and then much lower and uniform reflectivity from a depth of 62 ft to the bottom of the borehole (fig. 12). These clearly defined changes in the borehole logs are probably because of textural changes in the rhyolite lava flows. A side-by-side comparison of multiple logs from Howard Mountain indicates variations in the gamma and reflectivity logs for the units interpreted as rhyolite and very clear delineations between rhyolite and the mafic dikes.

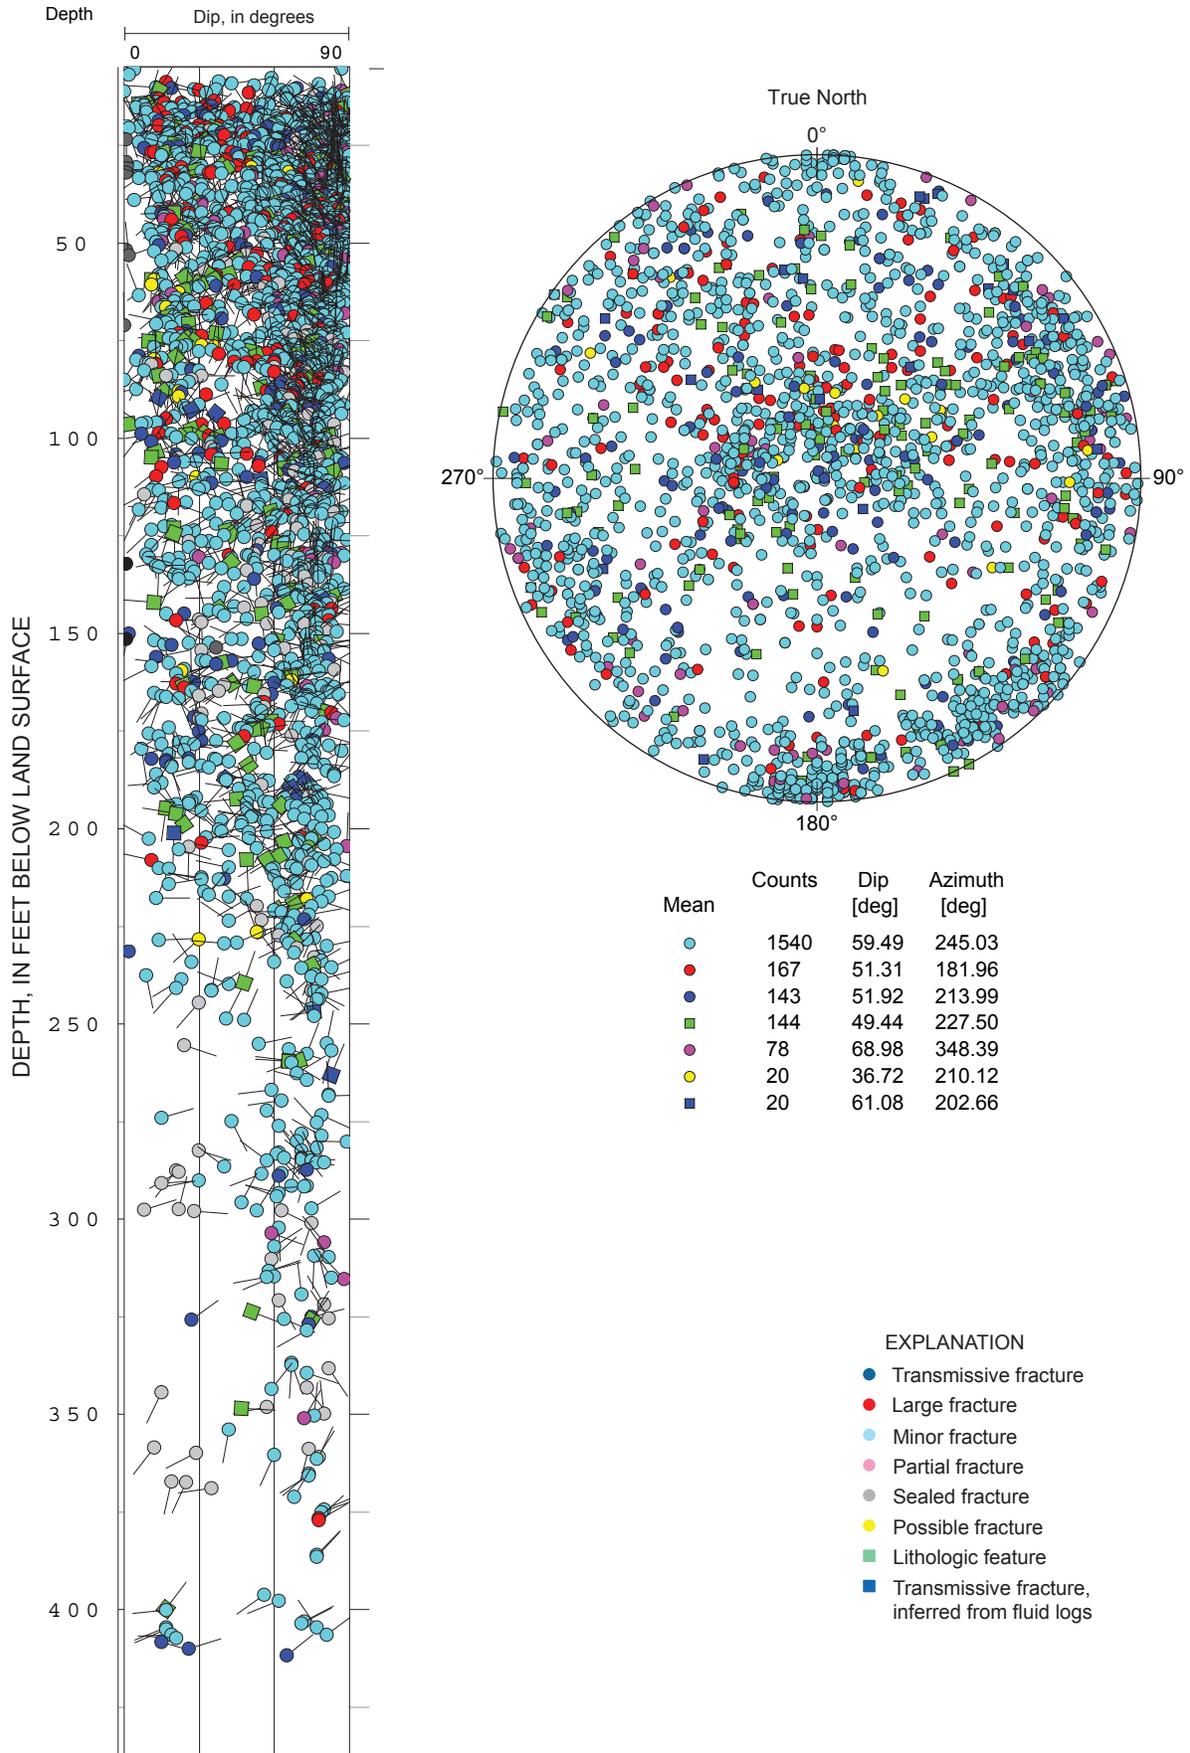
Figure 14. Tadpole plot and stereonet showing all fractures and lithologic features in the 37 boreholes near Machiasport, Maine. Stereonet is lower hemisphere Schmidt, equal area plot. (deg, degrees)

readily shows a very high proportion of vertical fractures, no vertical-bias corrections were applied. It is noteworthy that there are so many steeply dipping fractures because they may serve to connect low-dip-angle unloading or sheeting fractures that mimic the topography and are ubiquitous in the near surface. These sub-horizontal fractures appear to decrease in frequency with depth, as indicated by the lack of shallow-dipping tadpoles at depth, relative to the number of steeply dipping fractures at depth (fig. 14). A total of 144 lithologic features were identified and coded with green squares in the stereo and tadpole plots (fig. 14). These lithologic features show a wide range of orientations.

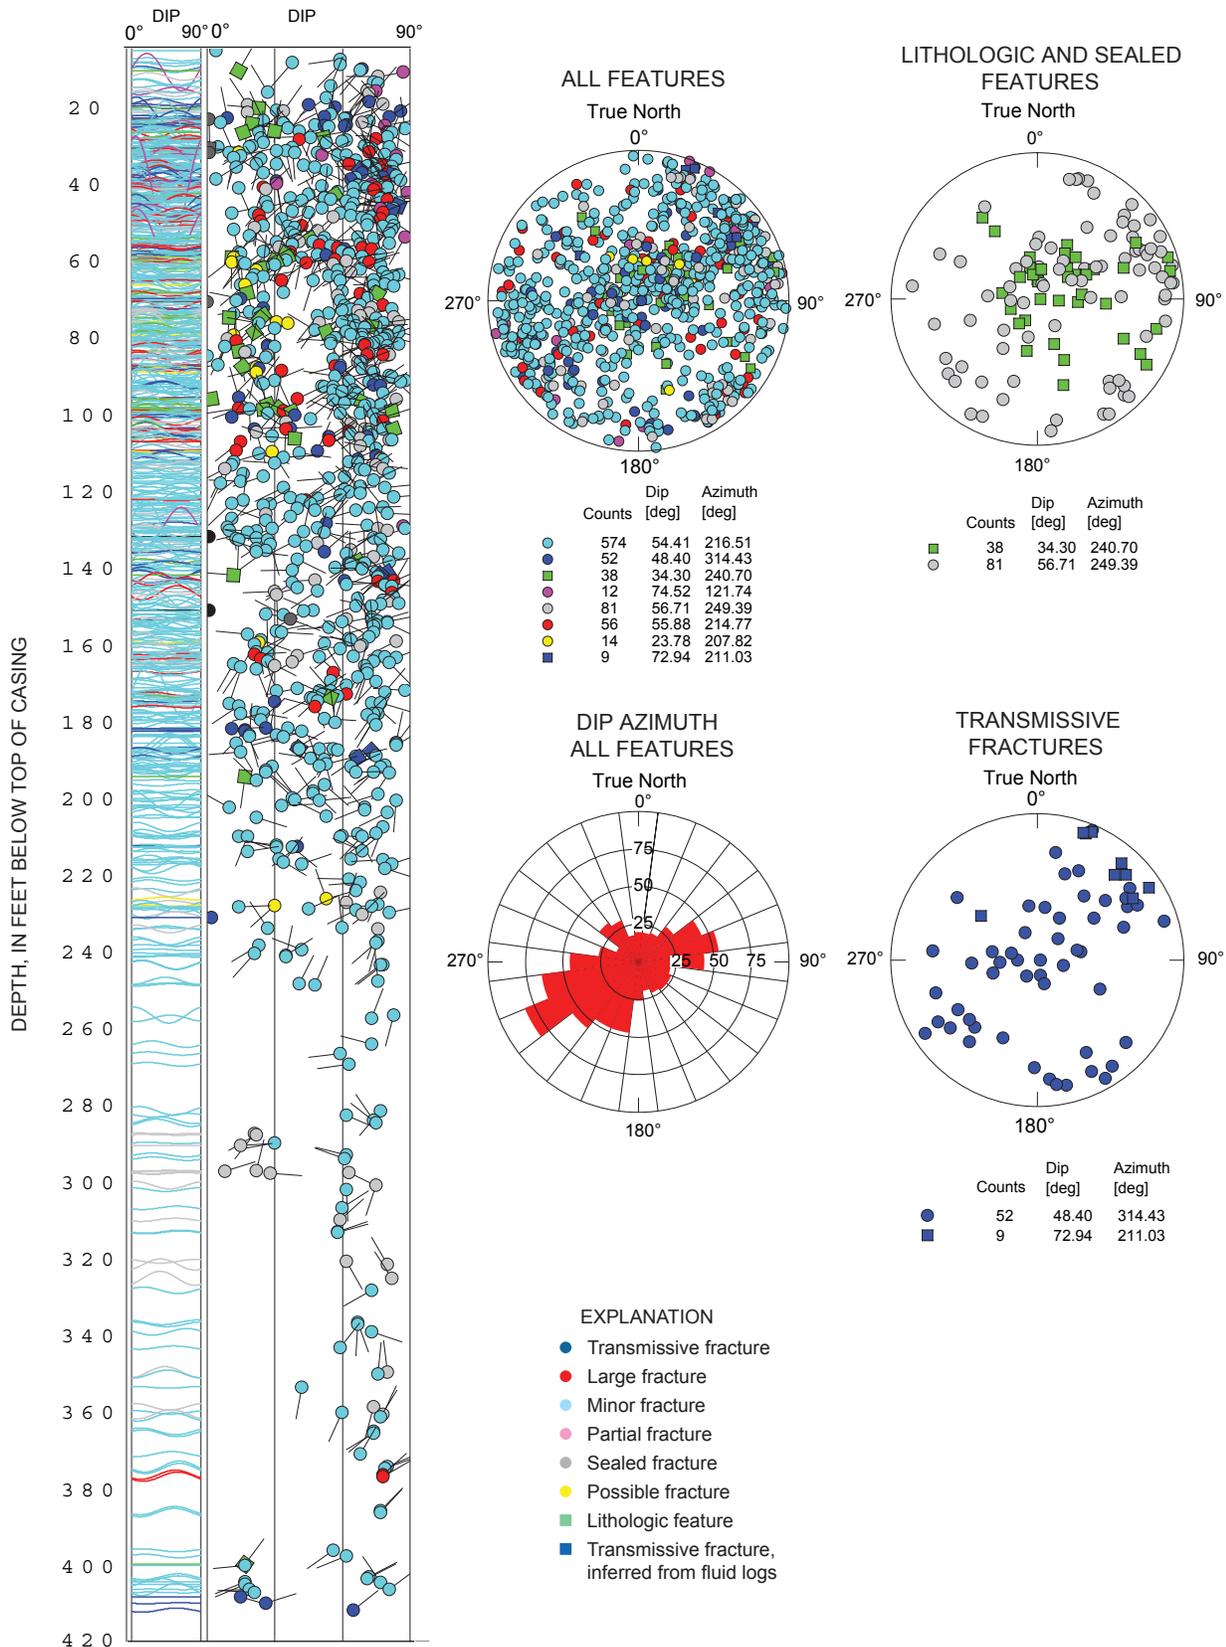
Figure 15. Tadpole plots, stereoplots, and rose diagram showing all fractures and lithologic features in 14 boreholes on or near Miller Mountain, near Machiasport, Maine. Stereoplots are lower hemisphere Schmidt, equal area plots. Rose diagram shows direction of dip azimuth, which is 90 degrees to the right of the strike. (deg, degrees)

A total of 836 fractures and lithologic features were identified in the 14 boreholes on and near Miller Mountain. A stereoplot of the fractures shows a wide distribution of orientations (fig. 15). The maximum cluster of poles to fracture planes plots towards the center of the stereoplot and

A total of 38 lithologic features were identified and coded with green squares in the stereo and tadpole plots (fig. 15). The lithologic features identified in the Miller Mountain boreholes were either very shallow dipping or steeply dipping towards the northwest. Fractures with infilling (gray circles) appeared to have the same orientations as the transmissive fractures and the total population of fractures for the Miller Mountain boreholes.

The tadpole and projection plots (fig. 15) and 100-ft incremental stereoplots and rose diagrams (appendix 6) show that as depth increases, the fracture orientation remains fairly constant. The transmissive fractures show a small amount of rotation with depth in the fracture strike (and dip azimuth) towards the west. Density plots, which show the number of fractures for a fixed-depth interval, were constructed for 10- and 100-ft intervals to quantify the intensity of fracturing with depth. Density plots constructed with 10-ft intervals for all the wells in the Miller Mountain area show an apparent decrease in fracture density with depth (appendix 6, fig. 6A–1). Because of the sampling bias of the well depths, more near-surface fractures were encountered in the shallow boreholes relative to the total population. When density is plotted as a function of elevation, the highest fracture density still shows a sampling bias. Hence, an assessment of fracture density with depth is probably best estimated by looking at the deepest boreholes individually. The OTV log for borehole WY-GATR (appendix 6, fig. 6A–4) shows only a small decrease in number of fractures with depth and an increase in sealed fractures with depth. The tadpole plot indicates most of the fractures at depth are steeply dipping, although the transmissive fractures in the bottom of borehole WY-GATR have shallow dips (fig. 6A–4).

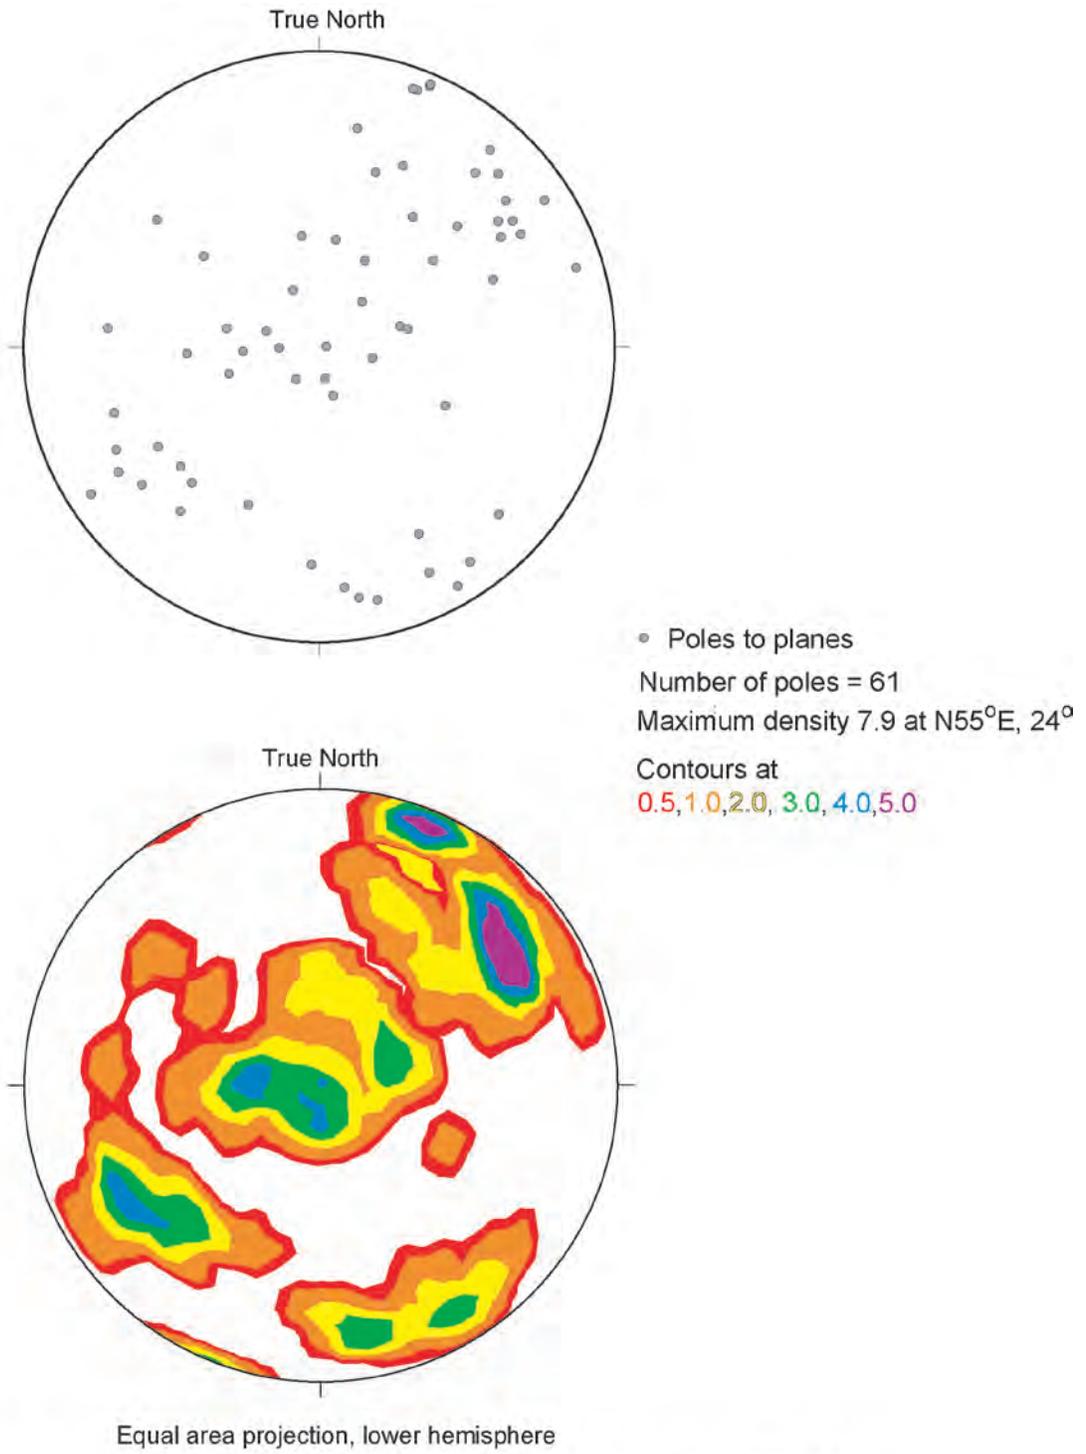
Figure 16. Poles to planes of transmissive fractures in 14 boreholes on or near Miller Mountain, near Machiasport, Maine.

represents shallow-dipping fractures that strike northeast with an average bearing of about N55°E (fig. 16). These shallow-dipping fractures are most likely caused by unloading. The total population of fractures and the population of transmissive fractures in the Miller Mountain wells strike northwest and southeast and dip moderately to steeply towards the northeast and southwest, respectively. These fractures are parallel to local faulting and parallel to the incised valley between Miller and Bucks Mountains. Another cluster of poles to fracture planes strikes southwest and dips very steeply to the northwest at a dip azimuth of N335°E, which is parallel to the regional trend of fractures.

A total of 61 fractures were identified as transmissive in the 14 boreholes on and near Miller Mountain. The transmissive fractures are shown with dark blue circles for fractures identified with the HPFM and dark-blue squares for fractures inferred by water-quality or temperature logs. A stereoplot showing contours of transmissive fractures indicates the majority of these fractures strike southeast and dip southwest (fig. 16).

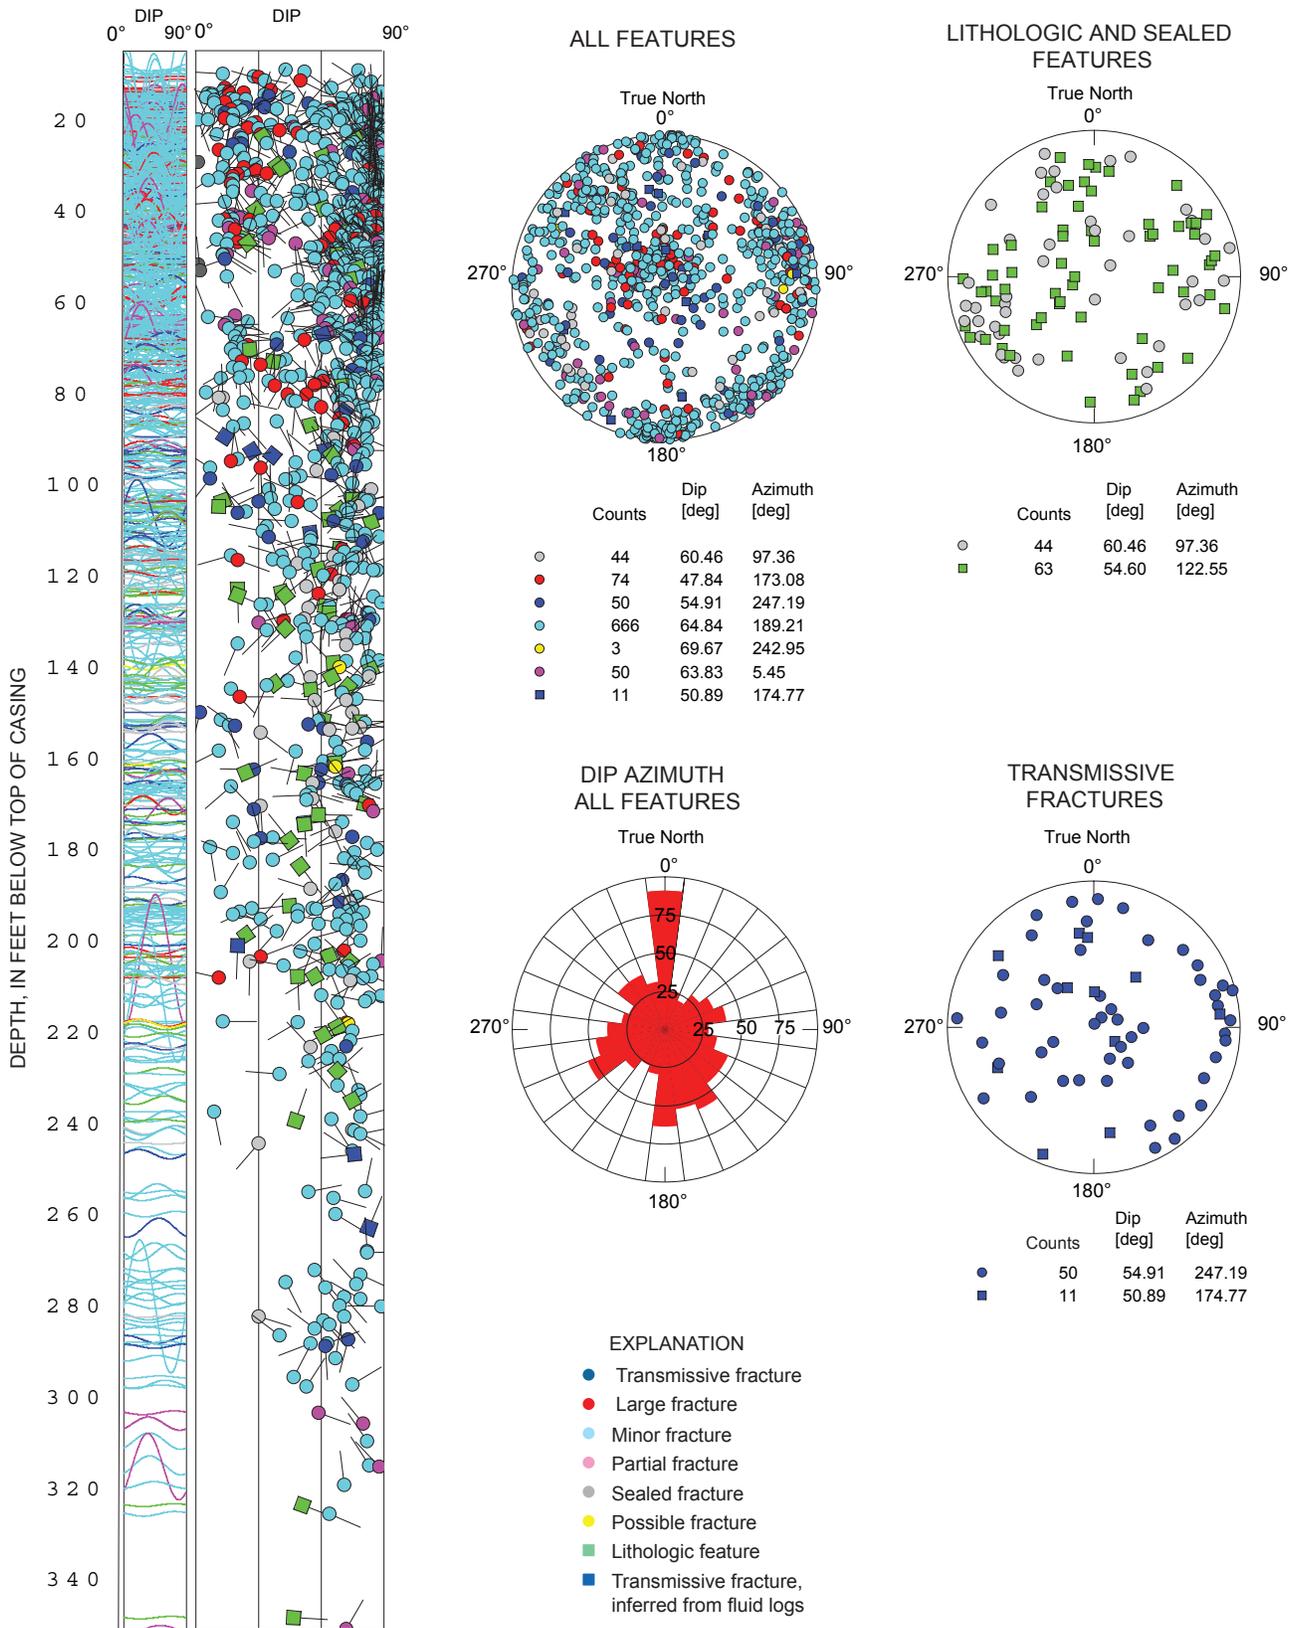
Figure 17. Tadpole plots, stereoplots, and rose diagram showing all fractures and lithologic features in 17 boreholes near the Air Force Radar Tracking Station on Howard Mountain, near Machiasport, Maine. Stereoplots are lower hemisphere Schmidt, equal area plots. Rose diagram shows direction of dip azimuth, which is 90 degrees to the right of the strike. (deg, degrees)

A total of 898 fractures and lithologic features in 17 boreholes on or near Howard Mountain shows a wide range of orientations in the poles to fracture planes, with some minor clustering in the stereoplot. The stereo and tadpole plots for Howard Mountain indicate most of the fractures are steeply dipping; a smaller subset of fractures is sub-horizontal and dips towards the southeast (fig. 17). Similar to the fractures on Miller Mountain, there are many southeast-northwest striking fractures that dip very steeply toward the southwest and northeast, respectively. Numerous fractures strike southwest-northeast and dip very steeply to the northwest and southeast, respectively. There is a very large population of steeply dipping fractures, as indicated by the dense population of tadpoles on the right side of the tadpole plot; this is uncorrected for the vertical sampling bias. The majority of fractures dip towards N237°E and strike and dip N147°E, 85°SE. In general, the fracture orientation on or near Howard Mountain is more variable than on or near Miller Mountain or at the Transmitter Site. This variability in the Howard Mountain data may be

A stereoplot of the 61 transmissive fractures (poles to fracture planes shown in dark blue circles and squares) from the 17 boreholes on or near Howard Mountain is similar to the overall fracture population for Howard Mountain (fig. 17). Contoured stereoplots show the clustering of poles to fracture planes for all fractures identified as transmissive (fig. 18). The transmissive fractures strike (and dip) in almost every direction, but most notably they do not strike west (and dip due north), as do many of the fractures, which dip due north, in the entire fracture population for Howard Mountain (fig. 17). This observation is confirmed by the lack of contours on the southern side of the stereoplot (fig. 18). The lithologic features identified in the Howard Mountain boreholes (coded in green) show a wide range of orientations, without a strong pattern of clustering of the poles to the planes (fig. 17).

An assessment of fracturing with depth indicates a strong sampling bias when all boreholes are included (fig. 17 and appendix 6, figs. 6B1–3). Because most of the boreholes are about 120 ft deep, the fracture count in the total population appears to decline abruptly below a depth of about 120 ft below land surface. However, the fracture density for the three deepest wells in the Howard Mountain area, WY-3, WY-3B, and WY-15, does not show a decline in fracturing with depth (appendix 6, fig. 6B–4). Most of the fractures below a depth of 200 ft are moderately to steeply dipping, indicating a decline in the frequency of shallow-dipping unloading or sheeting fractures with depth.

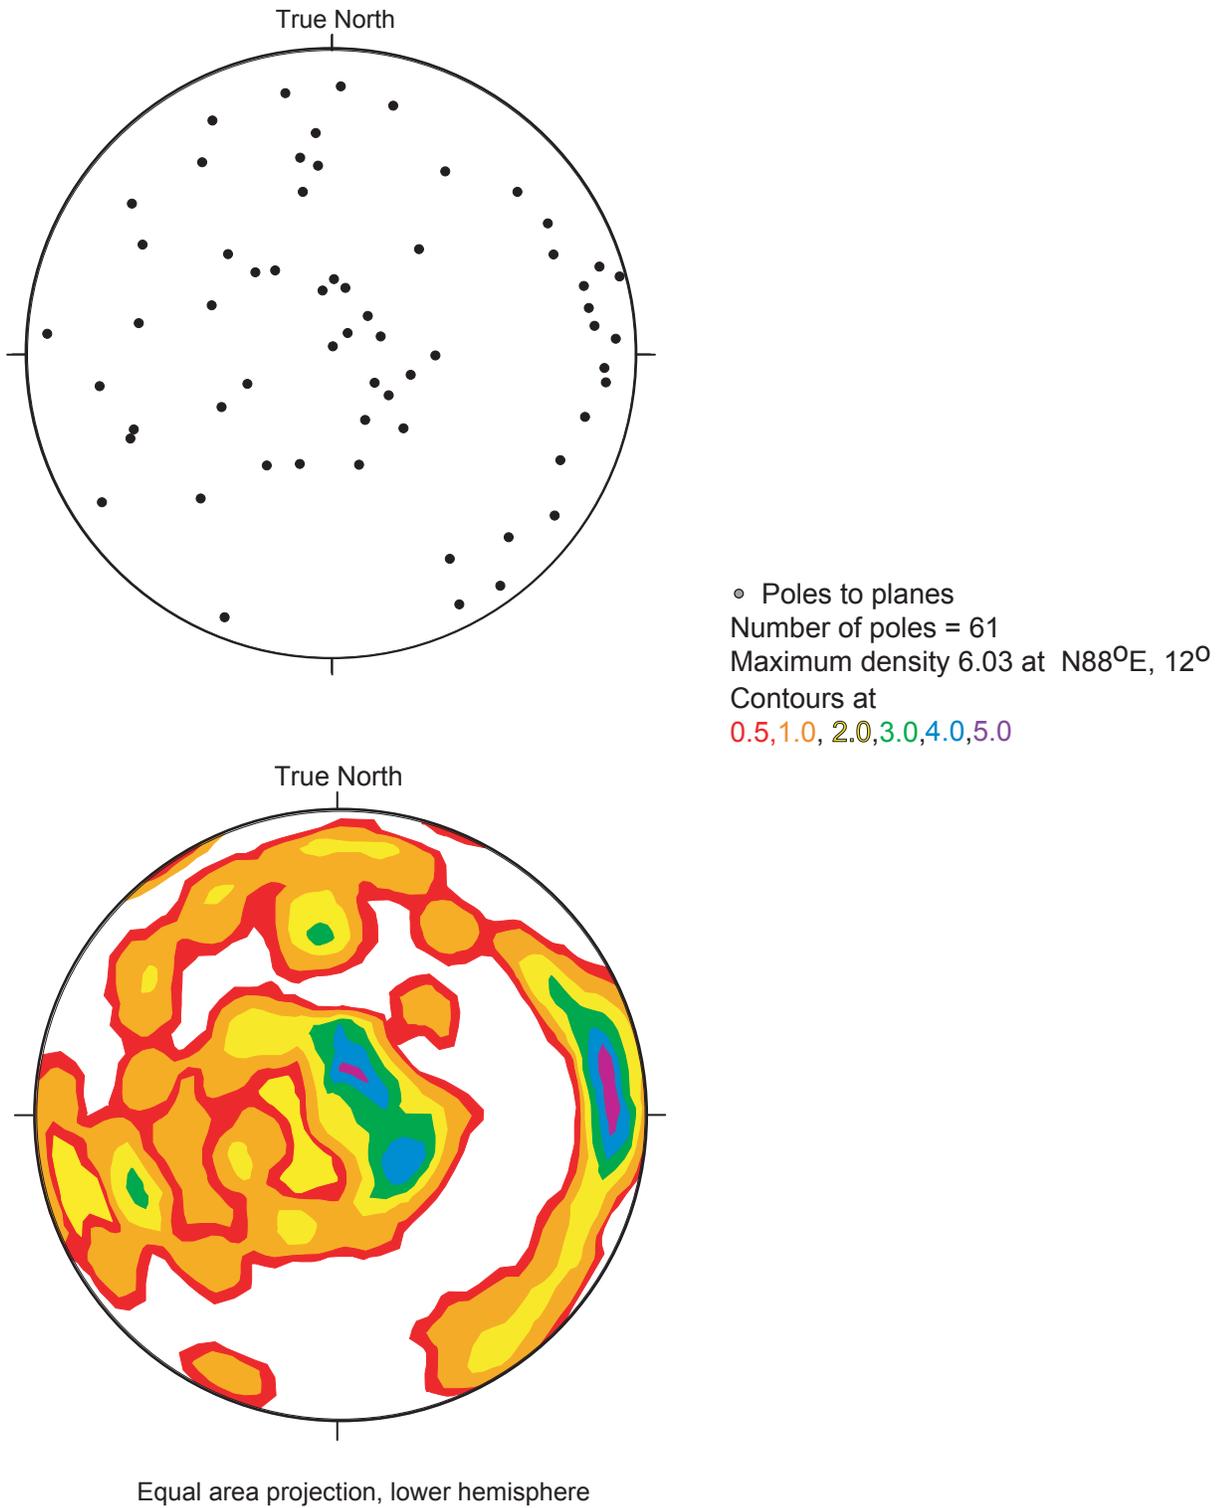
Figure 18. Poles to planes of transmissive fractures in 17 boreholes near the Air Force Radar Tracking Station on Howard Mountain, near Machiasport, Maine.

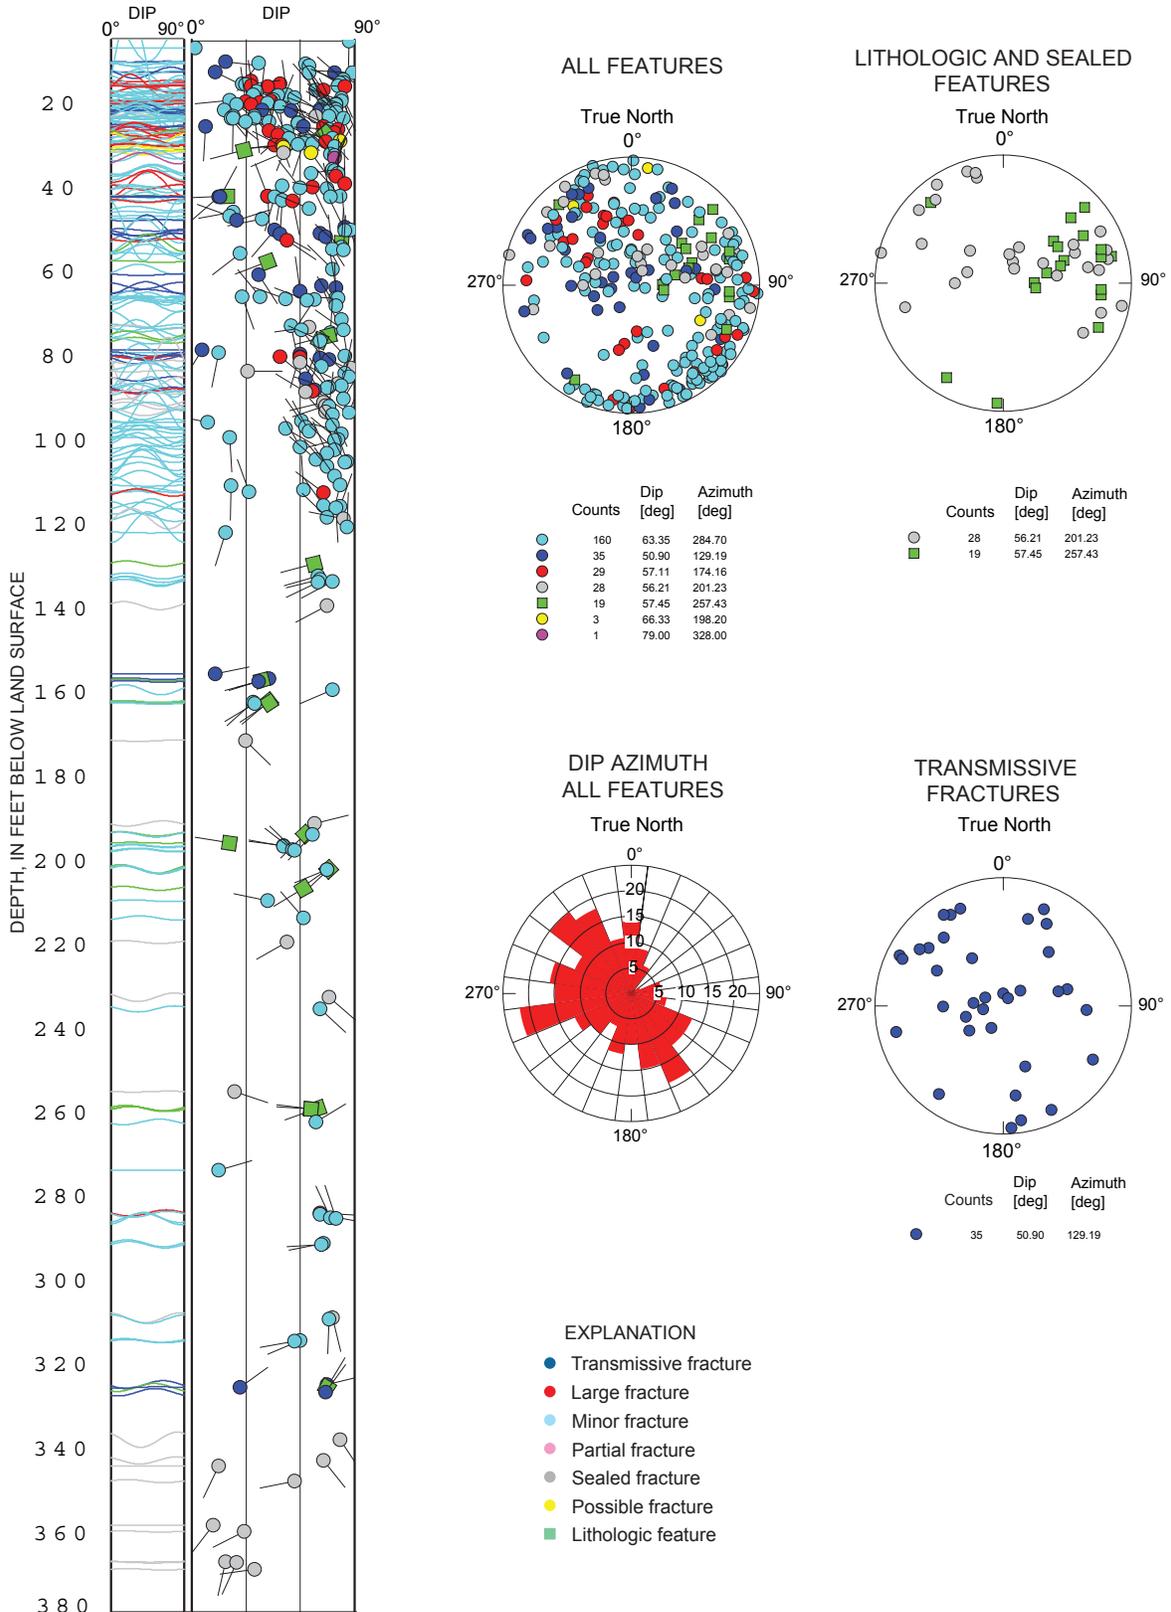
Figure 19. Tadpole plots, stereoplots, and rose diagram showing all fractures and lithologic features in six boreholes near the Transmitter Site on Howard Mountain, near Machiasport, Maine. Stereoplots are lower hemisphere Schmidt, equal area plots. Rose diagram shows direction of dip azimuth, which is 90 degrees to the right of the strike. (deg, degrees)

A total of 275 fractures and lithologic features were identified in the six boreholes near the Transmitter Site on the southwest side of Howard Mountain (fig. 19). The fractures show a wide range of orientations in poles to fracture planes, with some minor clustering on the stereoplot. The stereo and tadpole plots for the Transmitter Site indicate fractures trend in two directions—southwest-northeast and southeast-northwest. The fractures that strike southwest and northeast dip steeply towards the northwest and southeast, respectively. Another substantial cluster of poles to fracture planes indicates fractures strike south and southeast and dip toward the west-southwest.

A stereoplot of the 35 transmissive fractures (dark blue circles) is similar to the overall fracture population for the Transmitter Site (figs. 19 and 20). There are clusters of poles to transmissive fracture planes that dip steeply towards the southeast and towards the northwest (fig. 20). These fracture orientations appear to follow the regional pattern of northeast-southwest striking fractures with dip directions towards the southeast and northwest. Another small cluster of poles to planes of transmissive fractures occurs near the center of the stereoplot, indicating a shallow dip towards the east (fig. 20).

Mafic dikes strike to the south-southeast and dip moderately to steeply towards the west-southwest at an average dip azimuth of N275°E (appendix 3 and fig. 19). Many of the mafic dikes generally parallel a subset of the transmissive fractures at the Transmitter Site. The lithologic features (coded in green, fig. 19) generally dip moderately to very steeply to the west. Sealed fractures dip at all angles towards the west and the east-southeast and were observed at all depths.

An assessment of fracturing with depth indicates fractures from a depth of 0 to 100 ft below land surface at the Transmitter Site strike to the southwest and northeast and dip steeply towards the northwest and southeast (tadpole and stereoplots, appendix 6, fig. 6C–2). These fractures tend to parallel the regional structural northeast trend. From depths of 100 to 200 ft below land surface, the fractures dip towards the northwest and southwest. Deeper than 200 ft below land surface, the limited number of fractures dip towards the east and west. Because most of the boreholes are less than 120 ft deep, the analysis with depth is limited to borehole DW-10 (appendix 6, fig. 6C–4). In general, the fracturing appears to be fairly uniform with depth.

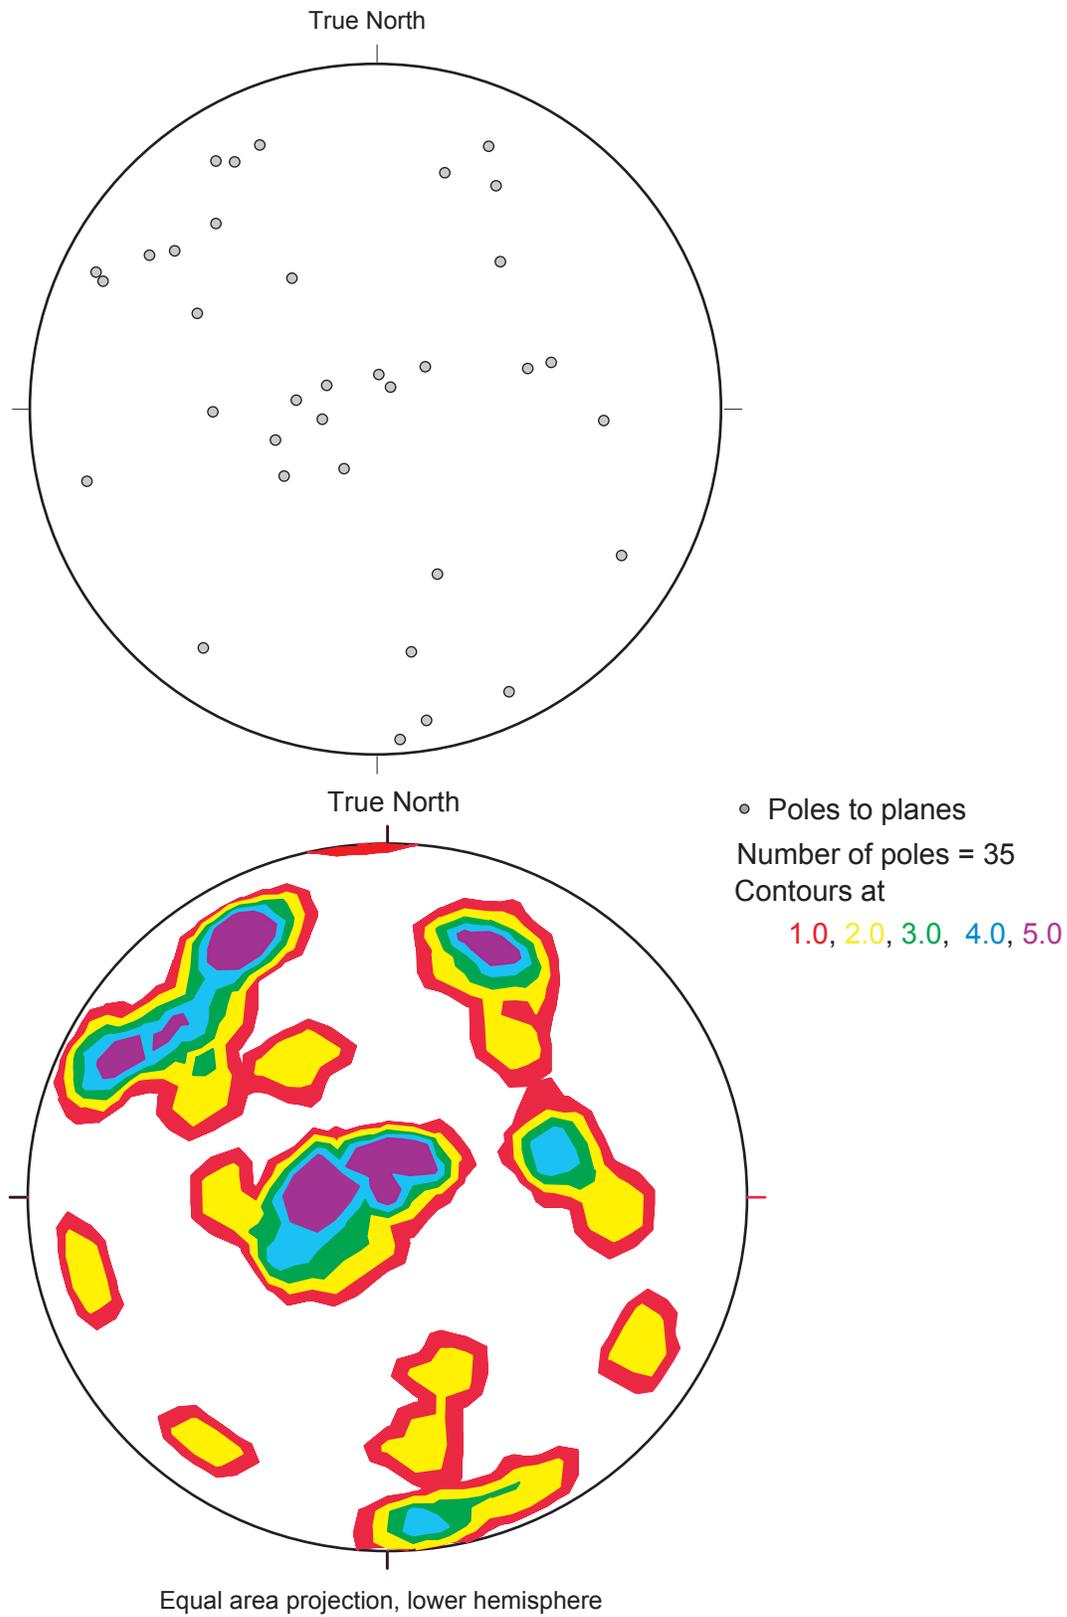
Figure 20. Poles to planes of transmissive fractures in six boreholes near the Transmitter Site on Howard Mountain, near Machiasport, Maine.

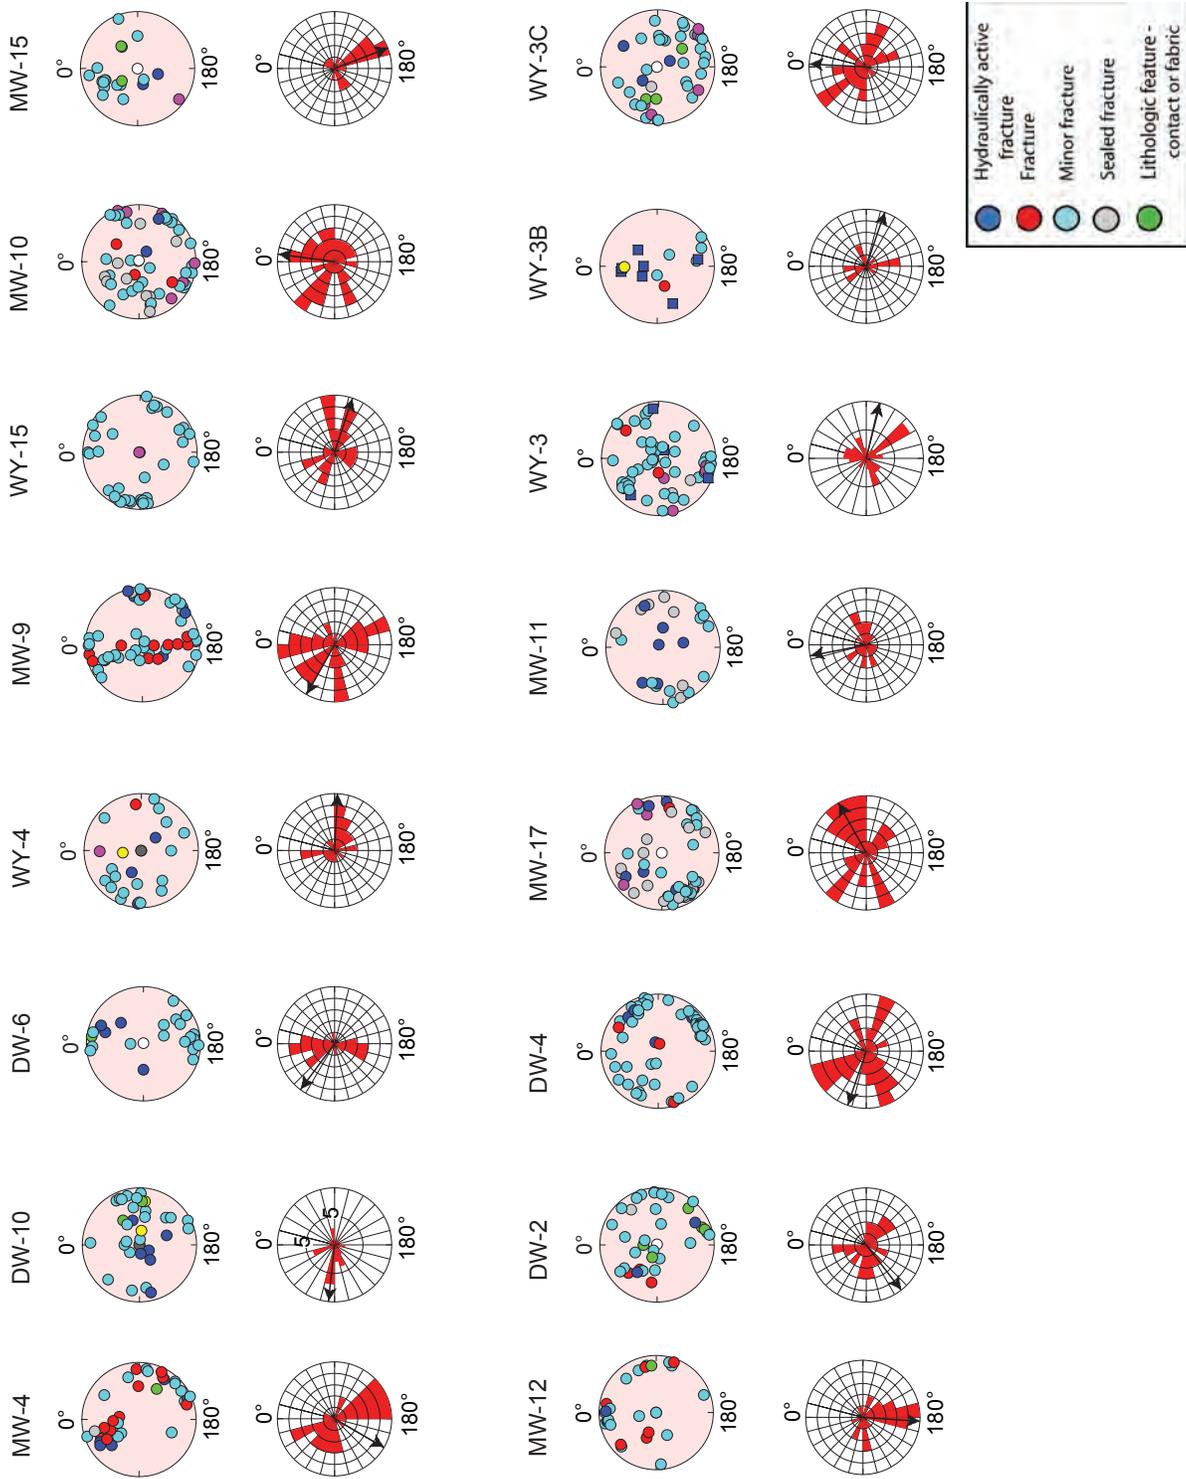
Figure 21. Stereoplots and rose diagrams for selected boreholes on or near Howard Mountain, Machiasport, Maine. Rose diagrams show the direction of dip azimuth.

In order to assess the pattern of the fracture populations with respect to proximity to the northwest-trending fault that bounds the northeast side of Howard Mountain, a series of stereoplots and rose diagrams are shown side-by-side for selected Howard Mountain boreholes (fig. 21). The plots represent a cross section extending from the southwest at the Transmitter Site towards the northeast, Howard Mountain, and the fault location. The stereoplots and rose diagrams show numerous fractures in these boreholes with a wide variation in fracture orientation. Many of the boreholes across this section have fractures that are parallel to the regional northeast trend. Boreholes MW-4, DW-6, MW-9, WY-15, MW-10, MW-15, MW-12, DW-2, DW-4, and WY-3C have dominant fracture sets that strike northeast and southwest and dip southeast and northwest, respectively. Other boreholes, including WY-3 and MW-17, have lesser amounts of northeast-southwest striking fractures. The fractures in boreholes MW-17, WY-4, MW-9, and DW-6 predominantly strike northwest-southeast, parallel to the northwest trending fault north of Howard Mountain. Most of the fractures in boreholes MW-10 and MW-11 strike north and south and dip towards the east and west, respectively; boreholes WY-3B, MW-9, and MW-4 show small numbers of north-south striking fractures. Boreholes DW-6, MW-12, WY-3, and WY-3B have prominent fracture sets that strike east and west and dip south and north, respectively. Also, boreholes DW-2 and WY-4 have minor fracture sets that strike east and west. Collectively, these observations indicate similarities in the orientations of fracture sets between the boreholes, but there does not appear to be a consistent pattern associated with topography or distance from the fault. When all the other Transmitter Site boreholes are included in the analysis (appendix 4), a general observation is that the fracture pattern goes from mostly southwest-northeast striking to more variable near the summit of Howard Mountain and in the boreholes near the fault.

The stereoplots for Howard Mountain (fig. 21) show more variation in strike than the Miller Mountain stereoplots, but they also show less variation in dip. In general, the fracture populations in the Howard Mountain boreholes are dominated by steeply dipping fractures that dip at steeper angles than the Miller Mountain fractures.

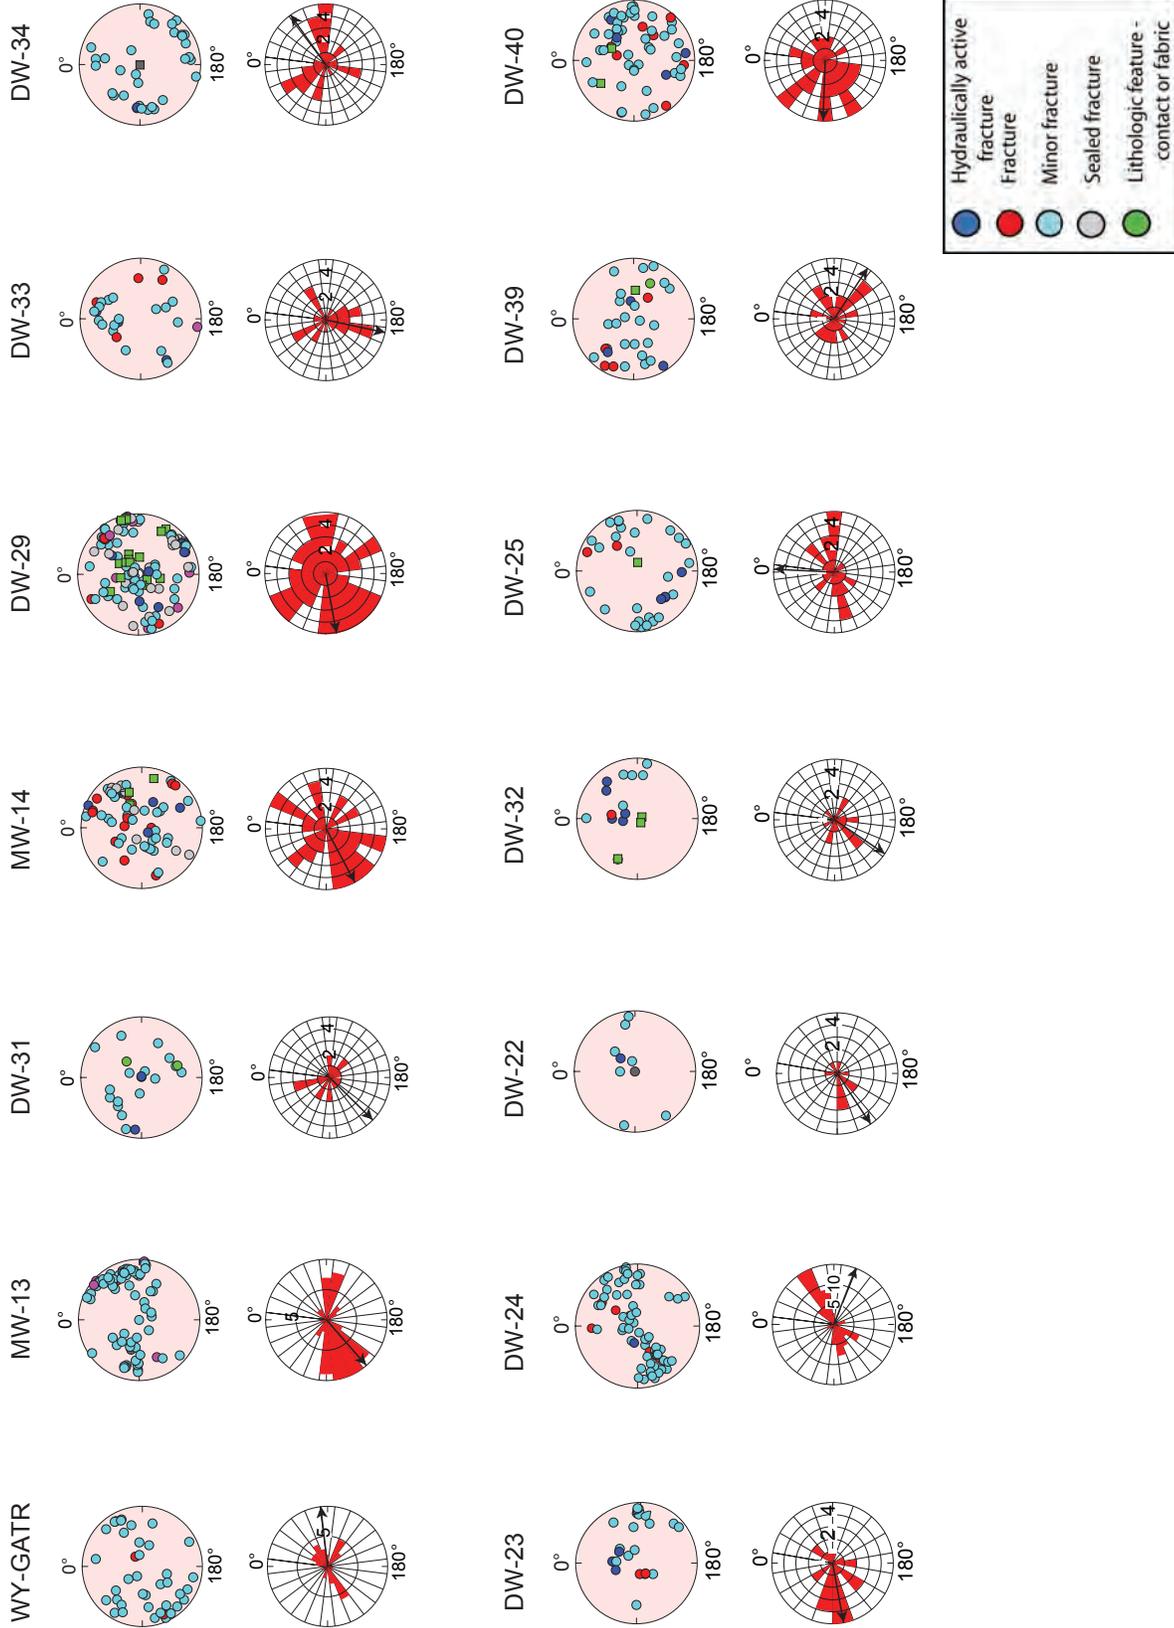
Figure 22. Stereoplots and rose diagrams for selected boreholes on or near Miller Mountain, Machiasport, Maine. Rose diagrams show the direction of dip azimuth.

A similar series of stereoplots and rose diagrams were plotted side-by-side for adjacent boreholes on or near Miller Mountain (fig. 22). Boreholes DW-39, DW-31, DW-33, DW-23, and DW-34 have dominant fracture orientations that strike northeast and southwest. Boreholes WY-GATR, MW-13, DW-32, and DW-24 have fracture orientations that strike to the northwest and southeast, and boreholes DW-25 and DW-40 have fracture sets that strike both northeast-southwest and northwest-southeast.
