Borehole Geophysical Investigation of a Formerly Used Defense Site, Machiasport, Maine, 2003–2006

By Carole D. Johnson, Remo A. Mondazzi, and Peter K. Joesten

Scientific Investigations Report 2009–5120

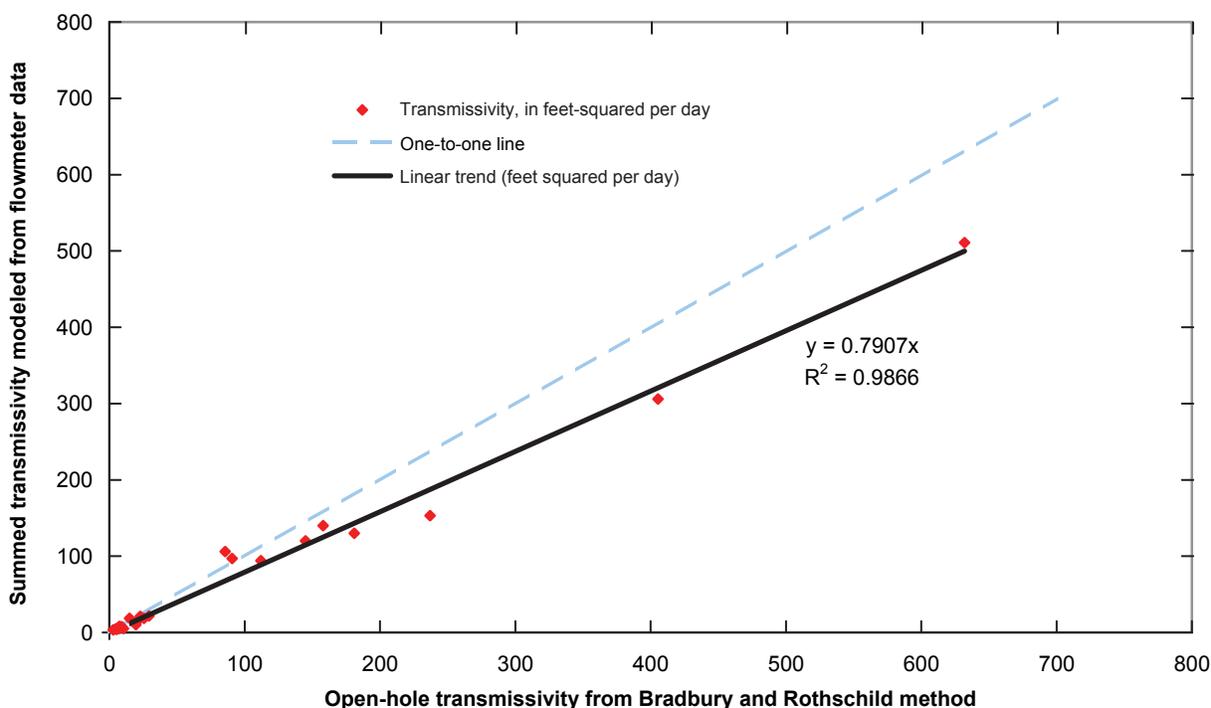
Figure 23. Comparison of open-hole transmissivity determined from Bradbury and Rothschild (1985) method and summed transmissivity determined from modeled heat-pulse flowmeter profiles and water levels. The black line indicates the best fit regression line, and the blue dashed line indicates a line showing one-to-one correlation.

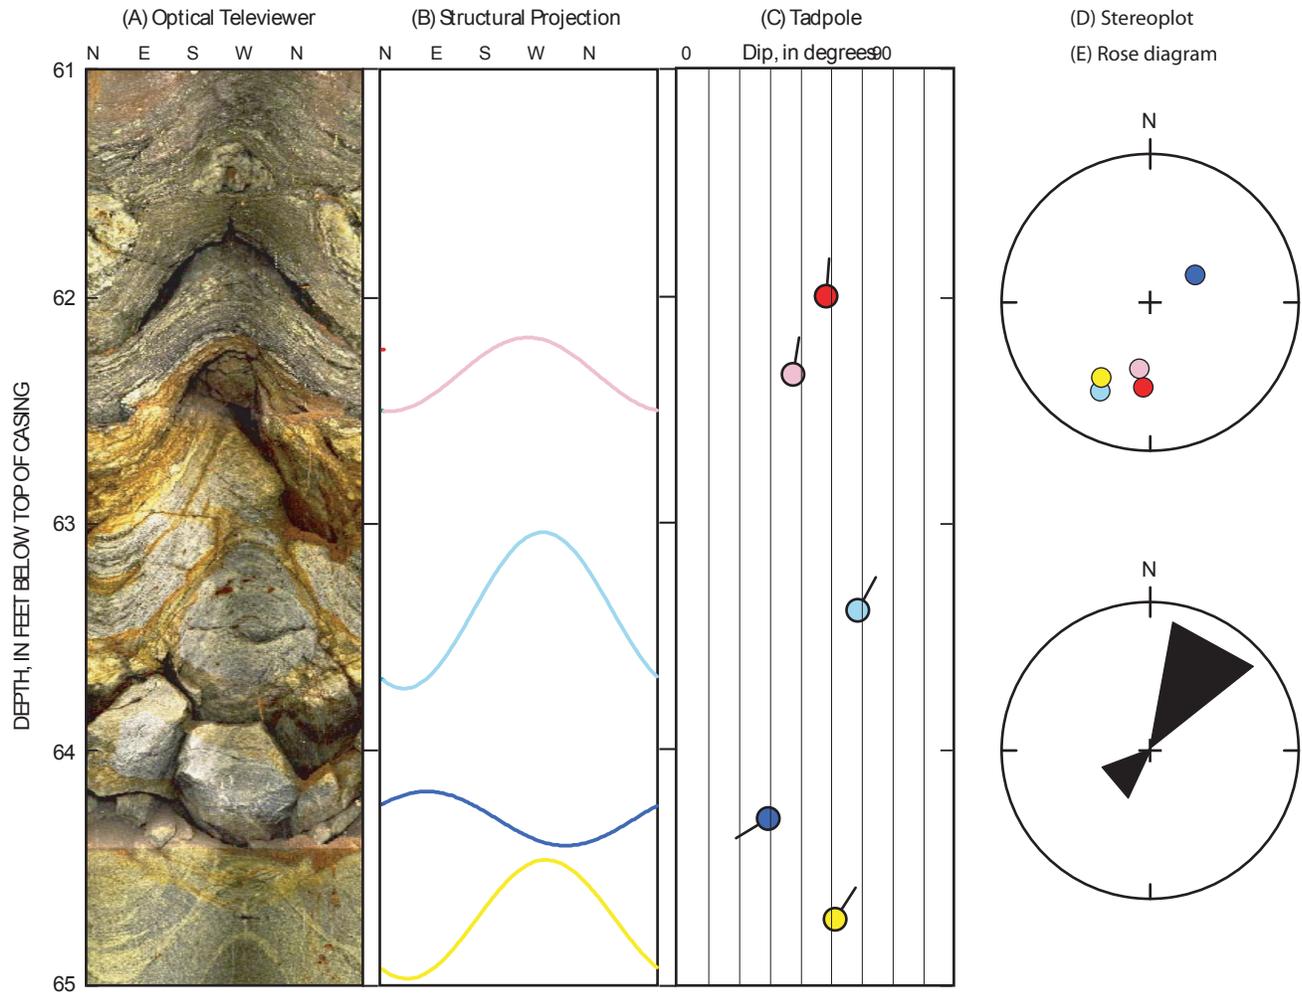
Figure. Example of interpretation of borehole imaging data.

(A) Optical televiewer image and the corresponding interpretation of planar data in (B) structural, (C) tadpole, and (D) stereographic projection plots. The trace of the features on the structural projection (B) directly overlays on the image (A). In the tadpole plot (C), depth is plotted along the y axis, and the magnitude of dip is plotted on the x axis. The tail of the tadpole points in the direction of dip relative to True North, which is at the top of the page. The poles to the planar features are shown in a lower-hemisphere equal-area stereonet (stereonet) (D), which reduces the plane to a point. (E) Rose diagram, which shows frequency of dip direction.

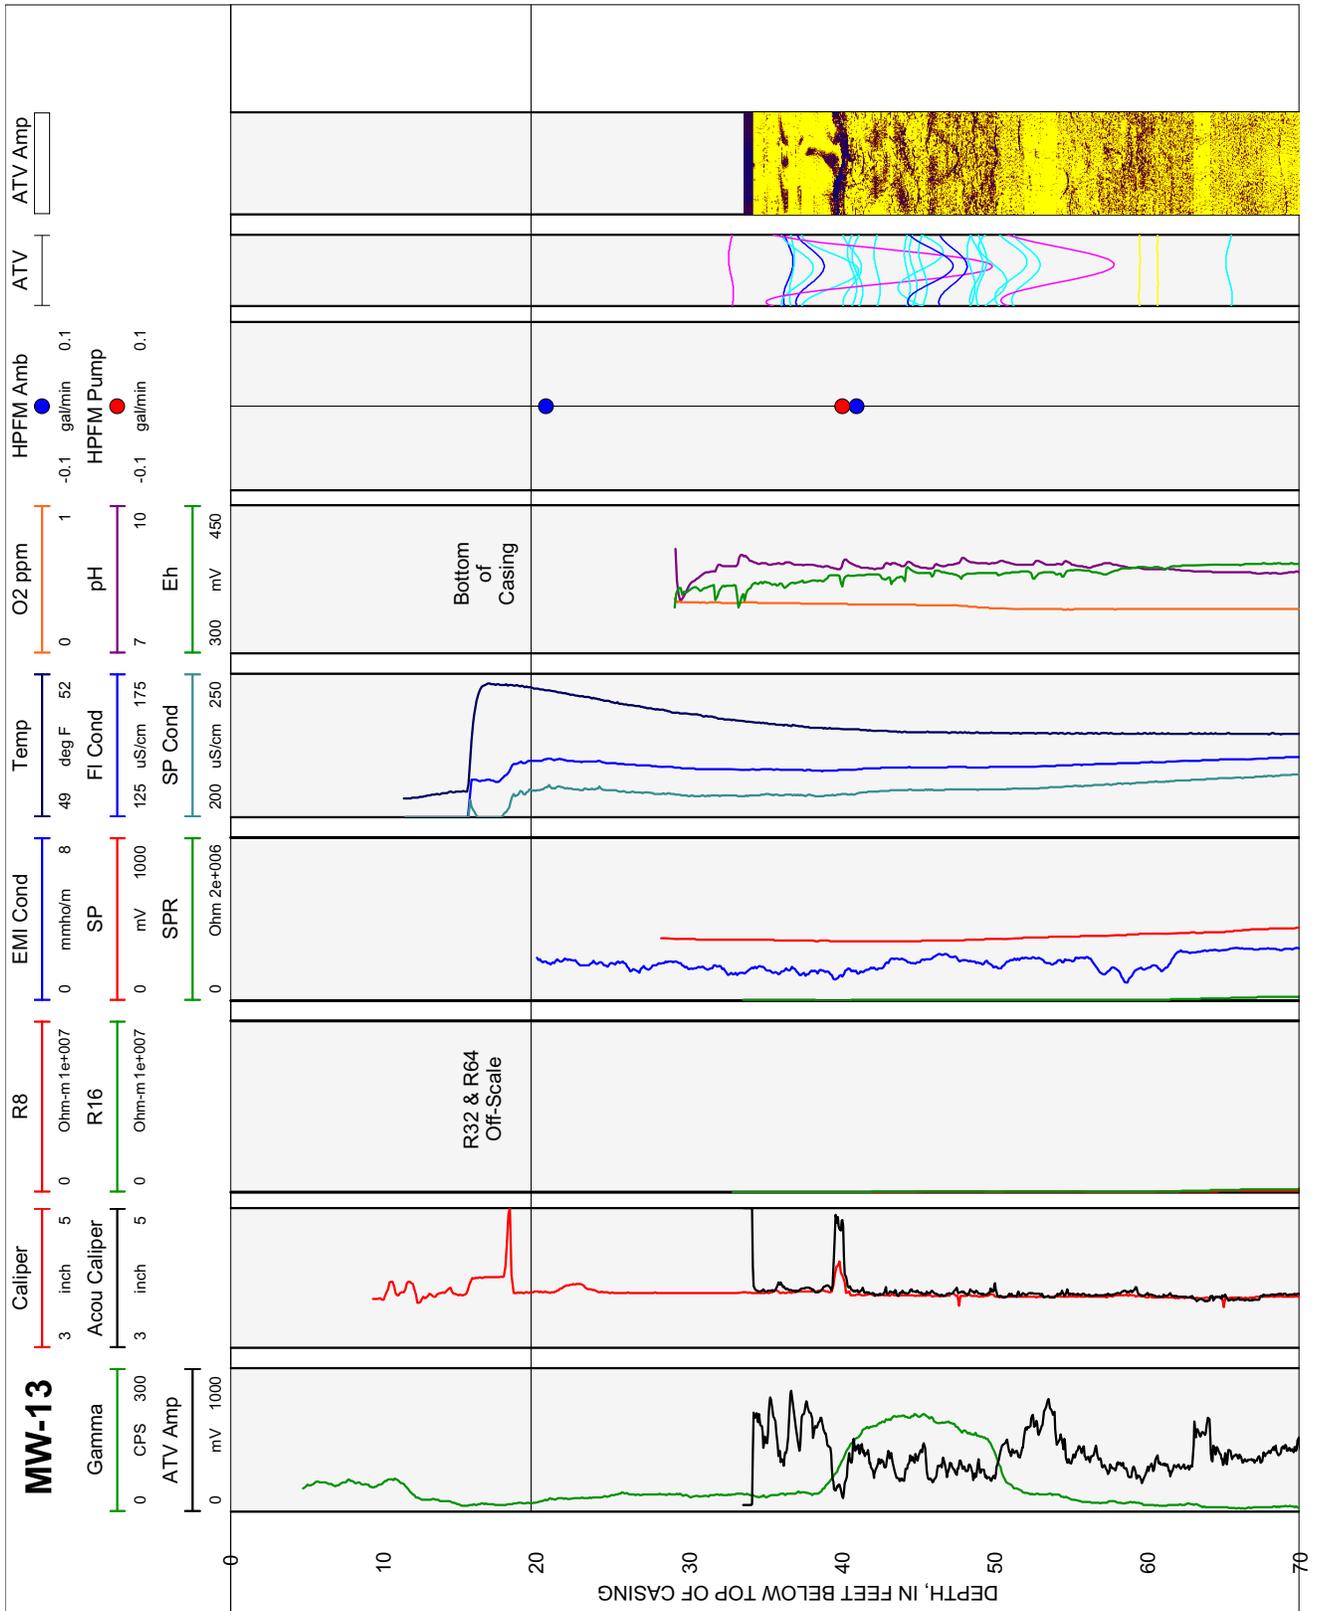
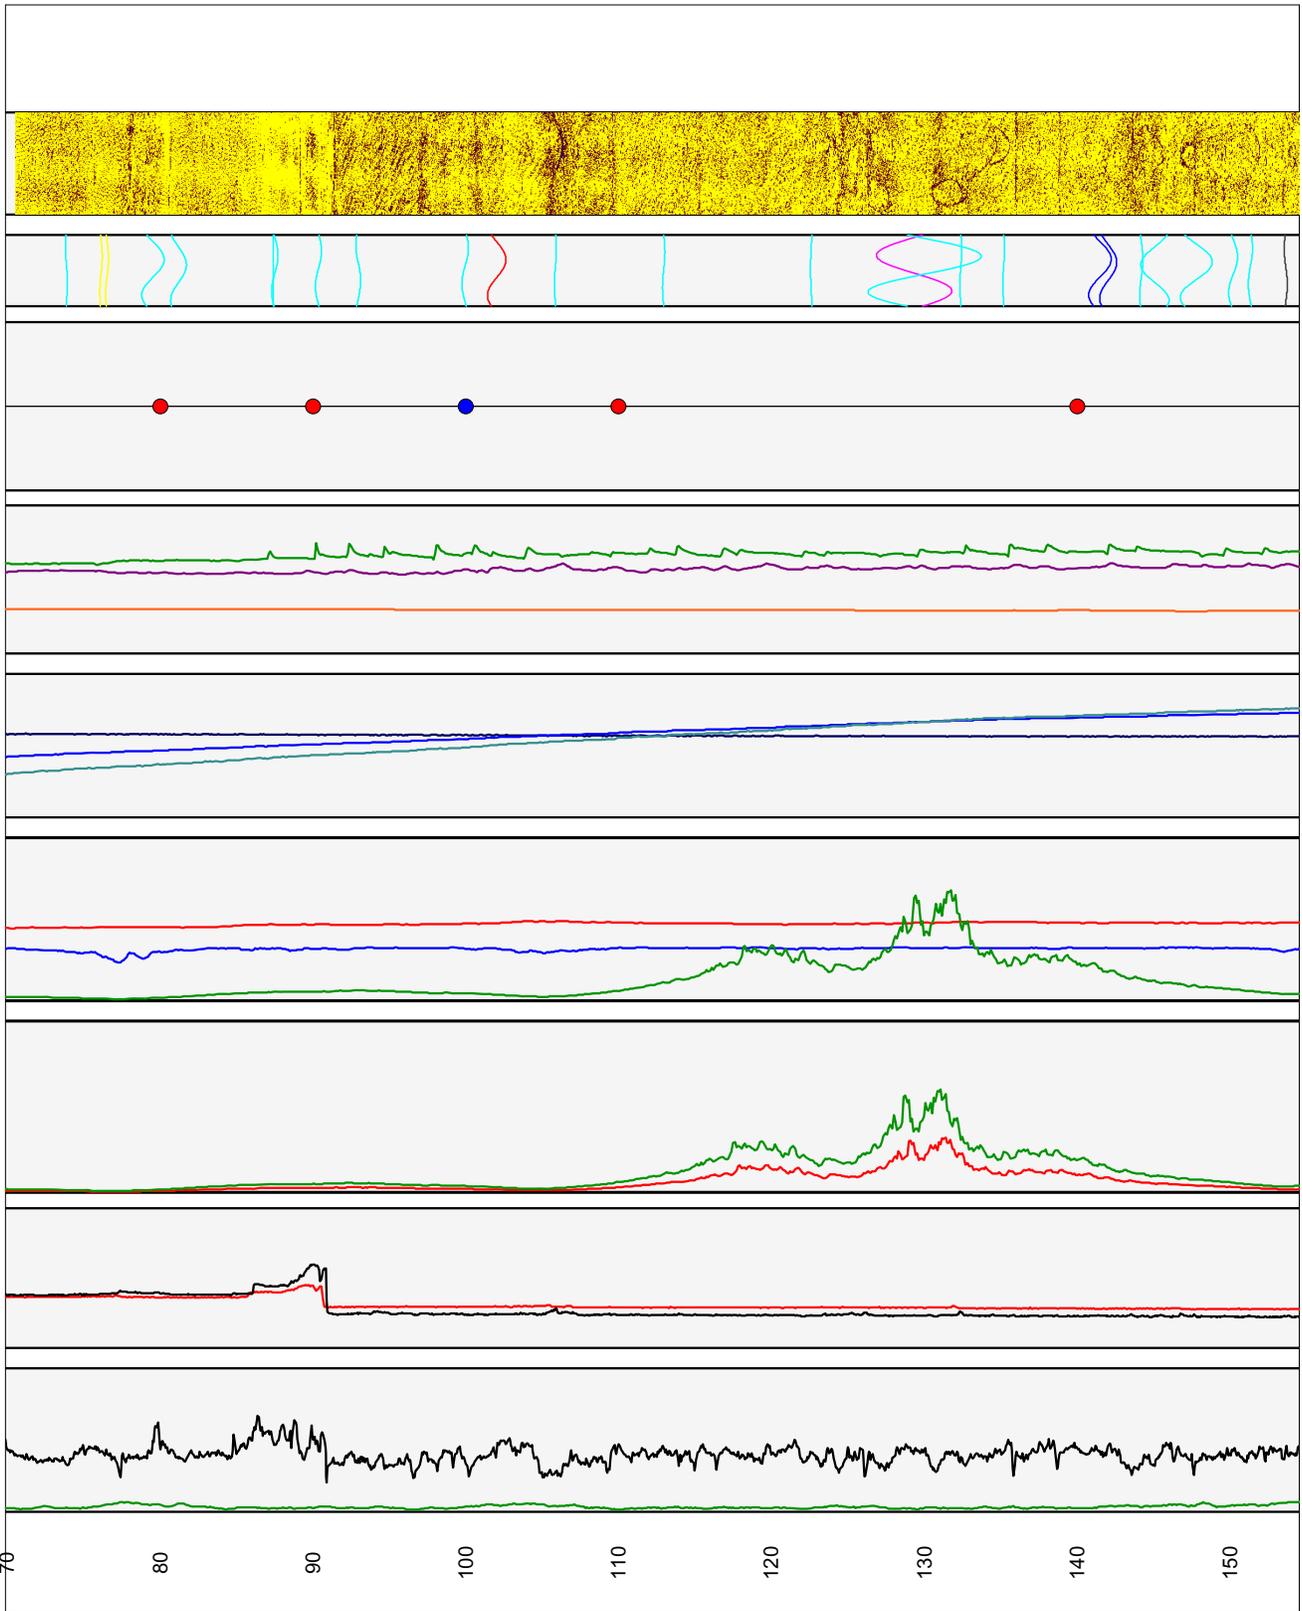
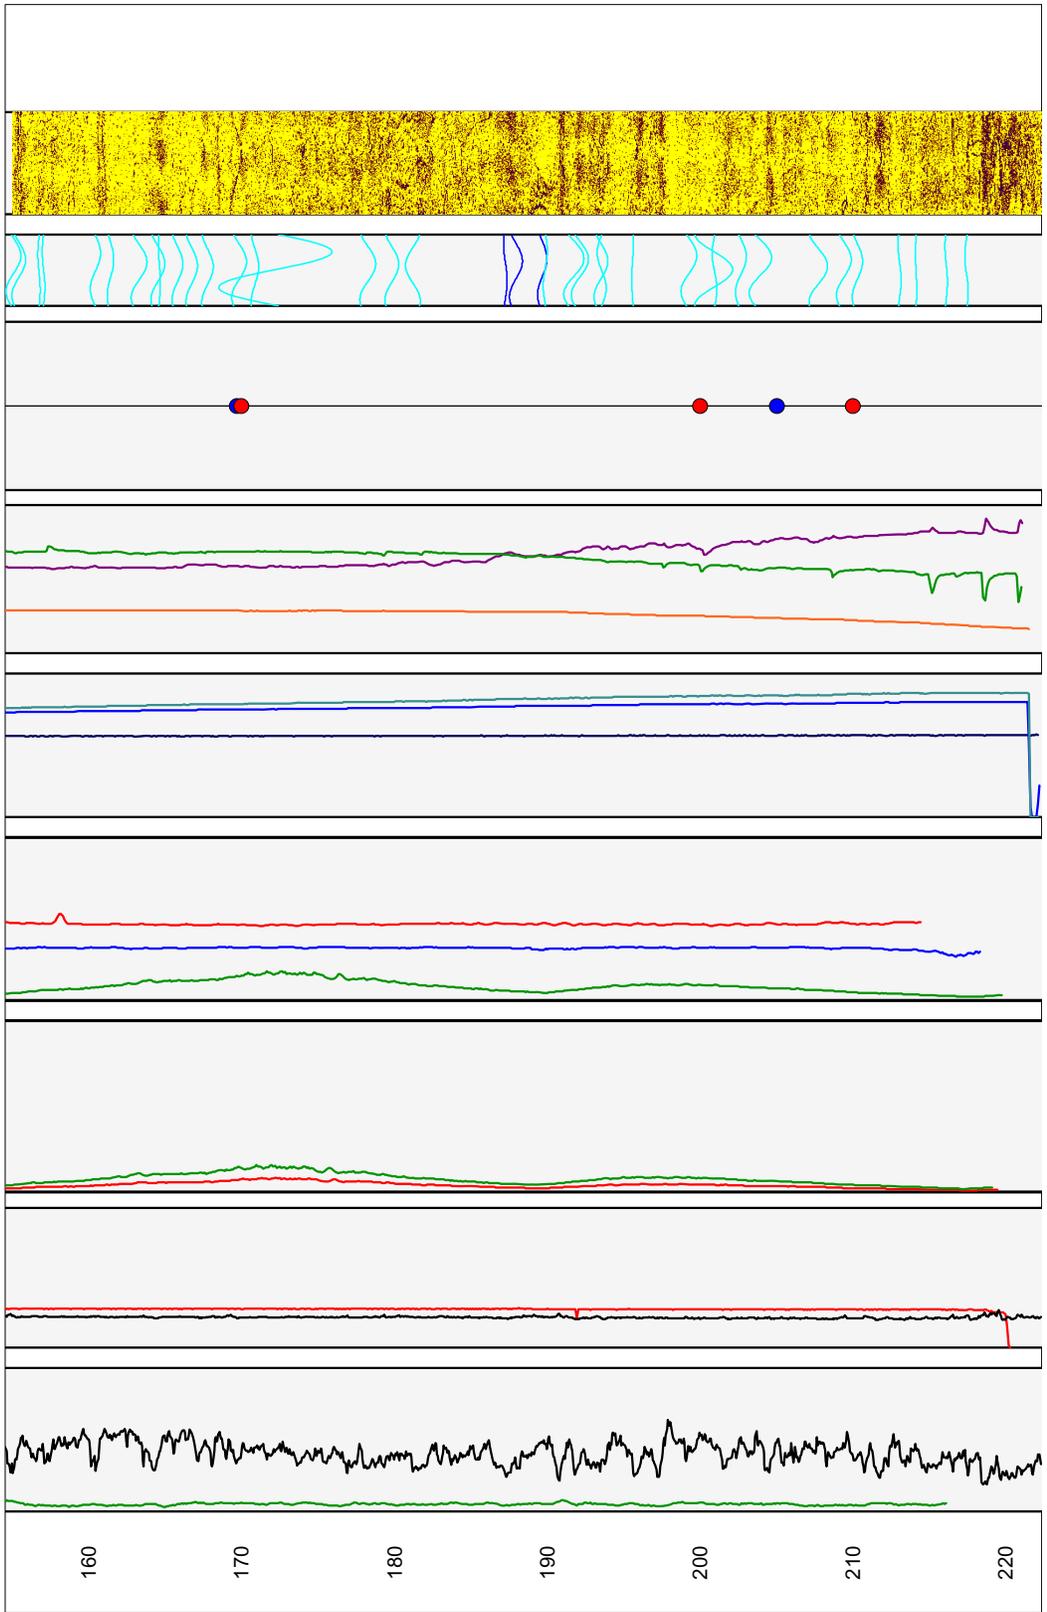
Figure 1A-1. Caliper, acoustic caliper, gamma, electromagnetic conductivity, fluid temperature, specific conductance, DO, pH, reduction oxidation, multi-space resistivity, oriented acoustic and optical borehole images, and heat-pulse flowmeter logs for borehole MW-13, near Machiasport, Maine.

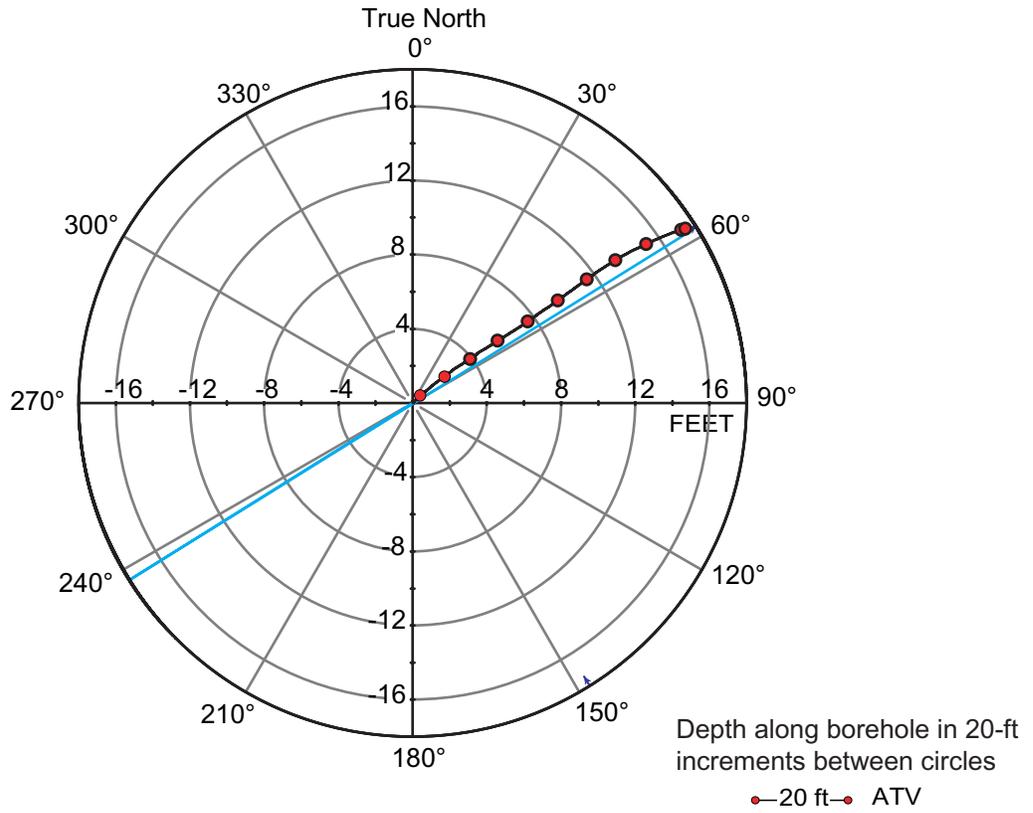
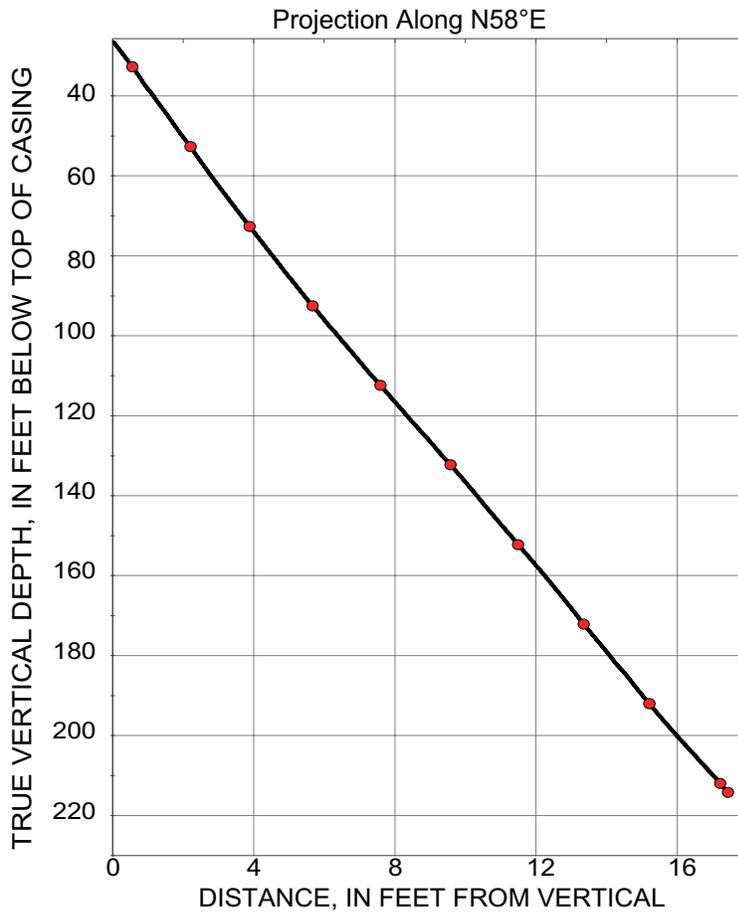
Figure 1A-2. Borehole deviation logs for borehole MW-13, near Machiasport, Maine. Blue line on radial plot (top) is line of projection for vertical plot (bottom).
[ft, foot; ATV, acoustic televiewer]

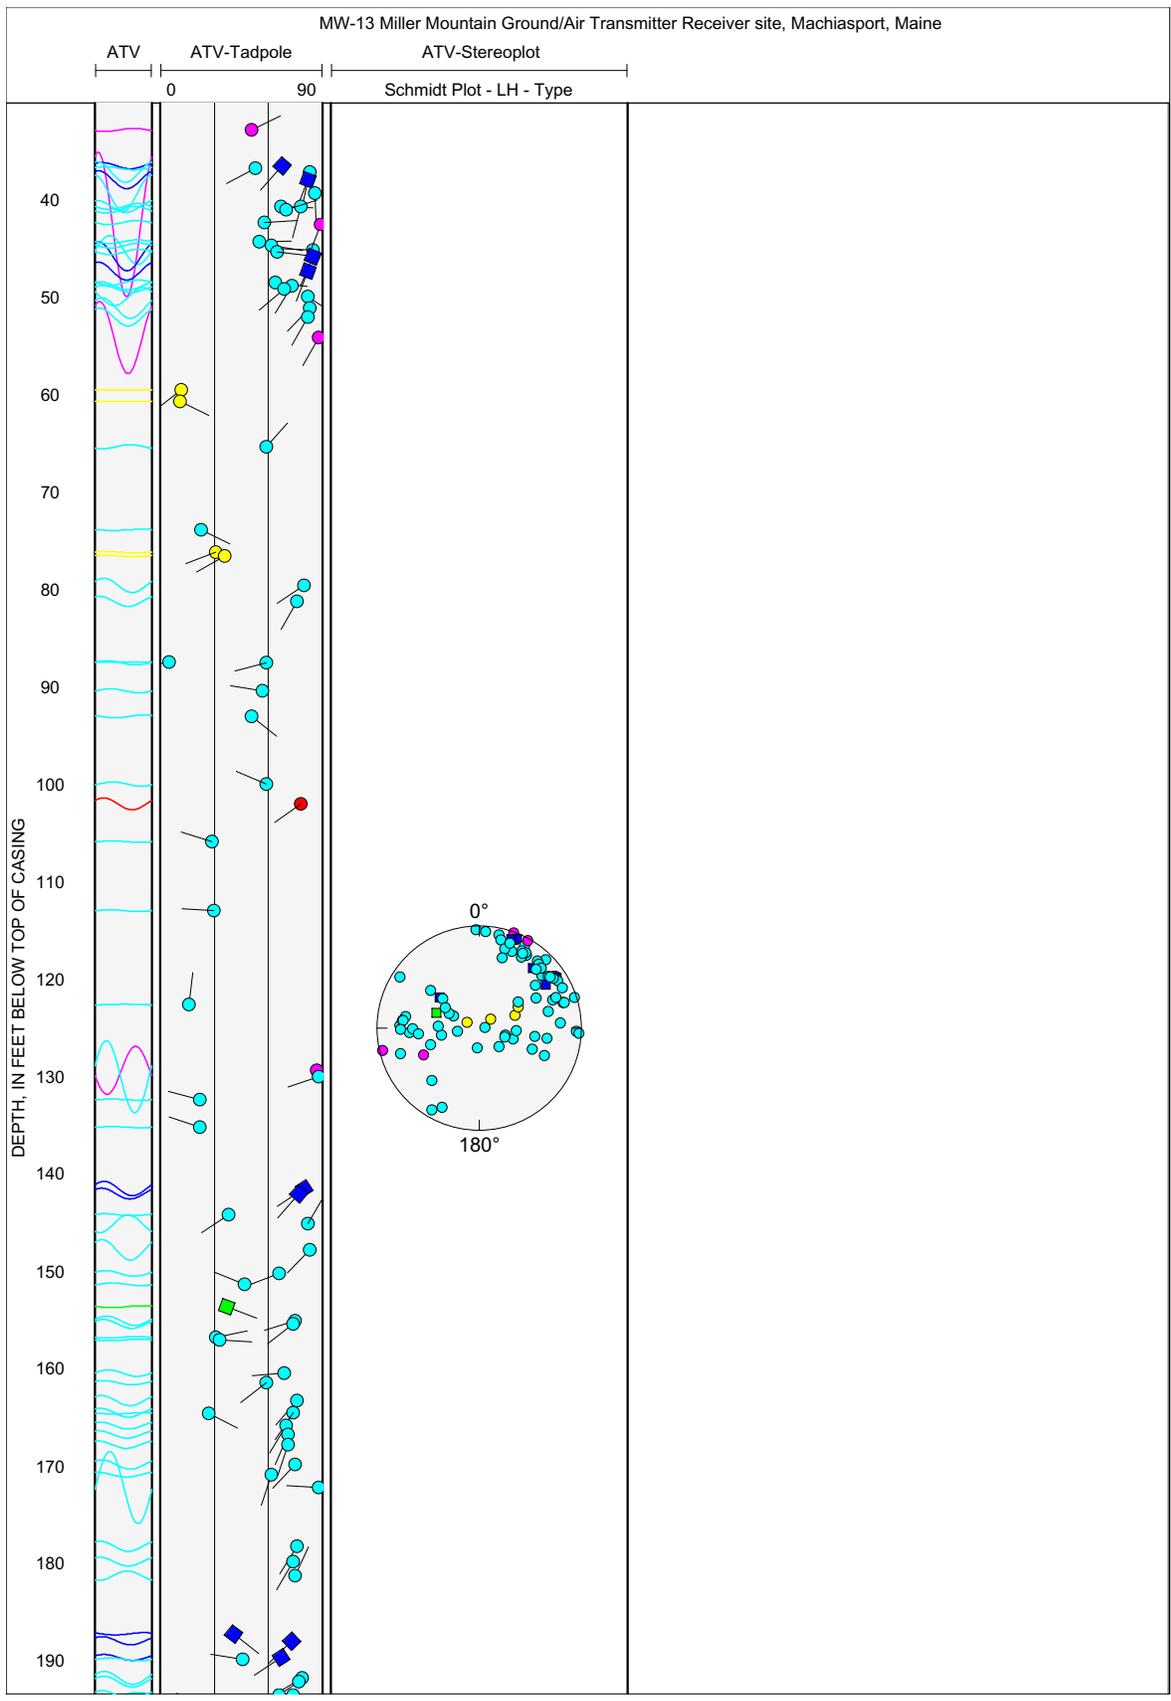
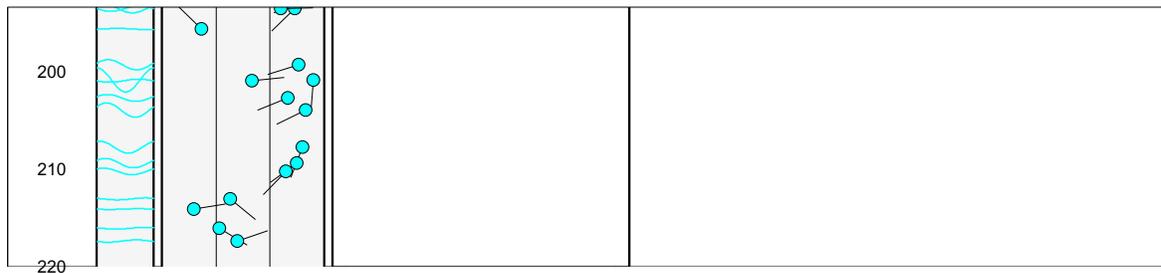
Figure 1A-3. Projection, tadpole, and stereoplots of interpretation of borehole image data for borehole MW-13, near Machiasport, Maine.

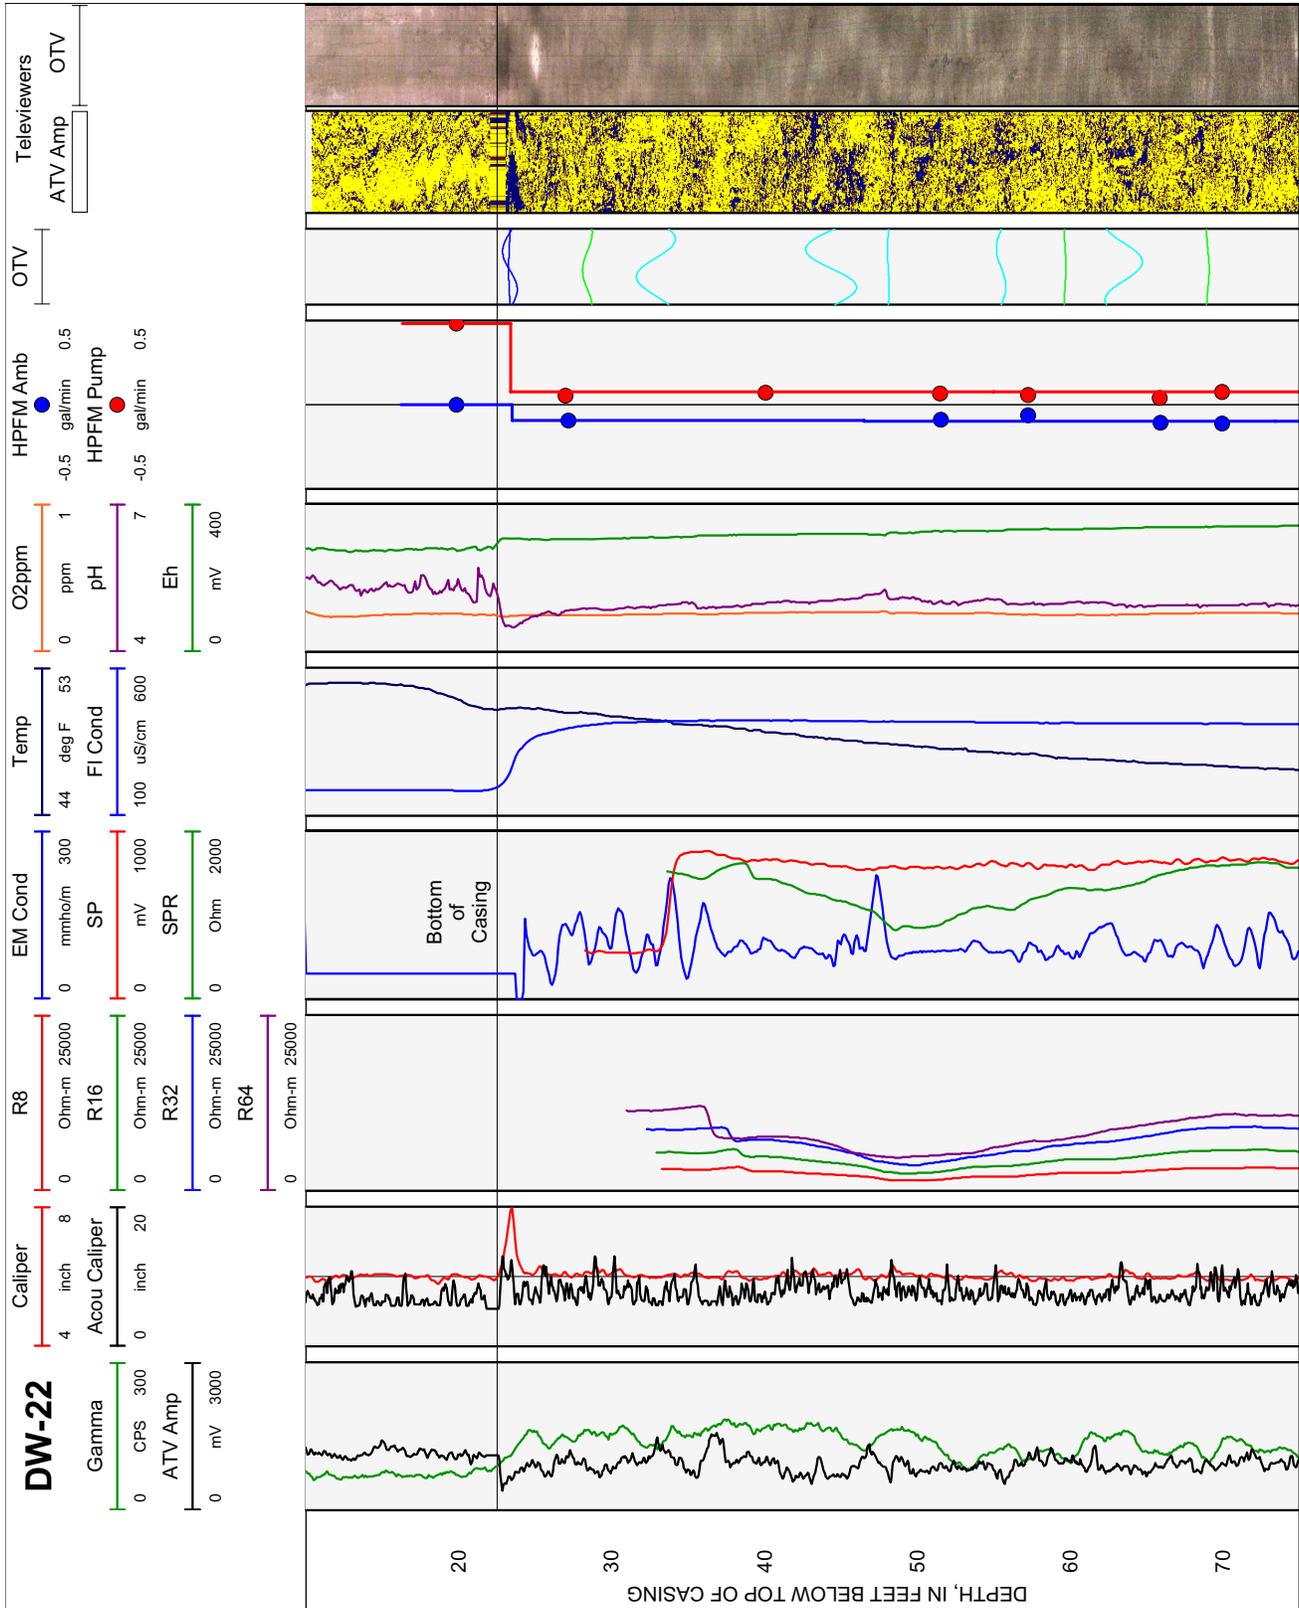
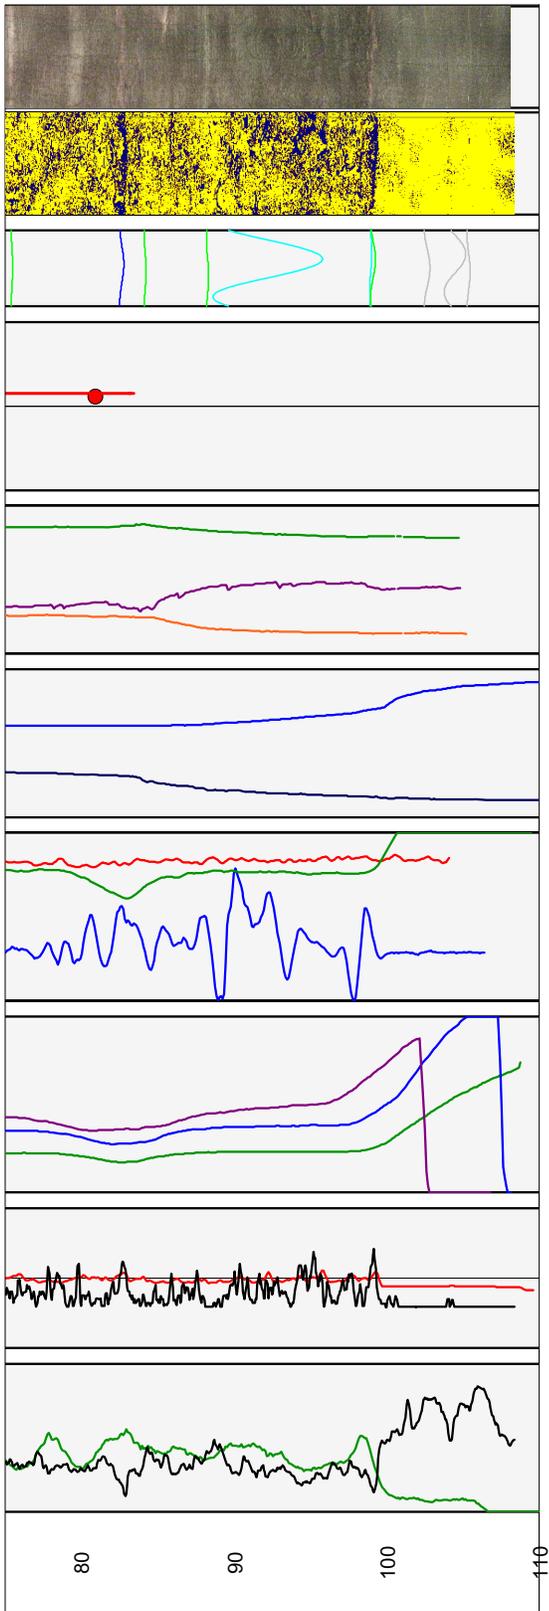
Figure 1B-1. Caliper, acoustic caliper, gamma, electromagnetic conductivity, fluid temperature, specific conductance, DO, pH, reduction oxidation, multi-space resistivity, oriented acoustic and optical borehole images, and heat-pulse flowmeter logs for borehole DW-22, near Machiasport, Maine.

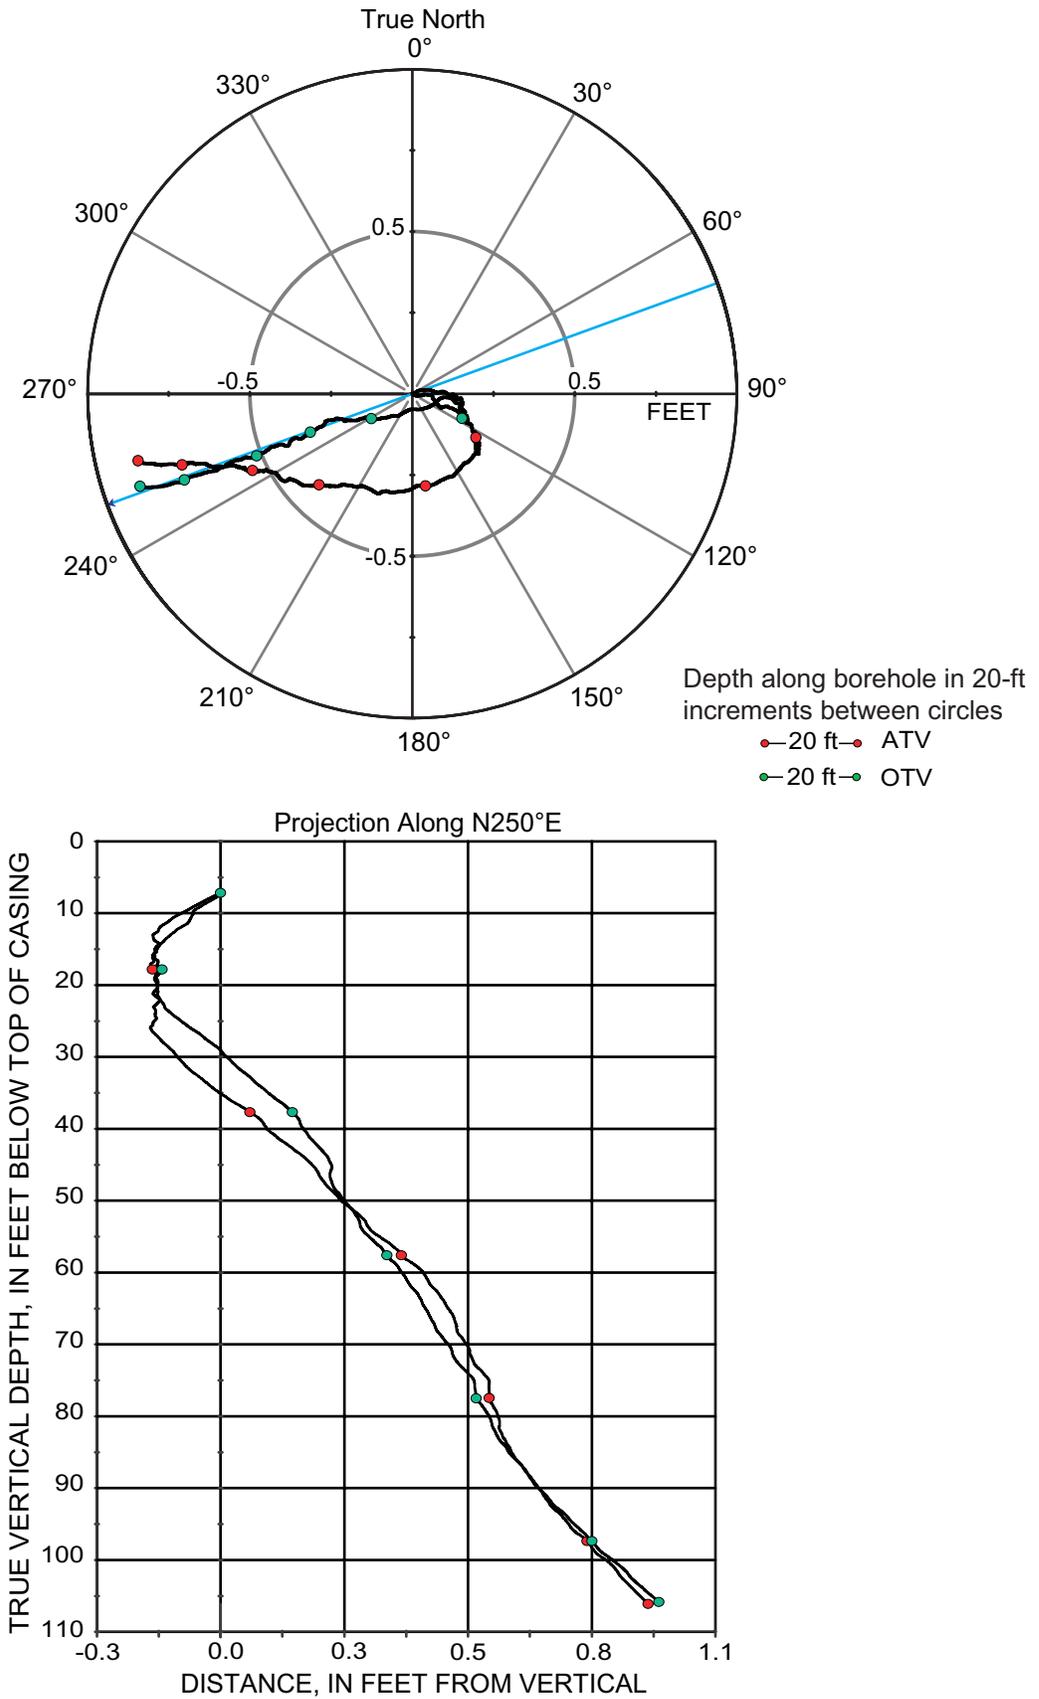
Figure 1B-2. Borehole deviation logs for borehole DW-22, near Machiasport, Maine. Blue line on radial plot (top) is line of projection for vertical plot (bottom).
 [ft, foot; ATV, acoustic televier; OTV, optical televier]

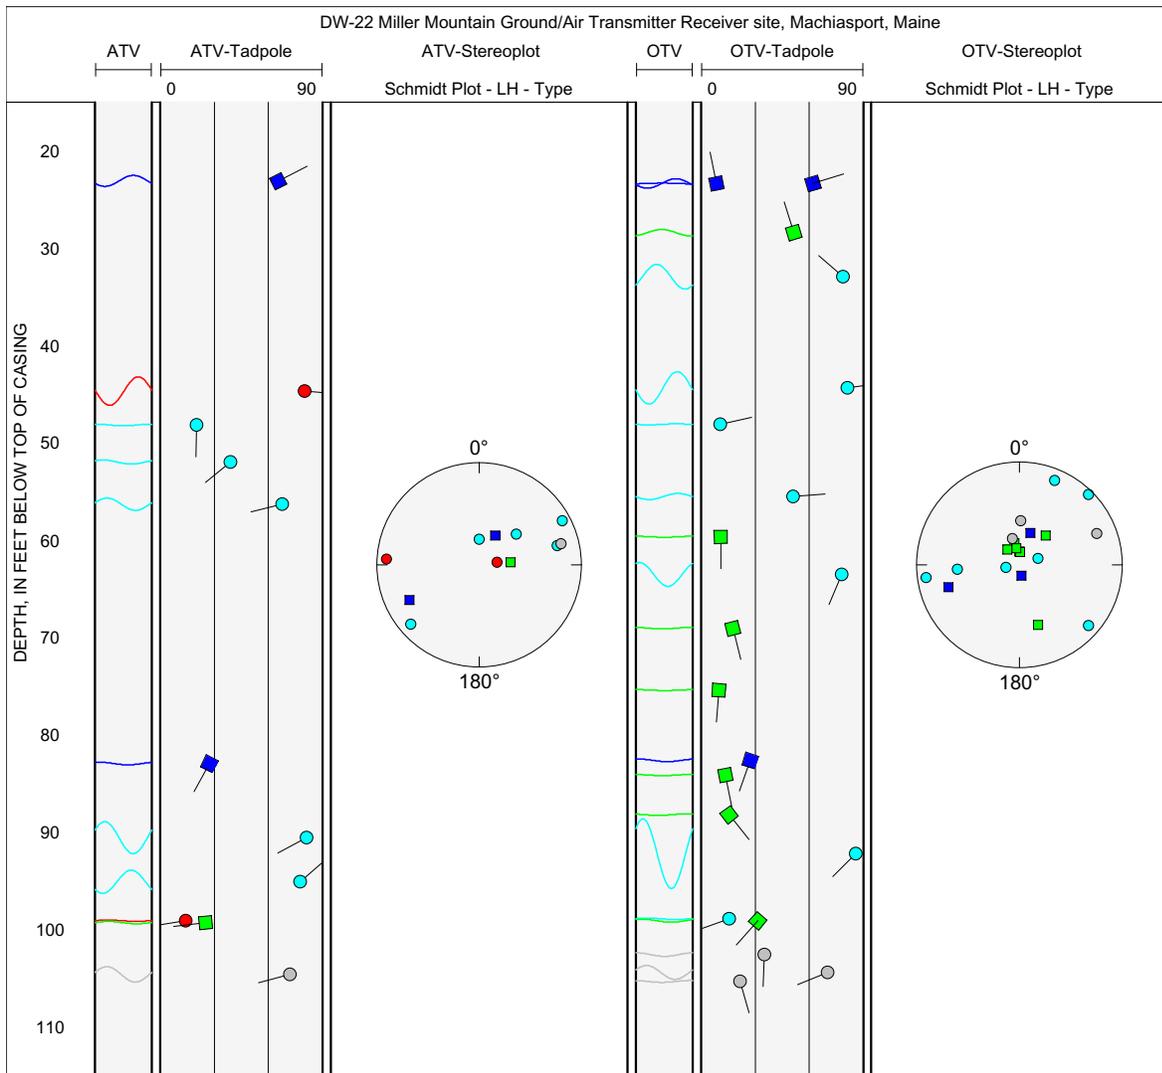
Figure 1B-3. Projection, tadpole, and stereoplots of interpretation of borehole image data for borehole DW-22, near Machiasport, Maine.

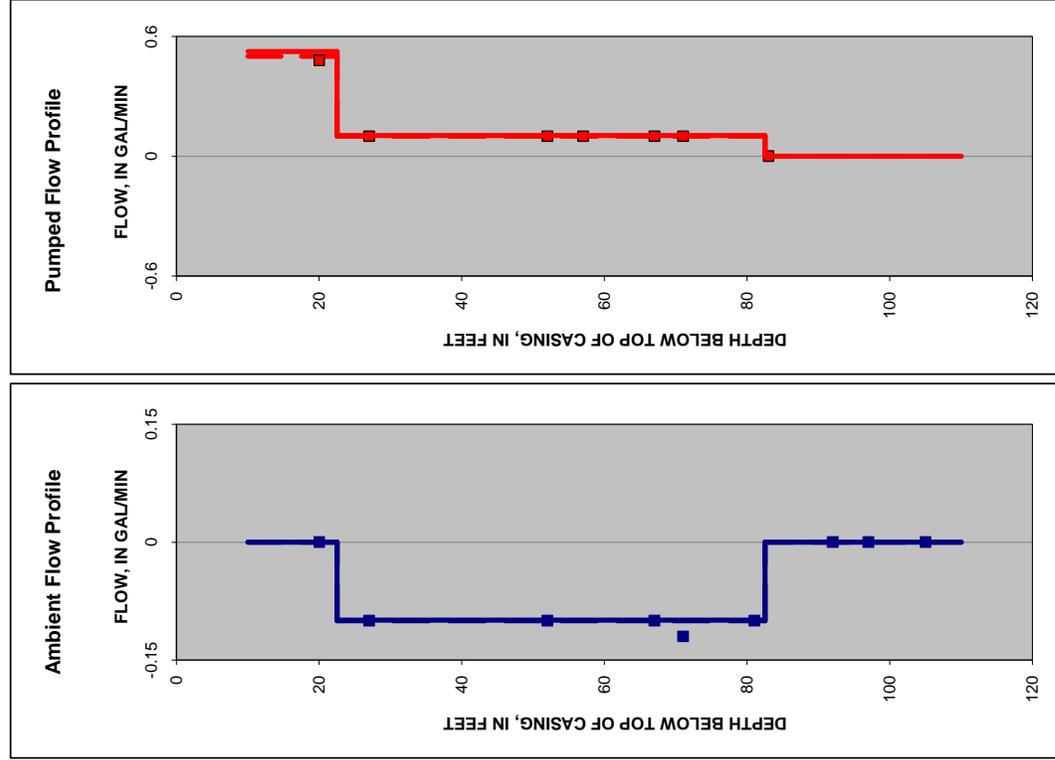
Dashed line indicates measured flow.
 Solid line indicates modeled flow.
 Points indicate measured heat-pulse flowmeter data.

Figure 1B-4. Interpretation and modeling of heat-pulse flowmeter logs for borehole DW-22, near Machiasport, Maine. [gal/min, gallon per minute; ft, feet; ft²/d, feet squared per day; positive values of flow are upward flow, negative values of flow are downward flow]
