Borehole Geophysical Investigation of a Formerly Used Defense Site, Machiasport, Maine, 2003–2006

By Carole D. Johnson, Remo A. Mondazzi, and Peter K. Joesten

Scientific Investigations Report 2009–5120

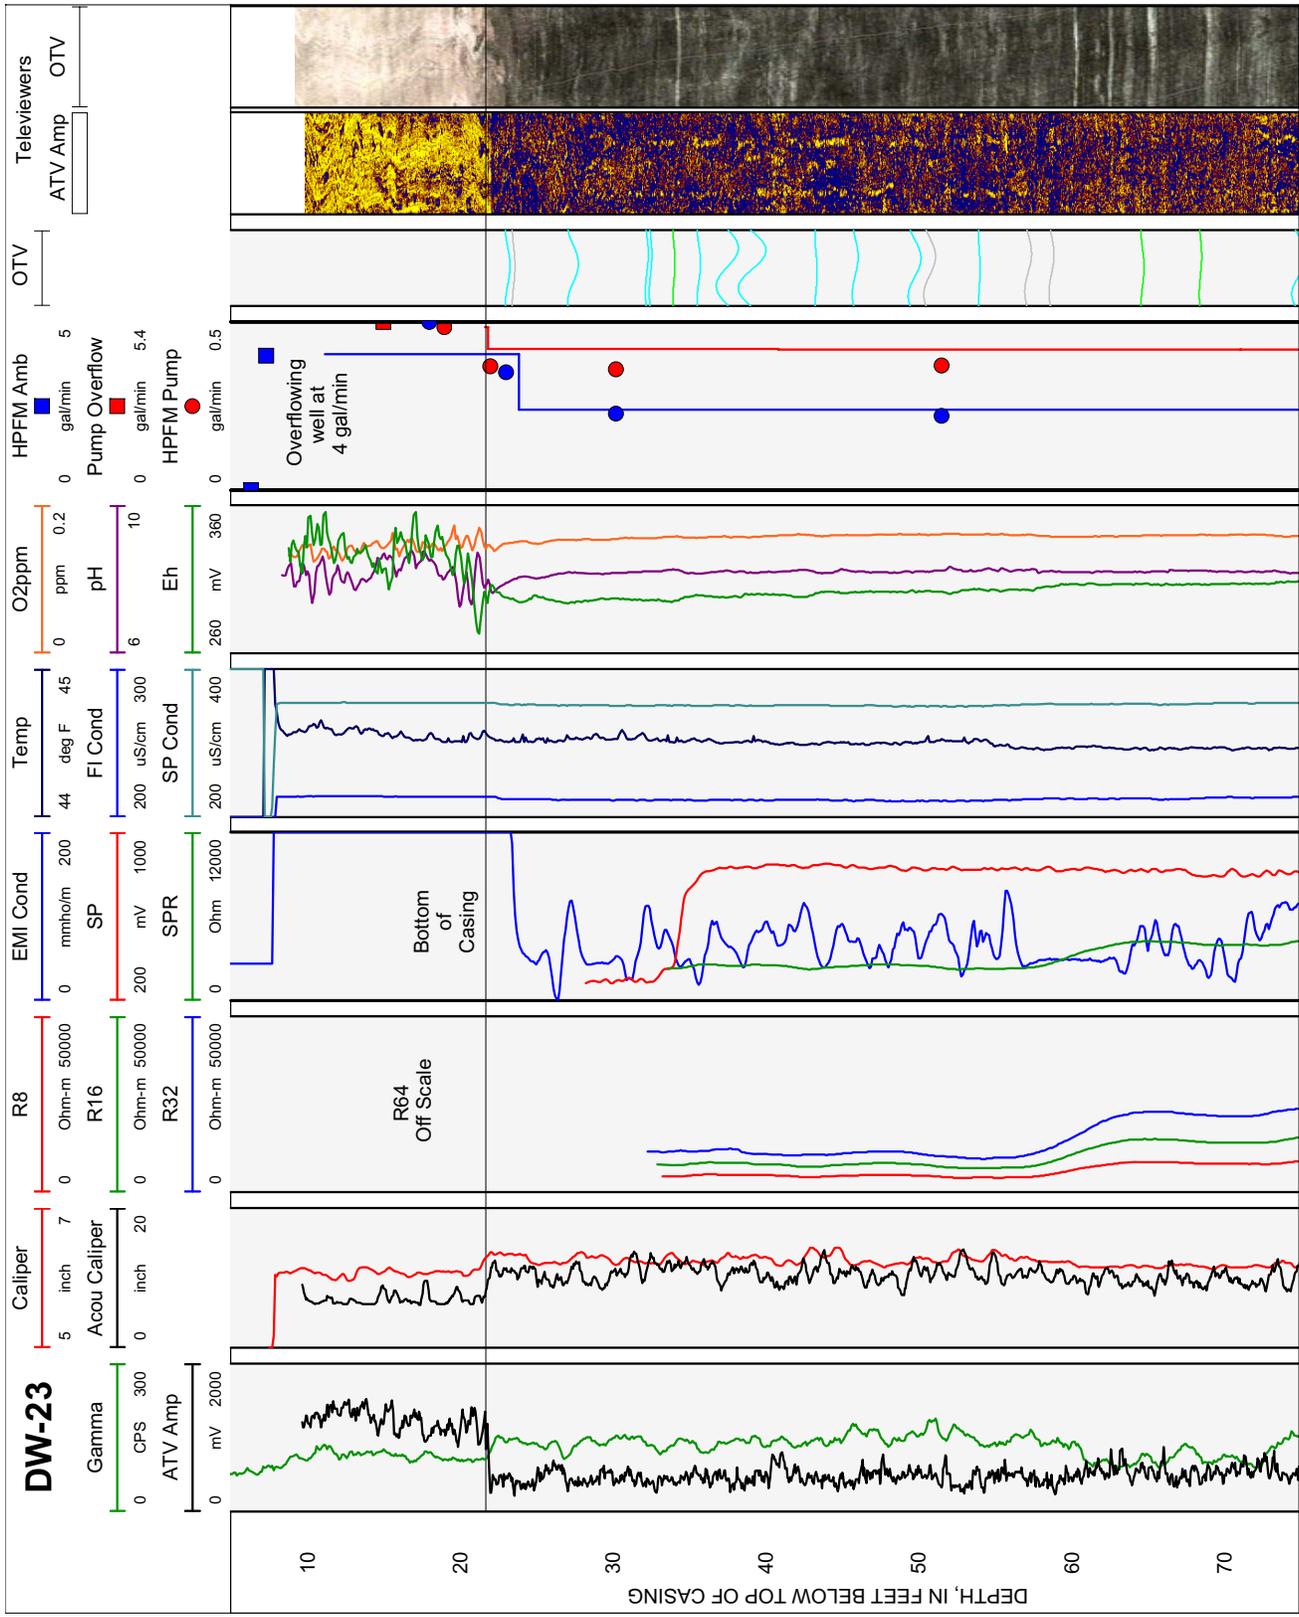
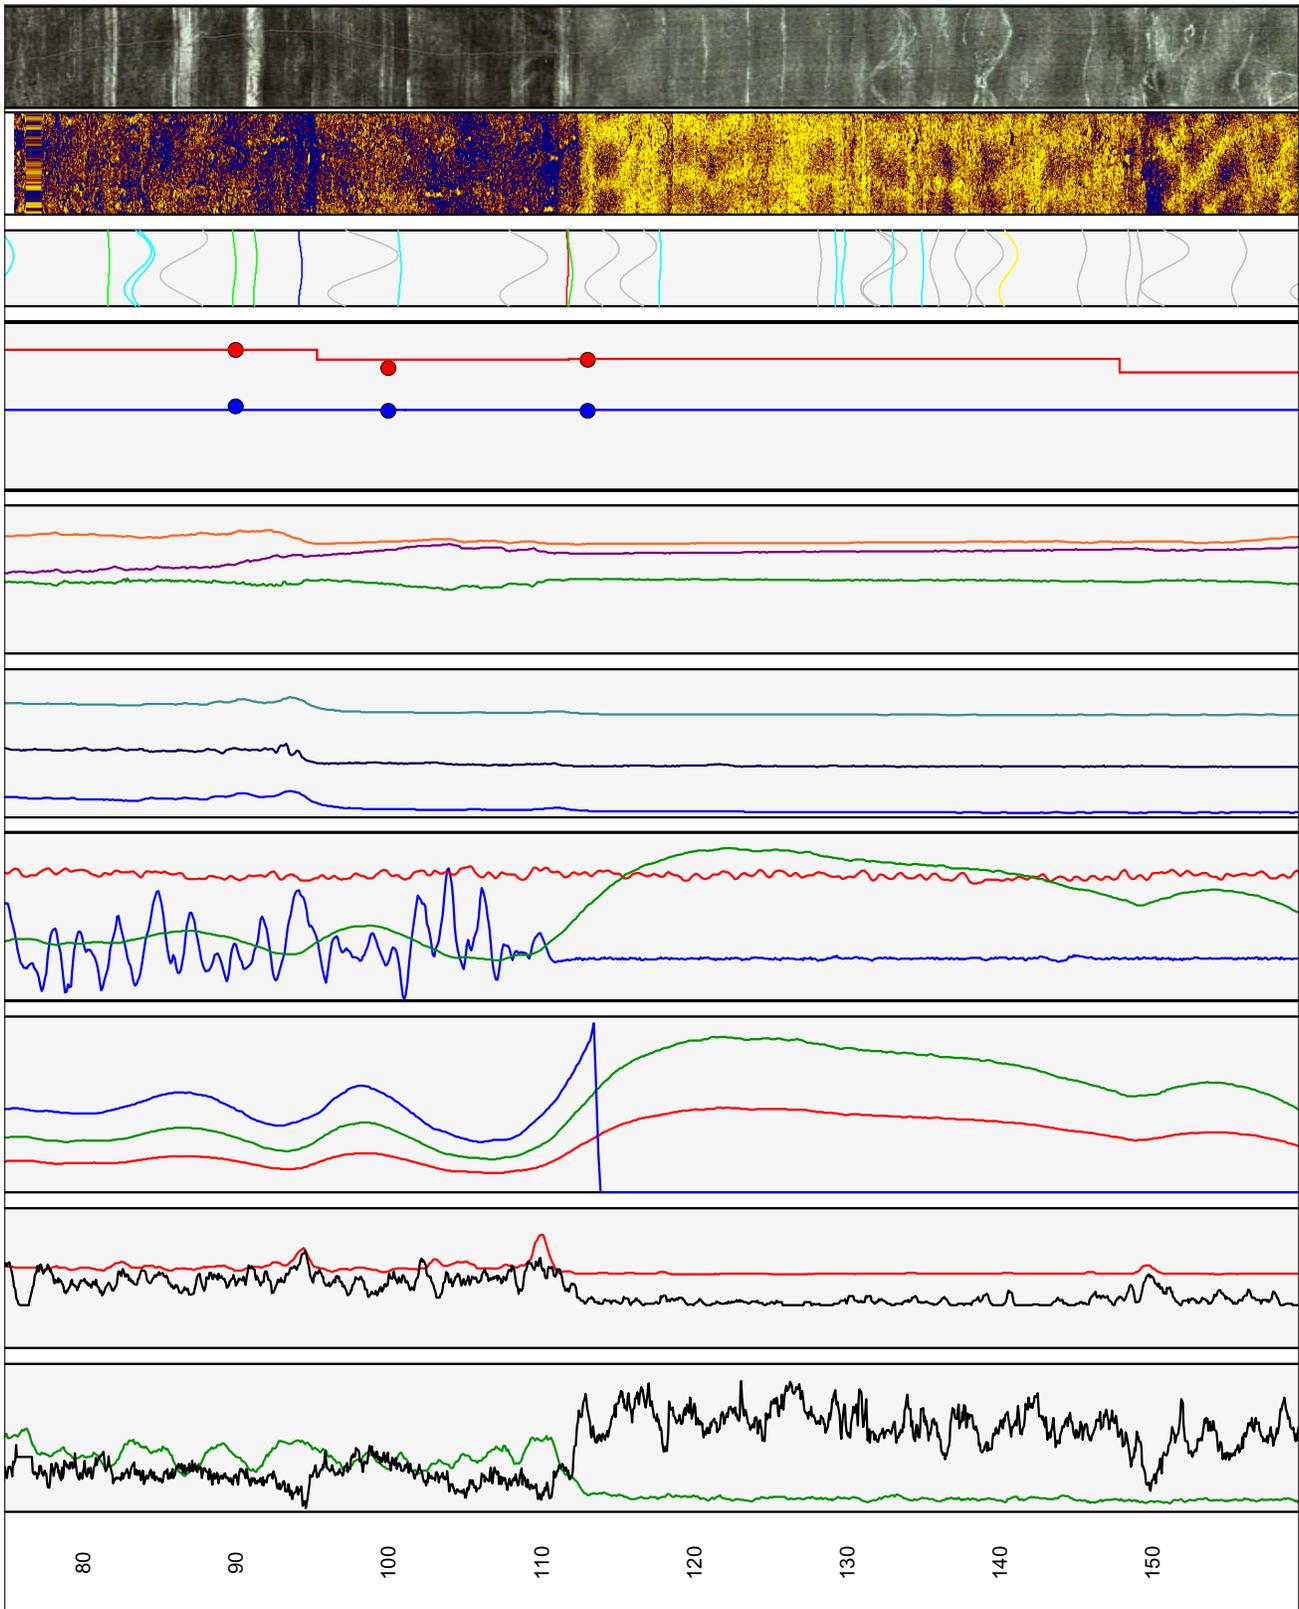
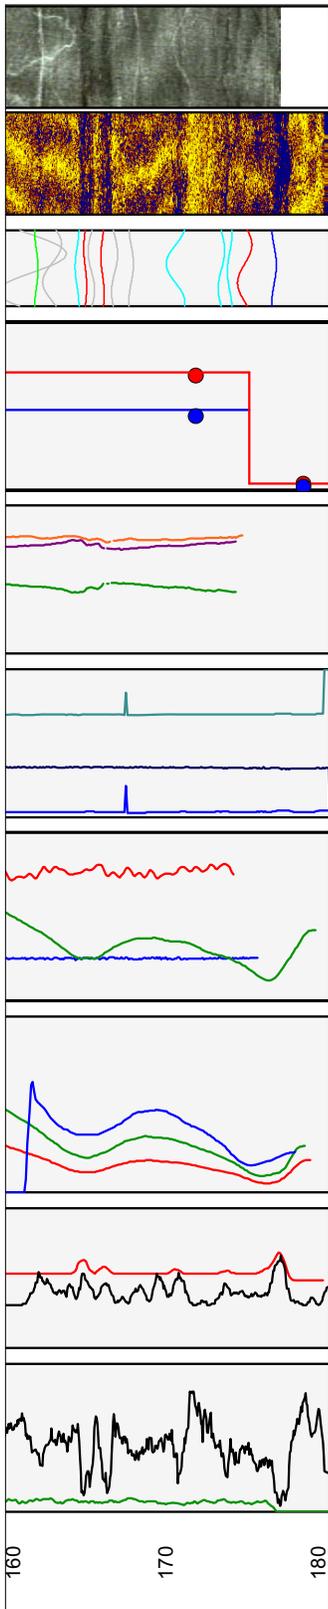
Figure 1C-1. Caliper, acoustic caliper, gamma, electromagnetic conductivity, fluid temperature, specific conductance, DO, pH, reduction oxidation, multi-space resistivity, oriented acoustic and optical borehole images, and heat-pulse flowmeter logs for borehole DW-23, near Machiasport, Maine.

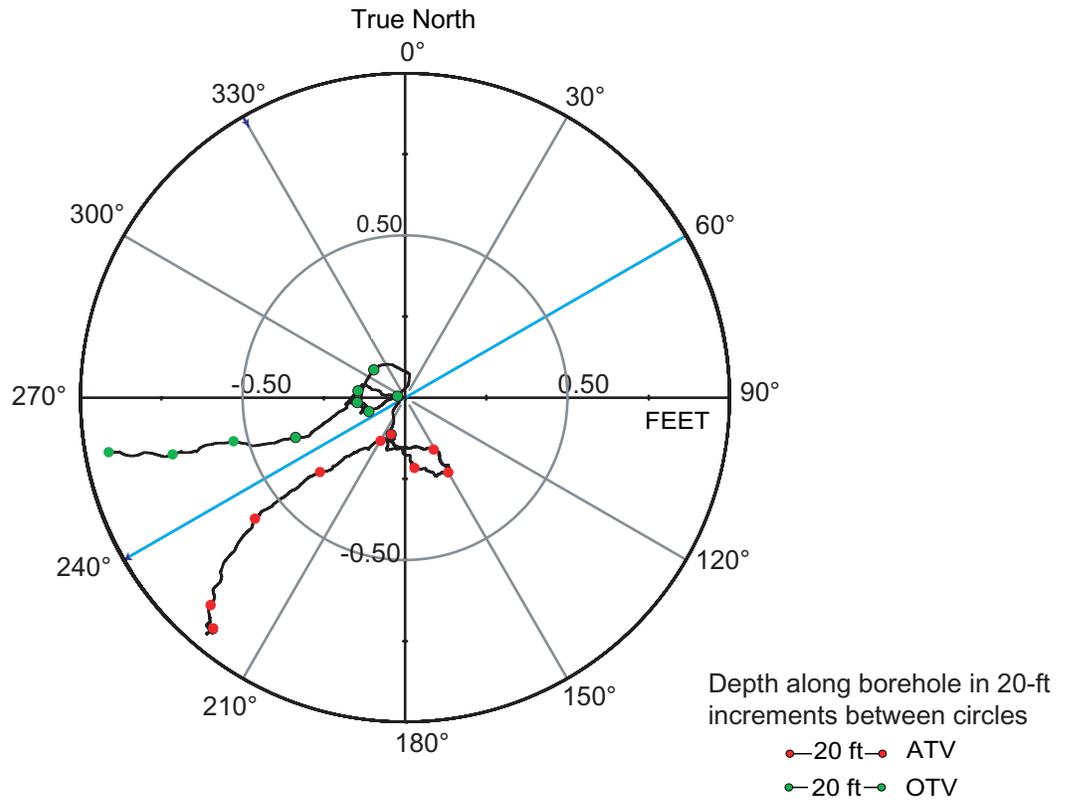
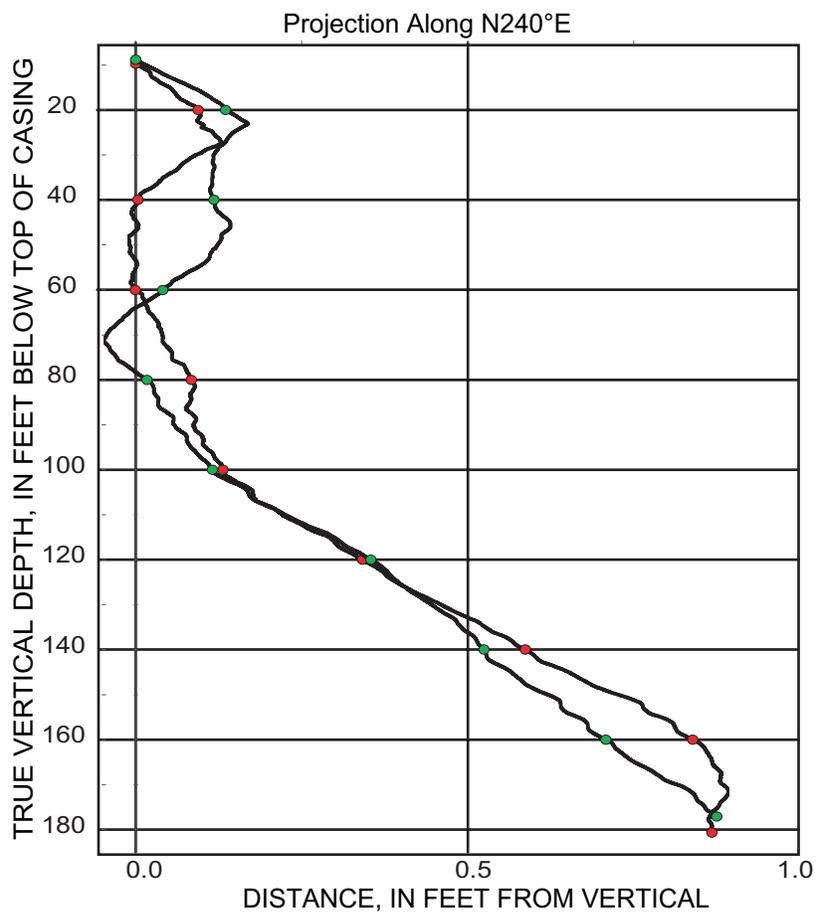
Figure 1C-2. Borehole deviation logs for borehole DW-23 near Machiasport, Maine. Blue line on radial plot (top) is line of projection for vertical plot (bottom).
[ft, foot; ATV, acoustic televiewer; OTV, optical televiewer]

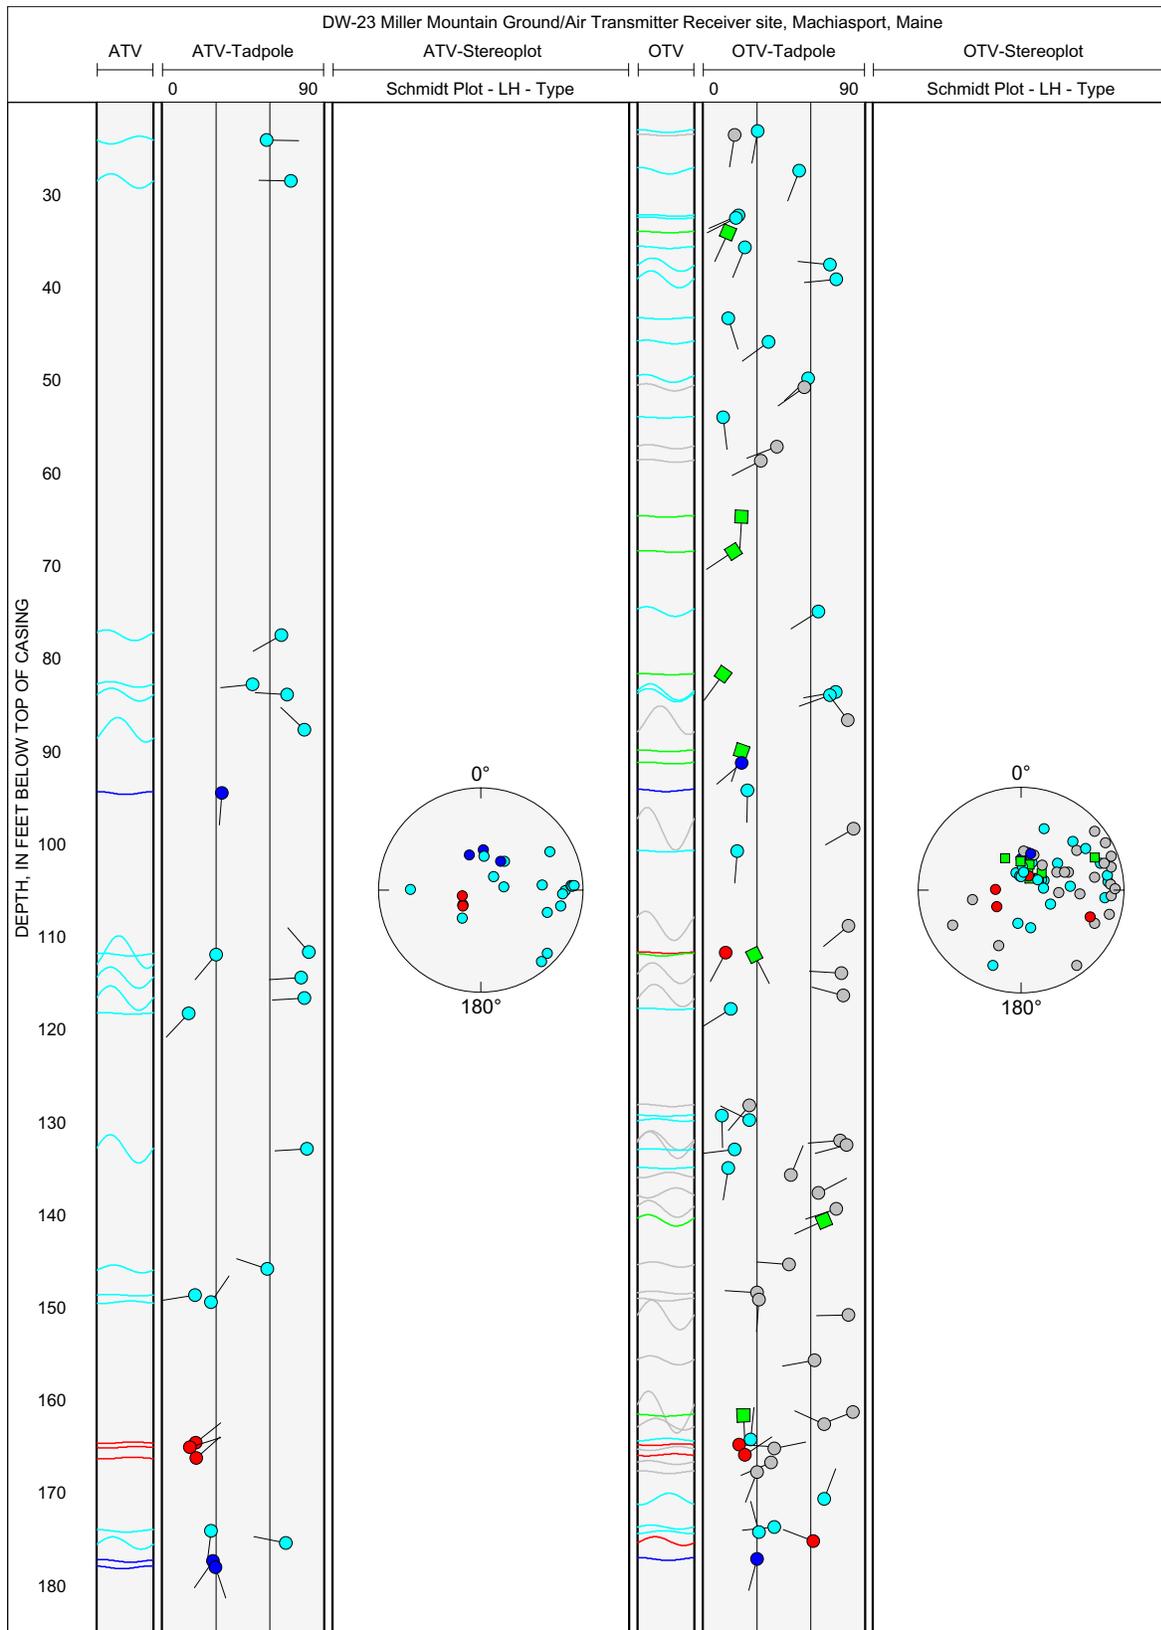
Figure 1C-3. Projection, tadpole, and stereoplots of interpretation of borehole image data for borehole DW-23, near Machiasport, Maine.

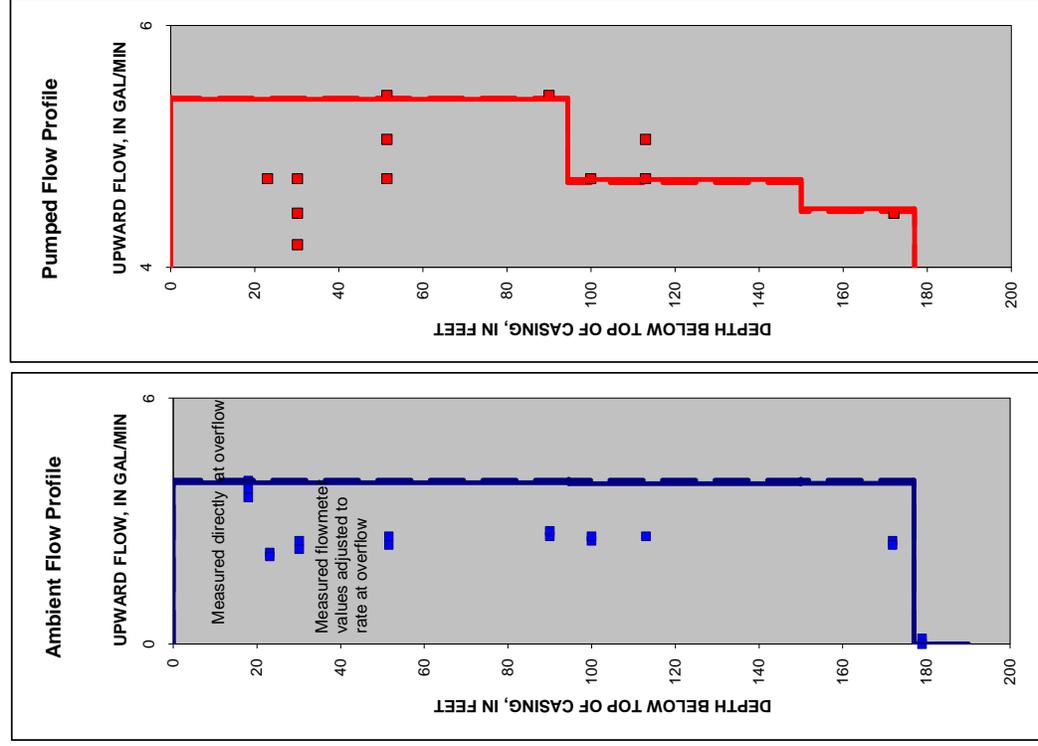
Dashed line indicates measured flow.
 Solid line indicates modeled flow.
 Points indicate measured heat-pulse flowmeter data.

Figure 1C-4. Interpretation and modeling of heat-pulse flowmeter logs for borehole DW-23, near Machiasport, Maine. [gal/min, gallon per minute; ft, feet; ft²/d, feet squared per day; positive values of flow are upward flow, negative values of flow are downward flow]

Elevation, ambient water level	52.70	feet					
Elevation, pumped water level	51.40	feet					
Fracture number	Depth (ft)	Ambient flow above fracture (gal/min)	Pumped flow above fracture (gal/min)	Zone transmissivity (ft ² /d)	Water level (ft)	Elevation of water level (ft)	Percent transmissivity
3	94.5	3.939	5.388	69.00	6.88	53.12	45
2	150	3.916	4.725	24.00	6.98	53.02	16
1	177.6	3.918	4.484	60.00	-4.52	64.52	39
Total borehole transmissivity				153.0	(ft ² /d)		
Sum of squares error				2.74000	(gal/min) ²		
Root mean square error				0.82800	(gal/min)

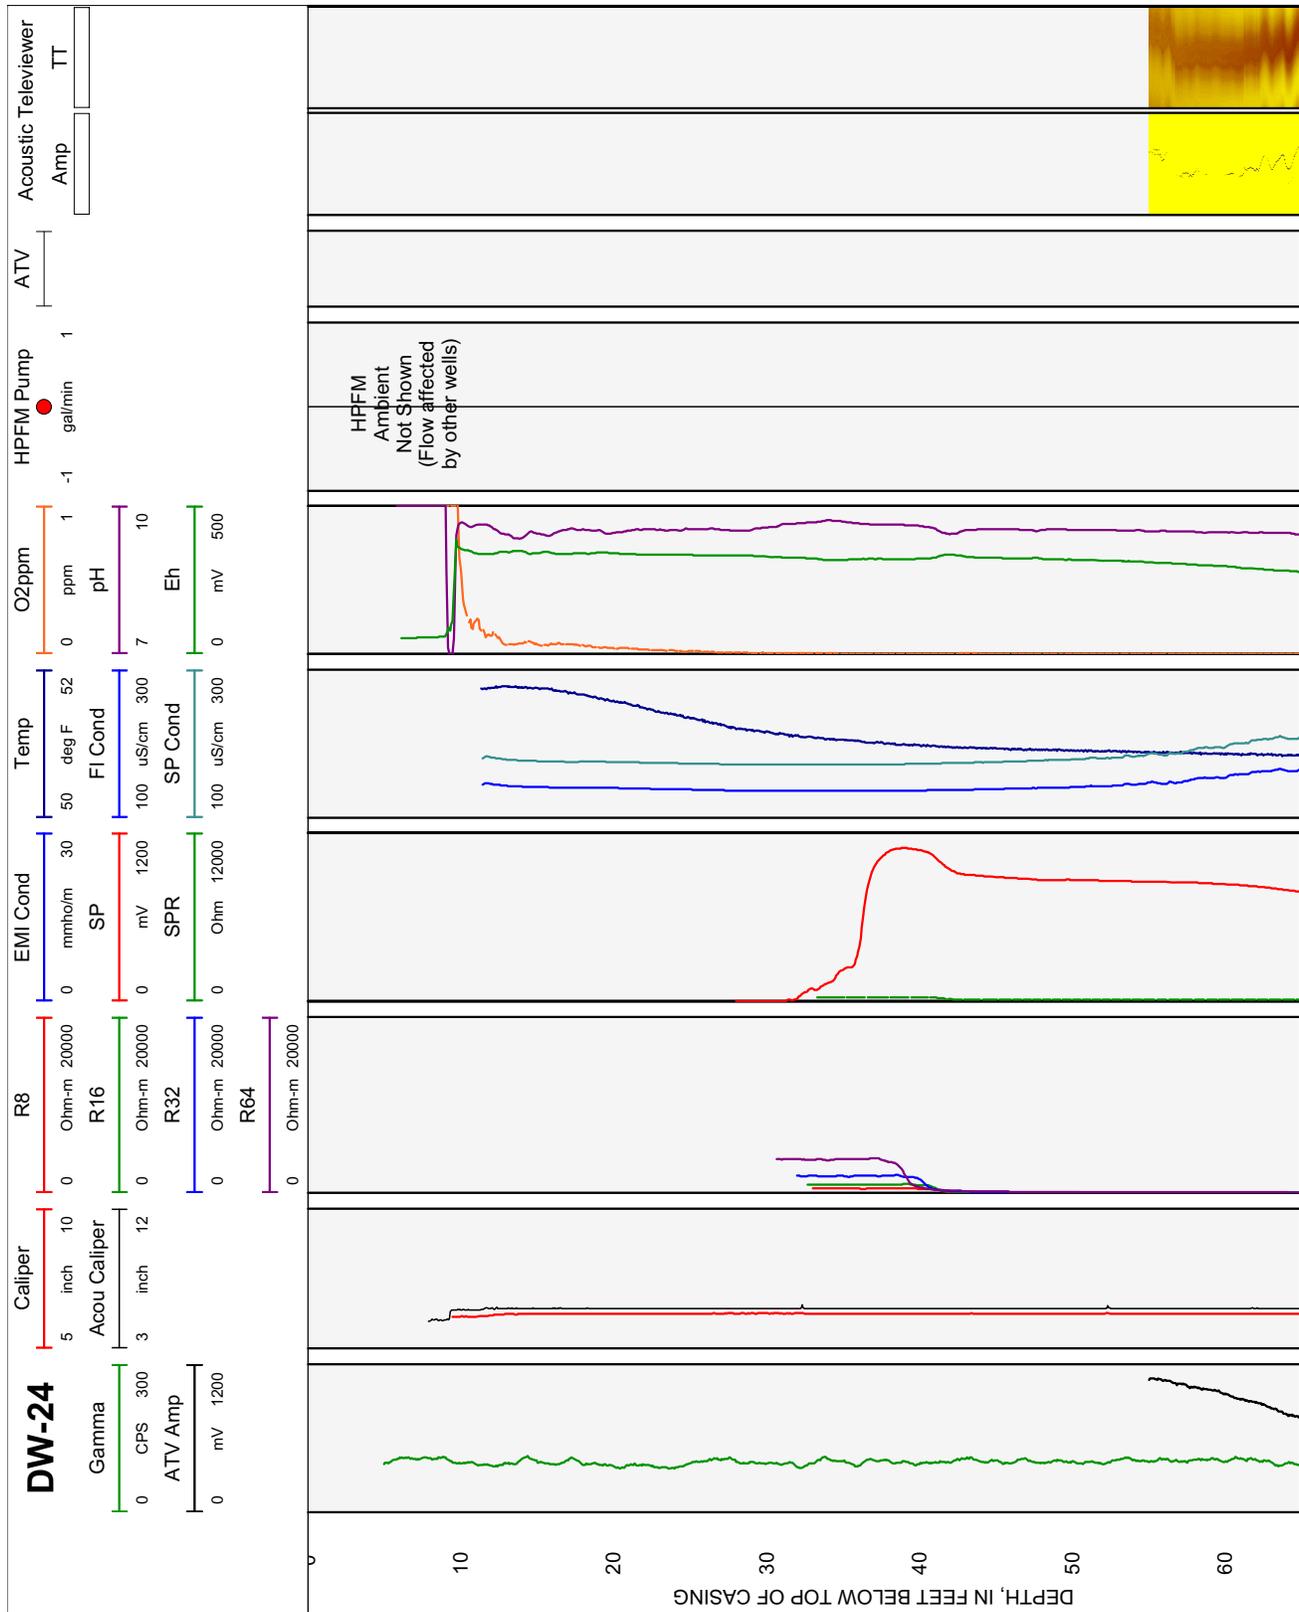
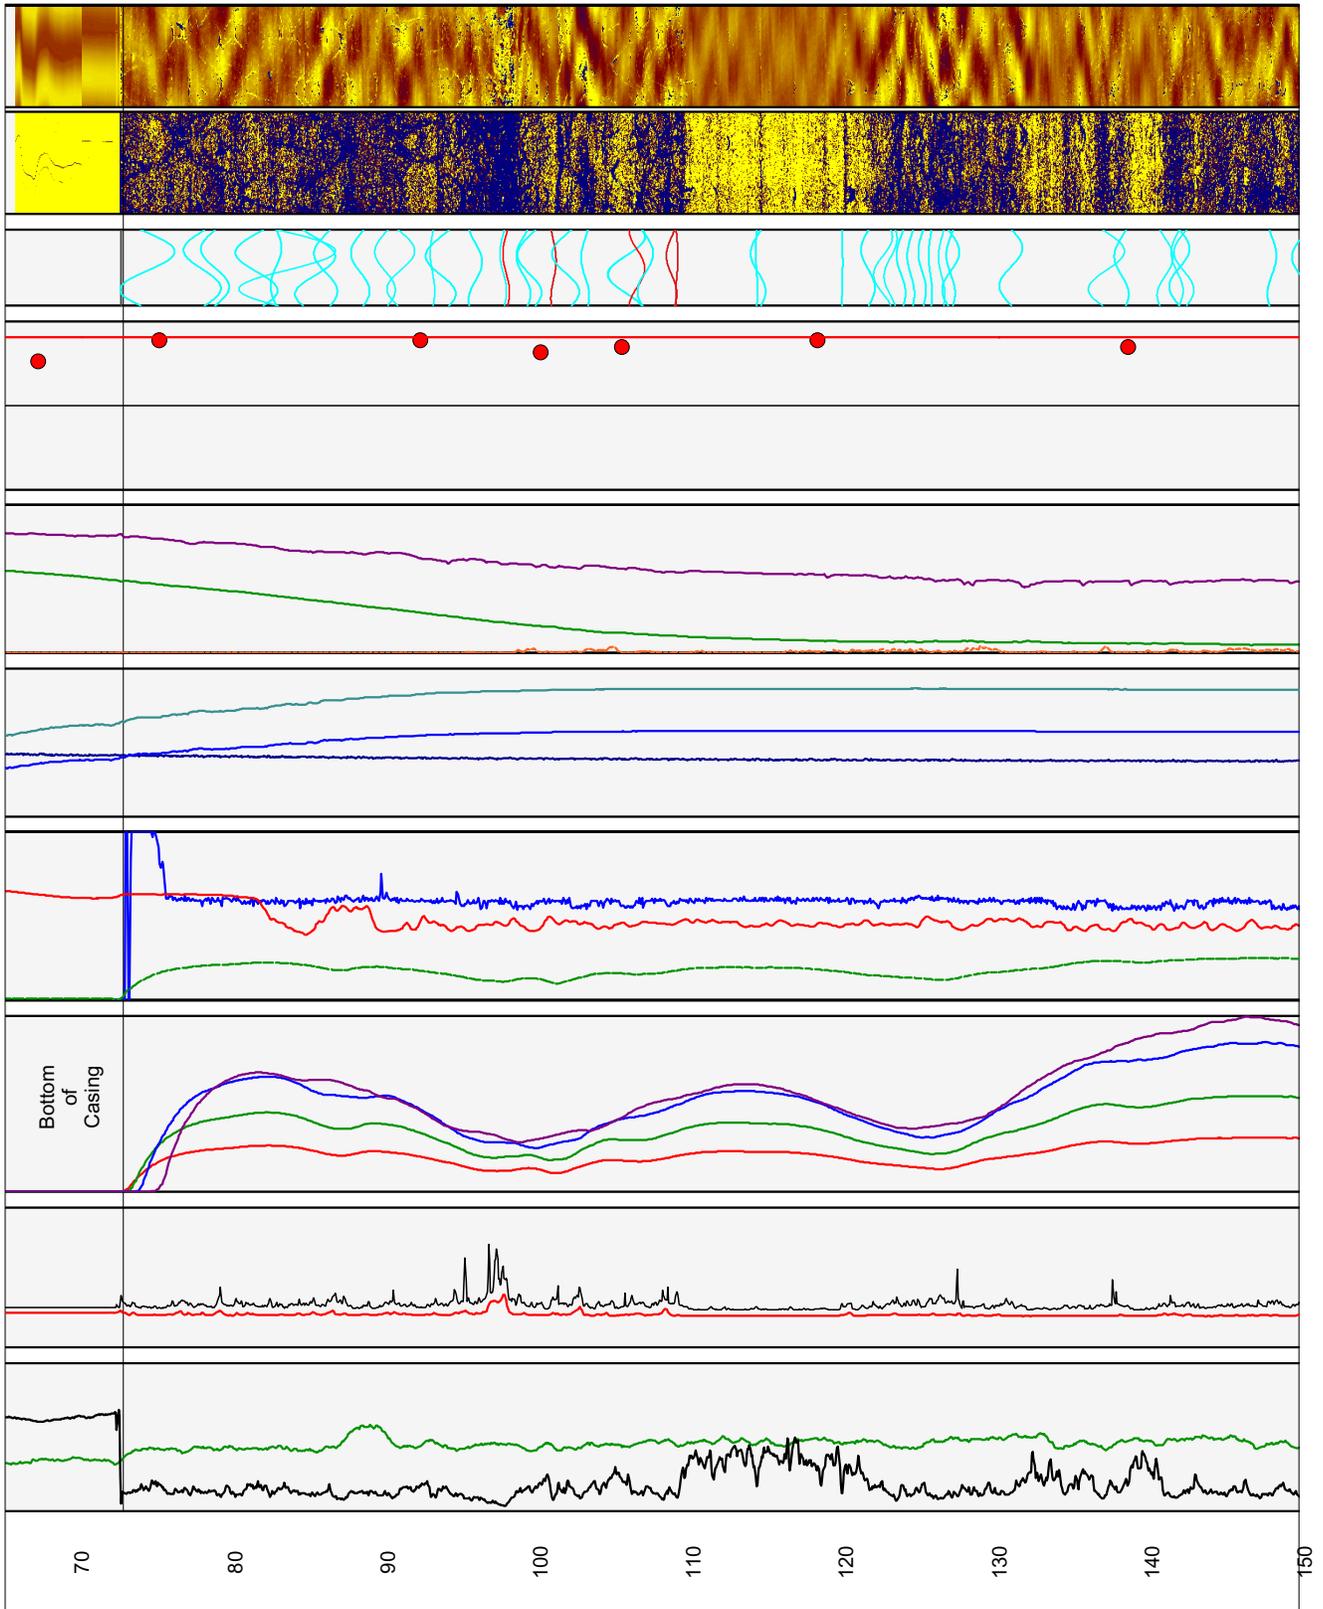
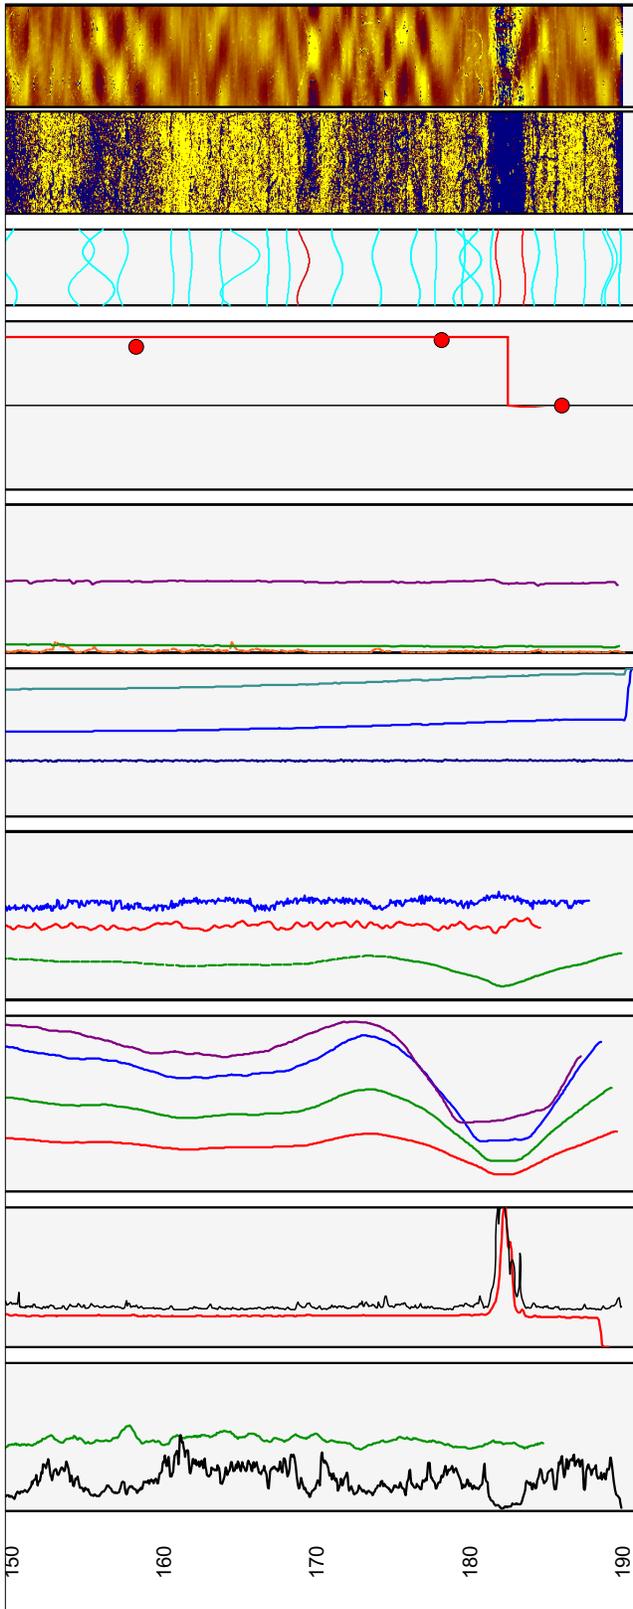
Figure 1D-1. Caliper, acoustic caliper, gamma, electromagnetic conductivity, fluid temperature, specific conductance, DO, pH, reduction oxidation, multi-space resistivity, oriented acoustic and optical borehole images, and heat-pulse flowmeter logs for borehole DW-24, near Machiasport, Maine.

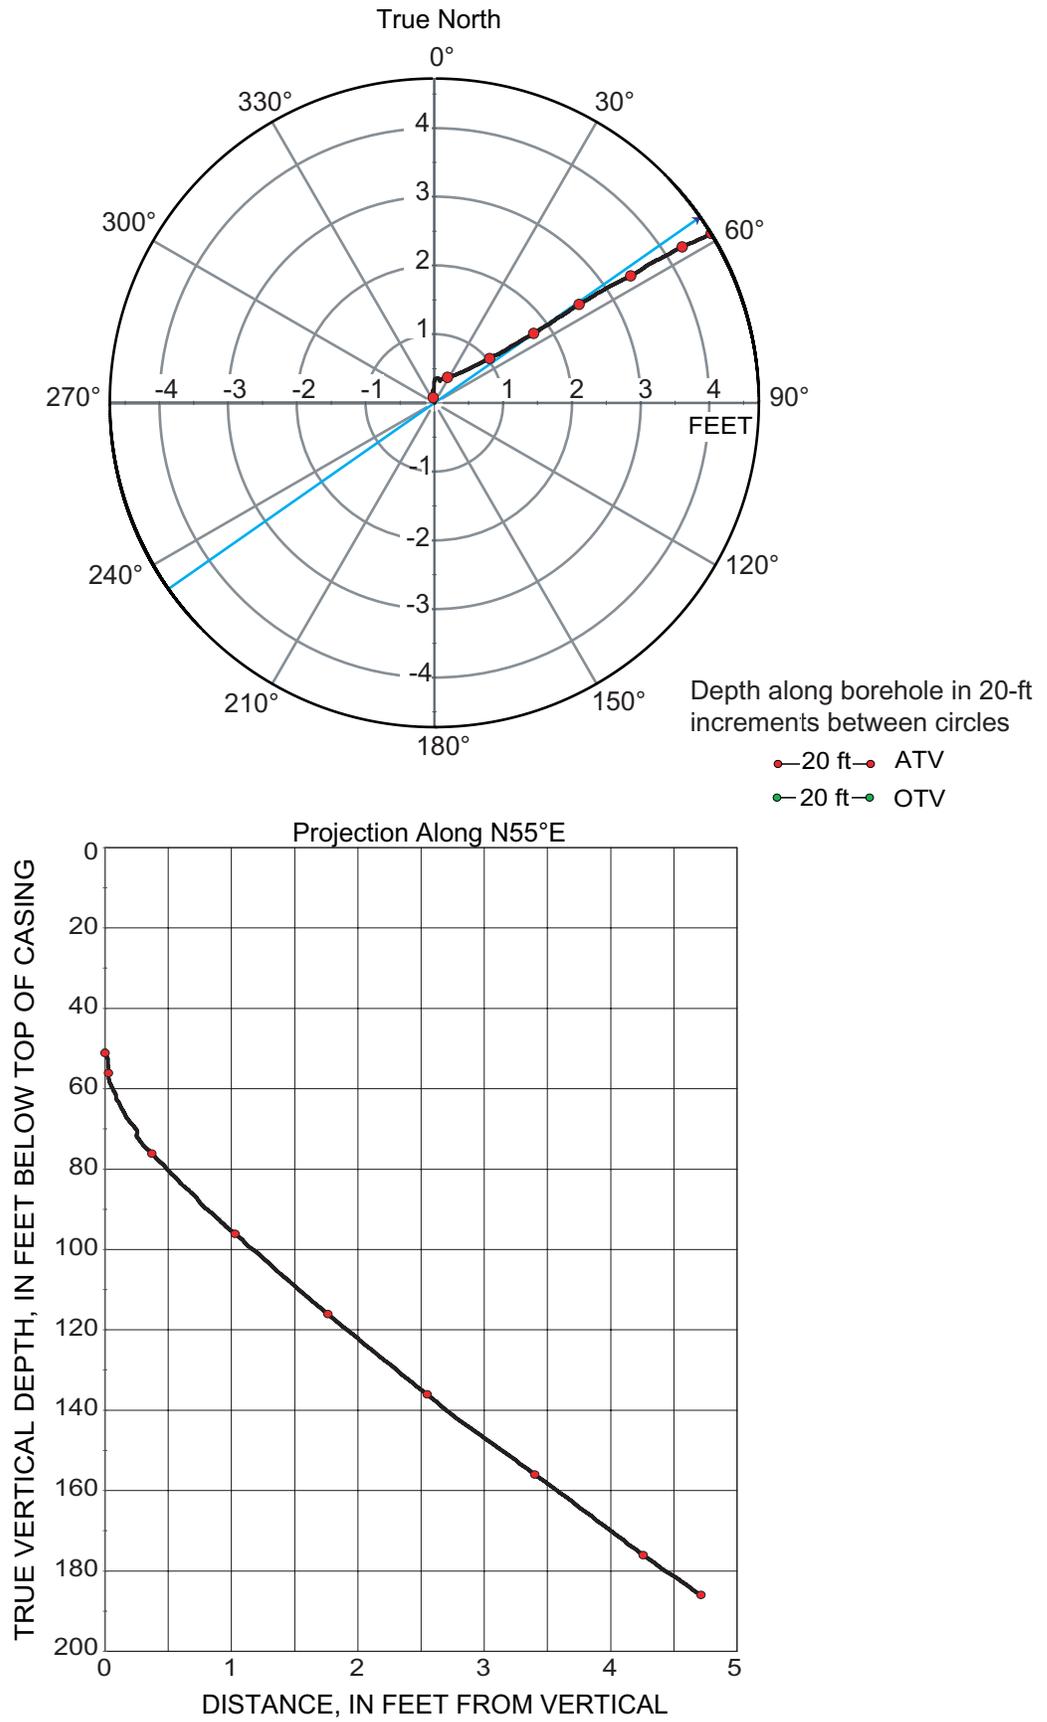
Figure 1D-2. Borehole deviation logs for borehole DW-24, near Machiasport, Maine. Blue line on radial plot (top) is line of projection for vertical plot (bottom).
 [ft, foot; ATV, acoustic televiewer; OTV, optical televiewer]

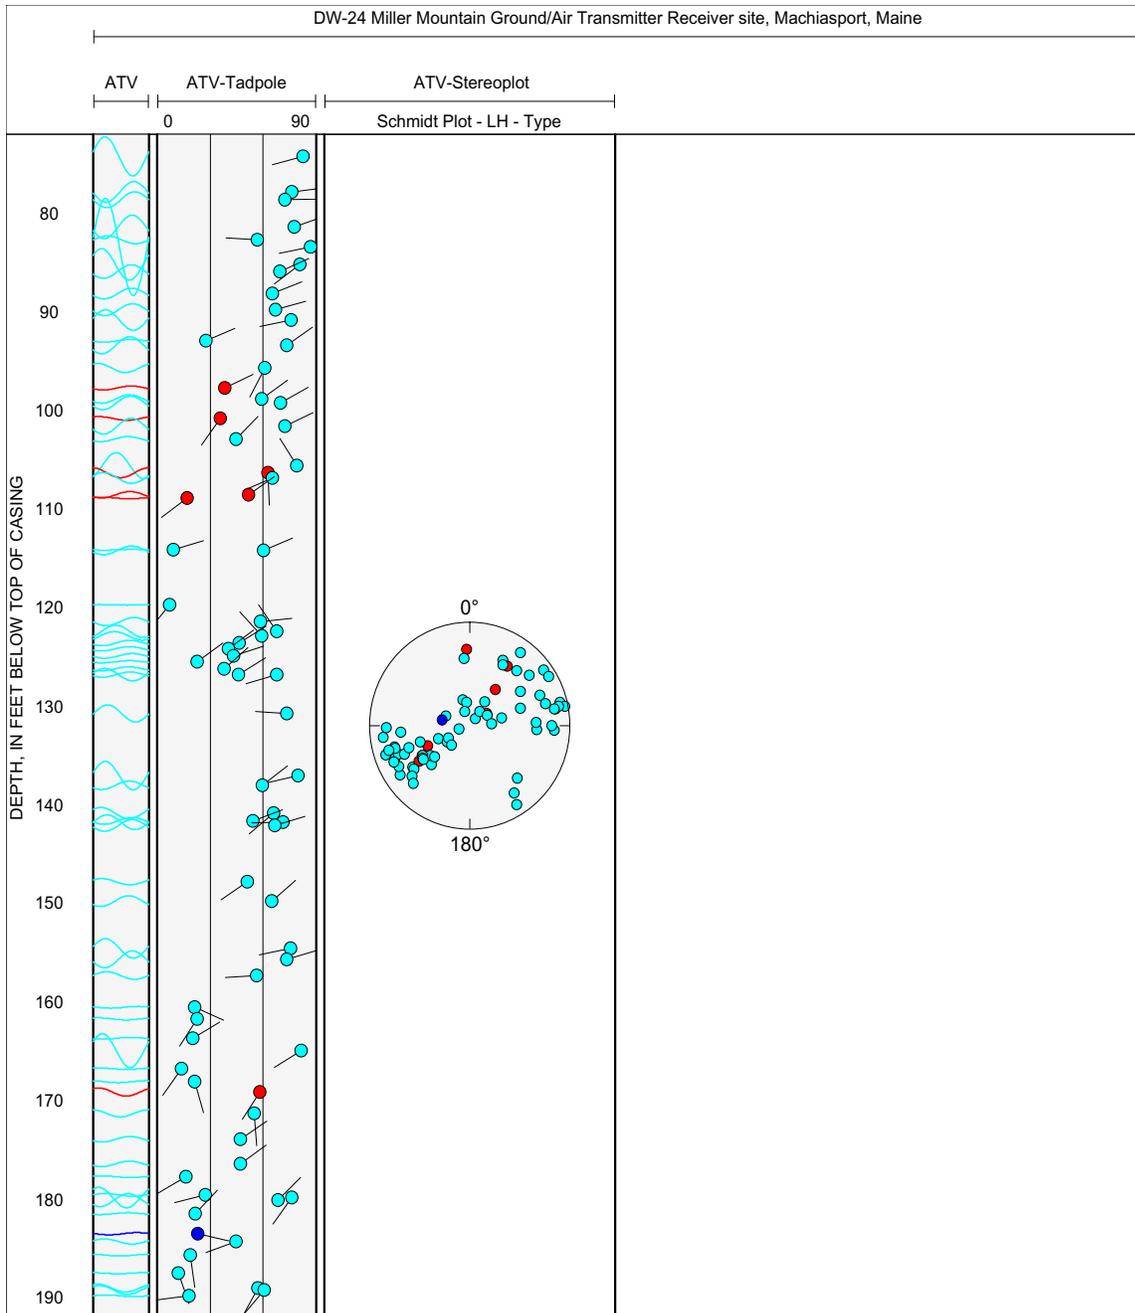
Figure 1D-3. Projection, tadpole, and stereoplots of interpretation of borehole image data for borehole DW-24, near Machiasport, Maine.

Table 1D-1. Interpretation of acoustic televiewer logs for borehole DW-24, near Machiasport, Maine.

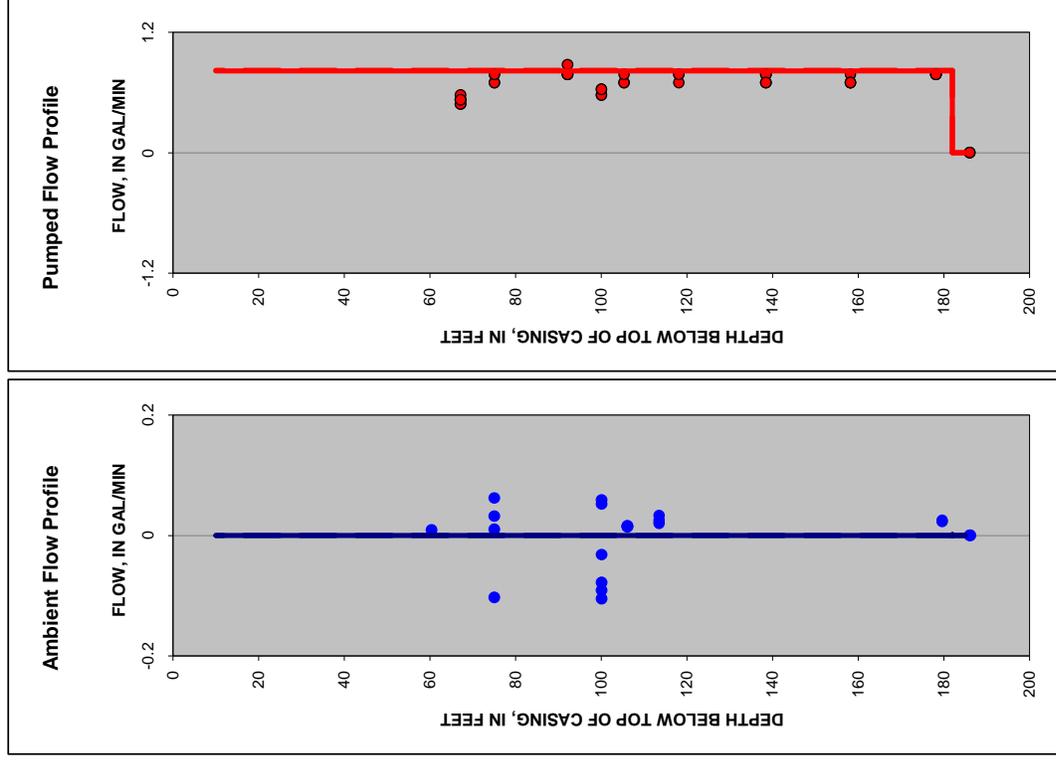
Dashed line indicates measured flow.
 Solid line indicates modeled flow.
 Points indicate measured heat-pulse flowmeter data.

Figure 1D-4. Interpretation and modeling of heat-pulse flowmeter logs for borehole DW-24, near Machiasport, Maine. [gal/min, gallon per minute; ft, feet; ft²/d, feet squared per day; positive values of flow are upward flow, negative values of flow are downward flow]

Fracture number	Depth (ft)	Ambient flow above fracture (gal/min)	Pumped flow above fracture (gal/min)	Zone transmissivity (ft ² /d)	Water level (ft)	Elevation of water level (ft)	Percent transmissivity
1	182.0	0.0	0.81	306.0	9.80	50.20	100

Total borehole transmissivity	306.0	(ft ² /d)
Sum of squares error	0.000	(gal/min) ²
Root mean square error	0.006	(gal/min)

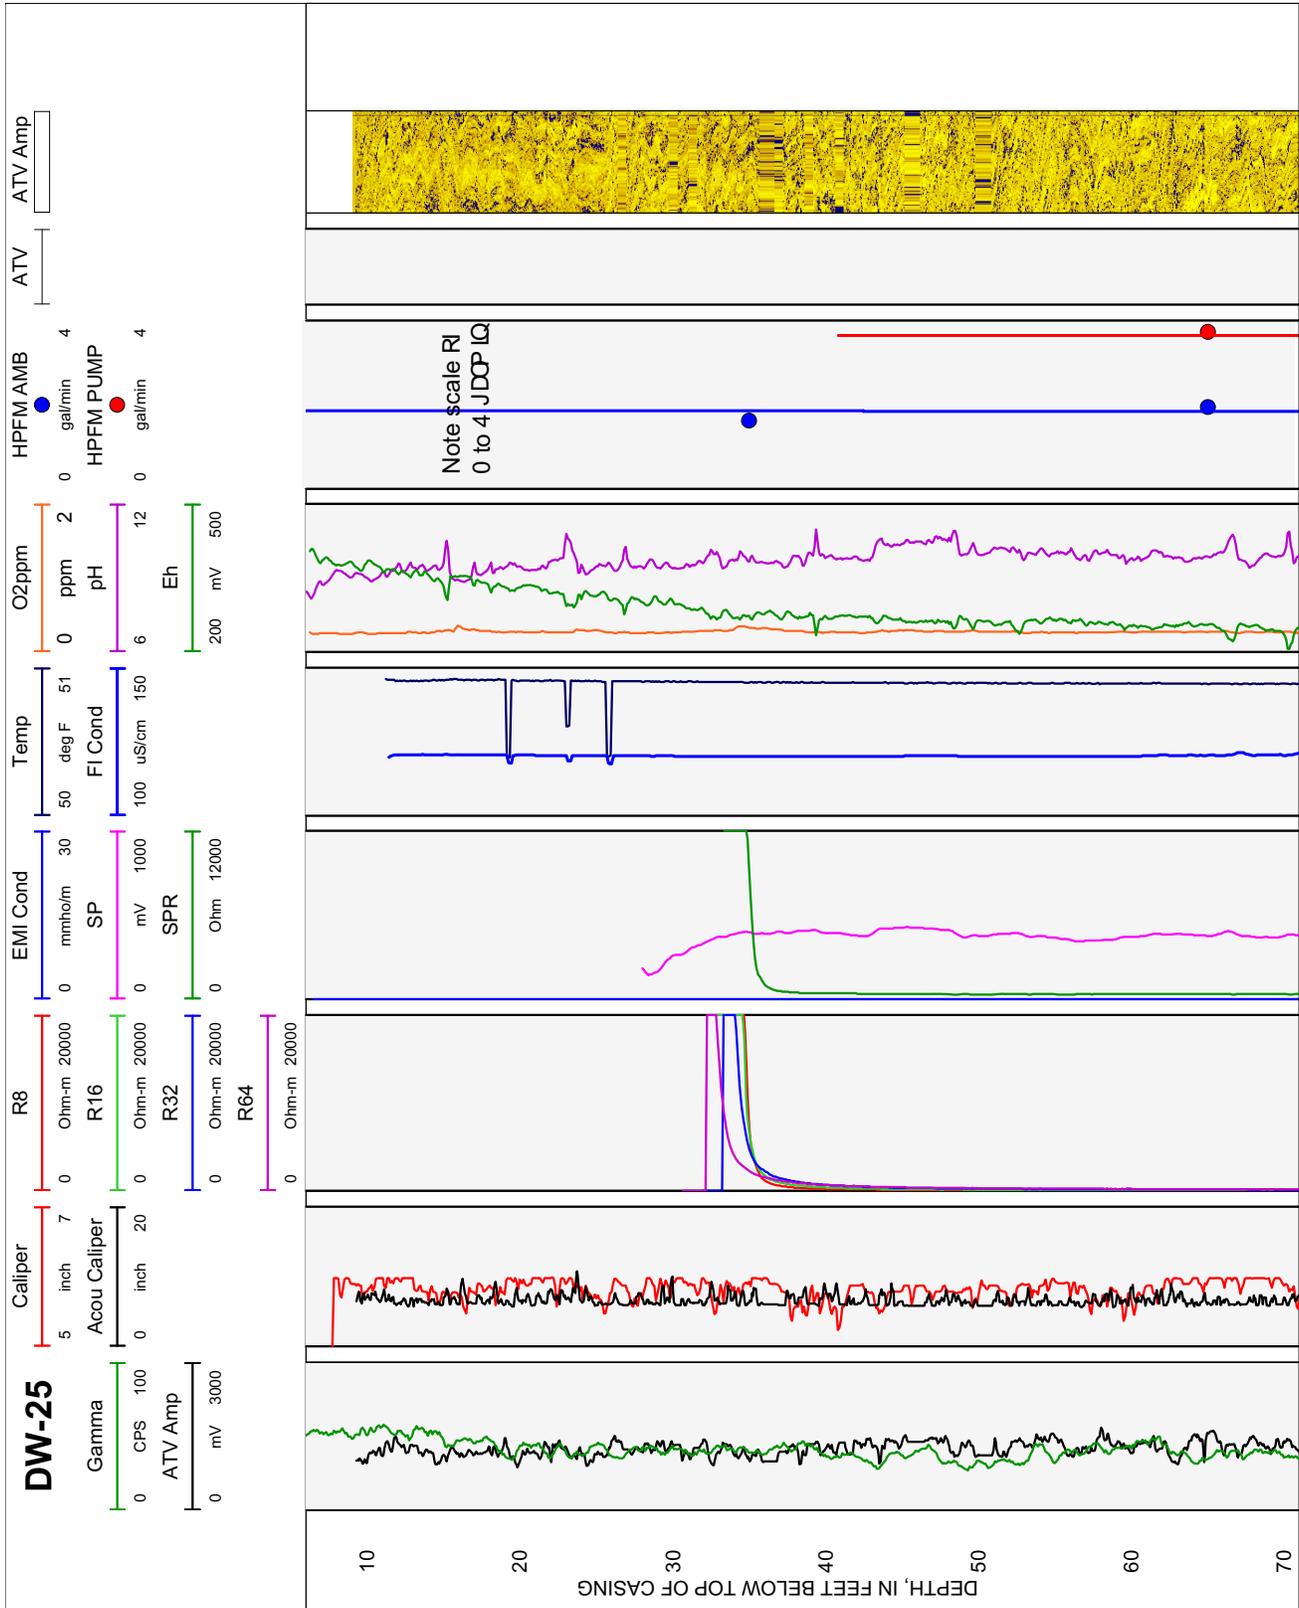
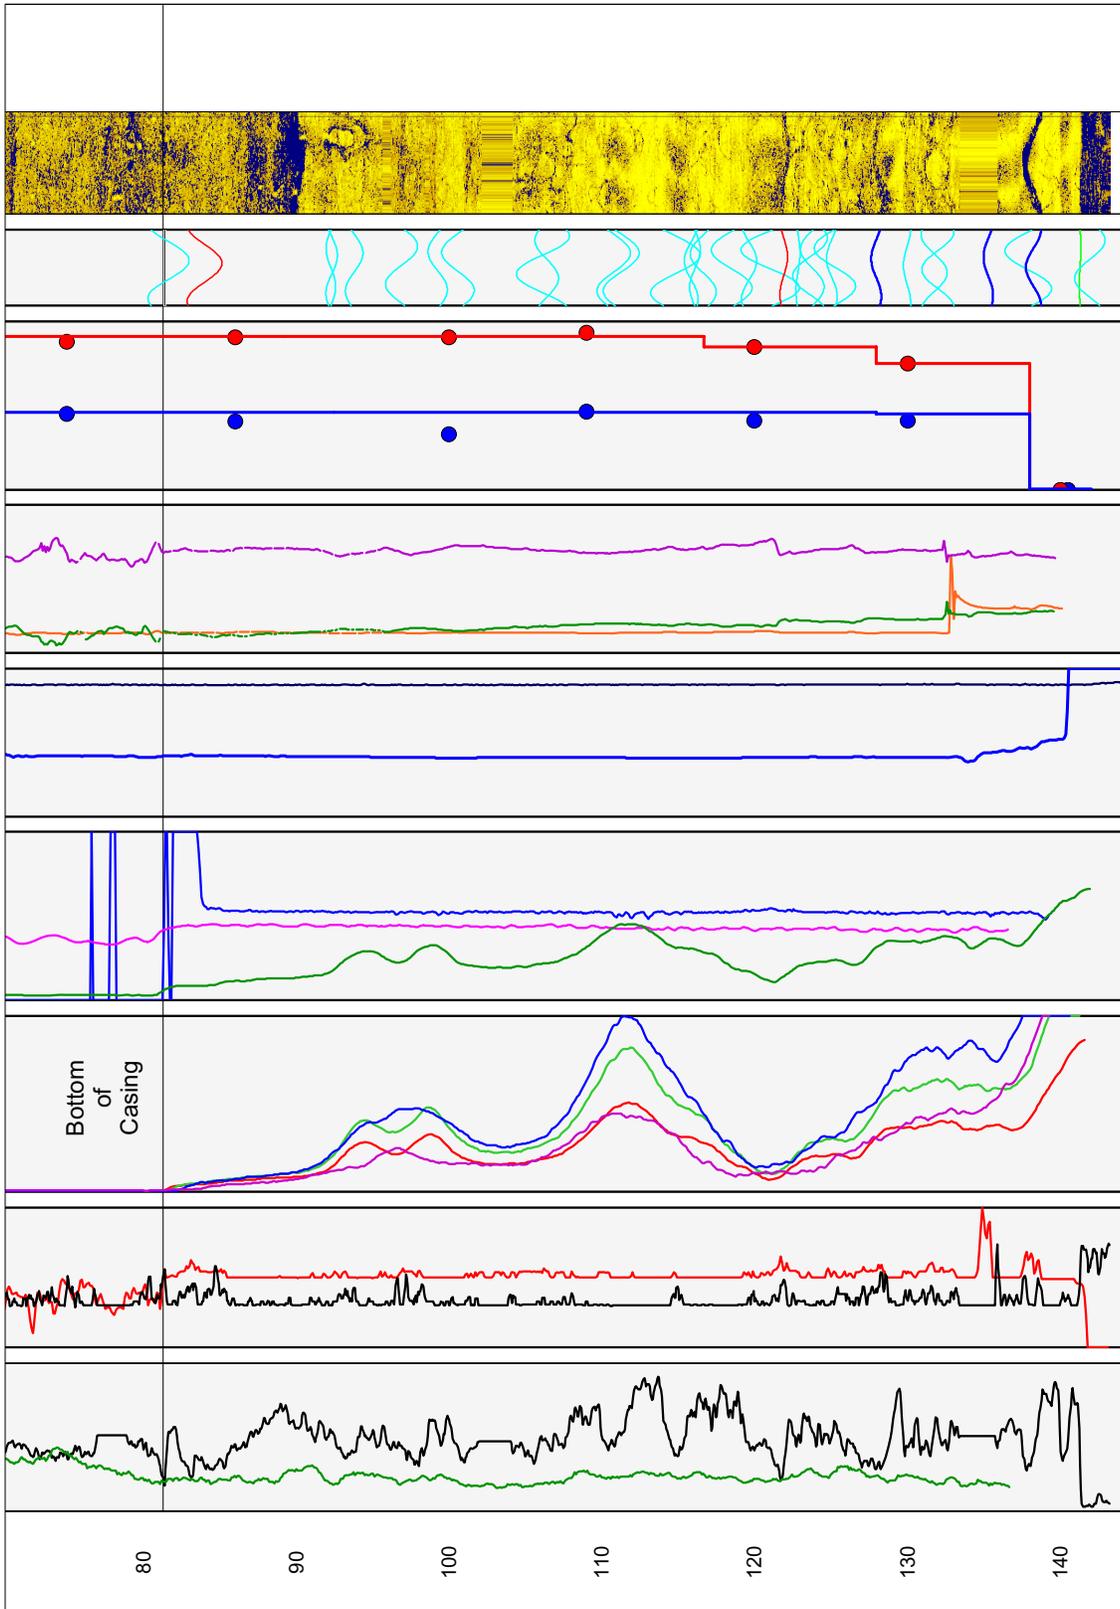
Figure 1E-1. Caliper, acoustic caliper, gamma, electromagnetic conductivity, fluid temperature, specific conductance, DO, pH, reduction oxidation, multi-space resistivity, oriented acoustic and optical borehole images, and heat-pulse flowmeter logs for borehole DW-25, near Machiasport, Maine.
