Borehole Geophysical Investigation of a Formerly Used Defense Site, Machiasport, Maine, 2003–2006

By Carole D. Johnson, Remo A. Mondazzi, and Peter K. Joesten

Scientific Investigations Report 2009–5120

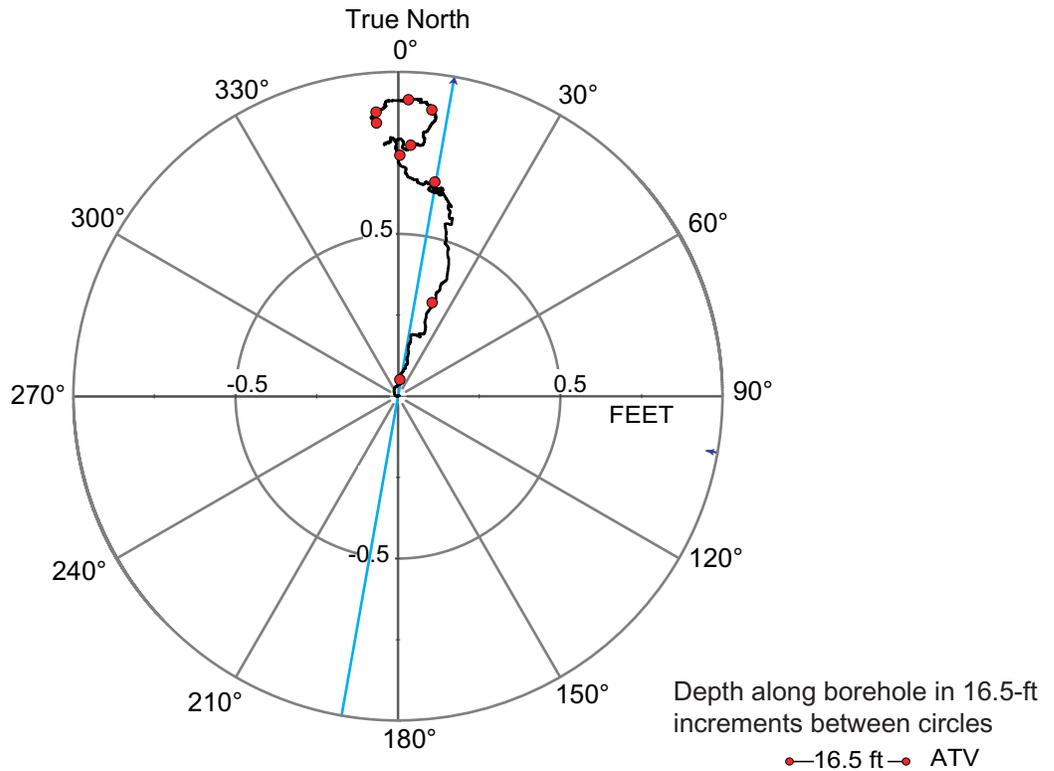
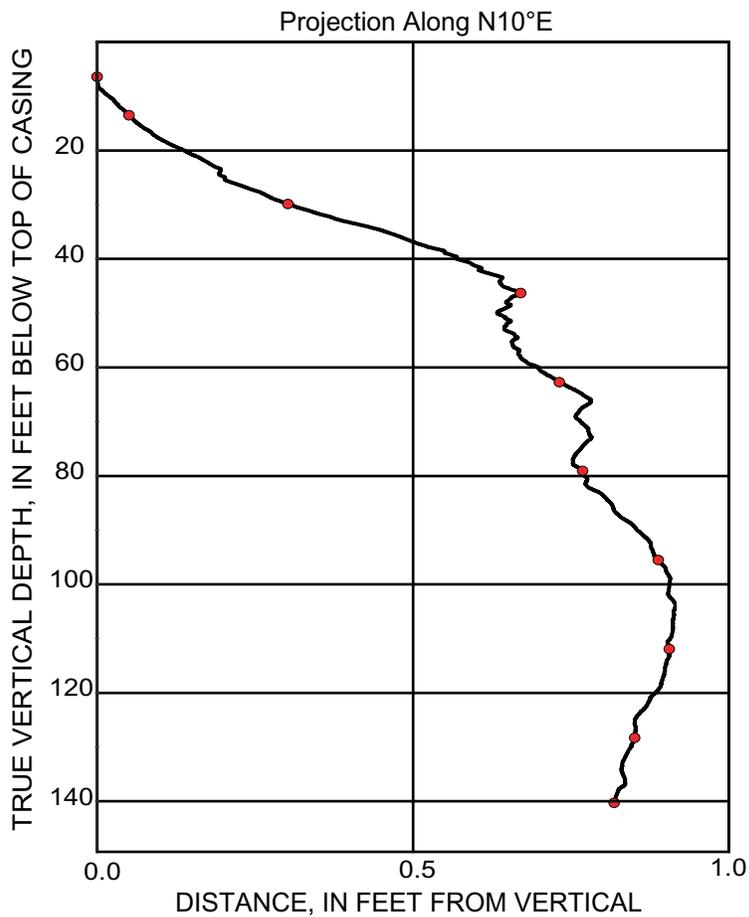
Figure 1E-2. Borehole deviation logs for borehole DW-25, near Machiasport, Maine. Blue line on radial plot (top) is line of projection for vertical plot (bottom).
[ft, foot; ATV, acoustic televiewer]

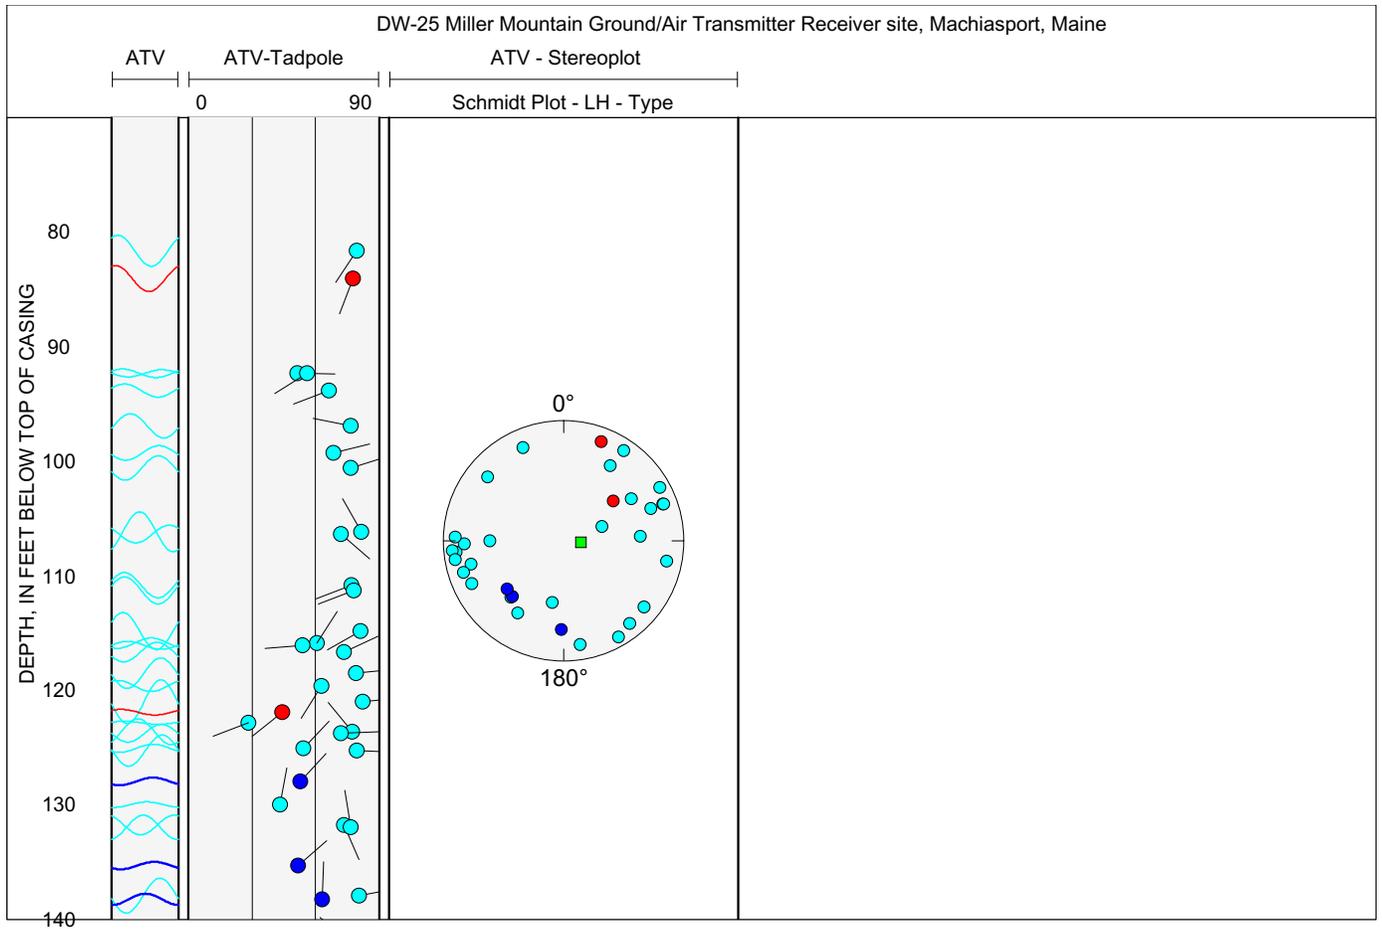
Figure 1E-3. Projection, tadpole, and stereoplots of interpretation of borehole image data for borehole DW-25, near Machiasport, Maine.

Table 1E-1. Interpretation of acoustic televiewer logs for borehole DW-25, near Machiasport, Maine.

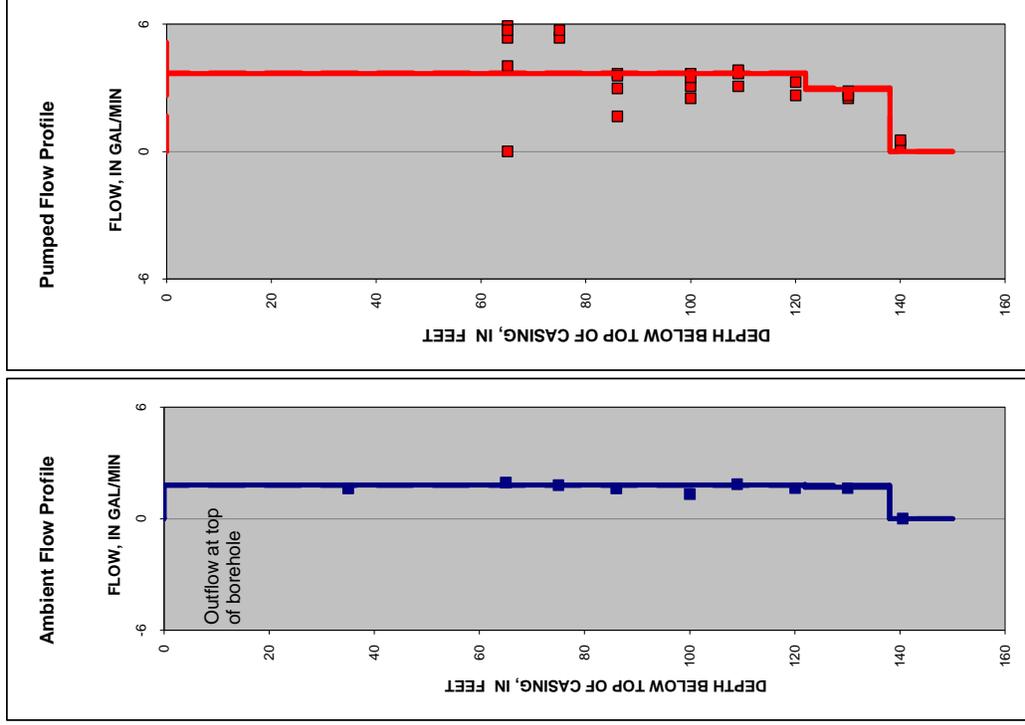
Dashed line indicates measured flow.
 Solid line indicates modeled flow.
 Points indicate measured heat-pulse flowmeter data.

Figure 1E-4. Interpretation and modeling of heat-pulse flowmeter logs for borehole DW-25, near Machiasport, Maine. Uppermost fracture used to simulate overflow at the top of casing is not shown in model results. [gal/min, gallon per minute; ft, feet; ft²/d, feet squared per day; positive values of flow are upward flow, negative values of flow are downward flow]

Fracture number	Depth (ft)	Ambient flow above fracture (gal/min)	Pumped flow above fracture (gal/min)	Zone transmissivity (ft ² /d)	Water level (ft)	Elevation of water level (ft)	Percent transmissivity
2	128.0	1.816	3.671	40.5	0.82	39.18	31
1	138.0	1.686	2.922	89.1	-2.18	42.18	69
Total borehole transmissivity			129.6	(ft ² /d)			
Sum of squares error			25.98	(gal/min) ²			
Root mean square error			2.94	(gal/min)

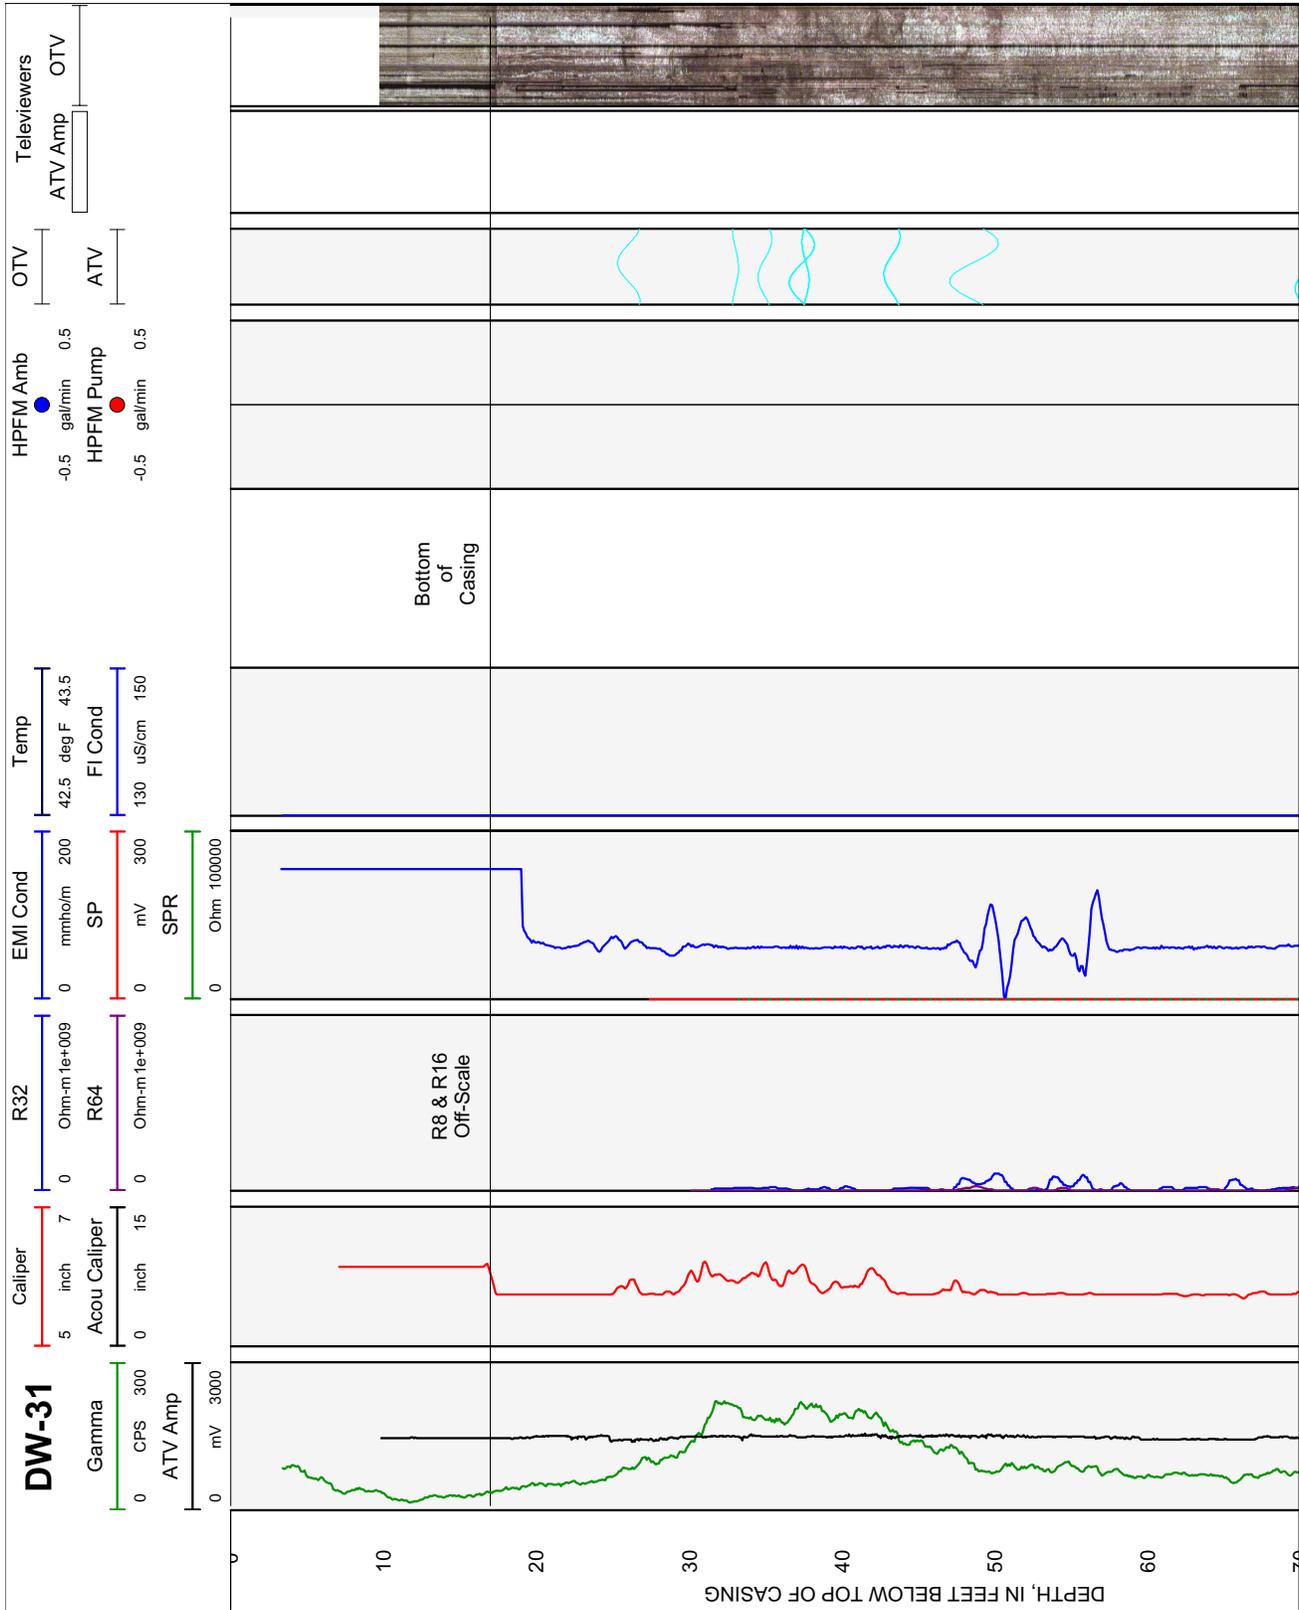
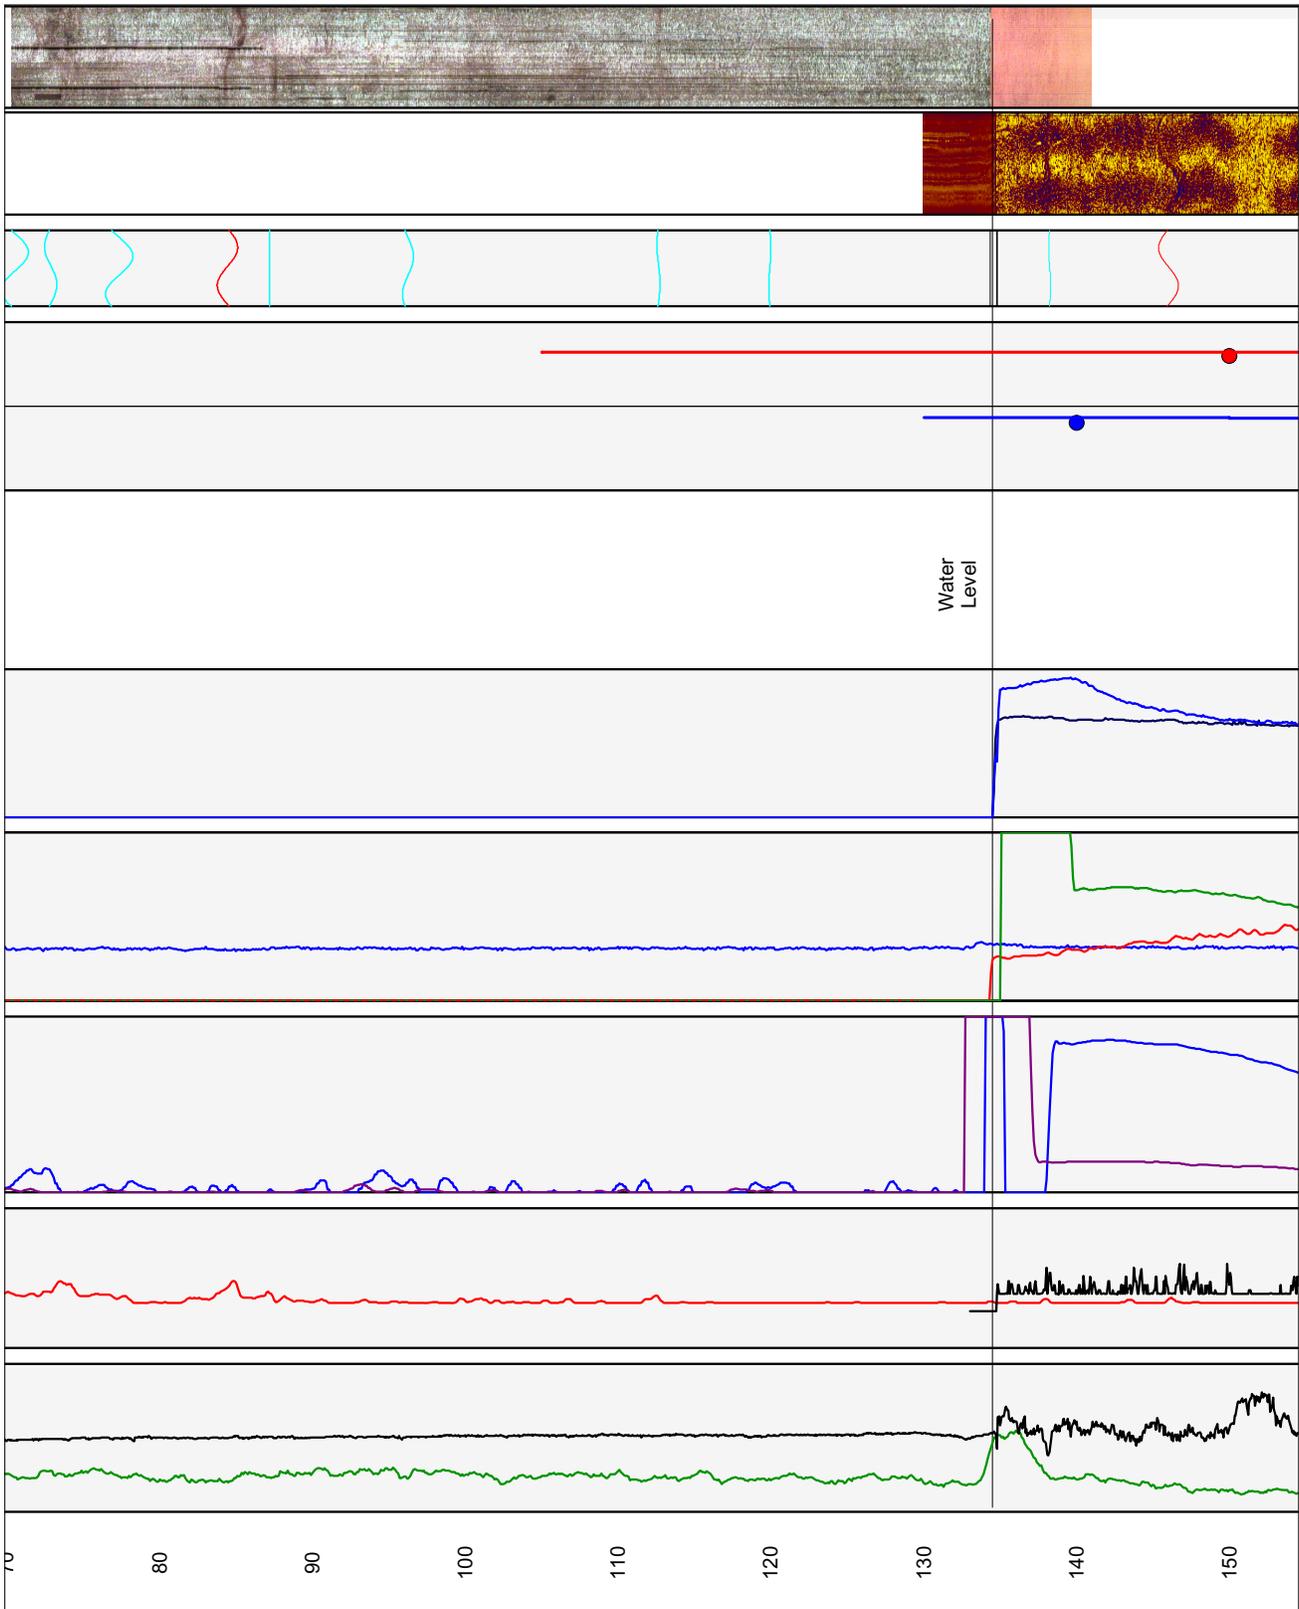
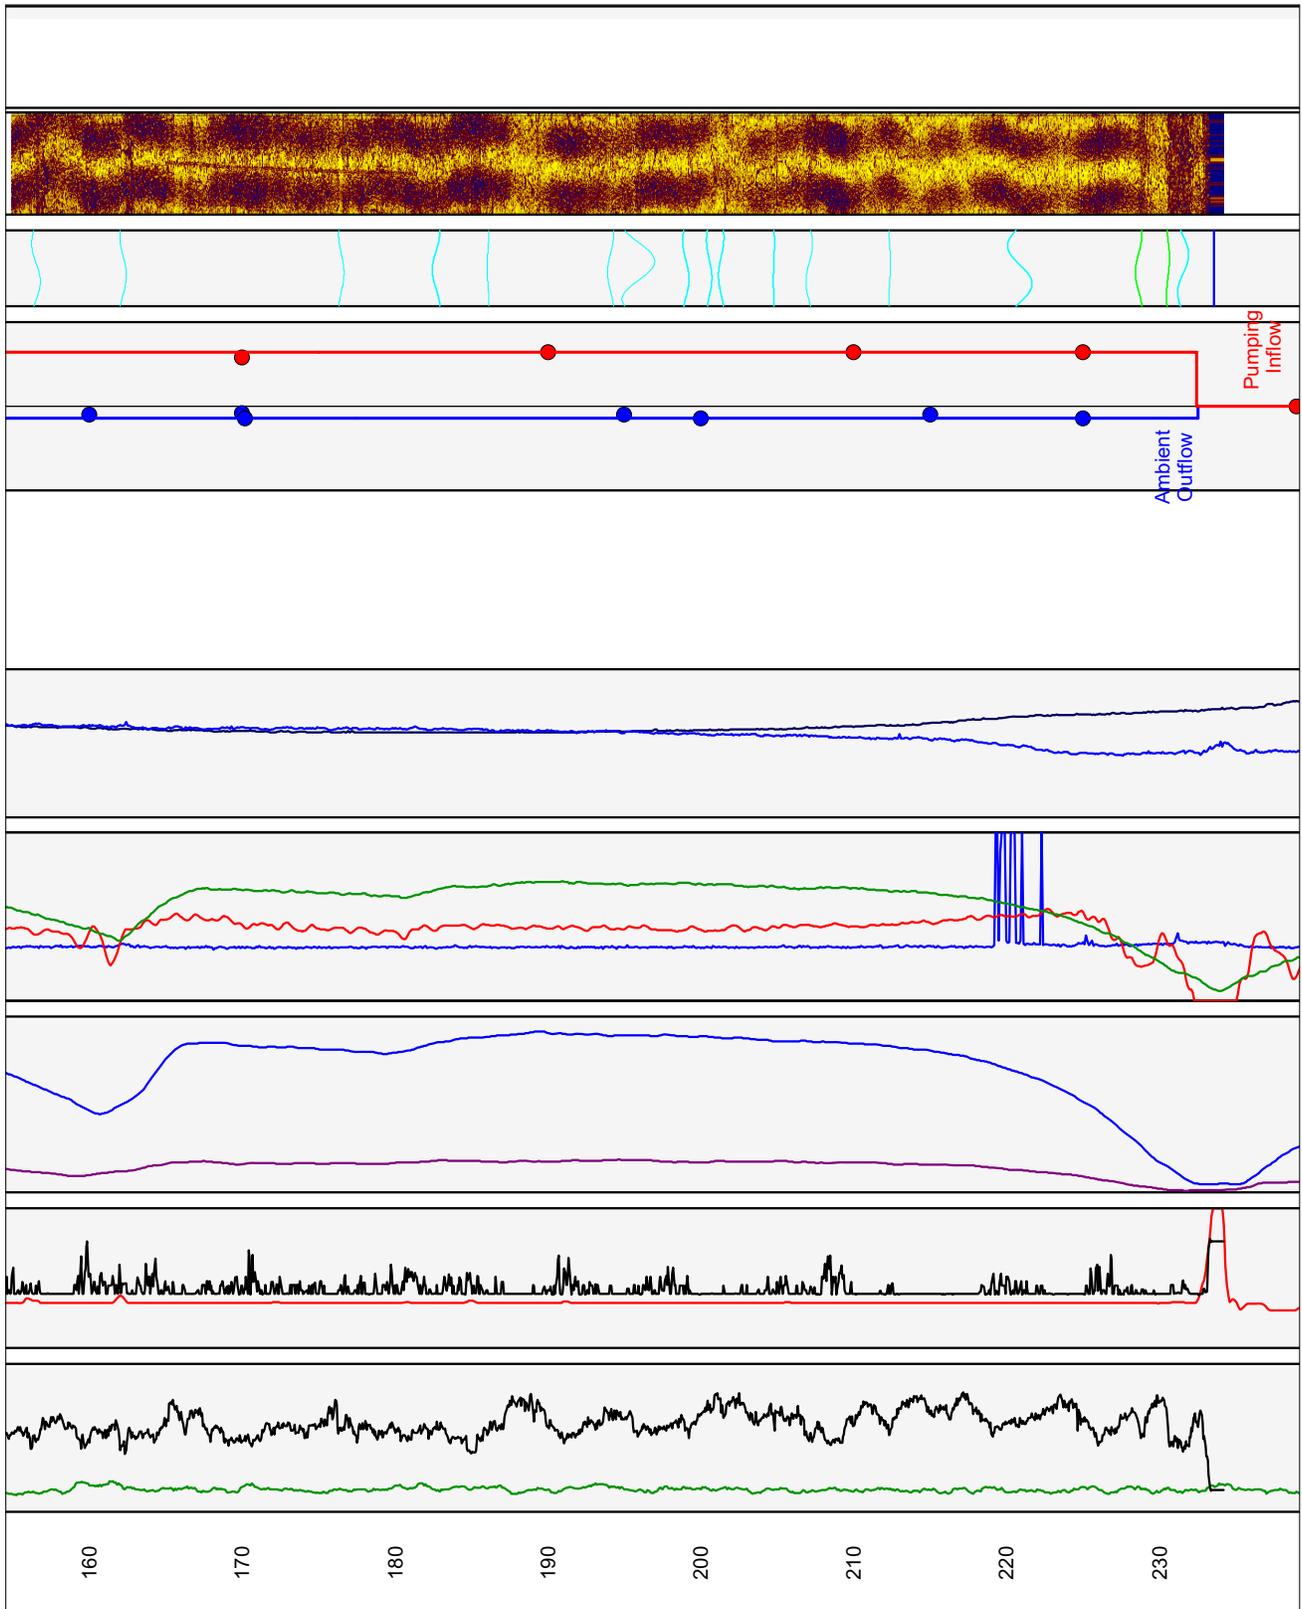
Figure 1F-1. Caliper, acoustic caliper, gamma, electromagnetic conductivity, fluid temperature, specific conductance, DO, pH, reduction oxidation, multi-space resistivity, oriented acoustic and optical borehole images, and heat-pulse flowmeter logs for borehole DW-31, near Machiasport, Maine.

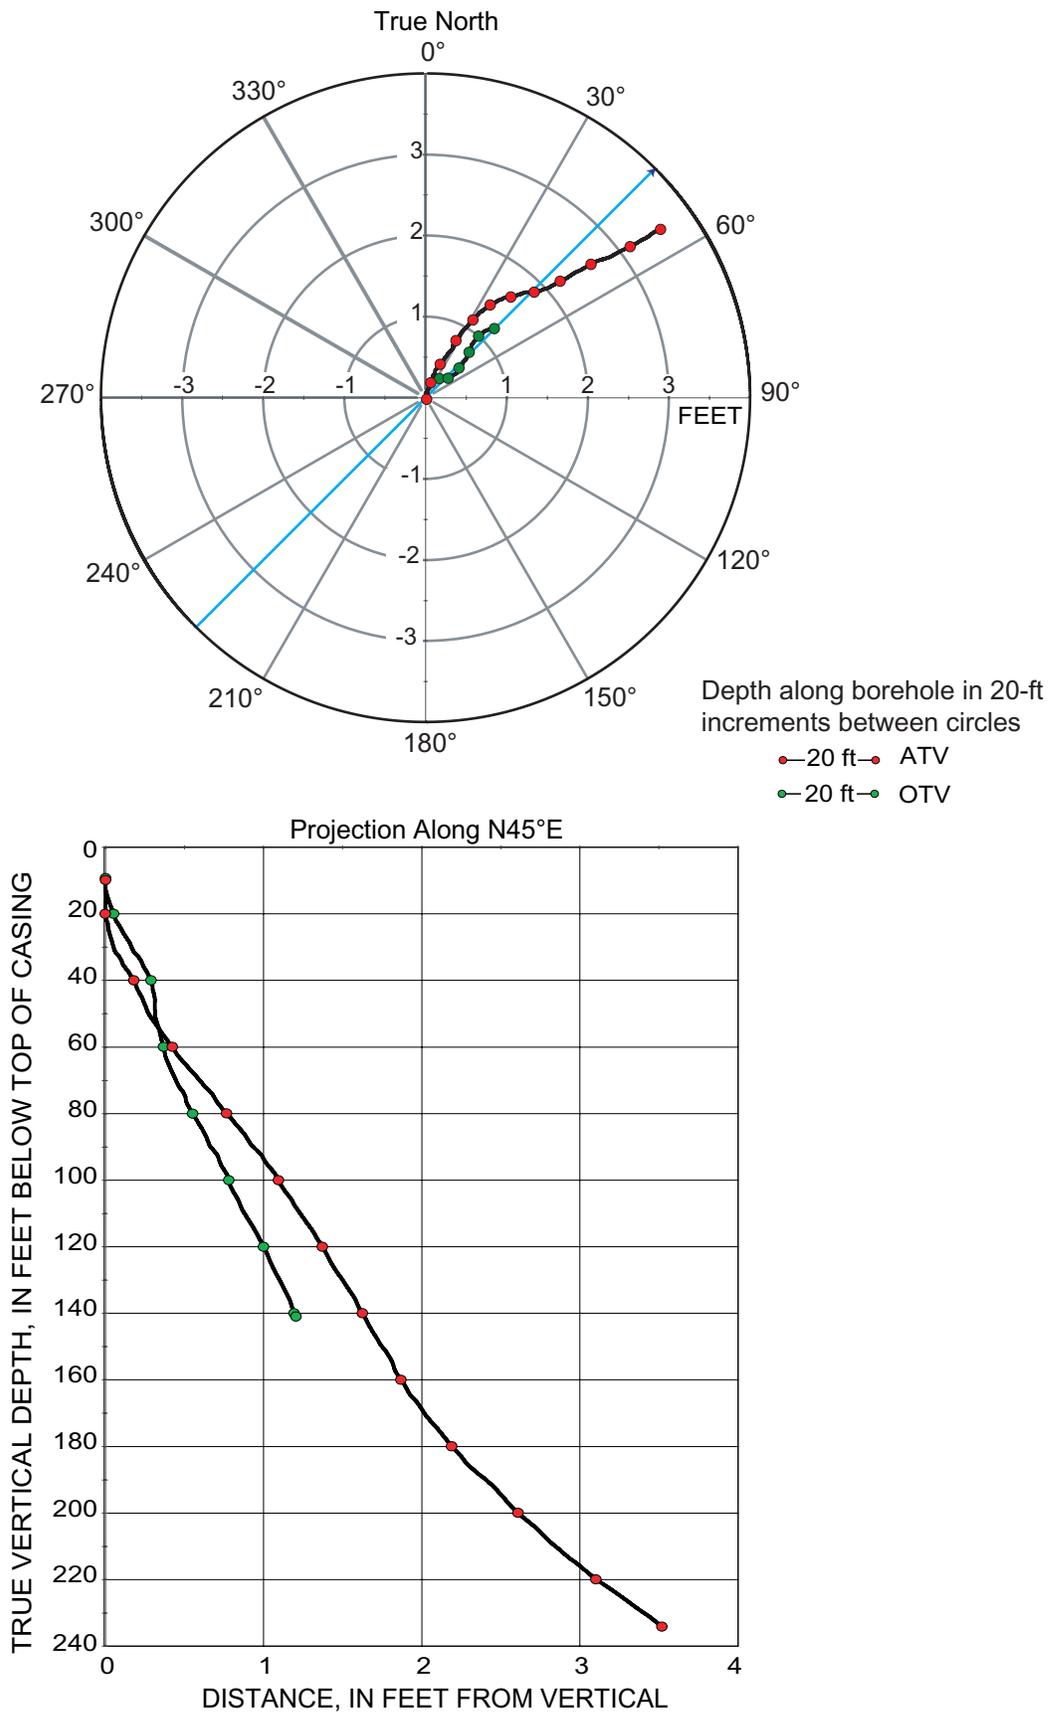
Figure 1F-2. Borehole deviation logs for borehole DW-31, near Machiasport, Maine. Blue line on radial plot (top) is line of projection for vertical plot (bottom).
 [ft, foot; ATV, acoustic televiewer; OTV, optical televiewer]

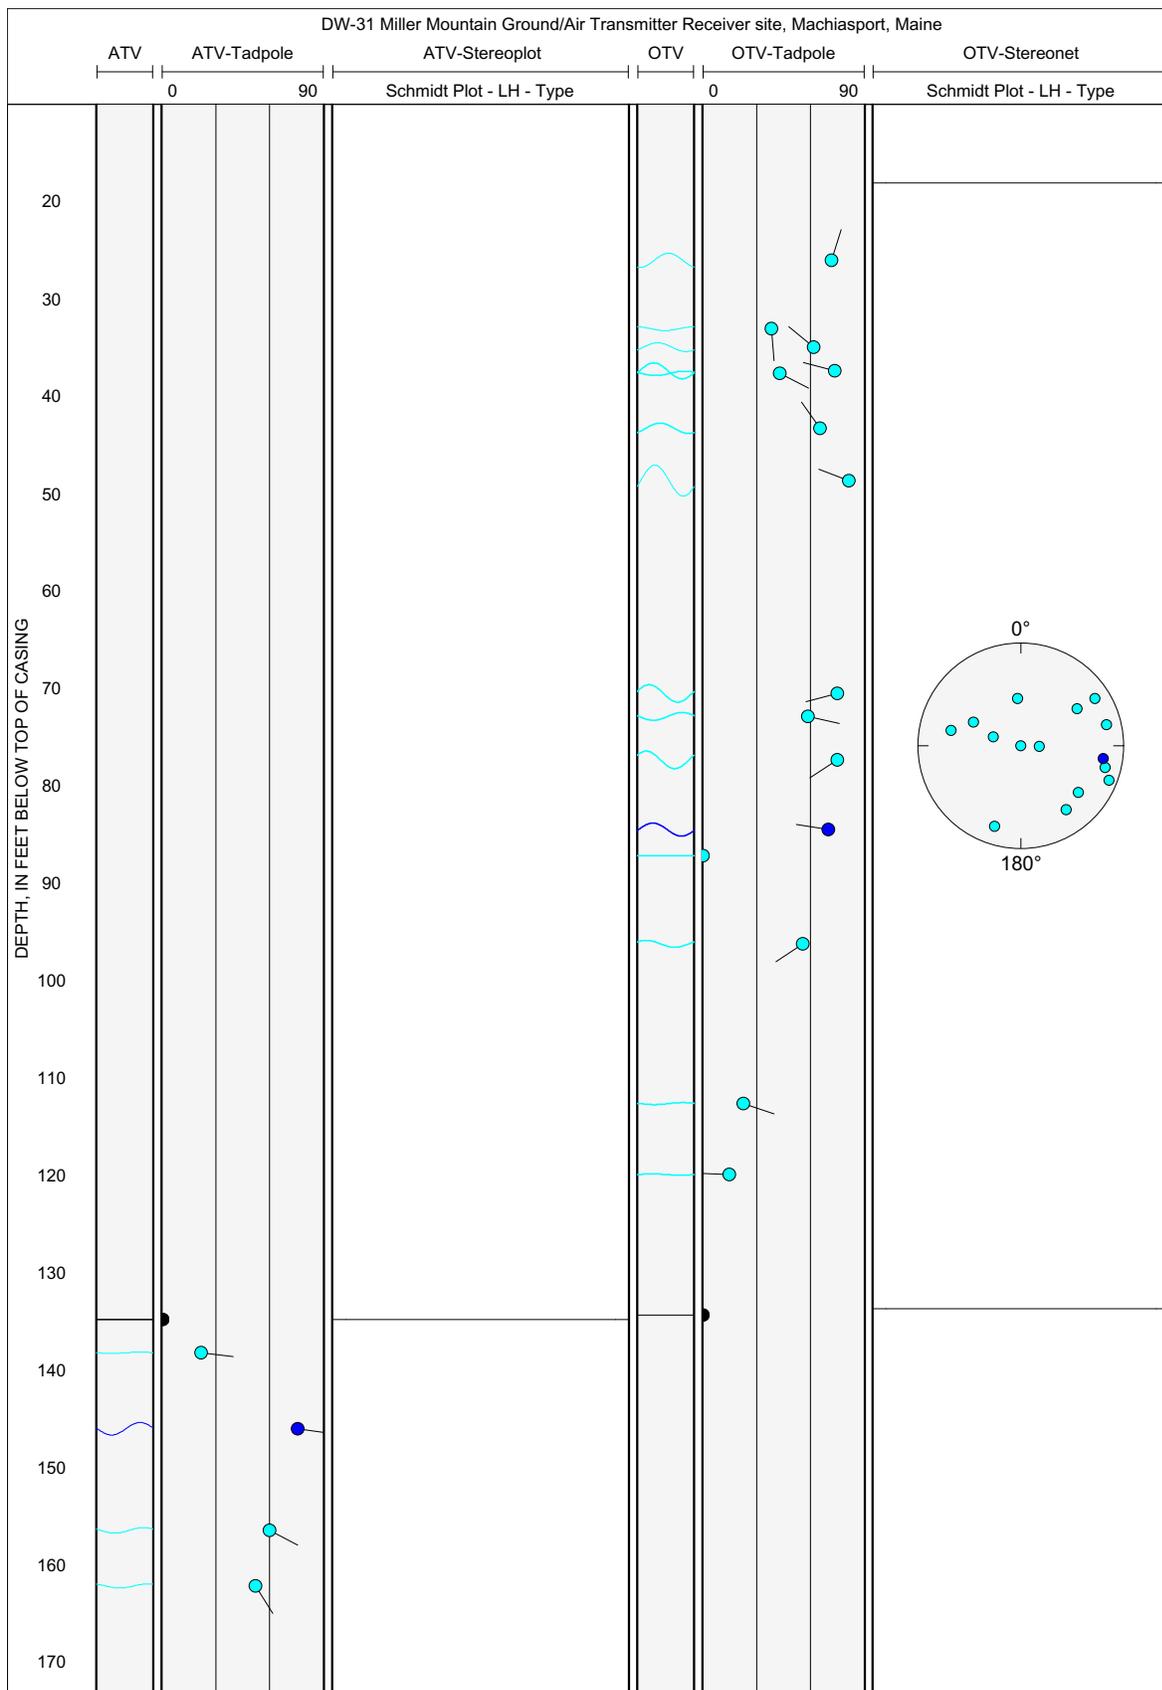
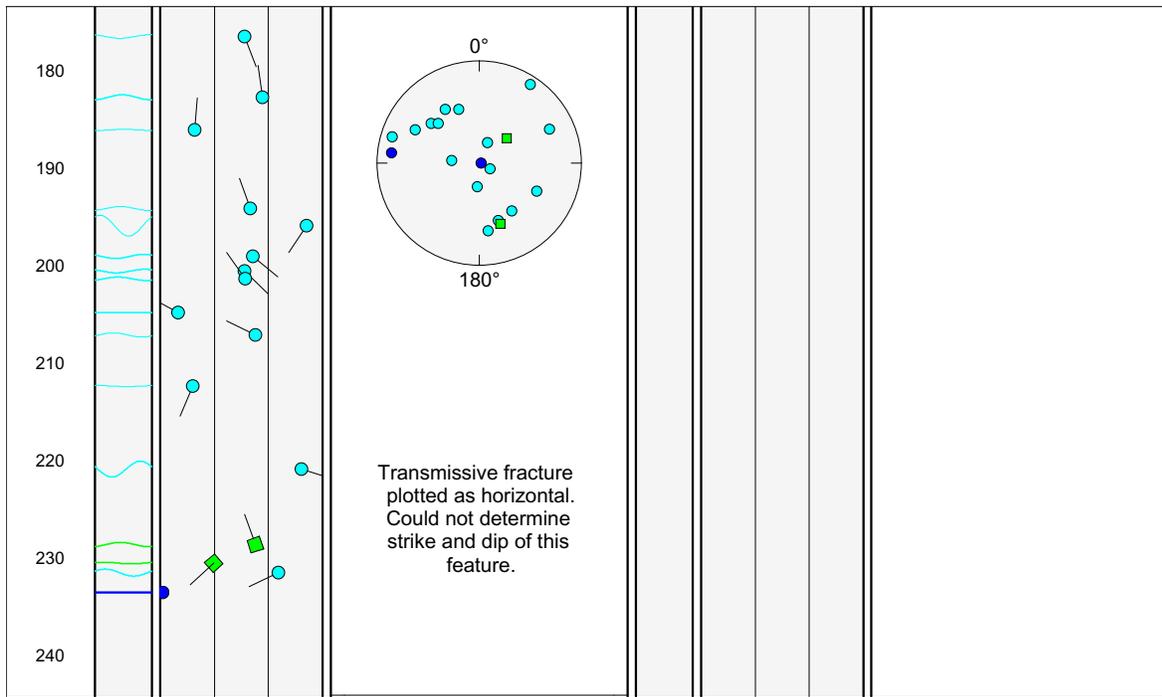
Figure 1F-3. Projection, tadpole, and stereoplots of interpretation of borehole image data for borehole DW-31, near Machiasport, Maine.

Table 1F-1. Interpretation of acoustic televiewer logs for borehole DW-31, near Machiasport, Maine.

[Televiewer data are corrected for deviation and magnetic declination, so orientations are relative to true north; depths are below top of casing, which is 2.2 feet above land surface; dip azimuth is given in degrees east of true north; strike is reported in right-hand-rule (RHR)-azimuthal degrees east of true north and where the direction of dip is 90 degrees to the right of strike; --, orientation of fracture could not be determined]

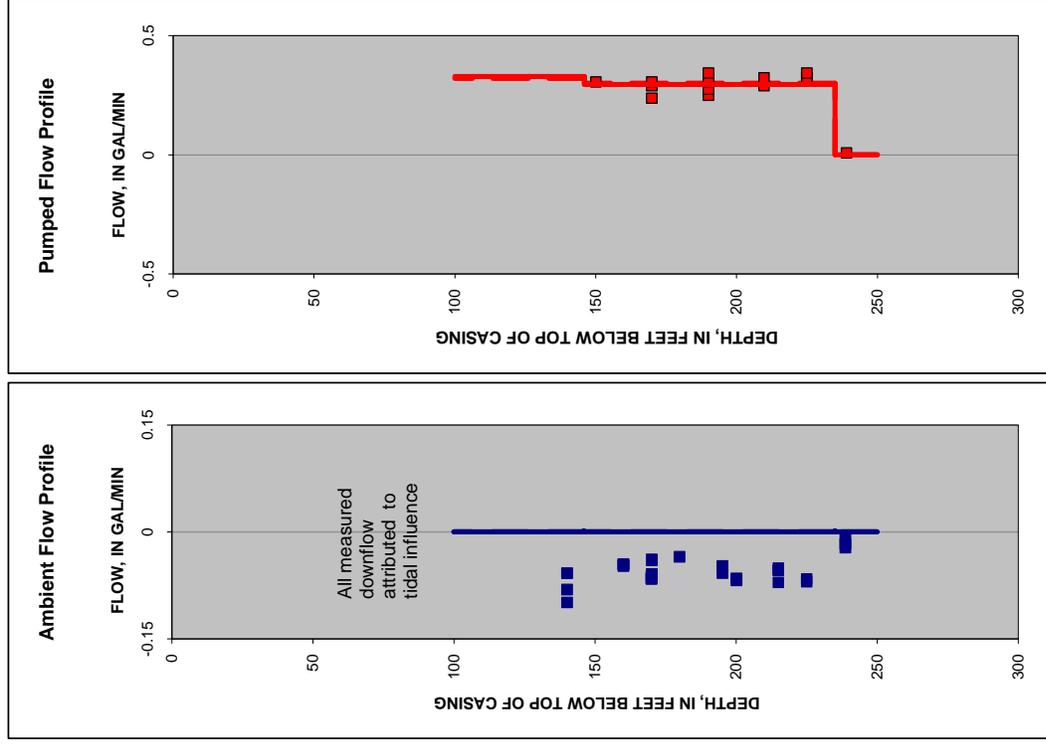
Dashed line indicates measured flow.
 Solid line indicates modeled flow.
 Points indicate measured heat-pulse flowmeter data.

Figure 1F-4. Interpretation and modeling of heat-pulse flowmeter logs for borehole DW-31, near Machiasport, Maine. [gal/min, gallon per minute; ft, feet; ft²/d, feet squared per day; positive values of flow are upward flow, negative values of flow are downward flow]

Fracture number	Depth (ft)	Ambient flow above fracture (gal/min)	Pumped flow above fracture (gal/min)	Zone transmissivity (ft ² /d)	Water level (ft)	Elevation of water level (ft)	Percent transmissivity
2	146	0	0.327	0.80	134.45	73.55	8
1	235	0	0.295	9.40	134.45	73.55	92

Total borehole transmissivity	10.2	(ft ² /d)
Sum of squares error	0.00008	(gal/min) ²
Root mean square error	0.00627	(gal/min)

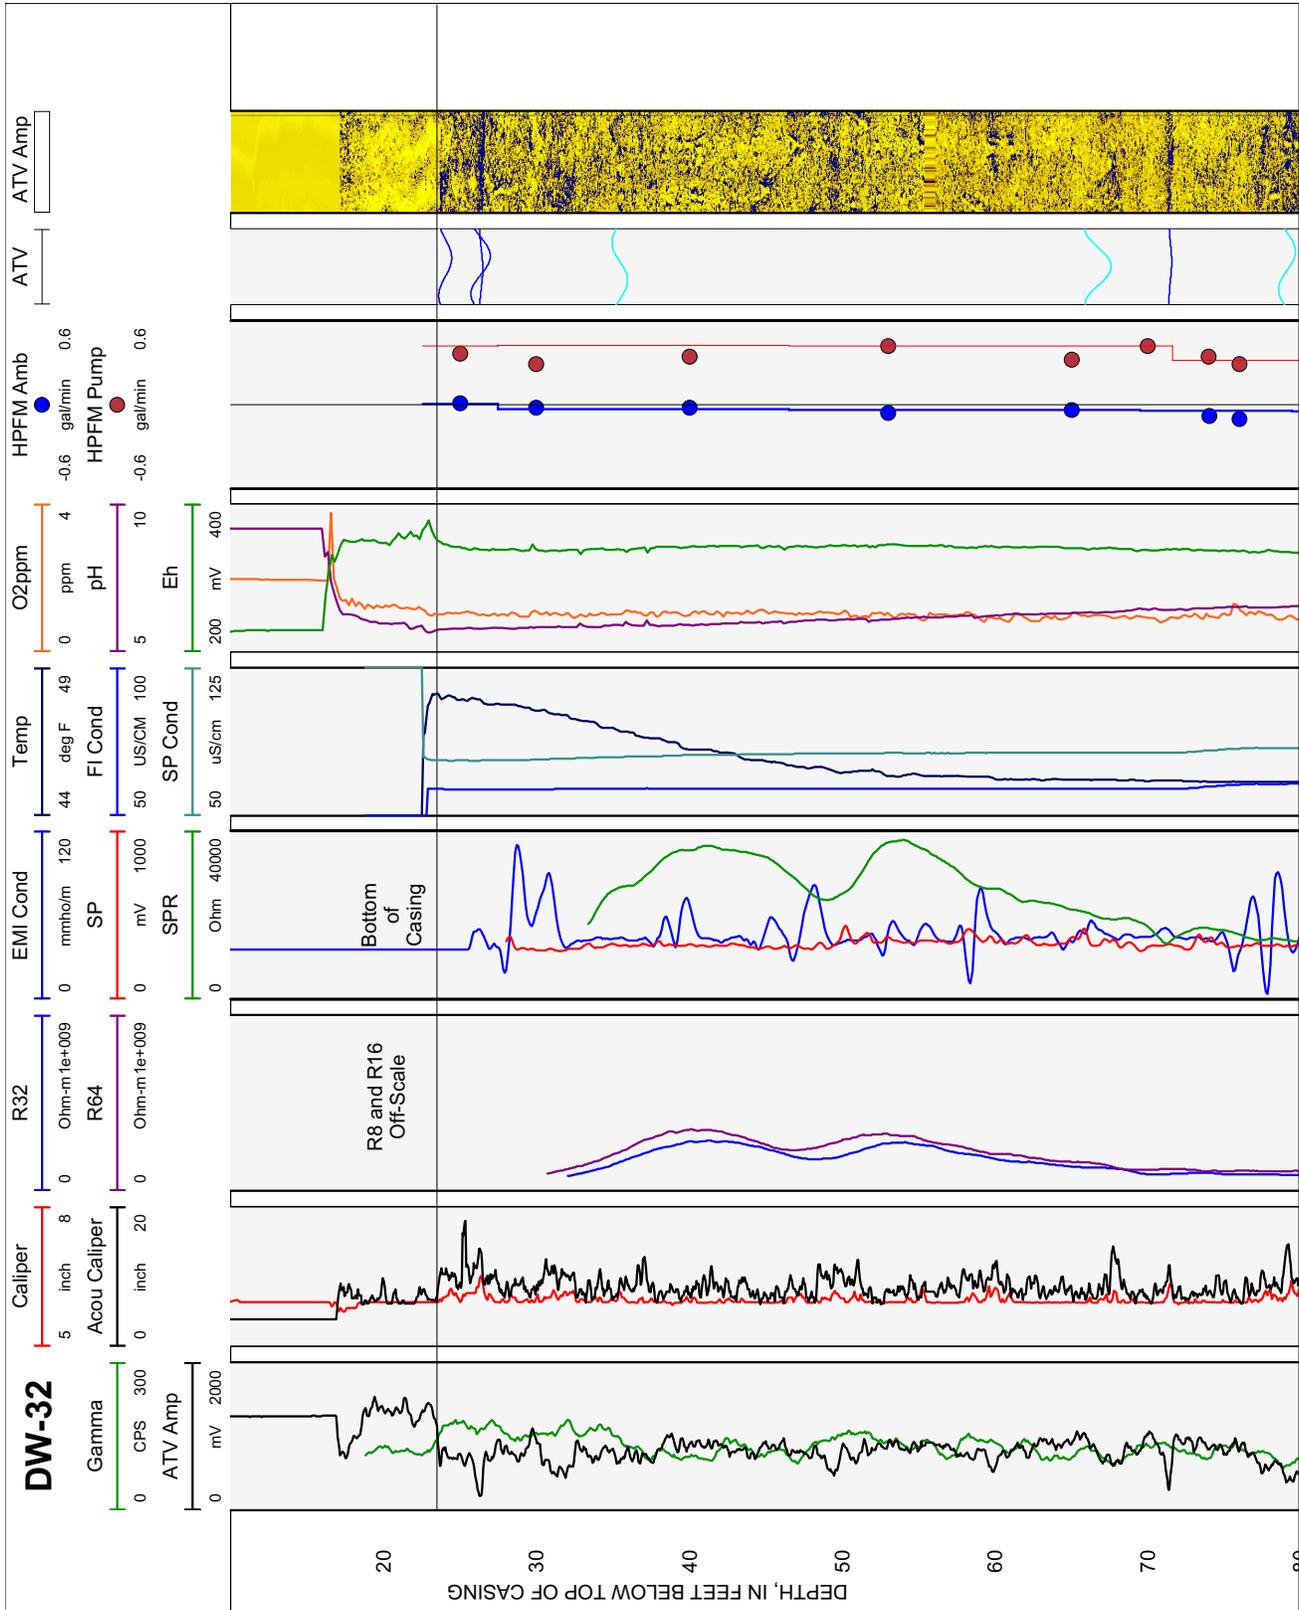
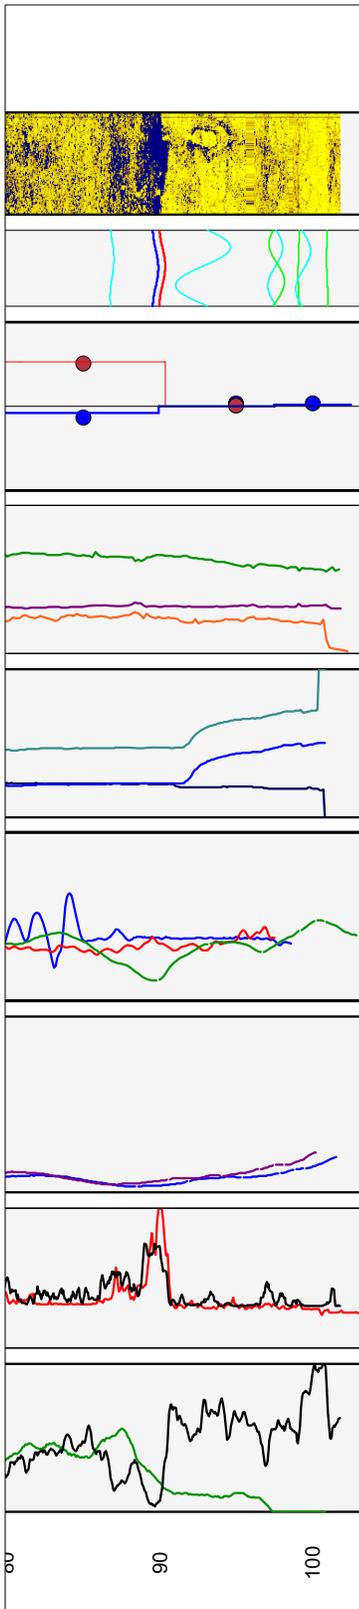
Figure 1G-1. Caliper, acoustic caliper, gamma, electromagnetic conductivity, fluid temperature, specific conductance, DO, pH, reduction oxidation, multi-space resistivity, oriented acoustic and optical borehole images, and heat-pulse flowmeter logs for borehole DW-32, near Machiasport, Maine.

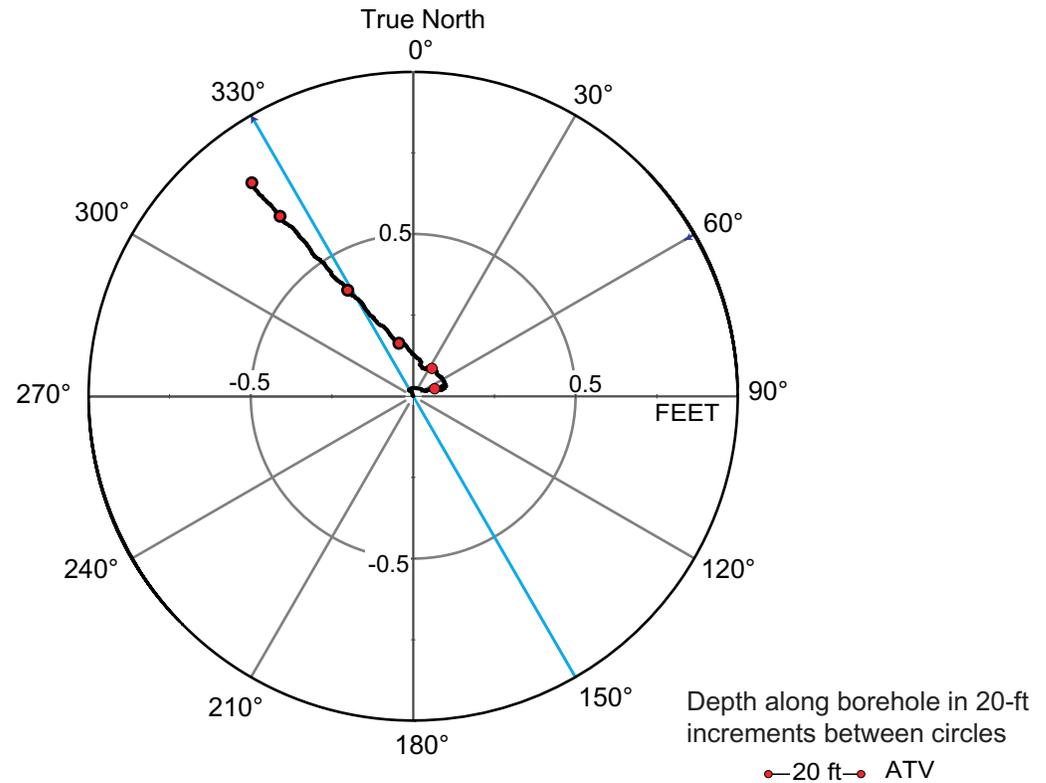
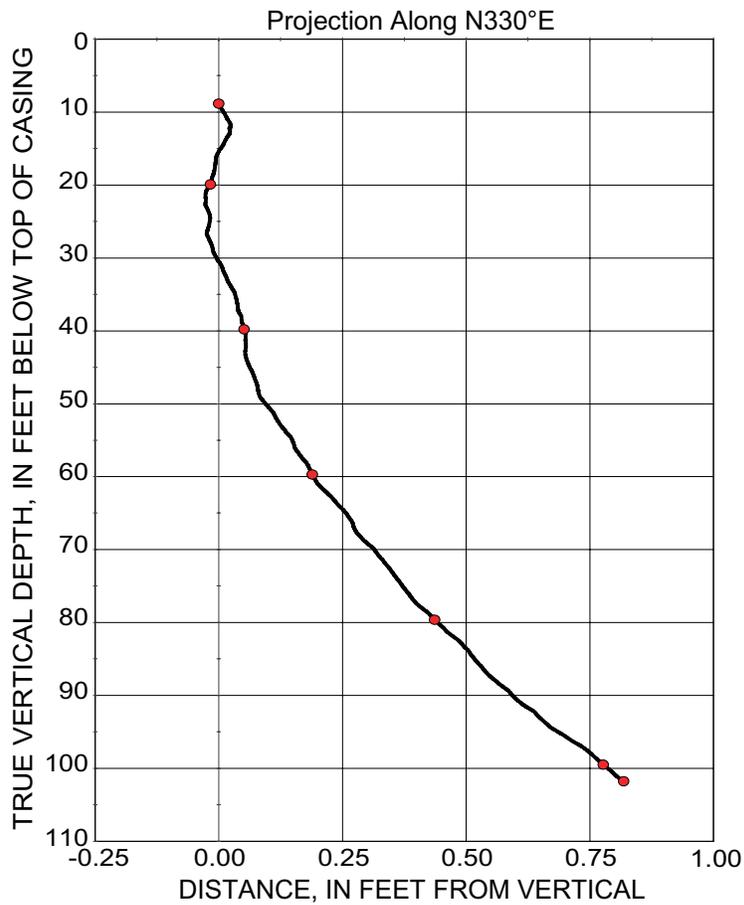
Figure 1G-2. Borehole deviation logs for borehole DW-32, near Machiasport, Maine. Blue line on radial plot (top) is line of projection for vertical plot (bottom).
 [ft, foot; ATV, acoustic televiewer]

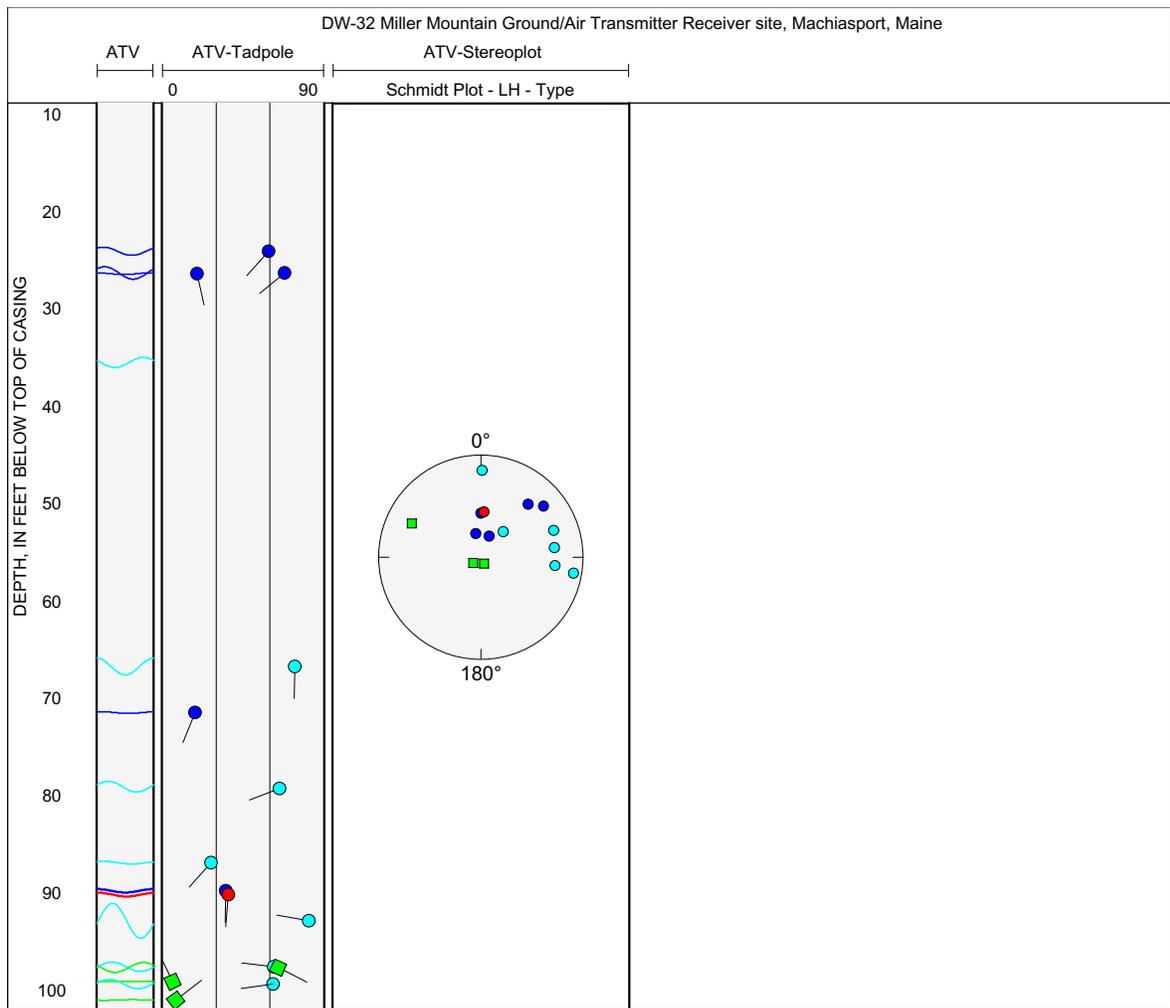
Figure 1G-3. Projection, tadpole, and stereoplots of interpretation of borehole image data for borehole DW-32, near Machiasport, Maine.

Table 1G–1. Interpretation of acoustic televiewer logs for borehole DW-32, near Machiasport, Maine.

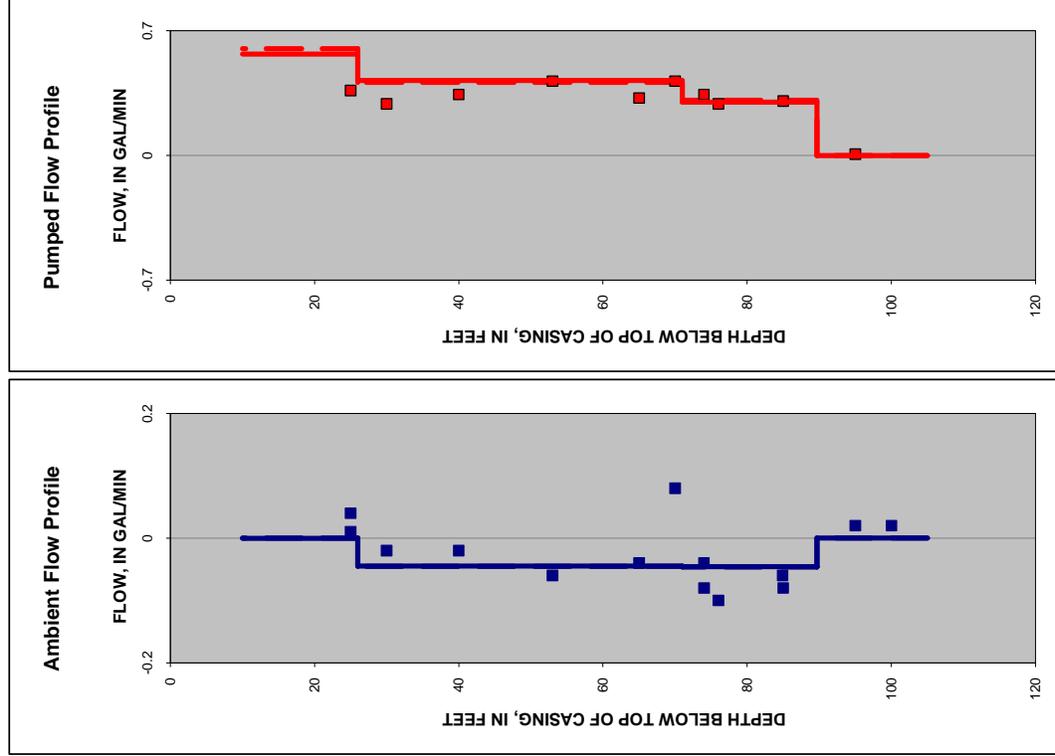
Dashed line indicates measured flow.
 Solid line indicates modeled flow.
 Points indicate measured heat-pulse flowmeter data.

Figure 1G-4. Interpretation and modeling of heat-pulse flowmeter logs for borehole DW-32, near Machiasport, Maine. [gal/min, gallon per minute; ft, feet; ft²/d, feet squared per day; positive values of flow are upward flow, negative values of flow are downward flow]

Fracture number	Depth (ft)	Ambient flow above fracture (gal/min)	Pumped flow above fracture (gal/min)	Zone transmissivity (ft ² /d)	Water level (ft)	Elevation of water level (ft)	Percent transmissivity
3	26.0	0.000	0.570	82.5	16.95	45.05	16
2	71.0	-0.045	0.422	99.0	17.04	44.96	19
1	89.7	-0.046	0.299	330.0	17.07	44.93	65

Total borehole transmissivity	511.5	(ft ² /d)
Sum of squares error	0.00116	(gal/min) ²
Root mean square error	0.01967	(gal/min)
