Borehole Geophysical Investigation of a Formerly Used Defense Site, Machiasport, Maine, 2003–2006

By Carole D. Johnson, Remo A. Mondazzi, and Peter K. Joesten

Scientific Investigations Report 2009–5120

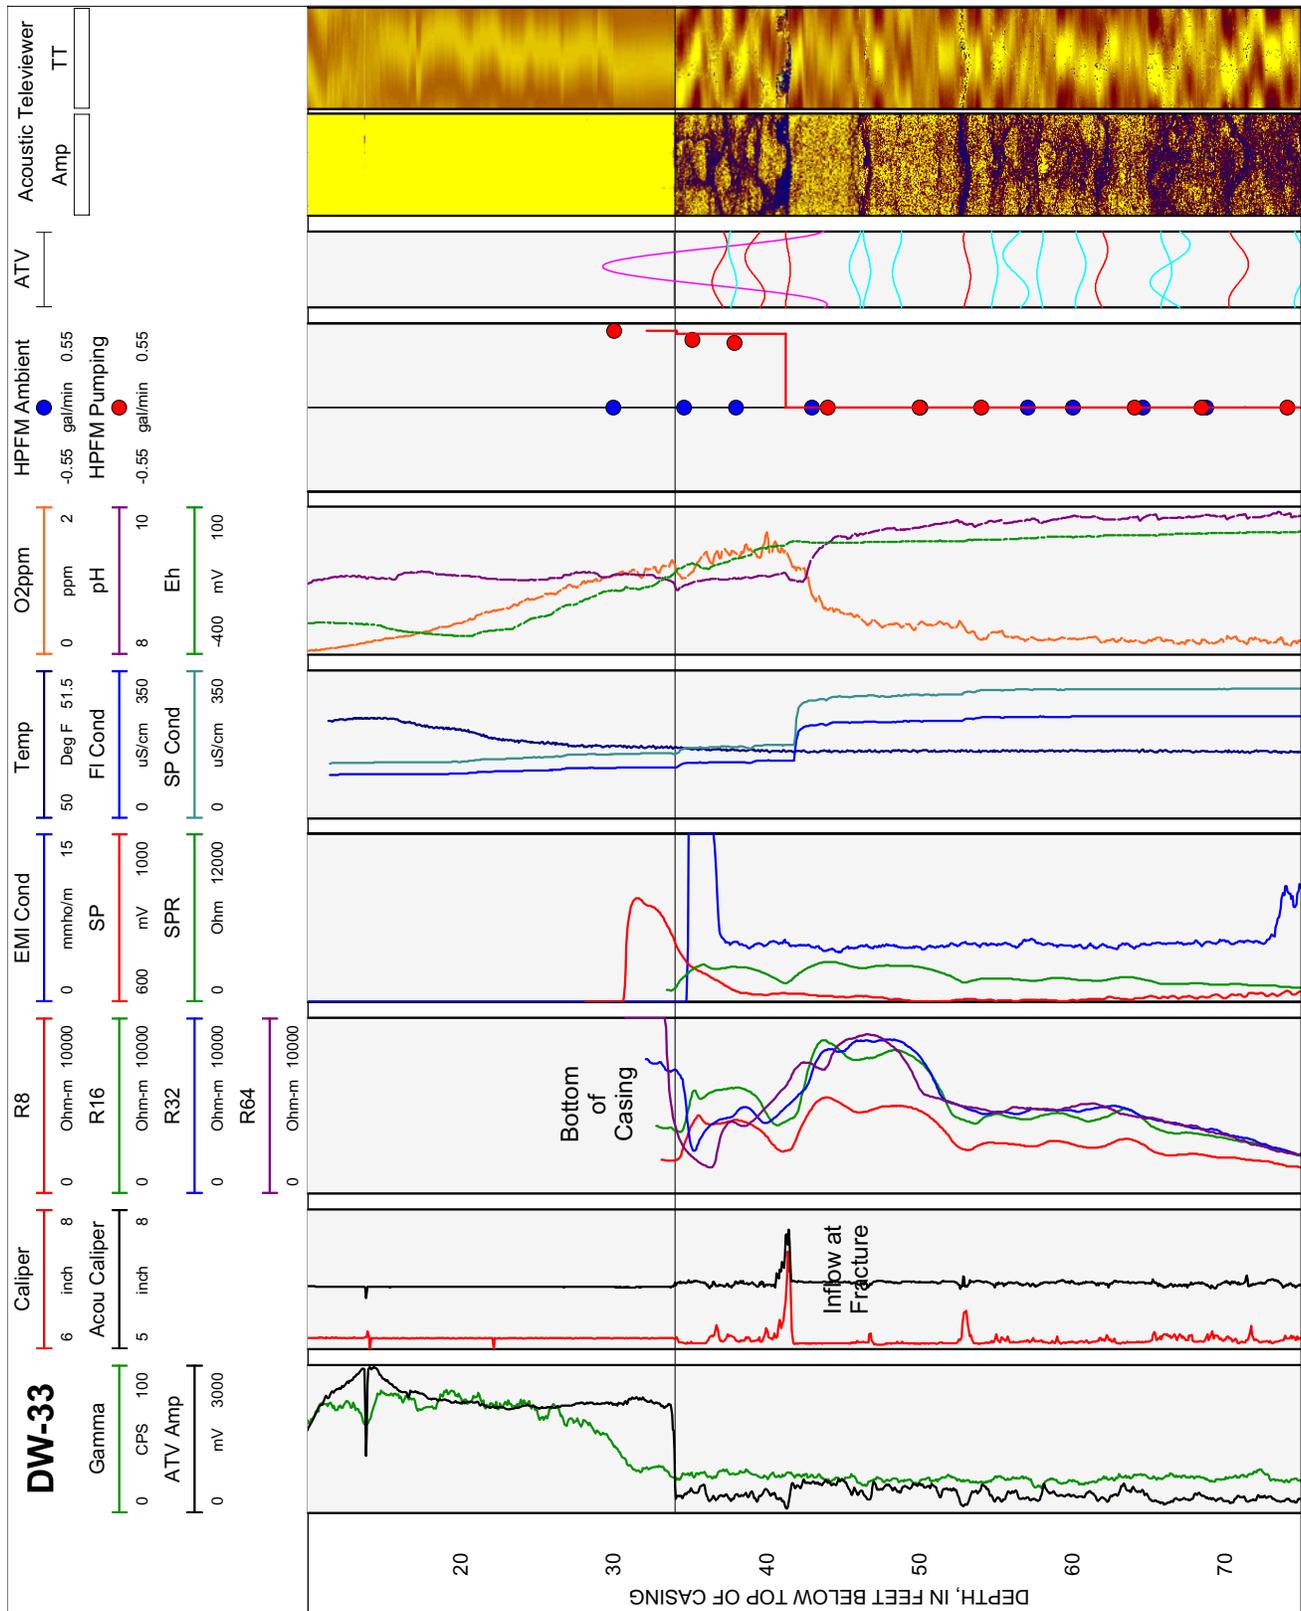
Figure 1H-1. Caliper, acoustic caliper, gamma, electromagnetic conductivity, fluid temperature, specific conductance, DO, pH, reduction oxidation, multi-space resistivity, oriented acoustic and optical borehole images, and heat-pulse flowmeter logs for borehole DW-33, near Machiasport, Maine.

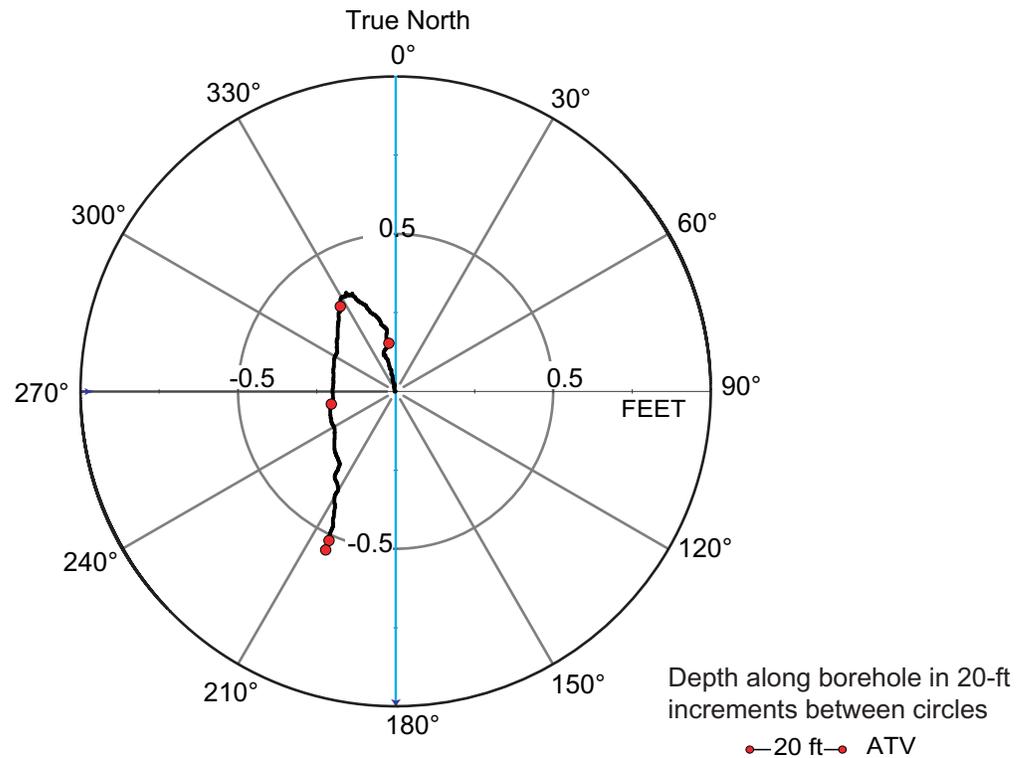
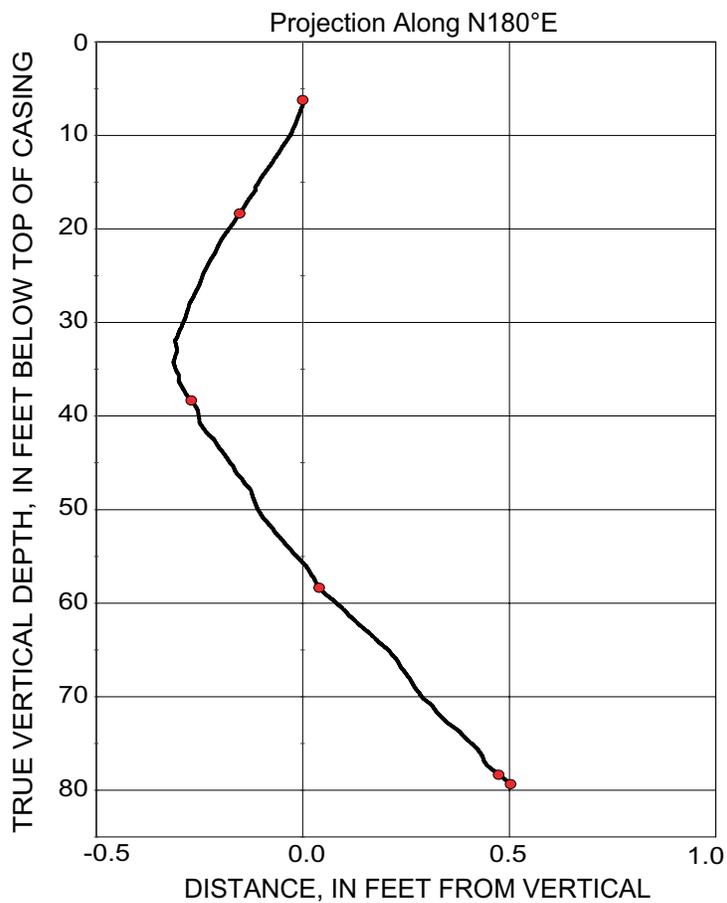
Figure 1H-2. Borehole deviation logs for borehole DW-33, near Machiasport, Maine. Blue line on radial plot (top) is line of projection for vertical plot (bottom).
[ft, foot; ATV, acoustic televiewer]

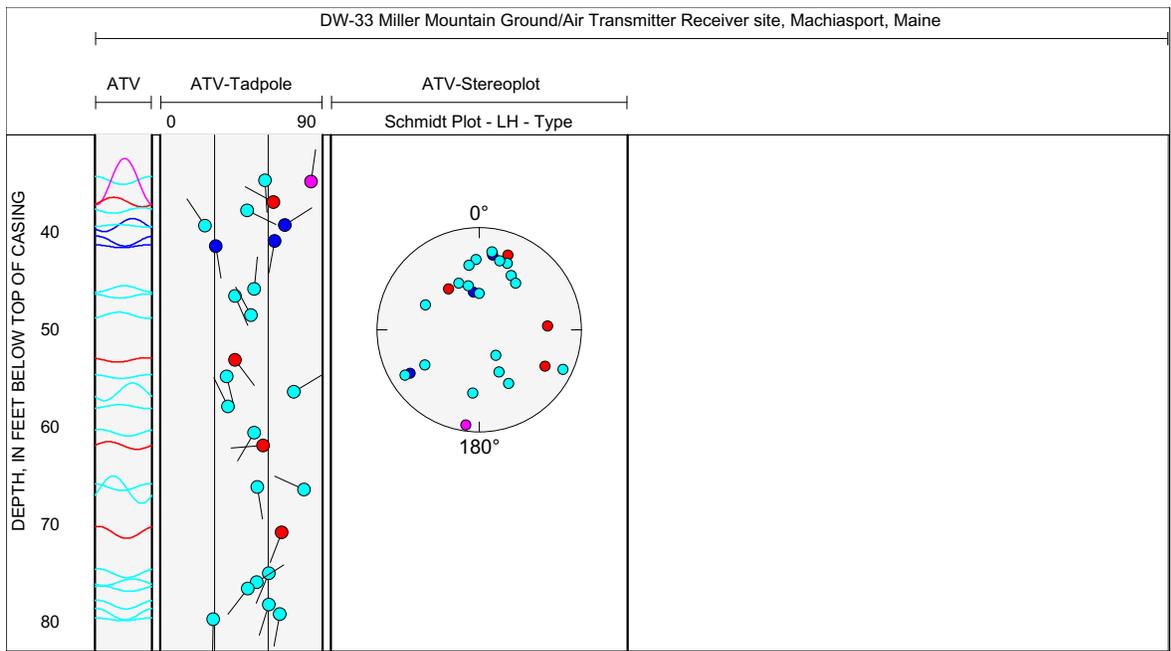
Figure 1H-3. Projection, tadpole, and stereoplots of interpretation of borehole image data for borehole DW-33, near Machiasport, Maine.

Table 1H-1. Interpretation of acoustic televiewer logs for borehole DW-33, near Machiasport, Maine.

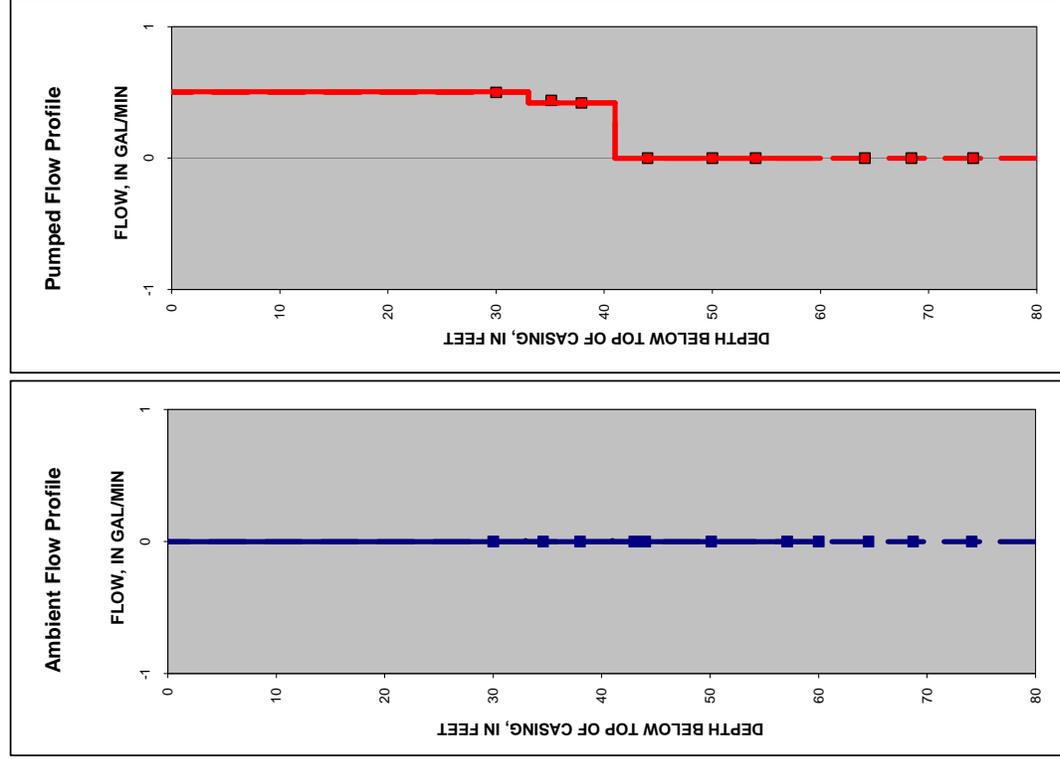
Dashed line indicates measured flow.
 Solid line indicates modeled flow.
 Points indicate measured heat-pulse flowmeter data.

Figure 1H-4. Interpretation and modeling of heat-pulse flowmeter logs for borehole DW-33, near Machiasport, Maine. [gal/min, gallon per minute; ft, feet; ft²/d, feet squared per day; positive values of flow are upward flow, negative values of flow are downward flow]

Fracture number	Depth (ft)	Ambient flow above fracture (gal/min)	Pumped flow above fracture (gal/min)	Zone transmissivity (ft ² /d)	Water level (ft)	Elevation of water level (ft)	Percent transmissivity
2	34.0	0.000	0.506	14.0	3.97	48.830002	14
1	41.0	0.000	0.420	84.0	3.97	48.830002	86

Total borehole transmissivity	98.0	(ft ² /d)
Sum of squares error	0.000	(gal/min) ²
Root mean square error	0.004	(gal/min)

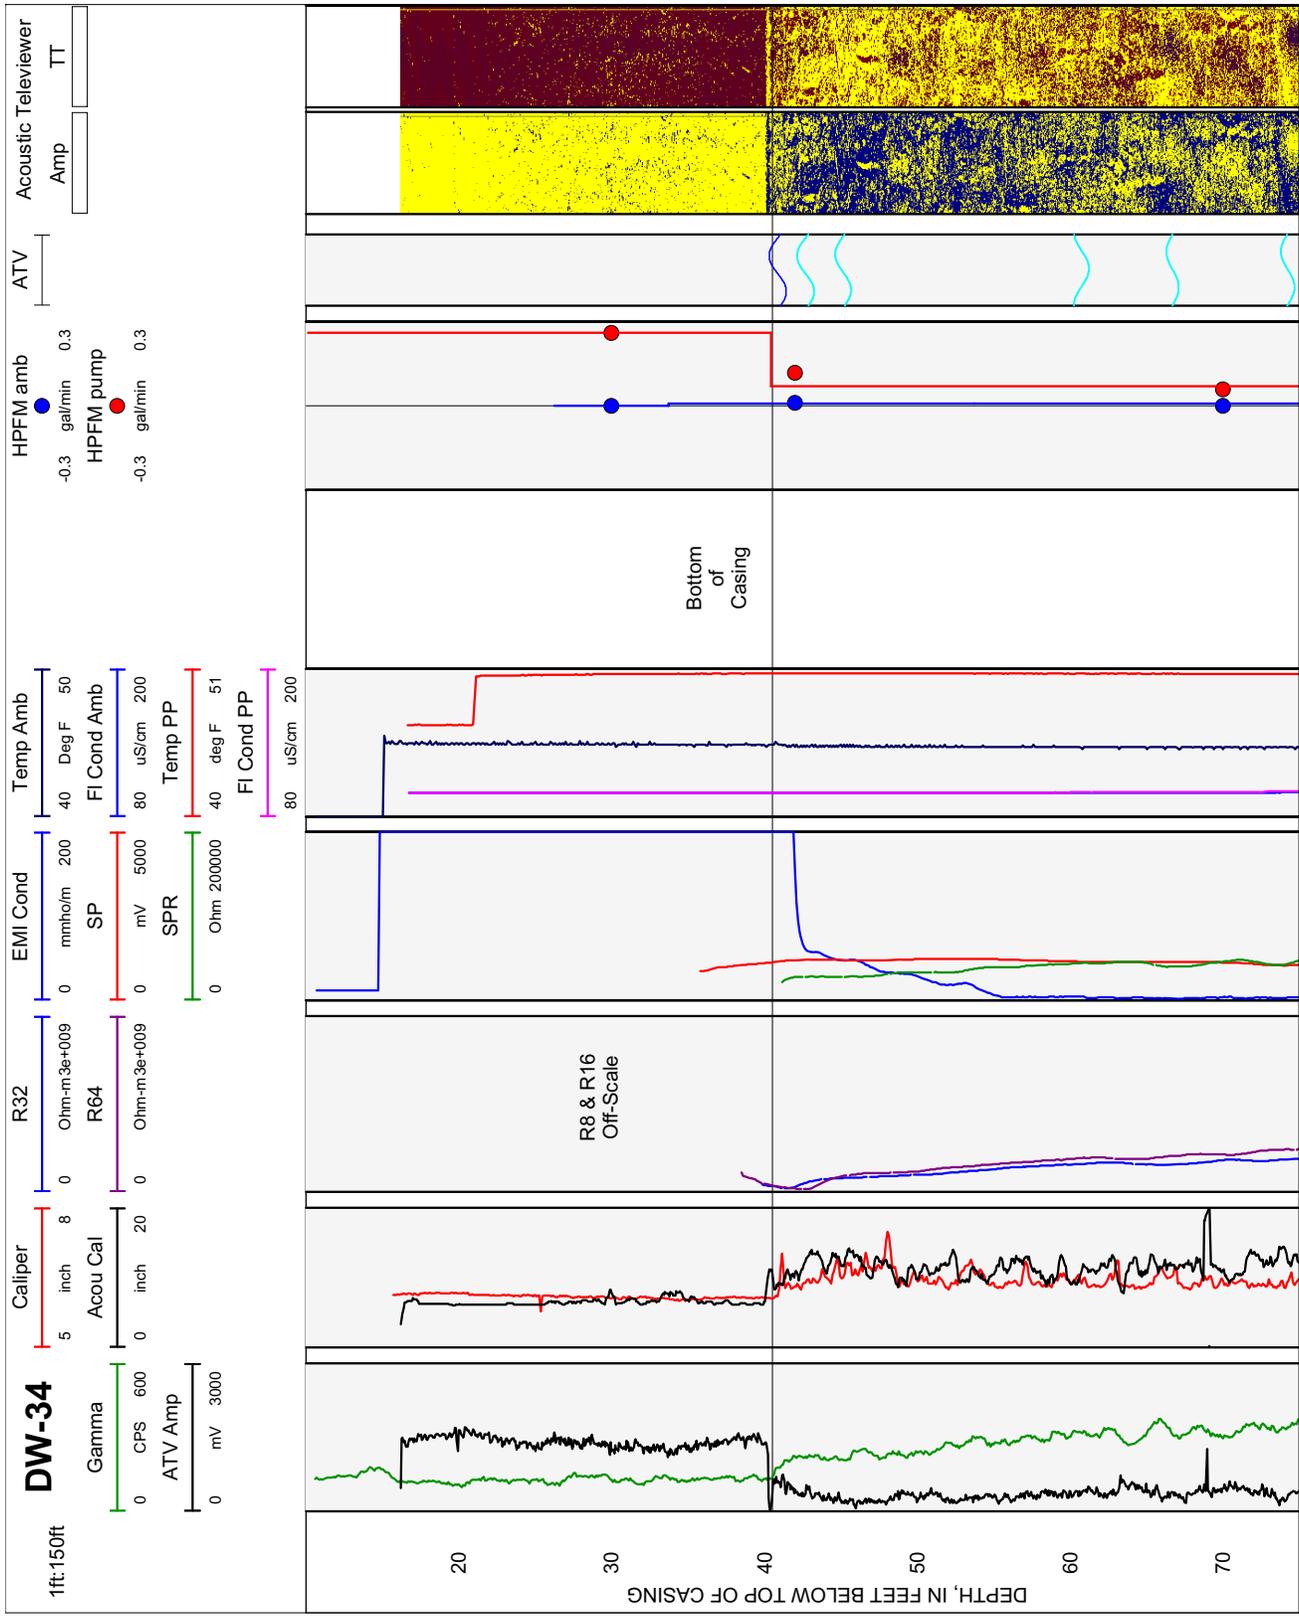
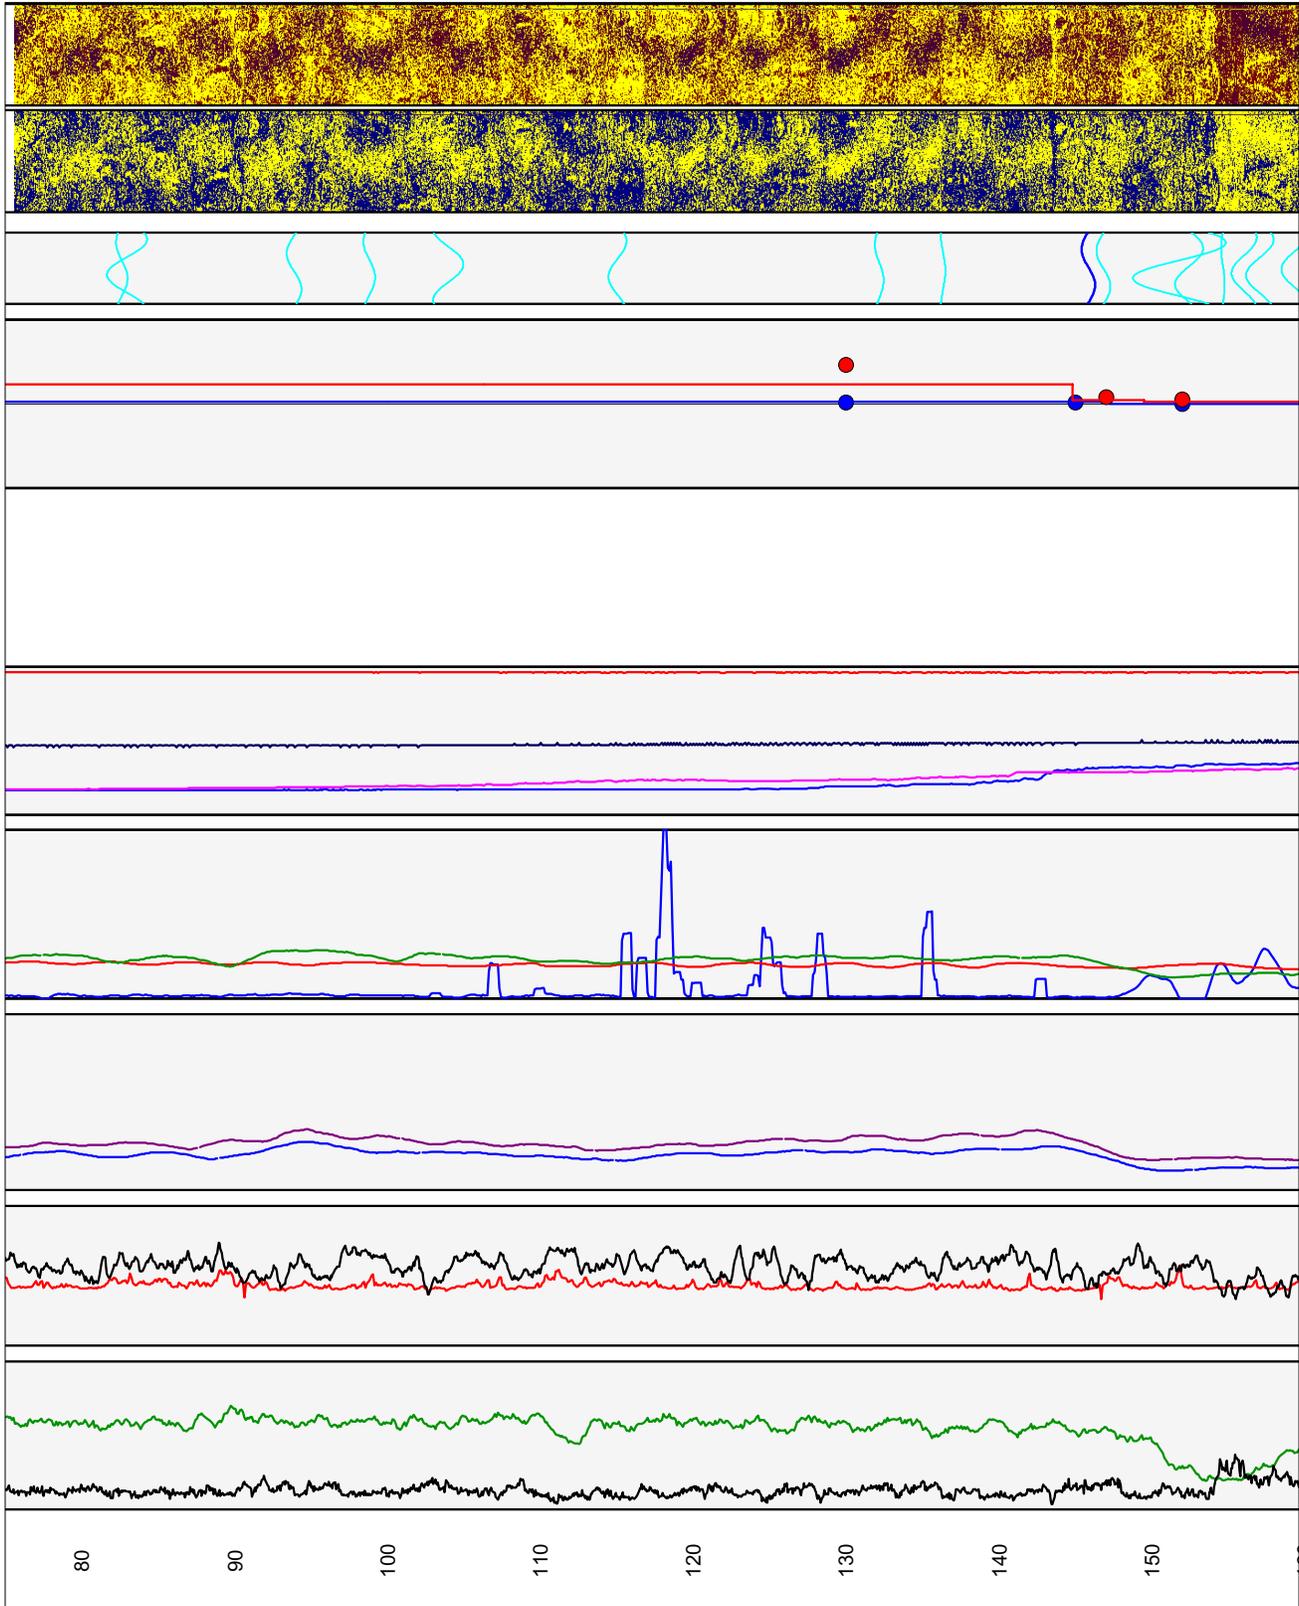
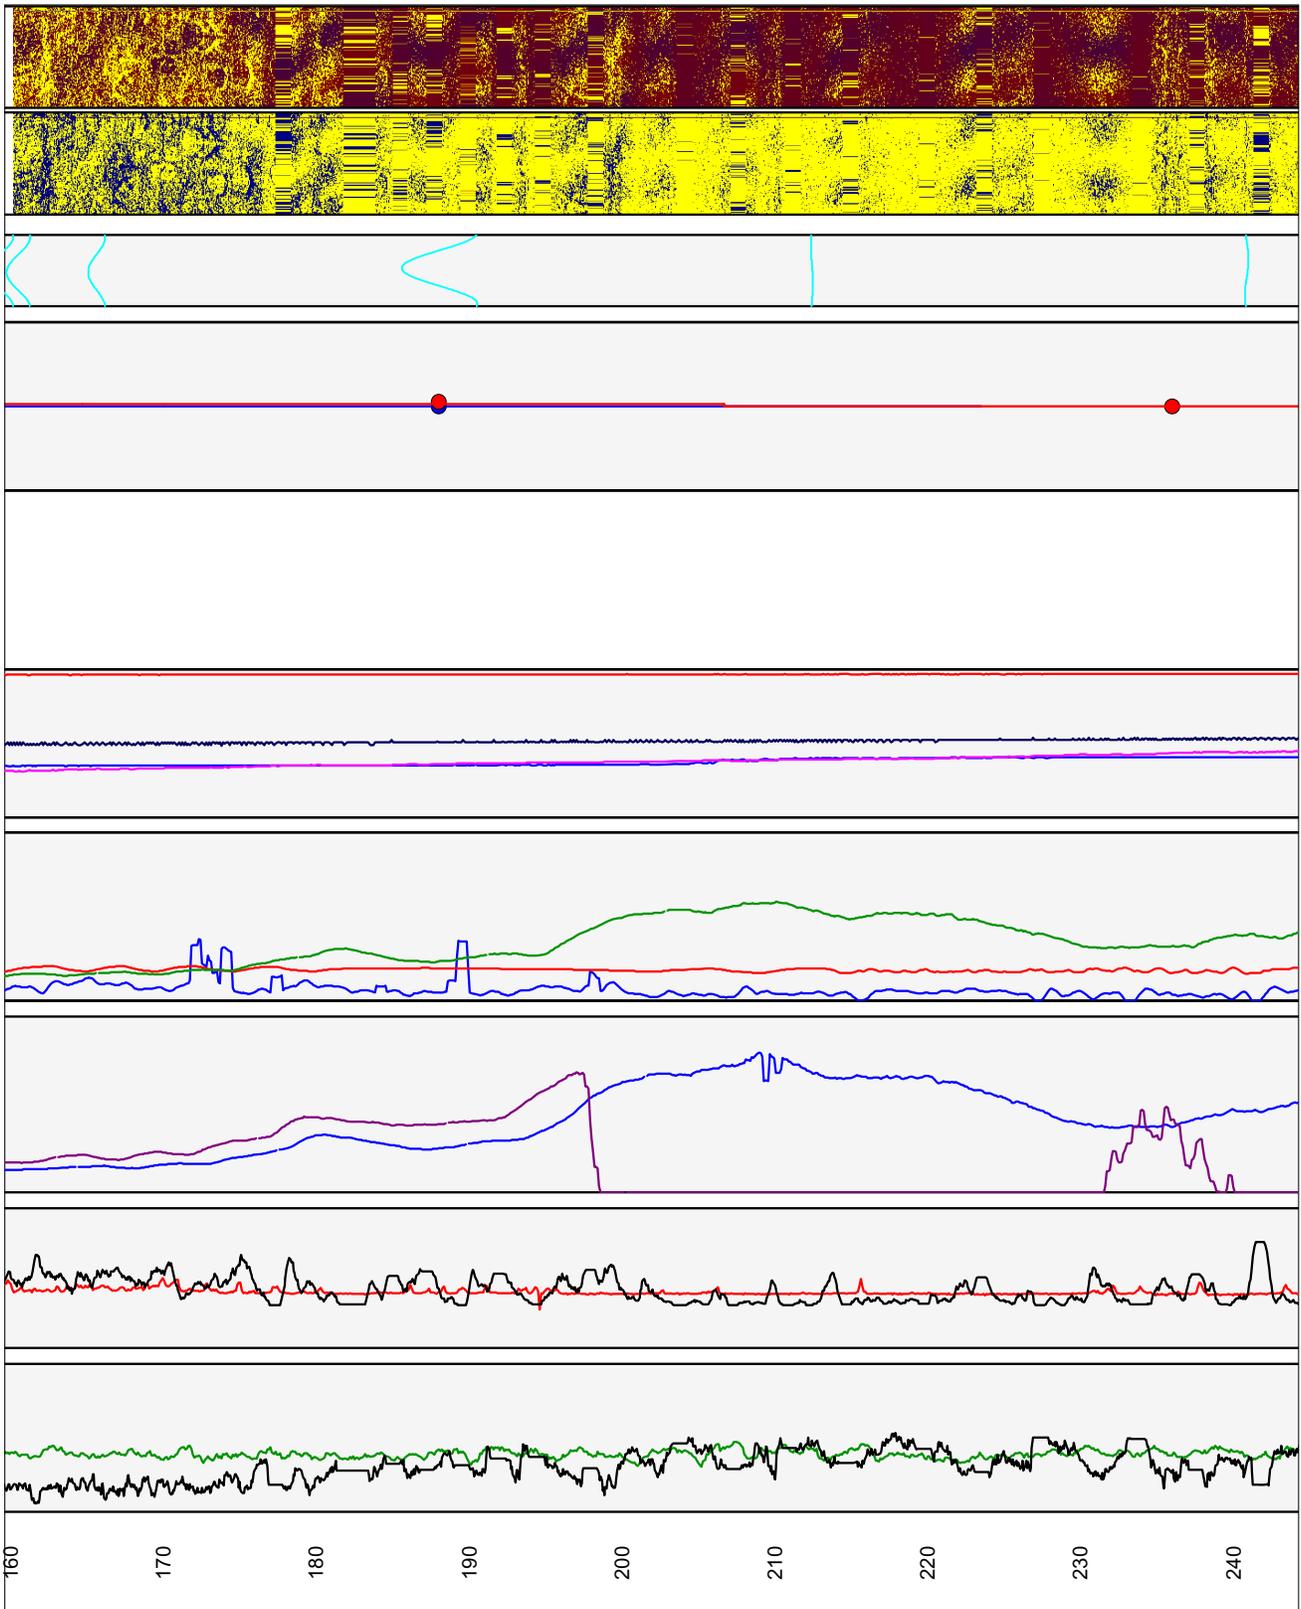
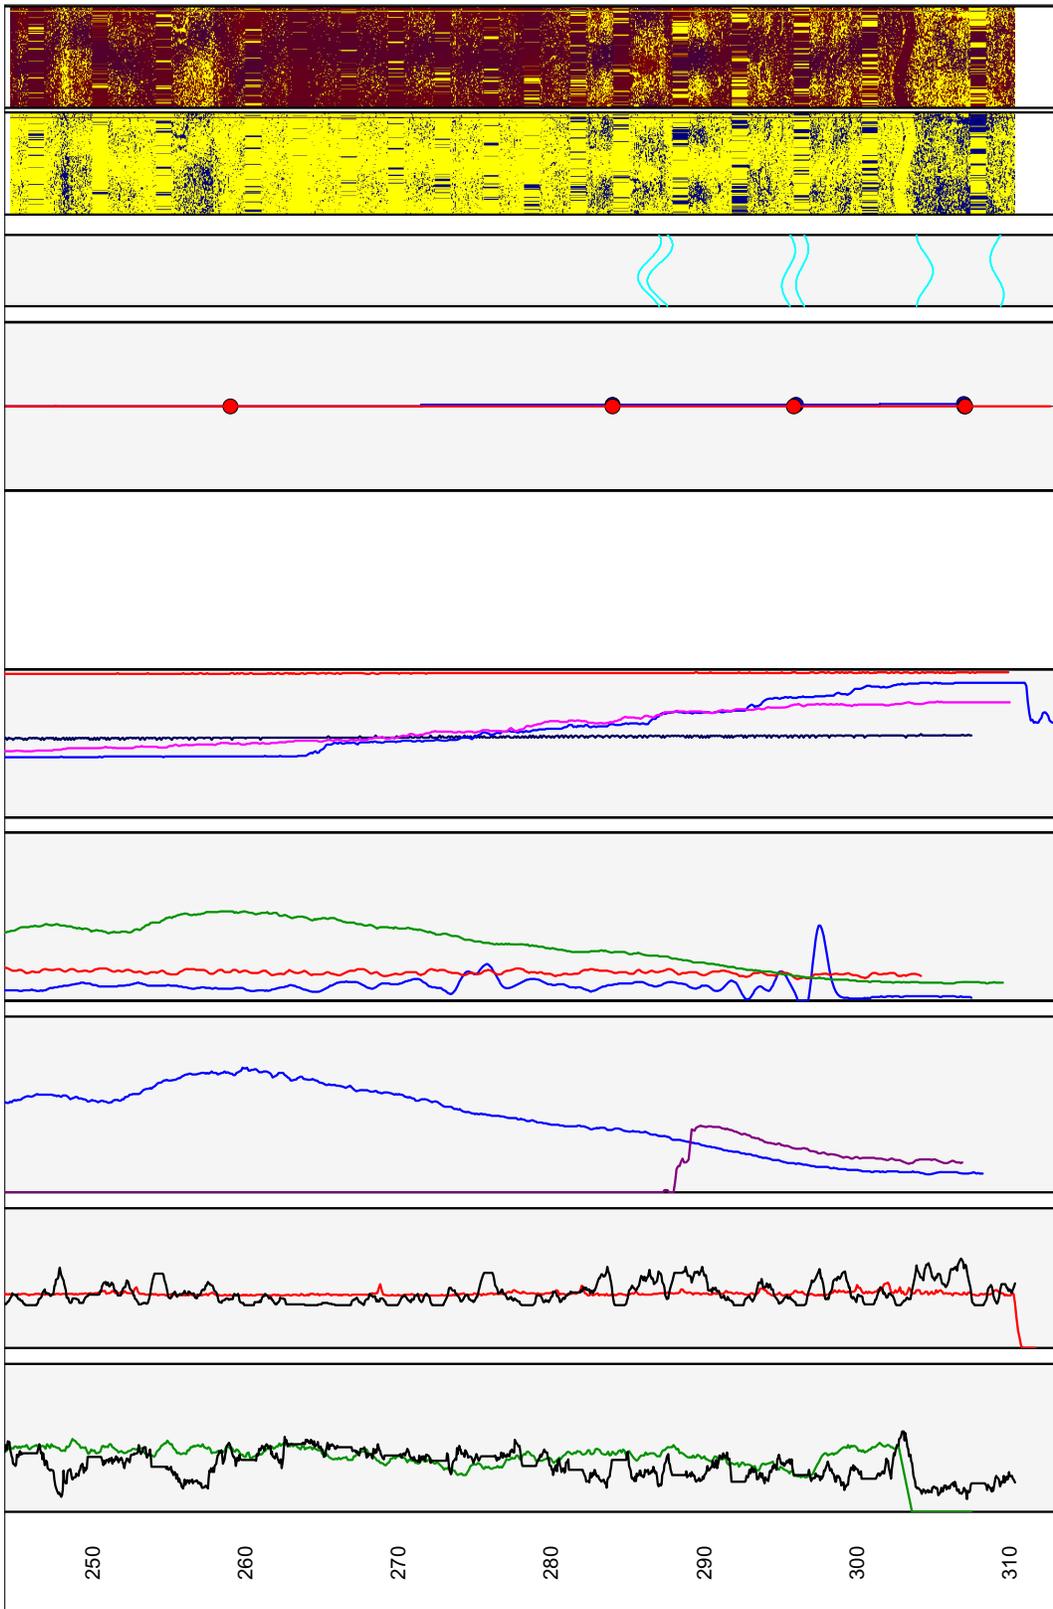
Figure 11-1. Caliper, acoustic caliper, gamma, electromagnetic conductivity, fluid temperature, specific conductance, DO, pH, reduction oxidation, multi-space resistivity, oriented acoustic and optical borehole images, and heat-pulse flowmeter logs for borehole DW-34, near Machiasport, Maine.

Figure 1I-1. Caliper, acoustic caliper, gamma, electromagnetic conductivity, fluid temperature, specific conductance, DO, pH, reduction oxidation, multi-space resistivity, oriented acoustic and optical borehole images, and heat-pulse flowmeter logs for borehole DW-34, near Machiasport, Maine.—Continued

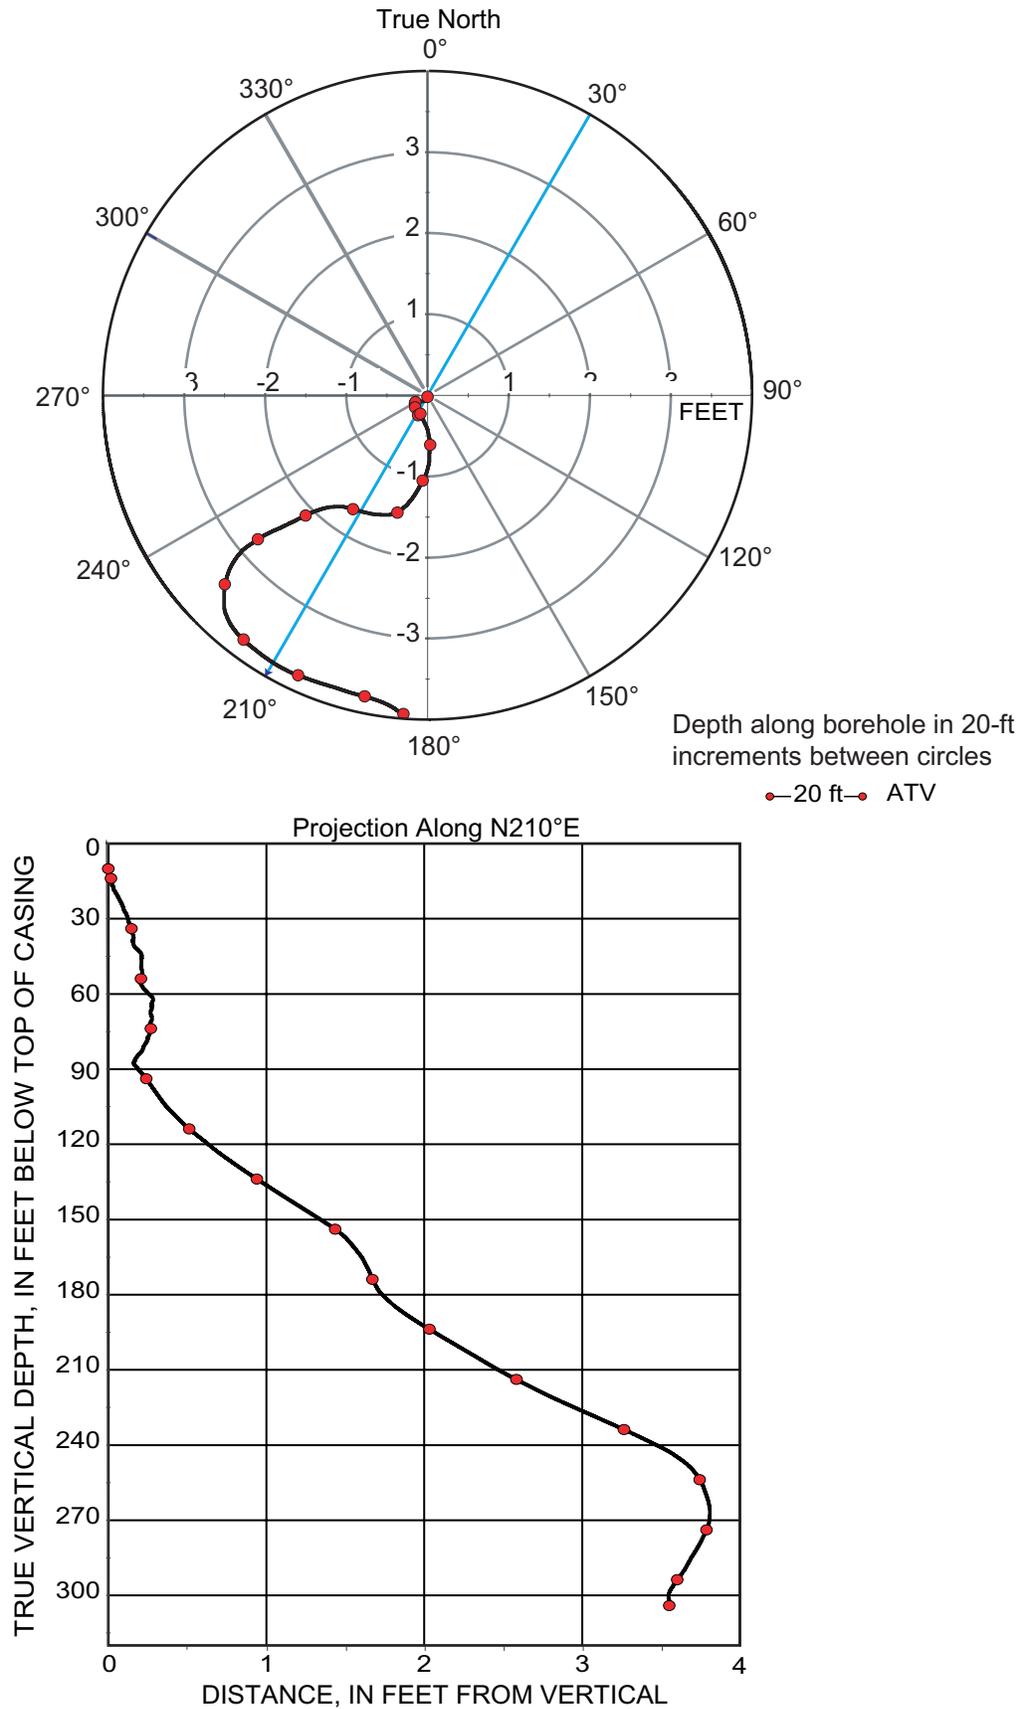
Figure 11-2. Borehole deviation logs for borehole DW-34, near Machiasport, Maine. Blue line on radial plot (top) is line of projection for vertical plot (bottom). Deviation (tilt) data interpolated from 95 to 295 feet below top of casing. [ft, foot; ATV, acoustic televiewer]

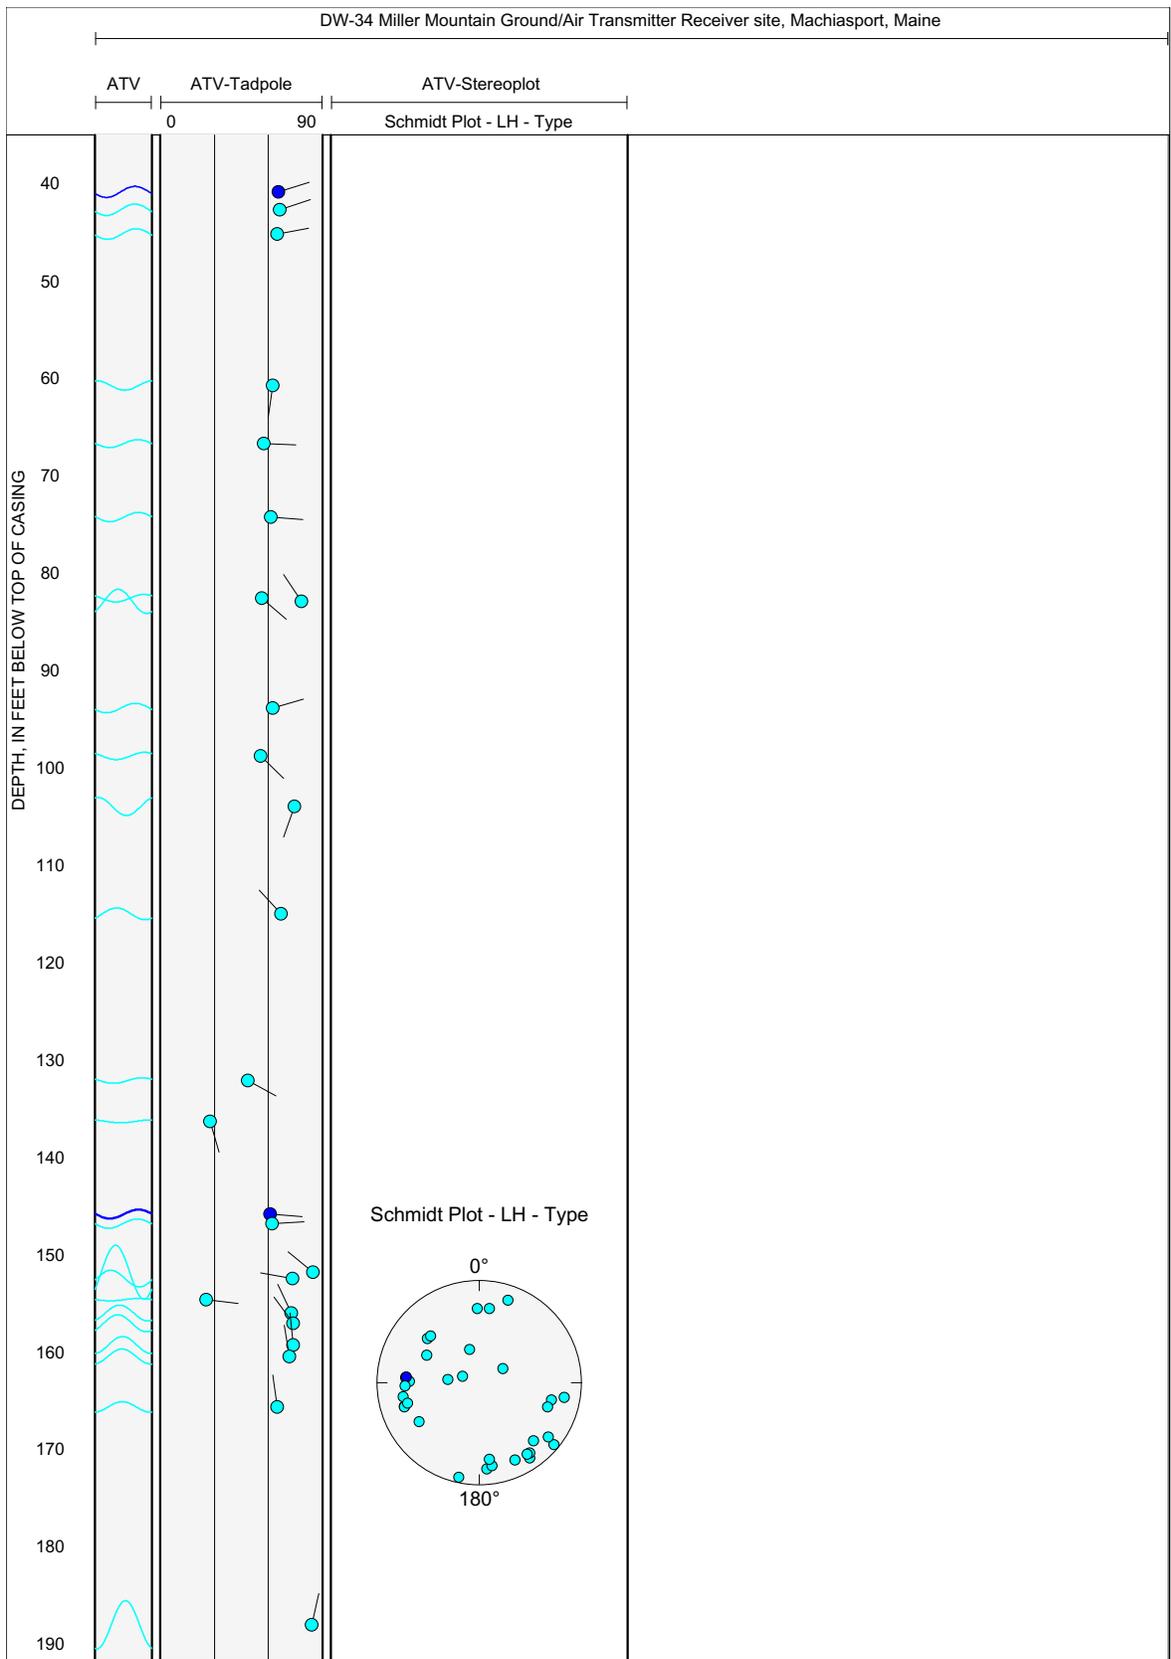
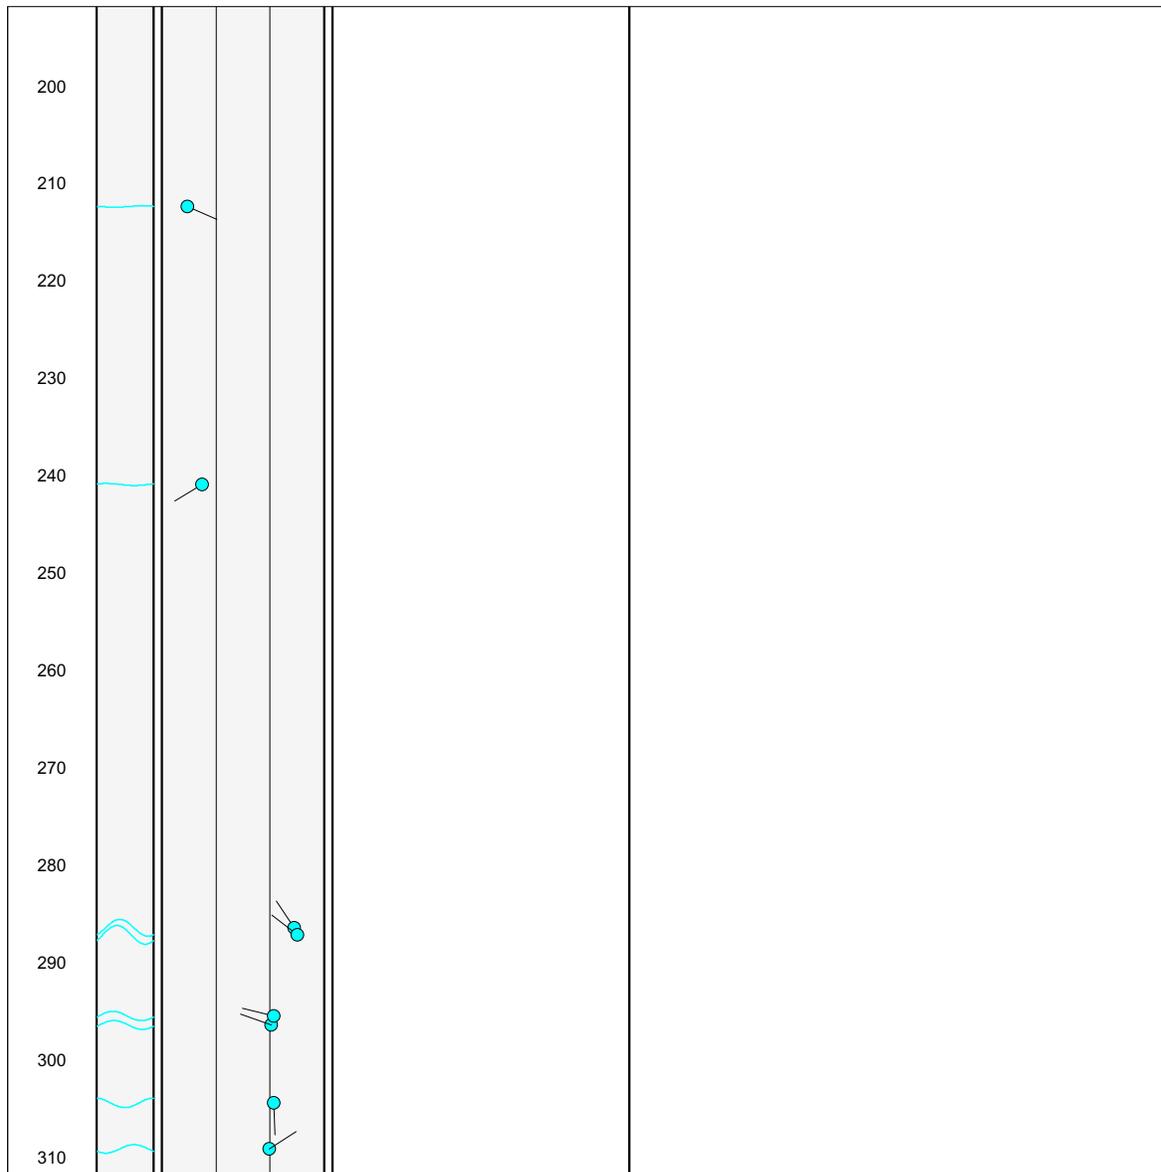
Figure 11-3. Projection, tadpole, and stereoplots of interpretation of borehole image data for borehole DW-34, near Machiasport, Maine.

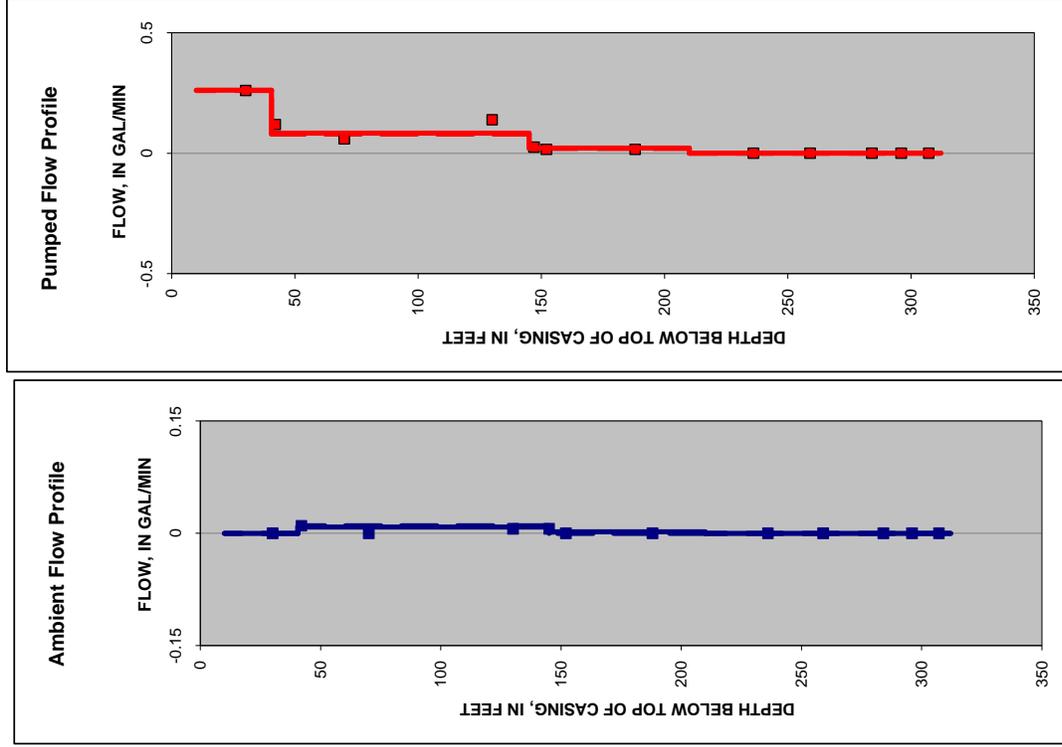
Dashed line indicates measured flow.
 Solid line indicates modeled flow.
 Points indicate measured heat-pulse flowmeter data.

Figure 11-4. Interpretation and modeling of heat-pulse flowmeter logs for borehole DW-34, near Machiasport, Maine. [gal/min, gallon per minute; ft, feet; ft²/d, feet squared per day; positive values of flow are upward flow, negative values of flow are downward flow]

Fracture number	Depth (ft)	Ambient flow above fracture (gal/min)	Pumped flow above fracture (gal/min)	Zone transmissivity (ft ² /d)	Water level (ft)	Elevation of water level (ft)	Percent transmissivity
3	40.5	0.000	0.262	6.00	8.65	58.25	75
2	145	0.009	0.084	1.50	7.65	59.25	19
1	210	0.002	0.022	0.48	7.65	59.25	6

Total borehole transmissivity	8.0	(ft ² /d)
Sum of squares error	0.00003	(gal/min) ²
Root mean square error	0.00298	(gal/min)
