Borehole Geophysical Investigation of a Formerly Used Defense Site, Machiasport, Maine, 2003–2006

By Carole D. Johnson, Remo A. Mondazzi, and Peter K. Joesten

Scientific Investigations Report 2009–5120

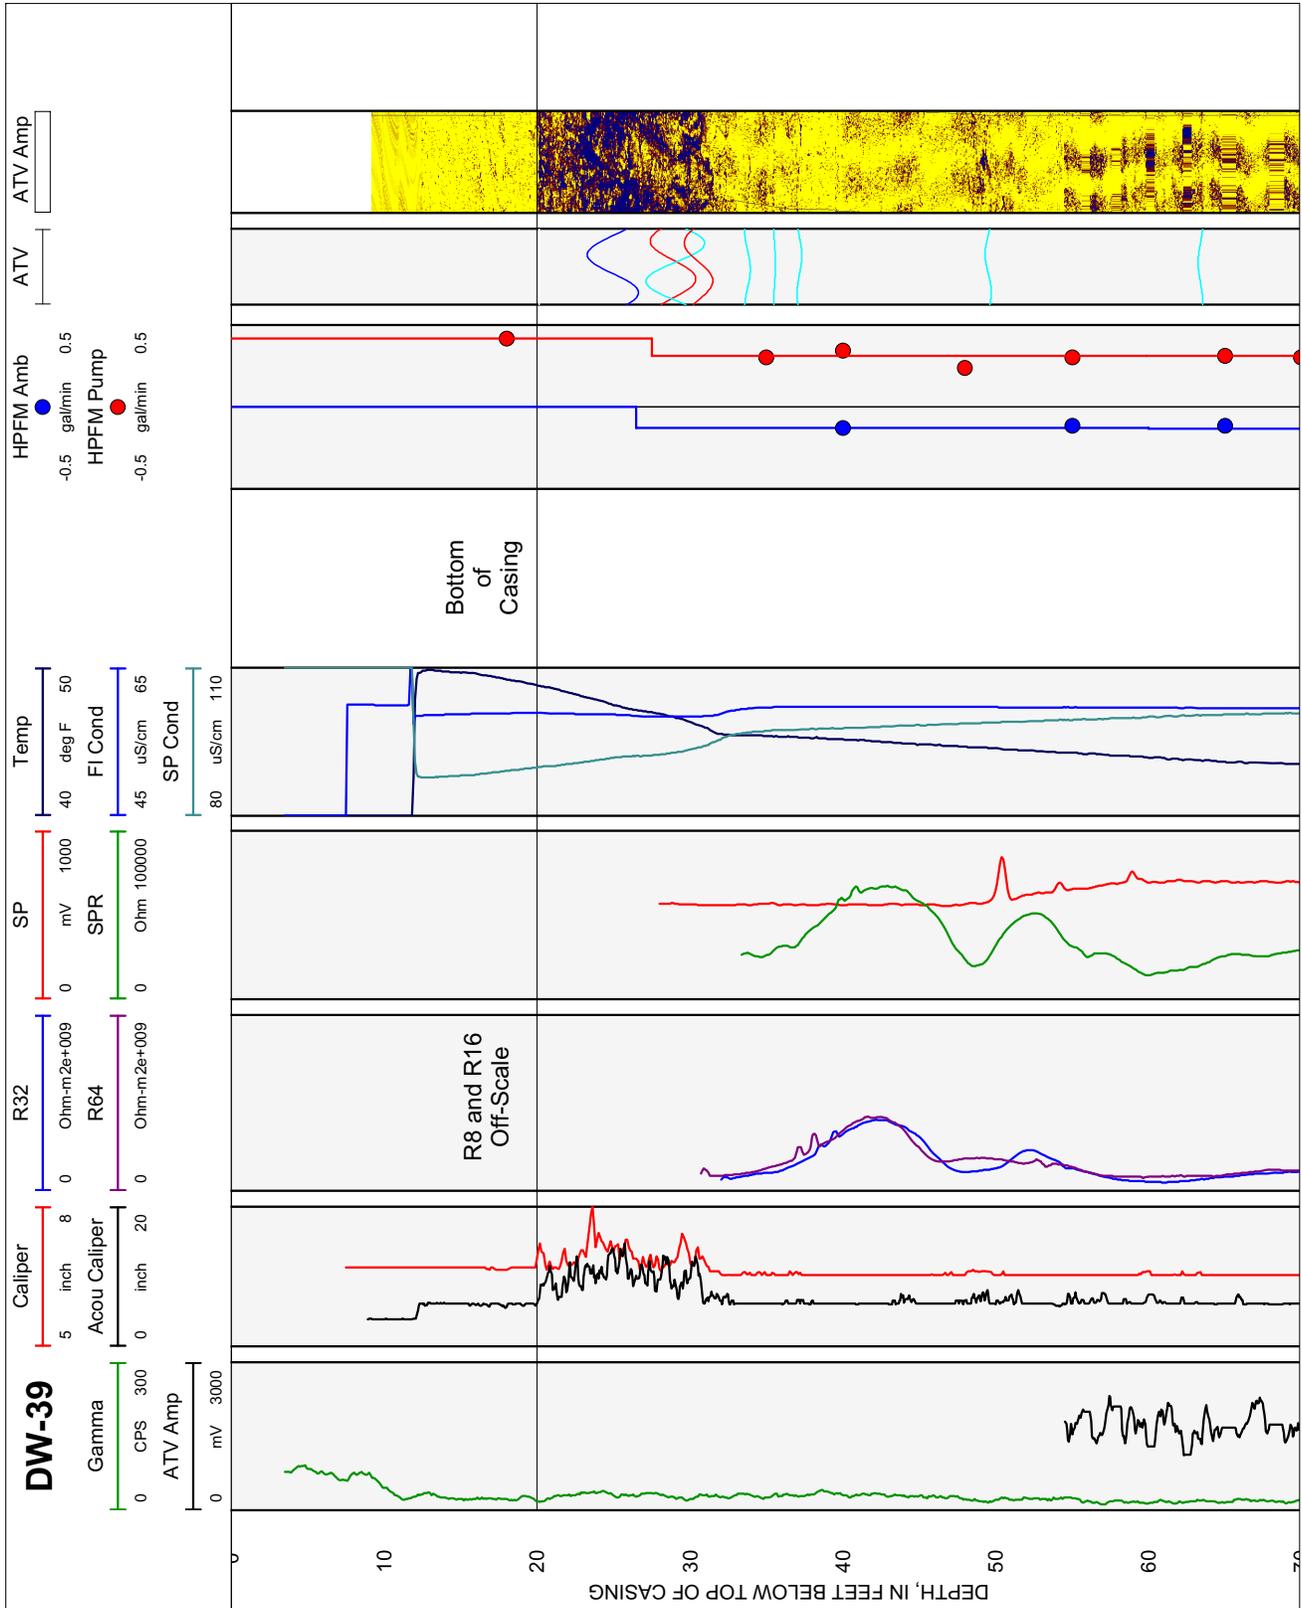
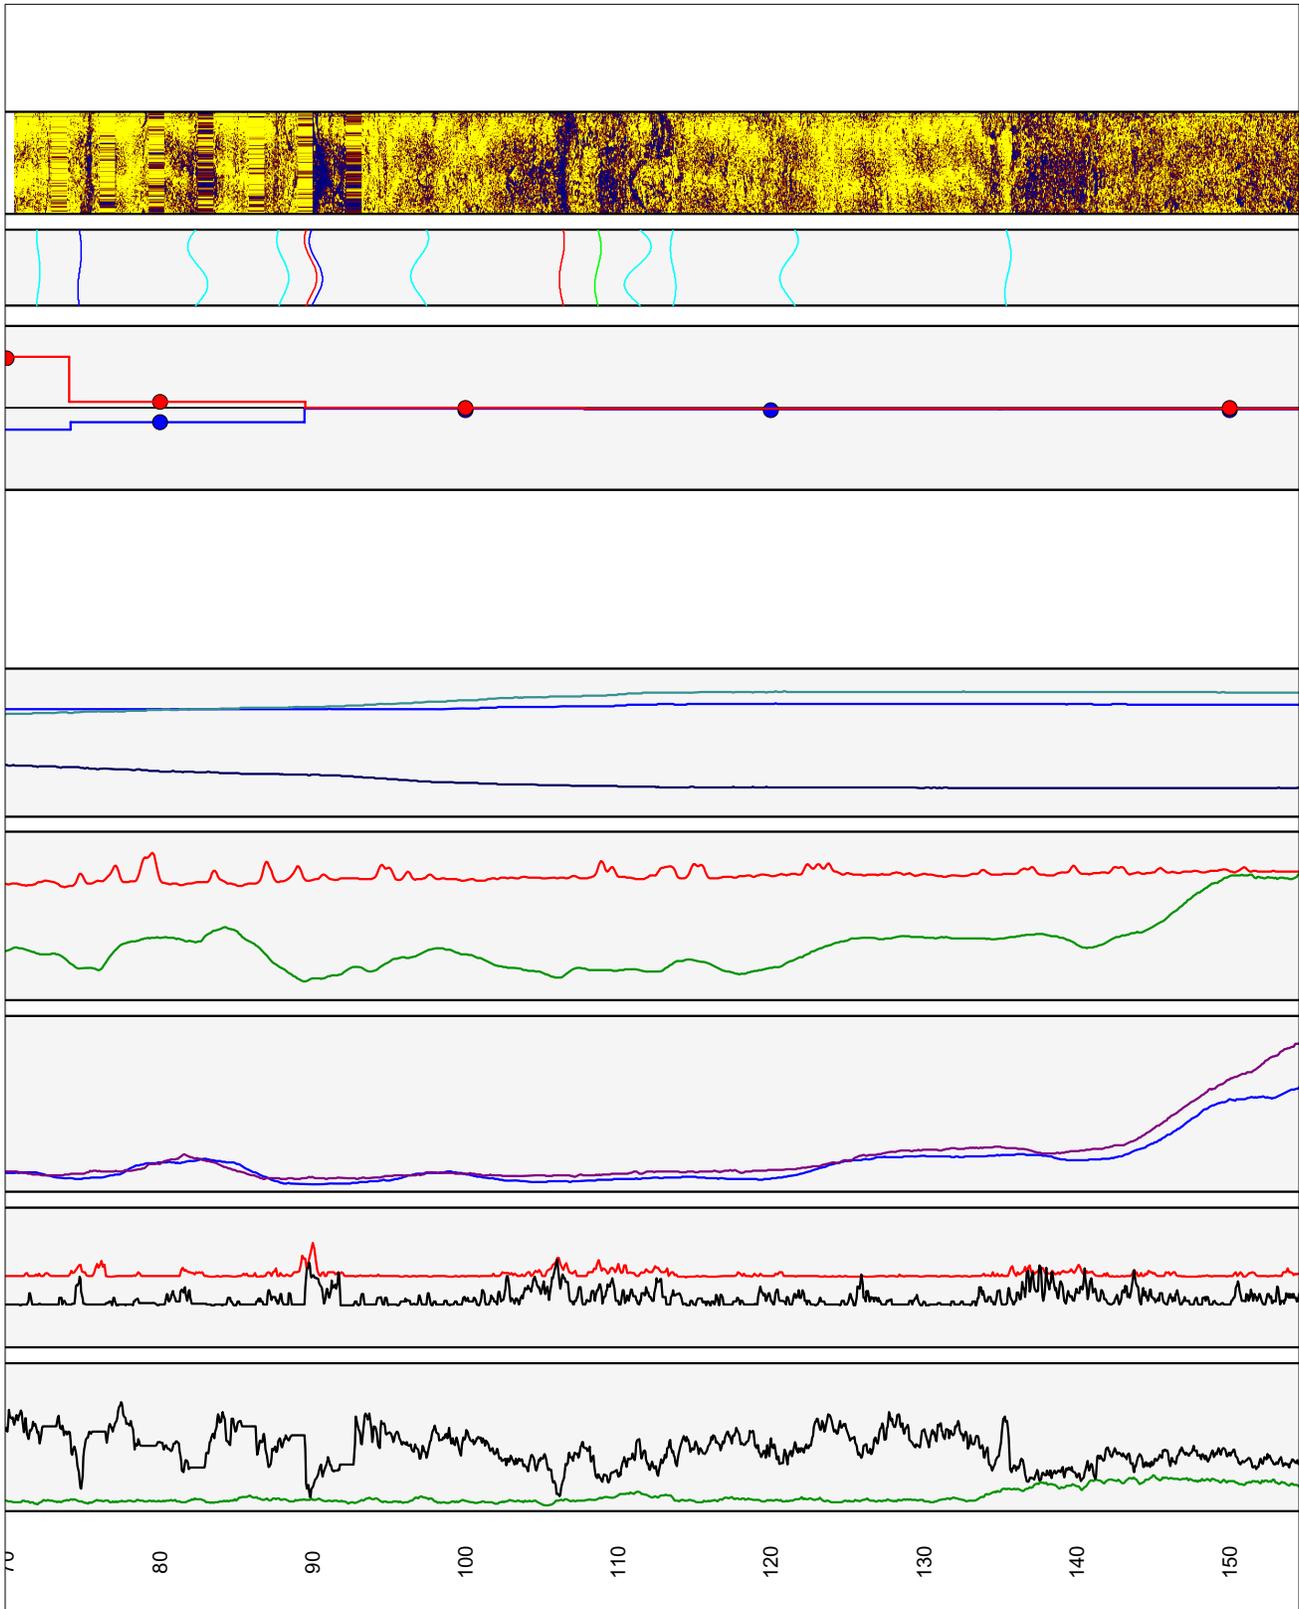
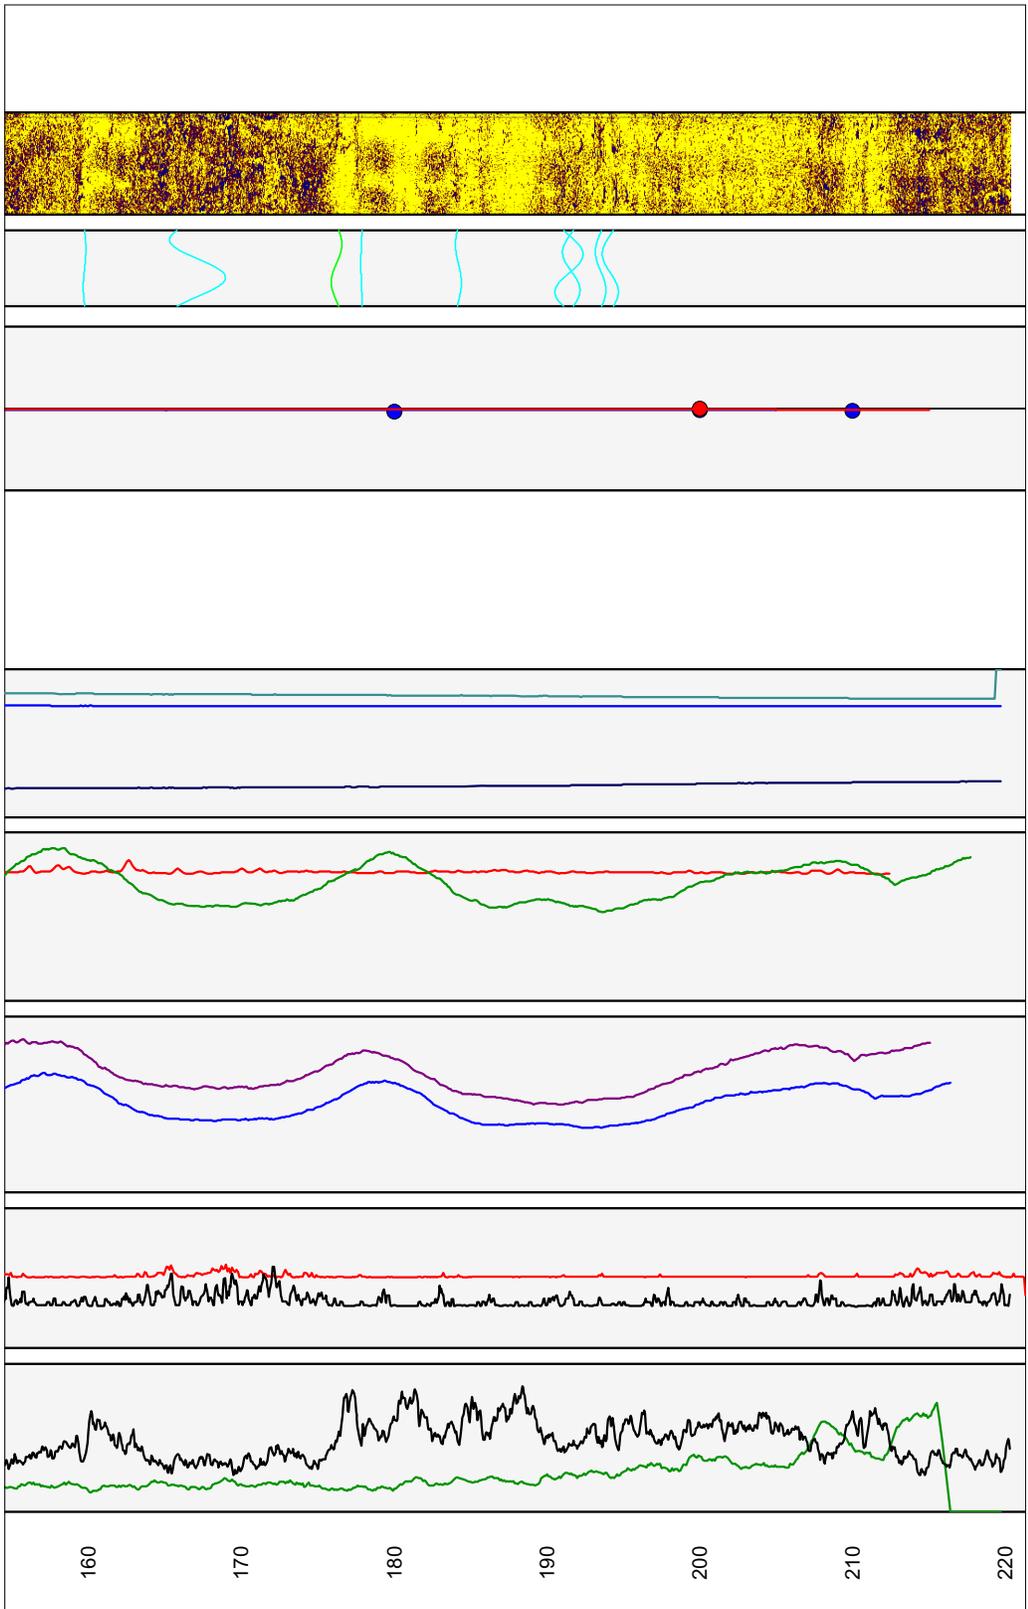
Figure 1J-1. Caliper, acoustic caliper, gamma, electromagnetic conductivity, fluid temperature, specific conductance, DO, pH, reduction oxidation, multi-space resistivity, oriented acoustic and optical borehole images, and heat-pulse flowmeter logs for borehole DW-39, near Machiasport, Maine.

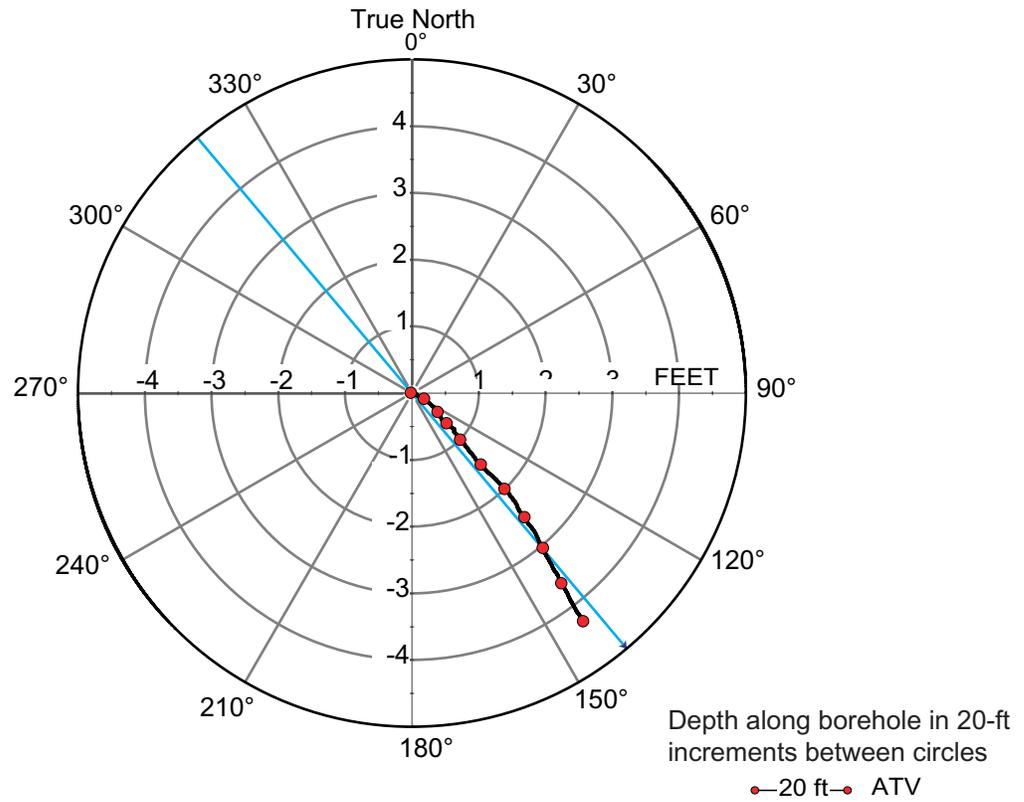
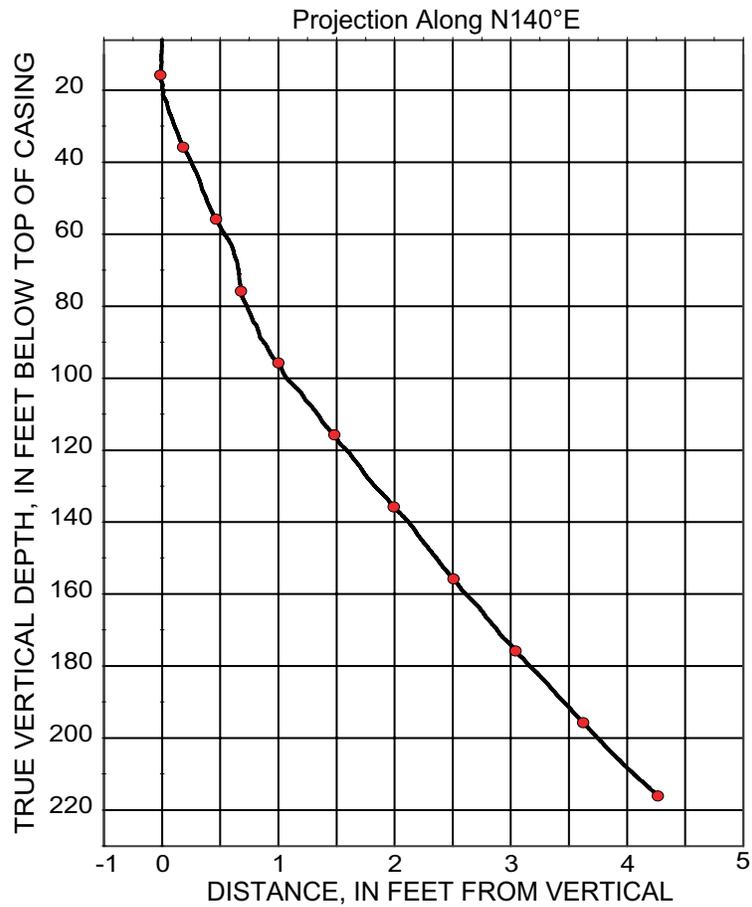
Figure 1J-2. Borehole deviation logs for borehole DW-39, near Machiasport, Maine. Blue line on radial plot (top) is line of projection for vertical plot (bottom).
[ft, foot; ATV, acoustic televiewer]

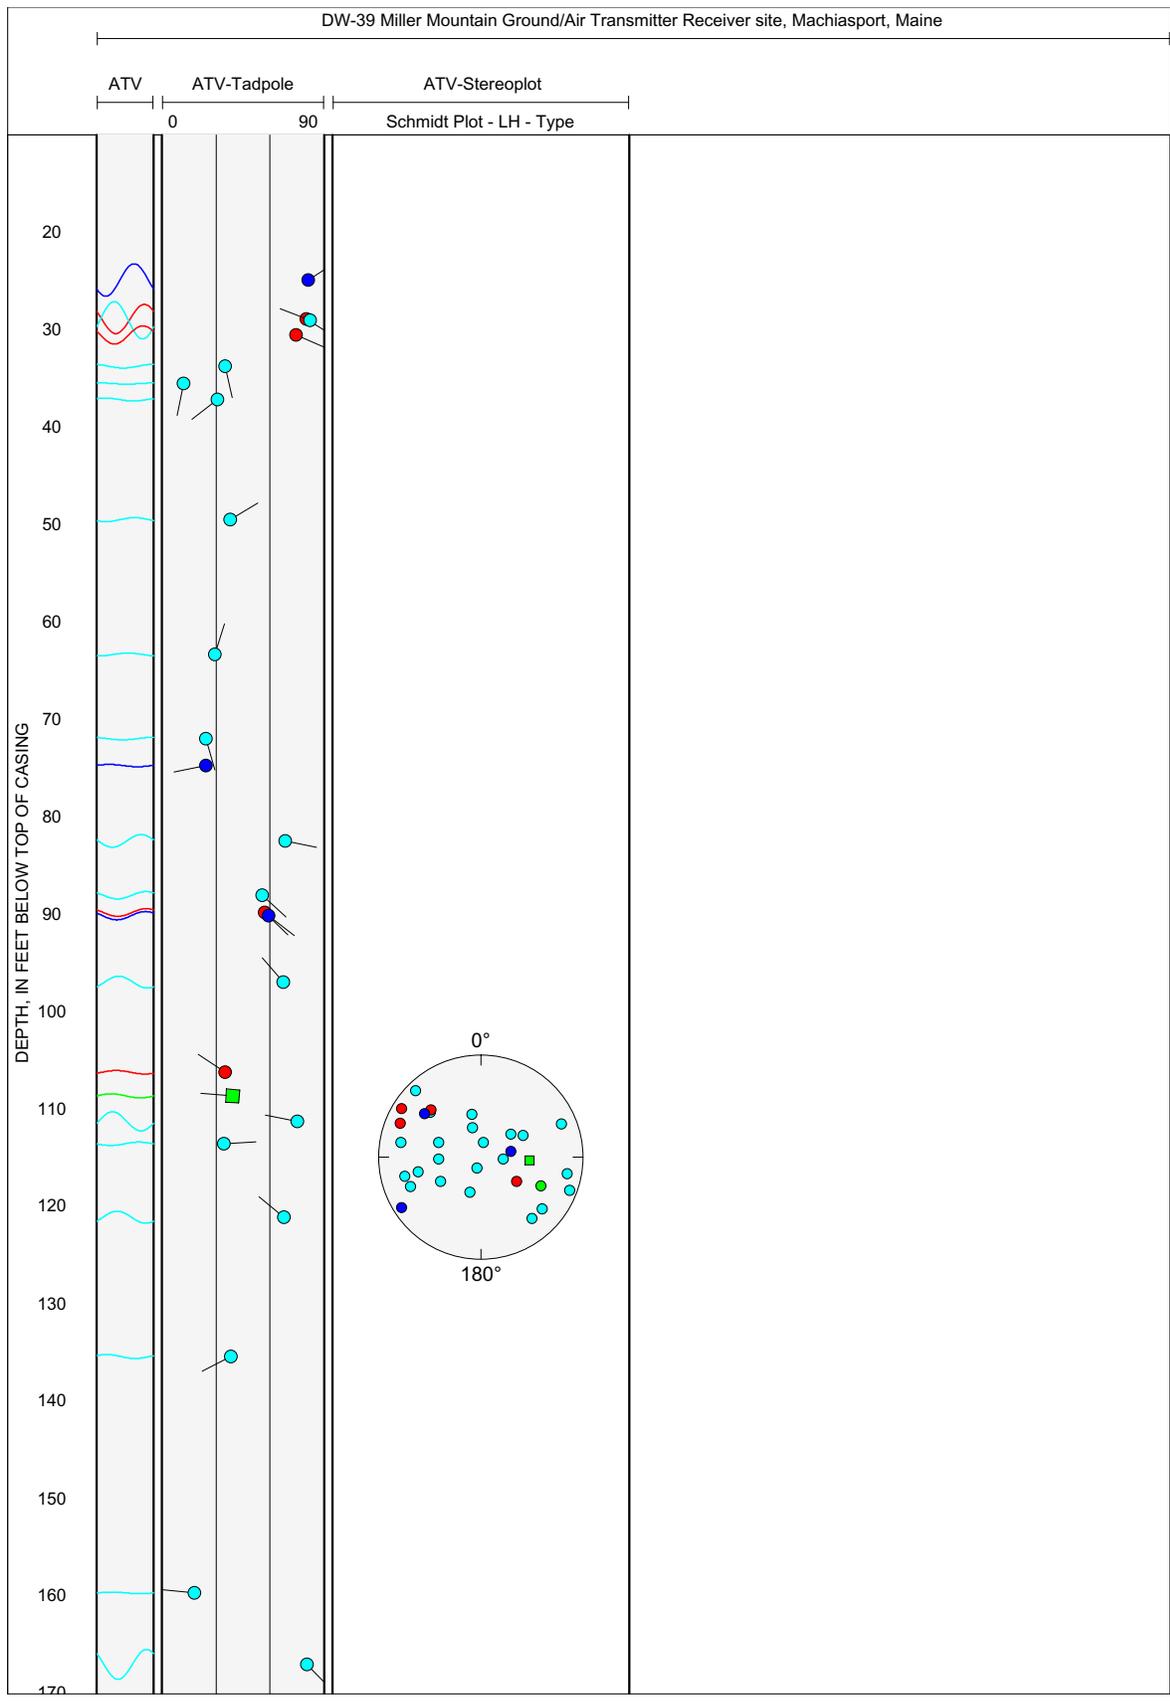
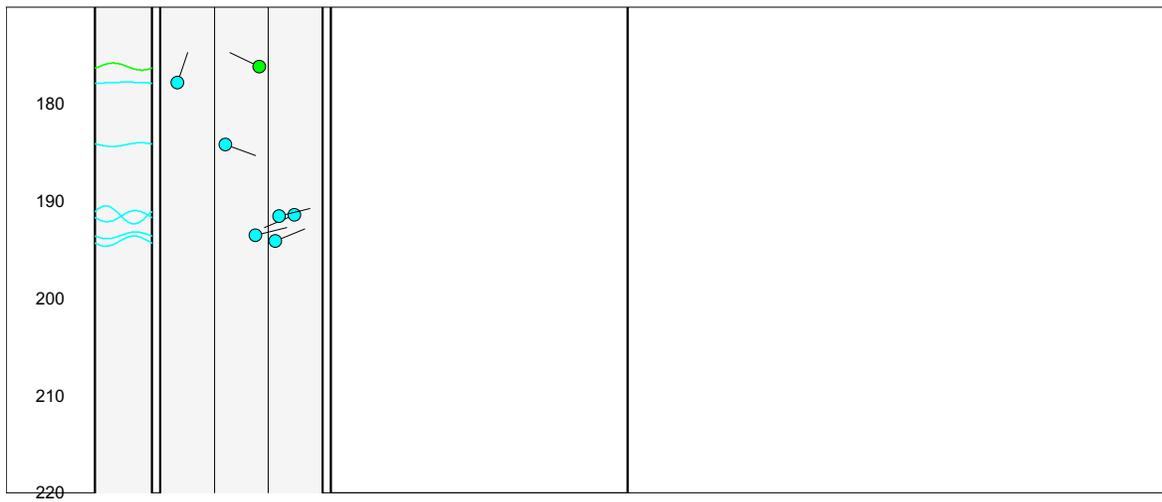
Figure 1J-3. Projection, tadpole, and stereoplots of interpretation of borehole image data for borehole DW-39, near Machiasport, Maine.

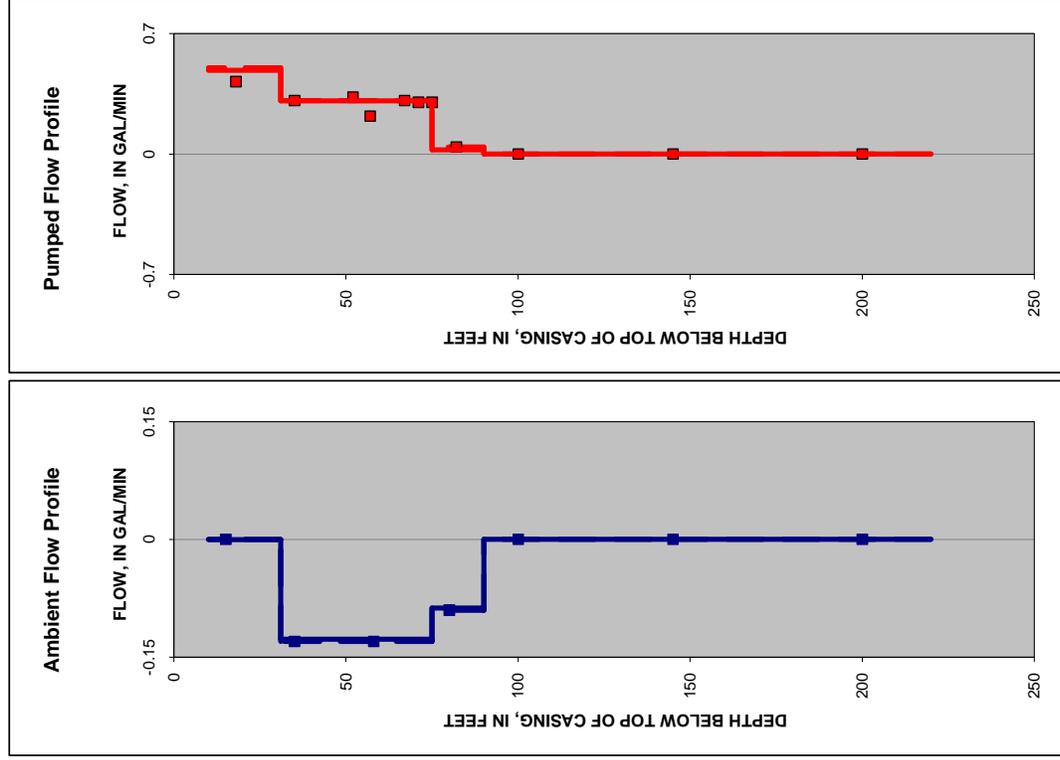
Dashed line indicates measured flow.
 Solid line indicates modeled flow.
 Points indicate measured heat-pulse flowmeter data.

Figure 1J-4. Interpretation and modeling of heat-pulse flowmeter logs for borehole DW-39, near Machiasport, Maine. [gal/min, gallon per minute; ft, feet; ft²/d, feet squared per day; positive values of flow are upward flow, negative values of flow are downward flow]

Fracture number	Depth (ft)	Ambient flow above fracture (gal/min)	Pumped flow above fracture (gal/min)	Zone transmissivity (ft ² /d)	Water level (ft)	Elevation of water level (ft)	Percent transmissivity
3	31.0	0.000	0.486	1.6	-3.81	133.81	9
2	75.0	-0.127	0.309	13.0	12.19	117.81	70
1	90.0	-0.087	0.024	4.0	16.19	113.81	22

Total borehole transmissivity	18.6	(ft ² /d)
Sum of squares error	0.00046	(gal/min) ²
Root mean square error	0.01236649	(gal/min)

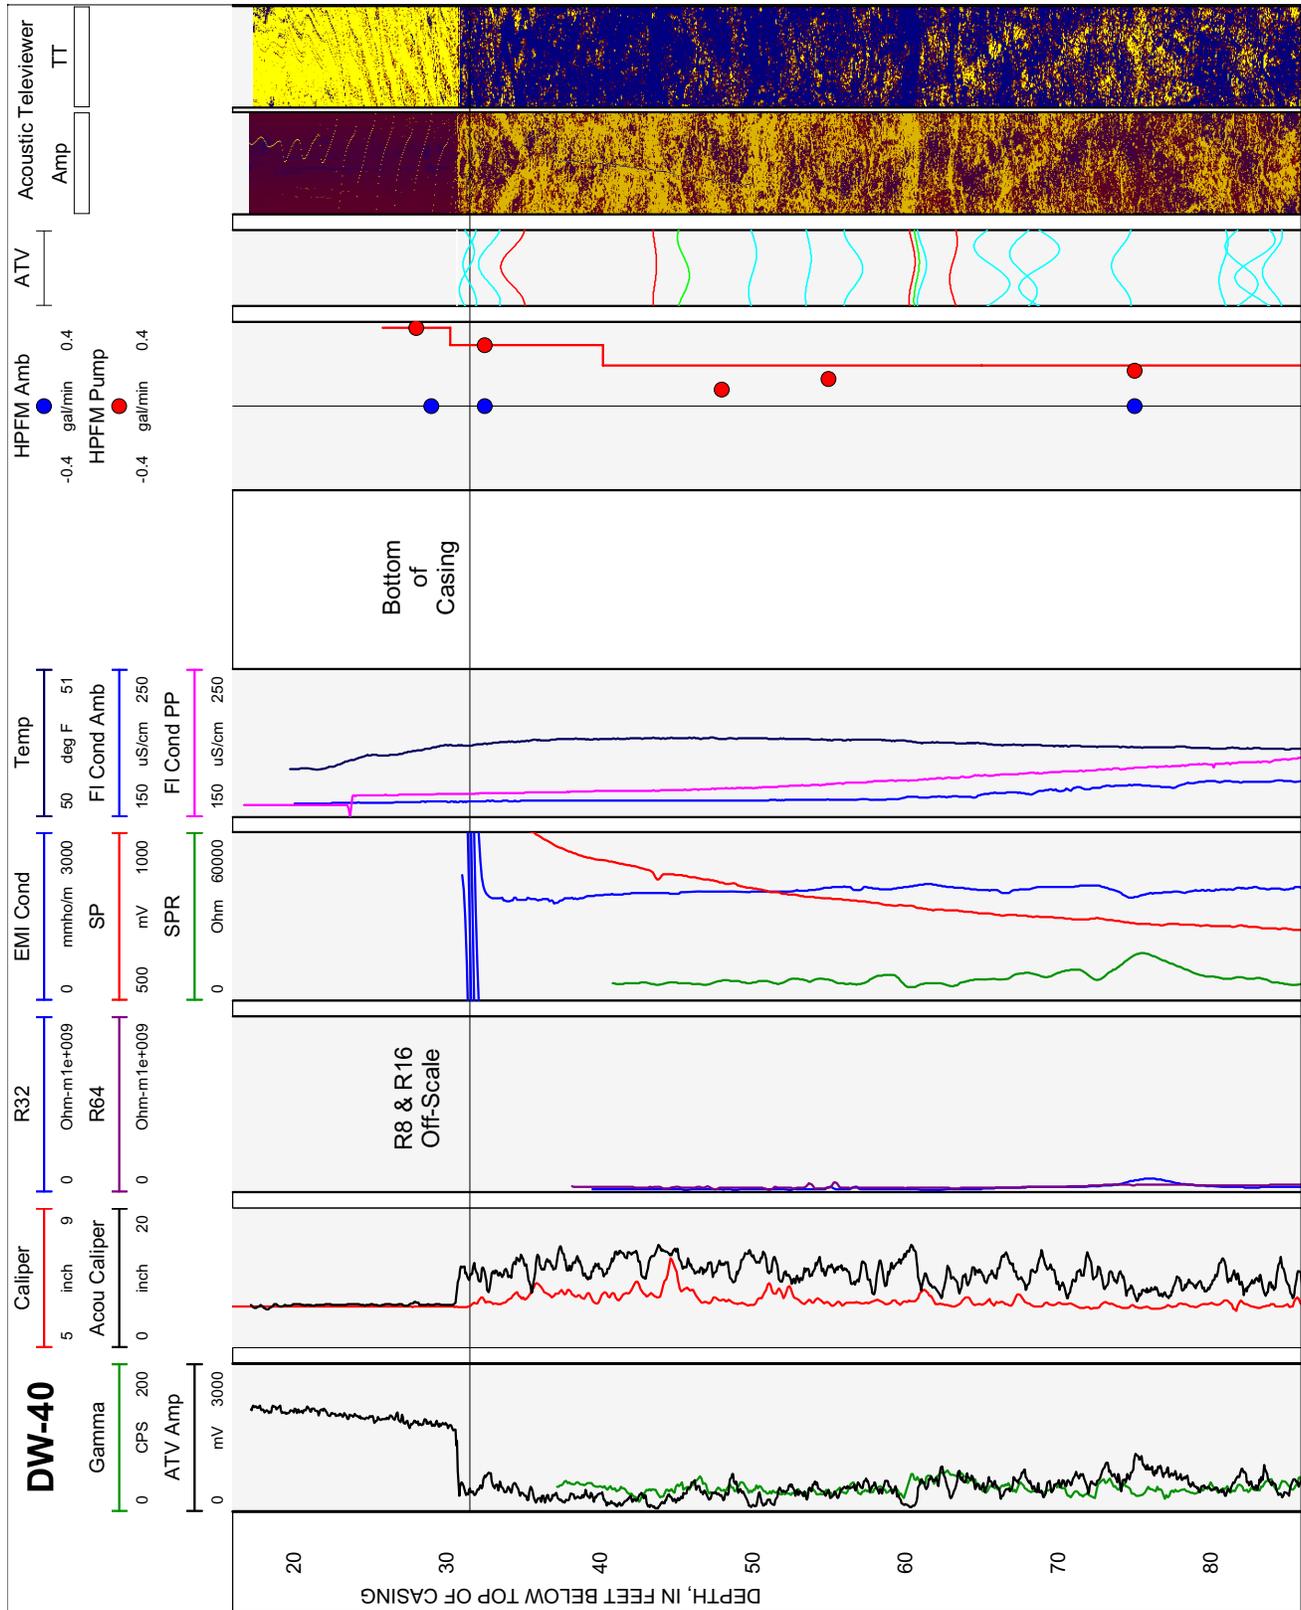
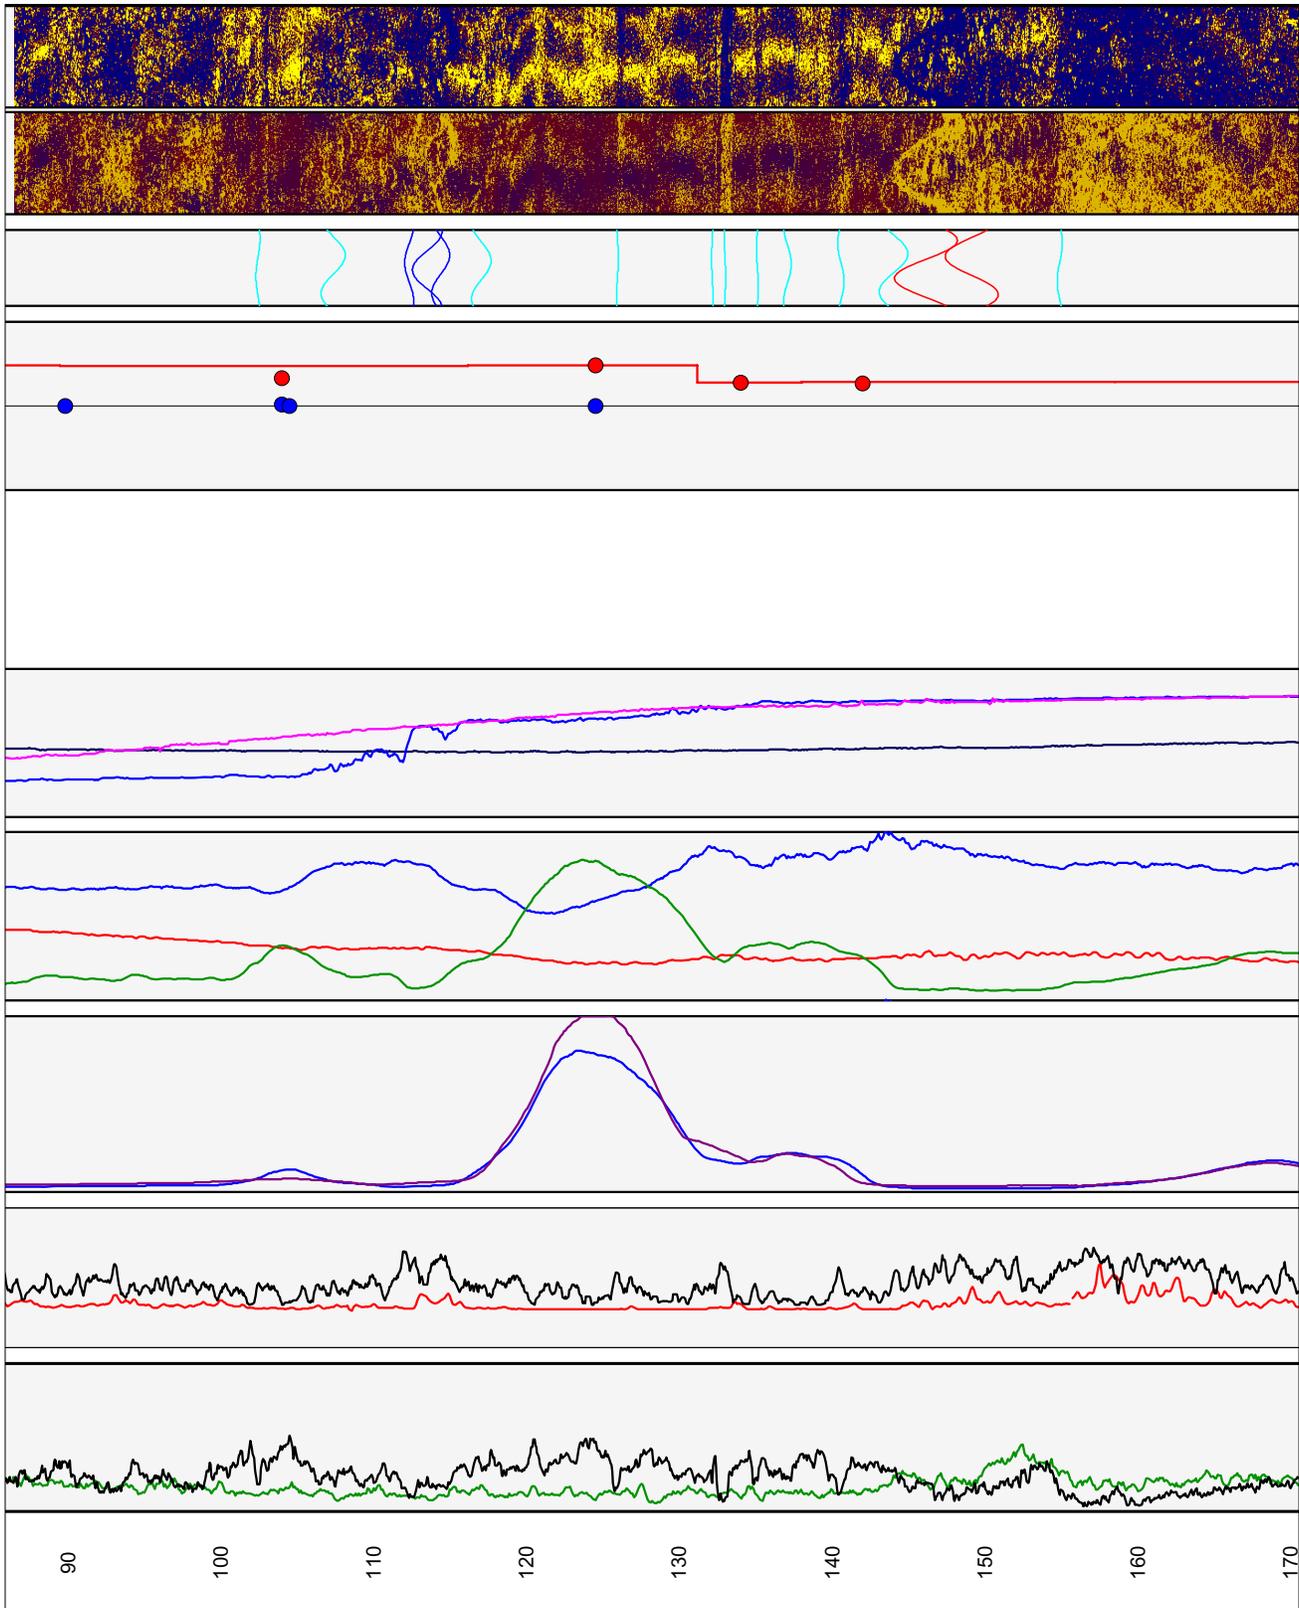
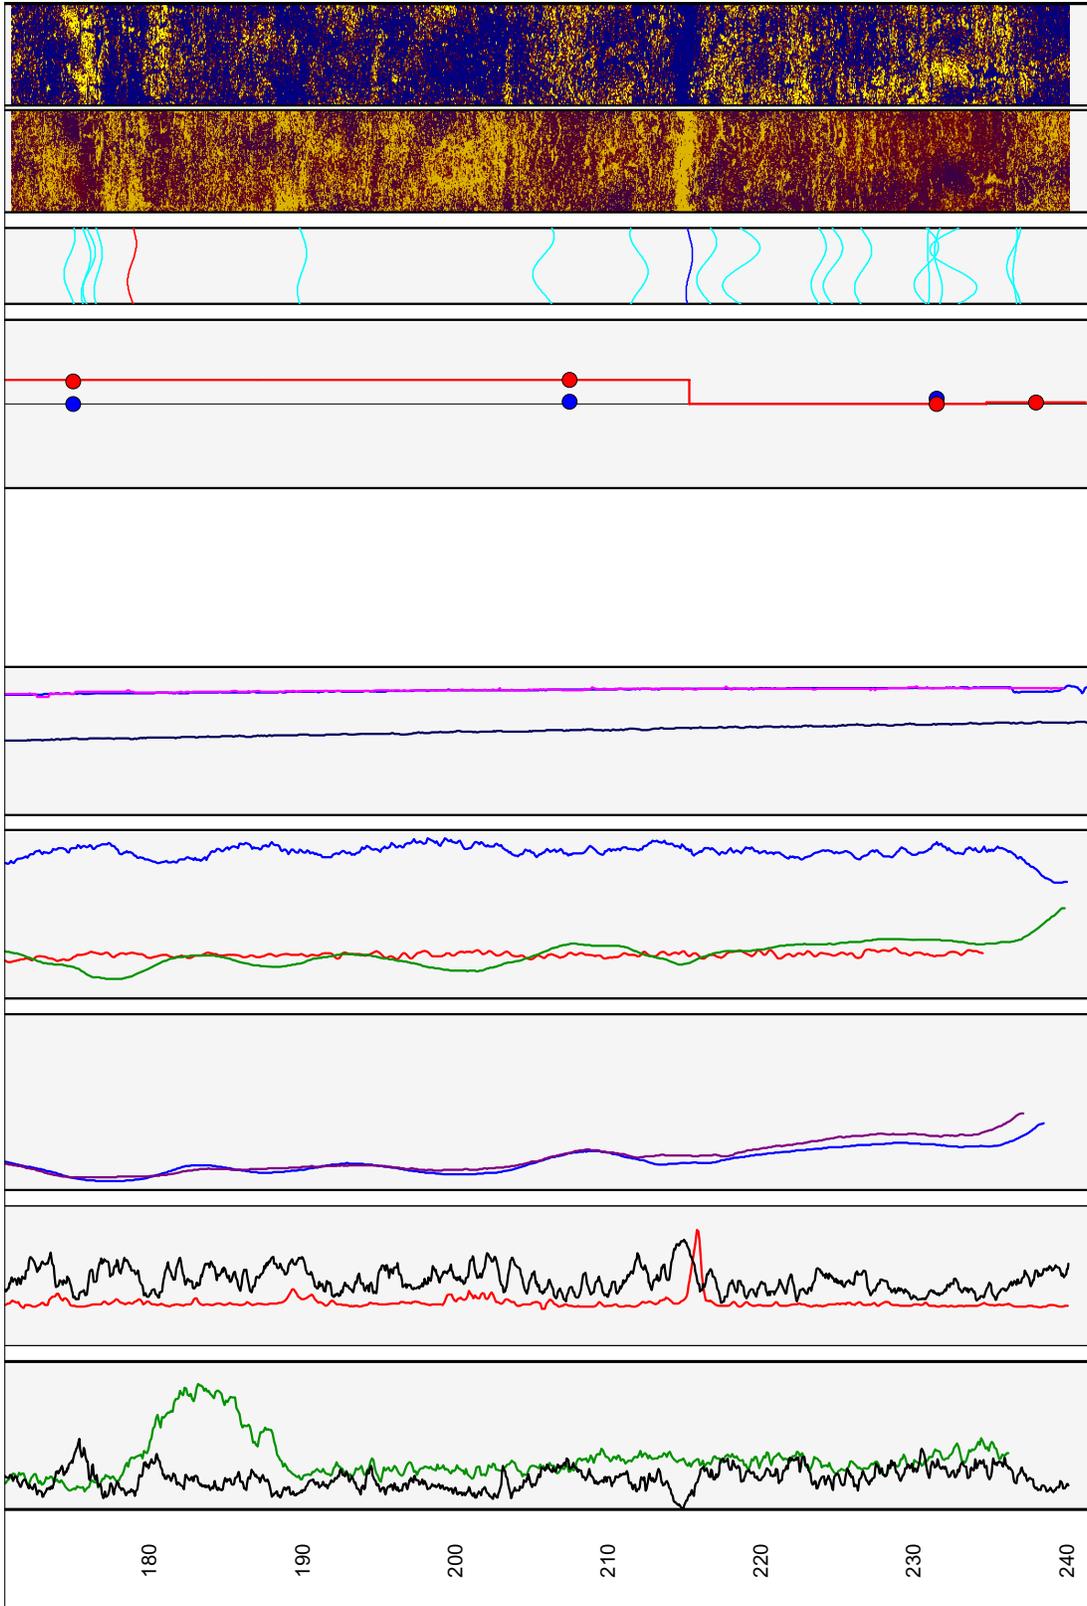
Figure 1K-1. Caliper, acoustic caliper, gamma, electromagnetic conductivity, fluid temperature, specific conductance, DO, pH, reduction oxidation, multi-space resistivity, oriented acoustic and optical borehole images, and heat-pulse flowmeter logs for borehole DW-40, near Machiasport, Maine.

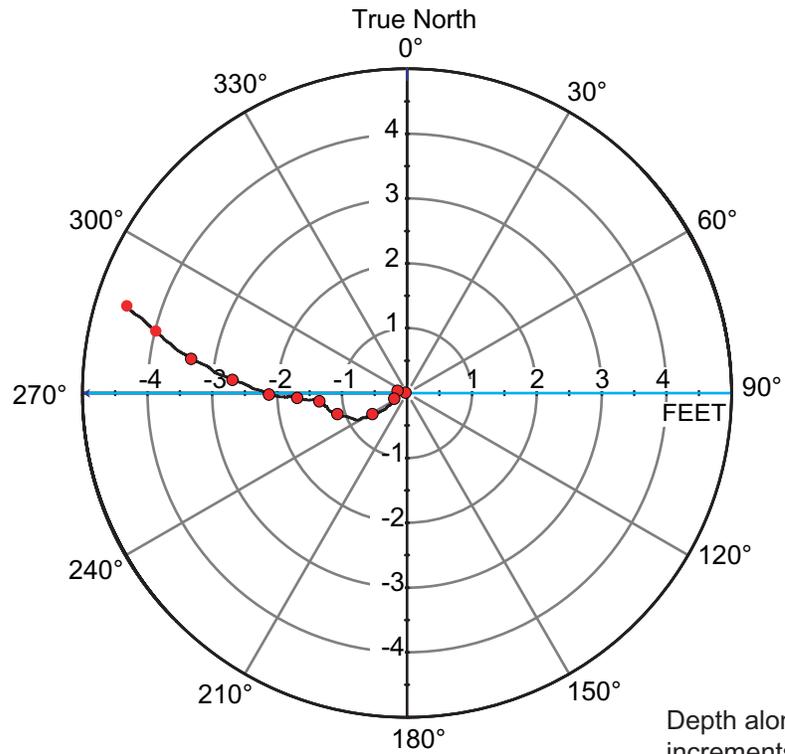
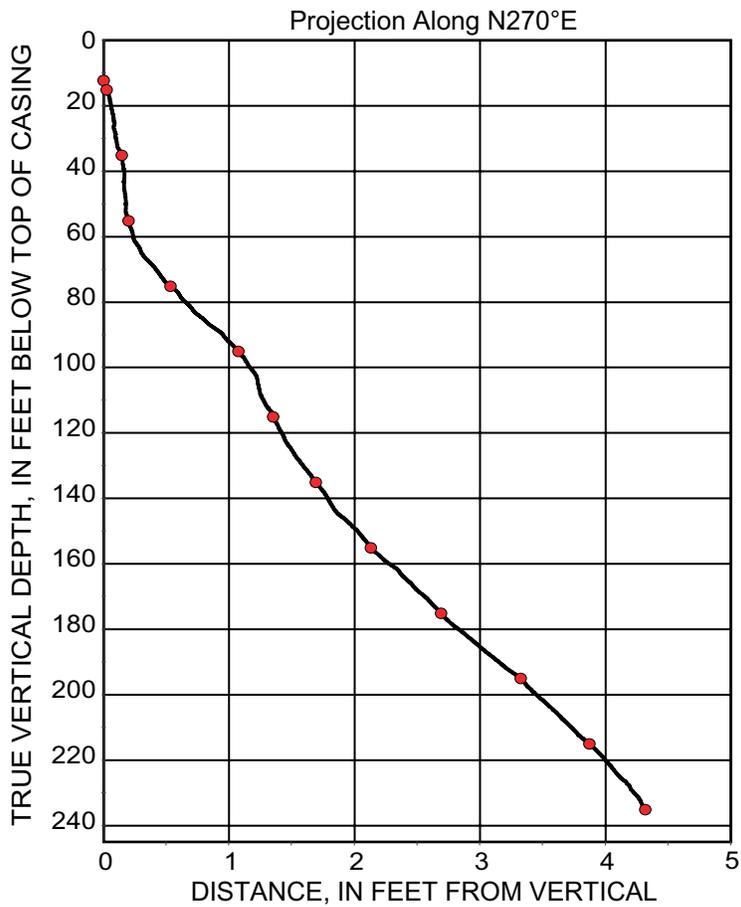
Depth along borehole in 20-ft increments between circles
 ●—20 ft—● ATV

Figure 1K-2. Borehole deviation logs for borehole DW-40, near Machiasport, Maine. Blue line on radial plot (top) is line of projection for vertical plot (bottom).
 [ft, foot; ATV, acoustic televiewer]

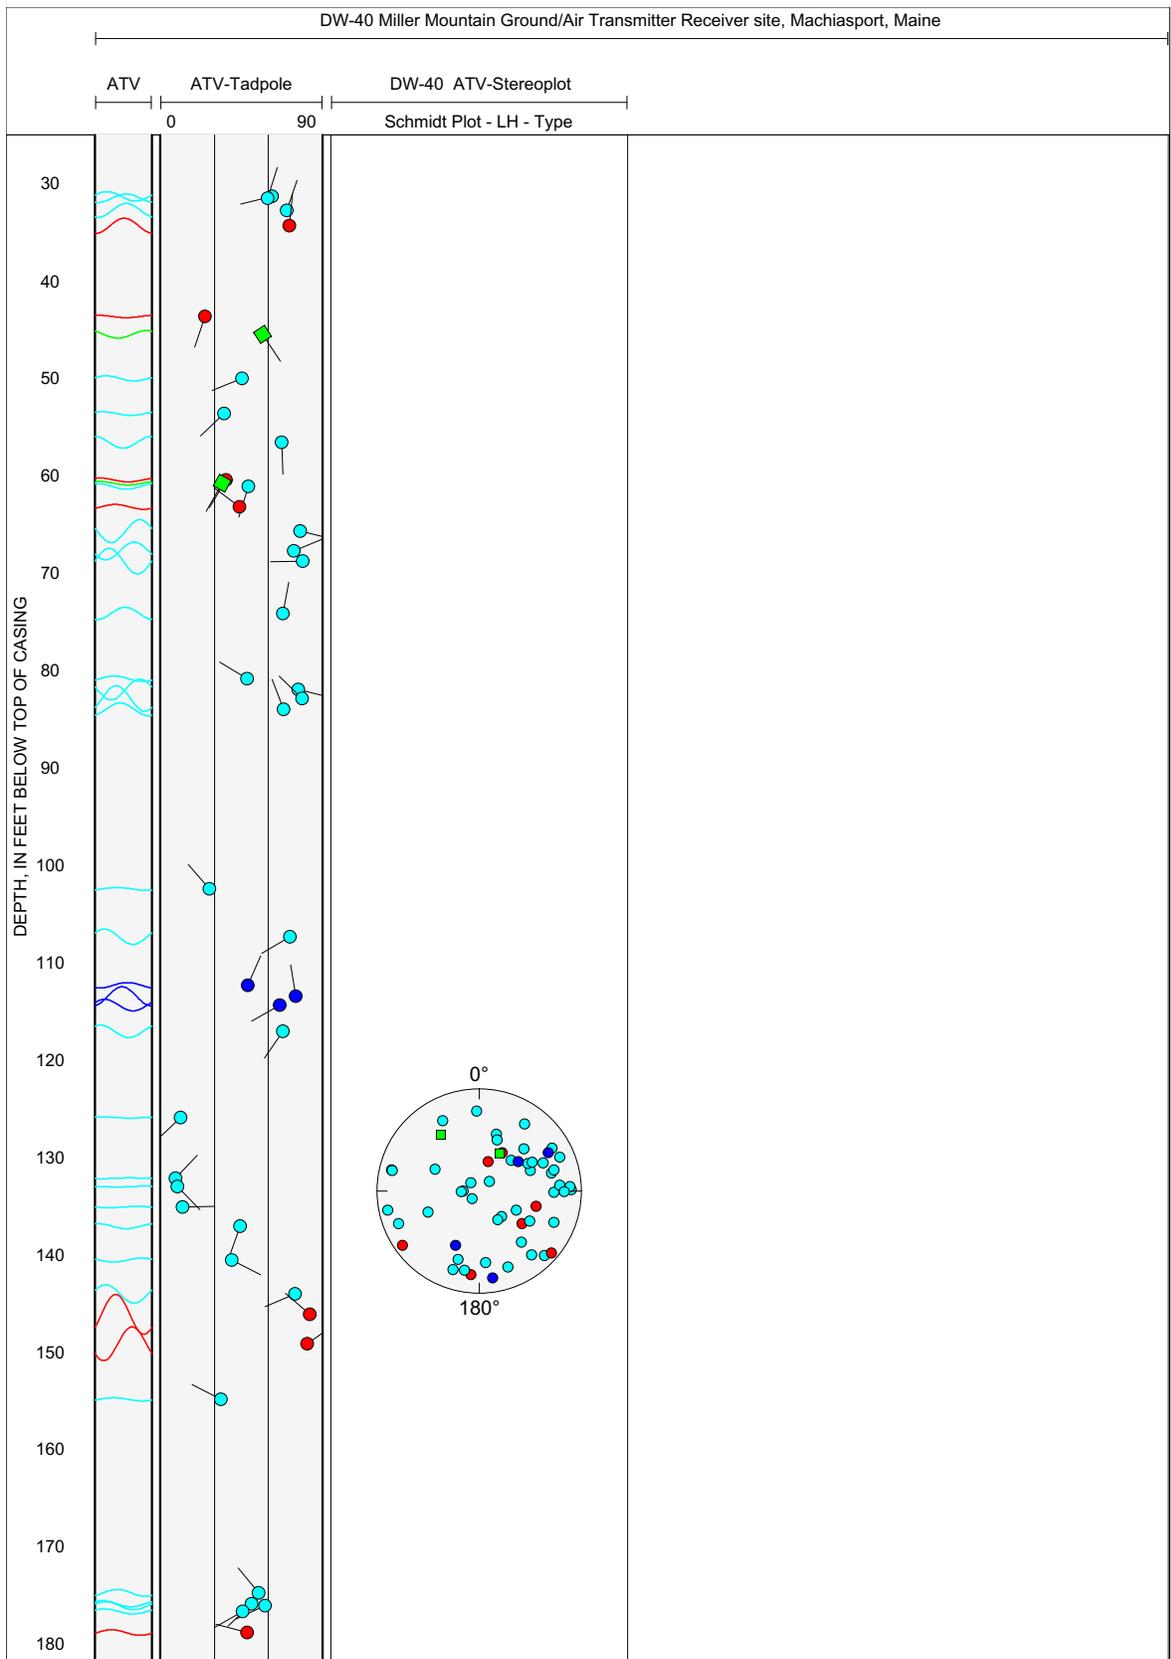
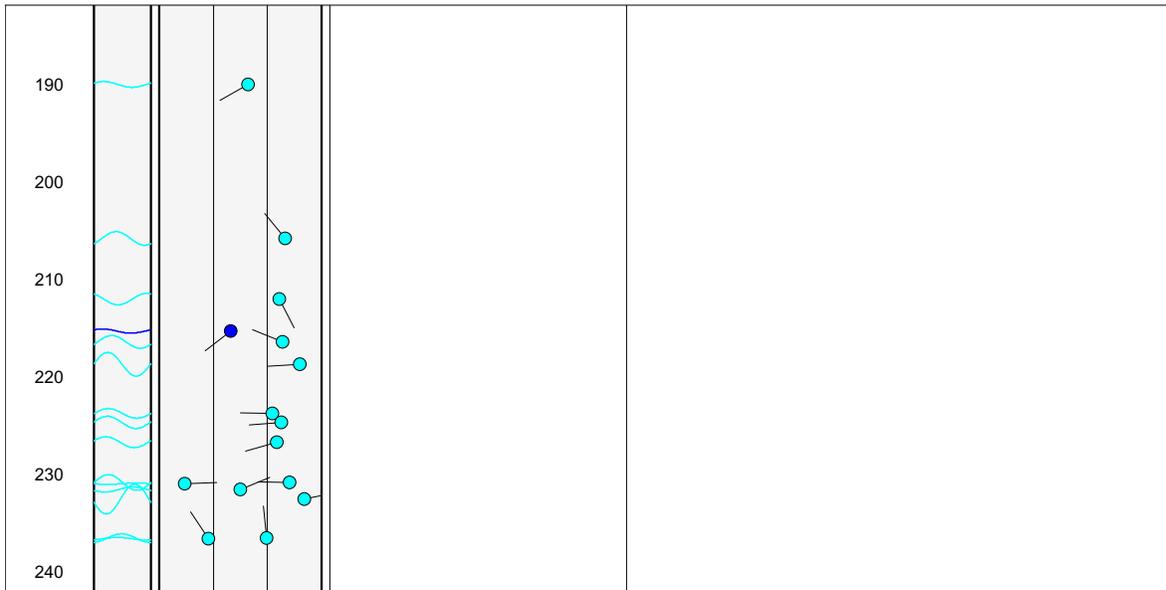
Figure 1K-3. Projection, tadpole, and stereoplots of interpretation of borehole image data for borehole DW-40, near Machiasport, Maine.

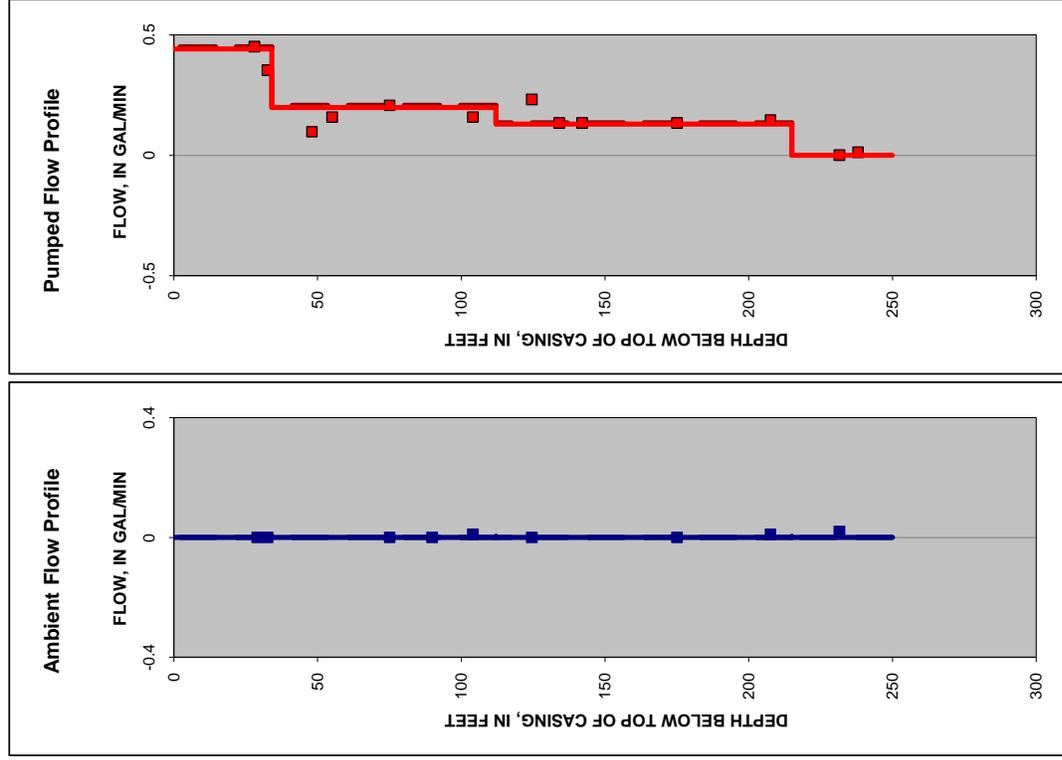
Dashed line indicates measured flow.
 Solid line indicates modeled flow.
 Points indicate measured heat-pulse flowmeter data.

Figure 1K-4. Interpretation and modeling of heat-pulse flowmeter logs for borehole DW-40, near Machiasport, Maine. [gal/min, gallon per minute; ft, feet; ft²/d, feet squared per day; positive values of flow are upward flow, negative values of flow are downward flow]

Fracture number	Depth (ft)	Ambient flow above fracture (gal/min)	Pumped flow above fracture (gal/min)	Zone transmissivity (ft ² /d)	Water level (ft)	Elevation of water level (ft)	Percent transmissivity
3	34	0	0.44	12.0	0.56	92.00	57
2	112	0	0.20	3.0	0.56	92.00	14
1	215	0	0.13	6.0	0.56	92.00	29

Total borehole transmissivity	21.0	(ft ² /d)
Sum of squares error	0.000	(gal/min) ²
Root mean square error	0.008	(gal/min)
