Borehole Geophysical Investigation of a Formerly Used Defense Site, Machiasport, Maine, 2003–2006

By Carole D. Johnson, Remo A. Mondazzi, and Peter K. Joesten

Scientific Investigations Report 2009–5120

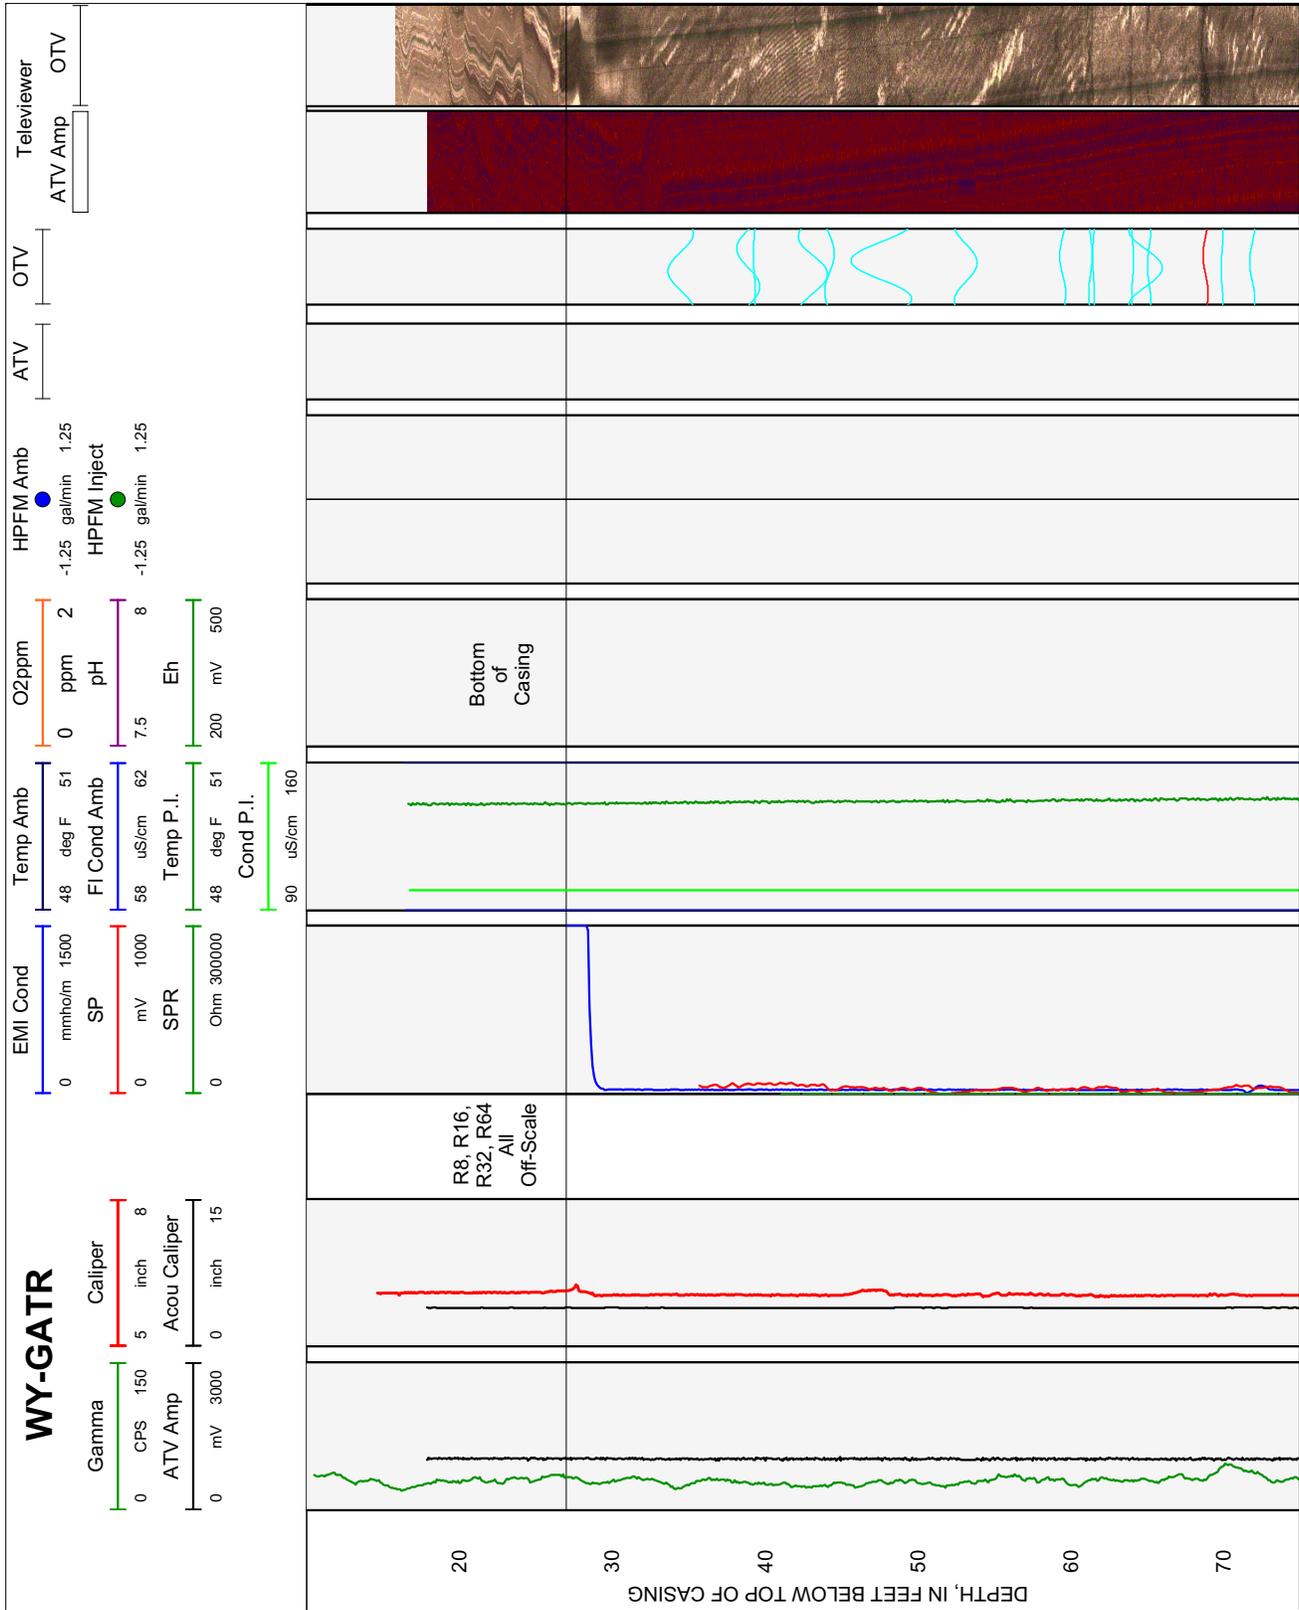
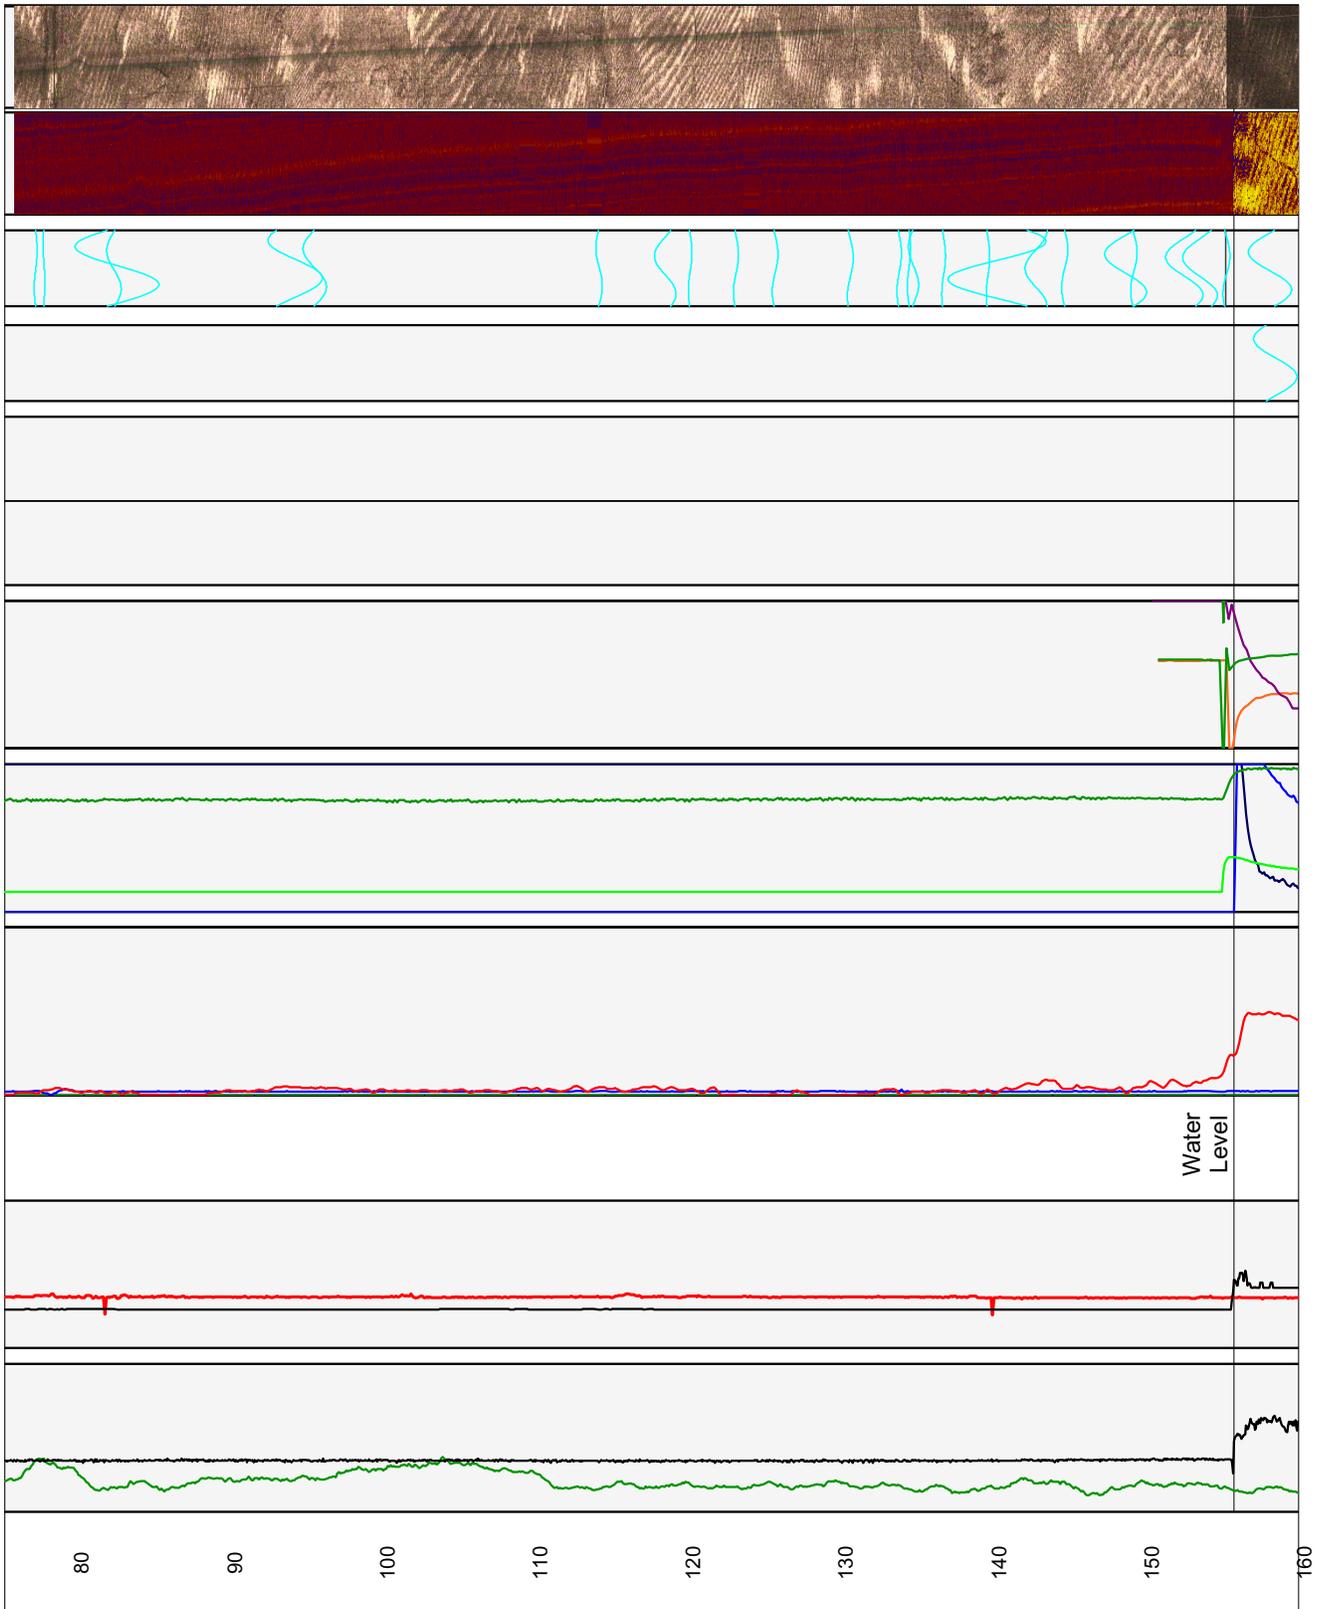
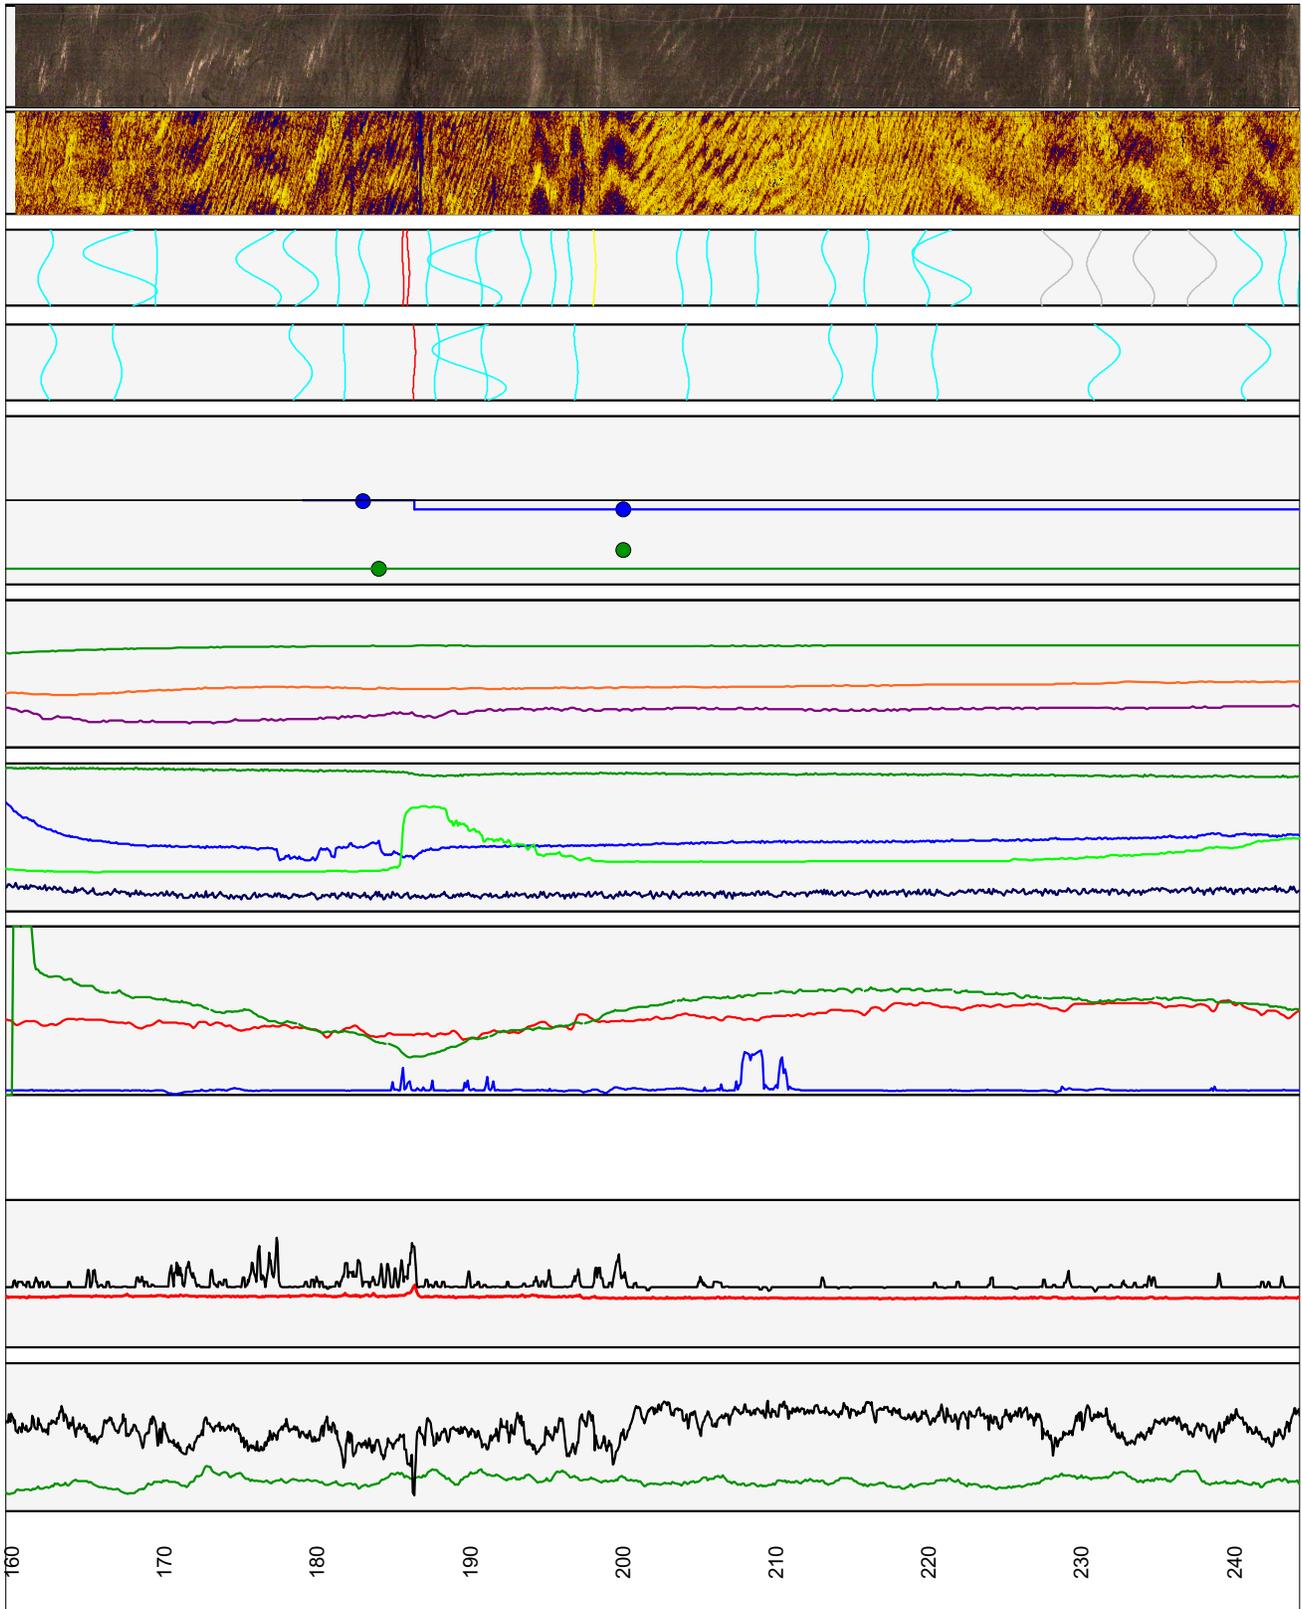
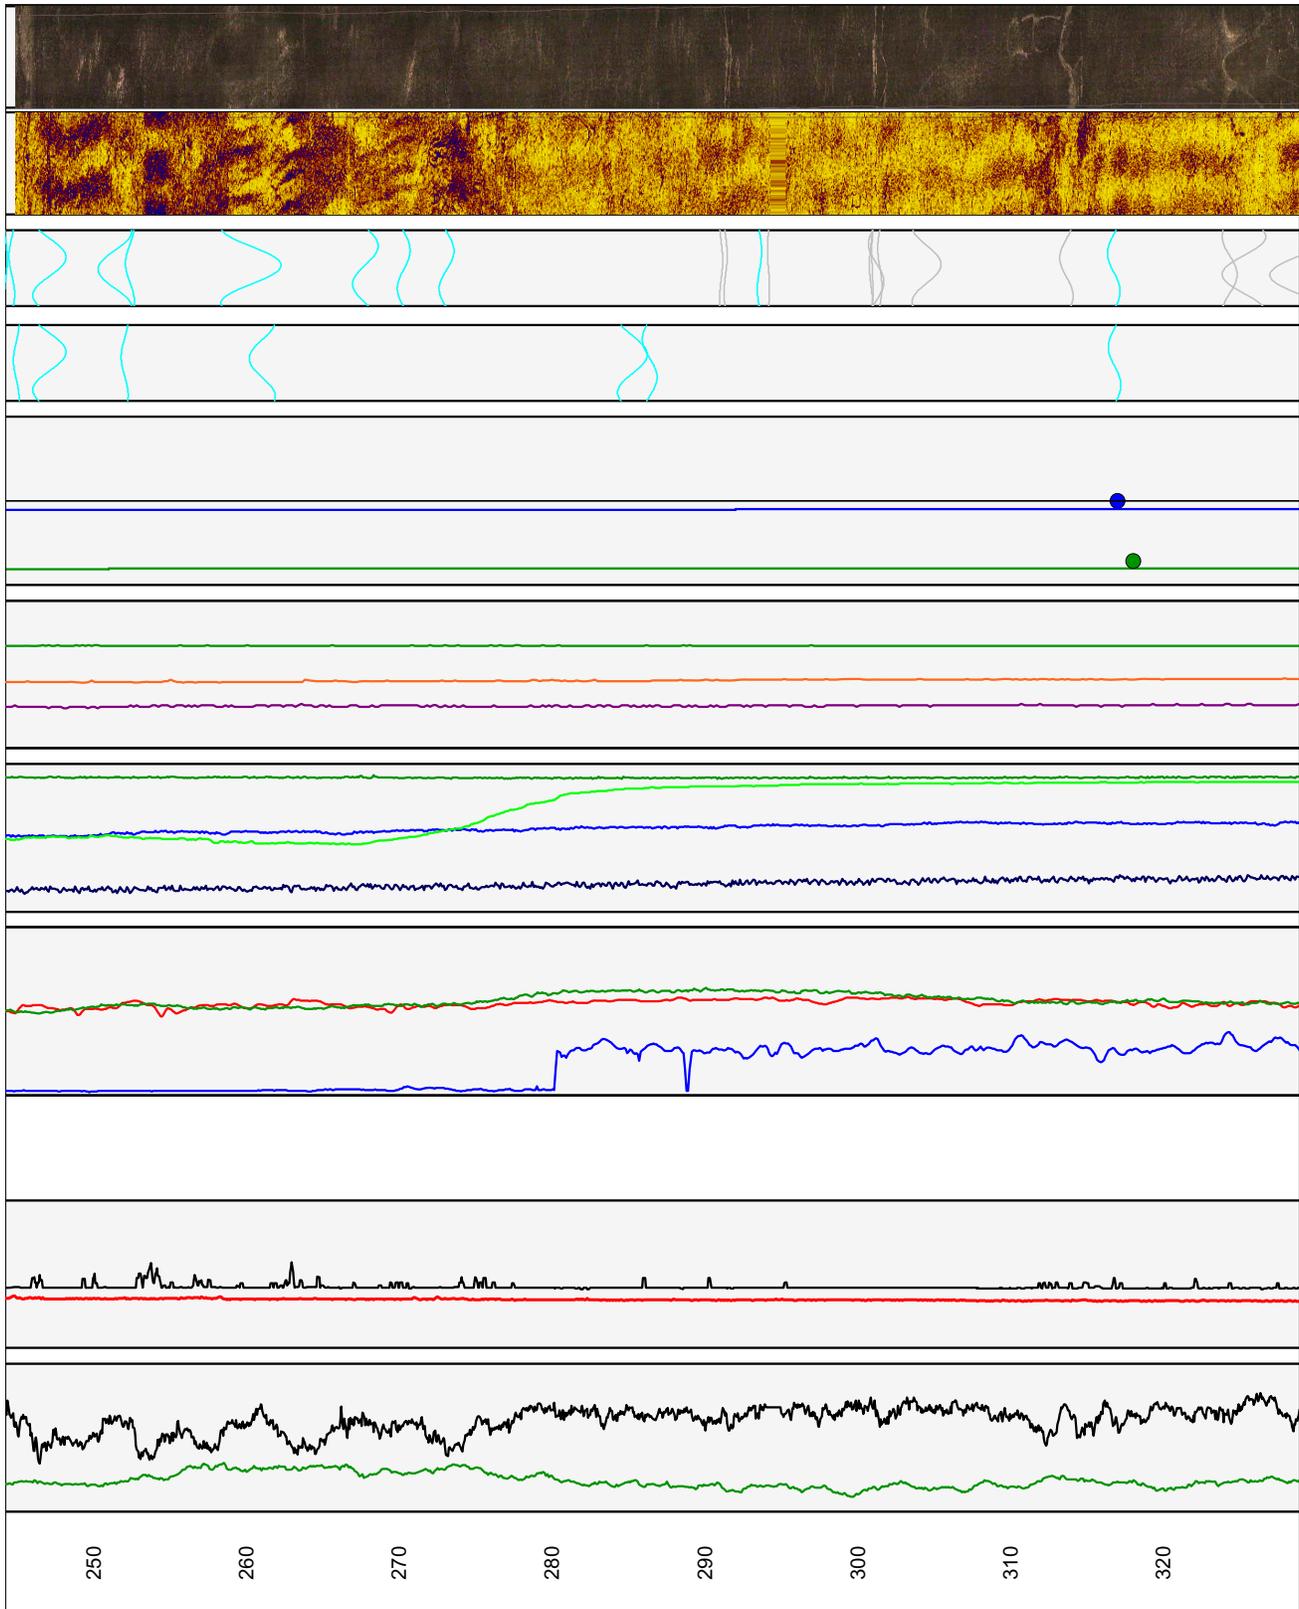
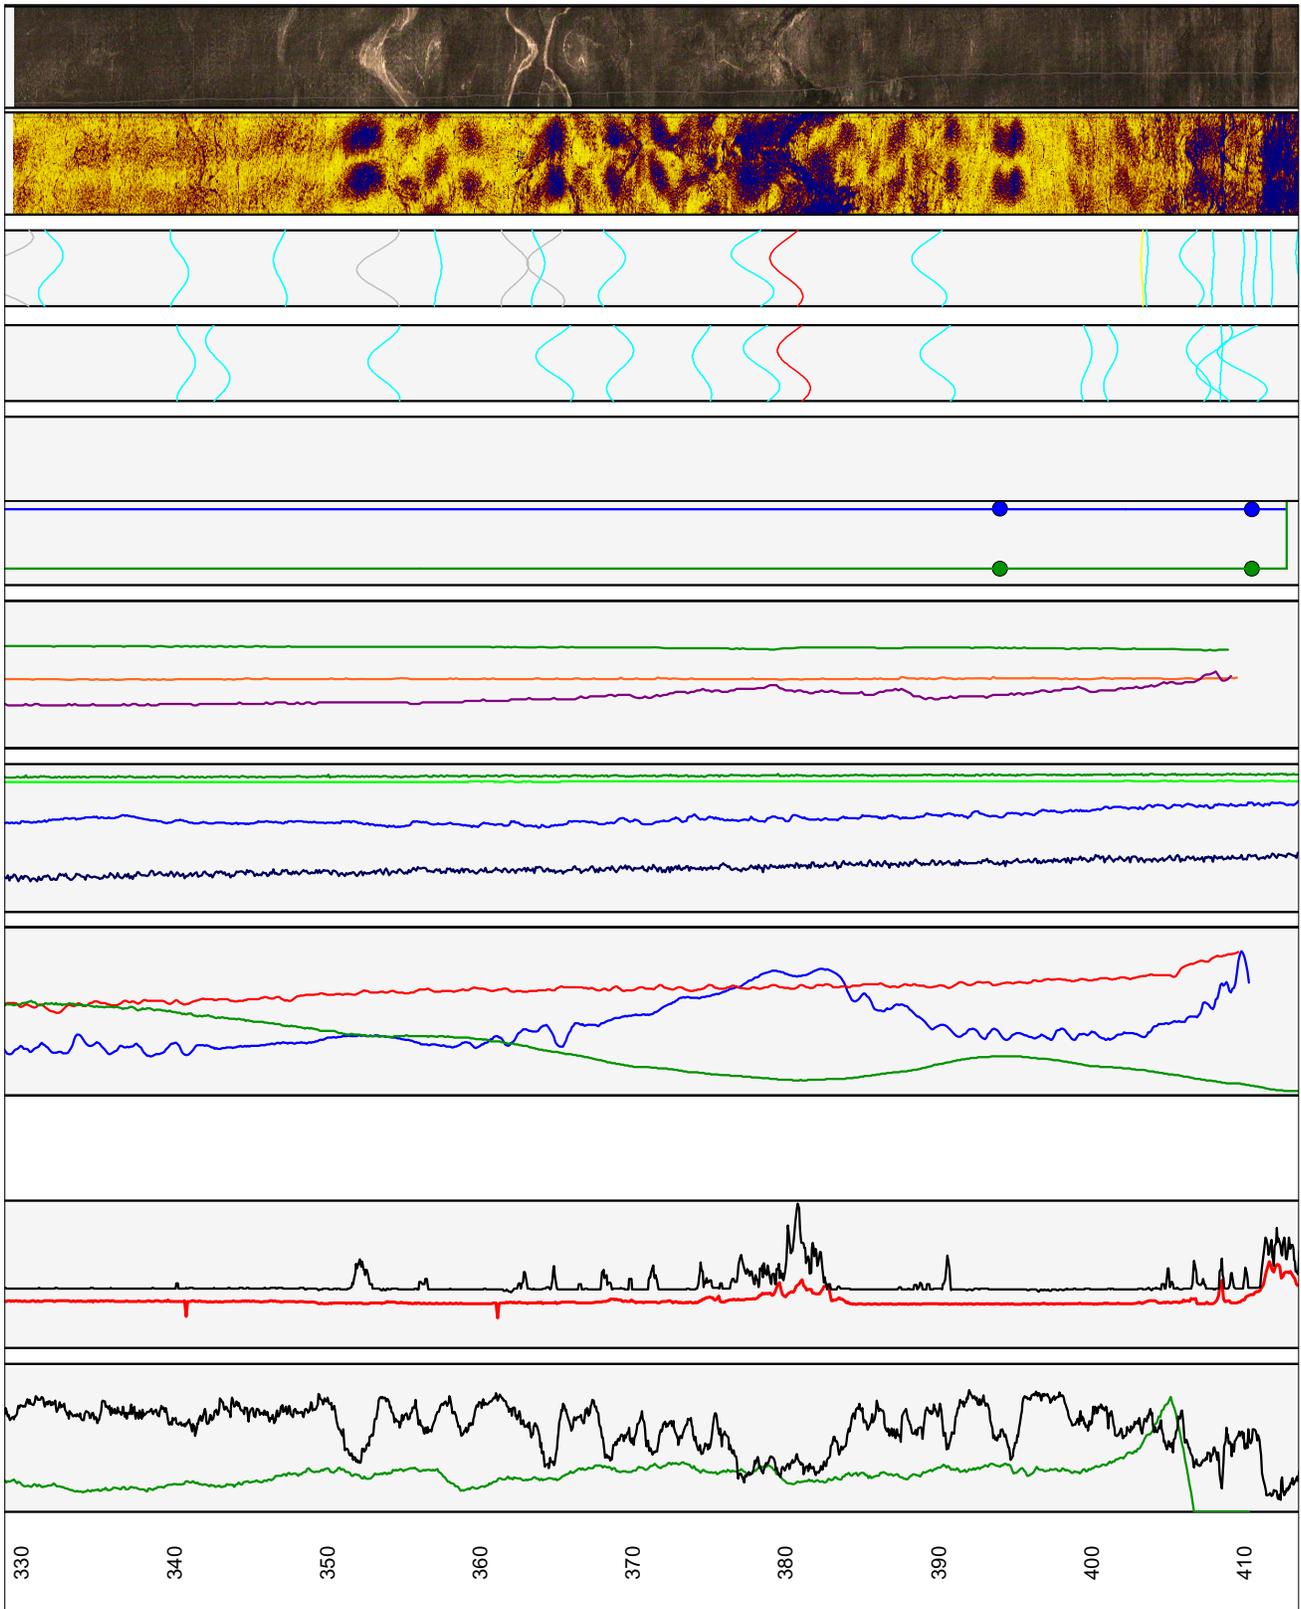
Figure 1L-1. Caliper, acoustic caliper, gamma, electromagnetic conductivity, fluid temperature, specific conductance, DO, pH, reduction oxidation, multi-space resistivity, oriented acoustic and optical borehole images, and heat-pulse flowmeter logs for borehole WY-GATR, near Machiasport, Maine.

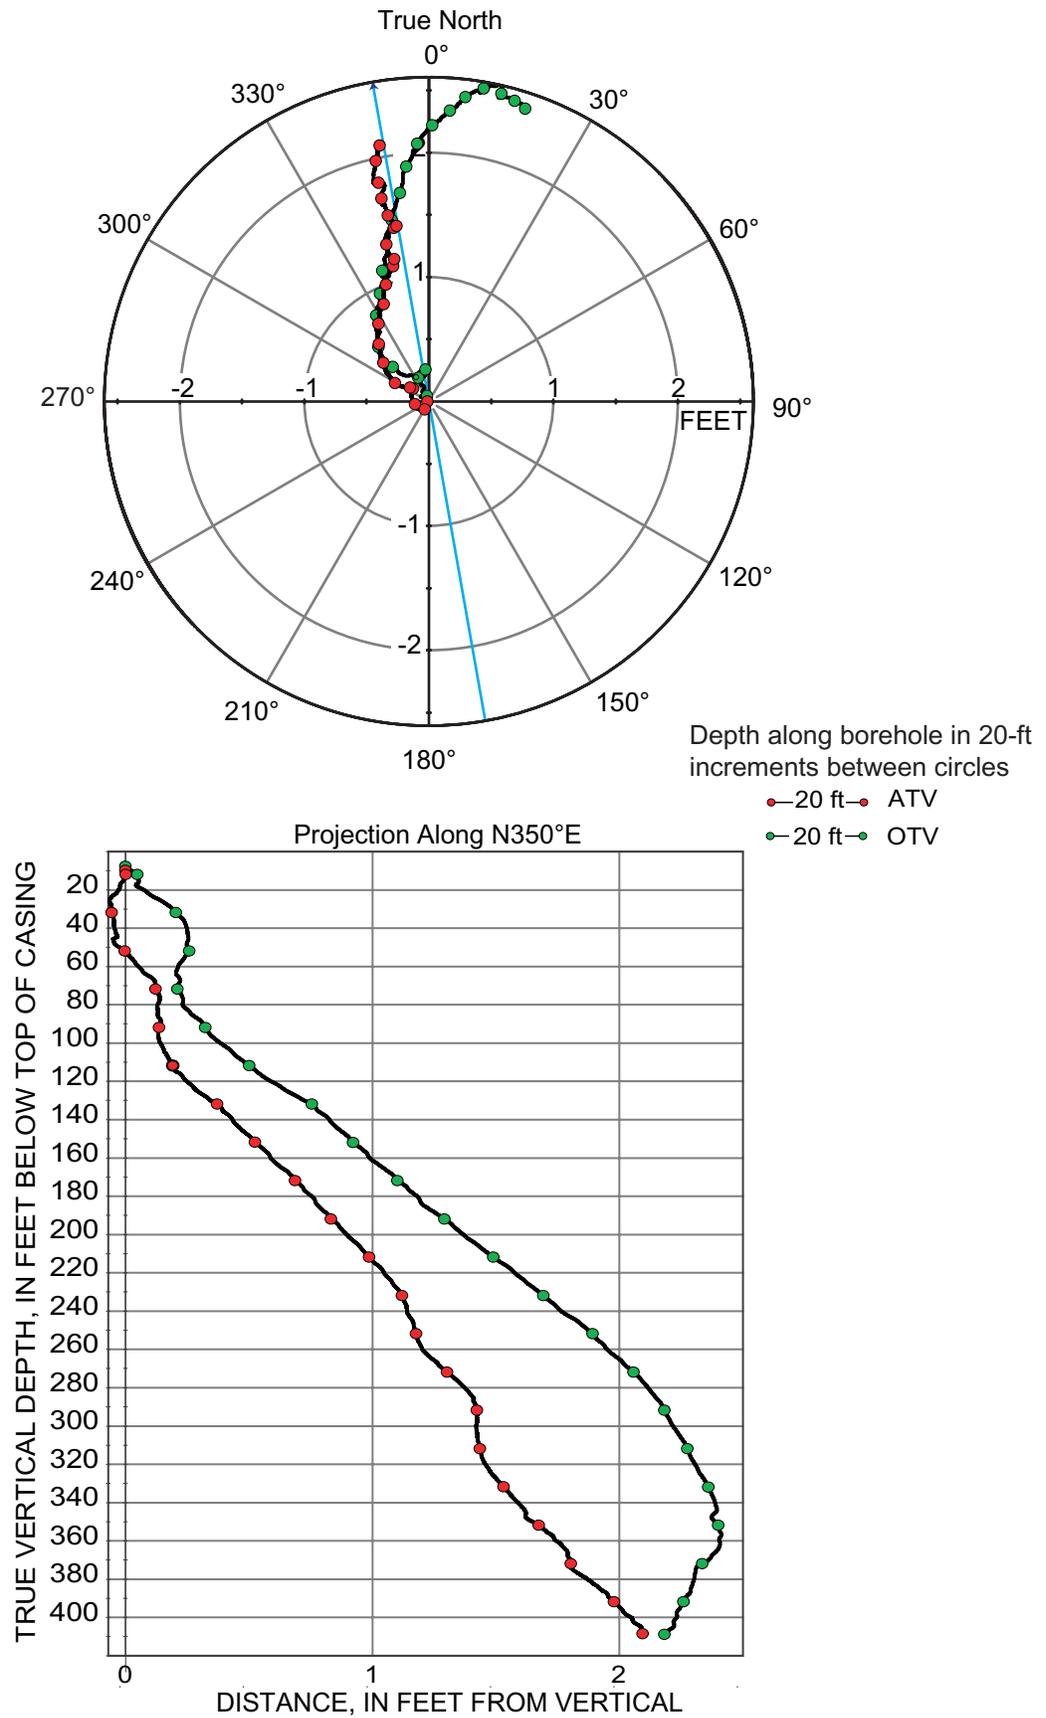
Figure 1L-2. Borehole deviation logs for borehole WY-GATR, near Machiasport, Maine. Blue line on radial plot (top) is line of projection for vertical plot (bottom).

[ft, foot; ATV, acoustic televiewer; OTV, optical televiewer]

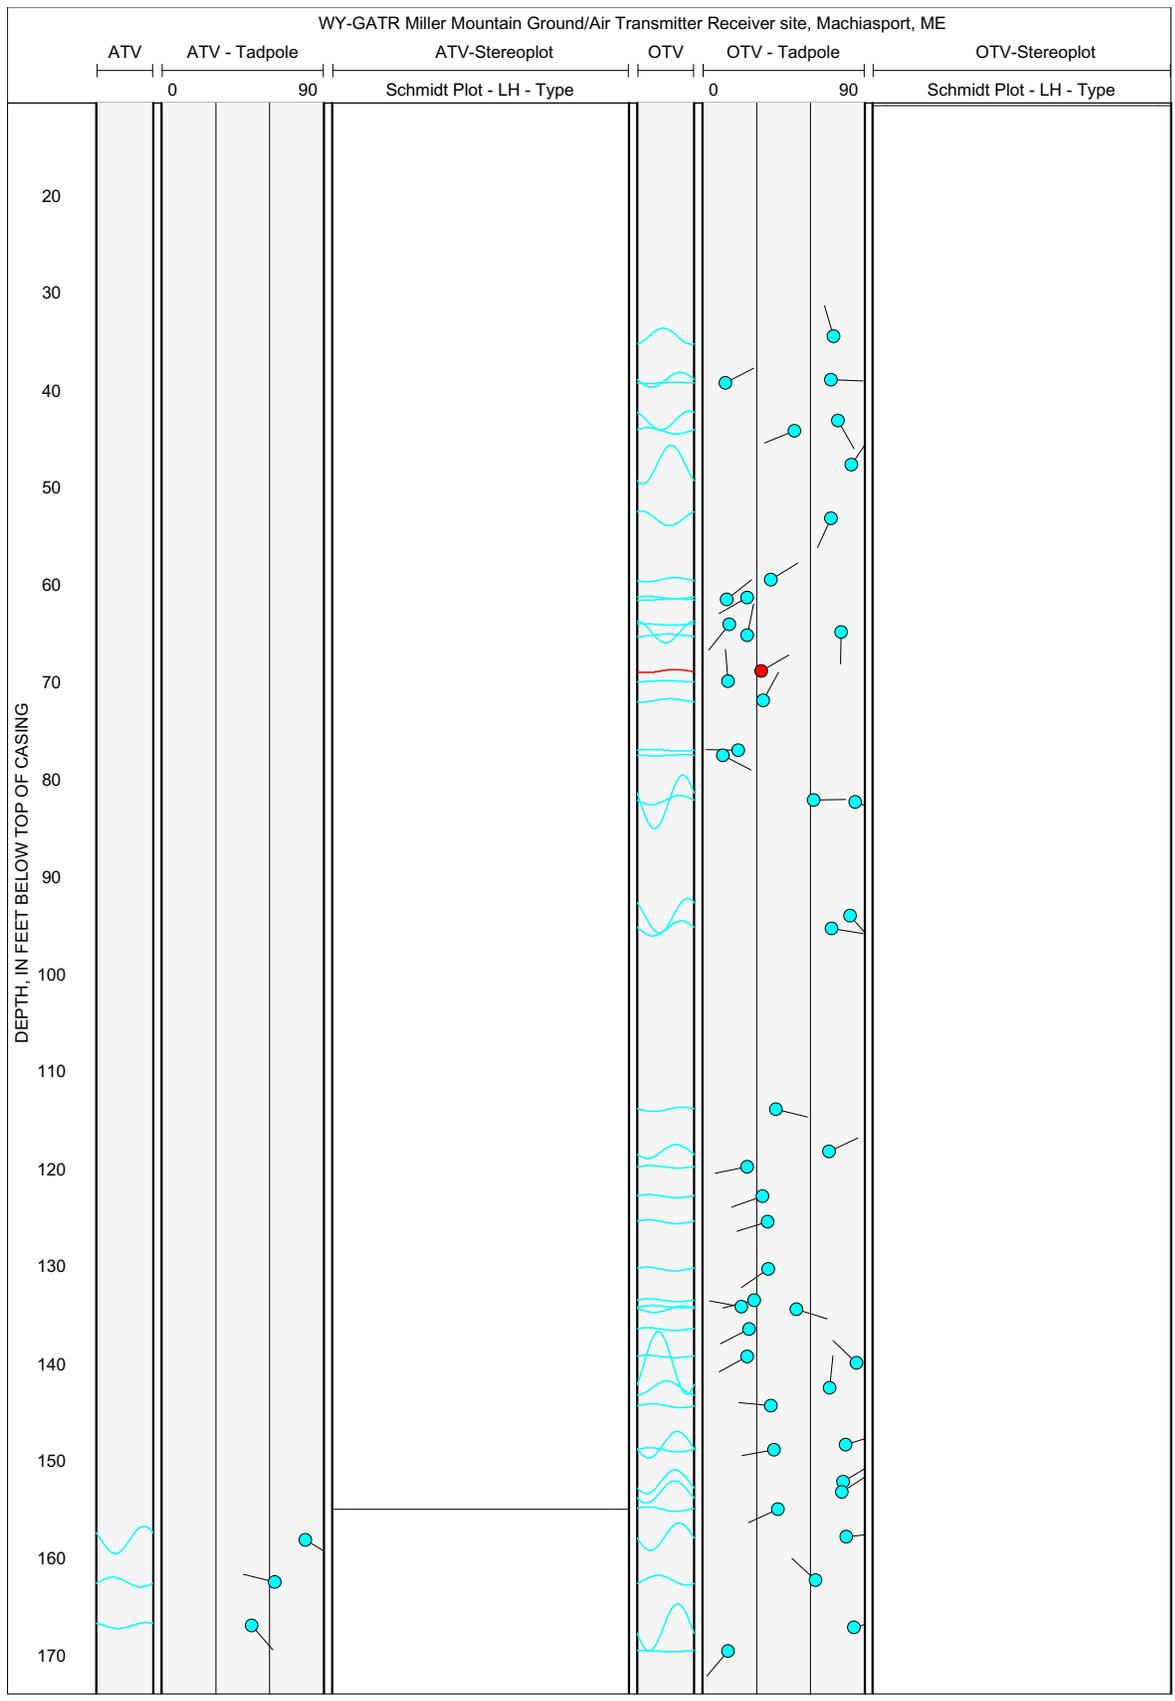
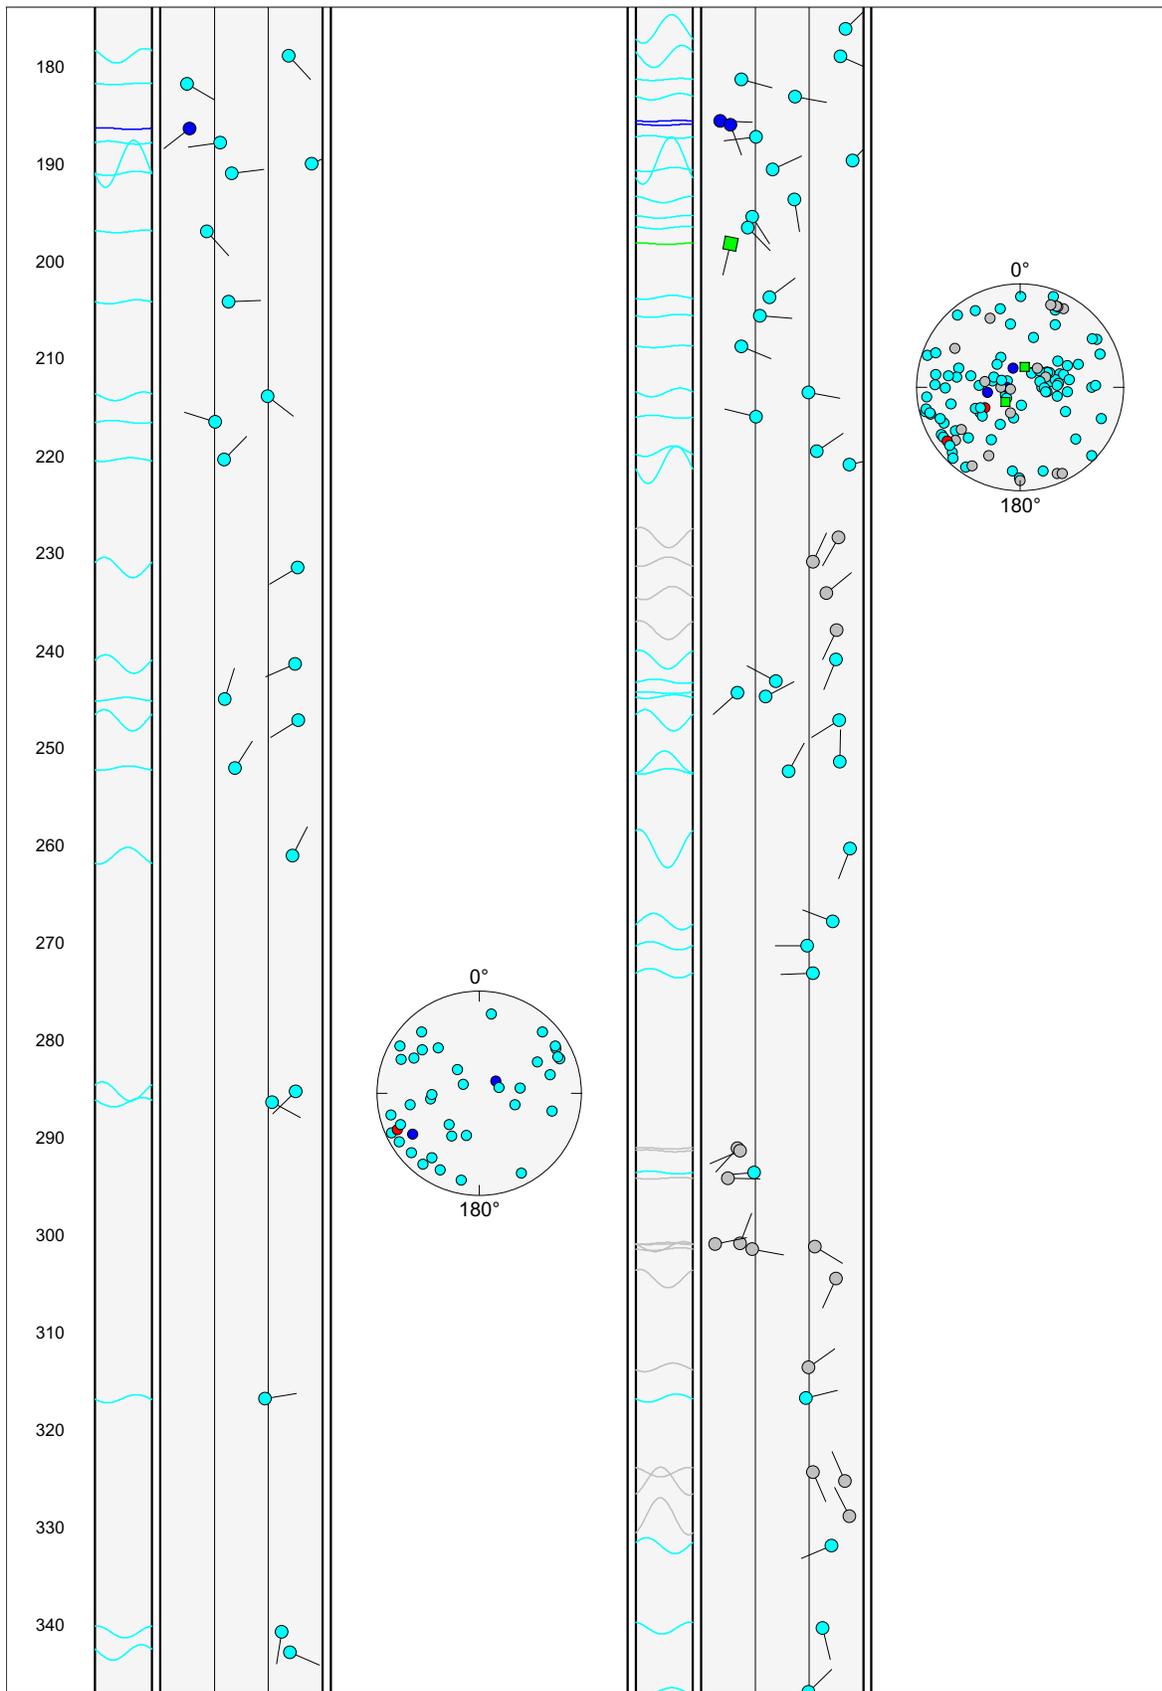
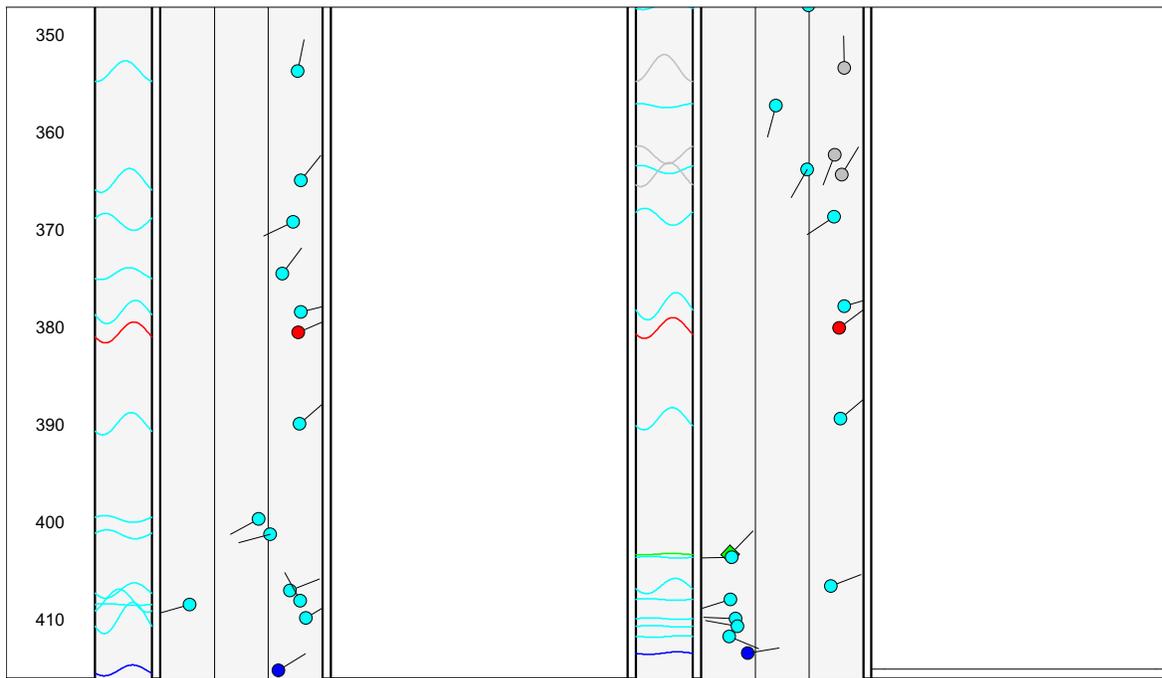
Figure 1L-3. Projection, tadpole, and stereoplots of interpretation of borehole image data for borehole WY-GATR, near Machiasport, Maine.

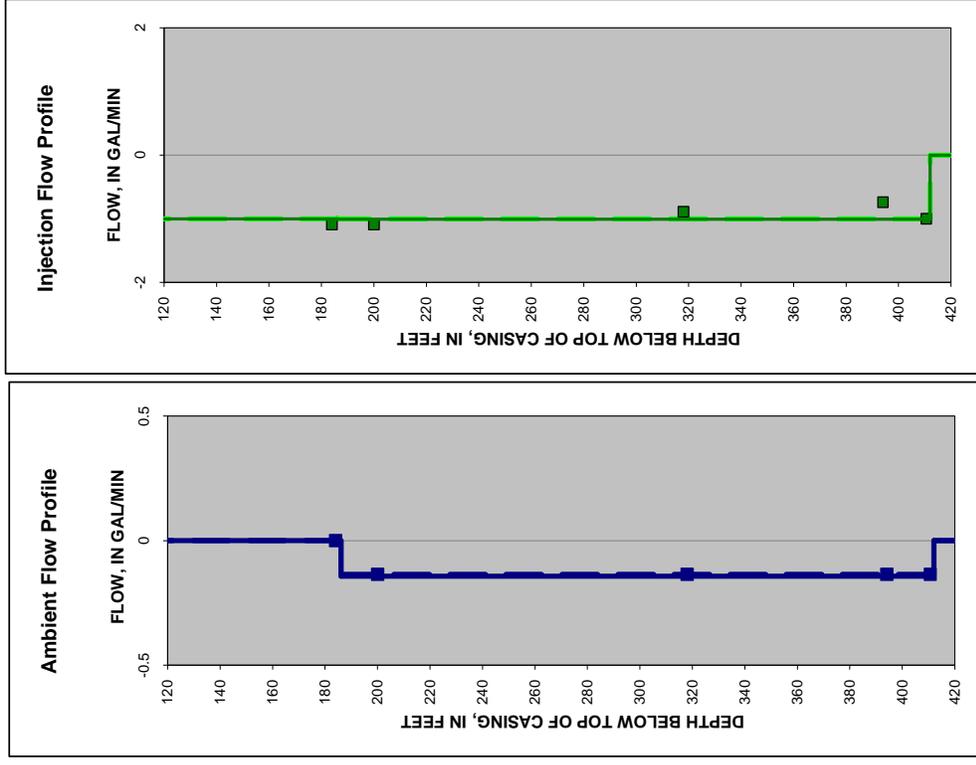
Dashed line indicates measured flow.
 Solid line indicates modeled flow.
 Points indicate measured heat-pulse flowmeter data.

Figure 1L-4. Interpretation and modeling of heat-pulse flowmeter logs for borehole WY-GATR, near Machiasport, Maine. [gal/min, gallon per minute; ft, feet; ft²/d, feet squared per day; positive values of flow are upward flow, negative values of flow are downward flow]

Fracture number	Depth (ft)	Ambient flow above fracture (gal/min)	Injected flow above fracture (gal/min)	Zone transmissivity (gal/min)	Water level (ft)	Elevation of water level (ft)	Percent transmissivity
2	186	0.000	-1.000	12	150.51	121.49	11
1	412	-0.142	-1.006	96	153.31	118.69	89

Total borehole transmissivity	108.0	(ft ² /d)
Sum of squares error	0.0001	(gal/min) ²
Root mean square error	0.0066	(gal/min)

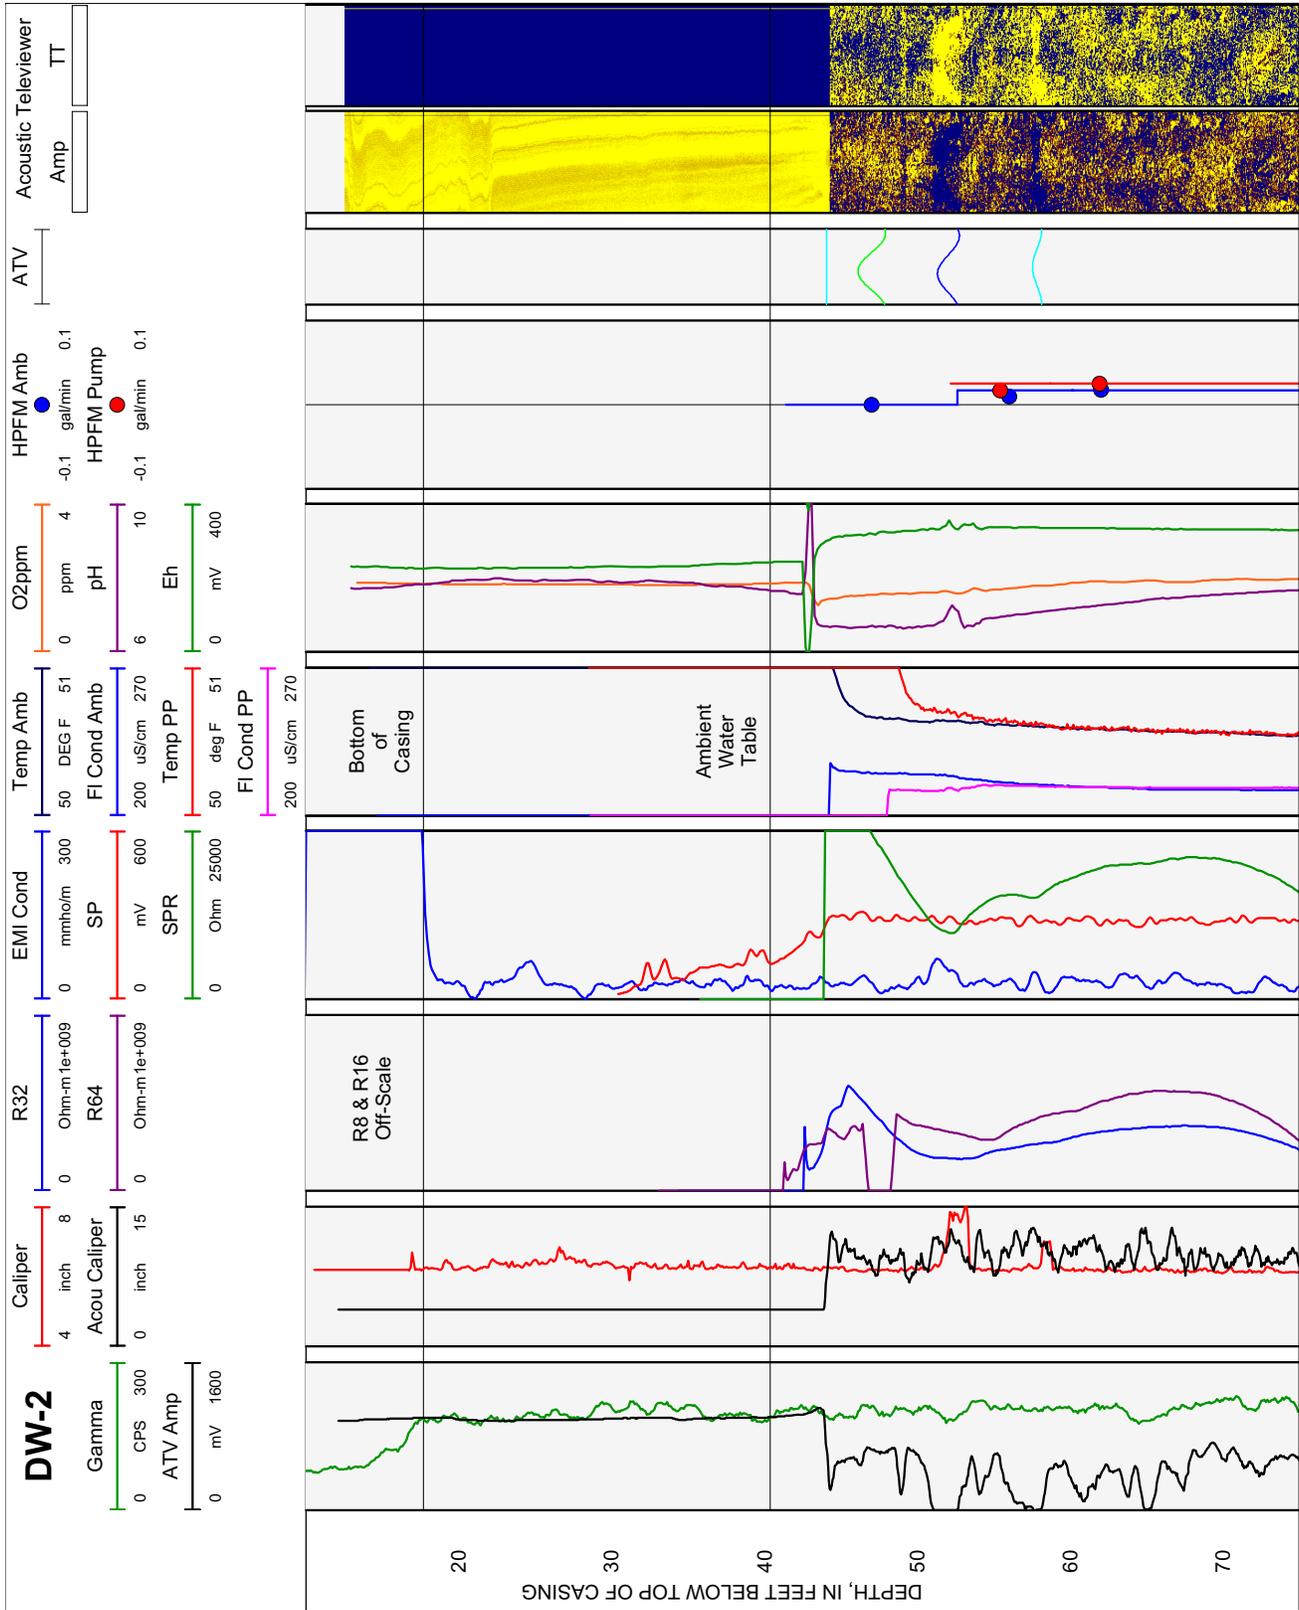
Figure 2A-1. Caliper, acoustic caliper, gamma, electromagnetic conductivity, fluid temperature, specific conductance, DO, pH, reduction oxidation, multi-space resistivity, oriented acoustic and optical borehole images, and heat-pulse flowmeter logs for borehole DW-2, near Machiasport, Maine.
