Borehole Geophysical Investigation of a Formerly Used Defense Site, Machiasport, Maine, 2003–2006

By Carole D. Johnson, Remo A. Mondazzi, and Peter K. Joesten

Scientific Investigations Report 2009–5120

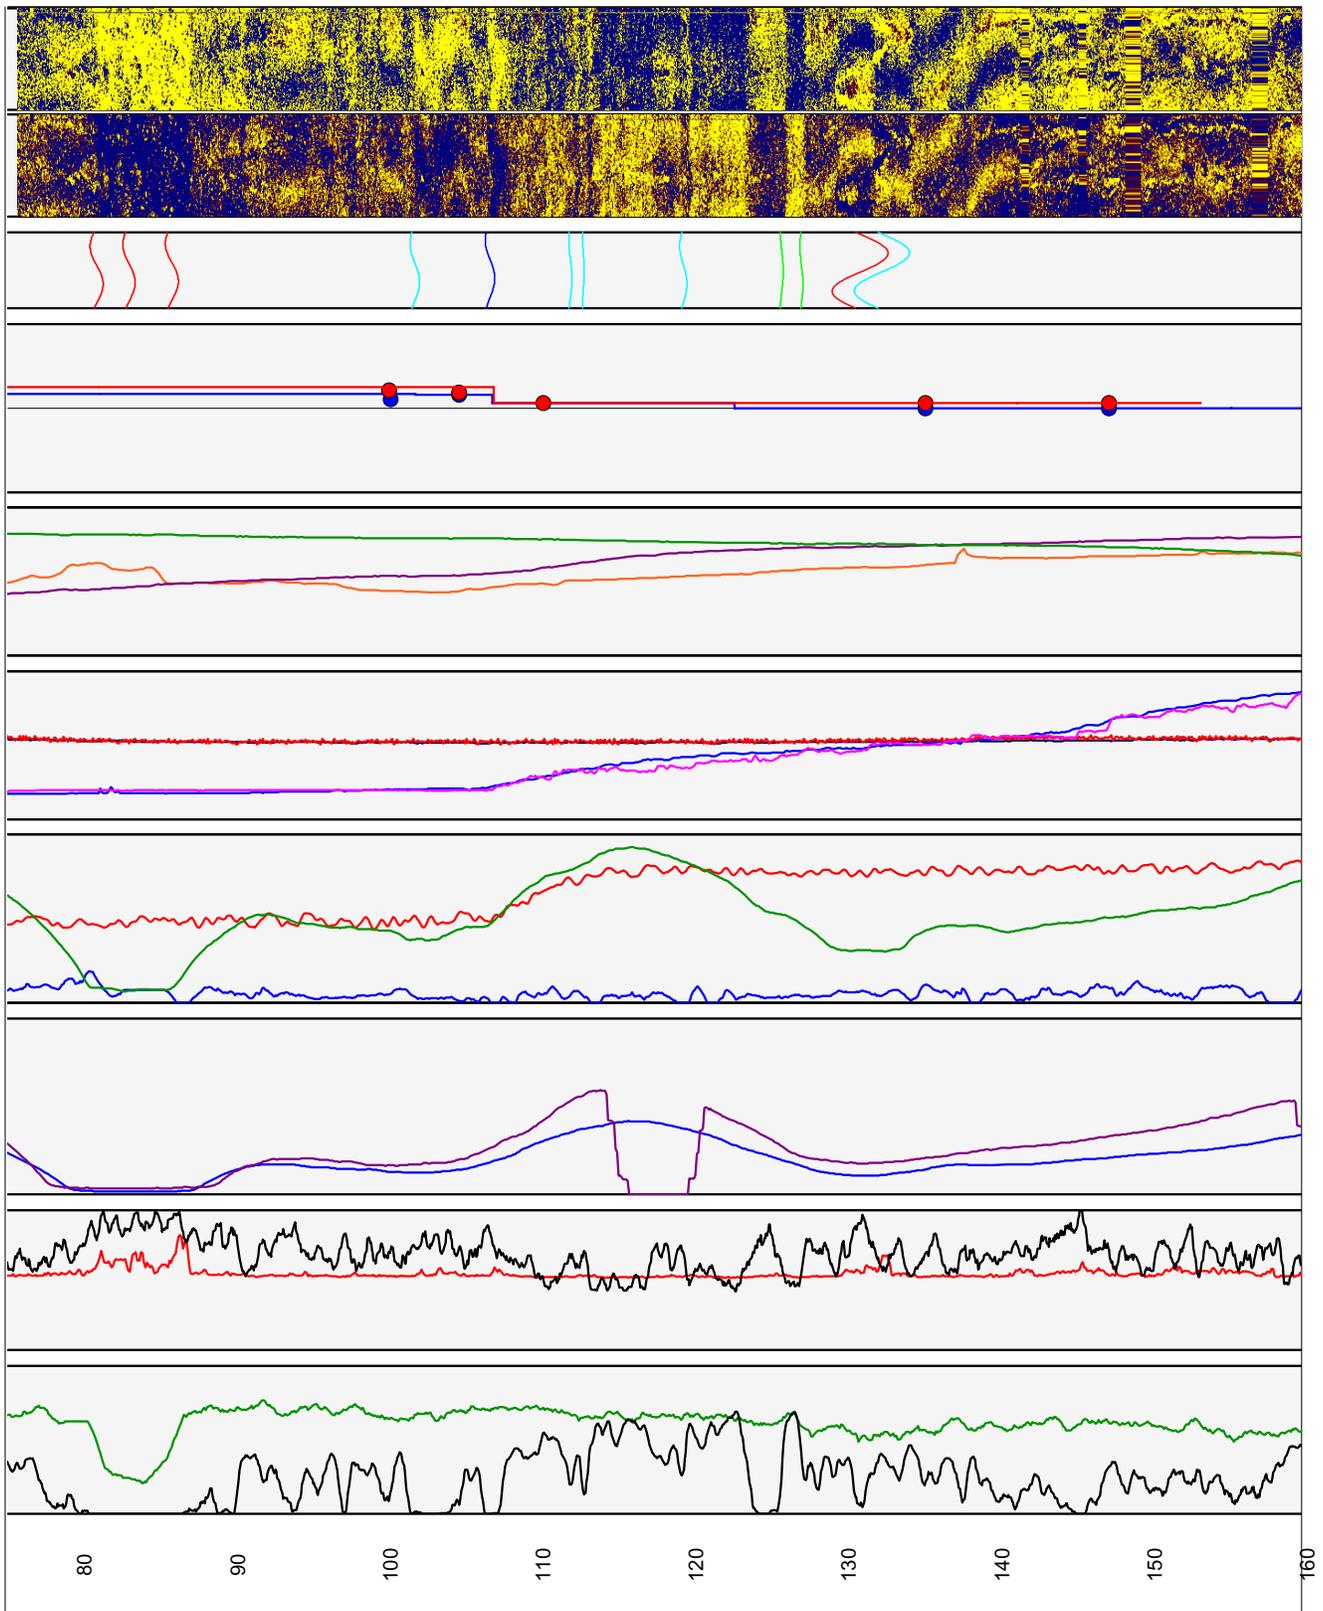
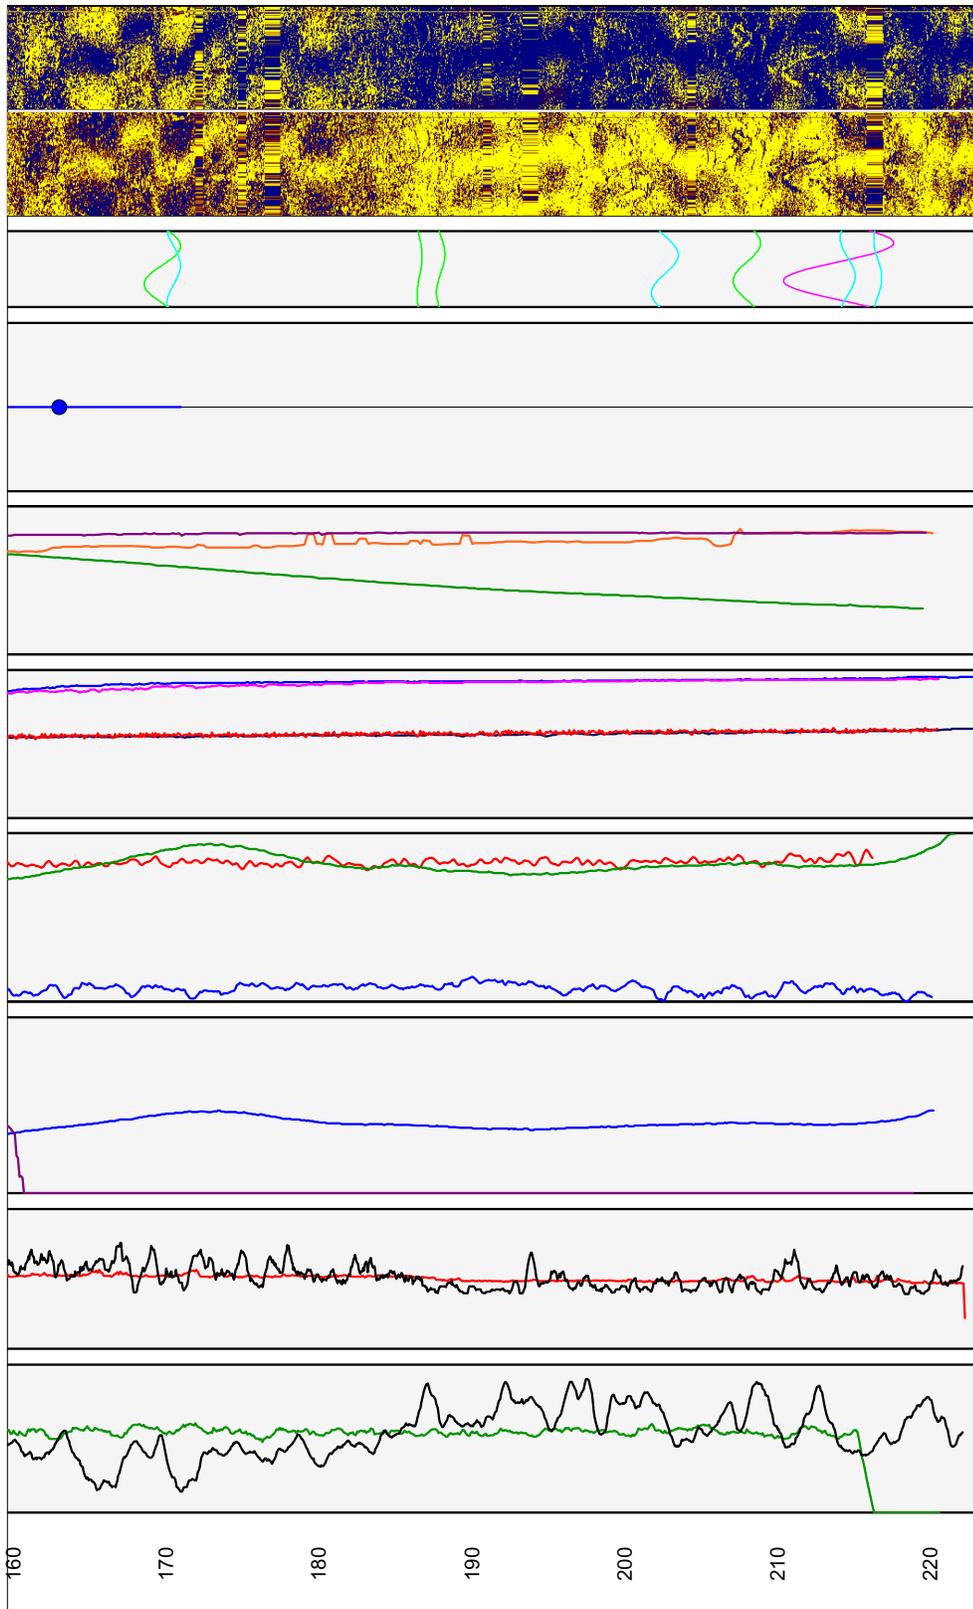
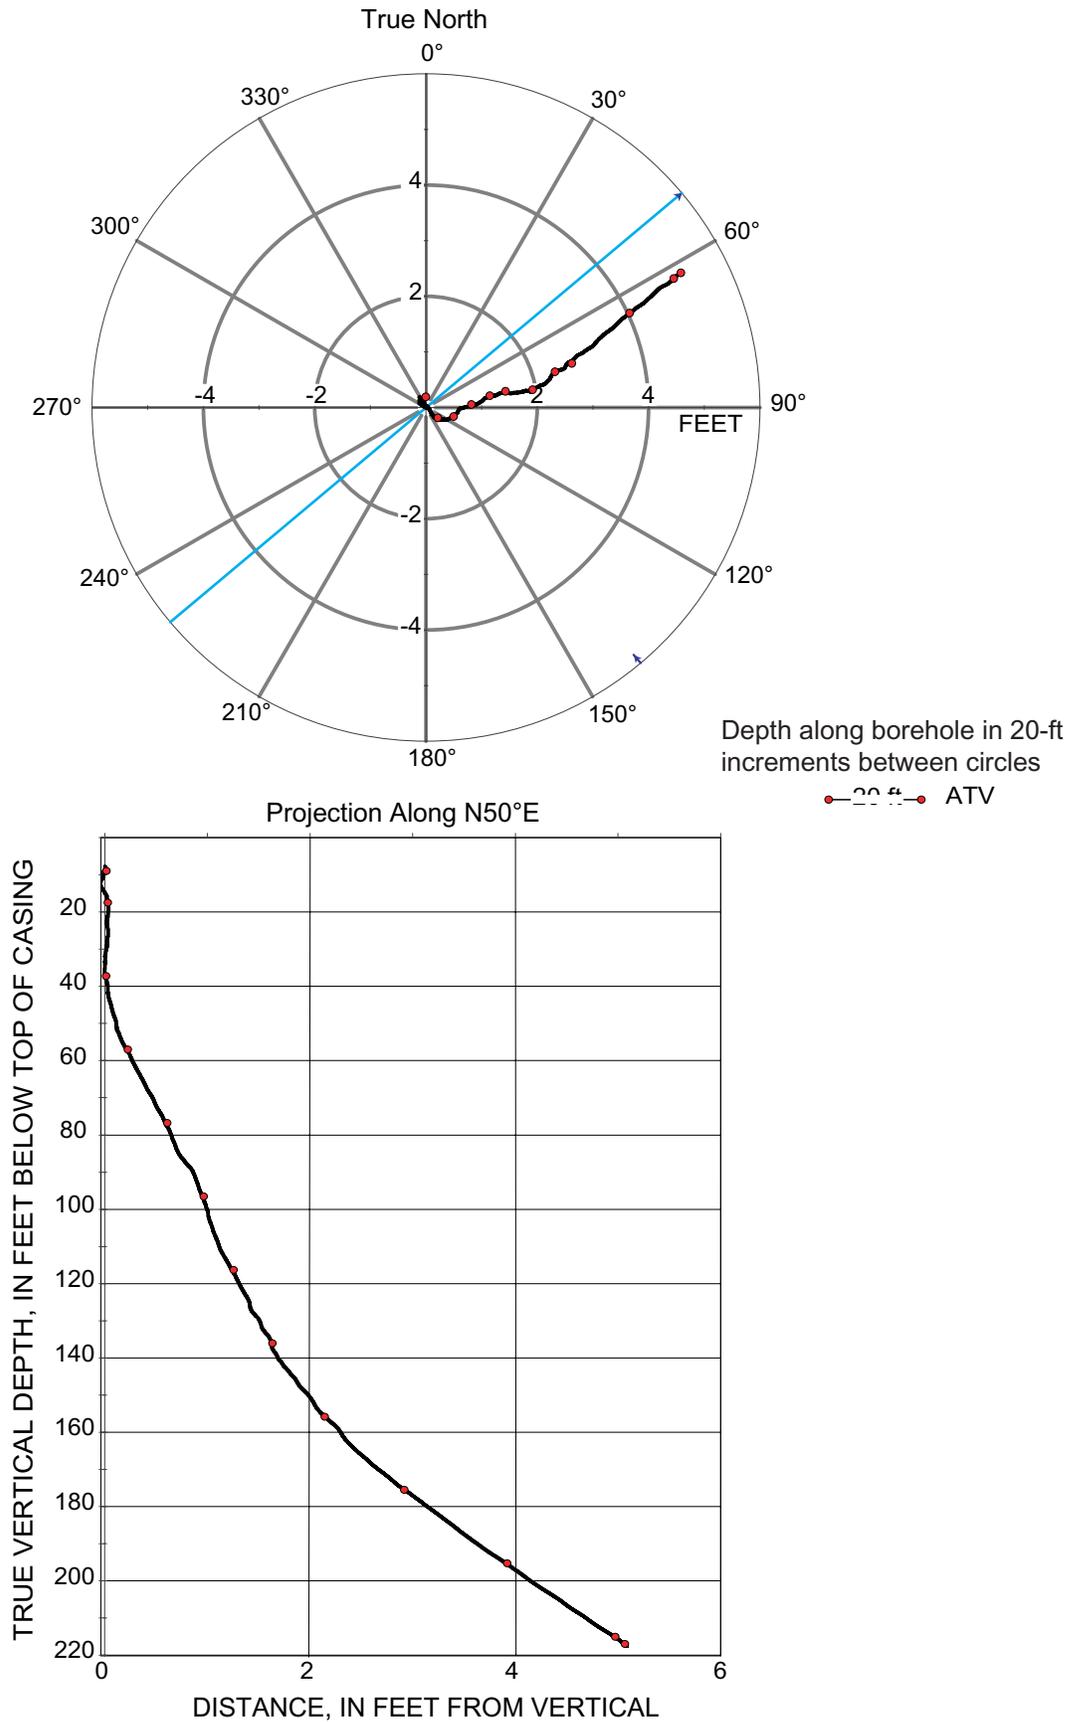
Figure 2A-1. Caliper, acoustic caliper, gamma, electromagnetic conductivity, fluid temperature, specific conductance, DO, pH, reduction oxidation, multi-space resistivity, oriented acoustic and optical borehole images, and heat-pulse flowmeter logs for borehole DW-2, near Machiasport, Maine.

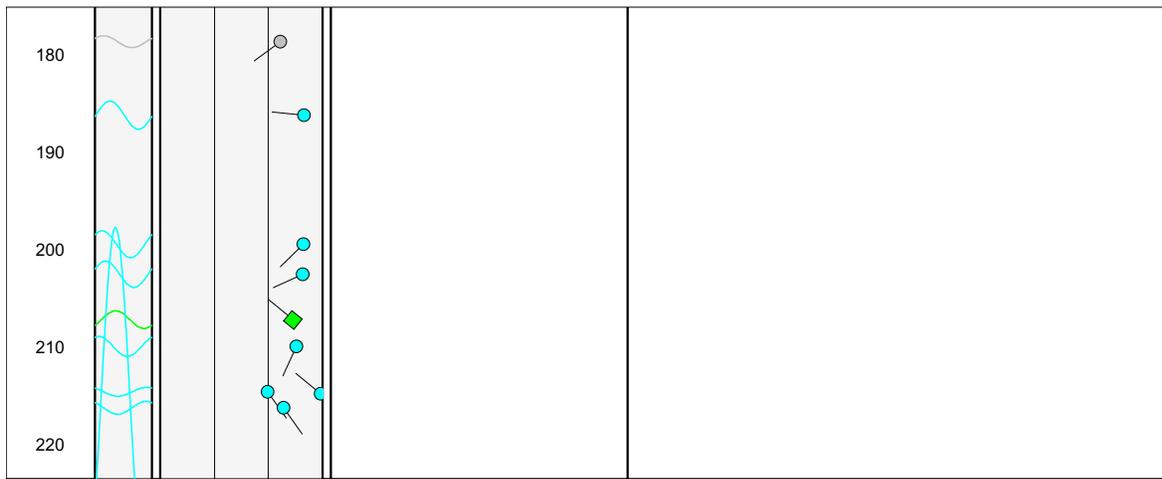
Figure 2A-3. Projection, tadpole, and stereoplots of interpretation of borehole image data for borehole DW-2 near Machiasport, Maine.

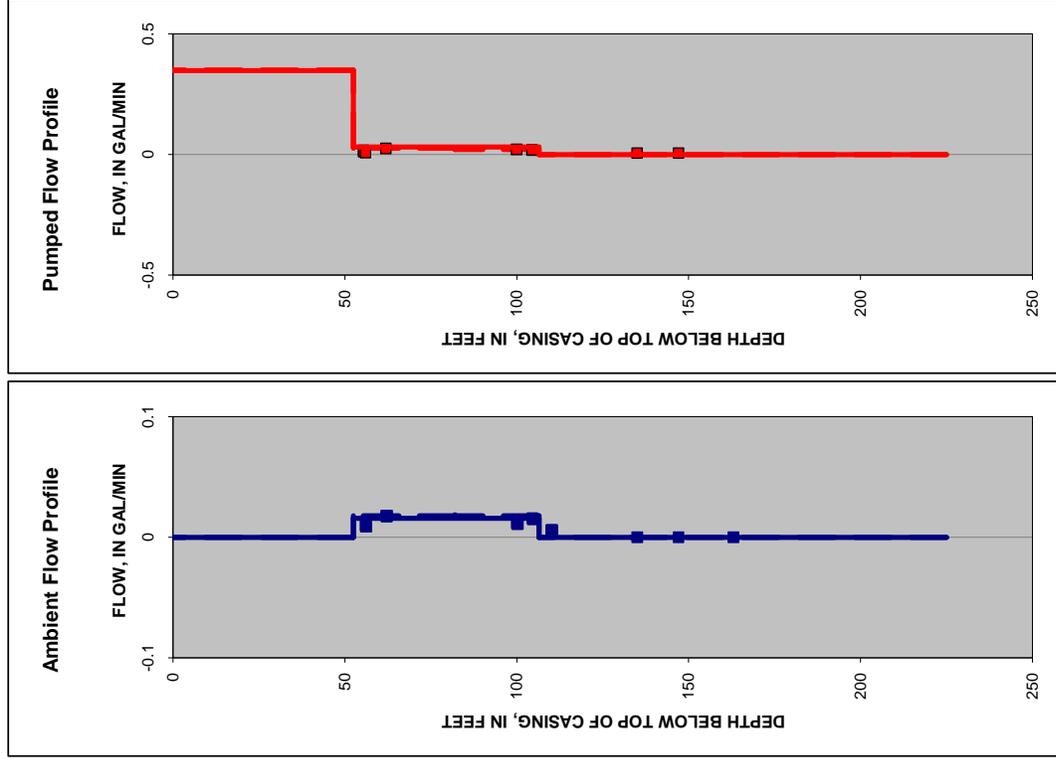
Fracture number	Depth (ft)	Ambient flow above fracture (gal/min)	Pumped flow above fracture (gal/min)	Zone transmissivity (ft ² /d)	Water level (ft)	Elevation of water level (ft)	Percent transmissivity
2	52.5	0.000	0.347	18	44.34	21.66	97
1	106.5	0.016	0.031	0.600000024	40.24	25.76	3

Total borehole transmissivity	18.6	(ft ² /d)
Sum of squares error	0.00012	(gal/min) ²
Root mean square error	0.00778	(gal/min)

Dashed line indicates measured flow.
 Solid line indicates modeled flow.
 Points indicate measured heat-pulse flowmeter data.

Figure 2A-4. Interpretation and modeling of heat-pulse flowmeter logs for borehole DW-2, near Machiasport, Maine. [gal/min, gallon per minute; ft, feet; ft²/d, feet squared per day; positive values of flow are upward flow, negative values of flow are downward flow]

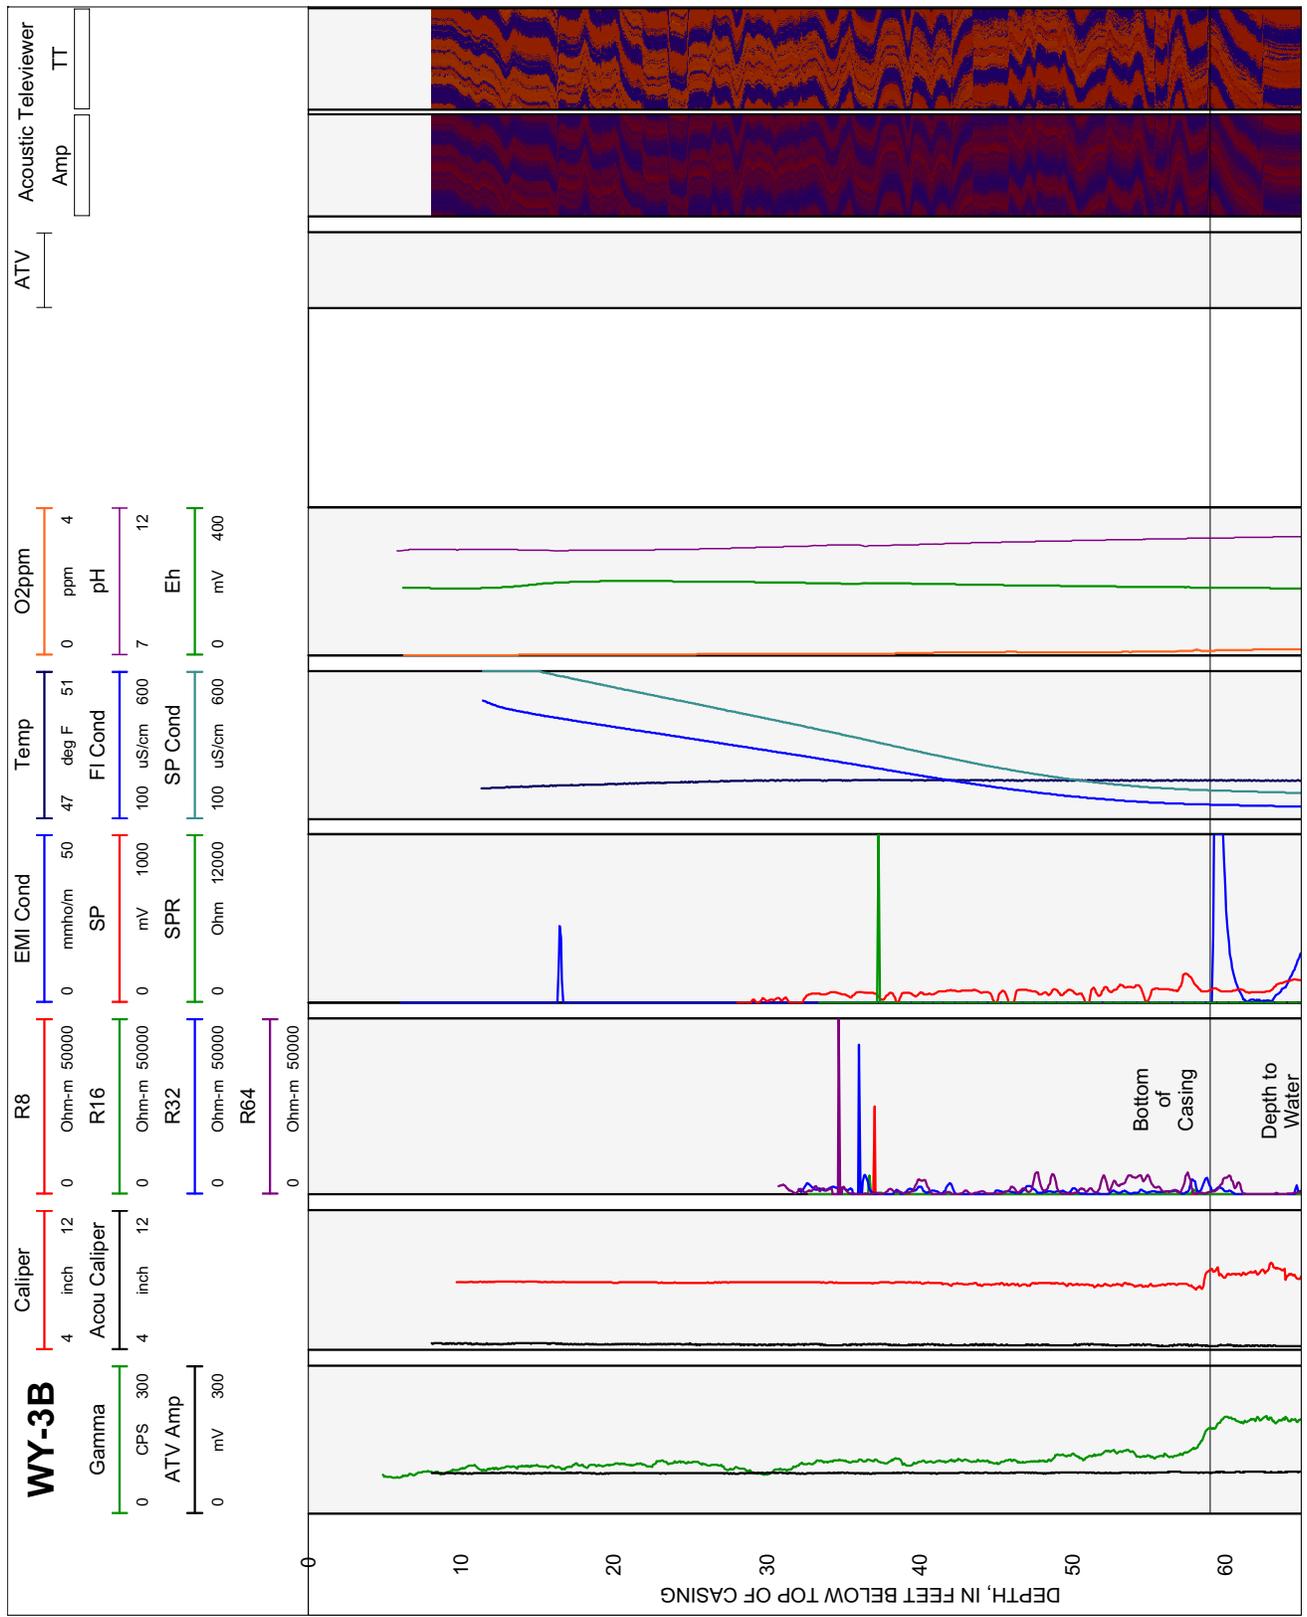
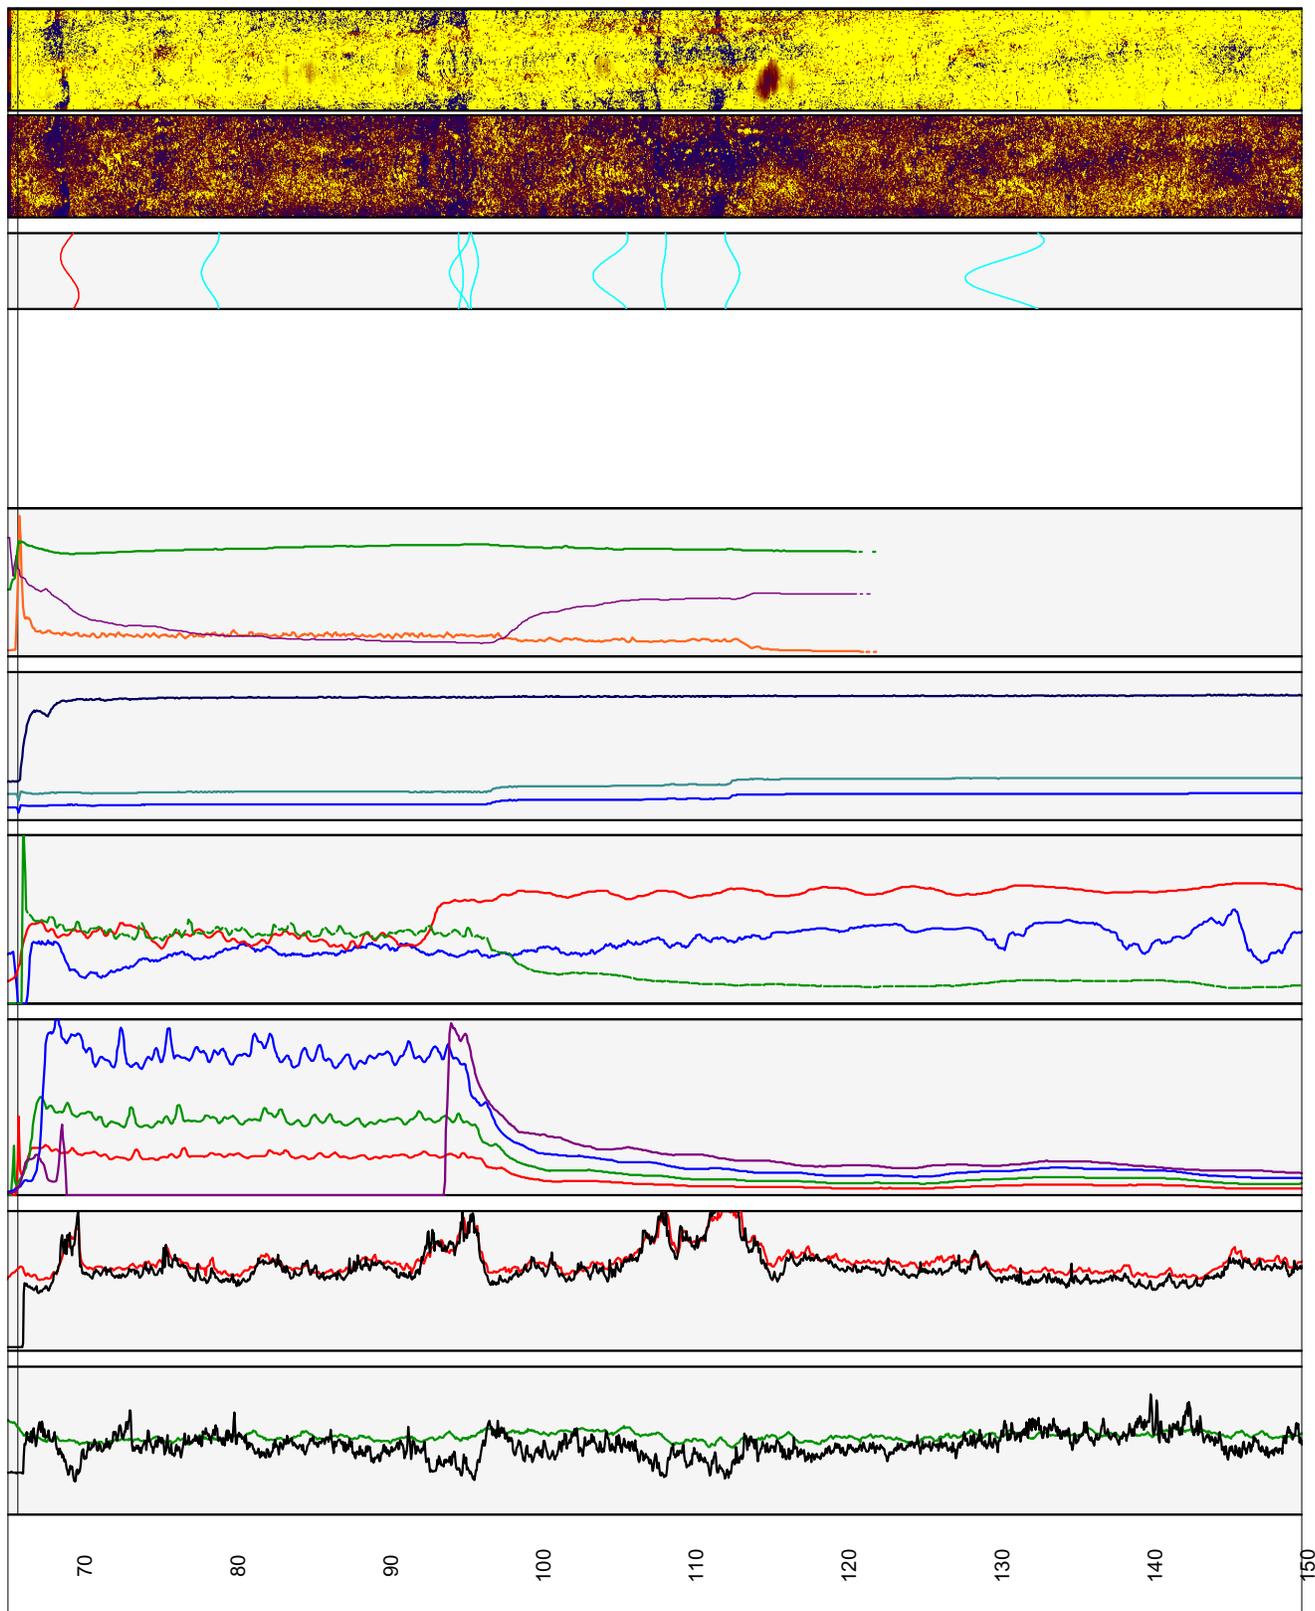
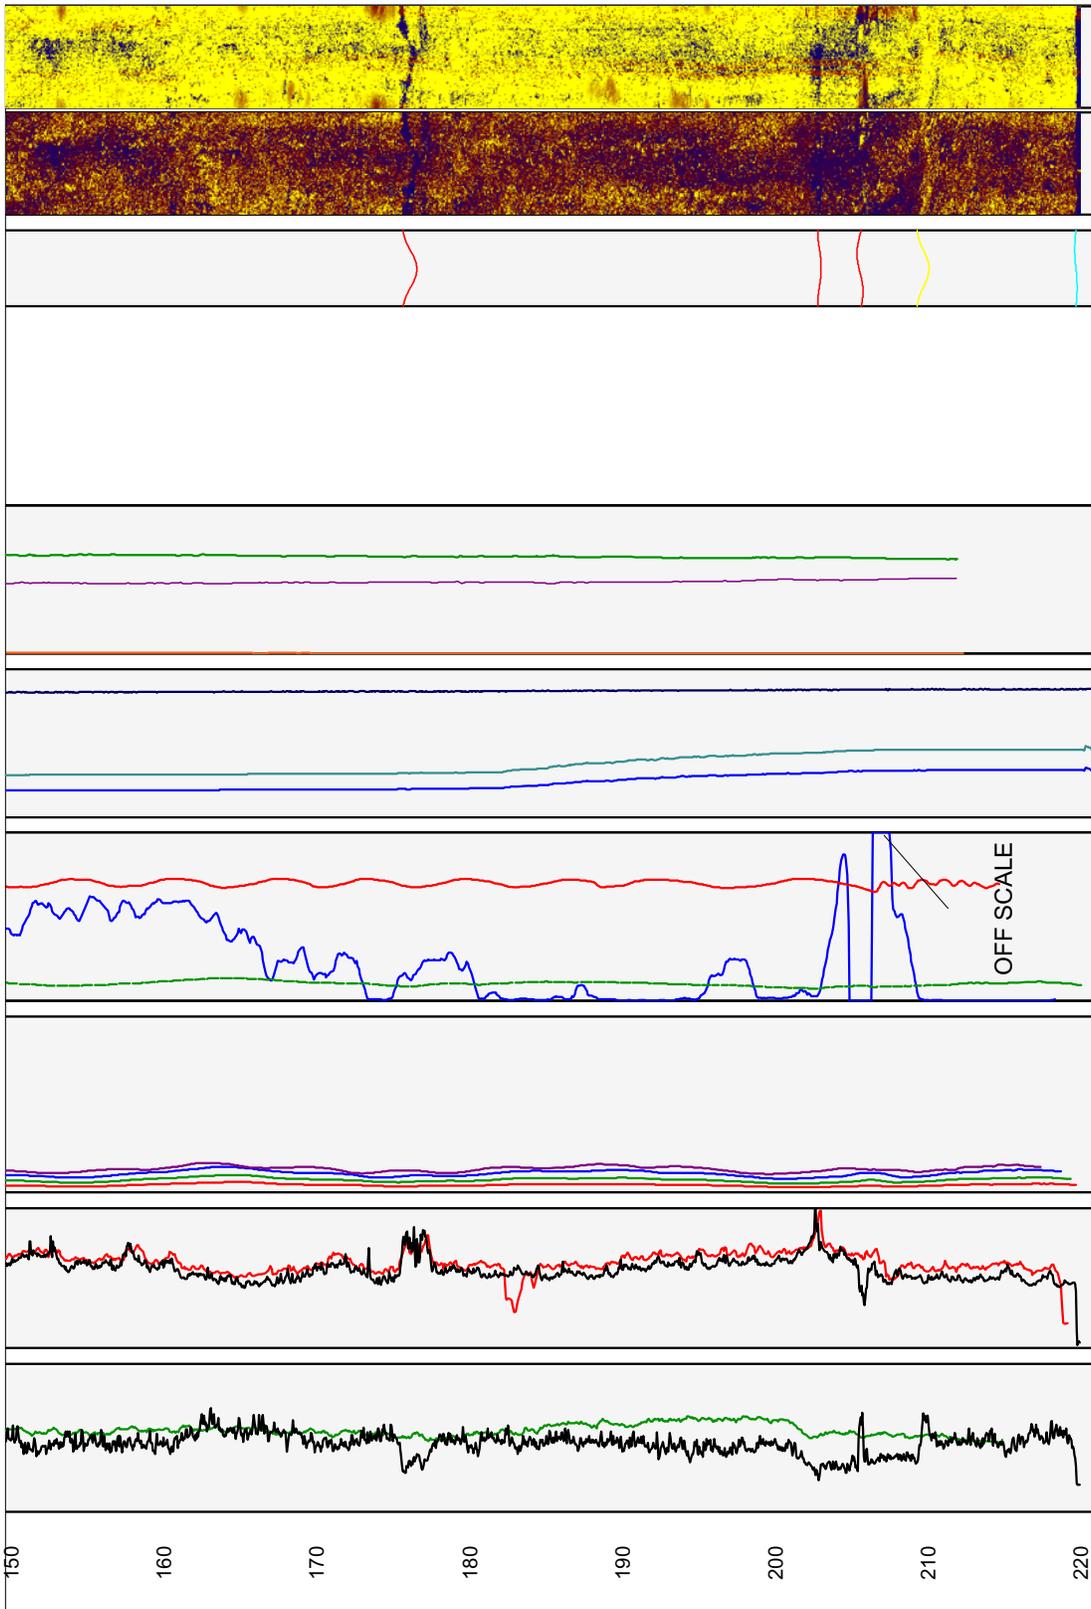
Figure 2B-1. Caliper, acoustic caliper, gamma, electromagnetic conductivity, fluid temperature, specific conductance, DO, pH, reduction oxidation, multi-space resistivity, oriented acoustic and optical borehole images, and heat-pulse flowmeter logs for borehole WY-3B, near Machiasport, Maine.

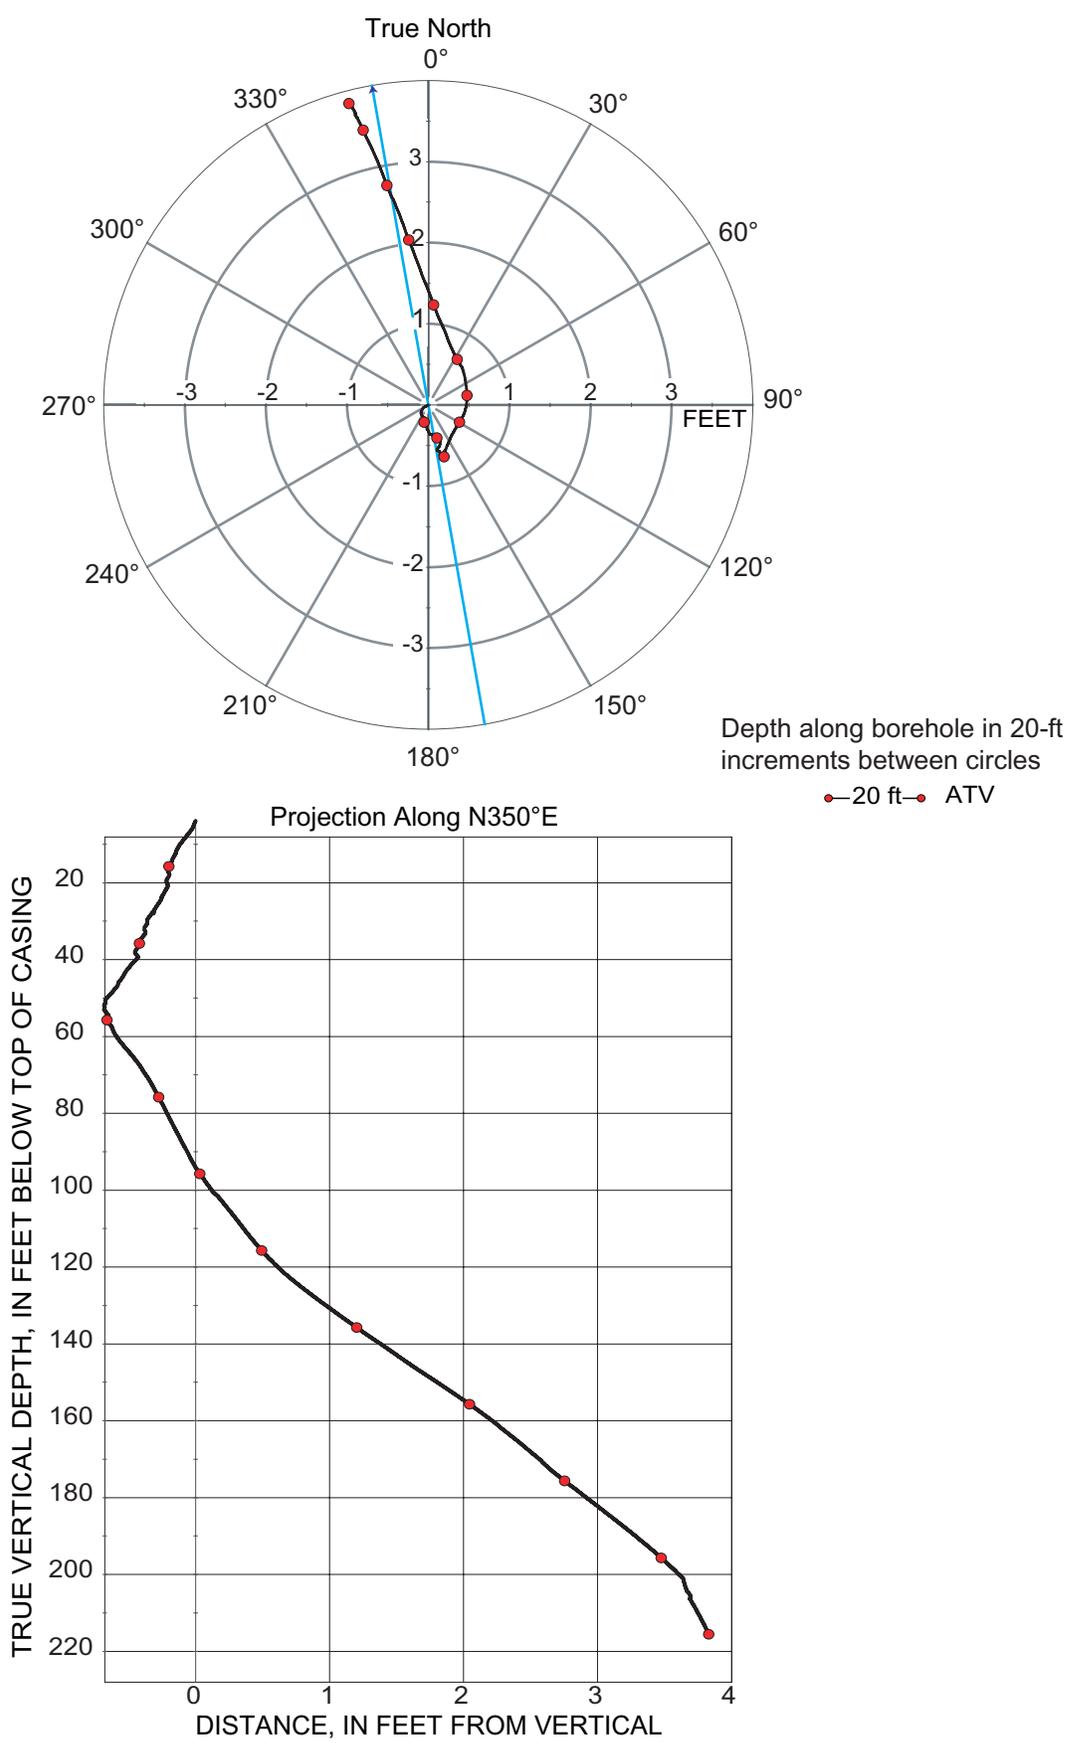
Figure 2B-2. Borehole deviation logs for borehole WY-3B, near Machiasport, Maine. Blue line on radial plot (top) is line of projection for vertical plot (bottom).
 [ft, foot; ATV, acoustic televiewer; OTV, optical televiewer]

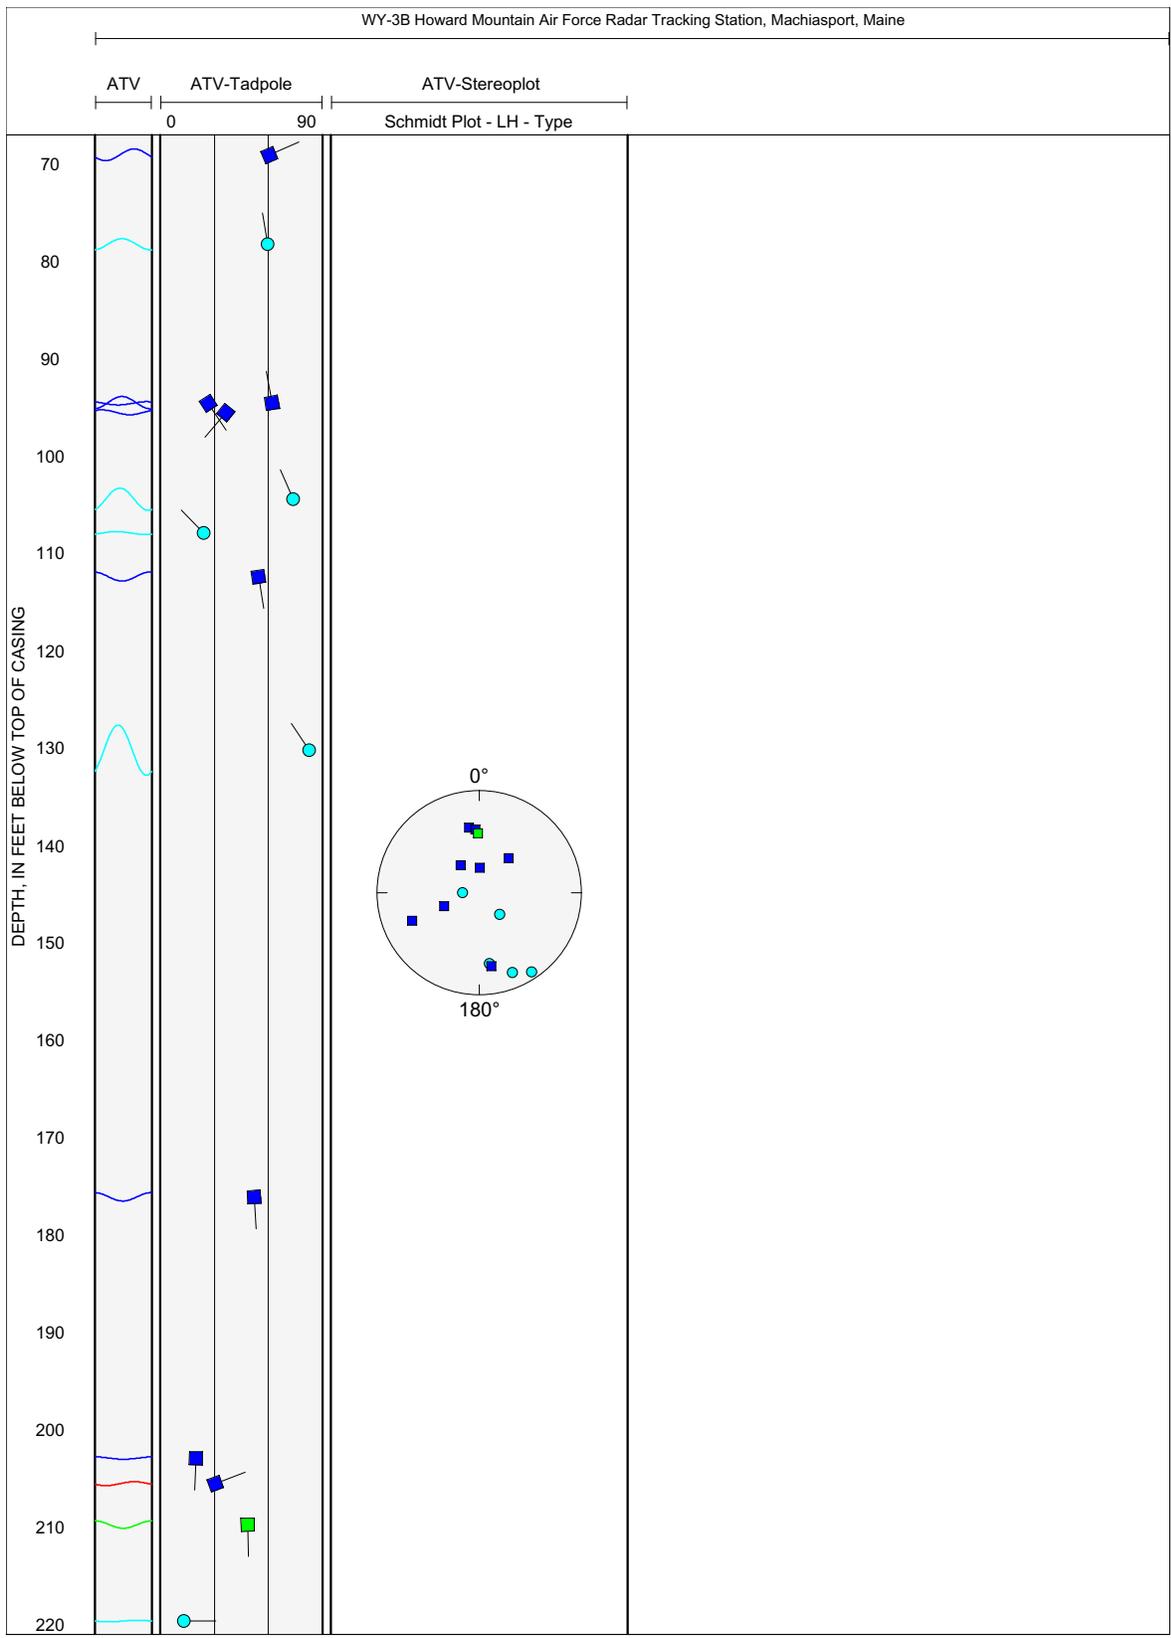
Figure 2B-3. Projection, tadpole, and stereoplots of interpretation of borehole image data for borehole WY-3B, near Machiasport, Maine.

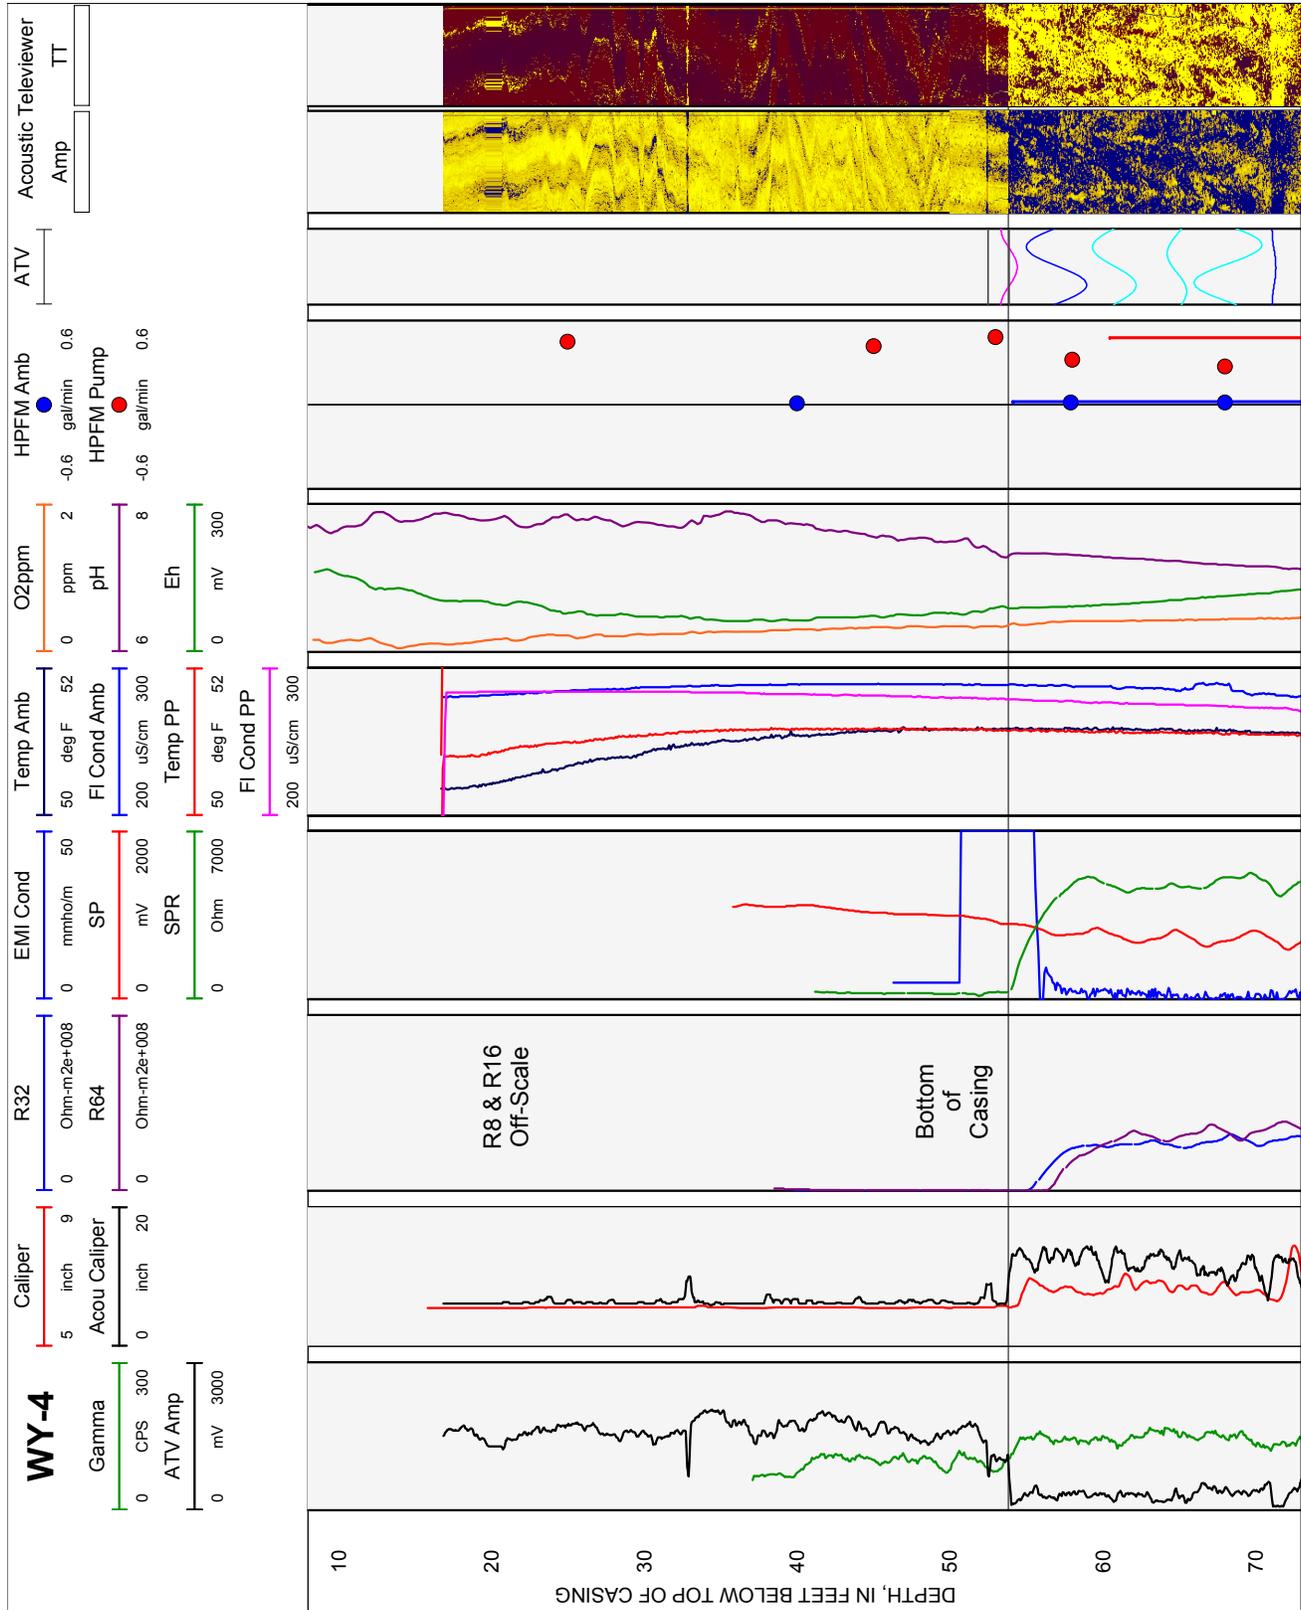
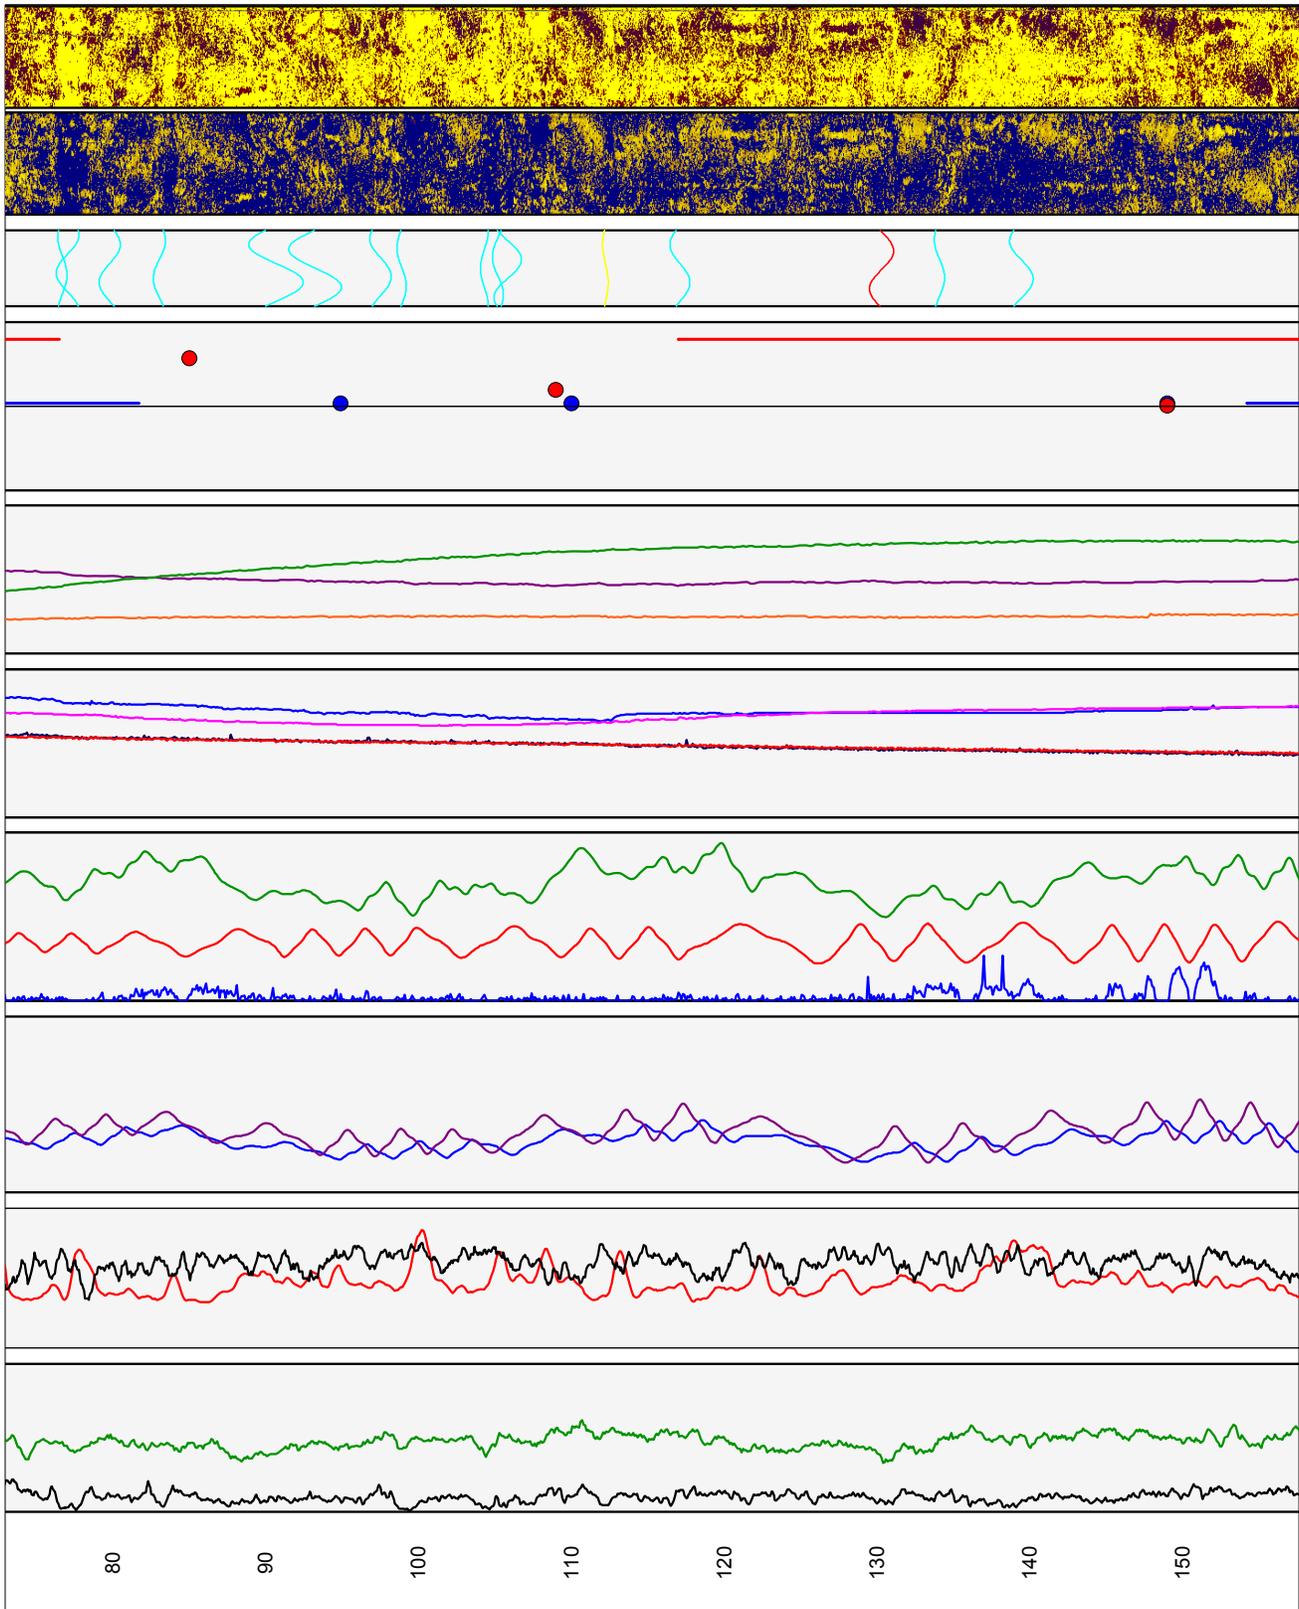
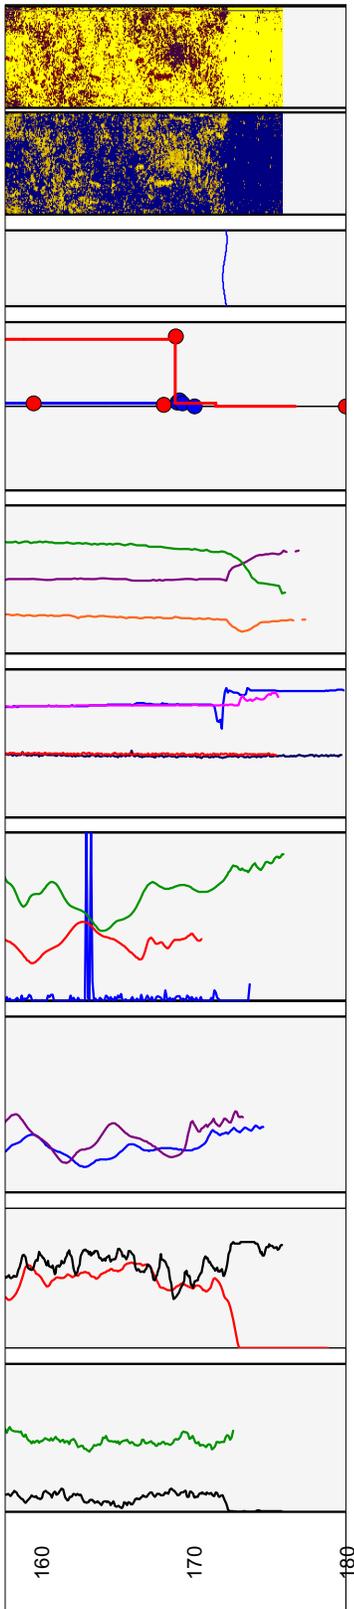
Figure 2C-1. Caliper, acoustic caliper, gamma, electromagnetic conductivity, fluid temperature, specific conductance, DO, pH, reduction oxidation, multi-space resistivity, oriented acoustic and optical borehole images, and heat-pulse flowmeter logs for borehole WY-4, near Machiasport, Maine.
