Borehole Geophysical Investigation of a Formerly Used Defense Site, Machiasport, Maine, 2003–2006

By Carole D. Johnson, Remo A. Mondazzi, and Peter K. Joesten

Scientific Investigations Report 2009–5120

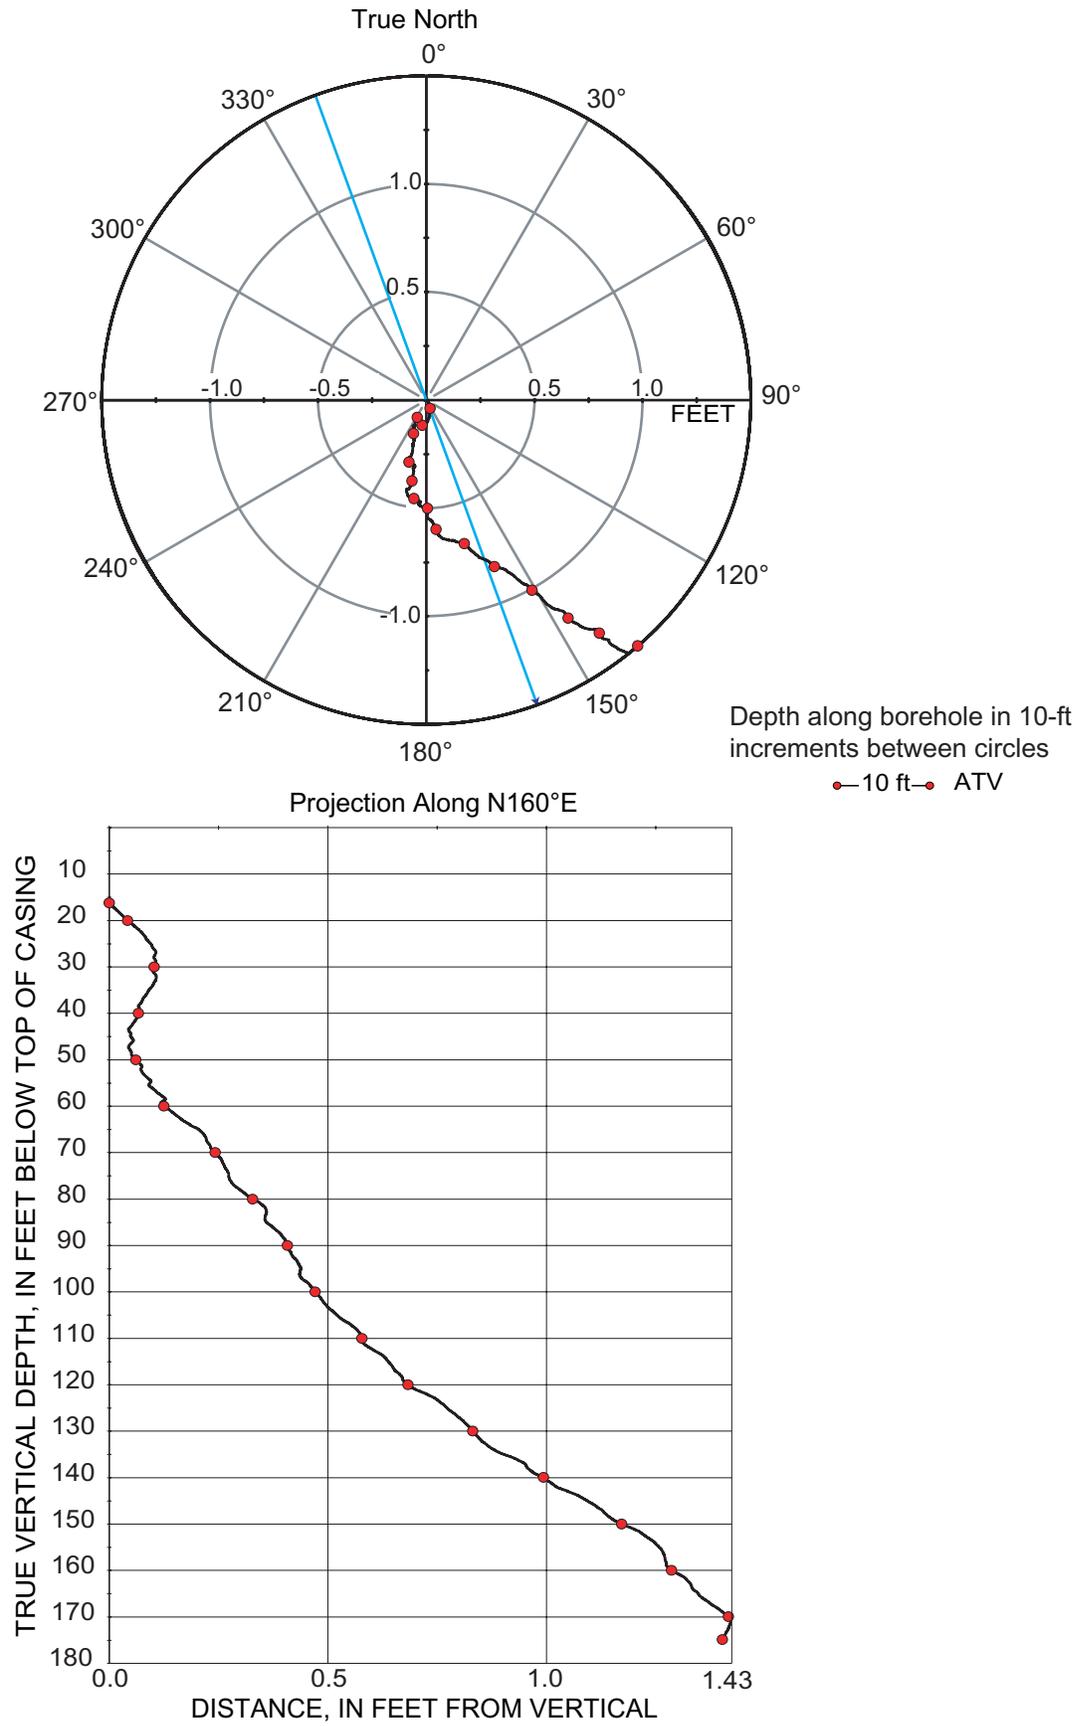
Figure 2C-2. Borehole deviation logs for borehole WY-4, near Machiasport, Maine. Blue line on radial plot (top) is line of projection for vertical plot (bottom).
[ft, foot; ATV, acoustic televiewer]

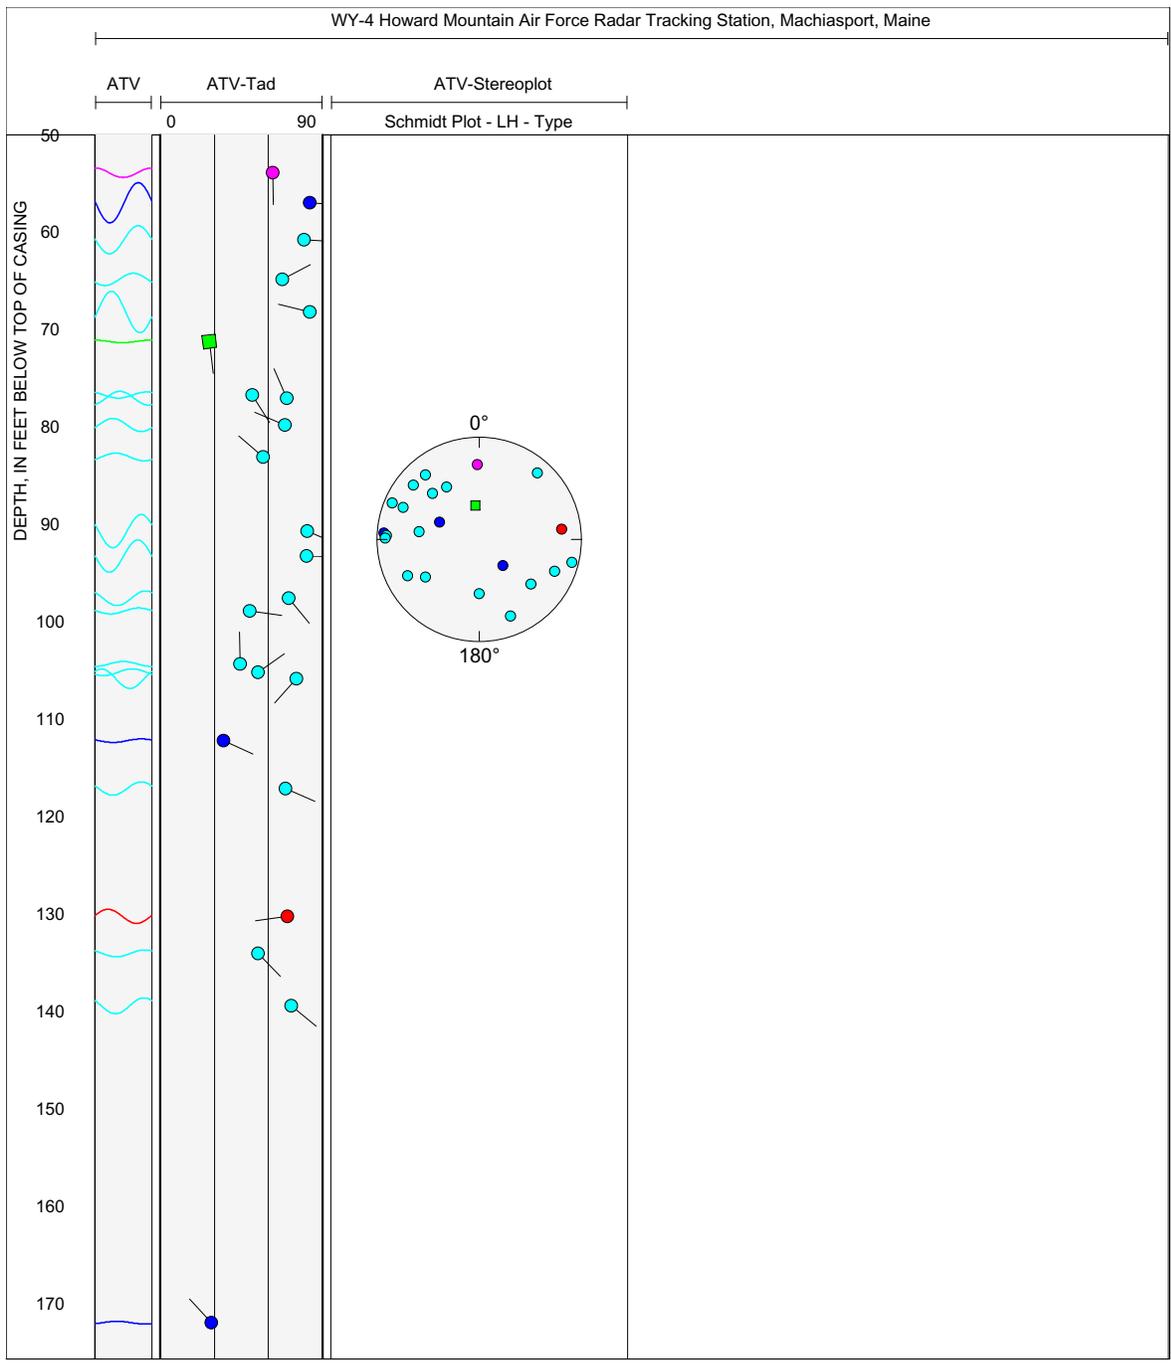
Figure 2C-3. Projection, tadpole, and stereoplots of interpretation of borehole image data for borehole WY-4, near Machiasport, Maine.

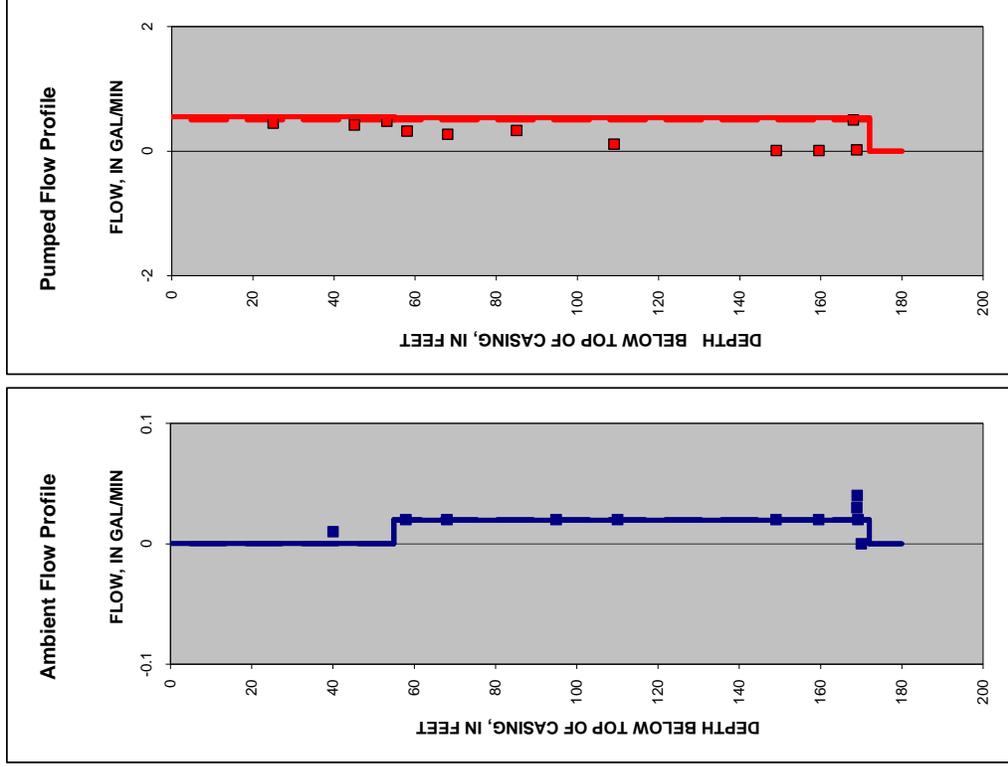
Fracture number	Depth (ft)	Ambient flow above fracture (gal/min)	Pumped flow above fracture (gal/min)	Zone transmissivity (ft ² /d)	Water level (ft)	Elevation of water level (ft)	Percent transmissivity
2	55.0	0.00	0.55	1.0	9.30	161.40	5
1	172.0	0.02	0.54	20.0	6.60	164.10	95

Total borehole transmissivity	21.0	(ft ² /d)
Sum of squares error	0.00394	(gal/min) ²
Root mean square error	0.04439	(gal/min)

Dashed line indicates measured flow.
 Solid line indicates modeled flow.
 Points indicate measured heat-pulse flowmeter data.

Figure 2C-4. Interpretation and modeling of heat-pulse flowmeter logs for borehole WY-4, near Machiasport, Maine. [gal/min, gallon per minute; ft, feet; ft²/d, feet squared per day; positive values of flow are upward flow, negative values of flow are downward flow]

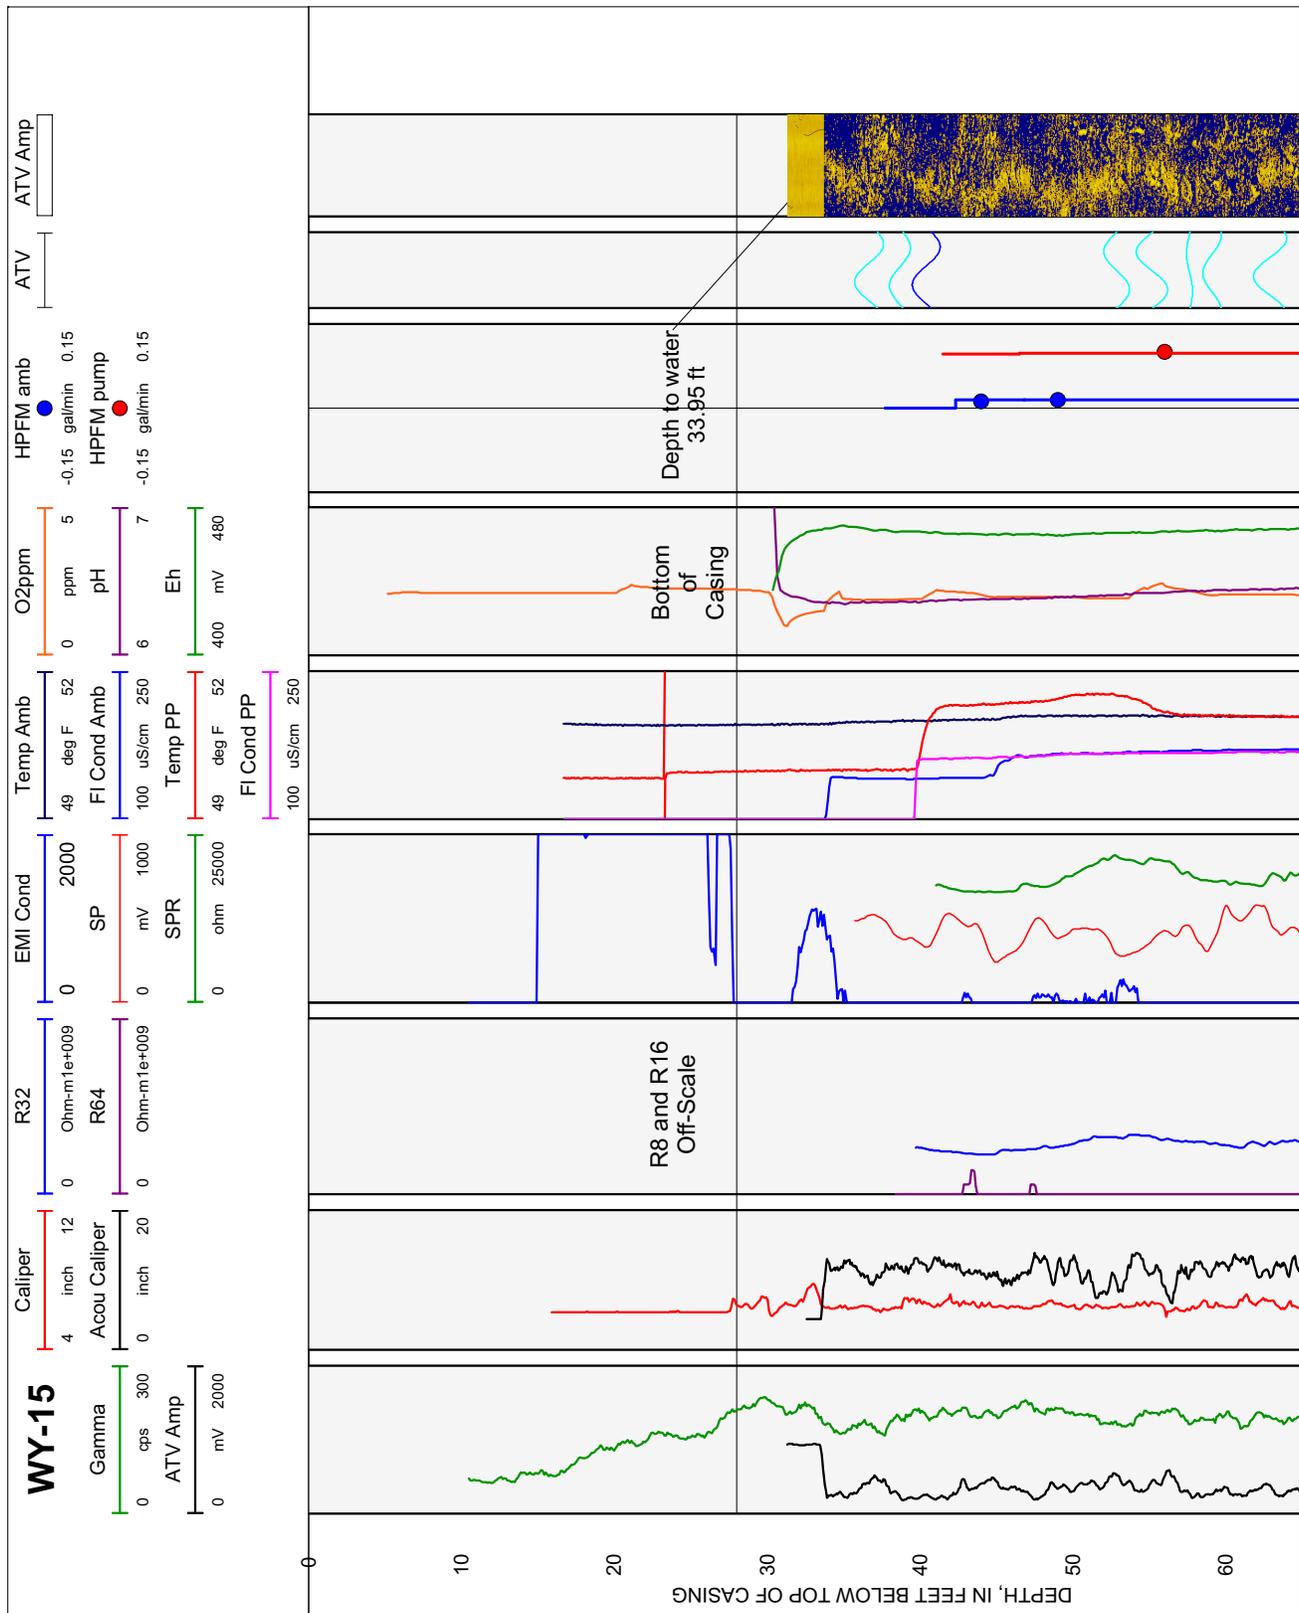
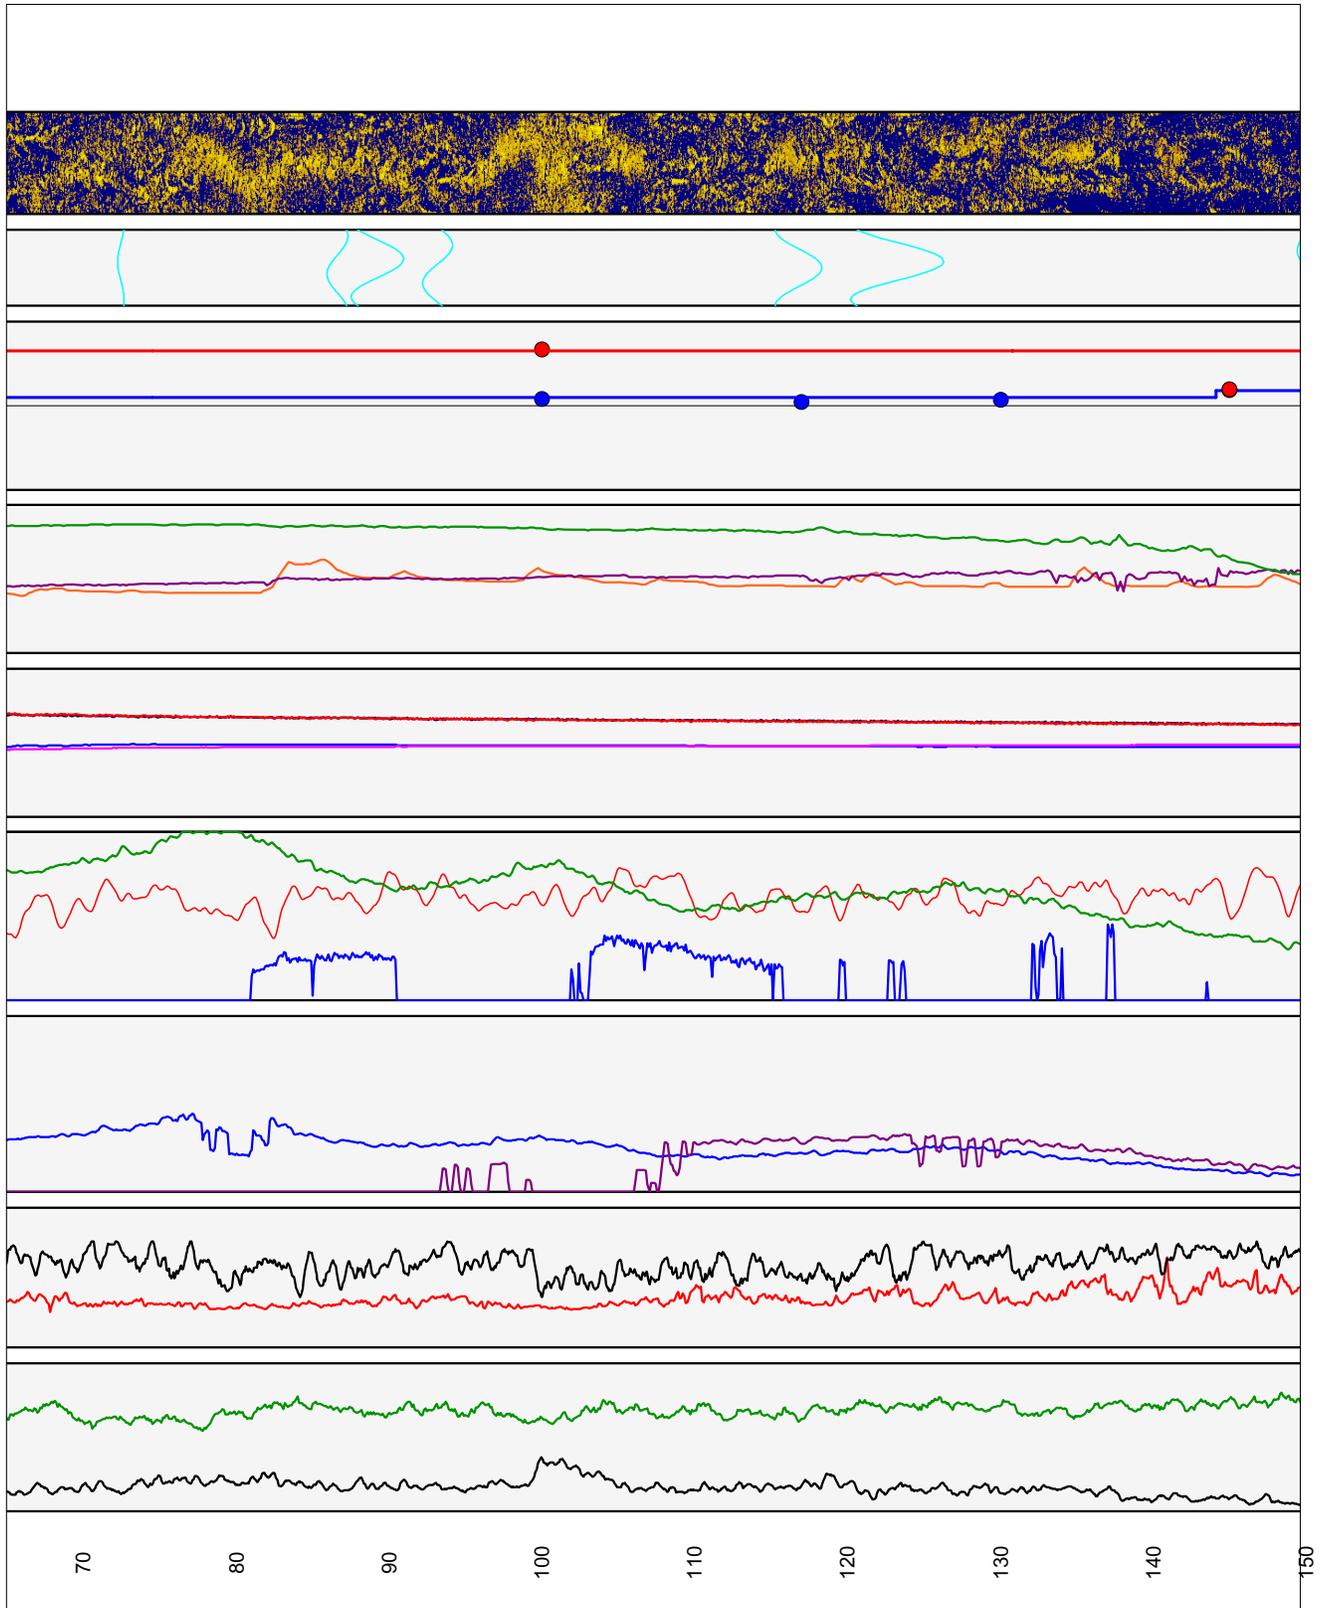
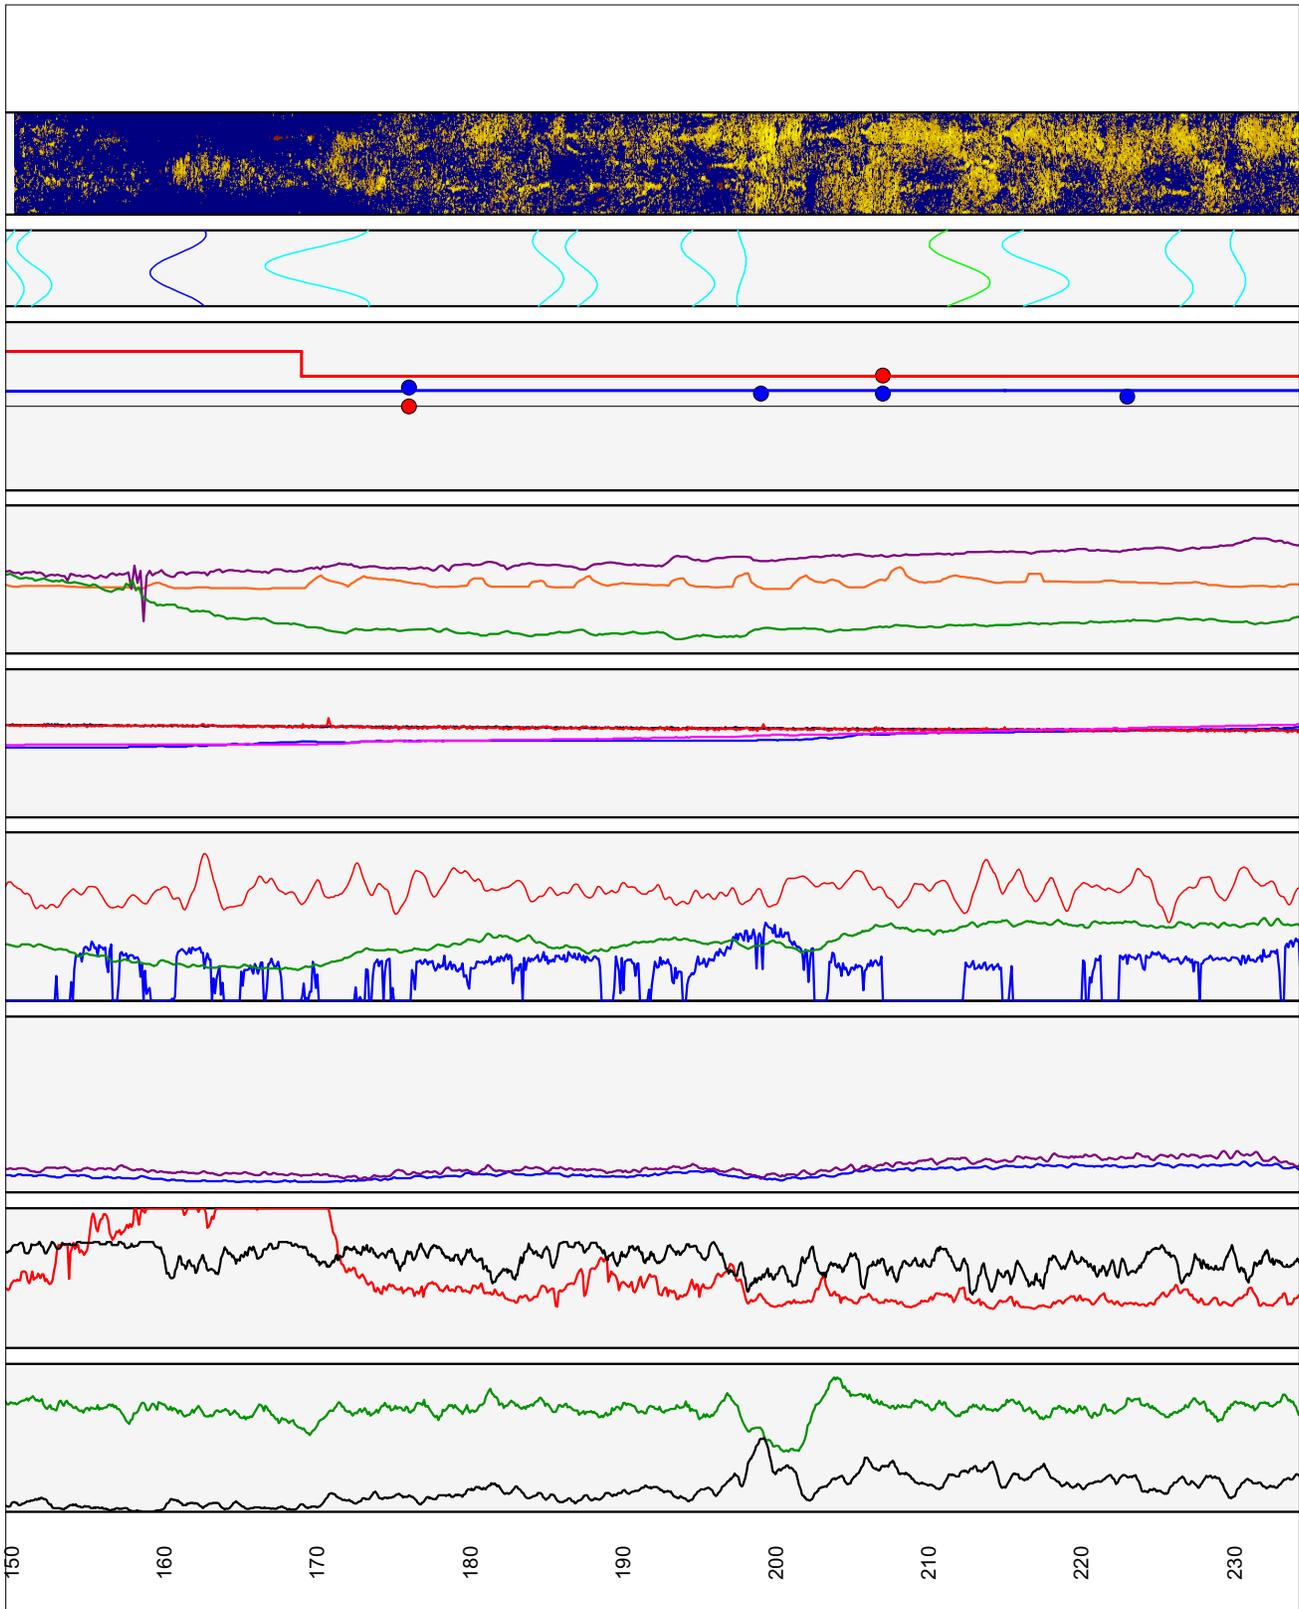
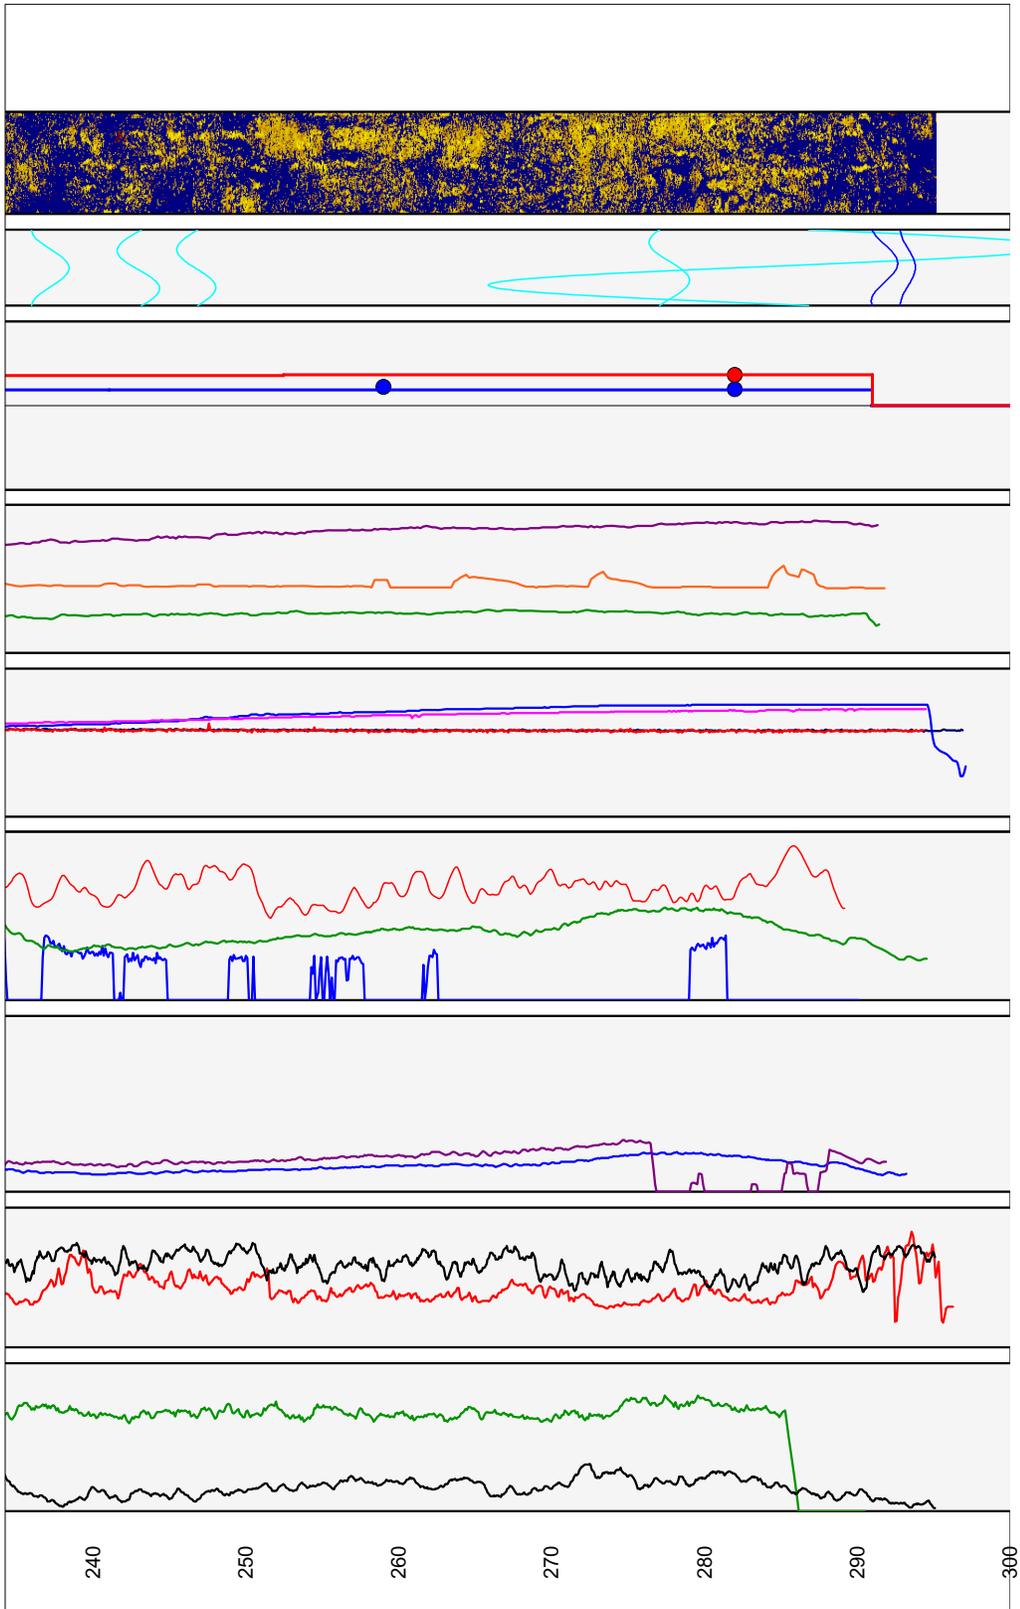
Figure 2D-1. Caliper, acoustic caliper, gamma, electromagnetic conductivity, fluid temperature, specific conductance, DO, pH, reduction oxidation, multi-space resistivity, oriented acoustic and optical borehole images, and heat-pulse flowmeter logs for borehole WY-15, near Machiasport, Maine.

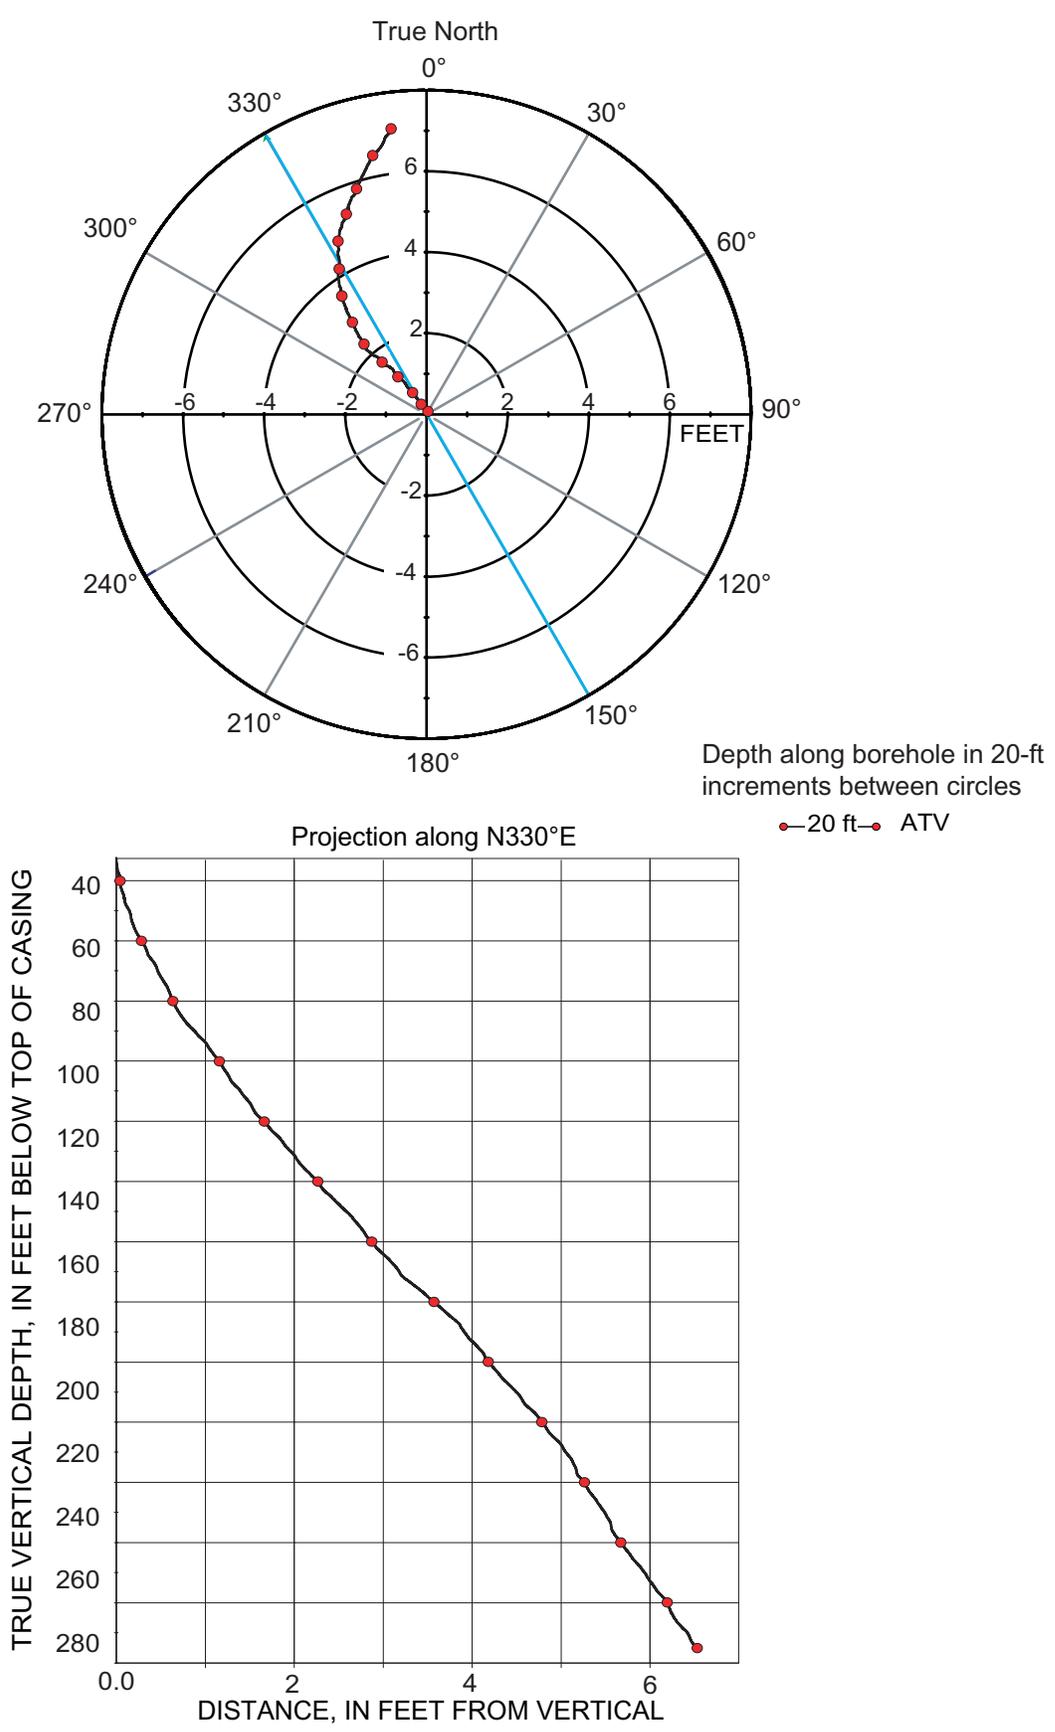
Figure 2D-2. Borehole deviation logs for borehole WY-15, near Machiasport, Maine. Blue line on radial plot (top) is line of projection for vertical plot (bottom).
[ft, foot; ATV, acoustic televiewer]

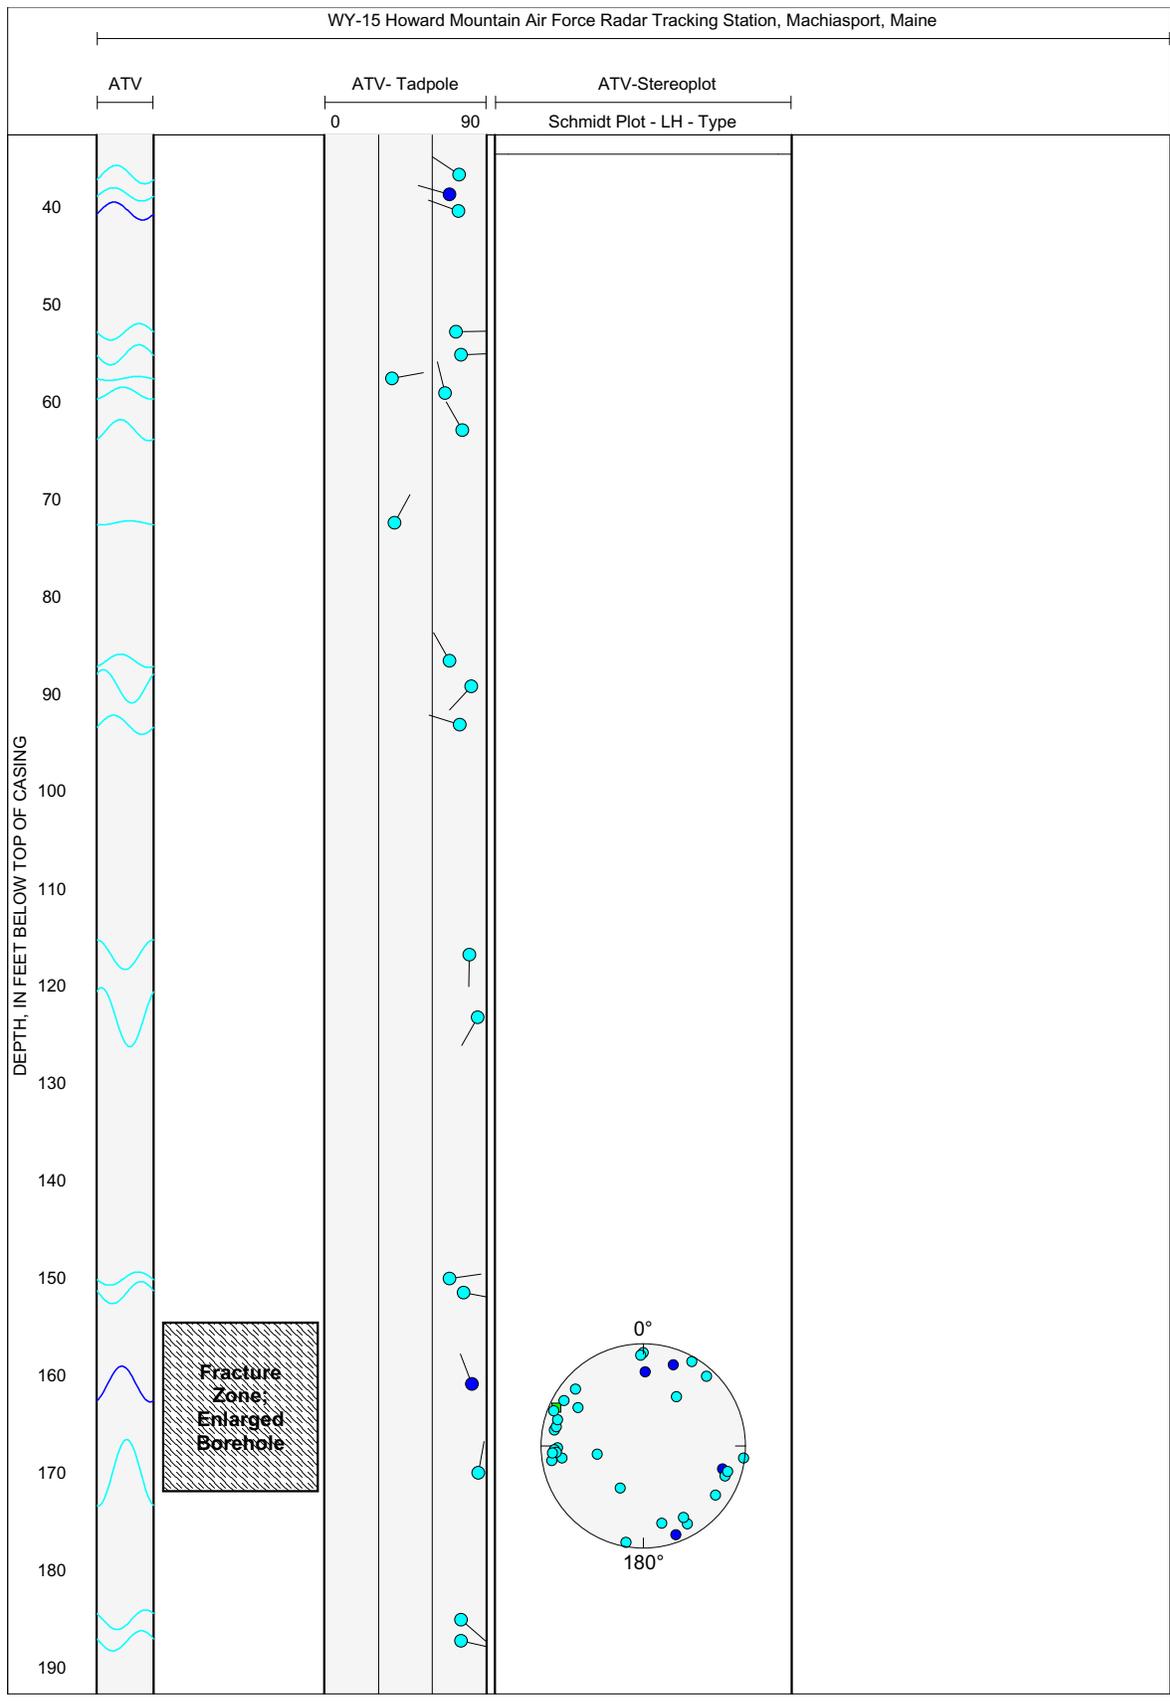
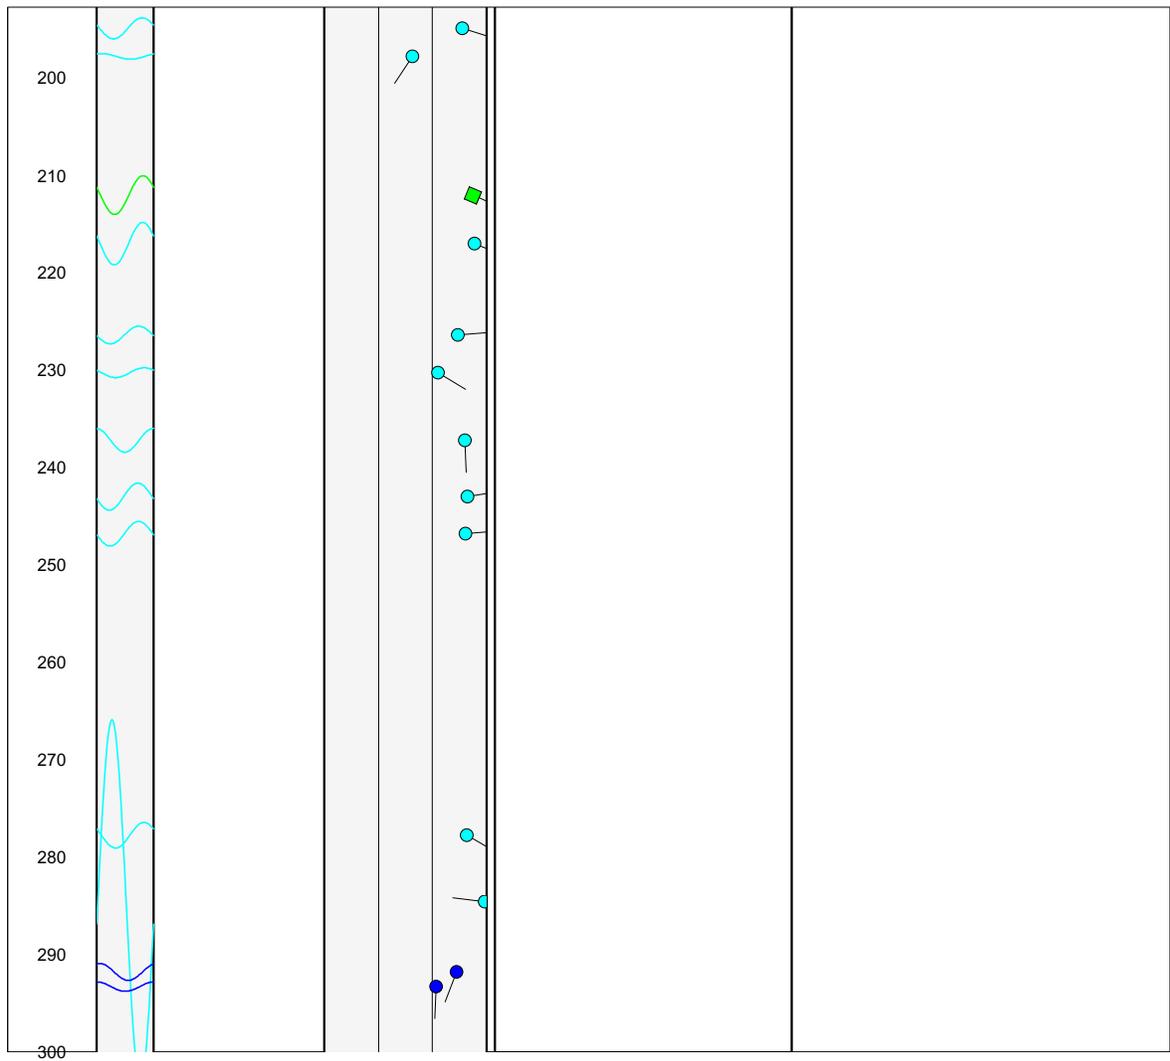
Figure 2D-3. Projection, tadpole, and stereoplots of interpretation of borehole image data for borehole WY-15, near Machiasport, Maine.

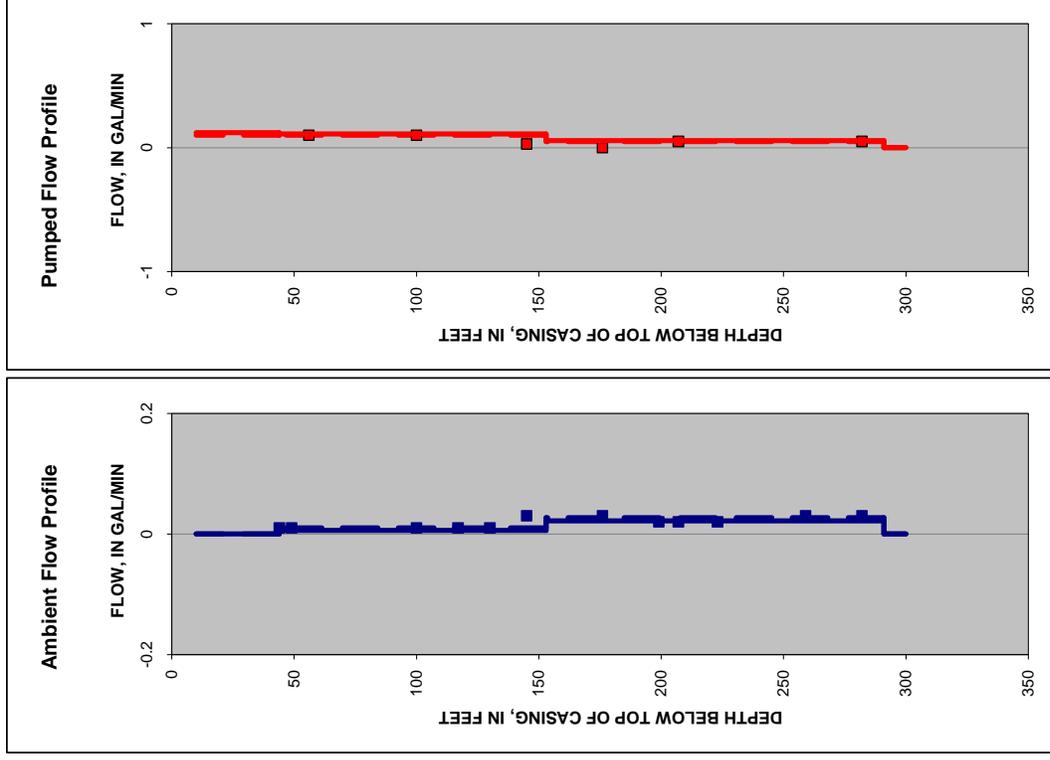
Fracture number	Depth (ft)	Ambient flow above fracture (gal/min)	Pumped flow above fracture (gal/min)	Zone transmissivity (ft ² /d)	Water level (ft)	Elevation of water level (ft)	Percent transmissivity
3	44	0.000	0.121	0.4	36.25	157.63	12
2	153	0.006	0.111	2.0	35.25	158.63	59
1	291	0.022	0.058	1.0	30.25	163.63	29

Total borehole transmissivity	3.4	(ft ² /d)
Sum of squares error	0.001	(gal/min) ²
Root mean square error	0.015	(gal/min)

Dashed line indicates measured flow.
 Solid line indicates modeled flow.
 Points indicate measured heat-pulse flowmeter data.

Figure 2D-4. Interpretation and modeling of heat-pulse flowmeter logs for borehole WY-15, near Machiasport, Maine. [gal/min, gallon per minute; ft, feet; ft²/d, feet squared per day; positive values of flow are upward flow, negative values of flow are downward flow]

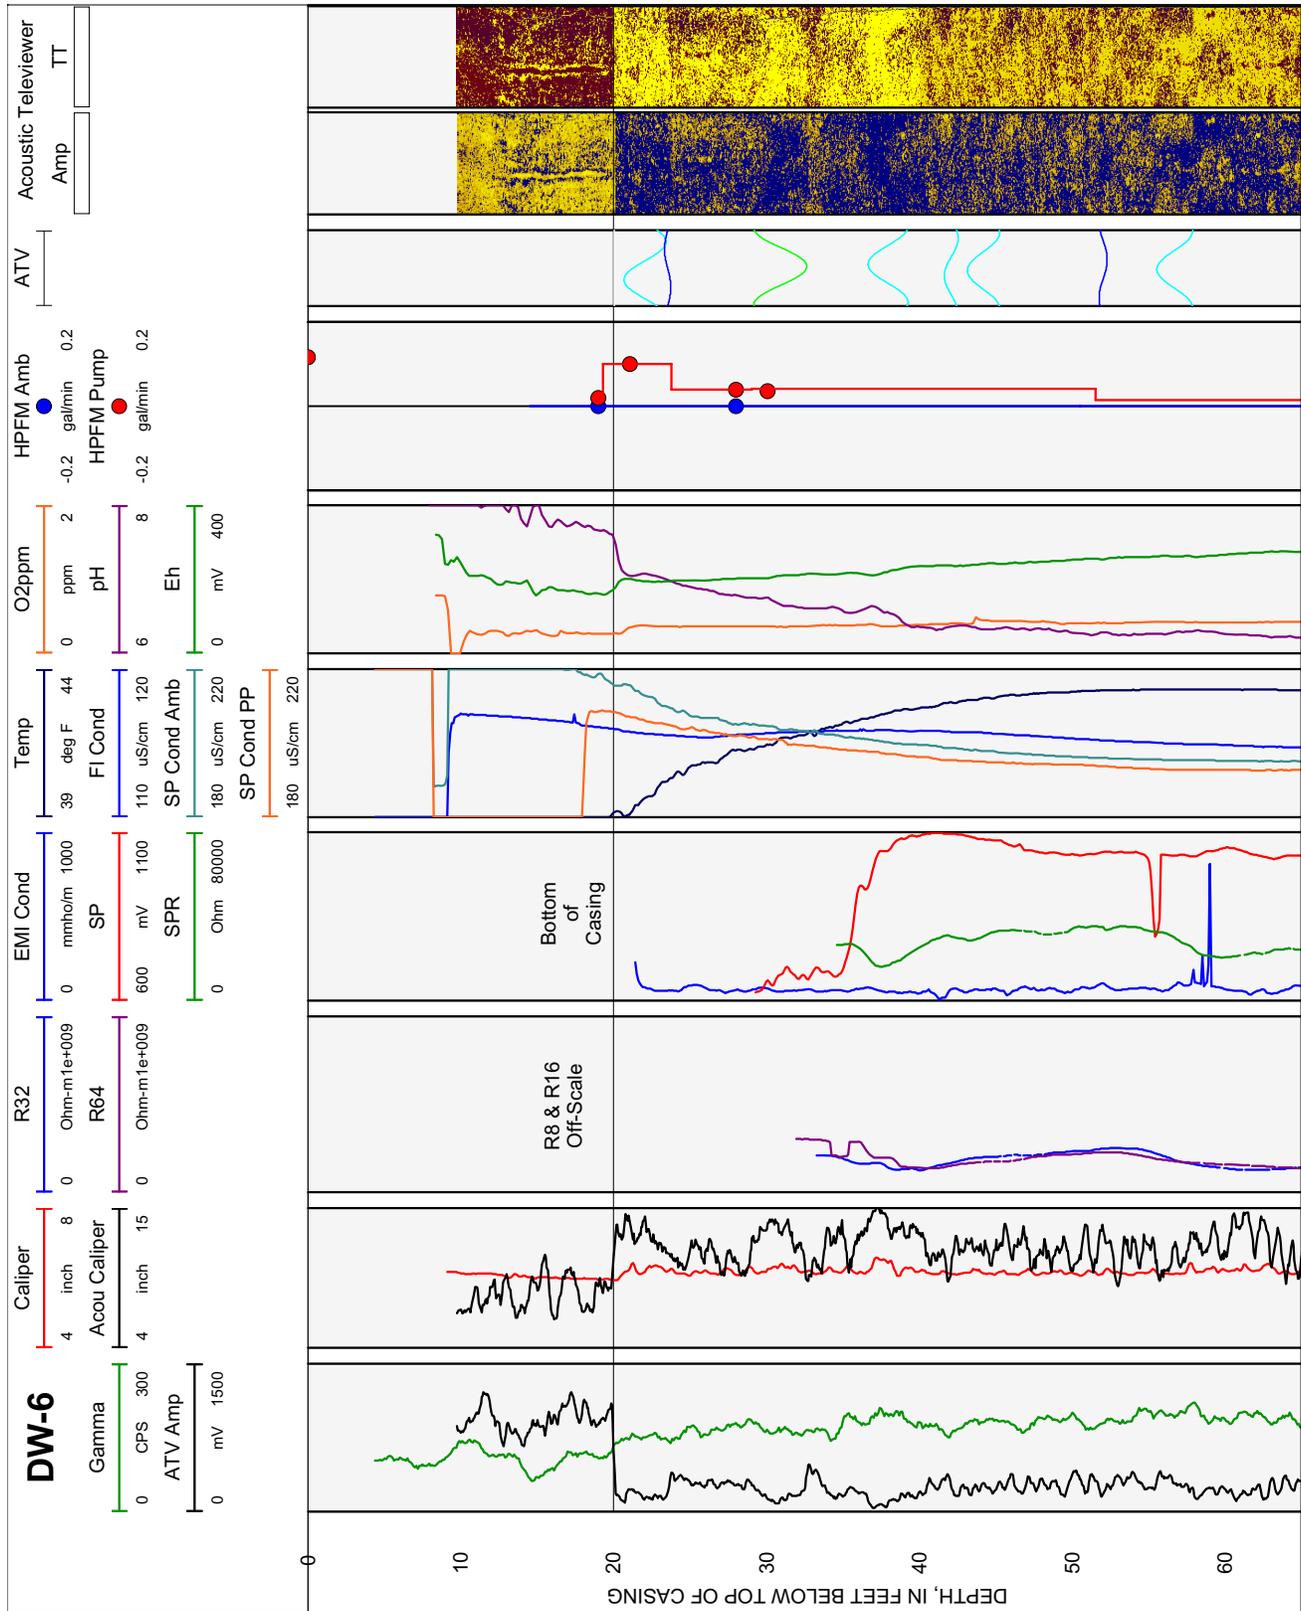
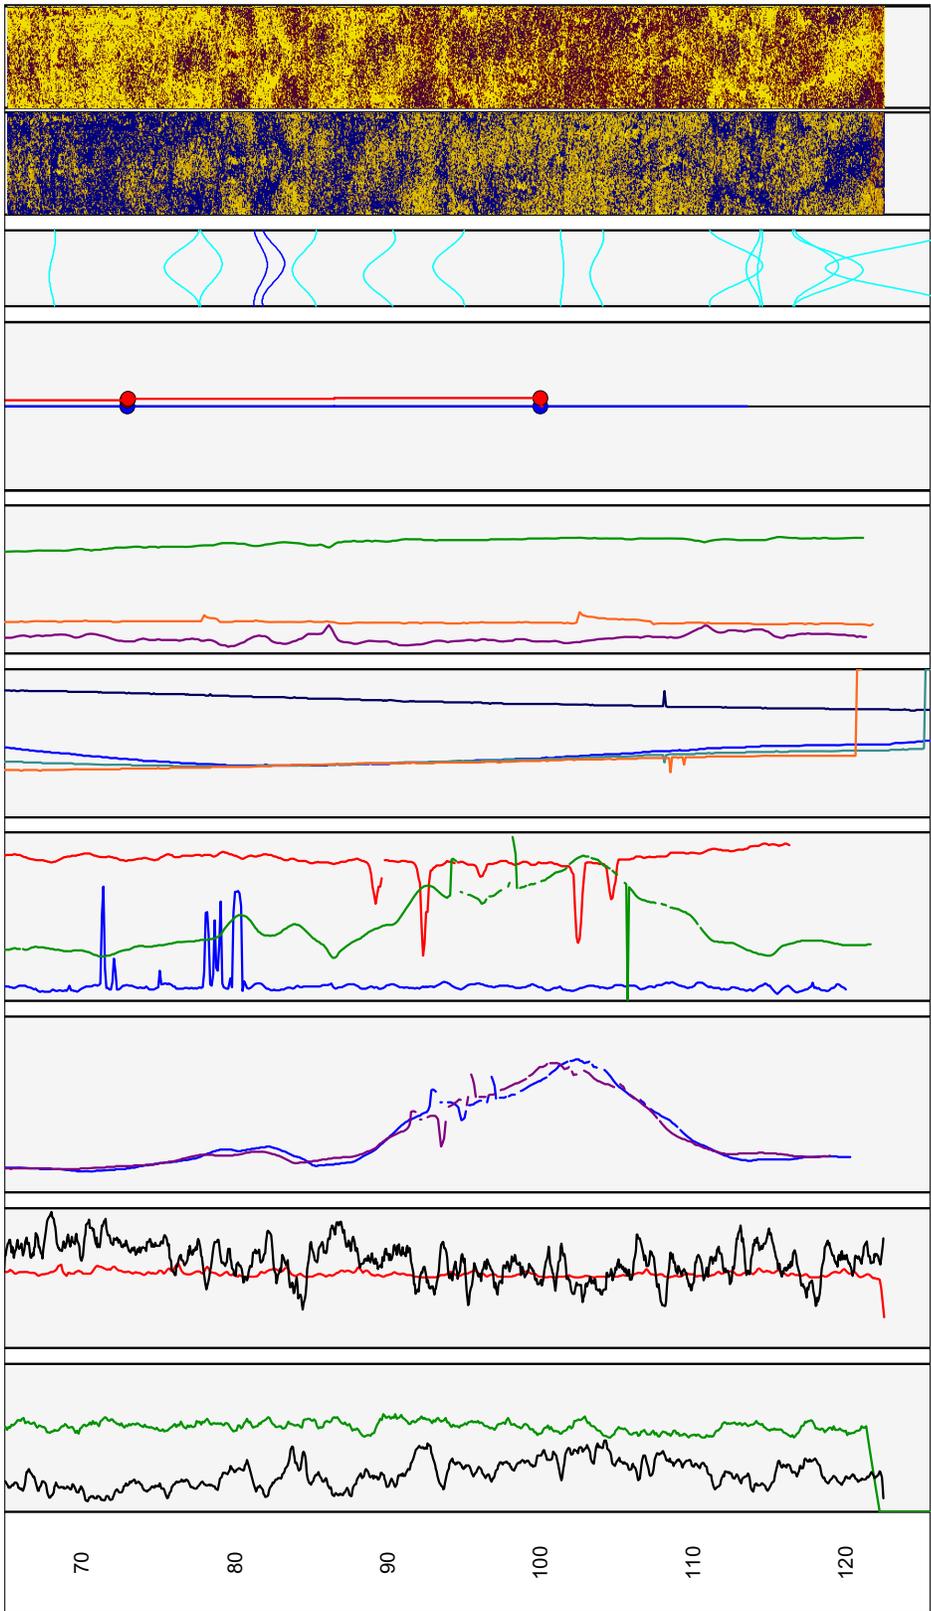
Figure 3A-1. Caliper, acoustic caliper, gamma, electromagnetic conductivity, fluid temperature, specific conductance, DO, pH, reduction oxidation, multi-space resistivity, oriented acoustic and optical borehole images, and heat-pulse flowmeter logs for borehole DW-6, near Machiasport, Maine.
