Borehole Geophysical Investigation of a Formerly Used Defense Site, Machiasport, Maine, 2003–2006

By Carole D. Johnson, Remo A. Mondazzi, and Peter K. Joesten

Scientific Investigations Report 2009–5120

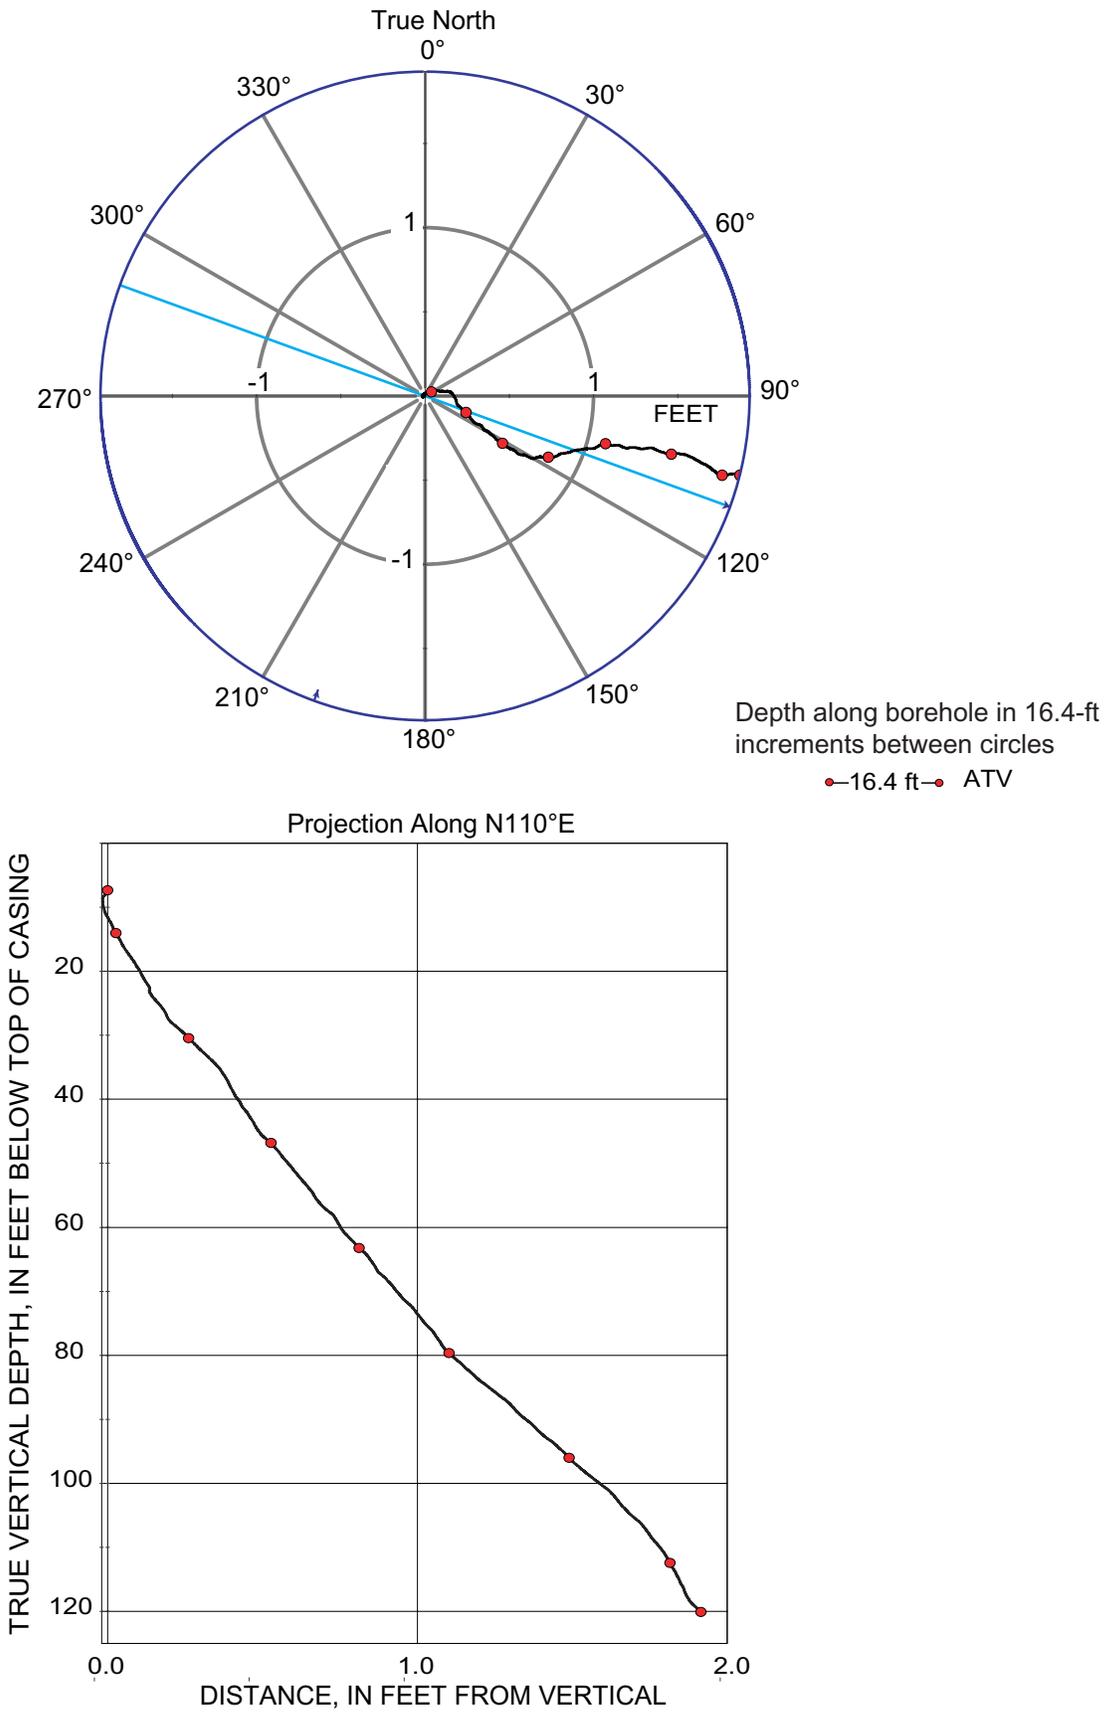
Figure 3A-2. Borehole deviation logs for borehole DW-6, near Machiasport, Main. Blue line on radial plot (top) is line of projection for vertical plot (bottom).
 [ft, foot; ATV, acoustic televiewer]

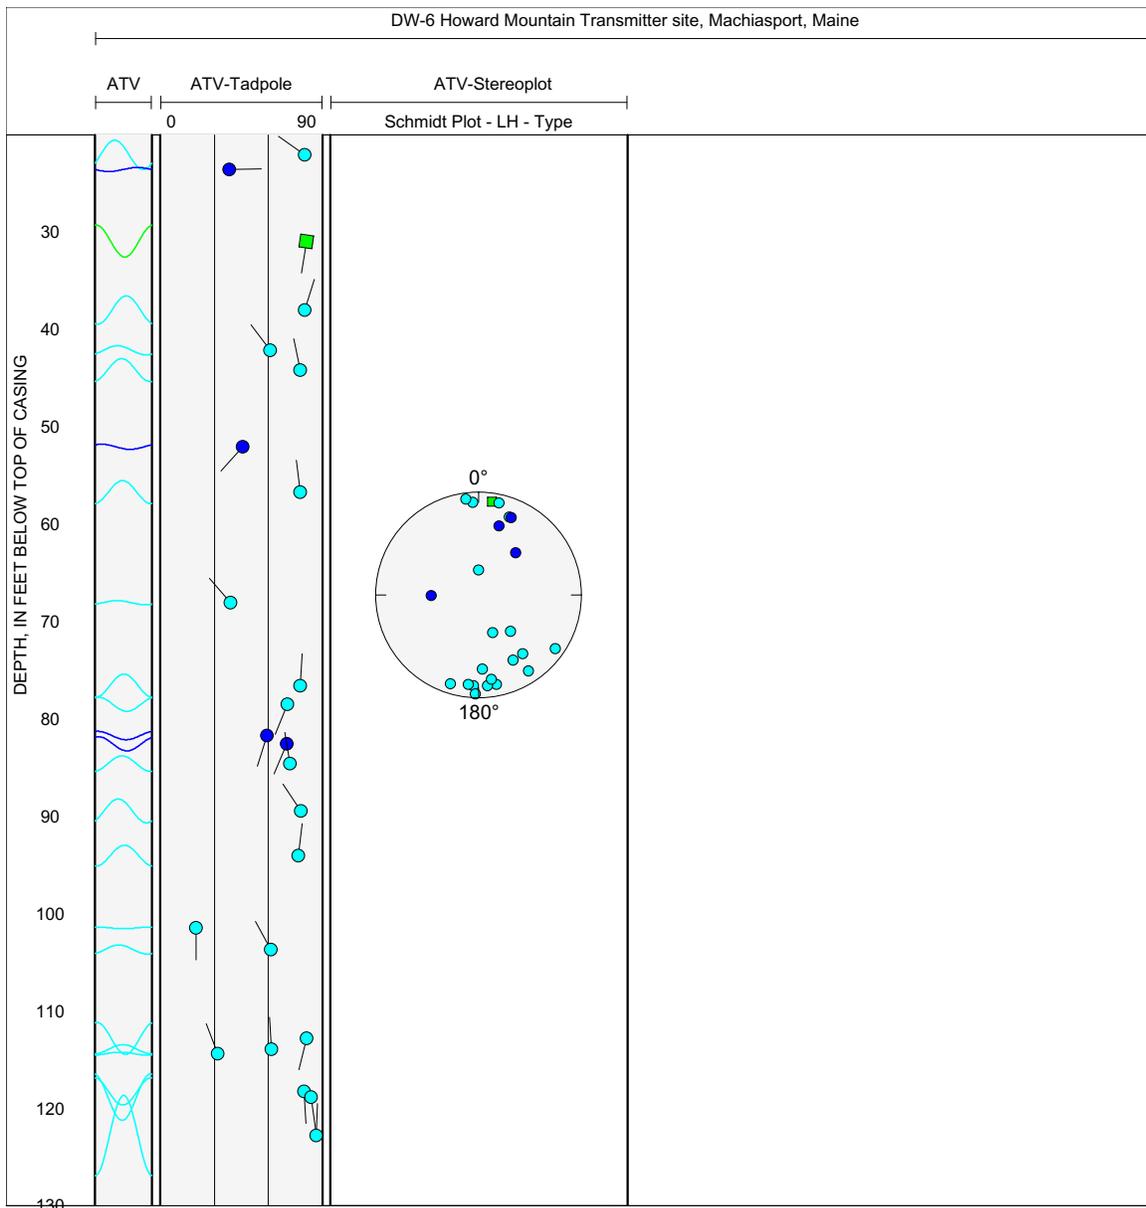
Figure 3A-3. Projection, tadpole, and stereoplots of interpretation of borehole image data for borehole DW-6, near Machiasport, Maine.

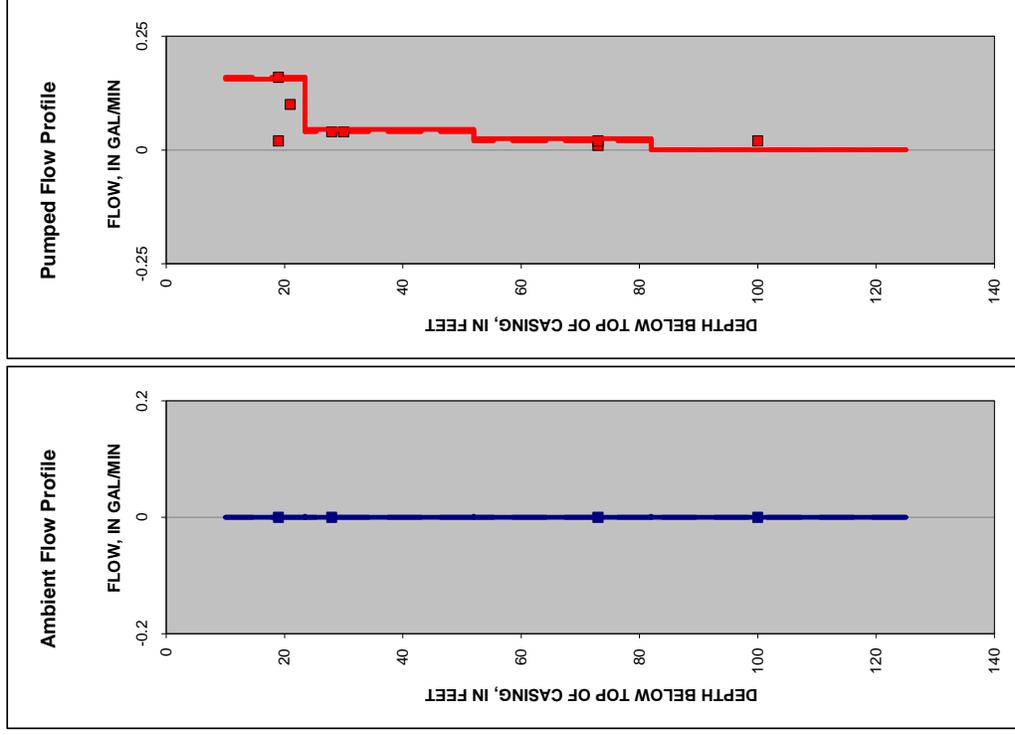
Fracture number	Depth (ft)	Ambient flow above fracture (gal/min)	Pumped flow above fracture (gal/min)	Zone transmissivity (ft ² /d)	Water level (ft)	Elevation of water level (ft)	Percent transmissivity
3	23.5	0	0.156	1.75	8.86	191.14	74
2	52.0	0	0.045	0.28	8.86	191.14	12
1	82.0	0	0.025	0.35	8.86	191.14	15

Total borehole transmissivity	2.4	(ft ² /d)
Sum of squares error	0.00007	(gal/min) ²
Root mean square error	0.00481	(gal/min)

Dashed line indicates measured flow.
 Solid line indicates modeled flow.
 Points indicate measured heat-pulse flowmeter data.

Figure 3A-4. Interpretation and modeling of heat-pulse flowmeter logs for borehole DW-6, near Machiasport, Maine. [gal/min, gallon per minute; ft, feet; ft²/d, feet squared per day; positive values of flow are upward flow, negative values of flow are downward flow]

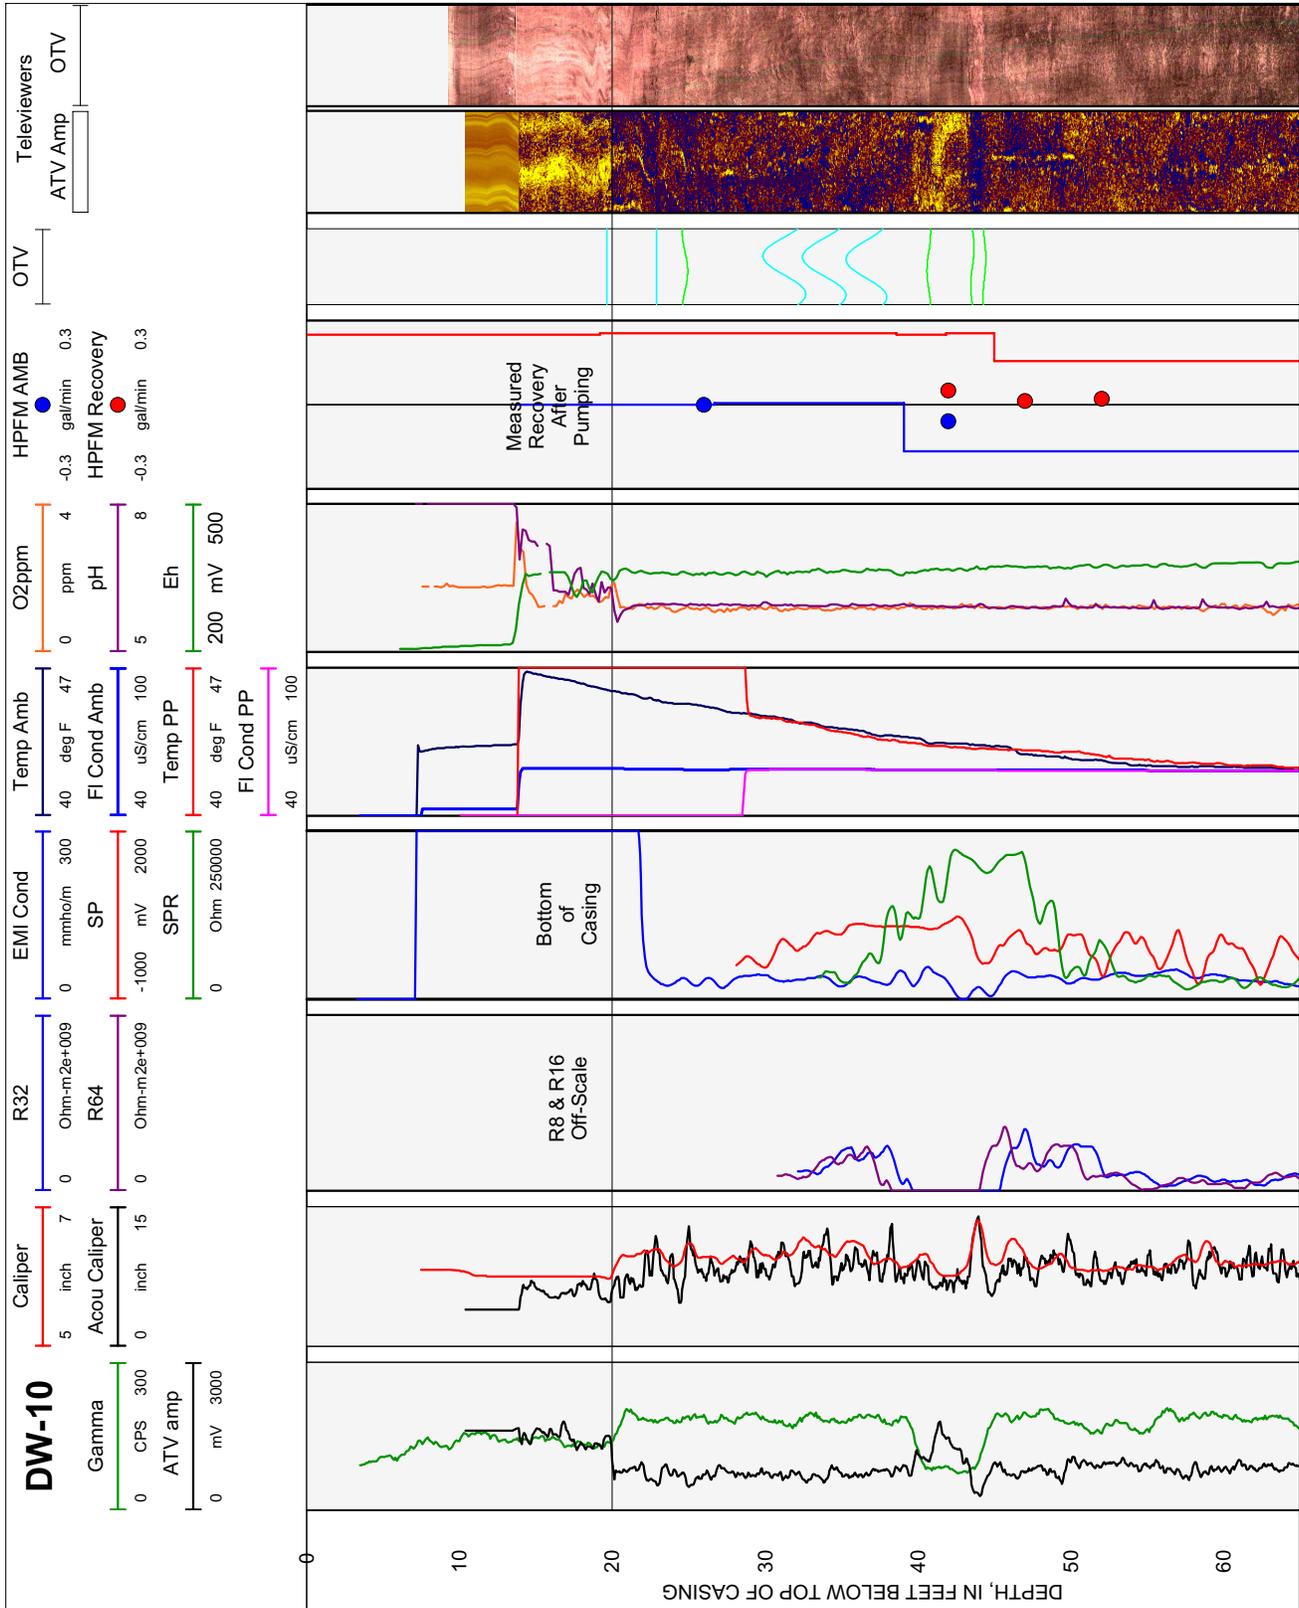
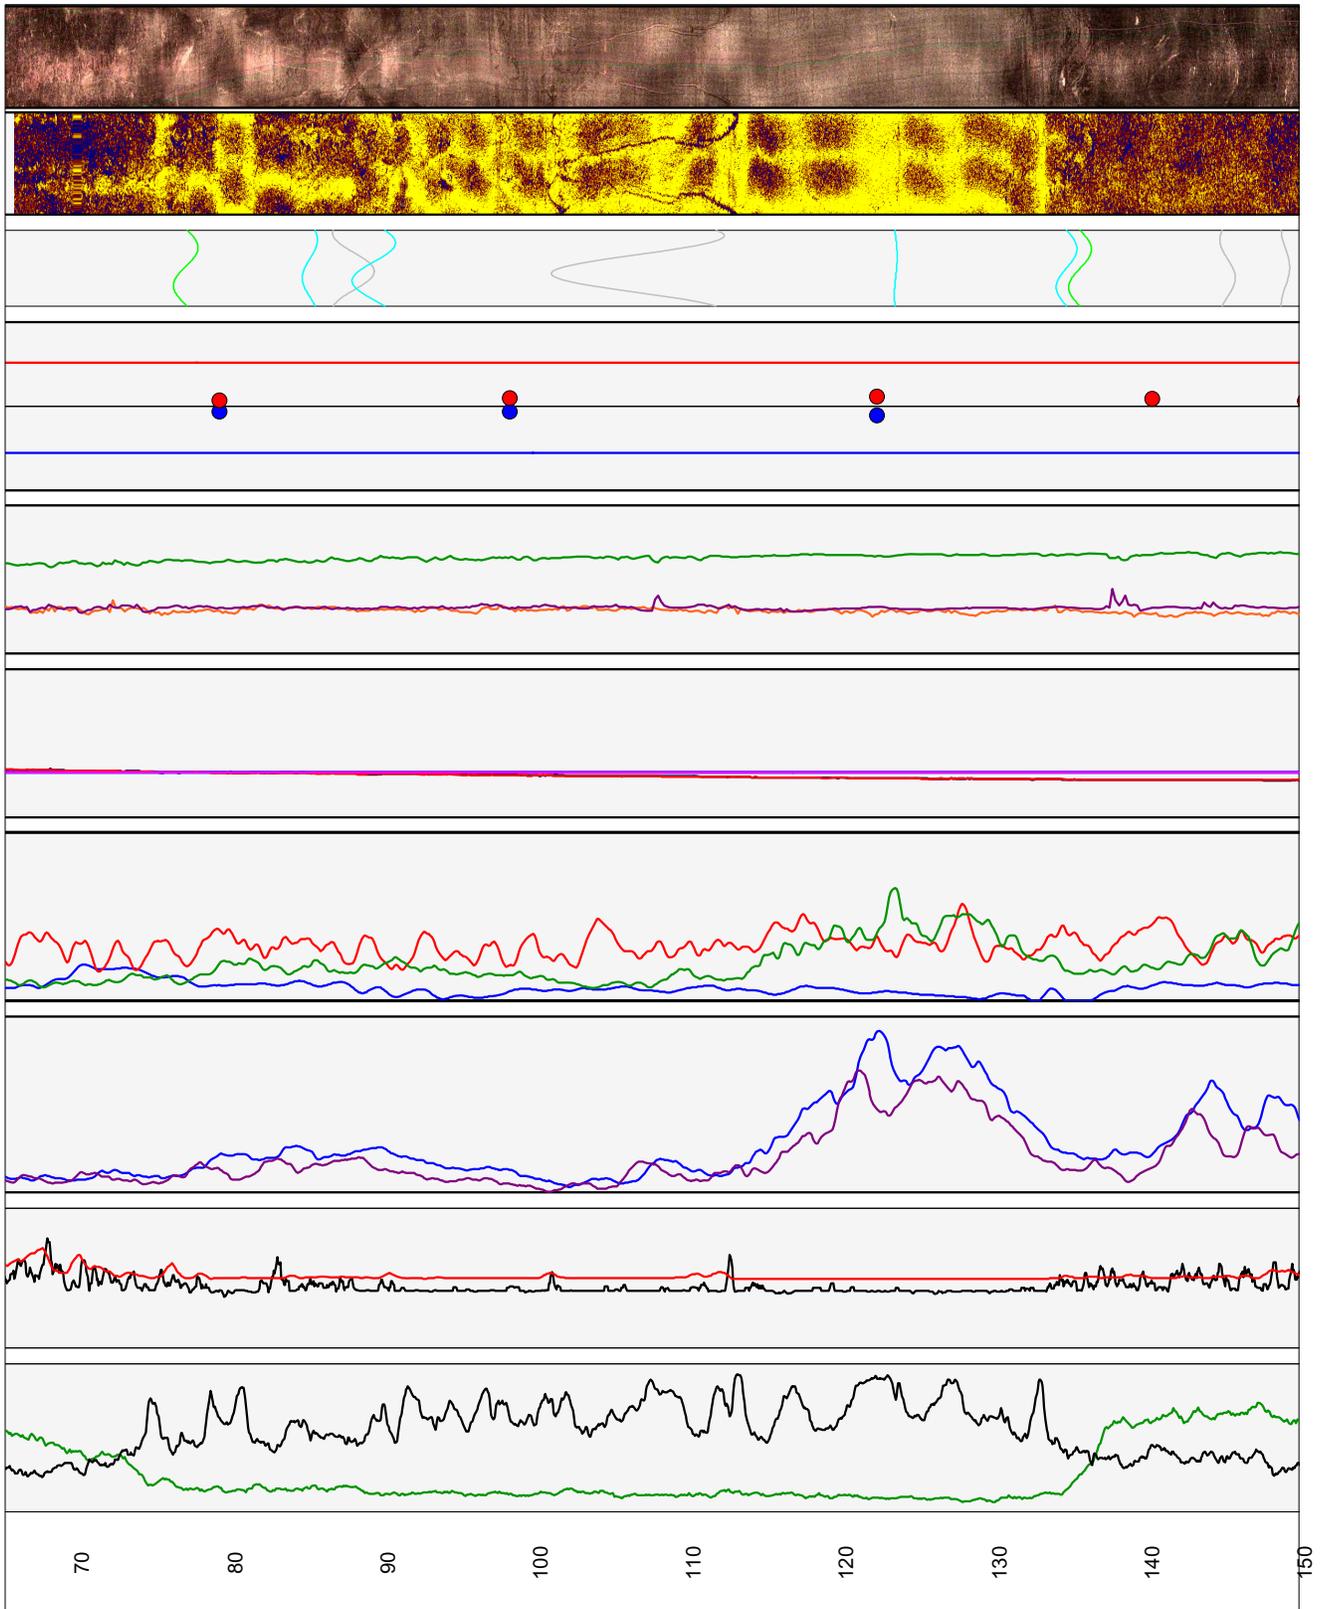
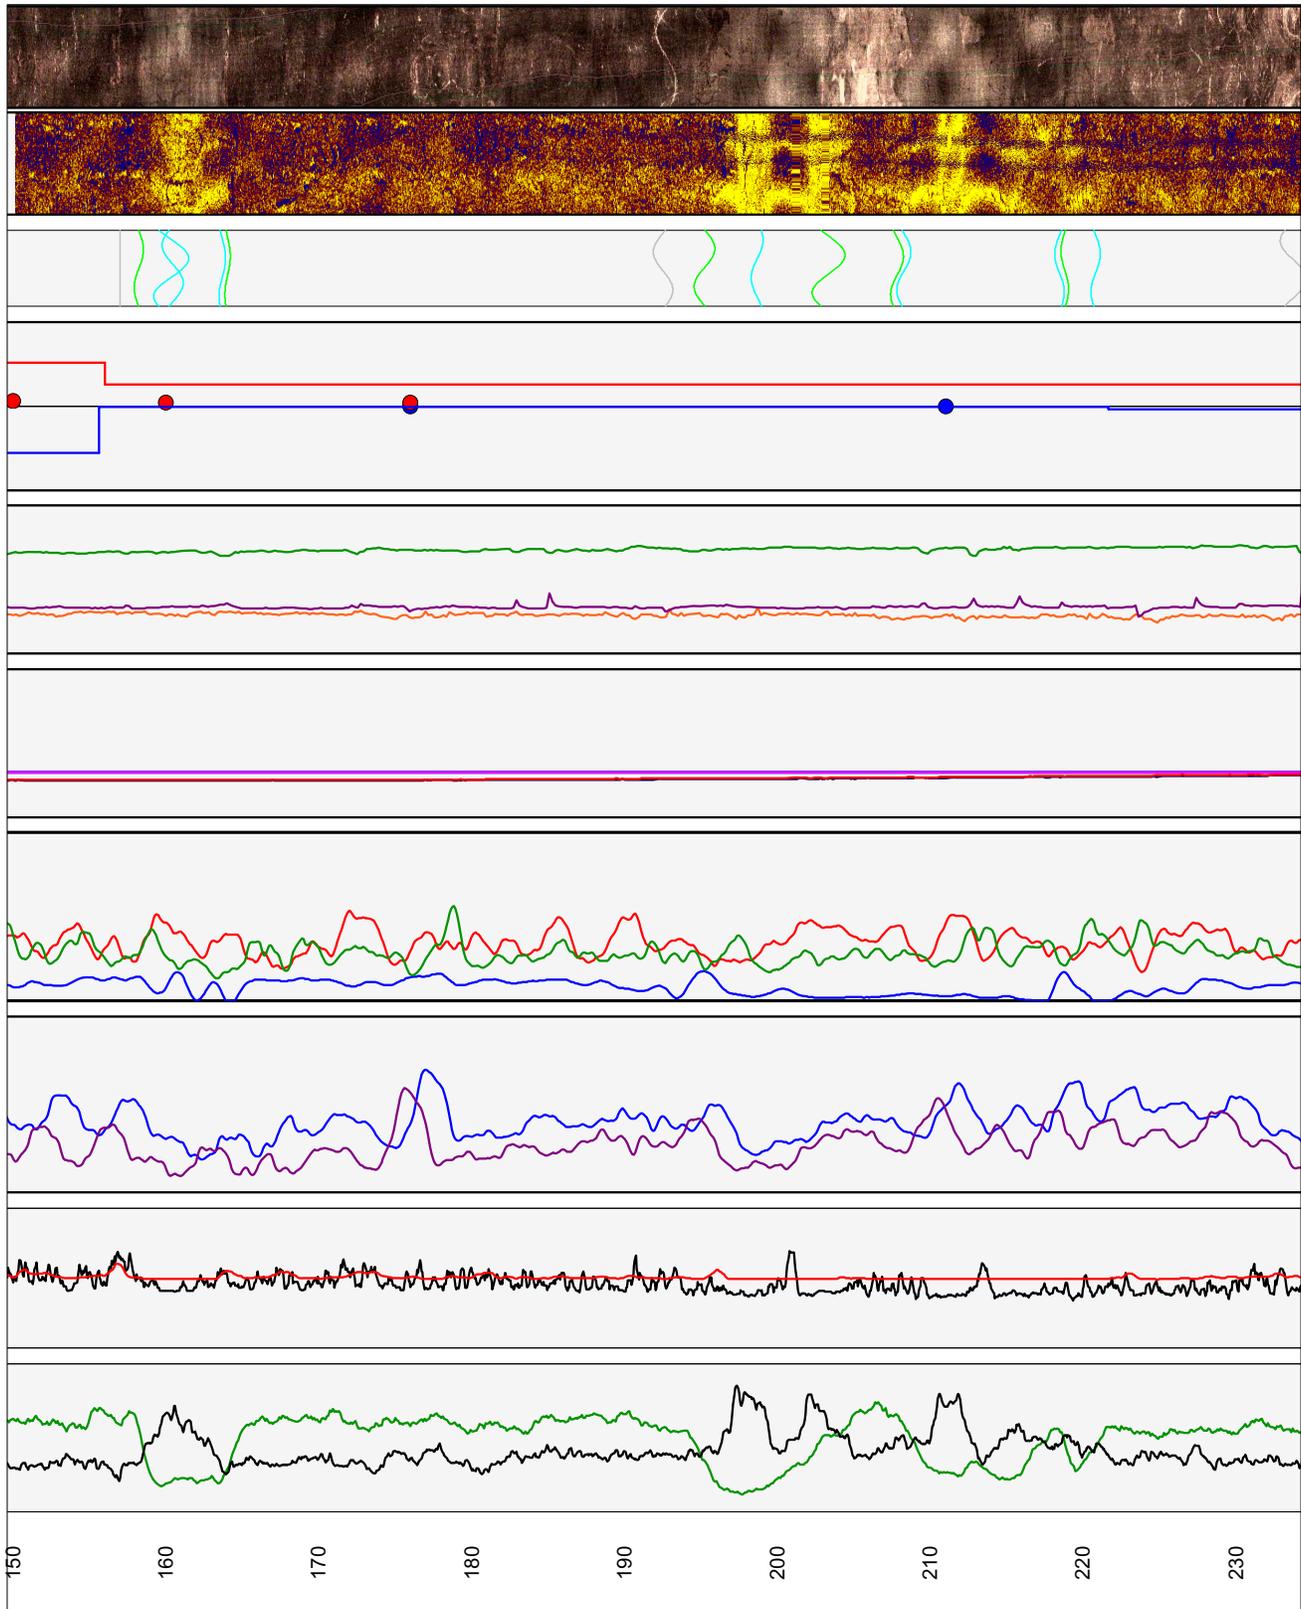
Figure 3B-1. Caliper, acoustic caliper, gamma, electromagnetic conductivity, fluid temperature, specific conductance, DO, pH, reduction oxidation, multi-space resistivity, oriented acoustic and optical borehole images, and heat-pulse flowmeter logs for borehole DW-10, near Machiasport, Maine.

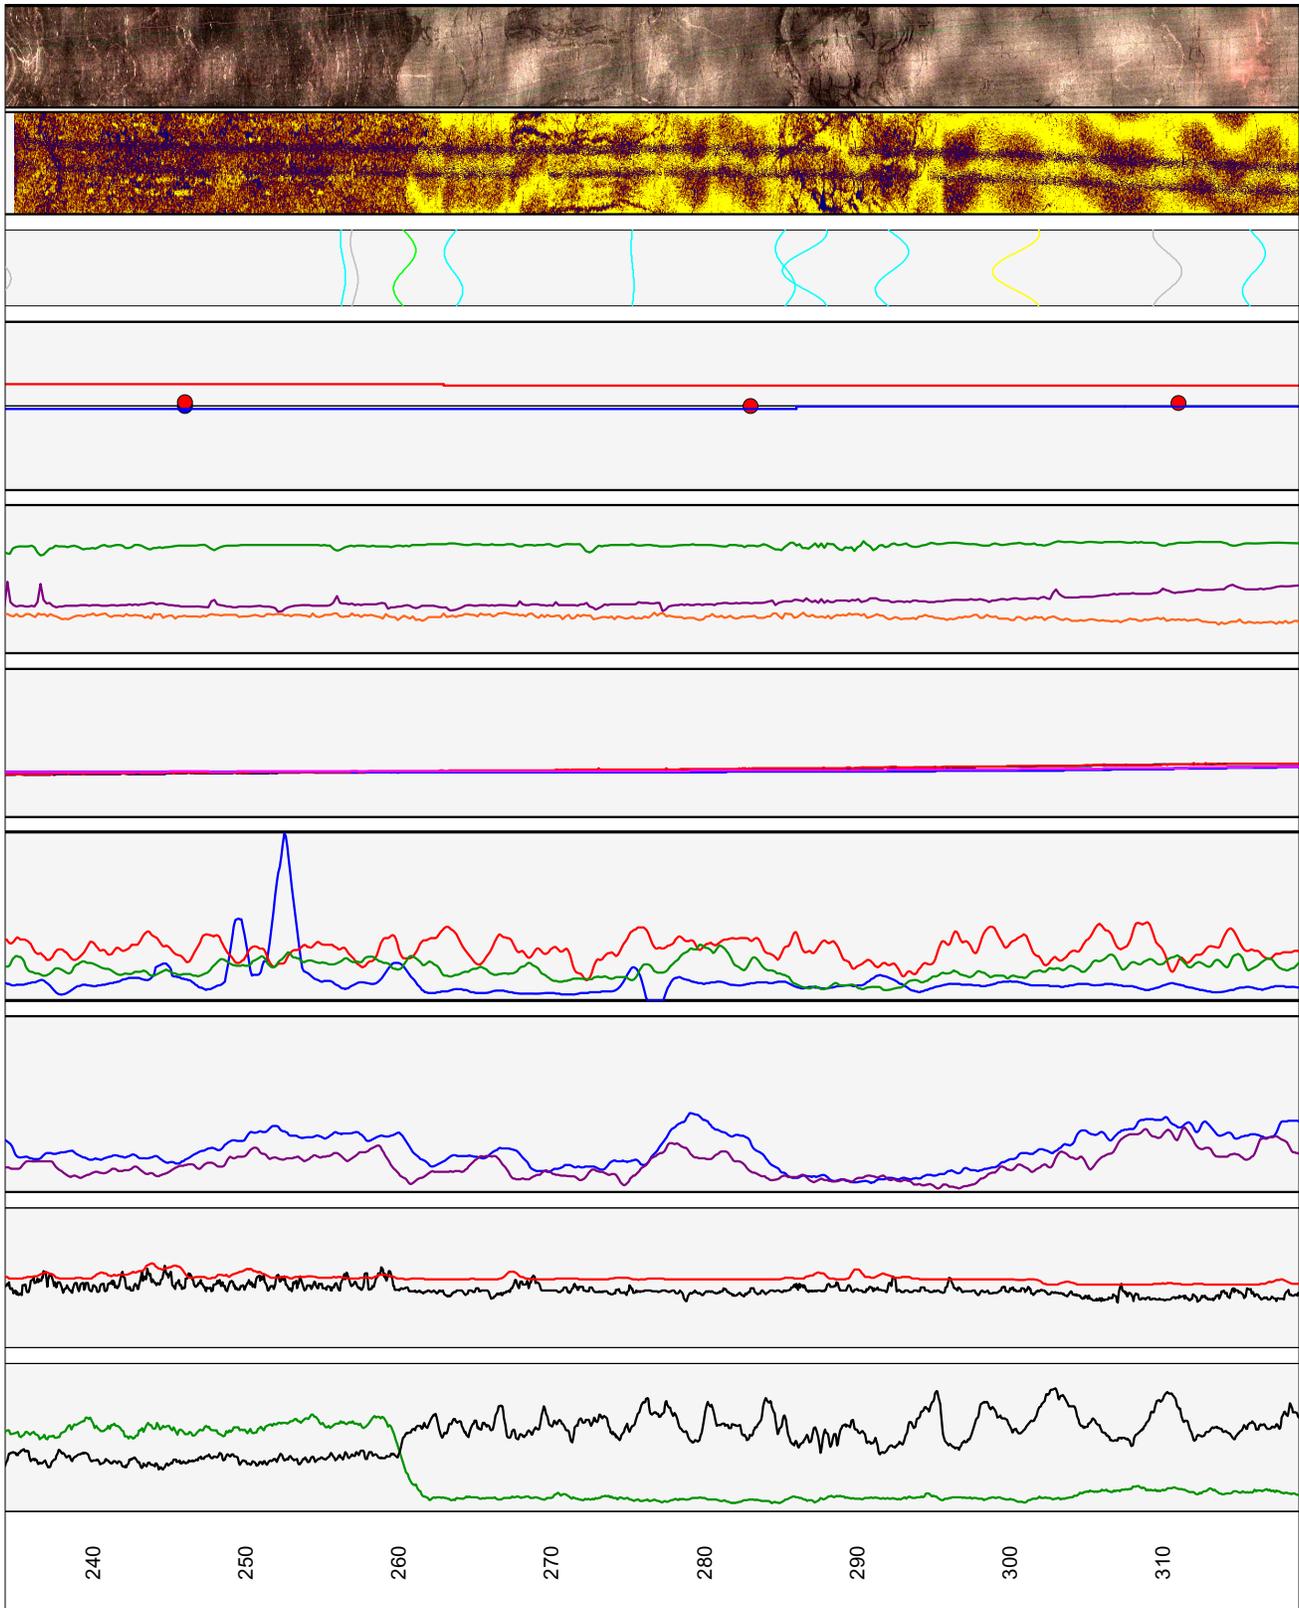
Figure 3B-1. Caliper, acoustic caliper, gamma, electromagnetic conductivity, fluid temperature, specific conductance, DO, pH, reduction oxidation, multi-space resistivity, oriented acoustic and optical borehole images, and heat-pulse flowmeter logs for borehole DW-10, near Machiasport, Maine.—Continued

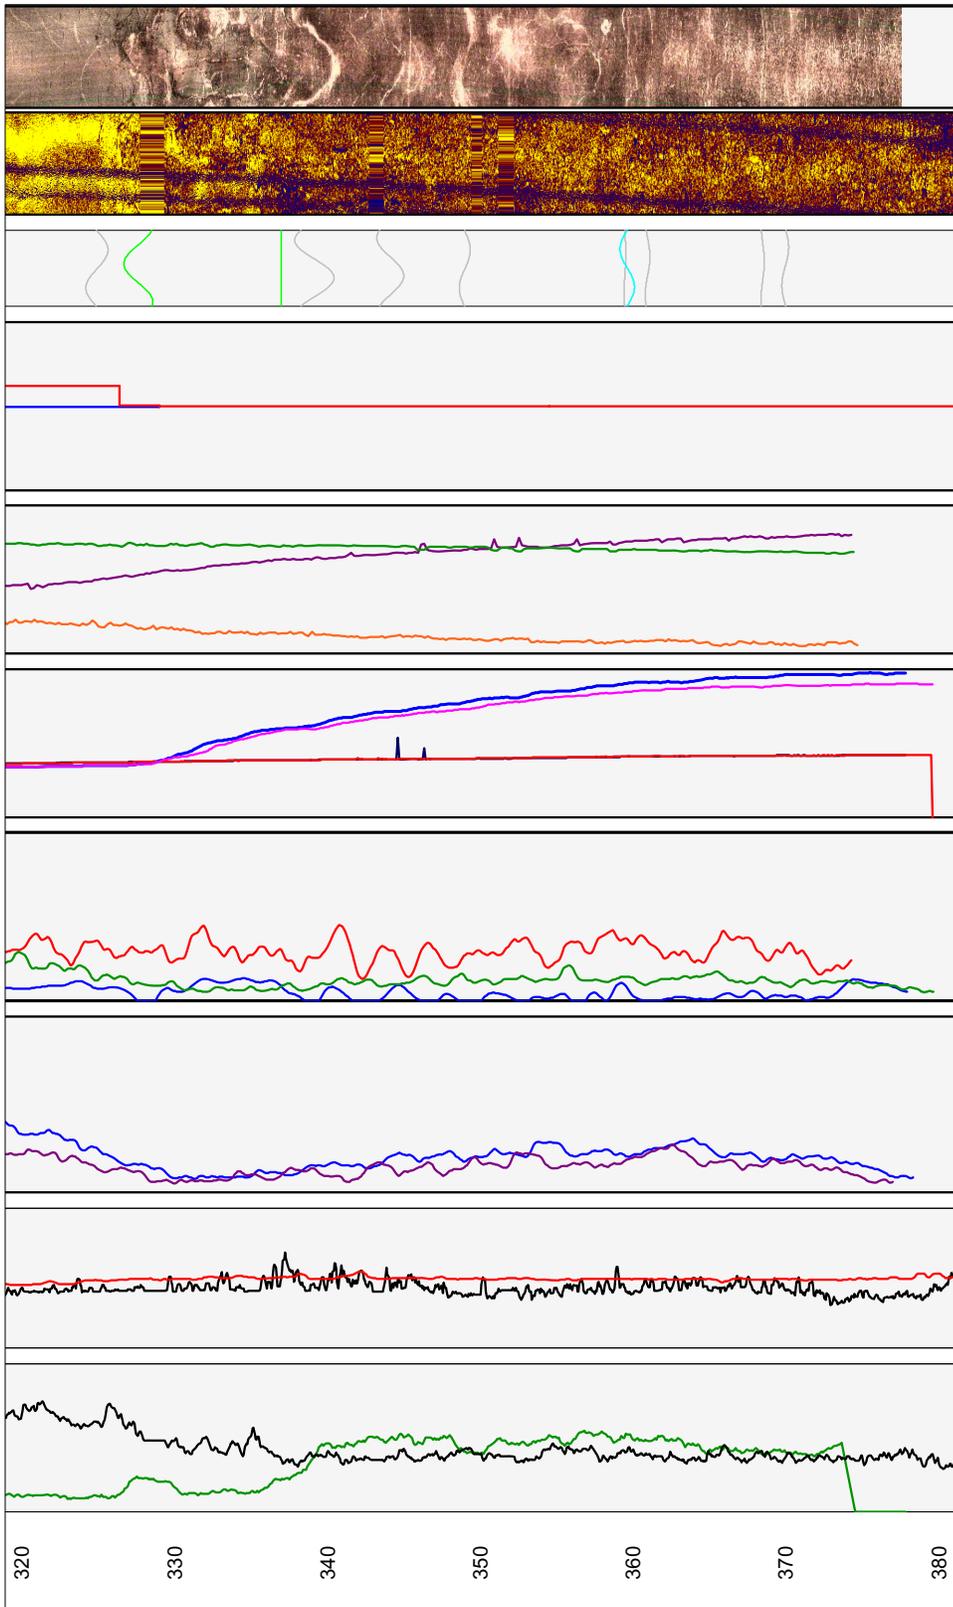
Figure 3B-1. Caliper, acoustic caliper, gamma, electromagnetic conductivity, fluid temperature, specific conductance, DO, pH, reduction oxidation, multi-space resistivity, oriented acoustic and optical borehole images, and heat-pulse flowmeter logs for borehole DW-10, near Machiasport, Maine.—Continued

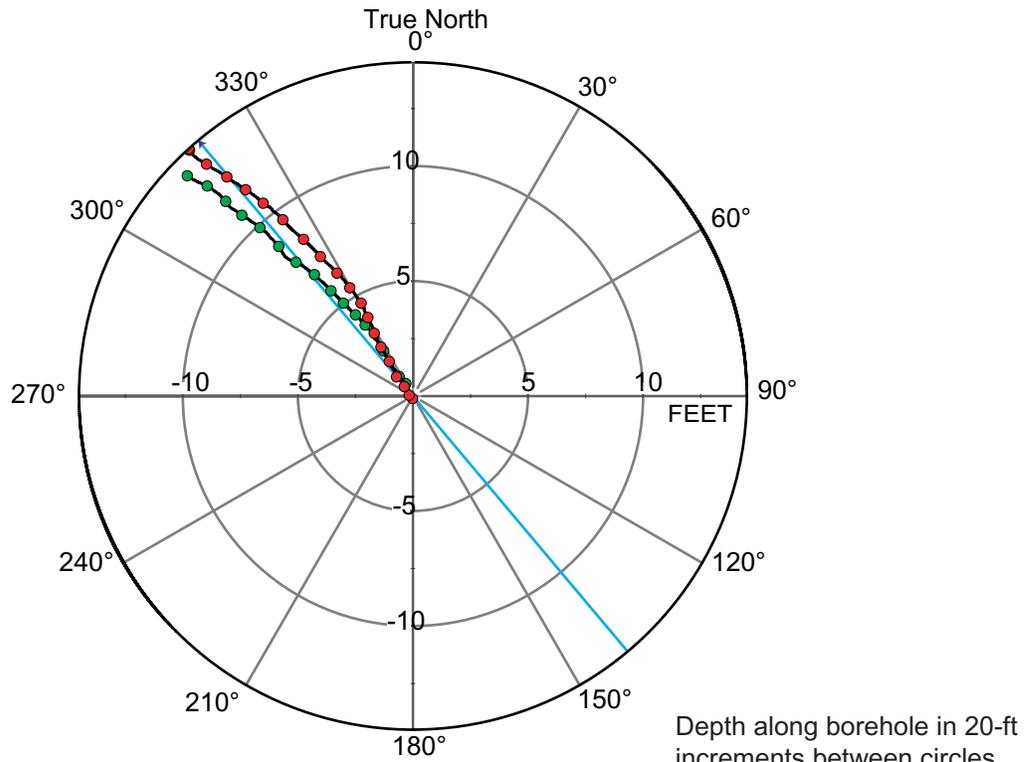
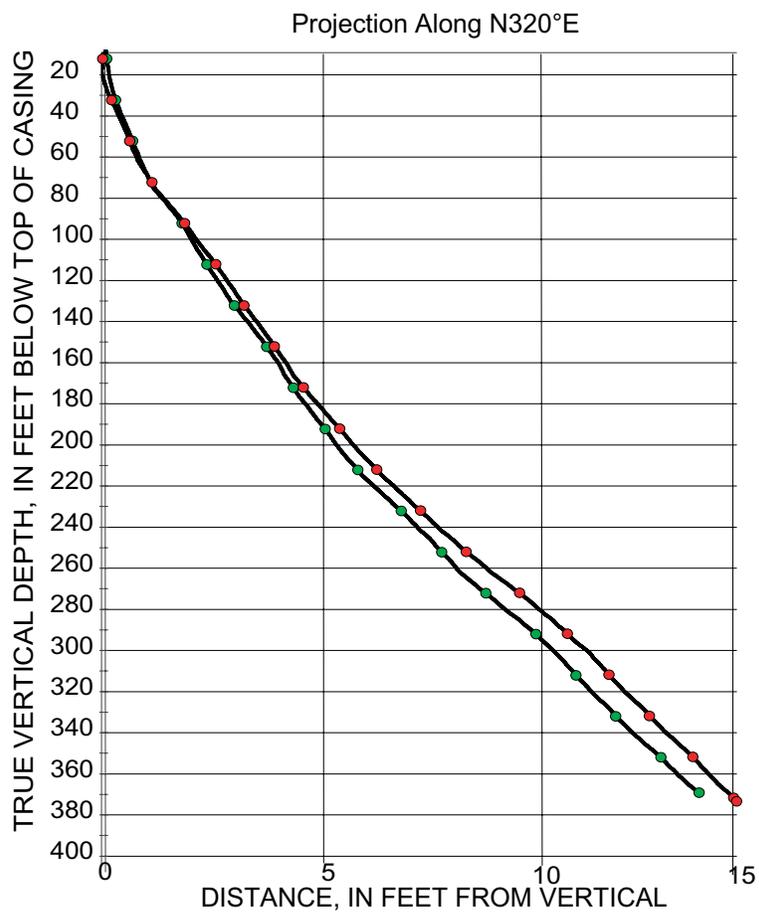
Figure 3B-2. Borehole deviation logs for borehole DW-10, near Machiasport, Maine. Blue line on radial plot (top) is line of projection for vertical plot (bottom).
 [ft, foot; ATV, acoustic televiewer; OTV, optical televiewer]

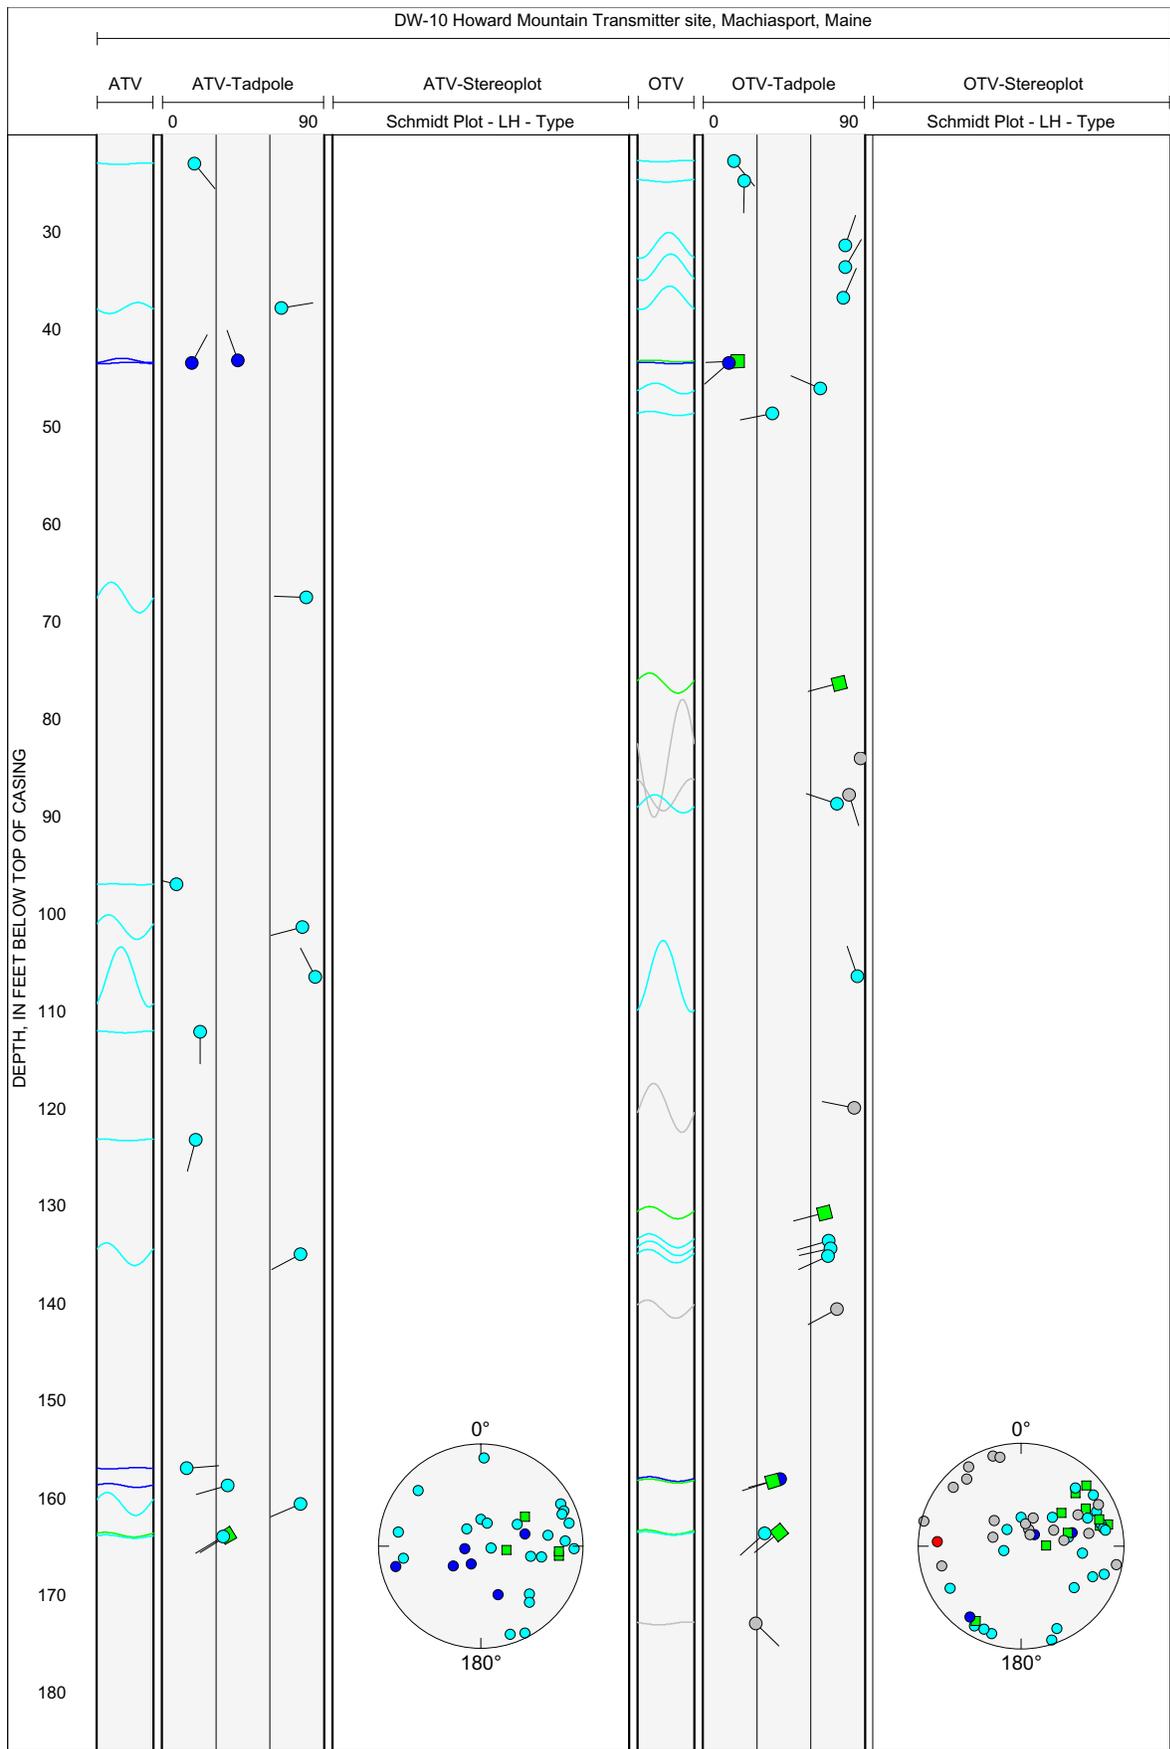
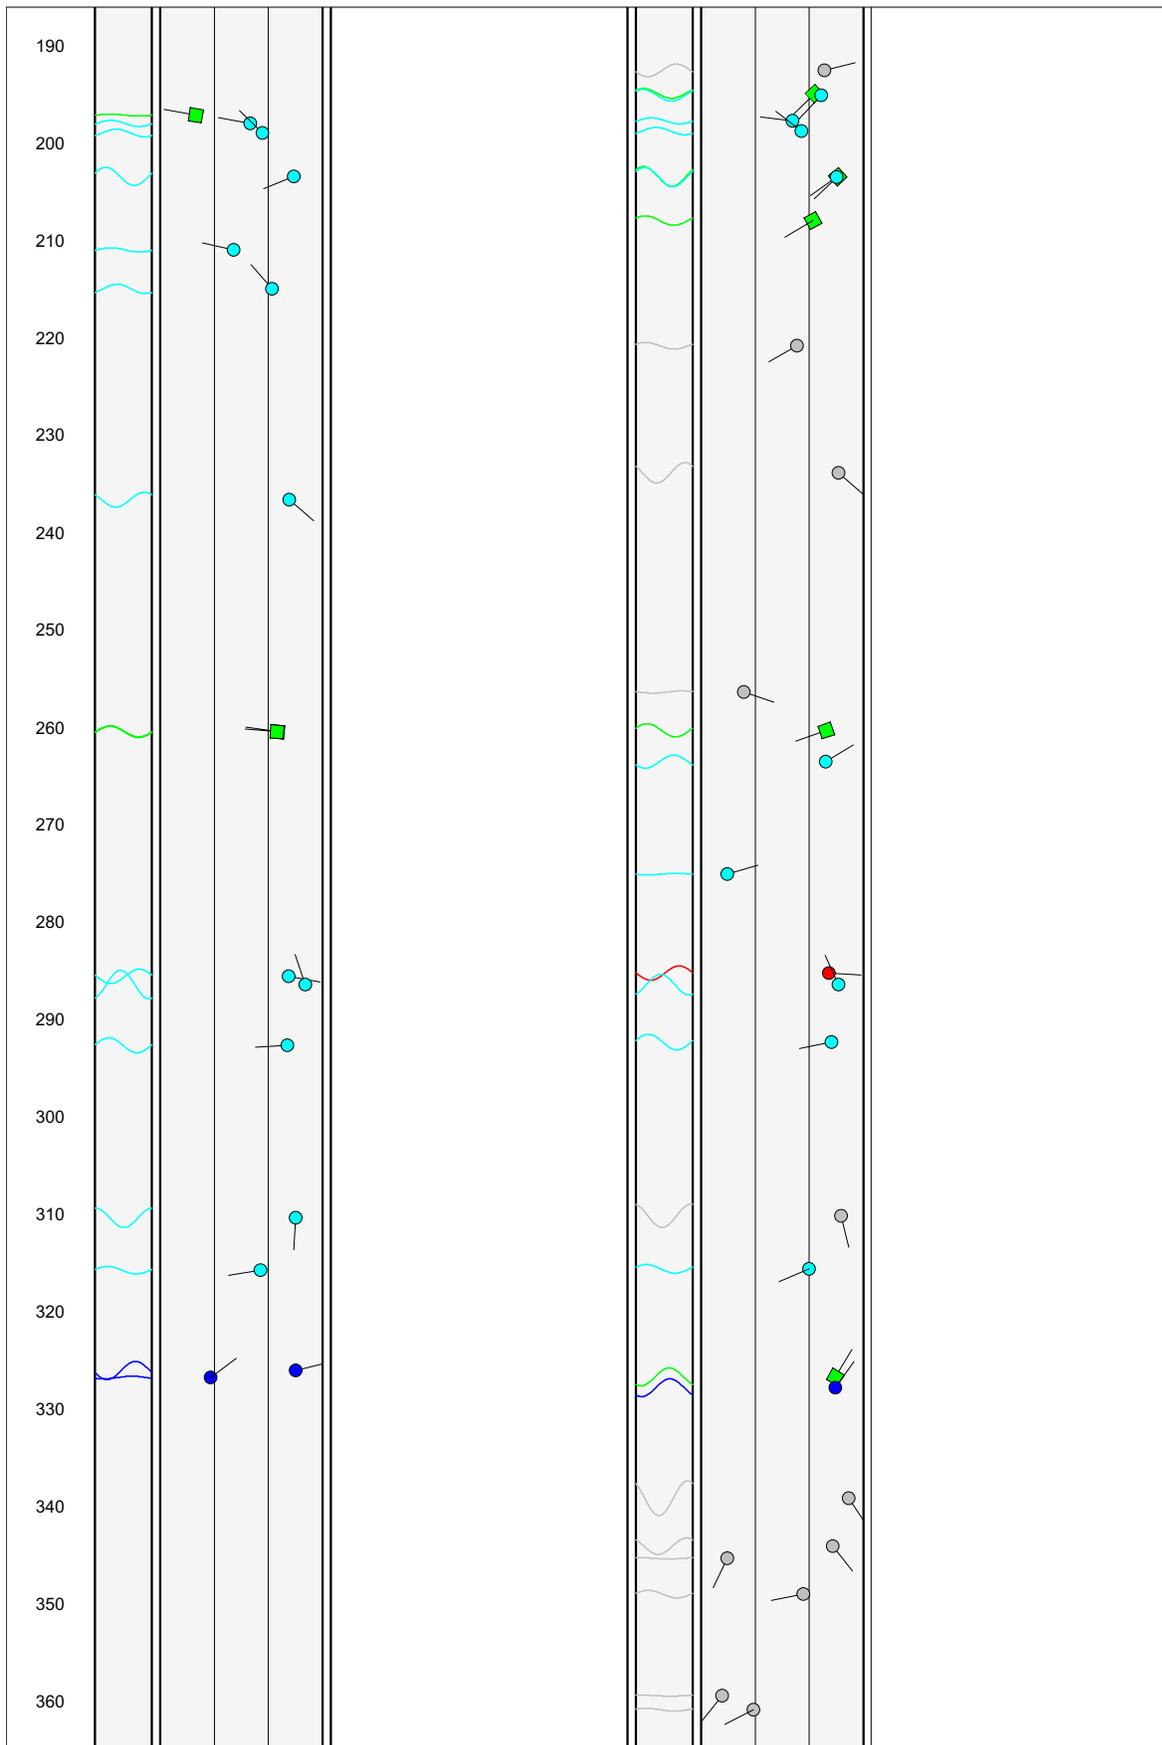
Figure 3B-3. Projection, tadpole, and stereoplots of interpretation of borehole image data for borehole DW-10, near Machiasport, Maine.

Figure 3B-3. Projection, tadpole, and stereoplots of interpretation of borehole image data for borehole DW-10, near Machiasport, Maine.—Continued

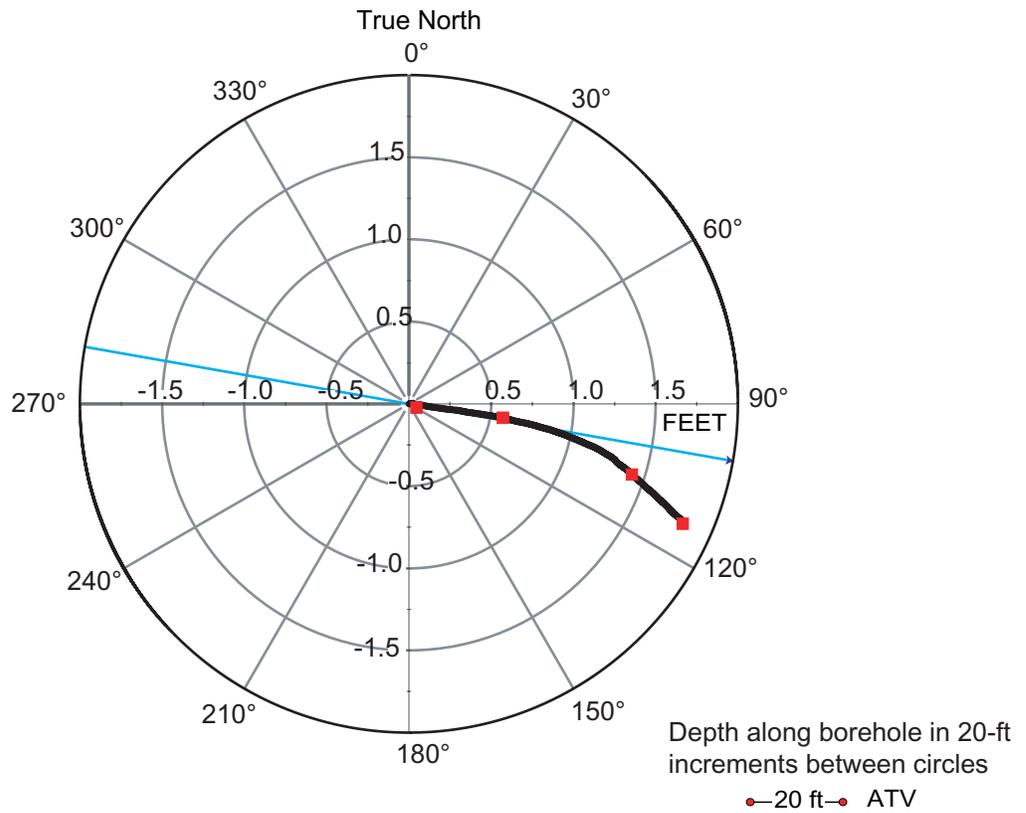
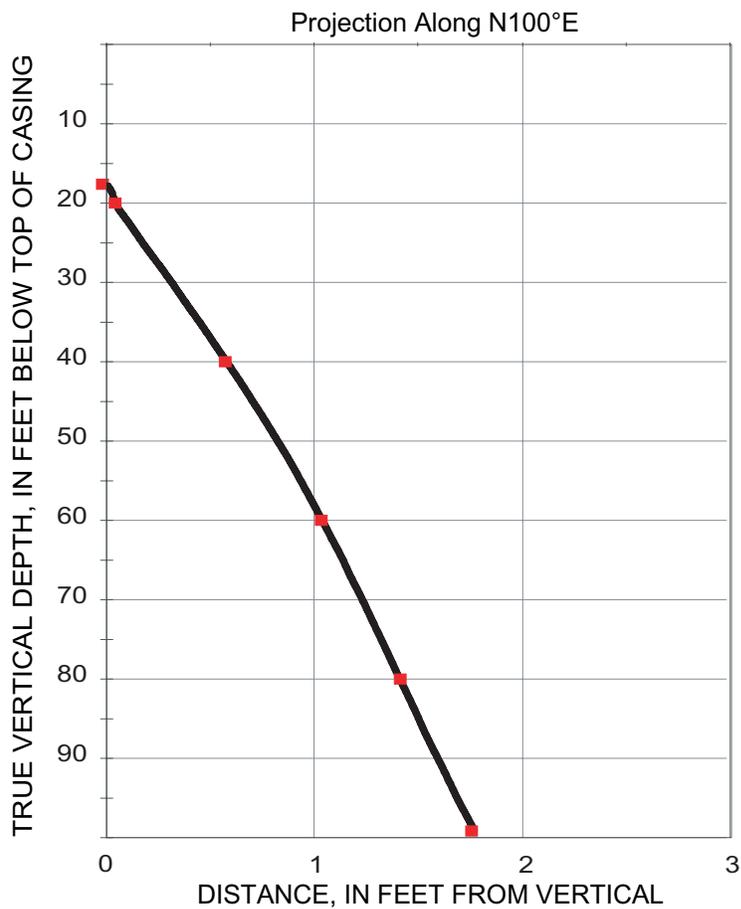
Figure 4A-1. Borehole deviation logs for borehole MW-14, near Machiasport, Maine. Blue line on radial plot (top) is line of projection for vertical plot (bottom).
 [ft, foot; ATV, acoustic televiewer]

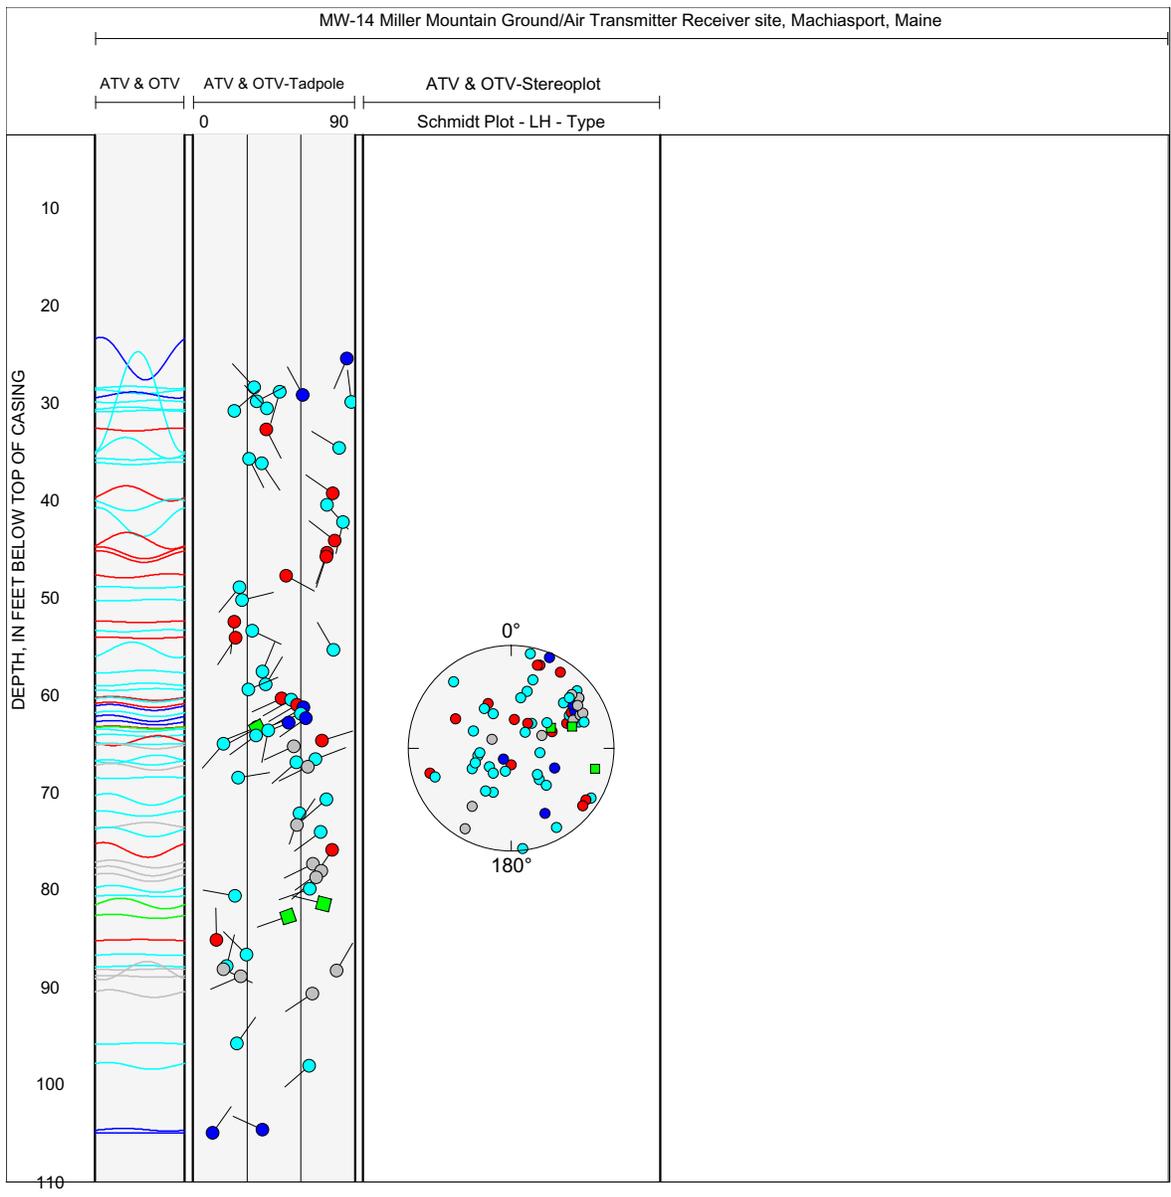
Figure 4A-2. Projection, tadpole, and stereoplots of interpretation of borehole image data for borehole MW-14, near Machiasport, Maine.
