Borehole Geophysical Investigation of a Formerly Used Defense Site, Machiasport, Maine, 2003–2006

By Carole D. Johnson, Remo A. Mondazzi, and Peter K. Joesten

Scientific Investigations Report 2009–5120

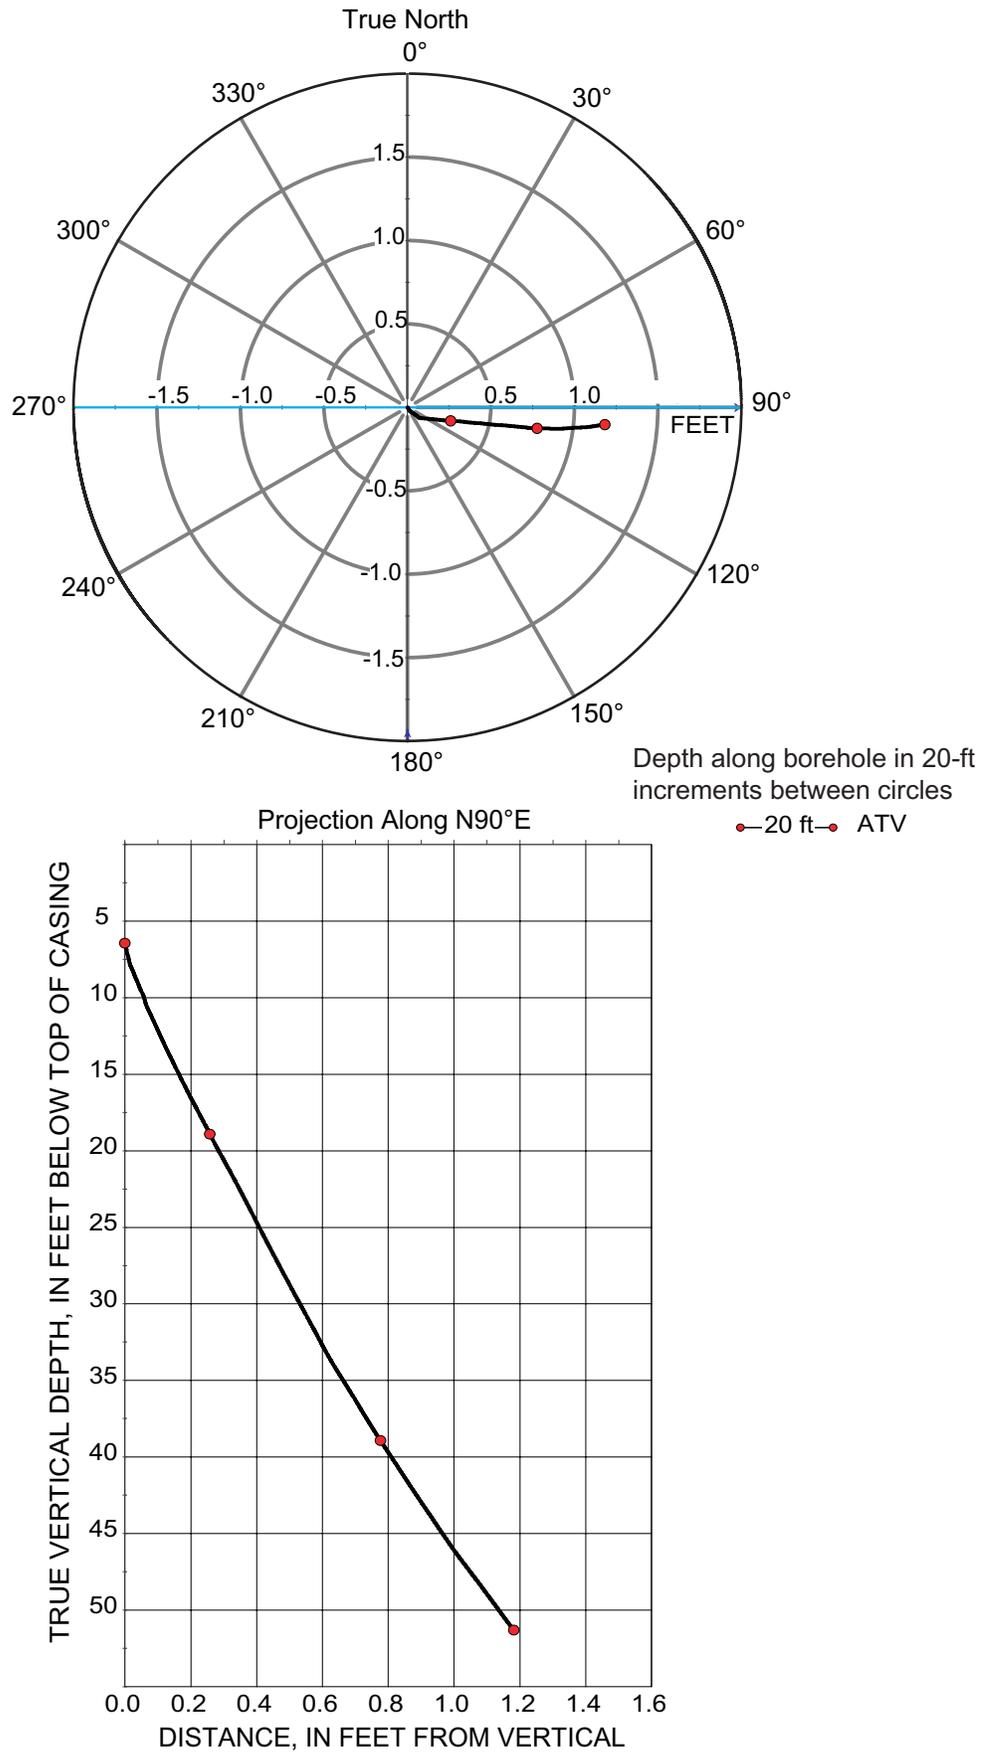
Figure 4B-1. Borehole deviation logs for borehole MW-8, near Machiasport, Maine. Blue line on radial plot (top) is line of projection for vertical plot (bottom).
 [ft, foot; ATV, acoustic televiewer]

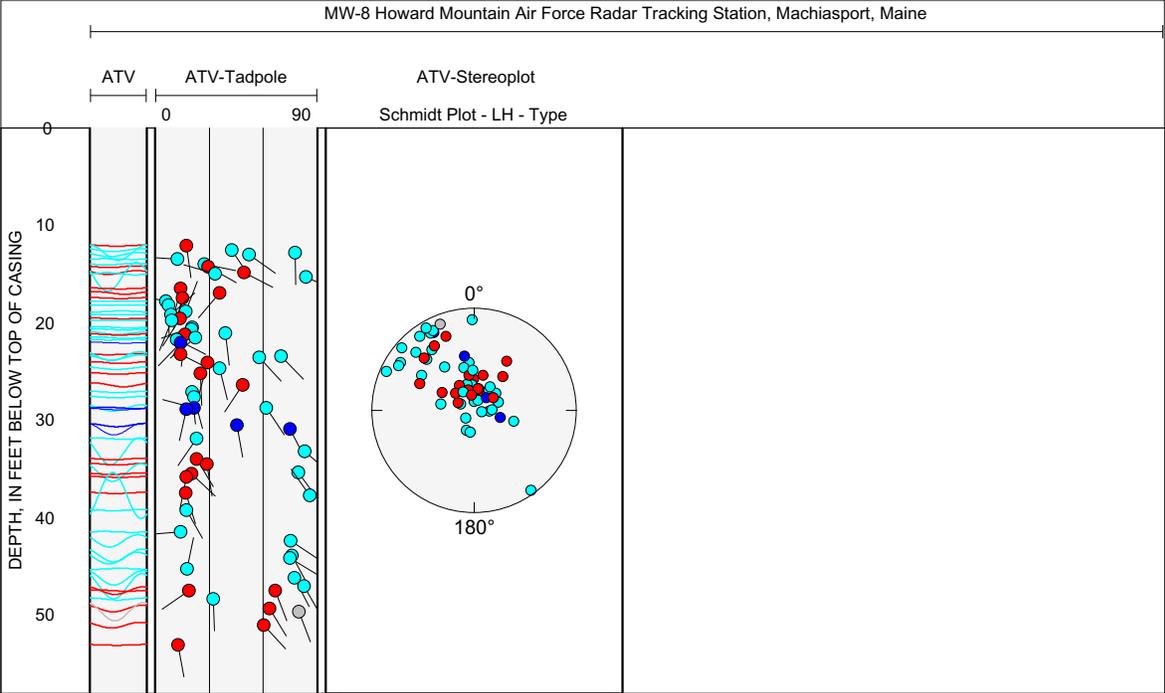
Figure 4B-2. Projection, tadpole, and stereoplots of interpretation of borehole image data for borehole MW-8, near Machiasport, Maine.

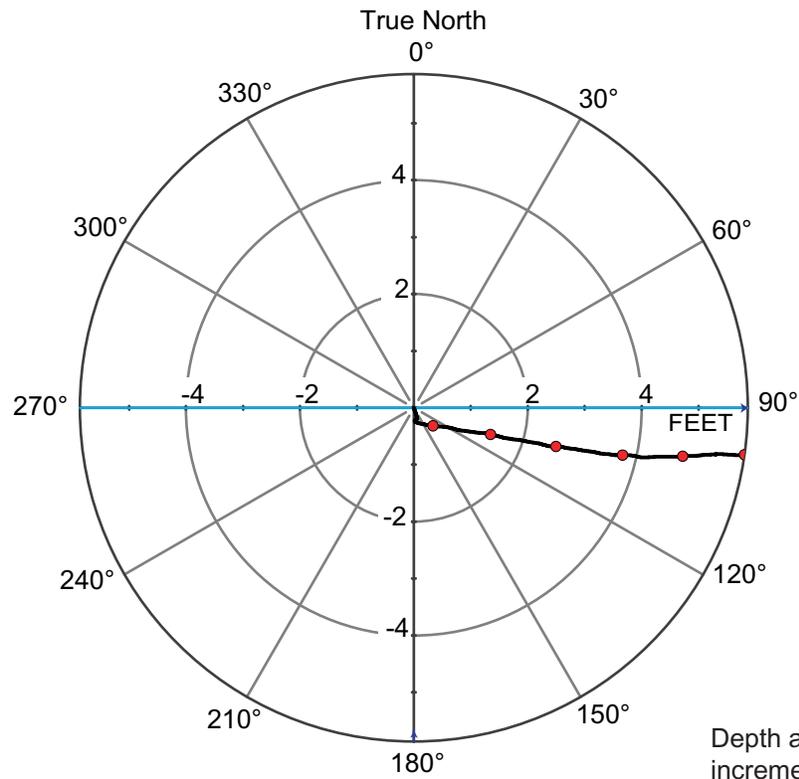
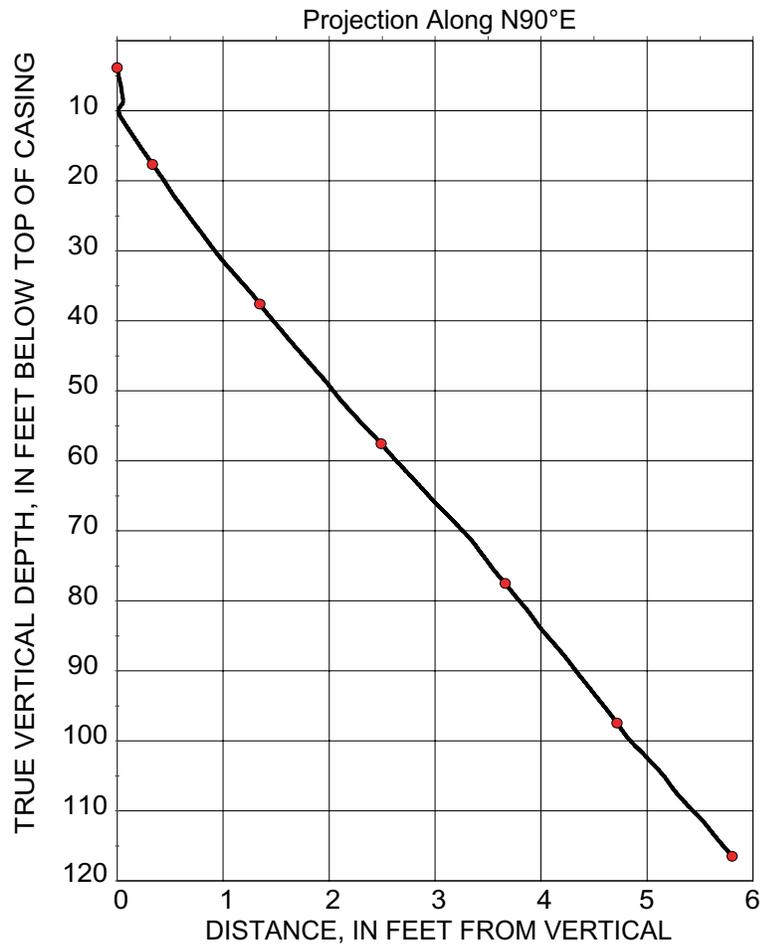
Figure 4C-1. Borehole deviation logs for borehole MW-9, near Machiasport, Maine. Blue line on radial plot (top) is line of projection for vertical plot (bottom).
[ft, foot; ATV, acoustic televiewer]

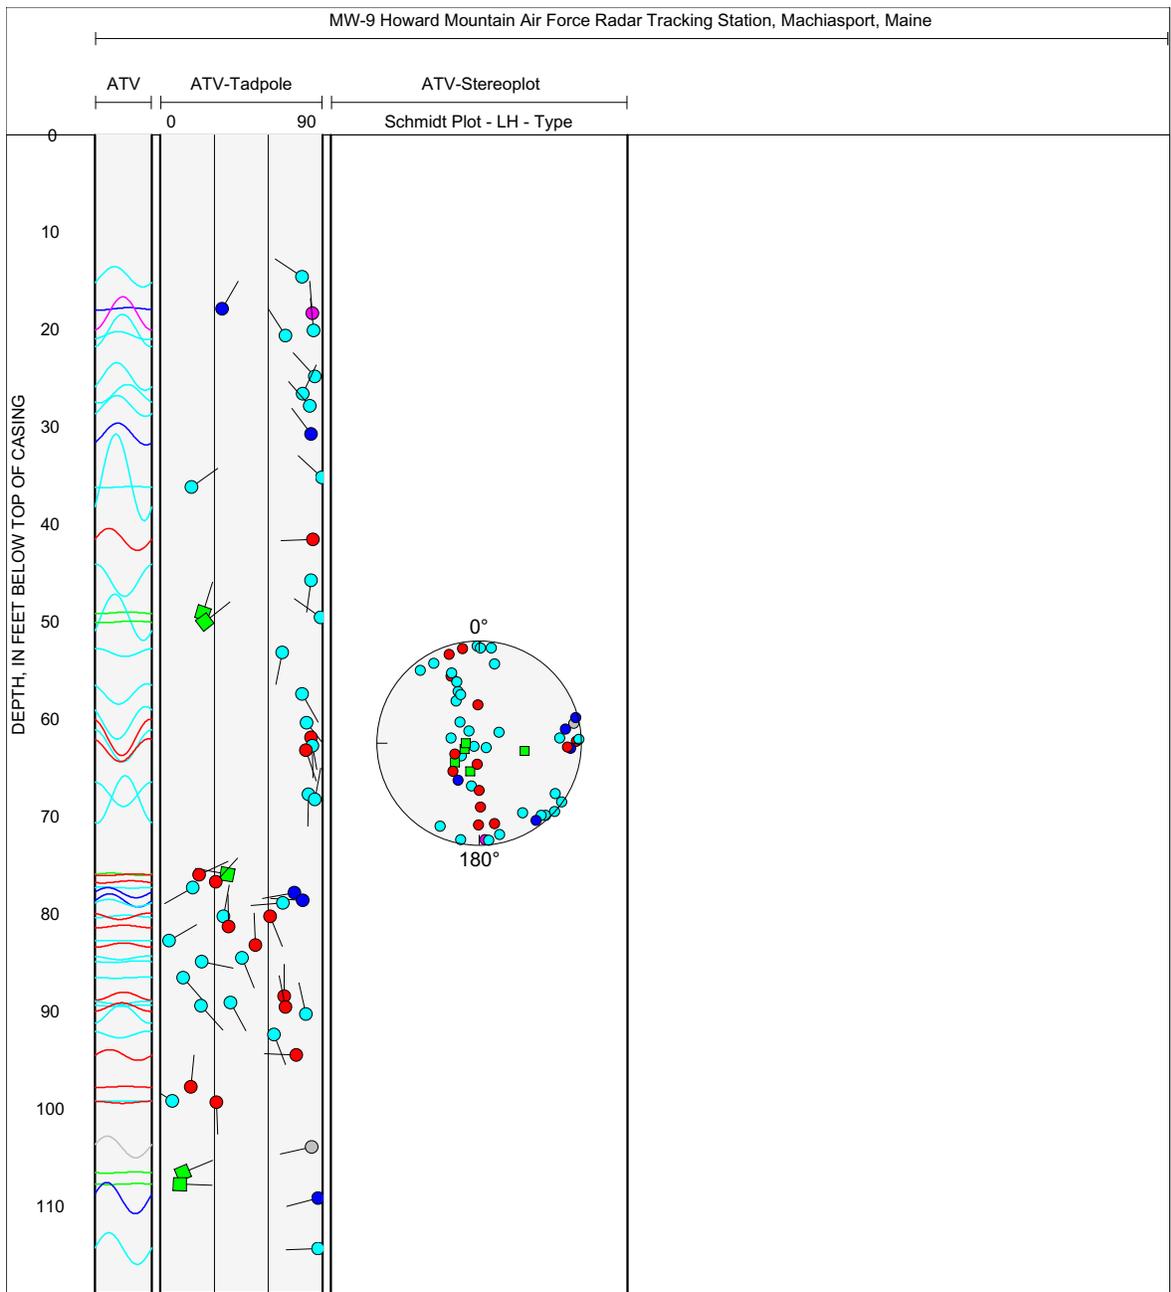
Figure 4C-2. Projection, tadpole, and stereoplots of interpretation of borehole image data for borehole MW-9, near Machiasport, Maine.

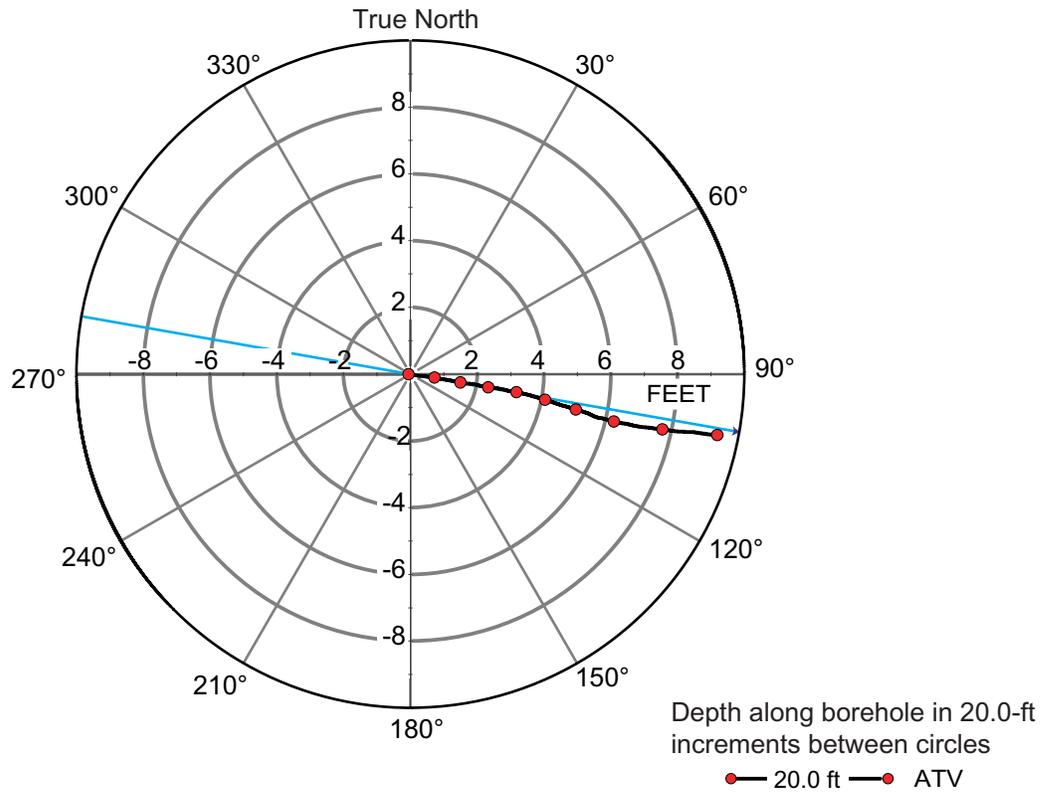
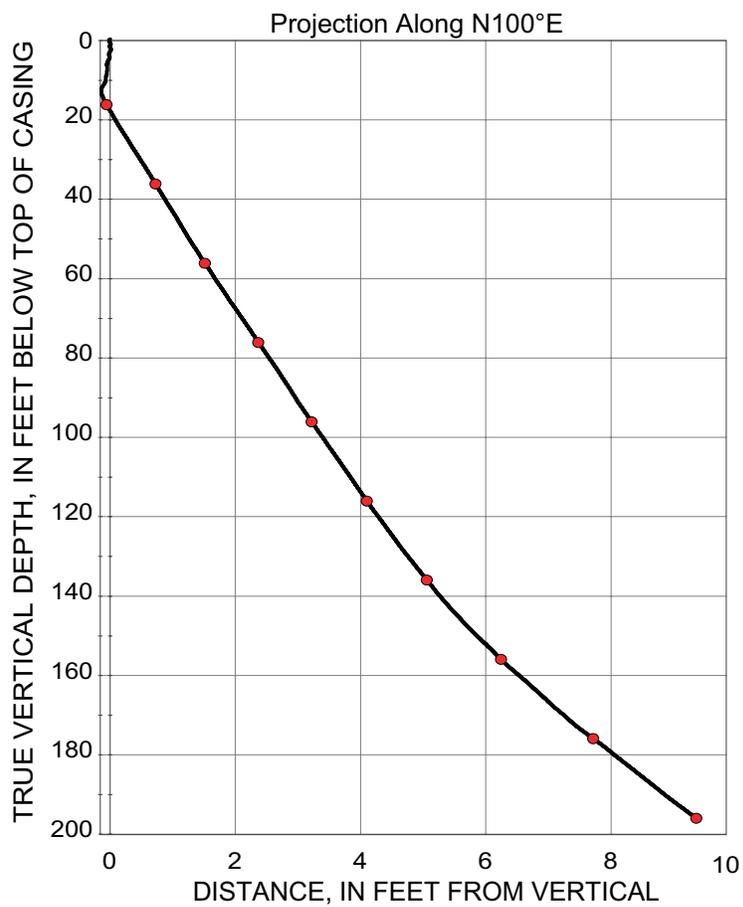
Figure 4D-1. Borehole deviation logs for borehole MW-10, near Machiasport, Maine. Blue line on radial plot (top) is line of projection for vertical plot (bottom).
 [ft, foot; ATV, acoustic televiewer]

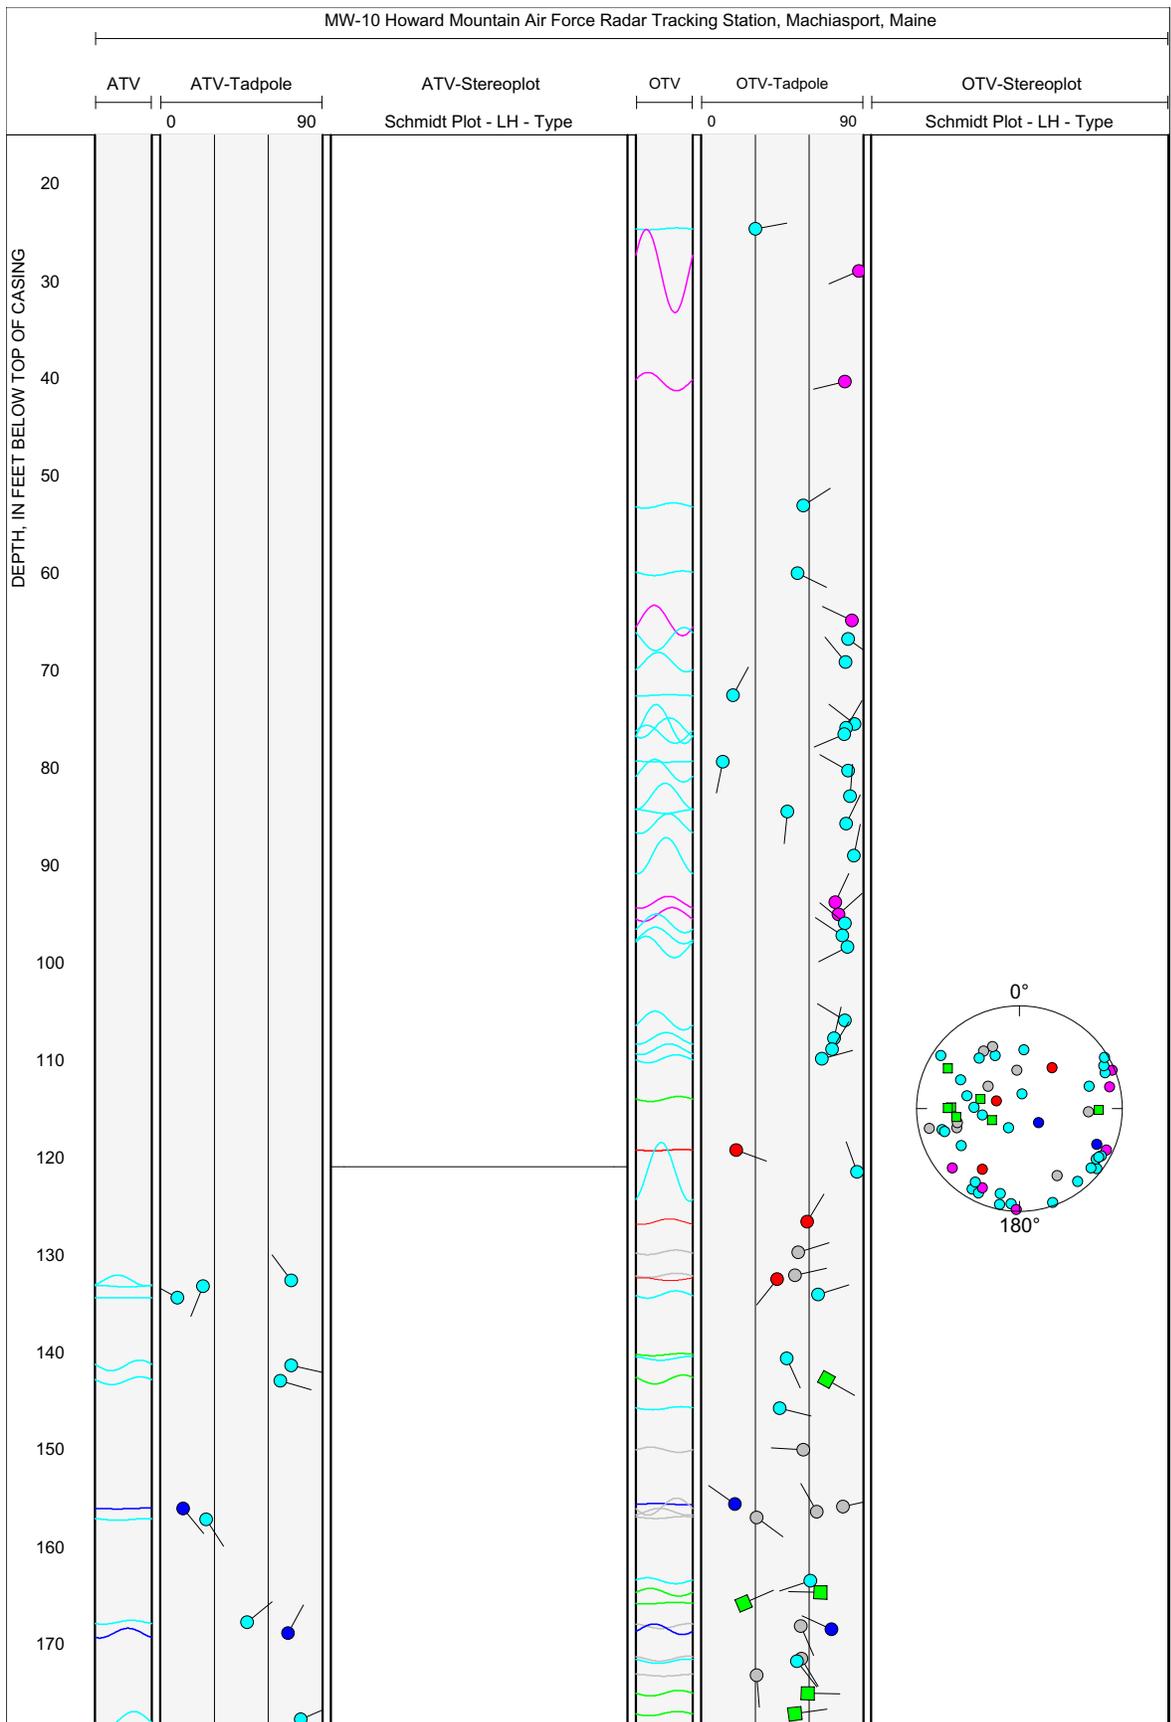
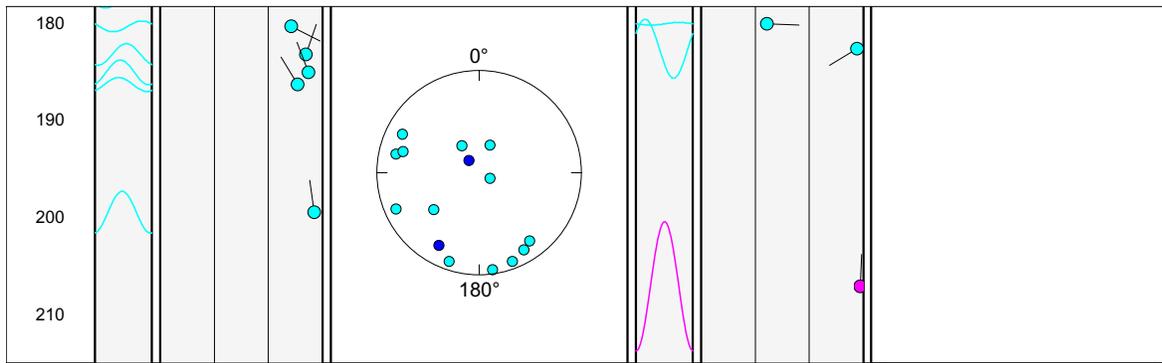
Figure 4D-2. Projection, tadpole, and stereoplots of interpretation of borehole image data for borehole MW-10, near Machiasport, Maine.

Figure 4D-2. Projection, tadpole, and stereoplots of interpretation of borehole image data for borehole MW-10, near Machiasport, Maine.—Continued

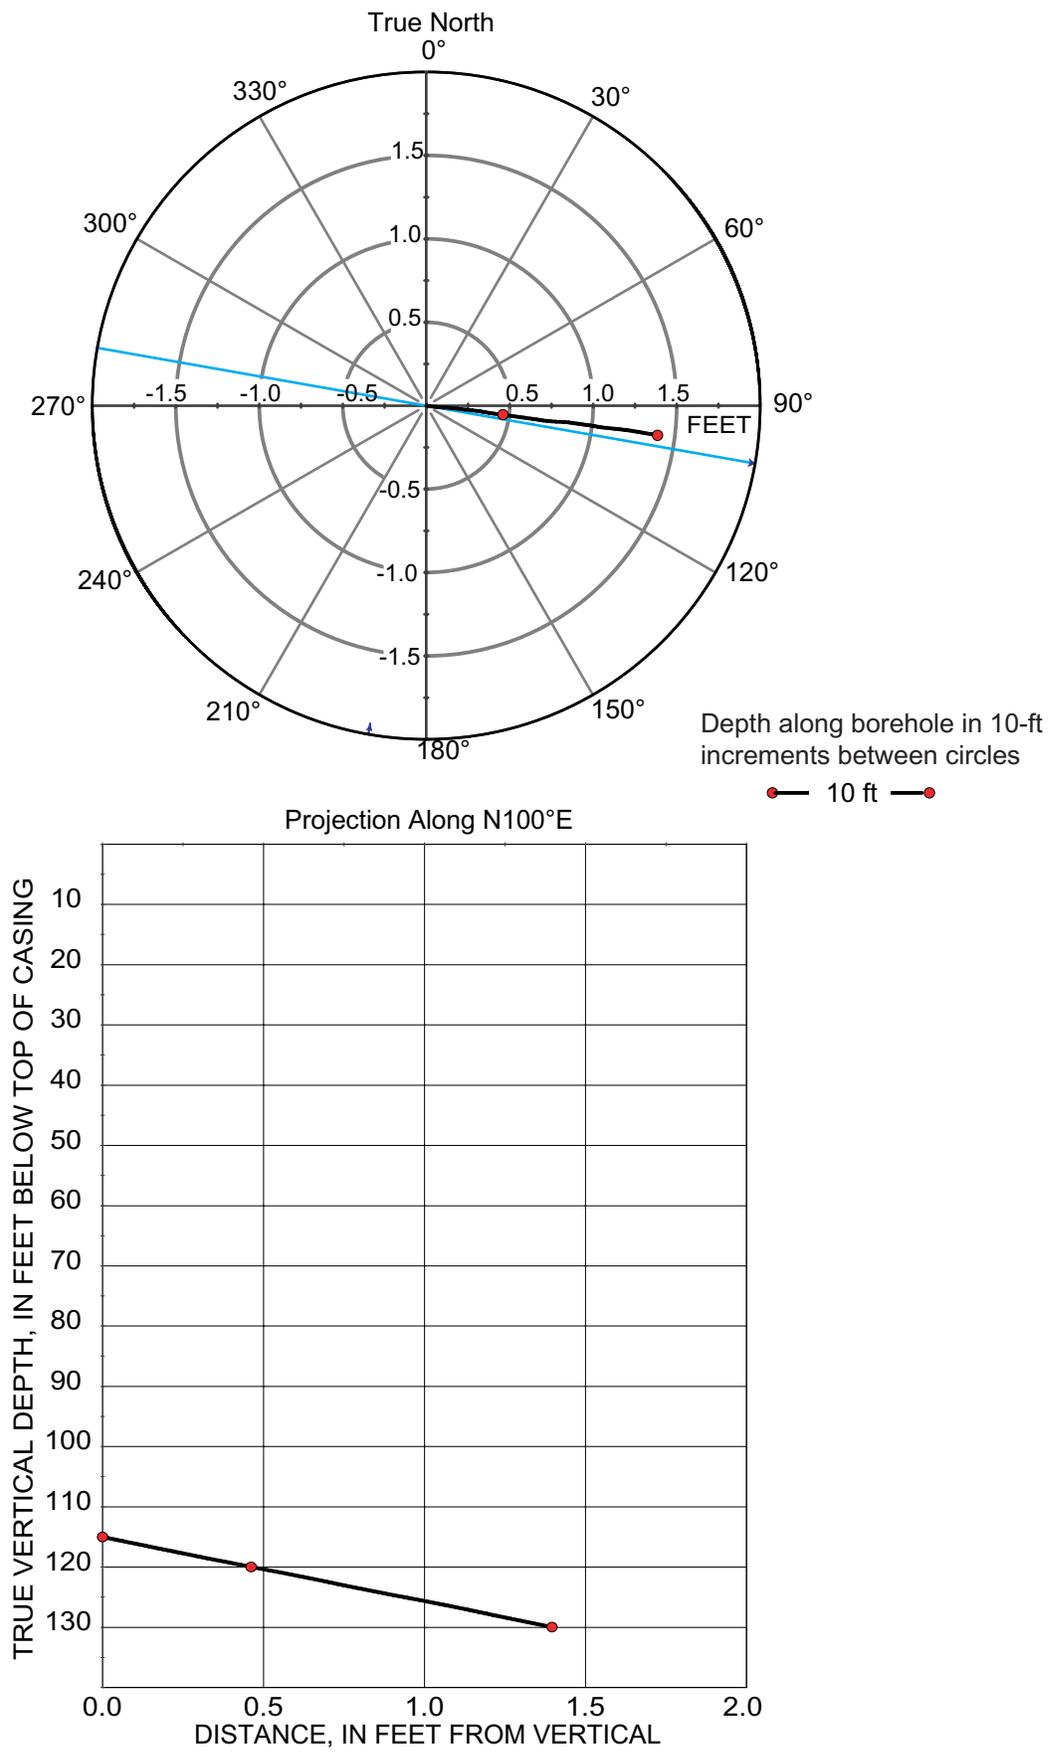
Figure 4E-1. Borehole deviation logs for borehole MW-11, near Machiasport, Maine. Blue line on radial plot (top) is line of projection for vertical plot (bottom).
 [ft, foot; ATV, acoustic televiewer]

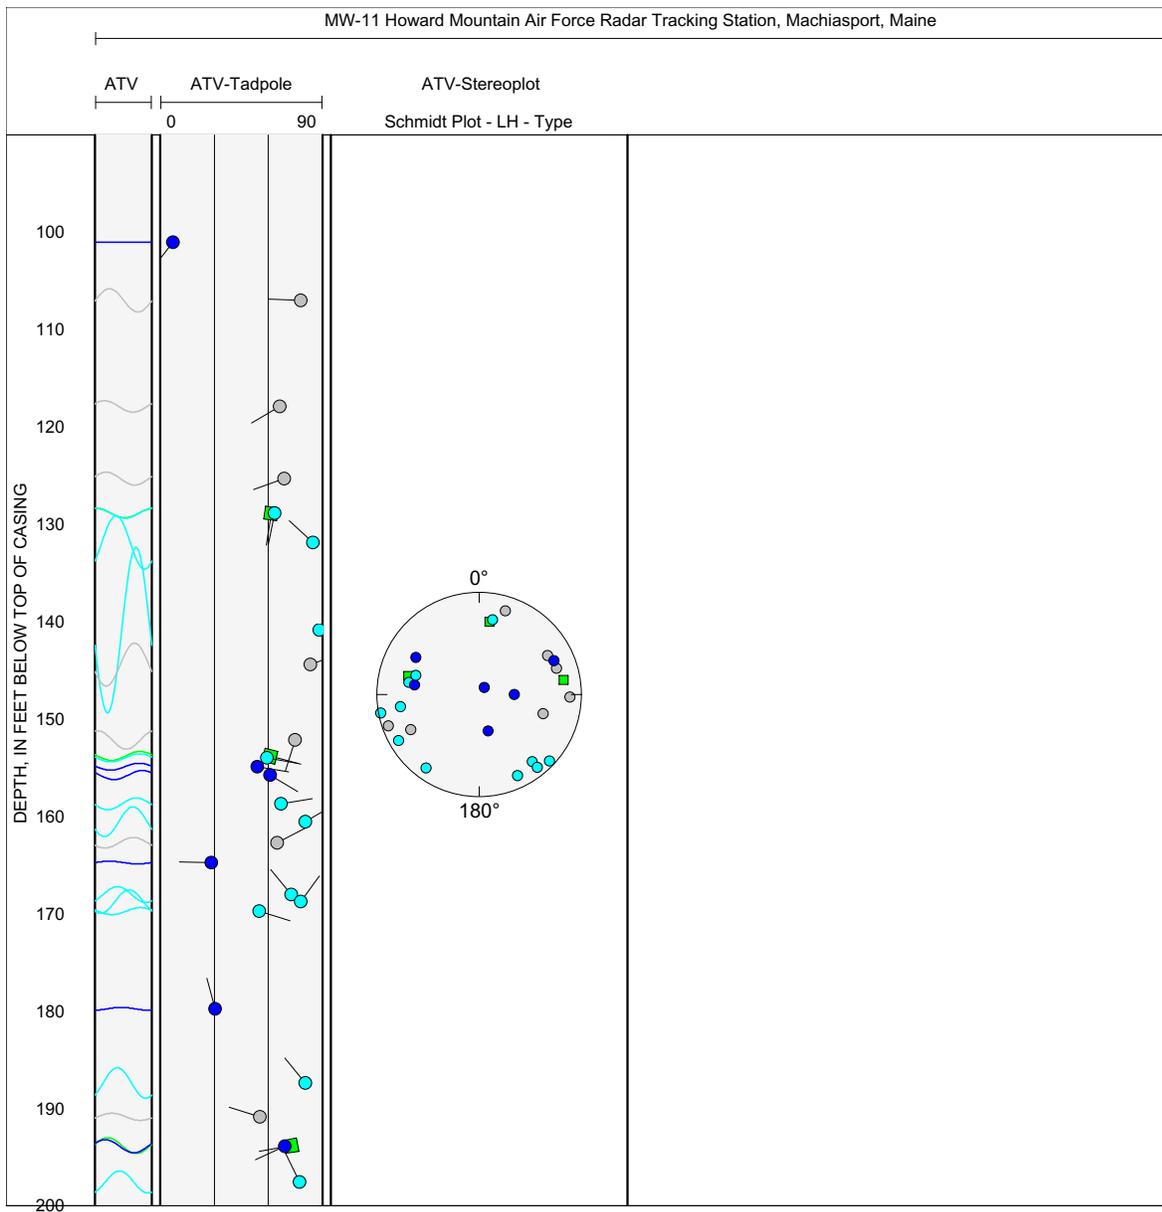
Figure 4E-2. Projection, tadpole, and stereoplots of interpretation of borehole image data for borehole MW-11, near Machiasport, Maine.

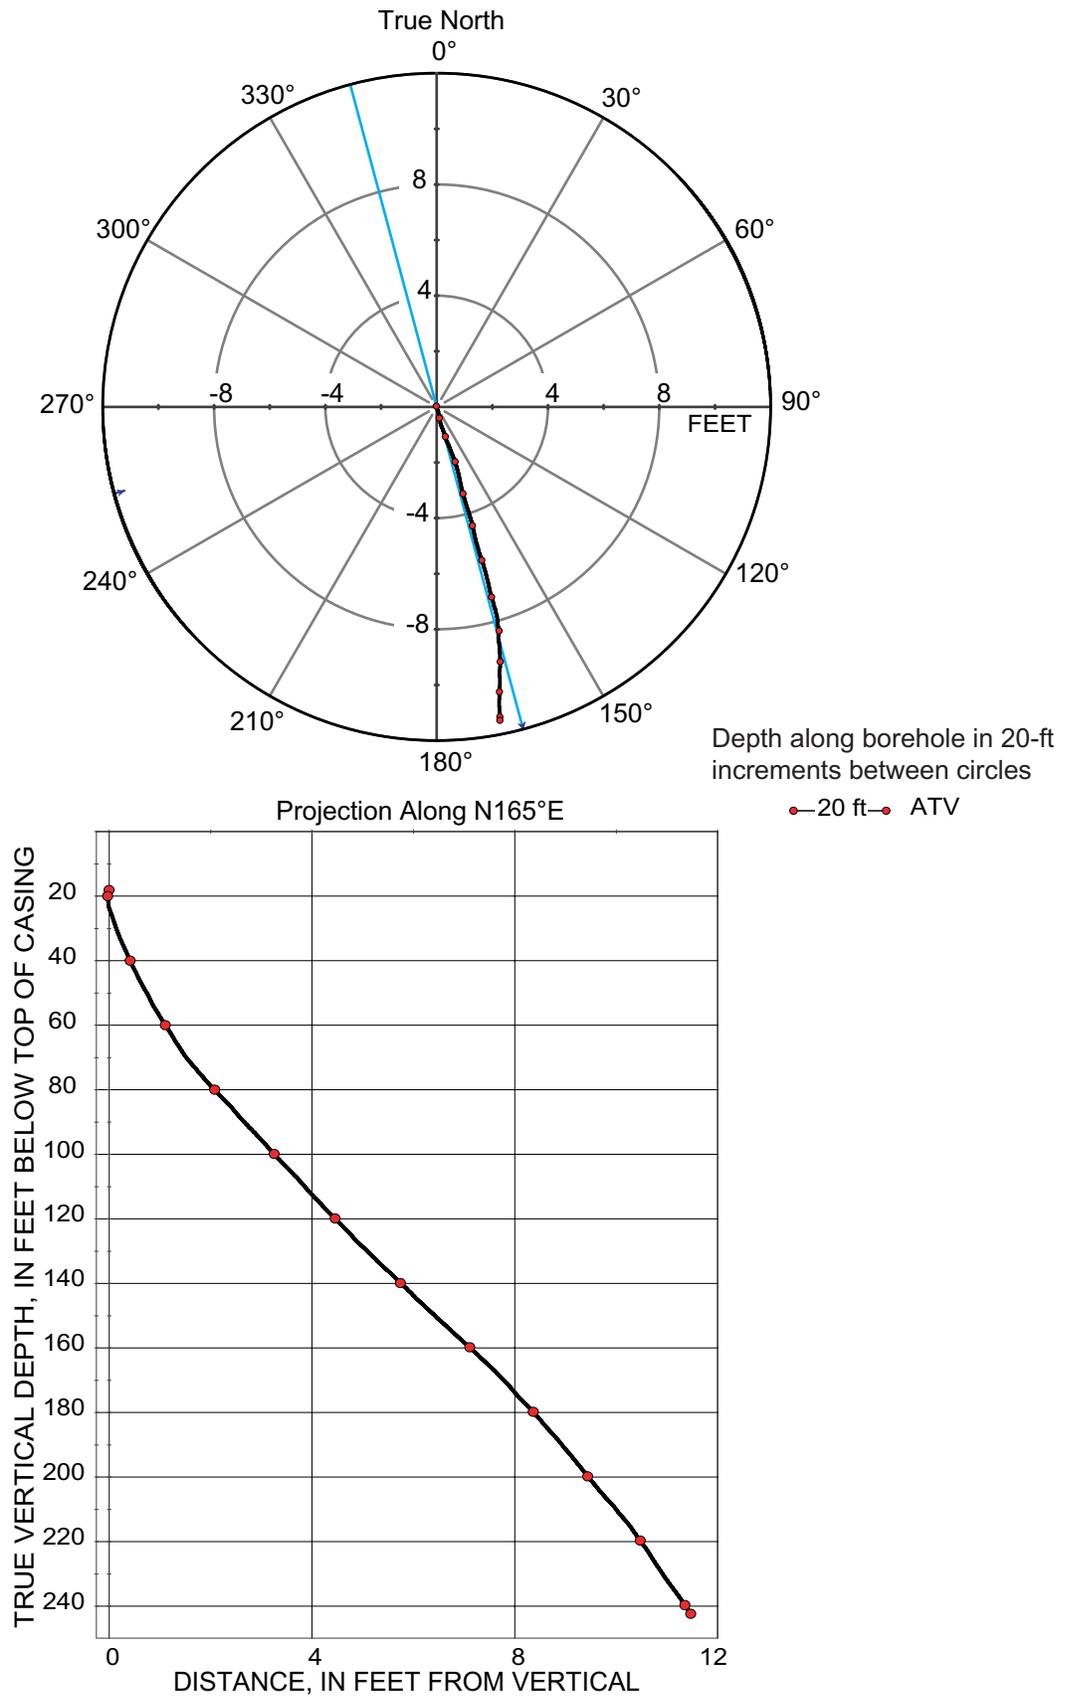
Figure 4F-1. Borehole deviation logs for borehole MW-12, near Machiasport, Maine. Blue line on radial plot (top) is line of projection for vertical plot (bottom).
[ft, foot; ATV, acoustic televiewer]

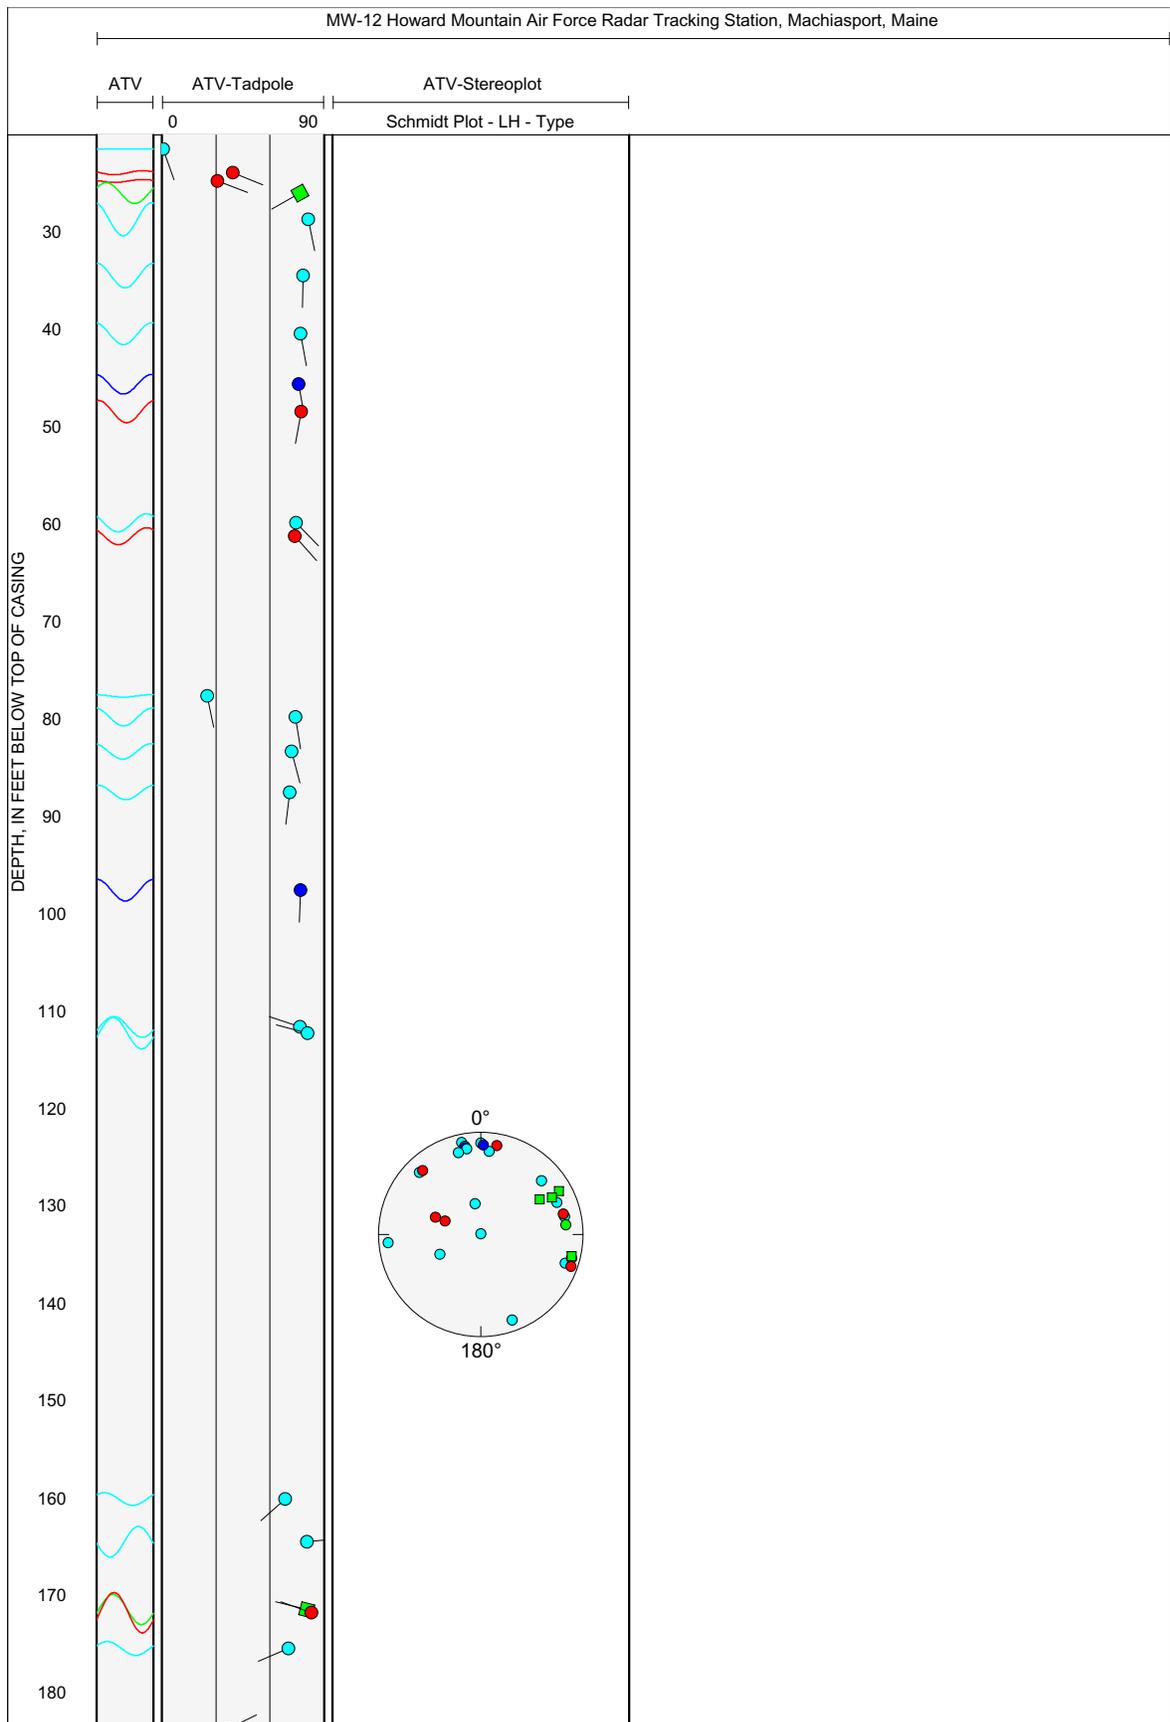
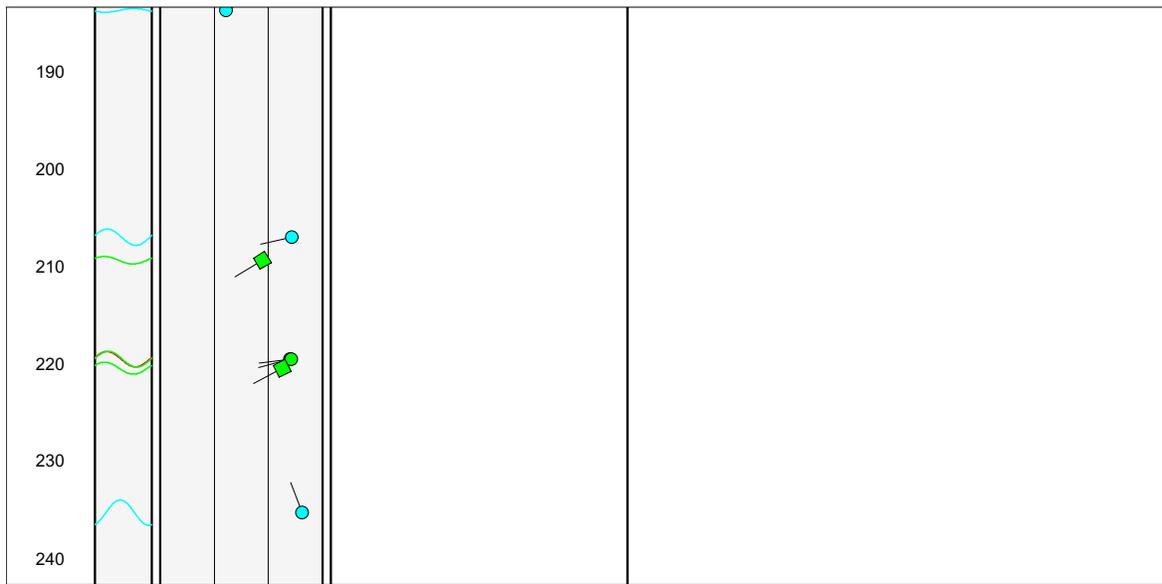
Figure 4F-2. Projection, tadpole, and stereoplots of interpretation of borehole image data for borehole MW-12, near Machiasport, Maine.

Figure 4F-2. Projection, tadpole, and stereoplots of interpretation of borehole image data for borehole MW-12, near Machiasport, Maine.—Continued

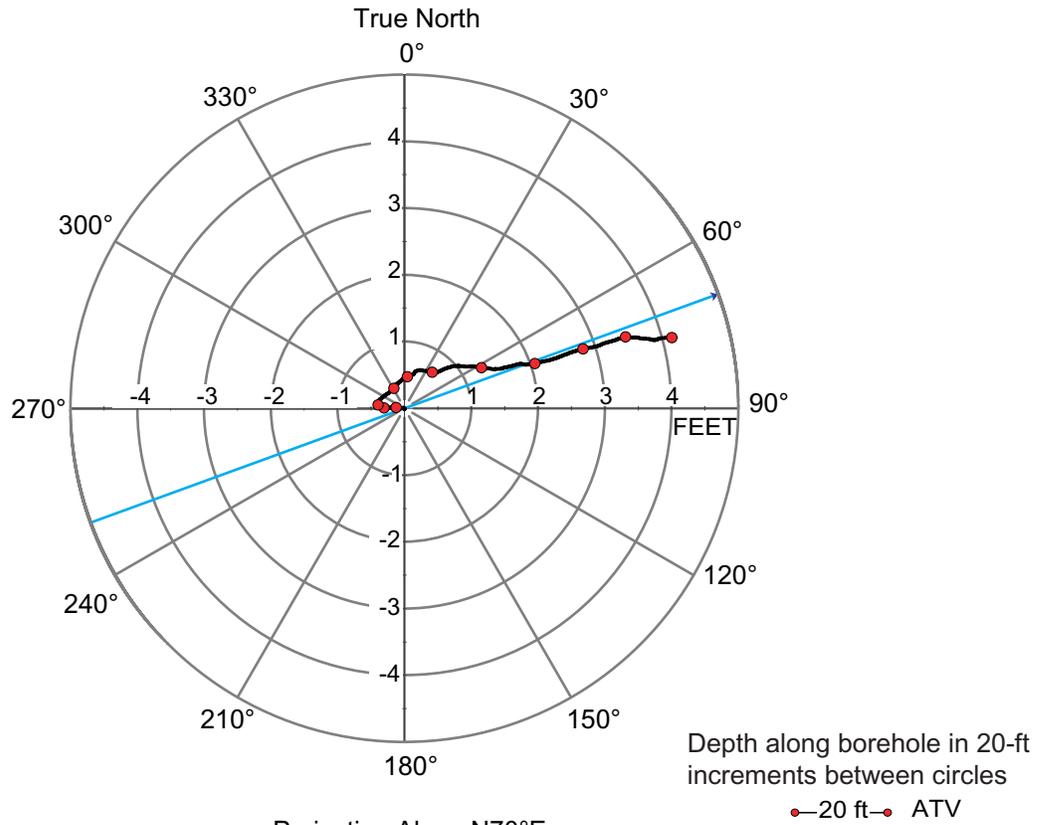
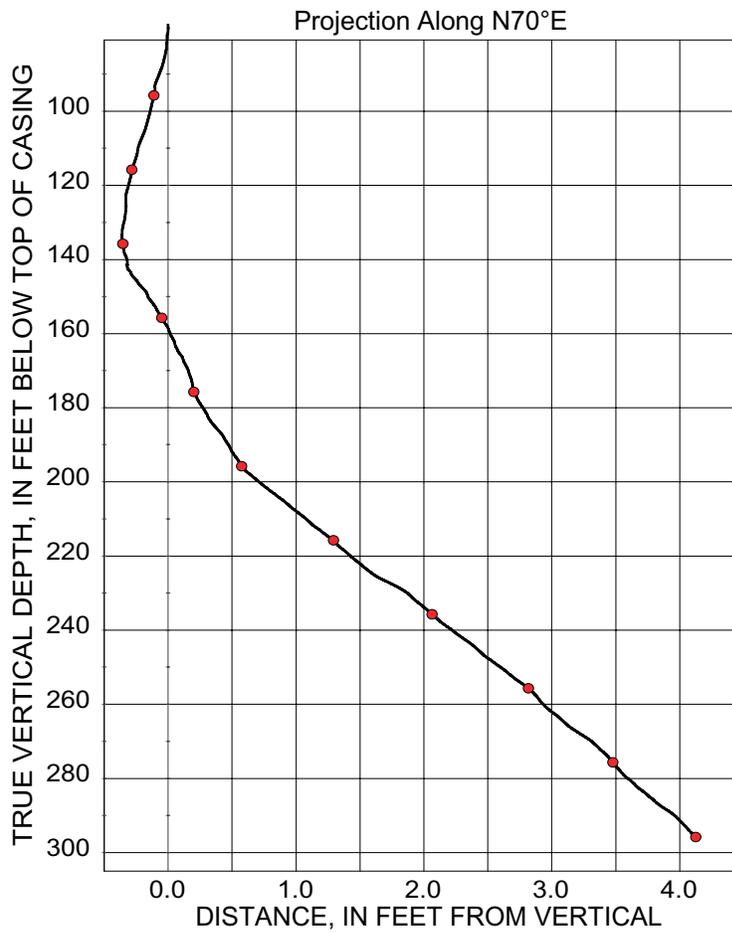
Figure 4G-1. Borehole deviation logs for borehole WY-3, near Machiasport, Maine. Blue line on radial plot (top) is line of projection for vertical plot (bottom).
[ft, foot; ATV, acoustic televiewer]

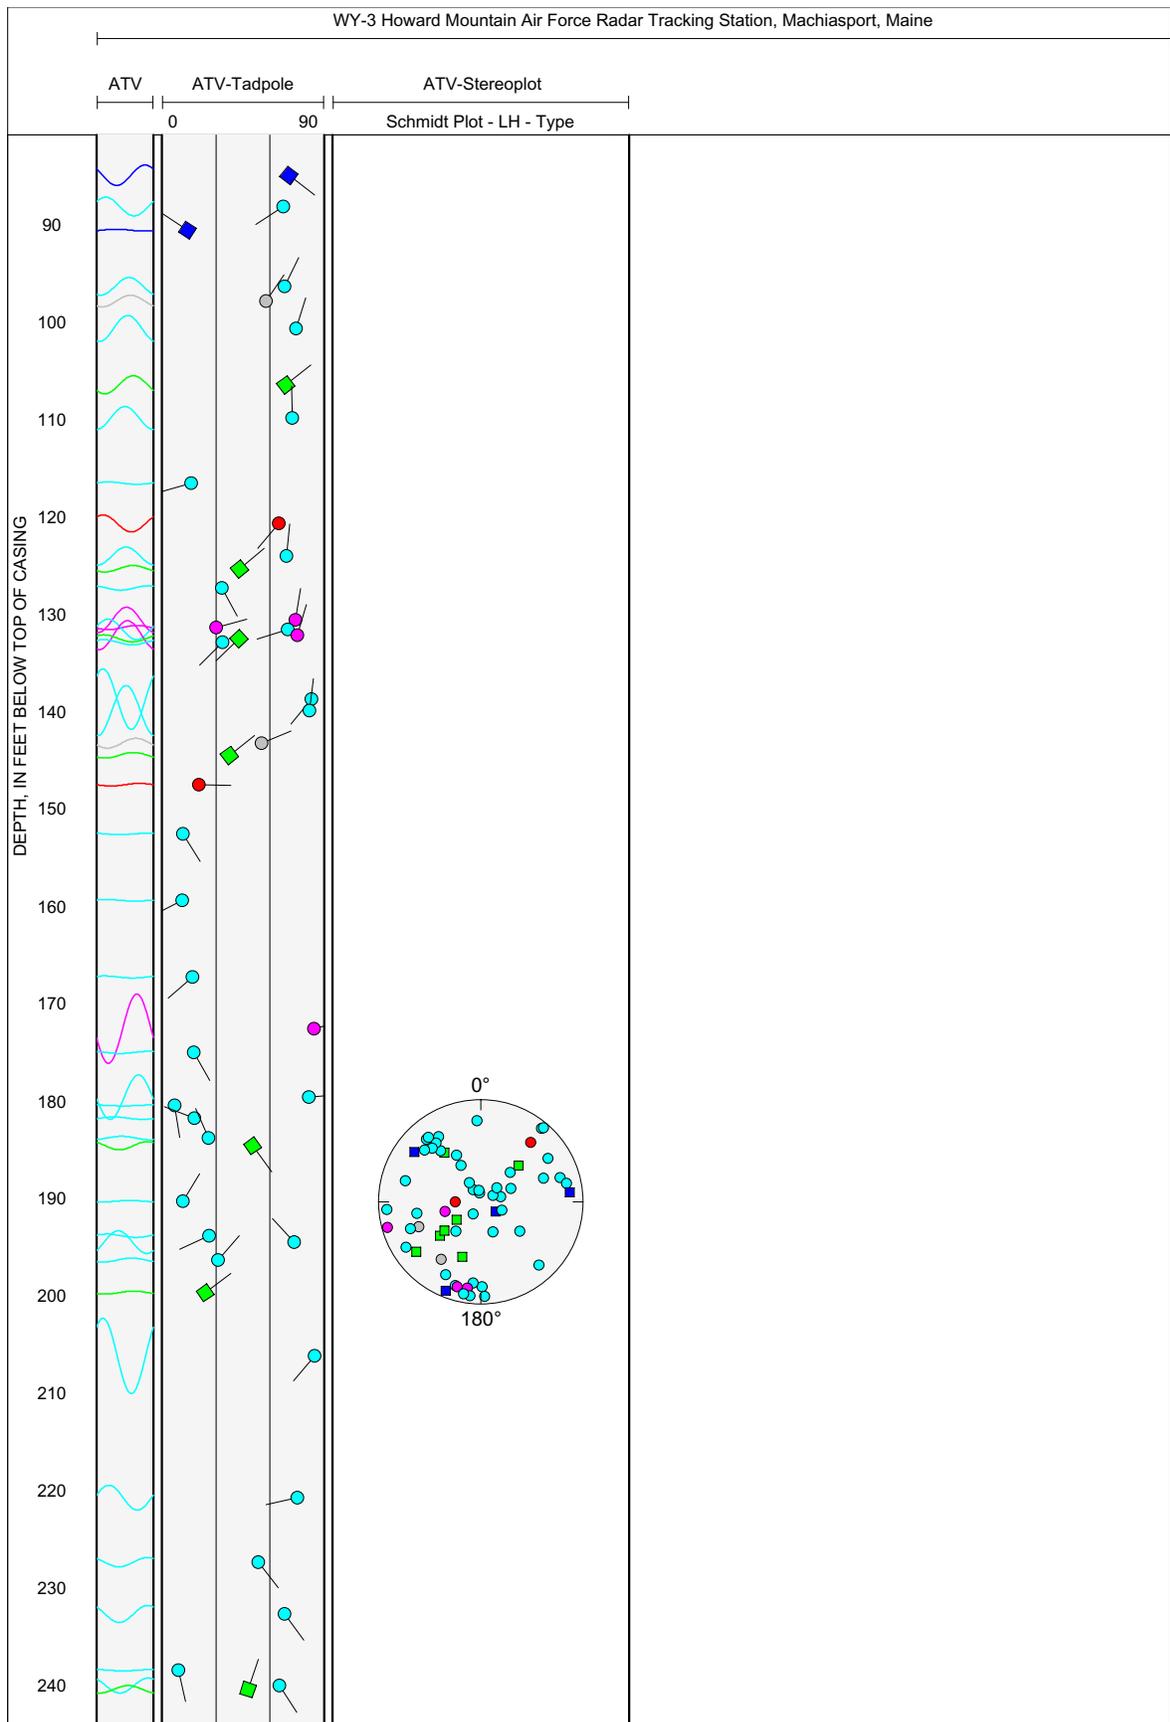
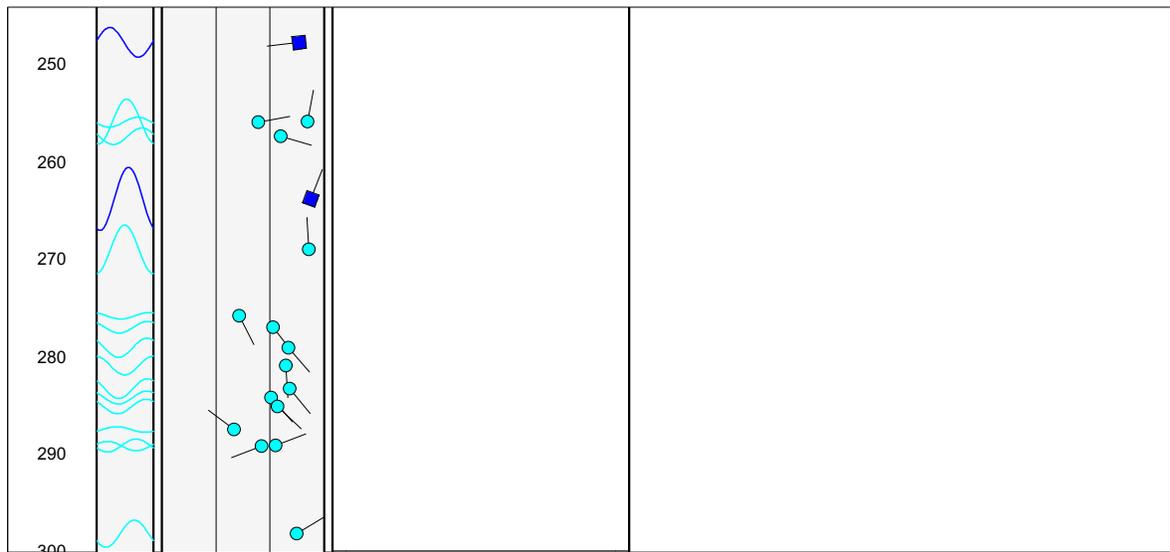
Figure 4G-2. Projection, tadpole, and stereoplots of interpretation of borehole image data for borehole WY-3, near Machiasport, Maine.

Figure 4G-2. Projection, tadpole, and stereoplots of interpretation of borehole image data for borehole WY-3, near Machiasport, Maine.—Continued

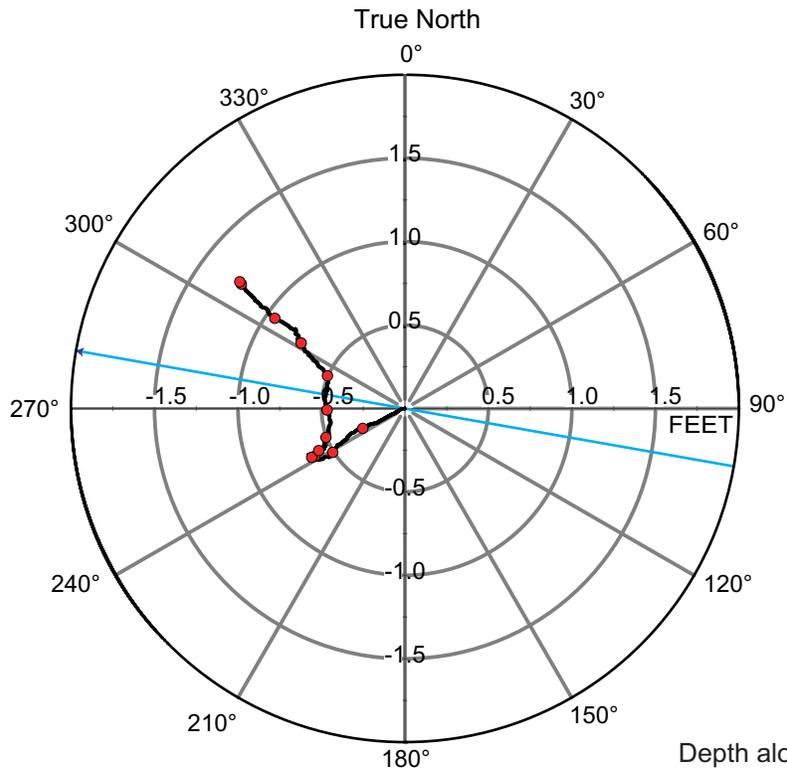
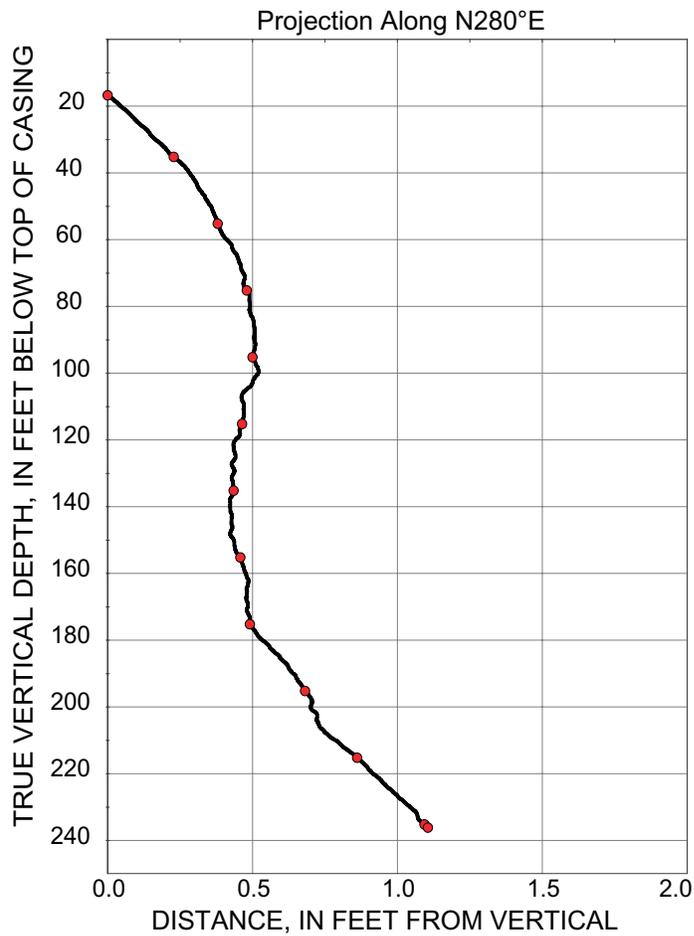
Depth along borehole in 20-ft increments between circles

Figure 4H-1. Borehole deviation logs for borehole DW-4, near Machiasport, Maine. Blue line on radial plot (top) is line of projection for vertical plot (bottom).
 [ft, foot; ATV, acoustic televiewer]
