Borehole Geophysical Investigation of a Formerly Used Defense Site, Machiasport, Maine, 2003–2006

By Carole D. Johnson, Remo A. Mondazzi, and Peter K. Joesten

Scientific Investigations Report 2009–5120

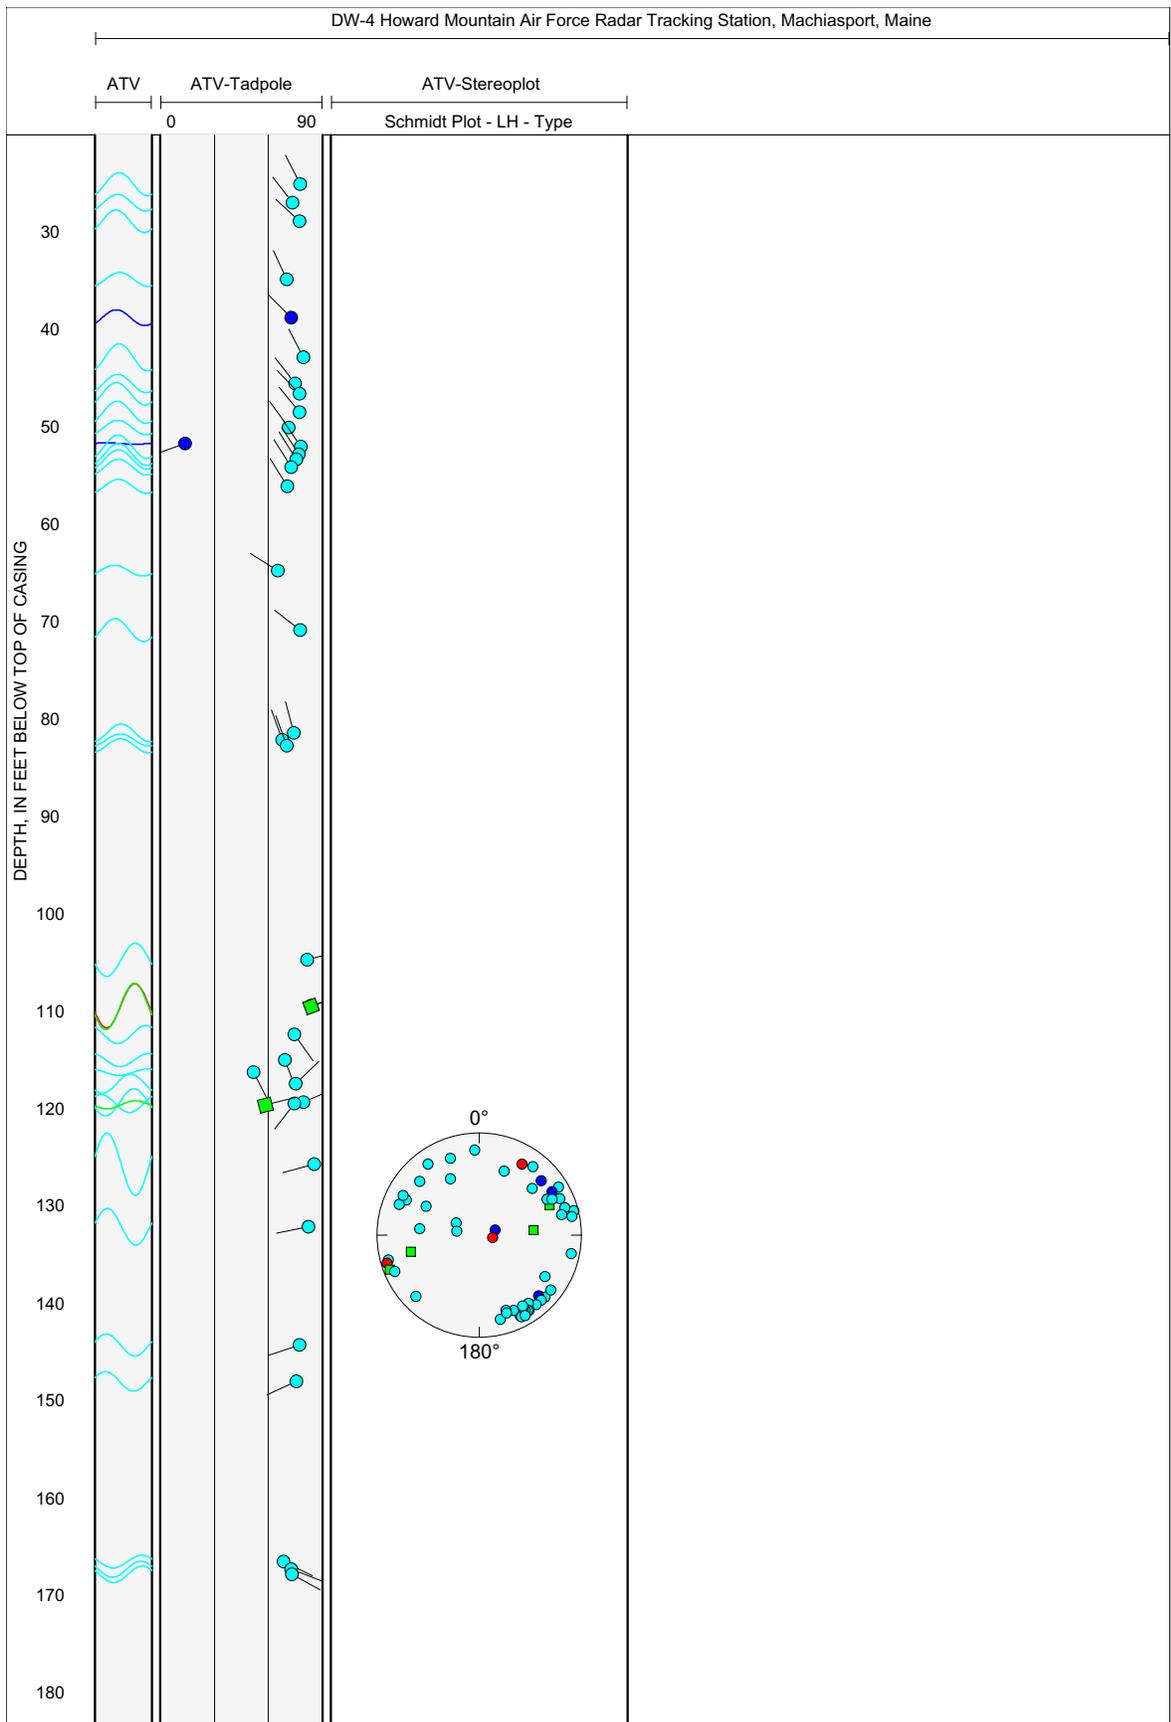
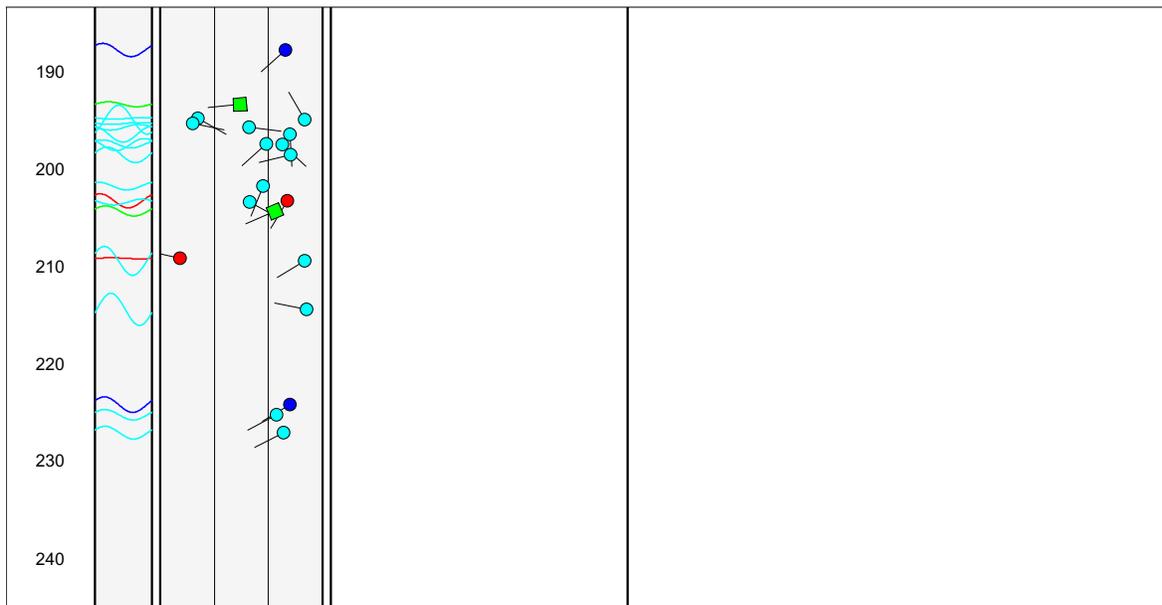
Figure 4H-2. Projection, tadpole, and stereoplots of interpretation of borehole image data for borehole DW-4, near Machiasport, Maine.

Figure 4H-2. Projection, tadpole, and stereoplots of interpretation of borehole image data for borehole DW-4, near Machiasport, Maine.—Continued

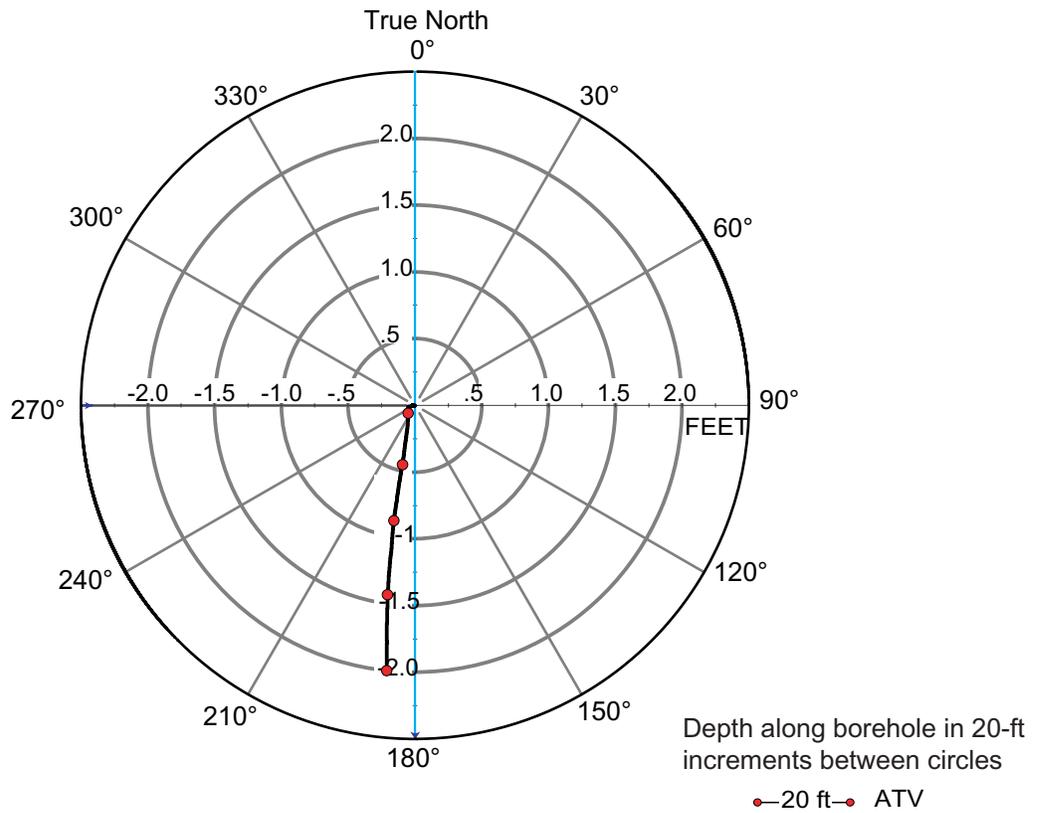
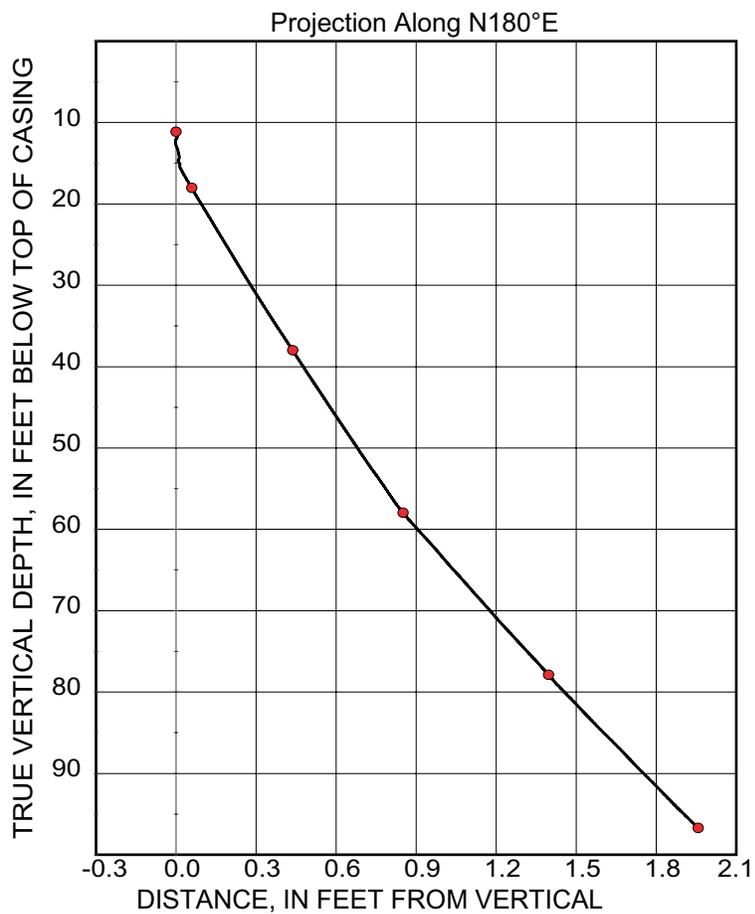
Figure 4I-1. Borehole deviation logs for borehole MW-4, near Machiasport, Maine. Blue line on radial plot (top) is line of projection for vertical plot (bottom).
[ft, foot; ATV, acoustic televiewer]

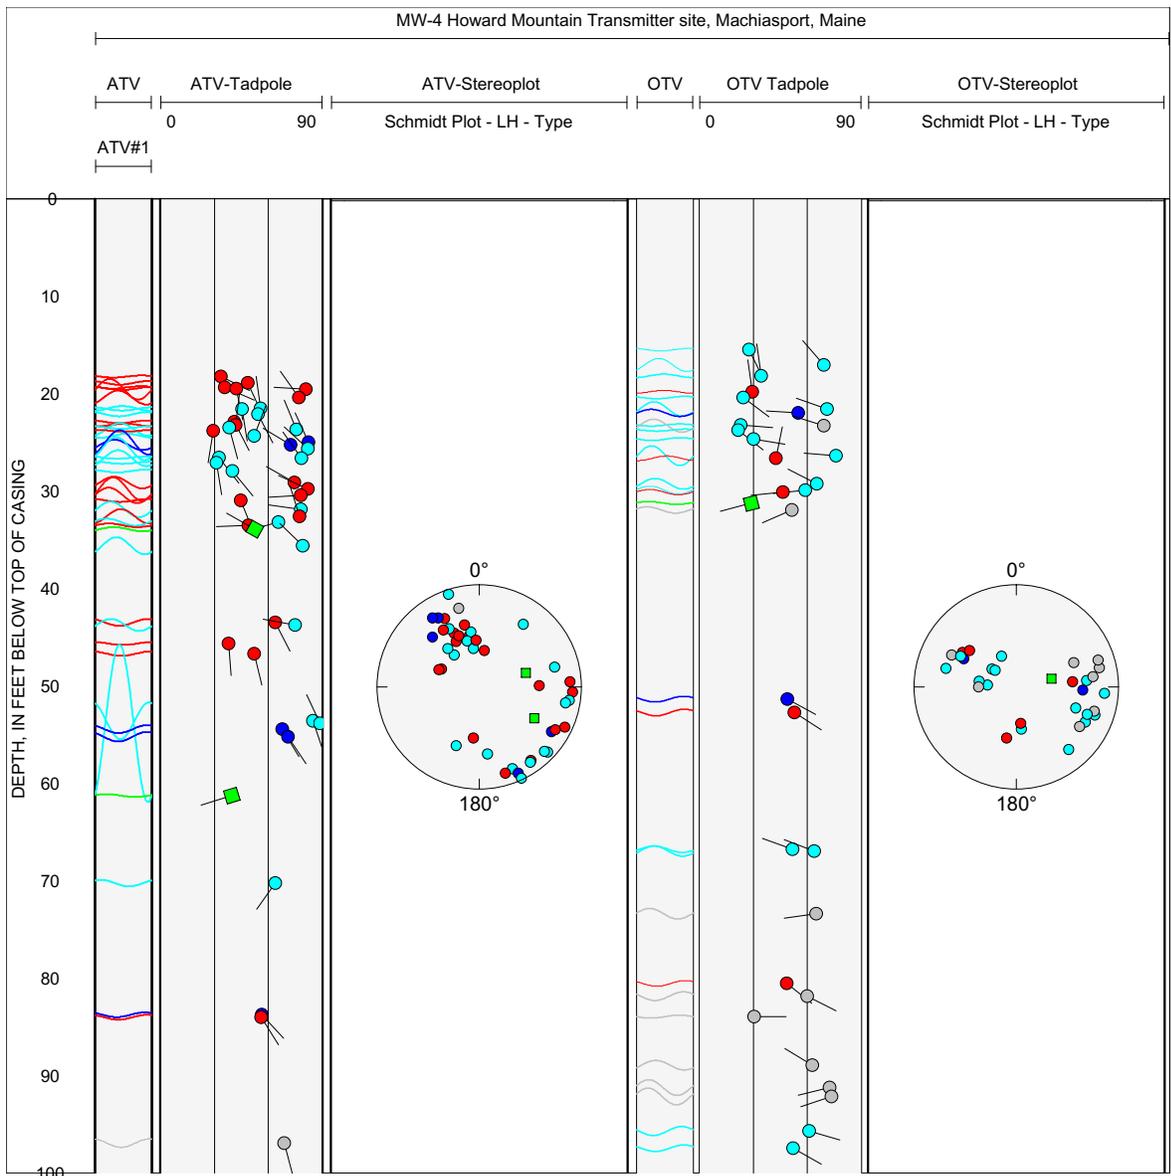
Figure 4I-2. Projection, tadpole, and stereoplots of interpretation of borehole image data for borehole MW-4, near Machiasport, Maine.

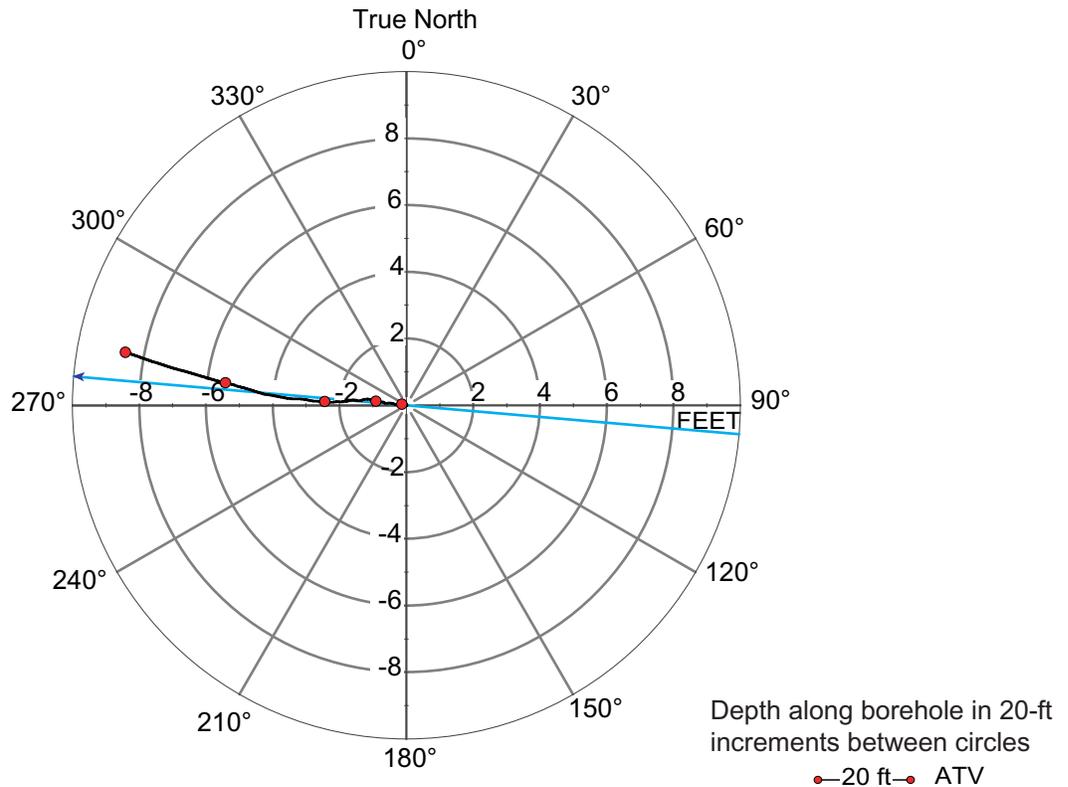
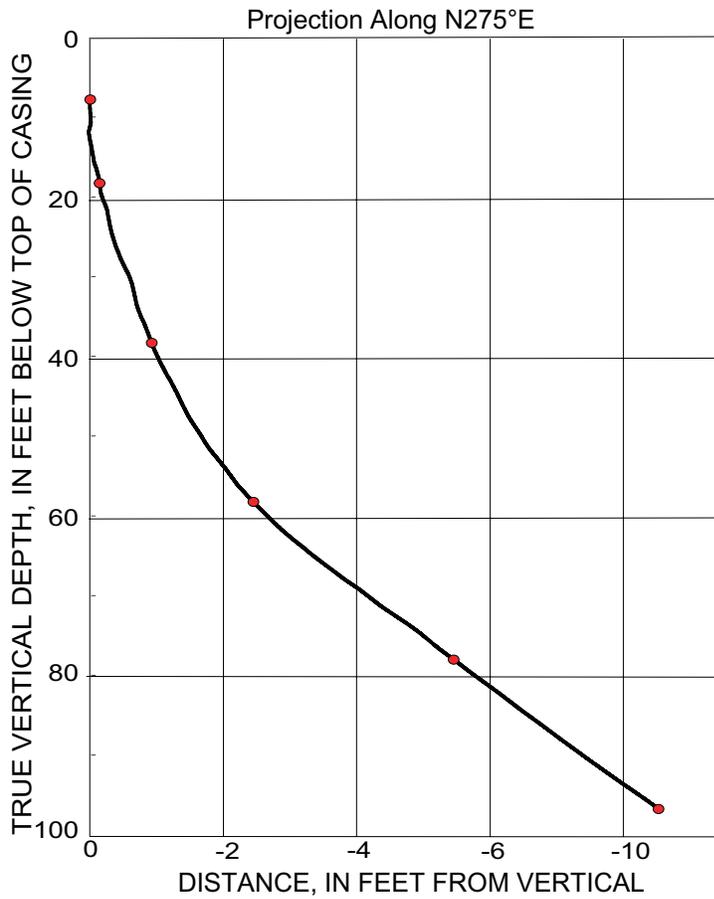
Figure 4J-1. Borehole deviation logs for borehole MW-5, near Machiasport, Maine. Blue line on radial plot (top) is line of projection for vertical plot (bottom).
[ft, foot; ATV, acoustic televiewer]

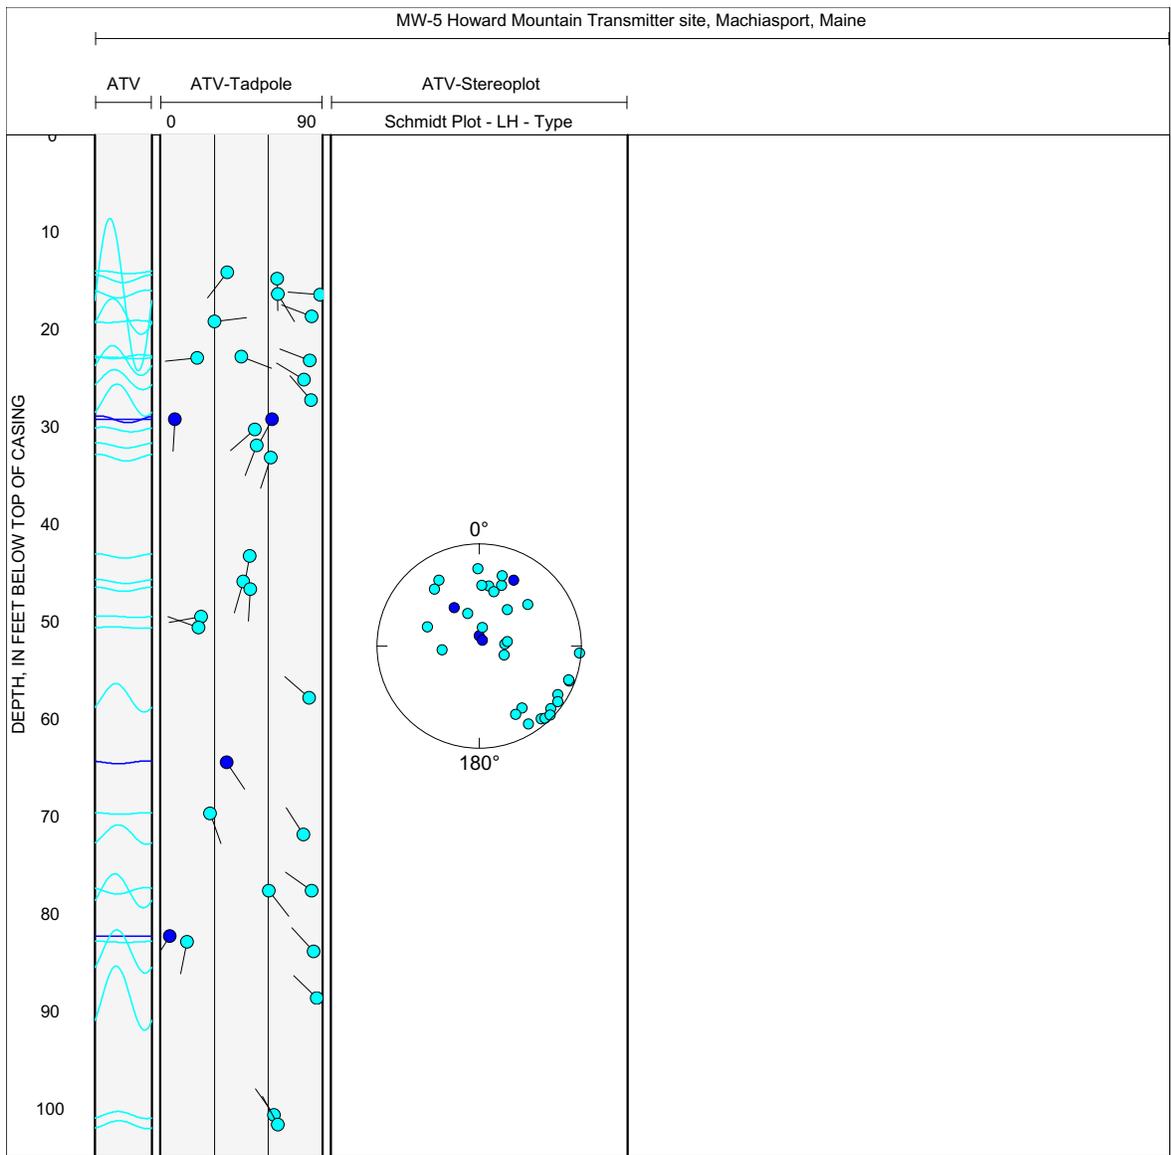
Figure 4J-2. Projection, tadpole, and stereoplots of interpretation of borehole image data for borehole MW-5, near Machiasport, Maine.

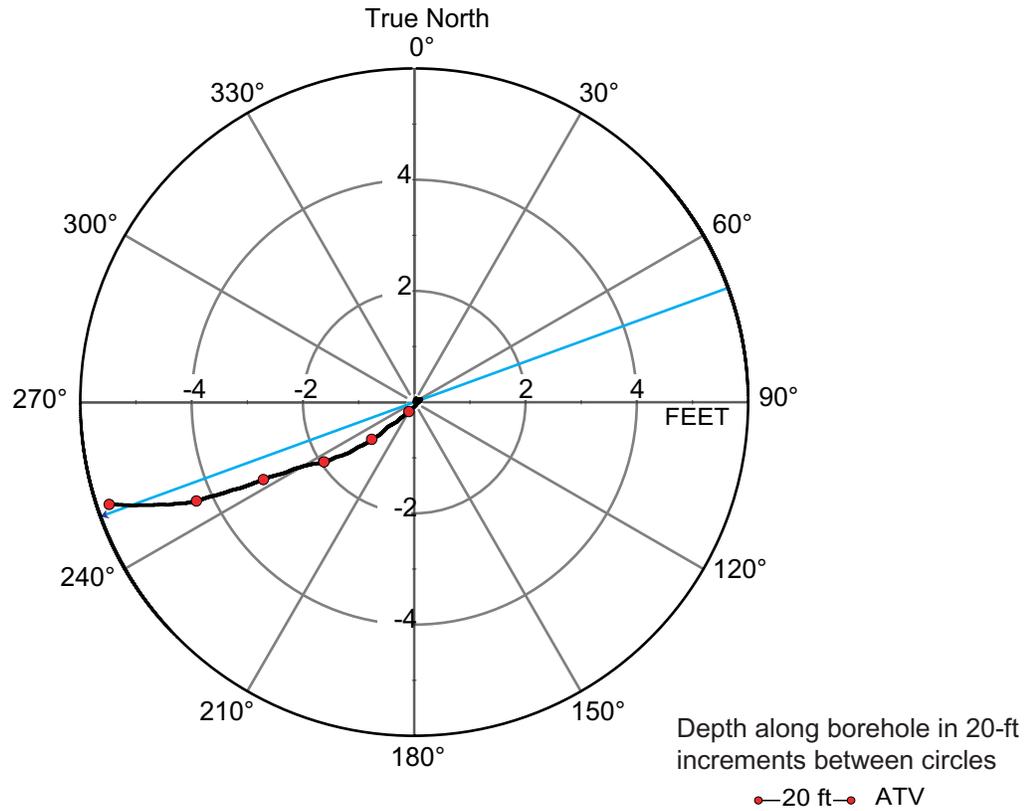
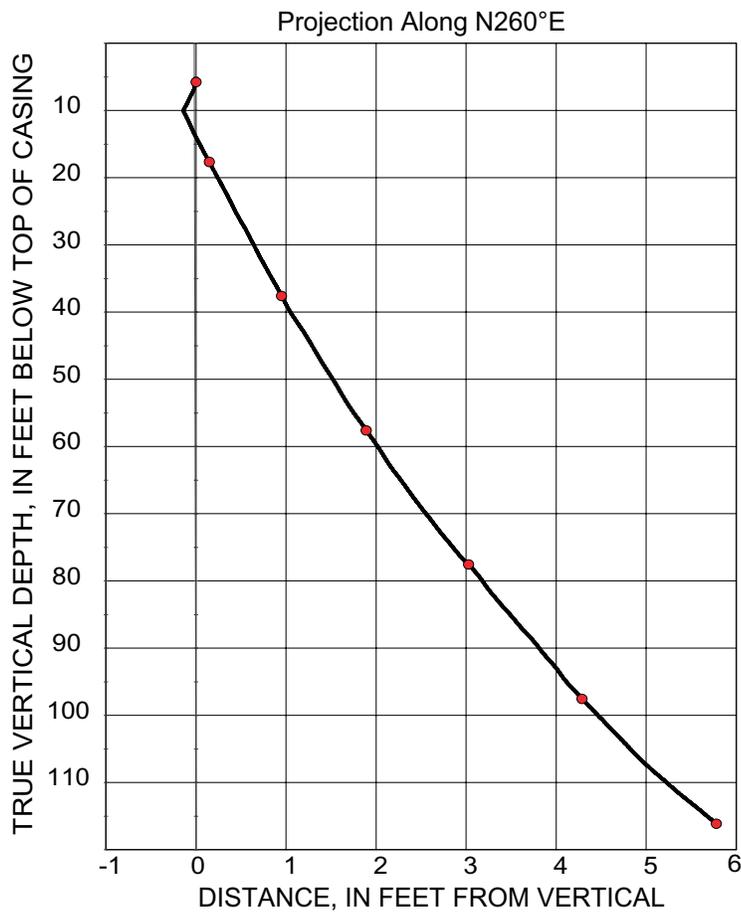
Figure 4K-1. Borehole deviation logs for borehole MW-6, near Machiasport, Maine. Blue line on radial plot (top) is line of projection for vertical plot (bottom).
[ft, foot; ATV, acoustic televiewer]

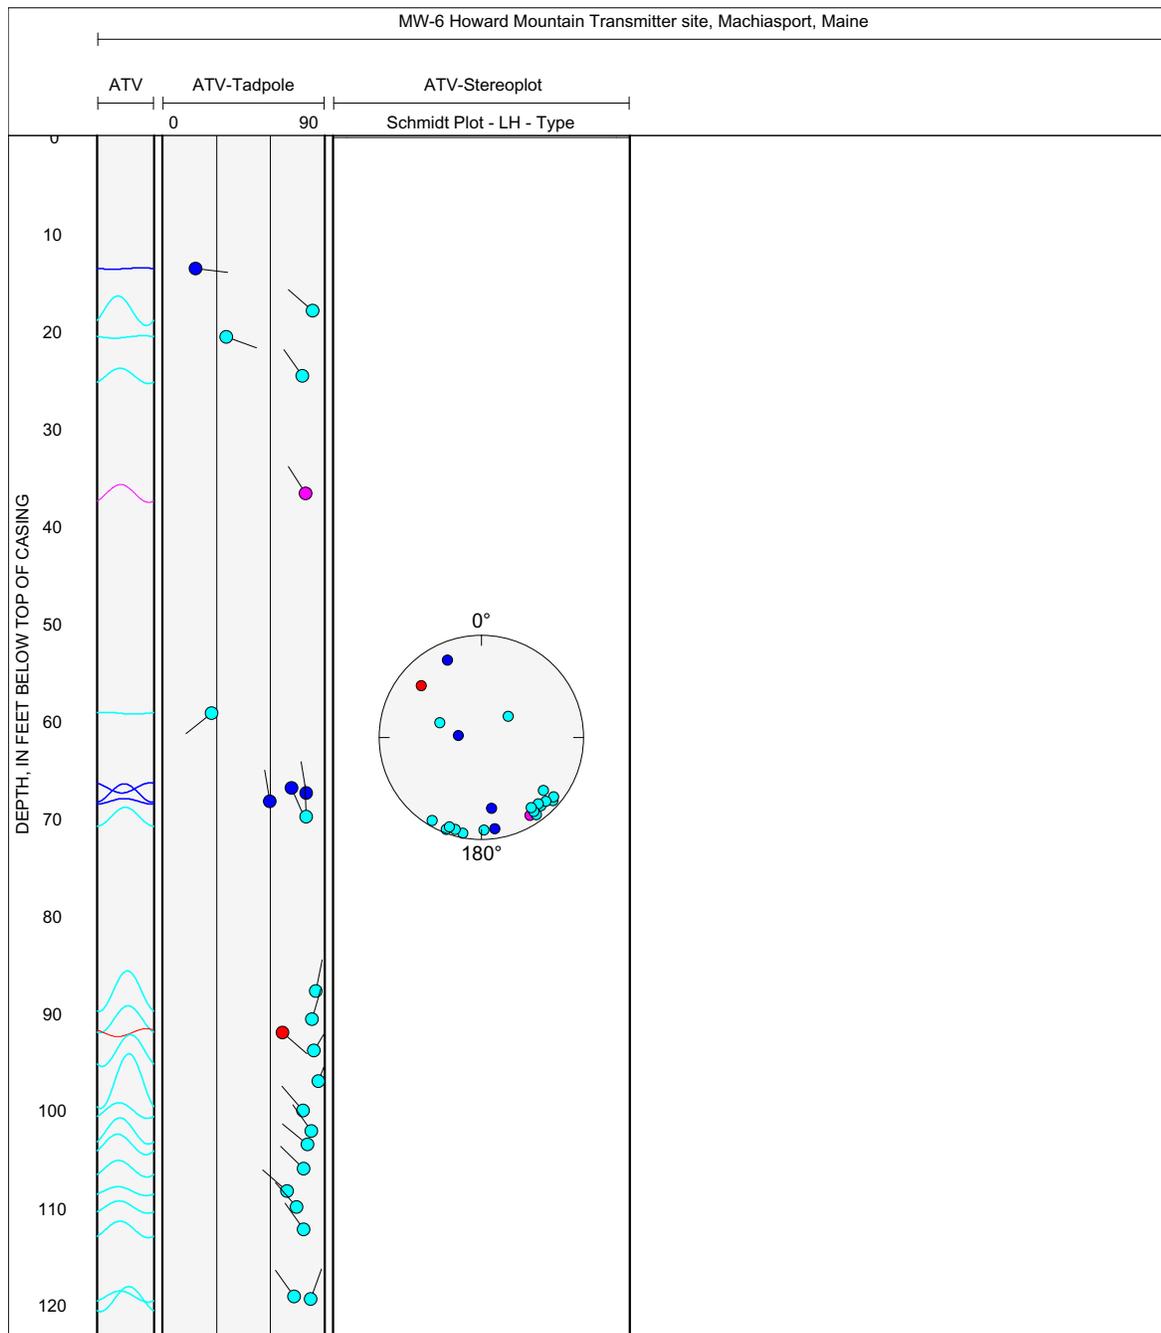
Figure 4K-2. Projection, tadpole, and stereoplots of interpretation of borehole image data for borehole MW-6, near Machiasport, Maine.

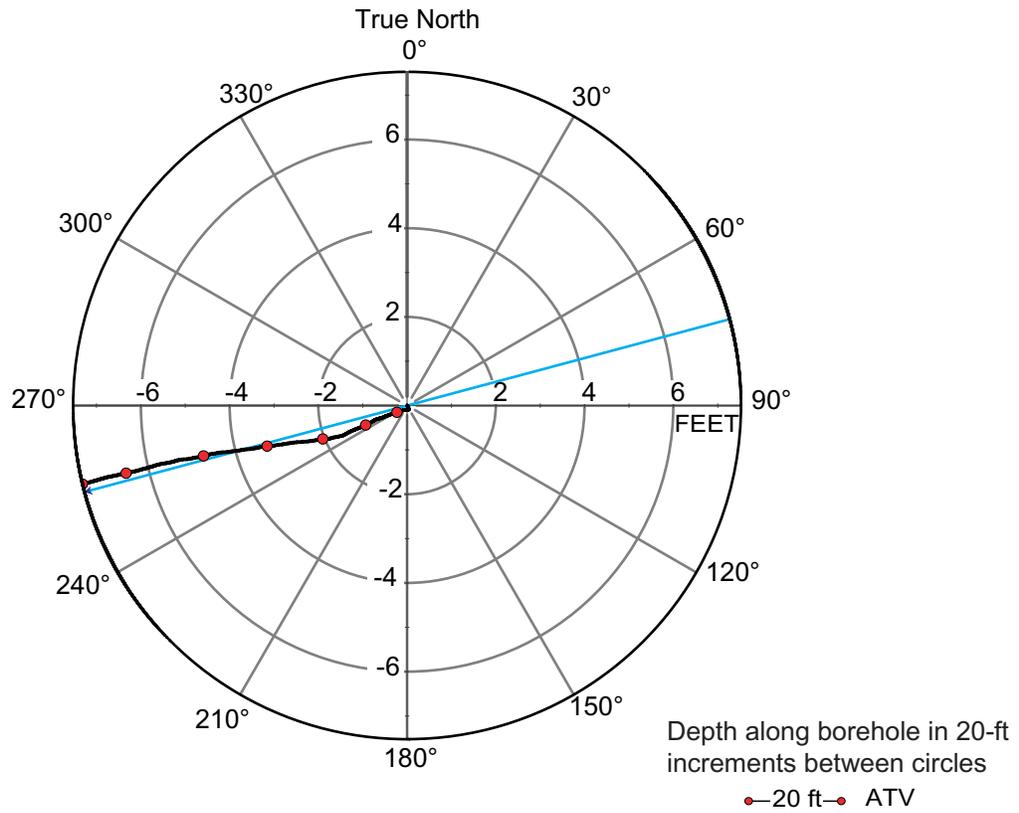
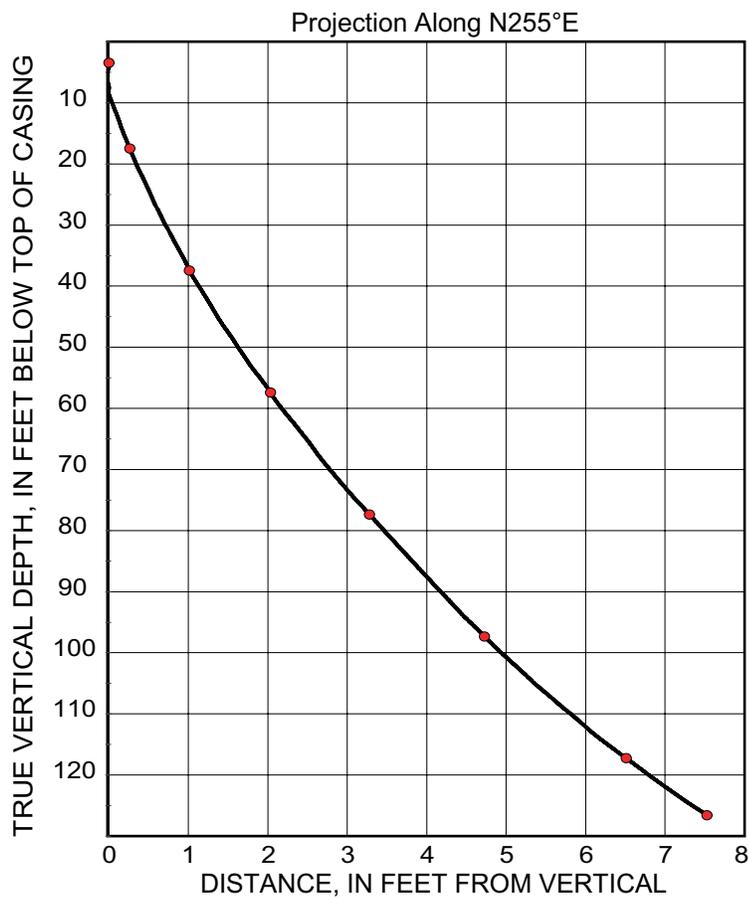
Figure 4L-1. Borehole deviation logs for borehole MW-7, near Machiasport, Maine. Blue line on radial plot (top) is line of projection for vertical plot (bottom).
[ft, foot; ATV, acoustic televiewer]

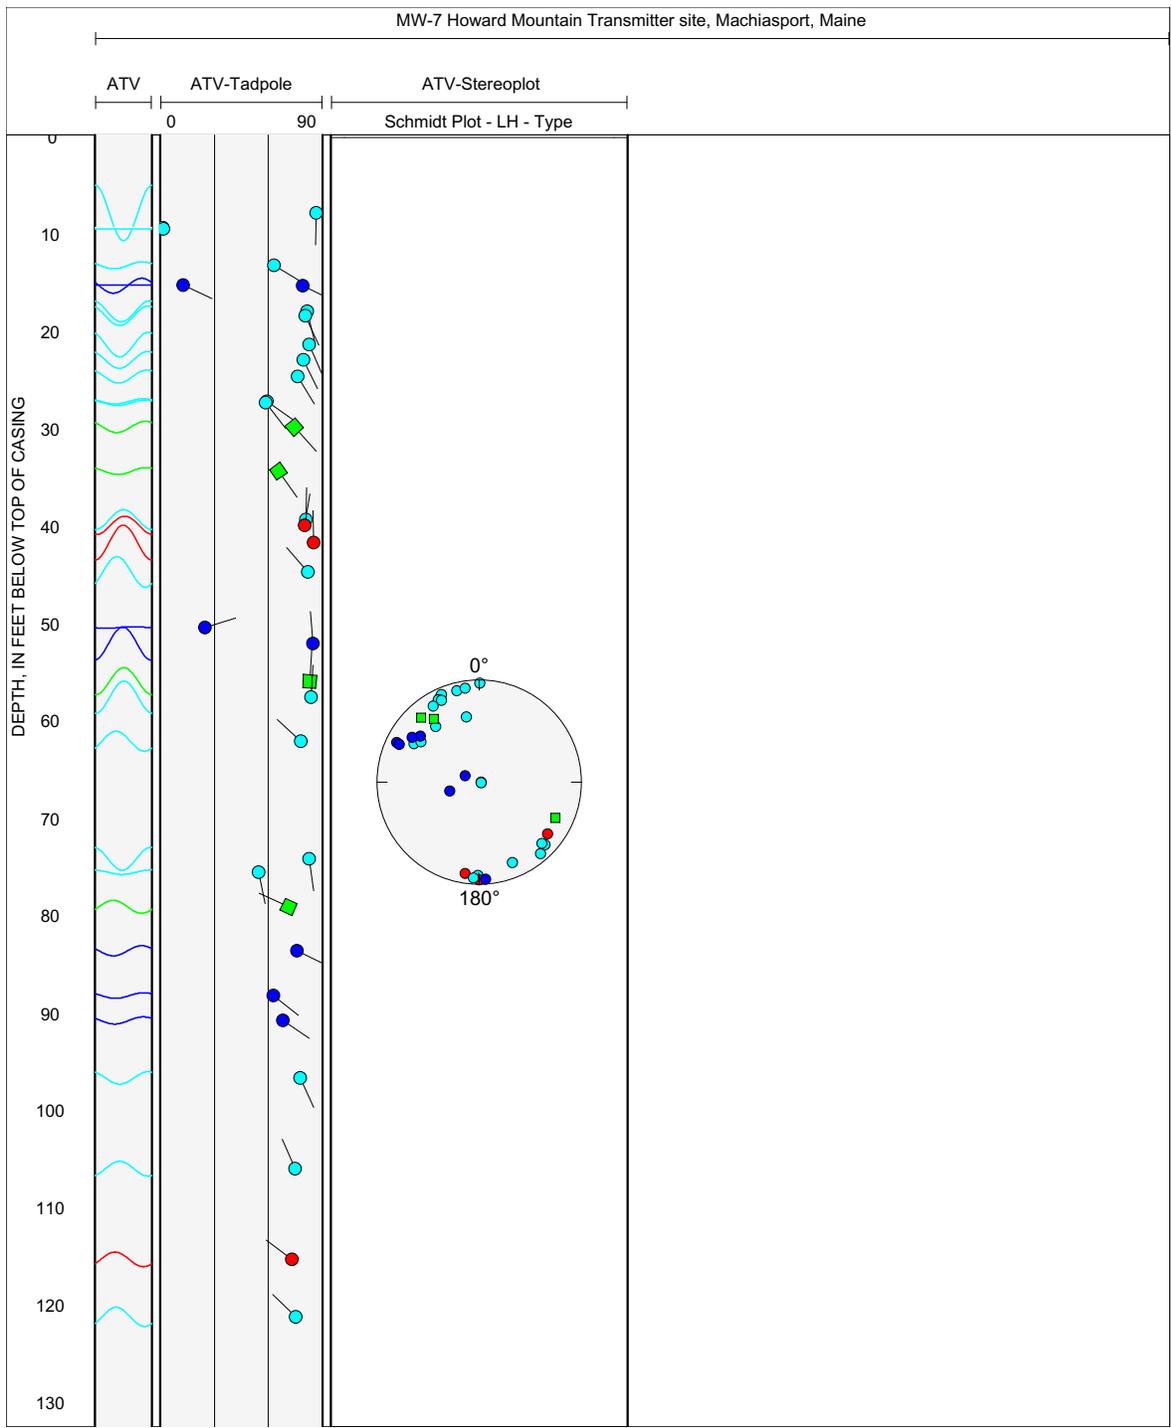
Figure 4L-2. Projection, tadpole, and stereoplots of interpretation of borehole image data for borehole MW-7, near Machiasport, Maine.

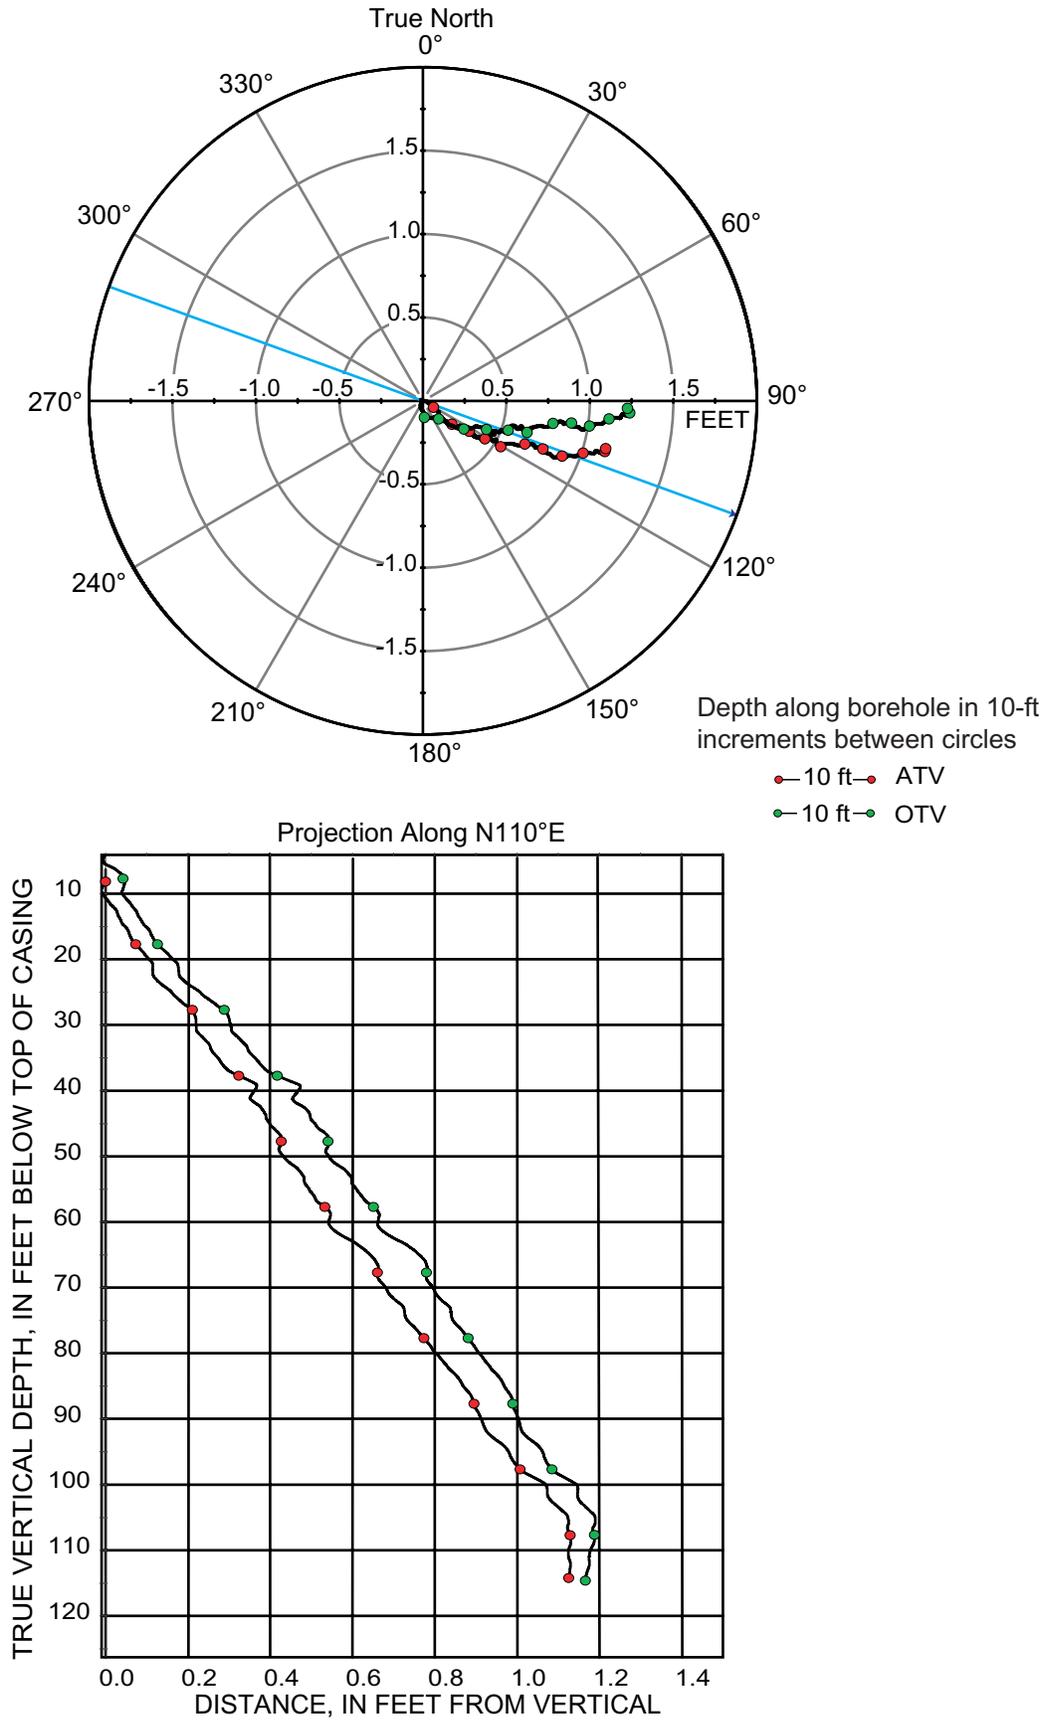
Figure 5A-1. Borehole deviation logs for borehole DW-29, near Machiasport, Maine. Blue line on radial plot (top) is line of projection for vertical plot (bottom).
 [ft, foot; ATV, acoustic televiwer; OTV, optical televiwer]

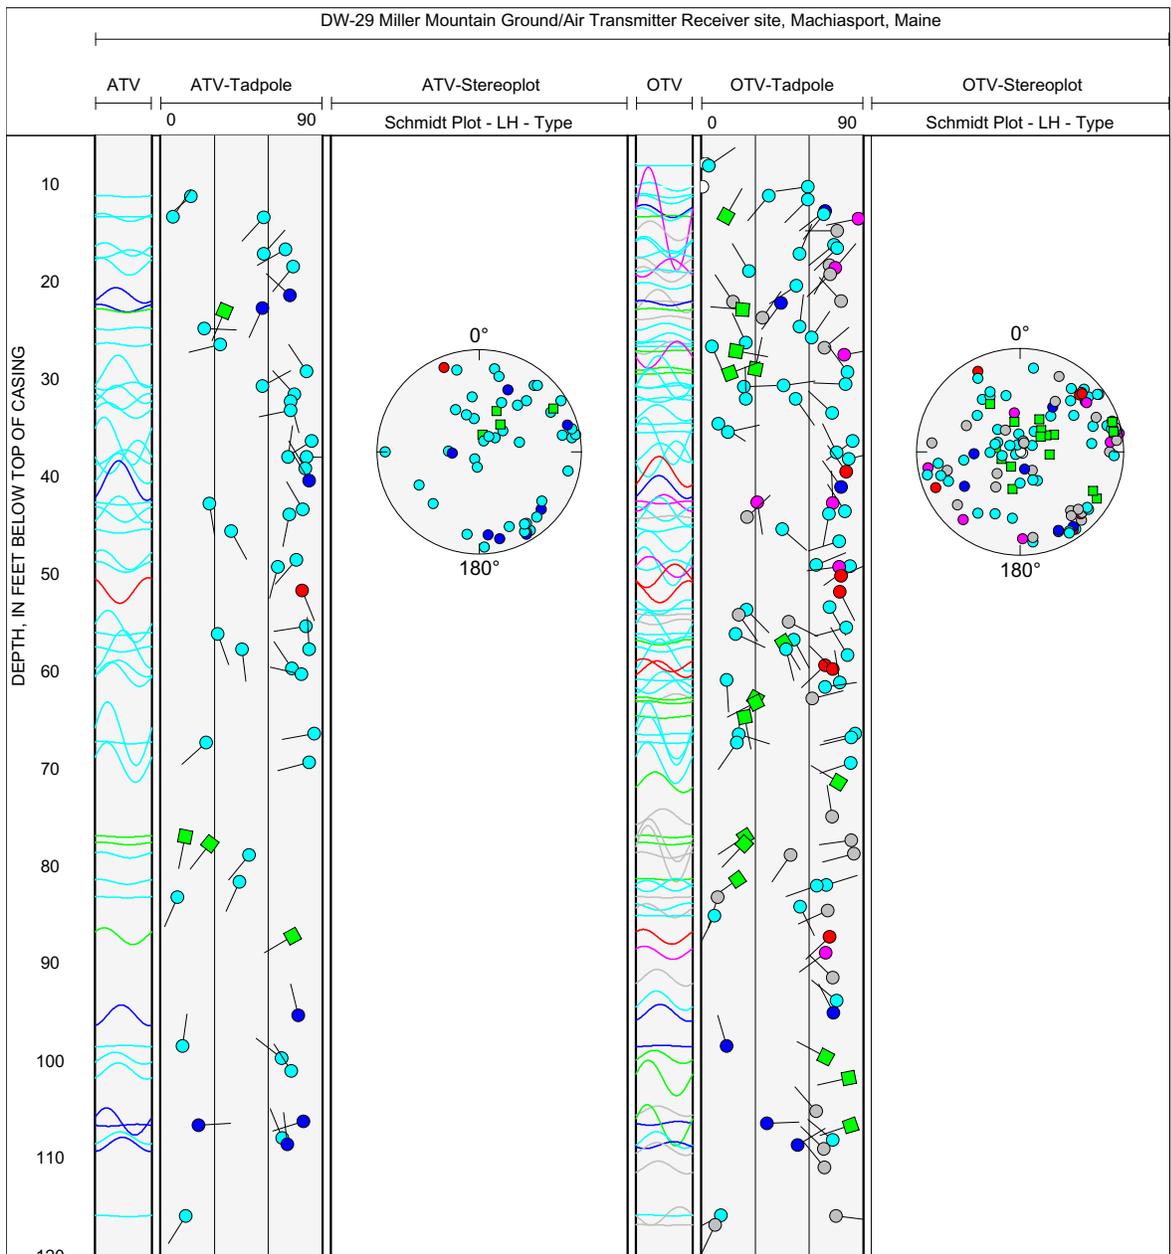
Figure 5A-2. Projection, tadpole, and stereoplots of interpretation of borehole image data for borehole DW-29, near Machiasport, Maine.

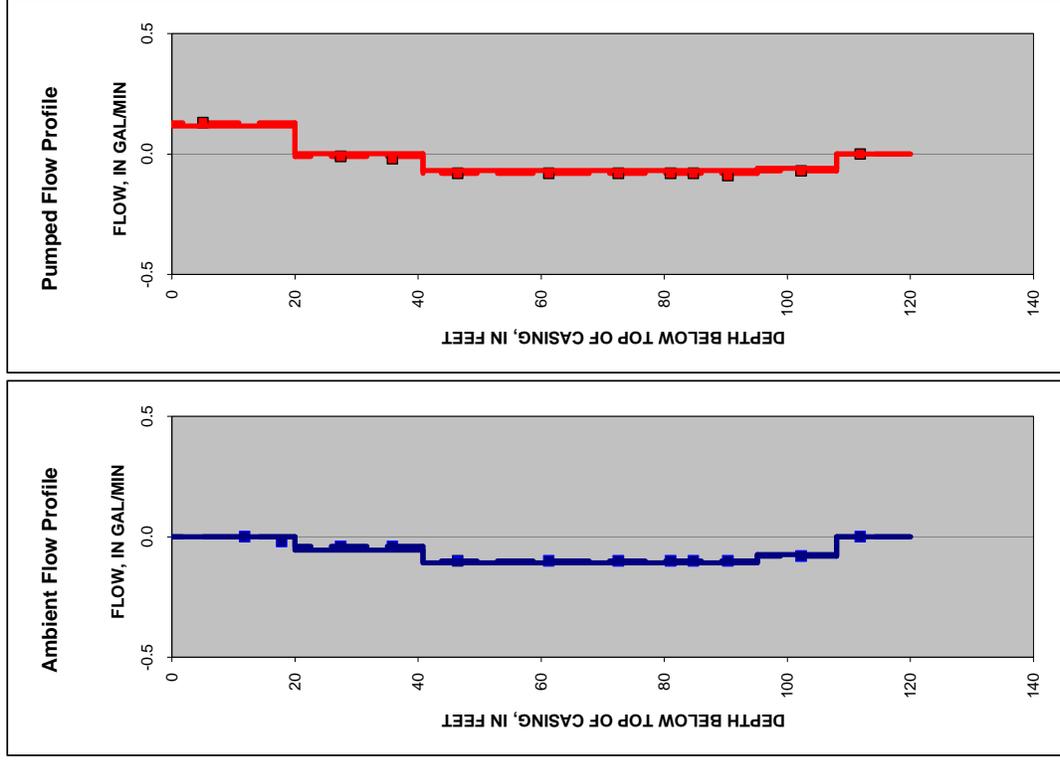
Dashed line indicates measured flow.
 Solid line indicates modeled flow.
 Points indicate measured heat-pulse flowmeter data.

Figure 5A-3. Interpretation and modeling of heat-pulse flowmeter logs for borehole DW-29, near Machiasport, Maine. [gal/min, gallon per minute; ft, feet; ft²/d, feet squared per day; positive values of flow are upward flow, negative values of flow are downward flow]

Fracture number	Depth (ft)	Ambient flow above fracture (gal/min)	Pumped flow above fracture (gal/min)	Zone transmissivity (ft ² /d)	Water level (ft)	Elevation of water level (ft)	Percent transmissivity
4	20.0	0.000	0.116	2.75	7.04	92.82	56
3	40.8	-0.055	0.002	0.60	-3.96	103.82	12
2	95.1	-0.109	-0.068	1.05	17.04	82.82	21
1	108.0	-0.073	-0.059	0.55	33.04	66.82	11

Total borehole transmissivity	4.9	(ft ² /d)
Sum of squares error	0.00094	(gal/min) ²
Root mean square error	0.01529687	(gal/min)

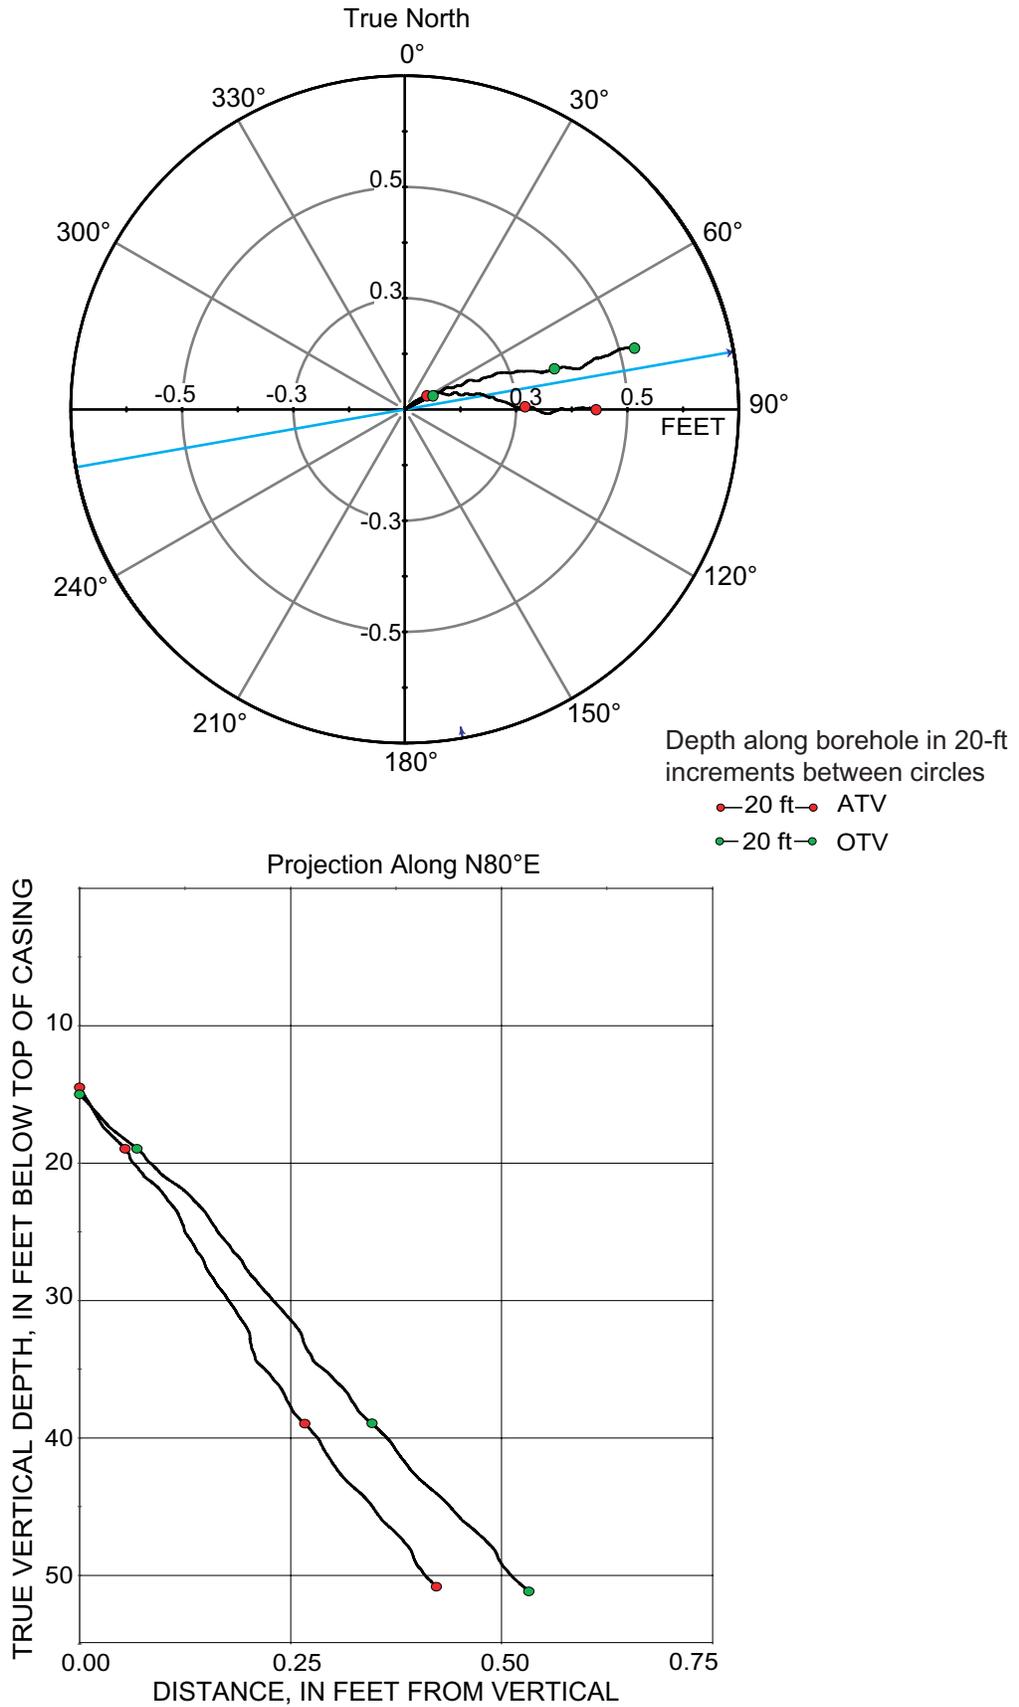
Figure 5B-1. Borehole deviation logs for borehole MW-15, near Machiasport, Maine. Blue line on radial plot (top) is line of projection for vertical plot (bottom).
 [ft, foot; ATV, acoustic televierer; OTV, optical televierer]

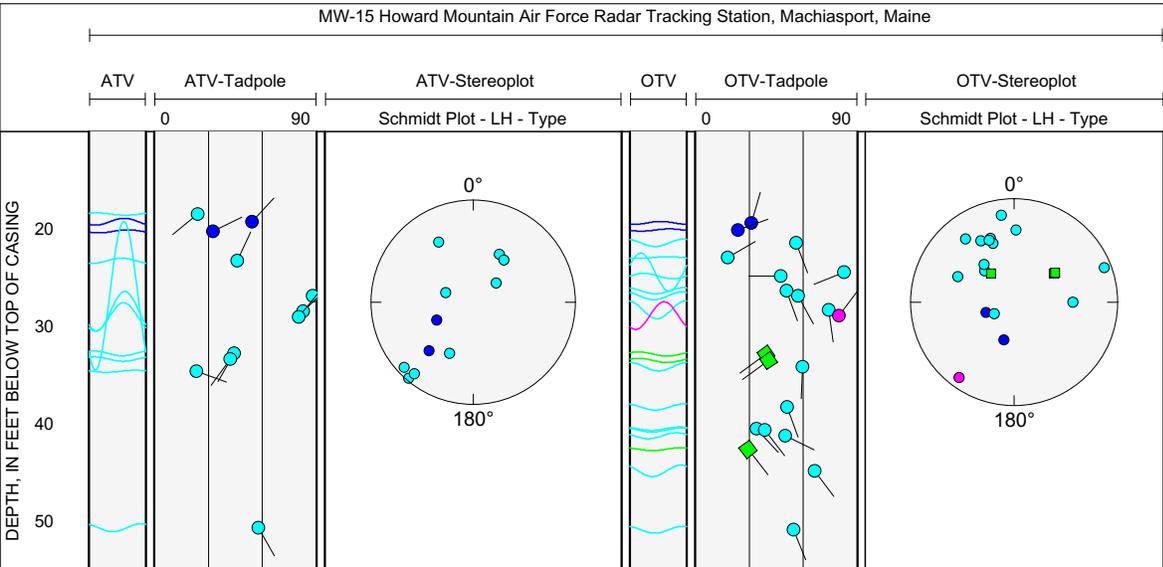
Figure 5B-2. Projection, tadpole, and stereoplots of interpretation of borehole image data for borehole MW-15, near Machiasport, Maine.

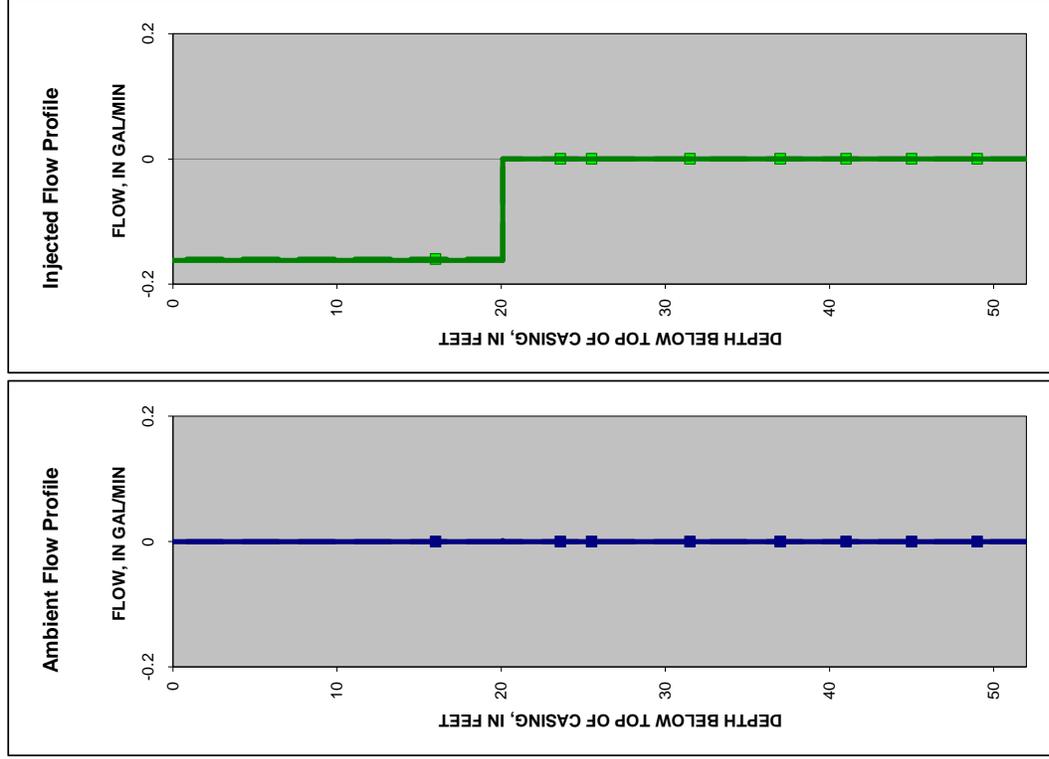
Dashed line indicates measured flow.
 Solid line indicates modeled flow.
 Points indicate measured heat-pulse flowmeter data.

Figure 5B-3. Interpretation and modeling of heat-pulse flowmeter logs for borehole MW-15, near Machiasport, Maine. [gal/min, gallon per minute; ft, feet; ft²/d, feet squared per day; positive values of flow are upward flow; negative values of flow are downward flow]

Fracture number	Depth (ft)	Ambient flow above fracture (gal/min)	Injected flow above fracture (gal/min)	Zone transmissivity (ft ² /d)	Water level (ft)	Elevation of water level (ft)	Percent transmissivity
1	20.1	0.000	-0.162	140	14.57	229.13	100

Total borehole transmissivity	140.0	(ft ² /d)
Sum of squares error	0.00000	(gal/min) ²
Root mean square error	0.00209	(gal/min)
